**Hamilton Township (Mercer County)
Stormwater Basin Assessment Summary
Addendum (Year 4)**

Developed by the Rutgers Cooperative Extension Water Resources Program
Funded by Hamilton Township, Mercer County, New Jersey

December 2017

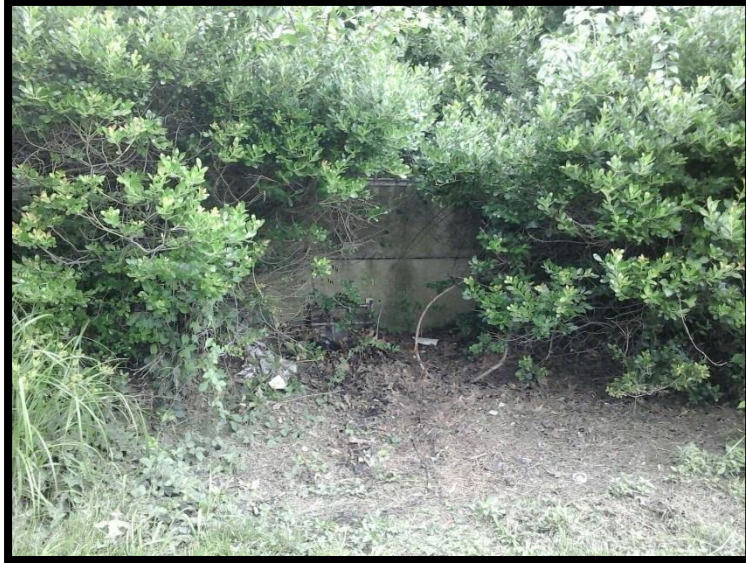
307. PITT OHIO Warehouse Basin

The detention basin located on the premises of the PITT OHIO Trucking Company Warehouse is in an area suitable for an infiltration retrofit. Currently, the outlet structure is covered by overgrown vegetation causing debris to collect at the grate on the outlet. The functionality of the basin is impaired because of these conditions. To improve infiltration, the retrofit could involve planting with native plants or allowing the basin to naturalize. The current vegetation should also be managed more frequently. This strategy will enhance the capture of debris entering the basin while simultaneously reducing pollutants before discharging downstream.

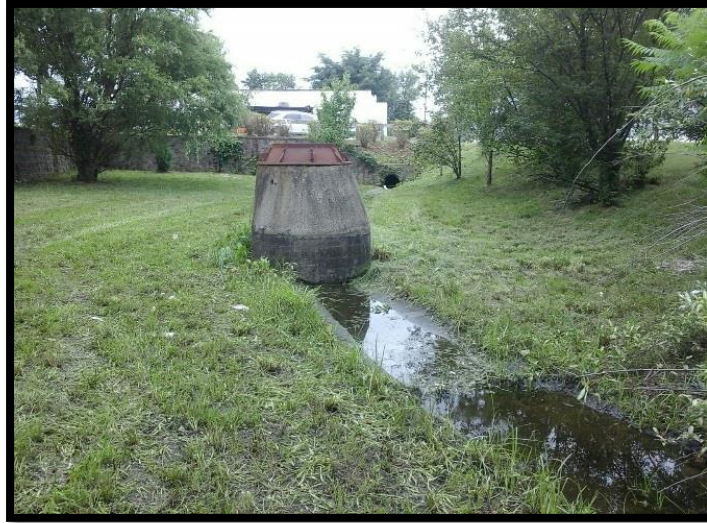
310. Sirius XM Radio Offices Basin

The basin near Sirius XM Radio on 1st Avenue is in need of repairs to remove the standing water from the basin. Evidence of excessive sediment accumulation at the inlets and low flow channel was noted during the assessment. Vegetation overgrowth was also noted at the inlet and should be regularly maintained to prevent the build up of sediment. This basin includes a concrete low flow channel, which could also be removed. Once removed, it could be replaced with a stone-lined feature to enhance stormwater infiltration, reduce pollutants, and improve water quality downstream.

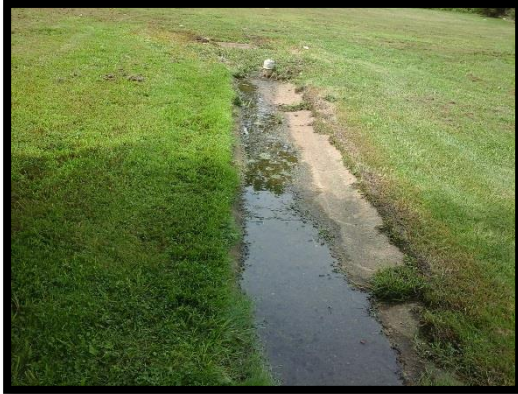
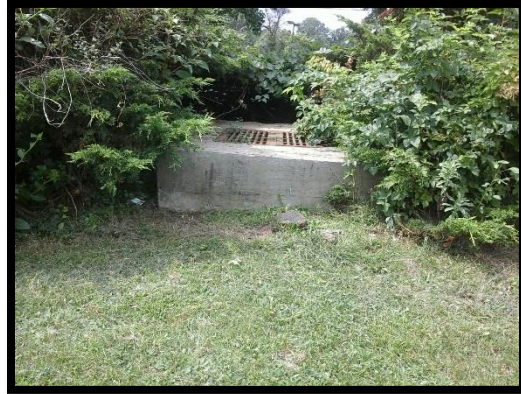
315. Hobbs Road Neighborhood Basin

The basin located behind the houses on Hobbs Road off of Cypress Lane features low flow channels that lead to a catch basin. This site is a high priority candidate for transforming the existing overgrown detention basin into a planted bioswale. The detention basin is approximately 450 feet long by 20 feet wide at its widest point and located at the southeastern corner of neighborhood. The basin currently is a mown lawn with wooded trees surrounding the low flow channels. To retrofit the present condition, plans should include removing the concrete and 12-18 inches of soil/sediment from the low flow channels and backfilling with appropriate bioretention soil amendments. The swale can then be planted with a diverse mix of native plants and meadow grasses that will provide color and visual interest, treat water quality, and reduce flooding. In addition to the environmental benefits, with proper signage this bioswale retrofit would provide an opportunity to the public in learning about native plants, local wildlife habitat, and water resources issues in New Jersey.

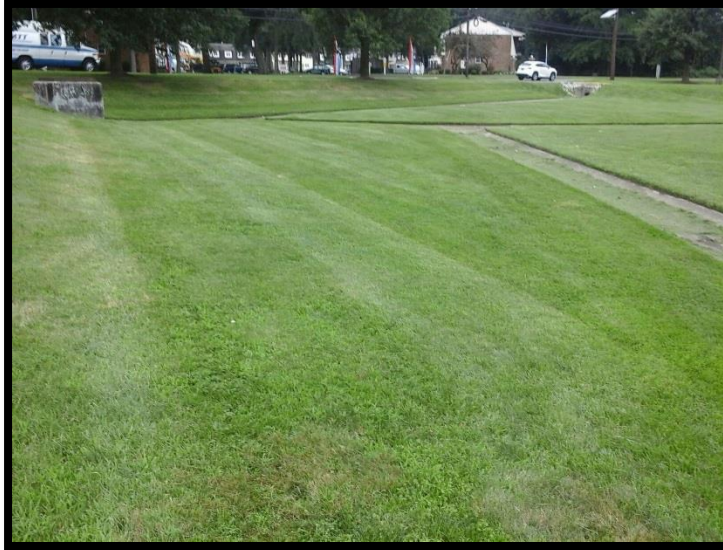
317. St. George Greek Orthodox Church Basin

The detention basin located at the St. George Greek Orthodox Church is in an area suitable for an infiltration retrofit. At the time of assessment, the basin appeared to be well maintained but there was standing water present in the outlet structure. A simple retrofit design can improve its functioning to address water quality concerns and promote infiltration. Currently the basin has a 15-inch diameter outlet orifice that provides little or no stormwater detention during small rain events. To mitigate this issue, a steel restrictor plate with a 4-6 inch outlet orifice can be installed over the existing 13-inch outlet pipe. In addition, the entire low flow channel can be replaced with a 3-foot wide by 6-12 inch deep stream-bed feature. This will in turn slow the volume of runoff travelling through the basin as well as allow water to infiltrate back into the soil.

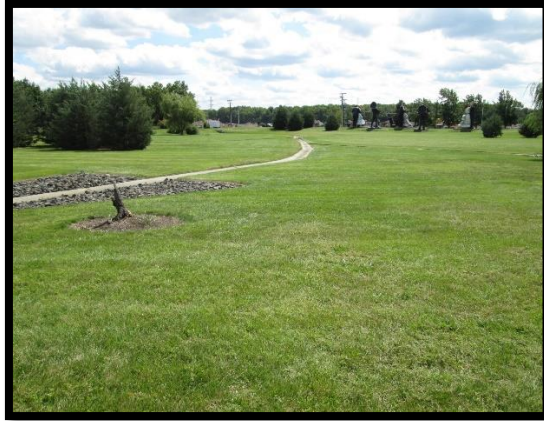
320. Hamilton Train Station Basin

The basin is located in the parking lot of the Hamilton train station and currently has an eroding inlet structures and outlet orifices clogged with sediment impeding their function. A viable retrofit for this basin would be to convert it to a swale-like feature with a stone lined channel. A vegetated swale would include removal of the concrete low flow channel and planting it with native plant species to improve infiltration and groundwater recharge. This mitigation strategy reduces total suspended solids while improving water quality and aesthetics.

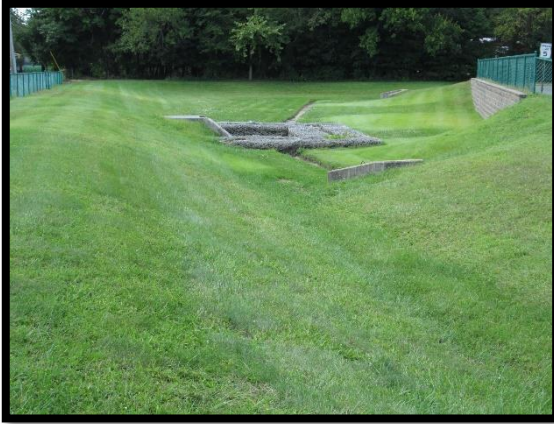
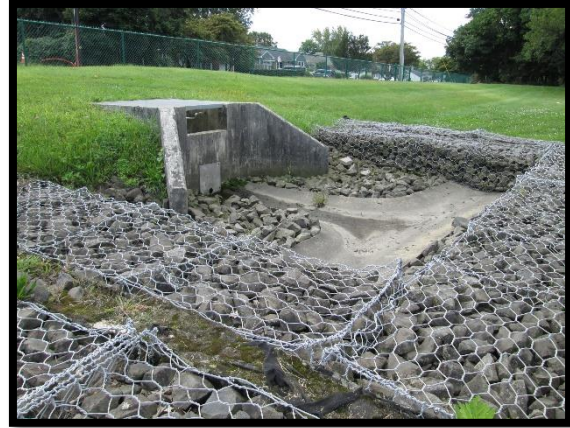
333. Mercer Elementary School Basin

The basin located at the Mercer Elementary School occupies an area suitable for an infiltration retrofit. Considering that this basin has soils with good infiltration rates, a relatively inexpensive retrofit design would include removing all or one section of the concrete low flow channel and allowing naturalization of the basin bottom. Currently, smaller more frequent storm events are travelling directly from the inlets to the outlet without any treatment. With this retrofit, sediment, litter, and debris will settle out in the grassed areas as the stormwater infiltrates, in turn reducing localized flooding and nonpoint source pollutants. Leaving the gabion baskets around the outlet will also help to catch sediment and debris, and keep the outlet area easy to access for maintenance.

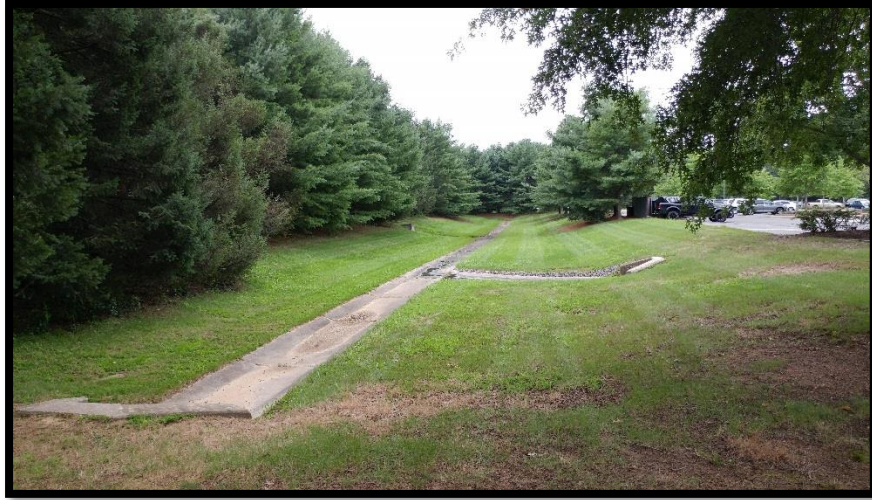
352. Himalaya International Basin

The detention basin located on the eastern side of the University Office Plaza II building is within an area suitable for an infiltration retrofit. Currently the basin is receiving excessive sediment loads from the parking lot. Sediment deposits have built-up in multiple locations restricting stormwater flow and causing erosion at the inlets and outlet. A retrofit plan is needed to alleviate the issue. First, removal of the sediment and existing concrete low flow channels from the basin should be done. A 12-18 inch deep, 3-4 foot wide stream-bed feature consisting of river stone can replace the concrete low flow channels and lead to a large rain garden near the outlet structure. Furthermore, planting and/or naturalizing the rain garden would contribute significantly to capturing and stabilizing the amount of sediment passing through the basin while improving water quality and enhancing aesthetics.

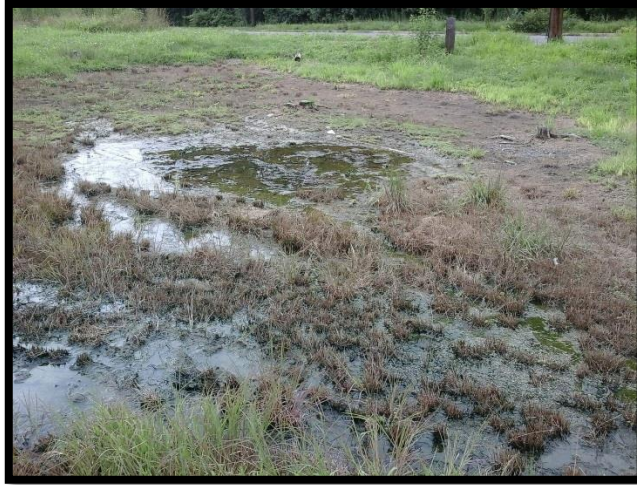
421. PSE&G Building Klockner Road Basin

The basin located in the front of the PSE&G building is considered in need of maintenance. It appears as though several trees were recently cut down from the center of this smaller sized basin. Standing water that is present at the basin appears to have been there for longer than 72 hours, due to the presence of algae in the water. The trees that were cut down are likely the cause for the lack of infiltration occurring in the basin. The basin is currently in need of cleaning and maintenance due to debris and water accumulated in the basin bottom. Naturalizing with woody vegetation will help to reduce standing water and increase the long term functionality of the basin. Routine scheduled maintenance of the inlet pipe is needed and will help to reduce labor and equipment costs without compromising the basin's functionality.

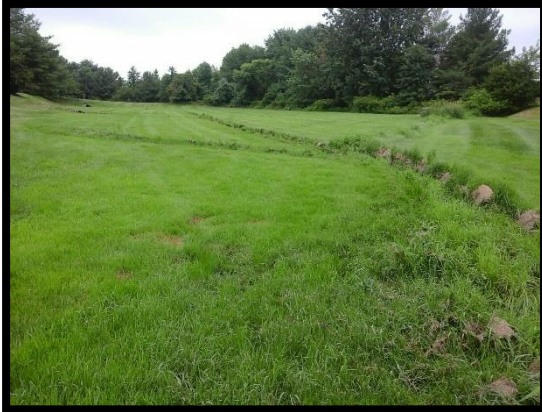
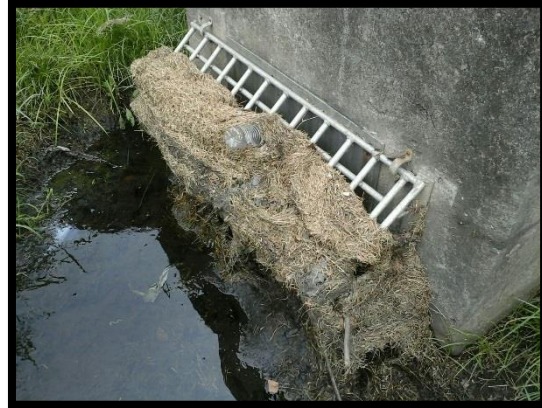
440. Great Oak Road Residential Basin

The basin behind the on Greak Oak Road is located in an area suitable for an infiltration retrofit. The preliminary step should involve removing excess sediment and debris from the inlets and outlet grate. A retrofit design could include transforming the existing basin into a naturalized meadow. The low flow channels can be removed and replaced with stone to allow for better infiltration. The basin bottom should then be left to naturalize or be planted with a meadow seed mix to establish plant growth with deep root systems to promote infiltration and reduce future clogging issues.

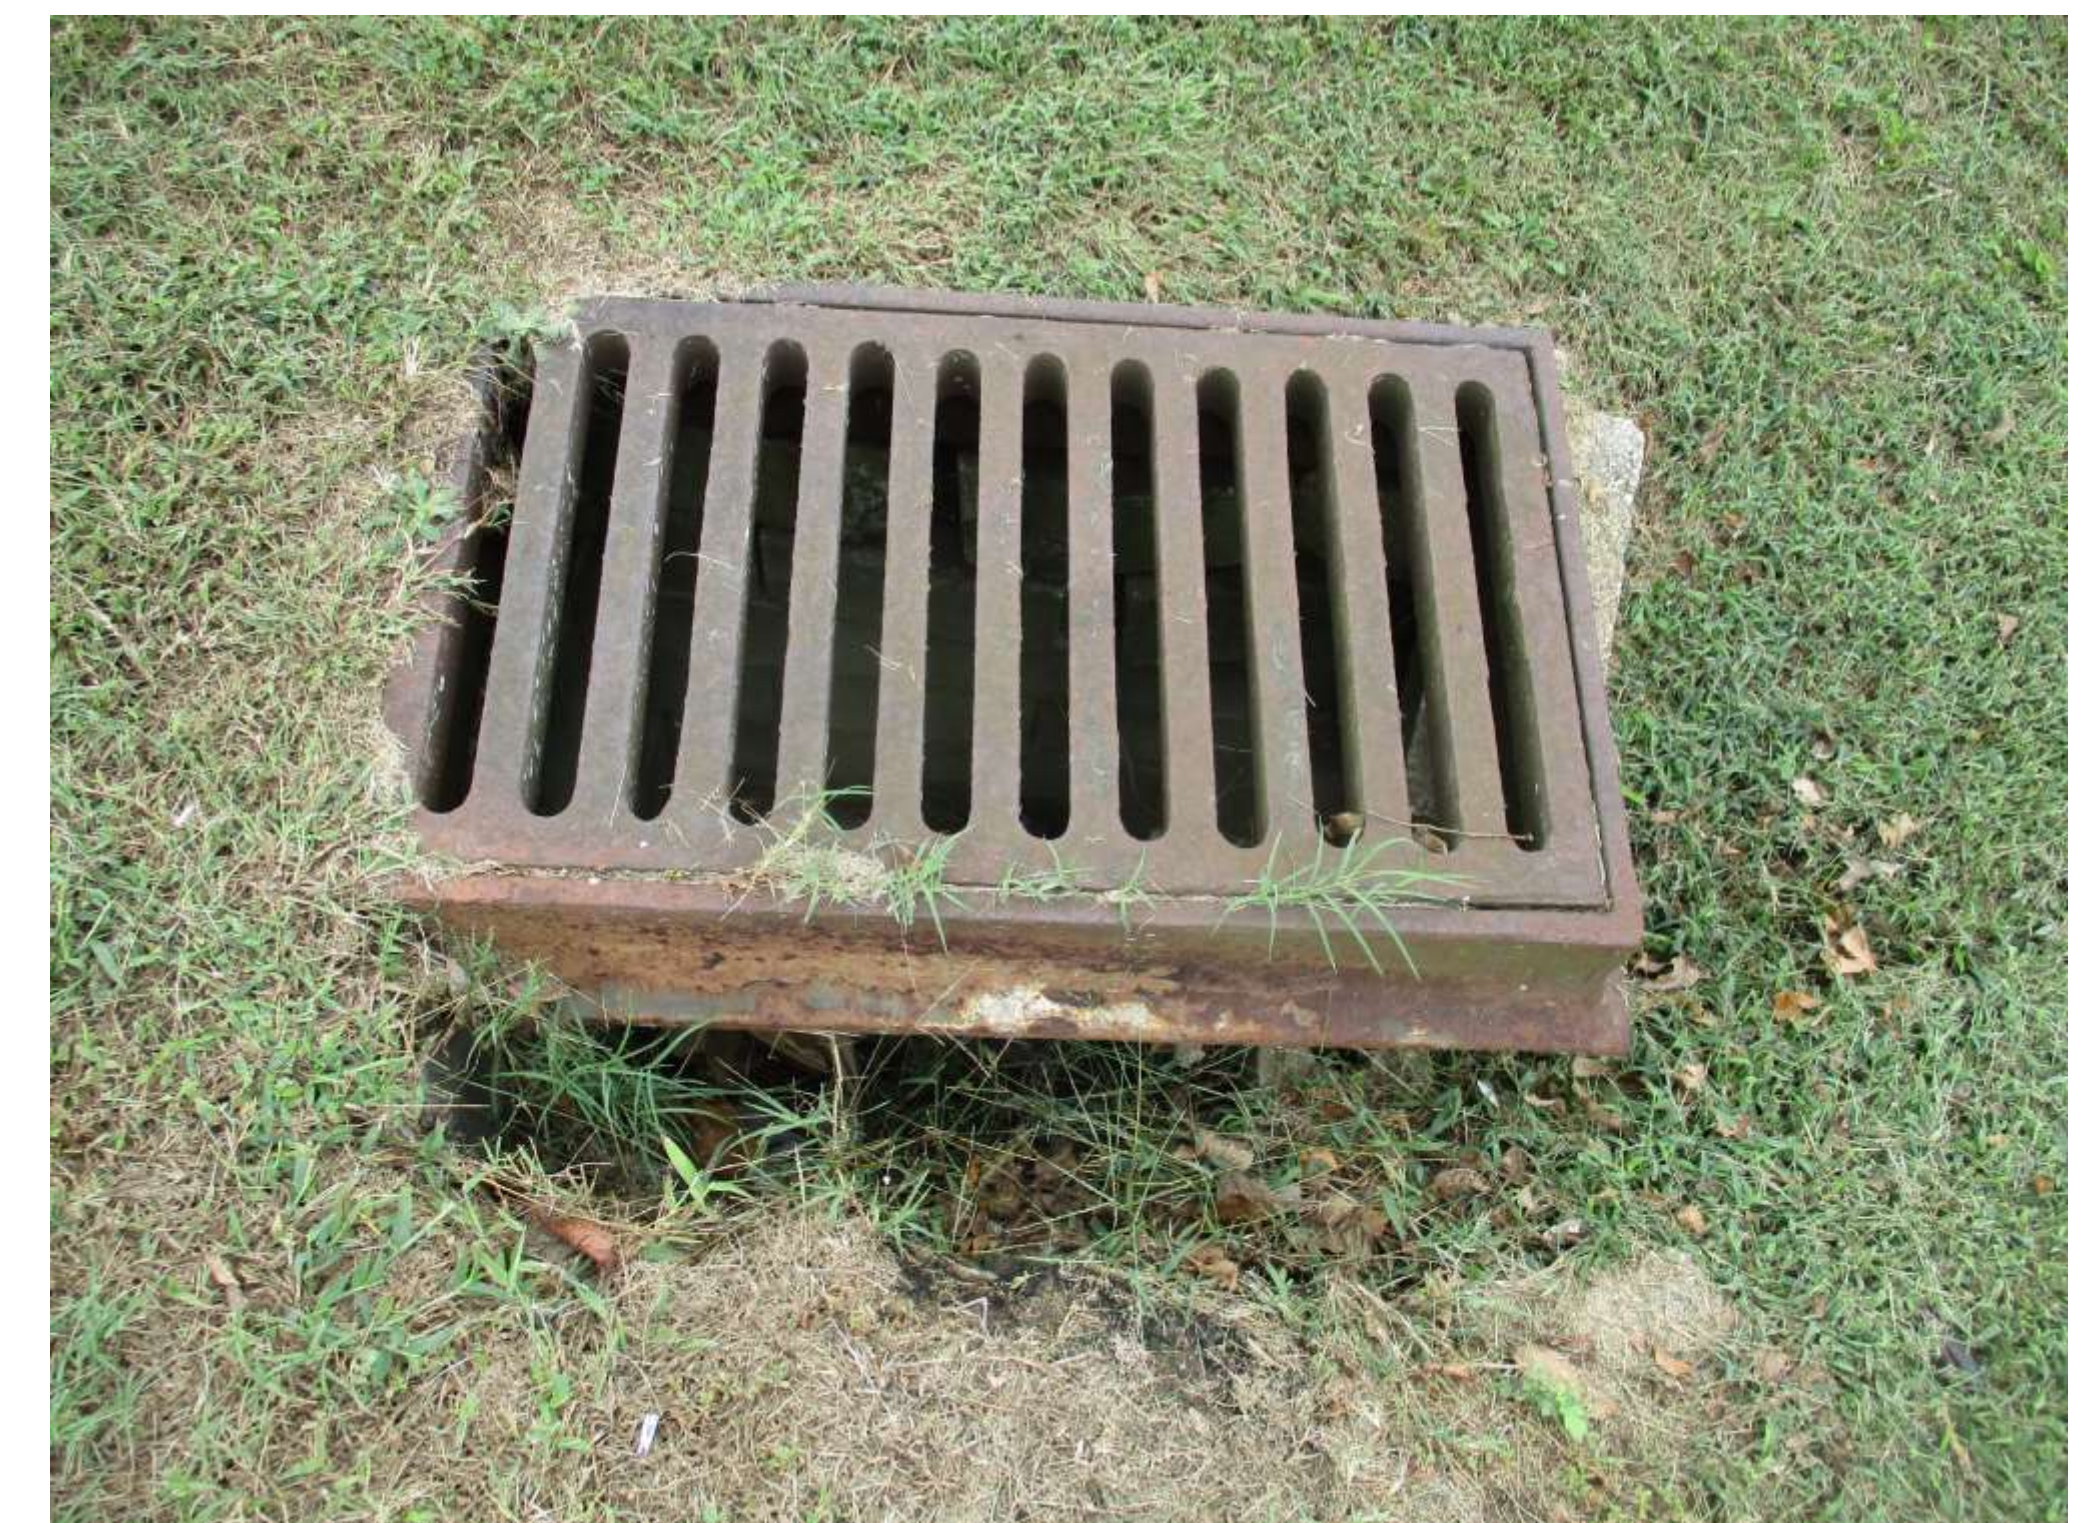
- Sediment accumulation in 371 low flow channel
- 371 outlet is covered with sediment
- Erosion around 372 outlet structure causing a dangerous hole, impairing the function of the outlet
- Reduce mowing and replace low flow channel with stone lined channel to improve infiltration

Outlet of 372 (southern basin) broken

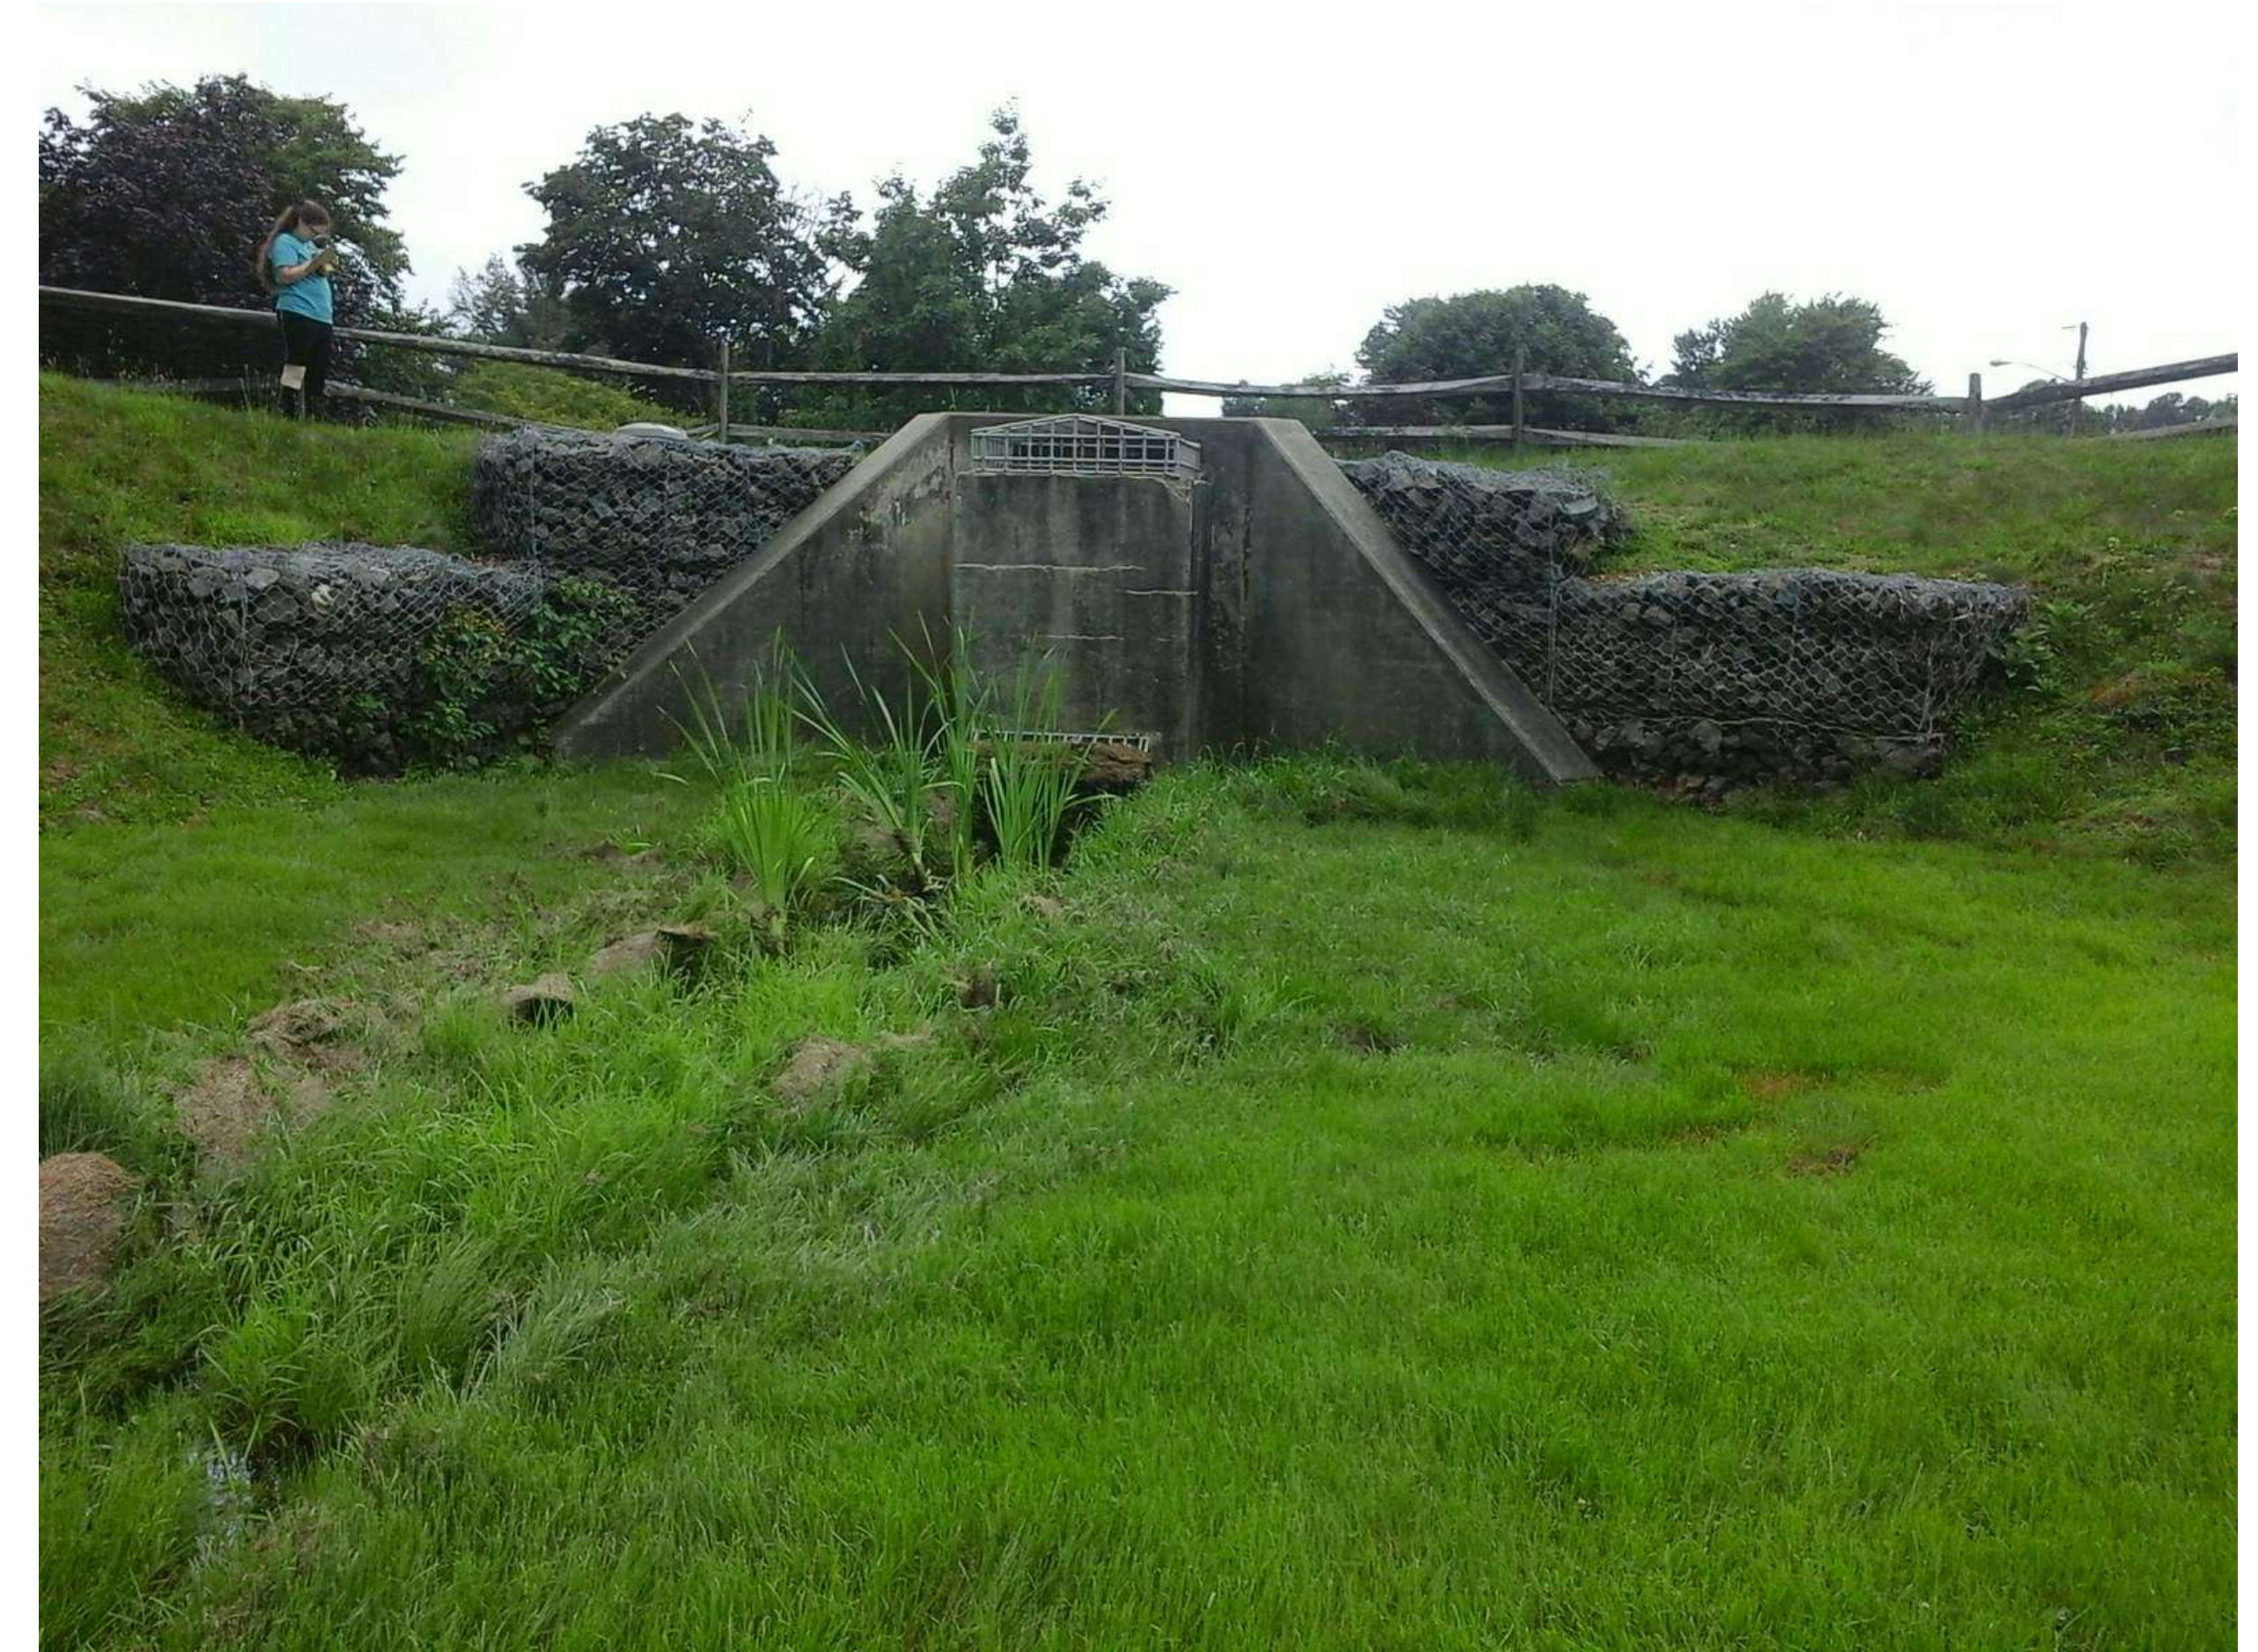
- Sediment and debris accumulation at outlet grate
- Standing water noted in basin bottom and outlet
- Use stone lined channels to increase infiltration
