**Hamilton Township (Mercer County)
Stormwater Basin Assessment Summary
Hamilton Owned Addendum (Year 5A)**

Developed by the Rutgers Cooperative Extension Water Resources Program
Funded by Hamilton Township, Mercer County, New Jersey

November 27, 2019

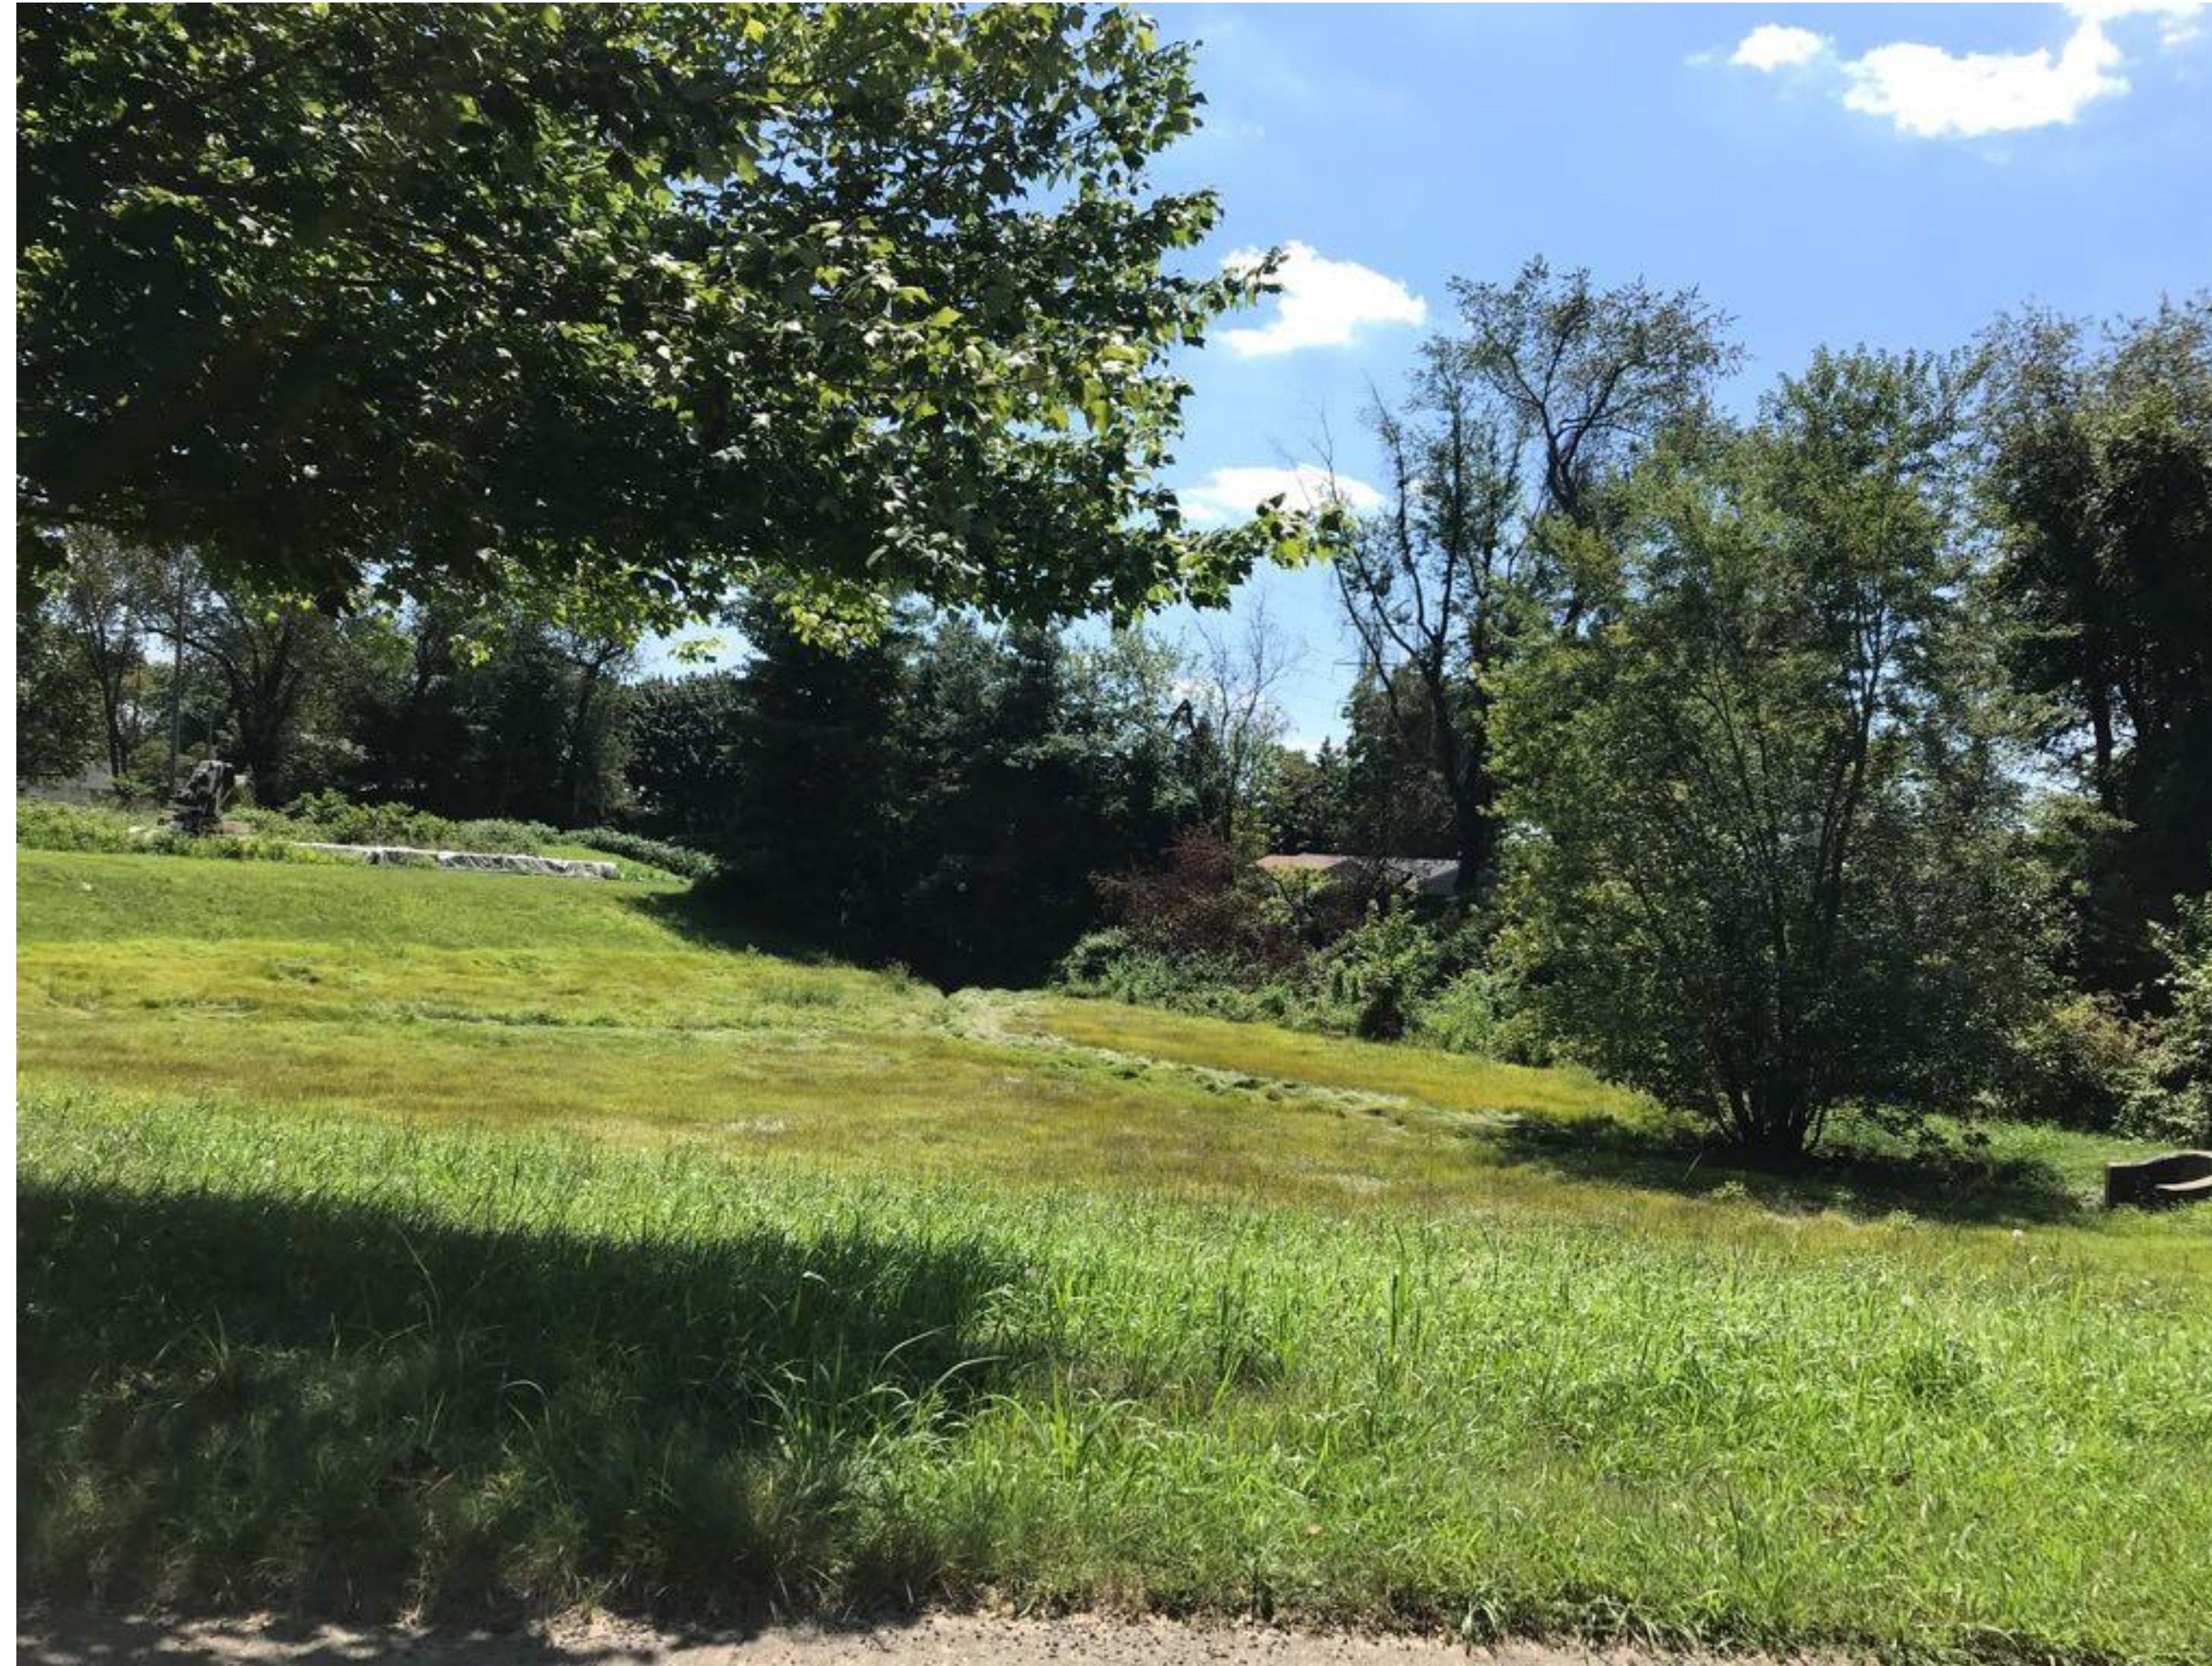
Hamilton Township
Stormwater Basin Assessment
4. Tara Ct. Residential Basin

- Two inlets and one outlet
- Concrete low flow channel has grass growing over it
- Opportunity to remove concrete low flow channels and replace with a stone channel

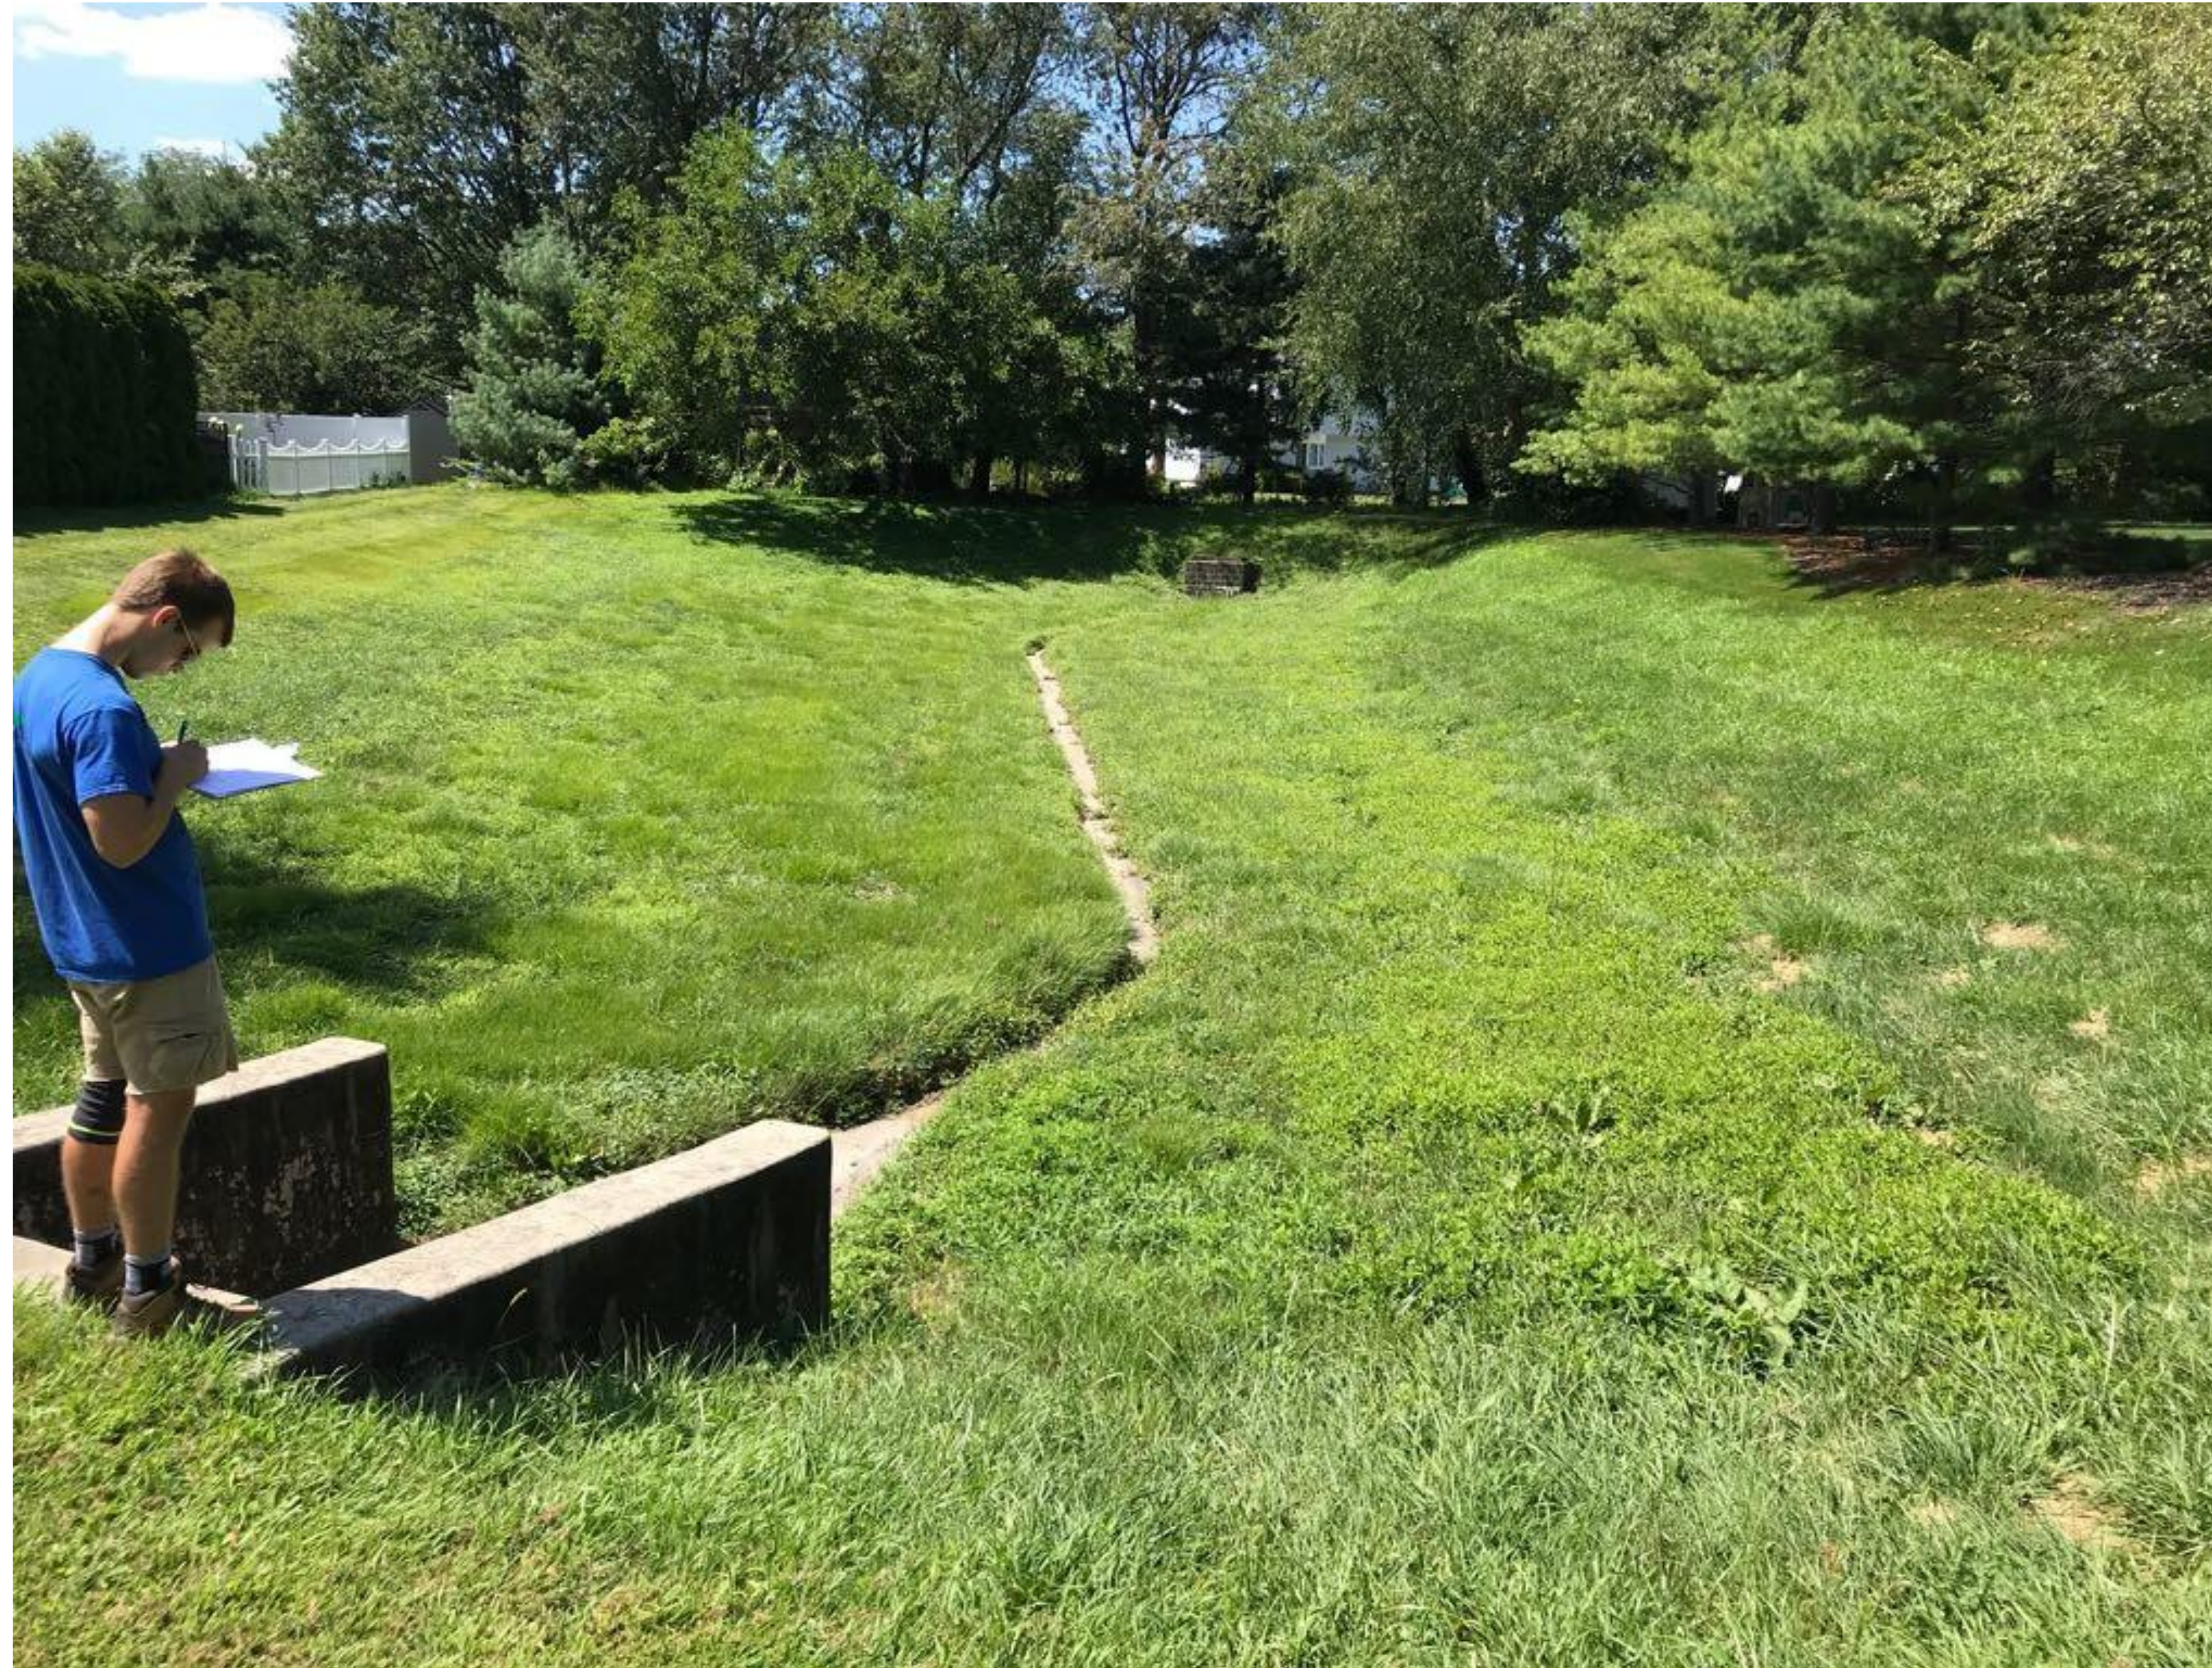
Hamilton Township
Stormwater Basin Assessment
9. Tar Heel Rd E Residential Basin

- Typical detention basin in good condition with one inlet and one outlet
- Rock flow channel opportunity
- Low flow channel could be removed and basin allowed to naturalize by reducing mowing

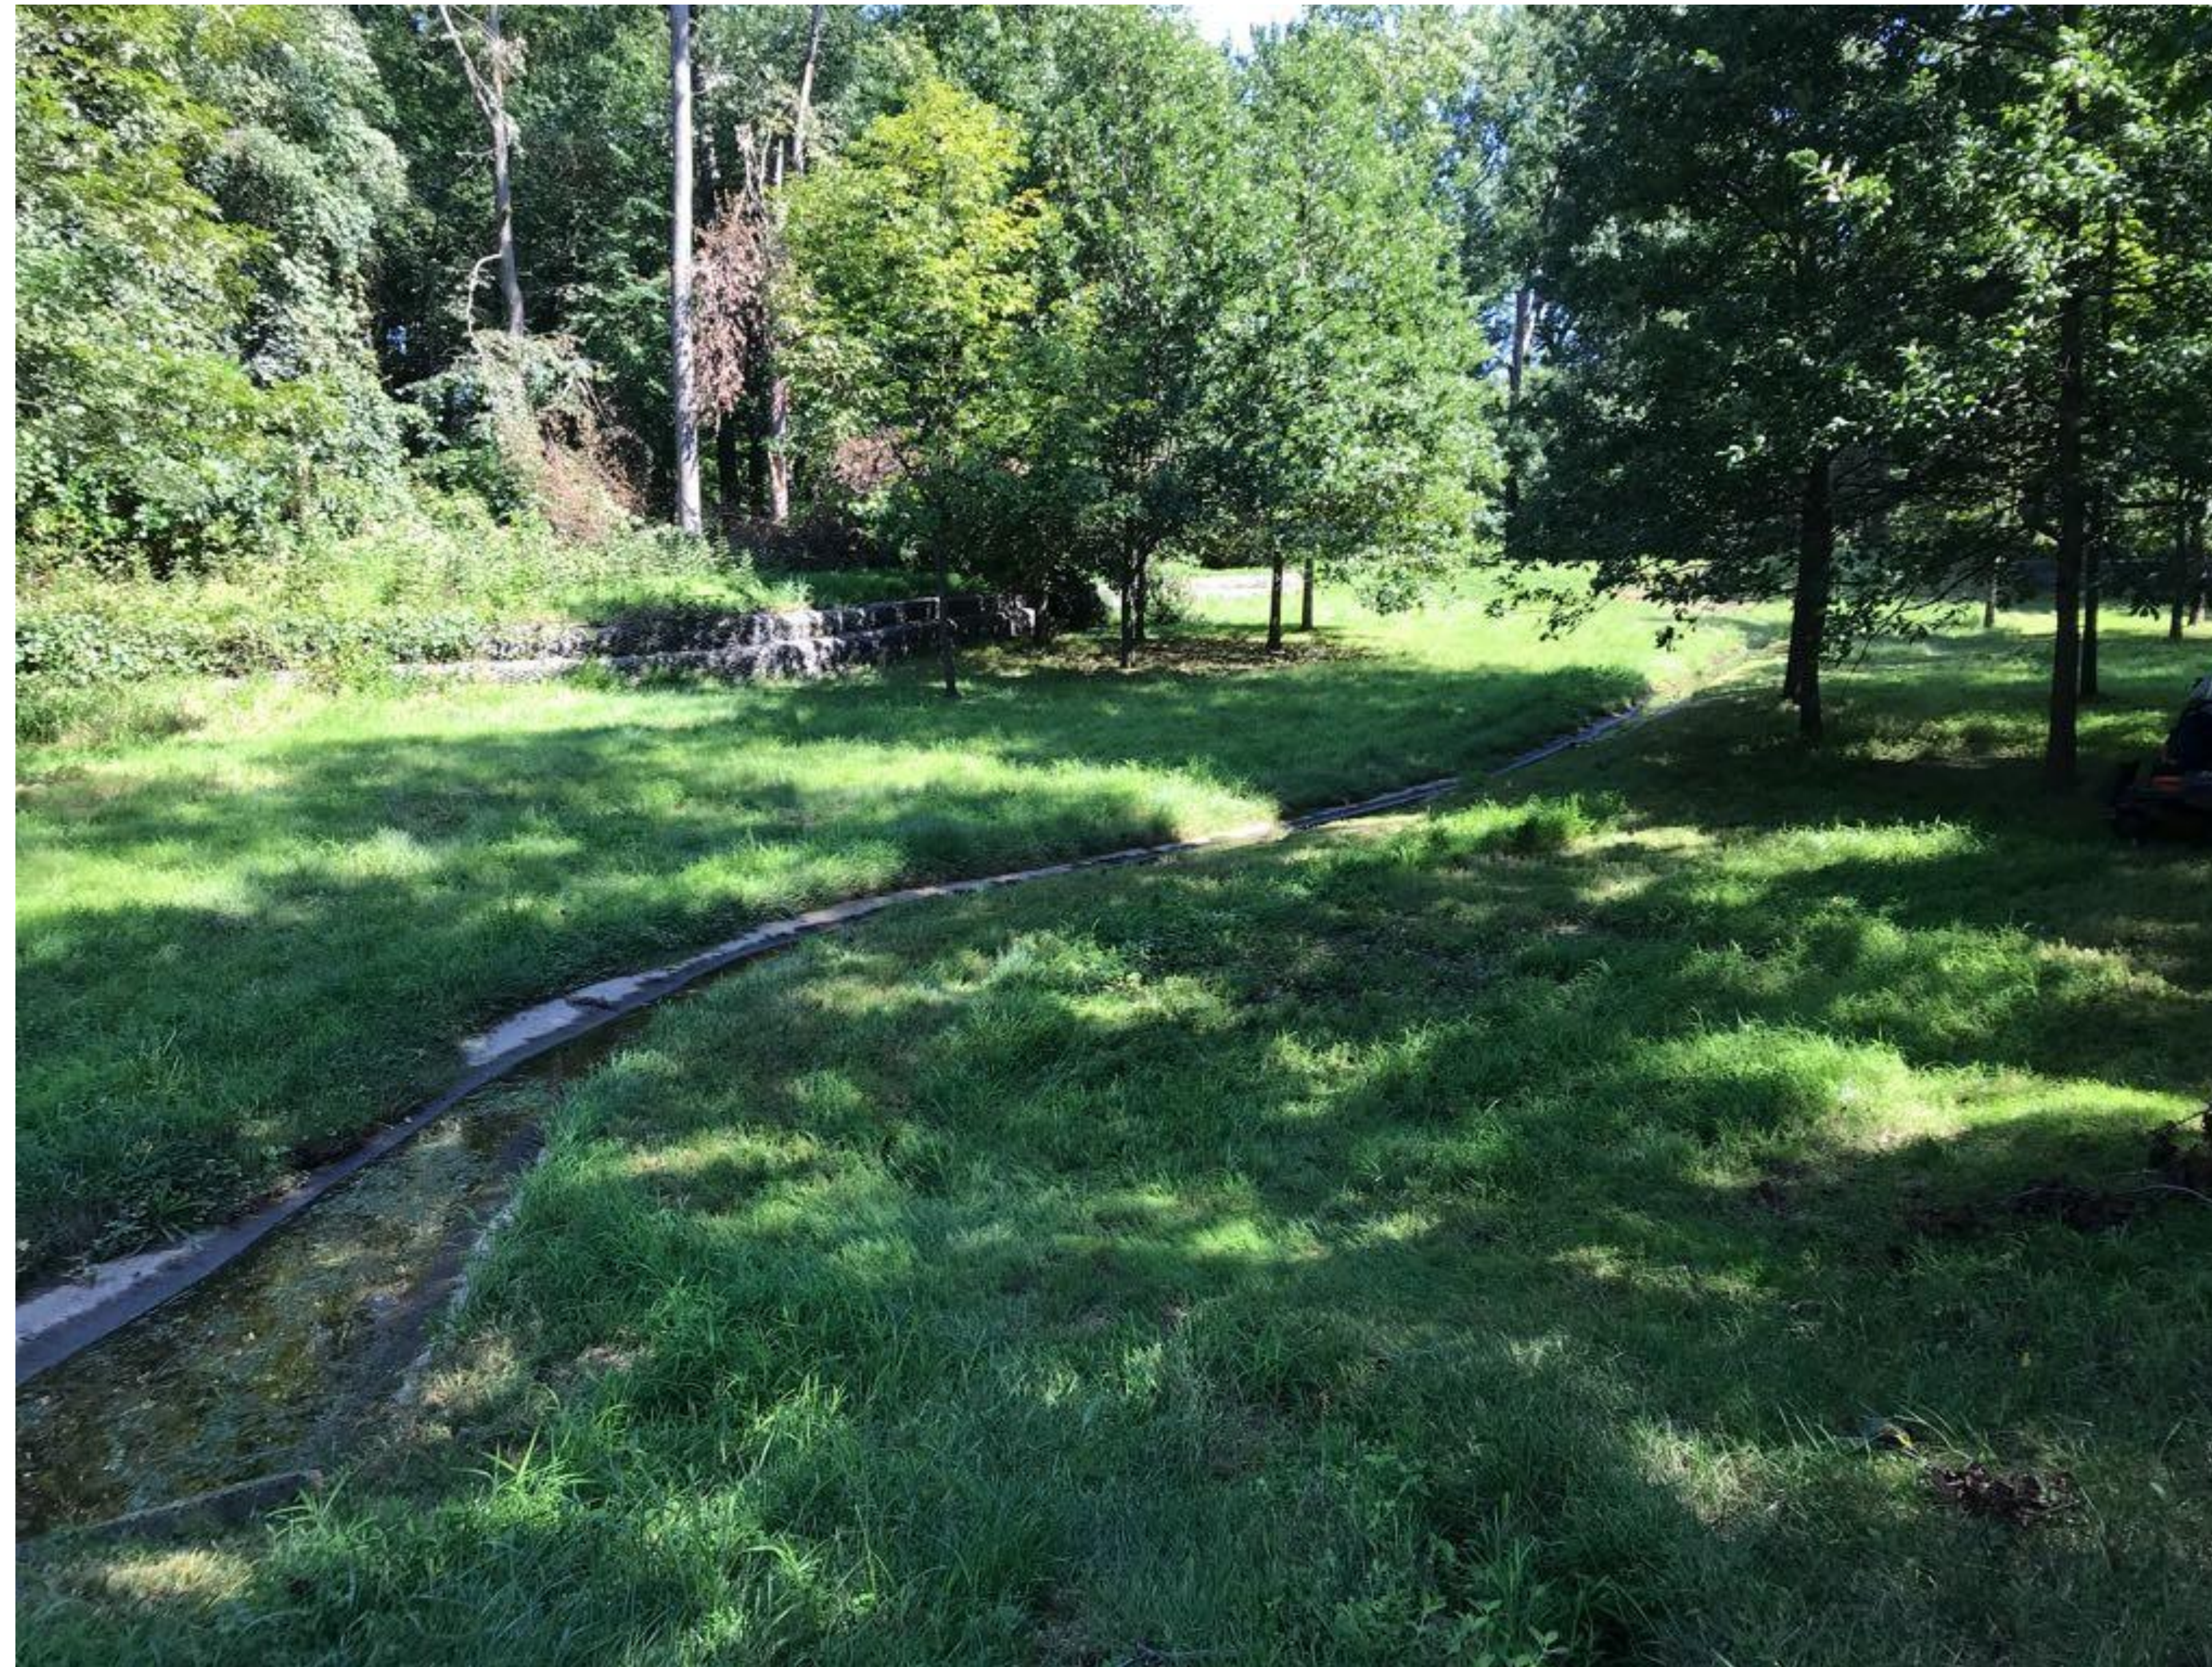
Hamilton Township
Stormwater Basin Assessment
30. Fordham Dr Residential Basin

- Standing water present in the low flow channel, and large amounts of vegetation around basin
- Low flow channel could be removed to promote infiltration instead of the standing water that is present.

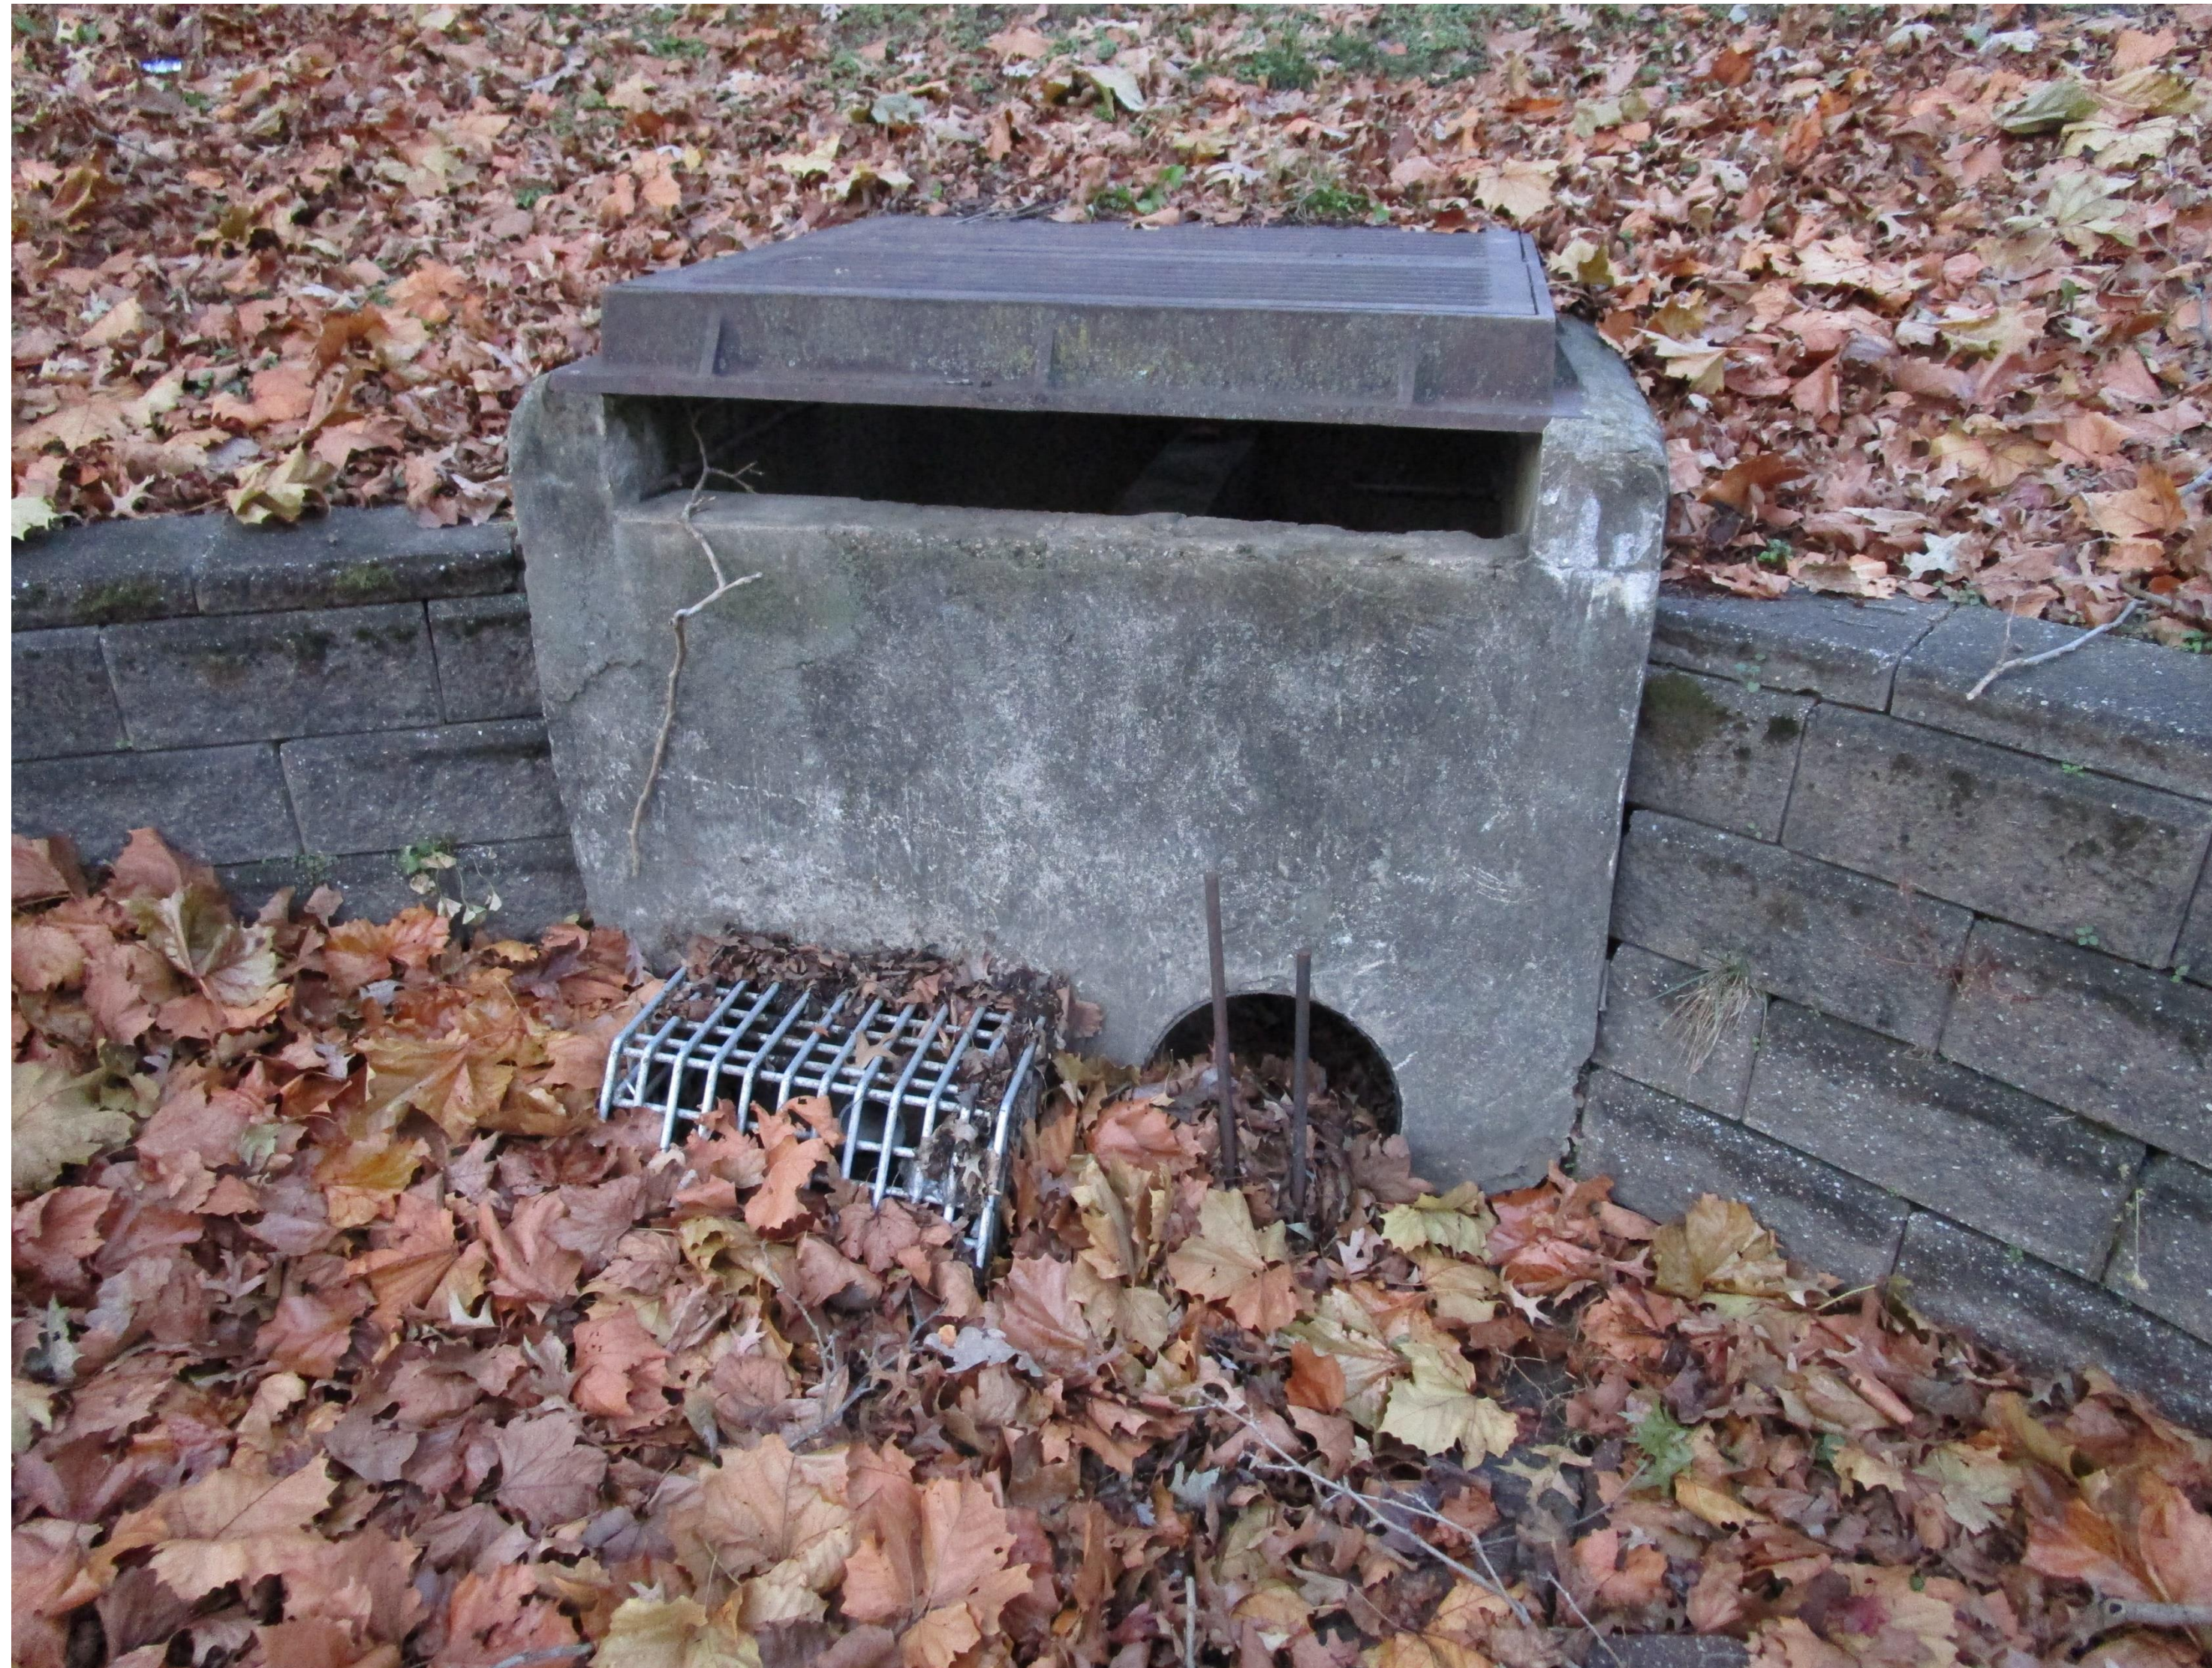
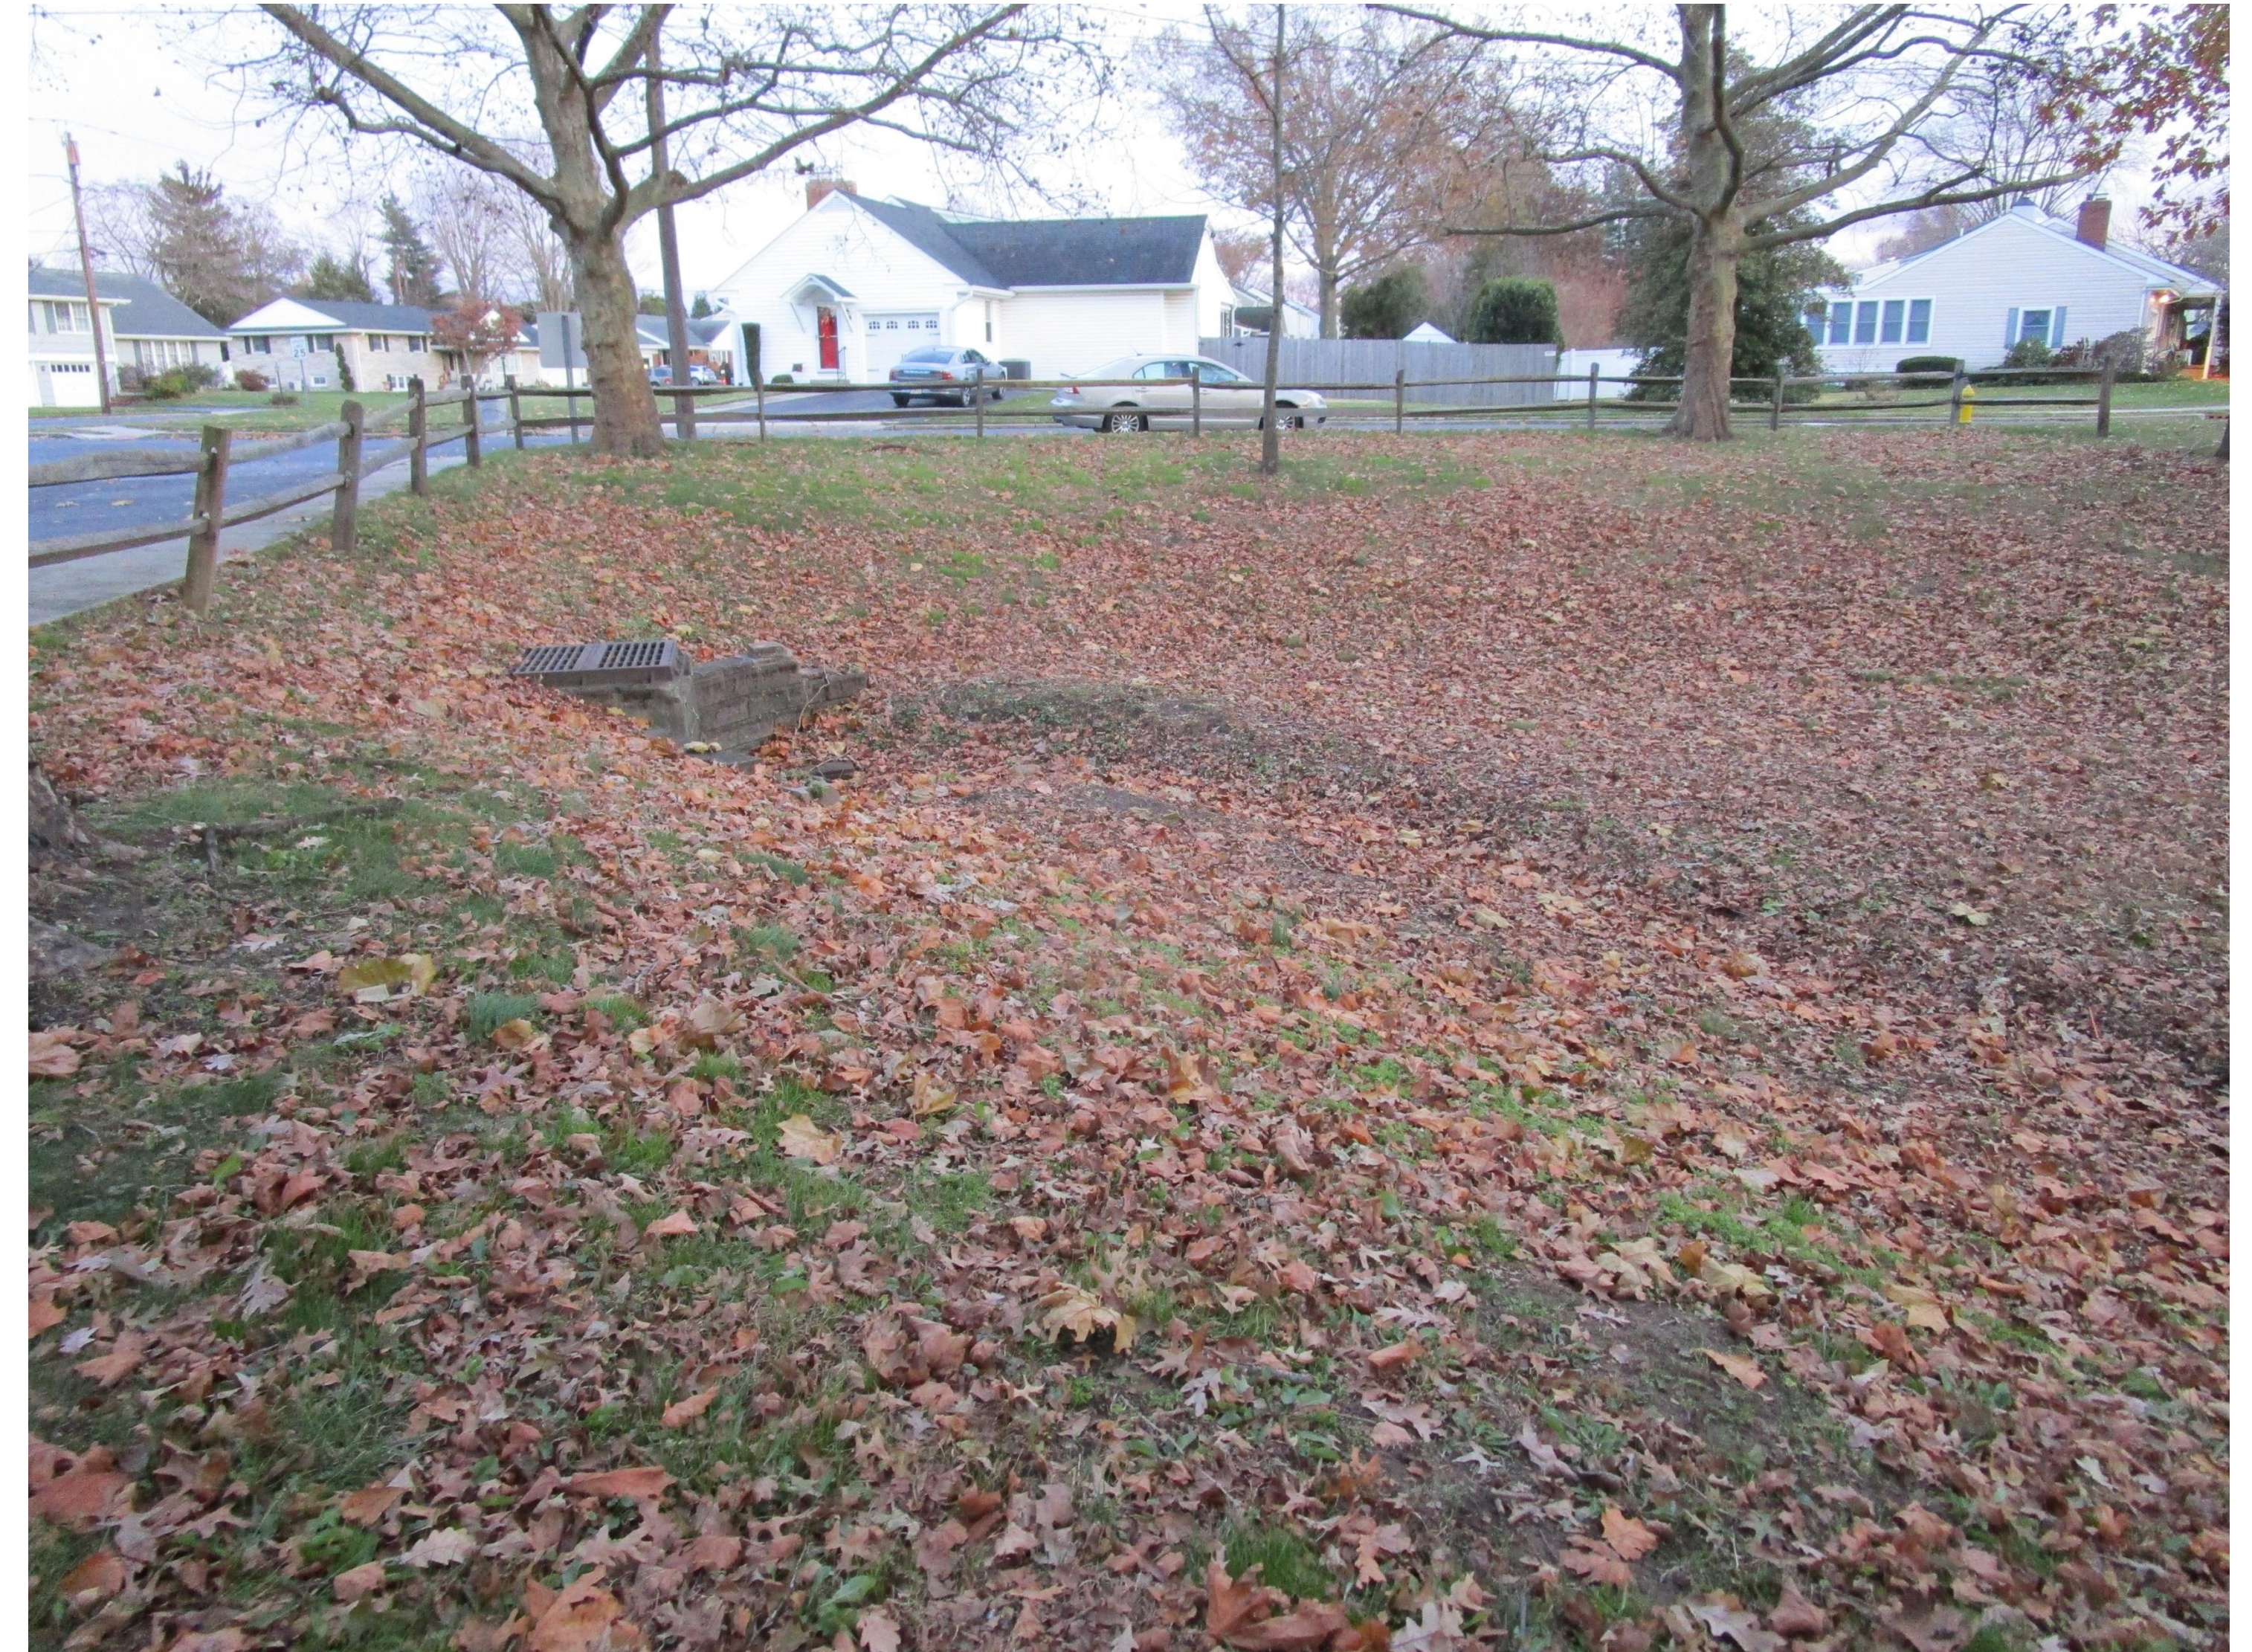
32. Nottingham Volunteer Fire Co Basin

- Basin in overall good condition
- Some slight scouring along main flow channel
- Outlet clogged with leaves

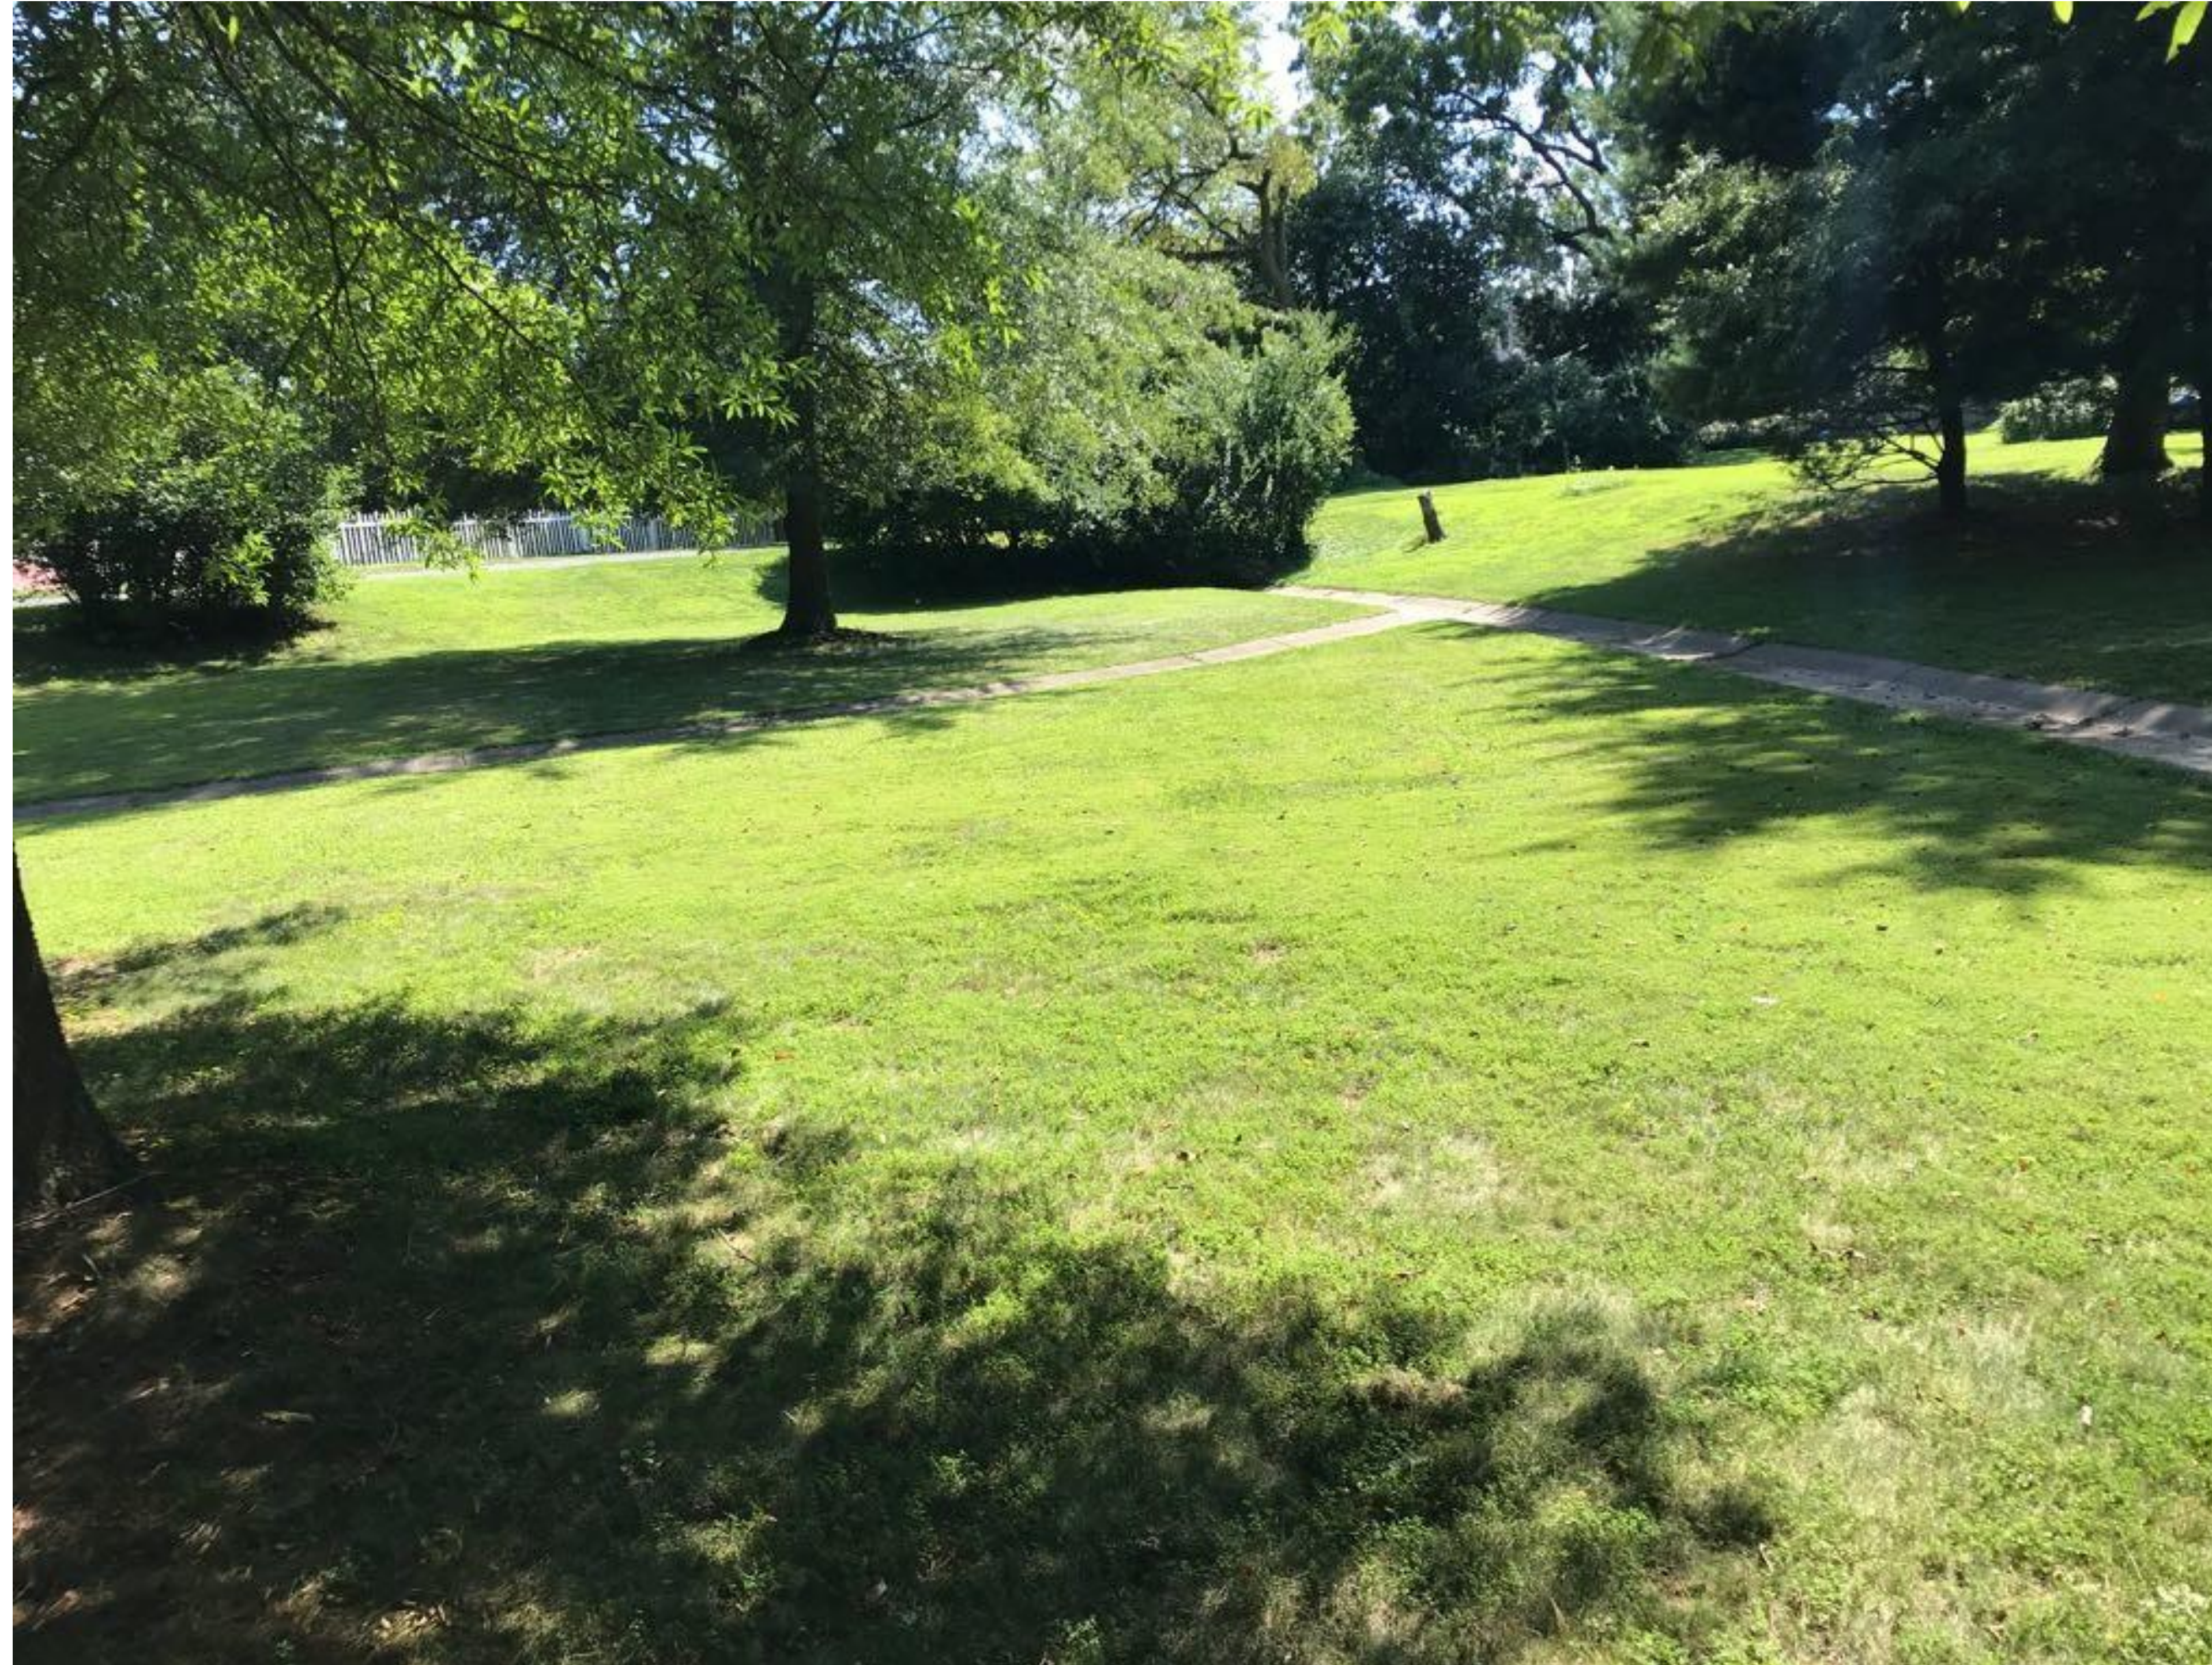
Hamilton Township
Stormwater Basin Assessment
33. Emily Place Residential Basin

- Heavily maintained detention basin in good condition
- Mown with trees around perimeter
- Remove low flow channel to promote more infiltration
