**Hamilton Township (Mercer County)
Stormwater Basin Assessment Summary
Hamilton Owned Addendum (Year 5A)**

Developed by the Rutgers Cooperative Extension Water Resources Program
Funded by Hamilton Township, Mercer County, New Jersey

November 27, 2019

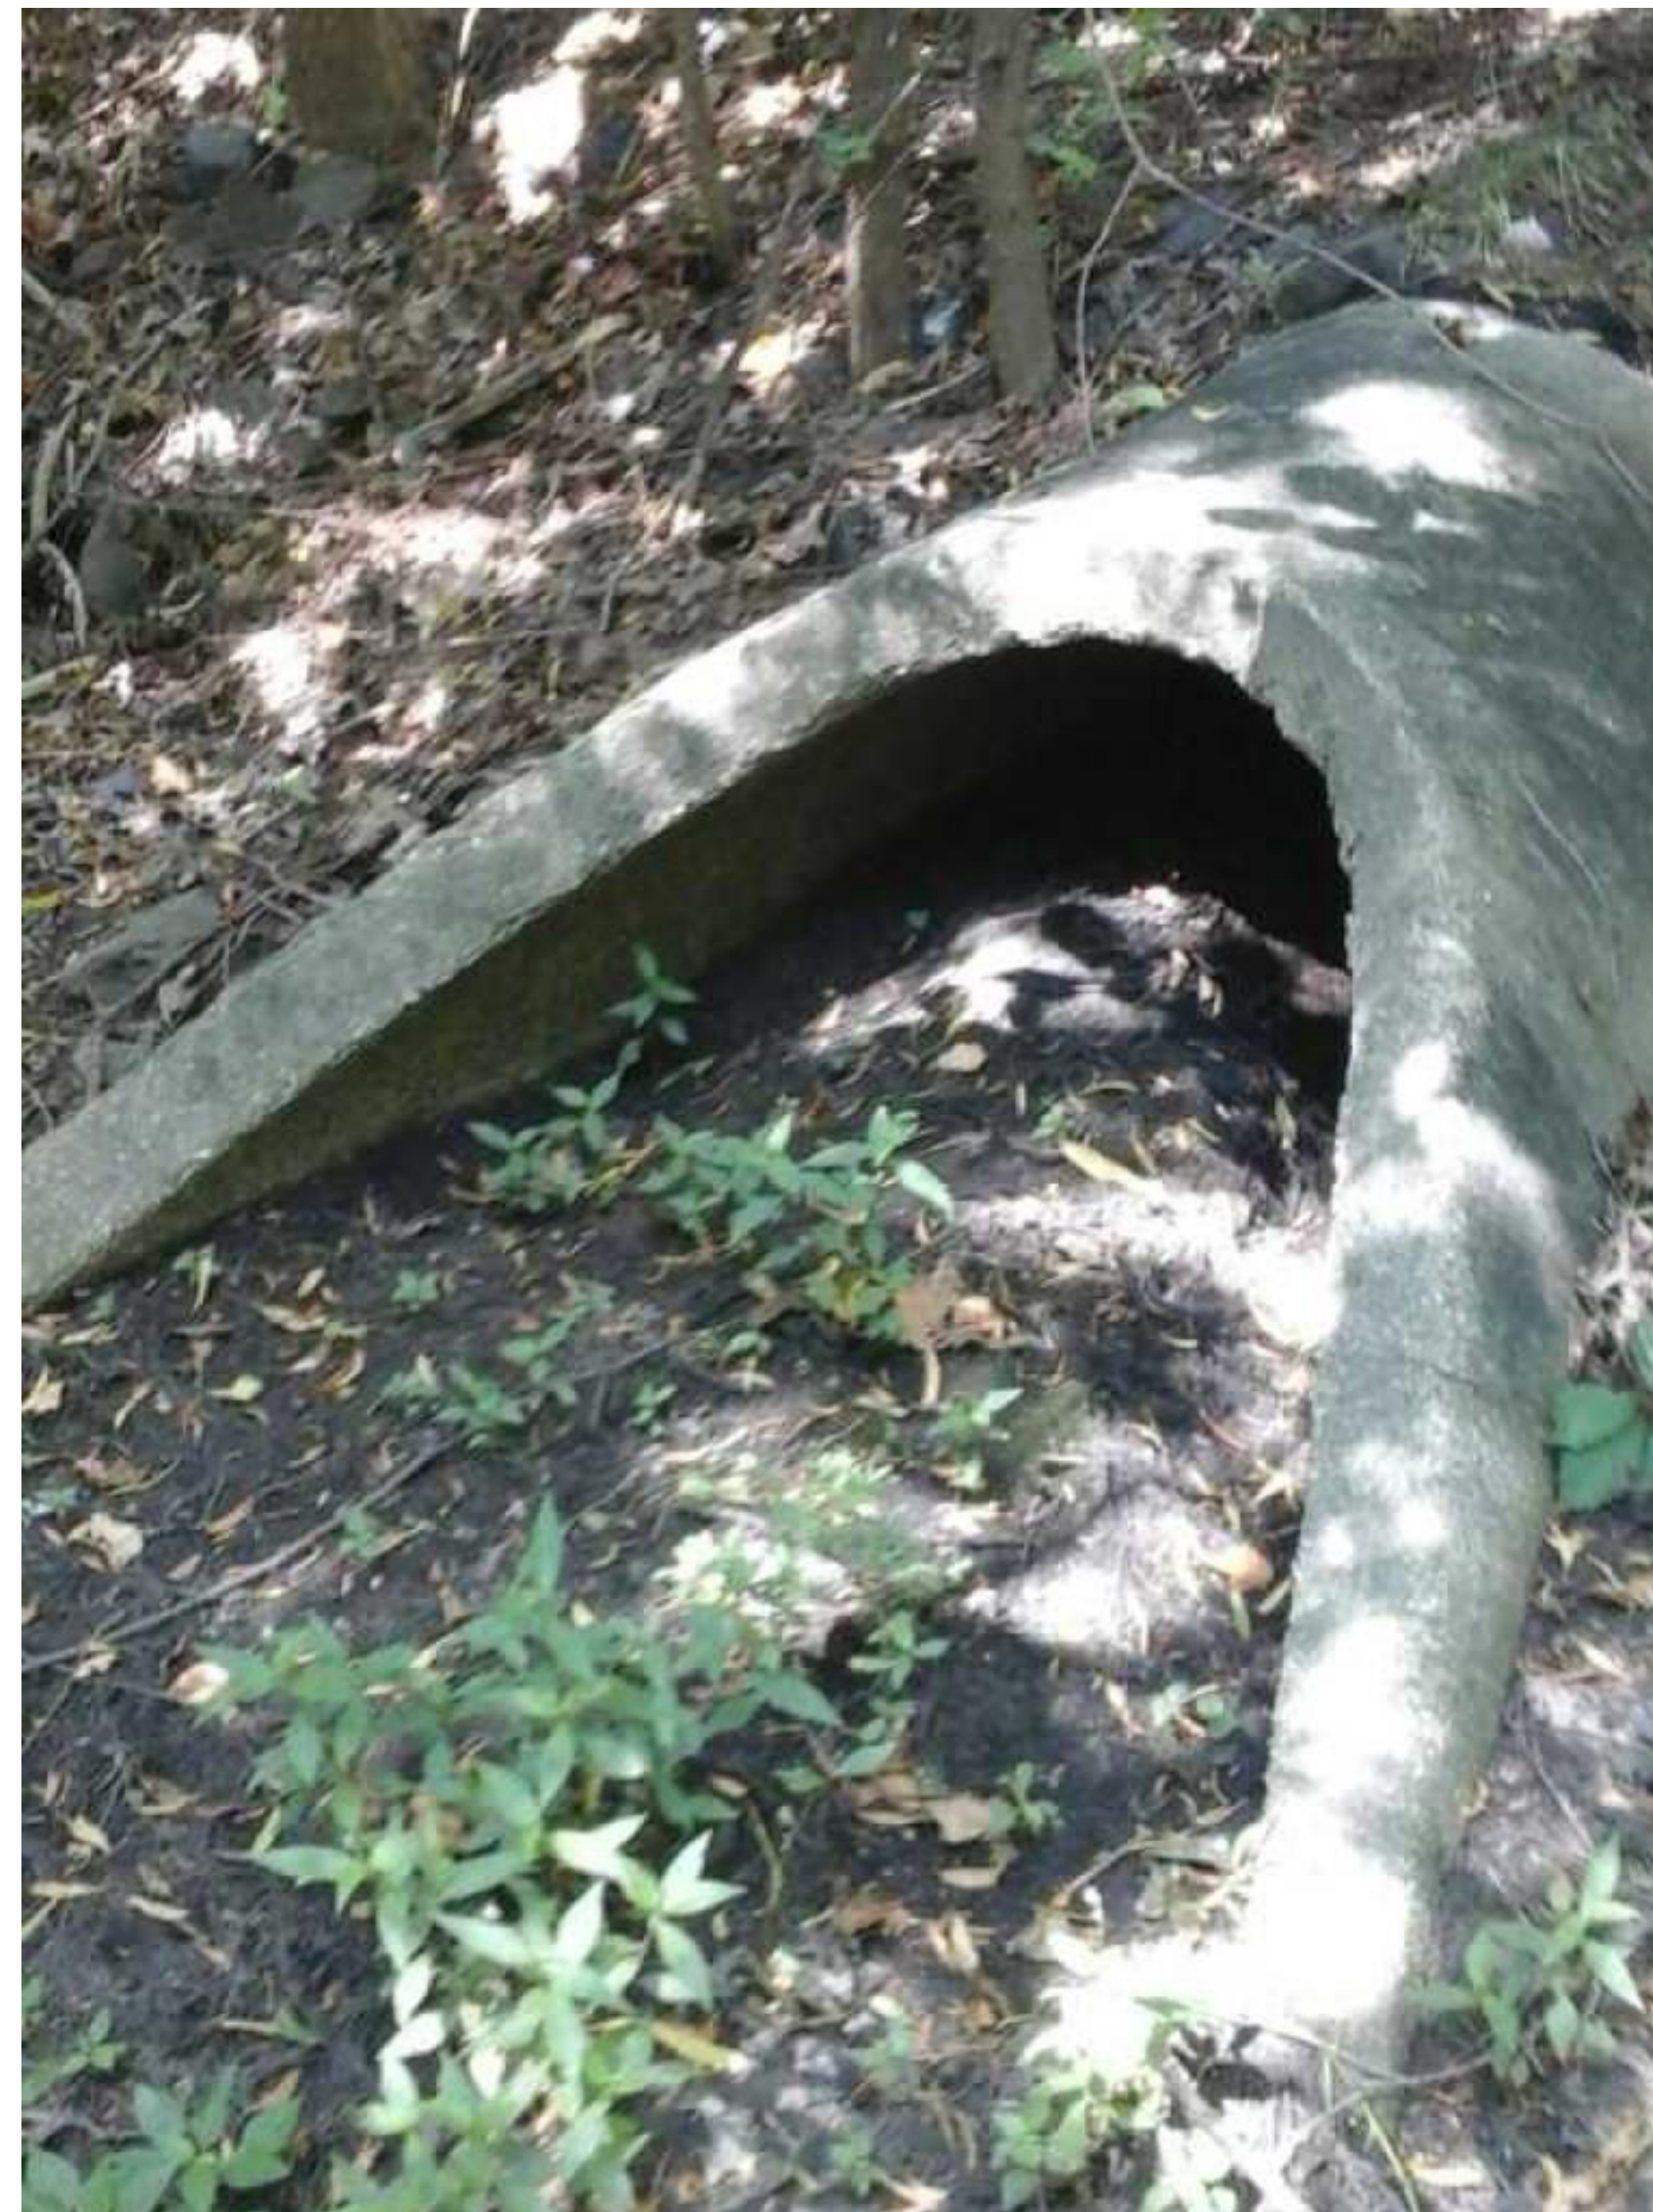
Hamilton Township
Stormwater Basin Assessment
87. Roadside Residential Basin

- Basin in good condition overall with two inlets
- Clean out inlets as they have accumulated sediment and restrict inflow

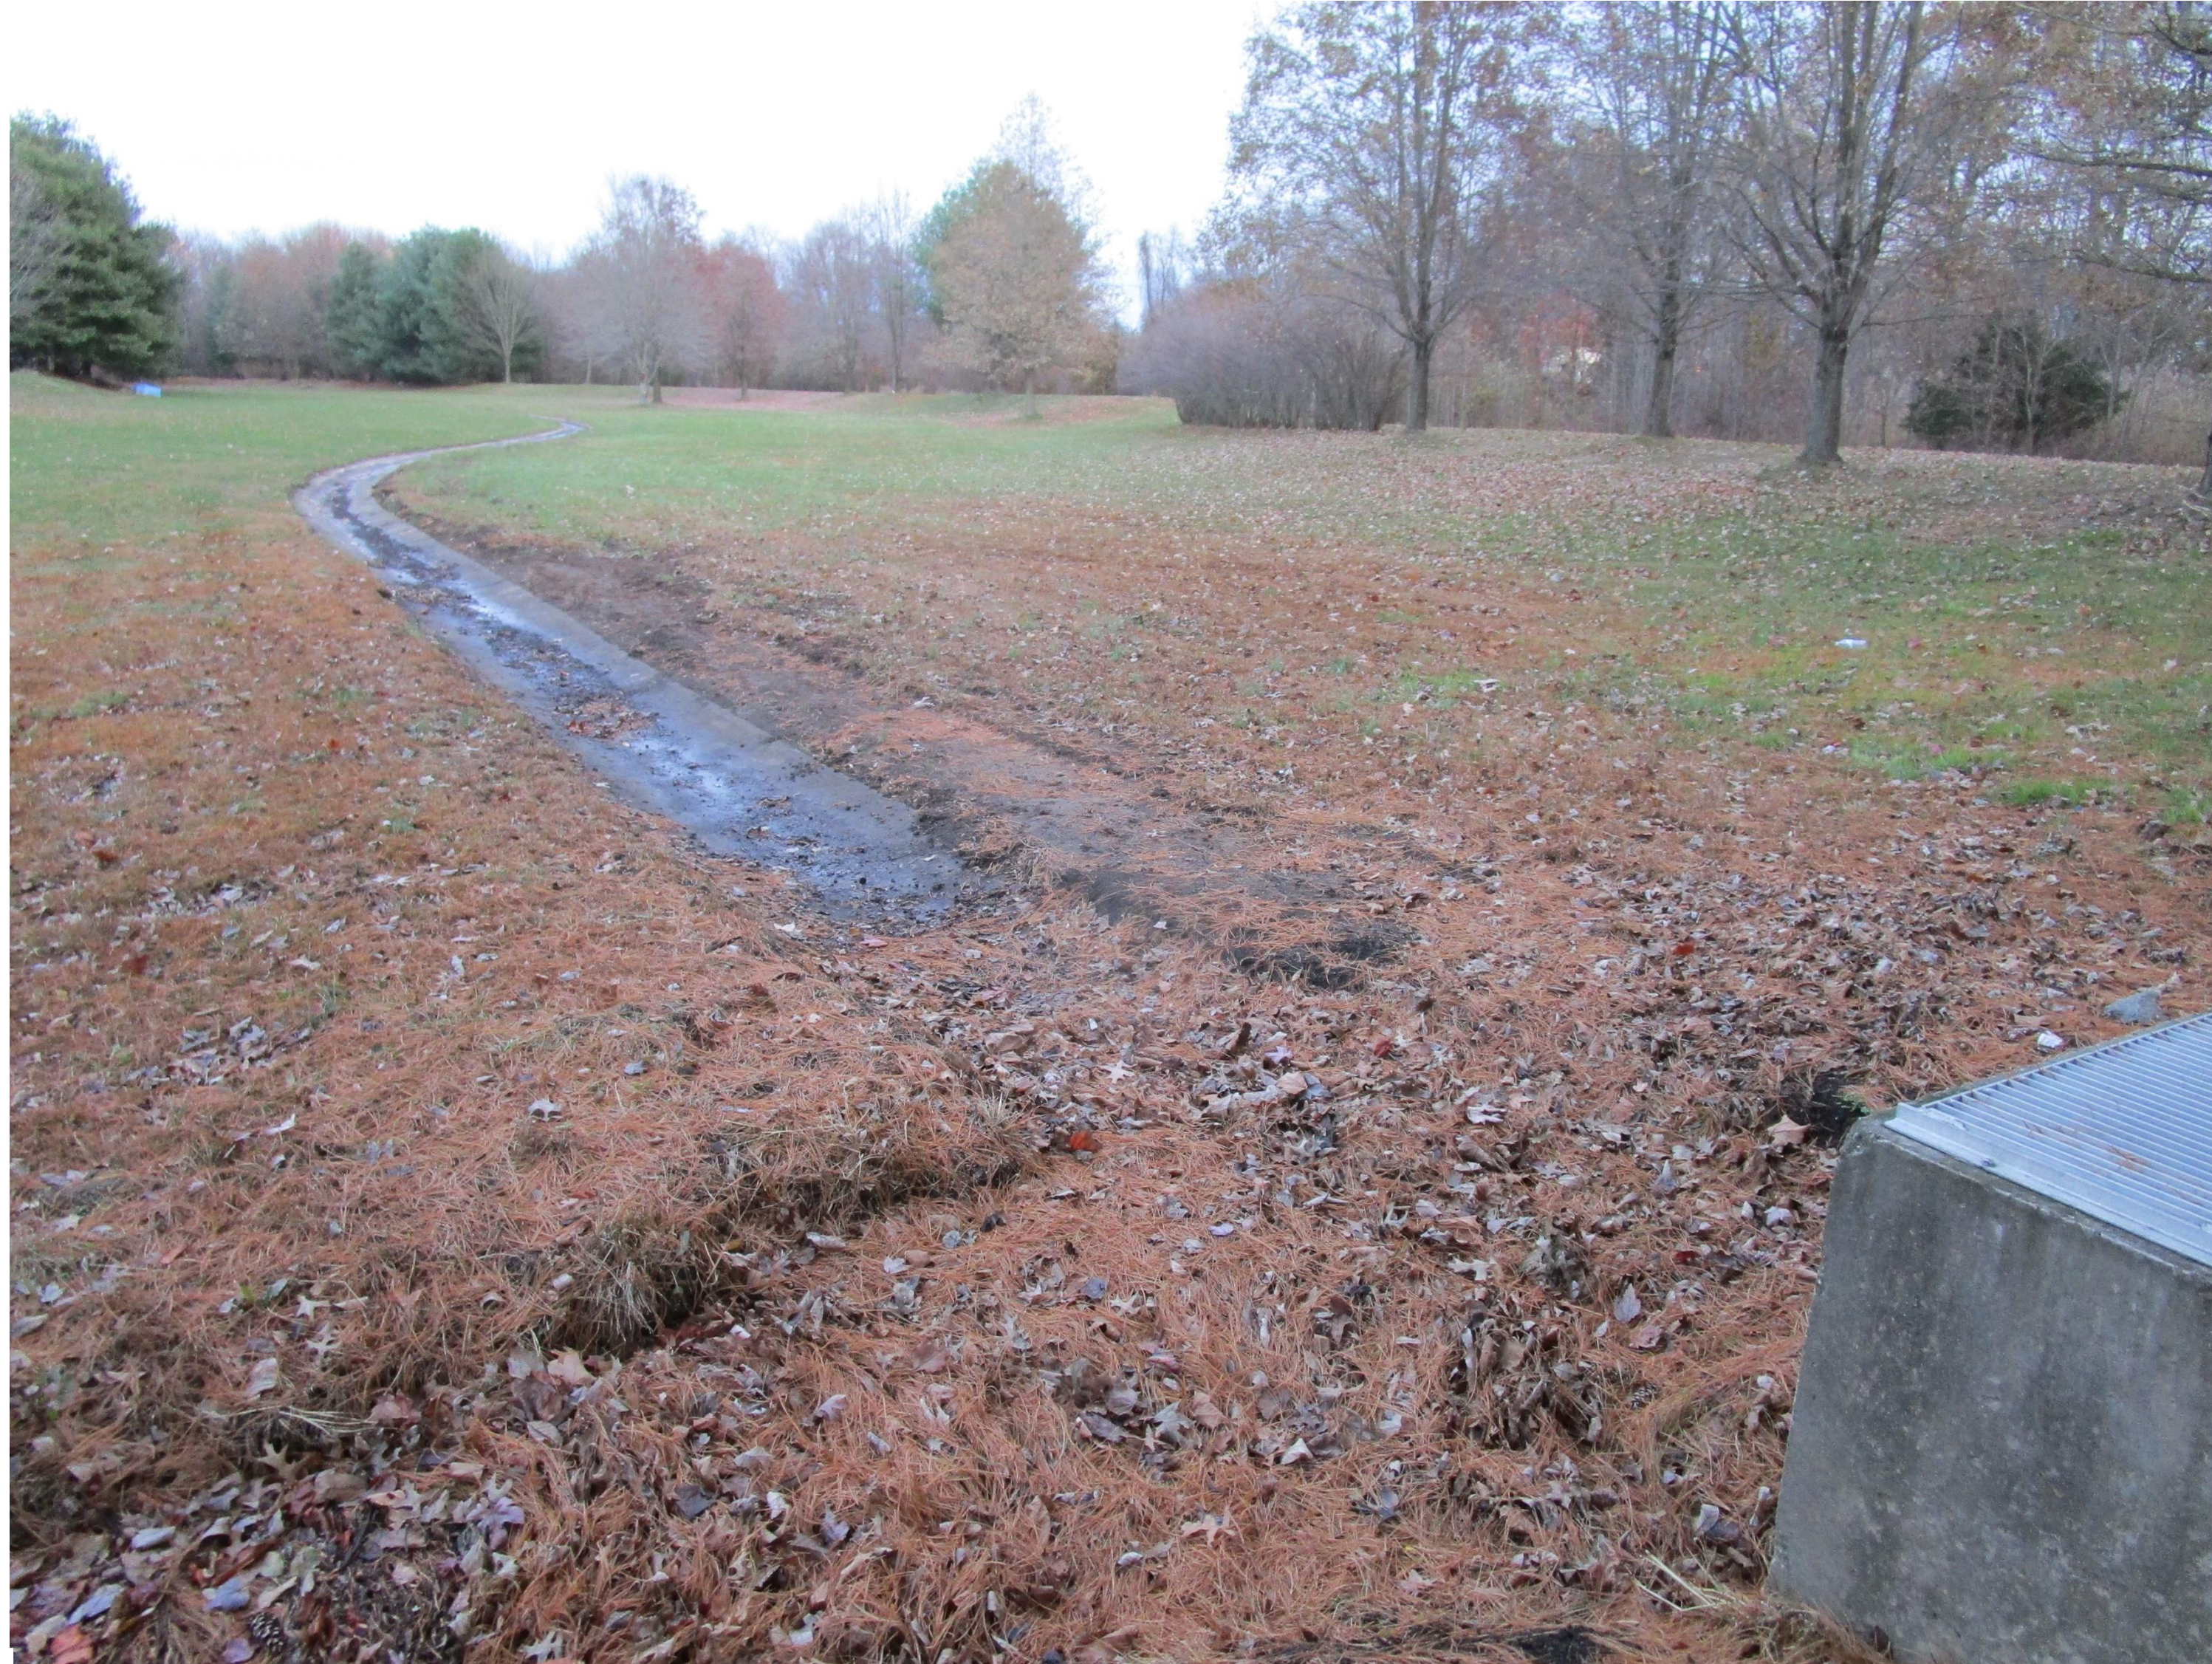
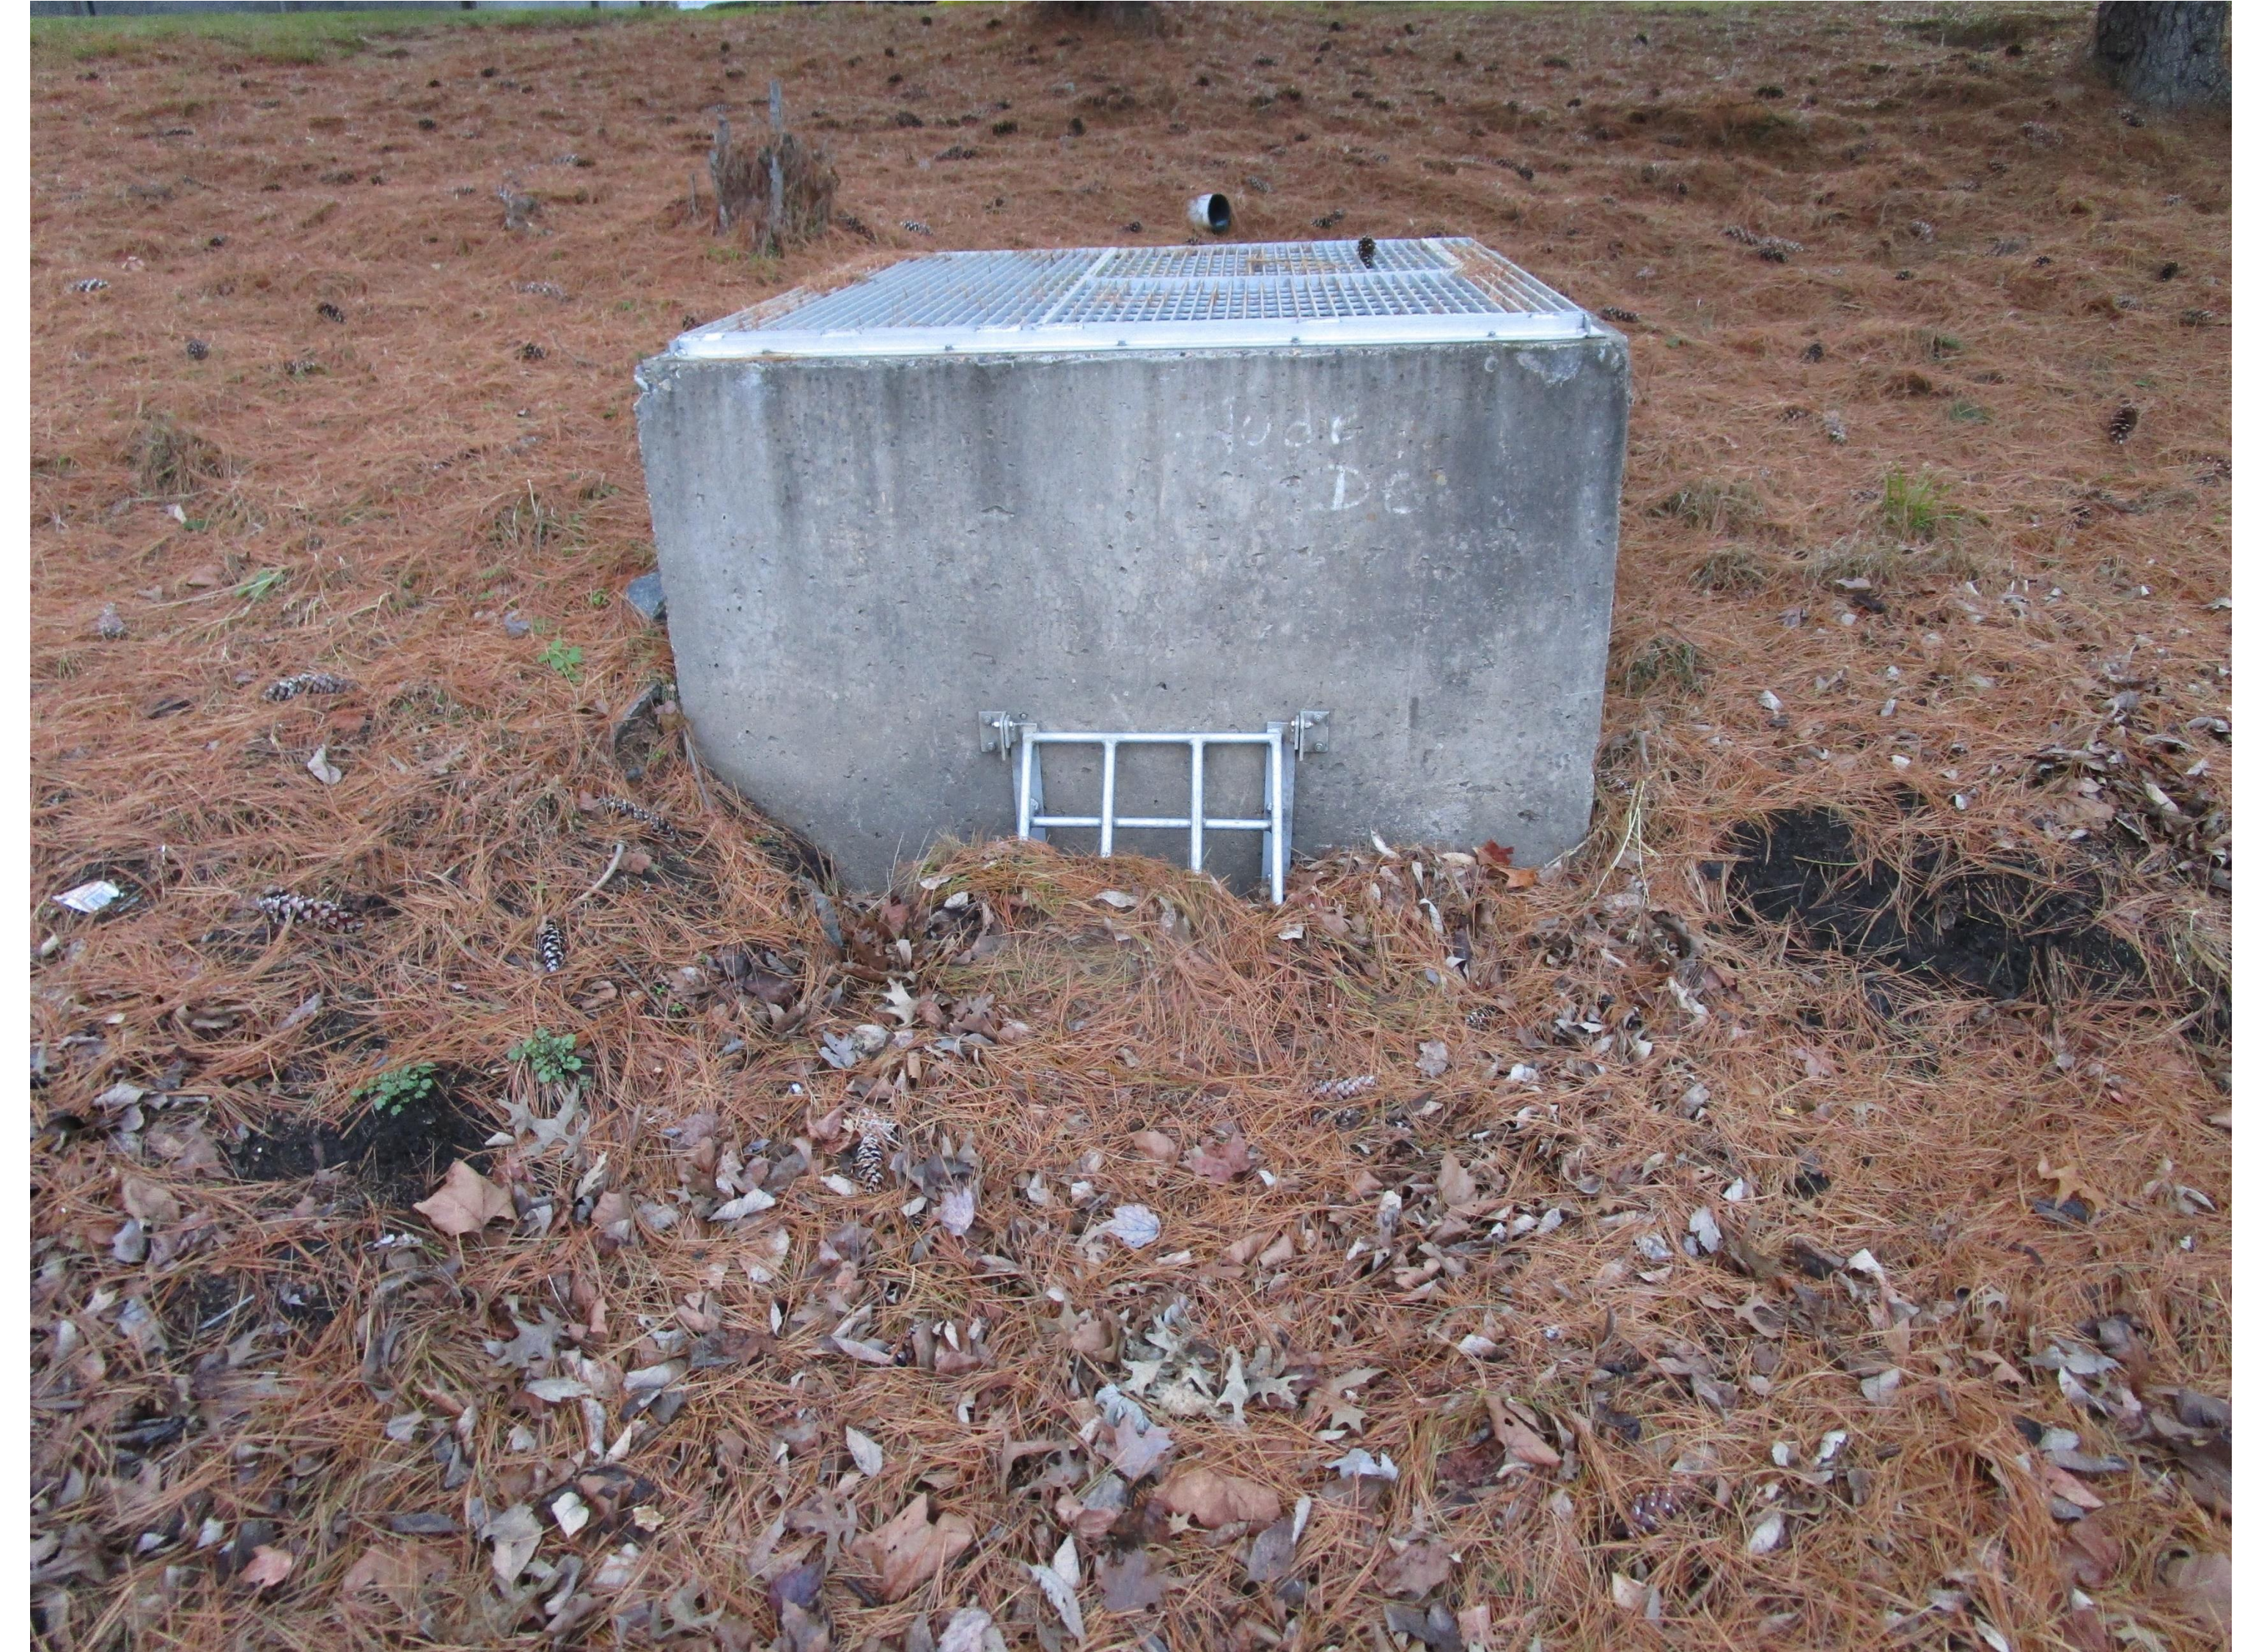
120. Imperial Drive Residential Detention Basin

- Basin in overall good condition, much improved from previous assessment with all inlet and outlets cleared
- Significant leaf litter clogging outlet structure
- Low flow channels could be removed to promote more infiltration throughout the basin

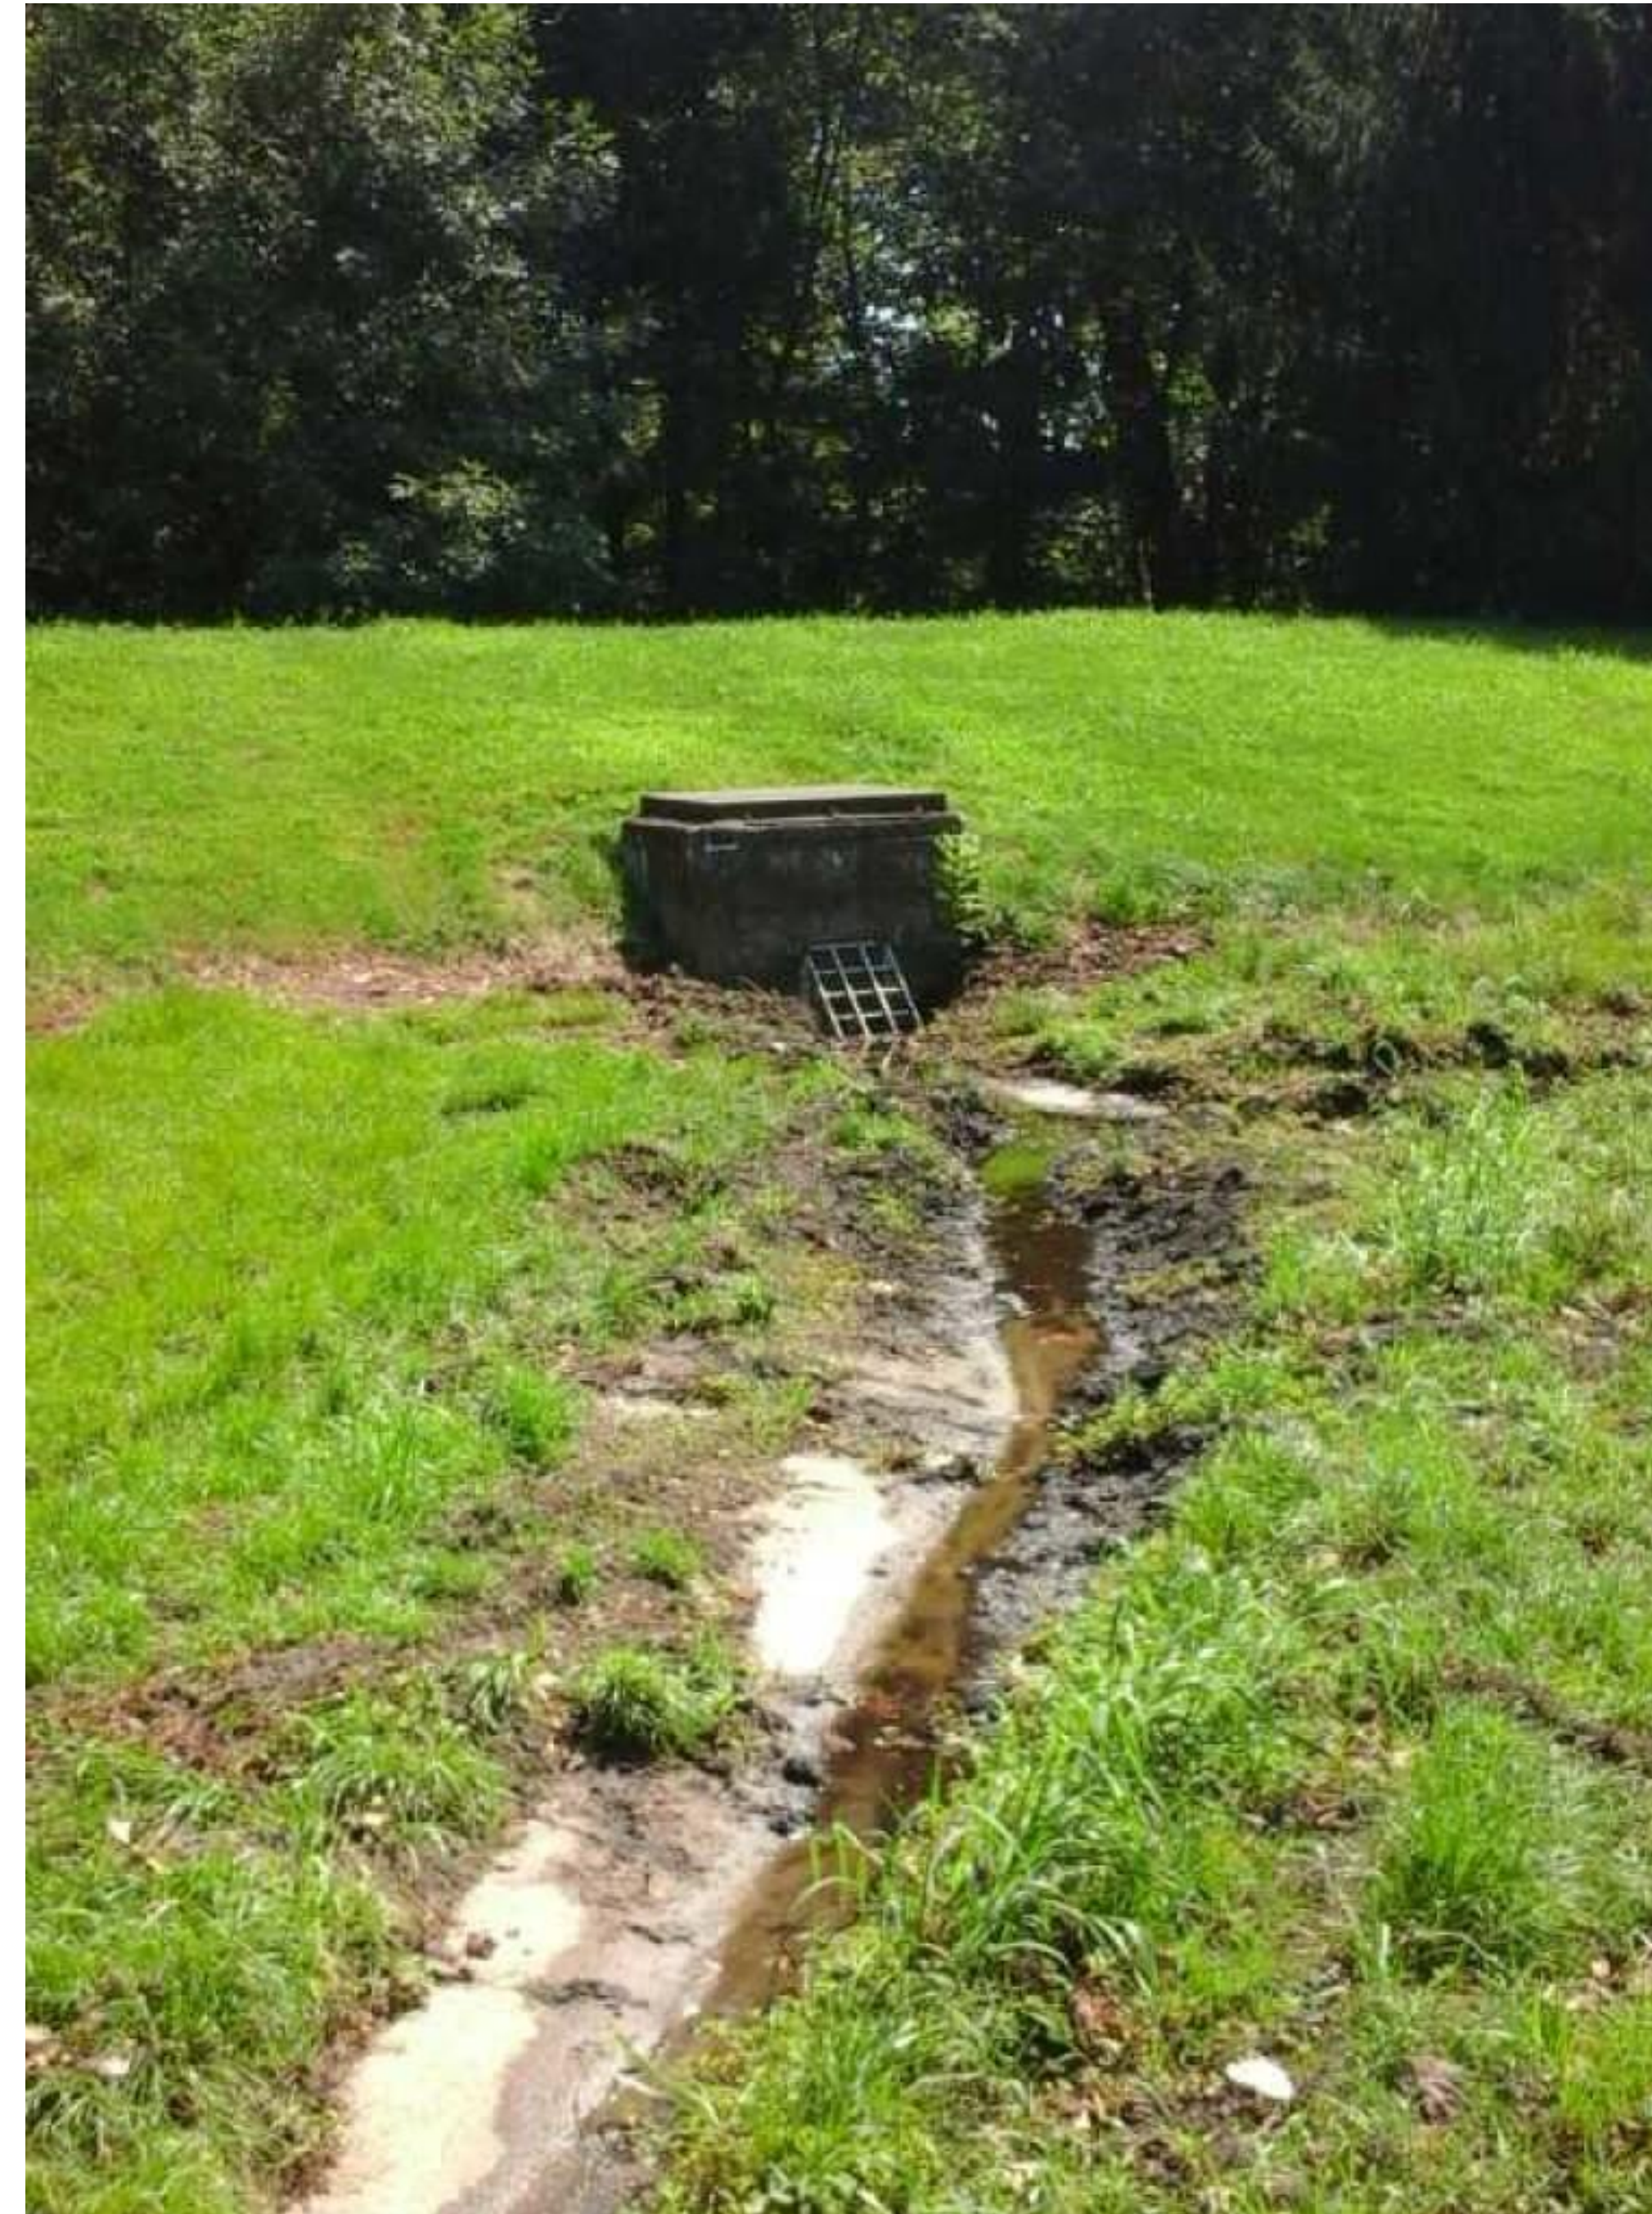
121. Foy Drive Residential Detention Basin

- Built up sediment in channel is leading to some standing water
- Clean out channel and potentially replace concrete channel with stone channel

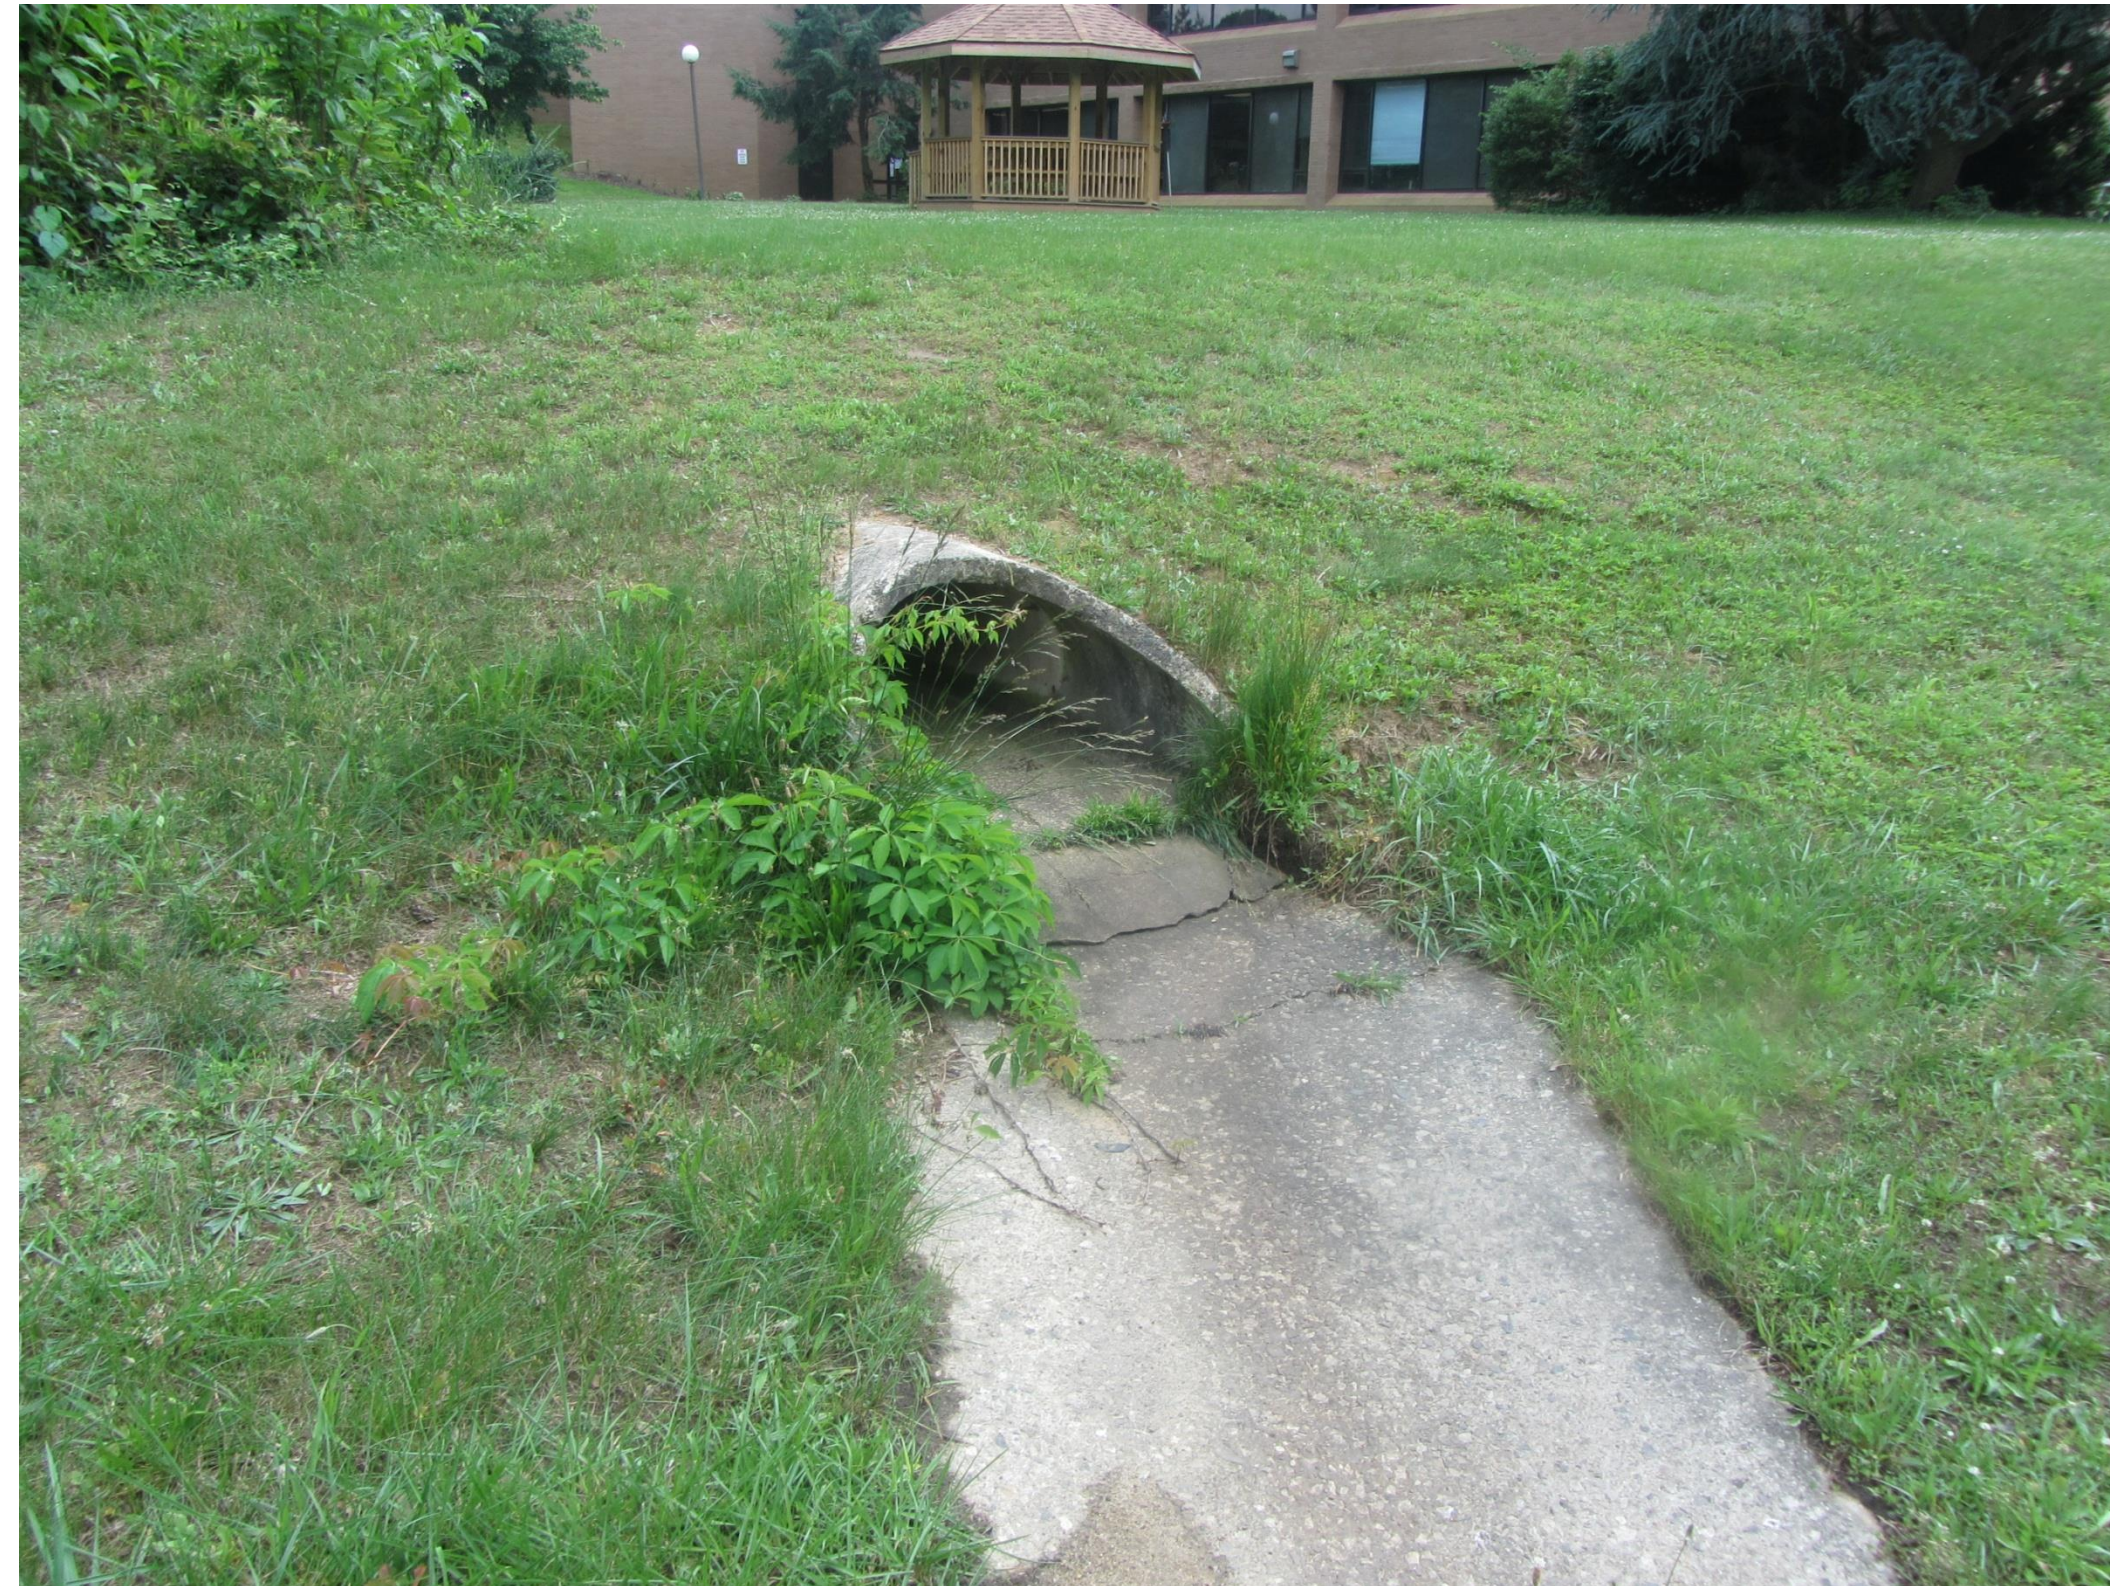
Concrete deterioration on southern inlet

- There is excessive ponding in the basin bottom, ponding reaches depths of about three feet
- Outlet is overgrown by brush, it is located in the northern corner. The outlet is clogged with sediment, causing the ponding in the basin
- There is concrete deterioration on both inlets

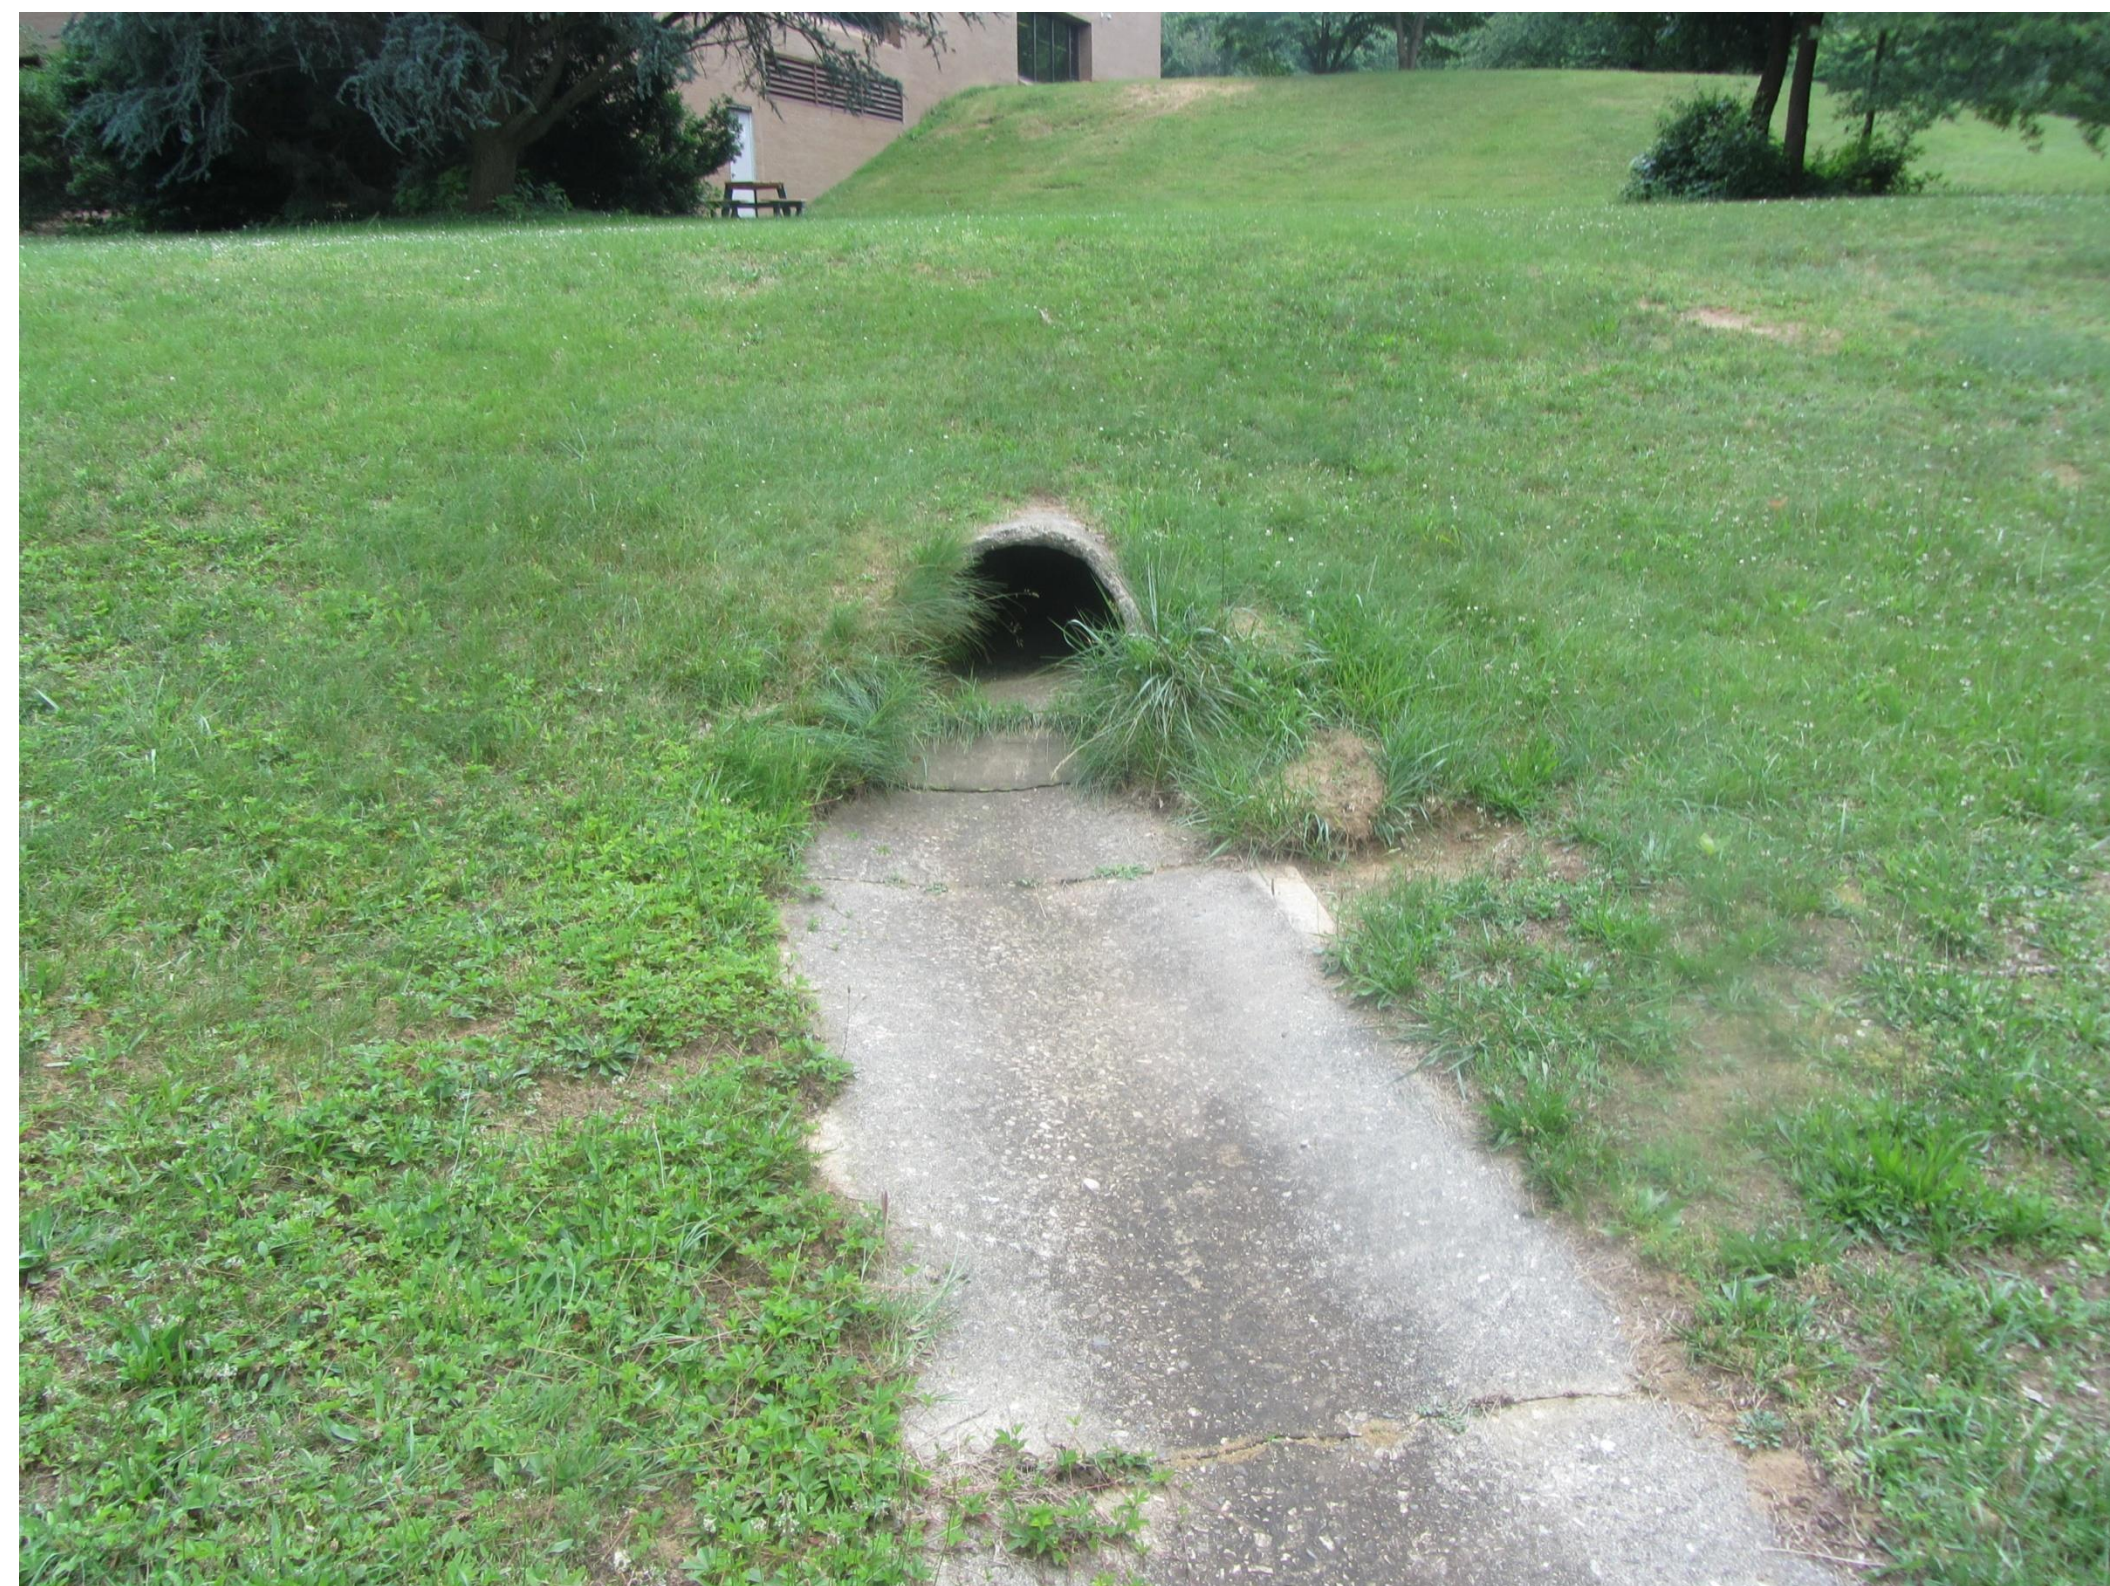
Concrete deterioration on northern inlet
