**Hamilton Township (Mercer County)
Stormwater Basin Assessment Summary
Hamilton Owned Addendum (Year 5A)**

Developed by the Rutgers Cooperative Extension Water Resources Program
Funded by Hamilton Township, Mercer County, New Jersey

November 27, 2019

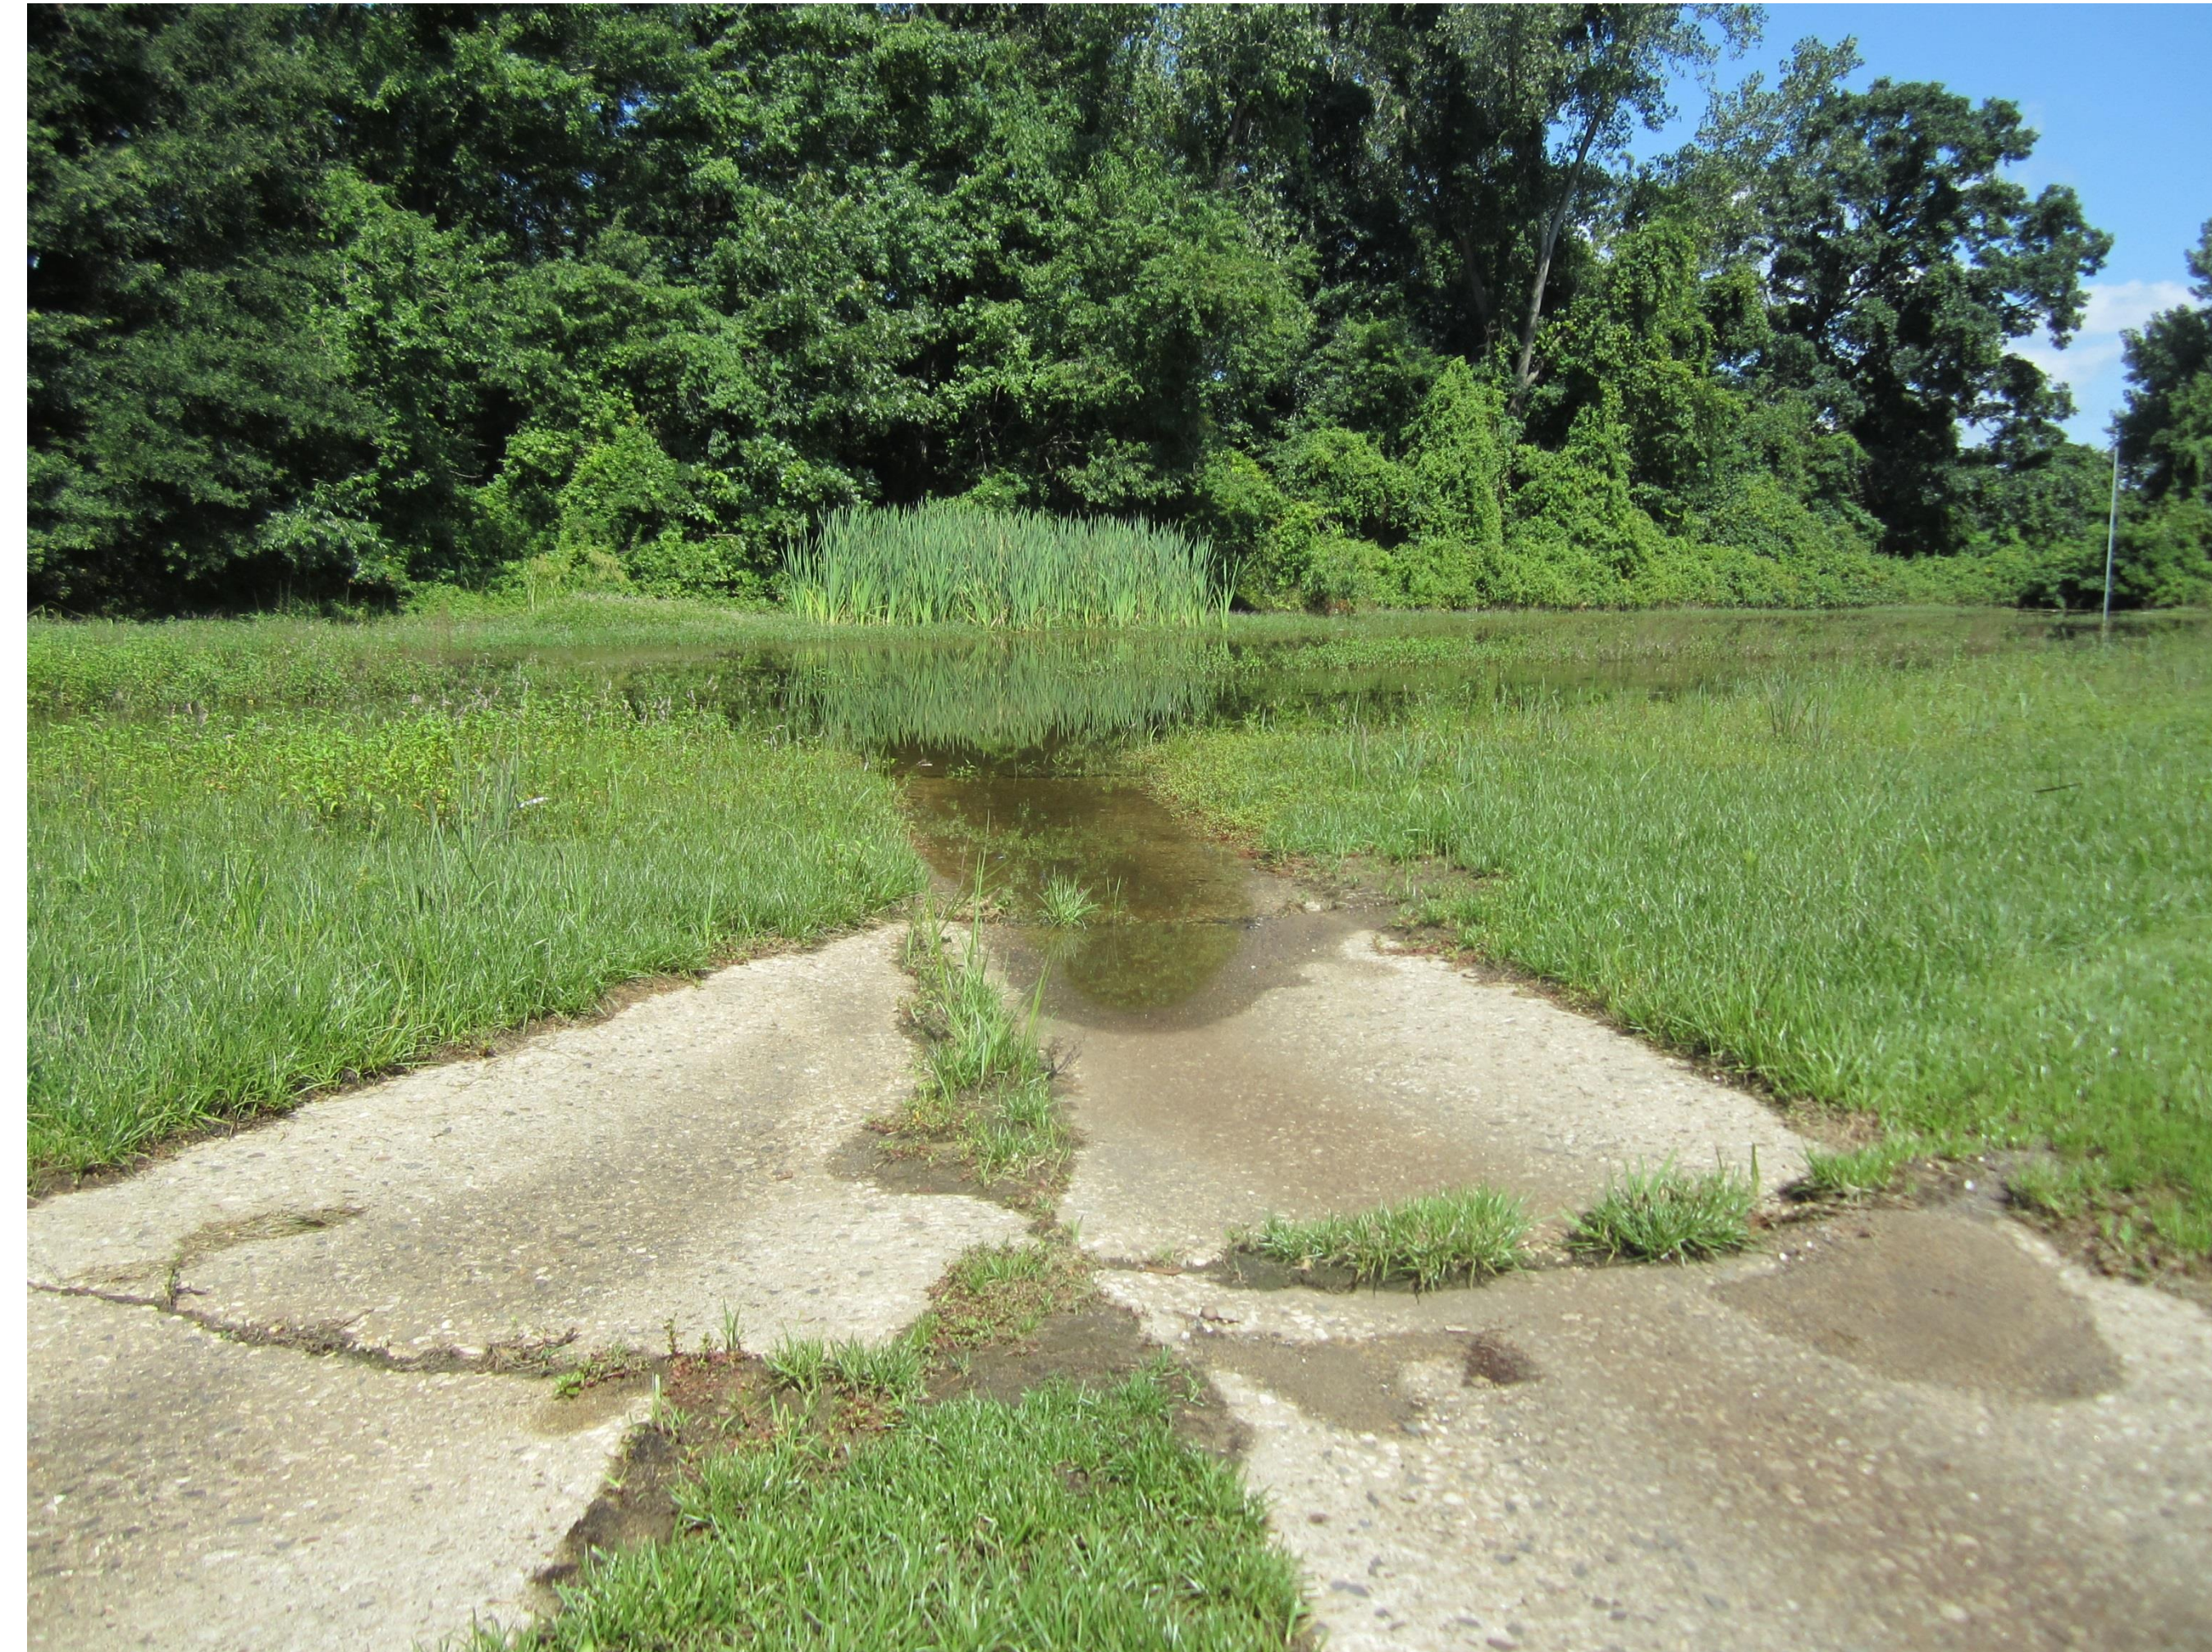
Basin bottom looking west

- There is excessive ponding in the basin bottom, ponding reaches depths of about three feet
- Outlet is overgrown by brush, it is located in the northern corner. The outlet is clogged with sediment, causing the ponding in the basin
- There is concrete deterioration on both inlets

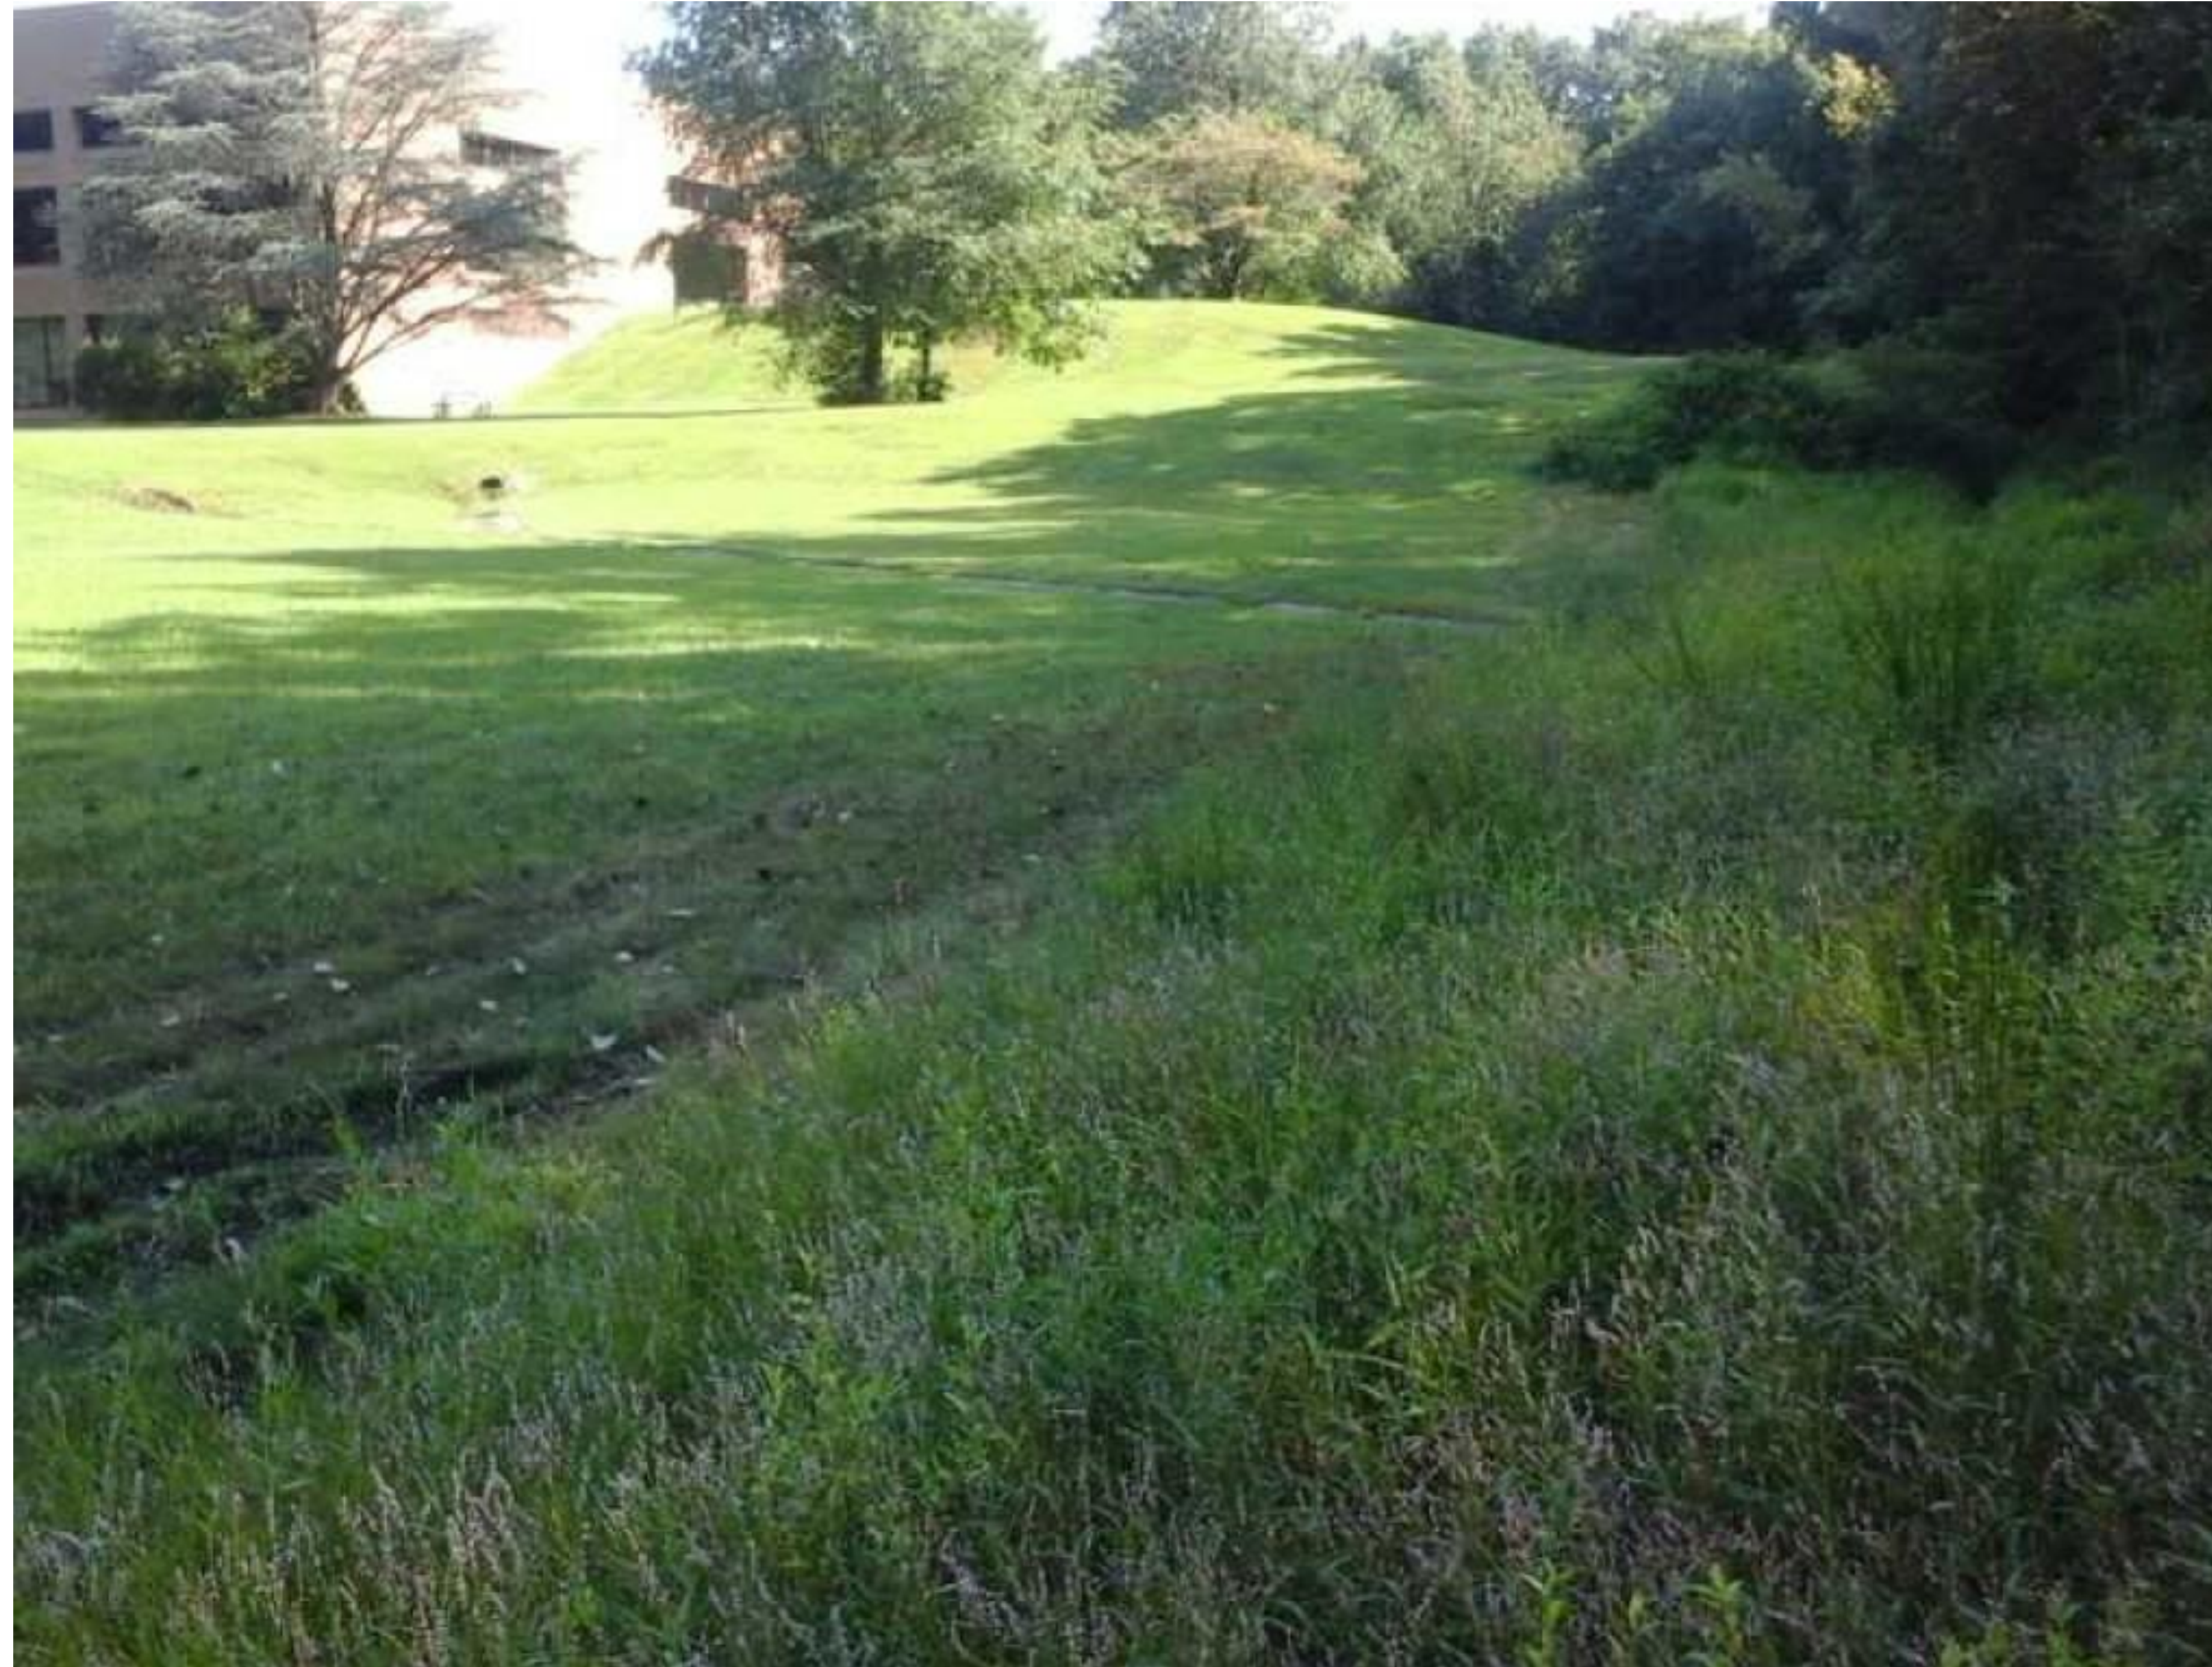
128. Hamilton Twp Library Detention Basin

- Low flow channel from two inlets flow into a vegetated swale to the outlet
- Standing water issues observed in previous assessment were not identified
- Basin can be naturalized with herbaceous plants

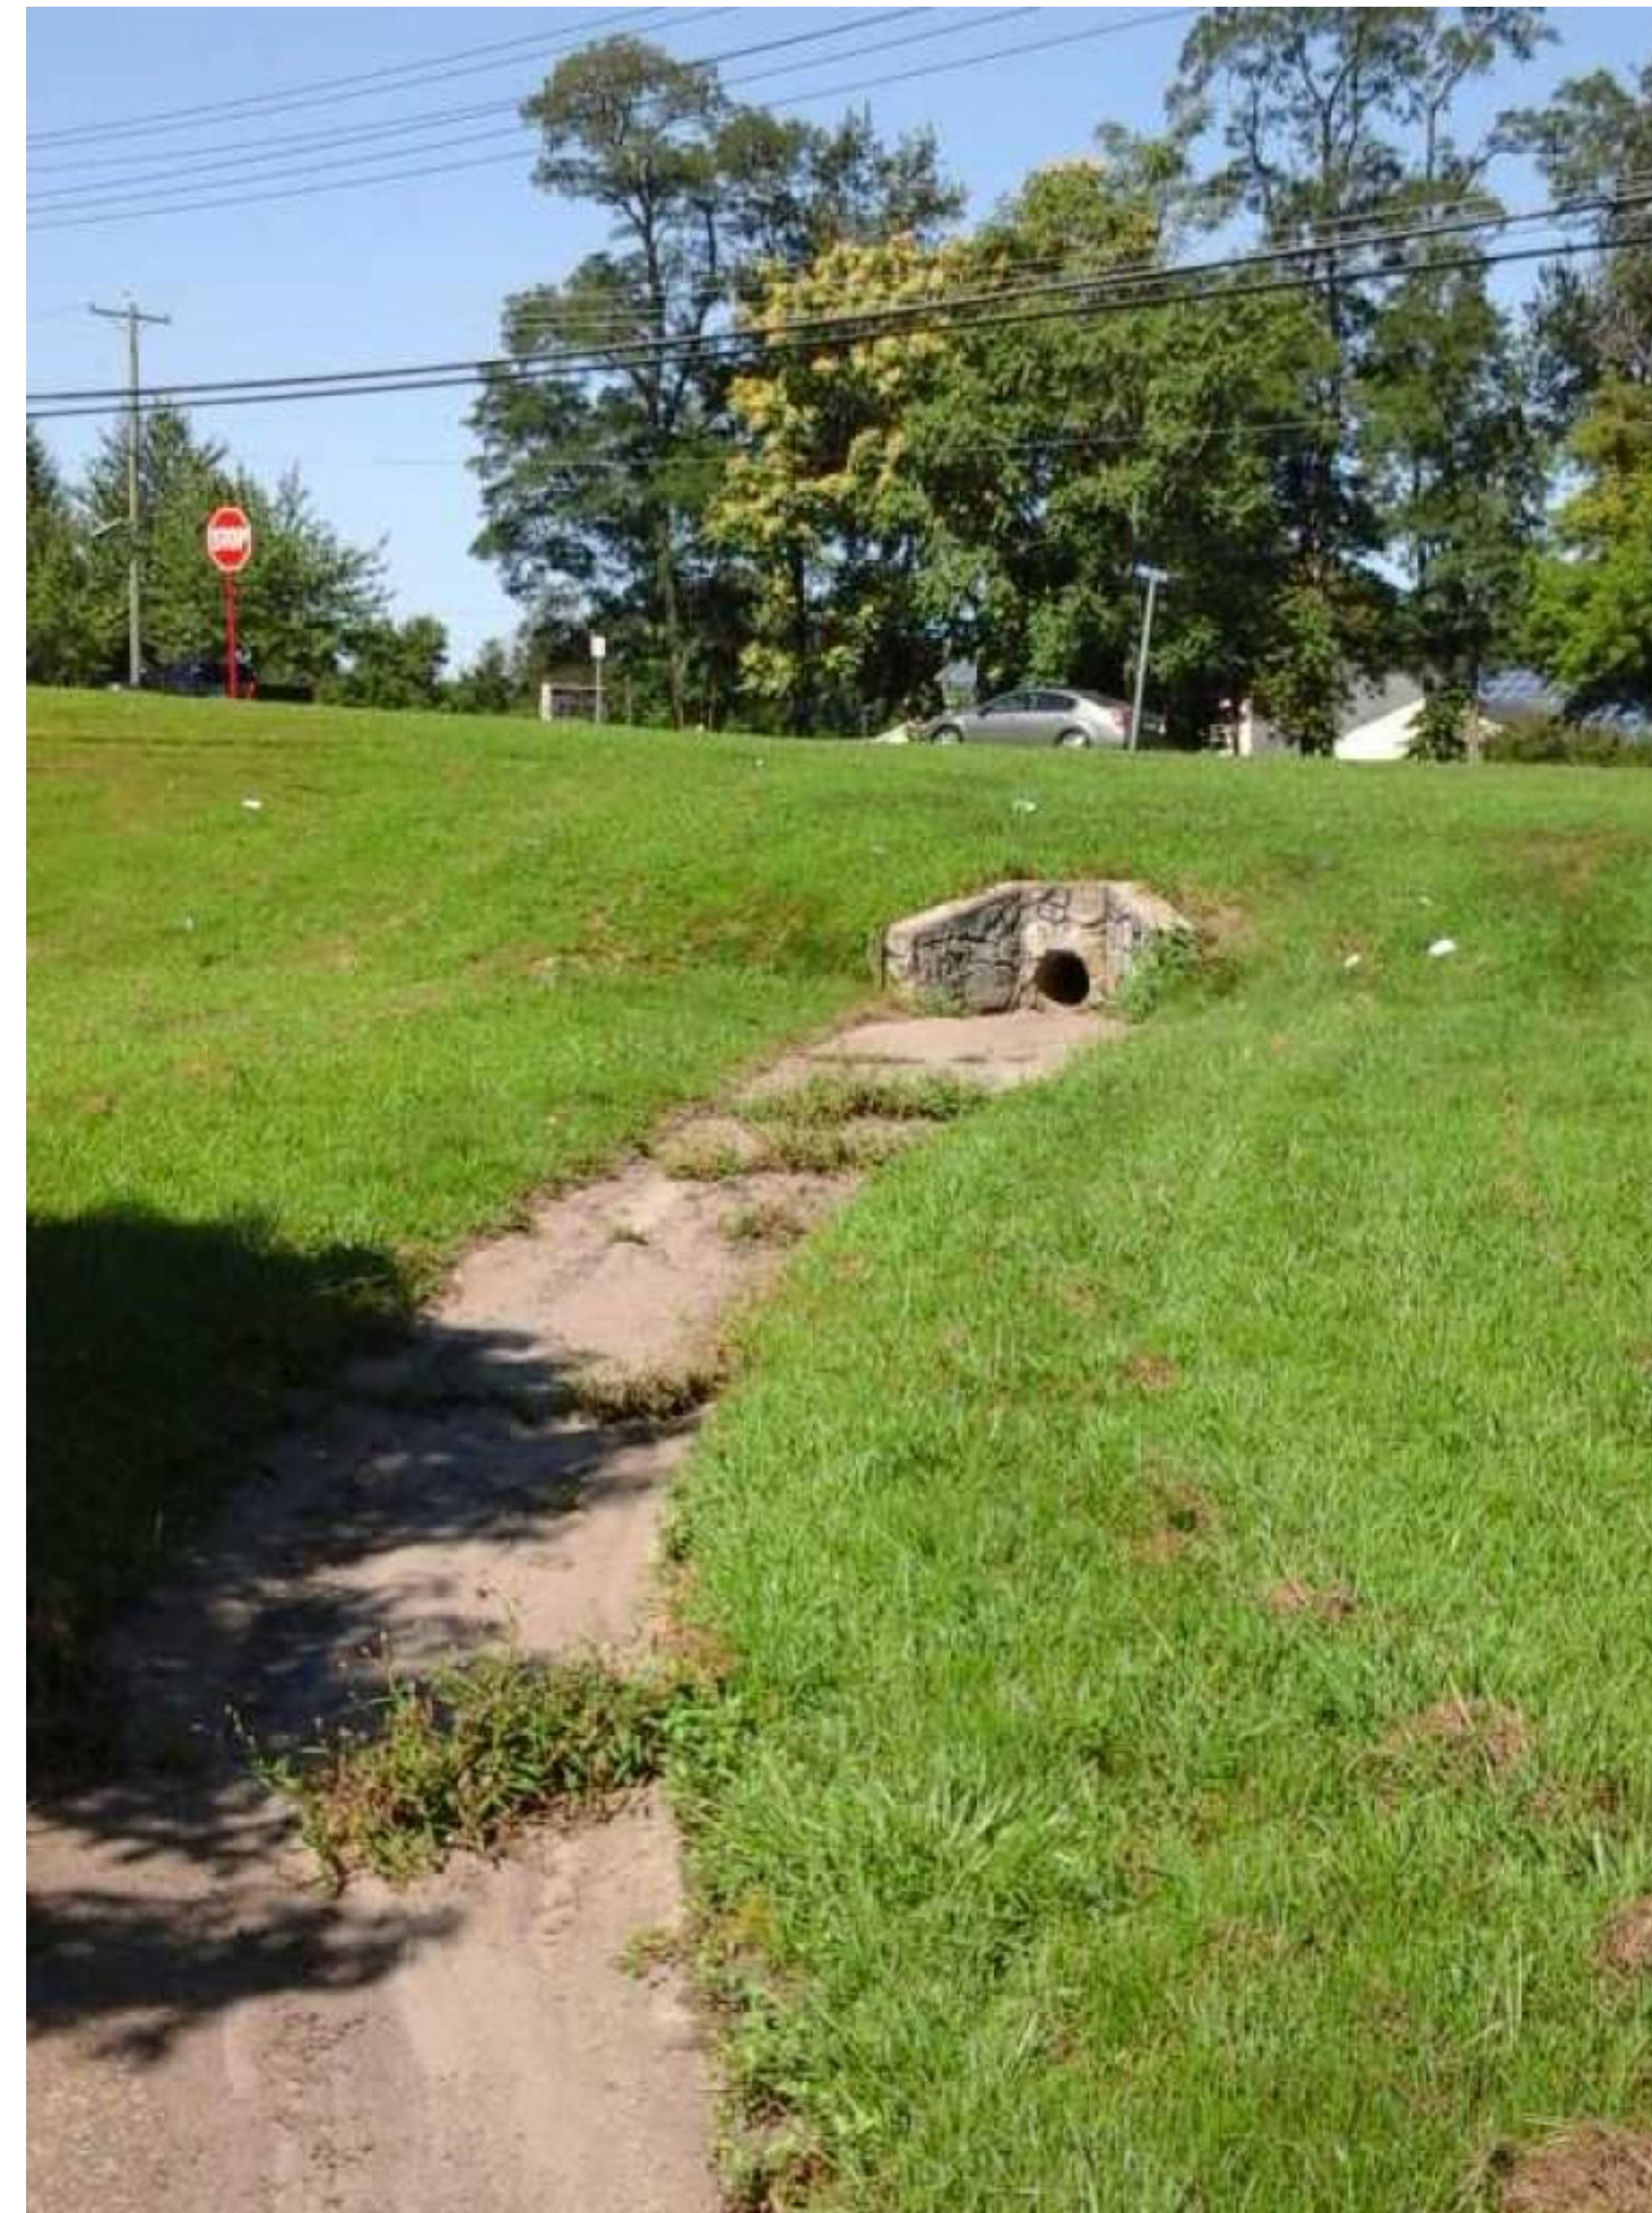
Hamilton Township
Stormwater Basin Assessment
137. Noa Court Residential Detention Basin

- Excessive sediment build up in front of outlet structure, grass growing over low flow channel
- Excess sediment and litter should be removed
- Opportunity to replace low flow channel with a stone channel to promote infiltration

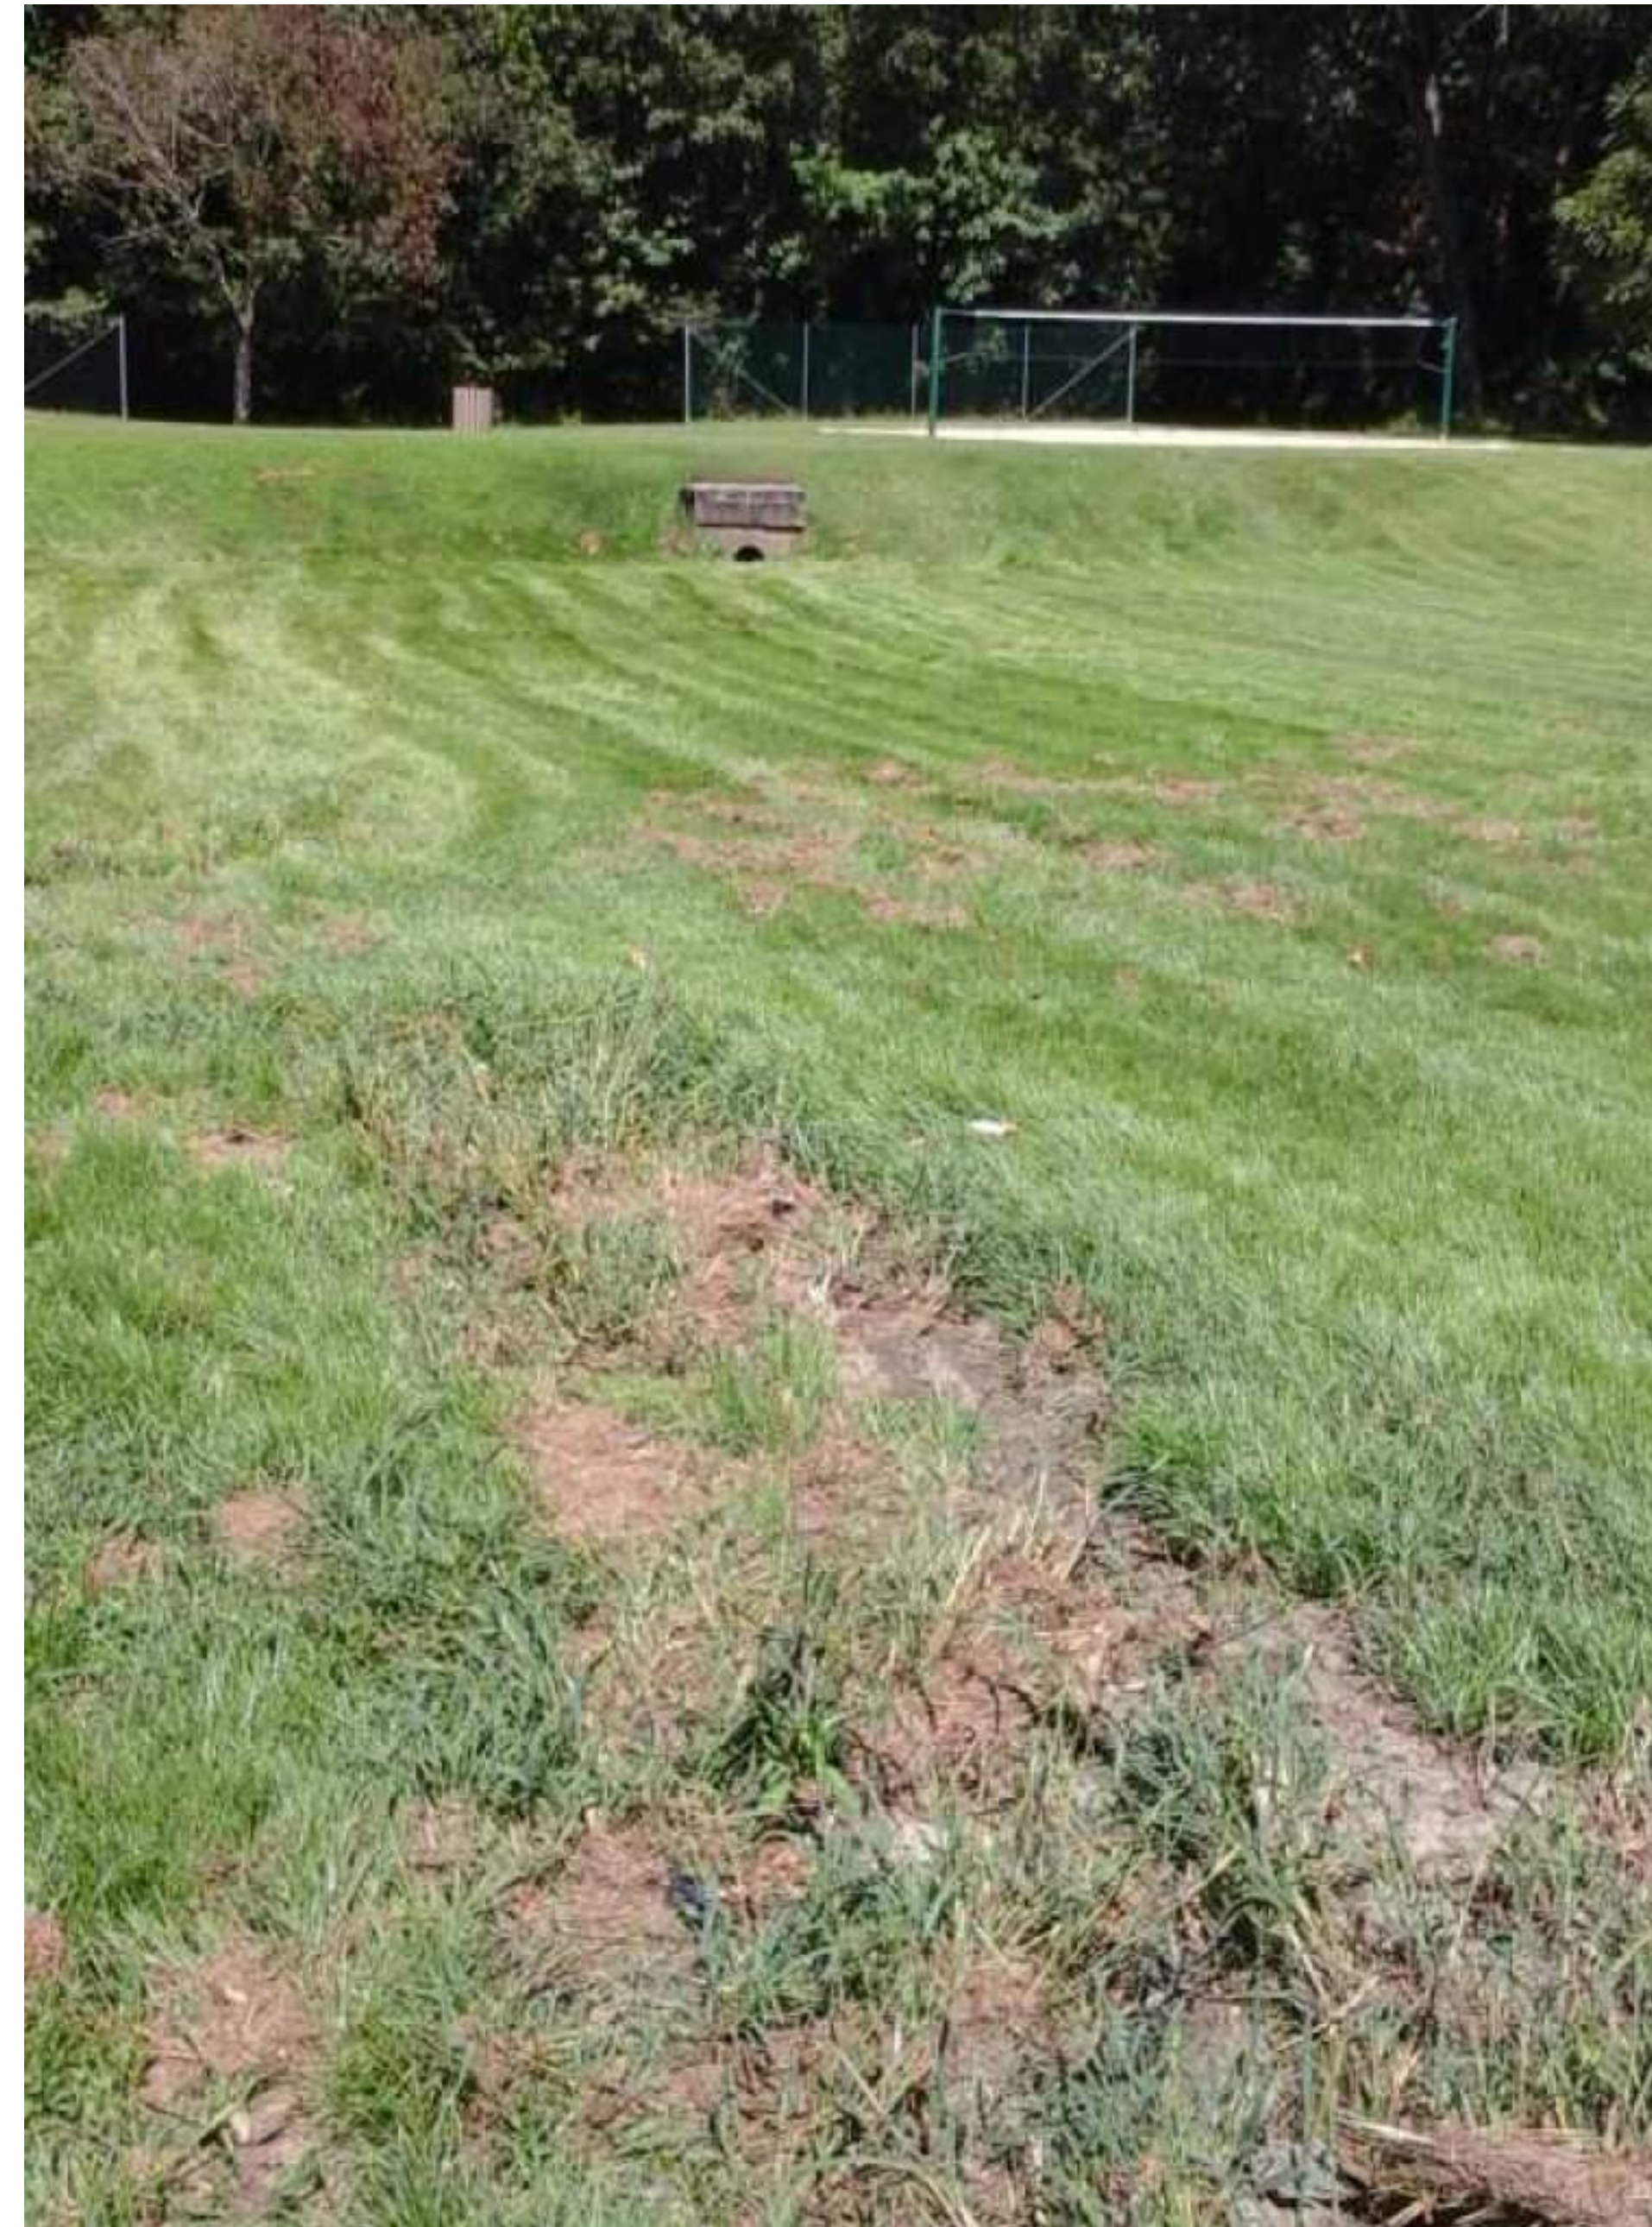
161. Hamilton Veterans Park Detention Basin (d)

- Basin overall in good condition
- Inlets have signs of erosion, implement rip rap aprons to prevent erosion
- Natural basin with herbaceous plants

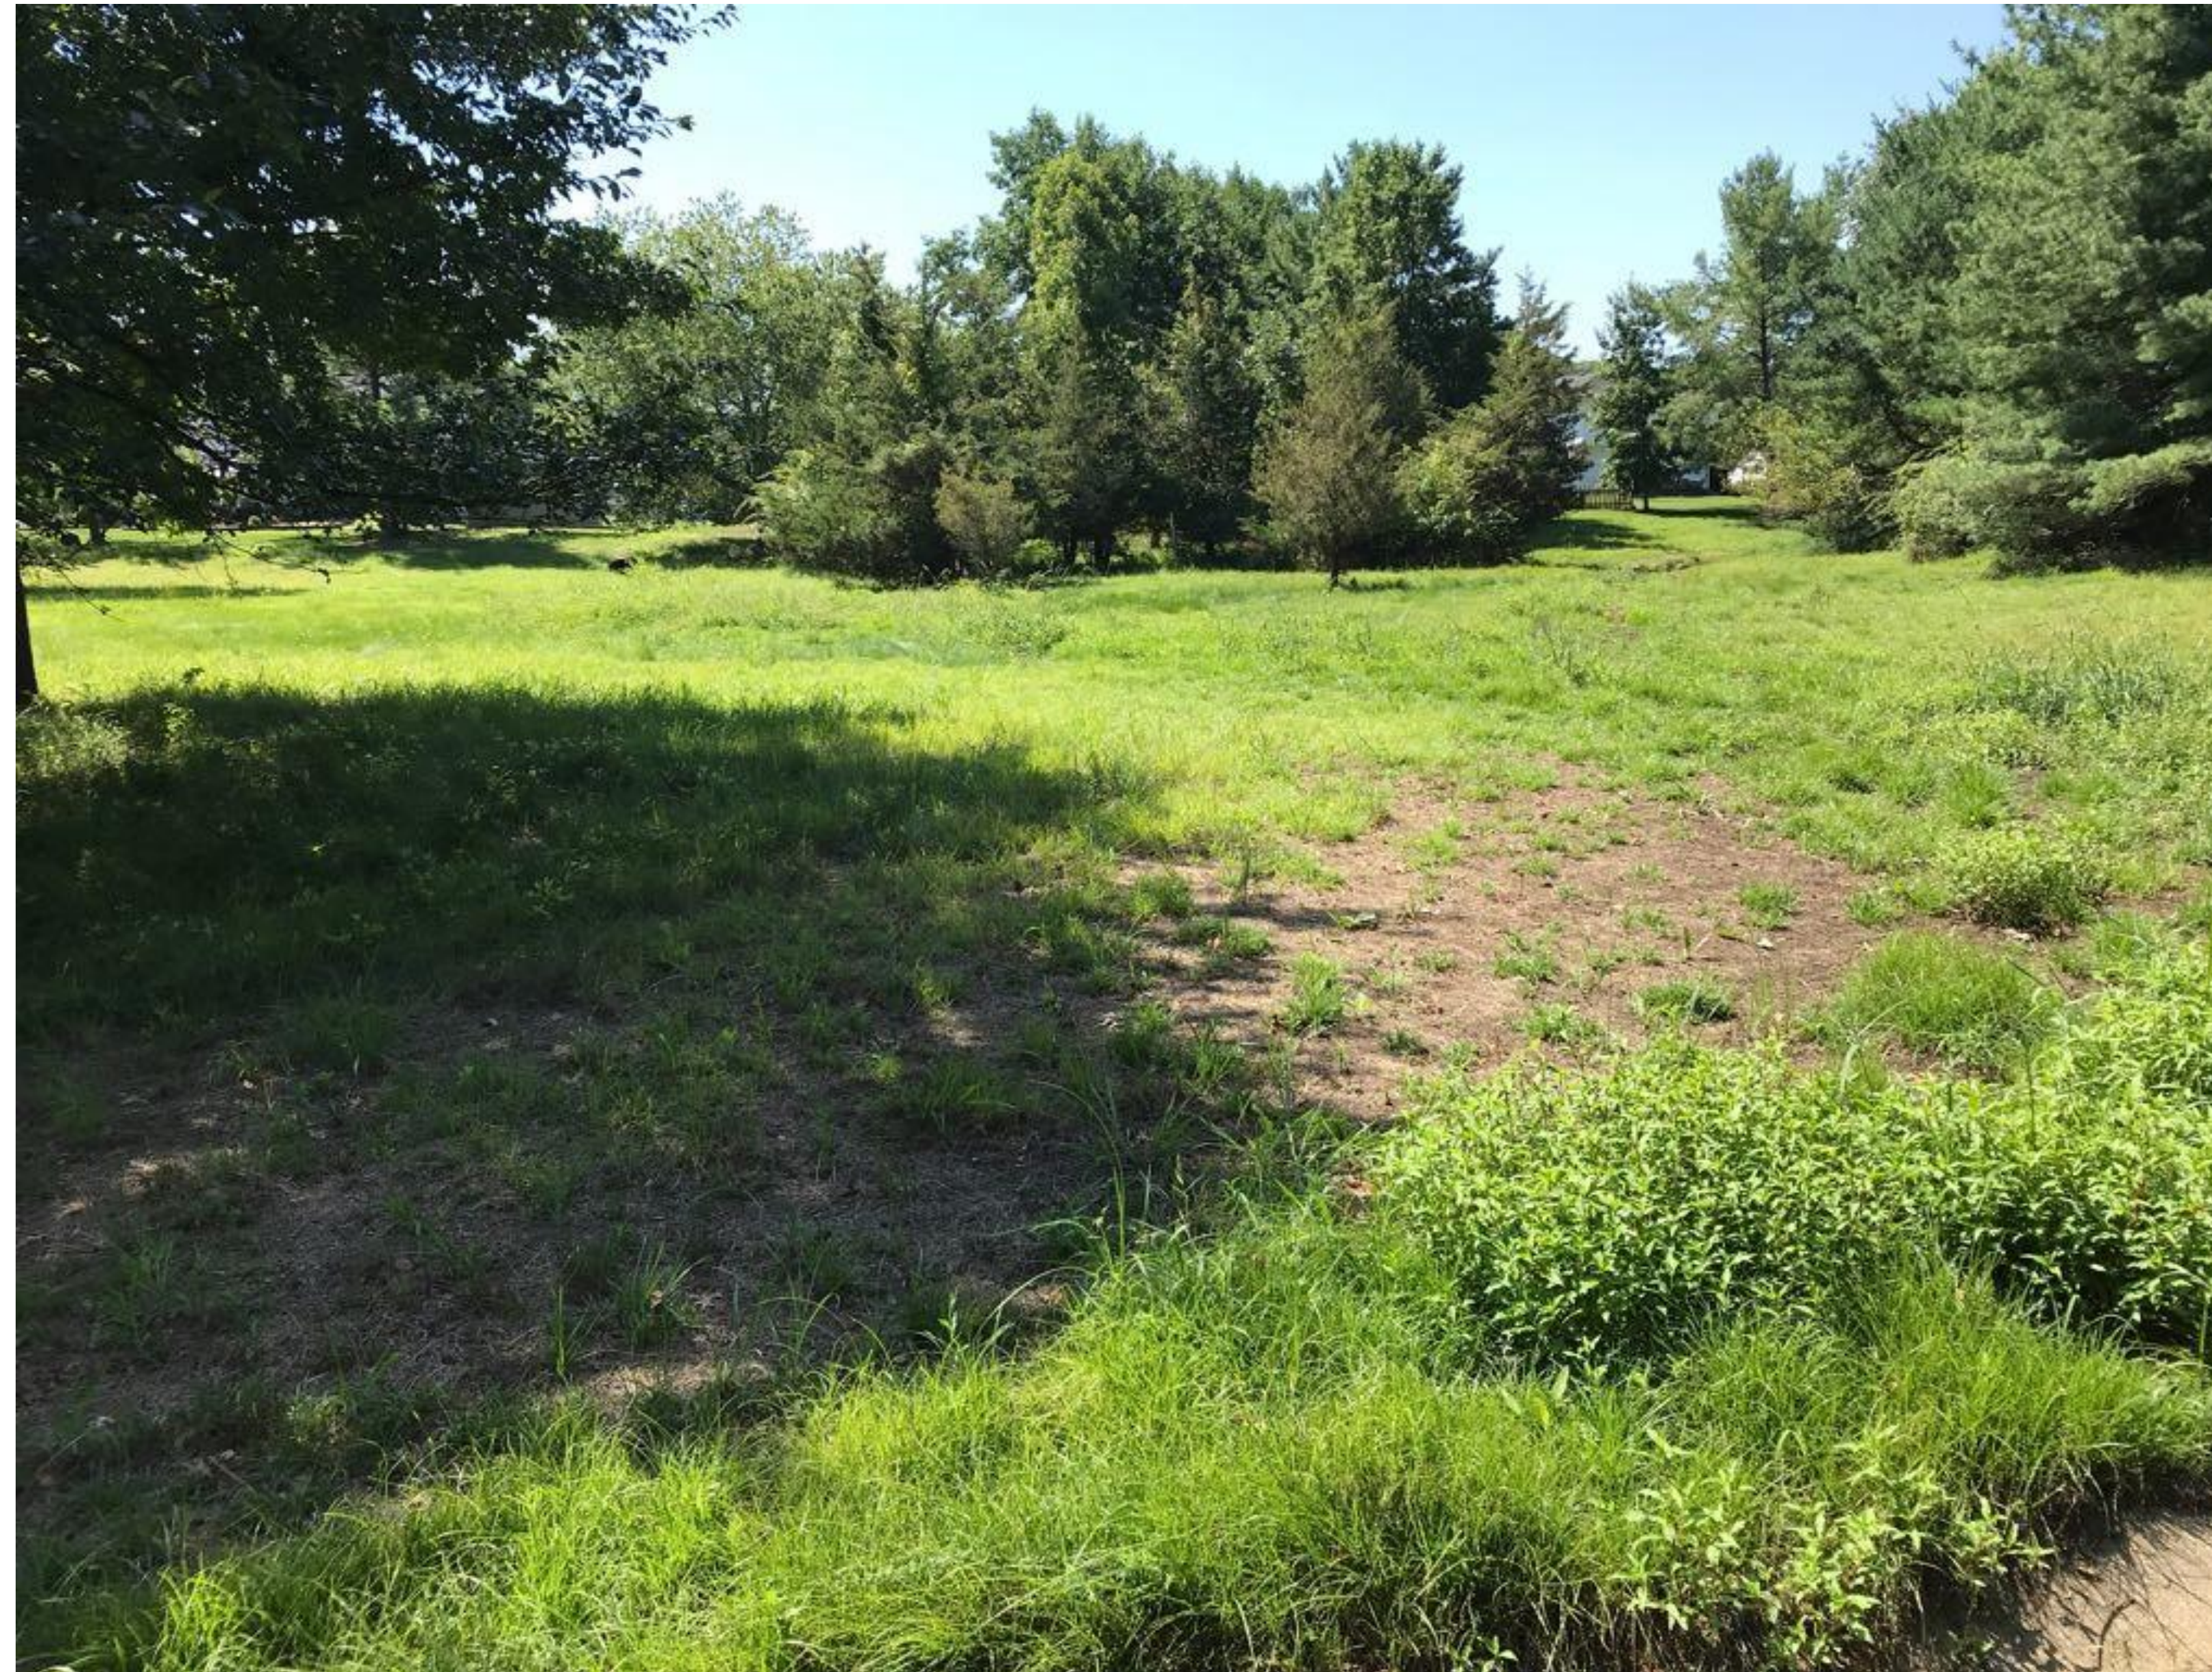
164. Great Oak Road Residential Detention Basin

- Large Infiltration basin with sediment filled low flow channels
- Vegetated with grasses and trees
- Clean out low flow channels and maintain areas with over grown vegetation
- Opportunity to remove low flow channels and replace with stone channels to allow infiltration

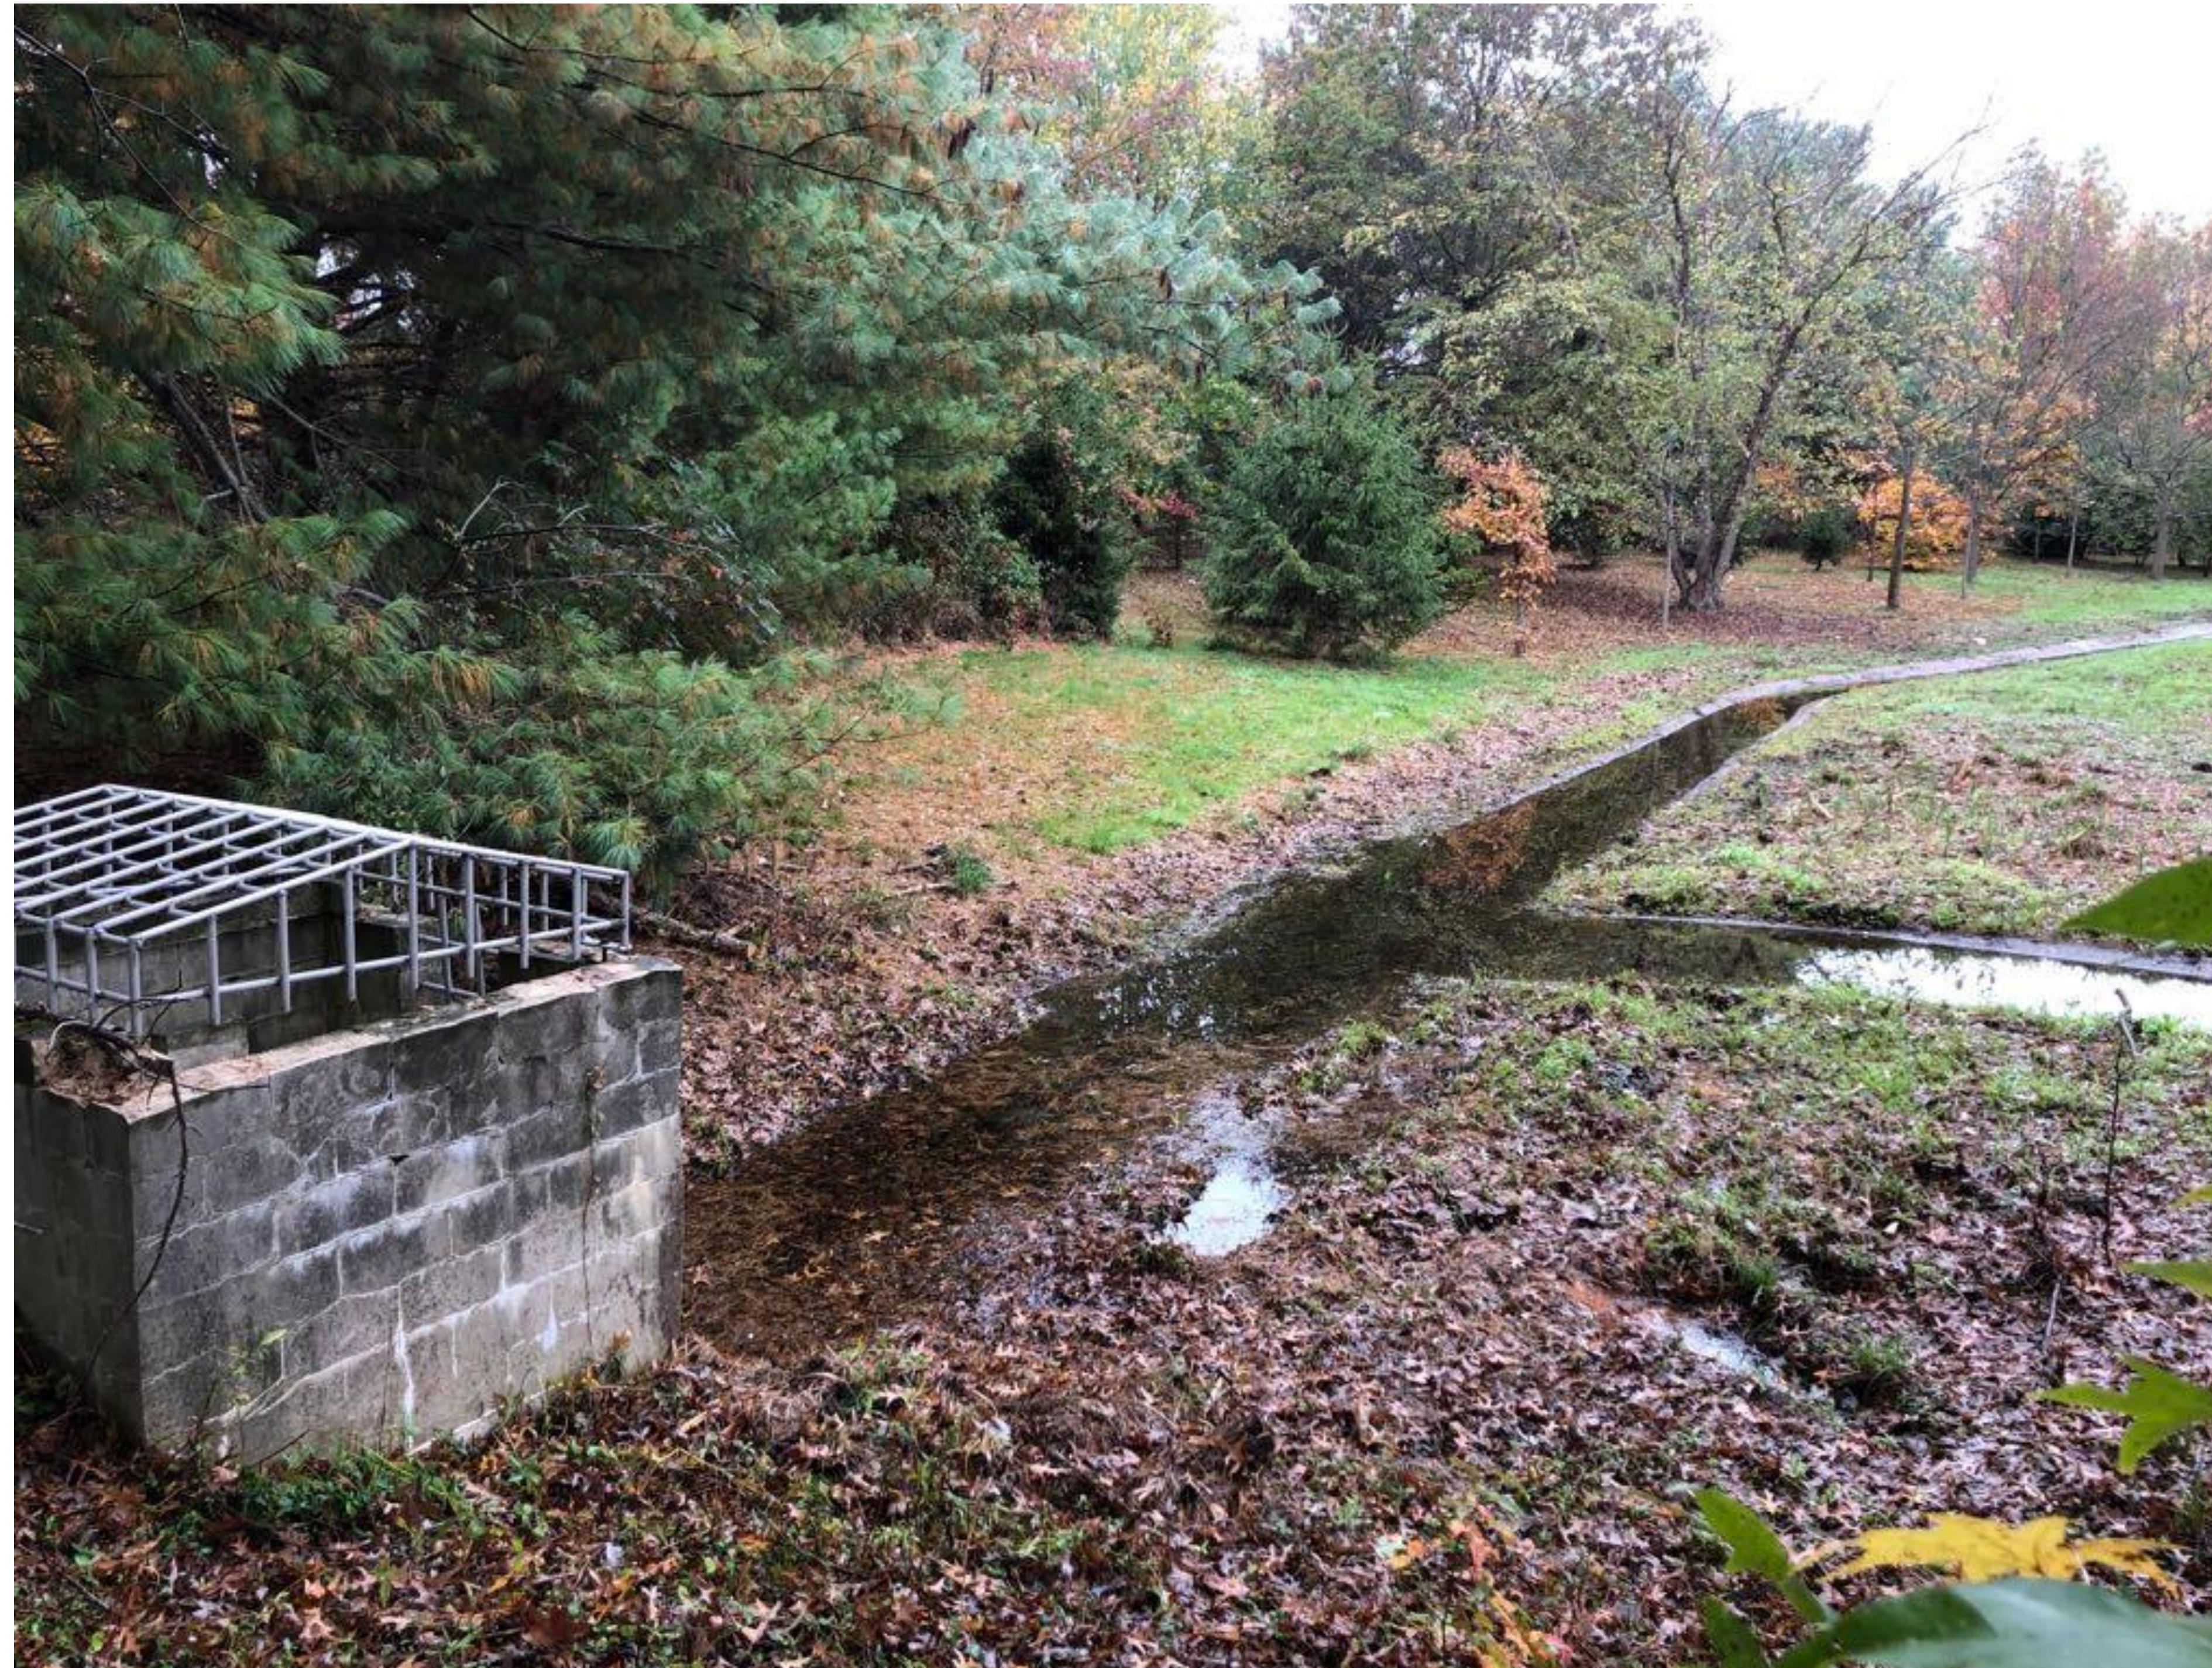
167. Innocenzi Drive Residential Detention Basin (b)

- Significant standing water in low flow channel and near outlet likely due to clogged low flow orifice
- Clear out outlet to allow basin to drain properly
- Low flow channel can be removed and replaced with a stone channel to allow more infiltration in smaller storm events
