**Hamilton Township (Mercer County)
Stormwater Basin Assessment Summary
Hamilton Owned Addendum (Year 5A)**

Developed by the Rutgers Cooperative Extension Water Resources Program
Funded by Hamilton Township, Mercer County, New Jersey

November 27, 2019

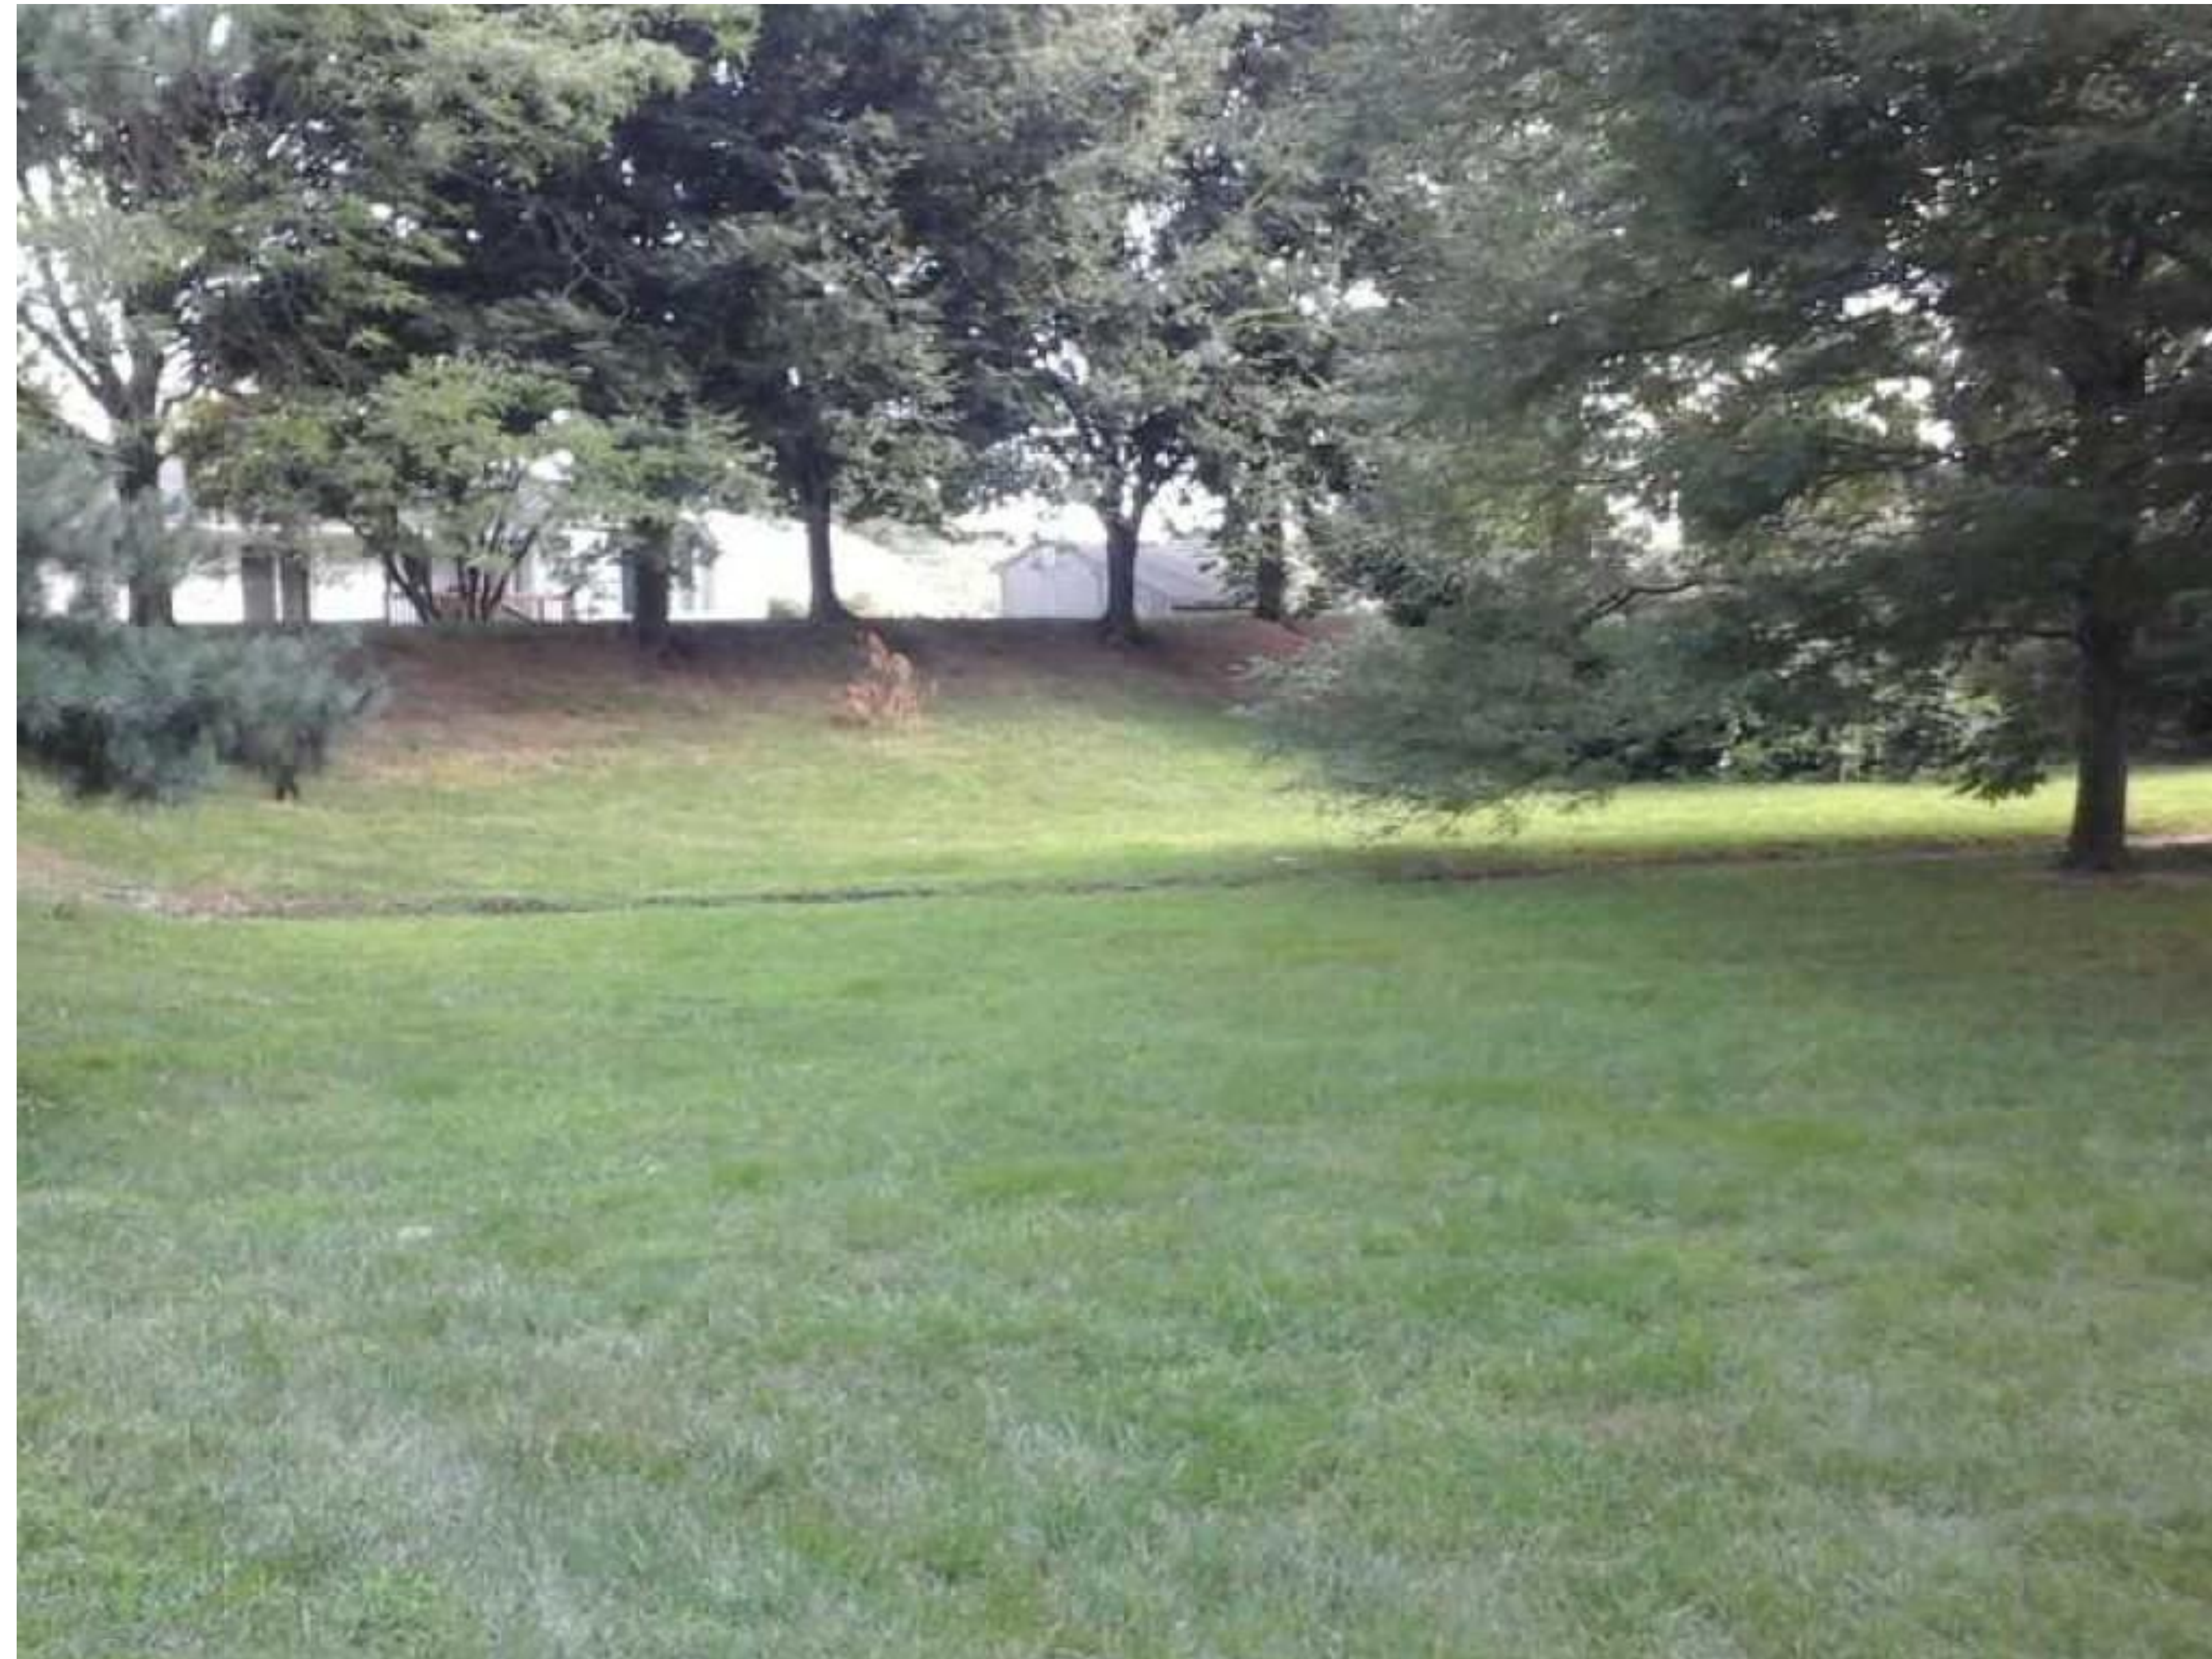
Hamilton Township
Stormwater Basin Assessment
188. Sharps Lane Residential Basin

- Trees existing in basin, some standing water present, fallen tree
- Replace low flow channel with stone channel to reduce standing water and allow infiltration
- Naturalize with herbaceous plants

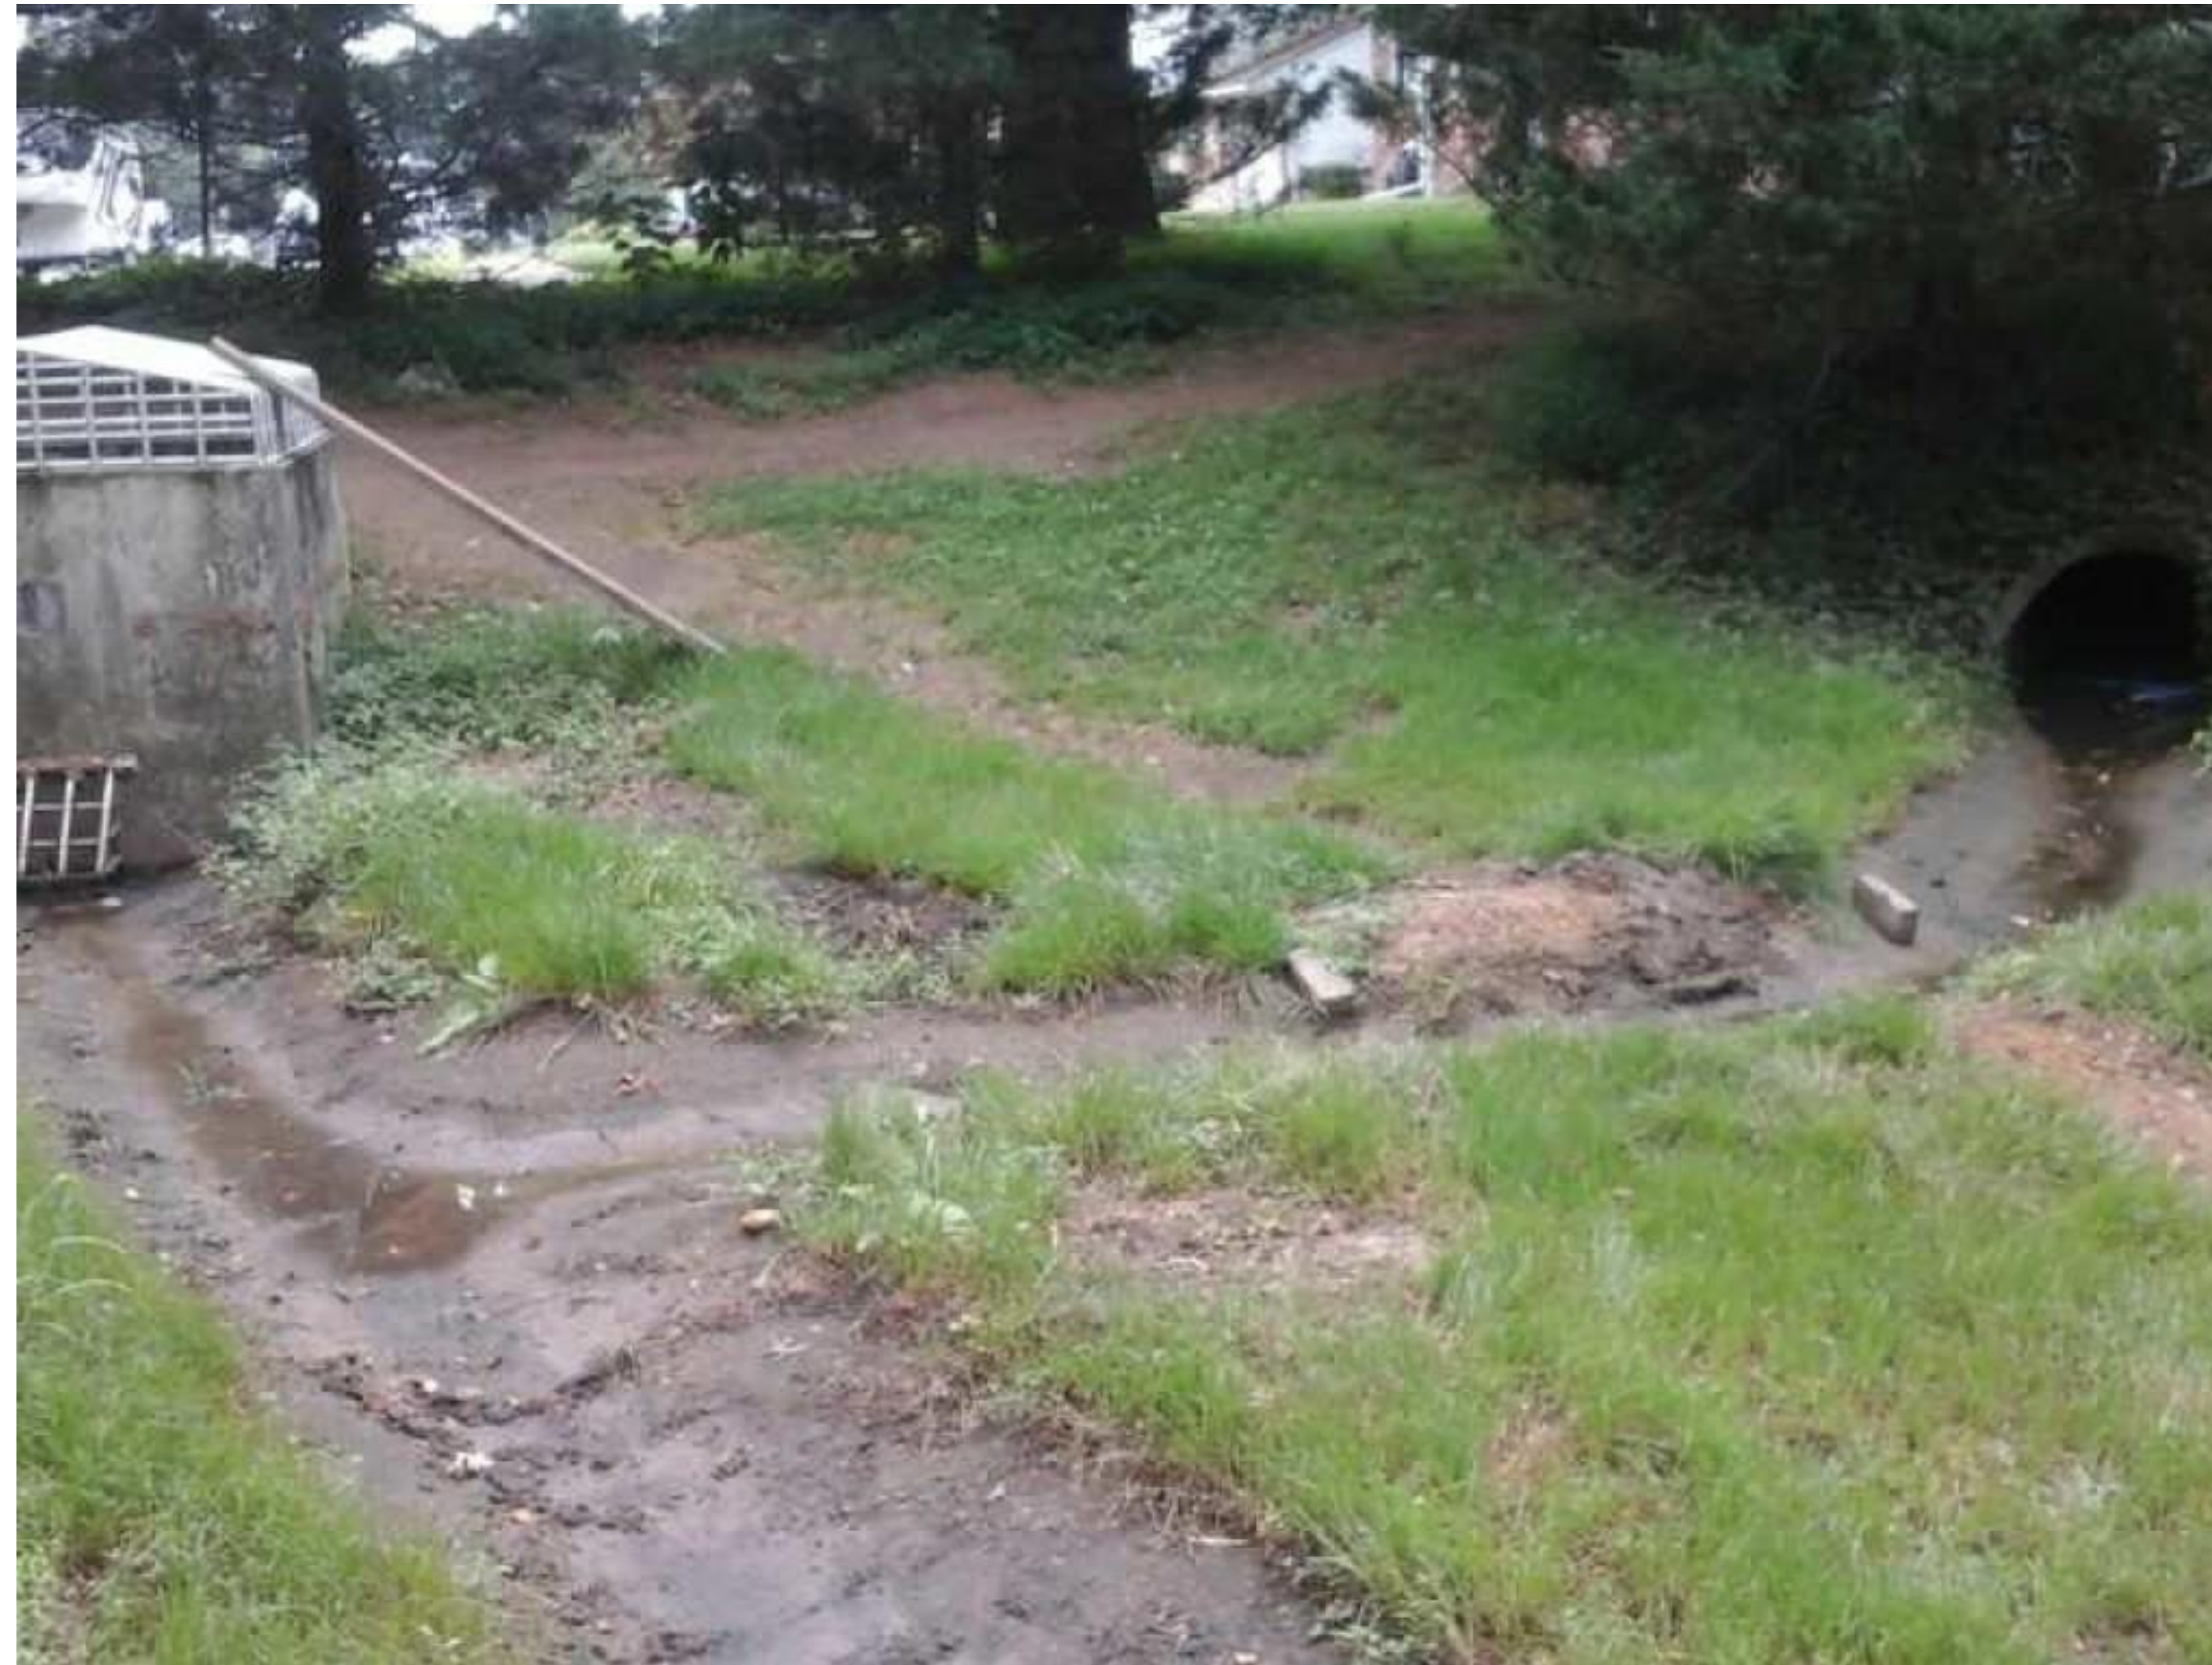
Hamilton Township
Stormwater Basin Assessment
190. Dark Leaf Drive Residential Basin

- Erosion present in basin
- Slight standing water in low flow channels
- Remove low flow channel to allow more infiltration
- Naturalize with herbaceous plants to help reduce erosion

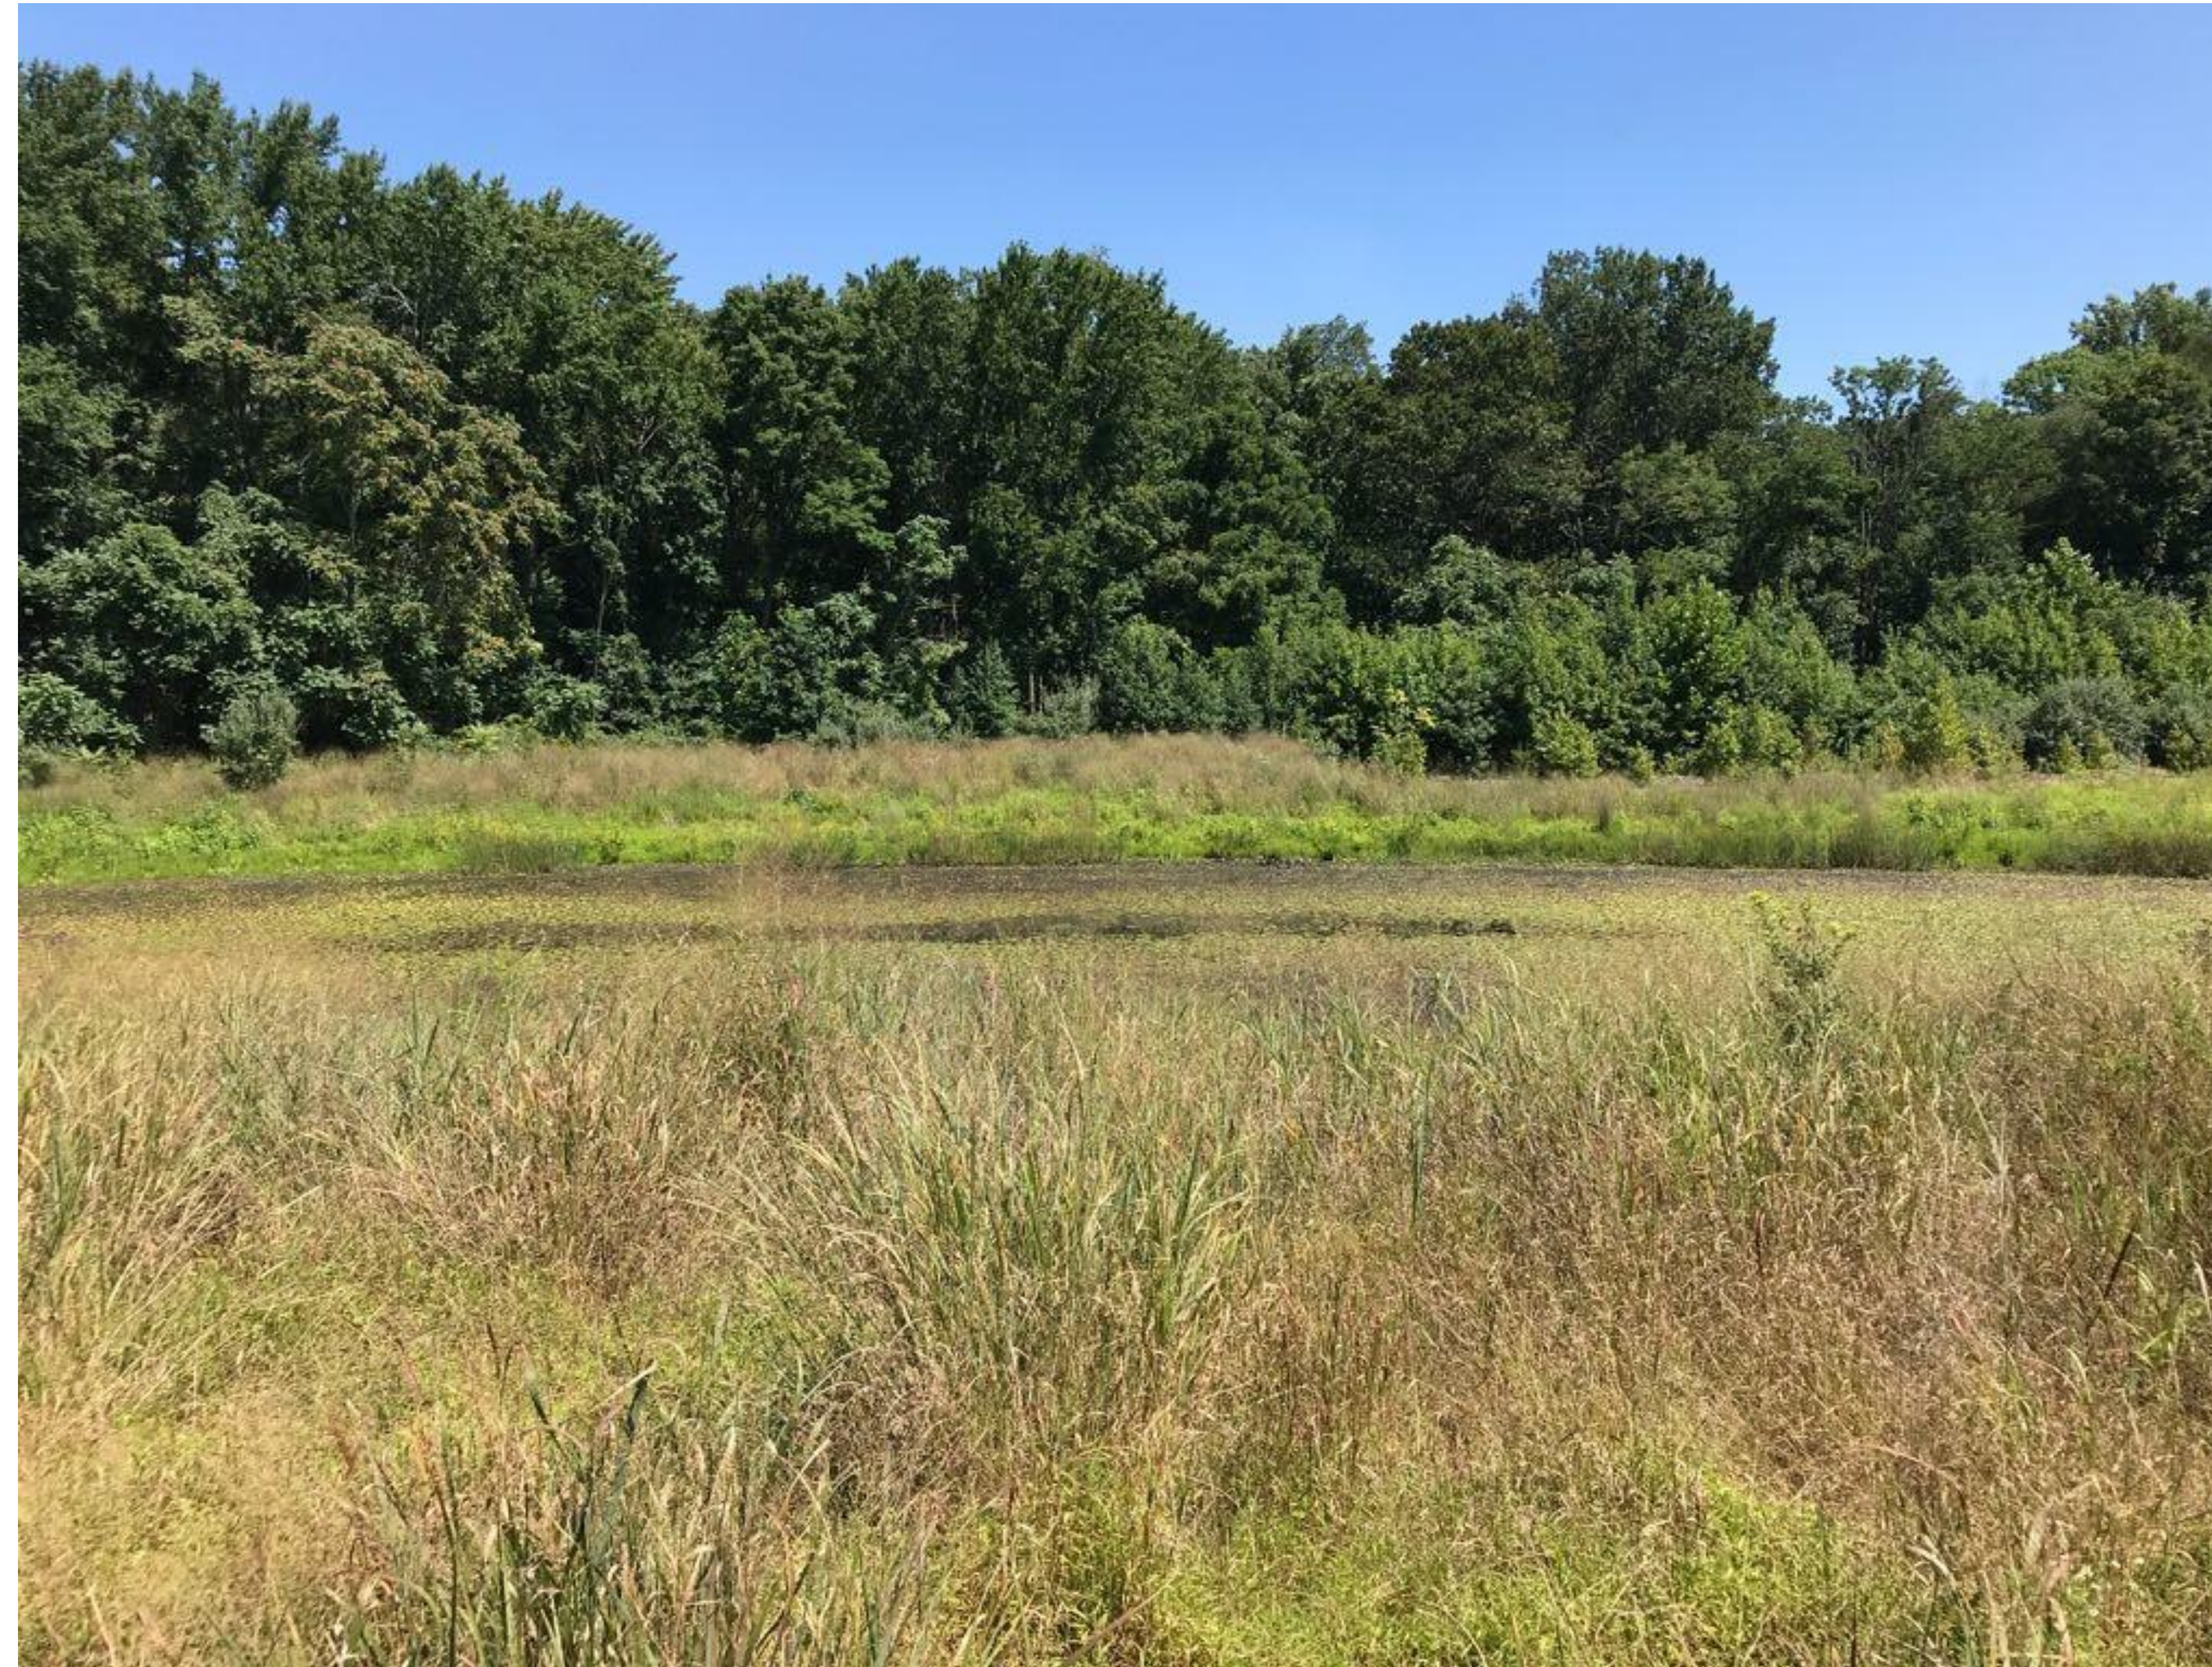
Hamilton Township
Stormwater Basin Assessment
238. Weathersfield Drive Residential Basin

- 2014 report did not include notes for this basin as retention basins were not being fully assessed at the time
- Massive retention basin surrounded by thick vegetation
- Appears in good condition, no recommendation

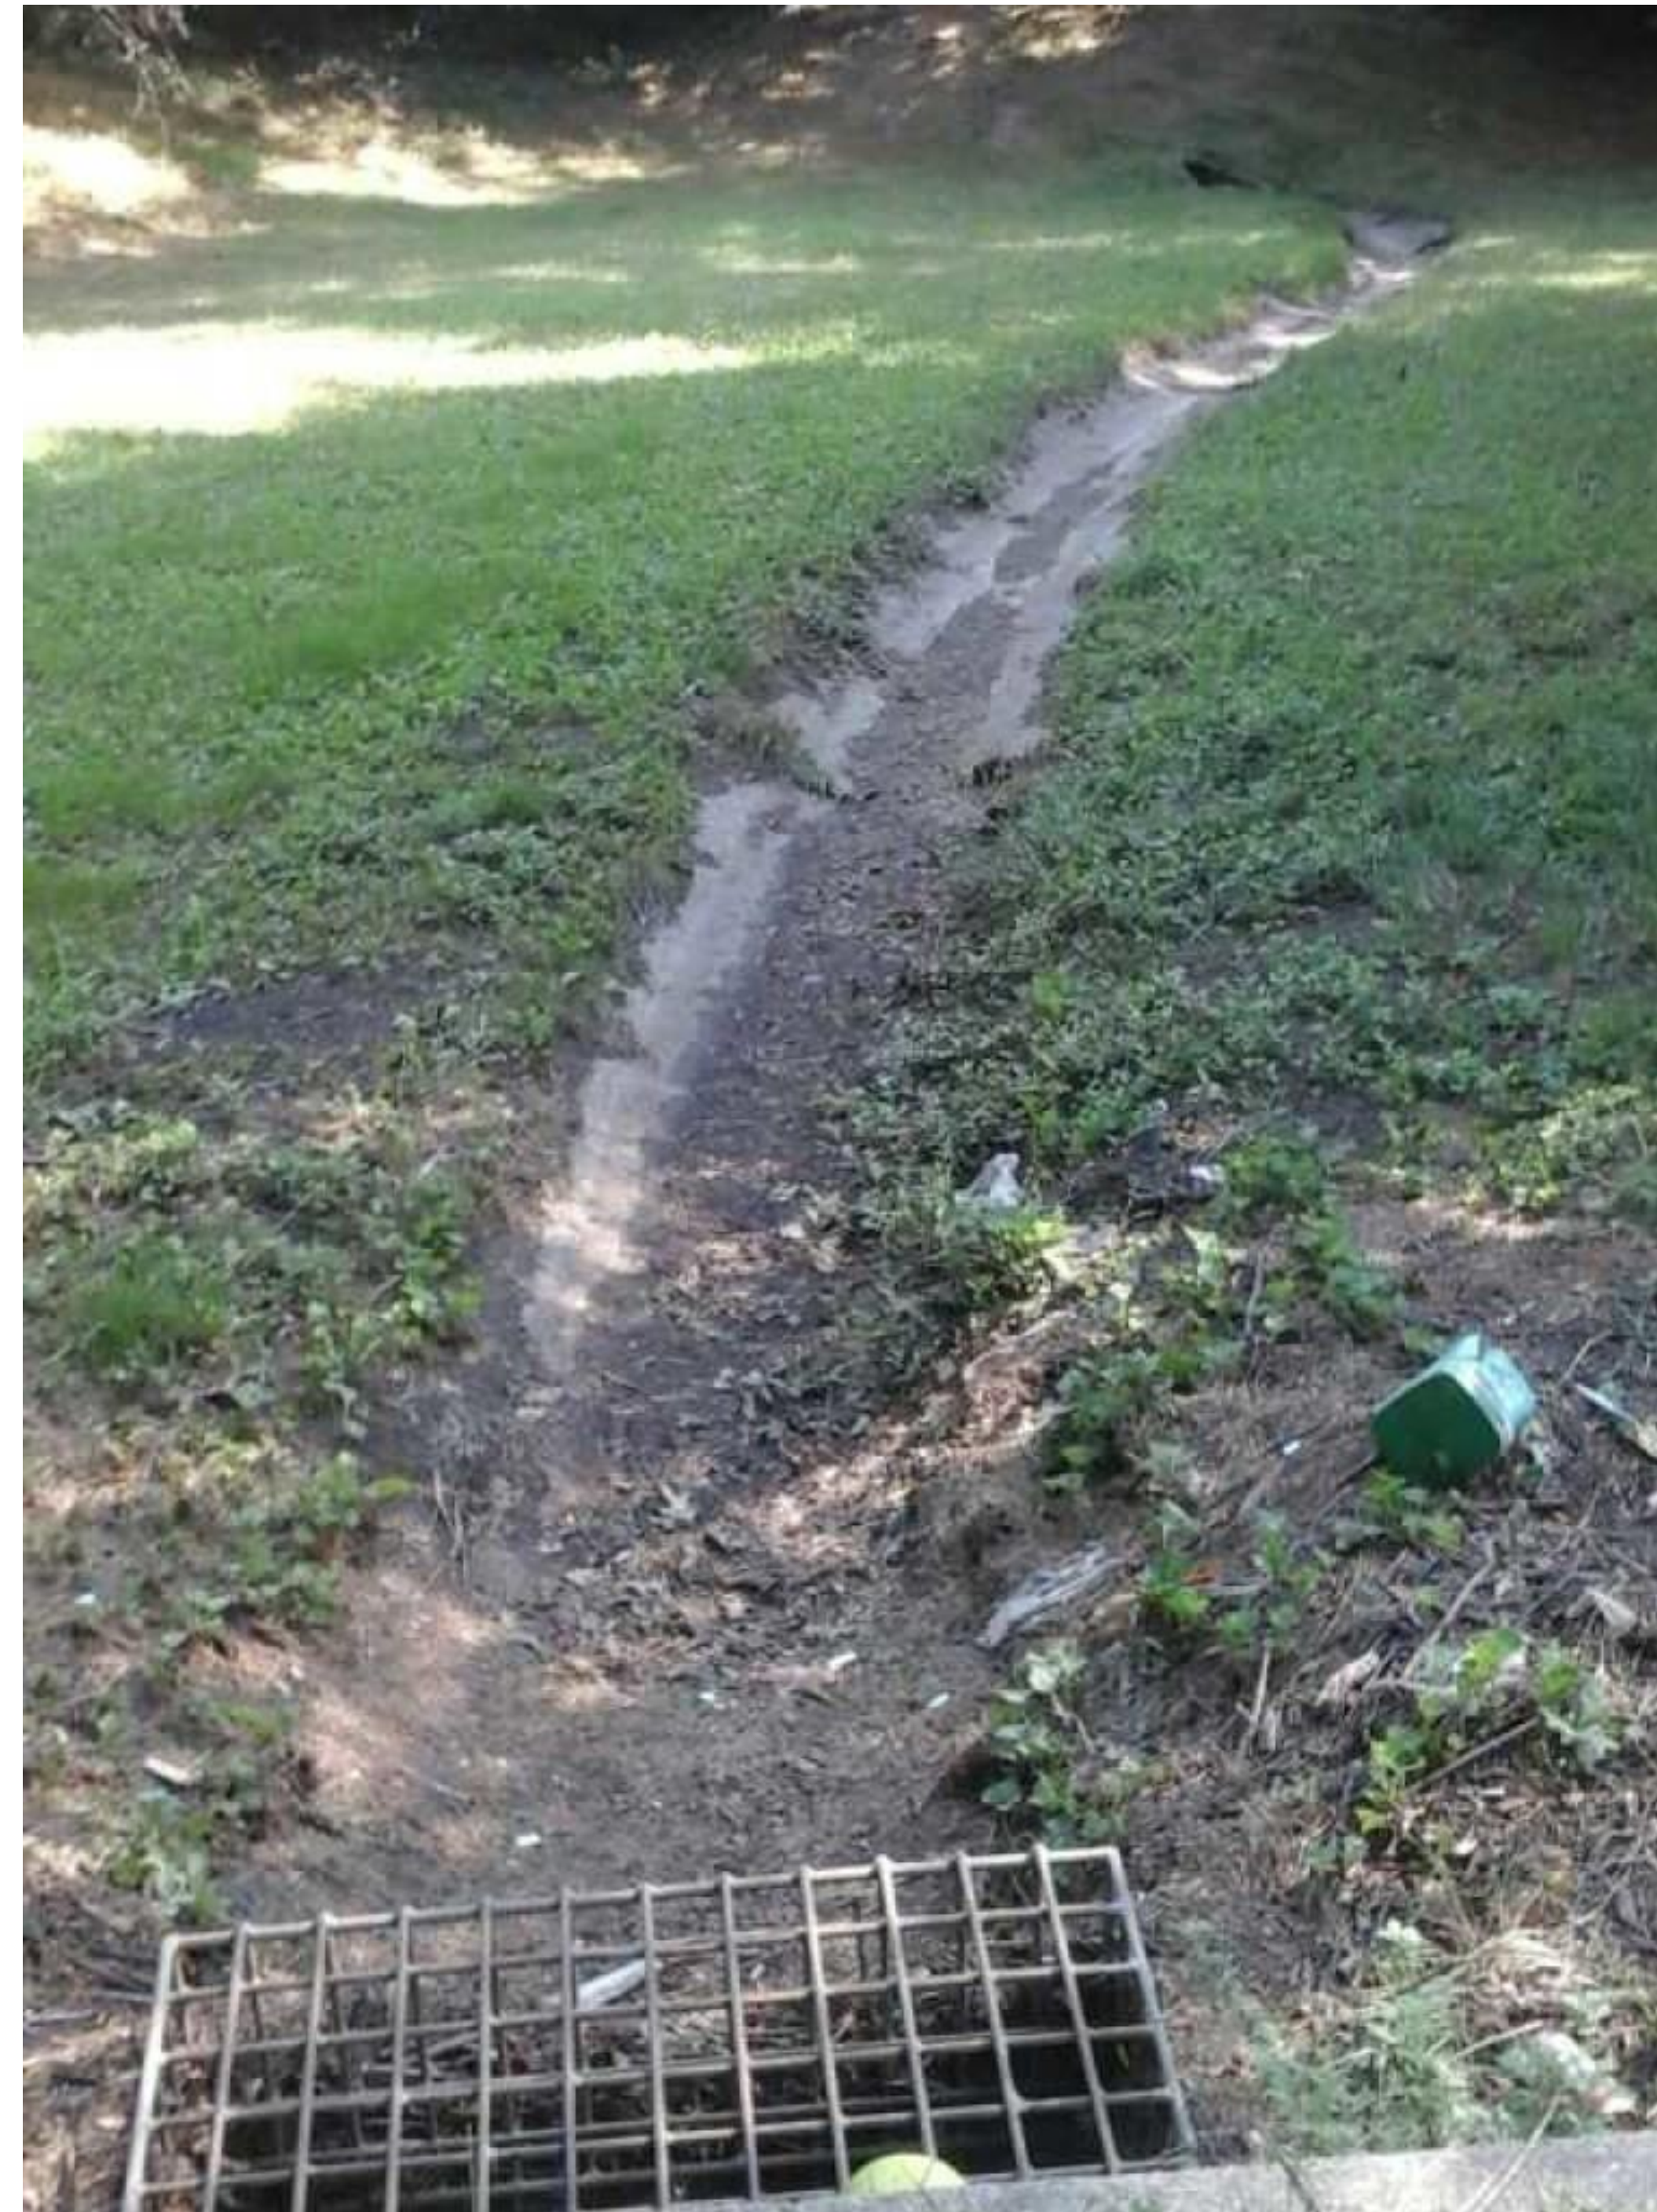
Hamilton Township
Stormwater Basin Assessment
264. Perilli Drive Residential Basin

- Outlet has excessive sediment accumulation clogging low flow orifice
- Remove low flow channel and replace with a rock-lined channel to allow infiltration
- Naturalize with herbaceous plants

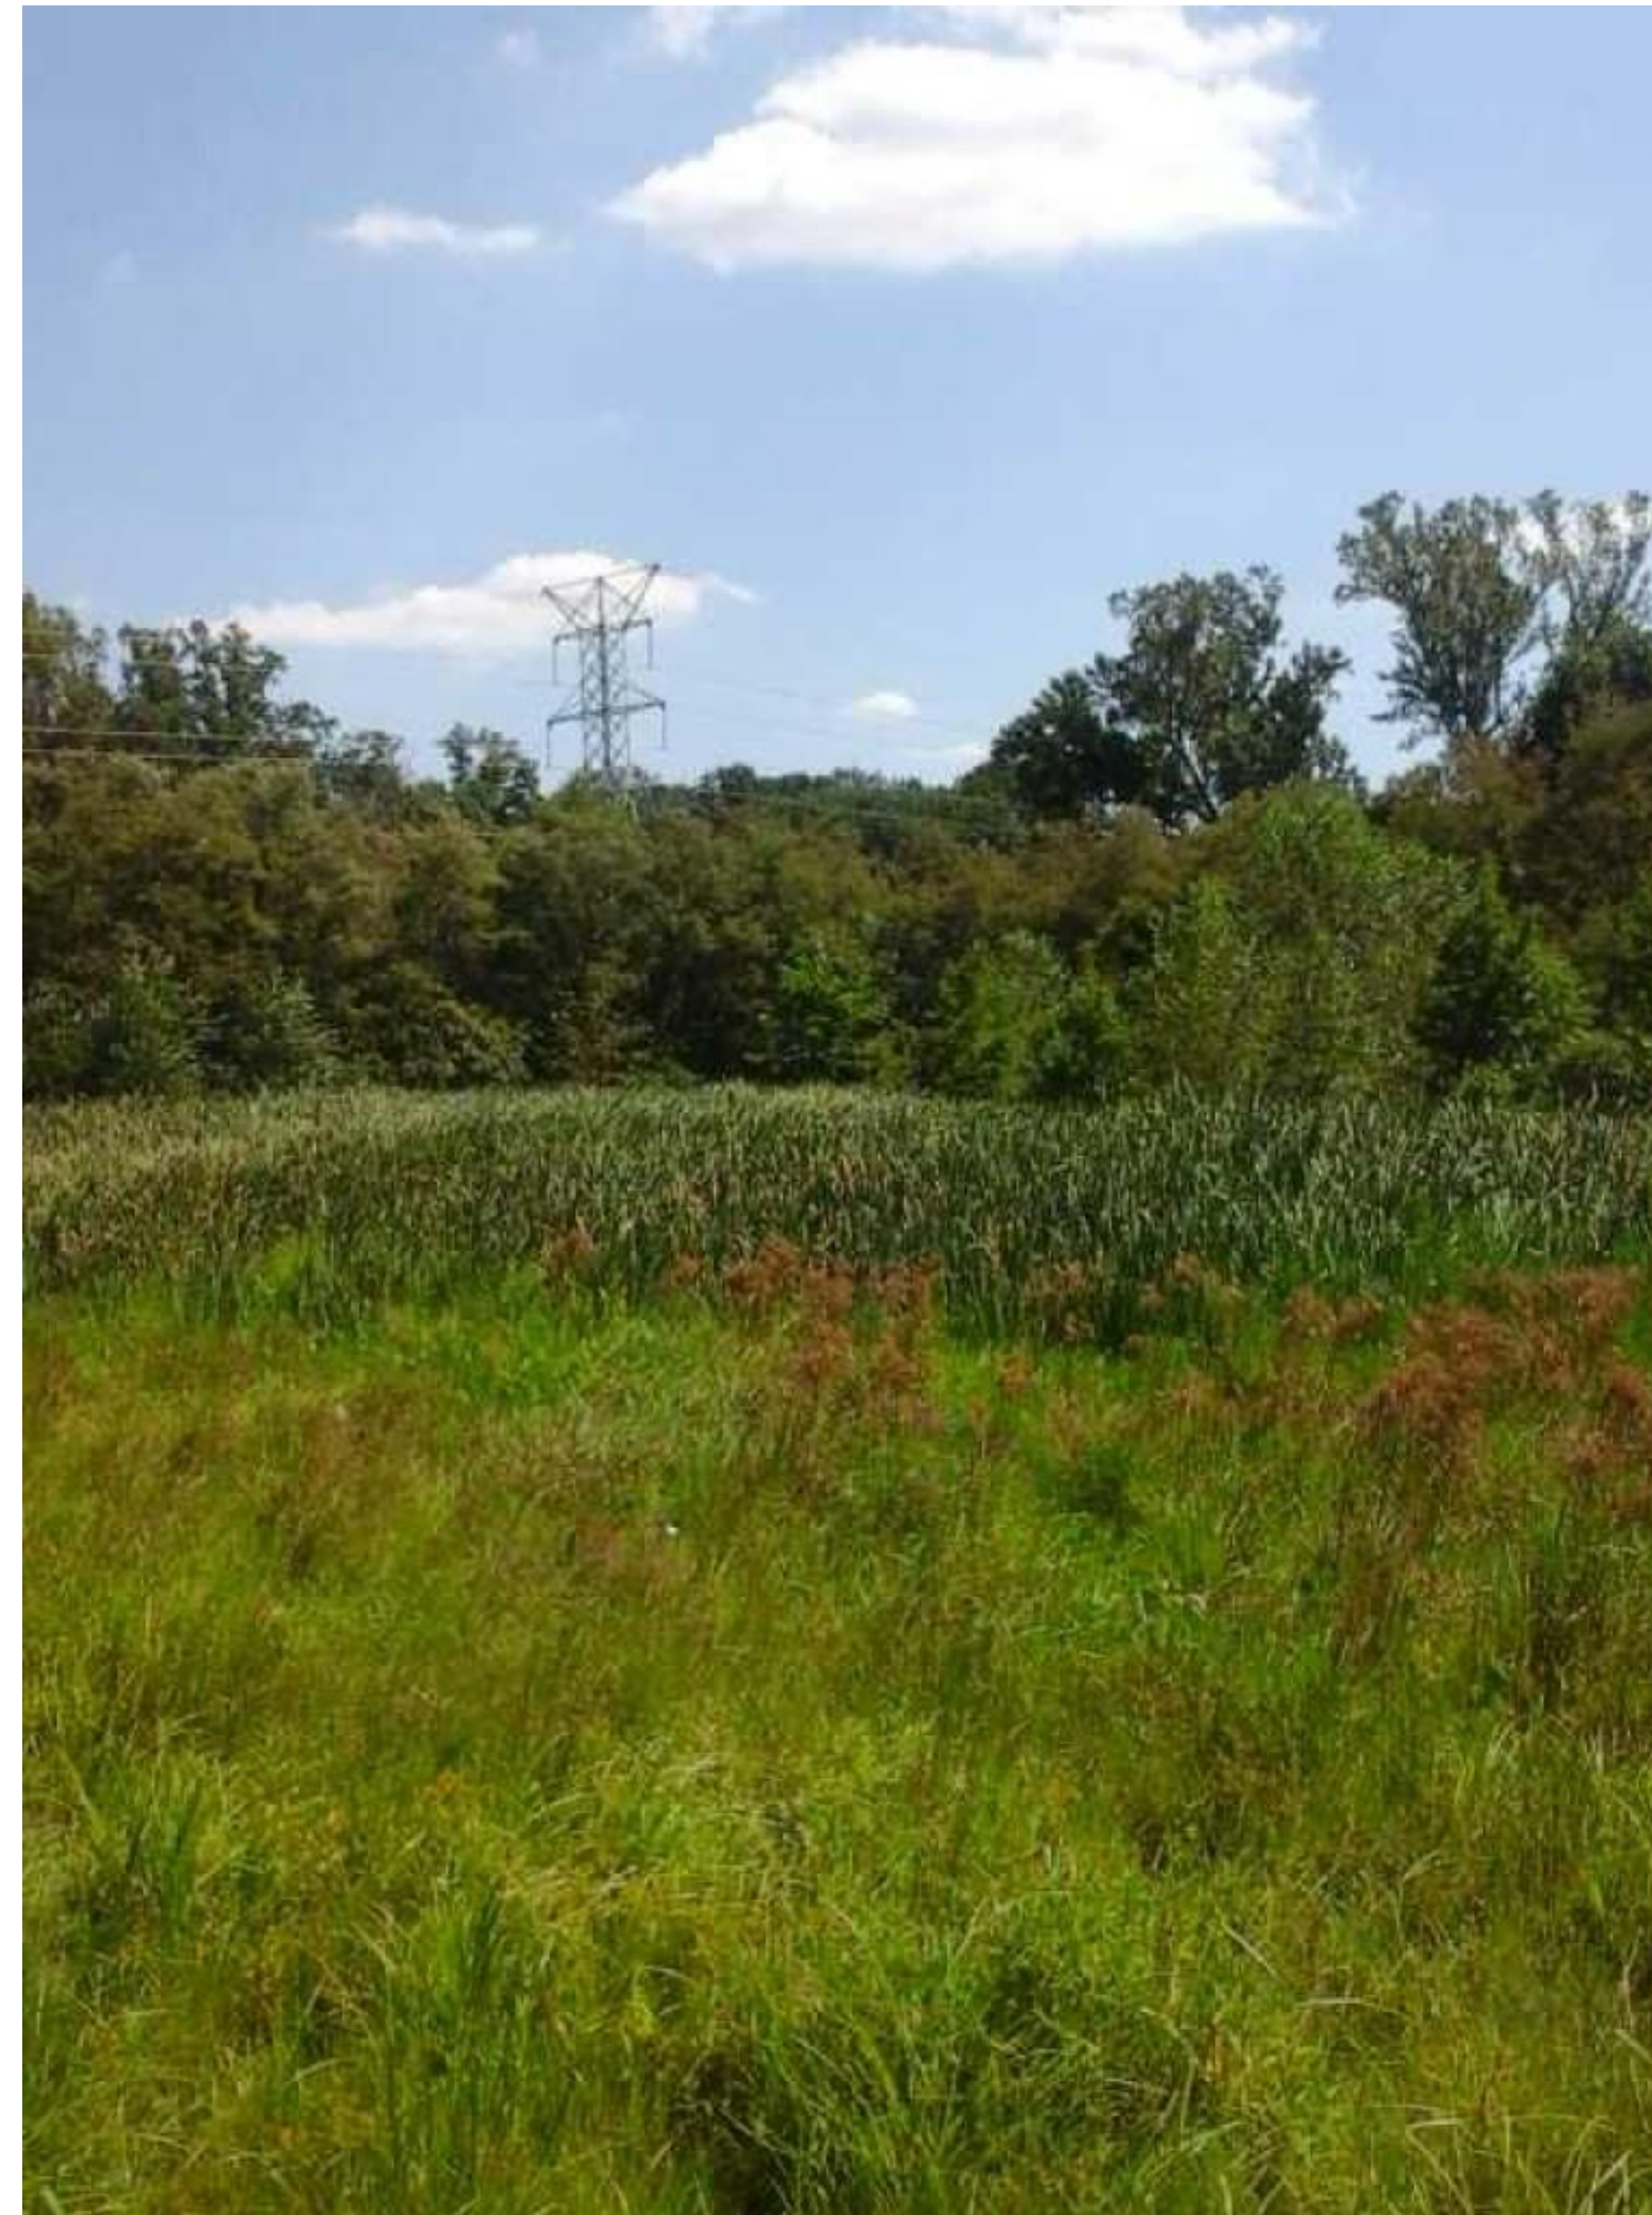
Hamilton Township
Stormwater Basin Assessment
269. Kristopher Drive Residential Basin

- Well establish meadow in basin with vegetation in good condition
- Better access to inlets and outlet could be added

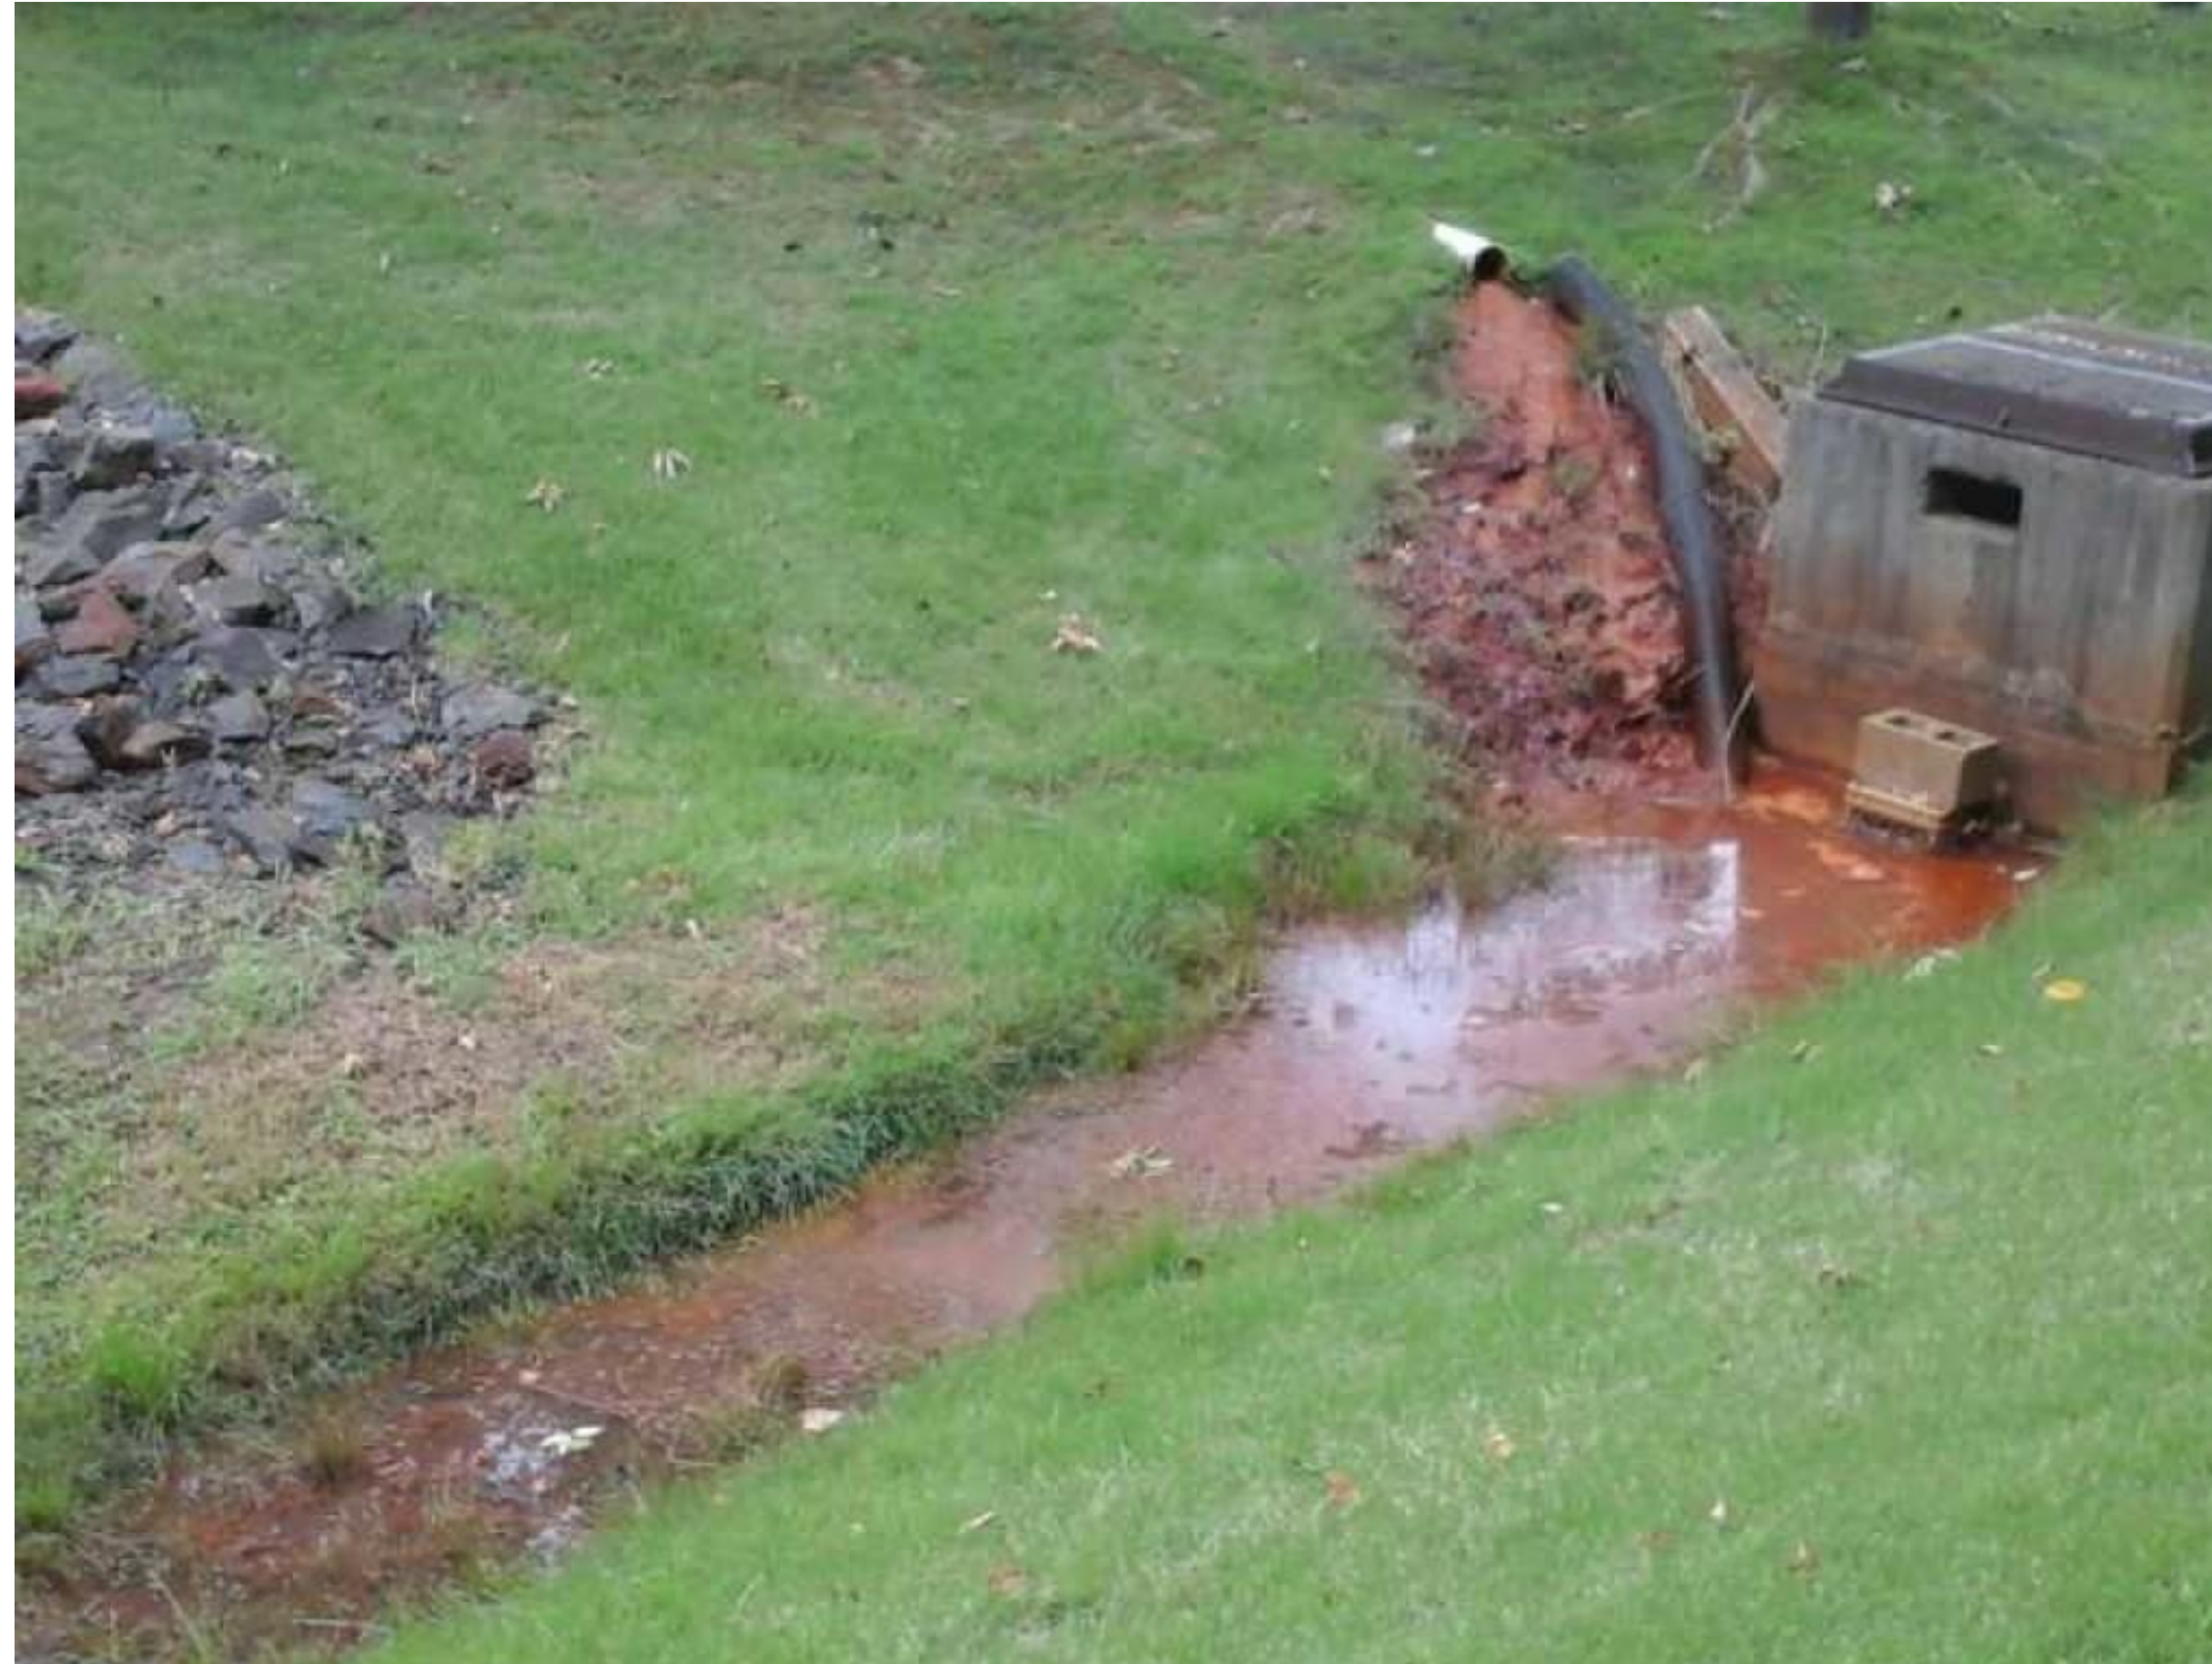
Hamilton Township
Stormwater Basin Assessment
288. Russo Music Center Basin

- The low flow outlet appears to be clogged leading to significant standing water in low flow channel
- Heavy erosion caused by small inlet pipe should be remediated
- Low flow channel can be replaced with a stone channel to provide better infiltration in smaller storm events
