**Hamilton Township (Mercer County)
Stormwater Basin Assessment Summary
Hamilton Owned Addendum (Year 5A)**

Developed by the Rutgers Cooperative Extension Water Resources Program
Funded by Hamilton Township, Mercer County, New Jersey

November 27, 2019

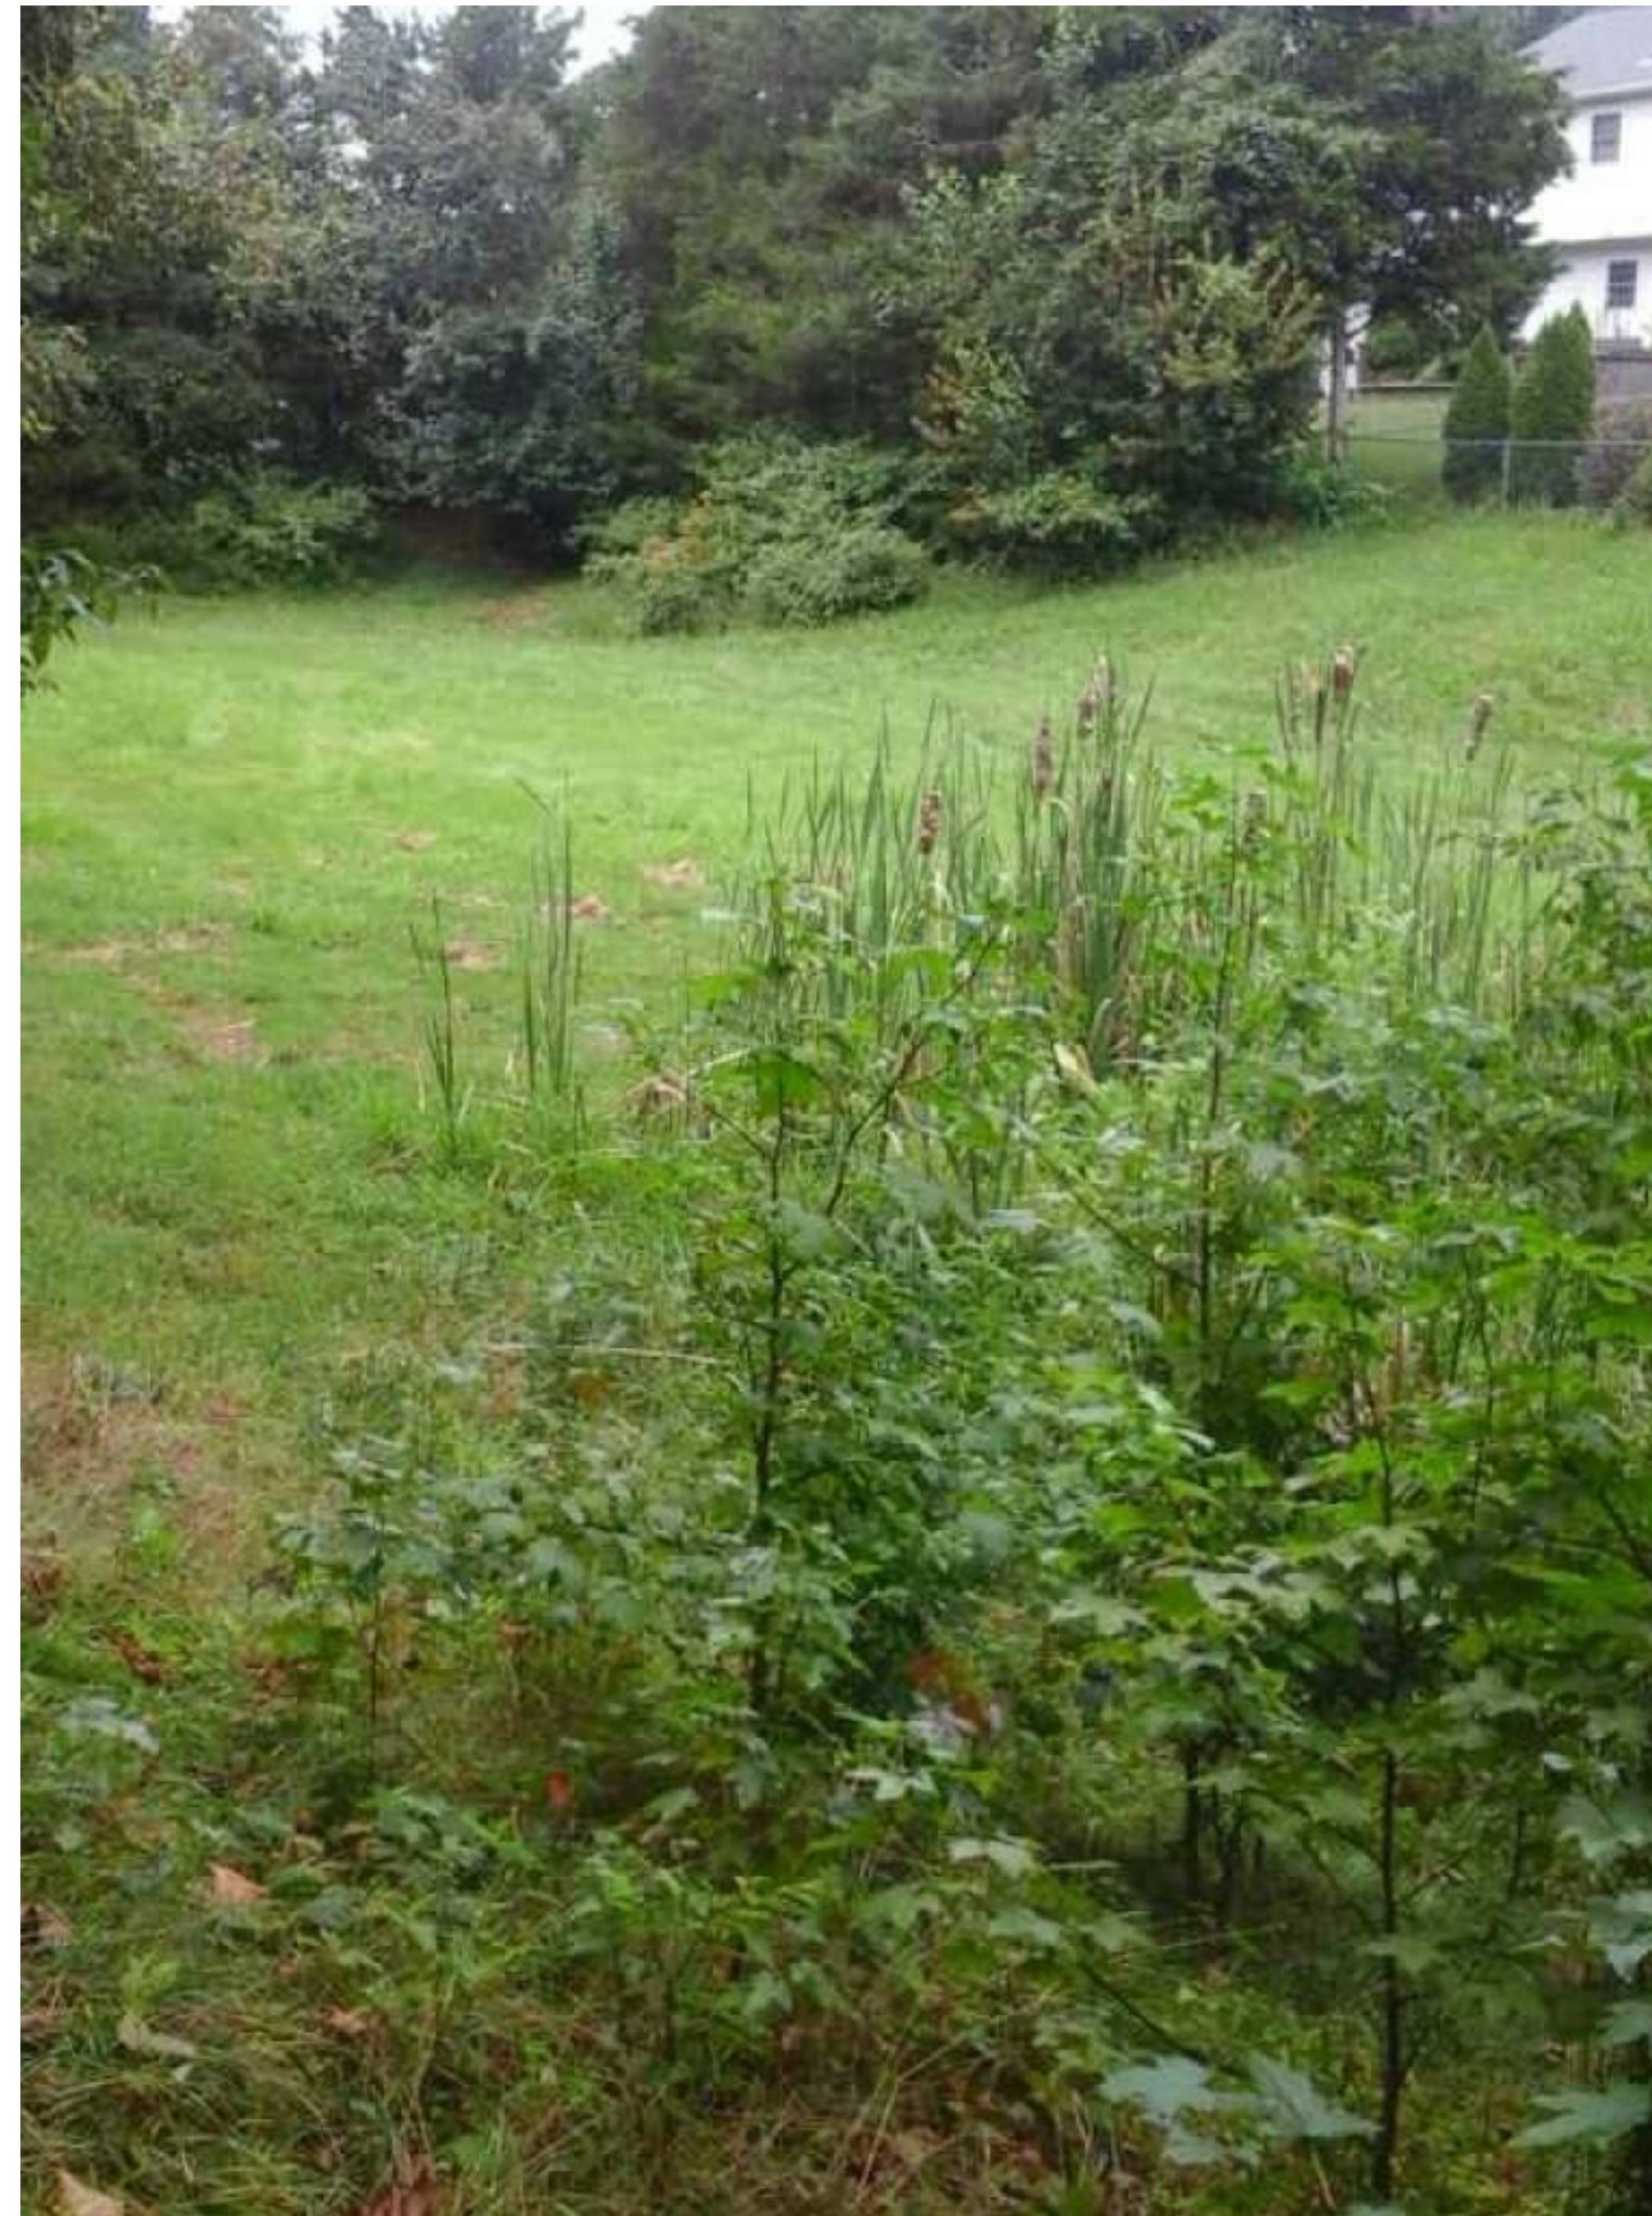
Hamilton Township
Stormwater Basin Assessment
303. Englewood Boulevard Residential Basin

- No notes from 2014, was believed to be a retention basin which were not fully assessed at the time
- May be detention or infiltration basin and is adjacent to a natural pond in the forested area
- Lots of herbaceous vegetation growing in portion of basin

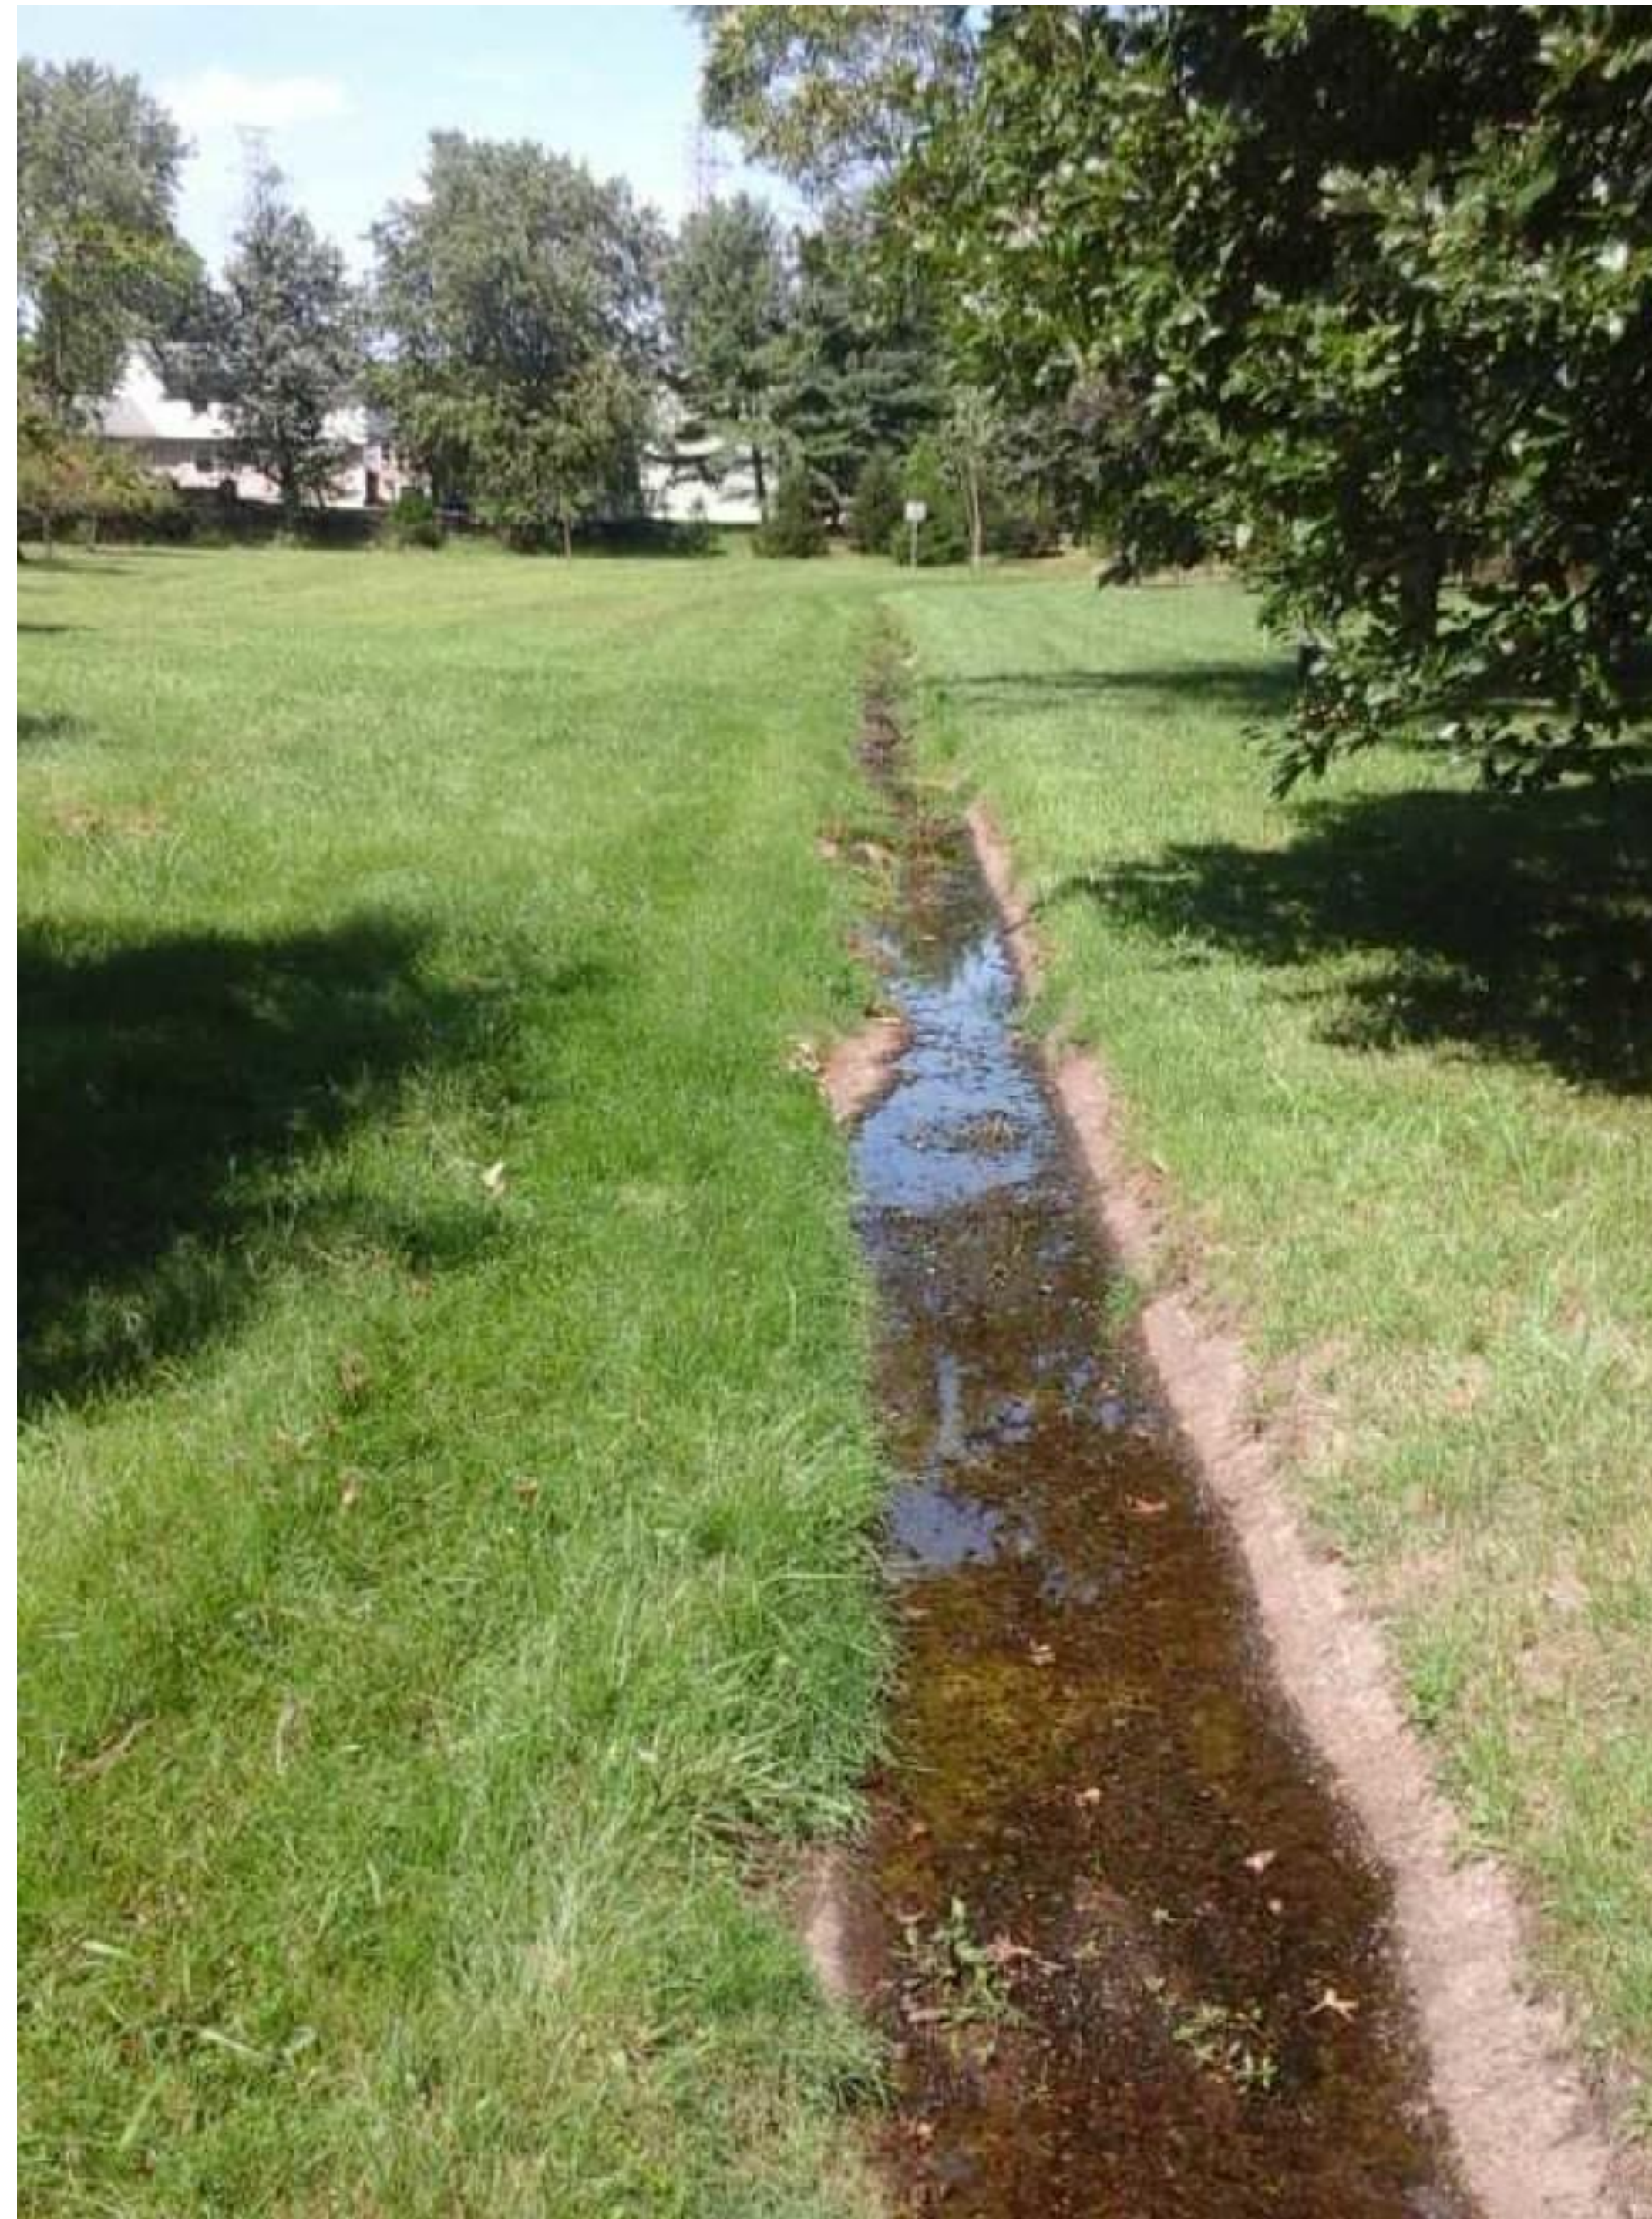
Hamilton Township
Stormwater Basin Assessment
315. Hobbs Road Residential Basin

- Sediment build up and grass in low flow channel leading to standing water
- Raise primary catch basin outlet and add low flow orifice to increase detention capacity
- Remove concrete low flow and add stone channel to enhance infiltration capacity
- Naturalize with herbaceous plants

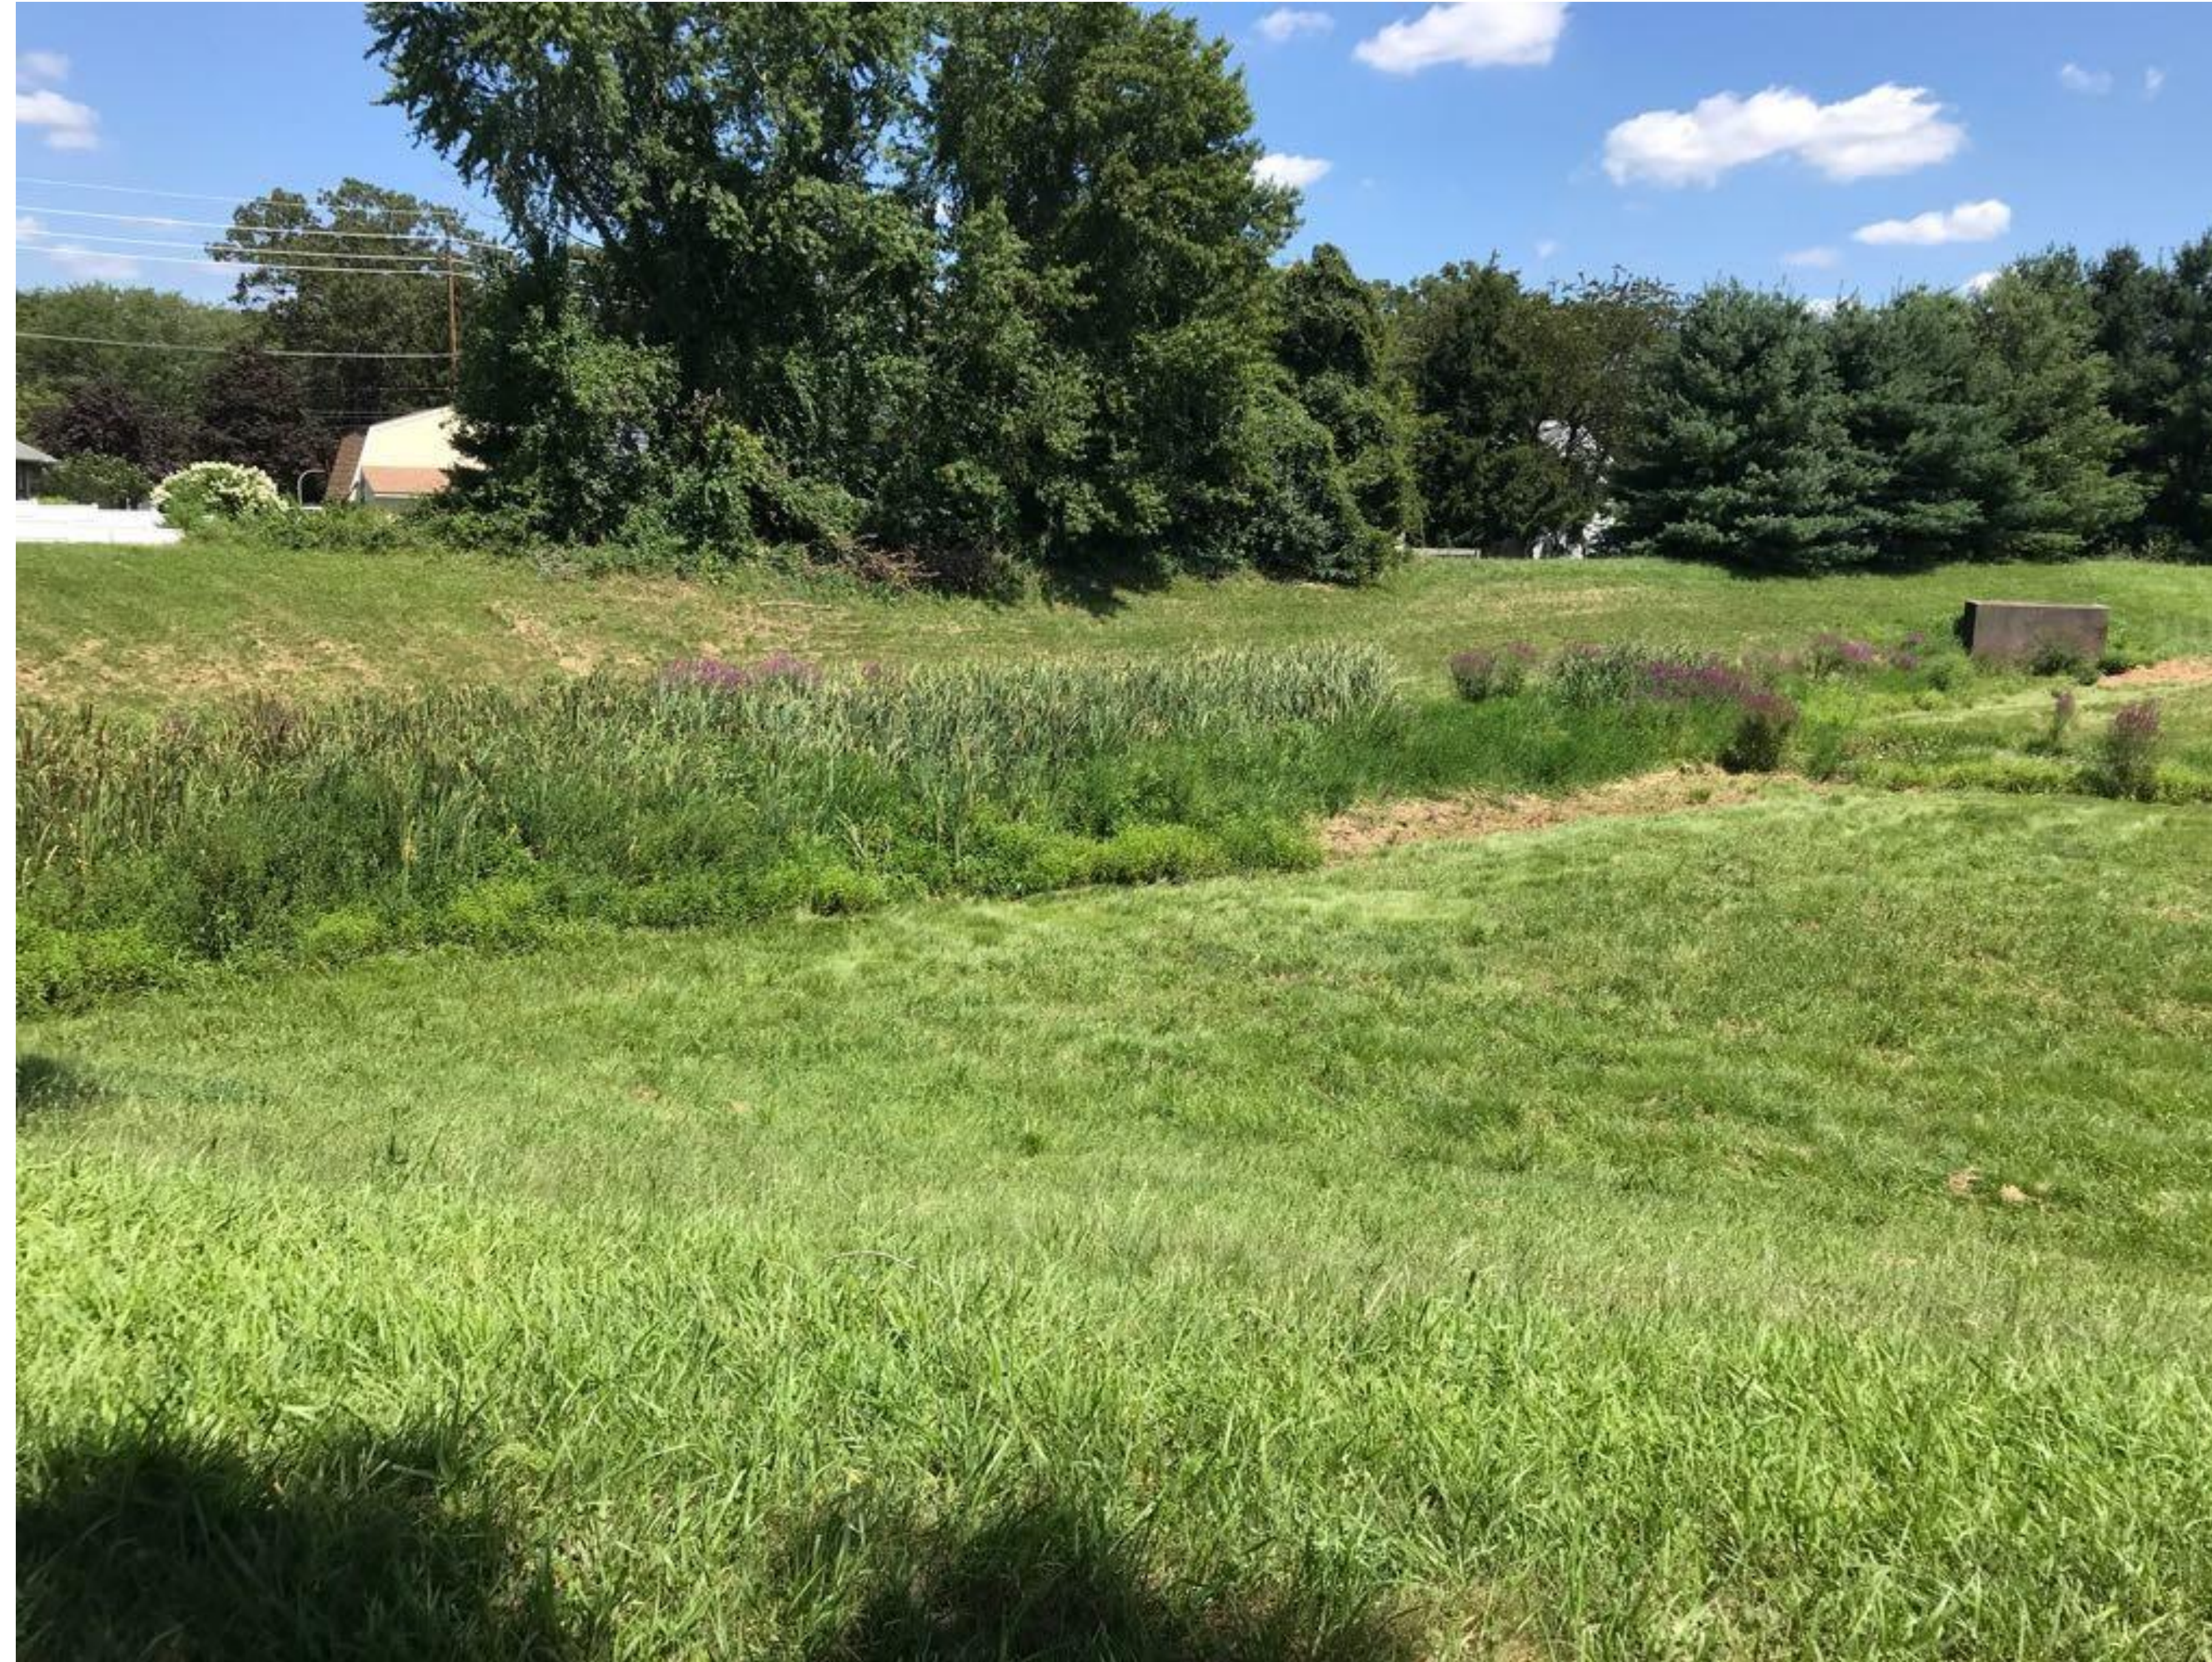
Hamilton Township
Stormwater Basin Assessment
332. Robin Drive Residential Basin

- Large vegetation growth around the channels. Large plants such as cat tails and lavender
- Make sure inflow and outflow areas are not too restricted by vegetation
- Low flow channel should be removed for proper naturalization to allow water to infiltrate
- Allow rest of basin to naturalize by converting to meadow by reducing mowing

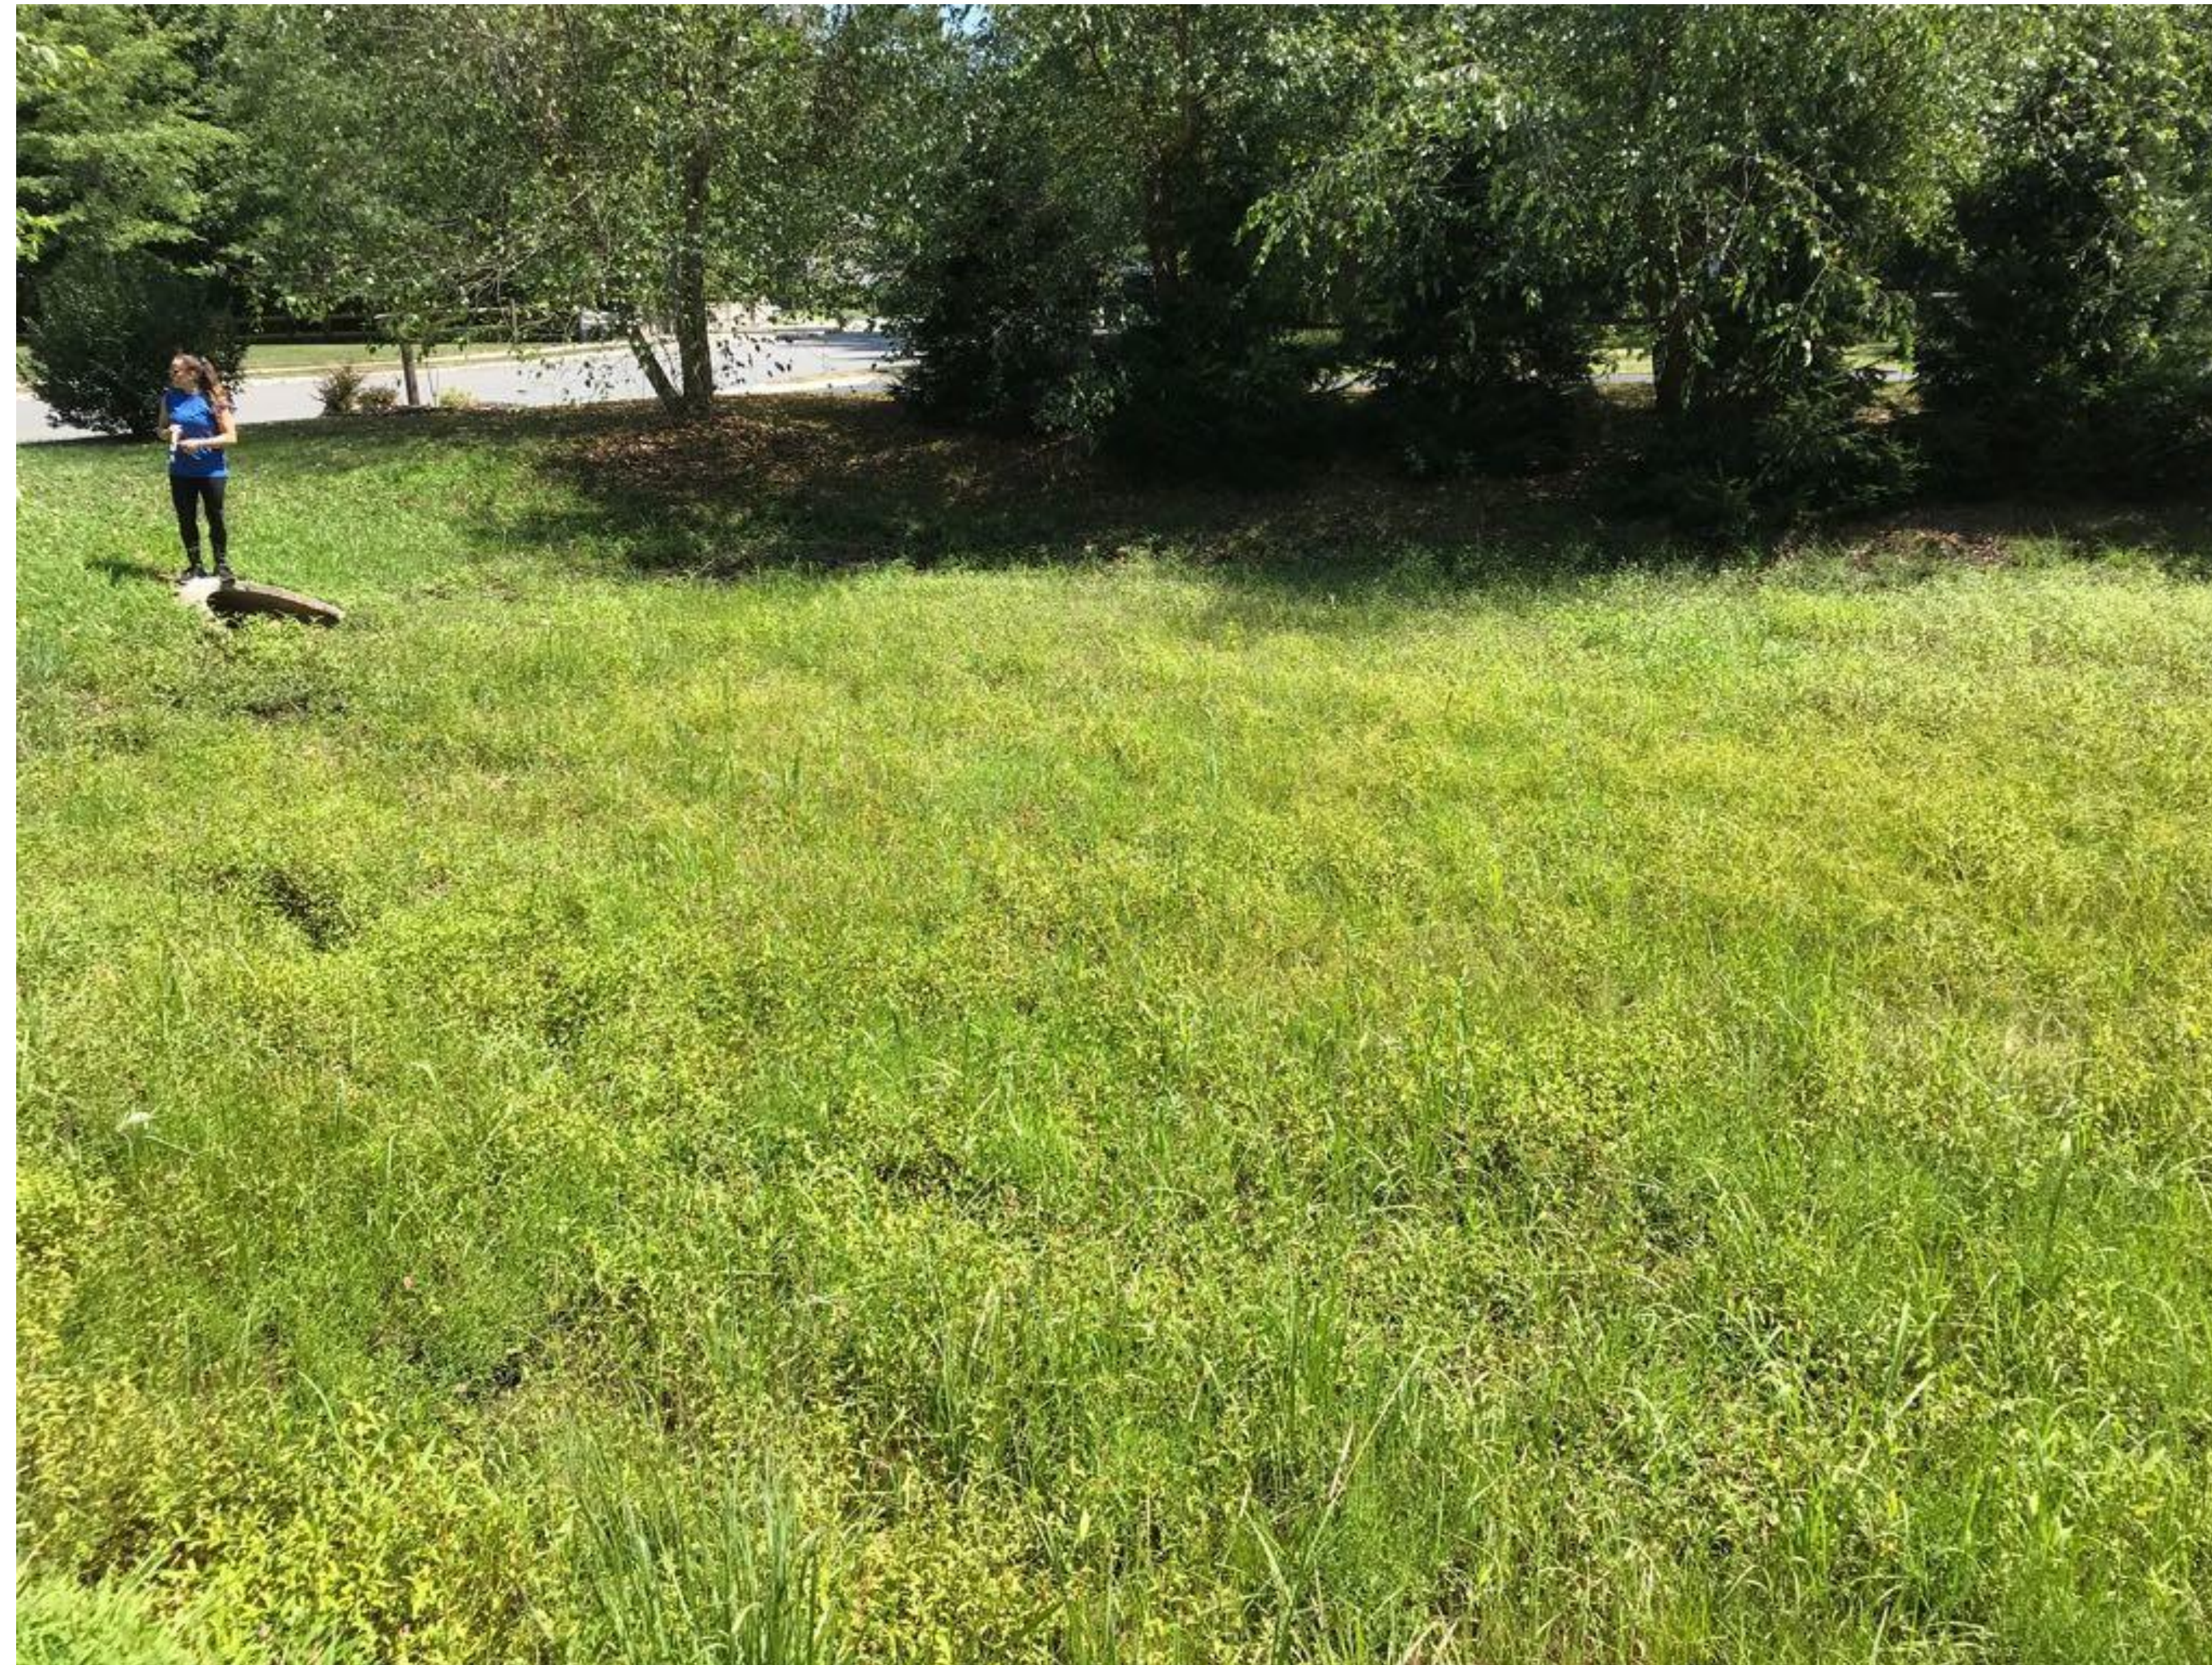
Address:
21 Dogwood Lane
Hamilton Township, NJ 08610

- Infiltration basin forebay with spillway into detention basin for larger storms
- Both basins could be naturalized with herbaceous plants
