Hamilton Township (Mercer County) Stormwater Outfall Assessment Summary 2019 Addendum

Developed by the Rutgers Cooperative Extension Water Resources Program
Funded by Hamilton Township, Mercer County, New Jersey
November 27, 2019

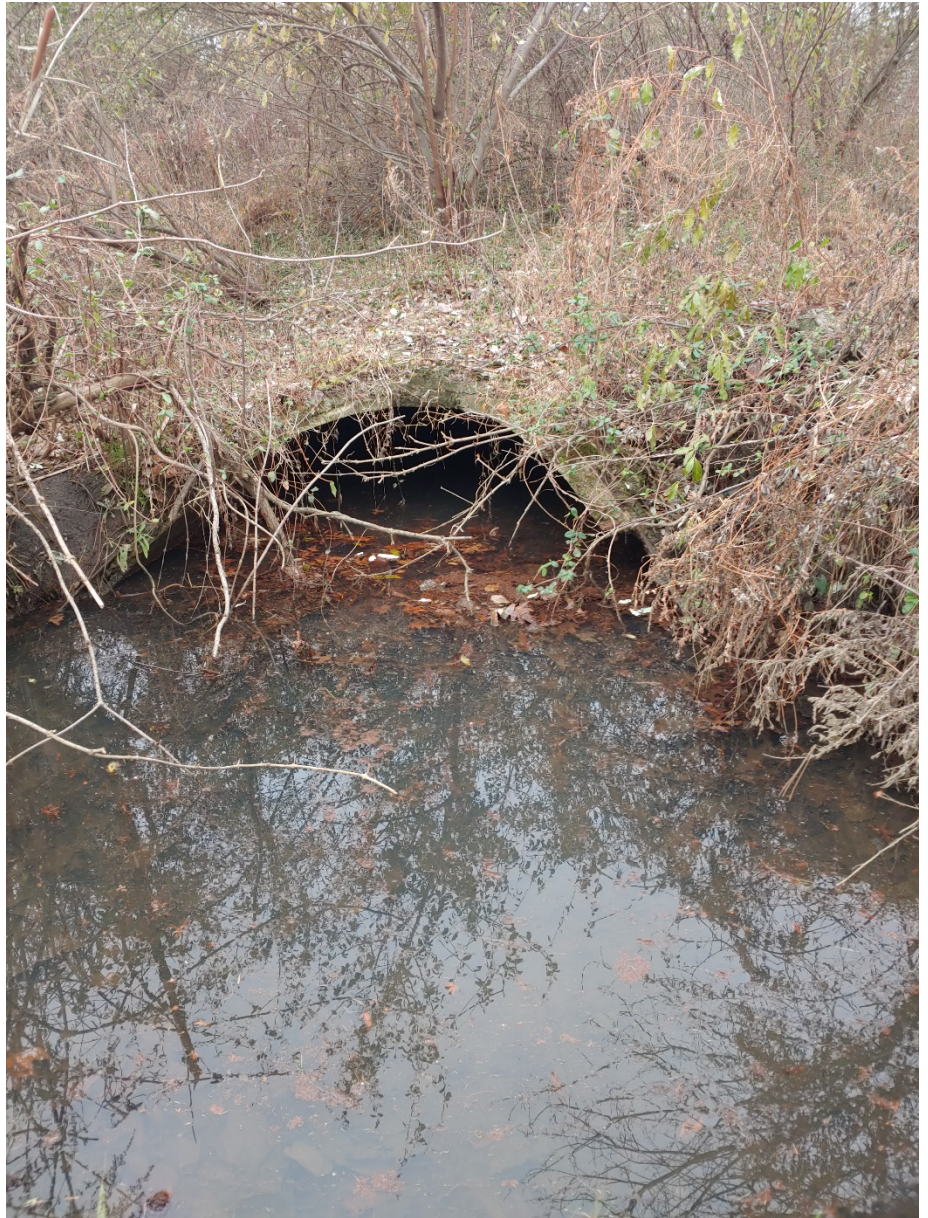
ID Number: 23

- 55" diameter concrete pipe
- Brown receiving waters
- Excessive vegetation growing around pipe

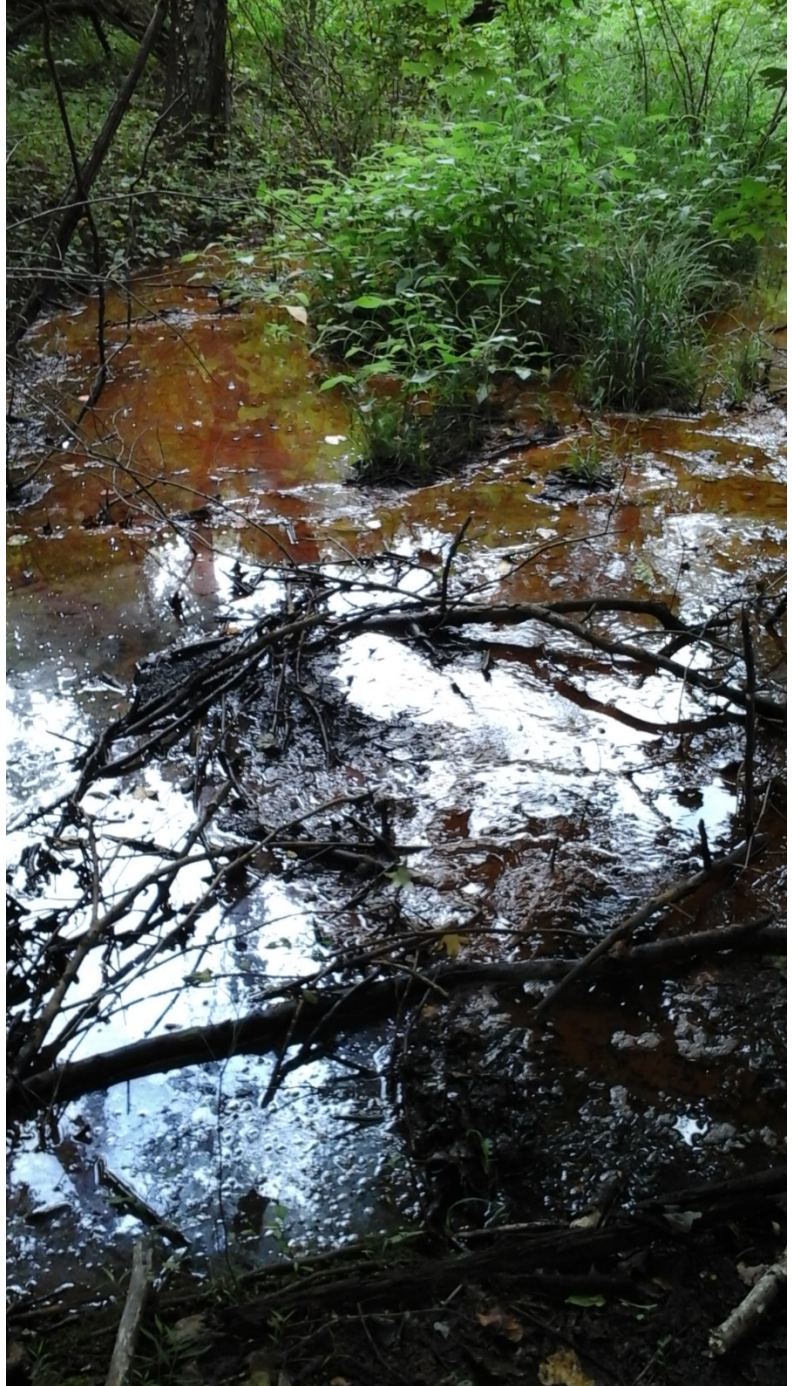
ID Number: 44

- Pipe is fully submerged
- Rancid smelling, opaque receiving water with oil slicks
- Water is flowing from pipe during dry weather

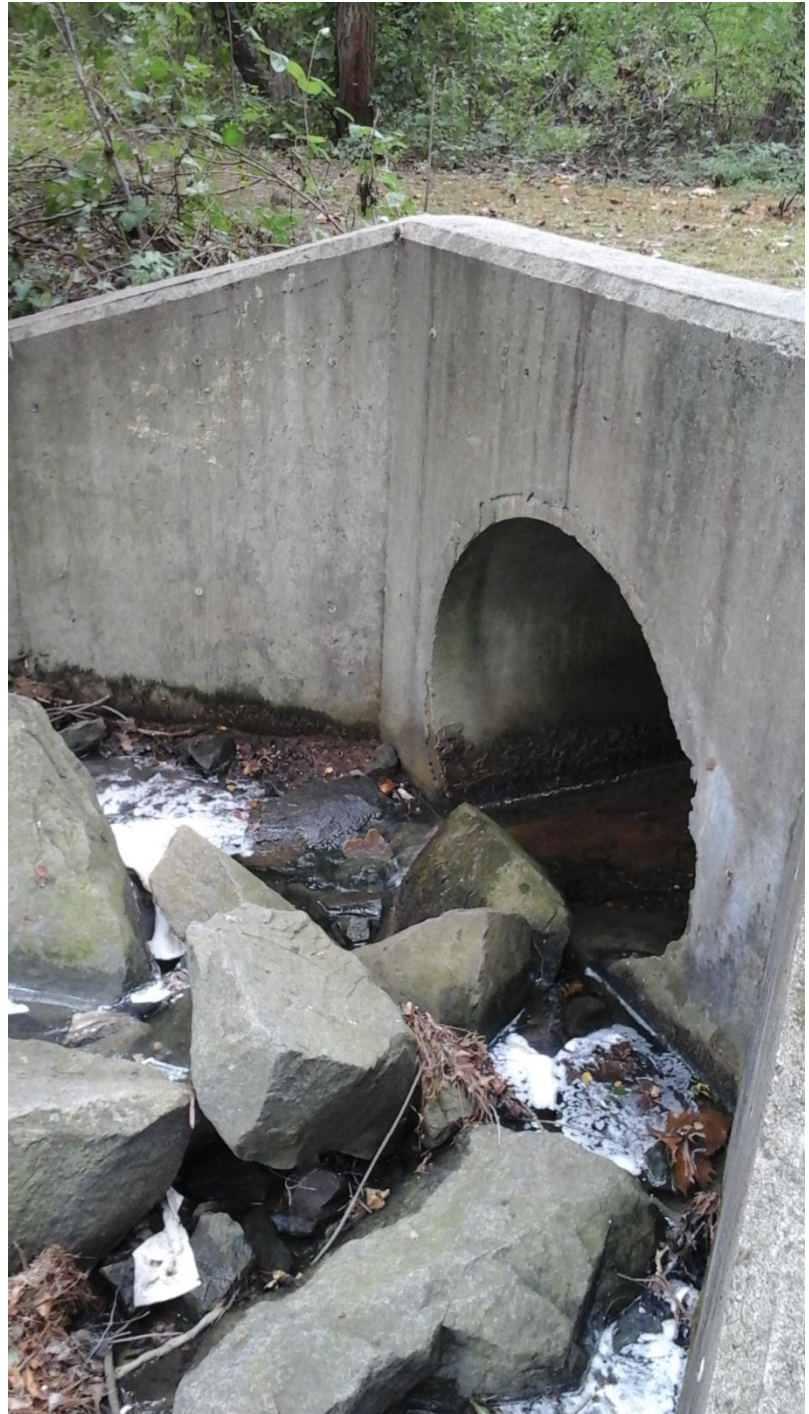
ID Number: 28

- 45" concrete pipe
- Water appears to have deposits of solvents

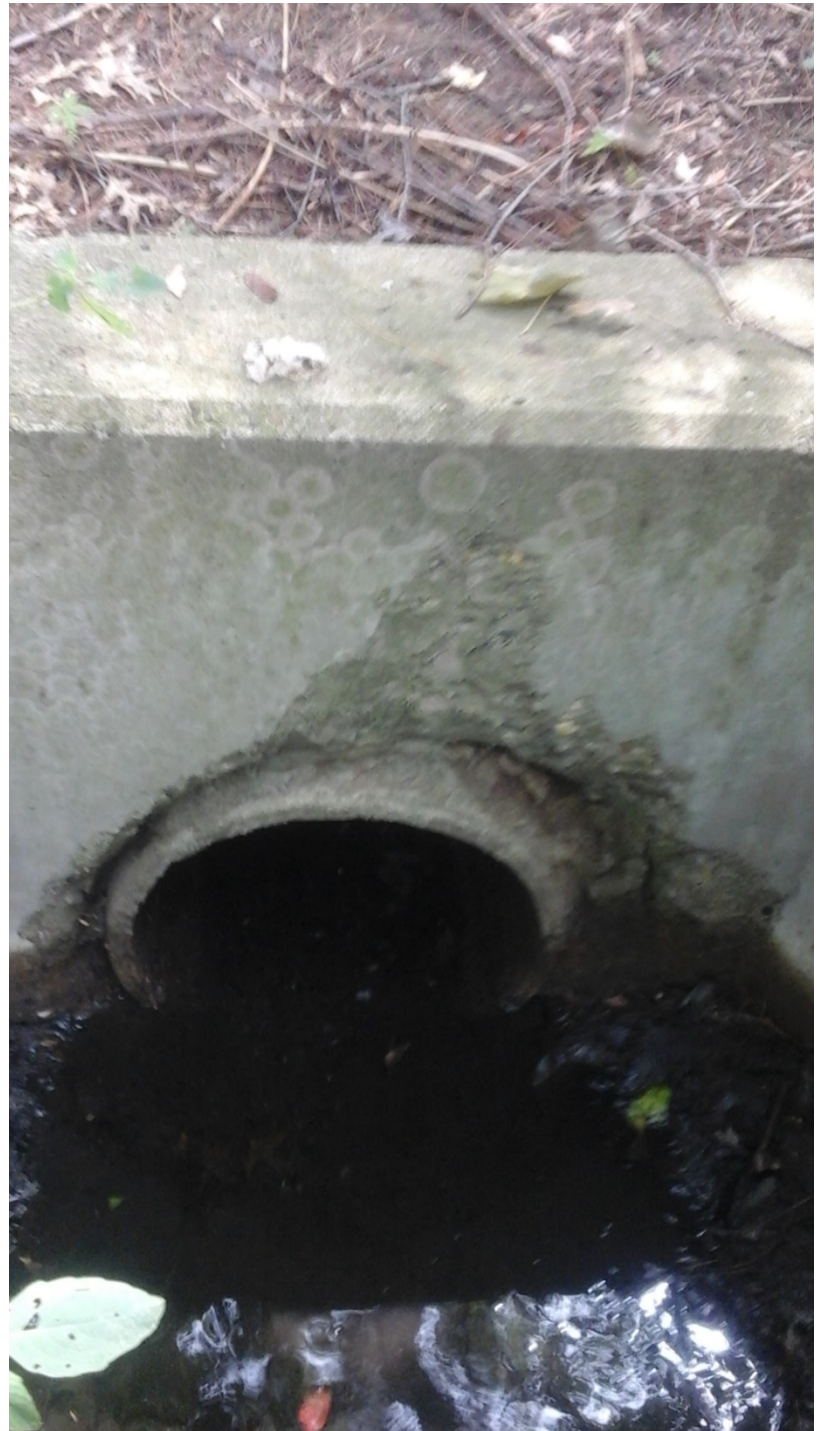
ID Number: 90

- 22" concrete pipe
- Sediment depositing in pipe
- Water appears stagnant

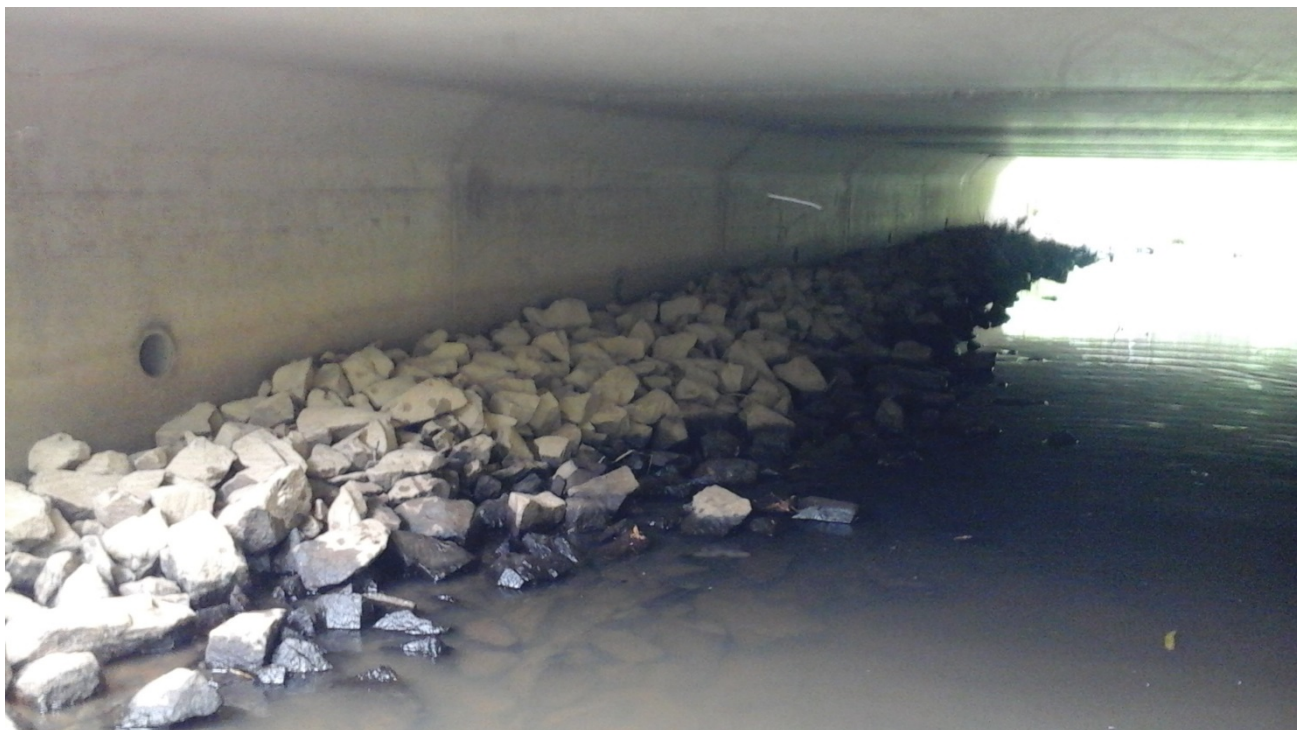
ID Number: 14,15,16,17,18

- 4" plastic pipes, 12 under bridge in total
- 4 pipes are obstructed by sediment build up

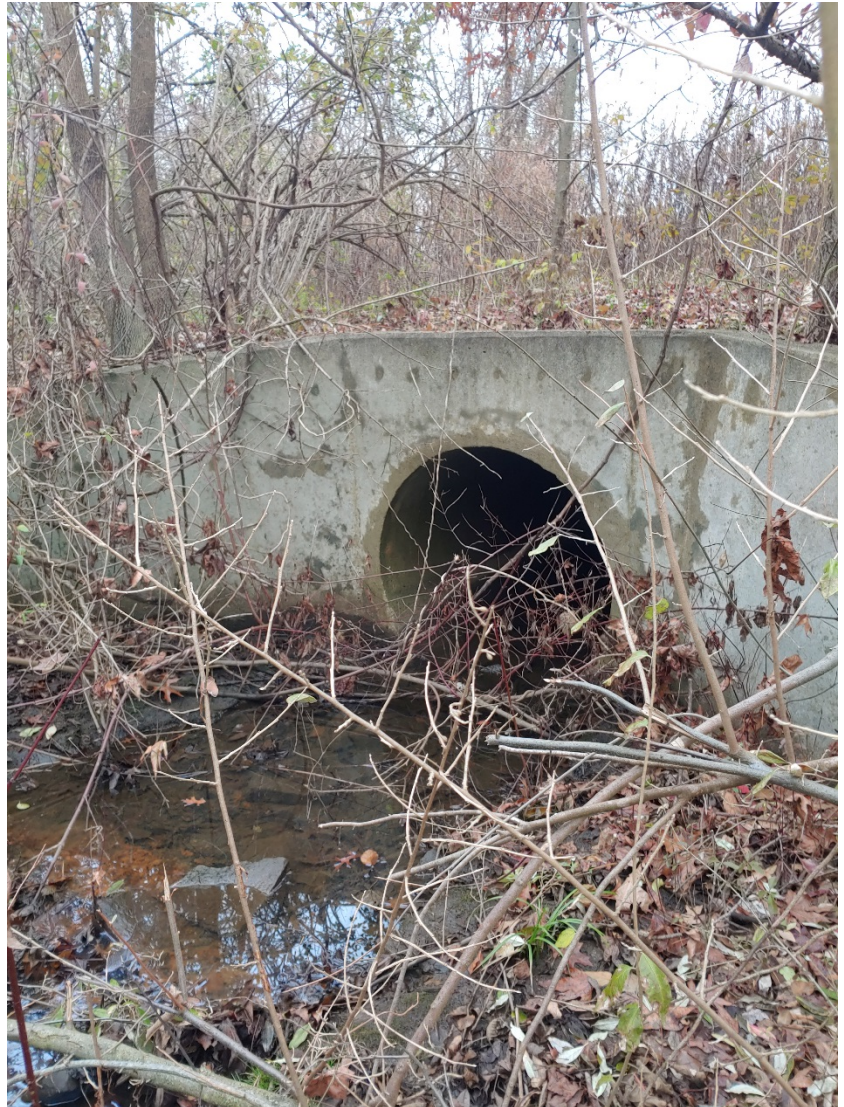
ID Number: 19

- 36" concrete pipe
- Cloudy water
- Excessive vegetation growth
- Looks new and generally in good condition

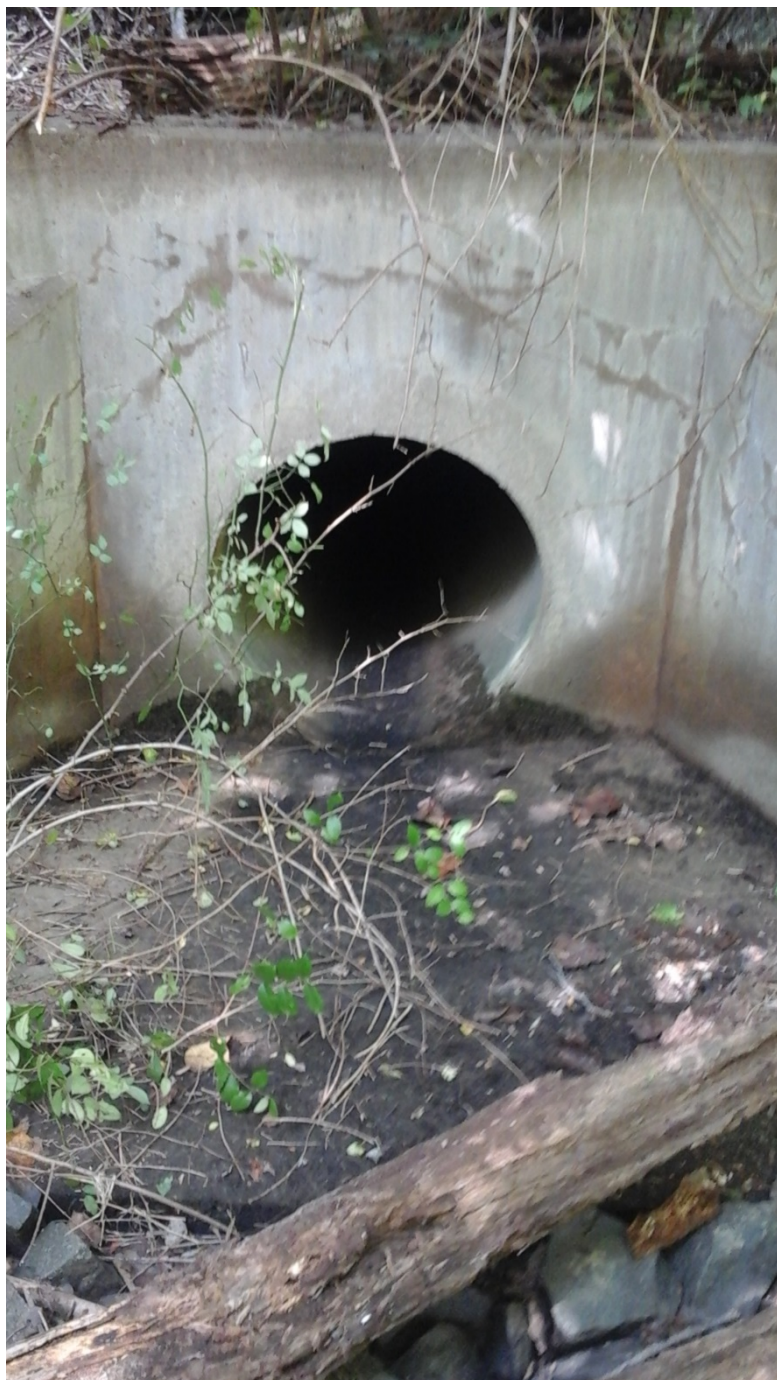
ID Number: 62

- 30" concrete pipe
- Overall in good condition

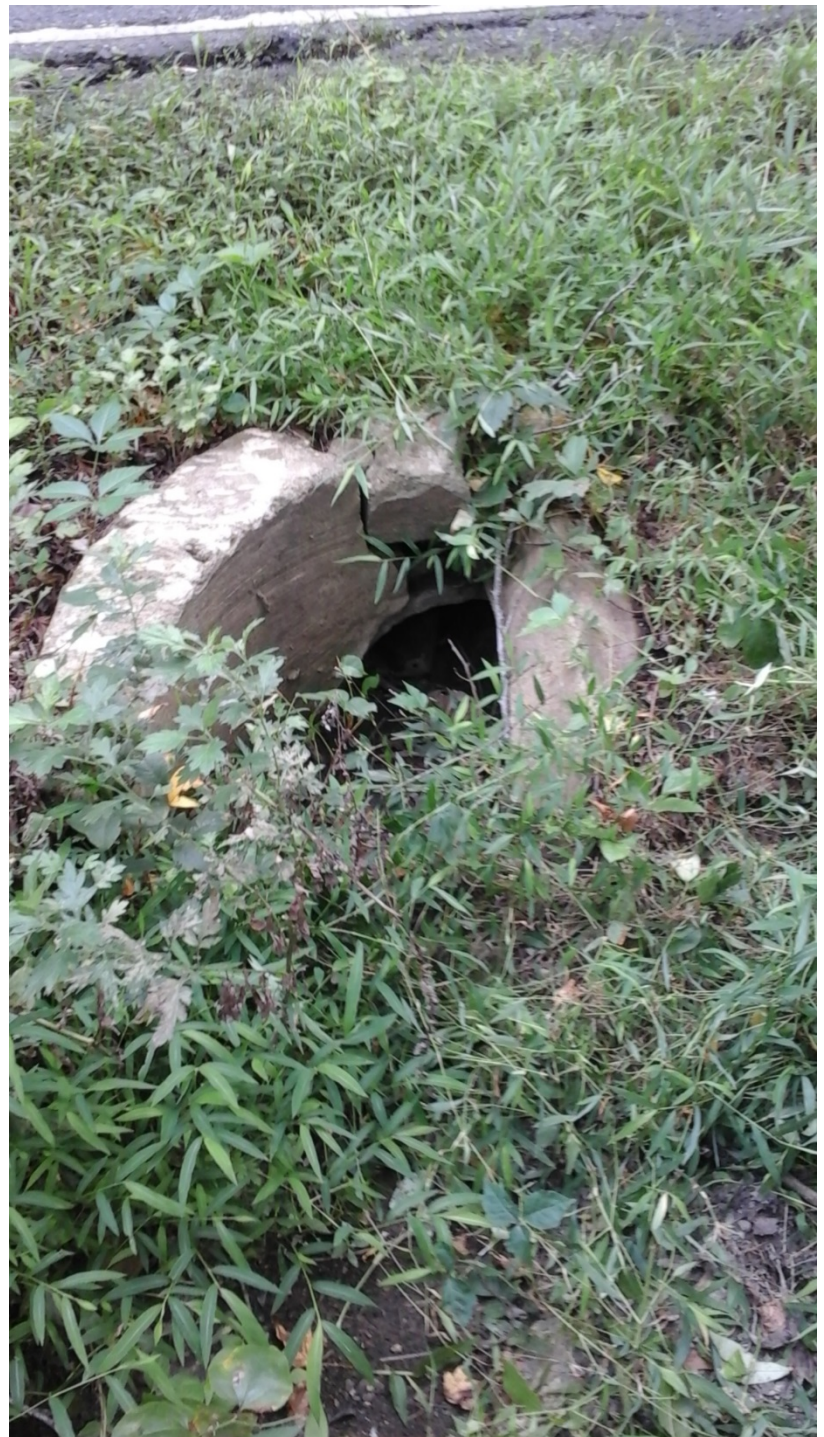
ID Number: 70

- 16" concrete pipe
- Outfall is collapsed on one side and crumbling
- Sediment depositing within pipe

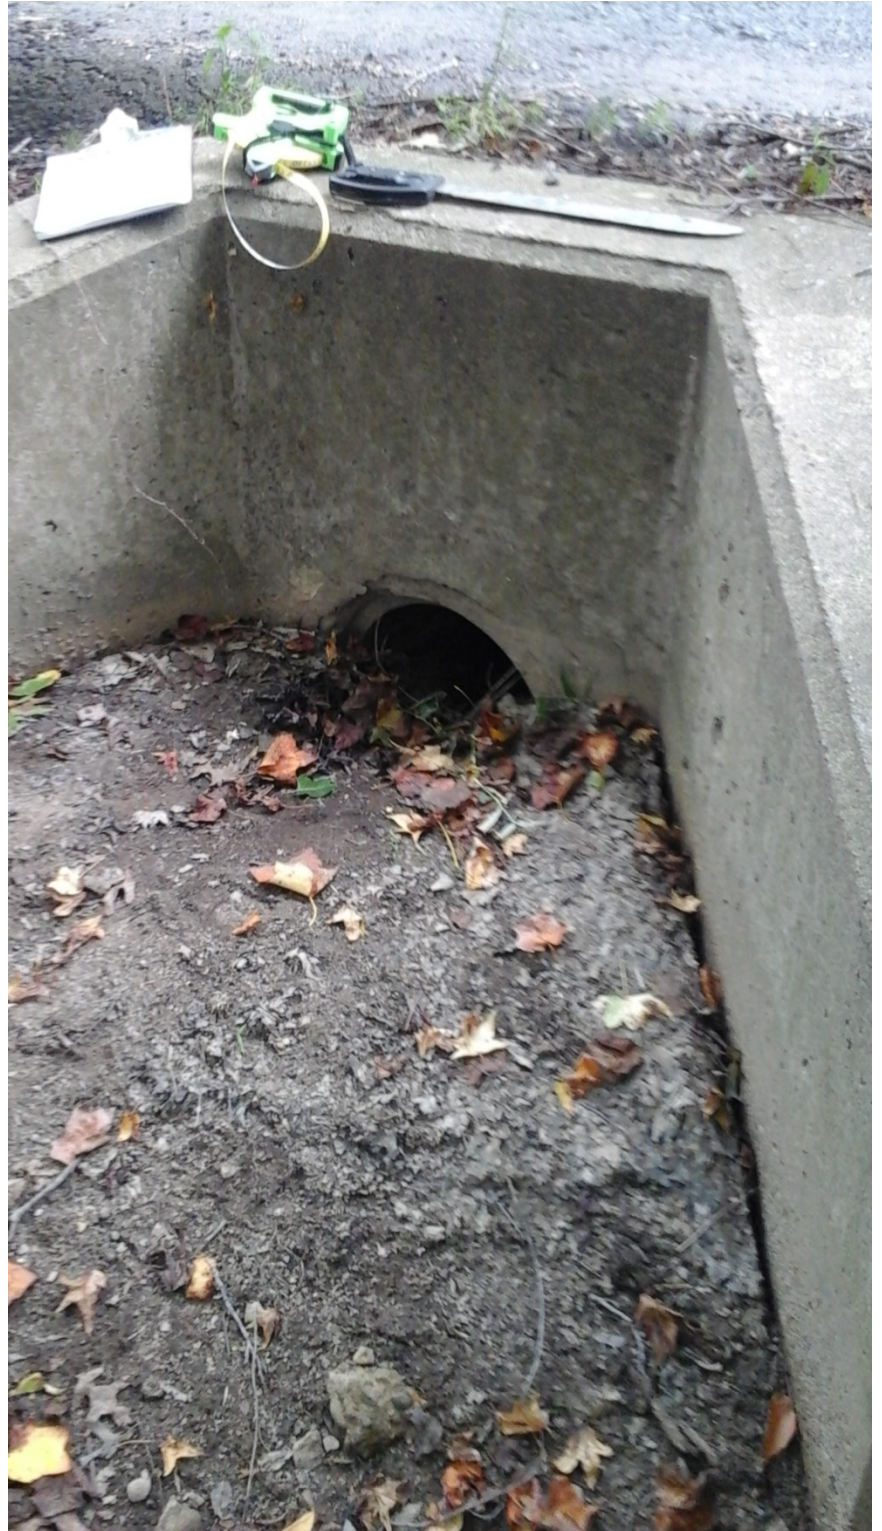
ID Number: 71

- 16" concrete pipe
- Trash present
- Large accumulation of dirt around outfall

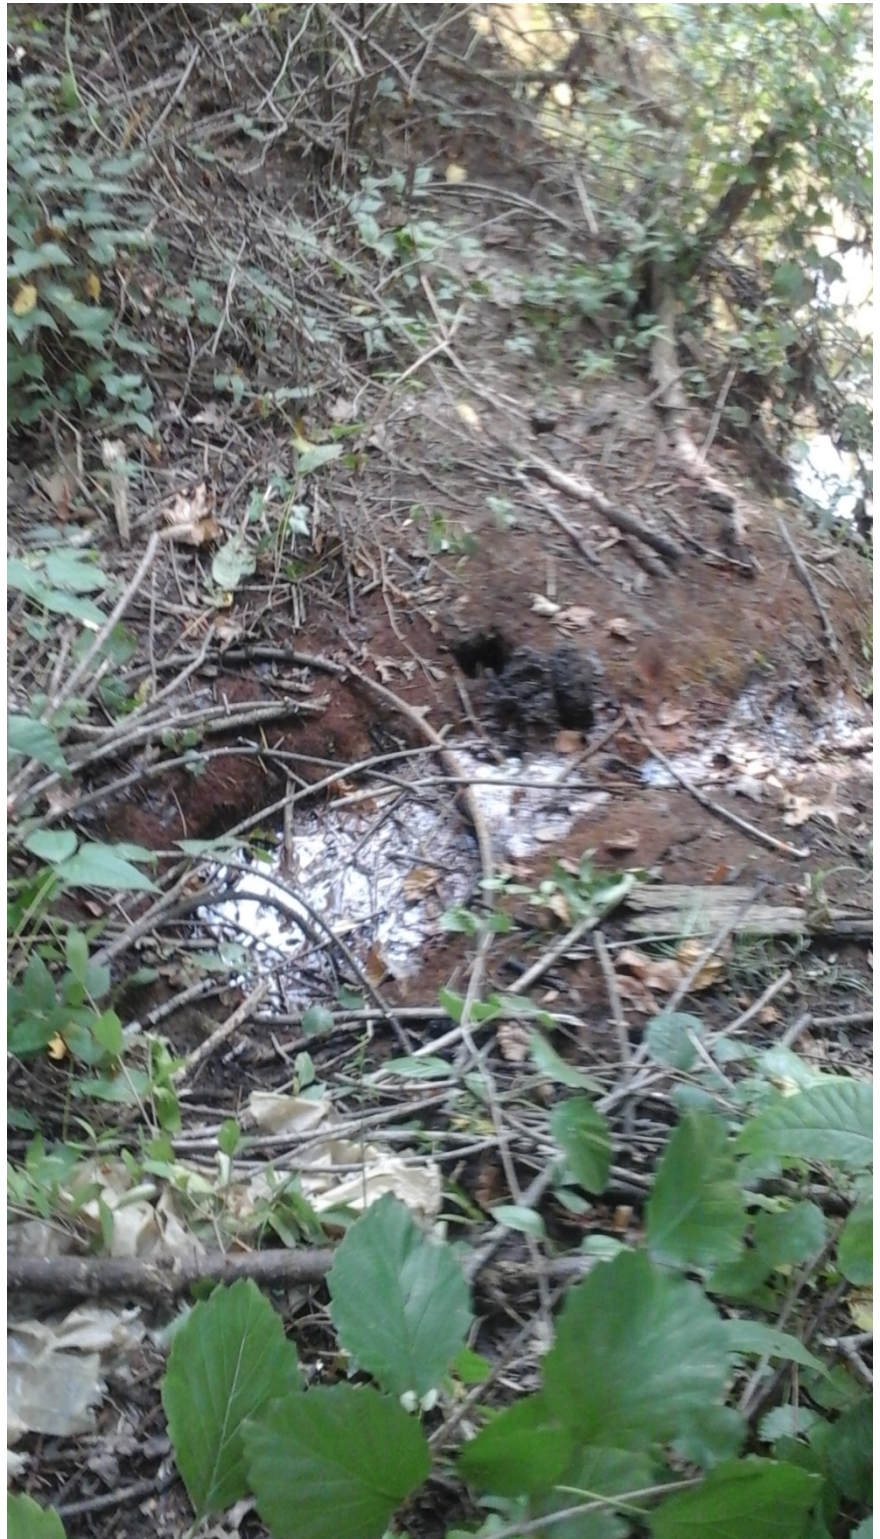
ID Number: 89

- 12" clay pipe
- Brown, opaque water flowing during dry weather
- Water is rancid smelling
- Sediment accumulation made pipe difficult to find

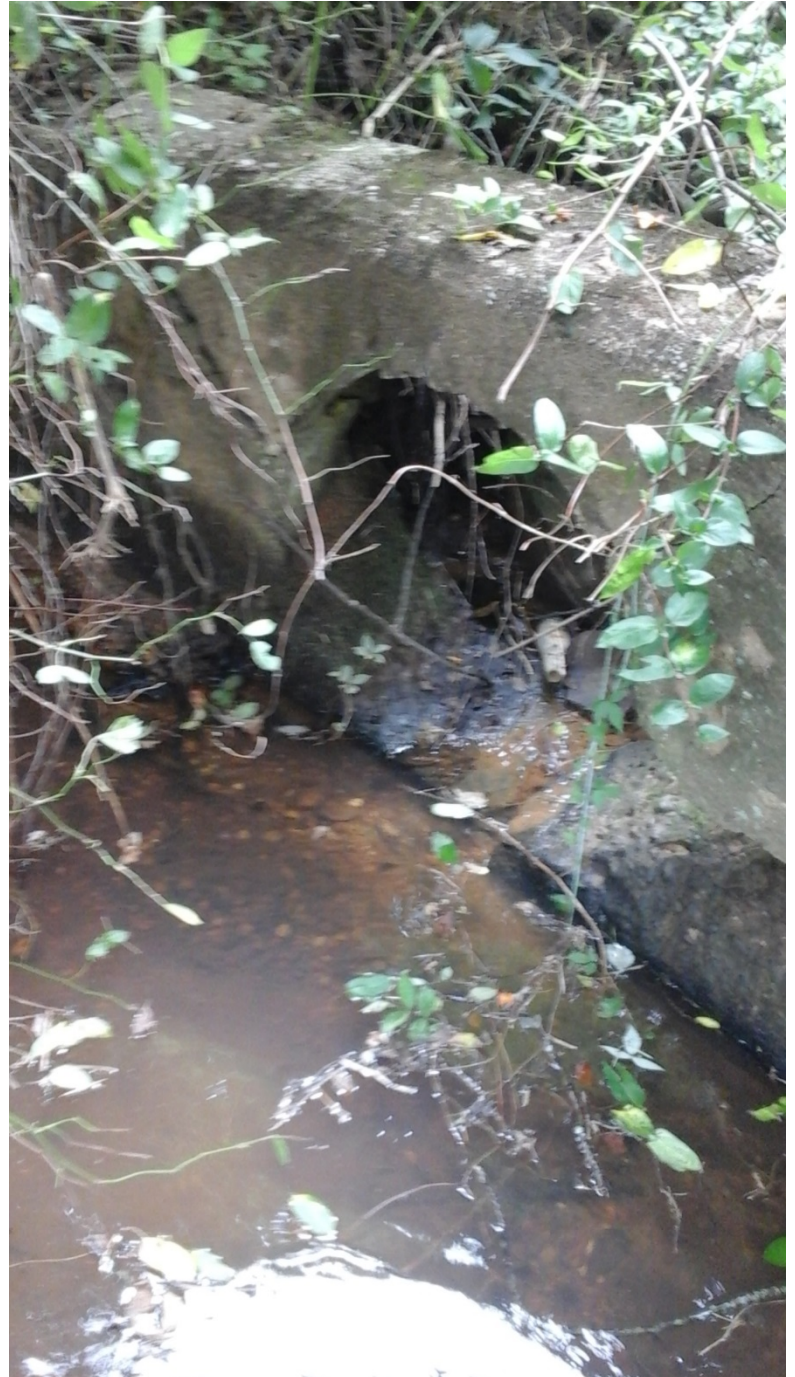
ID Number: 31

- 24" concrete pipe
- Brown, cloudy water
- Trash and sediment accumulations

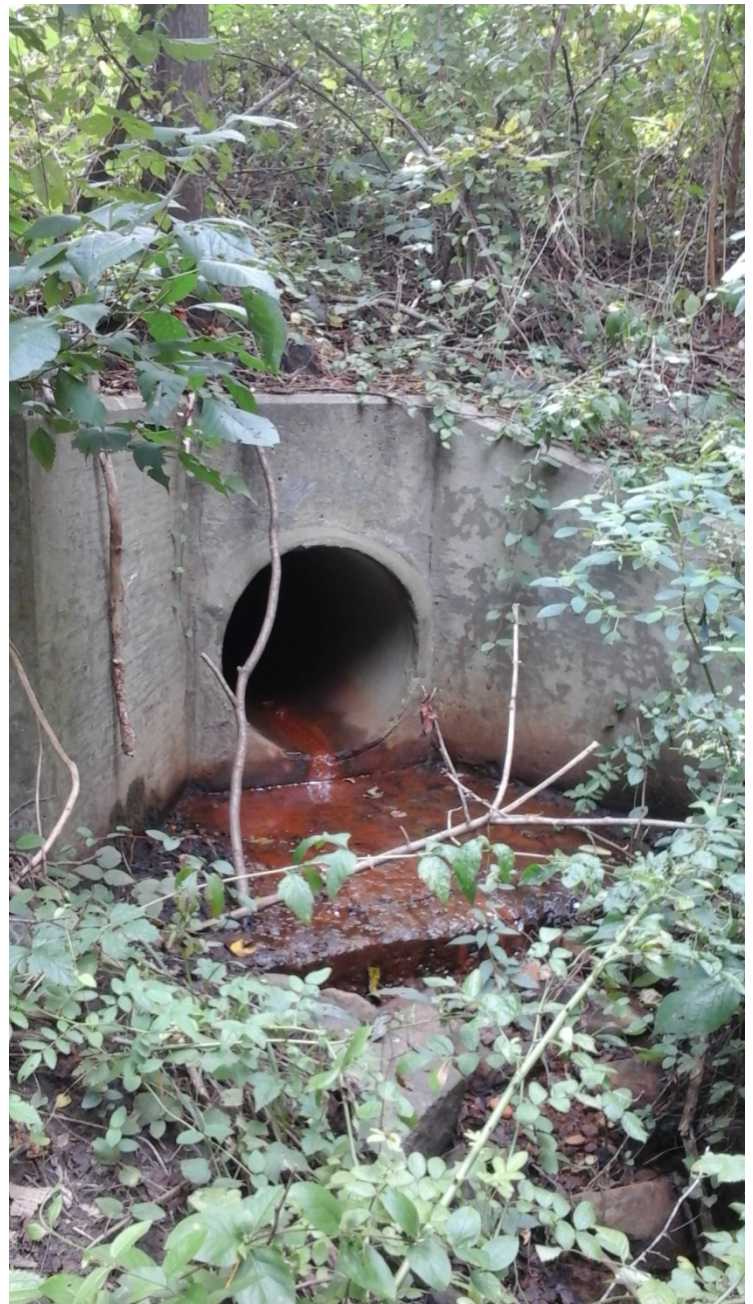
ID Number: 34

- 24" diameter concrete pipe
- Cloudy, brown water
- Sediment deposits

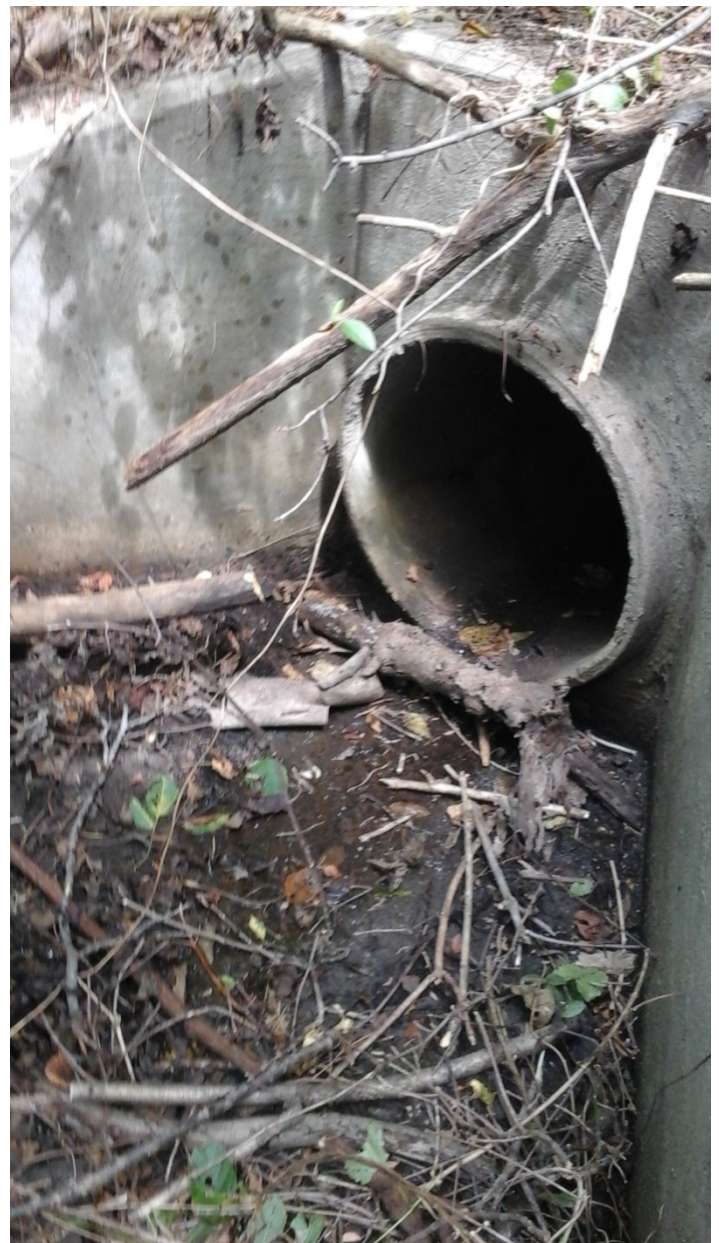
ID Number: 35

- 24" diameter concrete pipe
- Sediment deposits
- Excessive vegetation growth
- Small pool of stagnant water

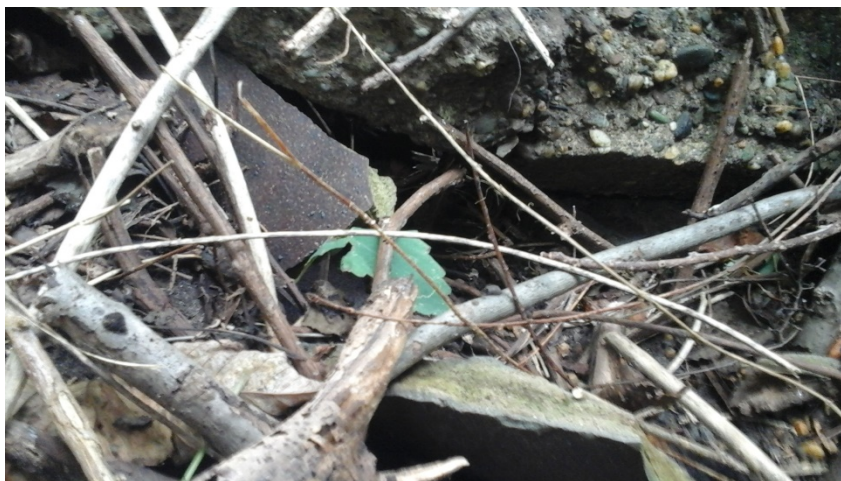
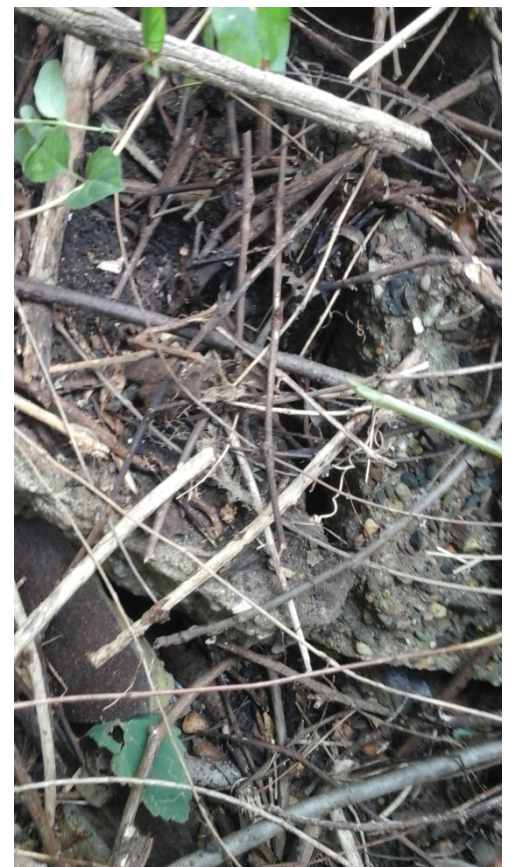
ID Number: 37

- 20" diameter concrete pipe
- Clear water
- Sediment deposits
- Excessive vegetation growth
- Erosion has undermined the stability of the outfall. The extent of erosion damage is under 100 sq. ft.
- Outfall completely destroyed.

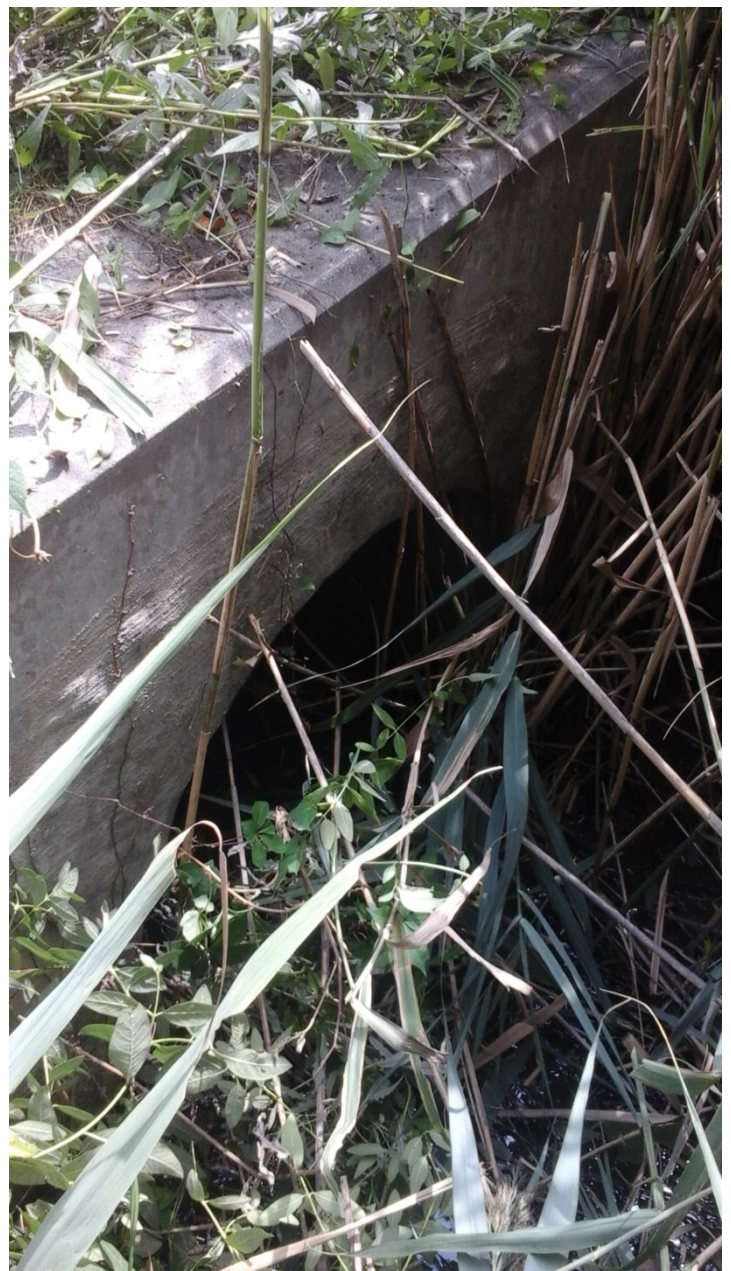
ID Number: 53

- 37" diameter concrete pipe
- Trash present
- Sediment deposits
- Excessive vegetation growth

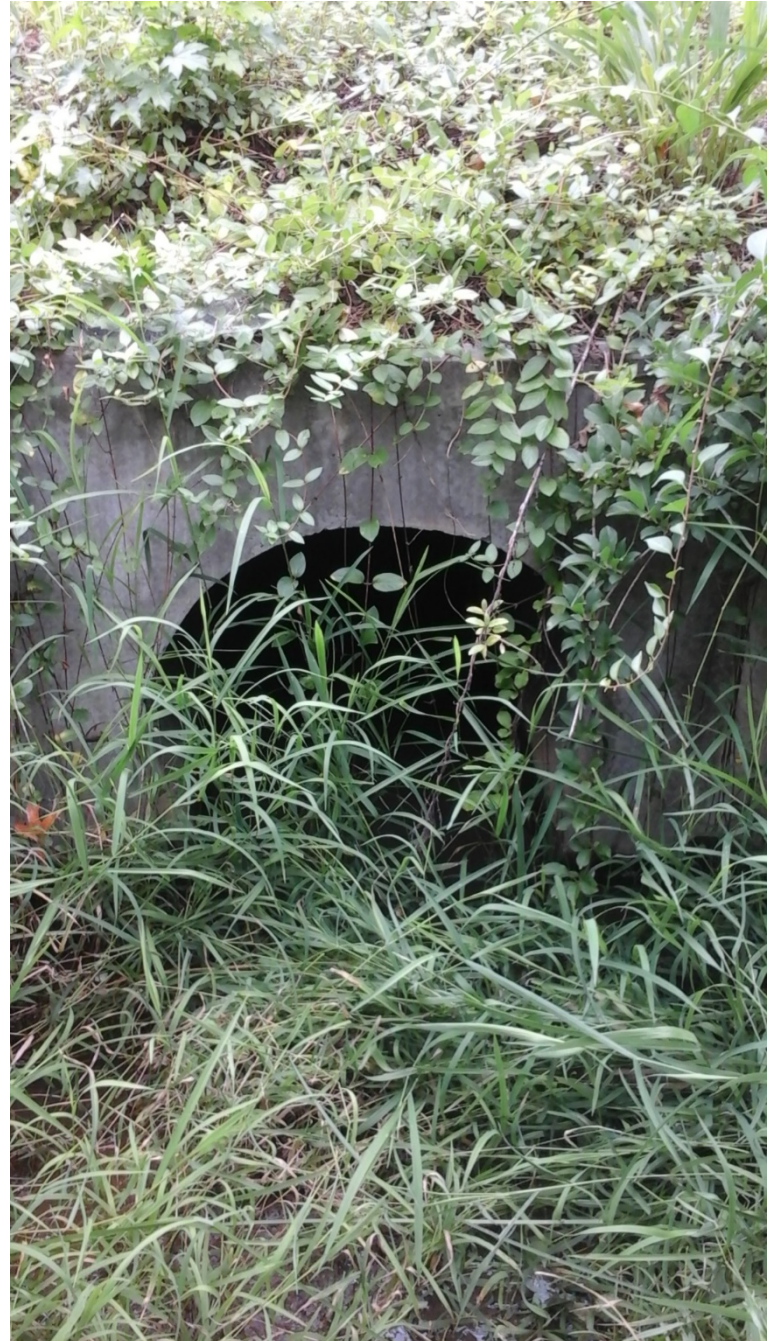
ID Number: 54

- 37" diameter concrete pipe
- Opaque, brown water
- Excessive vegetation growth
- Stagnant water in outflow

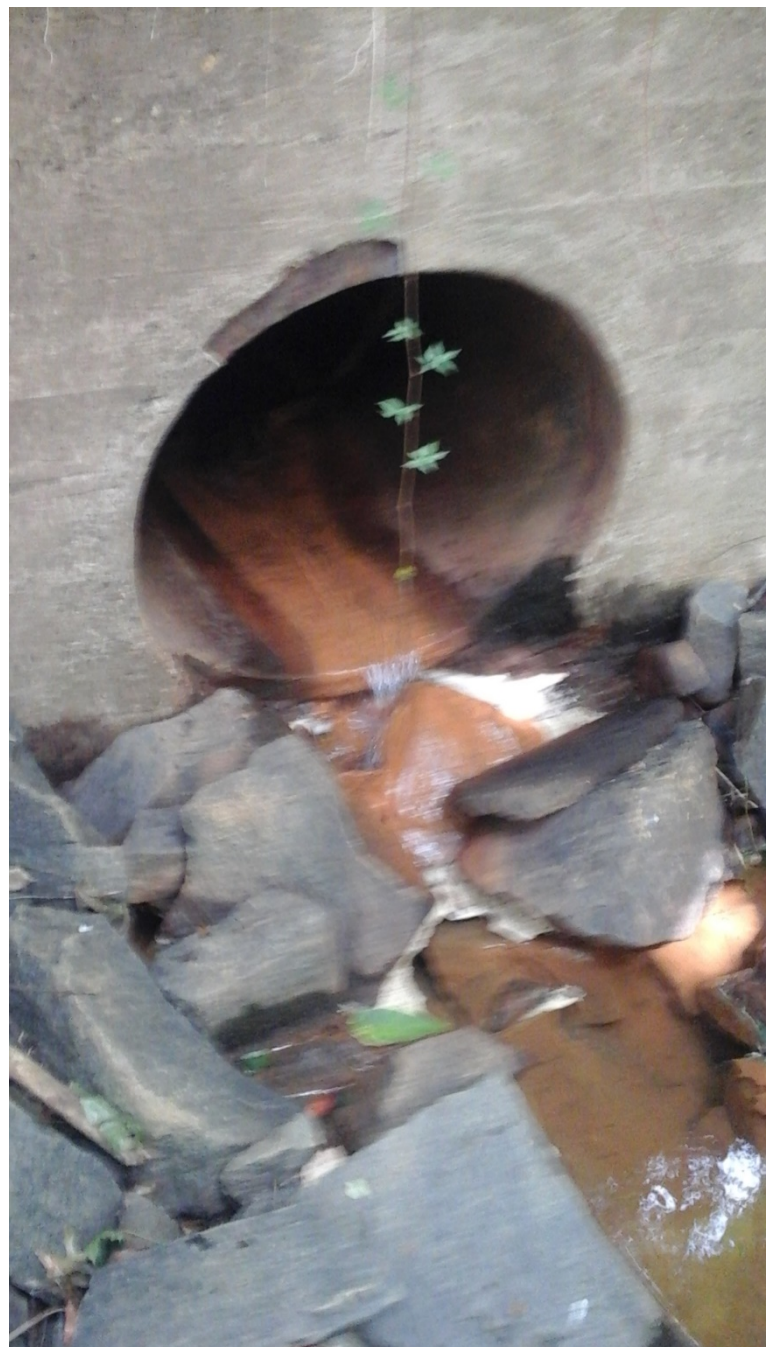
ID Number: 29

- 30" diameter concrete pipe
- Flowing during dry weather
- Brown, rusty water
- Sediment deposits

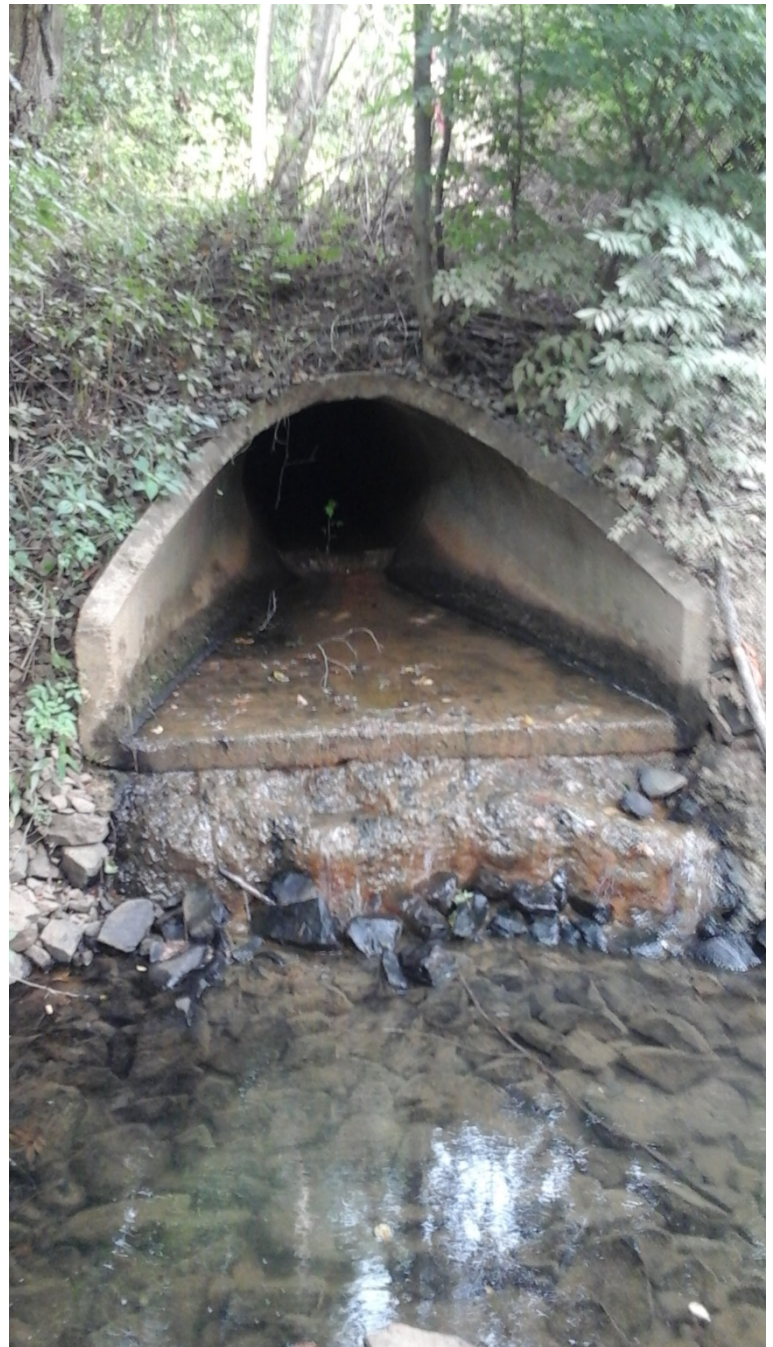
ID Number: 24

- 72" diameter concrete pipe
- Flowing during dry weather

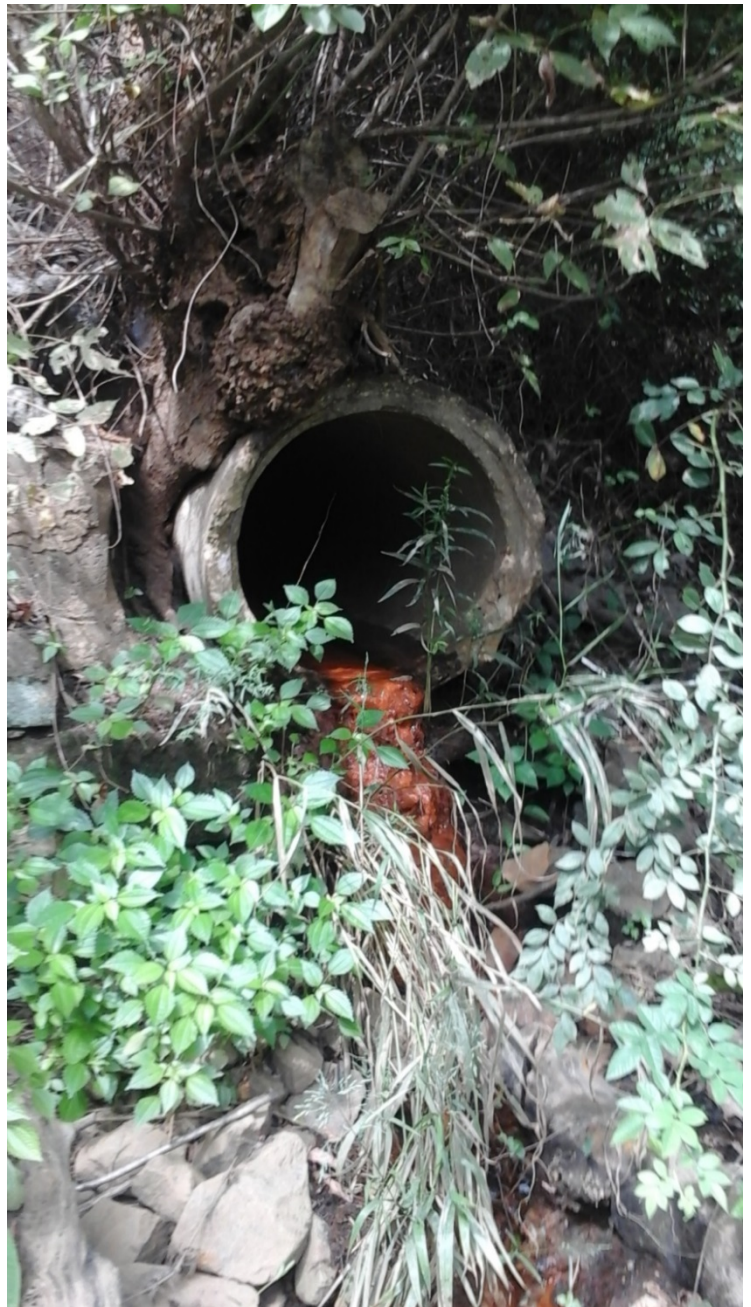
ID Number: 26

- 24" diameter concrete pipe
- Brown water
- Flowing during dry weather
- Sediment deposits
- Excessive vegetation growth
- Reddish staining exiting outfall

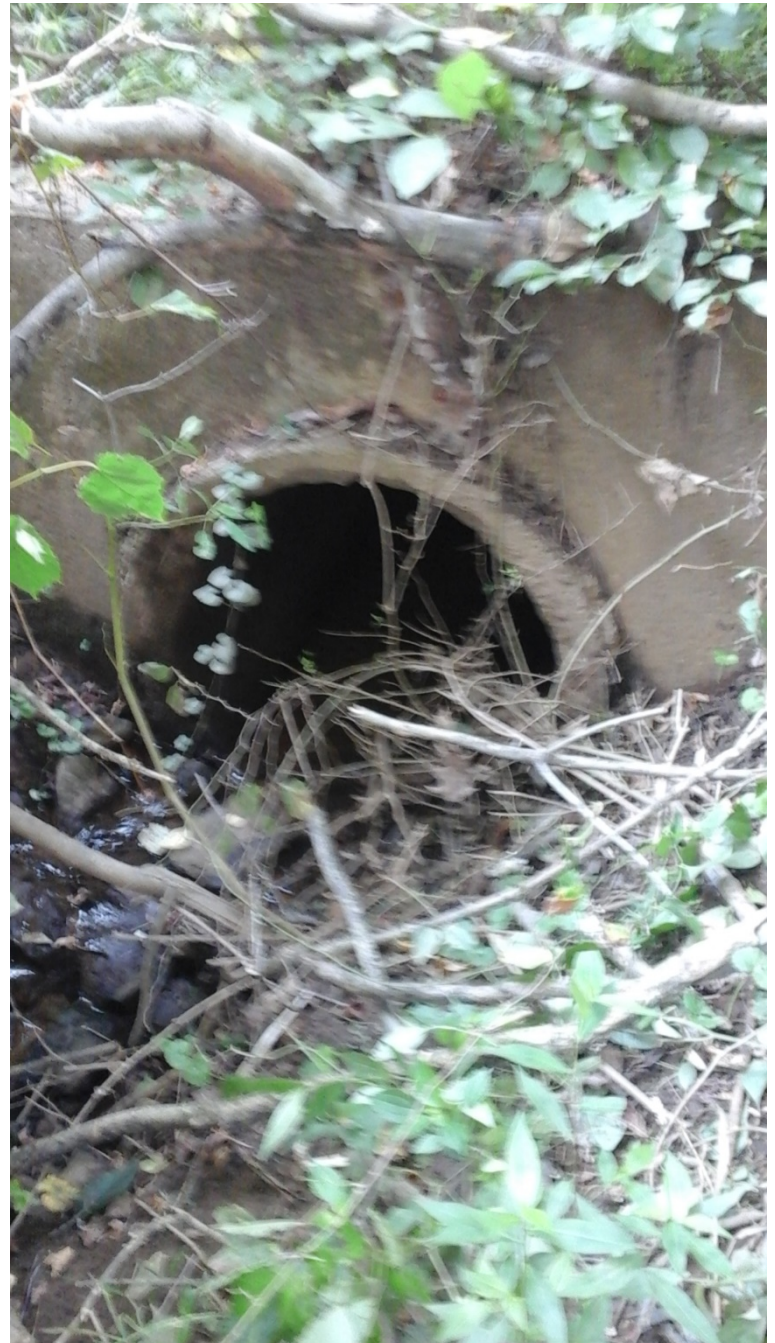
ID Number: 47

- 30" diameter concrete pipe
- Flowing during dry weather
- Excessive vegetation growth

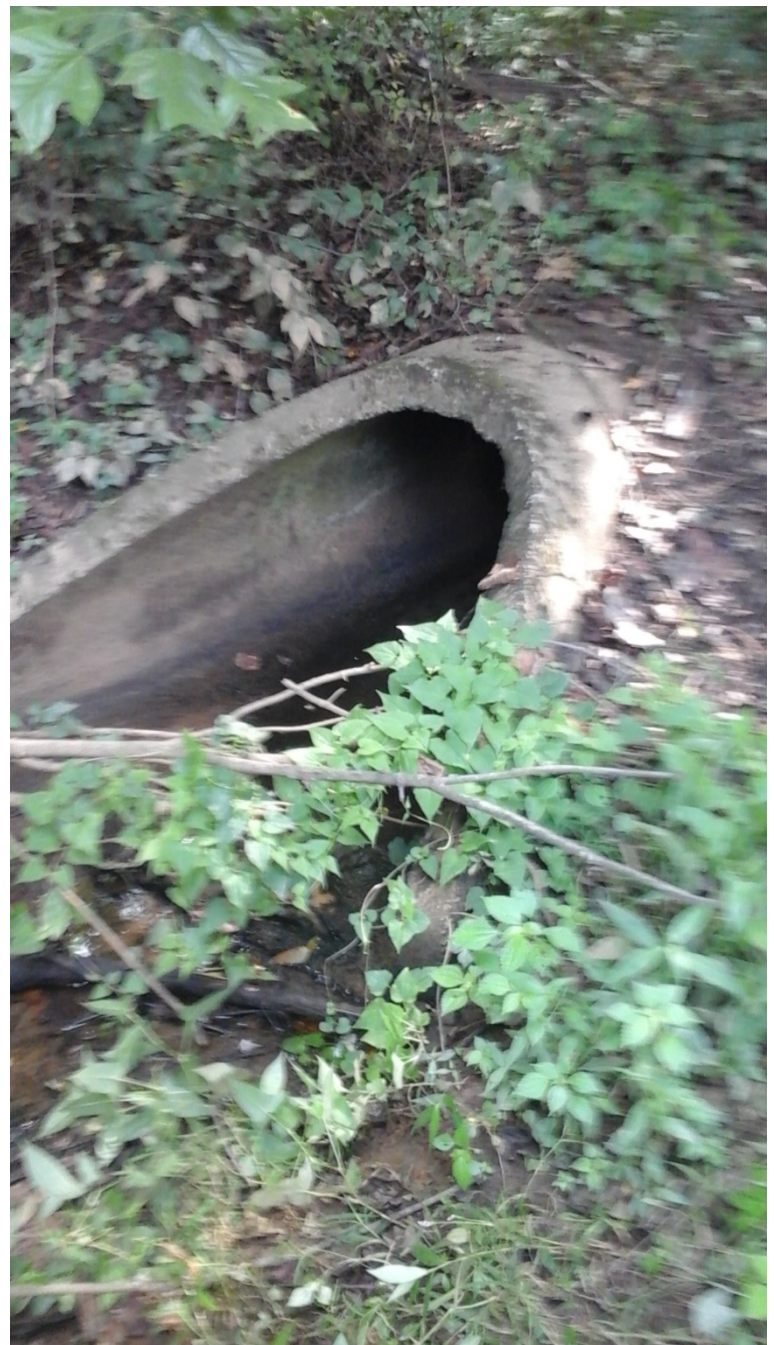
ID Number: 50

- 48" diameter concrete pipe
- Flowing during dry weather
- Raccoon tracks going in and out of outfall
