Hamilton Township (Mercer County) Stormwater Outfall Assessment Summary 2019 Addendum

Developed by the Rutgers Cooperative Extension Water Resources Program
Funded by Hamilton Township, Mercer County, New Jersey
November 27, 2019

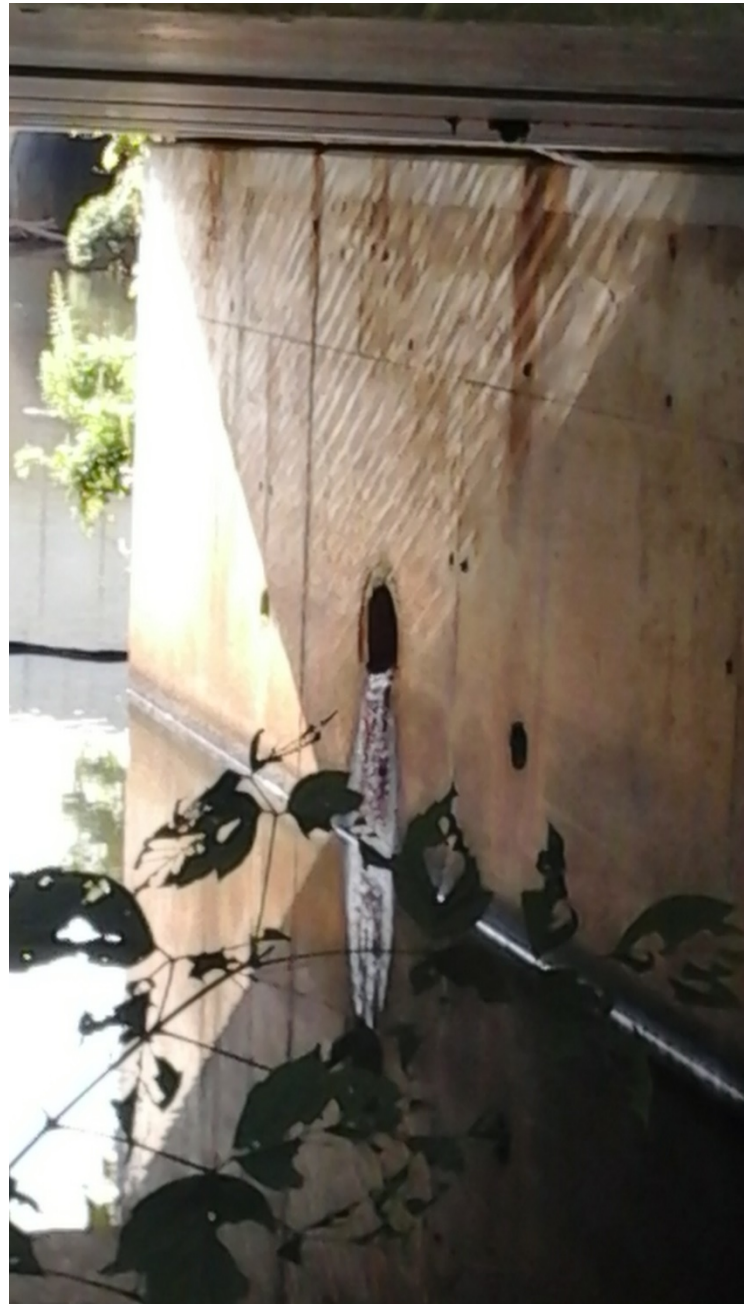
ID Number: 41

- 24" diameter concrete pipe
- Cloudy, yellow water
- Vegetation growing inside pipe

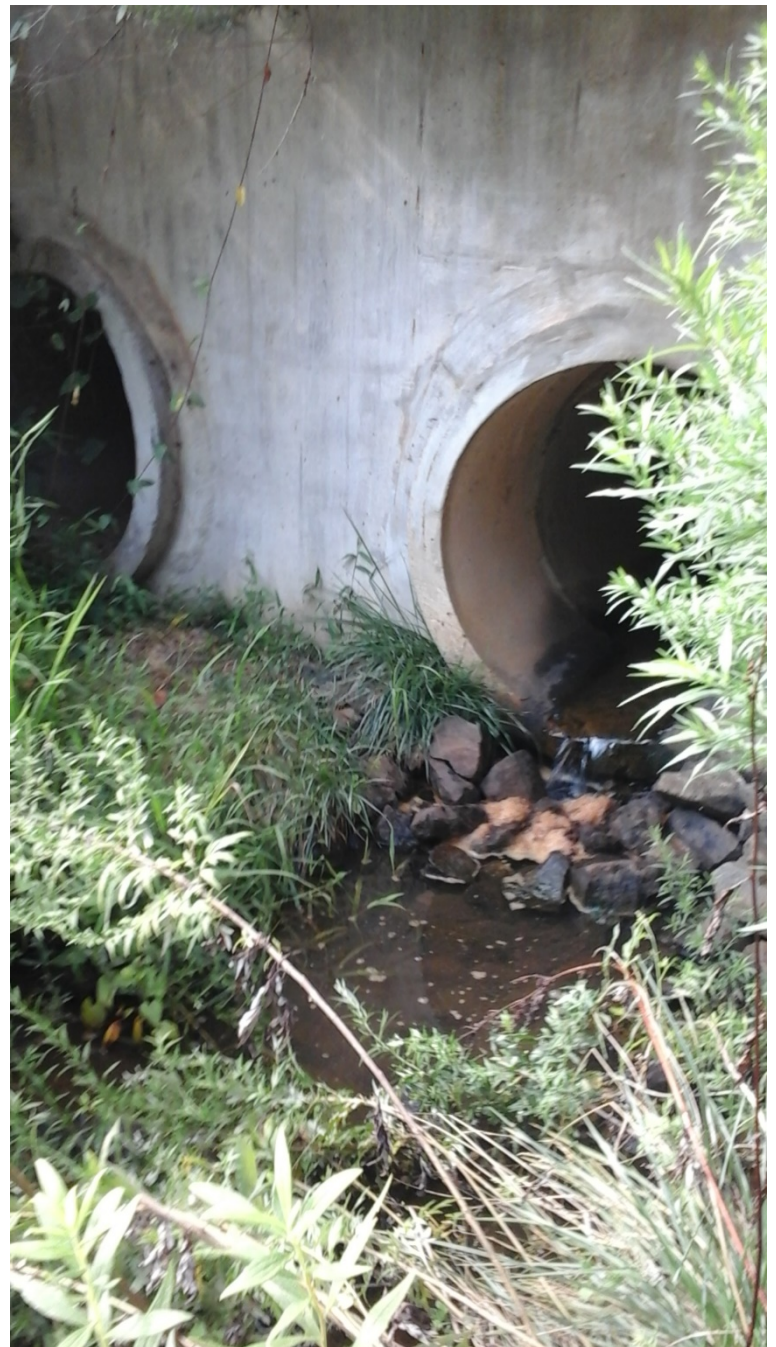
ID Number: 42

- 36" diameter concrete pipe
- Rancid/sour odor
- Cloudy, brown water
- Flowing during dry weather
- Excessive vegetation growth

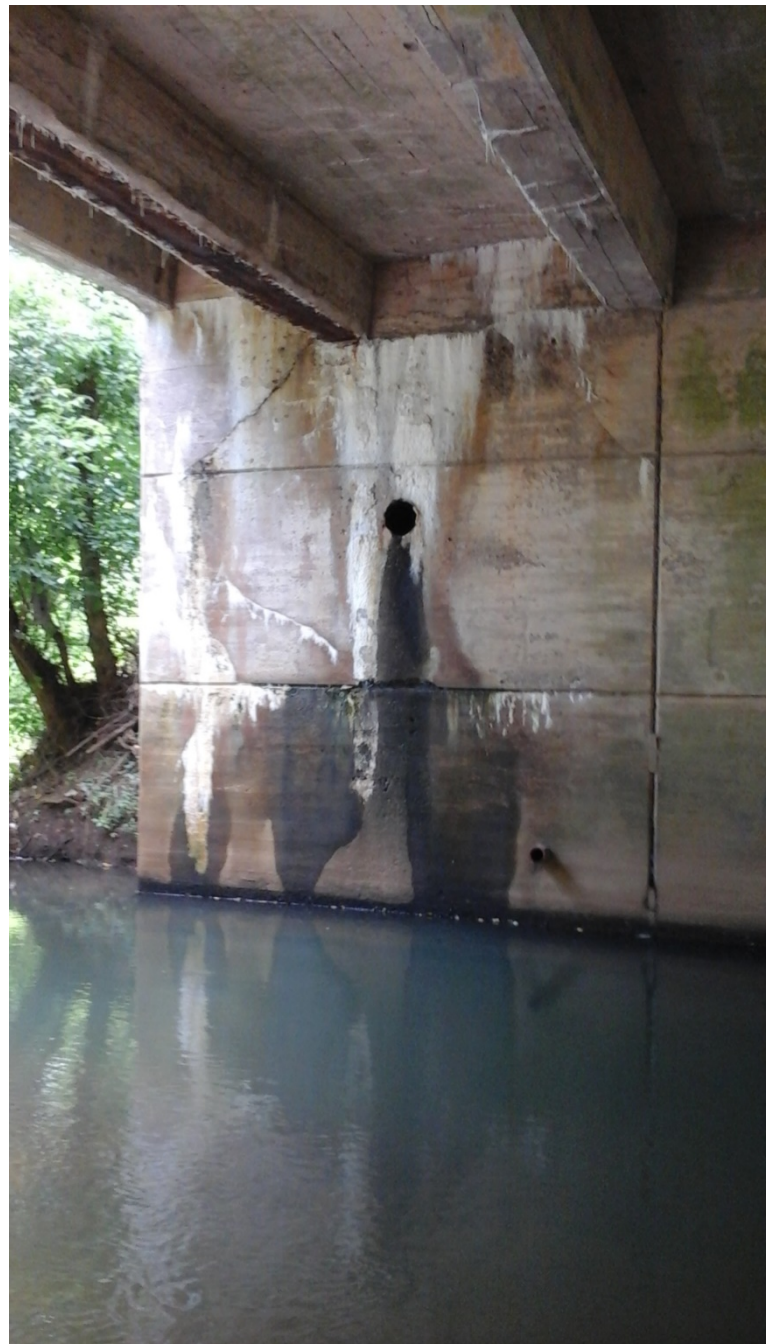
- 15" metal pipe
- Cloudy, brown water

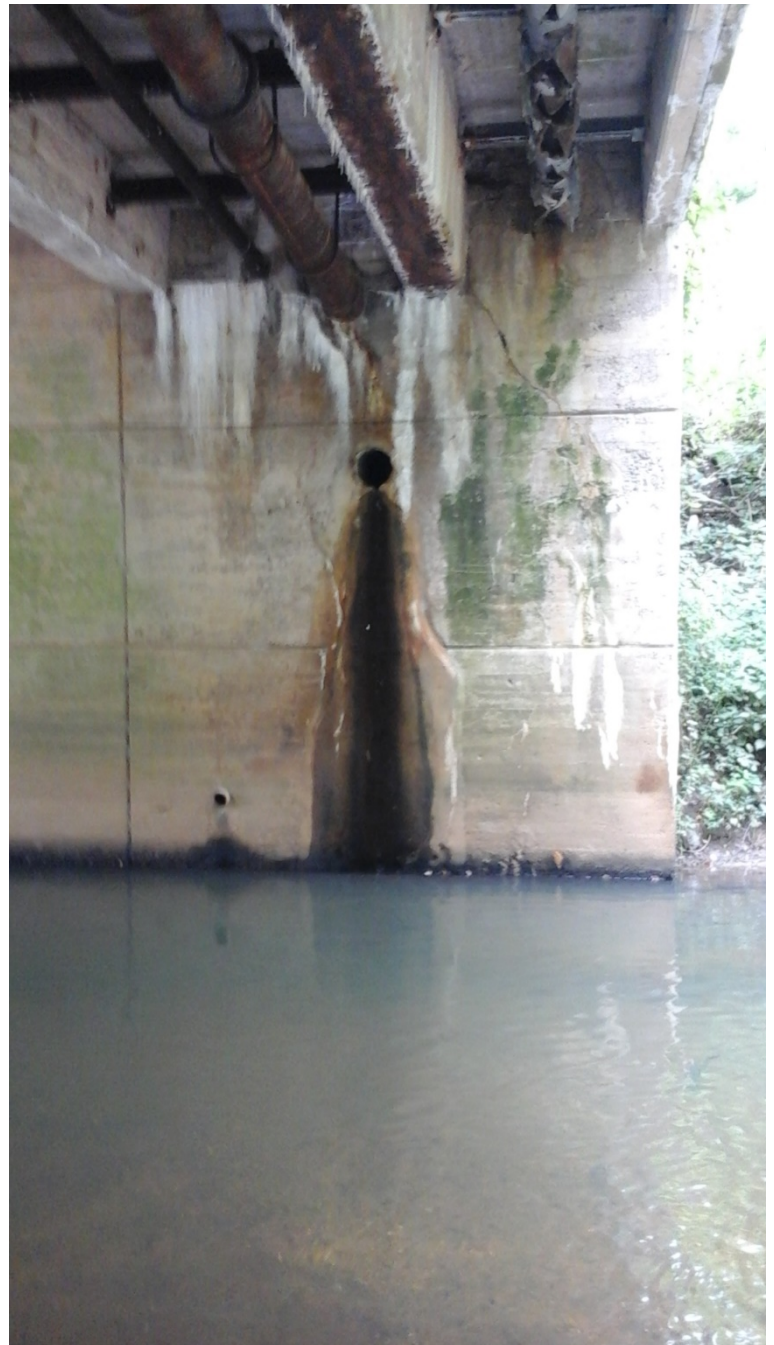
- 15" metal pipe
- Cloudy, brown water
- Outfall pipe is cracking

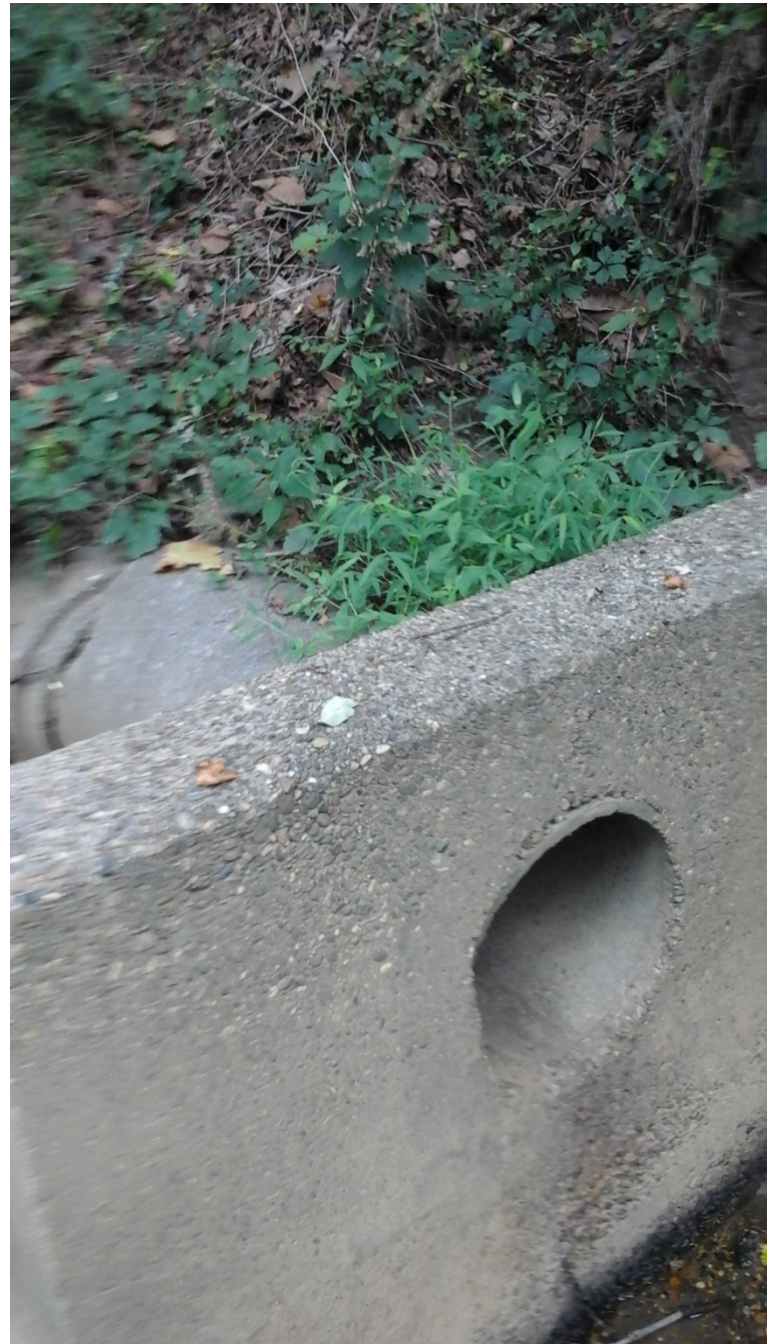
- 19" diameter concrete pipe
- Cloudy, green water
- Sediment deposits
- Outfall pipe is cracking
- Erosion has undermined the stability of the outfall. The extent of erosion damage is under 100 sq. ft.

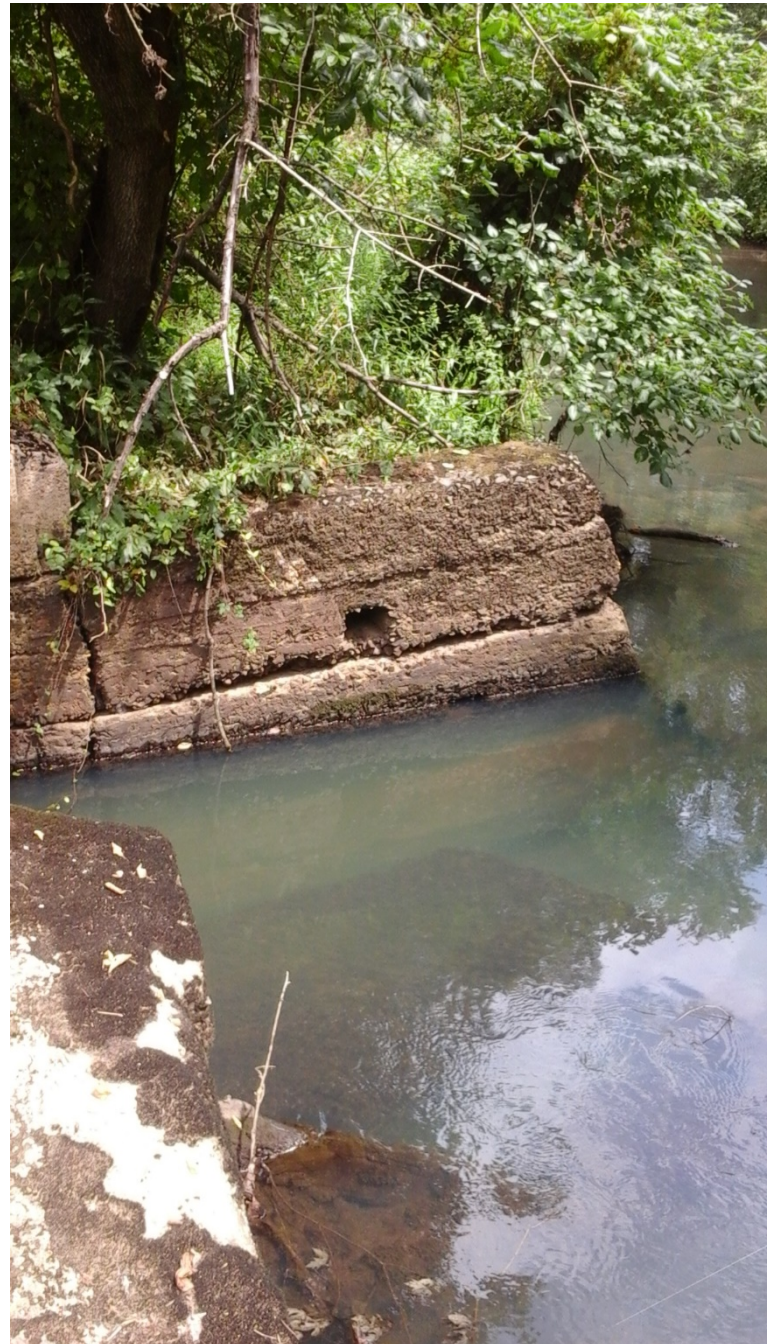
- 9" diameter concrete pipe
- Cloudy, green water
- Outfall pipe corrosion
- Erosion has undermined the stability of the outfall. The extent of erosion damage is under 100 sq. ft.

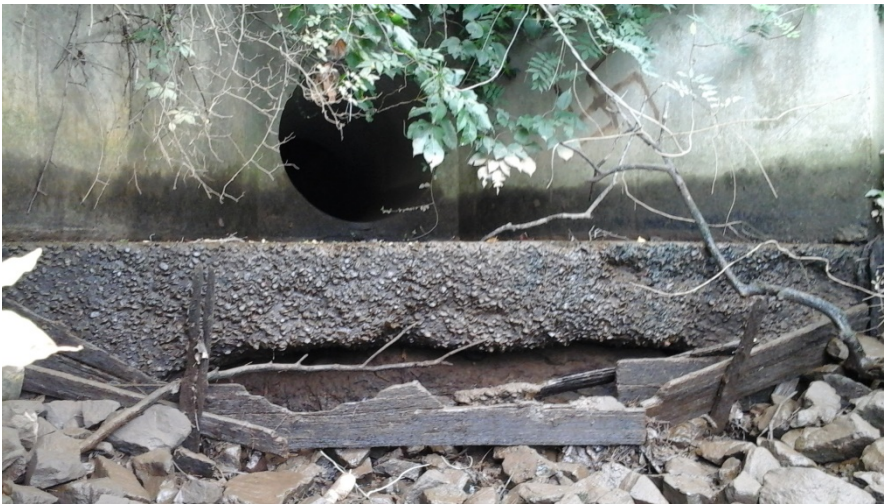
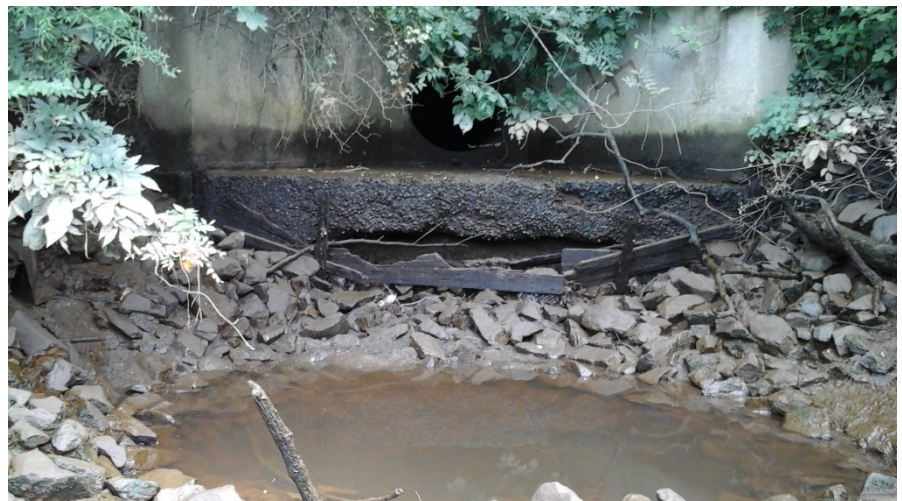
- 45" diameter concrete pipe
- Cloudy, brown water
- Excessive vegetation growth
- Outfall pipe spalling
- Erosion has undermined the stability of the outfall. The extent of erosion damage is under 100 sq. ft.
