**Hamilton Township (Mercer County)
Stormwater Basin Assessment Summary
Addendum (Year 3)**

Developed by the Rutgers Cooperative Extension Water Resources Program
Funded by Hamilton Township, Mercer County, New Jersey

September 30, 2014

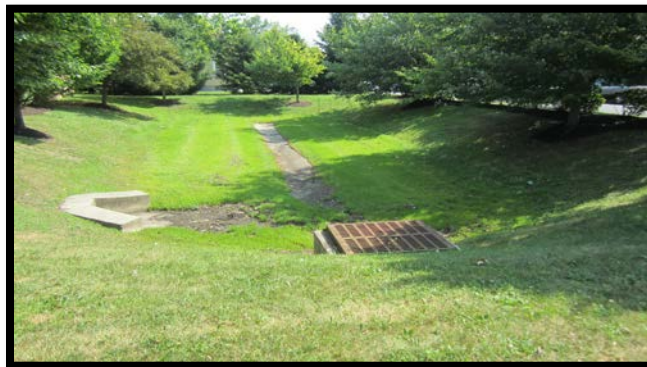
177. Sylvan Avenue Industrial Offices Basin

The basin near VACA on Sylvan Avenue is located in an area suitable for an infiltration retrofit. Evidence of excessive sediment accumulation was noted during the assessment. This problem can be alleviated by planting meadow grasses with deep root systems near the inlet and outlet structures to intercept incoming sediment and promote infiltration. This basin includes a concrete low flow channel, which could also be removed. Once removed, it could be replaced with a

stone-lined feature to enhance stormwater infiltration, reduce pollutants, and improve water quality downstream.

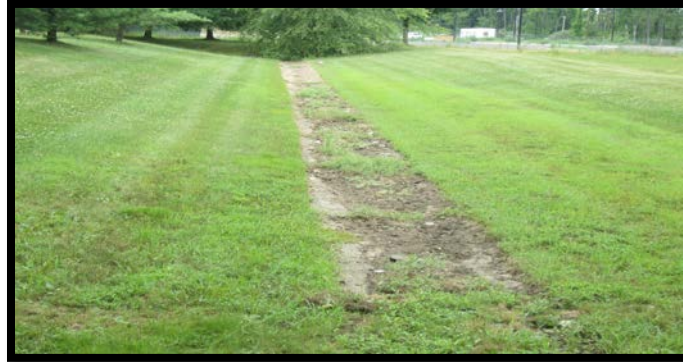
201. Goddard School Basin (A)

The basin located behind the Goddard School on Kuser Road appears to be in an area suitable for an infiltration system. The basin currently has an overgrown inlet structure, an outlet orifice clogged with sediment, and invasive vegetation impeding its function. A viable retrofit for this basin would be to convert it to a swale-like feature. A vegetated swale would include removal of the concrete low flow channel and planting it with native plant species to improve infiltration and groundwater recharge. This mitigation strategy reduces total suspended solids while improving water quality and aesthetics.

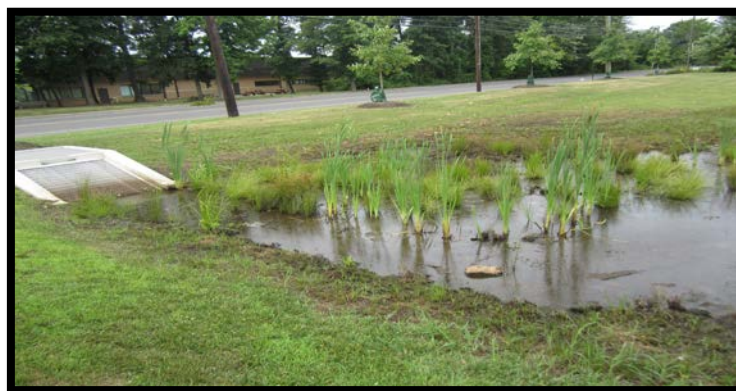
202. Weber Scientific Basin

The basin located at Weber Scientific near Kuser Road is considered suitable for infiltration. It is a candidate for a retrofit involving naturalization and planting of the basin. The basin is currently in need of maintenance and repair due to sediment accumulated in the basin bottom and

deteriorated landscape fabric in the low flow channel. Naturalizing and planting the basin bottom with meadows and routinely mowing a 6-8 foot section along the perimeter of the basin would improve water quality and the capacity of the basin to infiltrate stormwater runoff. Routine scheduled maintenance of the inlets and outlet structure, is needed and will help to reduce labor and equipment costs without compromising the basin's functionality.

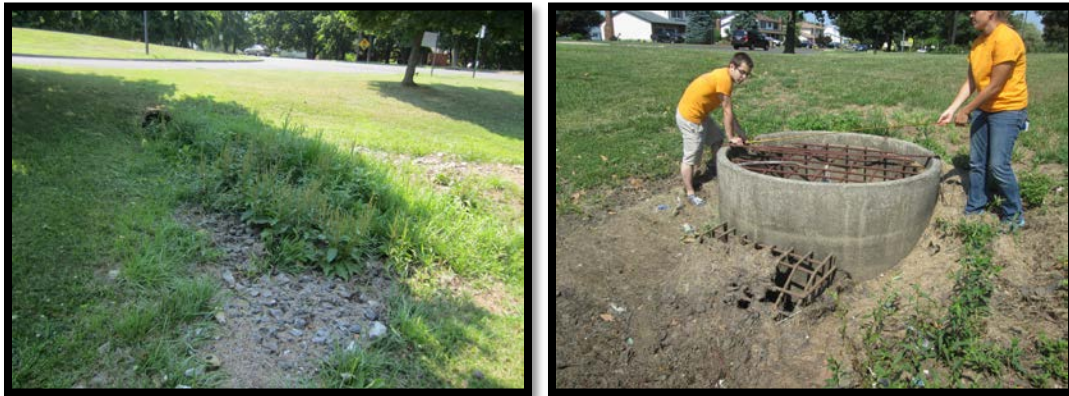
216. Richard C. Crockett Middle School Basin

The basin located at Richard C. Crockett Middle School features a narrow swale-like basin suitable for an infiltration retrofit. This site is a high priority candidate for transforming the existing overgrown detention basin into a planted bioswale. The detention basin is approximately 415 feet long by 45 feet wide and located north of the school. The basin currently has overgrown grass, excessive sediment, and erosion resulting from lack of maintenance and structural degradation. To retrofit the present condition, plans should include removing 12-18 inches of soil/sediment from the basin and backfilling with appropriate bioretention soil amendments. The swale can then be planted with a diverse mix of native plants and meadow grasses that will provide color and visual interest, treat water quality, and reduce flooding. In addition to the environmental benefits, this bioswale retrofit would provide an opportunity to engage students in learning about native plants, local wildlife habitat, and water resources issues in New Jersey.

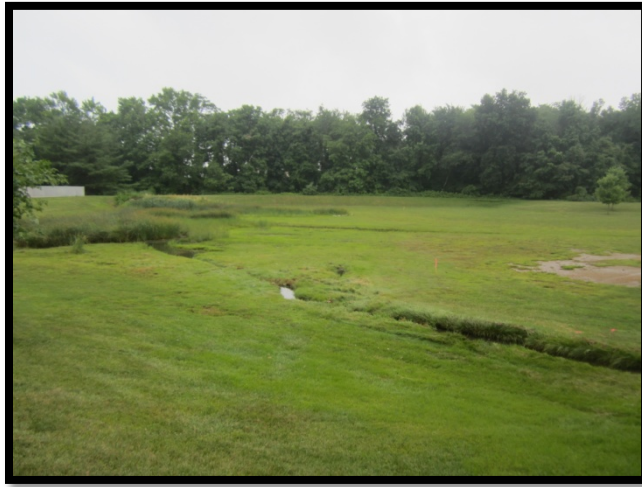
218. AAA Mid-Atlantic Basin

The detention basin located on the eastern side of AAA Mid-Atlantic resides in an area suitable for an infiltration retrofit. Currently the basin is receiving excessive sediment loads from the adjacent roadway. Sediment deposits have built-up in multiple locations restricting stormwater flow between the inlet and outlet. A retrofit plan is needed to alleviate the issue. First, removal of the sediment and existing concrete low flow channels from the basin should be done. A 12-18 inch deep, 3-4 foot wide stream-bed feature consisting of river stone can replace the concrete low flow channels and lead to a large rain garden near the outlet structure. Furthermore, planting and/or naturalizing the rain garden would contribute significantly to capturing and stabilizing the amount of sediment passing through the basin while improving water quality and enhancing aesthetics.

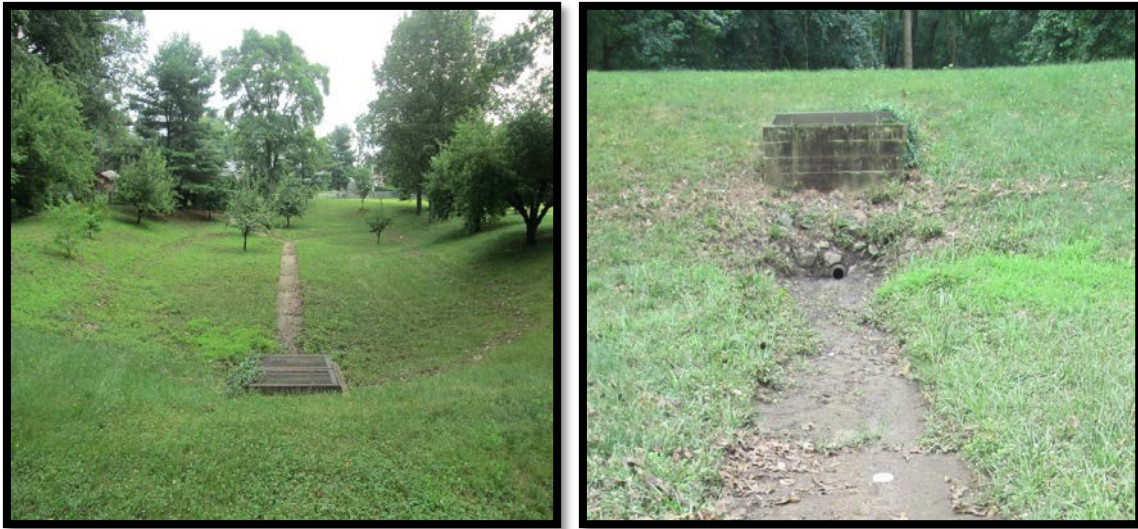
232. Betsy Court Basin

The basin located west of Betsy Court occupies an area suitable for an infiltration retrofit. Considering that this basin has soils with good infiltration rates, a relatively inexpensive retrofit design would include removing the 95-foot section of the concrete low flow channel up to the fork and allowing naturalization of the basin bottom. Currently smaller more frequent storm events are travelling directly from the inlets to the outlet without any treatment. Implementing a mow plan to maintain the inlets, outlet, and embankment of the basin clear of vegetation on a routine basis would ensure proper functioning of the system while addressing stormwater concerns. As a result, this would leave an approximate 4,600 square foot area of naturalized grass in the basin bottom. With this retrofit, sediment, litter, and debris will settle out in the grassed areas as the stormwater infiltrates, in turn reducing localized flooding and nonpoint source pollutants.

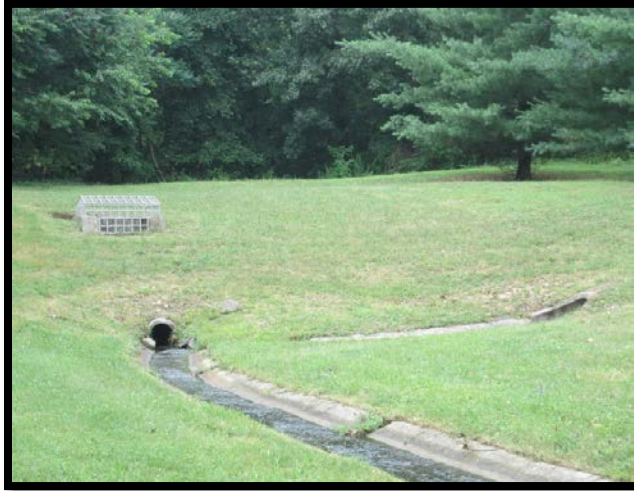
233. Alessio Terrace Basin

The detention basin located south of Alessio Terrace is in an area suitable for an infiltration retrofit. At the time of assessment, the basin appeared to be well maintained and functioning as designed. However, a simple retrofit design can improve its functioning to address water quality concerns and promote infiltration. Currently the basin has a 13-inch diameter outlet orifice that provides little or no stormwater detention during small rain events. To mitigate this issue, a steel restrictor plate with a 4-6 inch outlet orifice can be installed over the existing 13-inch outlet pipe. In addition, the entire low flow channel can be replaced with a 3-foot wide by 6-12 inch deep stream-bed feature. This will in turn slow the volume of runoff travelling through the basin as well as allow water to infiltrate back into the soil.

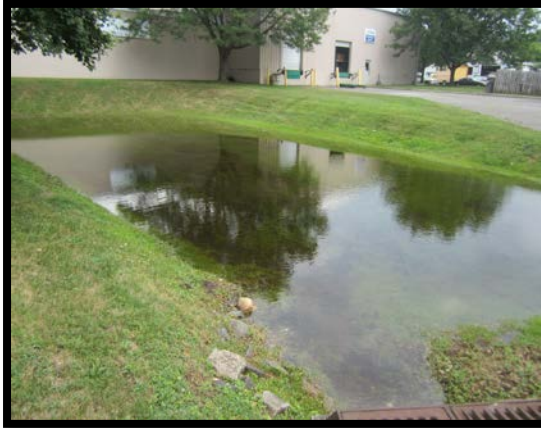
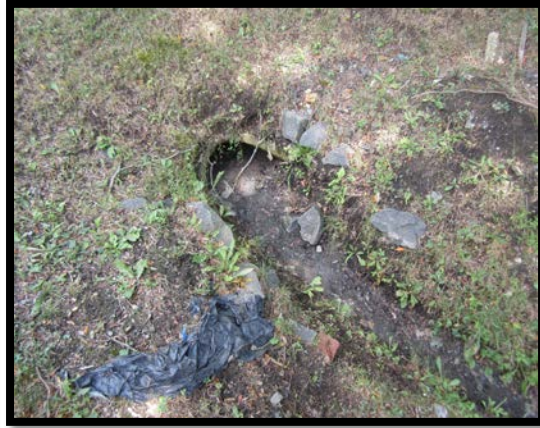
239. Adam's Party Rental Basin

The basin at Adam's Party Rental is located in an area suitable for an infiltration retrofit. The preliminary step should involve removing excess sediment and debris from the inlet and currently overgrown outlet orifice. A retrofit design could include transforming the existing basin into a 2,200 square foot rain garden. The eroded swale directing runoff from the northern parking lot should be addressed by adding soil and rip-rap to stabilize the inlet channel. The southeastern curb-cut inlet should also be cleared of overgrown turf grass. The basin bottom should then be left to naturalize or be planted with a meadow seed mix to establish plant growth with deep root systems to promote infiltration and reduce future clogging issues.

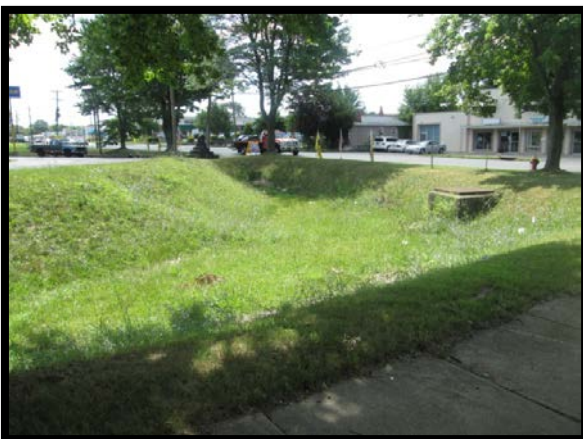
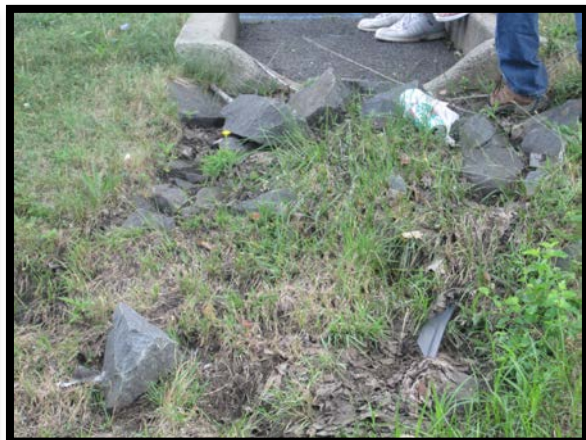
243. Good Year Auto Service Basin

The detention basin located on the premises of Good Year Auto Service is in an area suitable for an infiltration retrofit. The basin consists of two basin sections sharing one main outlet structure. During the assessment, overgrown vegetation and debris was found to be impeding the

functionality of the basin. The inlet is a 30-inch curb-cut from the most eastern portion of the parking lot; the erosion can be repaired by re-digging the trench, then adding soil and rip-rap to control the velocity of runoff entering the basin. To improve infiltration, the retrofit could involve planting with native plants or allowing the basin to naturalize. This strategy will enhance the capture of debris entering the basin while simultaneously reducing pollutants before discharging downstream.

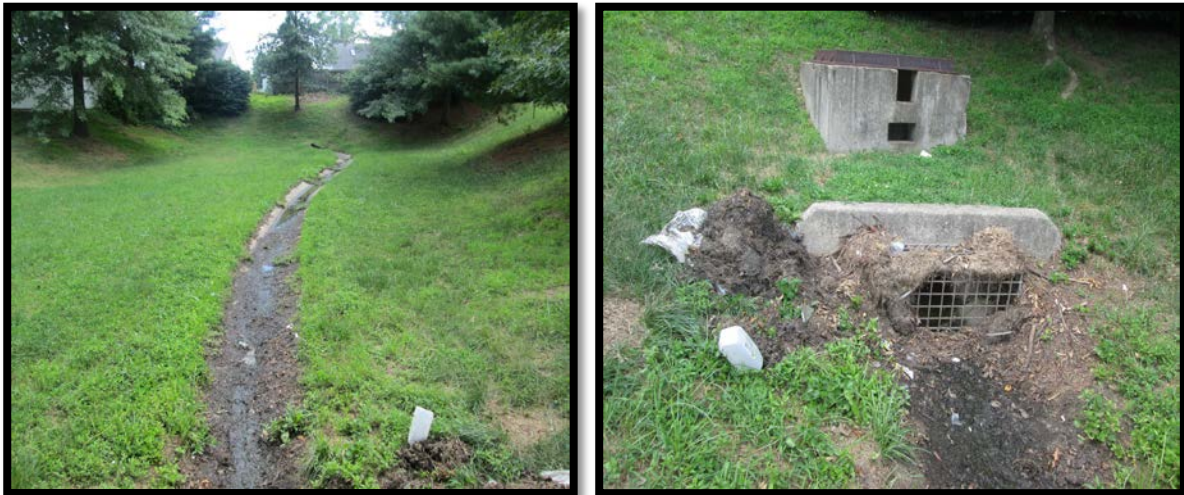
264. Perilli Drive Basin

The basin adjacent to Perilli drive is located in an area considered suitable for an infiltration retrofit. At the time of assessment, the basin had evidence of heavy debris and sediment loads near the primary structures that require removal. The outlet orifice diameter was measured to be 17 inches, which provides little or no detention time for small storms. Efforts to retrofit this basin could include replacing the concrete low flow channel with a 3-foot wide by 6-inch deep river stone stream-bed and subsurface perforated pipe leading to the outlet structure. In addition, planting meadows near the inlet and outlet structure can act as a buffer for incoming sediment and debris. This will enable incoming runoff to filter, and slowly percolate through the pipe with some preliminary treatment before discharging from the basin. At a minimum, a restrictor plate can be installed to reduce the outlet diameter, increasing detention time during small and large storm events. This will allow more time for the water to settle-out pollutants before infiltrating back into the soil.

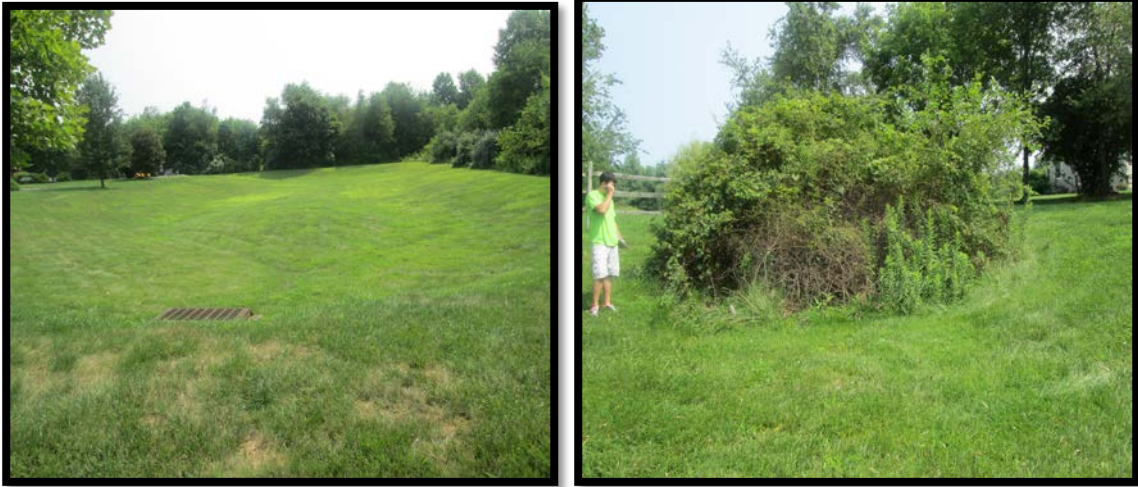
272. Iron Bridge Road Basin

The basin located east of Iron Bridge Road is in an area considered suitable for an infiltration retrofit. At the time of assessment, excessive vegetation was found to be obstructing the inlet. This basin does not have a low flow channel making it ideal for an infiltration retrofit. The first step should be to remove excessive plant growth from the inlet so runoff can flow unrestricted into the basin. A retrofit design for this basin would involve planting deep rooted native grasses in the area leading from the inlet to the basin. In addition, areas of meadows and native grasses should be planted near the outlet to increase detention time. These plantings will allow water to sheetflow throughout the basin, recharging groundwater and increasing pollutant removal. At a minimum, the perimeter and main structures of the basin should remain mowed on a scheduled (bi-weekly or monthly) basis, letting the basin bottom naturalize.

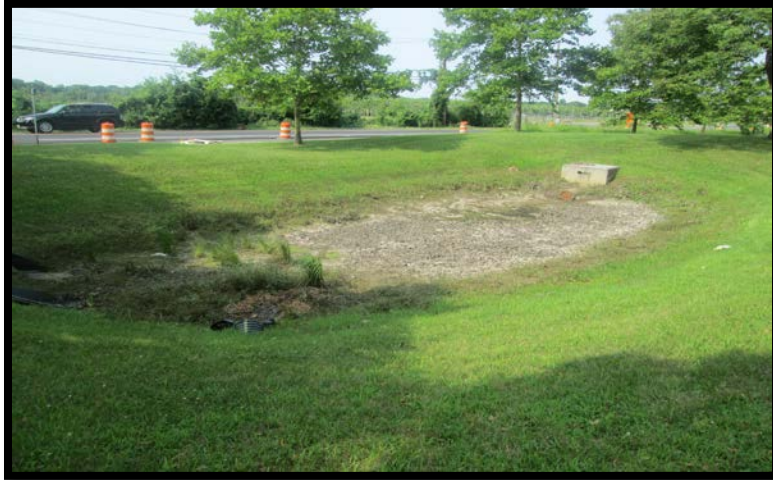
306. Saint James Church Basin

The detention basin located south of Saint James Church is in an area considered suitable for an infiltration retrofit. The basin consists of two basins sharing one common outlet structure. At the time of assessment, the western basin was found to have excessive sediment in the basin bottom, obstructing the outlet orifice. The basin is a priority candidate for a retrofit design that would transform the existing basin into a planted/naturalized system. A preliminary step would involve removing the 3-6 inch layer of sediment covering the basin bottom and planting with a meadow seed mix. The eastern basin can be planted with native grasses to filter sediment from stormwater entering the basins through the curbcut inlet. This will decrease stormwater peak runoff volume and nonpoint source pollutants discharging from the basin.

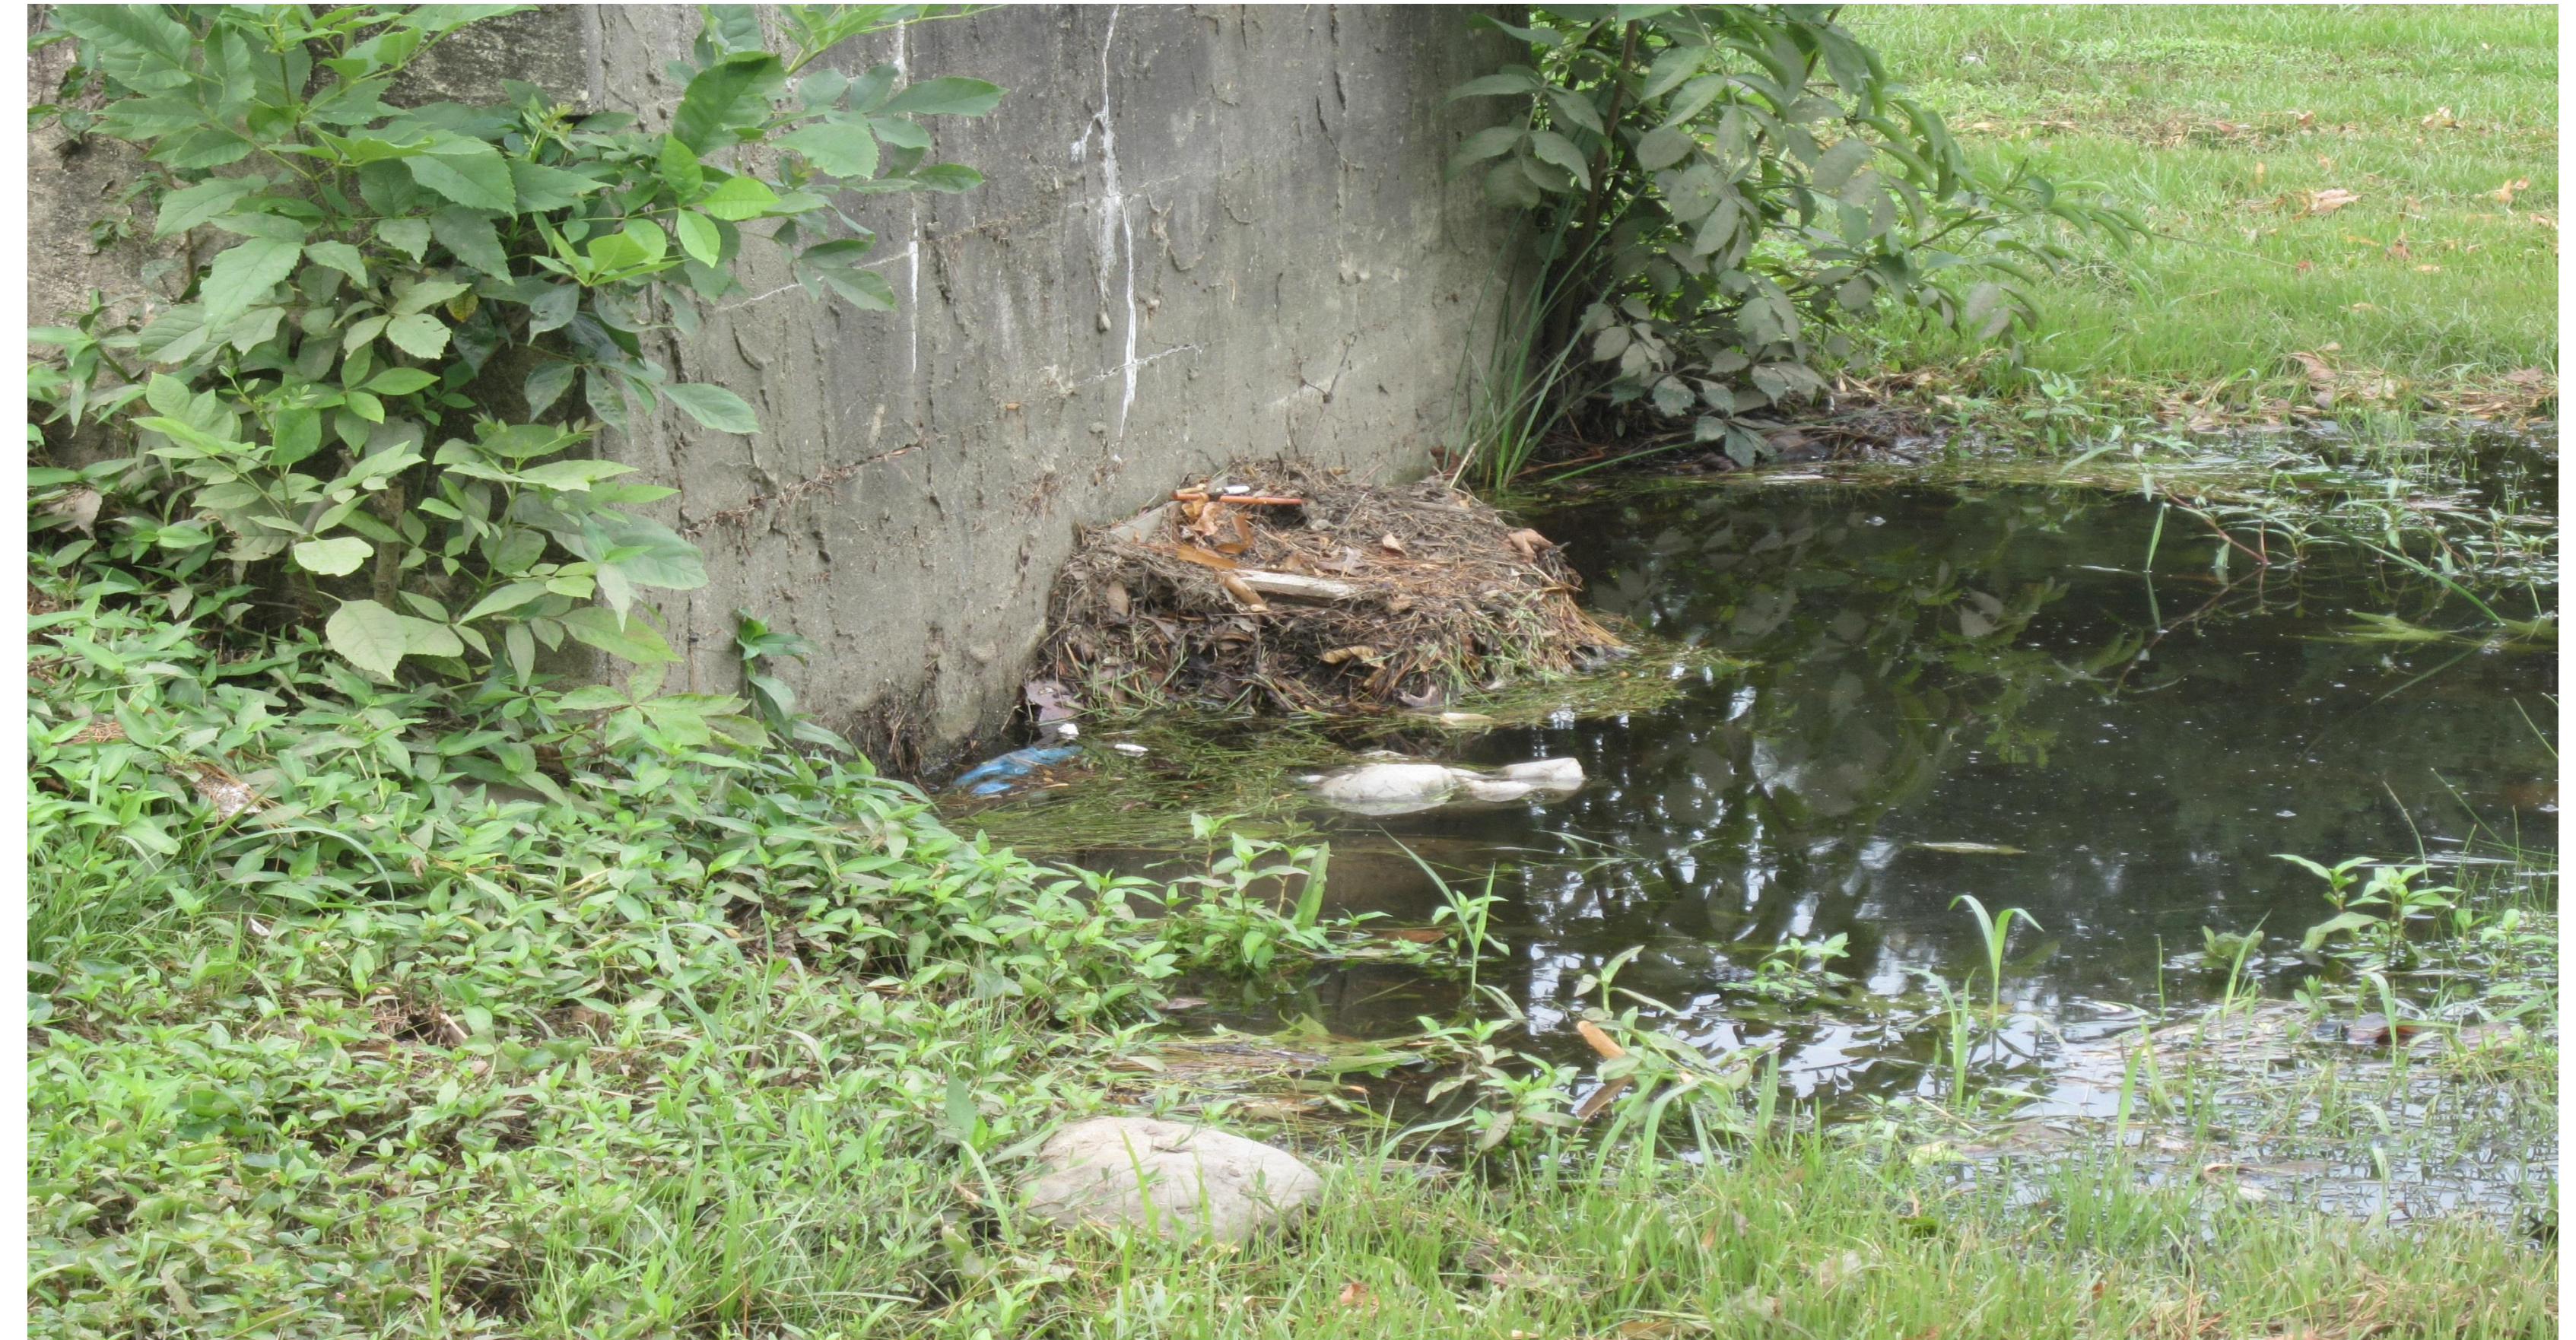
Basin bottom looking southwest

- Outlet orifice is clogged due to excess debris, litter, and sediment
- Outlet structure has cracks and breakage
- Ponding water in basin bottom
- One inlet has exposed wire due to erosion

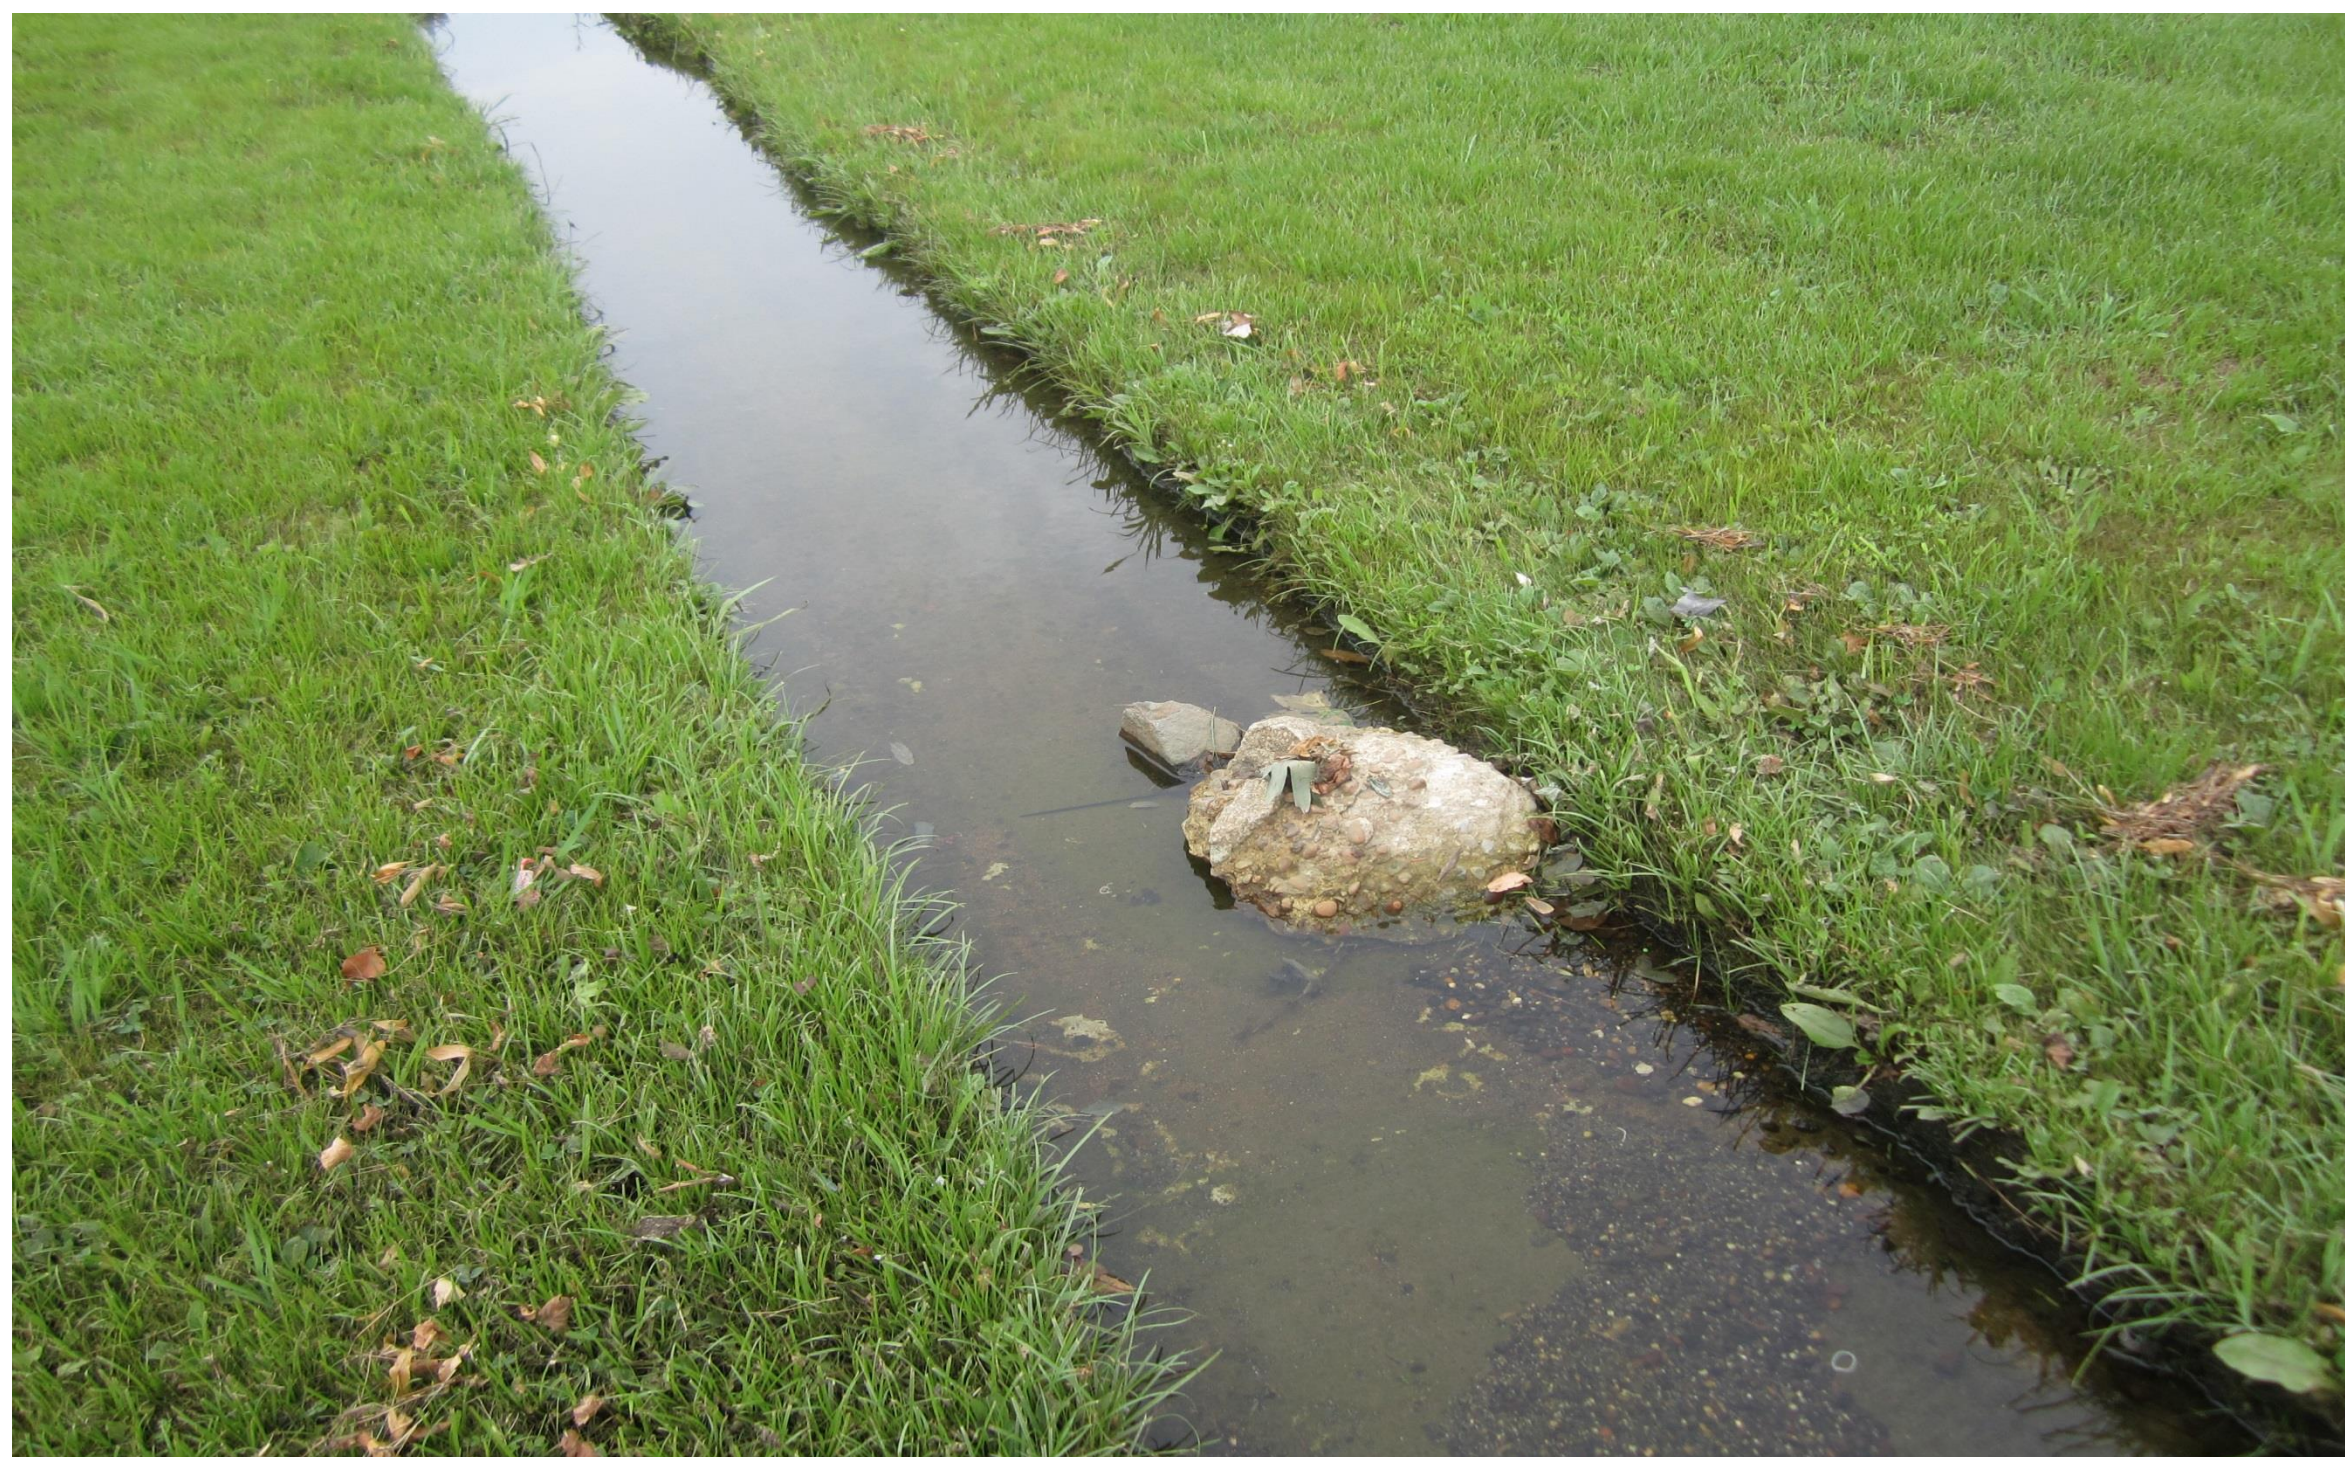
Standing water in low flow channel

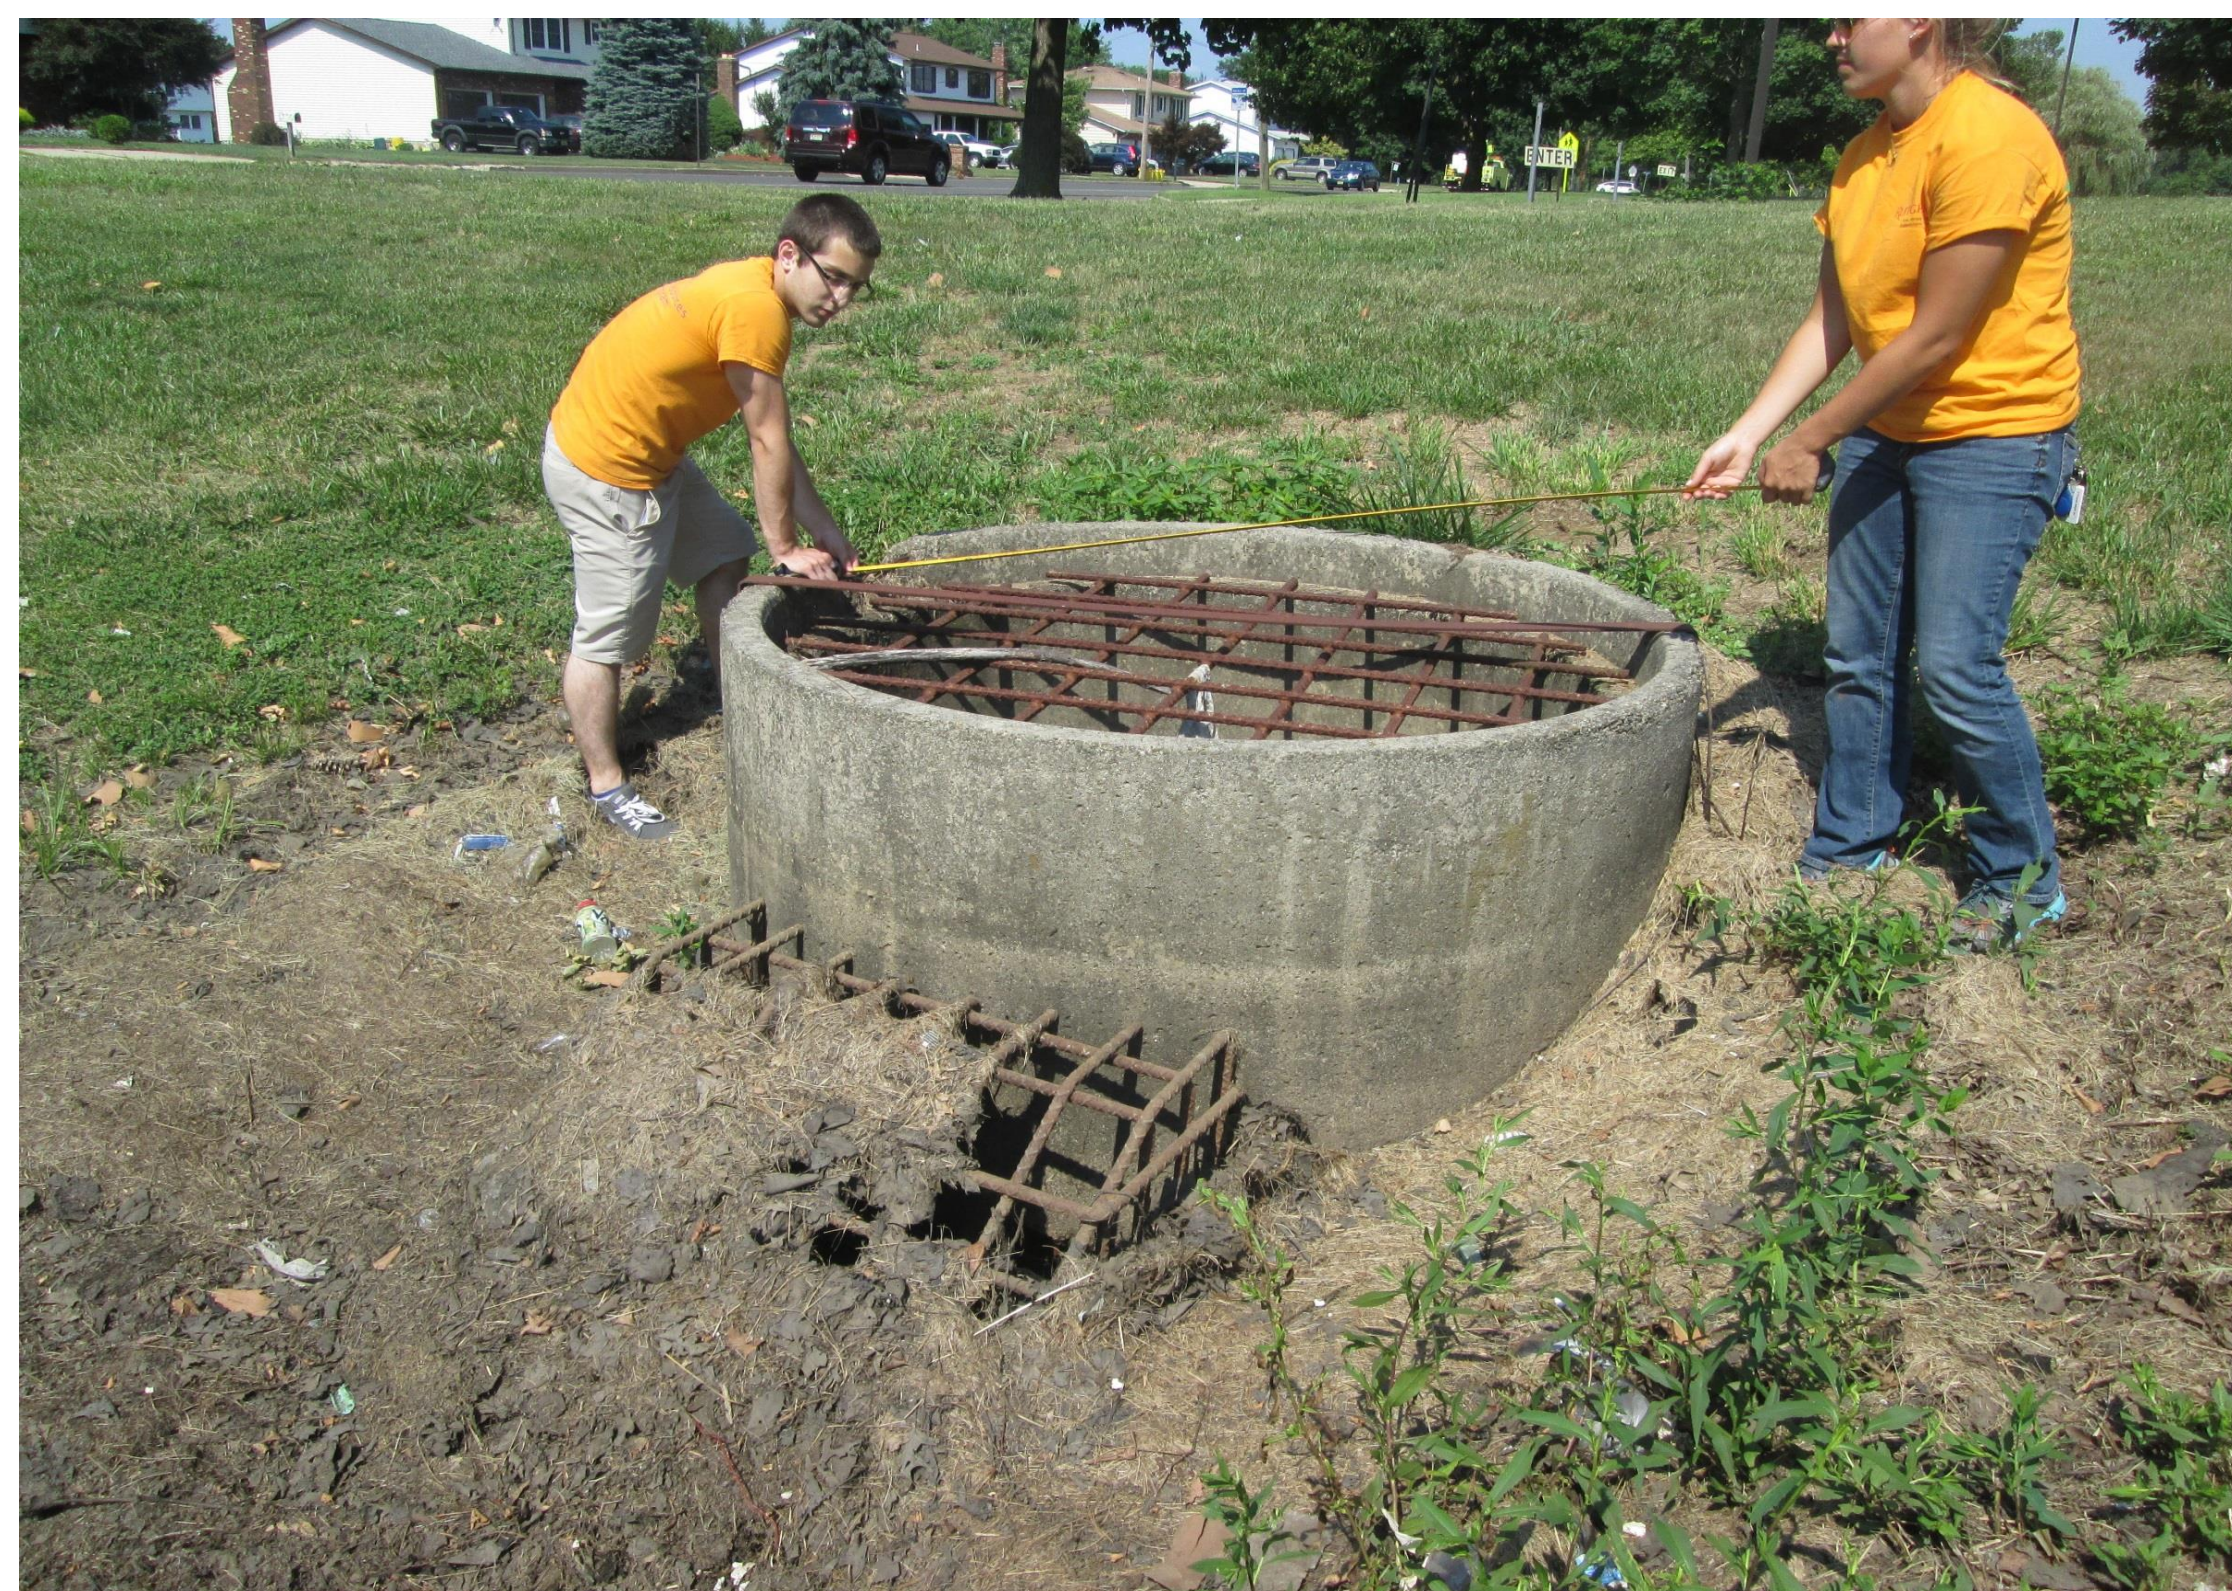
Degraded outlet structure
