MILESTONE 4 OF REGIONAL STORMWATER MANAGEMENT PLAN FOR THE  
 POMPESTON CREEK  
 NEW JERSEY DEPARTMENT OF ENVIRONMENTAL PROTECTION  
 FOUNDATION FARMS PARK, CINNAMINSON, NJ  
 STREAM BANK STABILIZATION

JOB	CONCEPT SHEET #
POMP	4
BID	TOTAL
4	12

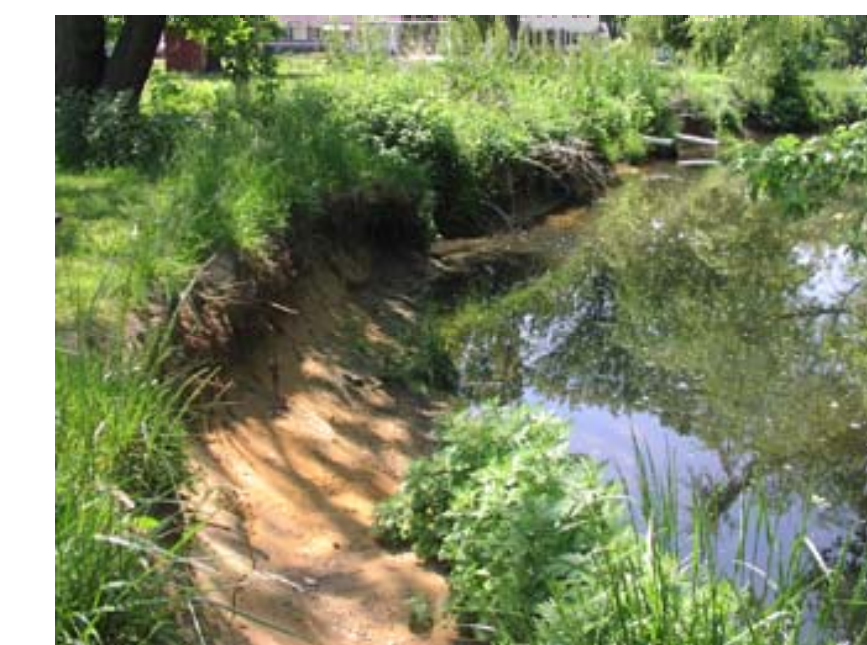
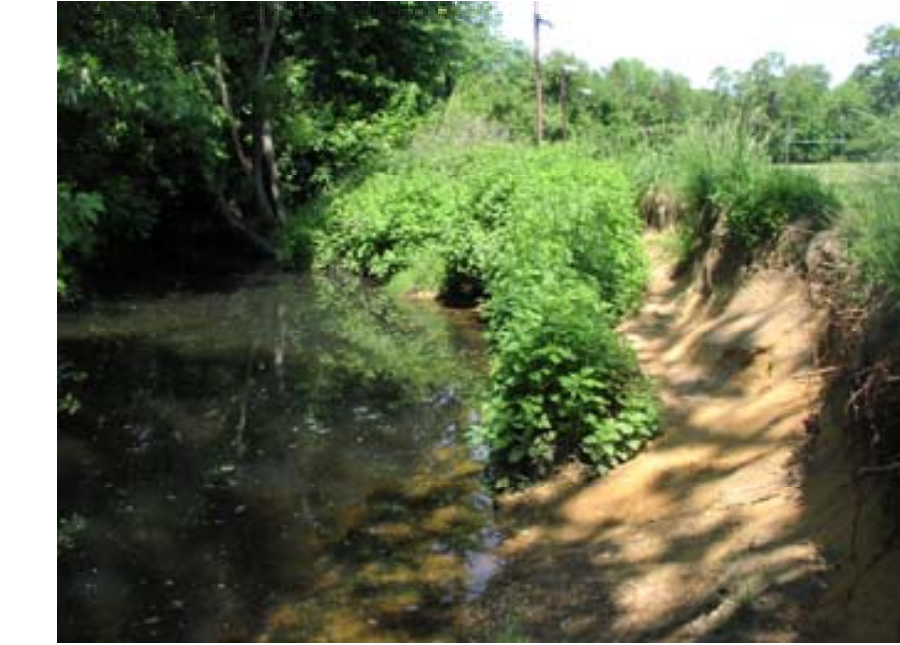
PHOTOS OF EXISTING UNSTABLE STREAM BANK

1. THE AREA INDICATED ON THE MAP IS SELECTED FOR STREAM BANK AND HABITAT RESTORATION. AS SHOWN IN THE PICTURES BELOW, OVER THE YEARS, THE STREAM BANK HAS ERODED INTO AN UNSTABLE PART OF THE STREAM. THIS CAN BE A SERIOUS HAZARD TO CHILDREN PLAYING IN THIS PARK. THE DROP FROM THE TOP OF THE BANK TO THE STREAM BED IS OVER 3 FEET. THIS PART OF THE STREAM IS LOCATED IN FOUNDATION FARMS PARK, THEREFORE CHILDREN ARE AROUND THIS HAZARD ON A FREQUENT BASIS.

2. THE PROBLEM IS THE ERODED STREAM BANK FOR THIS SECTION OF THE STREAM. IT CAN BE A HAZARD TO PEOPLE WHO MIGHT FALL IN. WHEN A STORM EVENT OCCURS THE STREAM LEVEL RISES AND ERODES THE STREAM BANK EVEN MORE CONTAMINATING THE STREAM WITH HEAVY LEVELS OF TOTALS SUSPENDED SOLIDS. THE GOAL OF THIS RESTORATION TO STABILIZE THE STREAM BANK WHILE CONTINUING TO ALLOW FOR RECREATIONAL FISHING.

8. DURING A SITE VISIT, ONE OF THE PIPES PRODDING OUT FROM THE STREAMBANK HAD WATER RUNNING FROM IT AND IT HAD NOT RAINED FOR AT LEAST 3 DAYS. RCE RECOMMENDS INVESTIGATING WHERE THIS WATER IS COMING FROM BEFORE RESTORING THIS STREAM BANK.

3. THE VARIOUS DETAILS BELOW DEMONSTRATE DIFFERENT METHODS THAT COULD BE BUILT TO REPAIR THE ERODED STREAM BANK.
4. THE TWO DETAILS ON THE FAR LEFT THAT INCLUDE ECO-NET STABILIZATION INVOLVE THE STREAM BANK BEING GRADED BACK FROM A NEAR STRAIGHT DROP TO A 2:1 SLOPE. THIS ELIMINATES THE FALL HAZARD FROM THE SITE. AFTER THE SITE IS REGRADED IT IS PLANTED WITH VARIOUS PLANTS MUCH LIKE THE ONES BELOW IN THE SUGGESTED PLANT LIST. THE PLANTS AS THEY GROW WILL HOLD THE SOIL AND VASTLY REDUCE THE AMOUNT OF TOTAL SUSPENDED SOLIDS FROM THAT STREAM BANK.
