Impervious Cover Assessment for Englishtown Borough, Monmouth County, New Jersey

Prepared for Englishtown Borough by the Rutgers Cooperative Extension Water Resources Program

February 4, 2015

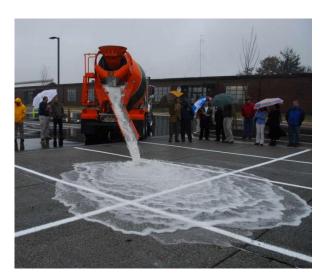
Figure 2: Rapid infiltration of water through porous pavement is demonstrated at the USEPA Edison New Jersey test site

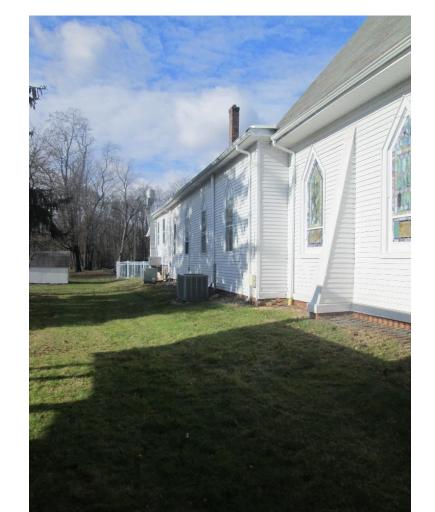
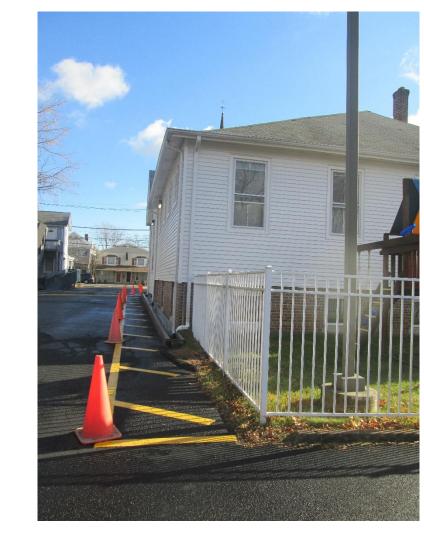
- BIOSWALE: A bioswale can be installed to treat runoff from the church roof. Bioswales are landscape features that convey stormwater from one location to another while removing pollutants and providing water an opportunity to infiltrate.
- **DOWNSPOUT PLANTER BOX:** Four downspout planter boxes could be installed at the north side of the building to collect water from the nearby downspout. Downspout planter boxes reduce runoff and allow water to slowly infiltrate while being treated for pollutants.
- DISCONNECTED DOWNSPOUTS: Downspouts can be disconnected to allow rainwater to flow into the grassed areas which will help remove pollutants and allow for the stormwater to infiltrate into the ground.

This site contains several impervious surfaces including driveways, walkways, a parking lot, and a church. These impervious surfaces are directly connected to a storm sewer system. The church's parking lot is relatively flat and the pavement is in good condition throughout the property. There are several downspouts that run down the northern and southern faces of the church. On the northern face of the church, there are four downspouts routed into a metal channel, which is not set into the ground. There is a parking space at the front of the church. A downspout runs into this parking space and the pavement allows runoff to flow into the street. A water valve was observed in the grass near this drive, and other utilities may be present. A depression runs along the southern side of the church where there are five downspouts (including the downspout near the parking space).

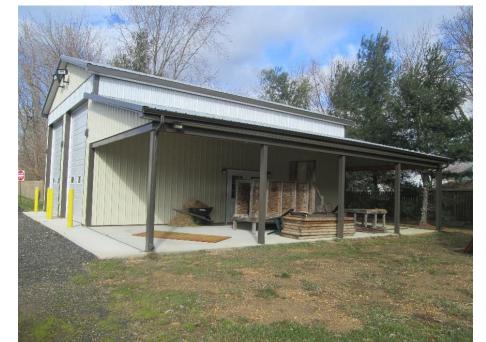
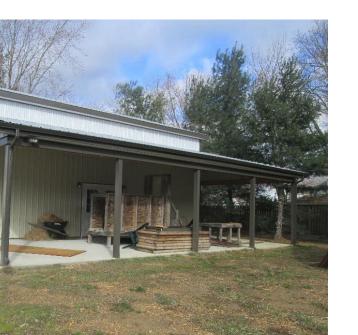
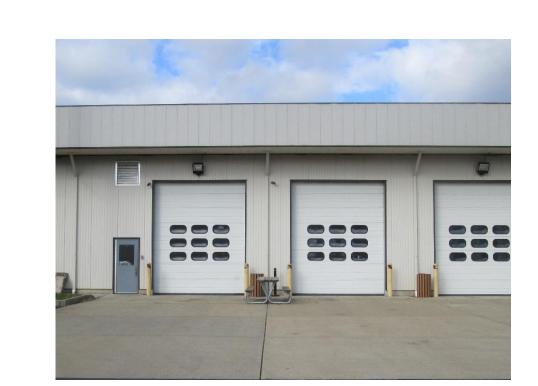
SITE PLAN:

- RAINWATER HARVESTING SYSTEM: Rainwater could be harvested from the roof of the south eastern building and stored in a cistern. The water can then be used to wash vehicles.
- BIORETENTION SYSTEM: A rain garden can be installed on a patch of turf grass to capture roof runoff by disconnecting the downspout located off the front of the building at the northeast corner. The bioretention system can reduce sediment and nutrient loading to the local waterways and increase groundwater recharge.
- **DOWNSPOUT PLANTER BOX:** A downspout planter boxes could be installed at the southeast side of the building to collect water from the nearby downspout. Downspout planter boxes reduce runoff and allow water to slowly infiltrate while being treated for pollutants.

This site contains several impervious surfaces including driveways, a parking lot, a garage, and the firehouse. The front of the firehouse is directly connected to a storm sewer system. The site's impervious surfaces produce stormwater runoff during rain events. Downspouts run in between each rear garage door, and there is approximately 5 feet of room between each door. At the time of the site visit, a picnic table was observed between one of these garage doors. There are two turf grass areas at the front of the building. There is a connected downspout at the northeastern corner of the firehouse. A garage is located to the east of the property. The parking lot is gravel and pavement, and both are in good condition. It should be noted that there is an existing wetland to the southeast of the site and an existing swale that runs into it from the western edge of the property. The swale is shared with the commercial property next door – a large warehouse, whose parking lot is littered with debris and sediment. Severe ponding was observed on this property at the time of the site visit, and the swale was full after a recent rain storm.
