**Impervious Cover Reduction Action Plan
for
Manville Borough, Somerset County, New Jersey**

*Prepared for Manville Borough by the
Rutgers Cooperative Extension Water Resources Program*

September 5, 2015

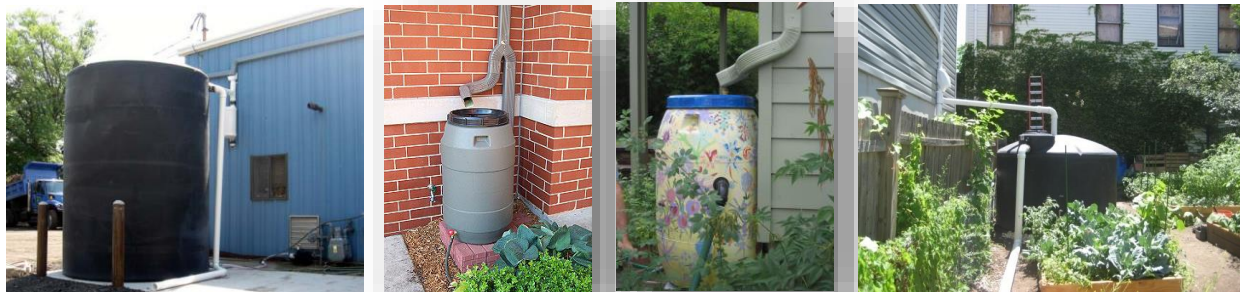
These systems capture rainwater, mainly from rooftops, in cisterns or rain barrels. The water can then be used for watering gardens, washing vehicles, or for other non-potable uses.

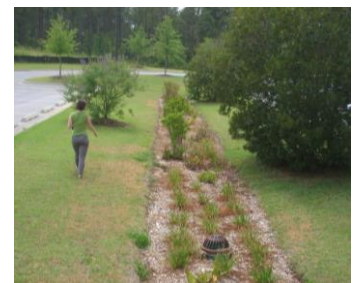
Bioswales are landscape features that convey stormwater from one location to another while removing pollutants and providing water an opportunity to infiltrate.

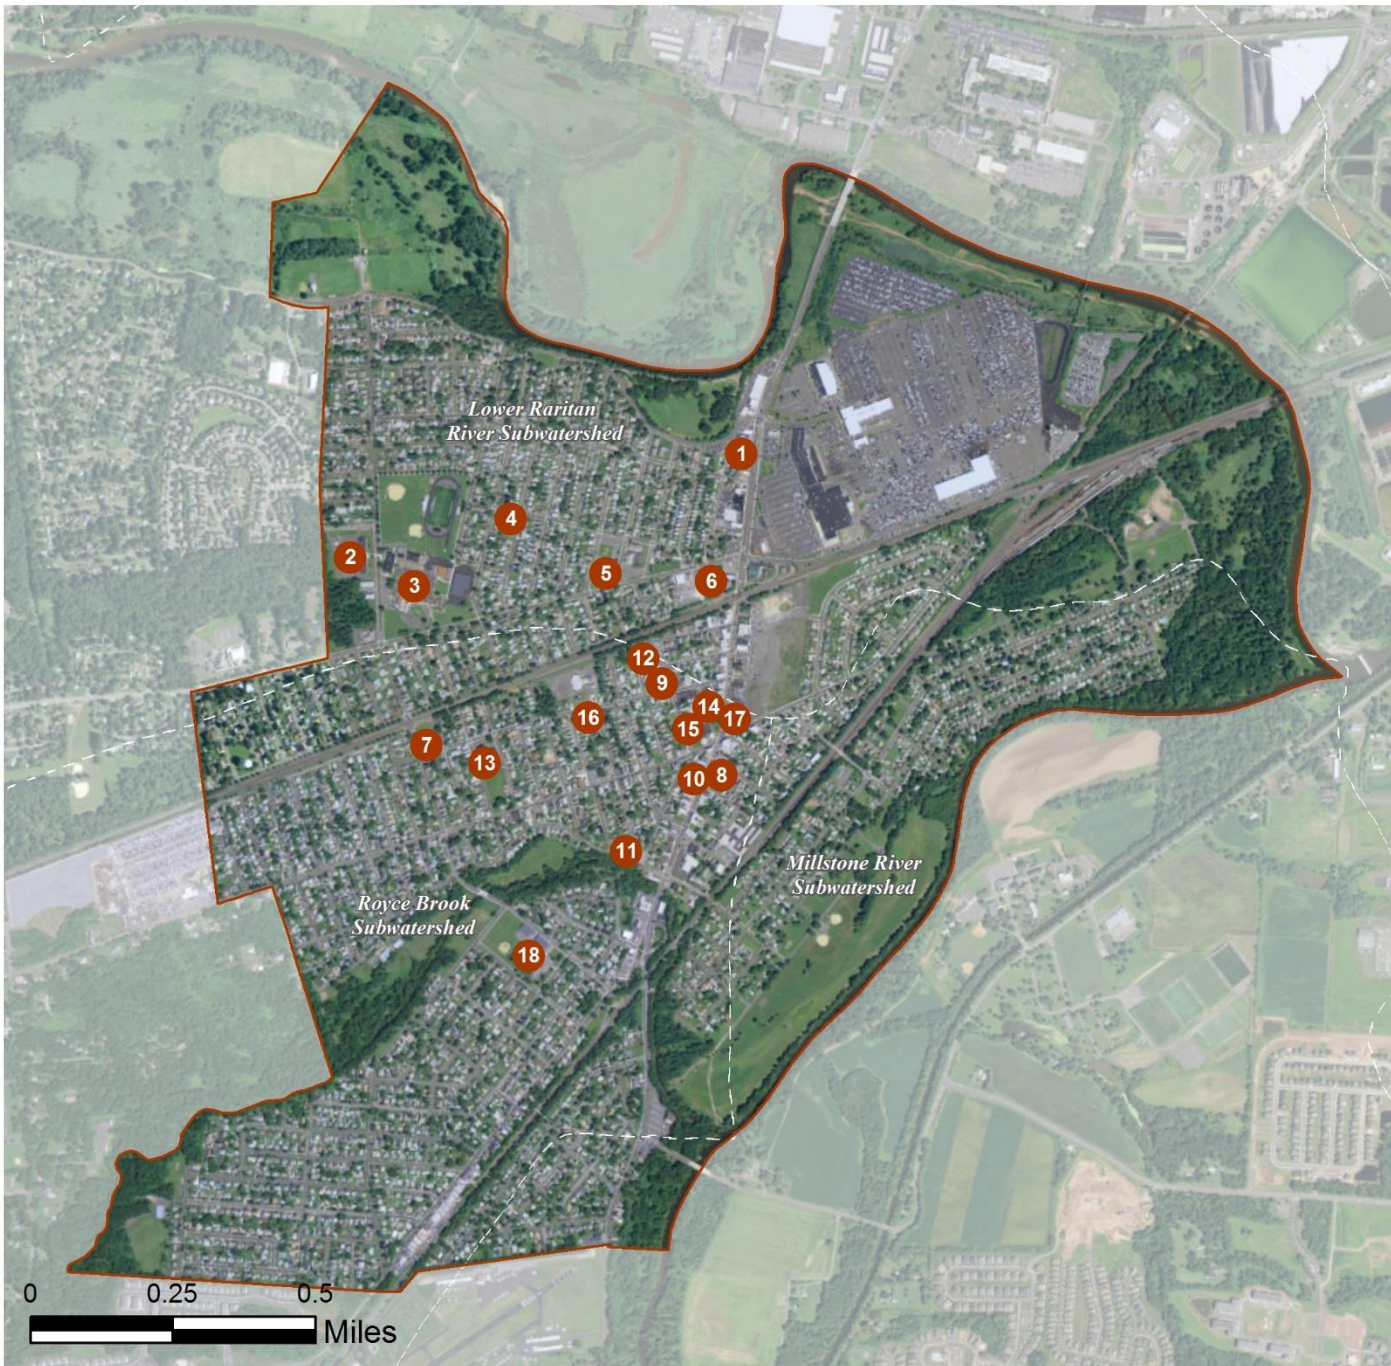
MANVILLE: GREEN INFRASTRUCTURE SITES

1. Borough of Manville Municipal Complex
2. Christ the King School
3. Manville High & Alexander Batcho Intermediate
4. North End Volunteer Fire Company #3
5. Roosevelt School
6. US Post Office

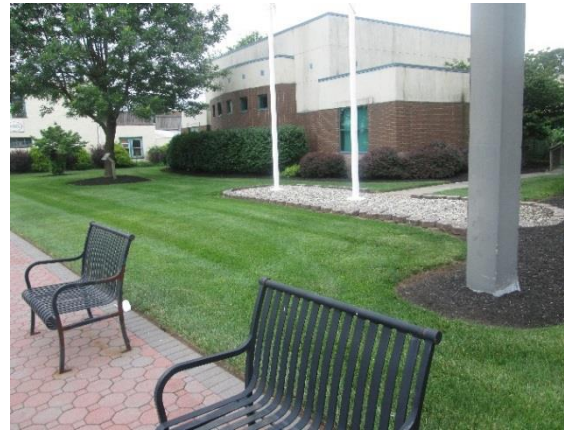
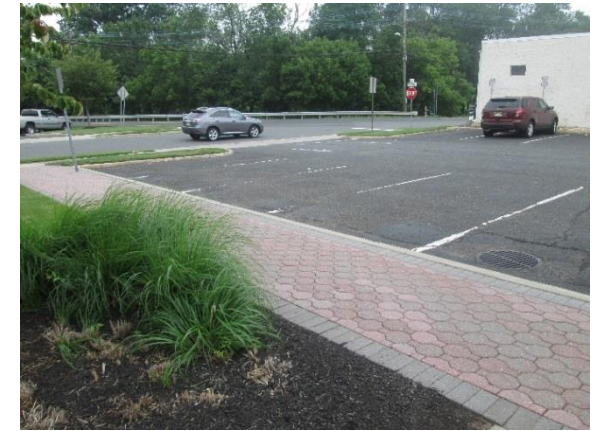
The building has an internal drainage system. Stormwater runoff can be reduced by installing a rain garden and replacing parking spots with porous asphalt. A preliminary soil assessment suggests that the soils have suitable drainage characteristics for green infrastructure.

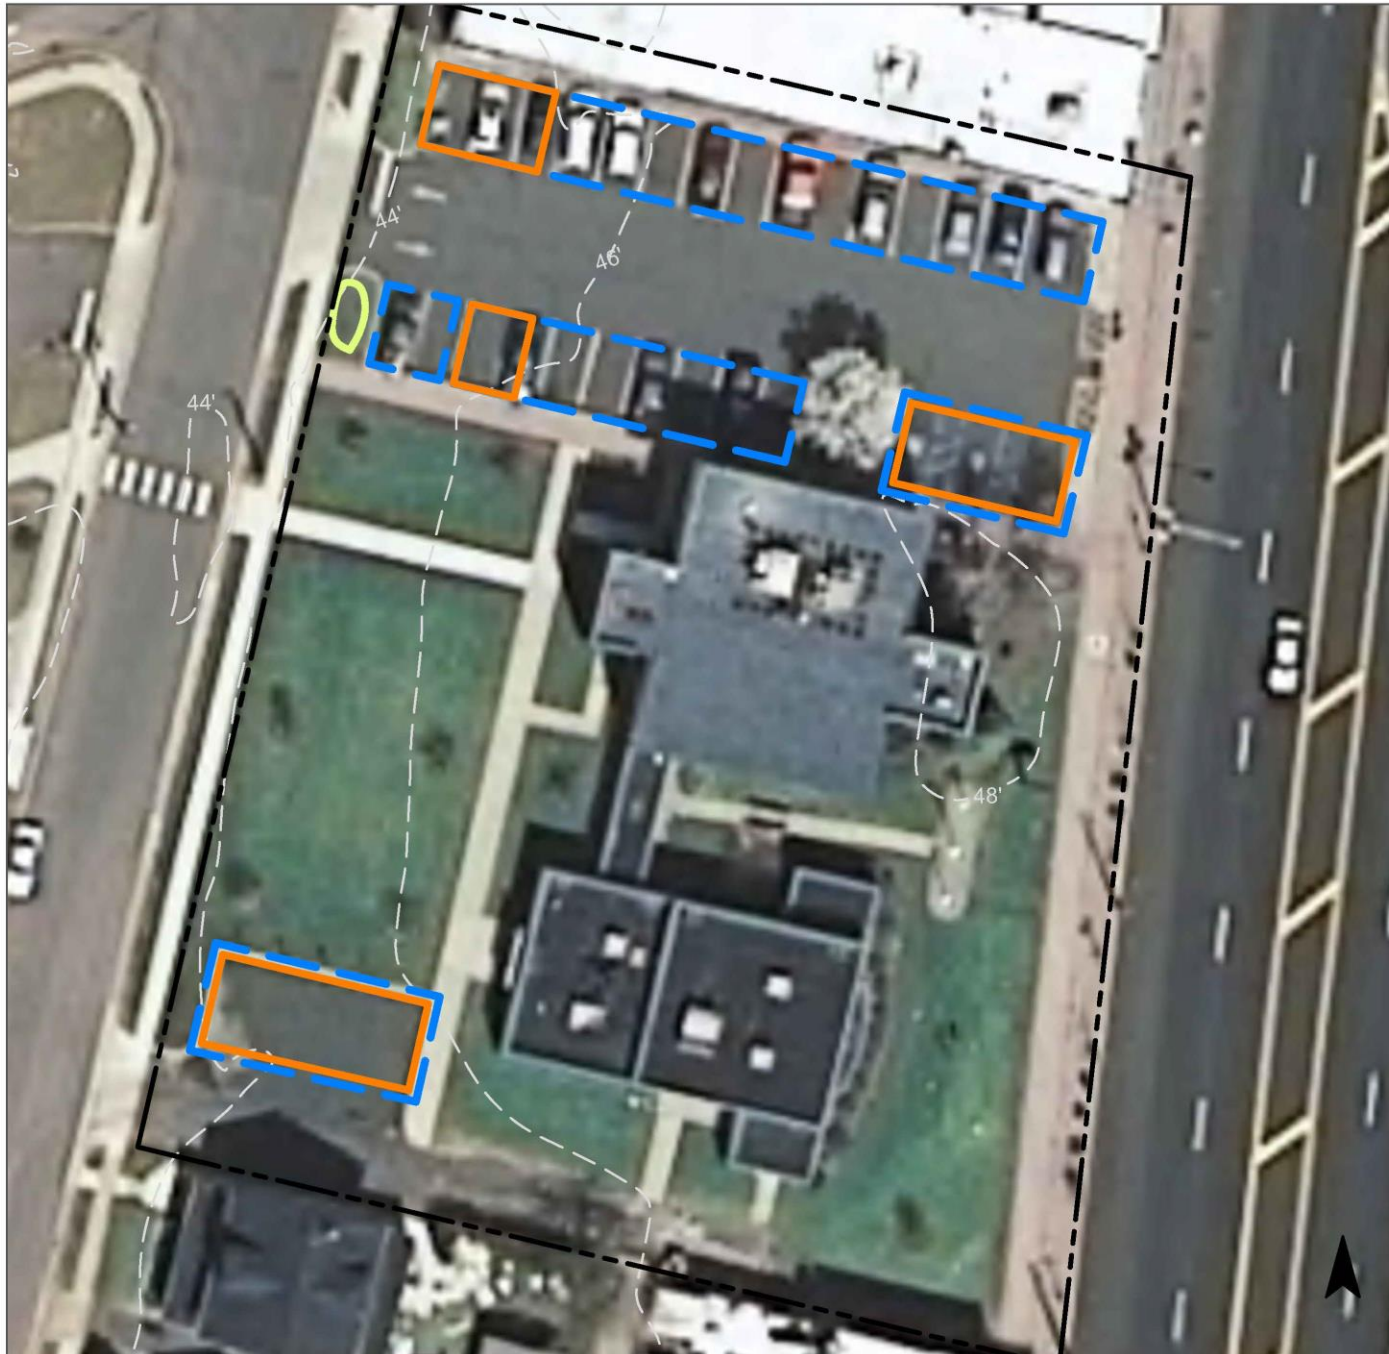
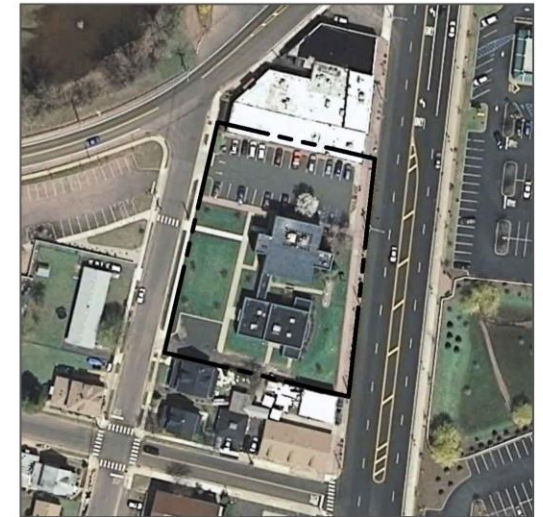
GREEN INFRASTRUCTURE RECOMMENDATIONS

Recommended Green Infrastructure Practices	Recharge Potential (Mgal/yr)	TSS Removal Potential (lbs/yr)	Maximum Volume Reduction Potential (gal/storm)	Peak Discharge Reduction Potential (cu. ft./second)	Estimated Size (sq. ft.)	Estimated Cost
Bioretention systems	0.008	1	554	0.02	72	\$360
Pervious pavements	0.132	22	9,672	0.36	2,557	\$63,925

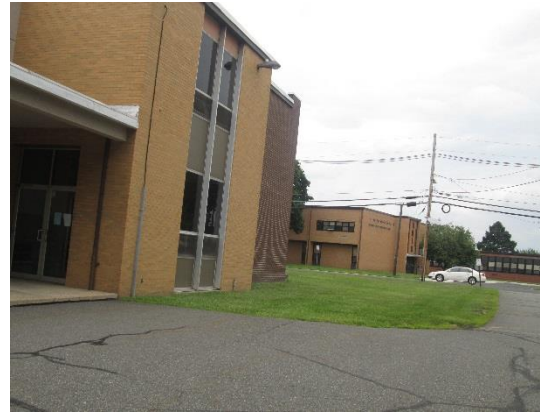
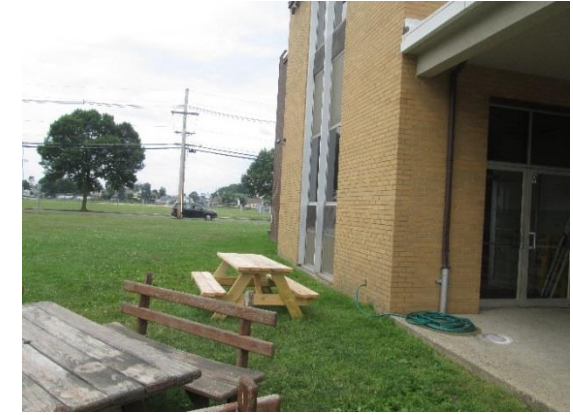
Block and Lot: Block 42.01, Lot 1.01

Stormwater is currently being directed to storm drains. Parking spots on both side of the building can be replaced with porous asphalt to capture and infiltrate stormwater. Rain gardens adjacent to the building can capture, treat, and infiltrate roof runoff. A preliminary soil assessment suggests that more soil testing would be required before determining the soil's suitability for green infrastructure.

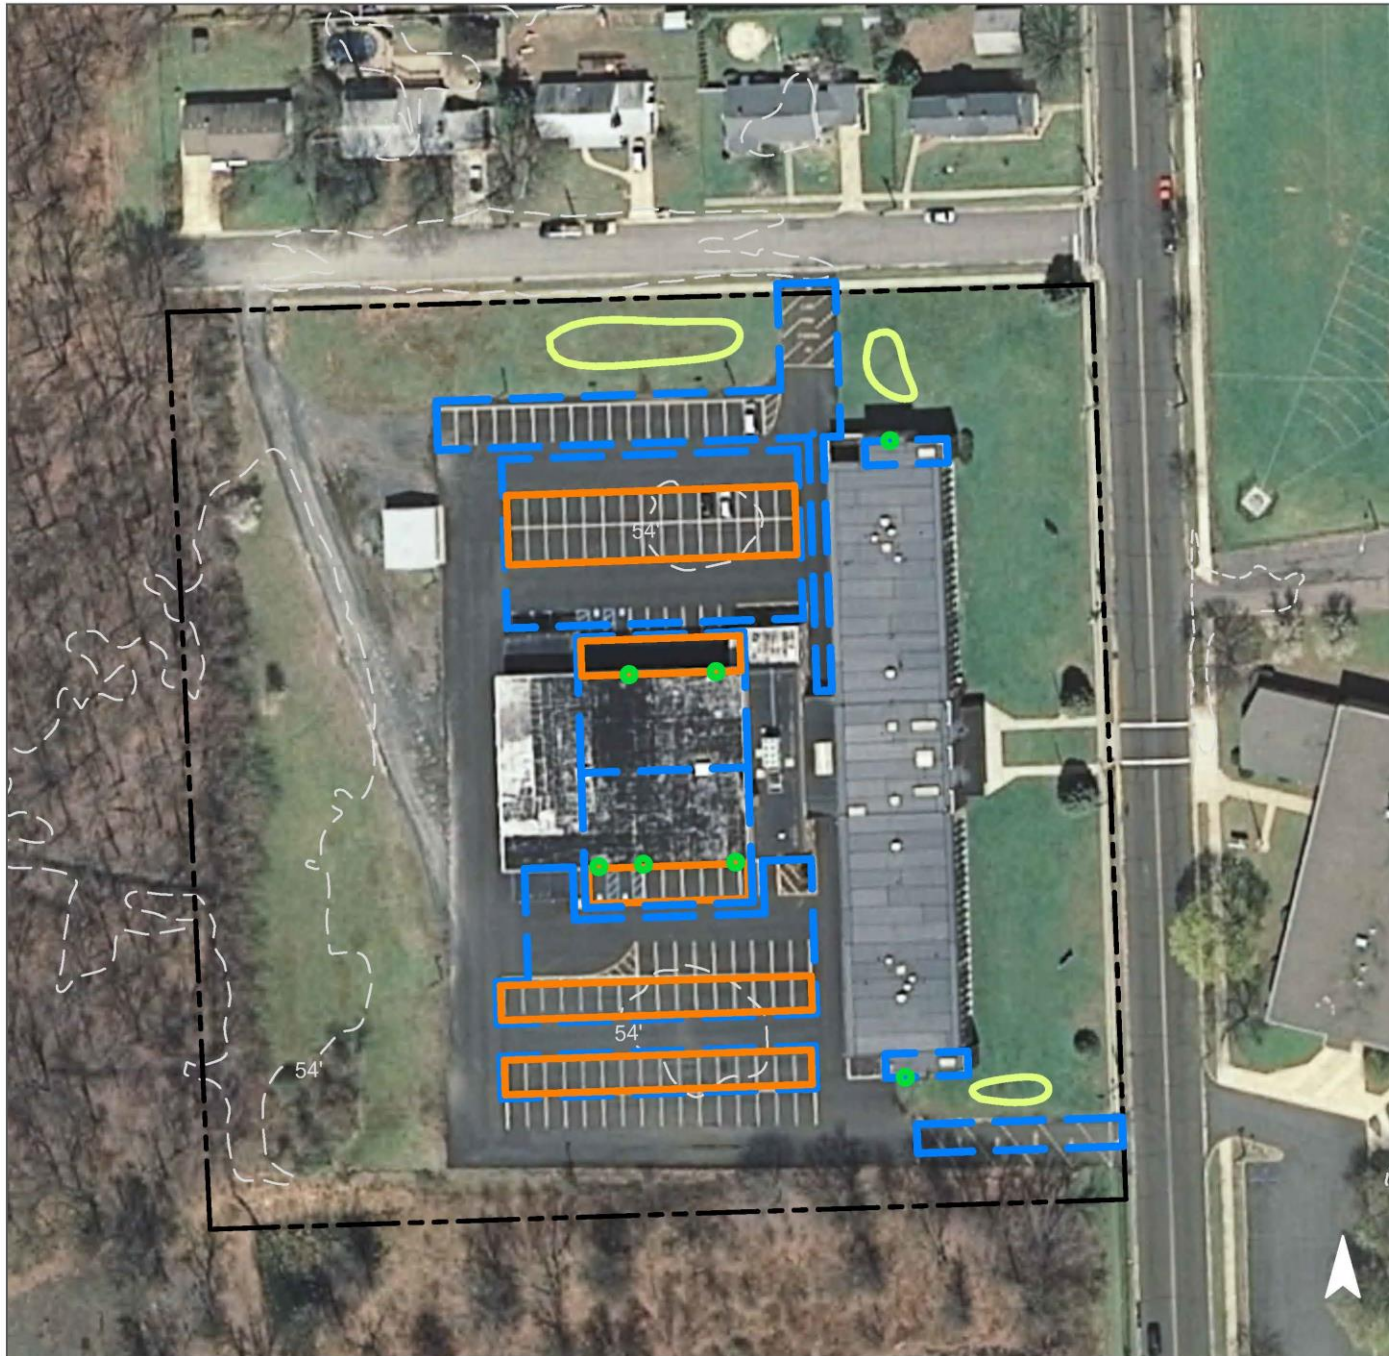
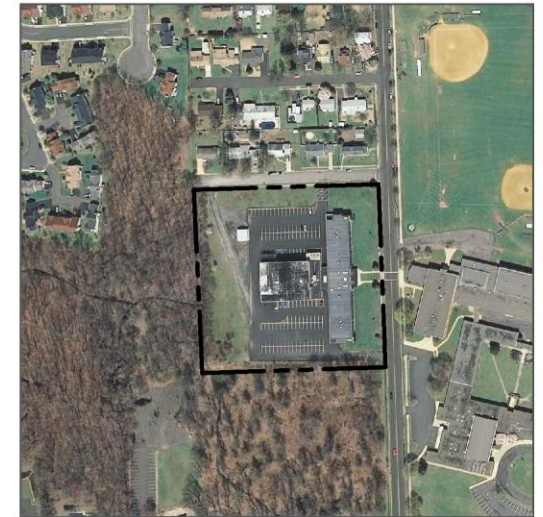
GREEN INFRASTRUCTURE RECOMMENDATIONS

Recommended Green Infrastructure Practices	Recharge Potential (Mgal/yr)	TSS Removal Potential (lbs/yr)	Maximum Volume Reduction Potential (gal/storm)	Peak Discharge Reduction Potential (cu. ft./second)	Estimated Size (sq. ft.)	Estimated Cost
Bioretention systems	0.279	47	20,450	0.77	2,970	\$14,850
Pervious pavements	1.007	169	73,872	2.78	14,250	\$356,250

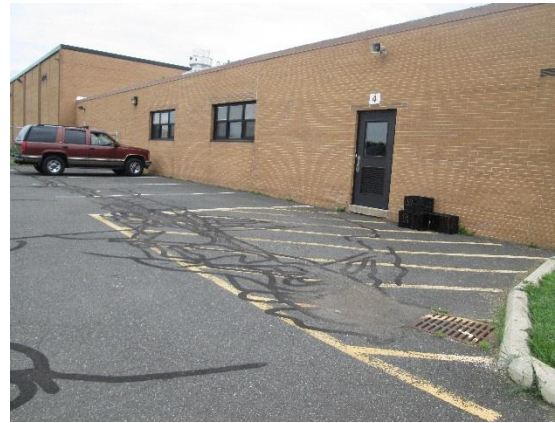
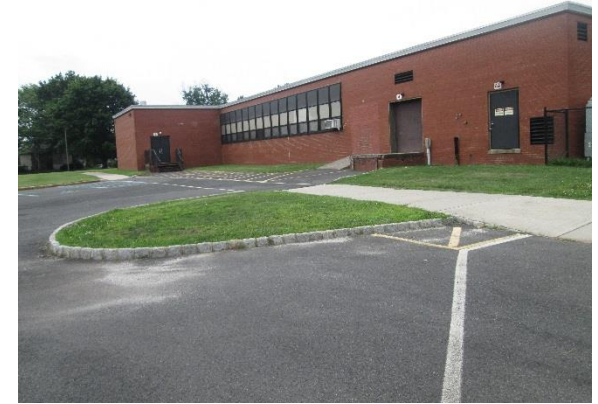
Block and Lot: Block 39.01, Lot 1.01

Both buildings have internal drainage systems. Parking spots around both buildings can be replaced with porous asphalt to capture and infiltrate stormwater. Rain gardens adjacent to the building can capture, infiltrate, and treat roof runoff. A preliminary soil assessment suggests that more soil testing would be required before determining the soil's suitability for green infrastructure.

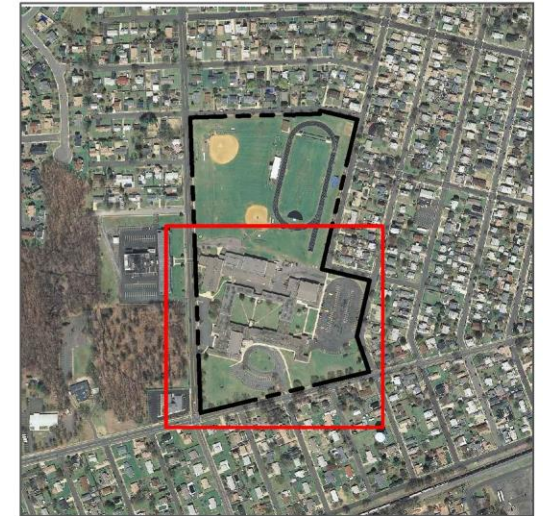
**Manville High School &
Alexander Batcho
Intermediate**

The parking lot is pitched towards the road. Rain gardens adjacent to the building can capture, treat, and infiltrate roof runoff. A preliminary soil assessment suggests that the soils have suitable drainage characteristics for green infrastructure.

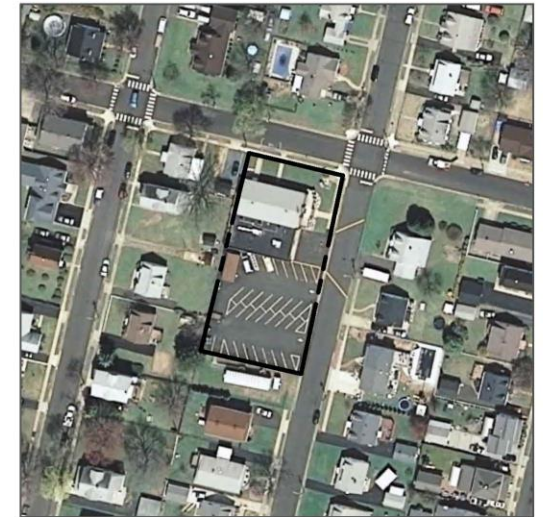
North End Fire Company #3

The building has internal downspouts. Parking spaces can be replaced with pervious pavement to capture and infiltrate stormwater. A preliminary soil assessment suggests that the soils have suitable drainage characteristics for green infrastructure.

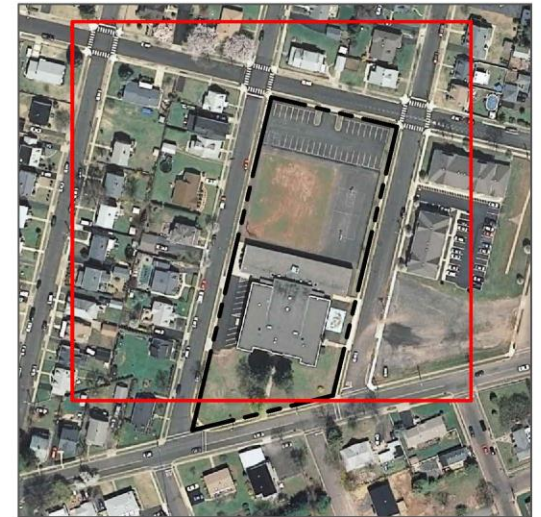
Roosevelt School

The parking lot is in poor condition and the building has internal drainage. Some of the parking spots around the building can be replaced with porous asphalt to capture and infiltrate stormwater. A preliminary soil assessment suggests that the soils have suitable drainage characteristics for green infrastructure.

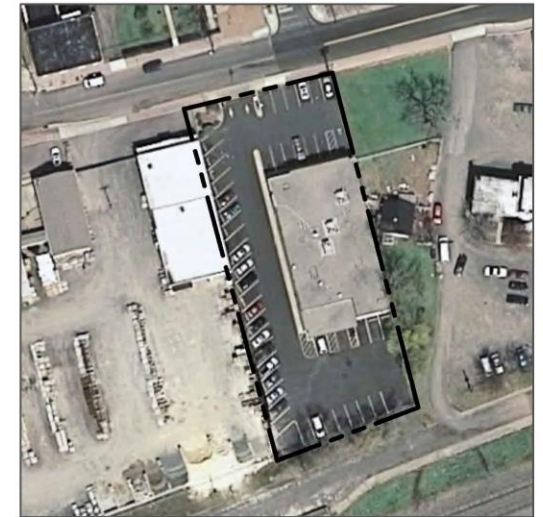
US Post Office

Parking spots behind the building can be replaced with porous asphalt to capture and infiltrate stormwater. A preliminary soil assessment suggests that the soils have suitable drainage characteristics for green infrastructure.

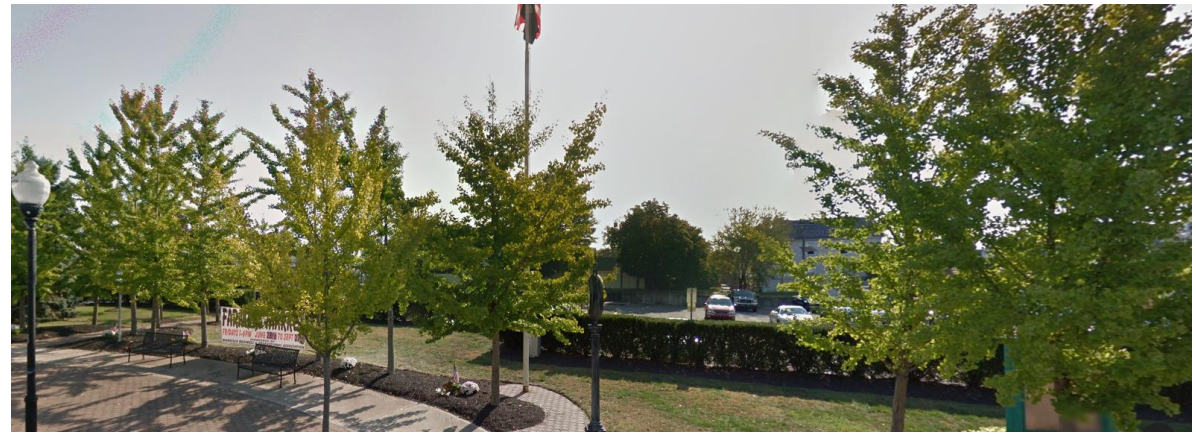
Stormwater is currently directed to an existing detention basin. Parking spots near Rosalie Avenue can be converted to porous asphalt to capture runoff. A preliminary soil assessment suggests that the soils have suitable drainage characteristics for green infrastructure.

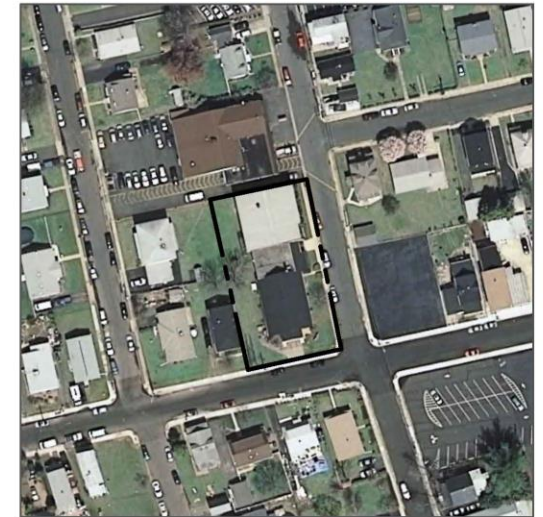
Emmanuel Baptist Church

There is an open field behind the building where downspouts can be disconnected and directed into a rain garden to capture, treat, and infiltrate runoff. A preliminary soil assessment suggests that the soils have suitable drainage characteristics for green infrastructure.

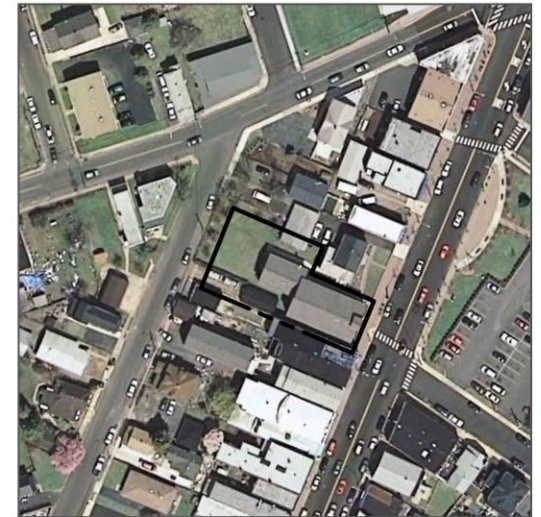
Faith in Action Church

Rain gardens adjacent to the building can capture, treat, and infiltrate roof runoff. A preliminary soil assessment suggests that the soils have suitable drainage characteristics for green infrastructure.

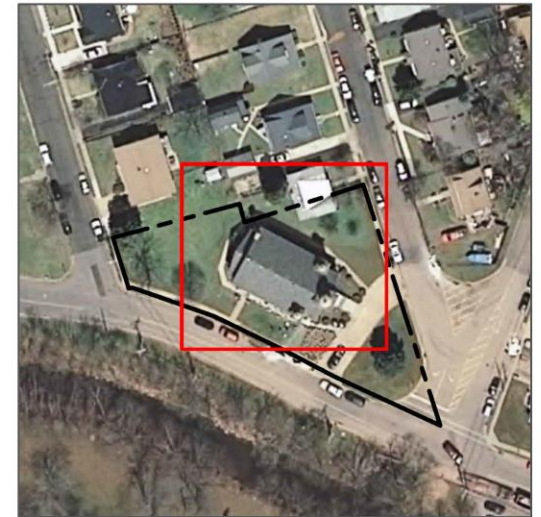
**Holy Ghost
Carpatho-Russian
Church**

Pervious pavement can replace existing parking spaces to infiltrate runoff and serve as overflow for planter boxes. In addition, a cistern can capture rooftop runoff and be used to wash service vehicles. A preliminary soil assessment suggests that the soils have suitable drainage characteristics for green infrastructure.

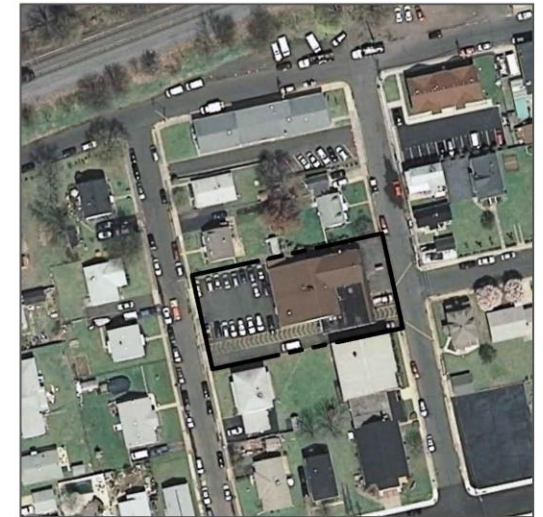
Manville Fire Co. #1

The building has internal drainage. Parking spaces can be replaced with porous asphalt to capture and infiltrate stormwater. A preliminary soil assessment suggests that the soils have suitable drainage characteristics for green infrastructure.

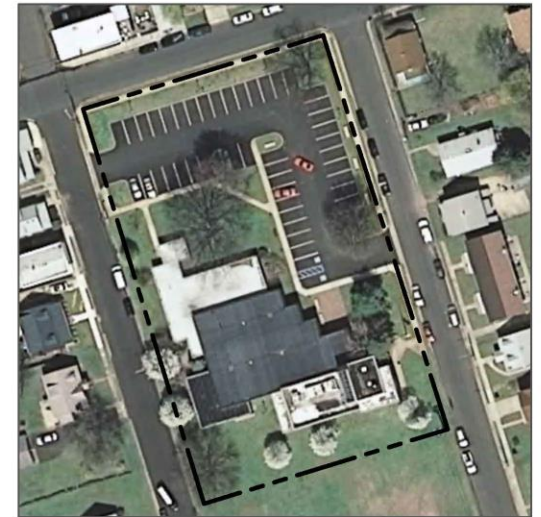
Manville Public Library

Parking spaces can be replaced with porous asphalt to capture and infiltrate stormwater. Planter boxes along the sidewalk can be set up to reuse roof runoff. A preliminary soil assessment suggests that the soils have suitable drainage characteristics for green infrastructure.

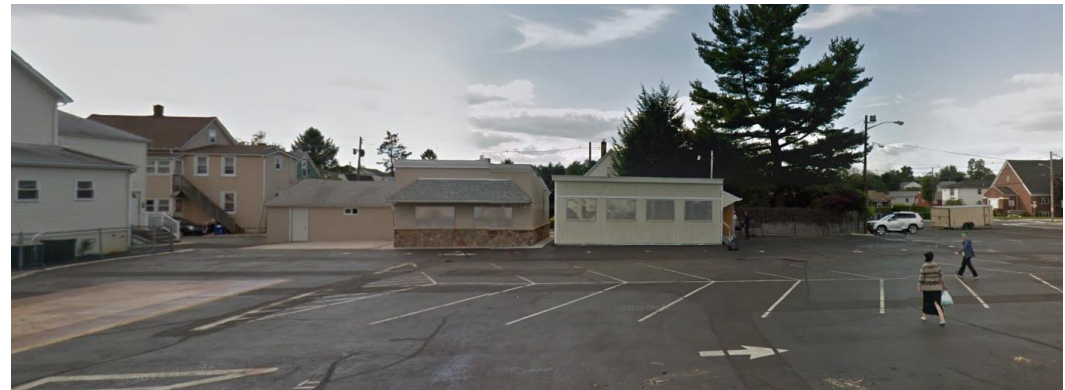
Block and Lot: Block 112, Lot 1-15

The pavement is currently in poor condition. Parking spaces can be replaced with porous asphalt to infiltrate runoff. A preliminary soil assessment suggests that the soils have suitable drainage characteristics for green infrastructure.

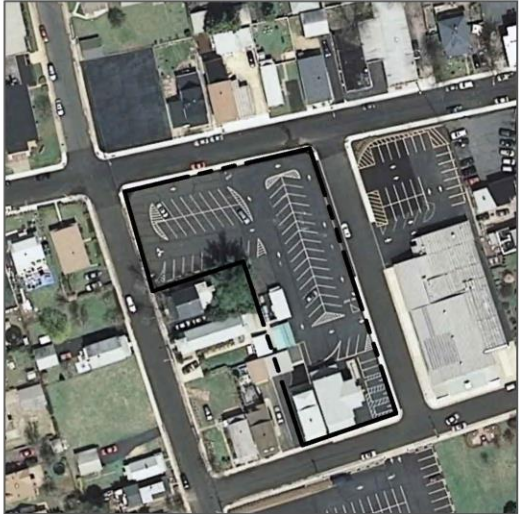
Sacred Heart Roman Catholic Parish Office

Rain gardens adjacent to the building can capture, treat, and infiltrate roof runoff. A preliminary soil assessment suggests that the soils have suitable drainage characteristics for green infrastructure.

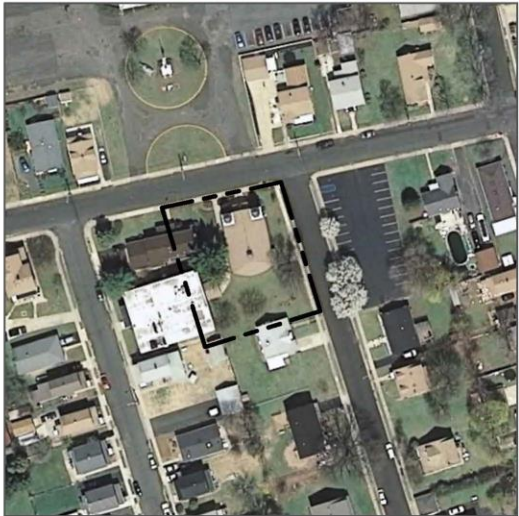
**Saints Peter and Paul
Orthodox Church**

Speed bumps in the parking lot are currently in poor condition. When the parking lot is repaved, it would be ideal to pitch the lot towards the field along East Camplain Road, so that rain gardens can capture, treat, and infiltrate runoff. Parking spaces can be replaced with porous asphalt to infiltrate stormwater. A preliminary soil assessment suggests that the soils have suitable drainage characteristics for green infrastructure.

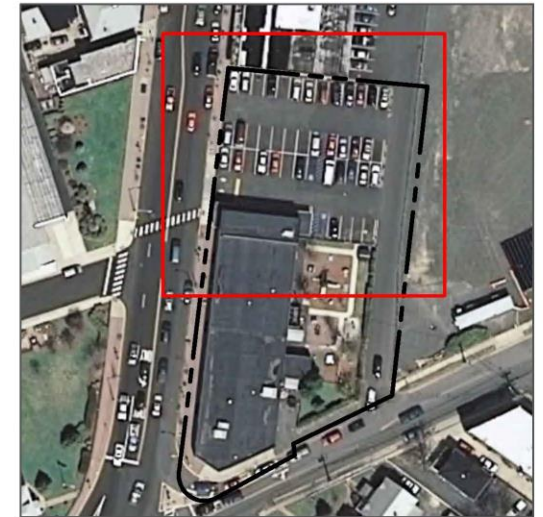
The Arc of Somerset County

One parking lot currently has solar panels installed. A row of parking spaces can be replaced with porous asphalt to infiltrate stormwater. Several rain gardens can be installed to capture, treat, and infiltrate roof and parking lot runoff. A preliminary soil assessment suggests that the soils have suitable drainage characteristics for green infrastructure.
