## **Upper Cohansey River Watershed Restoration and Protection Plan: Data Report**

Developed by the Rutgers Cooperative Extension Water Resources Program

Funded by the New Jersey Department of Environmental Protection  
RP 05-079

December 4, 2009

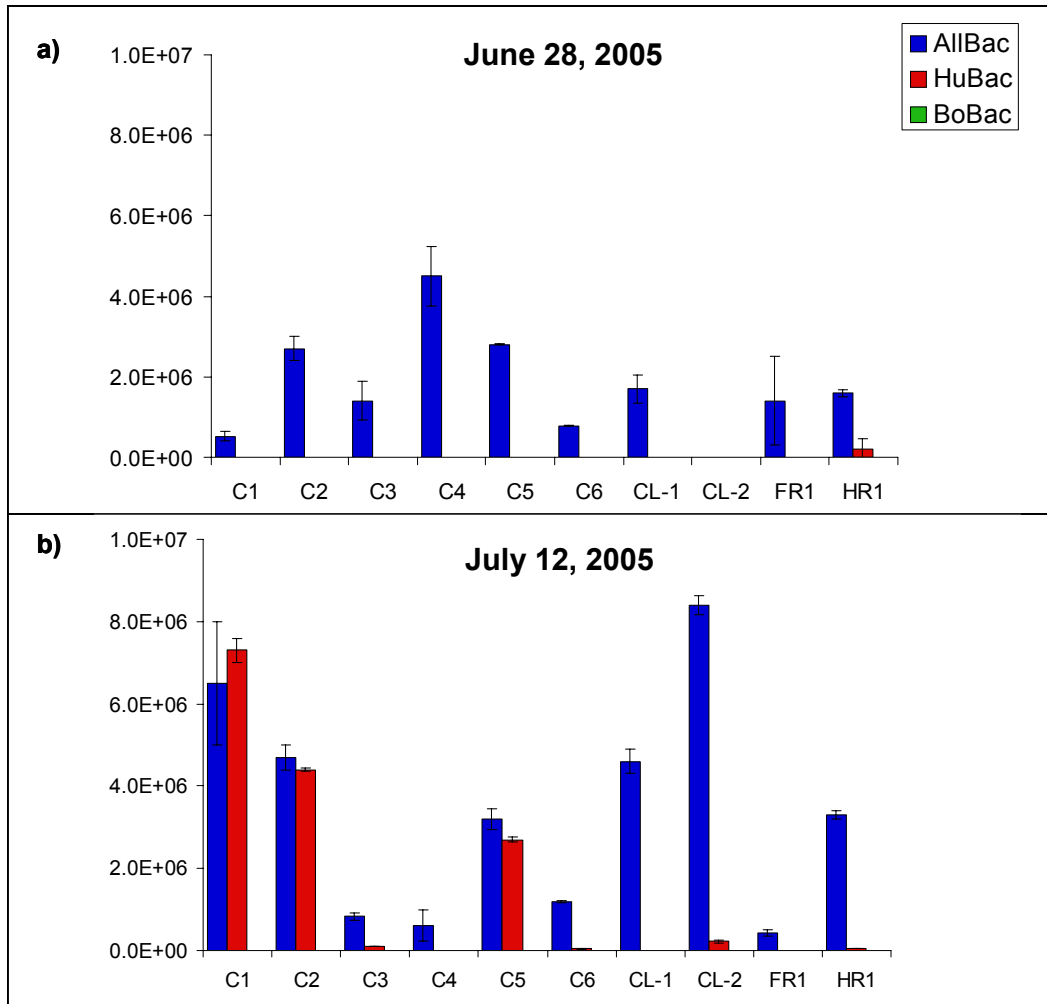
**Figure 7: Sample Data Showing the Numbers of *Bacteroides* Detected by the Three Primer Sets on Two Days of Sampling at 10 Stations**

*Bacteroides* from all sources could be readily detected in 100 ml surface water samples by using the qPCR assay. In addition, human and bovine contributions to fecal contamination could be easily distinguished from each other by the relative proportions of the three target sequences. Results from all ten sampling locations on two separate days are shown in Figure 7. There were 1.59 inches of rain on 6/28/05 (Figure 7a) and 0.14 inches on 7/12/05 (Figure 7b). Bovine *Bacteroides* were rarely detected.

The numbers of *Bacteroides* present in individual samples was also compared to the other indicators of water quality including fecal coliform (Table 7). Despite the lack of obvious correlations between total *Bacteroides* and fecal coliform, or any of the other water quality measurements, it is useful data in regard to the sources and extent of fecal contamination in the watershed. These data show the highly variable nature of all of the water quality measures used.
