**Appendix B: Upper Salem River Watershed Restoration  
and Protection Plan, Data Summary – Biological  
Assessment (Prepared January 2011)**

**UPPER SALEM RIVER WATERSHED RESTORATION & PROTECTION PLAN  
DATA SUMMARY – AUGUST 2007 BIOLOGICAL ASSESSMENT**

**Rutgers Cooperative Extension Water Resources Program**

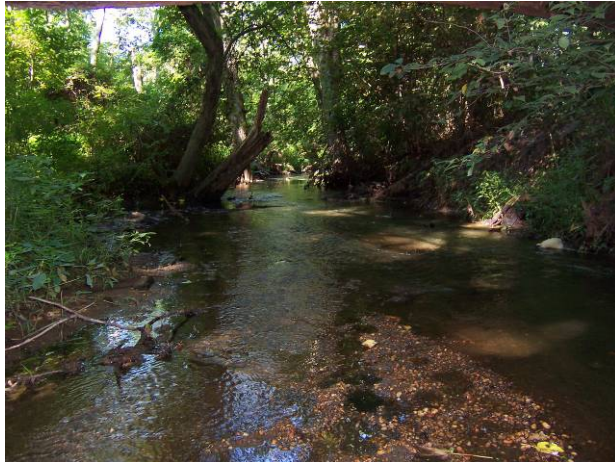
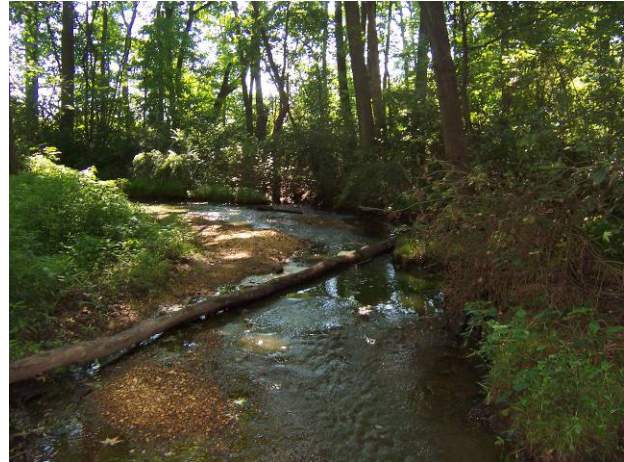
**TABLE 5A. Calculation of Biological Condition for Station S2**

The stream width at Station S2 was approximately 10 feet. The stream depth ranged from 0.1 feet to 0.3 feet in the run areas and was approximately 2.0 feet in pool areas. The stream velocity ranged from 0.1 ft/sec to 1.22 ft/sec. The canopy was closed at this location. The inorganic substrate at Station S2 consisted mostly of gravel and coarse sand over a silt layer. The organic substrate was comprised mainly of muck-mud and some detritus in the form of decomposing leaves and sticks. There was a distinct sulfur odor to the sediments, and slight sediment oils were present. Sediment deposits were comprised of sludge and fine sands. Water odors of sulfur were present, and surface oils were absent. The water was turbid. The water temperature was 25.2°C; the pH was 8.95 SU, and the dissolved oxygen was 5.18 mg/L. The predominant surrounding land uses at Station S2 were forest and open water (i.e., Daretown Lake). Erosion was moderate to heavy at this location, and some potential sources of local nonpoint sources of pollution were noted from the surrounding land uses (e.g., drainage from the lake and nearby roadway).

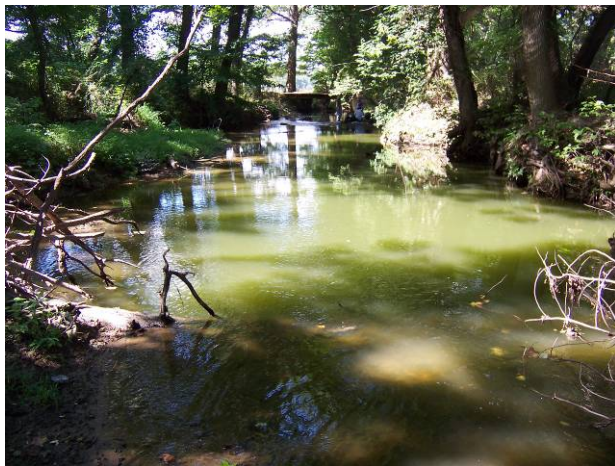
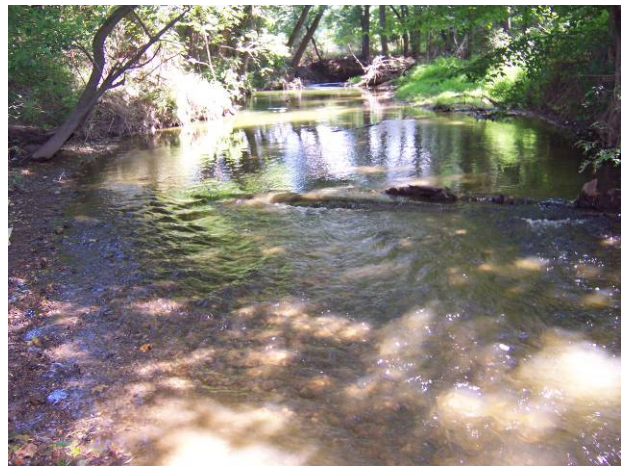
**TABLE 5B. Calculation of Biological Condition for Station S8**

The stream width at Station S8 was approximately 15 feet. The stream depth ranged from 0.1 feet to 2.0 feet in the riffle/run areas and was approximately 2.5 feet or greater in the pool areas. The stream velocity ranged from 0 ft/sec to 0.26 ft/sec. The canopy was mostly closed at this location. The inorganic substrate at Station S8 consisted mostly of gravel and coarse sand with some small cobbles. The organic substrate was comprised mainly of detritus in the form of sticks, decomposing leaves, and new fall with some muck-mud in pool areas. Sediment odors and oils were absent. The water was very turbid, almost opaque, and green in

color. Water odors and surface oils were absent. The water temperature was 25.6°C; the pH was 6.74 SU, and the dissolved oxygen was 5.50 mg/L. The predominant surrounding land uses at Station S8 were forest and field/pasture. Local watershed erosion was noted as being heavy, and some potential sources of nonpoint source pollution included road runoff and drainage from the field/pasture areas and a nearby dairy farm.

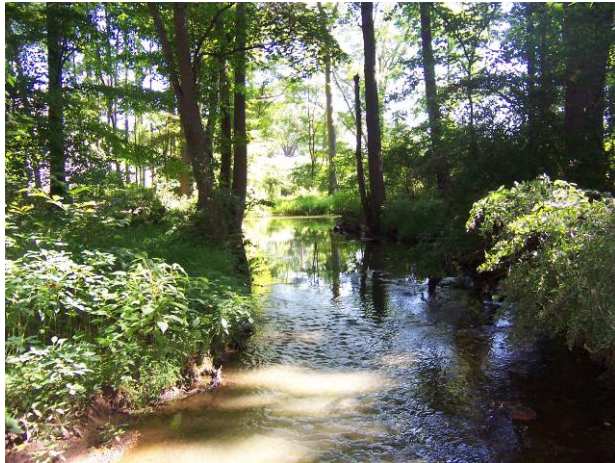
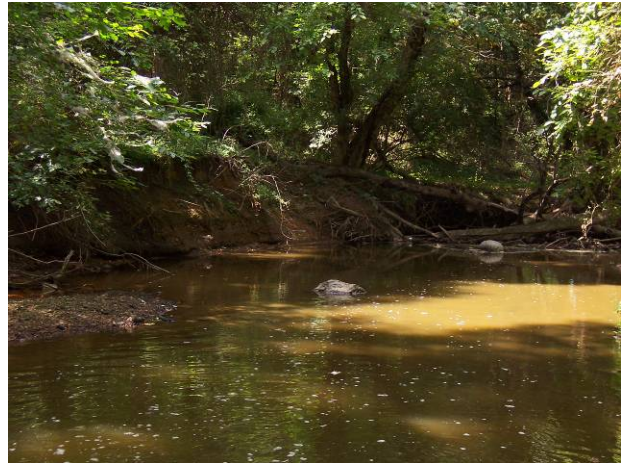
**TABLE 5C. Calculation of Biological Condition for Station S10**

The stream width at Station S10 was approximately 15 feet. The stream depth ranged from 0.2 feet to 0.5 feet in the riffle/run areas and was approximately 1.0 to 2.0 feet in the pool areas. The stream velocity ranged from 0.21 ft/sec to 1.15 ft/sec. The canopy was mostly closed at this location. The inorganic substrate at Station S10 consisted mostly of gravel and coarse sand with small cobbles. The organic substrate was minimal and was comprised mainly of detritus in the form of sticks, decomposing leaves, and new fall. Sediment odors and oils were absent. The water was turbid, and water odors and surface oils were absent. The water temperature was 28.2°C; the pH was 8.65 SU, and the dissolved oxygen was 7.60 mg/L. The predominant surrounding land uses for Station S10 included forest and open water (i.e., Memorial Lake). Heavy erosion was noted, and some potential nonpoint sources of pollution included runoff from the local roadway and drainage from the lake.
