Impervious Cover Reduction Action Plan for Fairfield Township, Cumberland County, New Jersey

Prepared for Fairfield Township by the Rutgers Cooperative Extension Water Resources Program

November 3, 2016

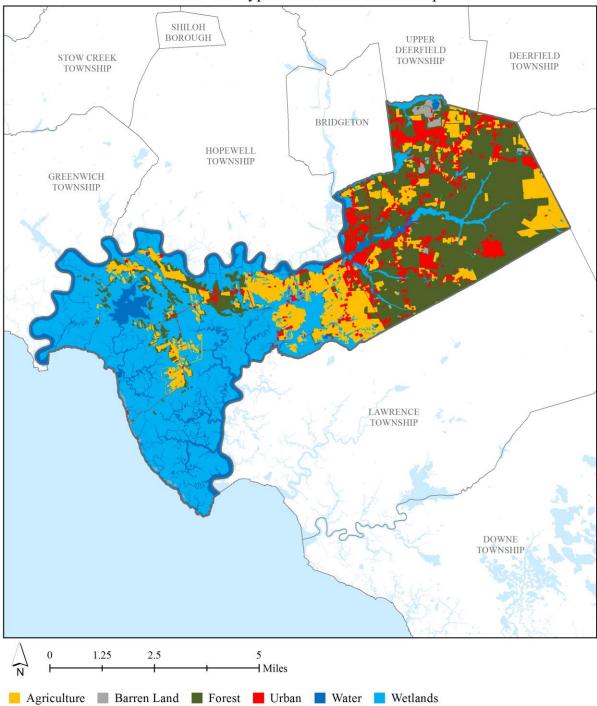
Figure 1: Map illustrating the land use in Fairfield Township

Located in Cumberland County in southern New Jersey, Fairfield Township covers approximately 43.5 square miles. Figures 1 and 2 illustrate that Fairfield Township is dominated by wetland land uses. A total of 8.4% of the municipality's land use is classified as urban. Of the urban land in Fairfield Township, rural residential is the dominant land use (Figure 3).

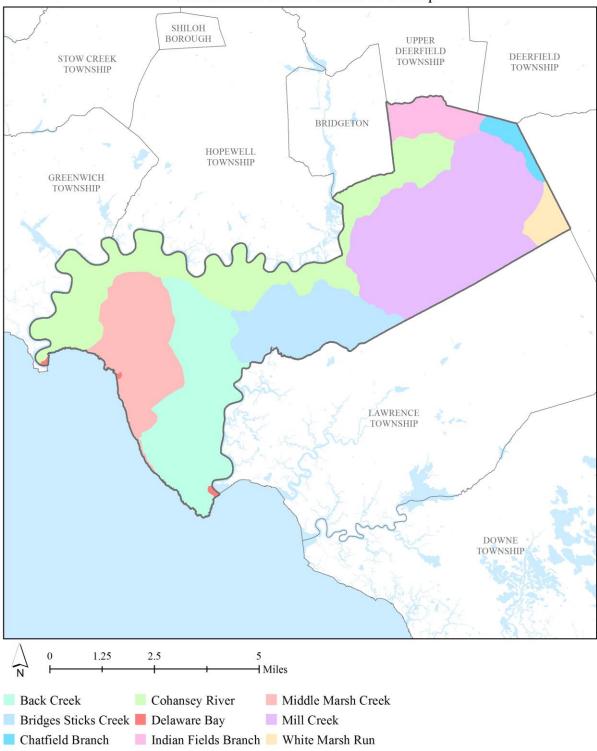
Figure 4: Map of the subwatersheds in Fairfield Township

Fairfield Township contains portions of nine subwatersheds (Figure 4). For this impervious cover reduction action plan, projects have been identified in each of these watersheds. Initially, aerial imagery was used to identify potential project sites that contain extensive impervious cover. Field visits were then conducted at each of these potential project sites to determine if a viable option exists to reduce impervious cover or to disconnect impervious surfaces from draining directly to the local waterway or storm sewer system. During the site visit, appropriate green infrastructure practices for the site were determined. Sites that already had stormwater management practices in place were not considered.

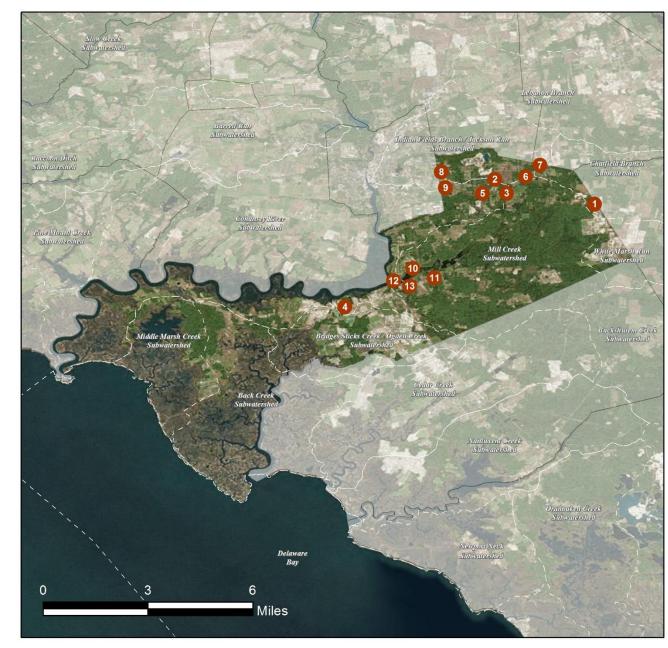
FAIRFIELD TOWNSHIP: GREEN INFRASTRUCTURE SITES

SITES WITHIN THE CHATERFIELD BRANCH SUBWATERSHED:

1. Maranatha Baptist Church

SITES WITHIN THE COHANSEY RIVER SUBWATERSHED:

- 2. Fairfield Township School
- 3. Gouldtown Fire Company Station 15
- 4. South Cumberland Medical Associates
- 5. Trinity AME Church

SITES WITHIN THE INDIAN FIELDS BRANCH SUBWATERSHED:

- 6. St. John's United Methodist Church
- 7. Trinity Holiness Church

SITES WITHIN THE JACKSON RUN SUBWATERSHED:

- 8. Crusaders for Christ Evangelistic Center
- 9. Glory Tabernacle Child Care

SITES WITHIN THE MILL CREEK SUBWATERSHED:

- 10. Church of God in Christ
- 11. Fairton Christian Academy
- 12. Fairfield Presbyterian Church
- 13. Salem County Special Services School District

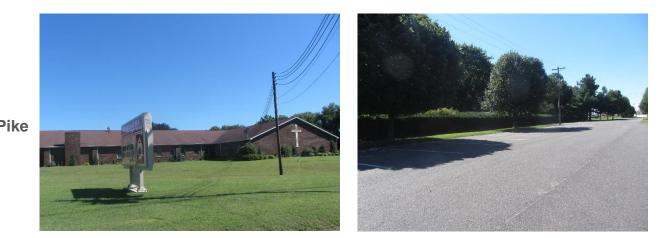
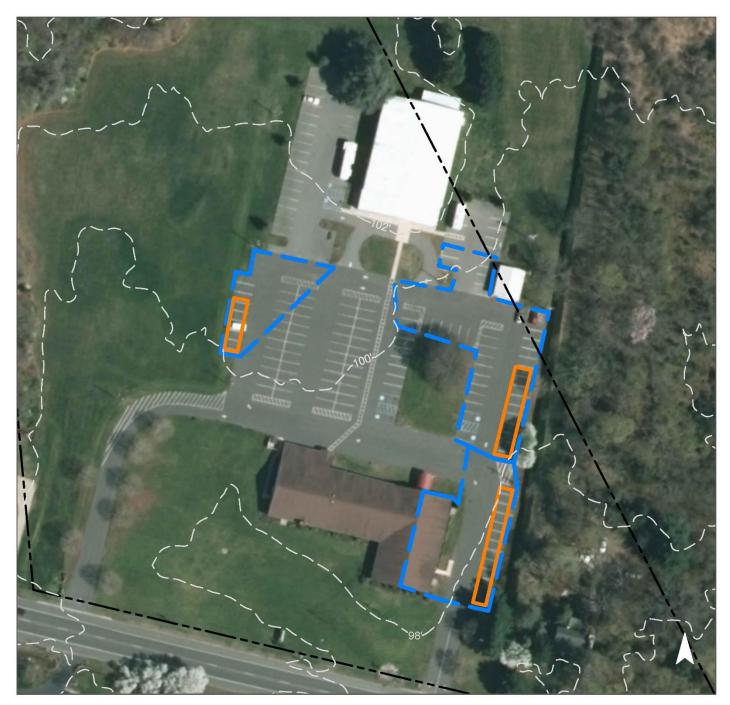
Maranatha Baptist Church

Stormwater is currently directed to existing catch basins throughout the parking lot. Parking spots on the far east and west sides of the parking lot can be replaced with porous asphalt to capture and infiltrate stormwater. A preliminary soil assessment suggests that the soils have suitable drainage characteristics for green infrastructure.

- pervious pavement
- drainage area
- [] property line
- 2015 Aerial: NJOIT, OGIS

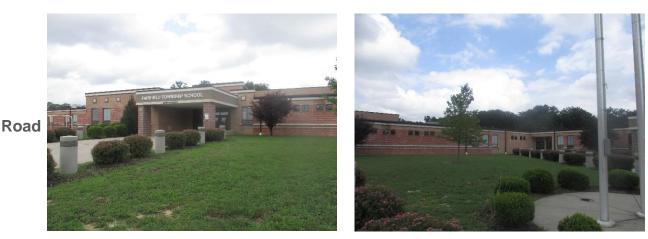
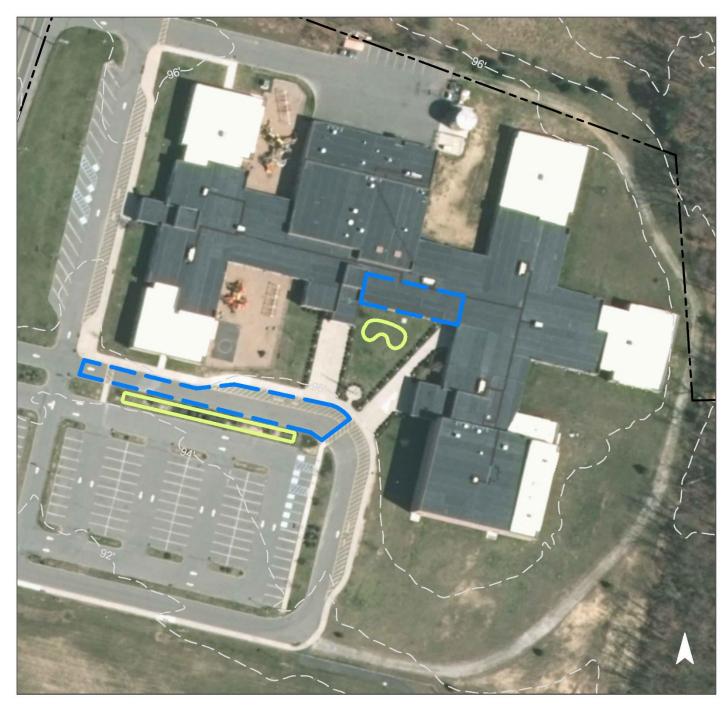
Fairfield Township School

Stormwater currently drains from disconnected downspouts. A rain garden in between the two main entrances of the school can capture, treat, and infiltrate roof runoff as well as add to the existing landscaping of the school. A preliminary soil assessment suggests that the soils have suitable drainage characteristics for green infrastructure.

- bioretention system
- drainage area
- **[]** property line
- 2015 Aerial: NJOIT, OGIS

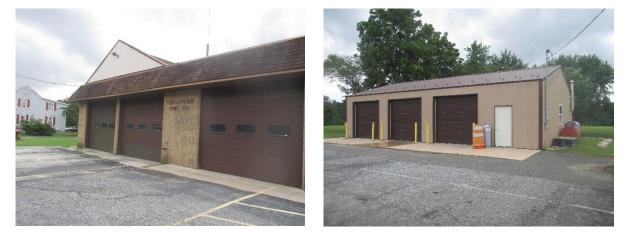
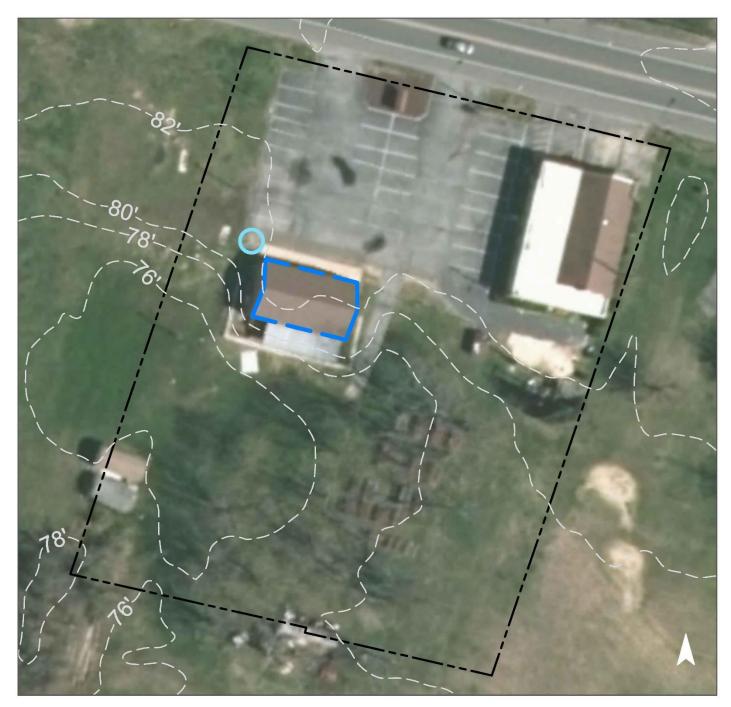
Gouldtown Fire Company

Stormwater currently drains from the property and the roofs of the buildings without downspouts. A cistern, as well as a downspout, can be installed on the northwest corner of the west building to capture stormwater runoff. The water can then be used for washing vehicles or for other non-potable uses such as car wash fundraisers or watering existing landscape plants. A preliminary soil assessment suggests that the soils have suitable drainage characteristics for green infrastructure.

- rainwater harvesting
- drainage area
- **[]** property line
- 2015 Aerial: NJOIT, OGIS

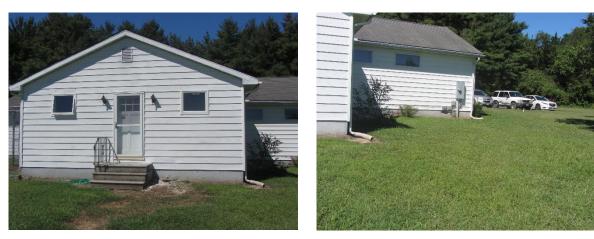
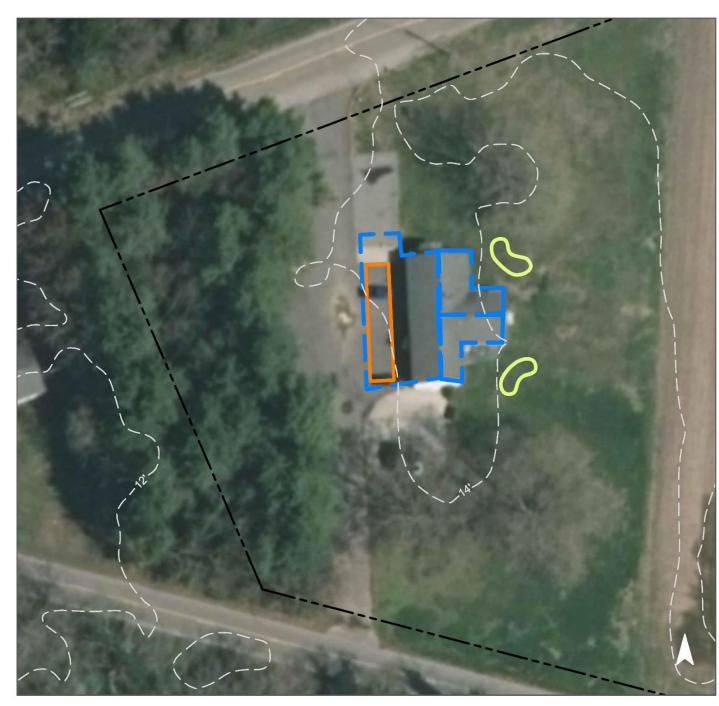
South Cumberland Medical Associates

Stormwater currently drains from the property to the roadway. Parking spots in front of the building can be replaced with porous asphalt to capture and infiltrate stormwater and roof runoff. Rain gardens adjacent to the rear side of the building can capture, treat, and infiltrate additional roof runoff. A preliminary soil assessment suggests that the soils have suitable drainage characteristics for green infrastructure.

- bioretention system
- pervious pavement
- drainage area
- **[]** property line
- 2015 Aerial: NJOIT, OGIS

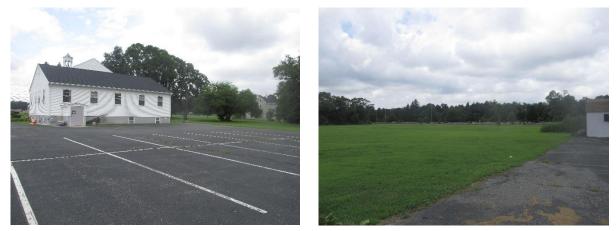
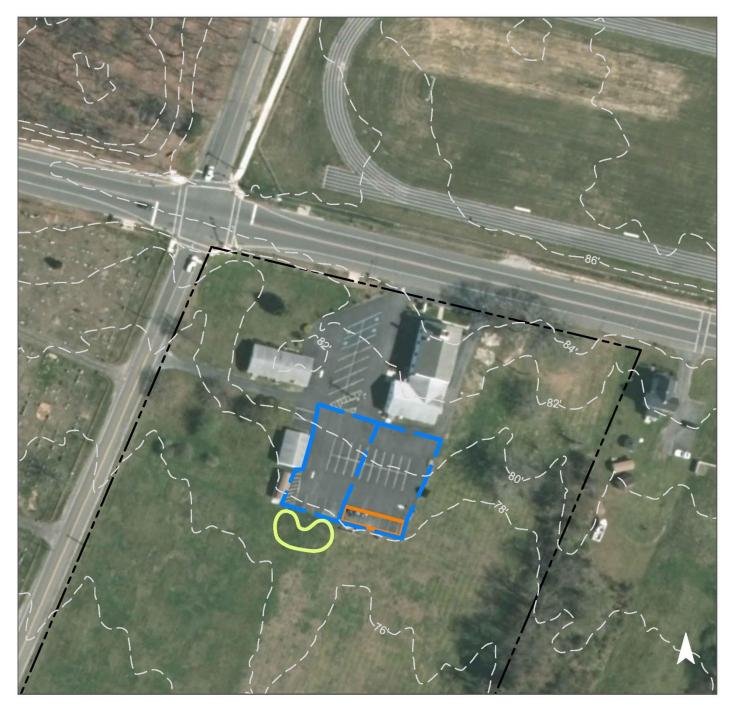
Trinity AME Church

Stormwater is currently directed to an existing detention basin. Parking spots in the southeast corner of the parking lot can be replaced with porous asphalt to capture and infiltrate stormwater. A rain garden on the southwest side of the parking lot can capture, treat, and infiltrate stormwater runoff. A preliminary soil assessment suggests that the soils have suitable drainage characteristics for green infrastructure.

- bioretention system
- pervious pavement
- C drainage area
- [] property line
- 2015 Aerial: NJOIT, OGIS

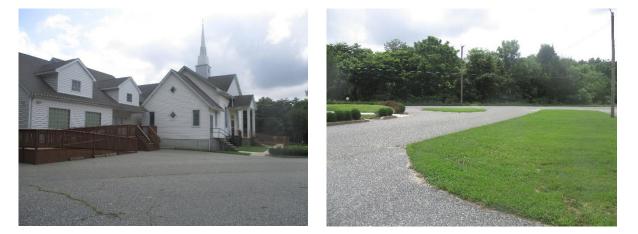
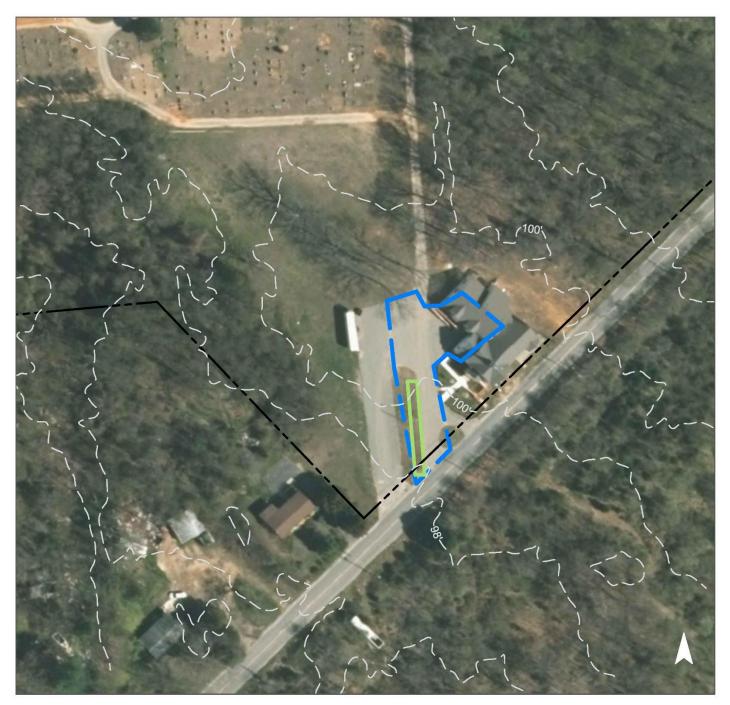
St. John's United Methodist Church

Stormwater currently drains from the property to the roadway. A bioswale placed on the east side of the island in the middle of the parking lot can capture, treat, and infiltrate roof runoff and stormwater runoff from a good portion of the parking lot. A preliminary soil assessment suggests that the soils have suitable drainage characteristics for green infrastructure.

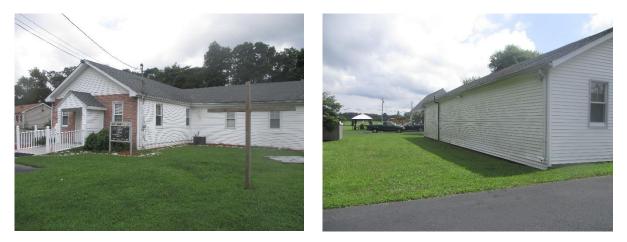
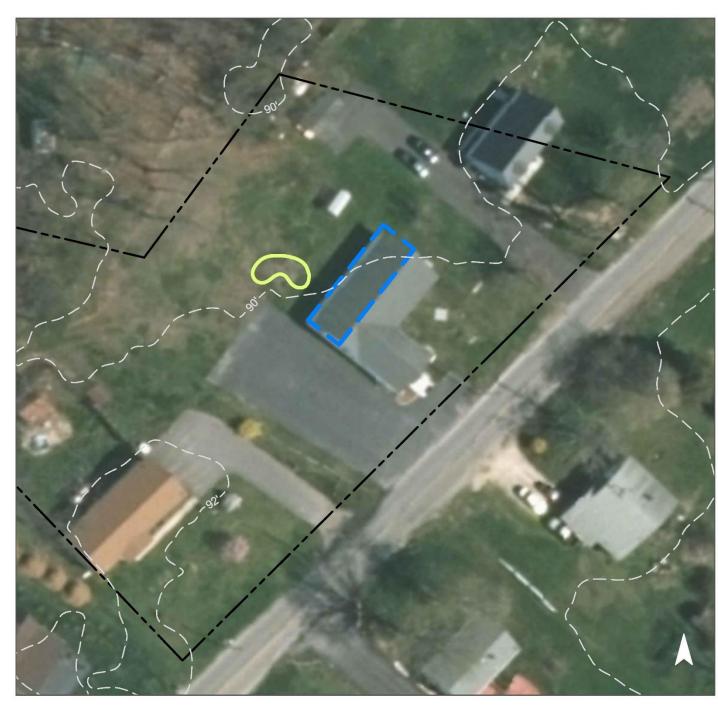
Trinity Holiness Church

Stormwater currently drains to the roadway. Installing a rain garden adjacent to the building can capture, treat, and infiltrate roof runoff. A preliminary soil assessment suggests that the soils have suitable drainage characteristics for green infrastructure.

- bioretention system
- C drainage area
- [] property line
- 2015 Aerial: NJOIT, OGIS

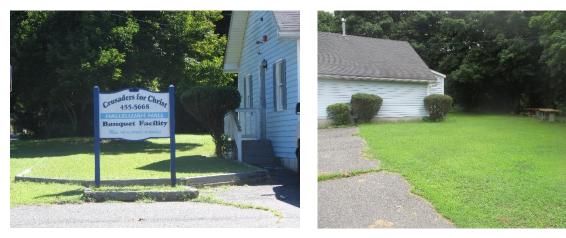
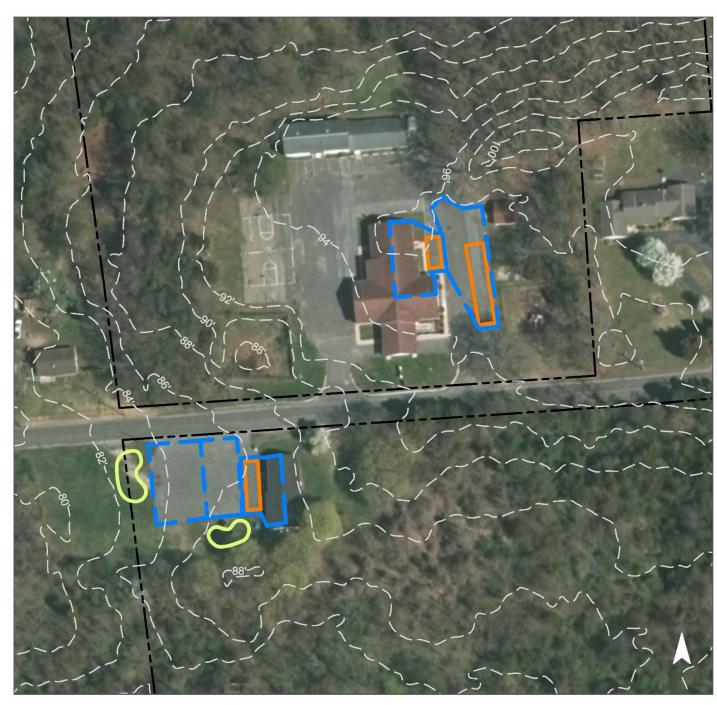
Crusaders for Christ Evangelistic Center

Stormwater currently drains from the property to the surrounding area. Parking spots adjacent to the south building and in the north parking lot can be replaced with porous asphalt to capture and infiltrate roof runoff. Installing rain gardens adjacent to the south building parking lot, on the south and west sides, can capture, treat, and infiltrate stormwater. A preliminary soil assessment suggests that the soils have suitable drainage characteristics for green infrastructure.

- bioretention system
- pervious pavement
- drainage area
- [] property line
- 2015 Aerial: NJOIT, OGIS

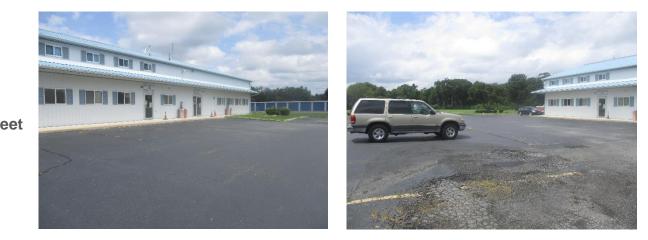
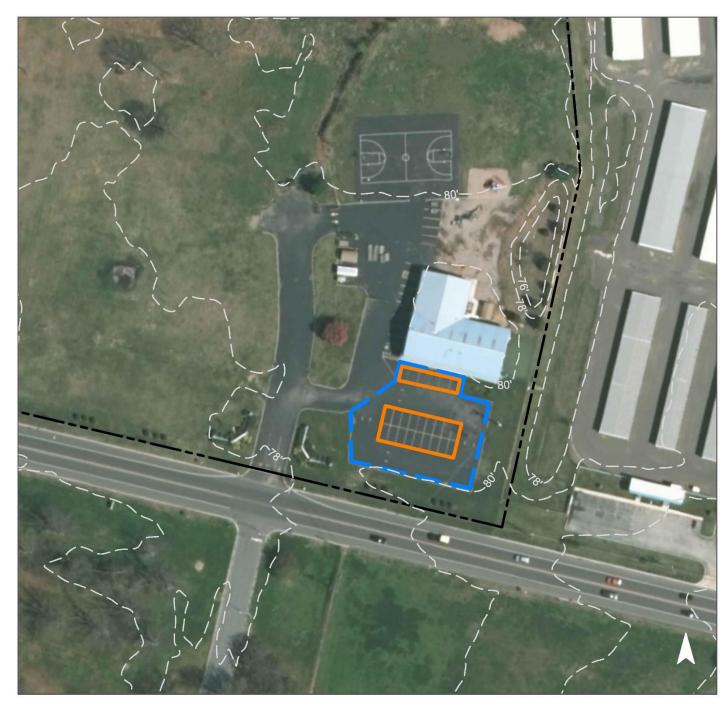
Glory Tabernacle Child Care

Stormwater is currently directed to existing catch basins. The main parking lot is in poor shape, and parking spots can be replaced with porous asphalt to capture and infiltrate stormwater runoff. A preliminary soil assessment suggests that the soils have suitable drainage characteristics for green infrastructure.

- pervious pavement
- drainage area
- [] property line
 - 2015 Aerial: NJOIT, OGIS

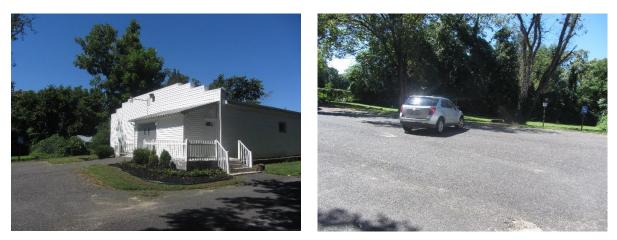
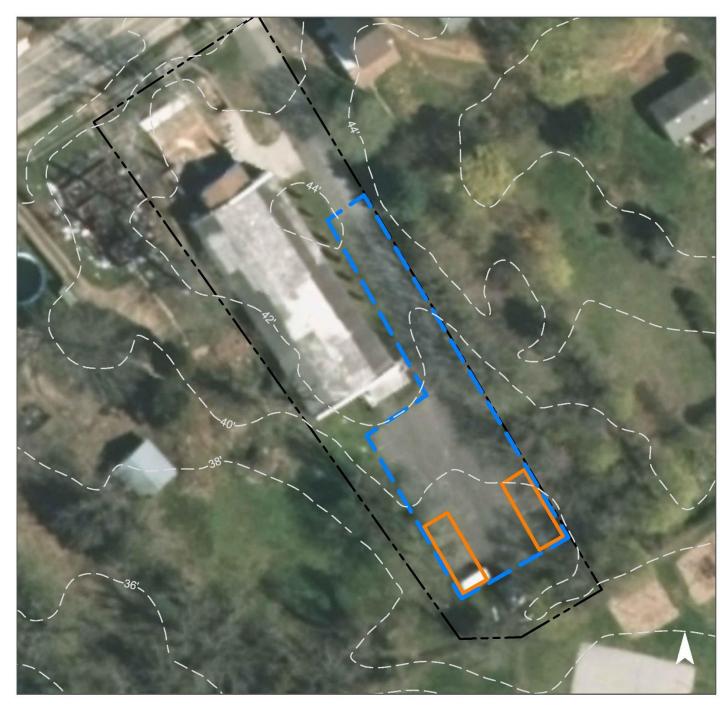
Church of God in Christ

Stormwater currently drains from the property. Parking spots in the rear of the property can be replaced with porous asphalt to capture and infiltrate the majority of stormwater runoff. A preliminary soil assessment suggests that the soils have suitable drainage characteristics for green infrastructure.

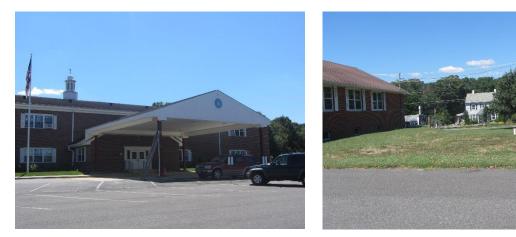
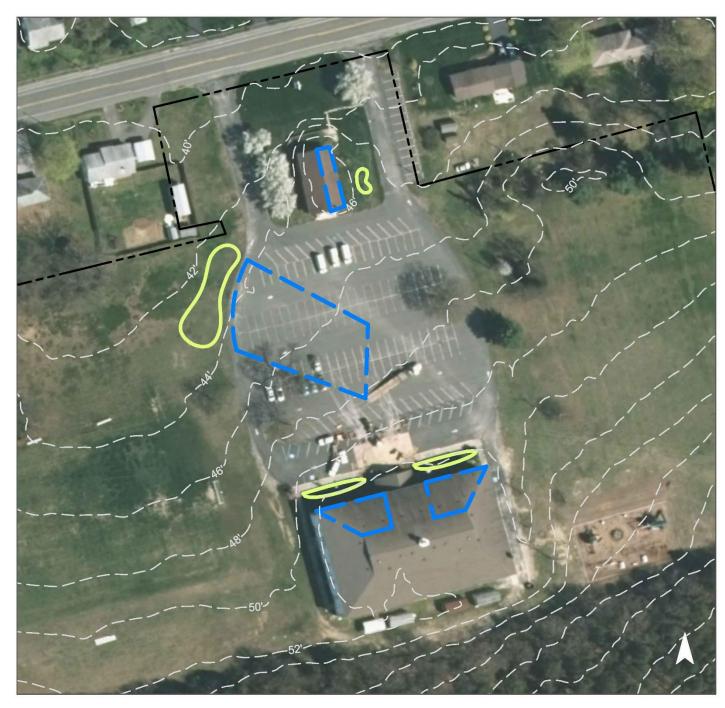
Fairton Christian Academy

Stormwater is currently directed to the ground through disconnected downspouts and the sewer system through connected downspouts. Rain gardens adjacent to the buildings can capture, treat, and infiltrate roof runoff. A preliminary soil assessment suggests that the soils have suitable drainage characteristics for green infrastructure.

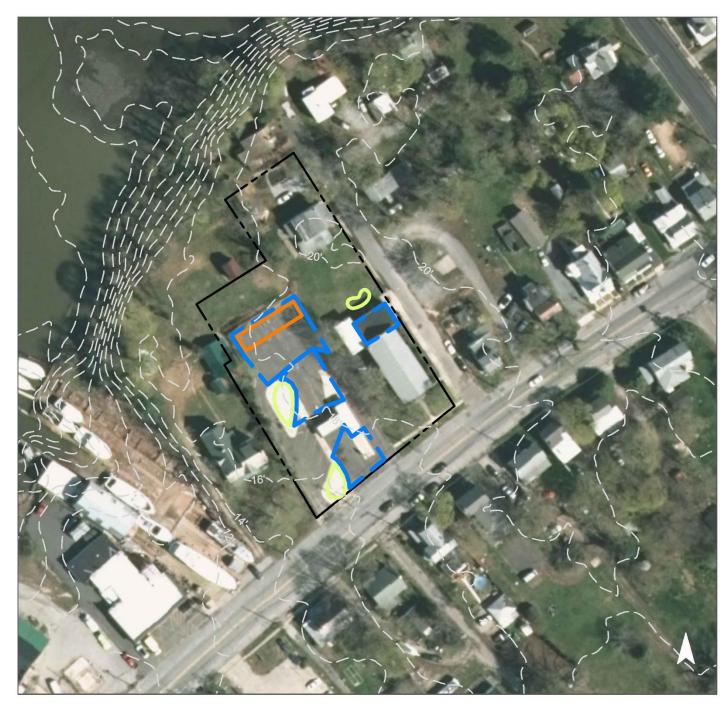
Fairfield Presbyterian Church

Stormwater currently drains from the property. Parking spots by the southwest building can be replaced with porous asphalt to capture and infiltrate stormwater. Rain gardens adjacent to the east building and in the parking lot of the southwest building can capture, treat, and infiltrate roof runoff. A preliminary soil assessment suggests that the soils have suitable drainage characteristics for green infrastructure.

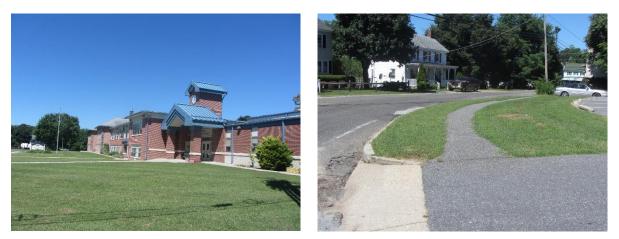
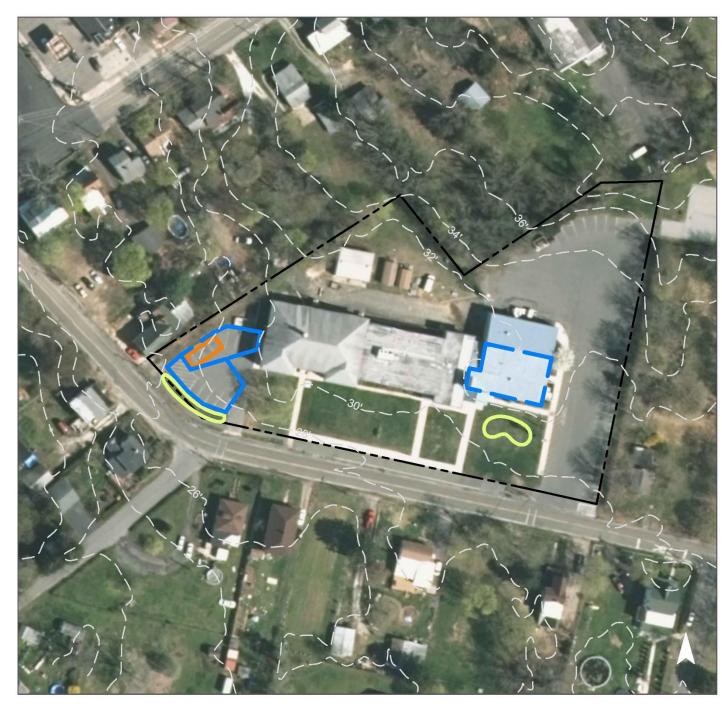
Salem County Special Services School District

Stormwater is currently directed to existing catch basins and the roadway. Parking spots on the west side of the building can be replaced with porous asphalt to capture and infiltrate stormwater. Rain gardens adjacent to the building and the west parking lot can capture, treat, and infiltrate stormwater and roof runoff. A preliminary soil assessment suggests that the soils have suitable drainage characteristics for green infrastructure.
