Bridgewater Raritan Middle School Student Rain Garden Demonstration Project 128 Merriwood Rd, Bridgewater Township, New Jersey 08807

CONSTRUCTION REPORT

PROJECT: Bridgewater Raritan Middle School (BRMS) Student Rain Garden

PREPARED BY: Christopher Perez

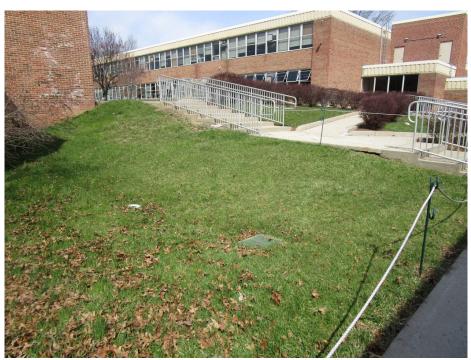
4/13/2018 - Site location identified with students and teachers during RCE Water Resources Program initial site visit with BRMS

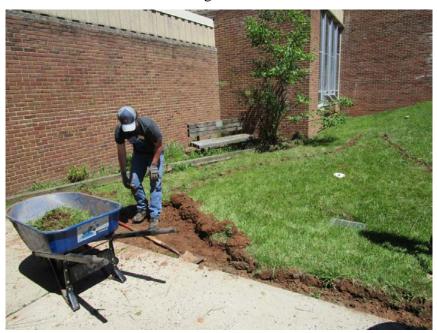
6/14/2018 – The rain garden location is measured and marked-out and sod is removed by RCE Water Resources Program staff and interns.

Following final approval of the student project proposal, RCE brought hand tools on-site that included wheelbarrows, shovels, rakes, etc. on June 14, 2018. RCE staff marked out the rain garden location and removed sod and 6"-12" of soil from the site. Soil was moved to a stockpile outside of the courtyard. This required several doors in the school to be left open throughout the duration of the project as RCE staff transported wheelbarrows of material to-and-from the site. Bioretention soil (sand, compost blend) was added back to the excavation and blended into the exsting grade, to ensure a gradual slope on all sides. Bioretention soil was provided by RCE. Students, teachers, and volunteers aided in the excavation and the rain garden was fully graded by the end of the day on June 14, 2018. Plants were delivered on-site by Peter Birnbaum, of Cooper's Hollow Farm on June 14, 2018.

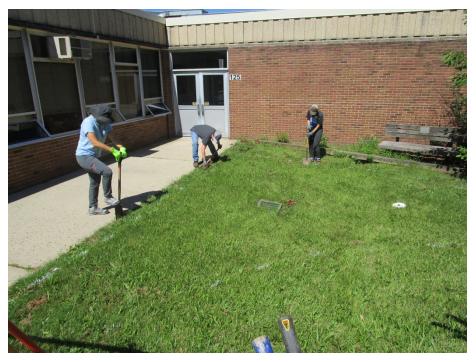
6/14/2018 RCE Water Resources Program staff and interns remove and stockpile sod and soil outside of the courtyard.

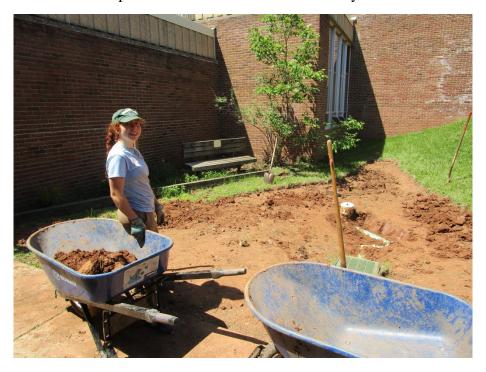
6/14/2018 – All materials were moved to and from the site with wheelbarrows through a short distance in the school building.

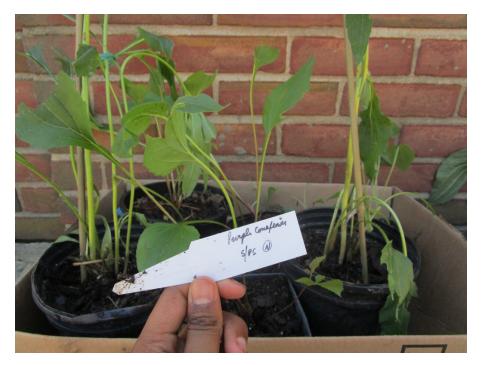
6/14/2018 Native plants, including this Purple Coneflower were donated in part by Cooper's Hollow Farm, of Bernardsville, NJ

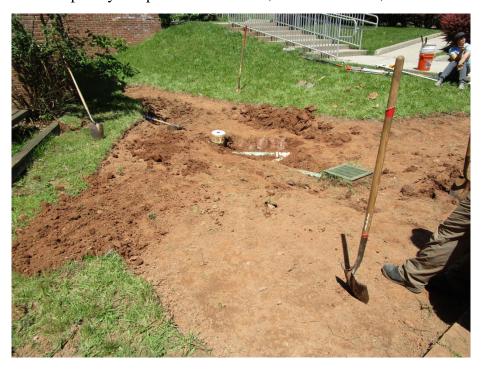
6/14/2018 – Existing catch basin and piping is uncovered and assessed for reuse.

The existing catch basin was inspected by RCE on June 14, 2018 for functionality within the design requirements of the rain garden. It was found to be at the incorrect elevation necessary for adequate ponding depth in the rain garden and was excavated and removed from the site by RCE on June 29, 2018. A replacement was sourced and procured by RCE from Kennedy Culvert & Supply Co. of Hillsborough, NJ. The catch basin was installed by RCE staff and interns on June 29, 2018.

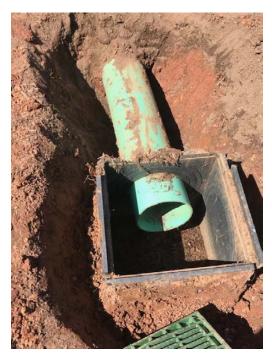
6/14/2018 RCE Water Resources Program staff determined that the catch basin would need to be retrofitted with new parts to raise the overflow inlet several inches.

6/29/2018 – RCE Water Resources Program staff and interns replaced the existing catch basin with a larger box, increasing the height of the inlet structure.

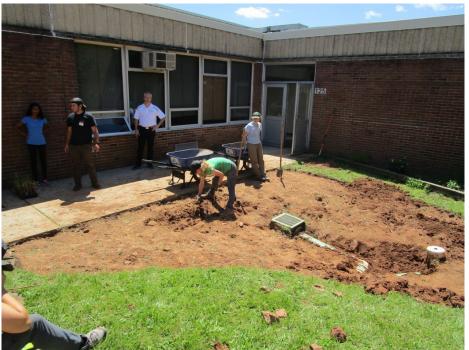
6/14/2018 RCE Water Resources Program staff share progress status and lead afternoon excavation with student and teacher volunteers.

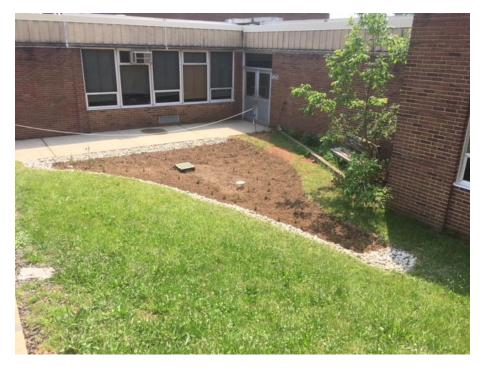
6/18/2018 Stone was placed around the perimeter of the garden to protect against erosion, the garden was planted and mulched by students and volunteers.

Thirty-one, fifty pound bags of 2"-3" sized river stone were placed in a 2' strip, on top of landscape fabric, along two edges of the garden to protect the soil from erosion. An additional area of erosion was identified during a rain event on June 19, 2019 and additional river stone was added to the identified area of erosion. Students from BRMS assisted with planting the native plants in the rain garden. The plant donation was supplemented with additional 50 native plants, in 2" plugs, purchased by RCE for an earlier project from Pinelands Nursery, of Columbus, NJ. Two yards of triple shredded hardwood mulch was placed into the garden in a 3"-thick layer.

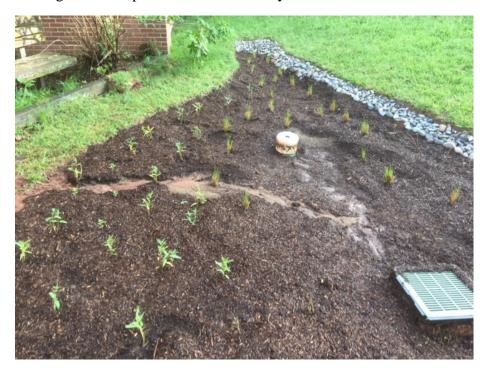
6/19/2018 Post-installation, additional erosion issues were noted.

6/29/2018 Mulch was replaced and stone was placed around the installed catch basin and area of erosion.

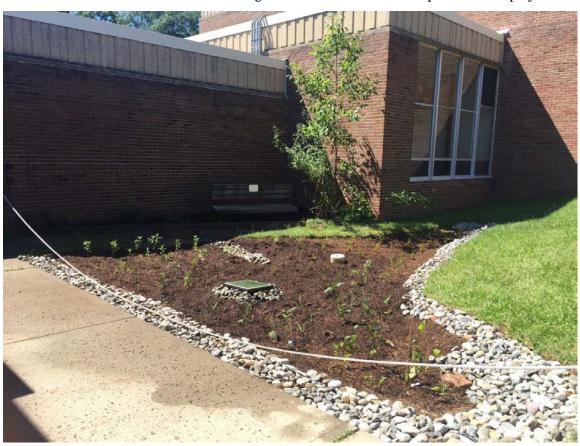
6/29/2018 - Completed rain garden project at Bridgewater Raritan Middle School

The rain garden is 450 square feet in area is designed to pond a maximum of six inches in a rain event. The rain garden is designed to manage runoff from a drainage area totaling 1,800 square feet, including from adjacent impervious surfaces totaling 820 square feet. The rain garden is designed to capture stormwater runoff generated by a rain event of 1.25 inches (NJDEP Water Quality Design Storm). The rain gardens have the potential to capture stormwater runoff generated by 90% of all rainfall events, or 1,402 gallons per individual rain event. The rain gardens have the potential to capture an annual runoff volume of 39,988 gallons per year, assuming an average rainfall total of 44 inches per year in New Jersey.
