Impervious Cover Assessment
for
Woodland Township, Burlington County, New Jersey

Prepared for Woodland Township by the
Rutgers Cooperative Extension Water Resources Program

April 25, 2018

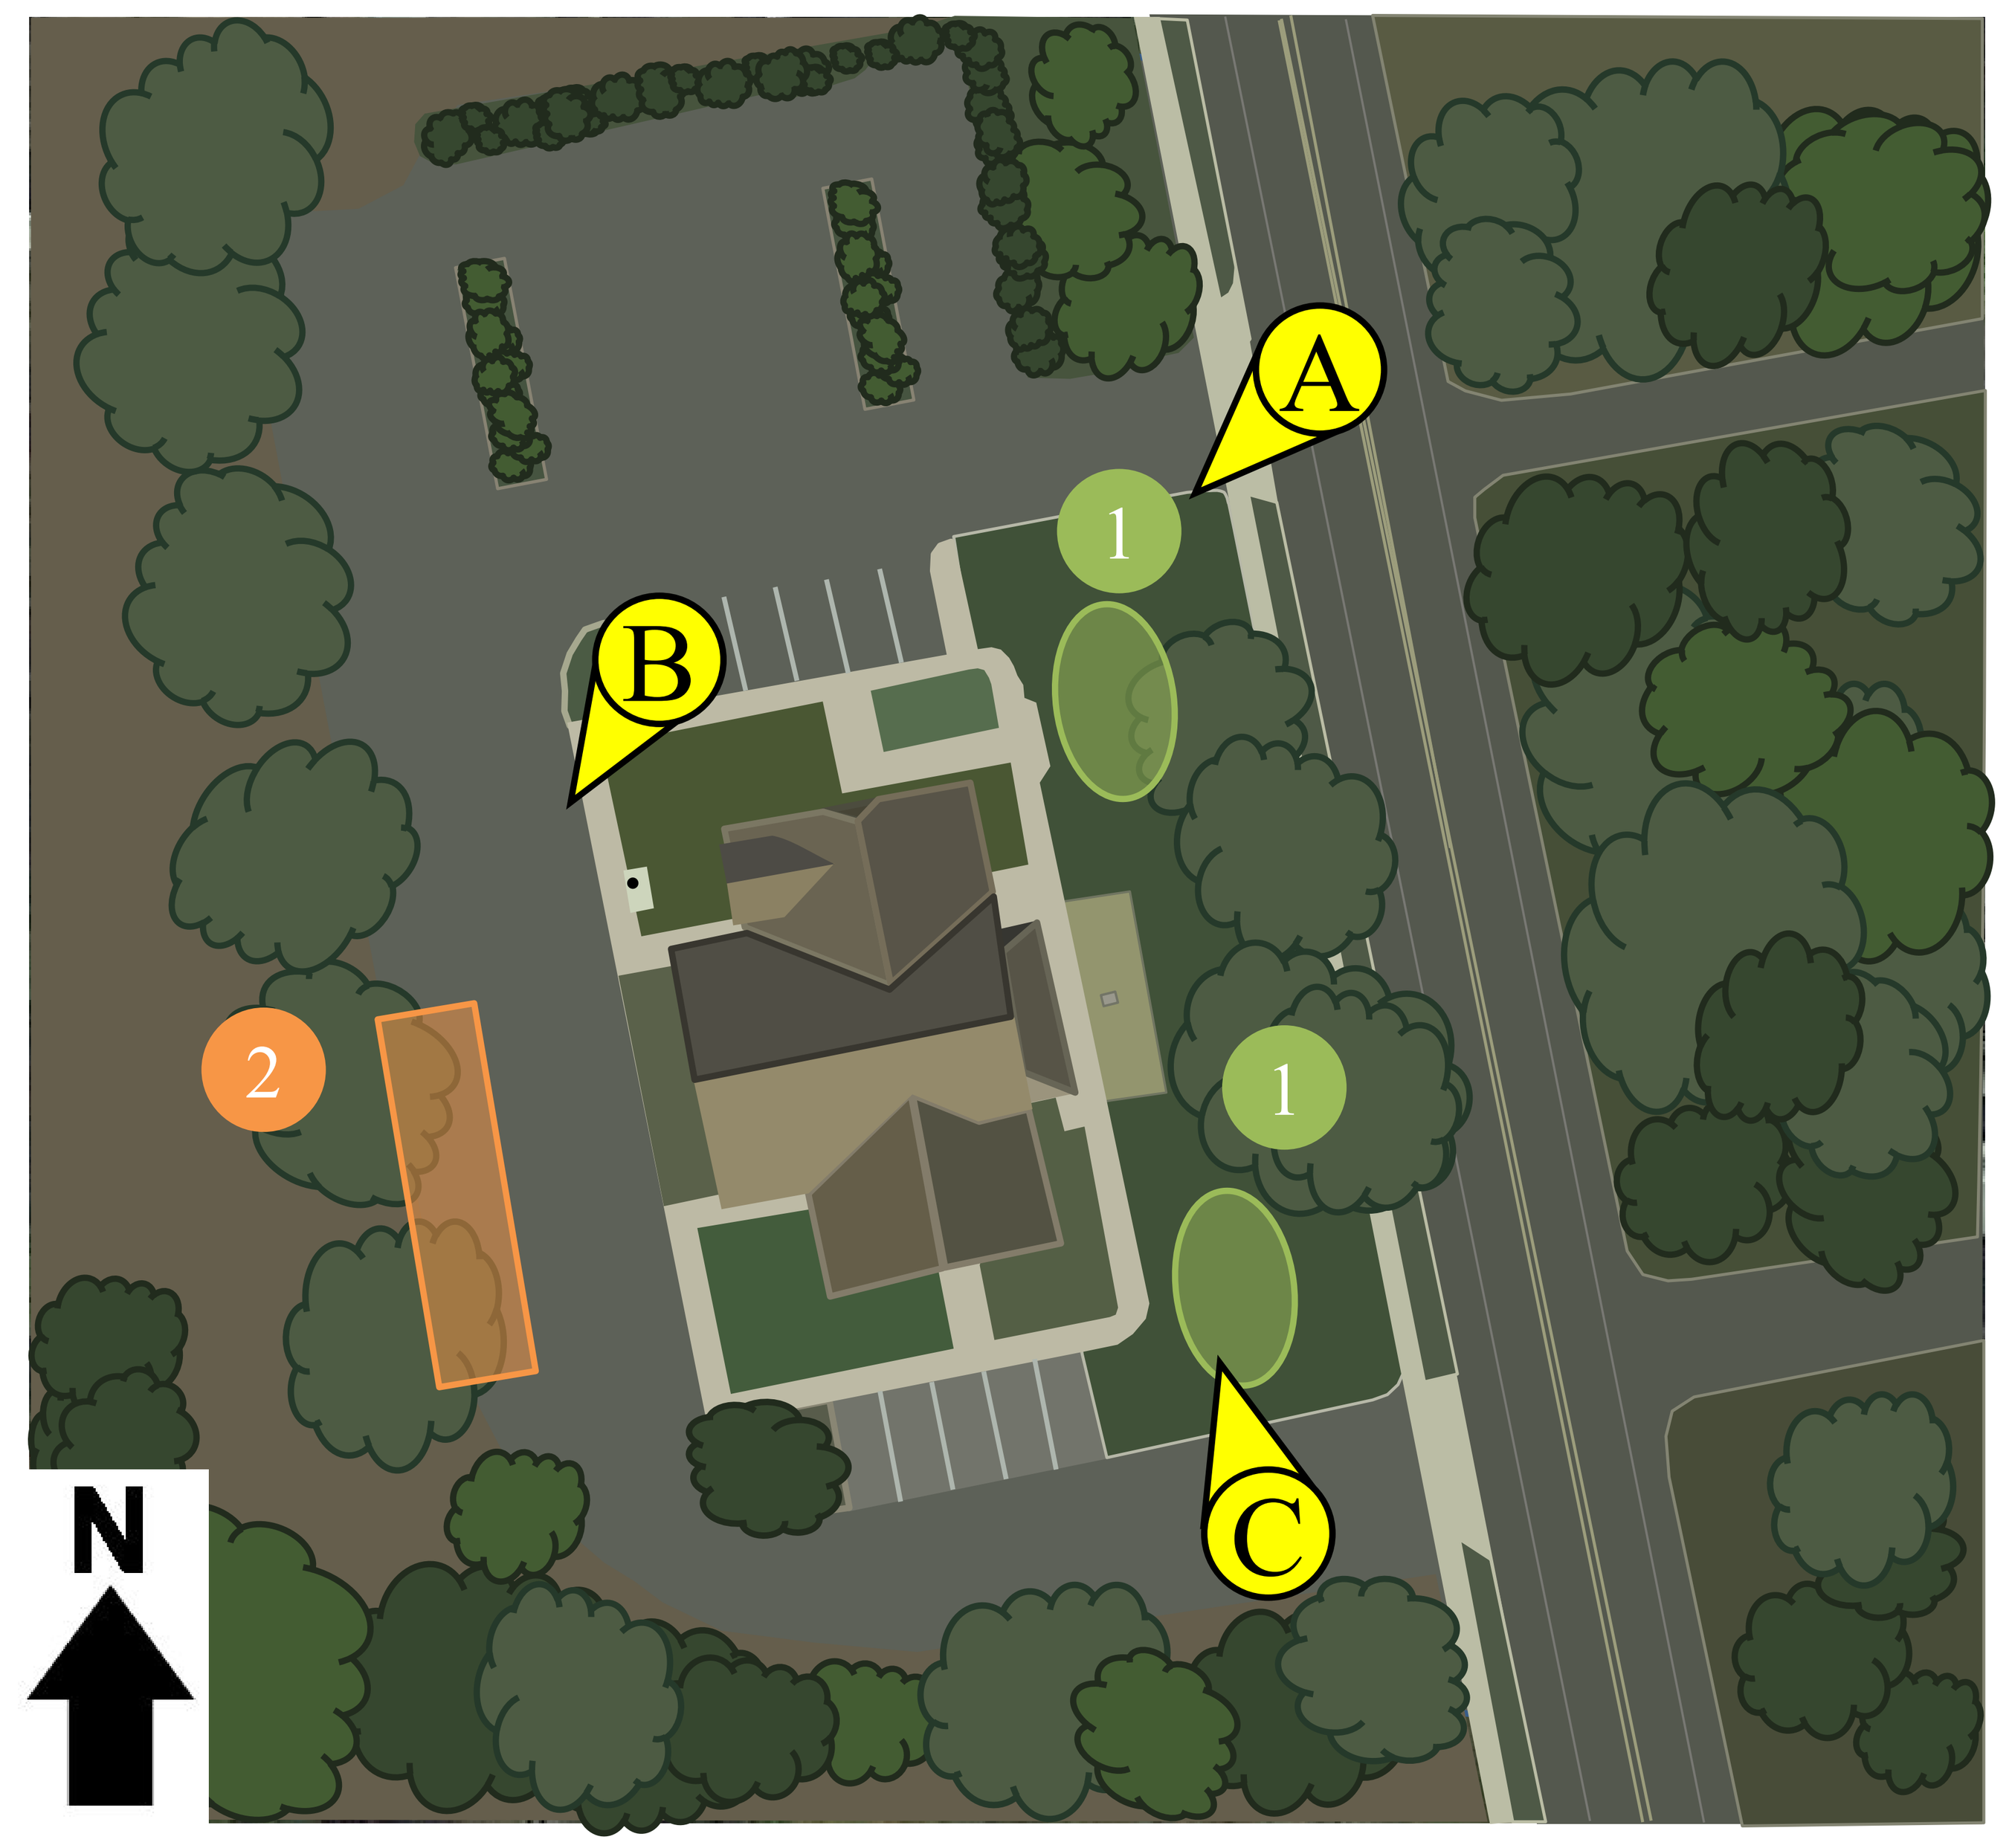
Woodland Township
Impervious Cover Assessment
Woodland Township Municipal Clerk, 3943 Main Street

Existing Conditions and Issues:
In the turfgrass area in front of the building towards the northeast, there are two manholes. Erosion was present at the parking spaces and on the pavement behind the building toward the west. Furthermore, a disconnected downspout leads the runoff from the roof onto the paved lot.

1 **BIORETENTION SYSTEM:** Two rain gardens can be installed east of the municipal building. Rain gardens are used to reduce sediment and nutrient loading to the local waterway and increase groundwater recharge.

2 **PERVIOUS PAVEMENT:** Pervious pavement can be used to replace parking spaces. Pervious pavement promotes groundwater recharge and filters stormwater.

Proposed Solution(s):
Two rain gardens can be installed east of the municipal building. Connected downspouts will have to be disconnected and redirected for the runoff from the roof of the building to be captured into the proposed rain gardens. Pervious pavement can be installed on the westernmost section of the pavement to capture stormwater from the parking lot and roof of the building.

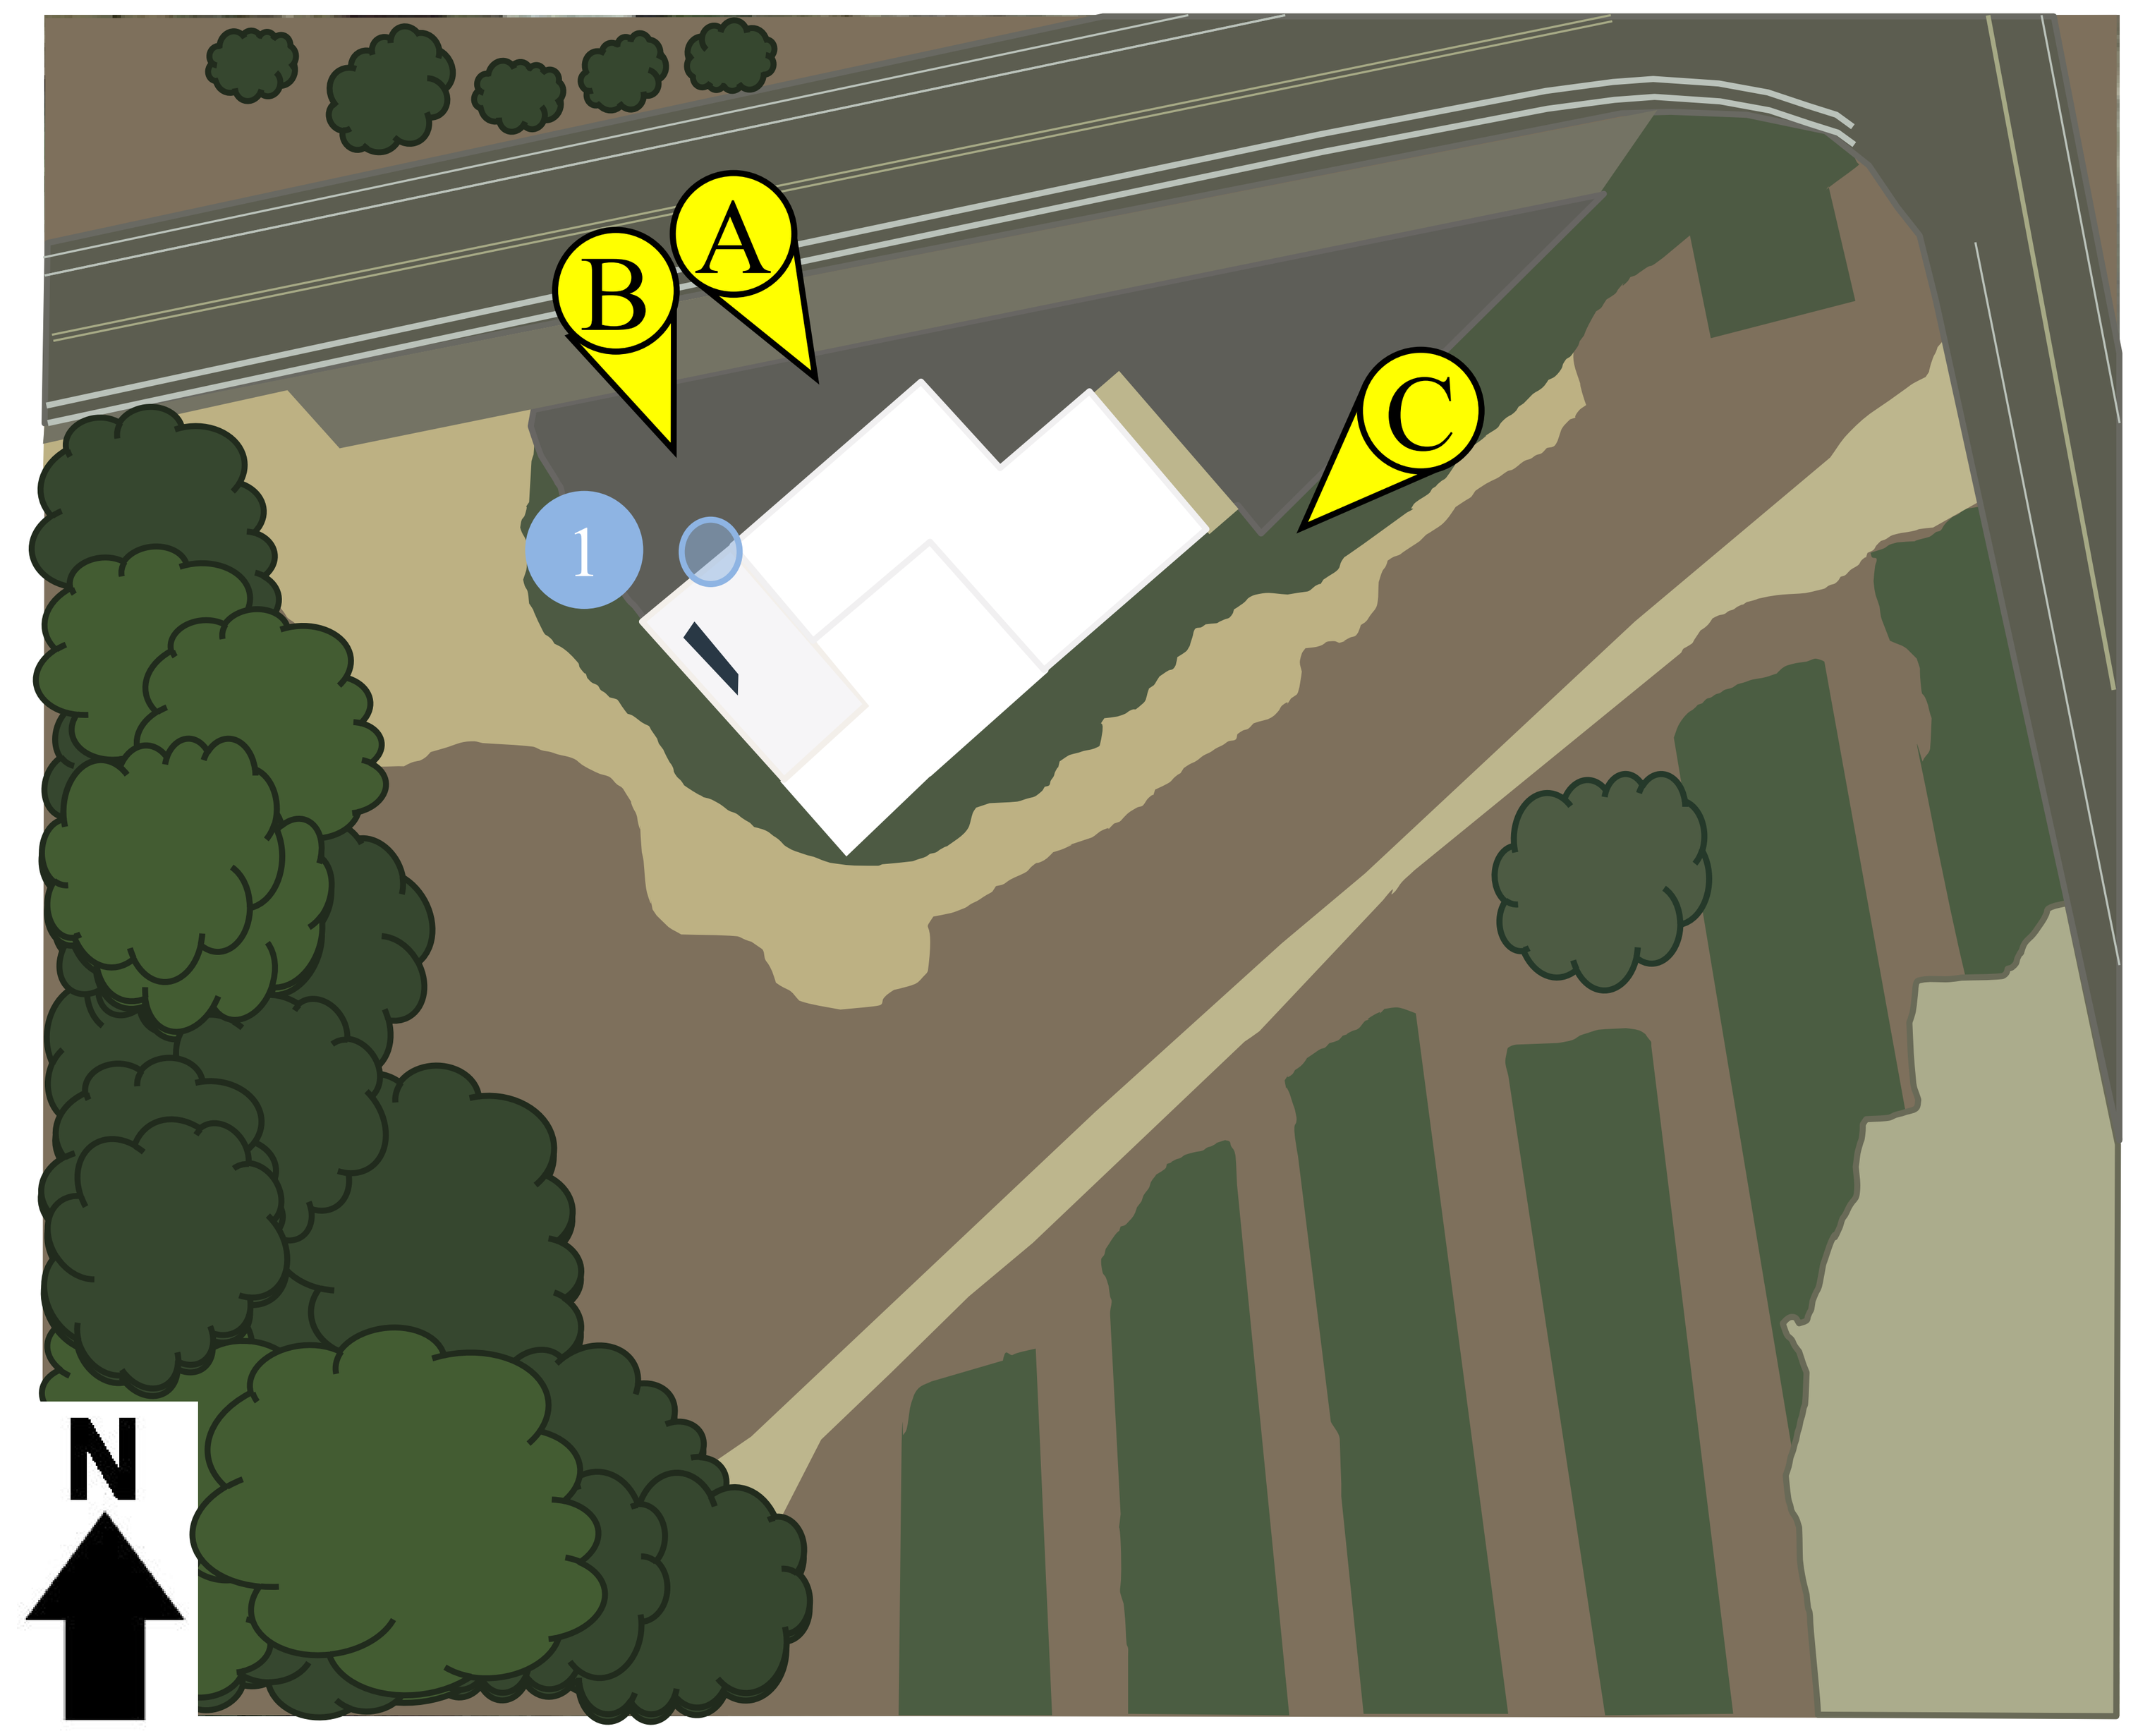
Woodland Volunteer Fire and EMS, 3991 County Road 563

Existing Conditions and Issues:
Asphalt surrounds the north side of the fire department, while loose sand and soil surrounds the southern side. Sediment accumulation exists on the asphalt between the building and street near the downspouts. Six downspouts surround the building; each are disconnected.

1 **RAINWATER HARVESTING SYSTEM:** Rainwater can be harvested from the roof of the building and stored in a cistern. The water can be used to wash fire vehicles, water existing landscaping, and other non-potable uses.

Proposed Solution(s):
On the patio area behind the building, there is space in which a cistern can be installed to capture stormwater runoff from the roof.

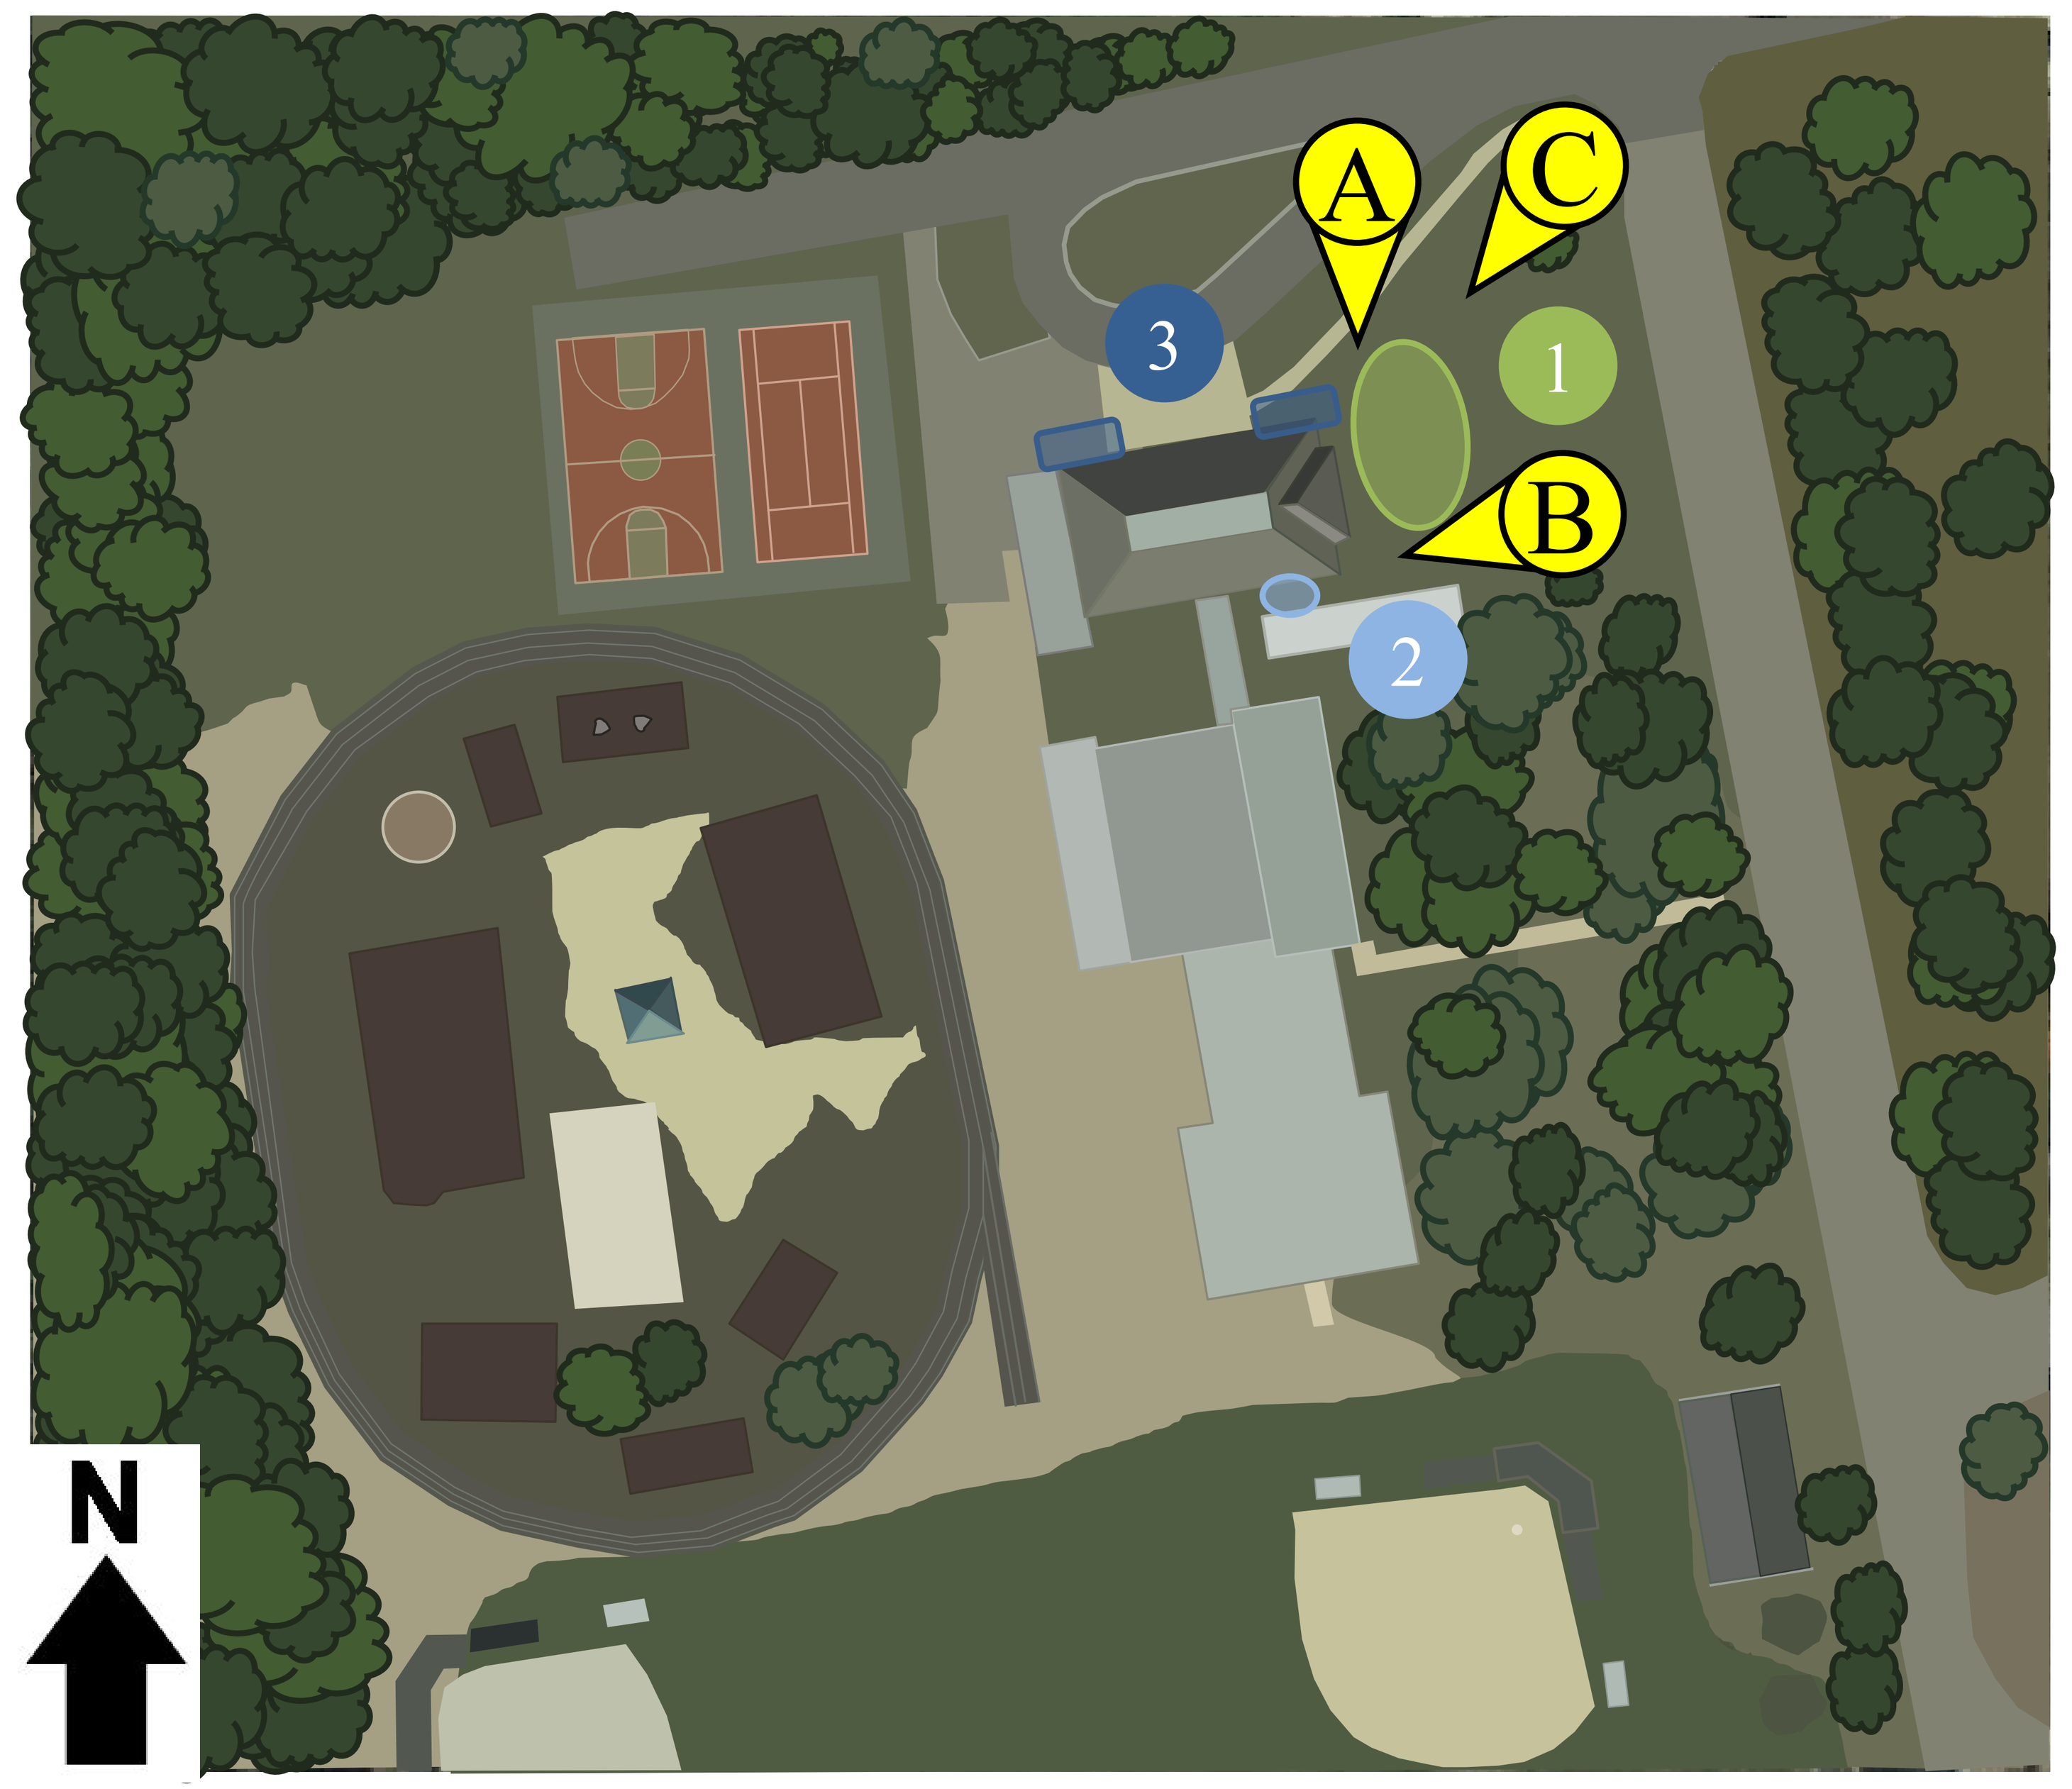
Woodland Township
Impervious Cover Assessment
Chatsworth Elementary School, 2 Giles Avenue

Existing Conditions and Issues:
The school building has existing disconnected downspouts that drain onto the surrounding turfgrass and pavement. Some erosion is present on the pavement and sidewalk. There are two rain gardens near the baseball field south of the school.

1 **BIORETENTION SYSTEM:** A rain garden can be installed in front of the school to capture roof runoff.

2 **RAINWATER HARVESTING SYSTEM:** Rainwater can be harvested from the roof of the building and stored in a cistern. The water can be used to wash vehicles and water existing landscape.

3 **DOWNSPOUT PLANTER:** These are wooden boxes with plants installed at the base of a downspout that provide an opportunity to beneficially reuse rooftop runoff.

Proposed Solution(s):
To capture stormwater runoff from the north side of the roof of the school building, downspout planter boxes can be installed to prevent further erosion on the driveway. East of the school, near the entrance, a rain garden can be built to capture roof runoff by redirecting the downspouts. A cistern can be set up at the southeast corner of the school to harvest rainwater.
