**Hamilton Township (Mercer County)
Stormwater Basin Assessment Summary
Addendum (Year 4)**

Developed by the Rutgers Cooperative Extension Water Resources Program
Funded by Hamilton Township, Mercer County, New Jersey

December 2017

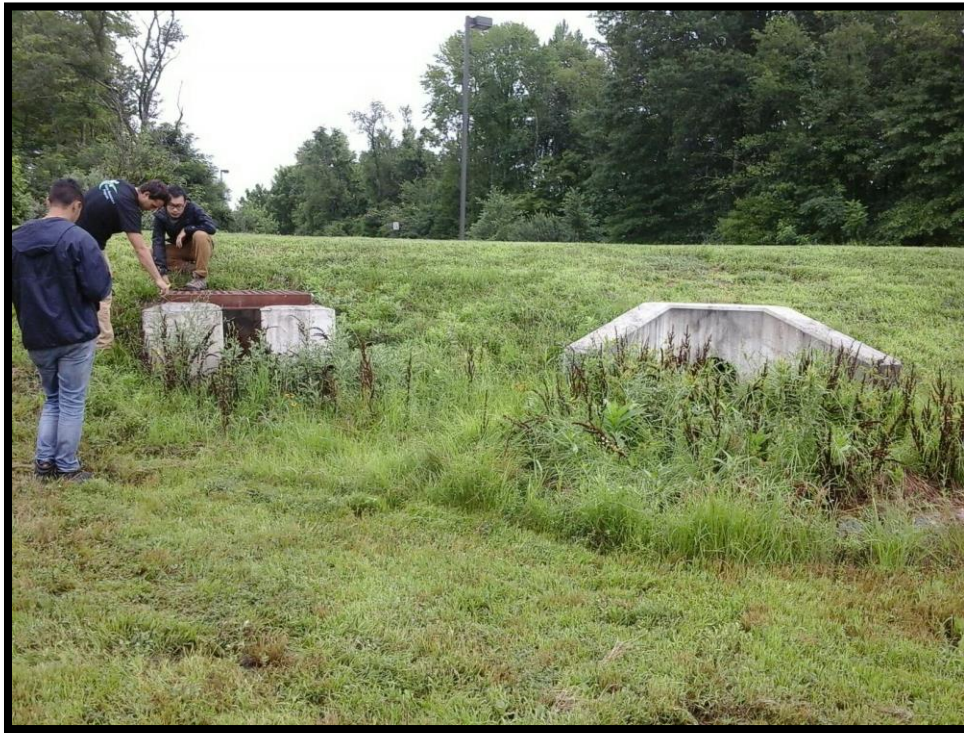
Student interns measure outlet structure at a Route 524 basin

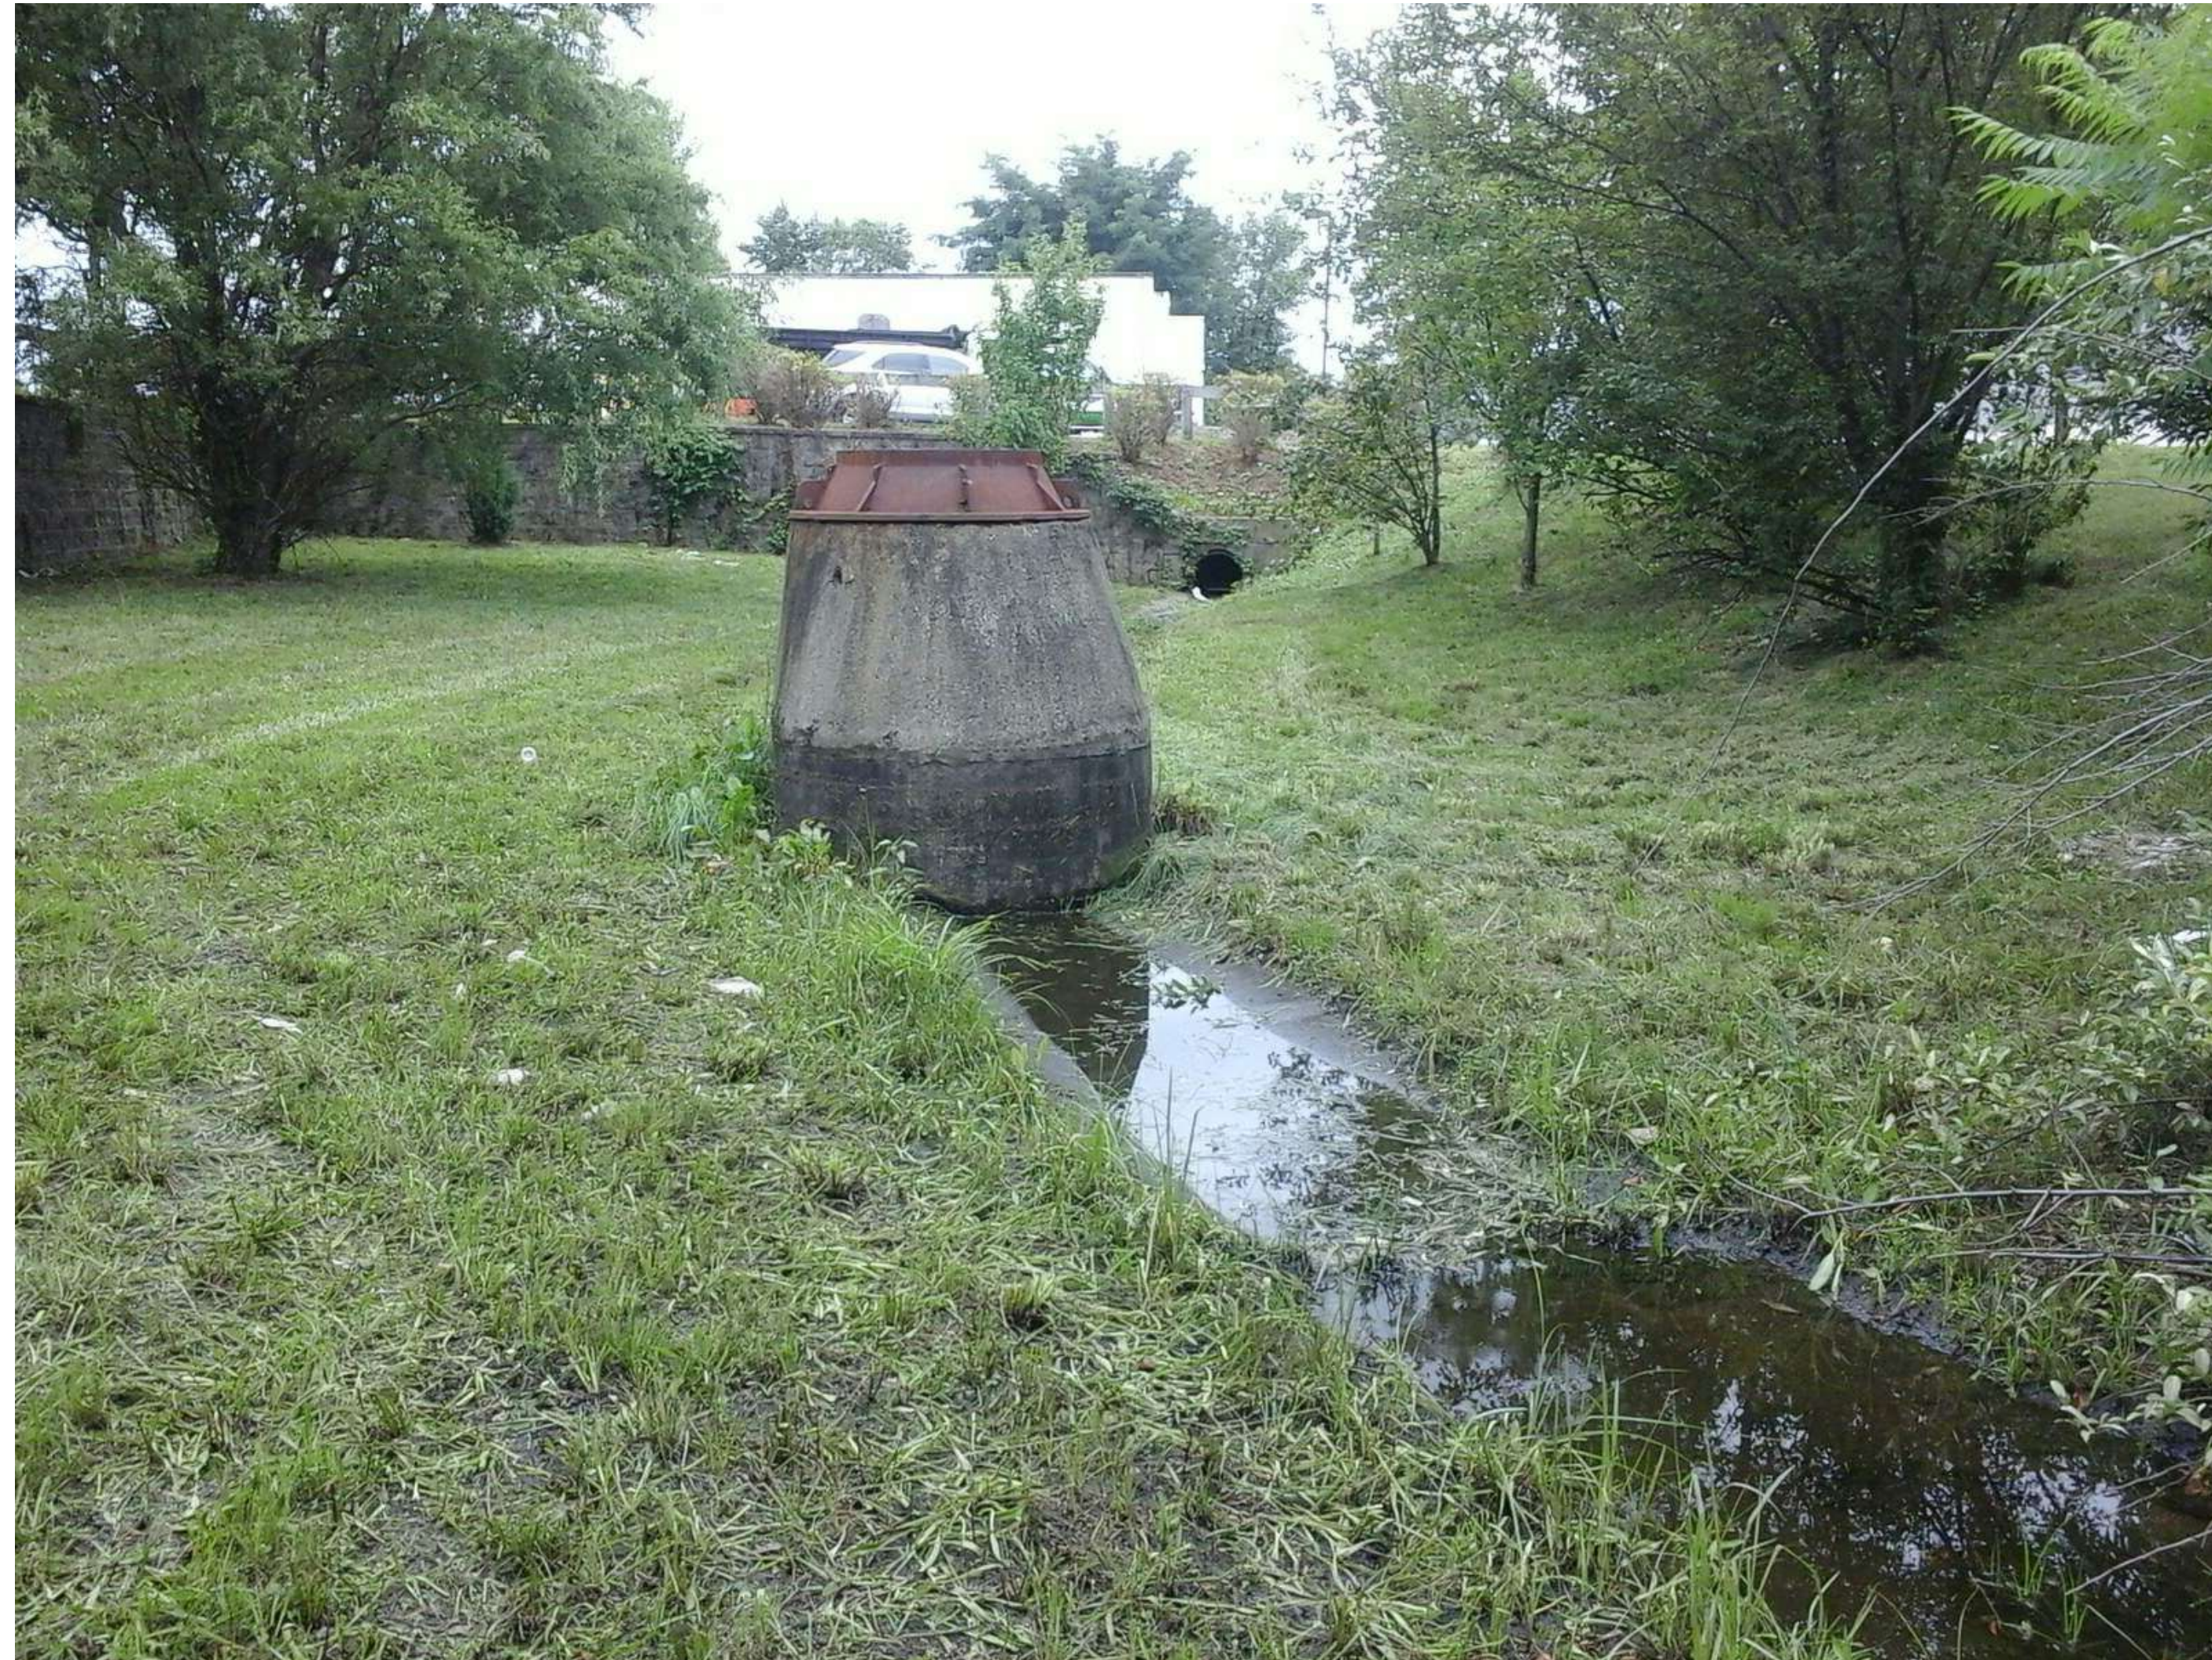
Overview of basin

The basin near Sirius XM Radio on 1st Avenue is in need of repairs to remove the standing water from the basin. Evidence of excessive sediment accumulation at the inlets and low flow channel was noted during the assessment. Vegetation overgrowth was also noted at the inlet and should be regularly maintained to prevent the build up of sediment. This basin includes a concrete low flow channel, which could also be removed. Once removed, it could be replaced with a stone-lined feature to enhance stormwater infiltration, reduce pollutants, and improve water quality downstream.

- Low flow channels had standing water present and stagnant
- Outlet structure may need to be replaced in near future
- Woody plants growing near outlet structure
- Stone lined channel can be used to replace low flow channel

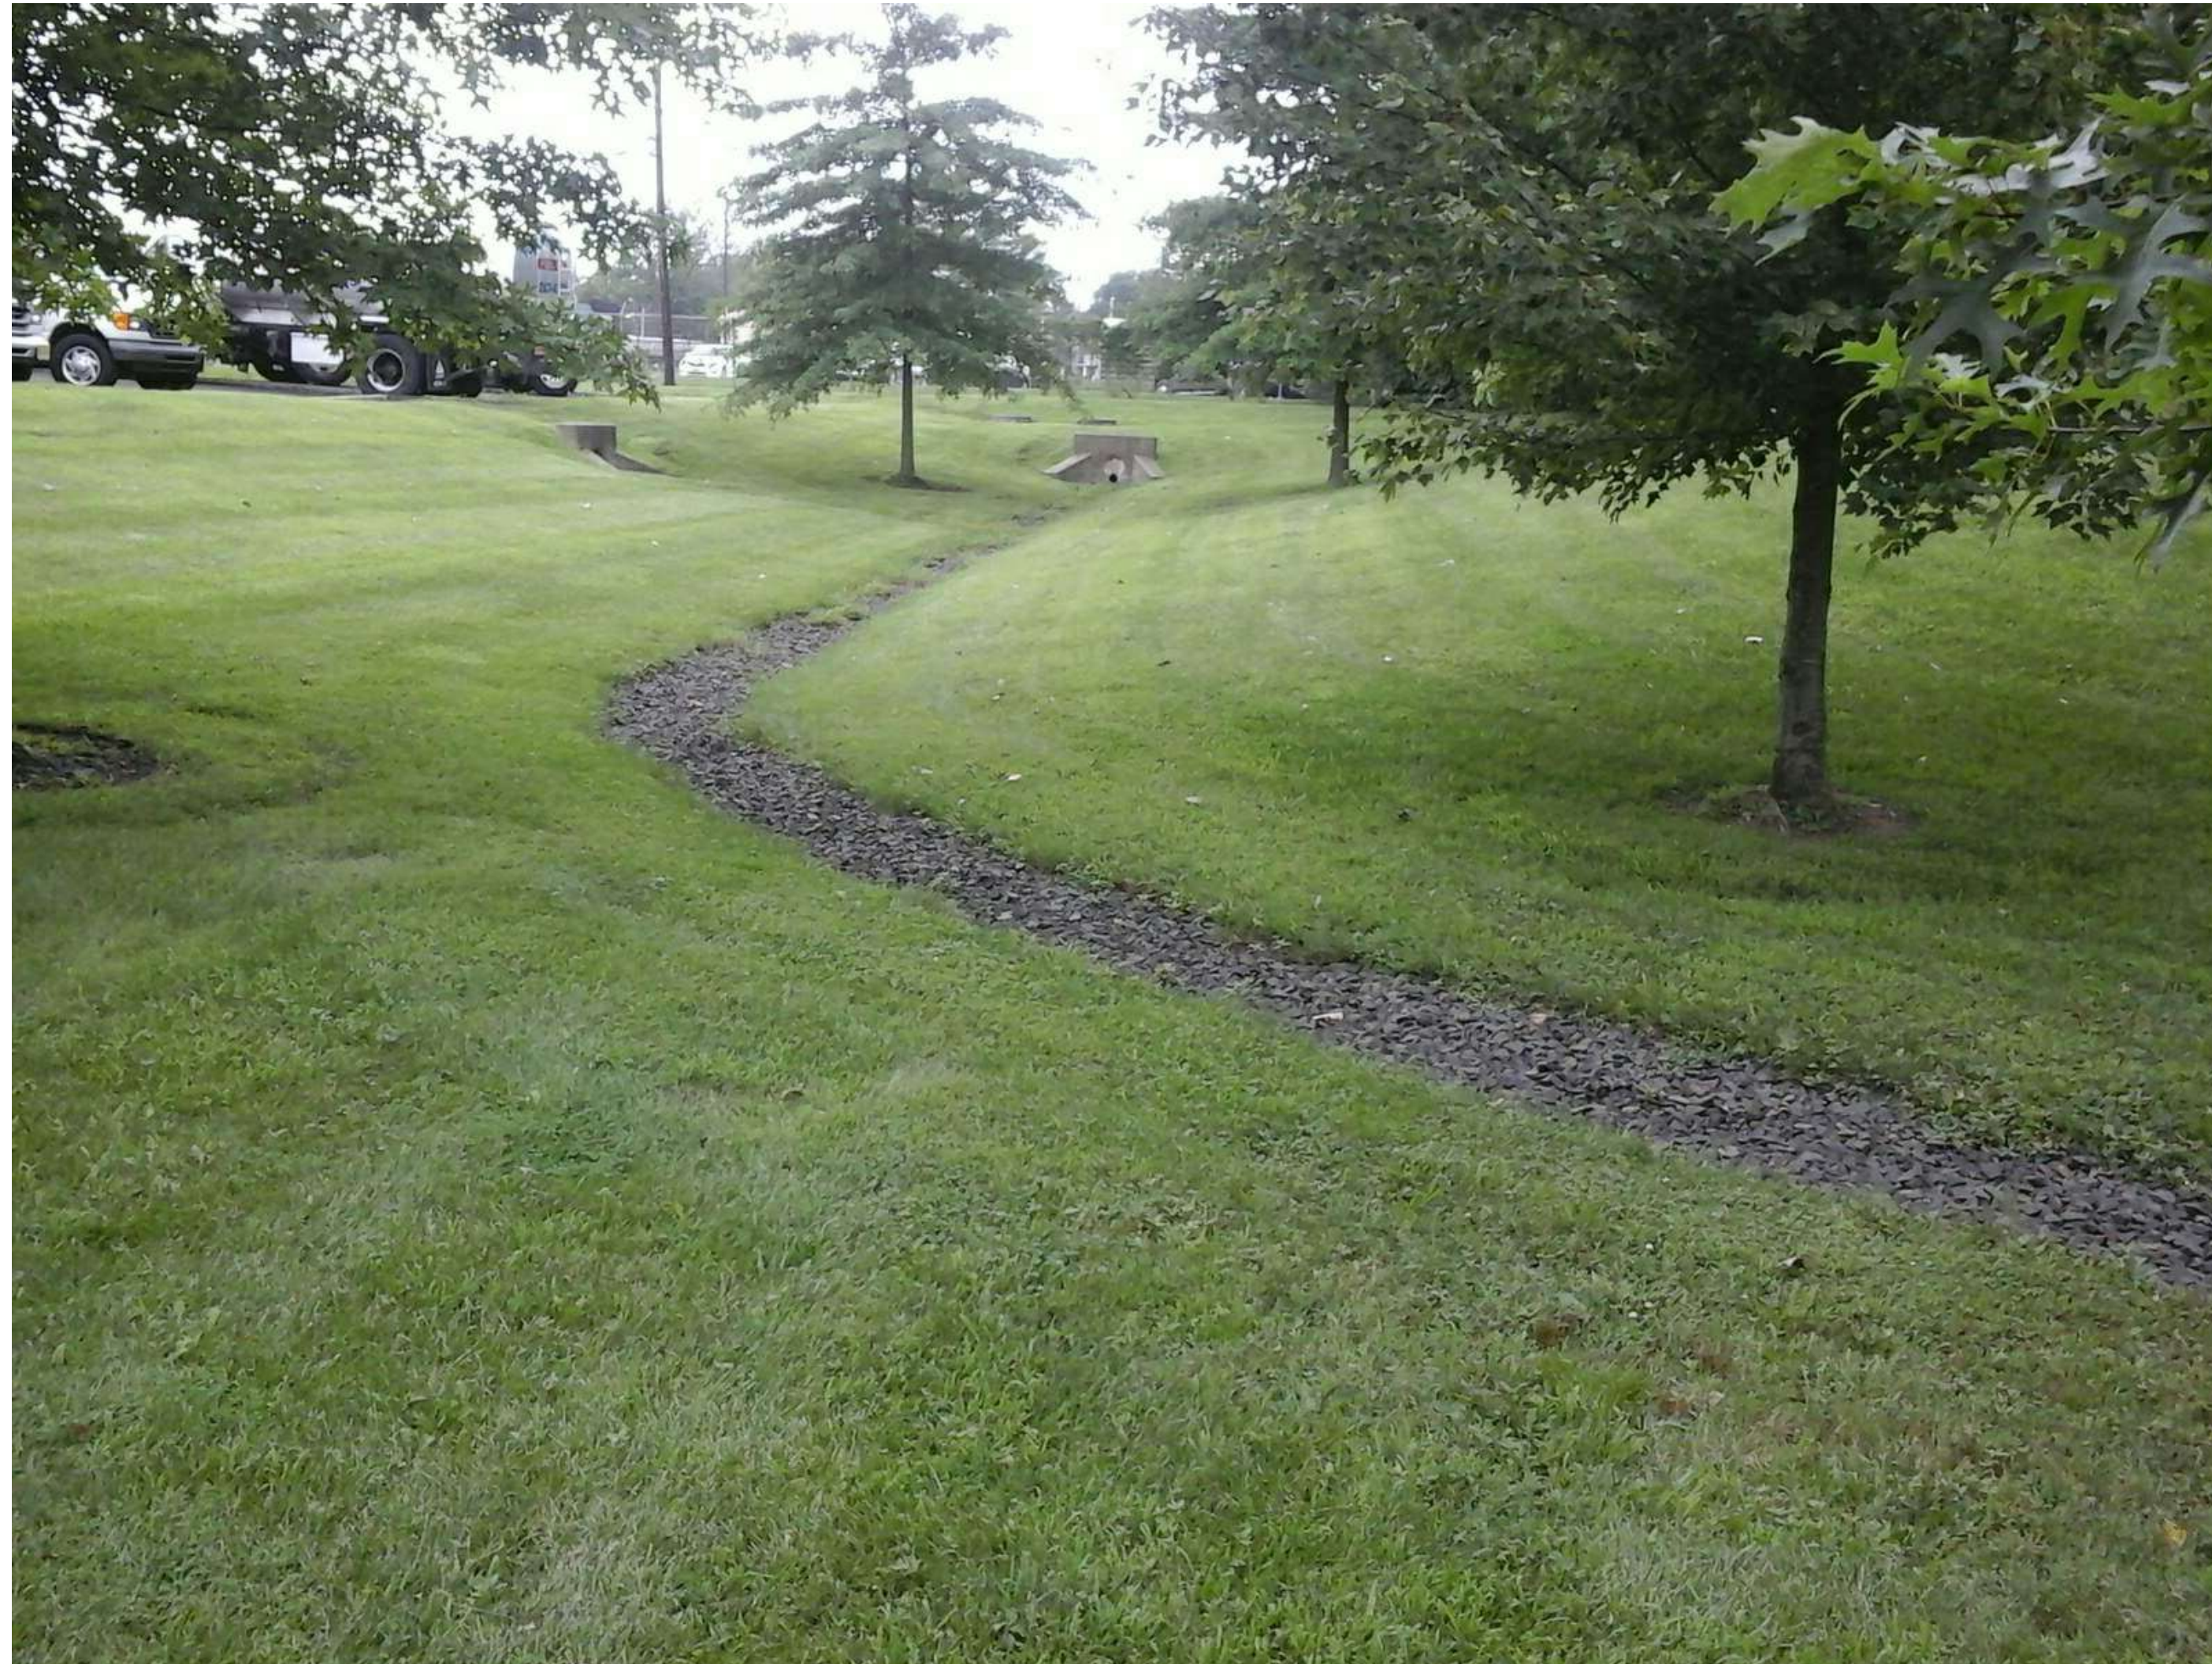
Overview of basin

- Stone lined flow channel
- Outlet structure needs to be repaired
- Overall well maintained besides outlet

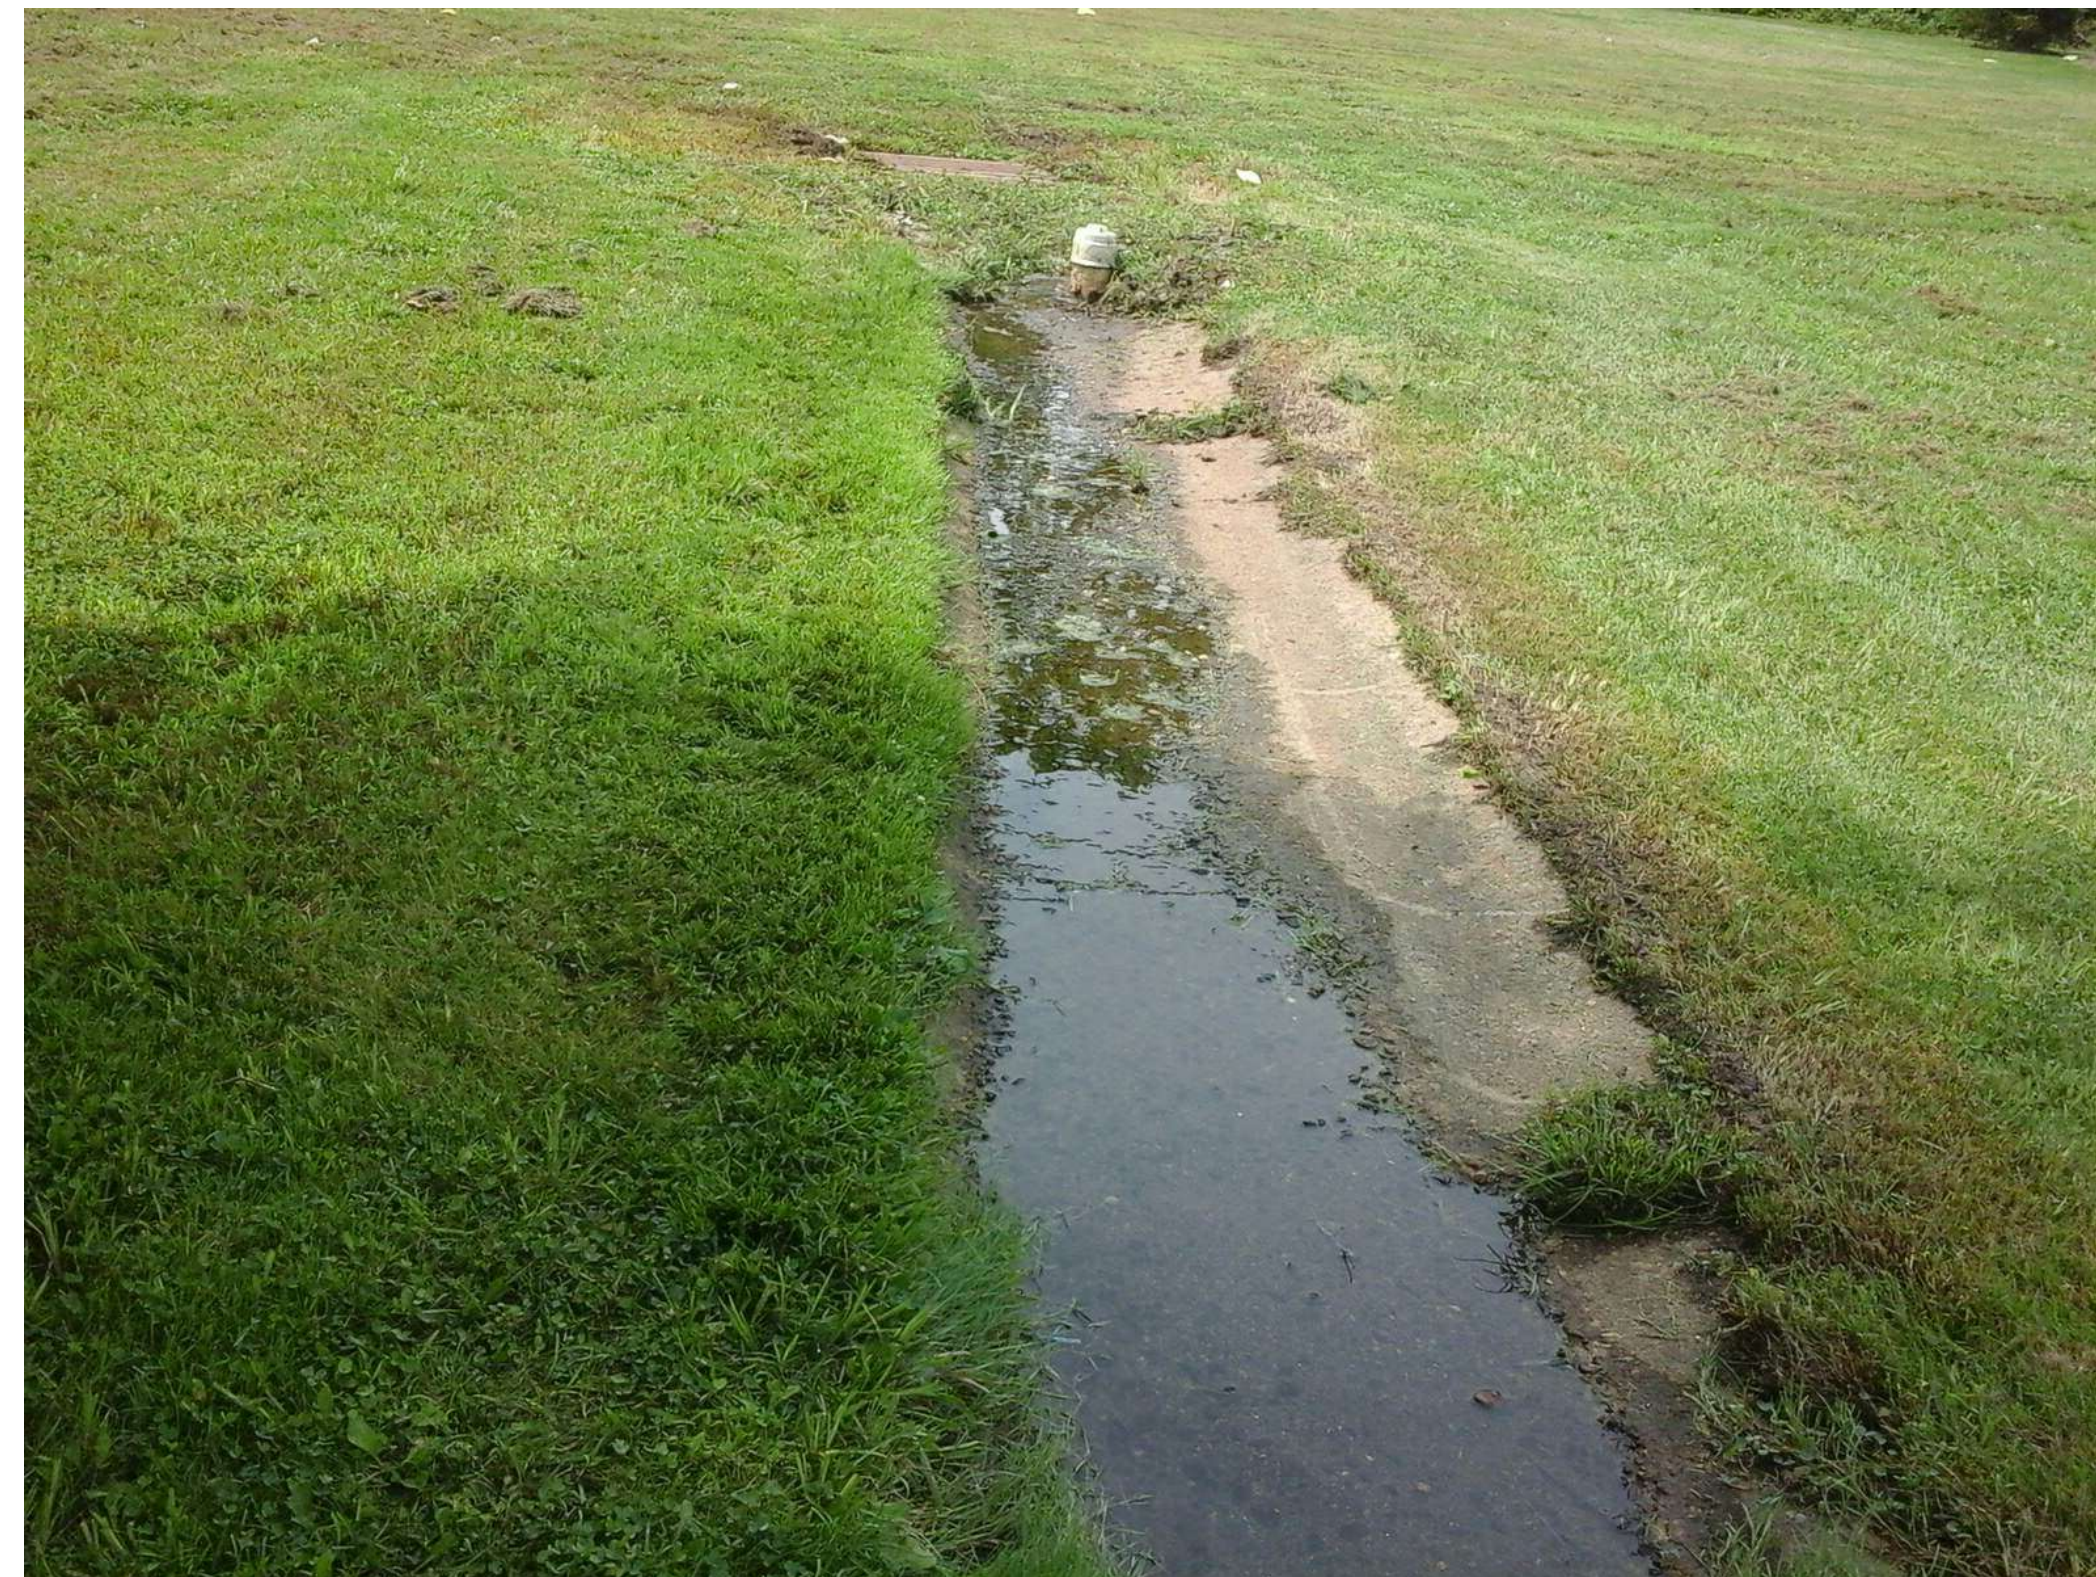
Low flow channel leading to catch basin

- Two low flow channels lead to a catch basin
- Basin can be naturalized using a stone lined channel to replace the low flow channel
- Reduce mowing and raise catch basin at the end of the low flow channels to allow better infiltration

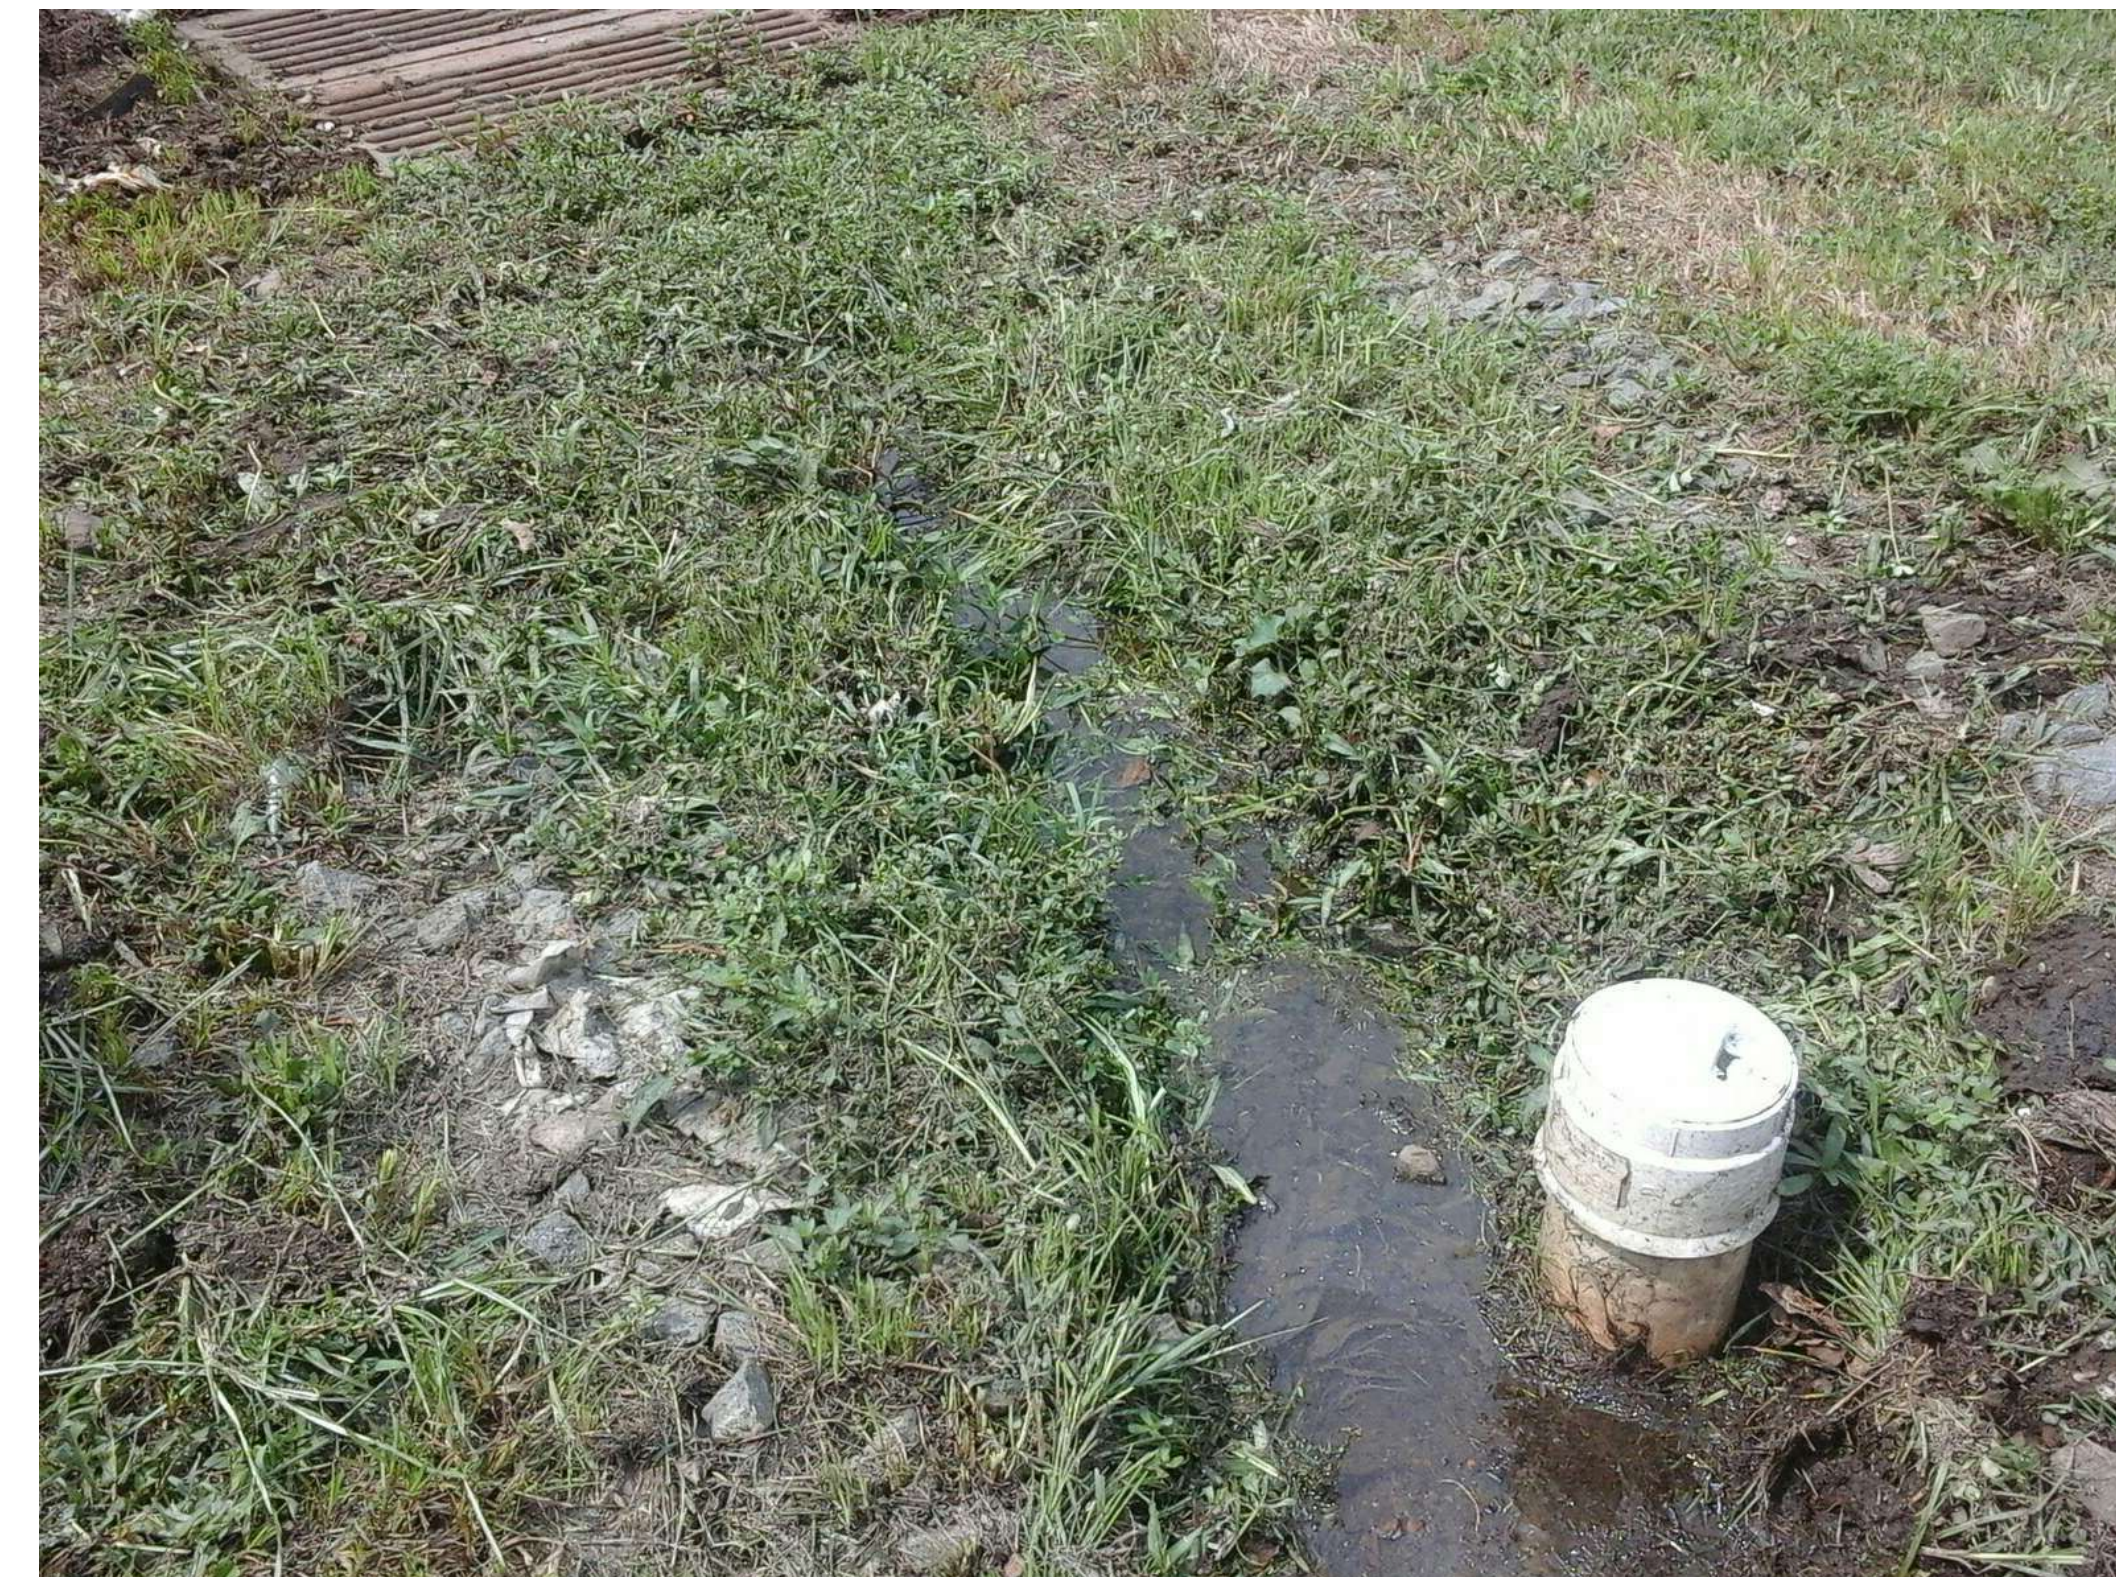
Clean out in low flow channel

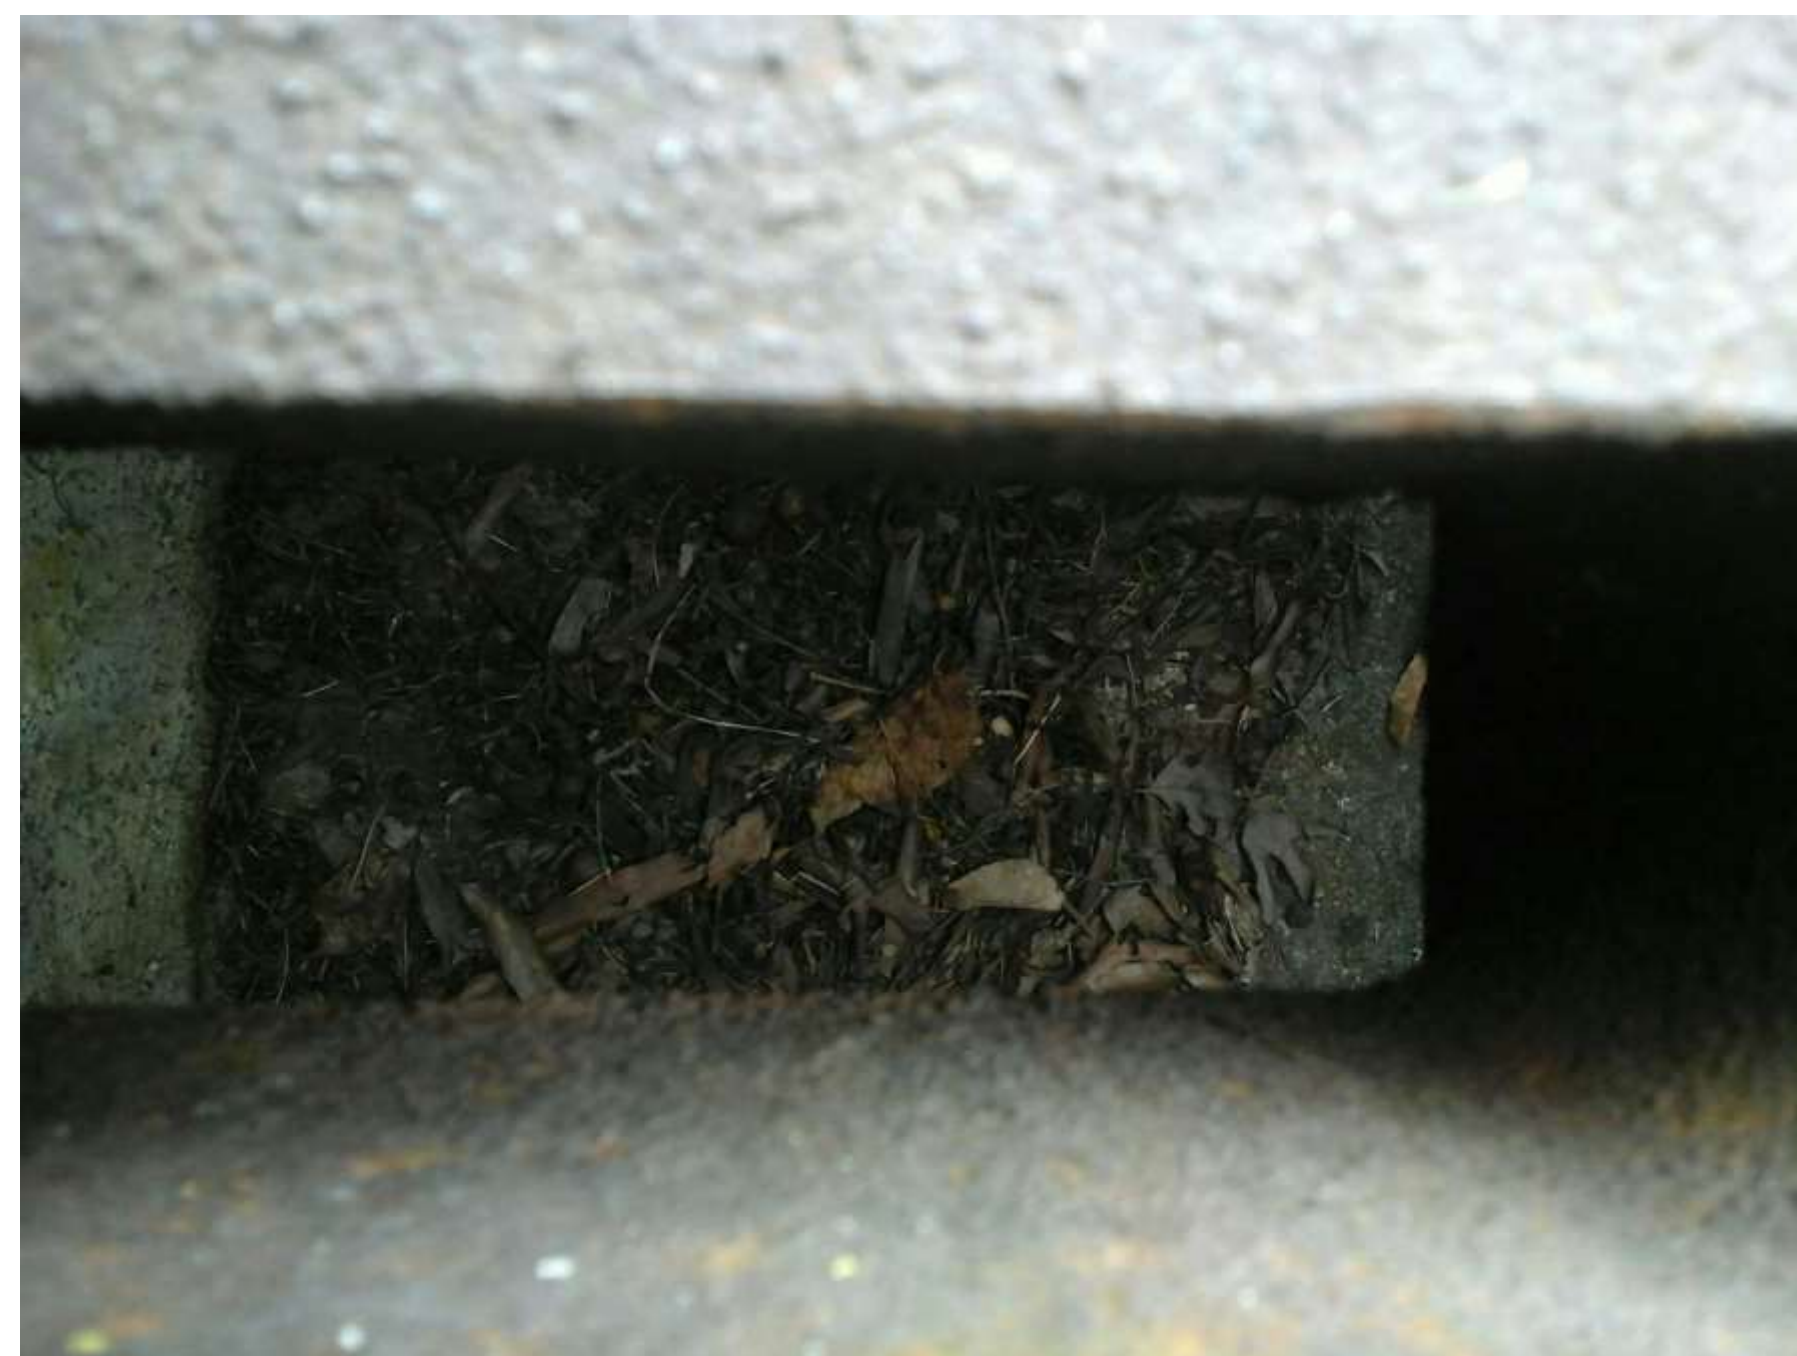
Sediment in outlet

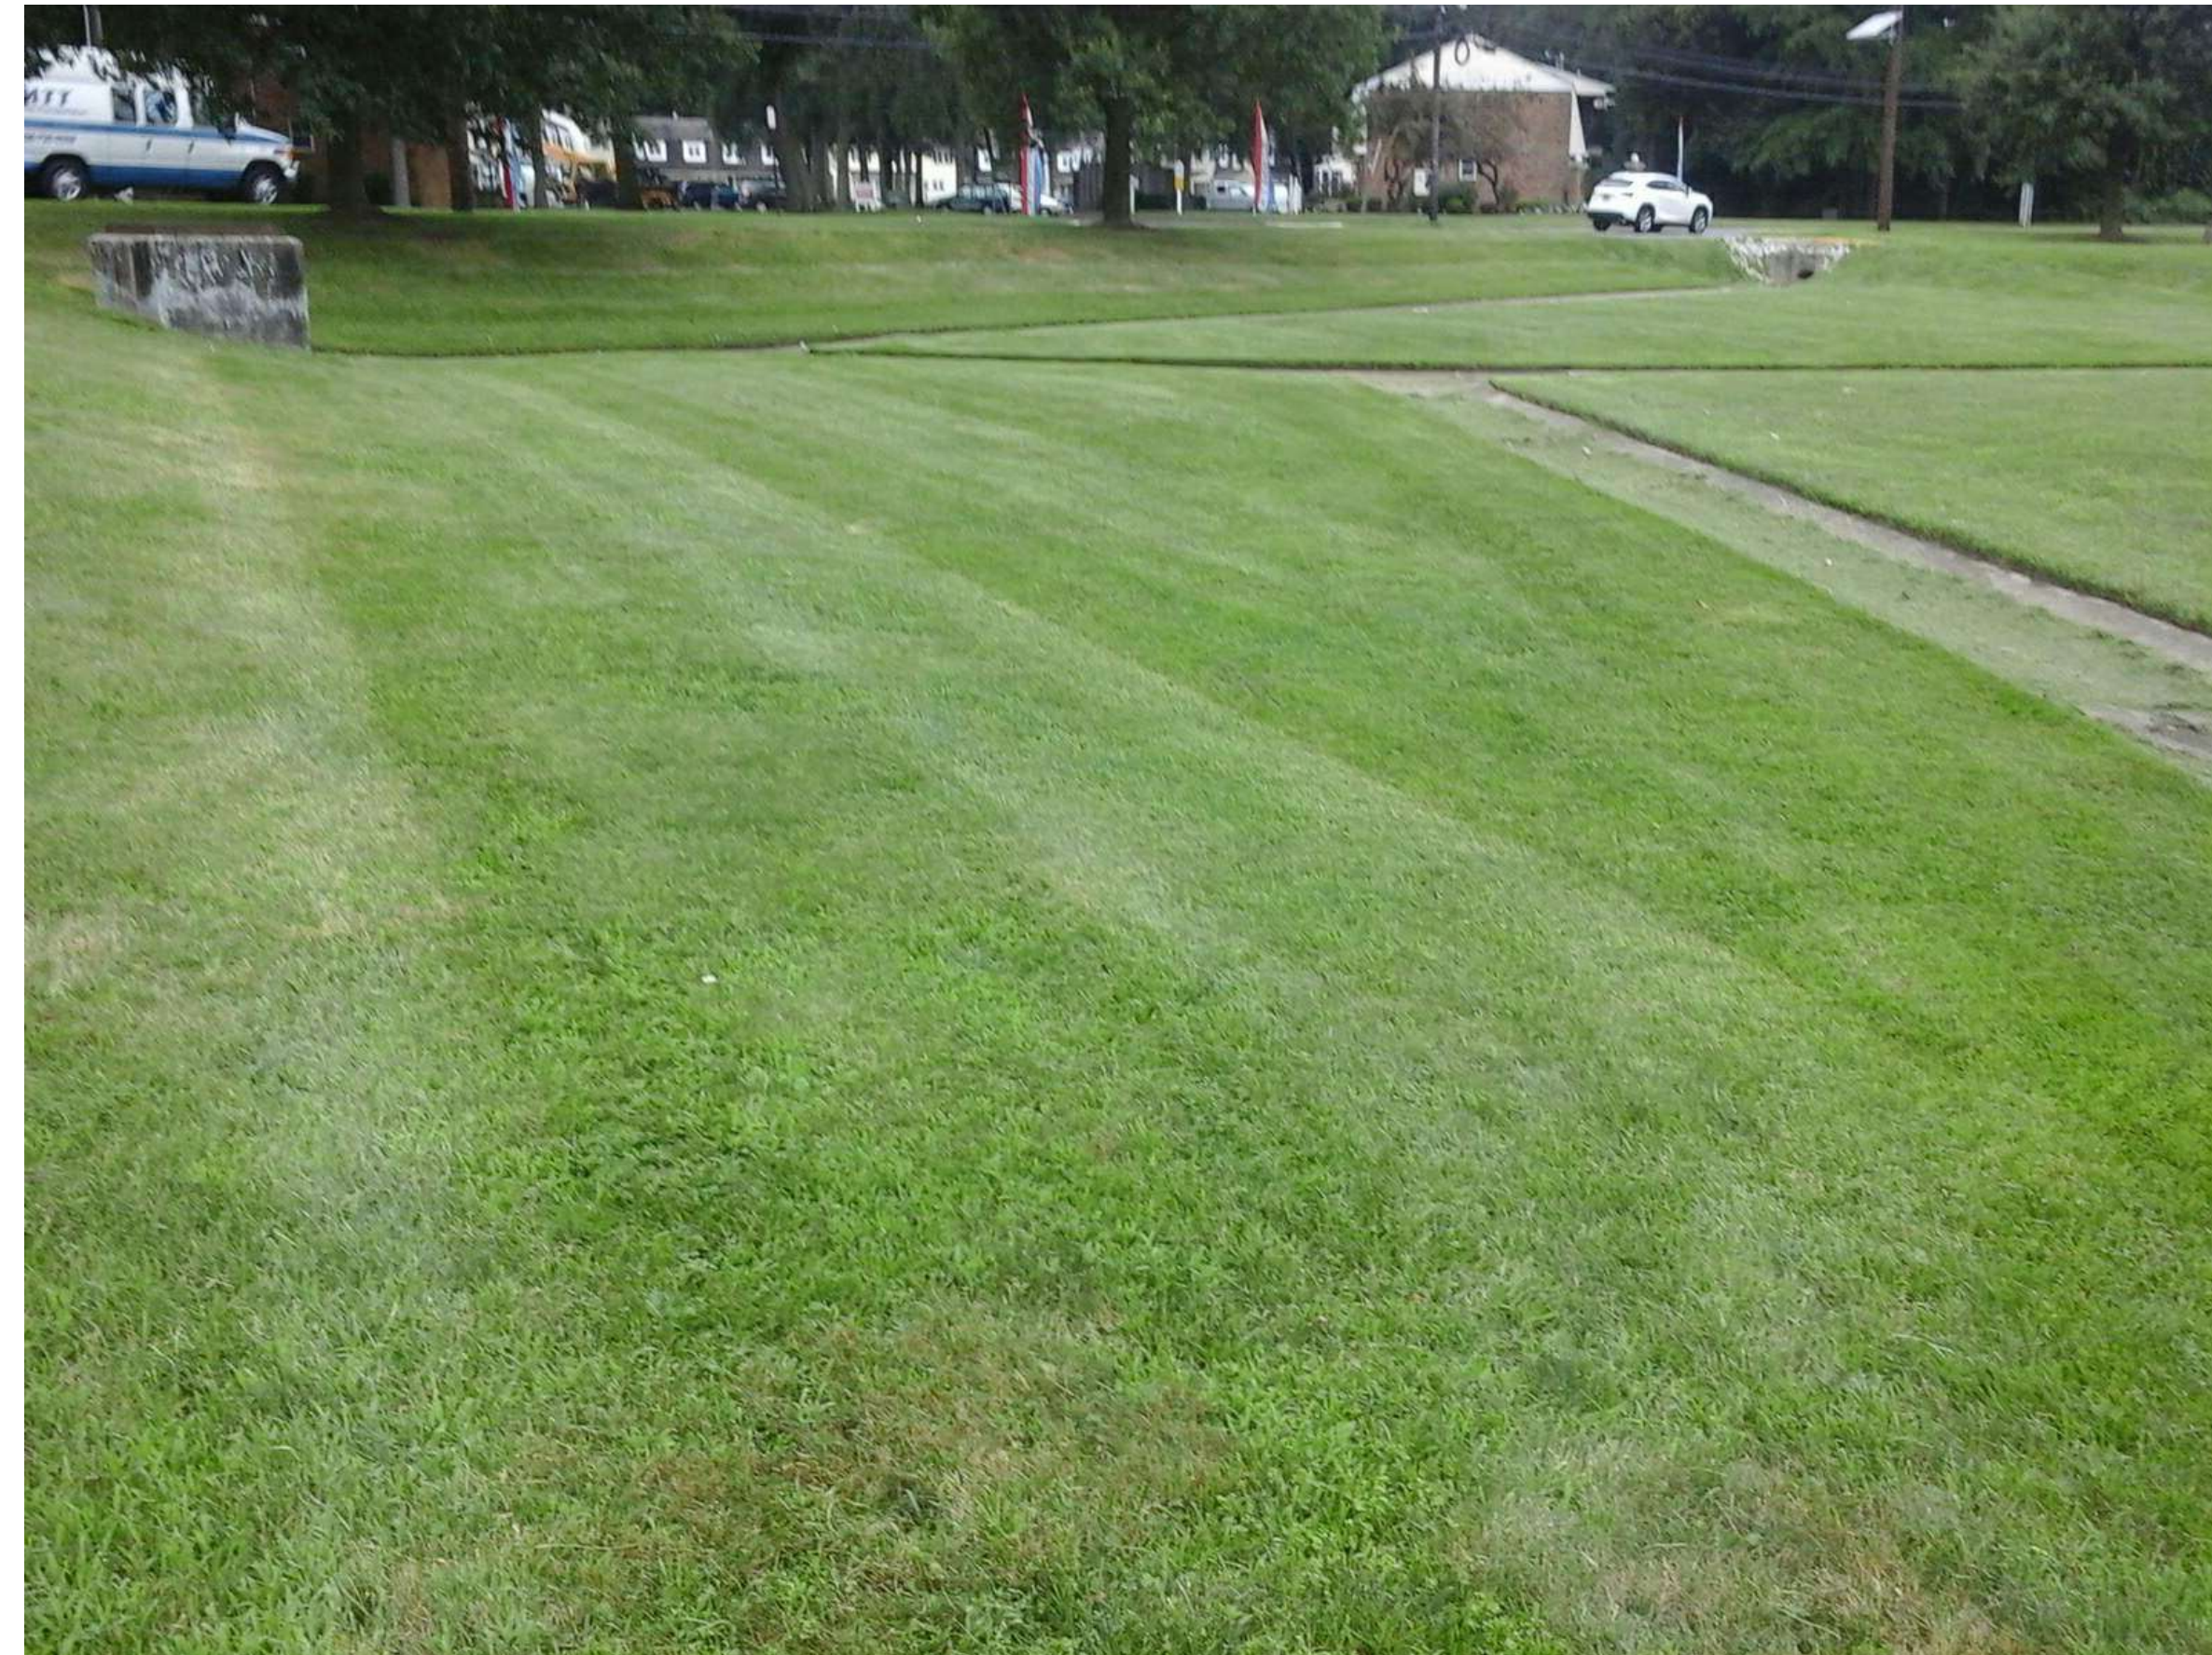
Overview of Basin
