**Hamilton Township (Mercer County)
Stormwater Basin Assessment Summary
Addendum (Year 4)**

Developed by the Rutgers Cooperative Extension Water Resources Program
Funded by Hamilton Township, Mercer County, New Jersey

December 2017

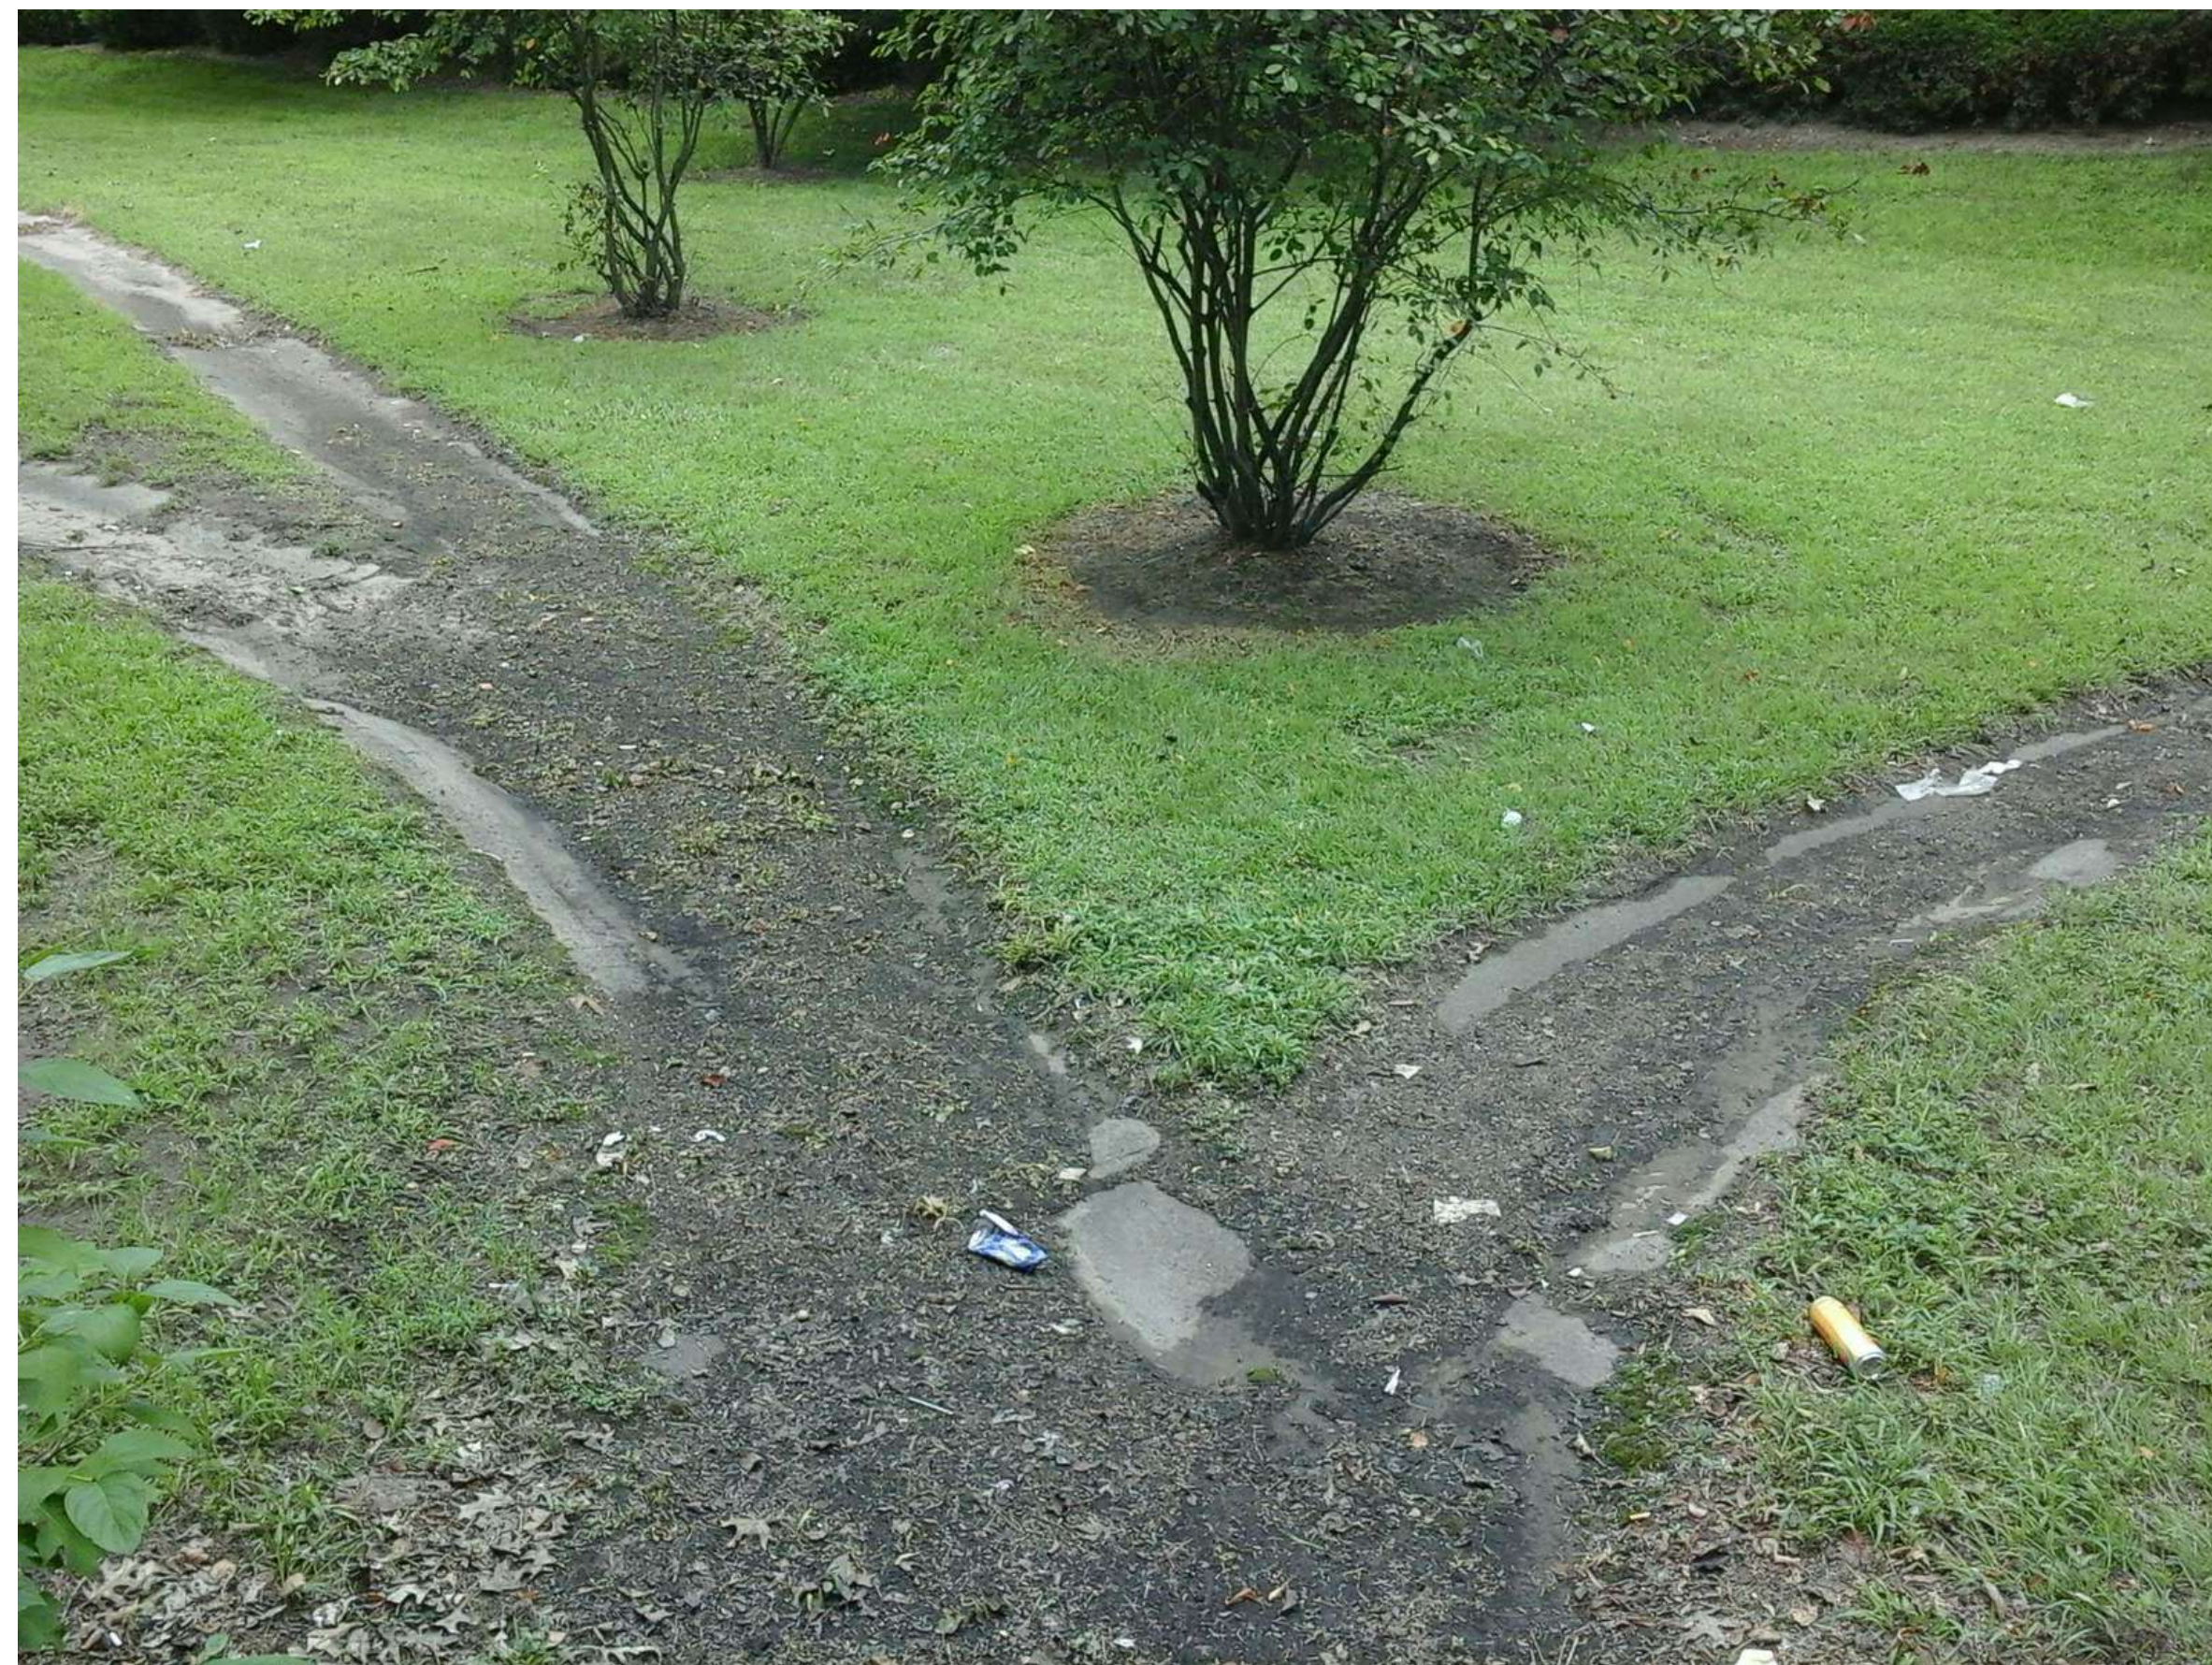
Overview of Basin

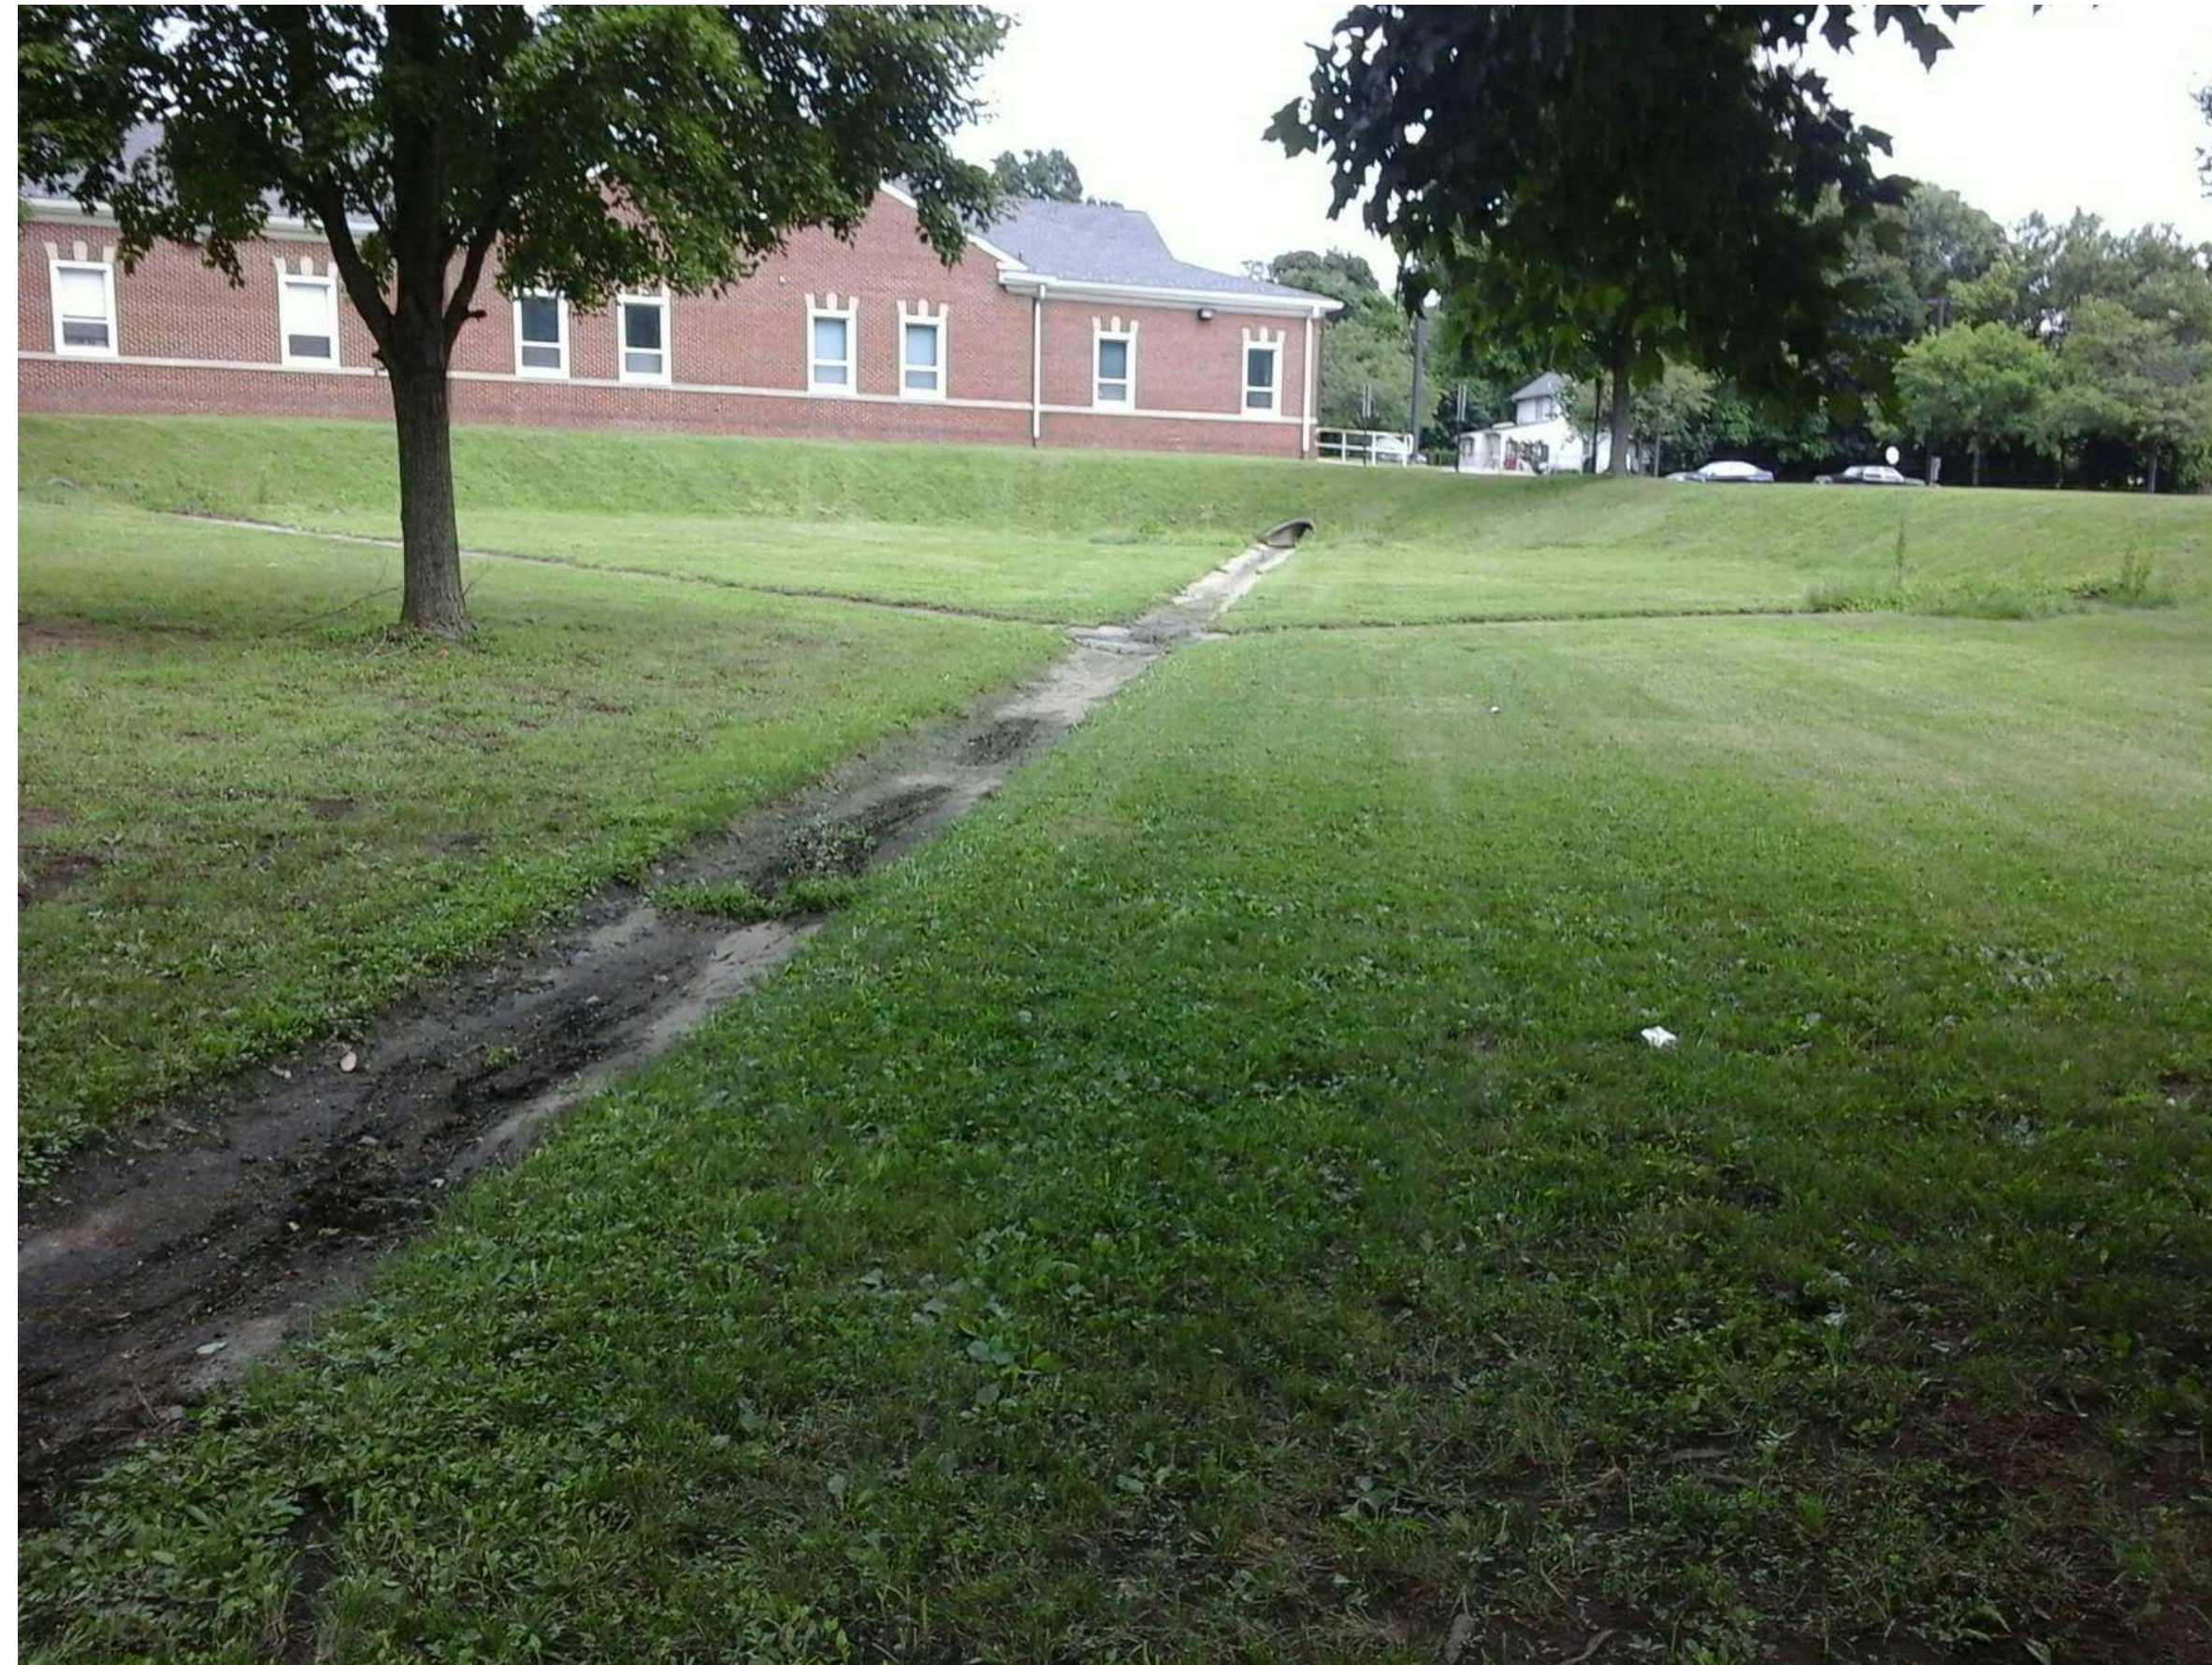
Overview of Basin

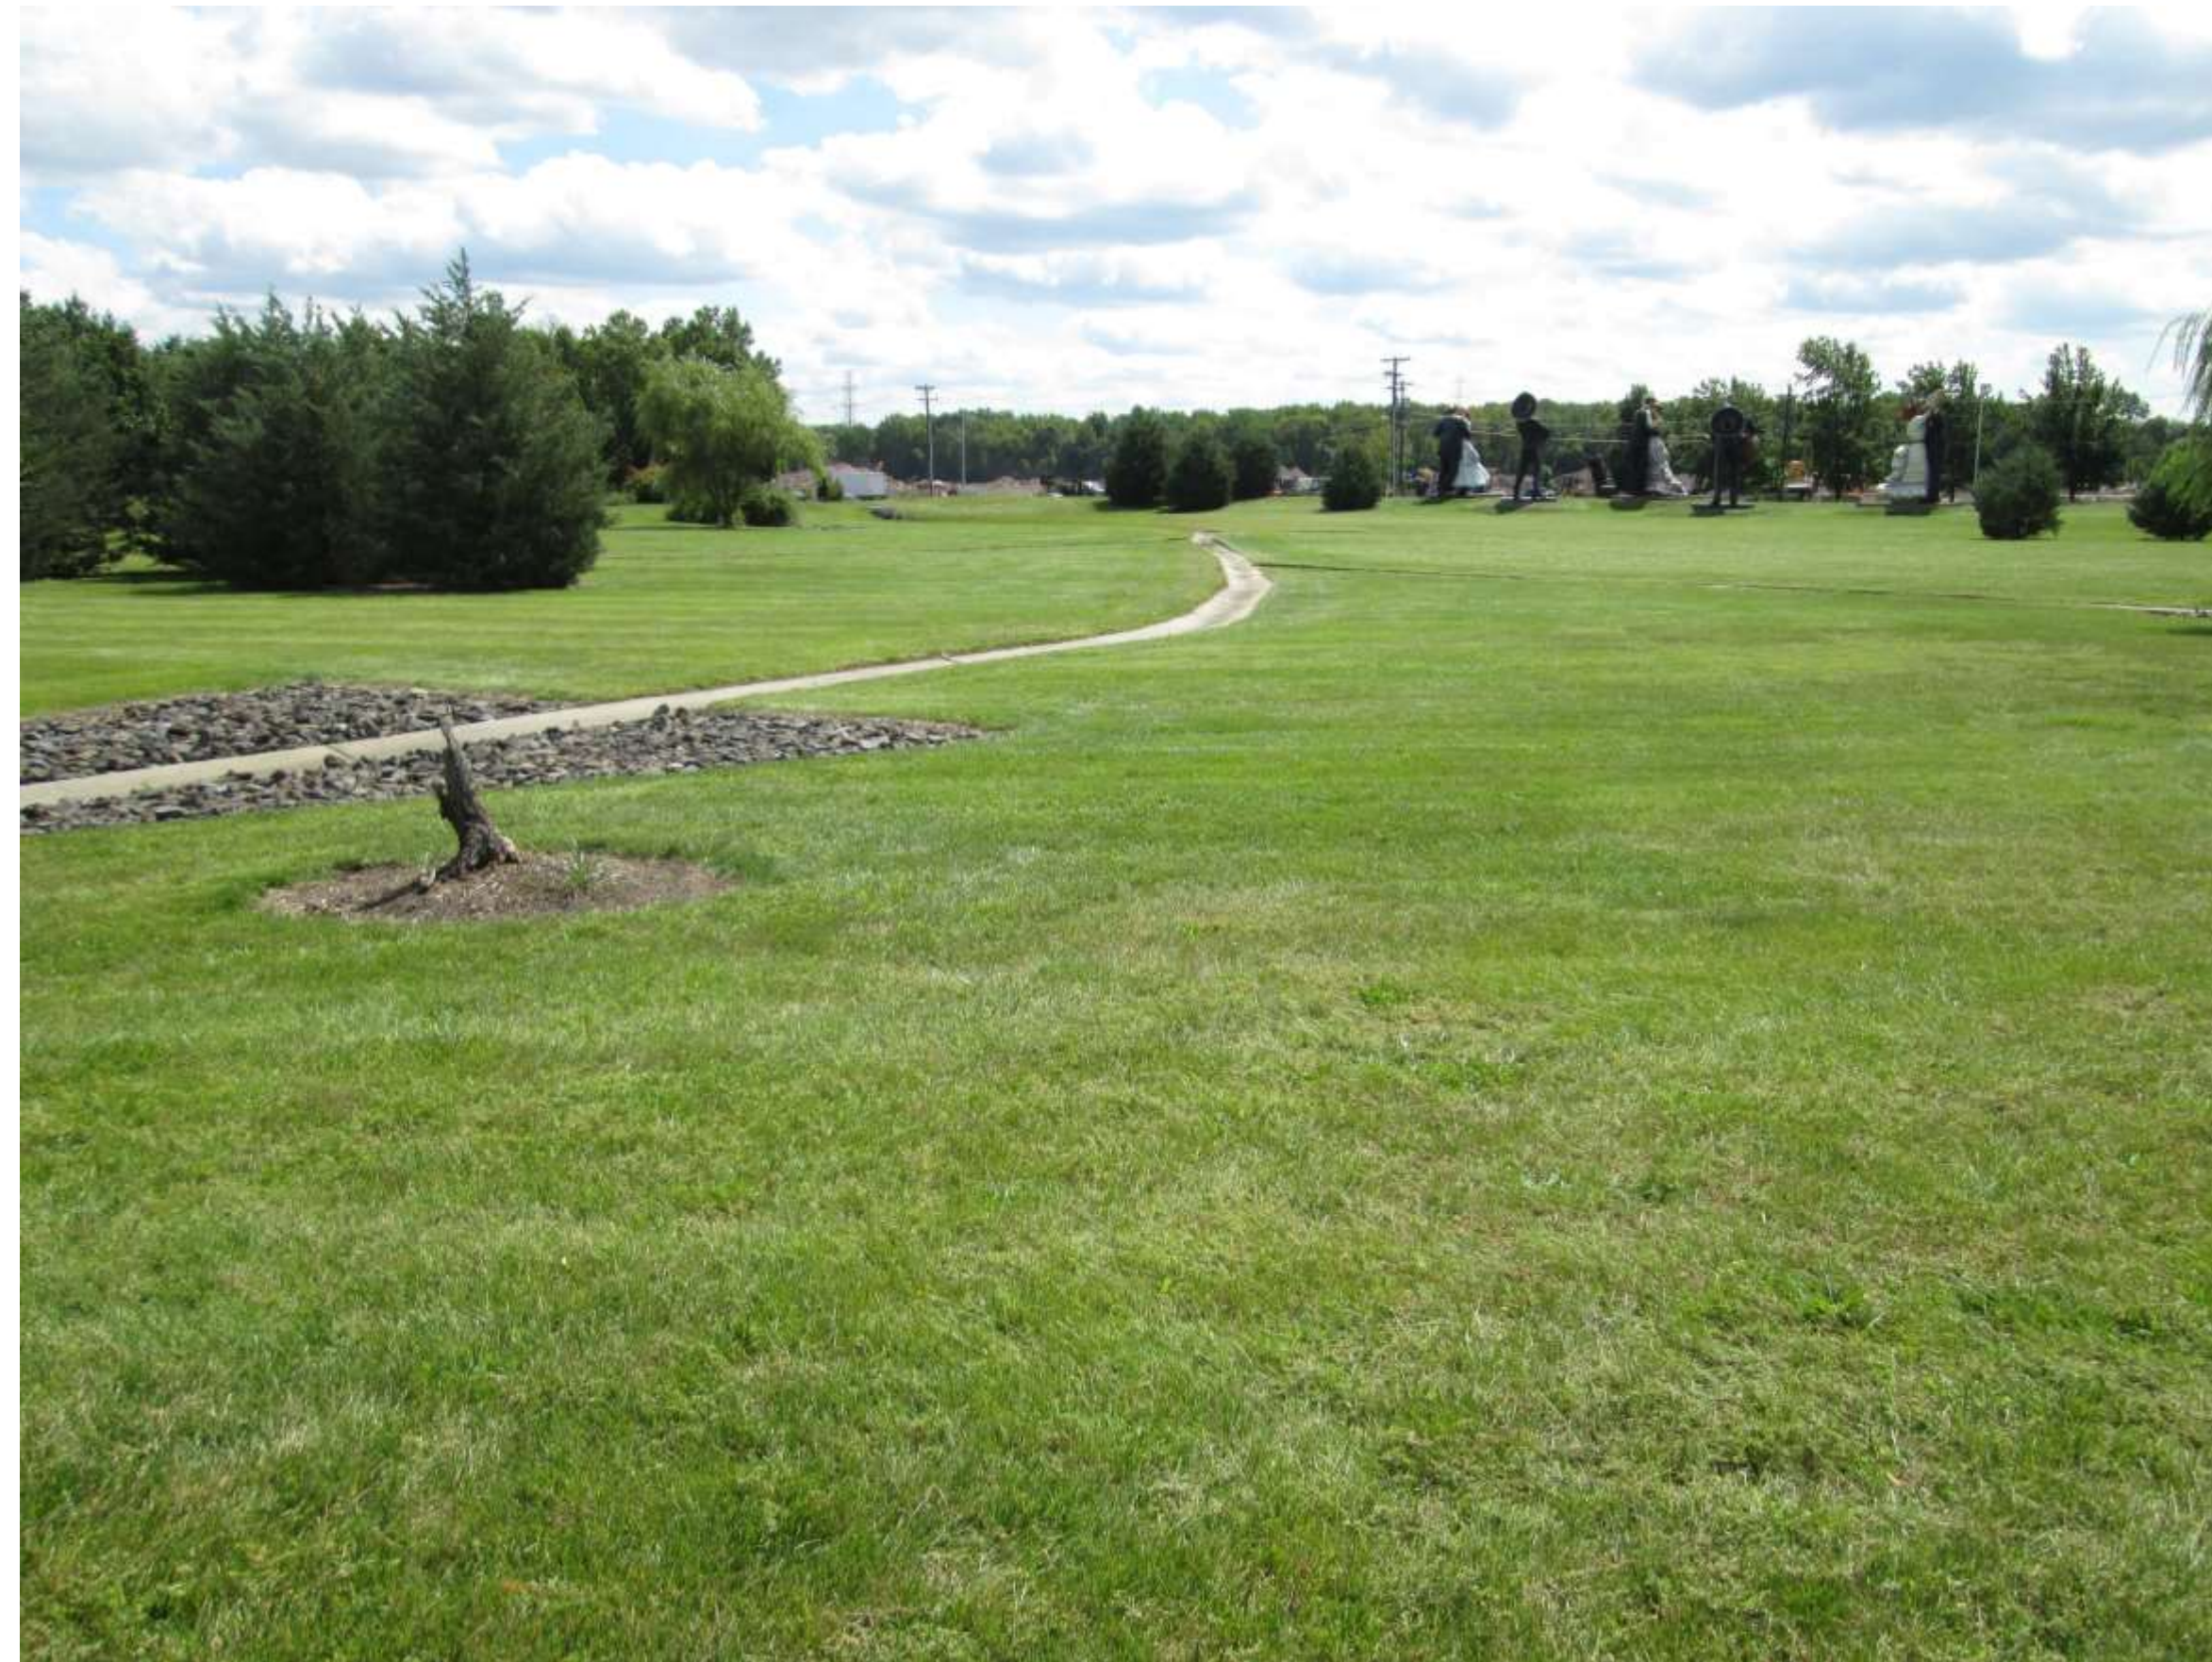
Overview of basin

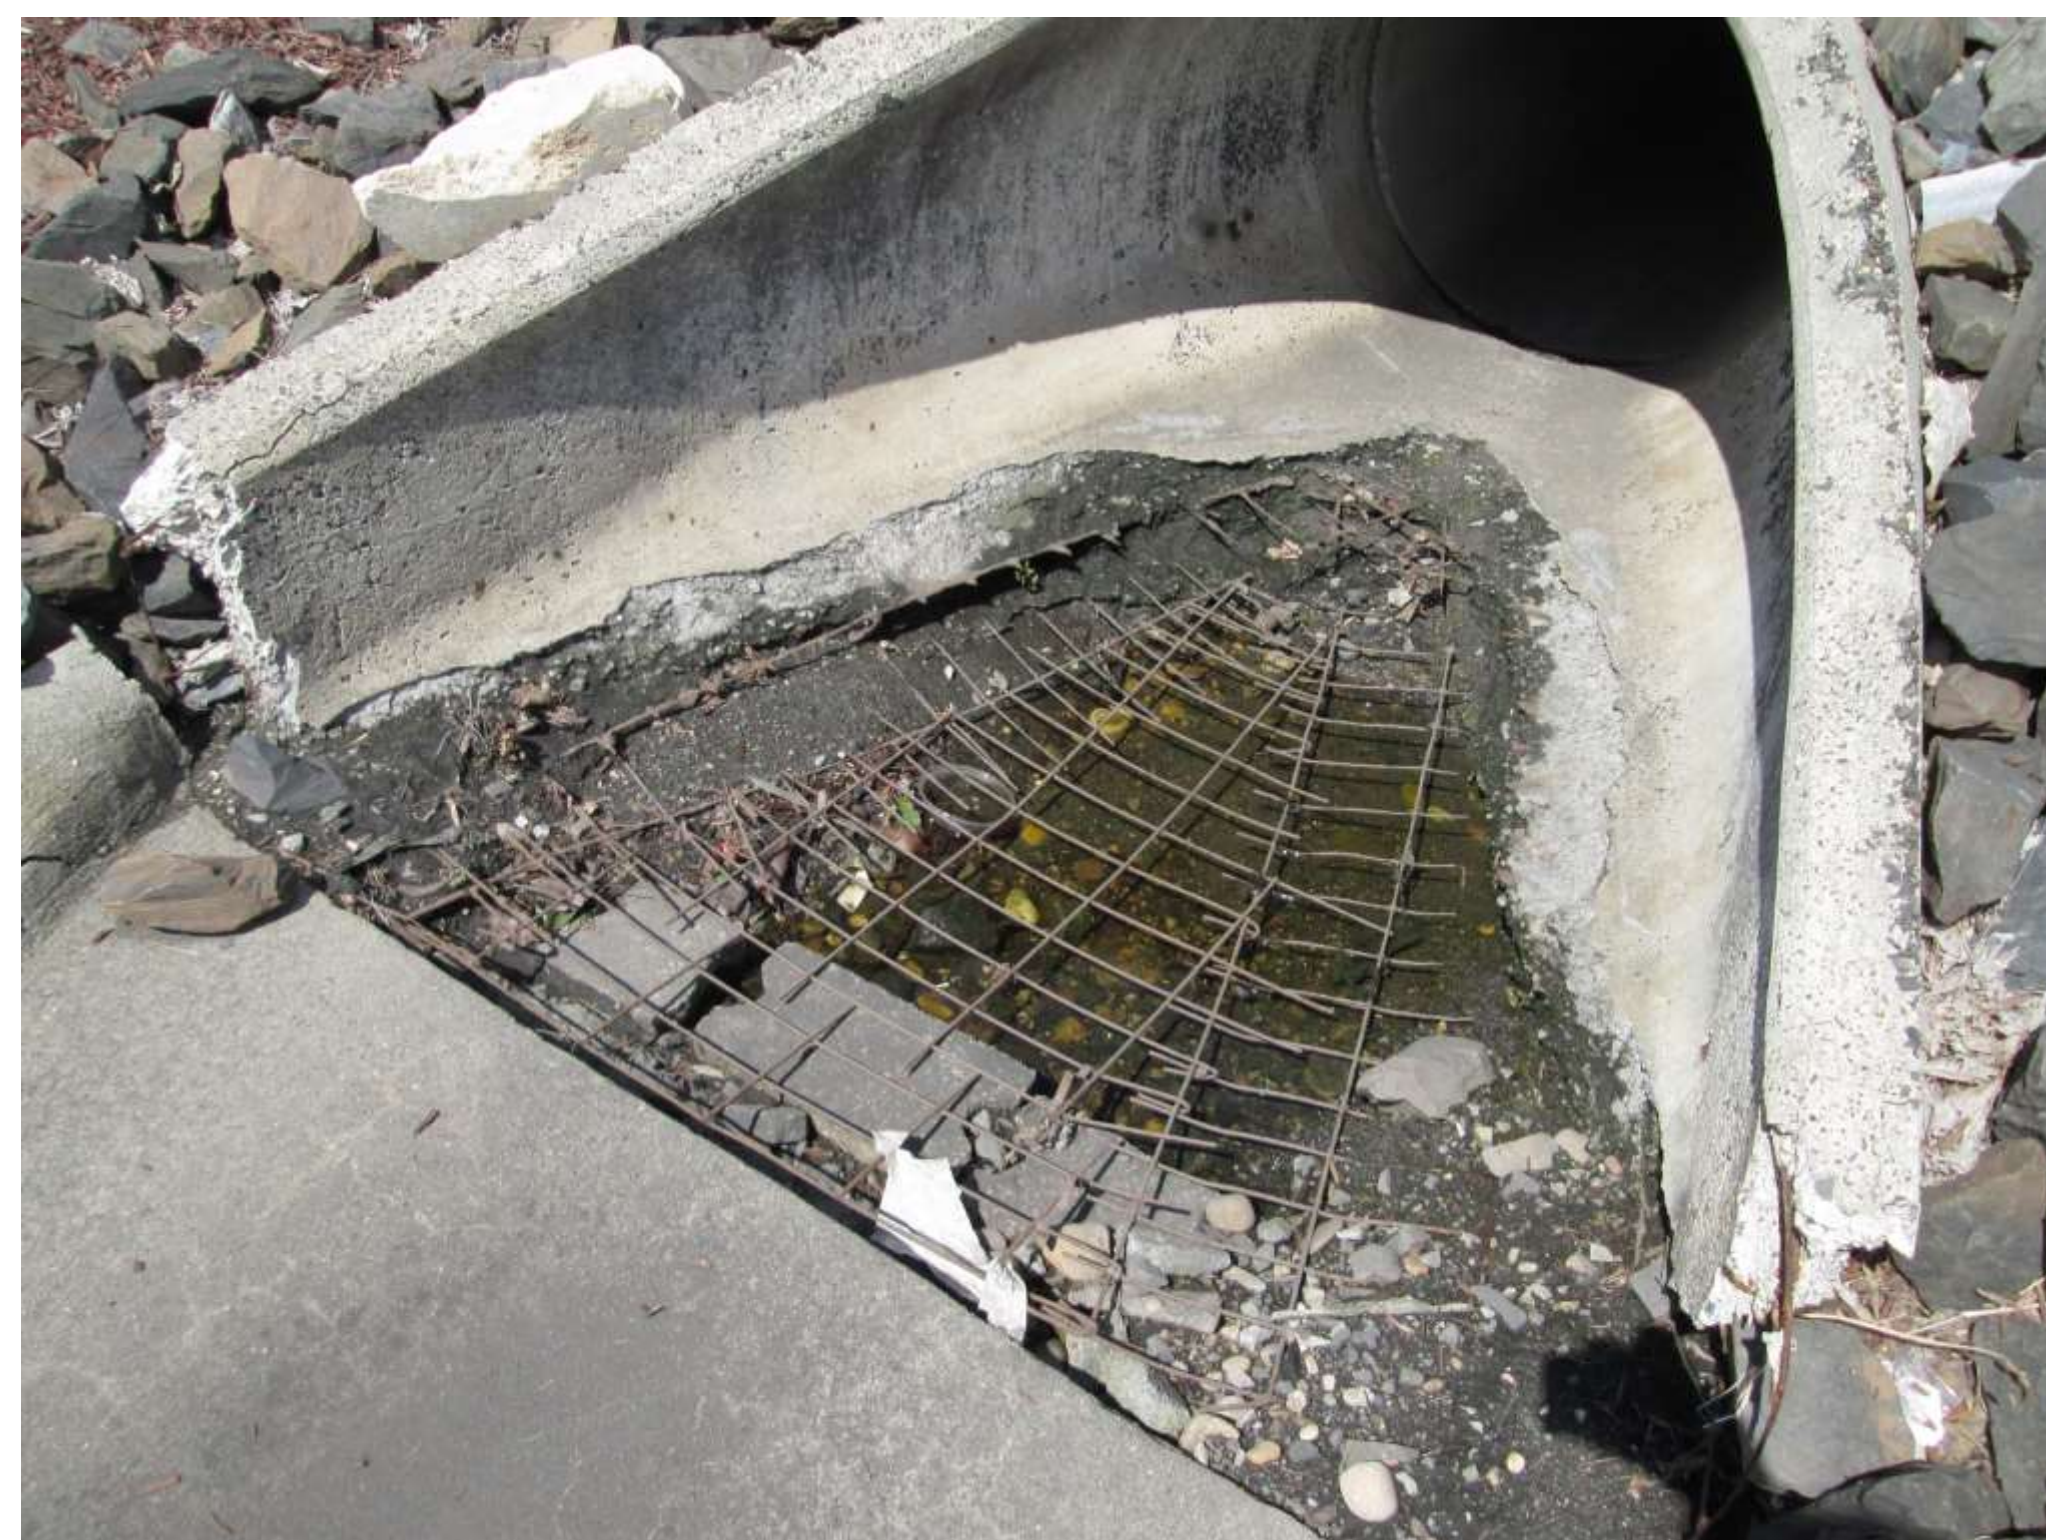
Erosion of inlet

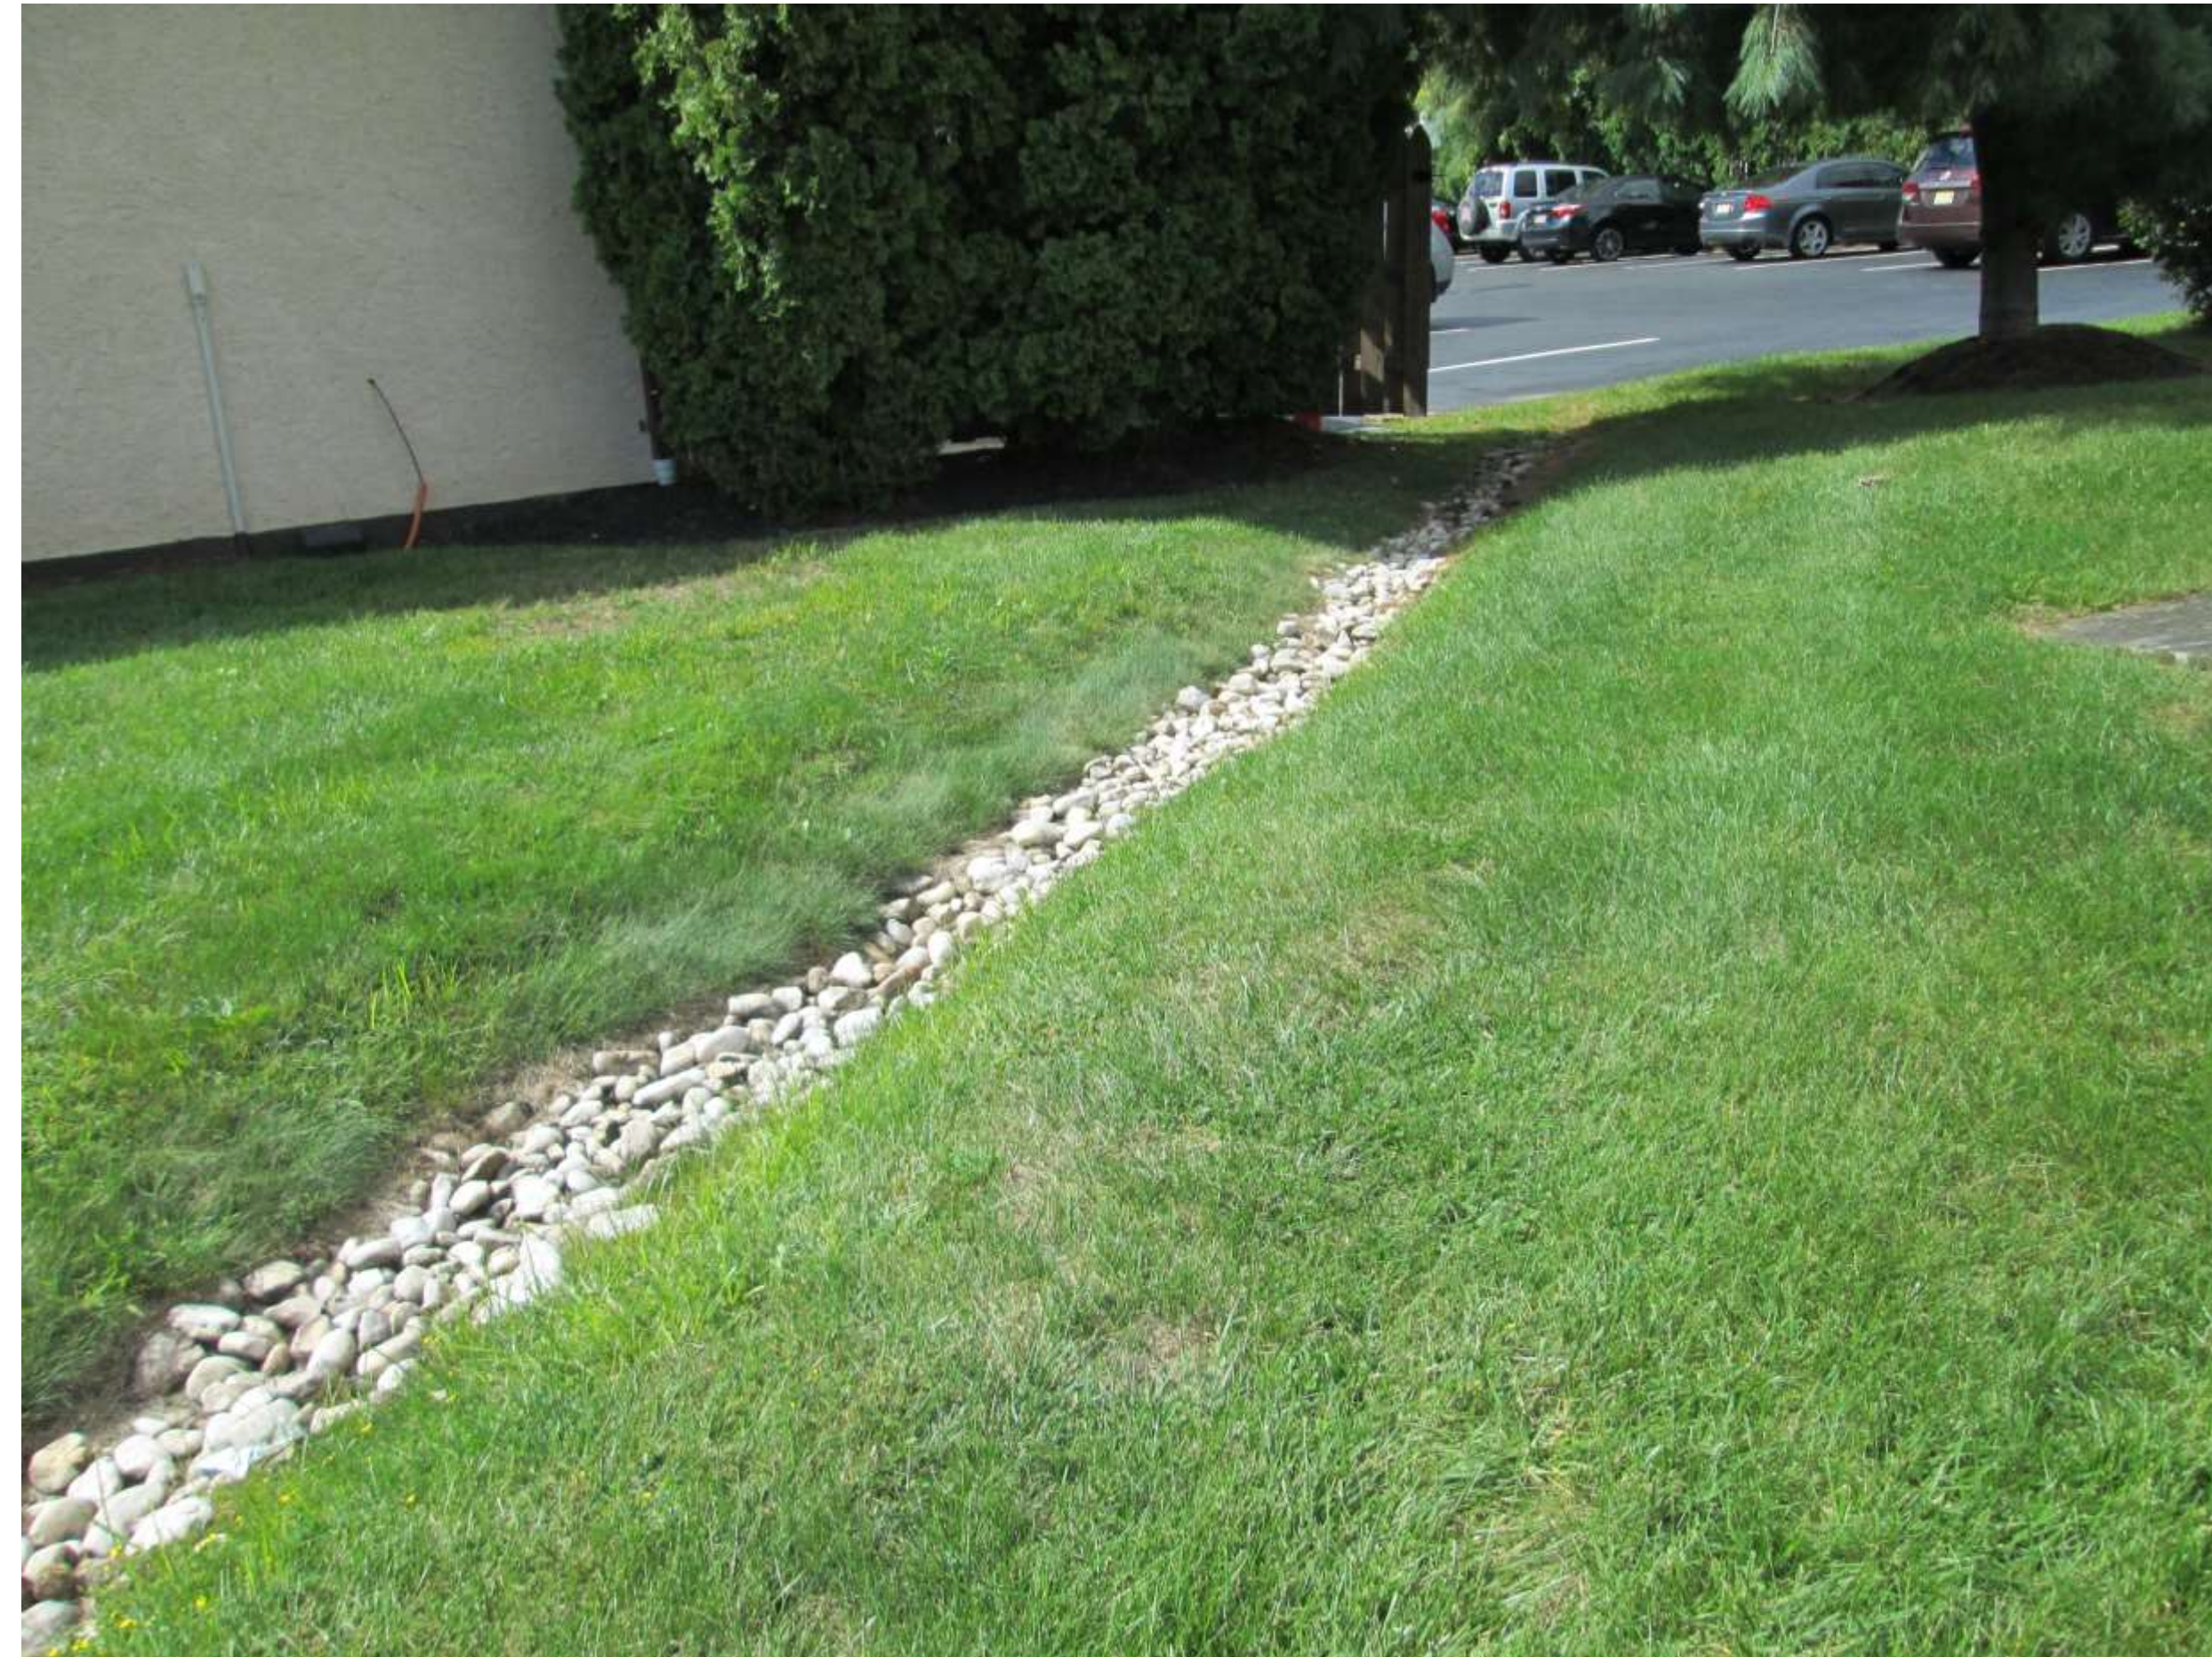
Stone lined infiltration channel

- Infiltration channel for Physical Therapy Services building
- Channel has minimal amounts of sediment
- Overall well maintained

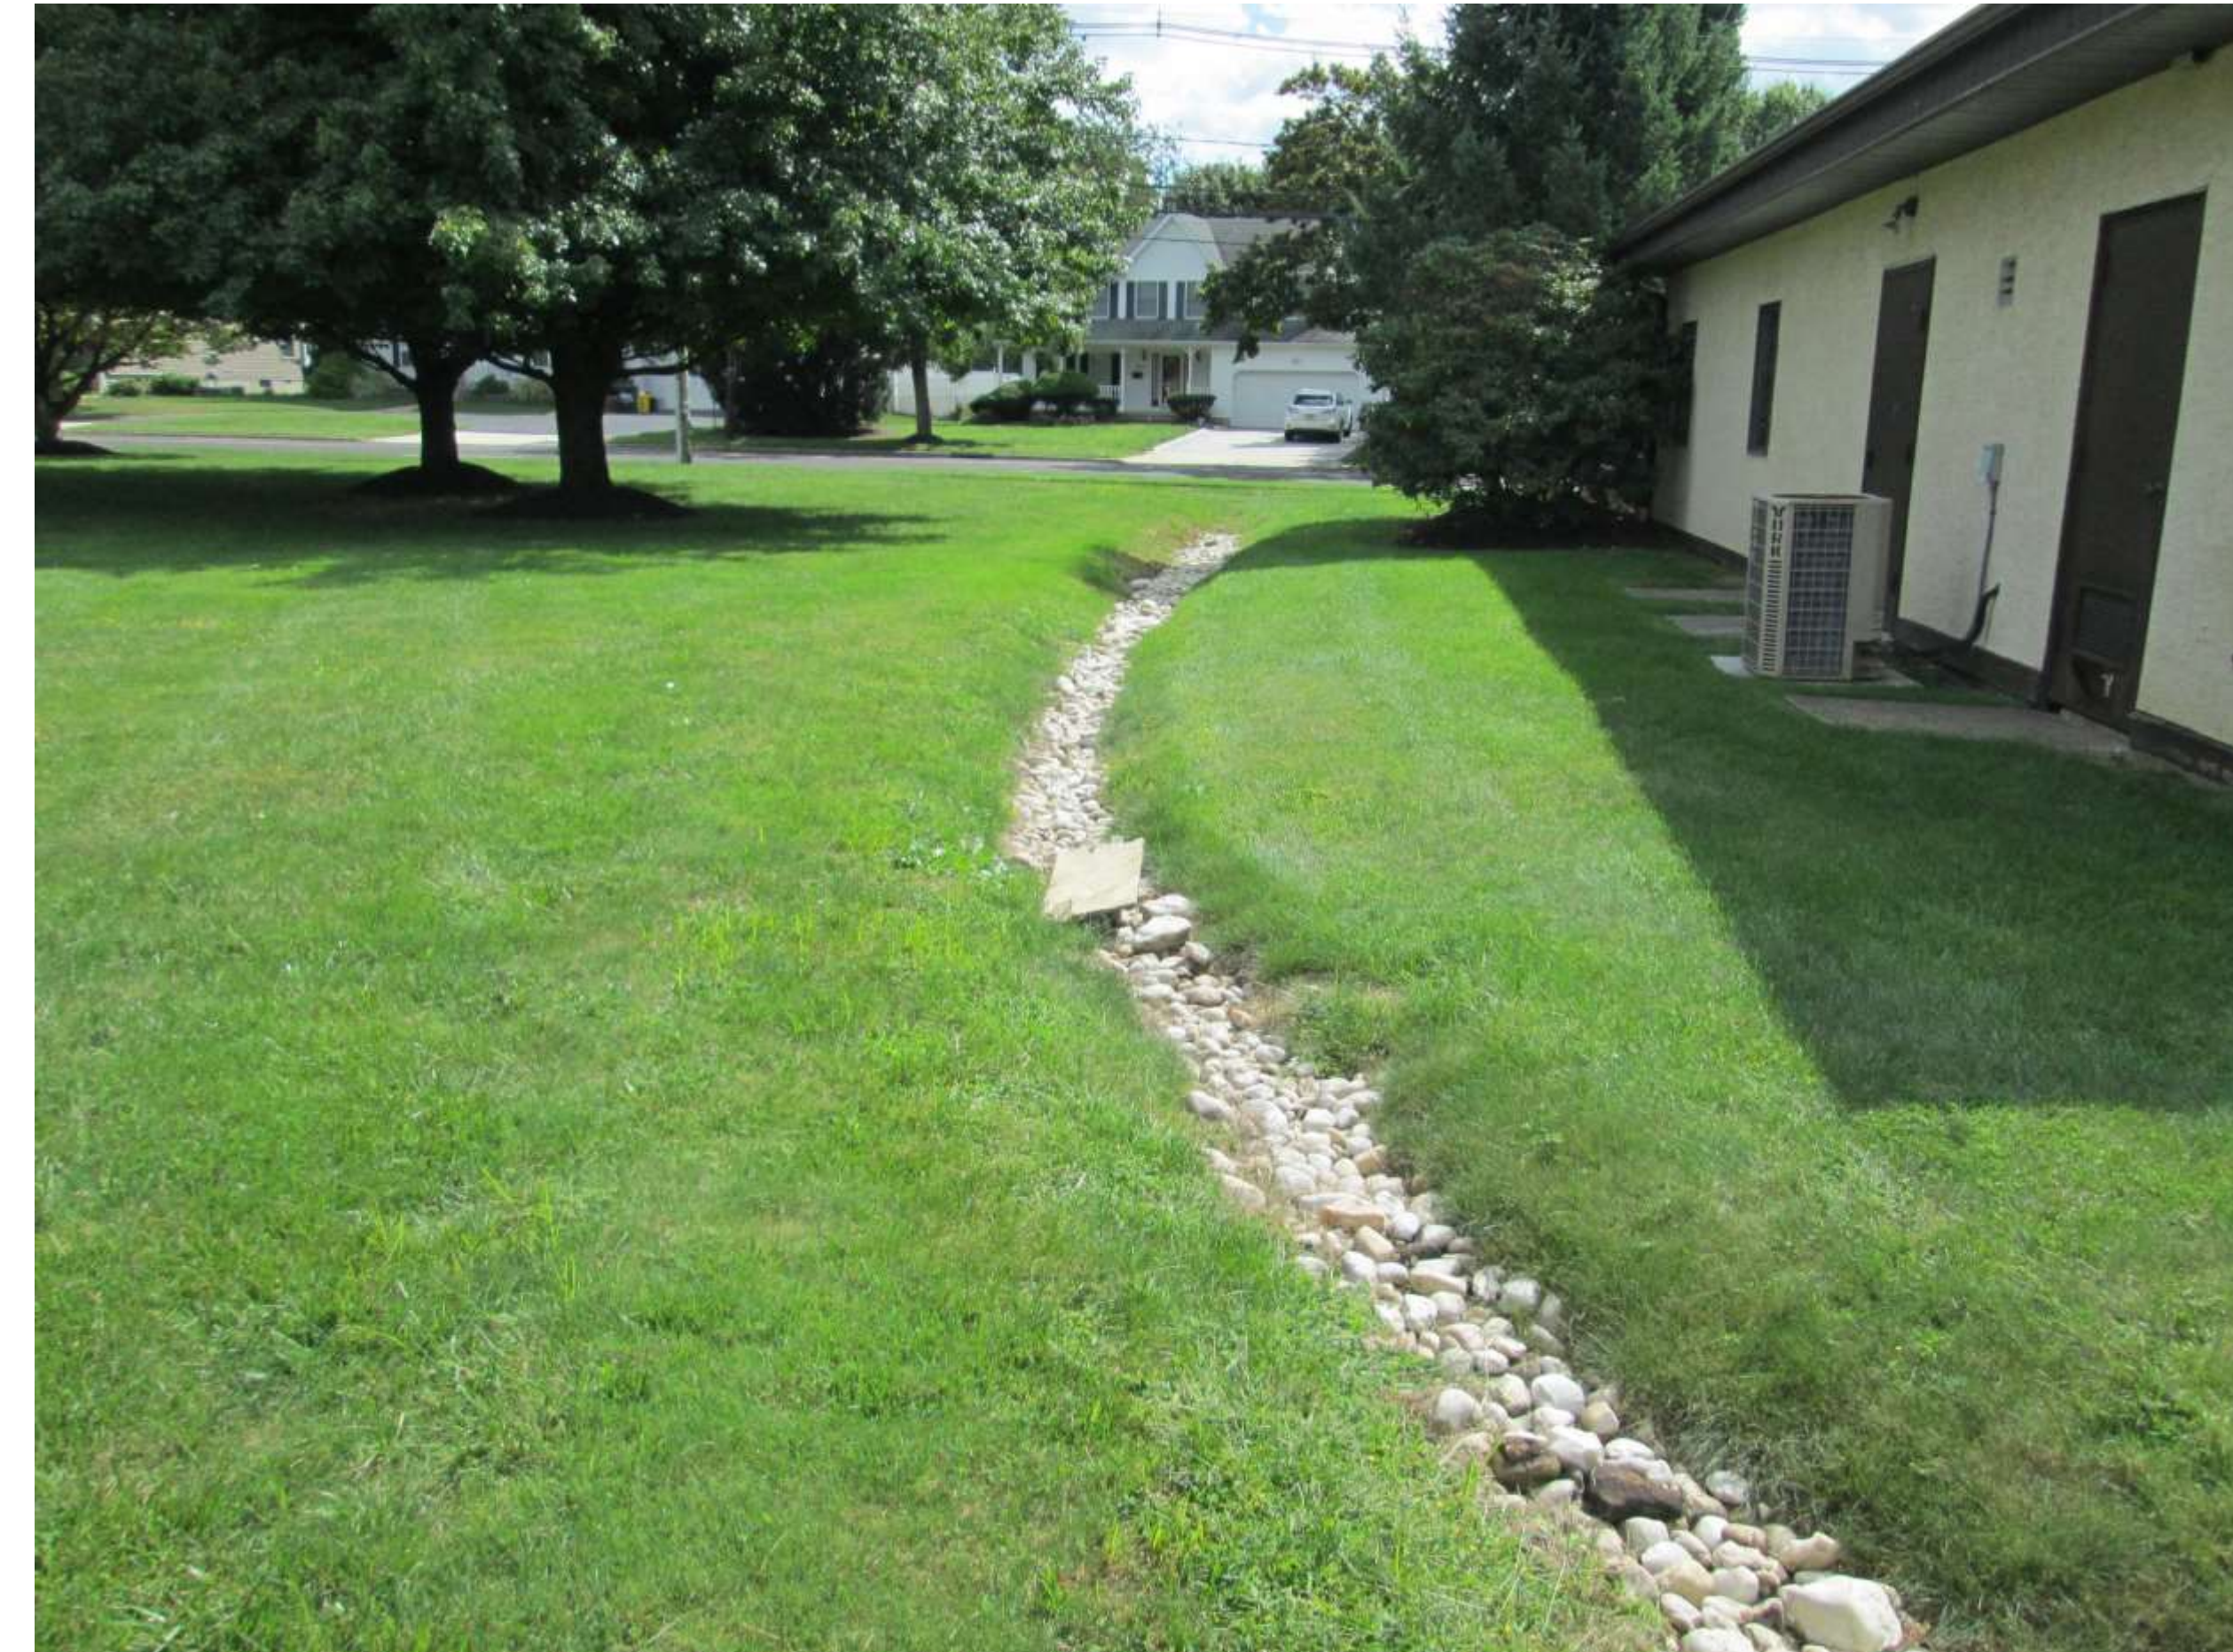
Overview of channel
