**Hamilton Township (Mercer County)
Stormwater Basin Assessment Summary
Addendum (Year 4)**

Developed by the Rutgers Cooperative Extension Water Resources Program
Funded by Hamilton Township, Mercer County, New Jersey

December 2017

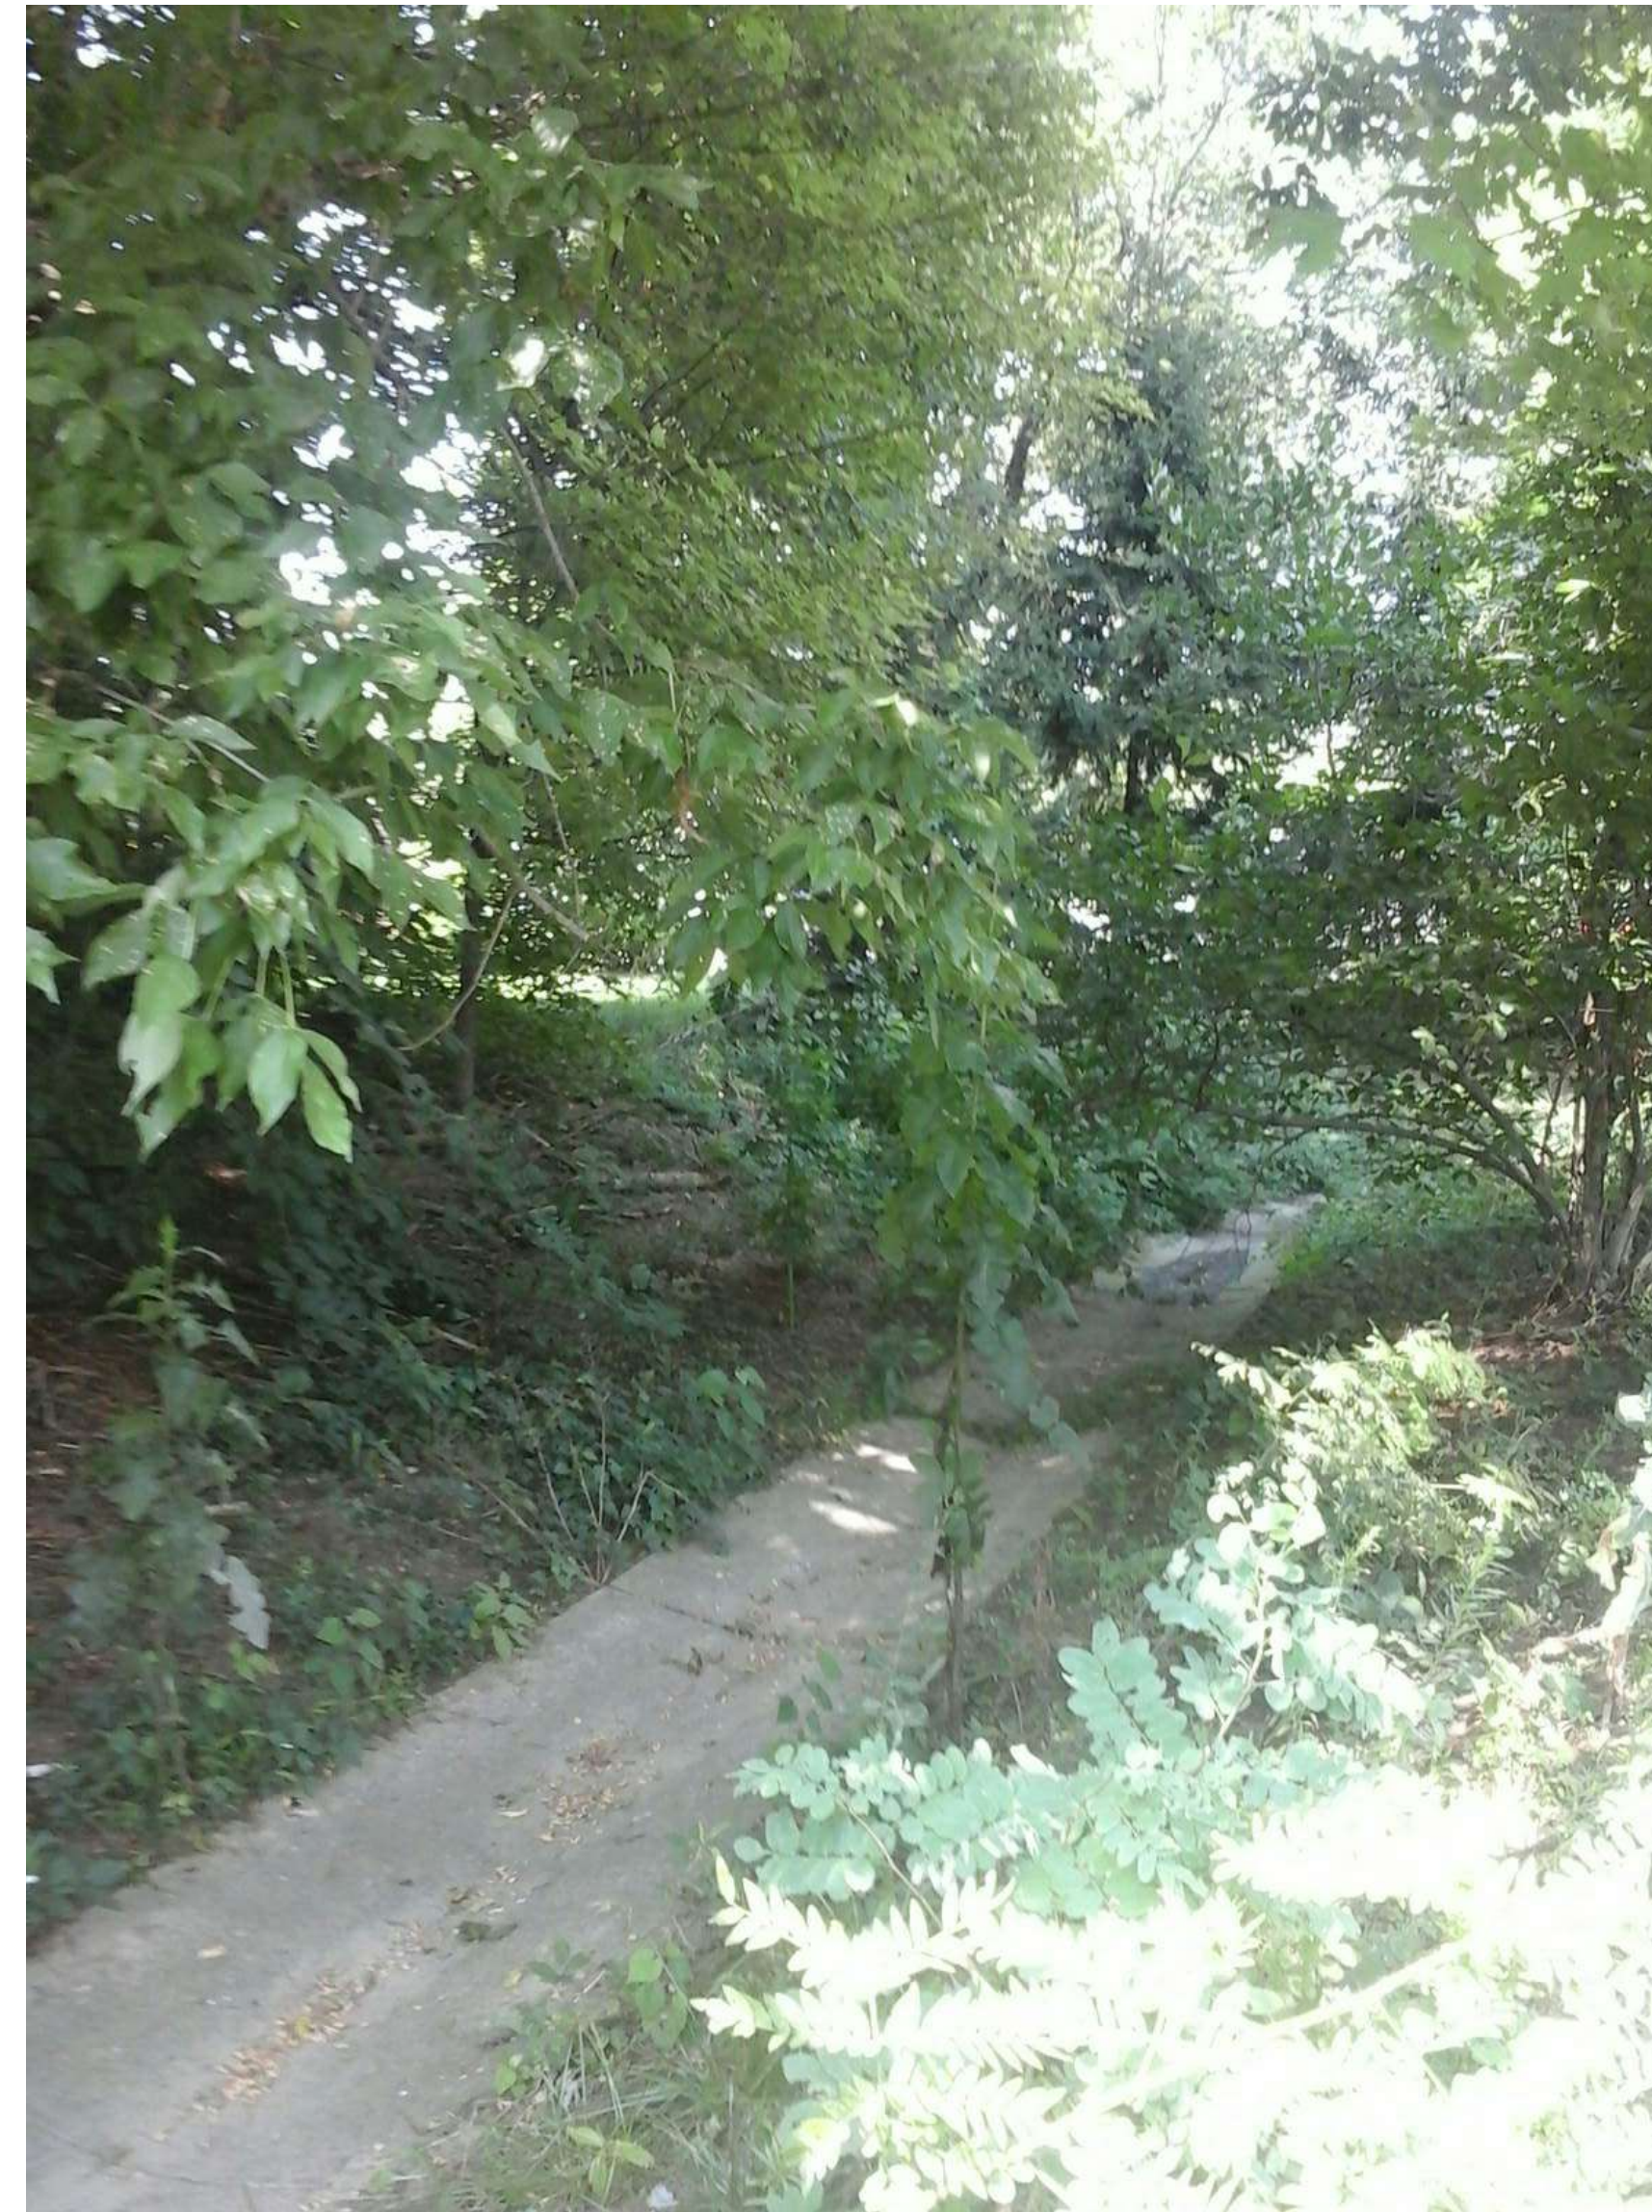
Sediment in low flow channel

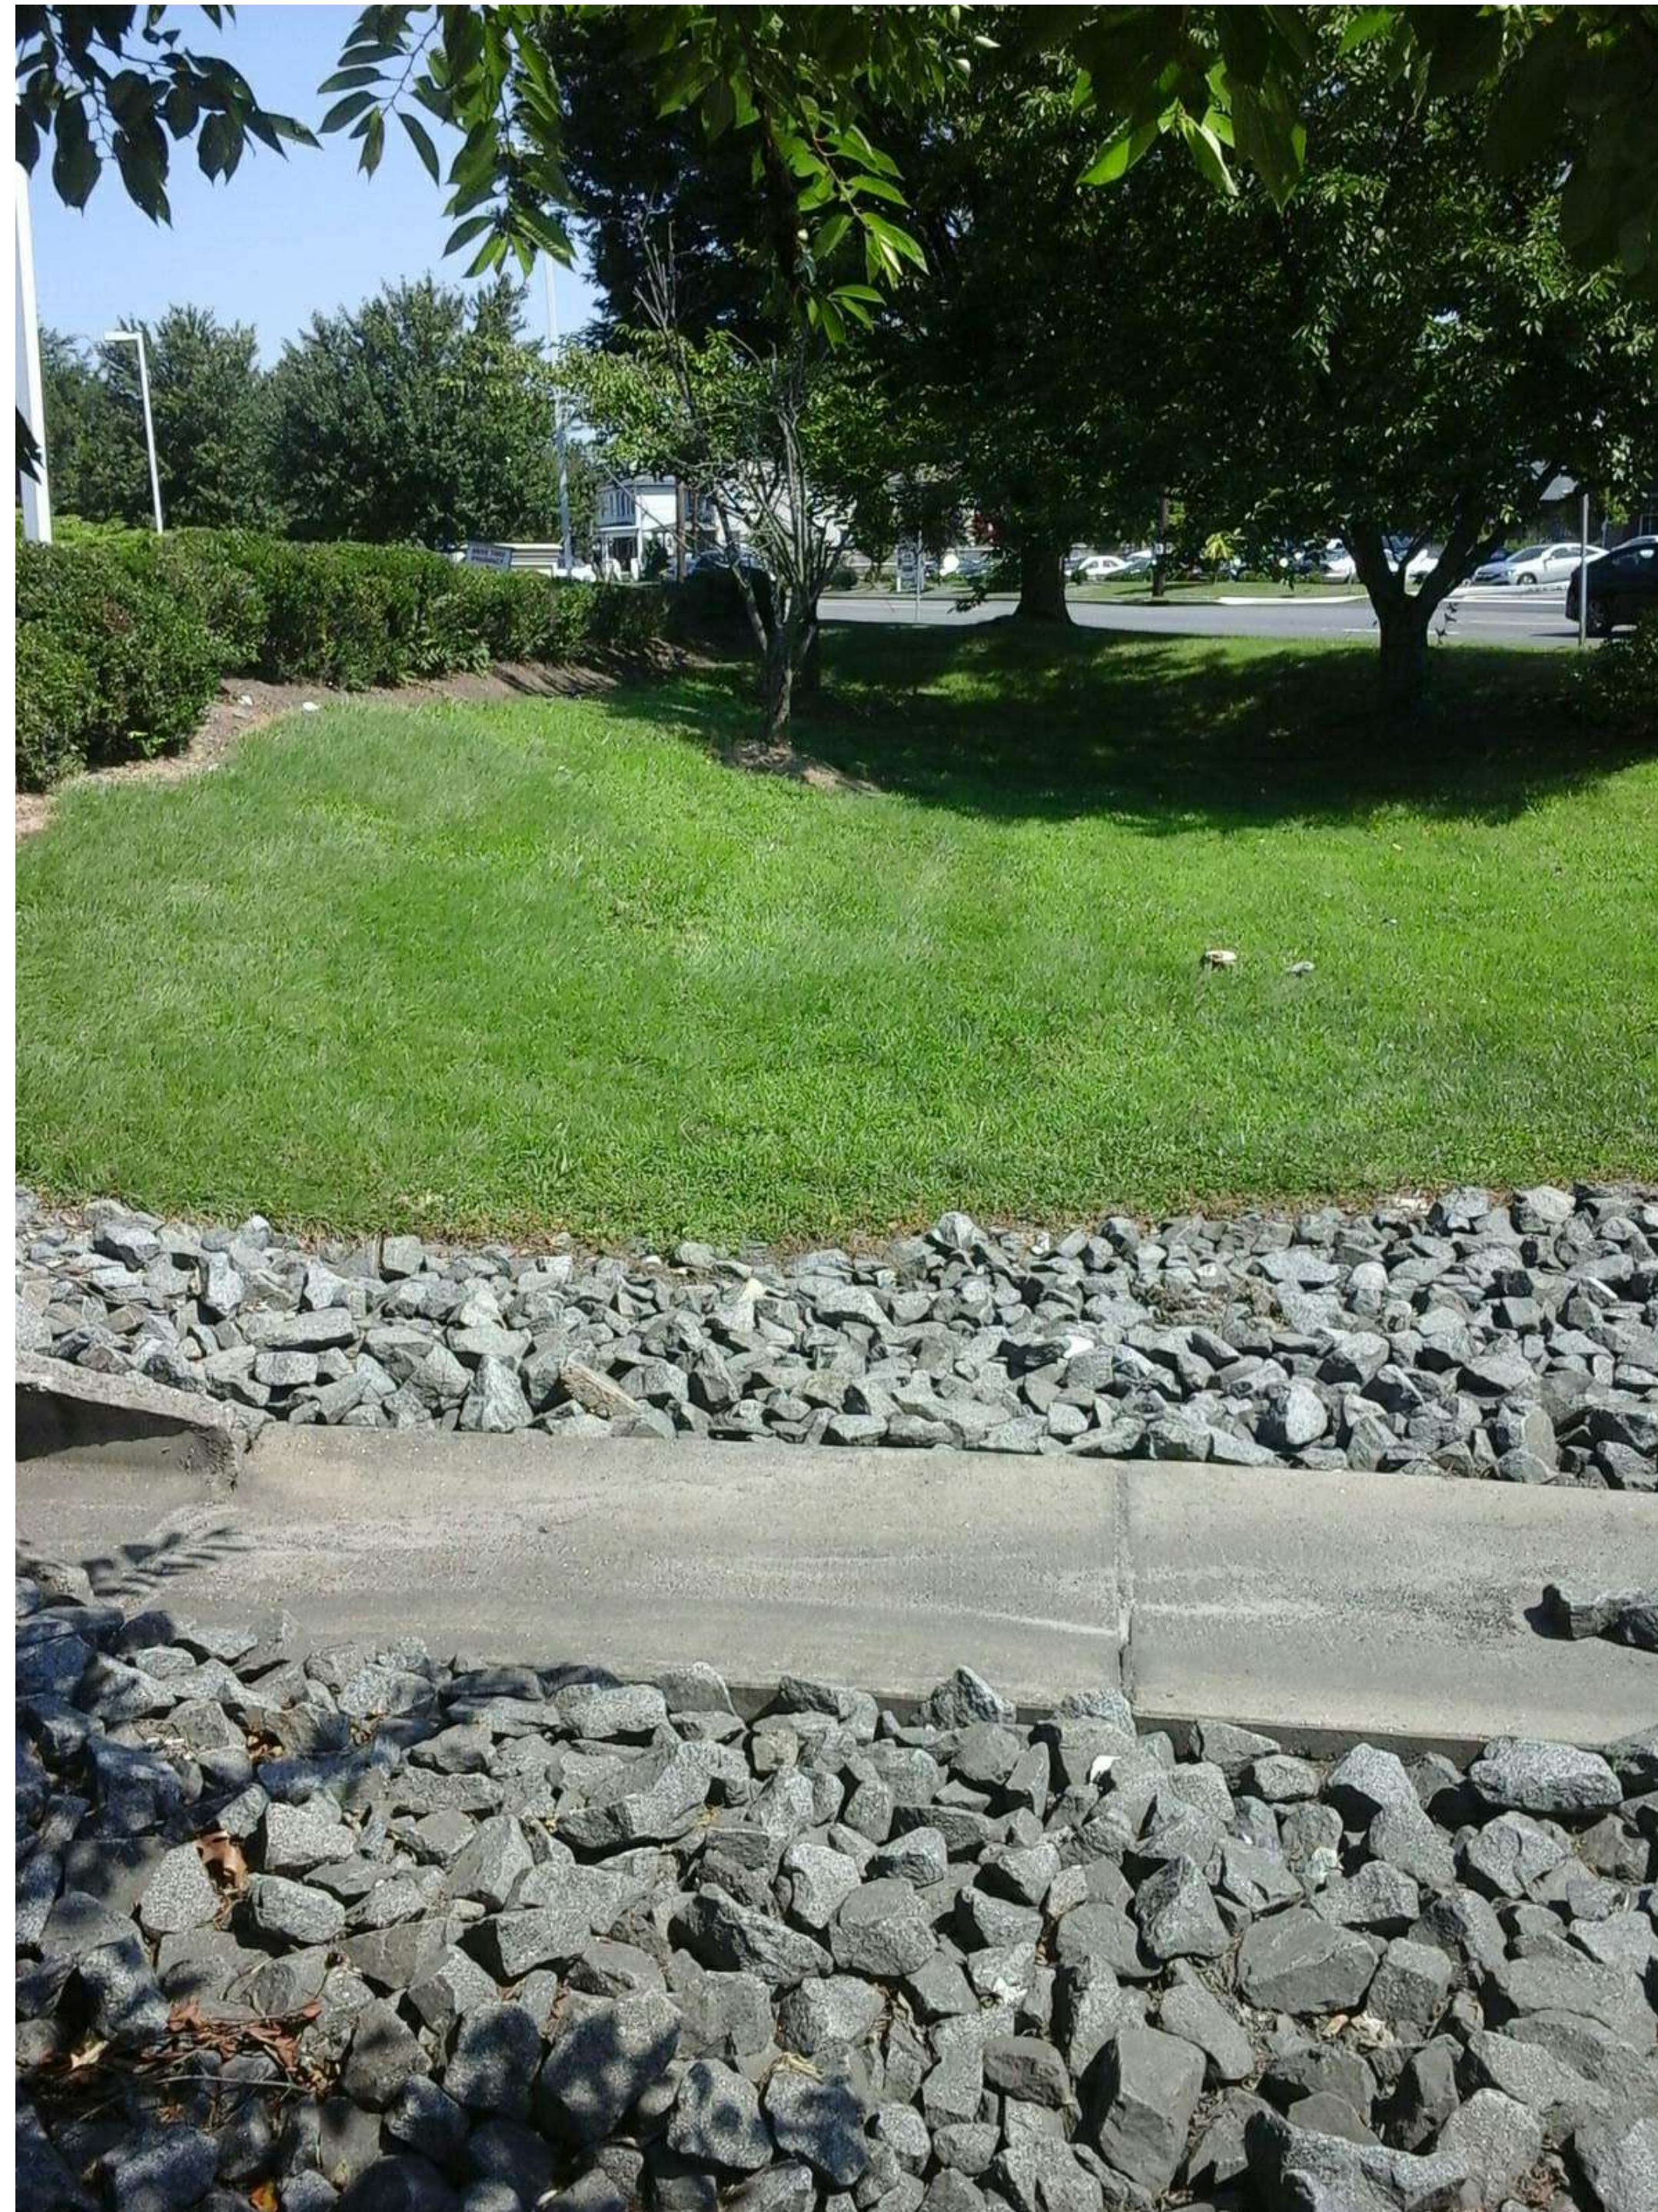
Inlet and low flow channel

- Minimal amounts of sediment near inlet and outlet structures
- Overall in good condition

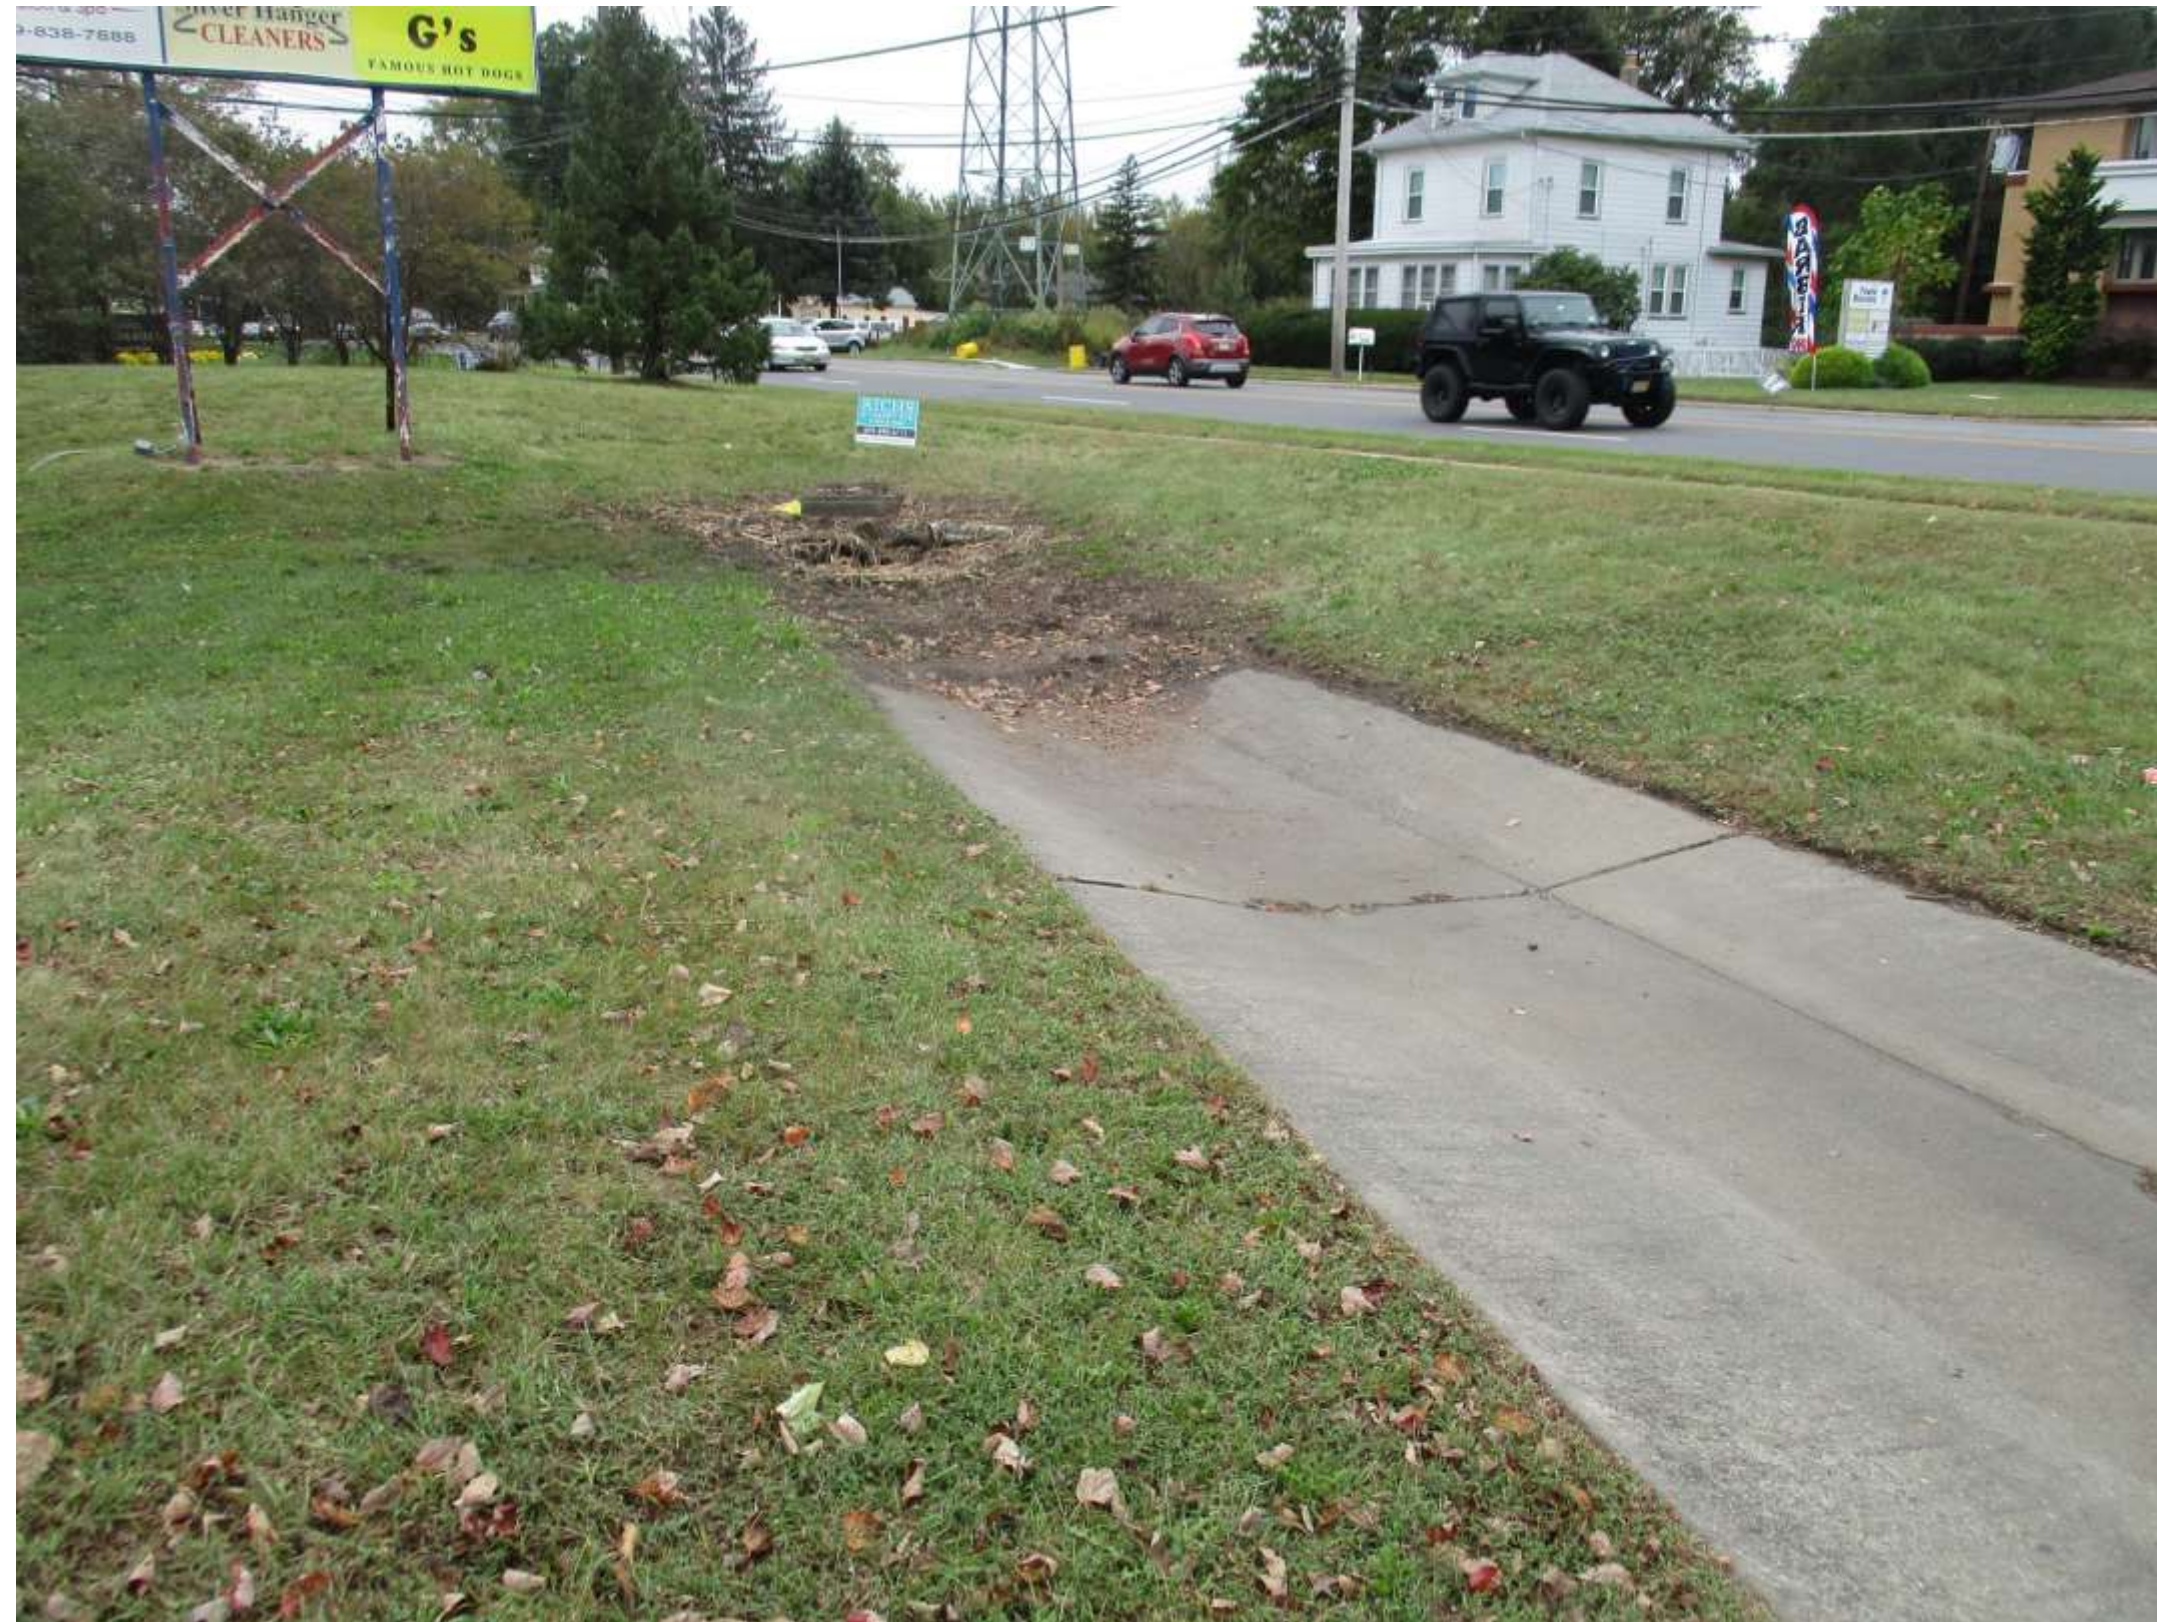
Sediment in low flow channel

- Inlet channel brings water directly from parking lot
- Excess sediment in low flow channel is restricting water flow
- Create stone lined channel to improve infiltration and reduce sediment accumulation at outlet

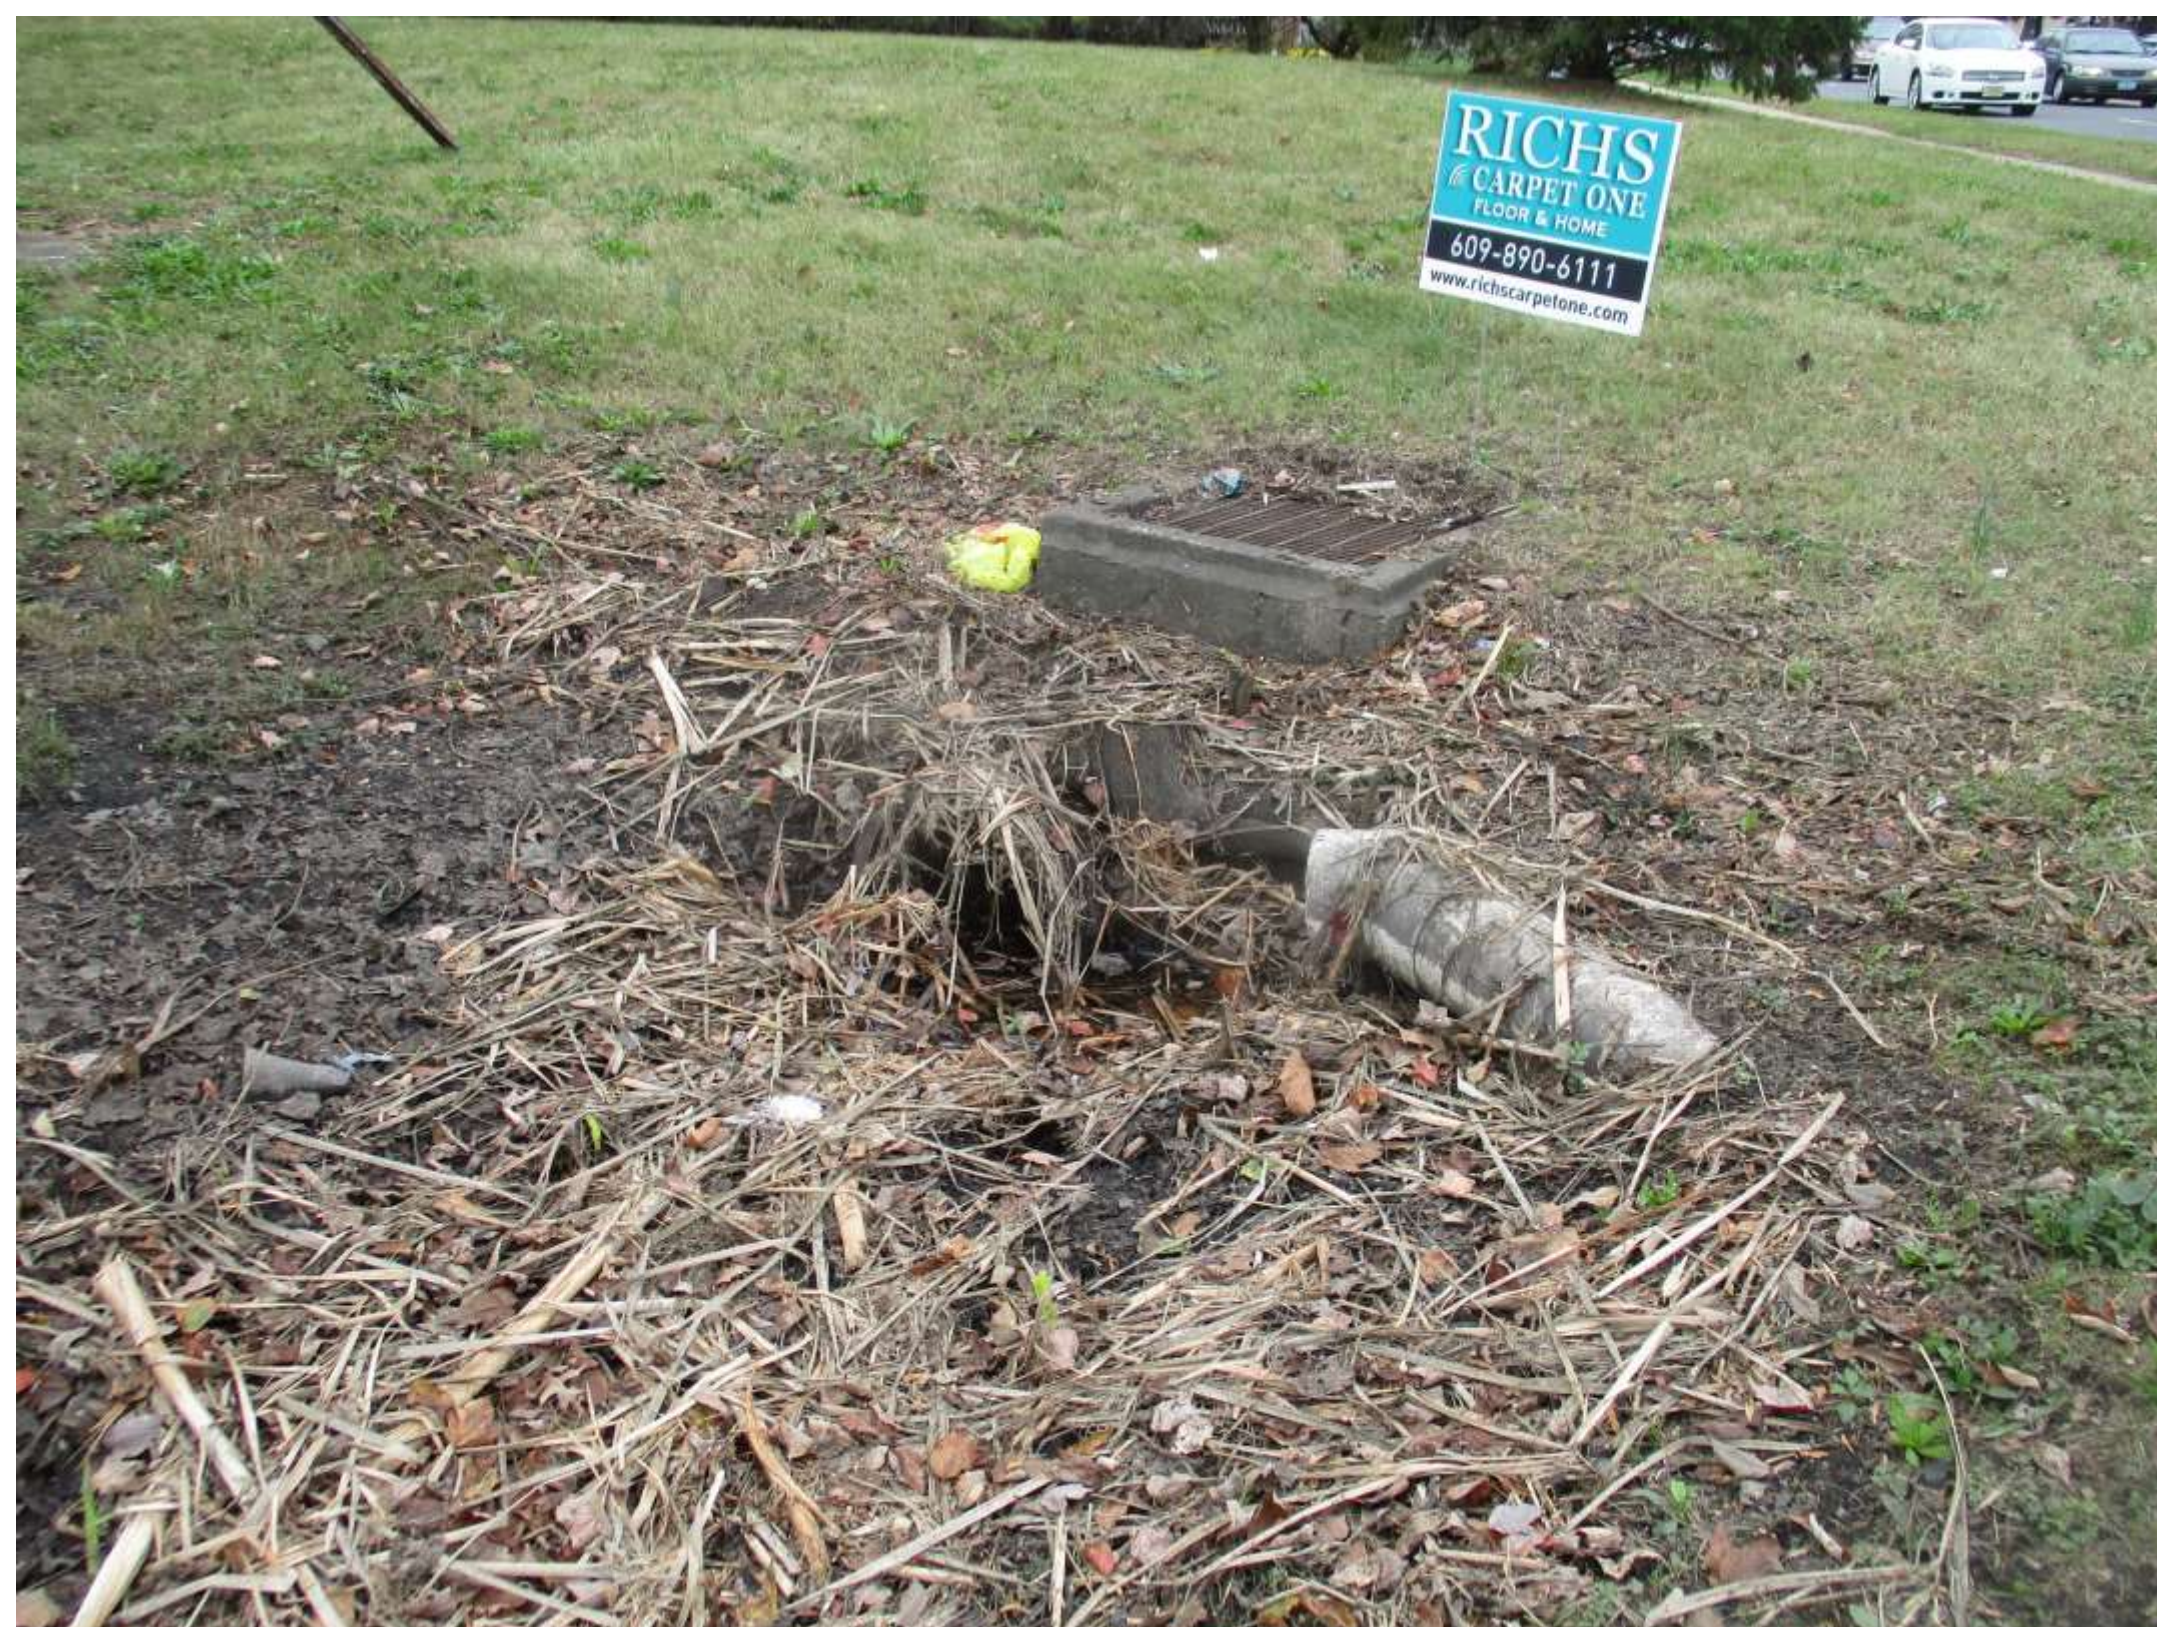
Sediment in outlet

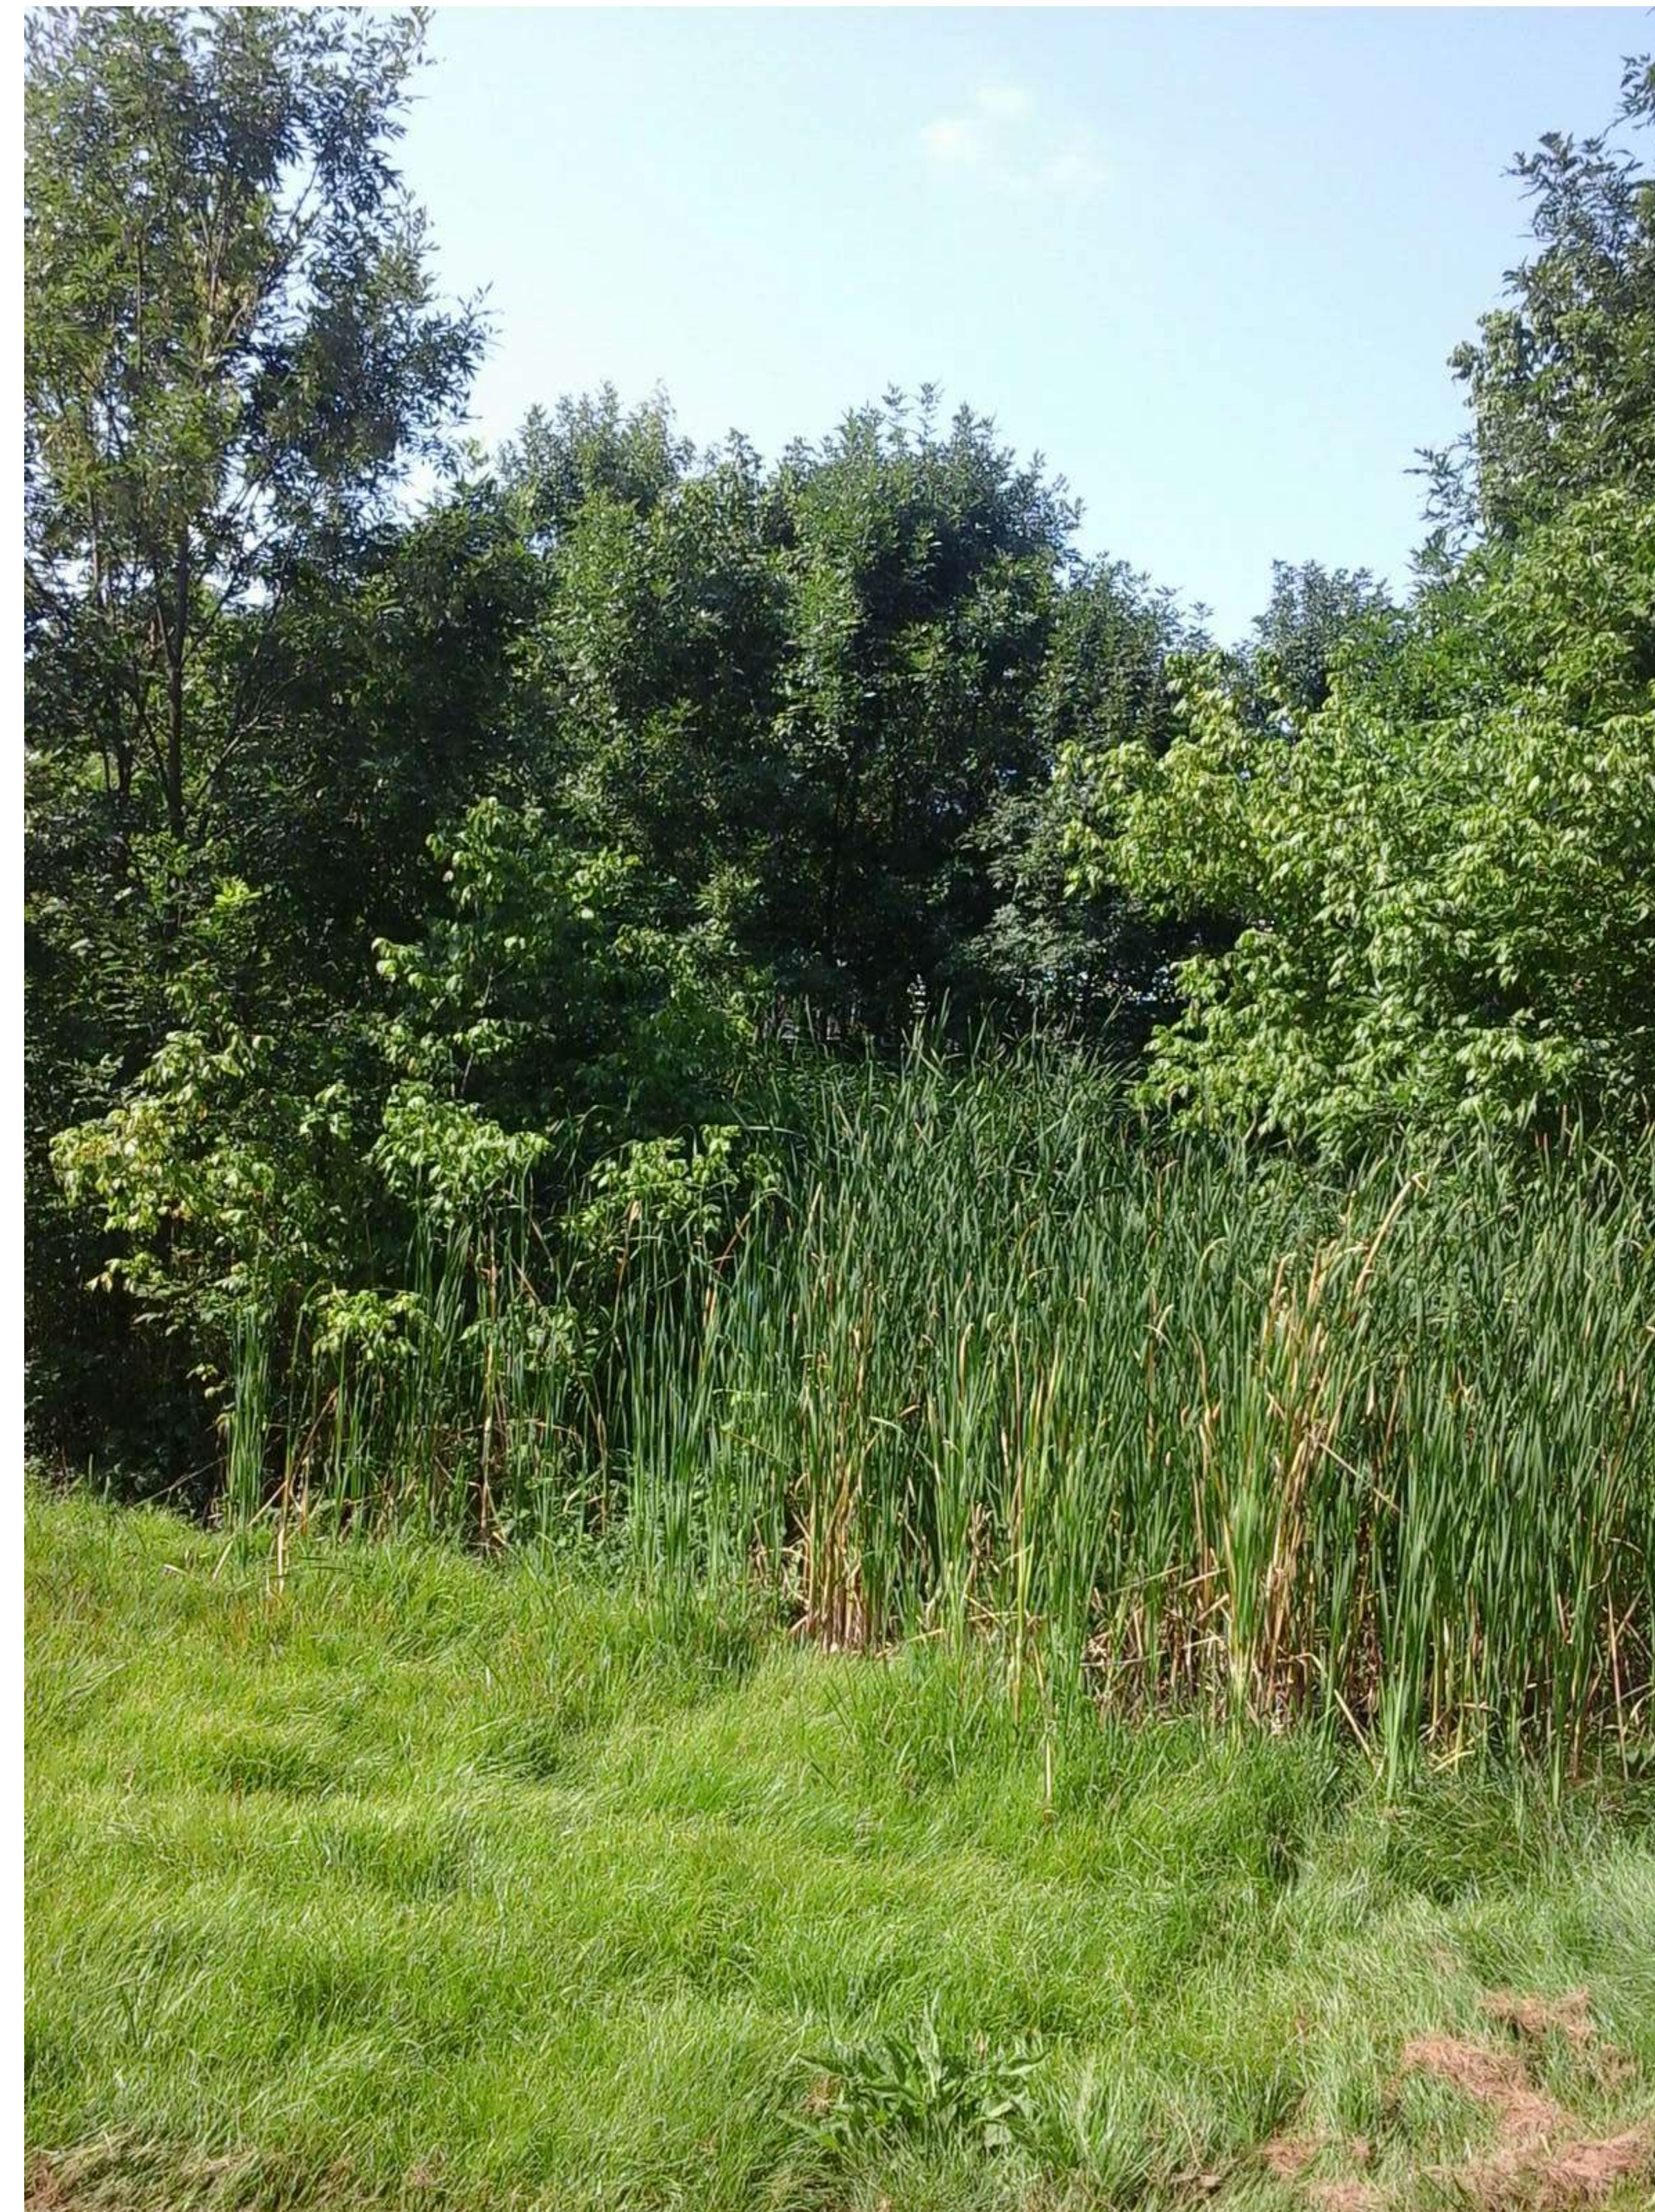
Standing water in basin bottom

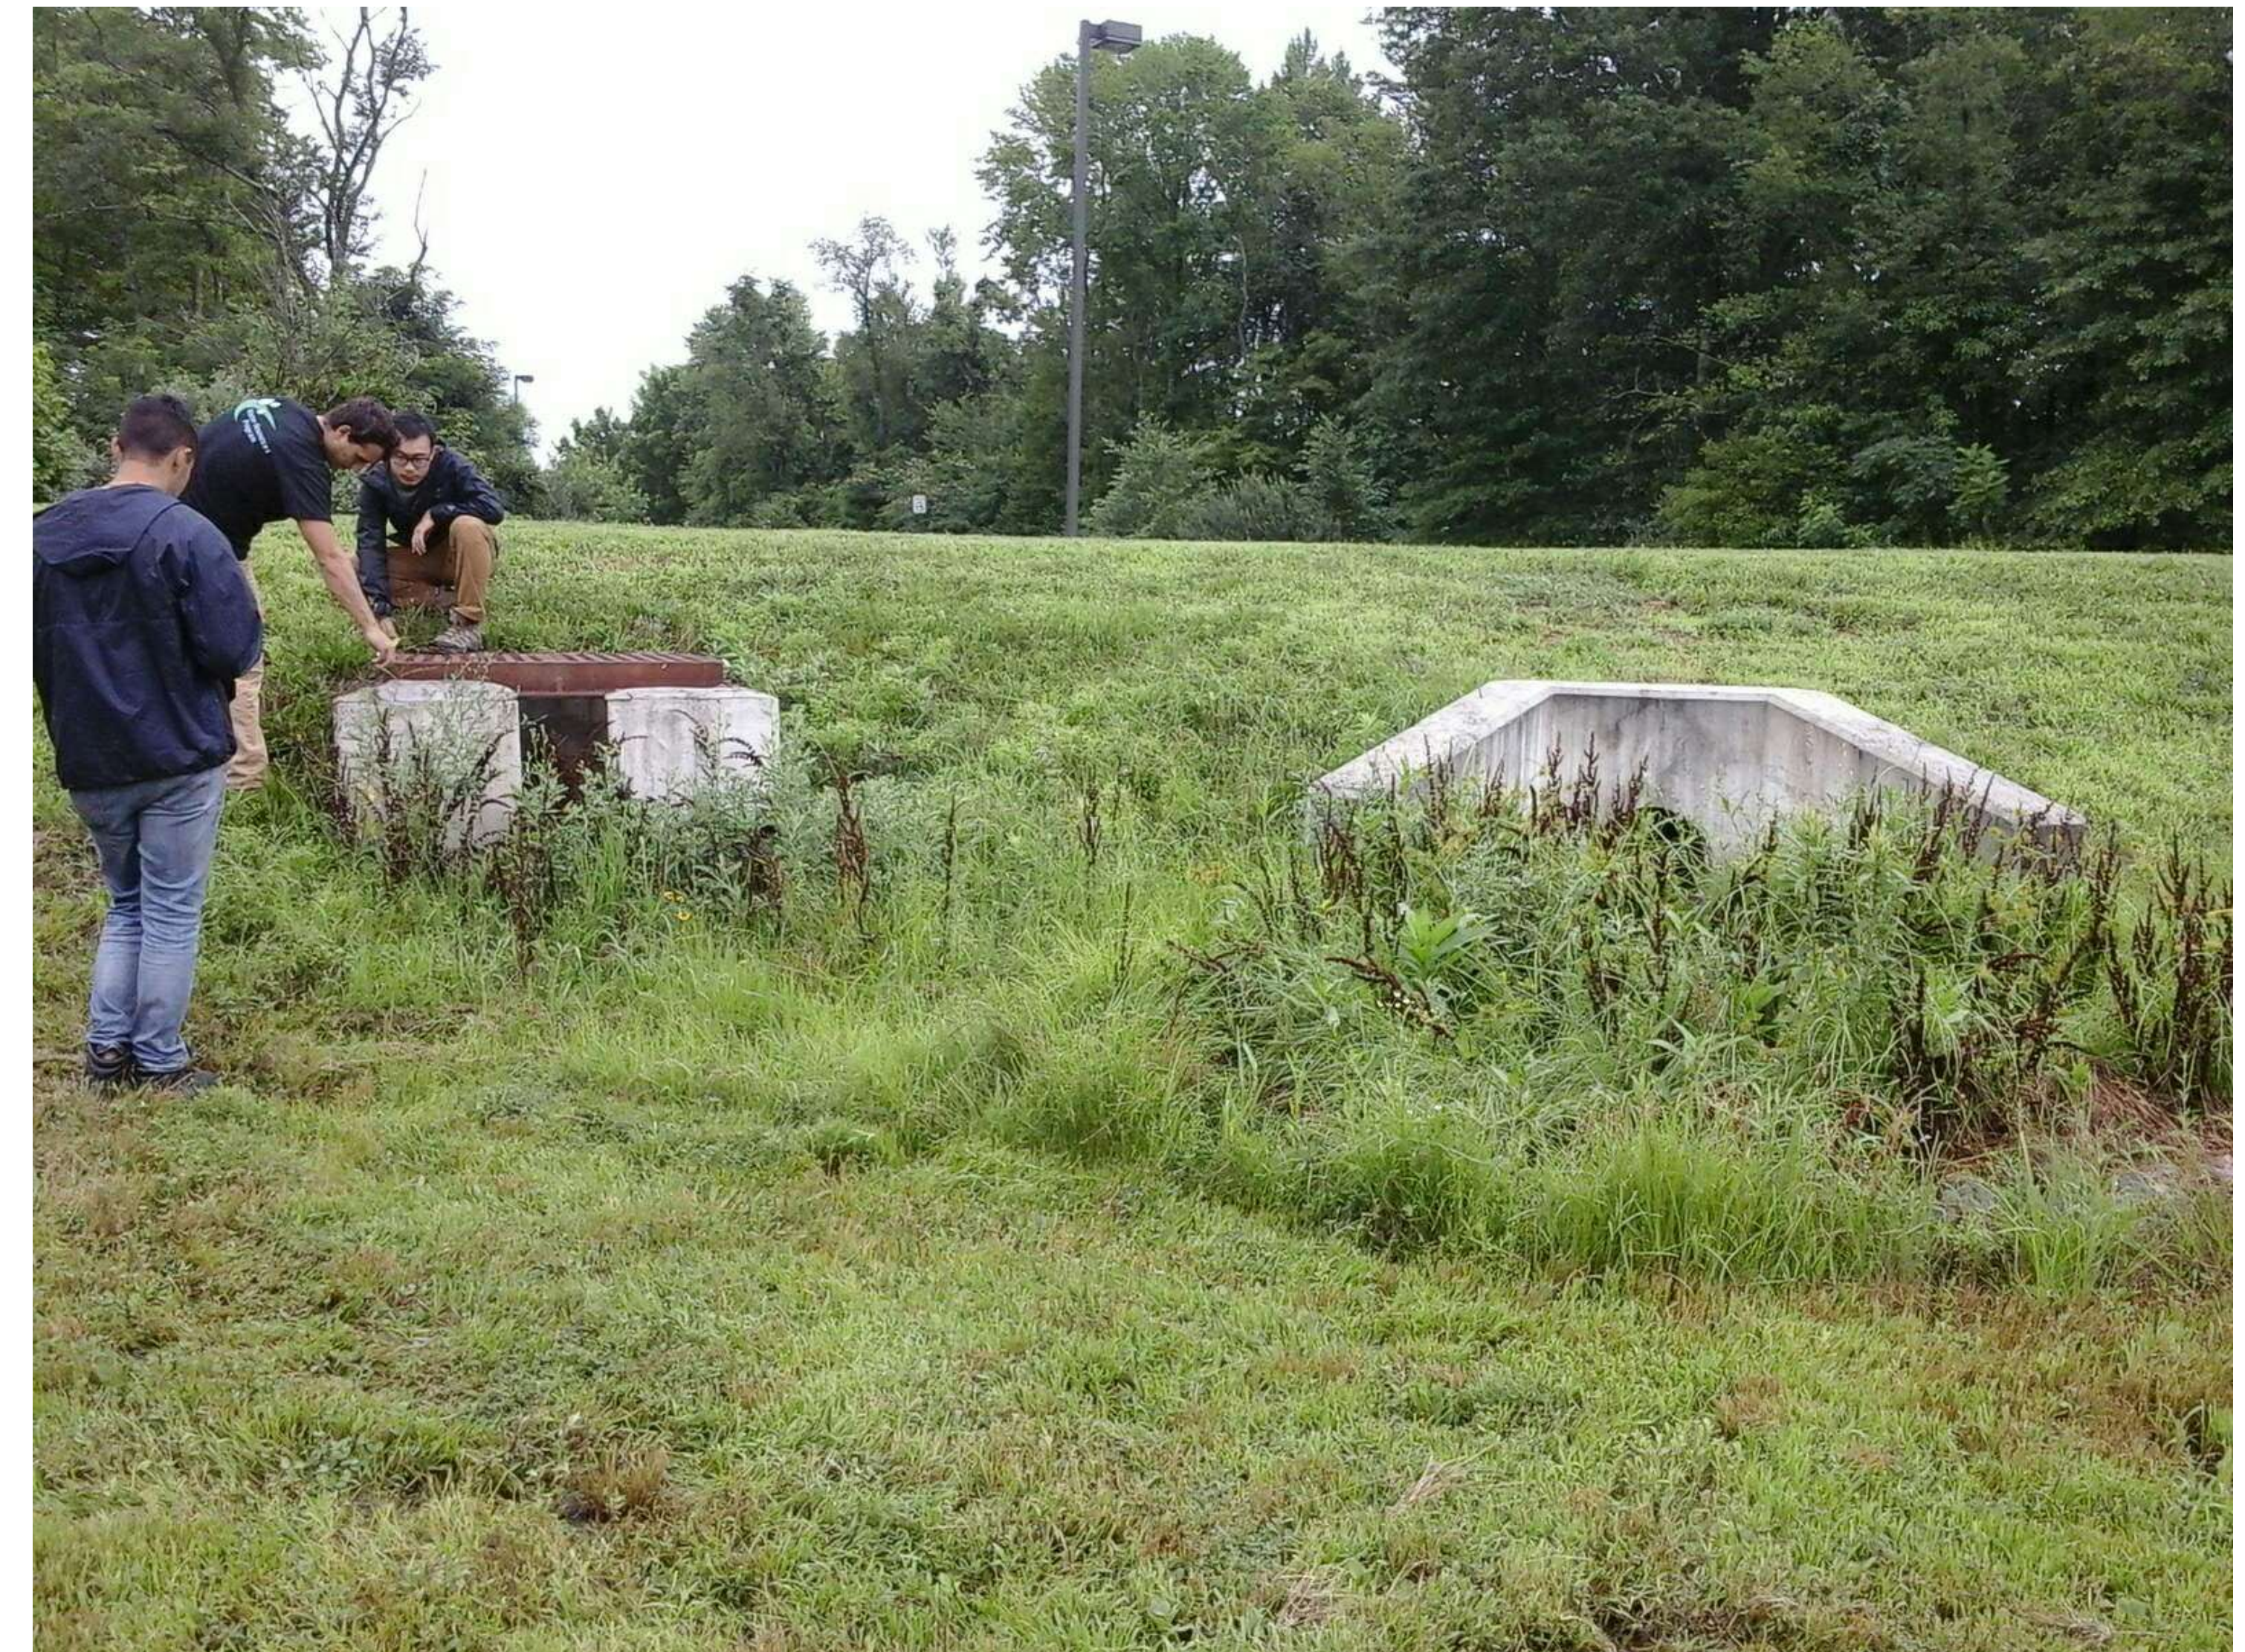
Inspecting outlet structure

- Infiltration basin with some natural vegetation growing
- Some standing water present
- Overall well maintained
