**Hamilton Township (Mercer County)
Stormwater Basin Assessment Summary
Addendum (Year 4)**

Developed by the Rutgers Cooperative Extension Water Resources Program
Funded by Hamilton Township, Mercer County, New Jersey

December 2017

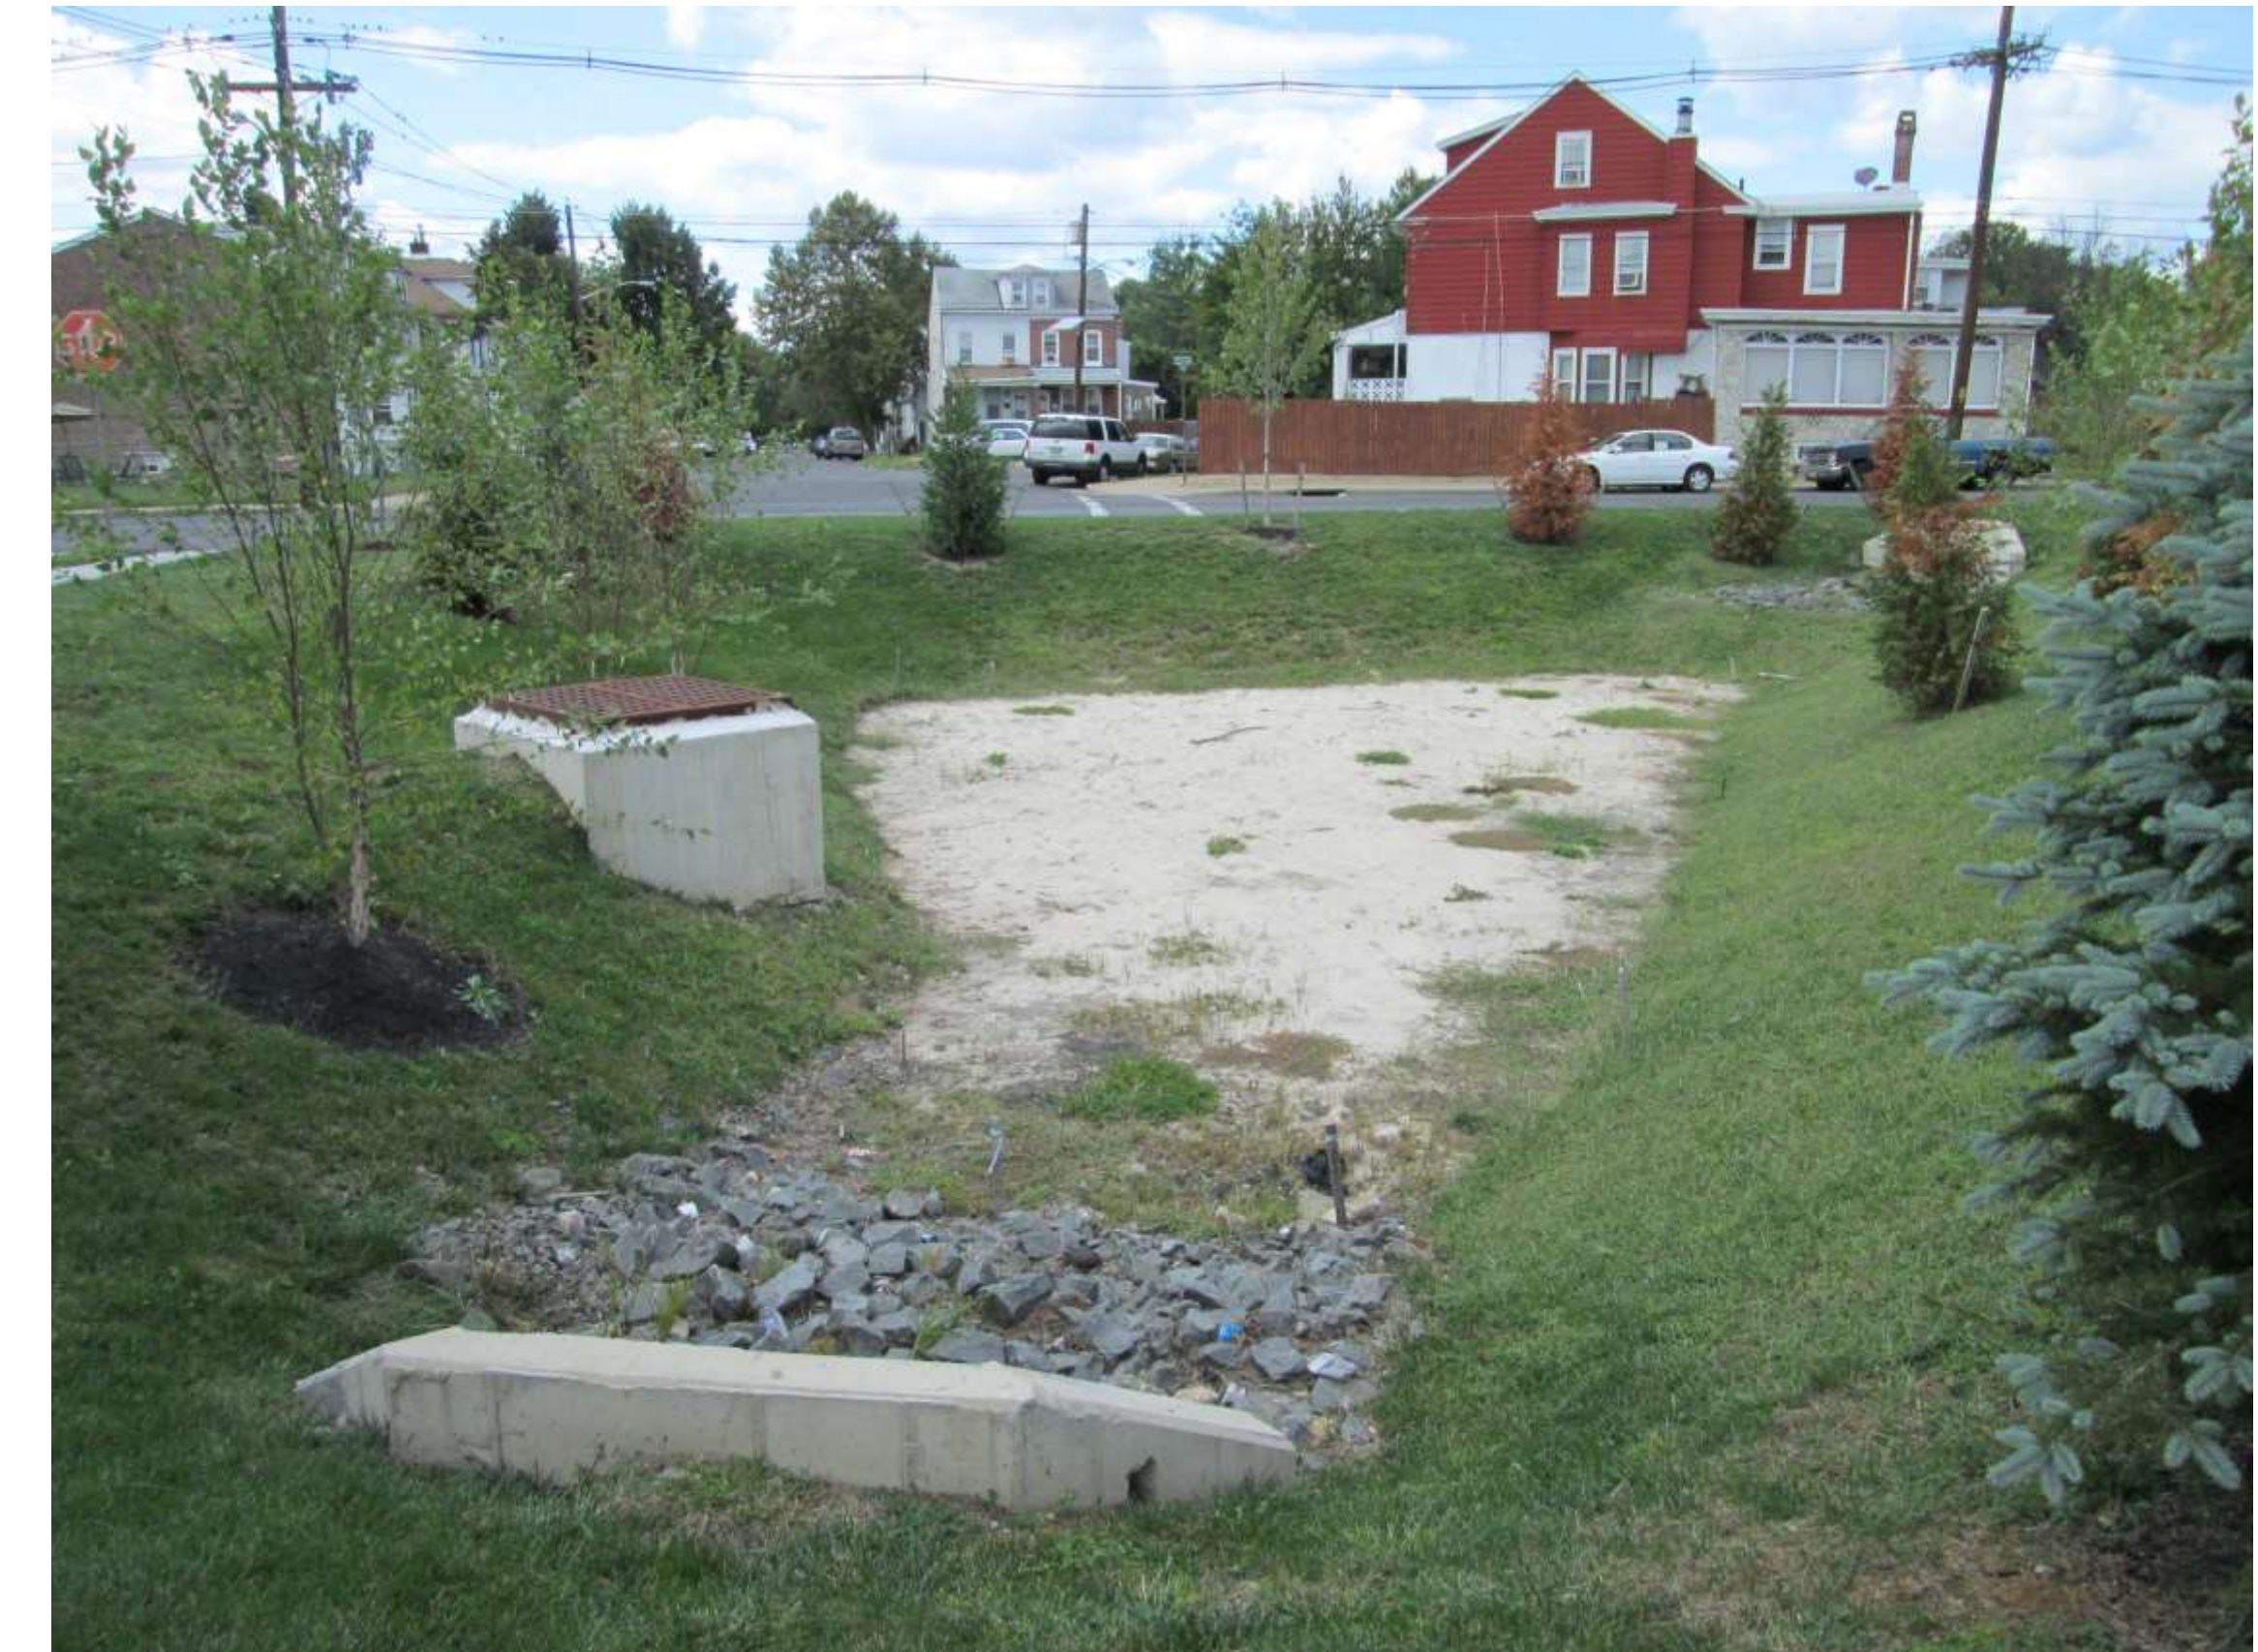
Overview of basin

- Newly constructed basin
- Sandy bottom likely to improve infiltration
- Some standing water in outlet structure
- Overall well maintained

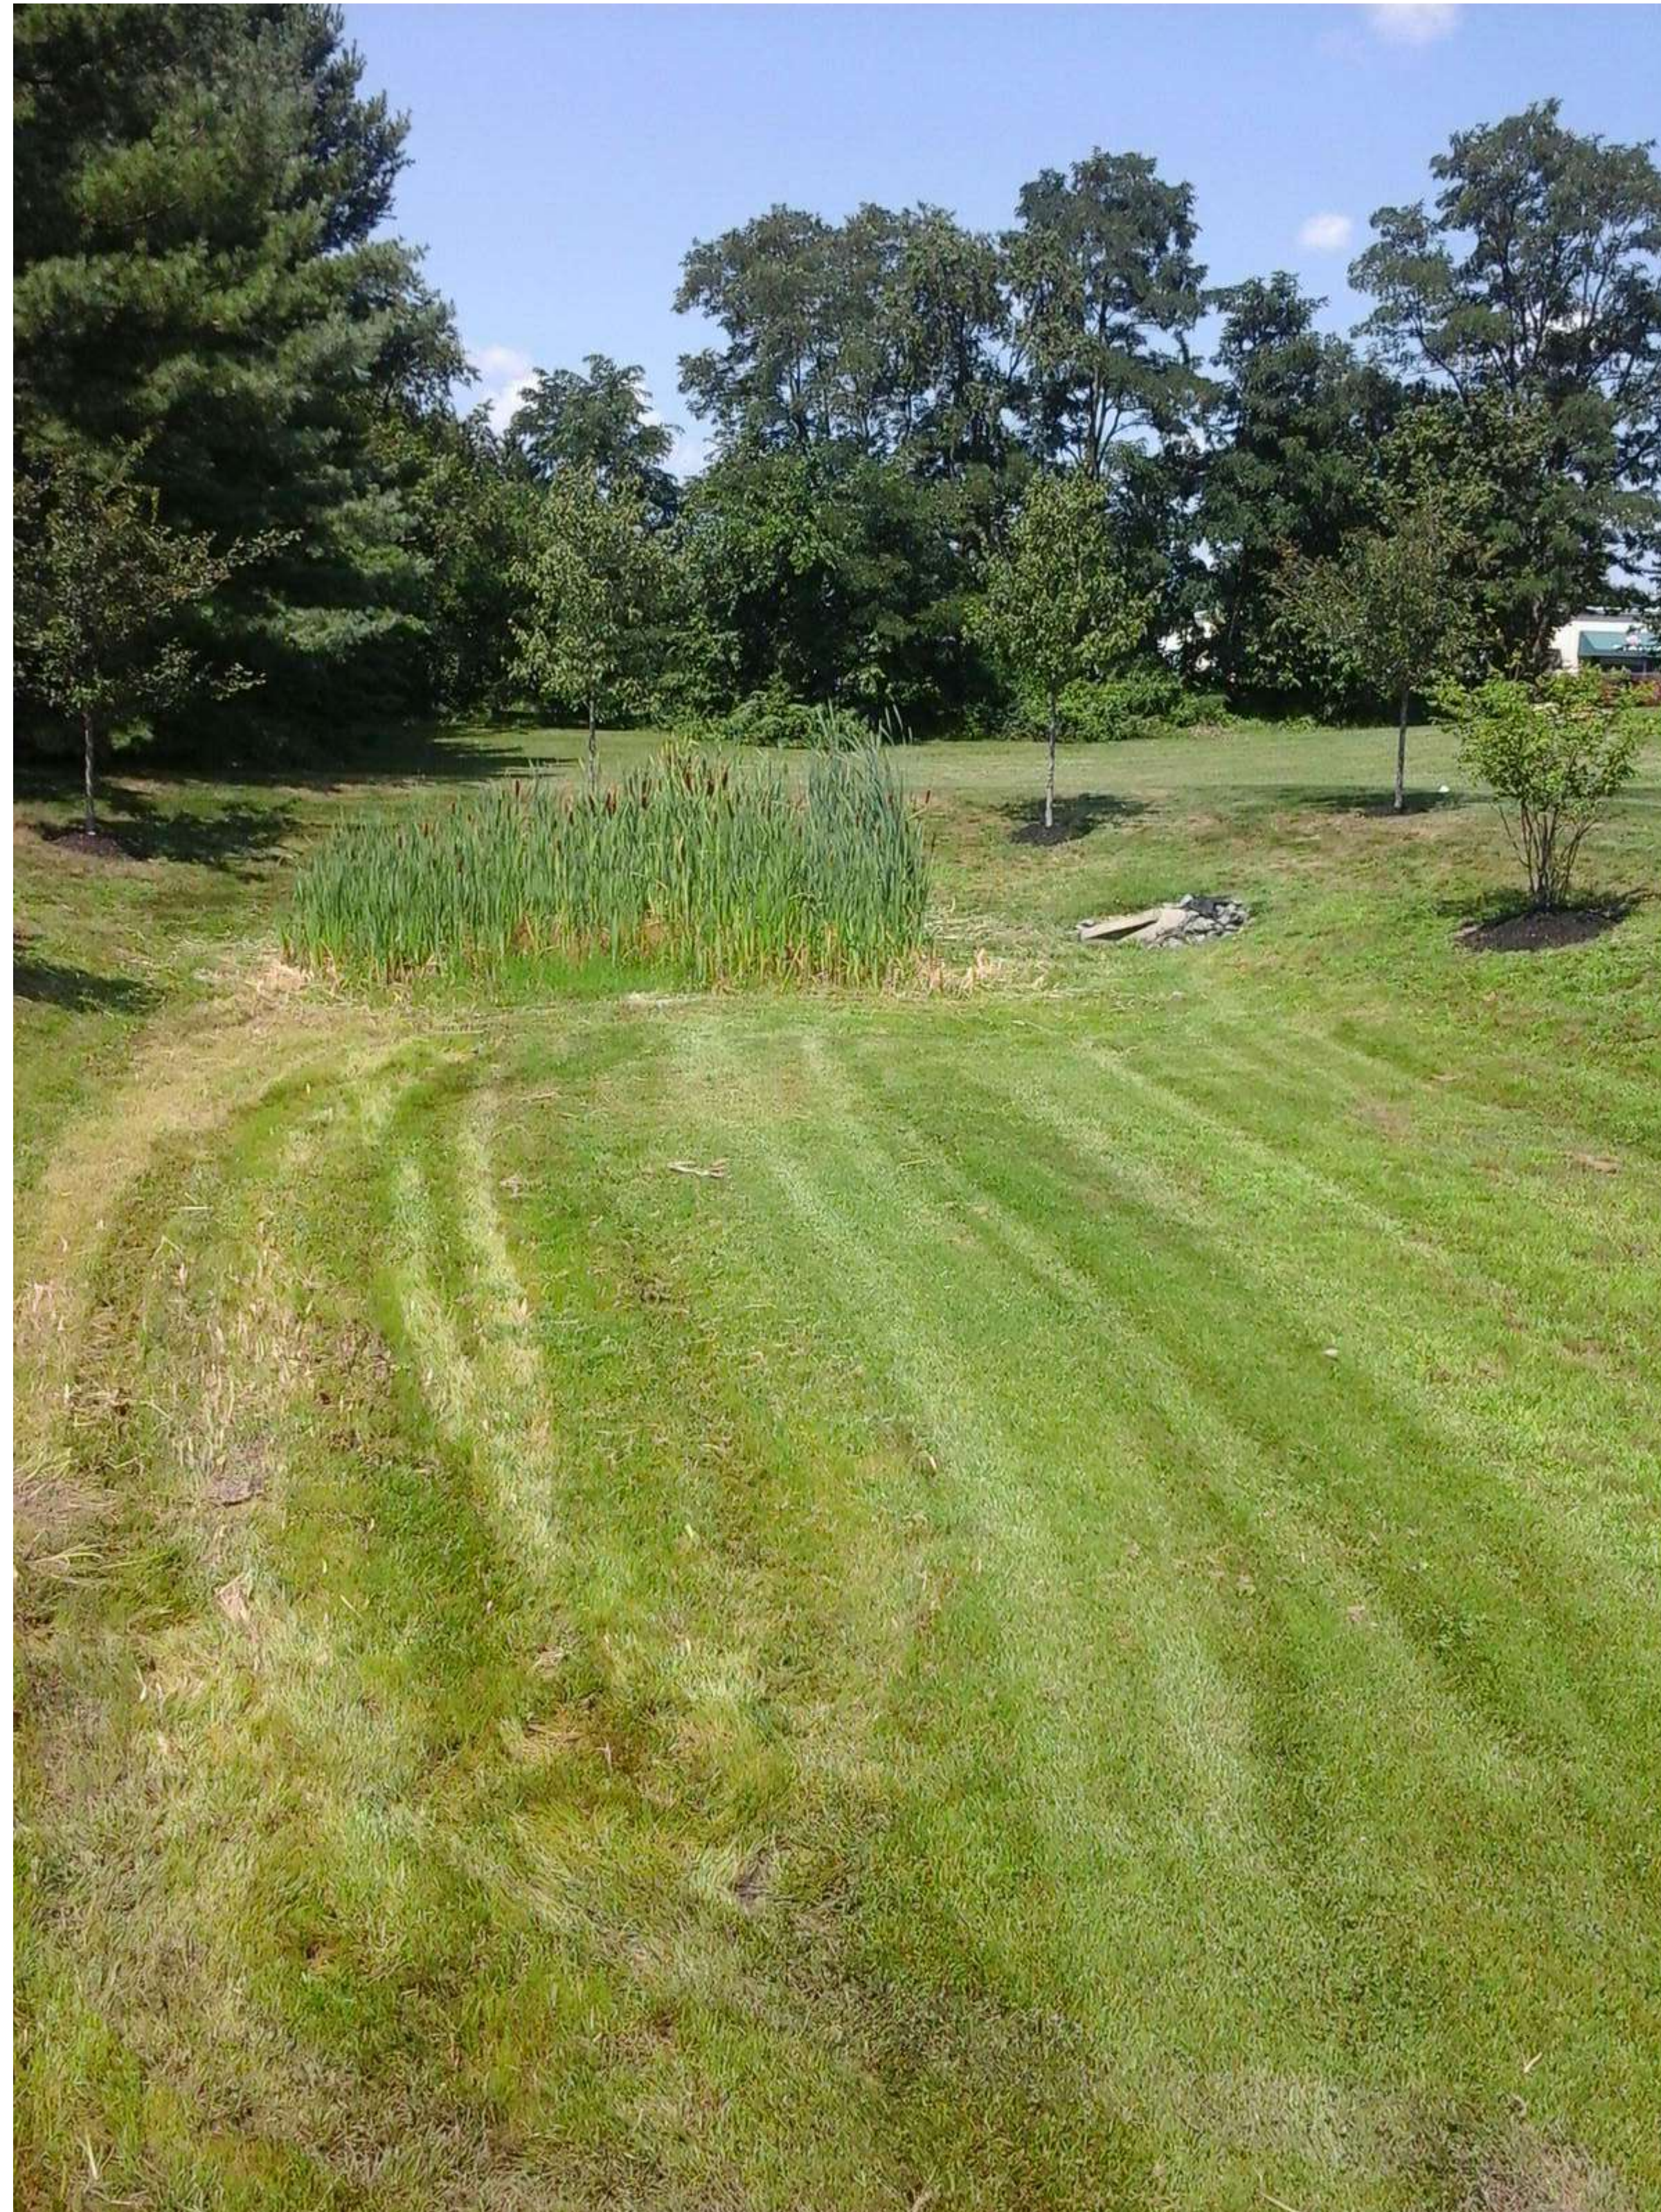
Hamilton Township
Stormwater Basin Assessment
355. Grand Bank Basin

Overview of basin

Outlet

- Some vegetation growing in outlet
- Reduce mowing to increase infiltration and improve habitat
- Overall well maintained

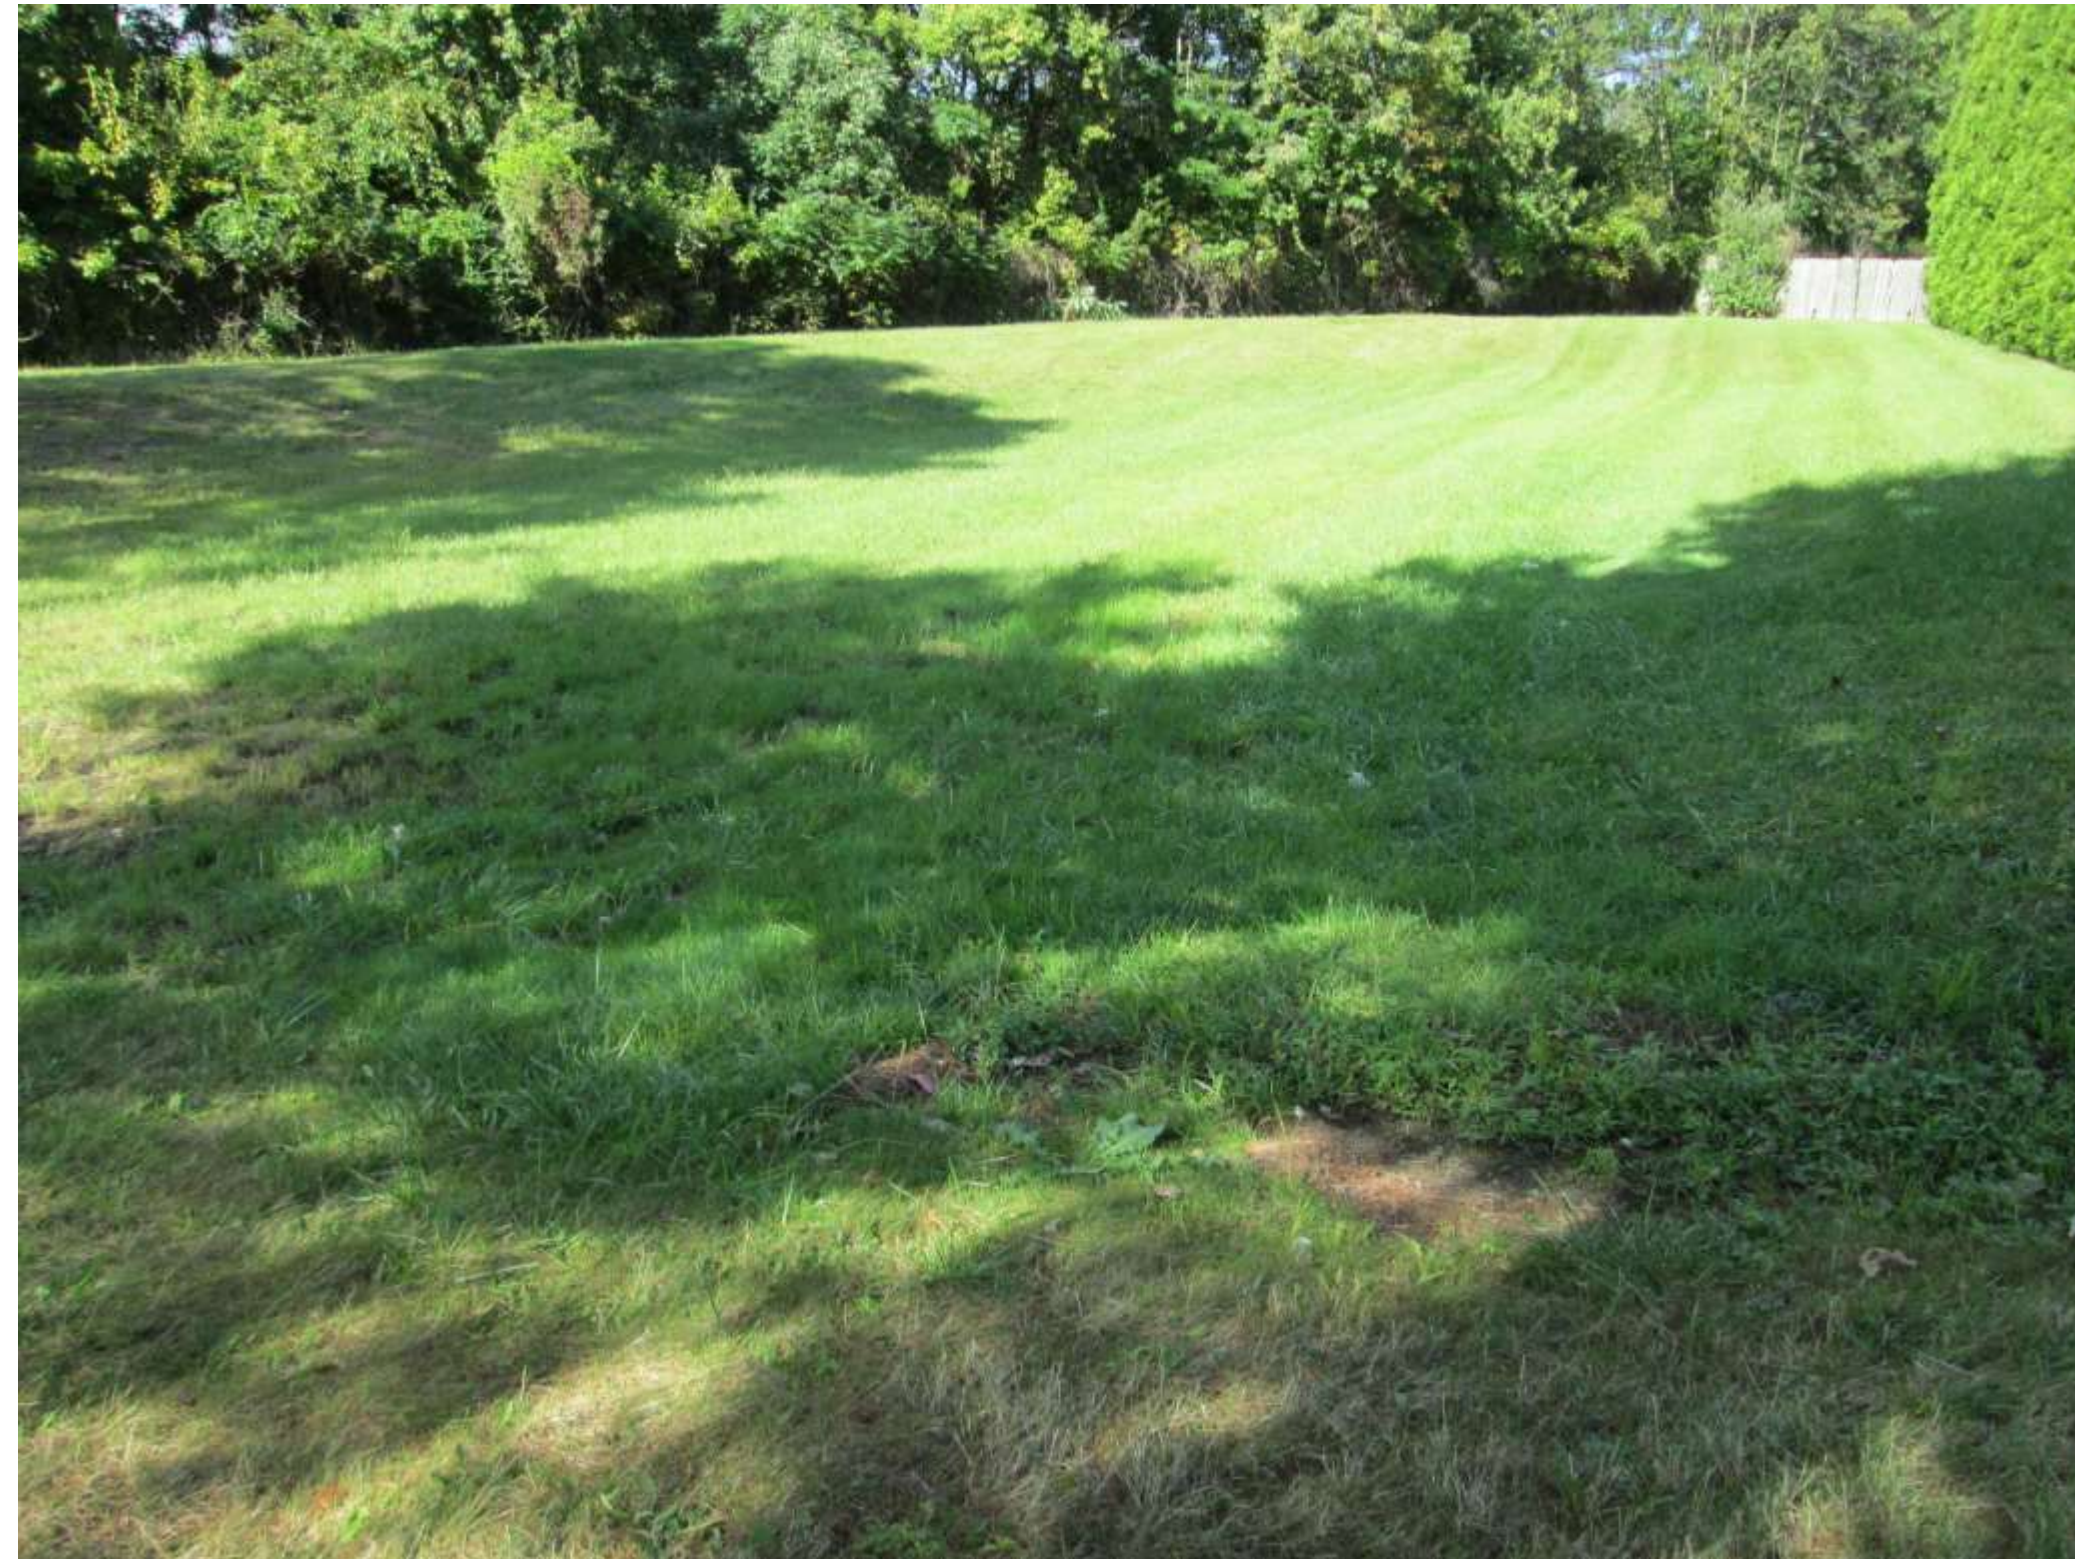
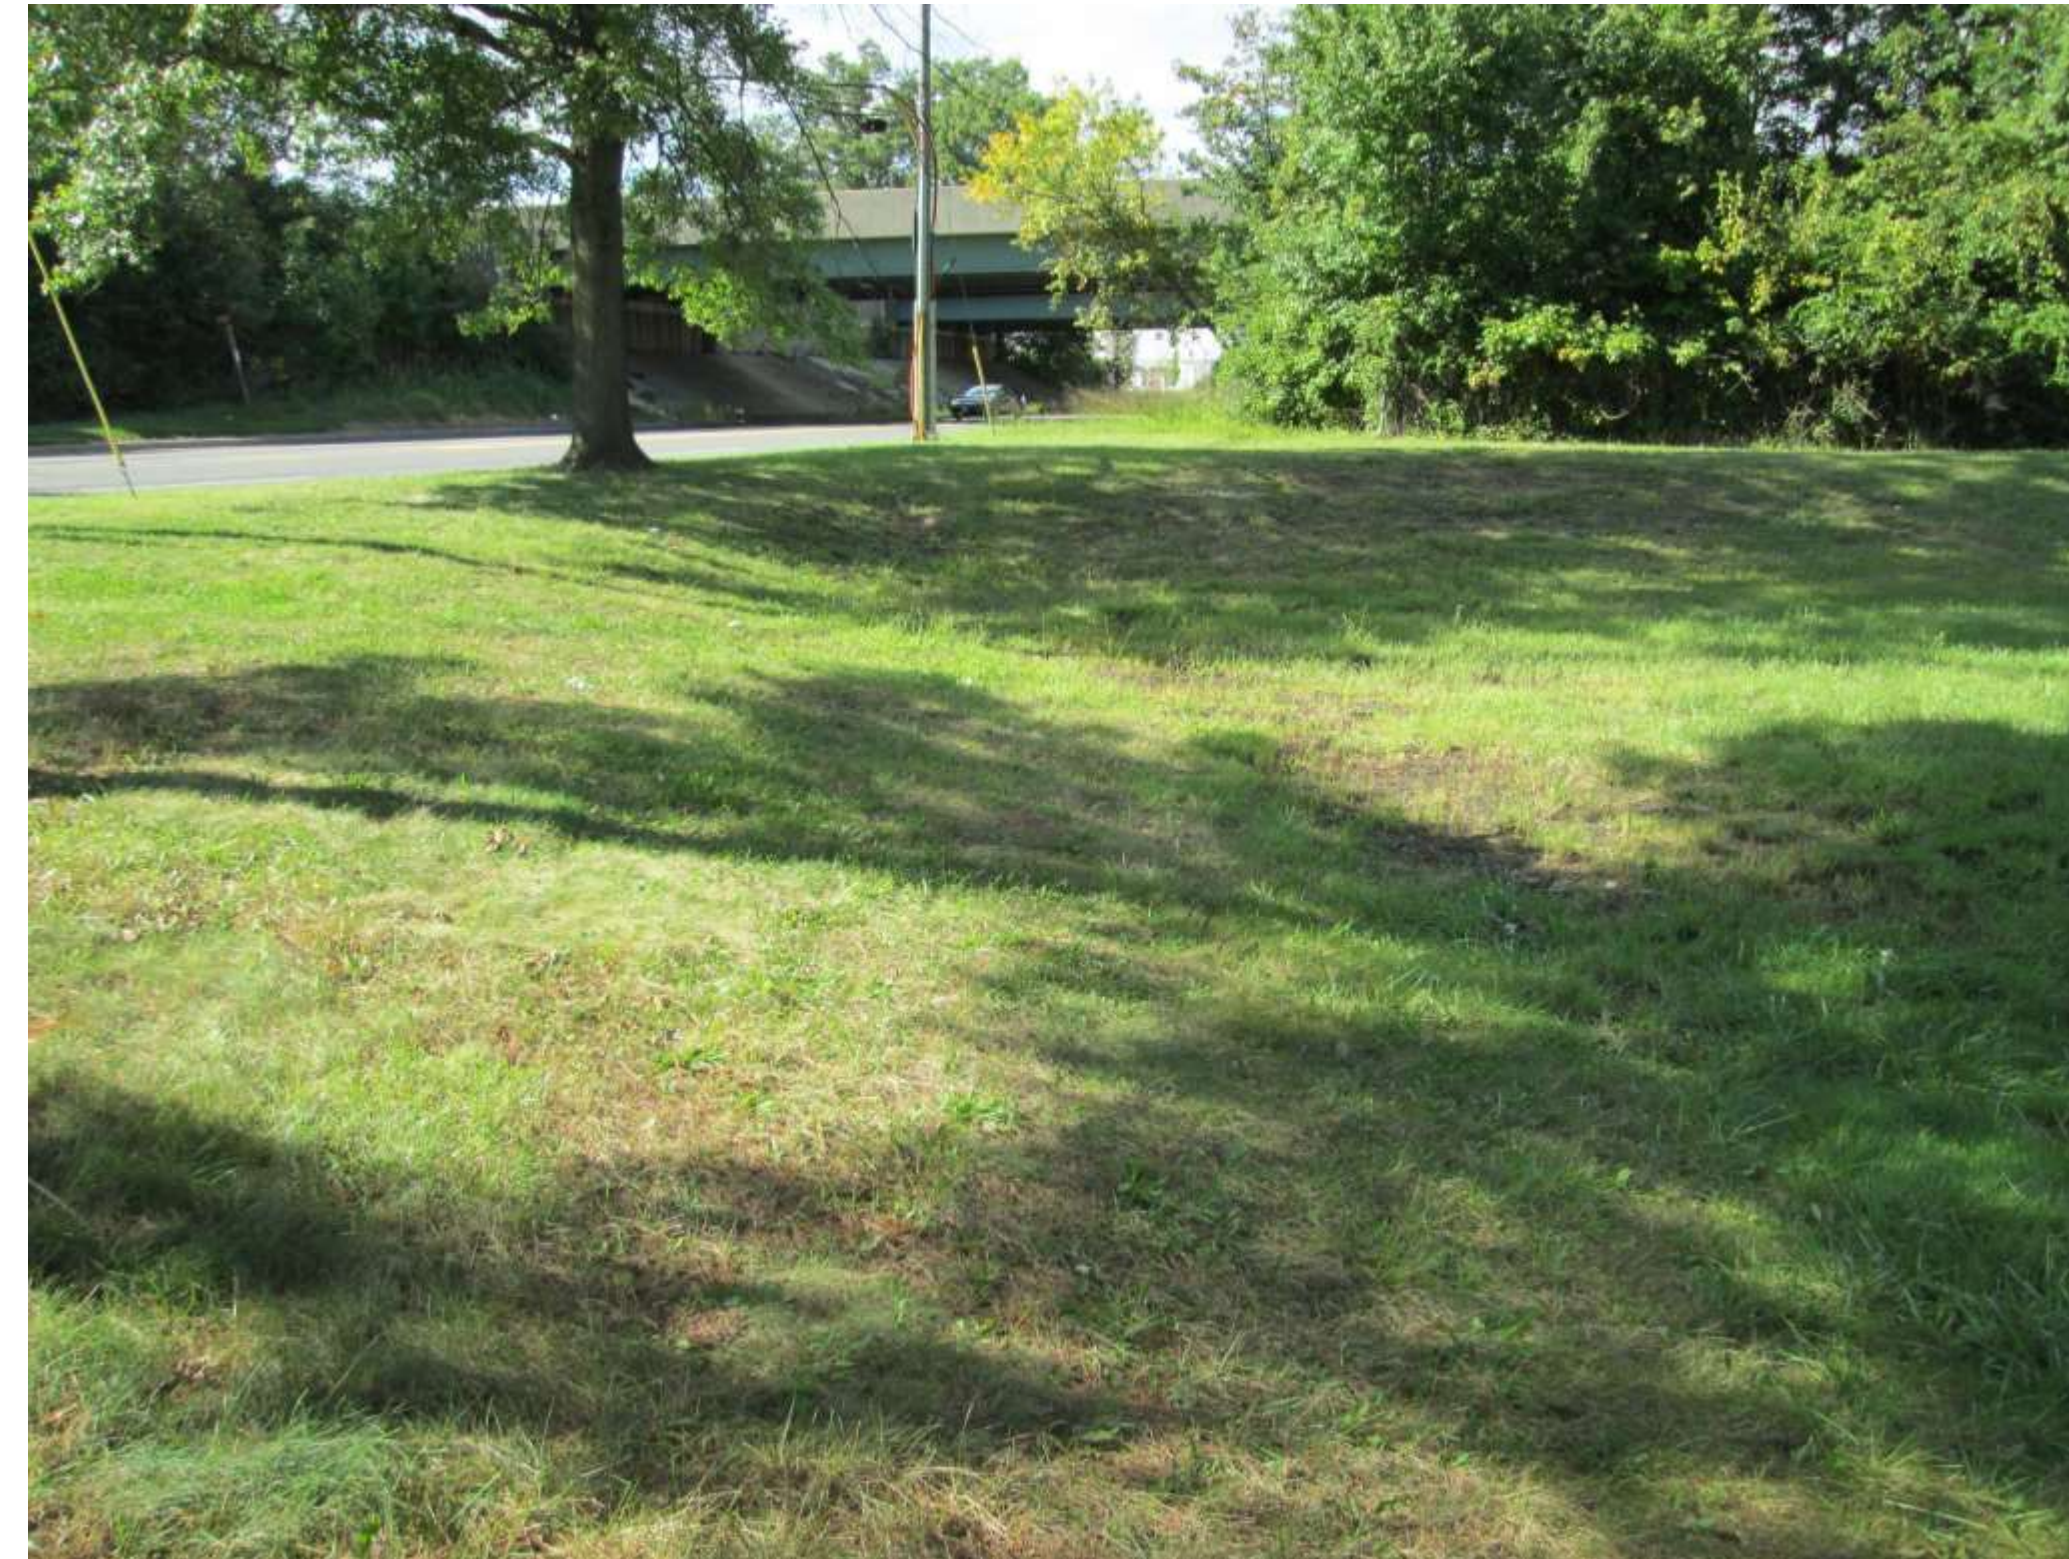
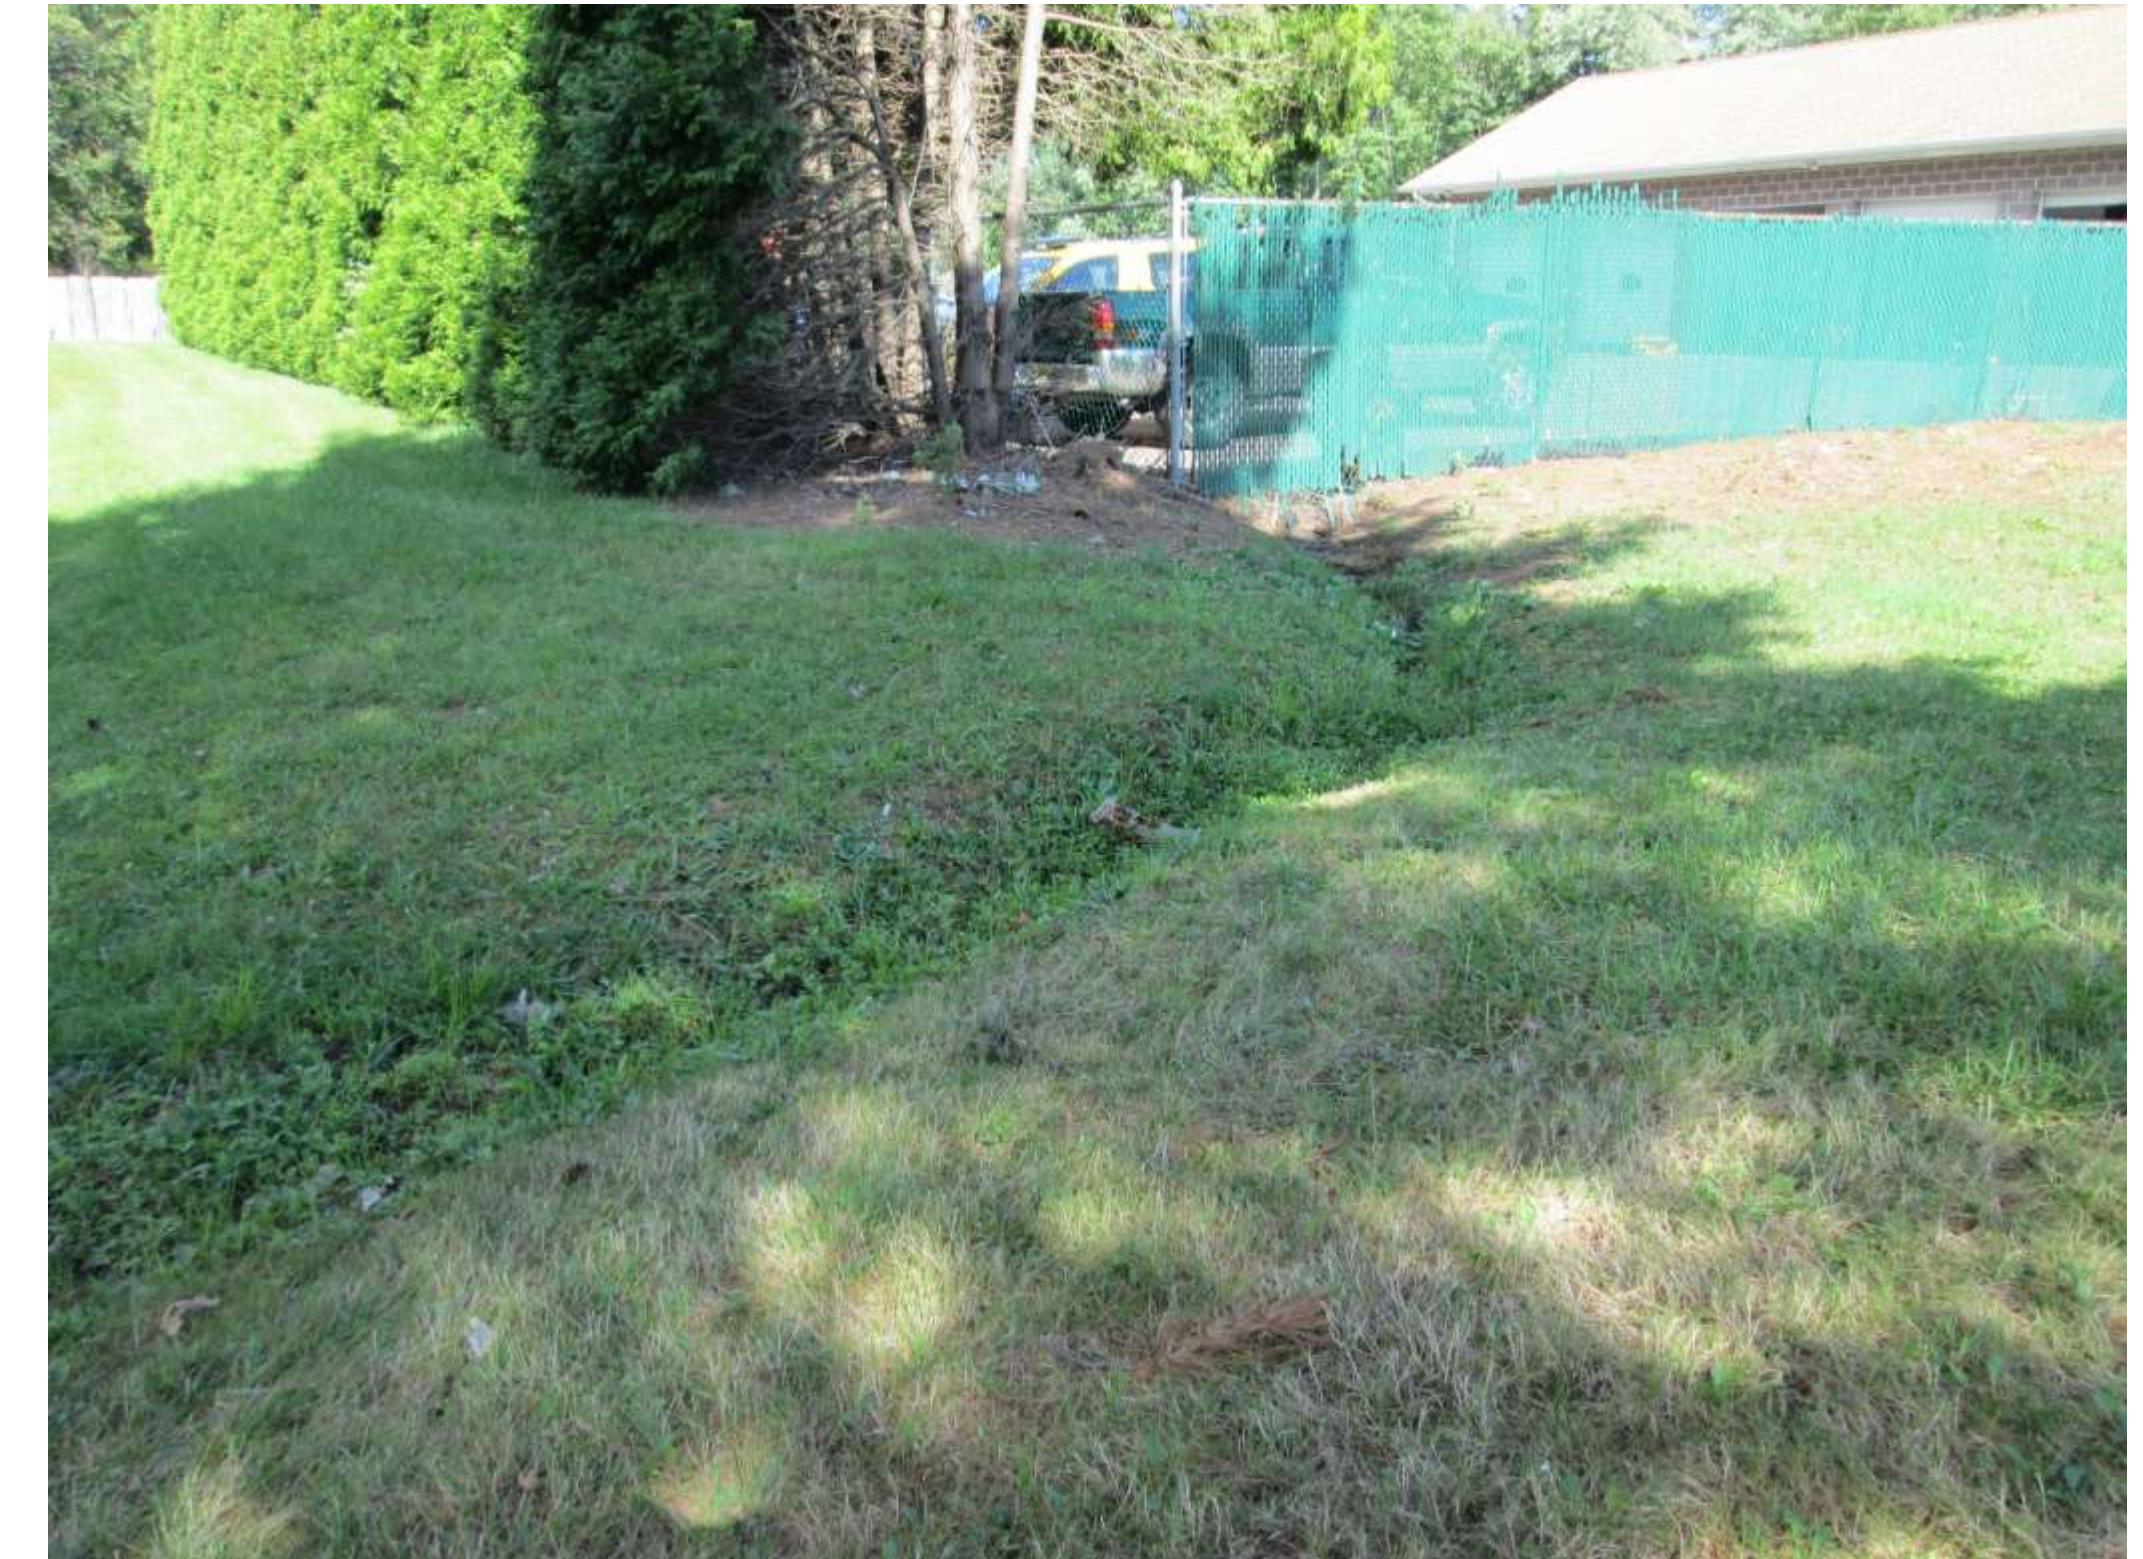
Hamilton Township
Stormwater Basin Assessment
356. City Auto Center II Basin

Overview of basin

Inlet from parking lot

- Catches runoff from business parking lot
- Infiltration basin
- Debris accumulation
- Establish meadows to improve habitat
- Overall well maintained

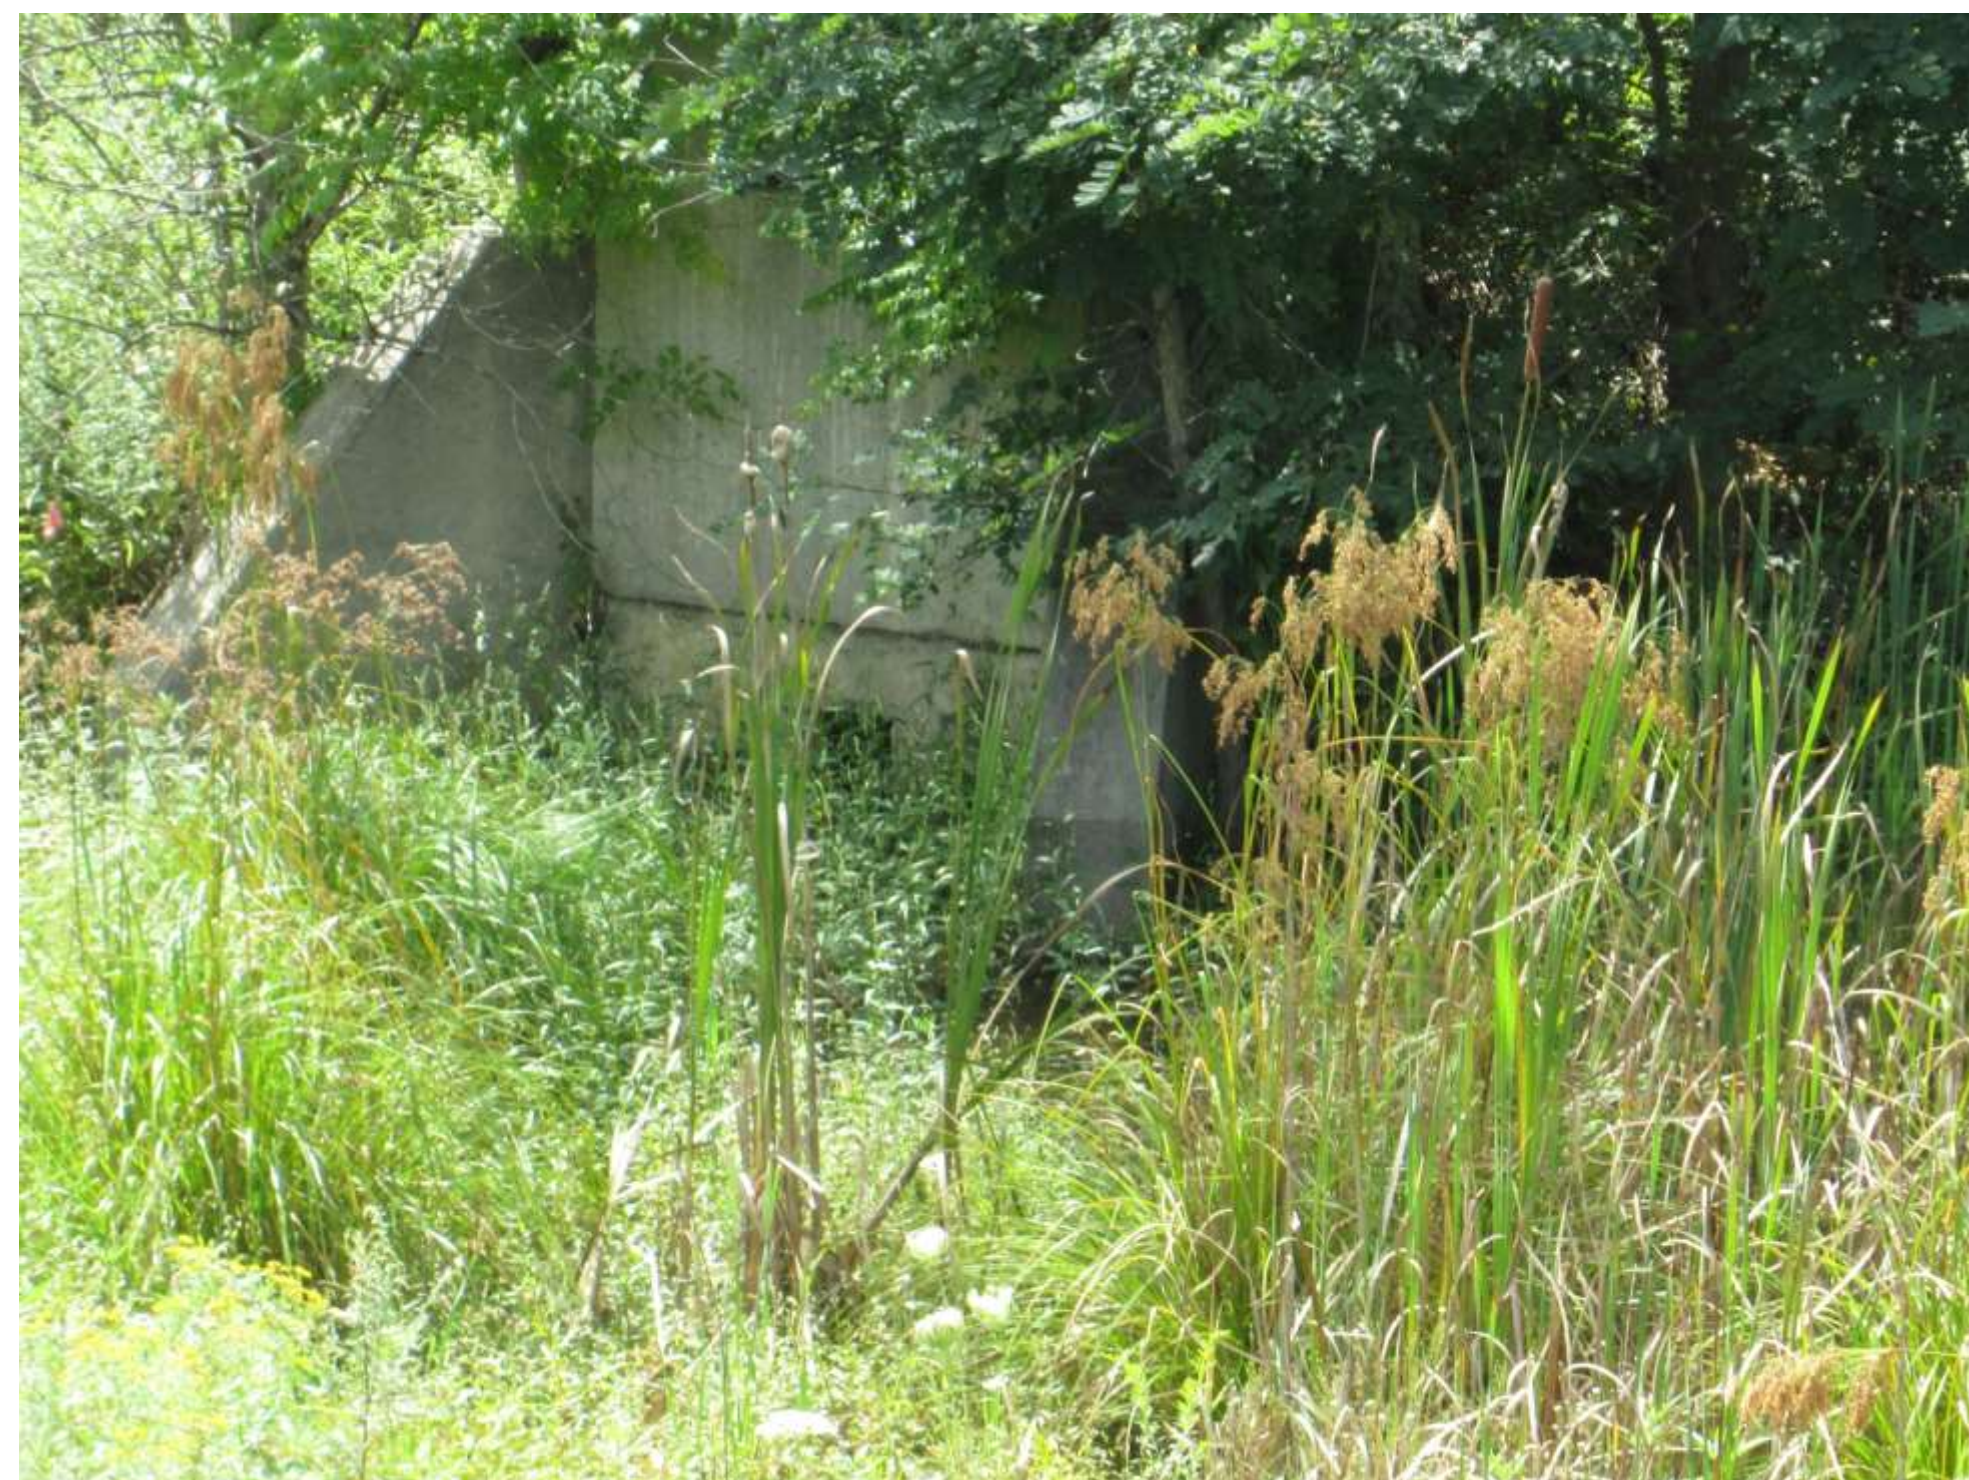
Southern basin overview and outlet structure

- Both basins have been left to fully naturalize
- Outlet structures are difficult to find and access
- Access to inlet and outlet structure should be mown once or twice a year

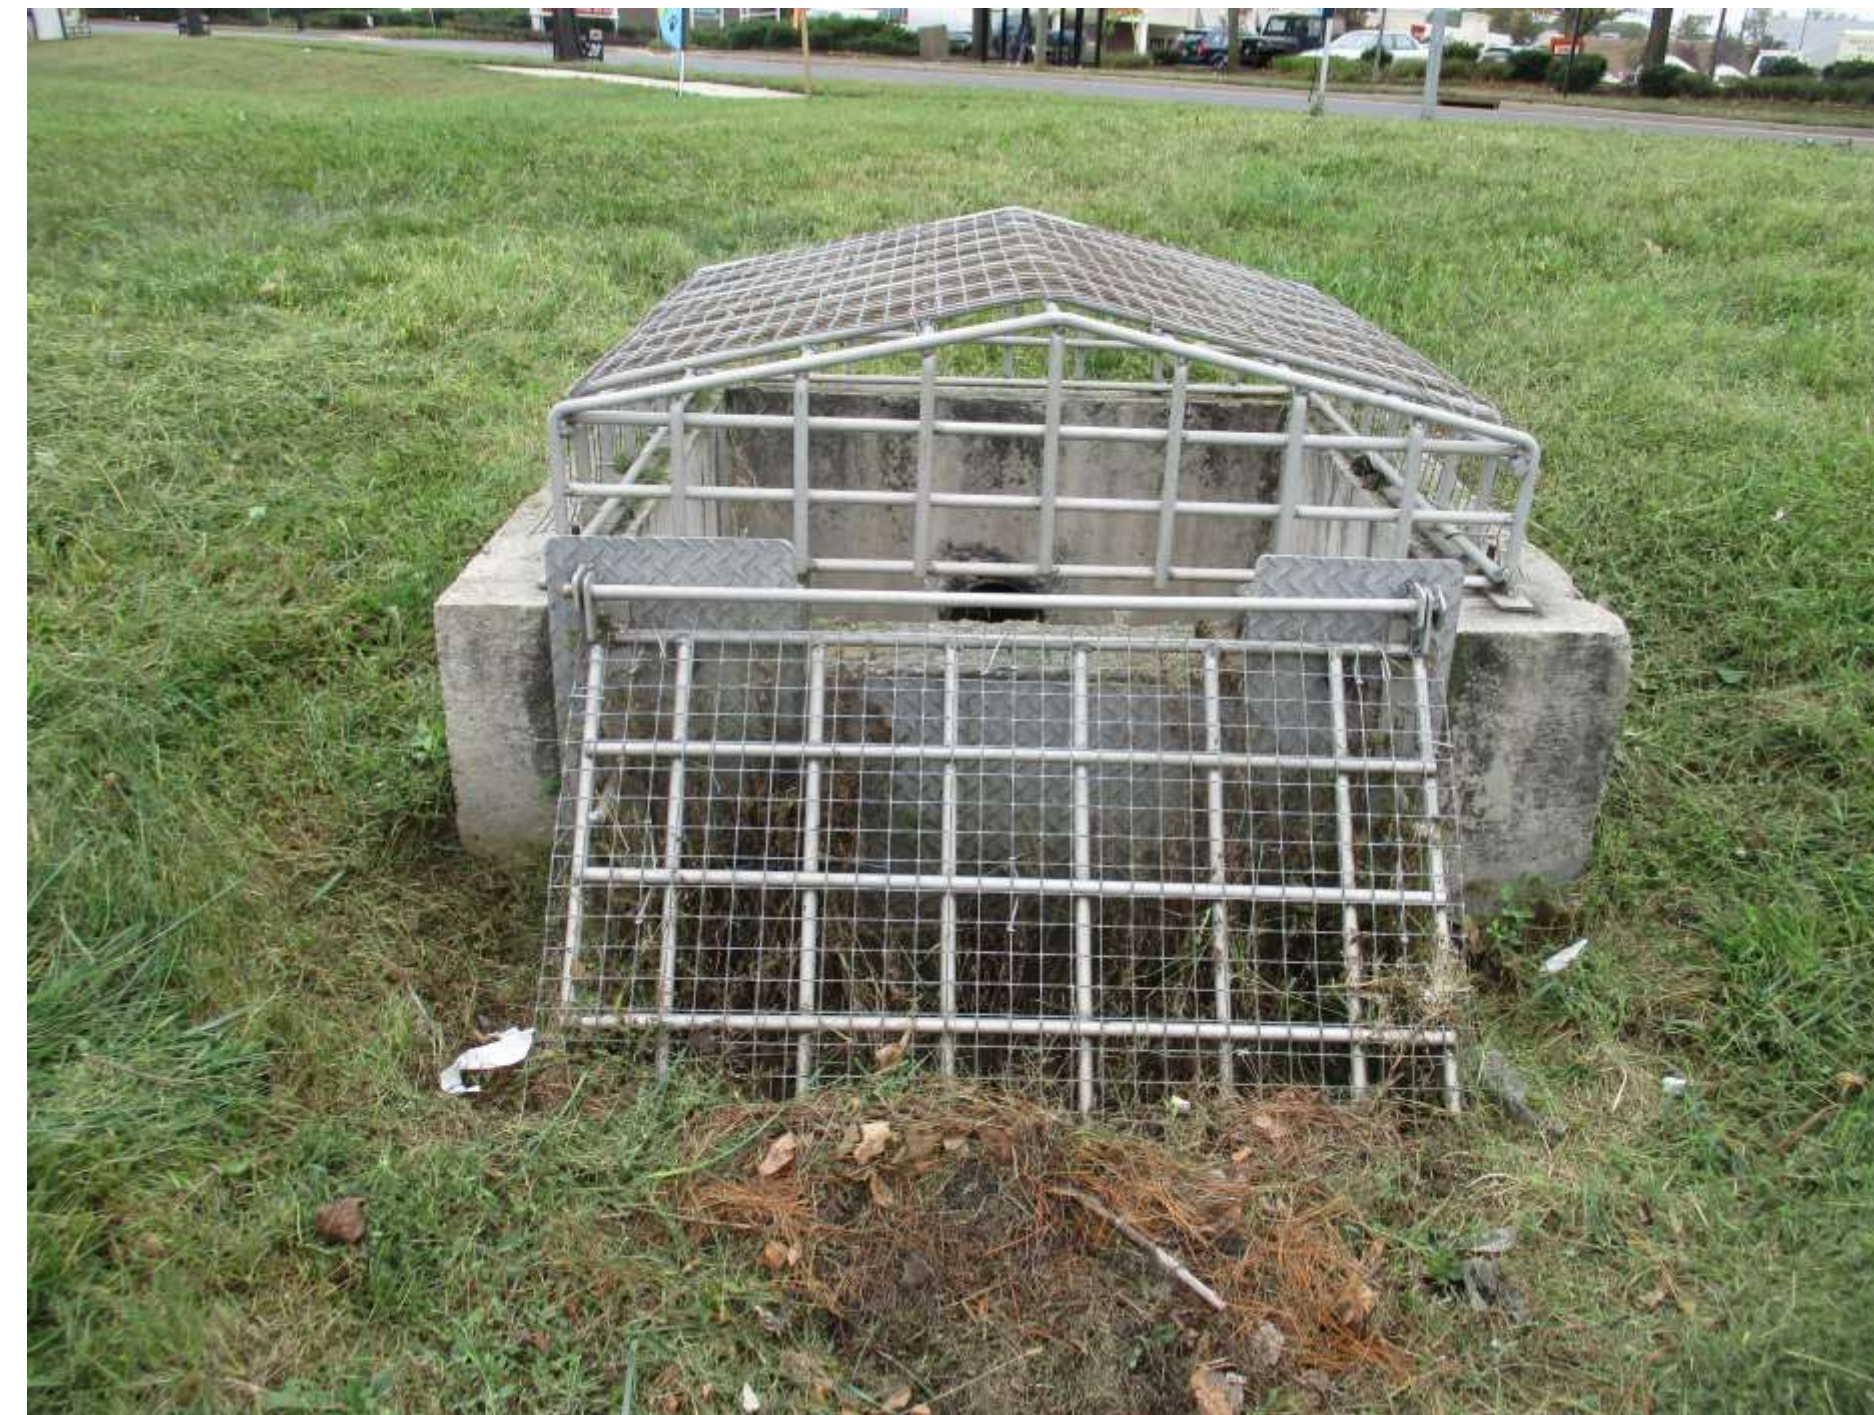
Outlet of 371 (northern basin)

- Sediment accumulation in 371 low flow channel
- 371 outlet is covered with sediment
- Erosion around 372 outlet structure causing a dangerous hole, impairing the function of the outlet
- Reduce mowing and replace low flow channel with stone lined channel to improve infiltration
