**Hamilton Township (Mercer County)
Stormwater Basin Assessment Summary
Addendum (Year 4)**

Developed by the Rutgers Cooperative Extension Water Resources Program
Funded by Hamilton Township, Mercer County, New Jersey

December 2017

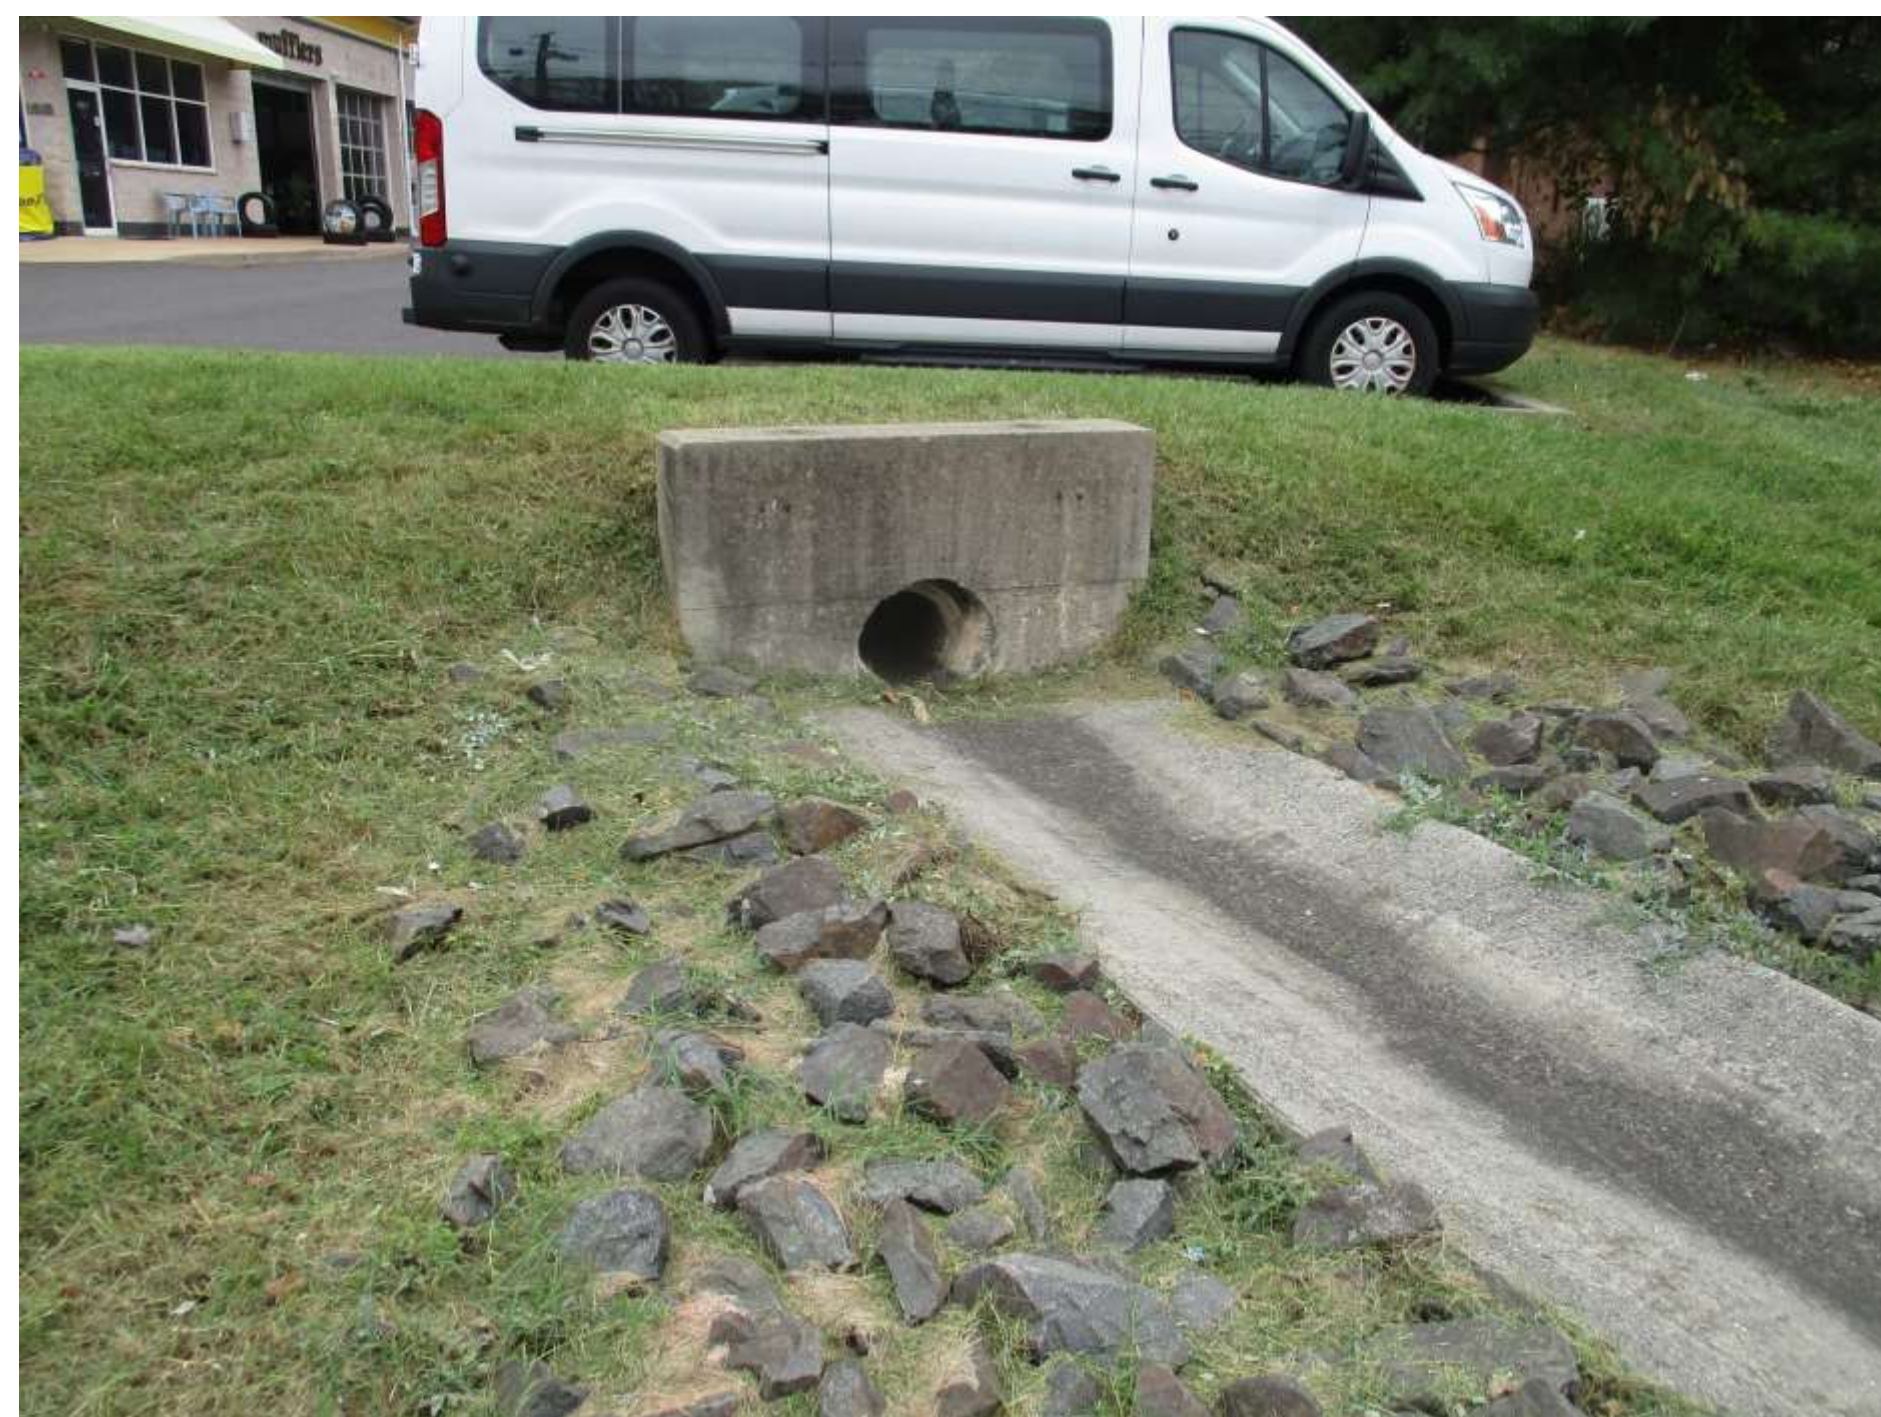
Inlet and low flow channel

- Sediment accumulation in 371 low flow channel
- 371 outlet is covered with sediment
- Erosion around 372 outlet structure causing a dangerous hole, impairing the function of the outlet
- Reduce mowing and replace low flow channel with stone lined channel to improve infiltration

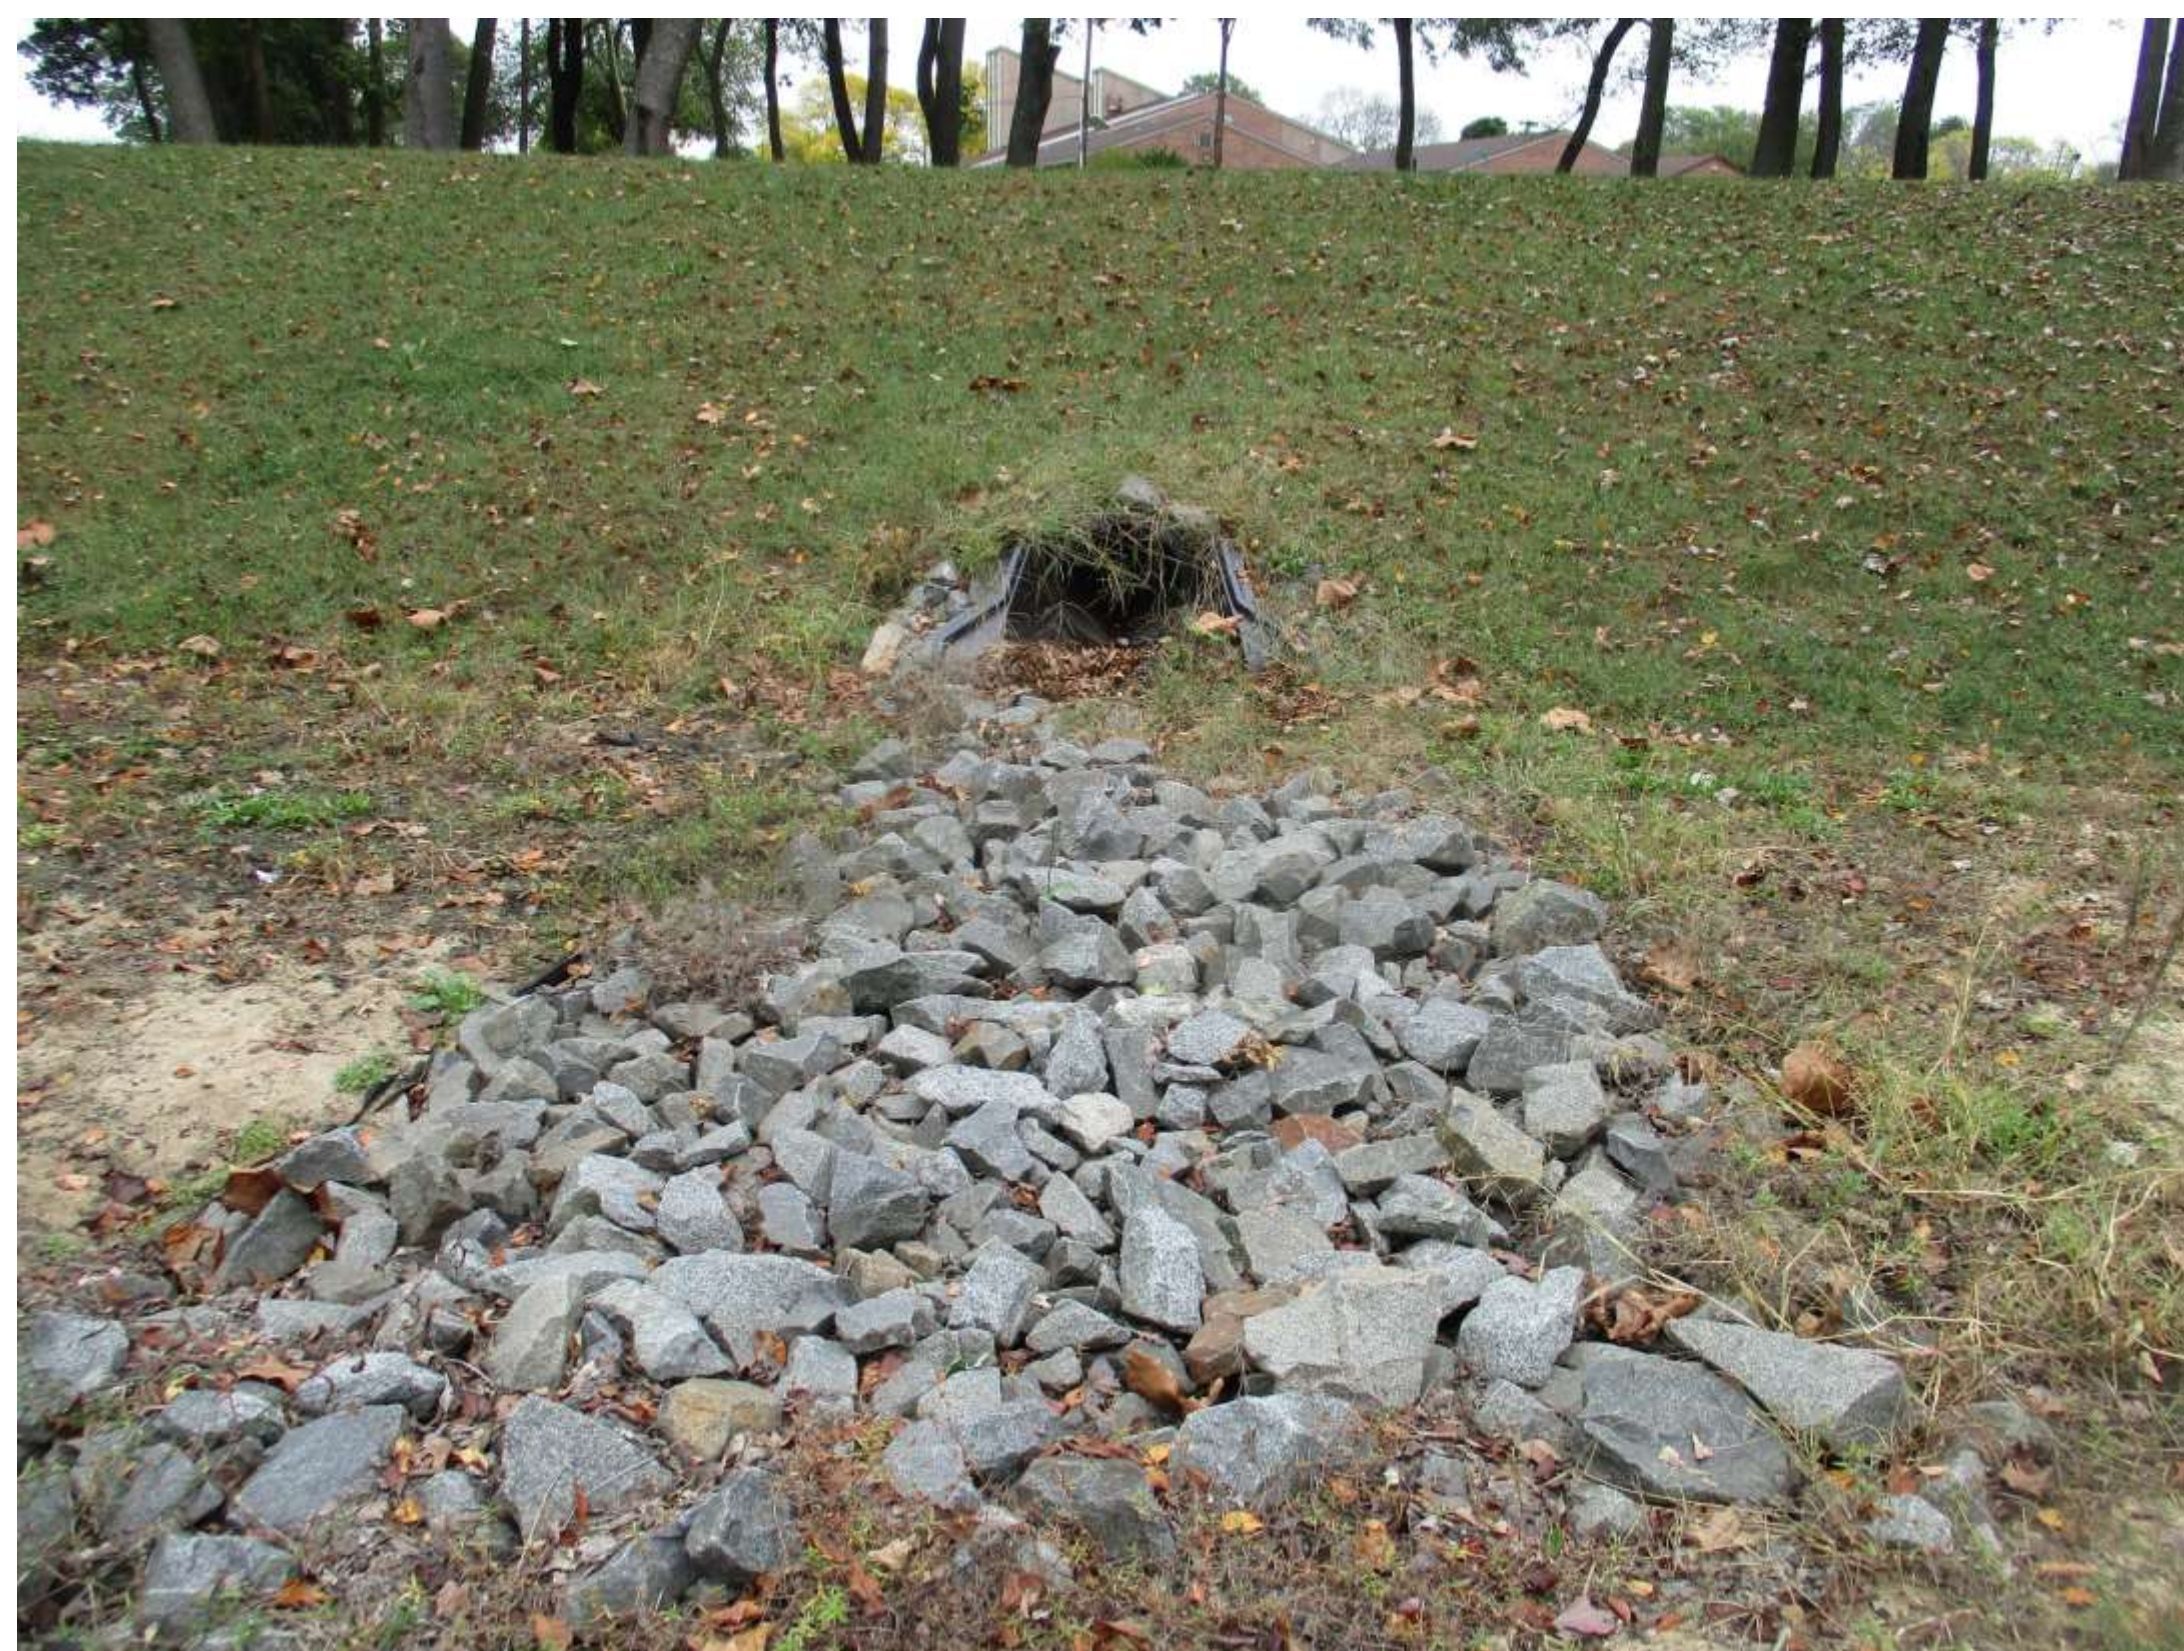
Inlet with rip rap

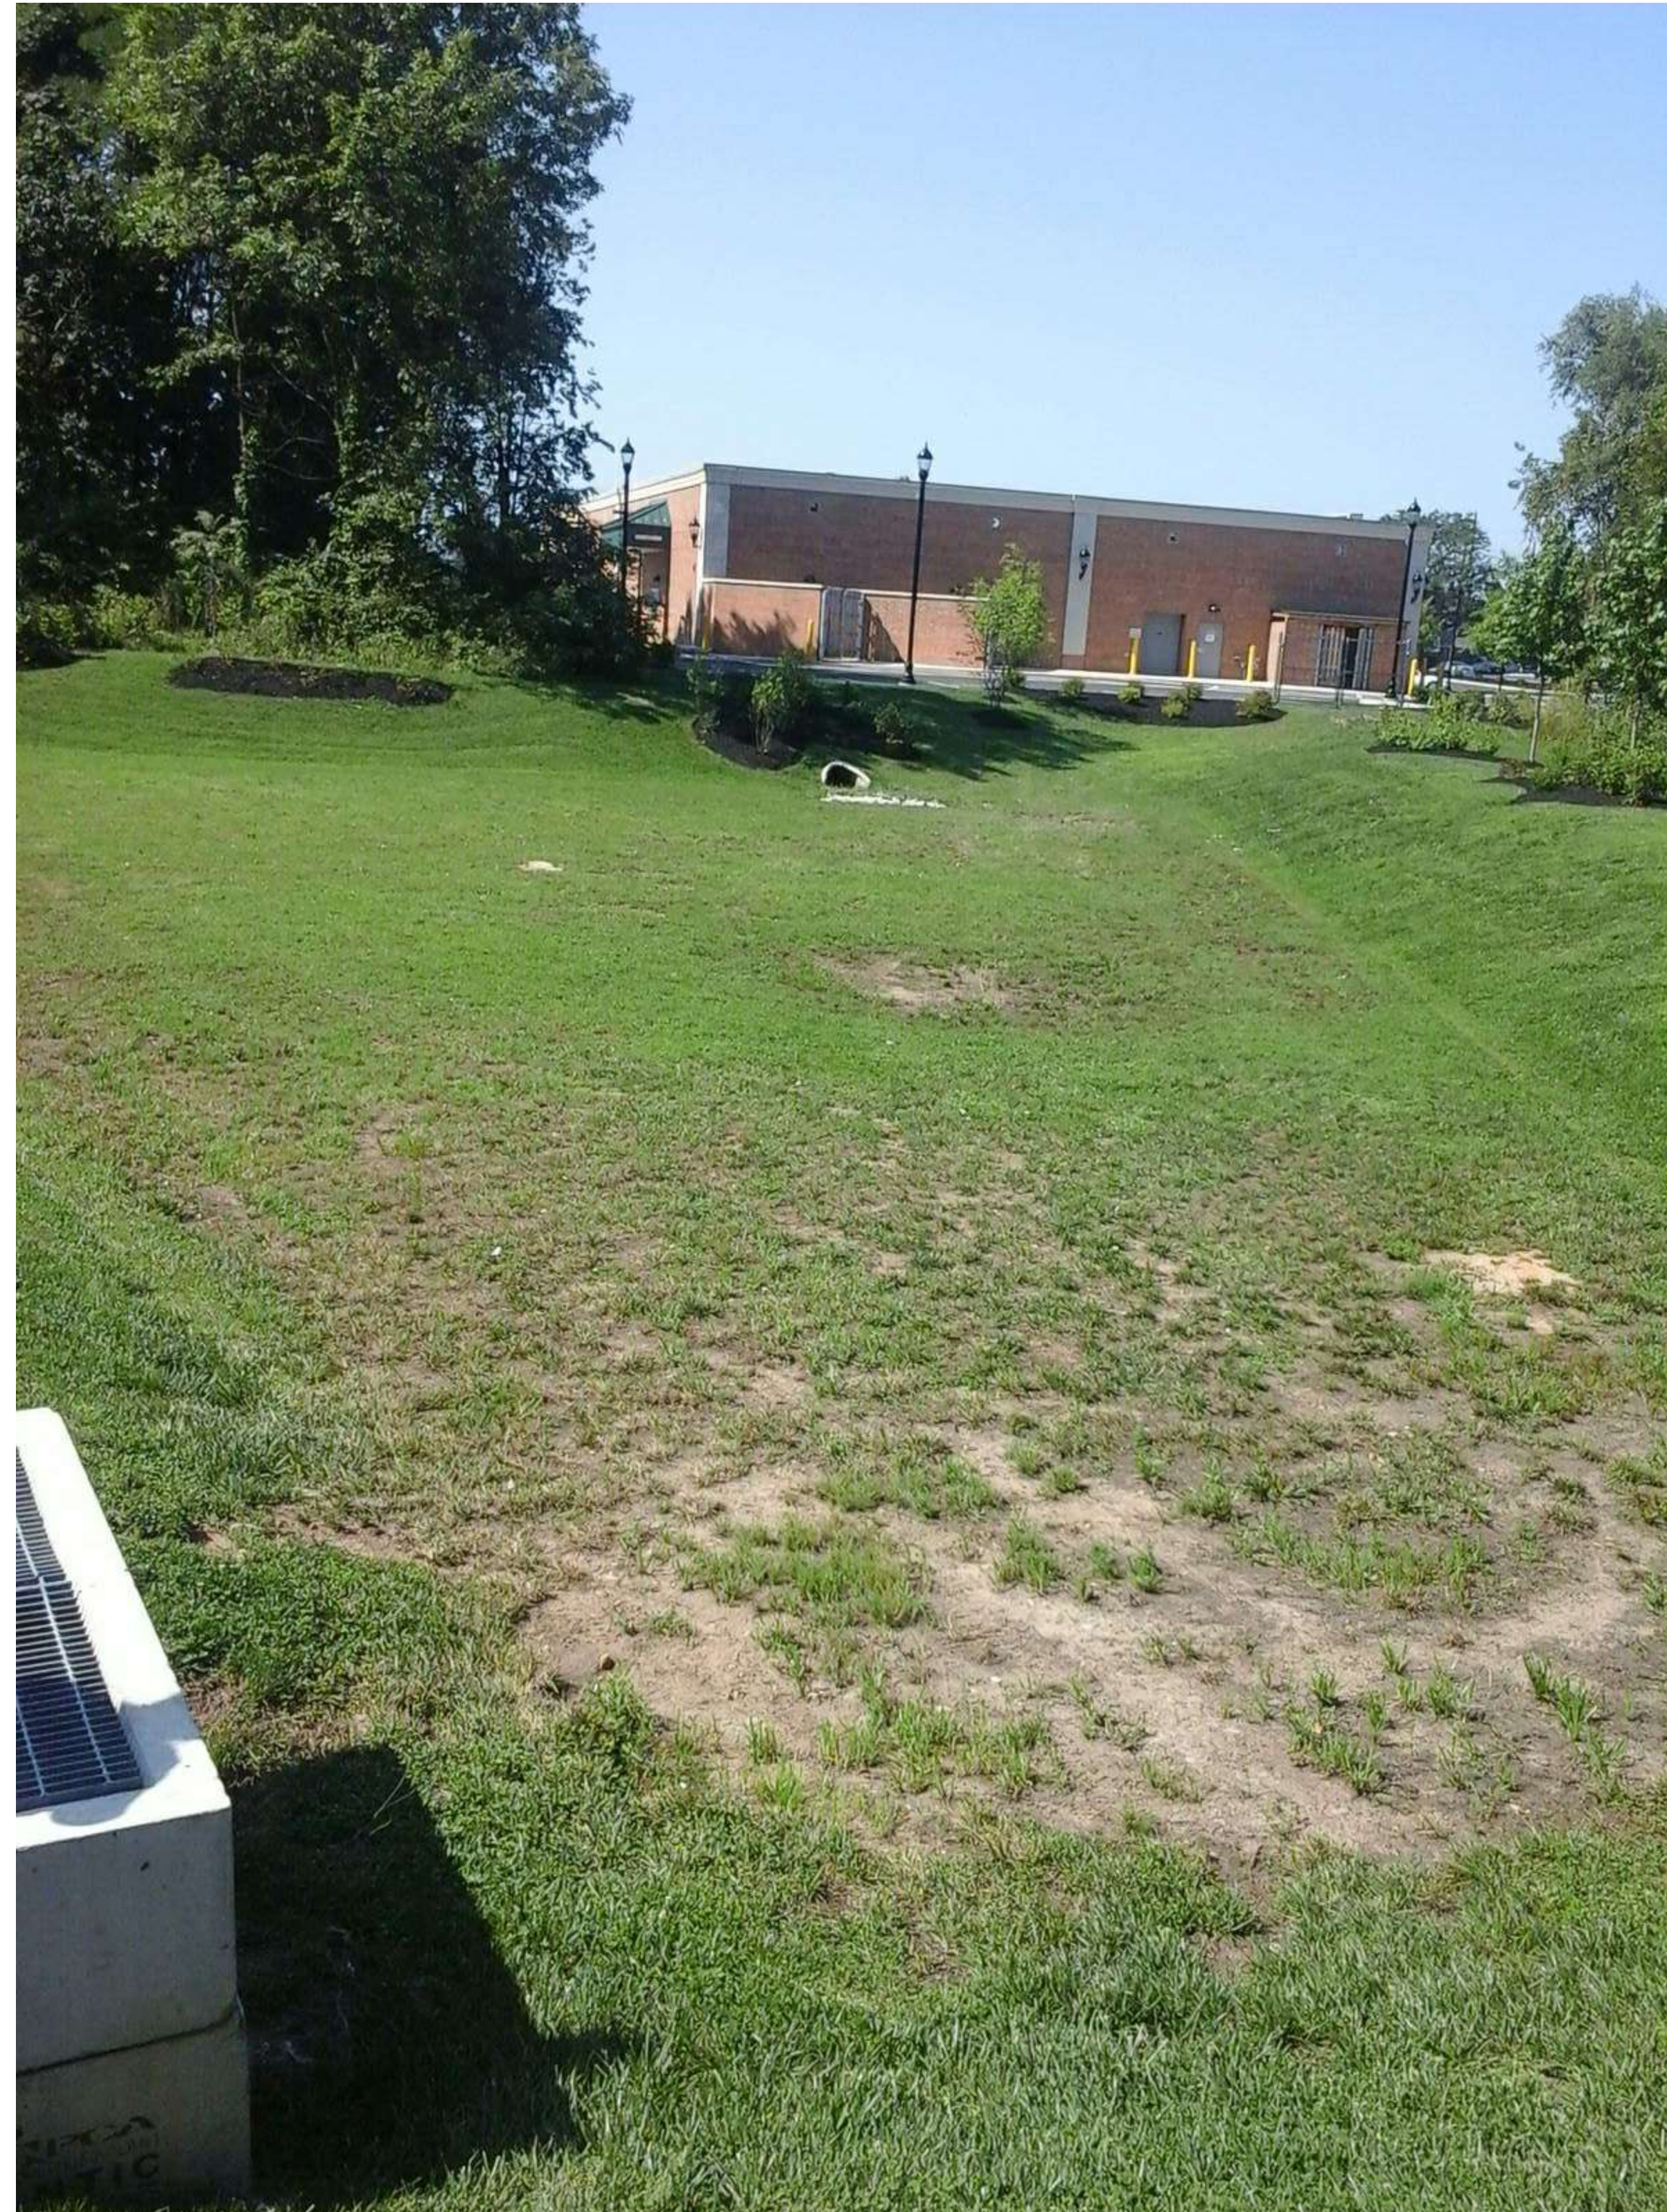
Overview of basin

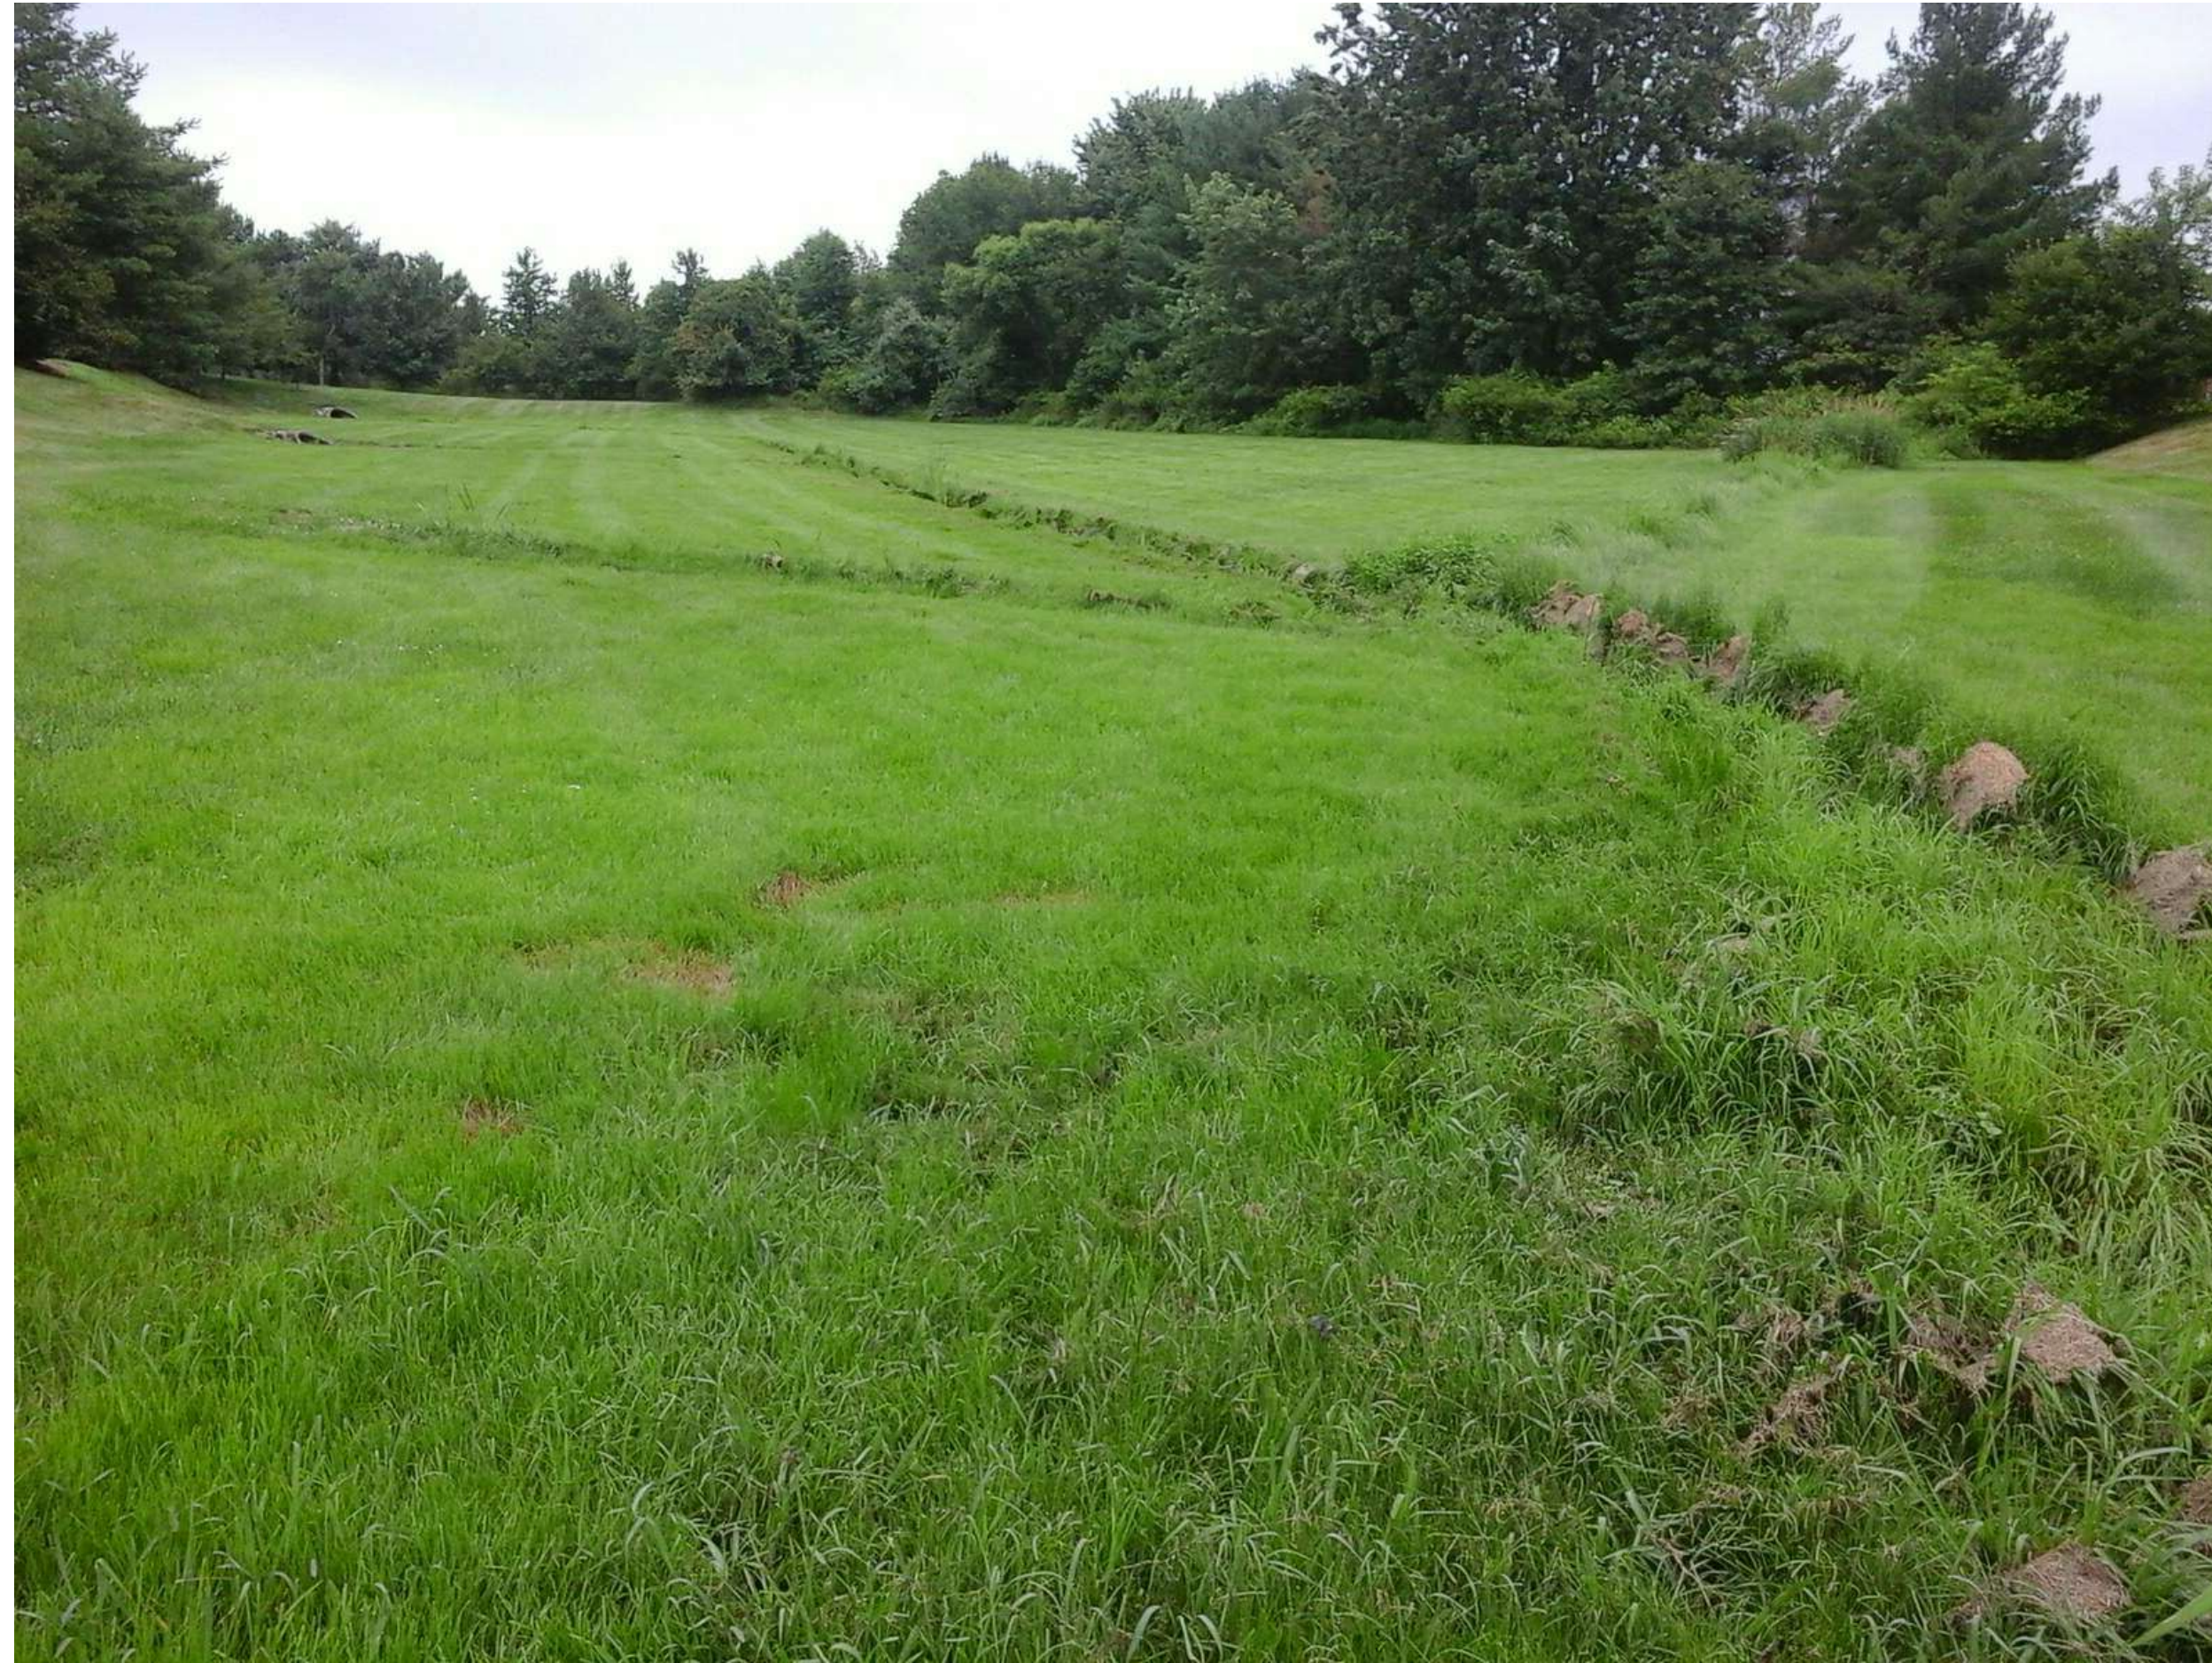
Overview of basin

- Sediment and debris accumulation at outlet grate
- Standing water noted in basin bottom and outlet
- Use stone lined channels to increase infiltration
