**Hamilton Township (Mercer County)
Stormwater Basin Assessment Summary
Hamilton Owned Addendum (Year 5A)**

Developed by the Rutgers Cooperative Extension Water Resources Program
Funded by Hamilton Township, Mercer County, New Jersey

November 27, 2019

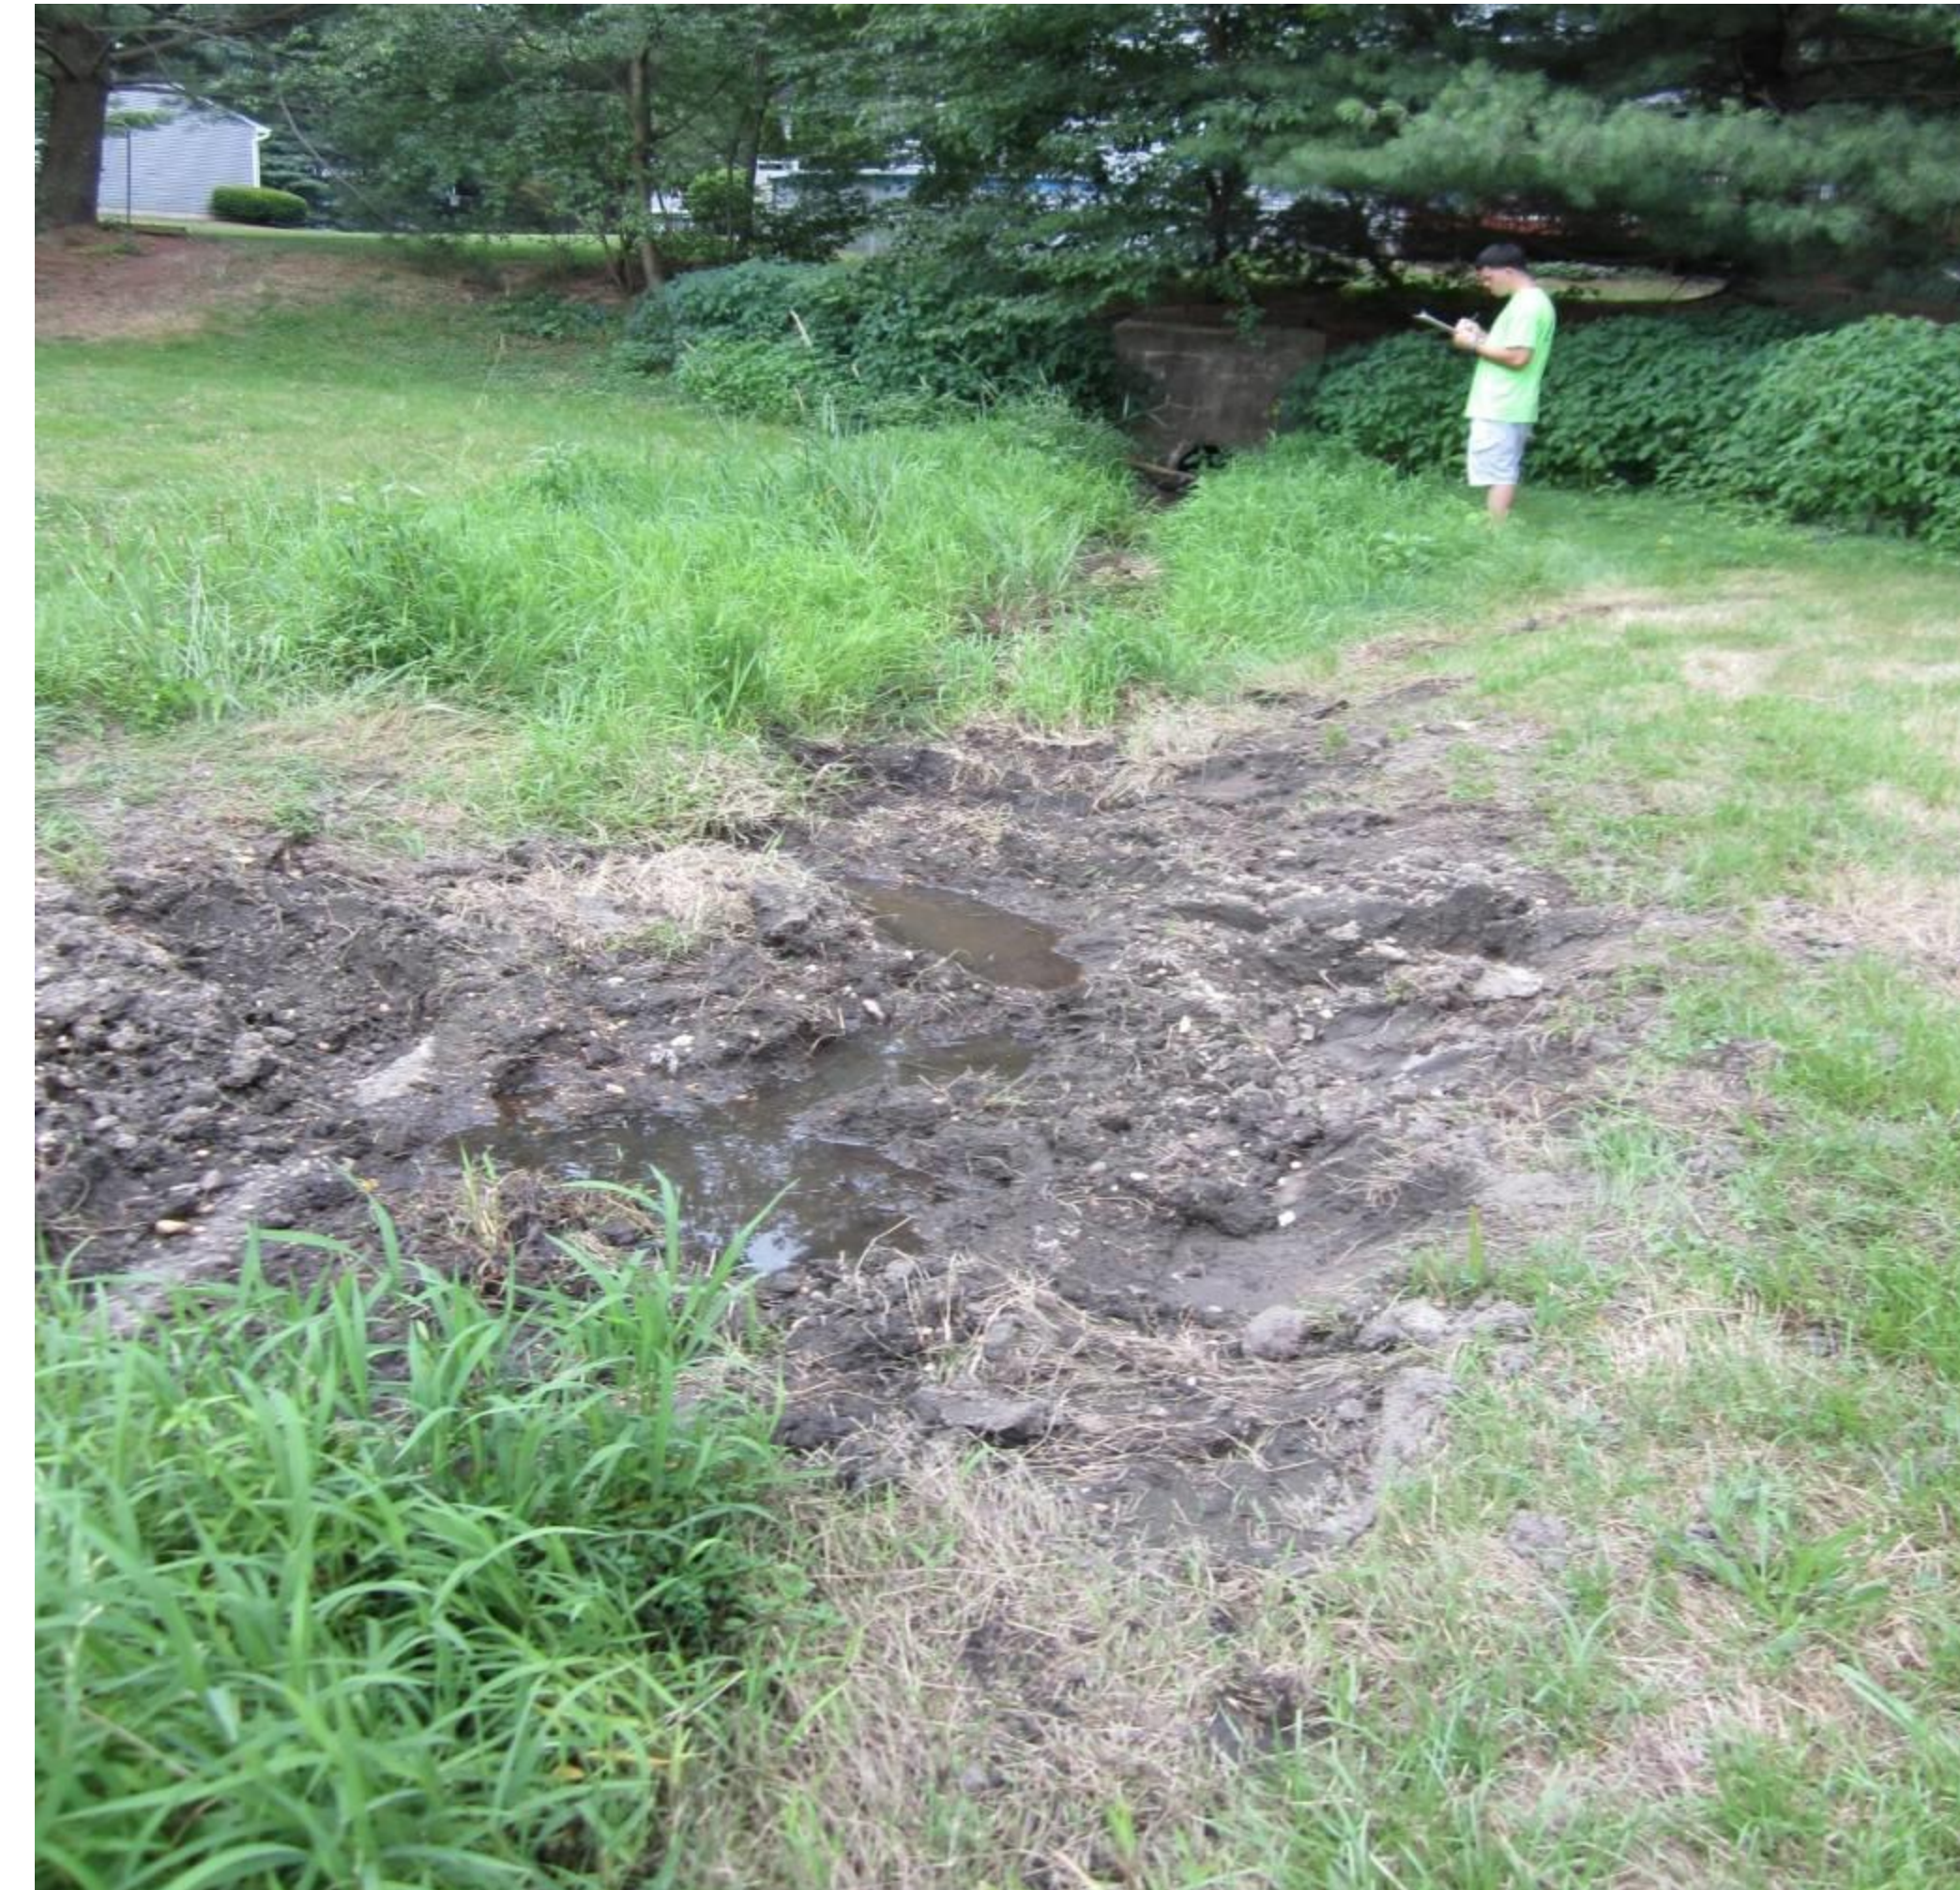
Clogged low flow and outlet.

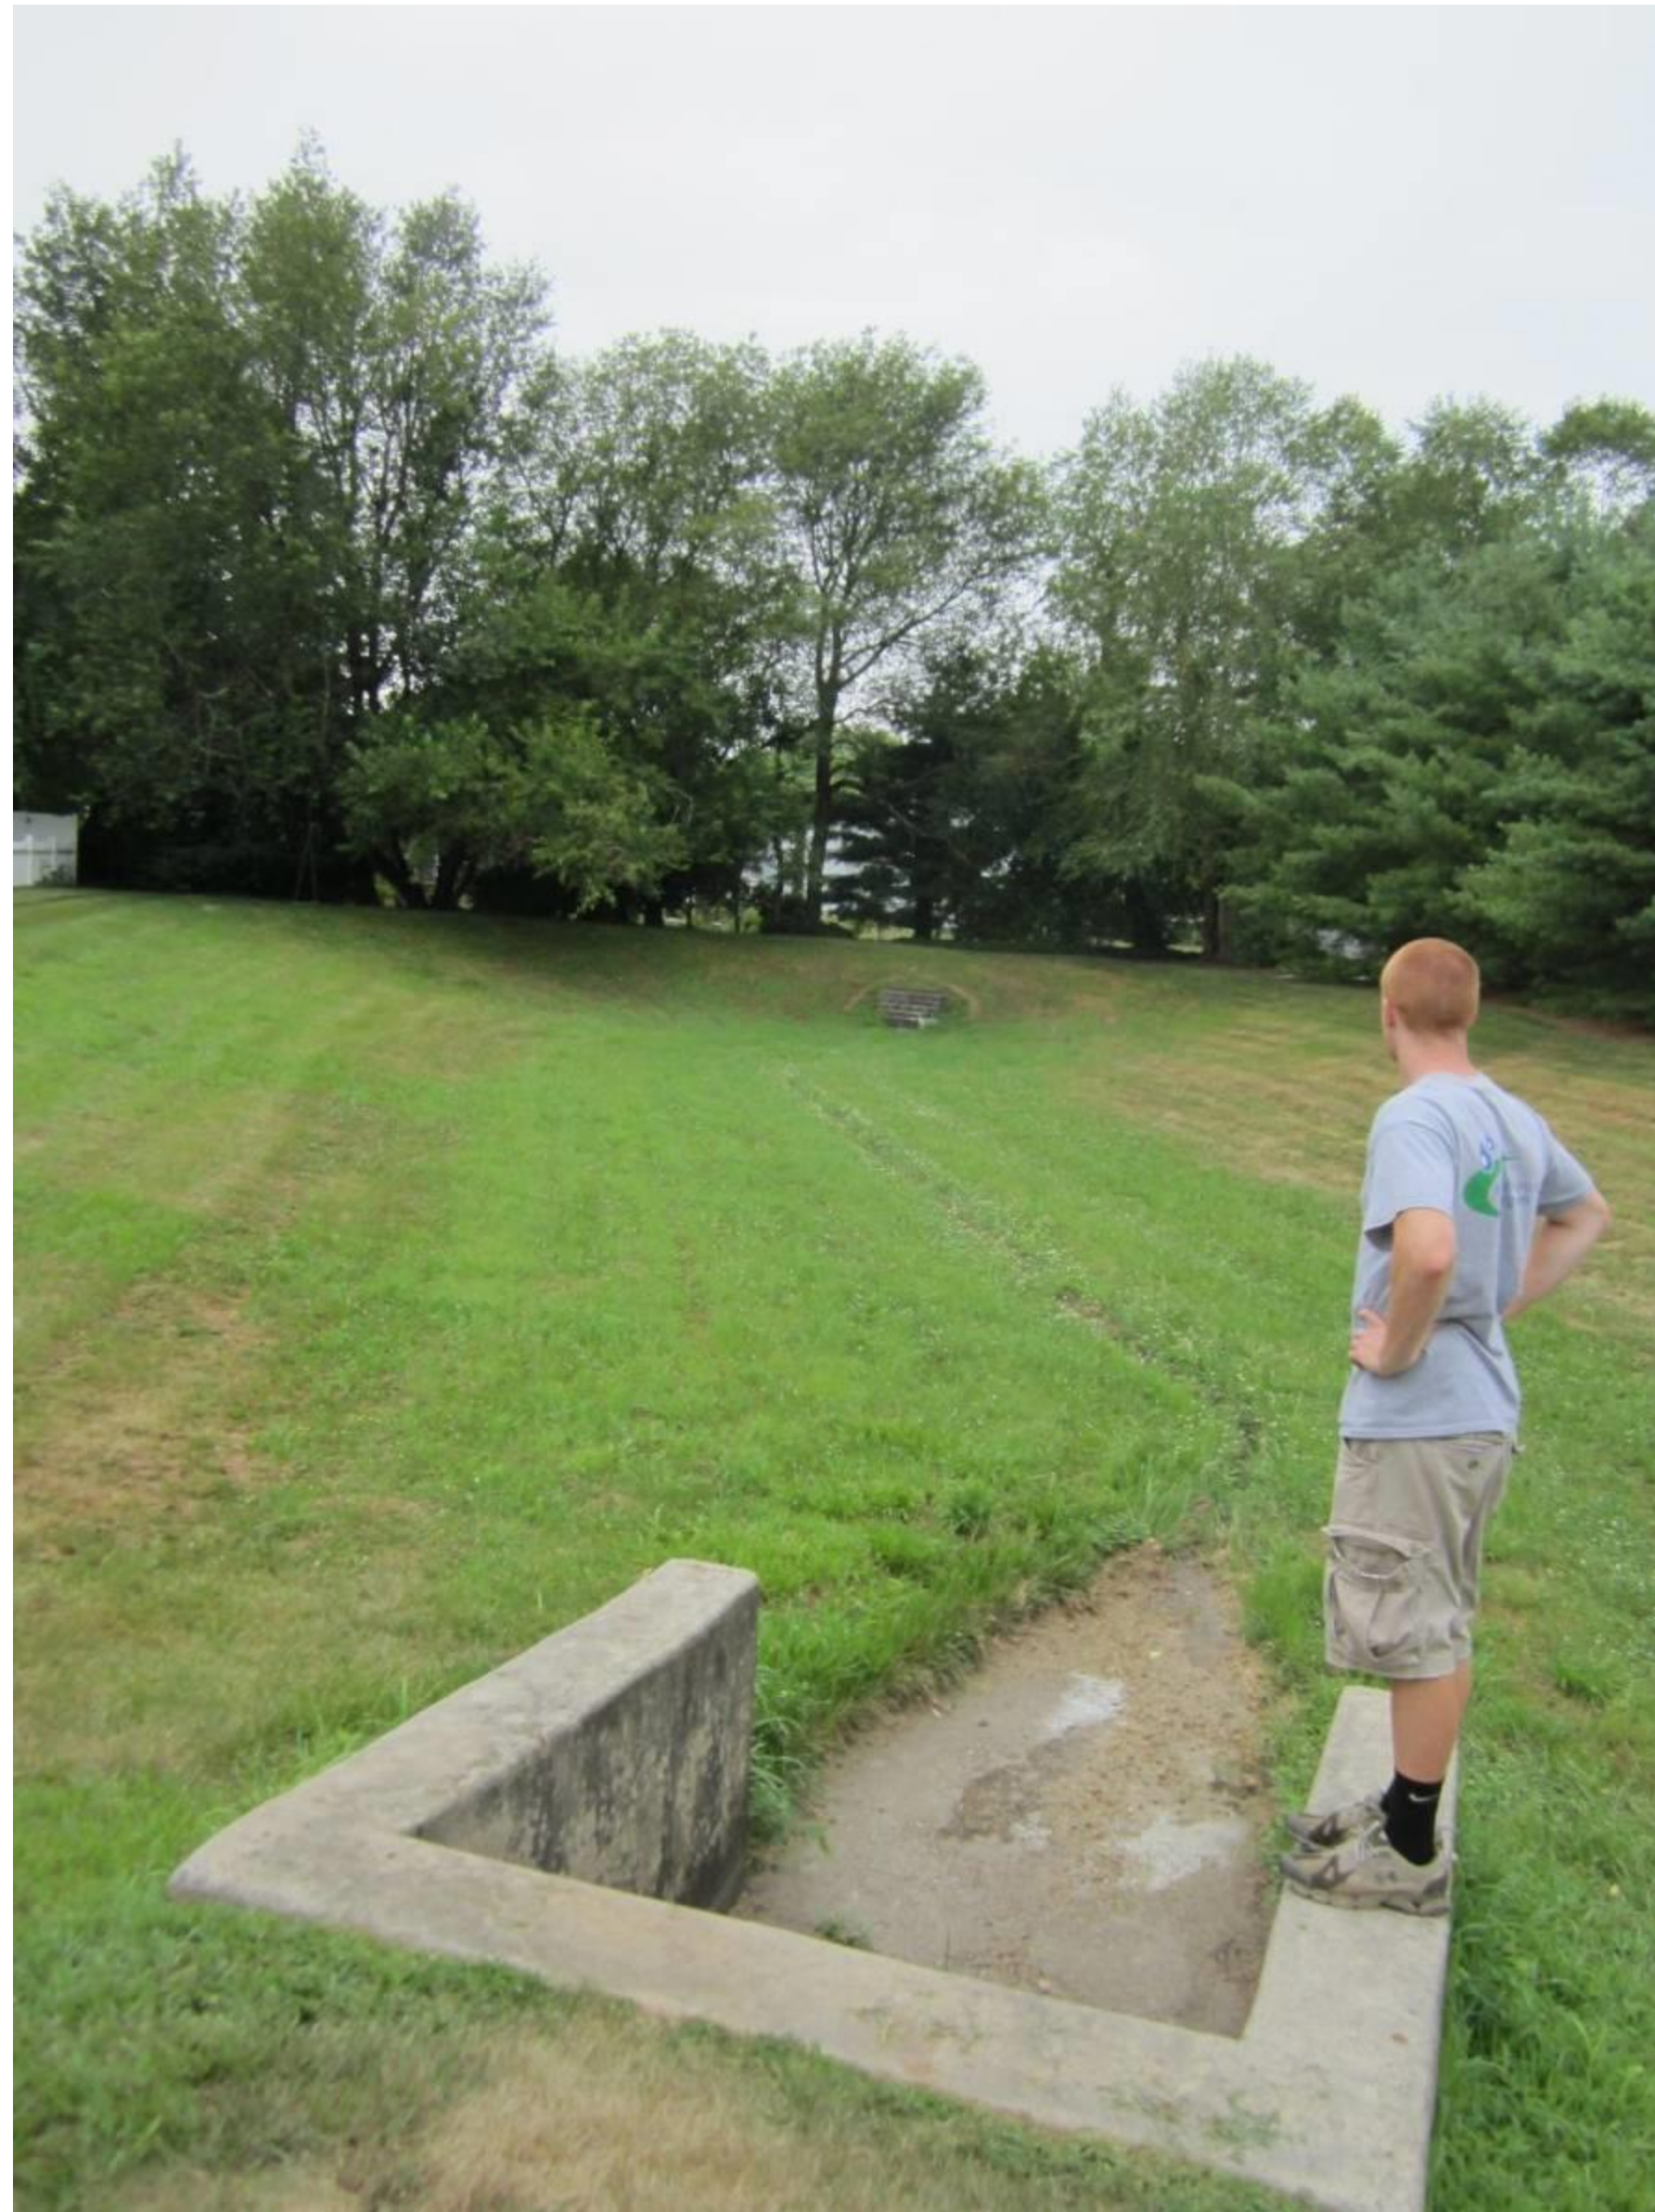
Basin bottom looking west

- Typical detention basin in good condition with one inlet and one outlet
- Rock flow channel opportunity
- Low flow channel could be removed and basin allowed to naturalize by reducing mowing

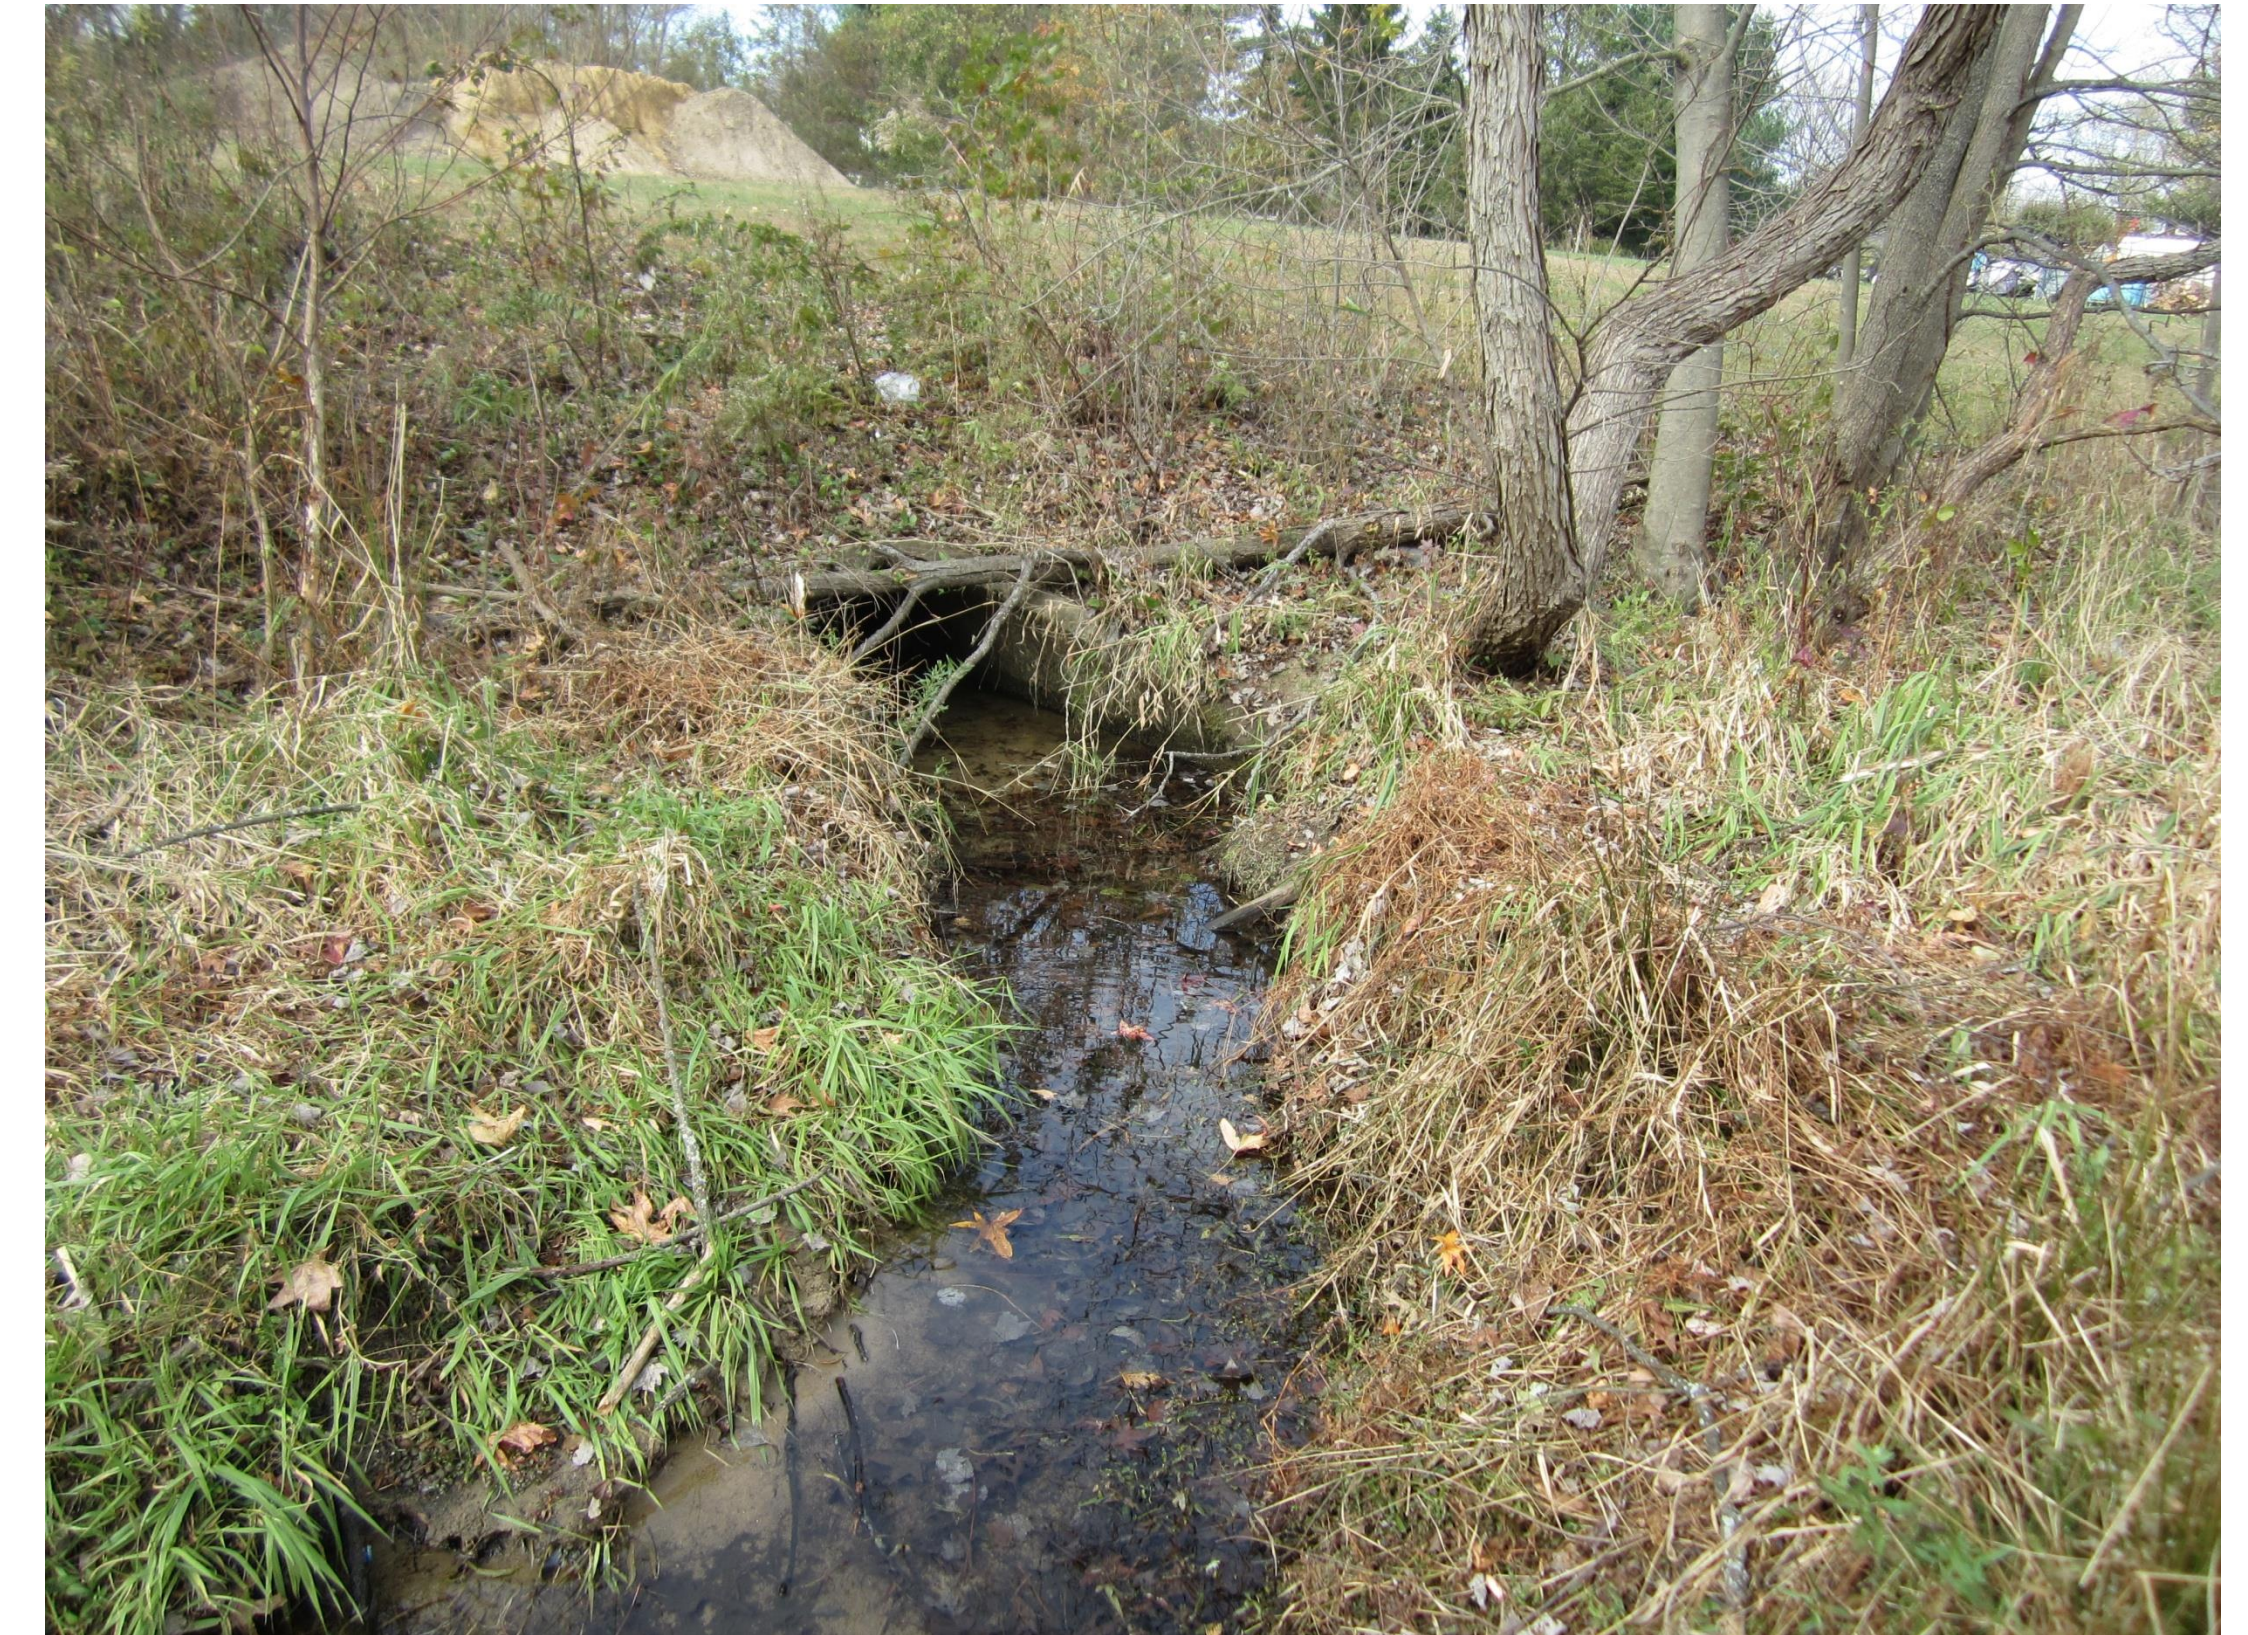
Inlet and erosion

- Basin is naturalized with dense vegetation
- Inlets and outlets are inaccessible due to vegetation growth in warm months
- Invasive plant species present including Phragmites and Purple Loosestrife
- Erosion present

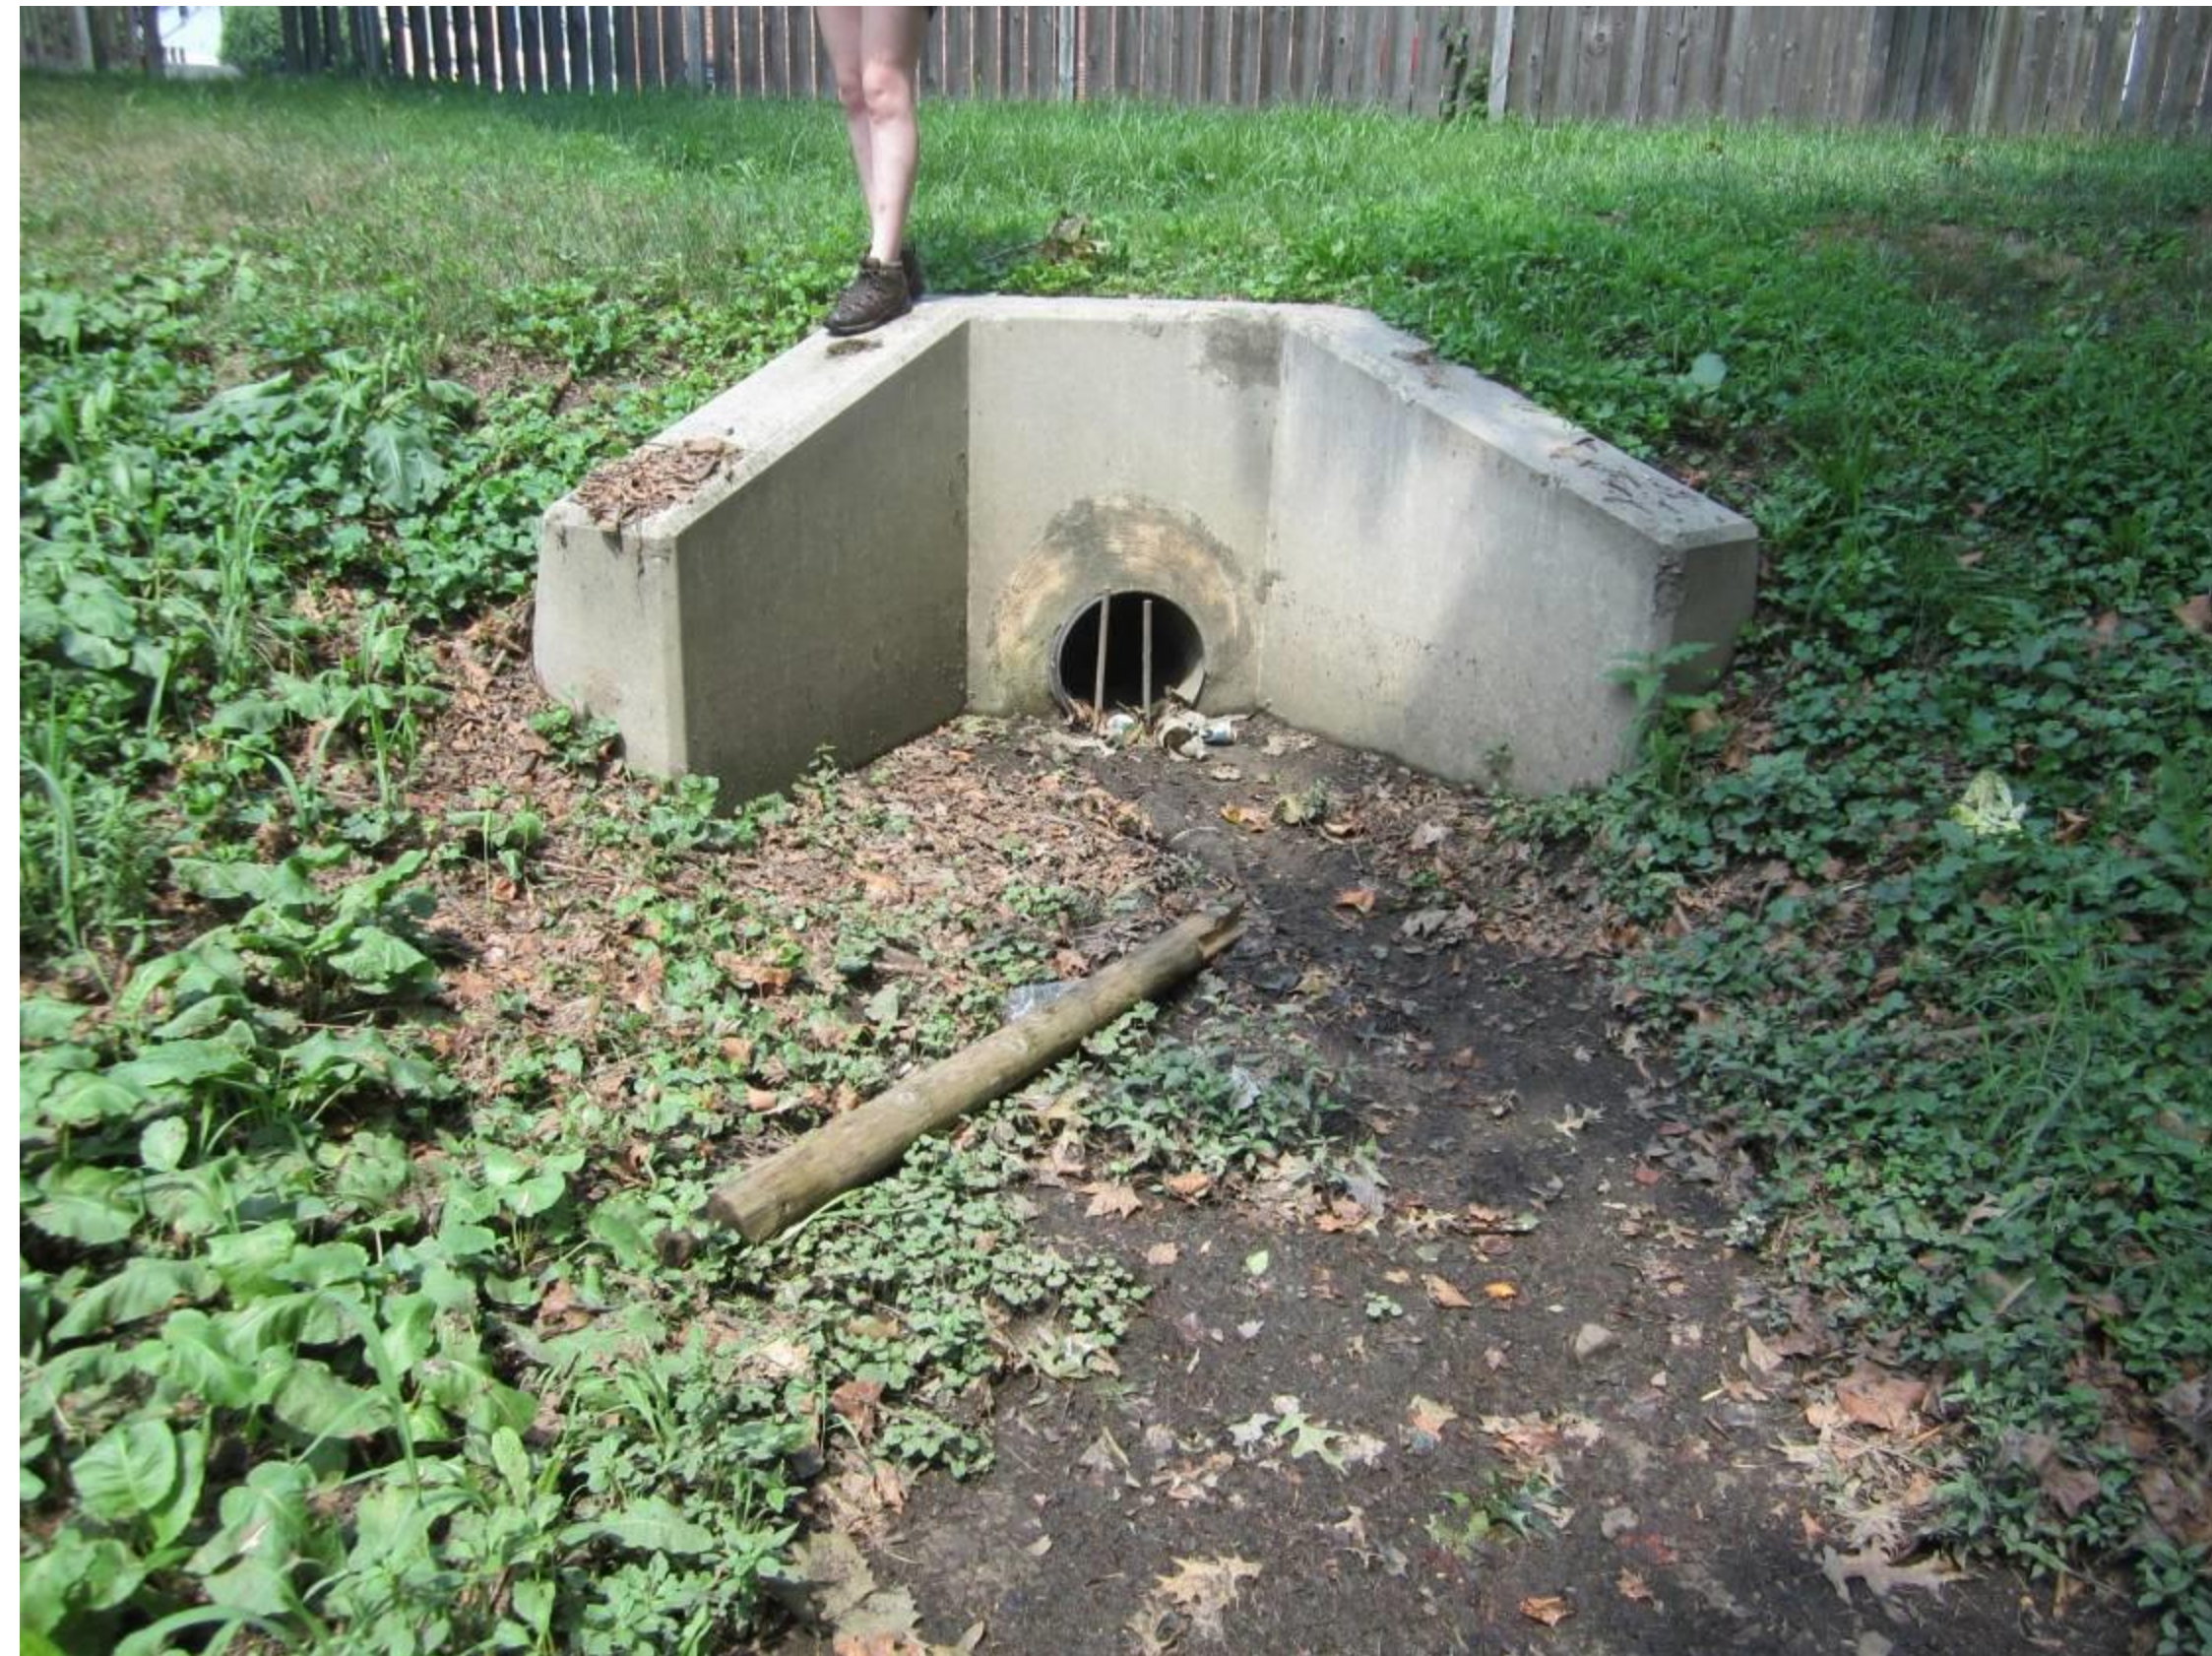
Inlet clogged with sediment

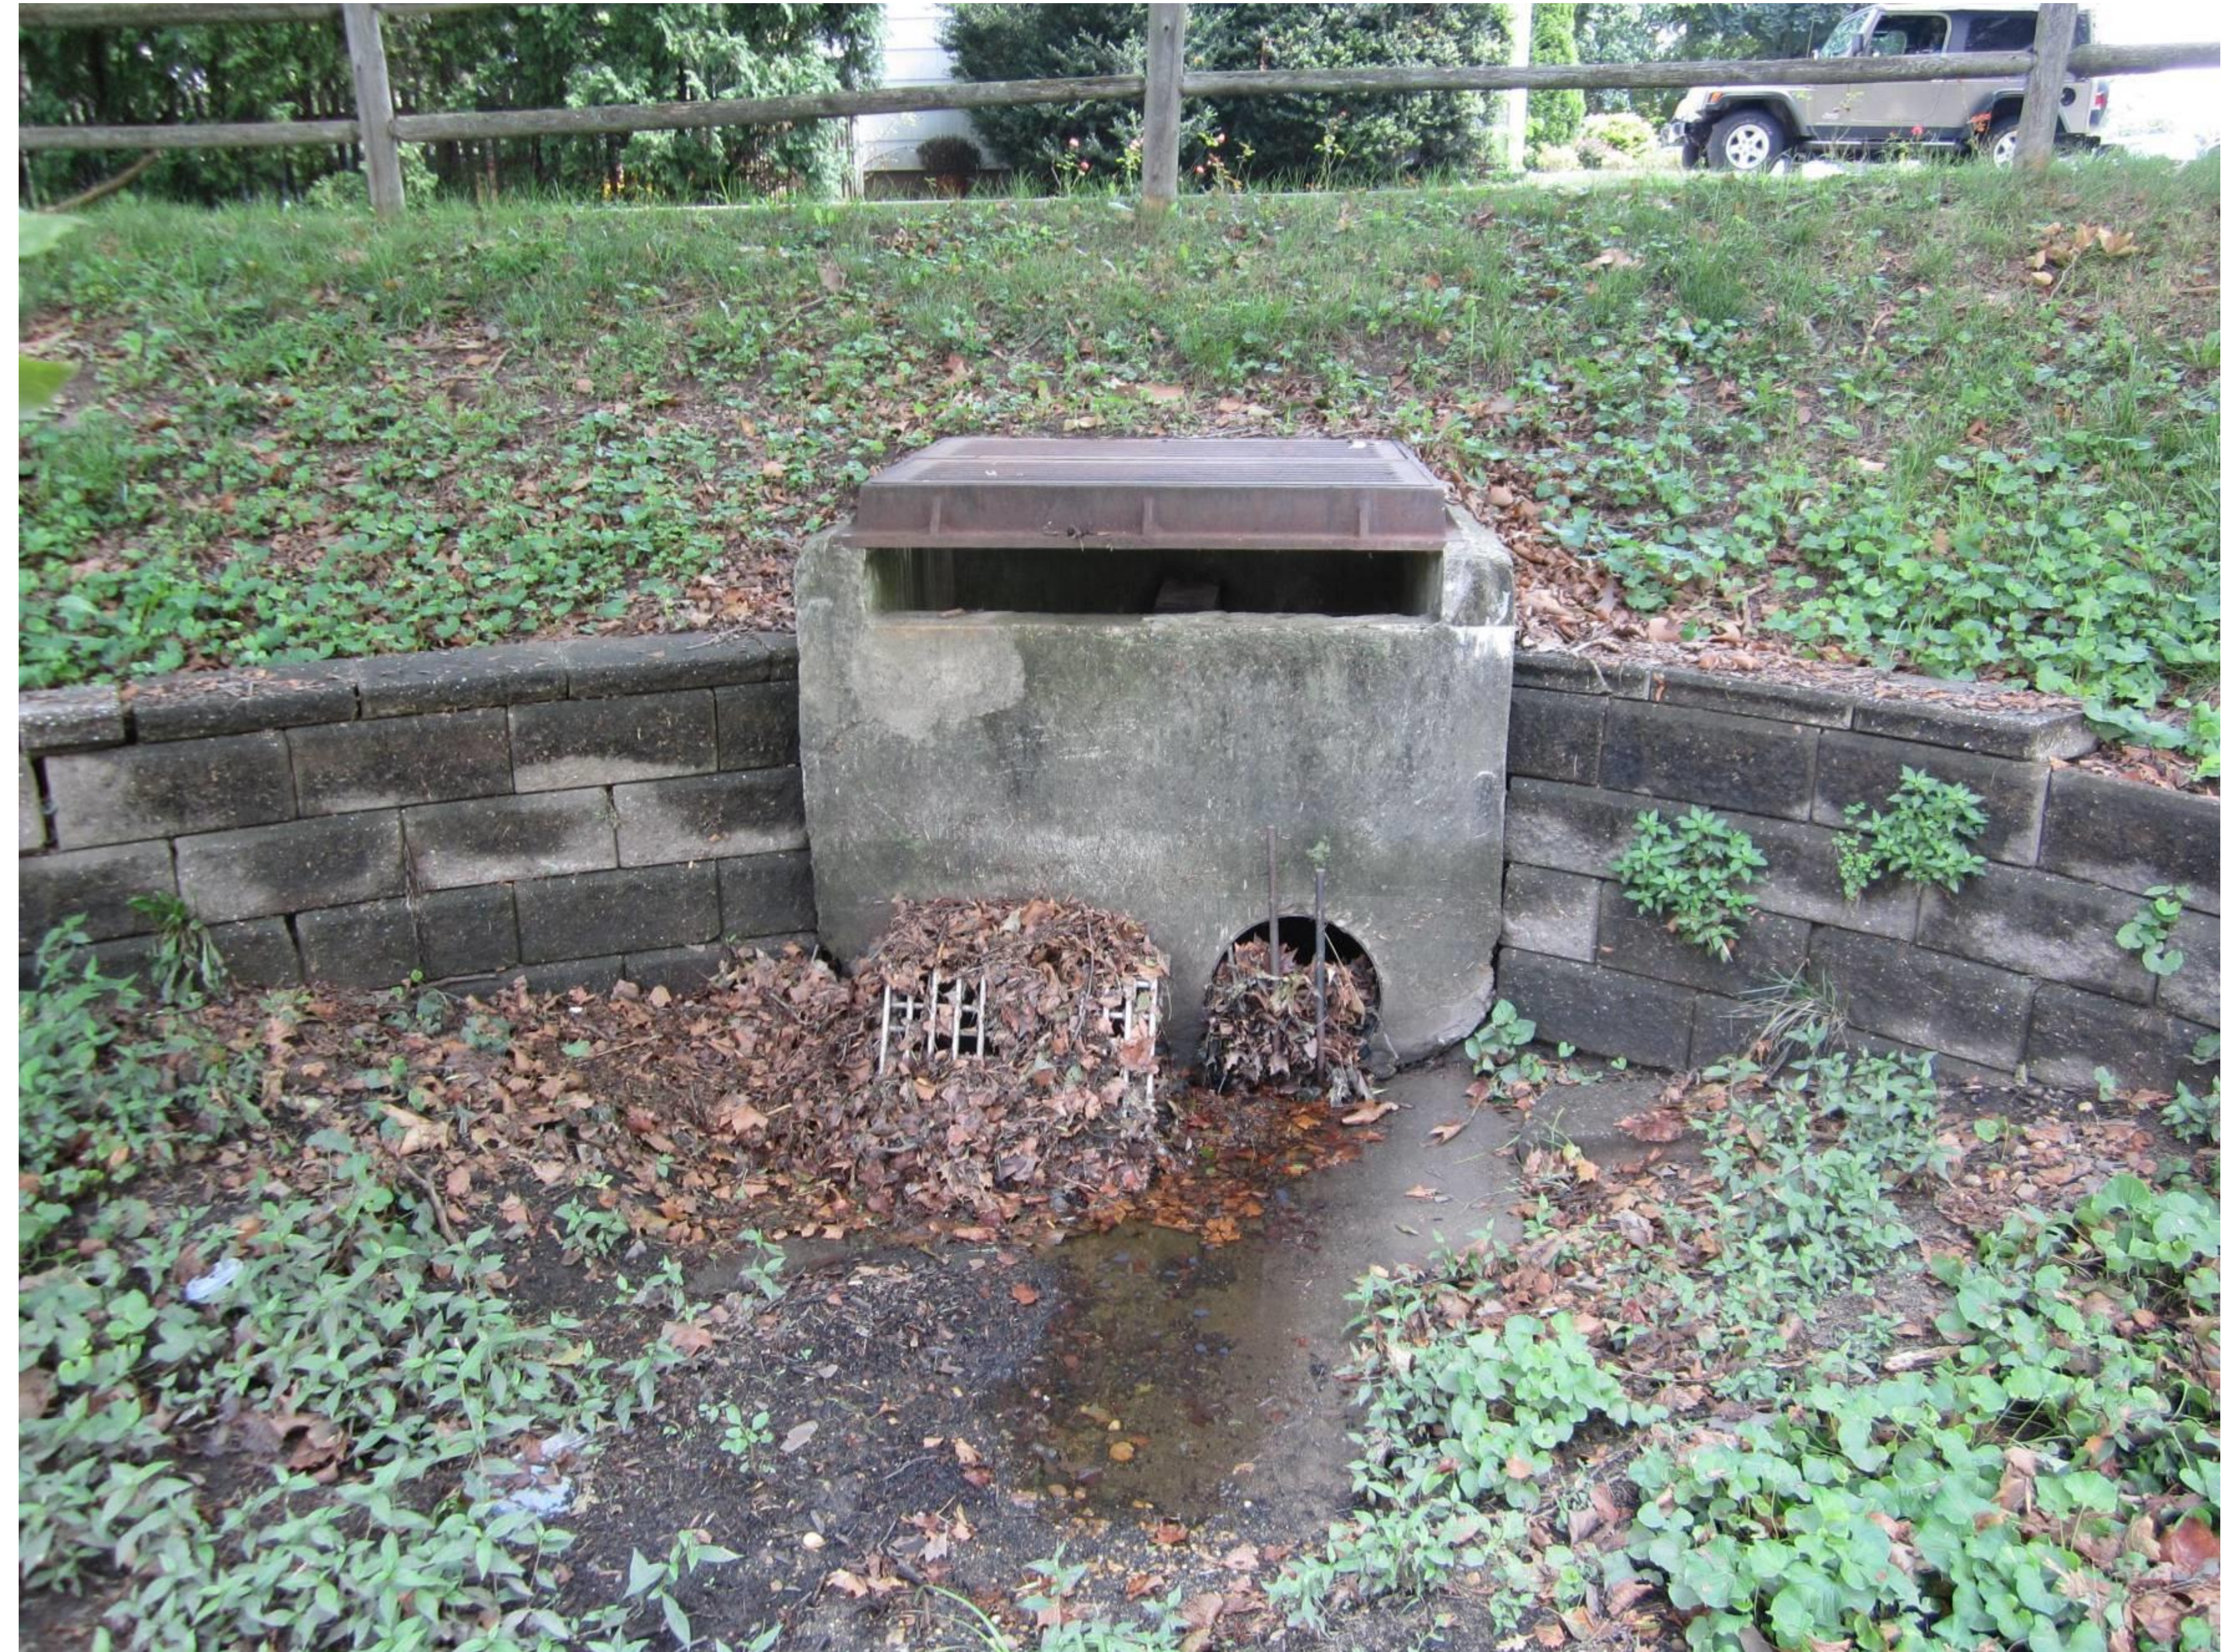
Clogged outlet structure

- Basin in overall good condition
- Some slight scouring along main flow channel
- Outlet clogged with leaves

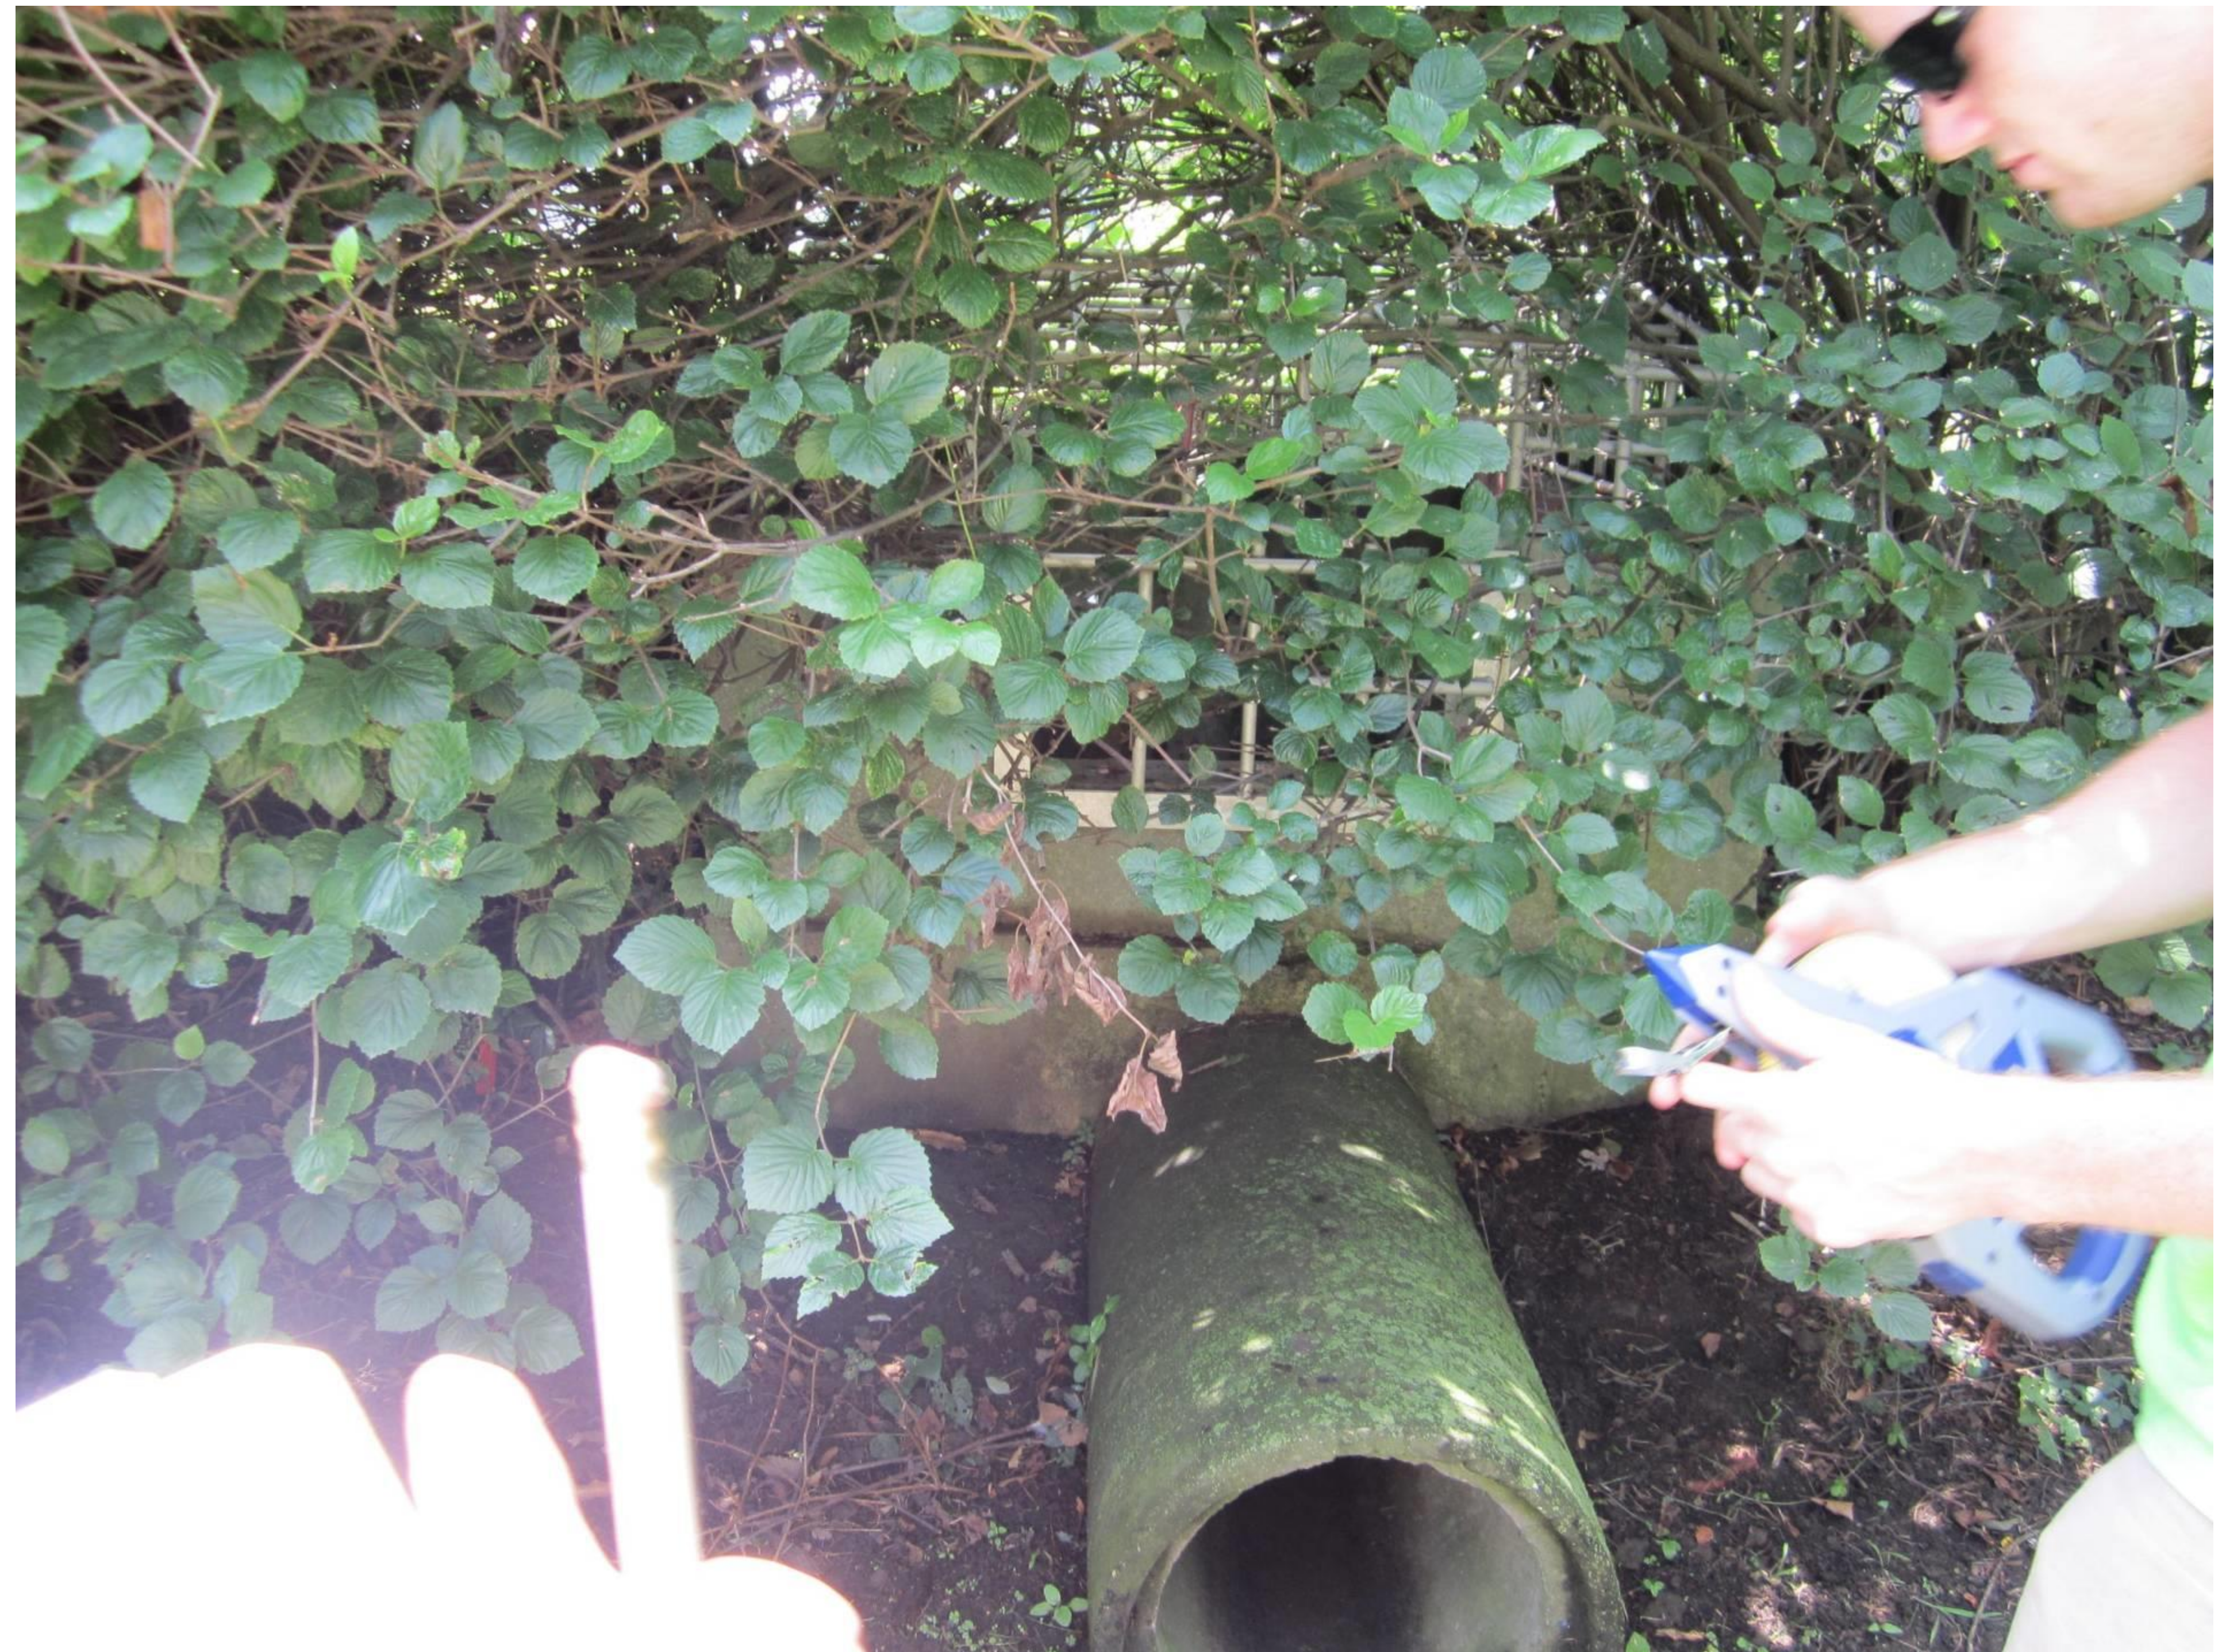
Woody vegetation growth around outlet
