**Hamilton Township (Mercer County)
Stormwater Basin Assessment Summary
Hamilton Owned Addendum (Year 5A)**

Developed by the Rutgers Cooperative Extension Water Resources Program
Funded by Hamilton Township, Mercer County, New Jersey

November 27, 2019

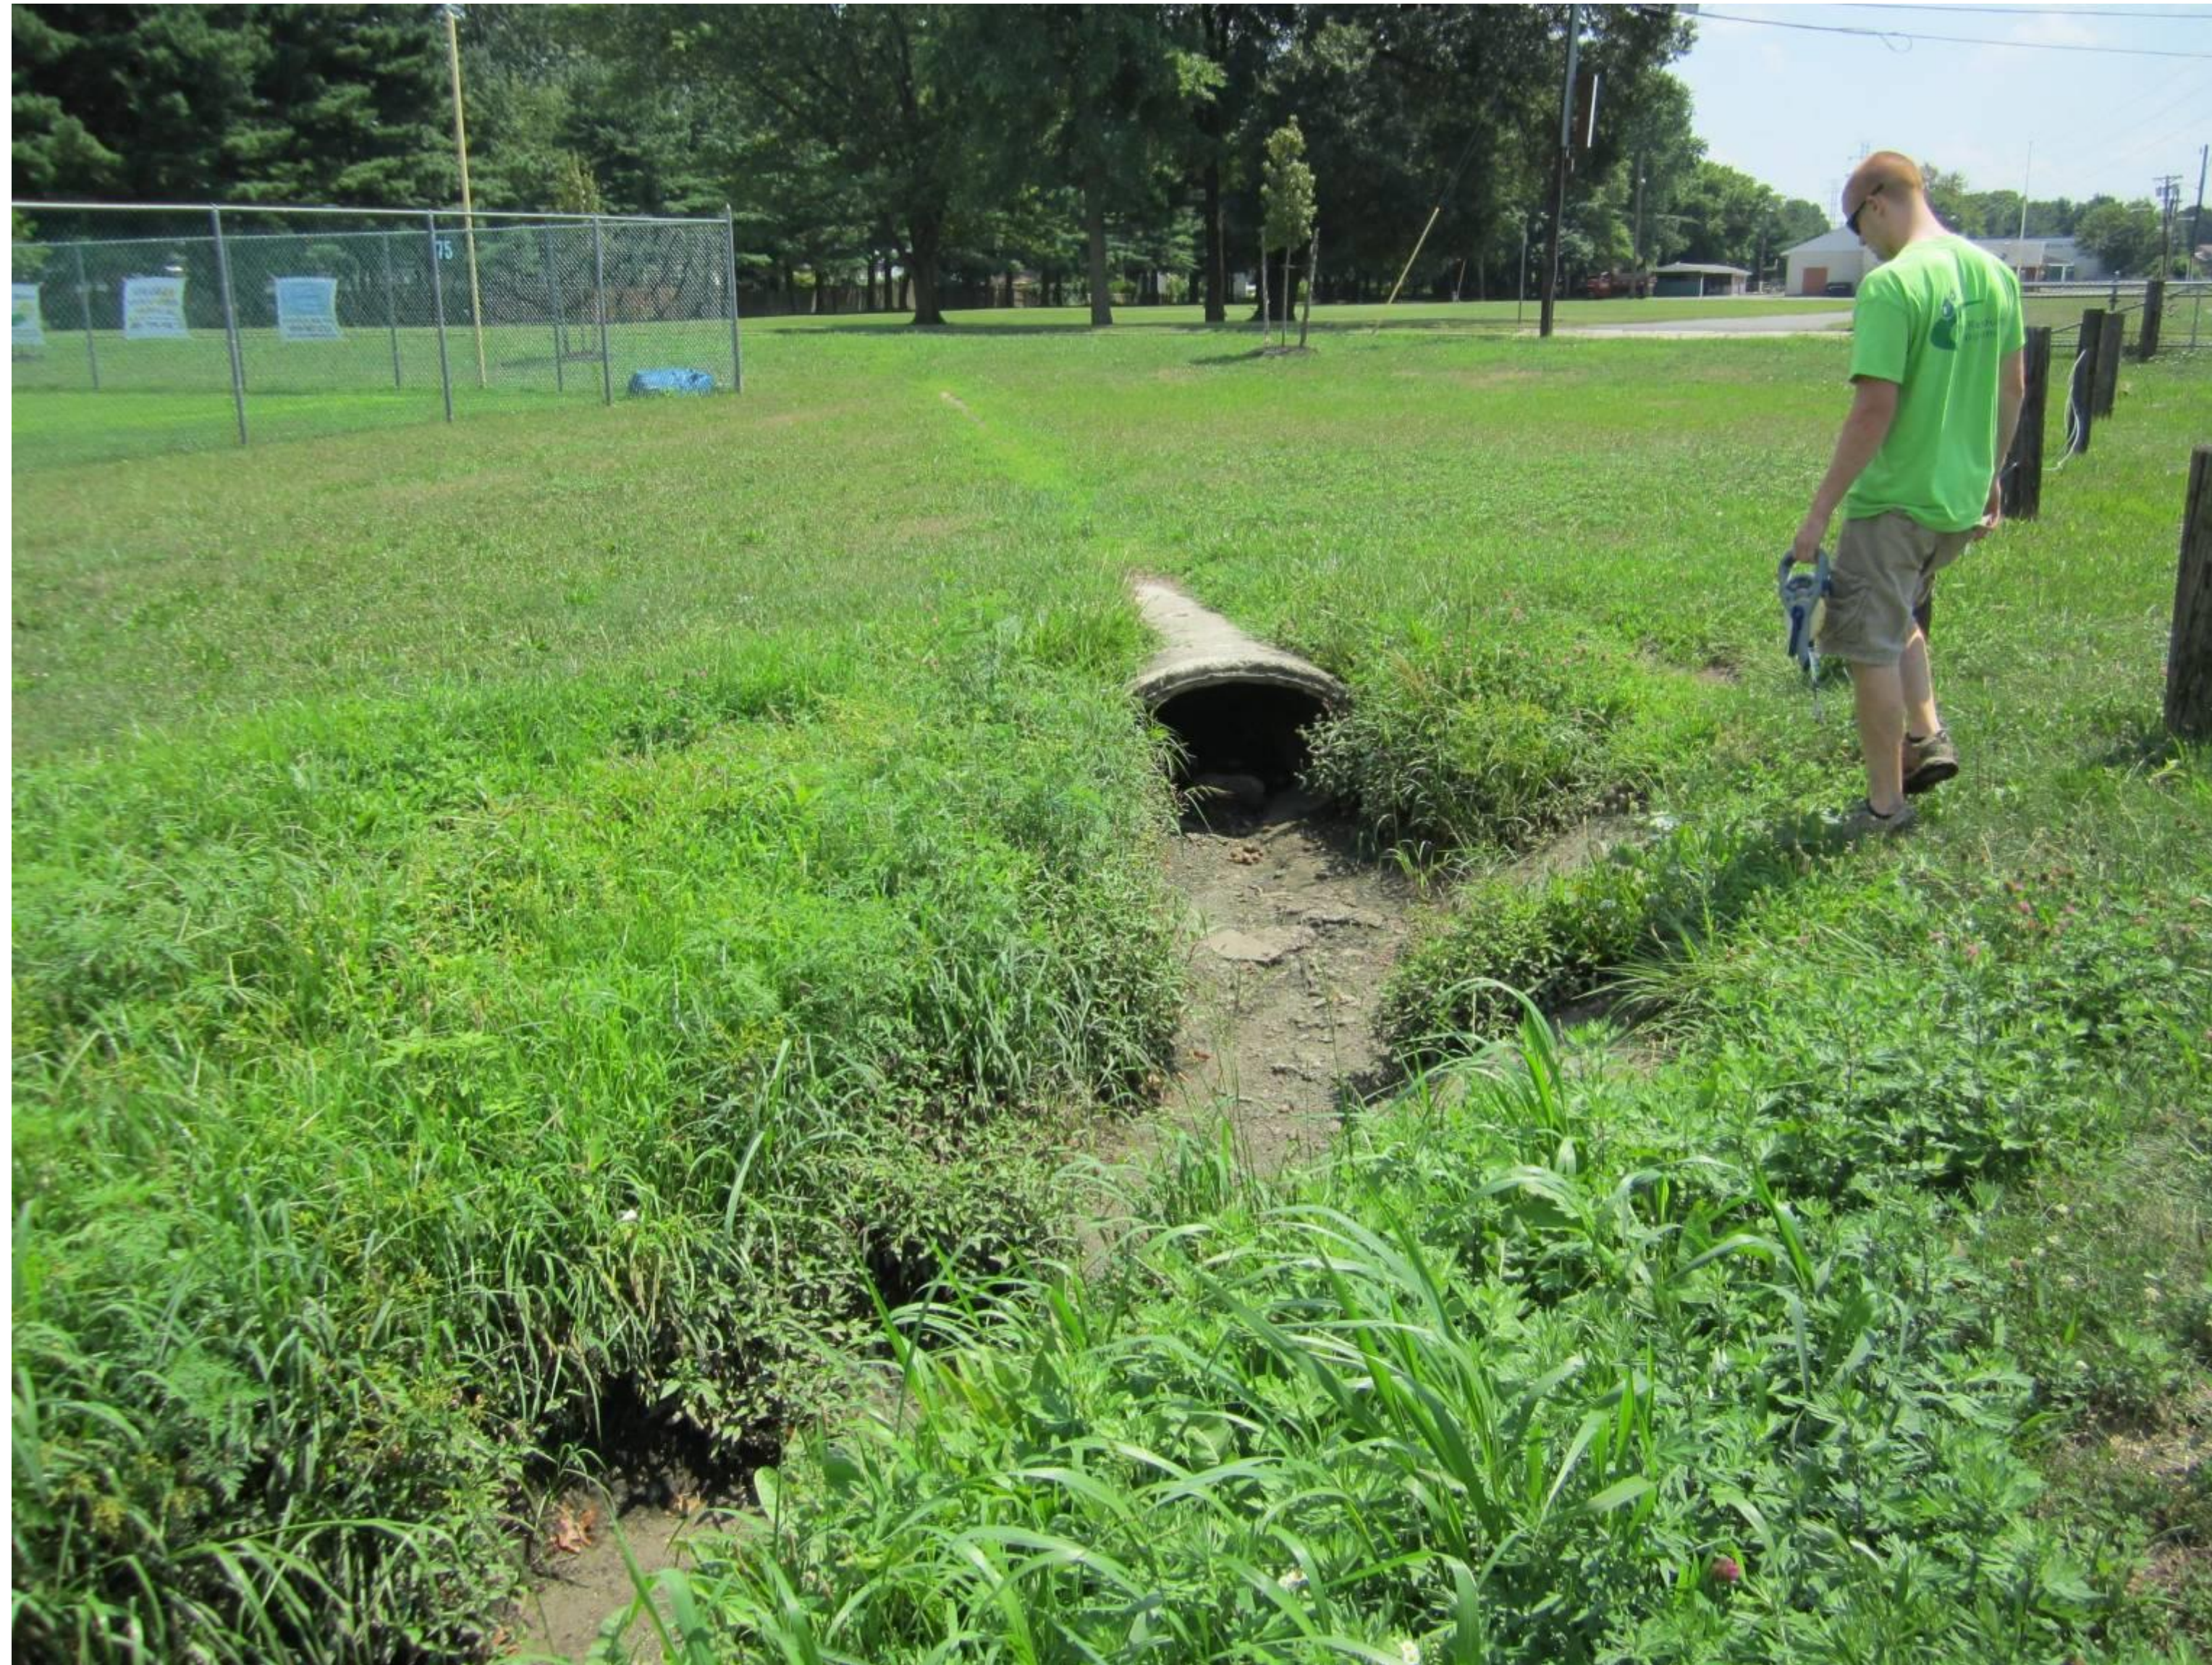
Inlet with sediment accumulation

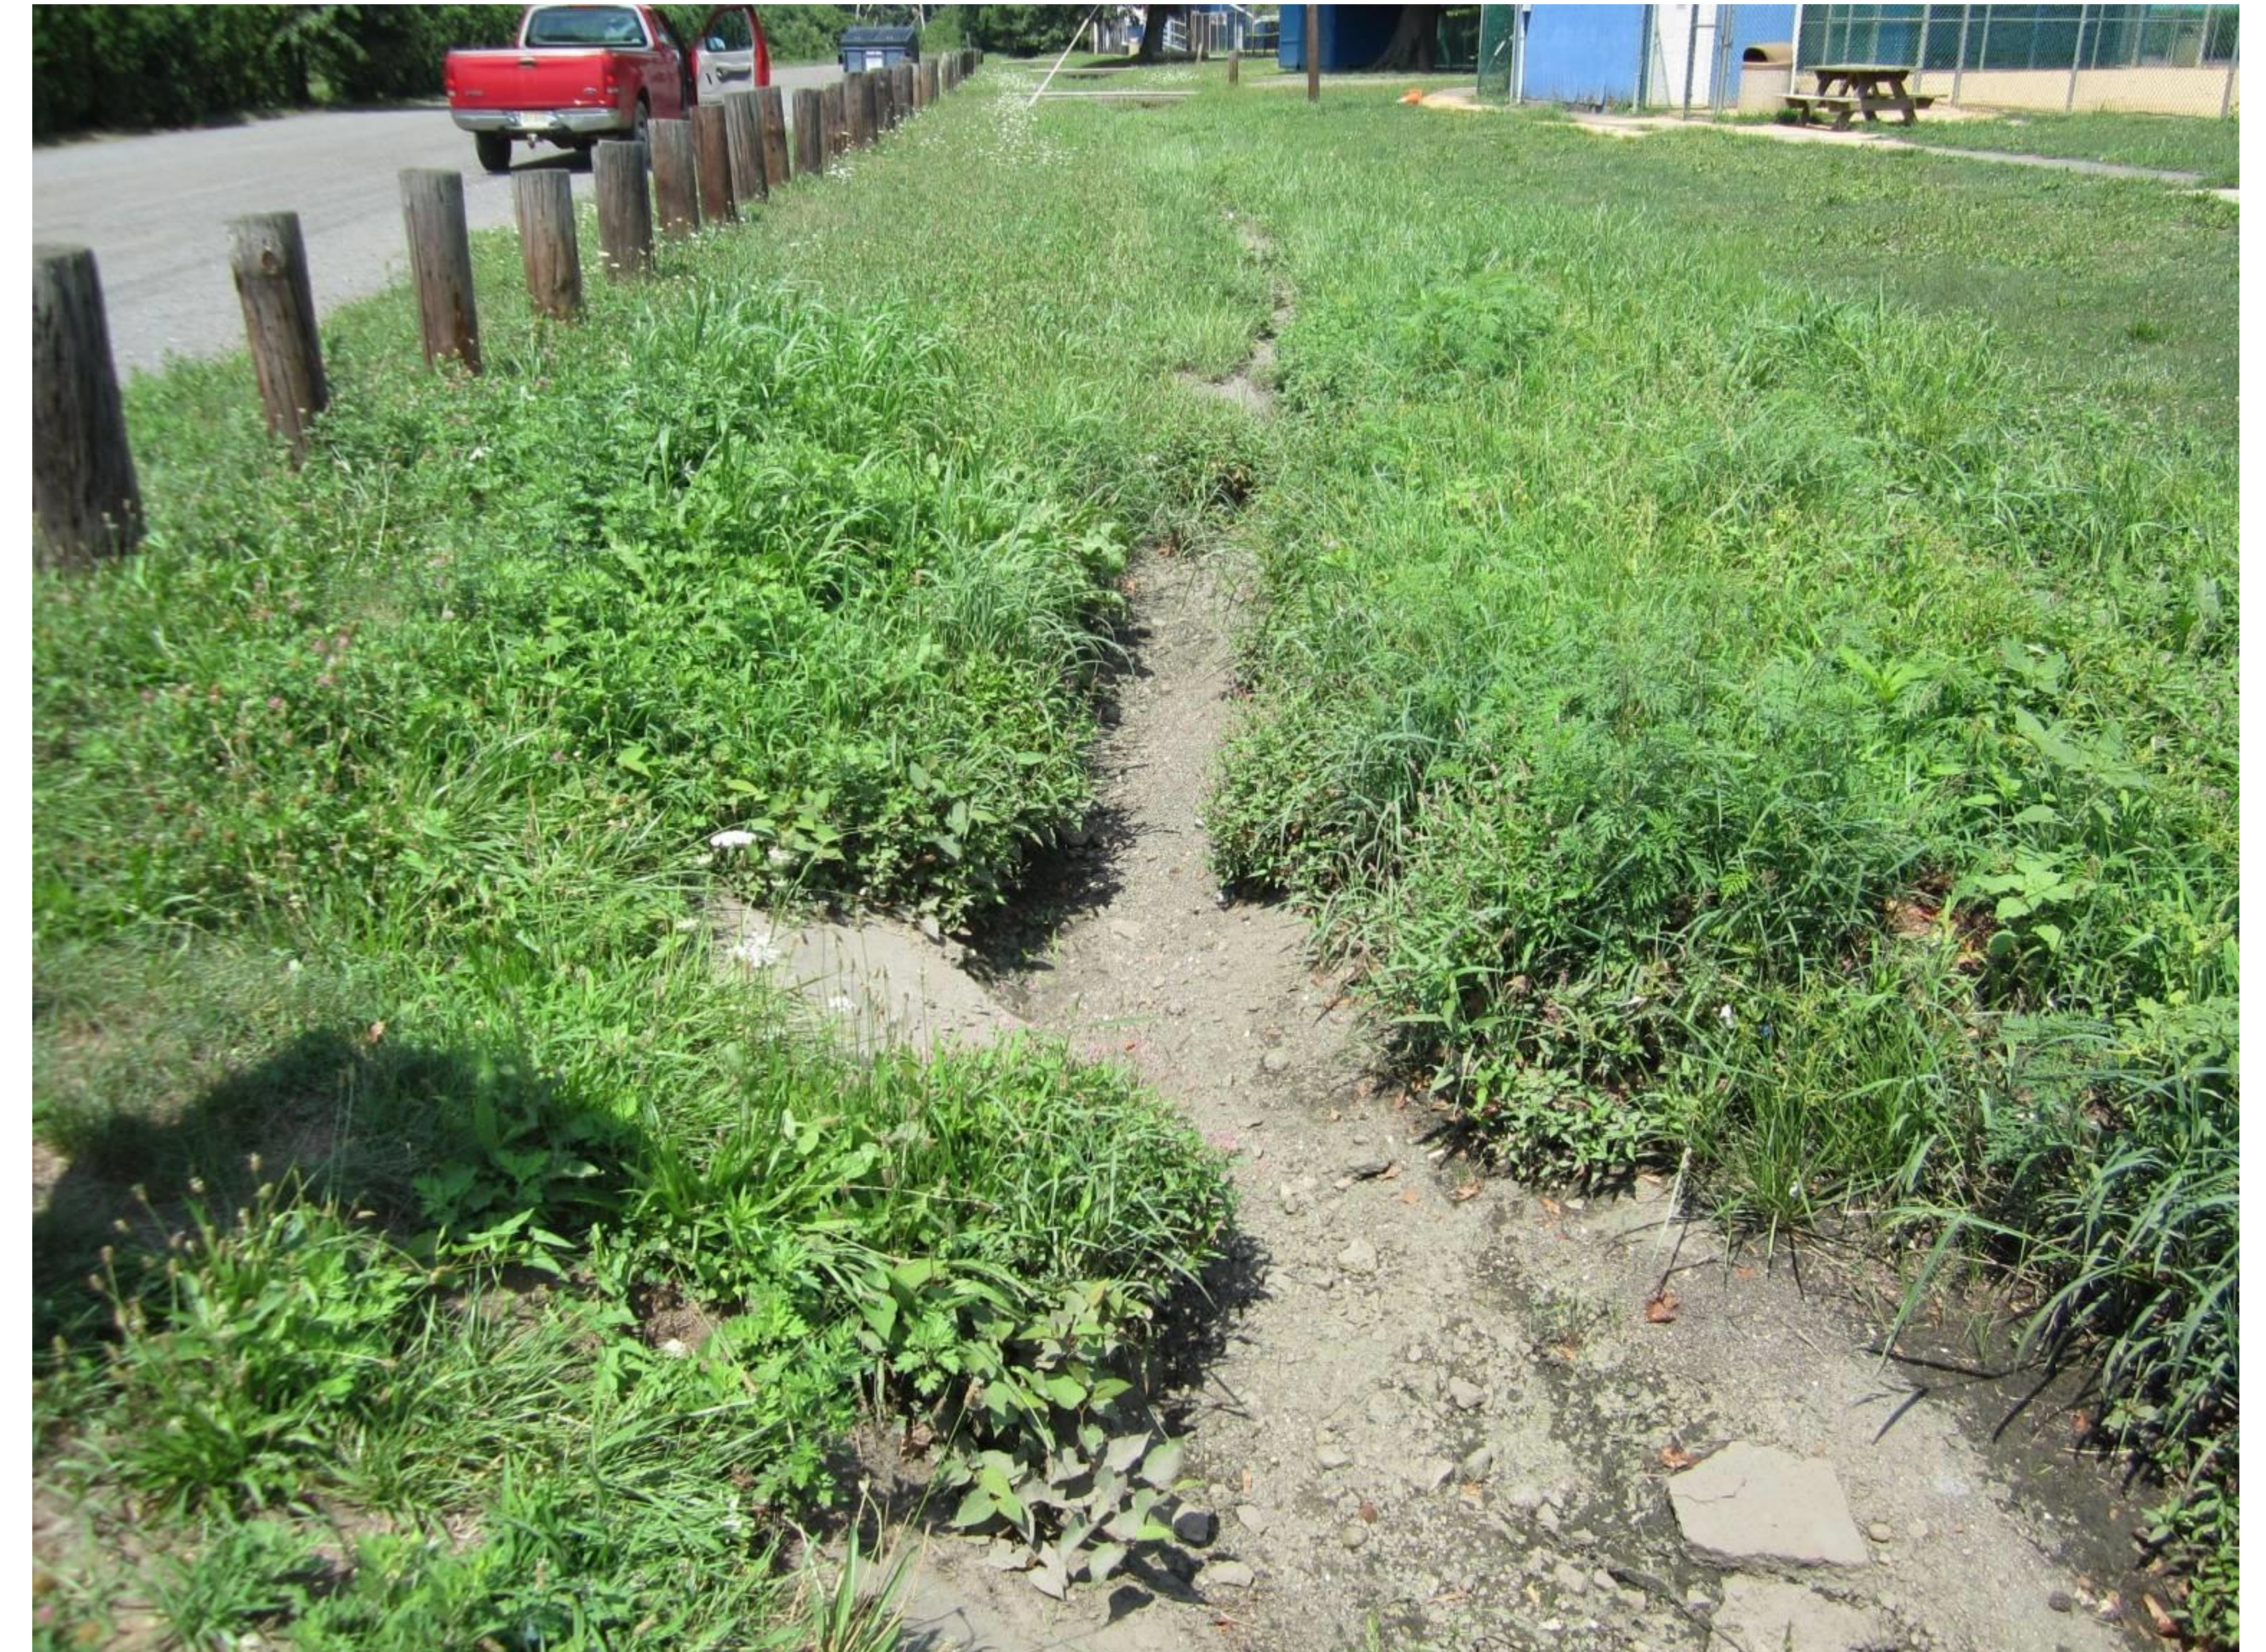
Basin bottom with erosion

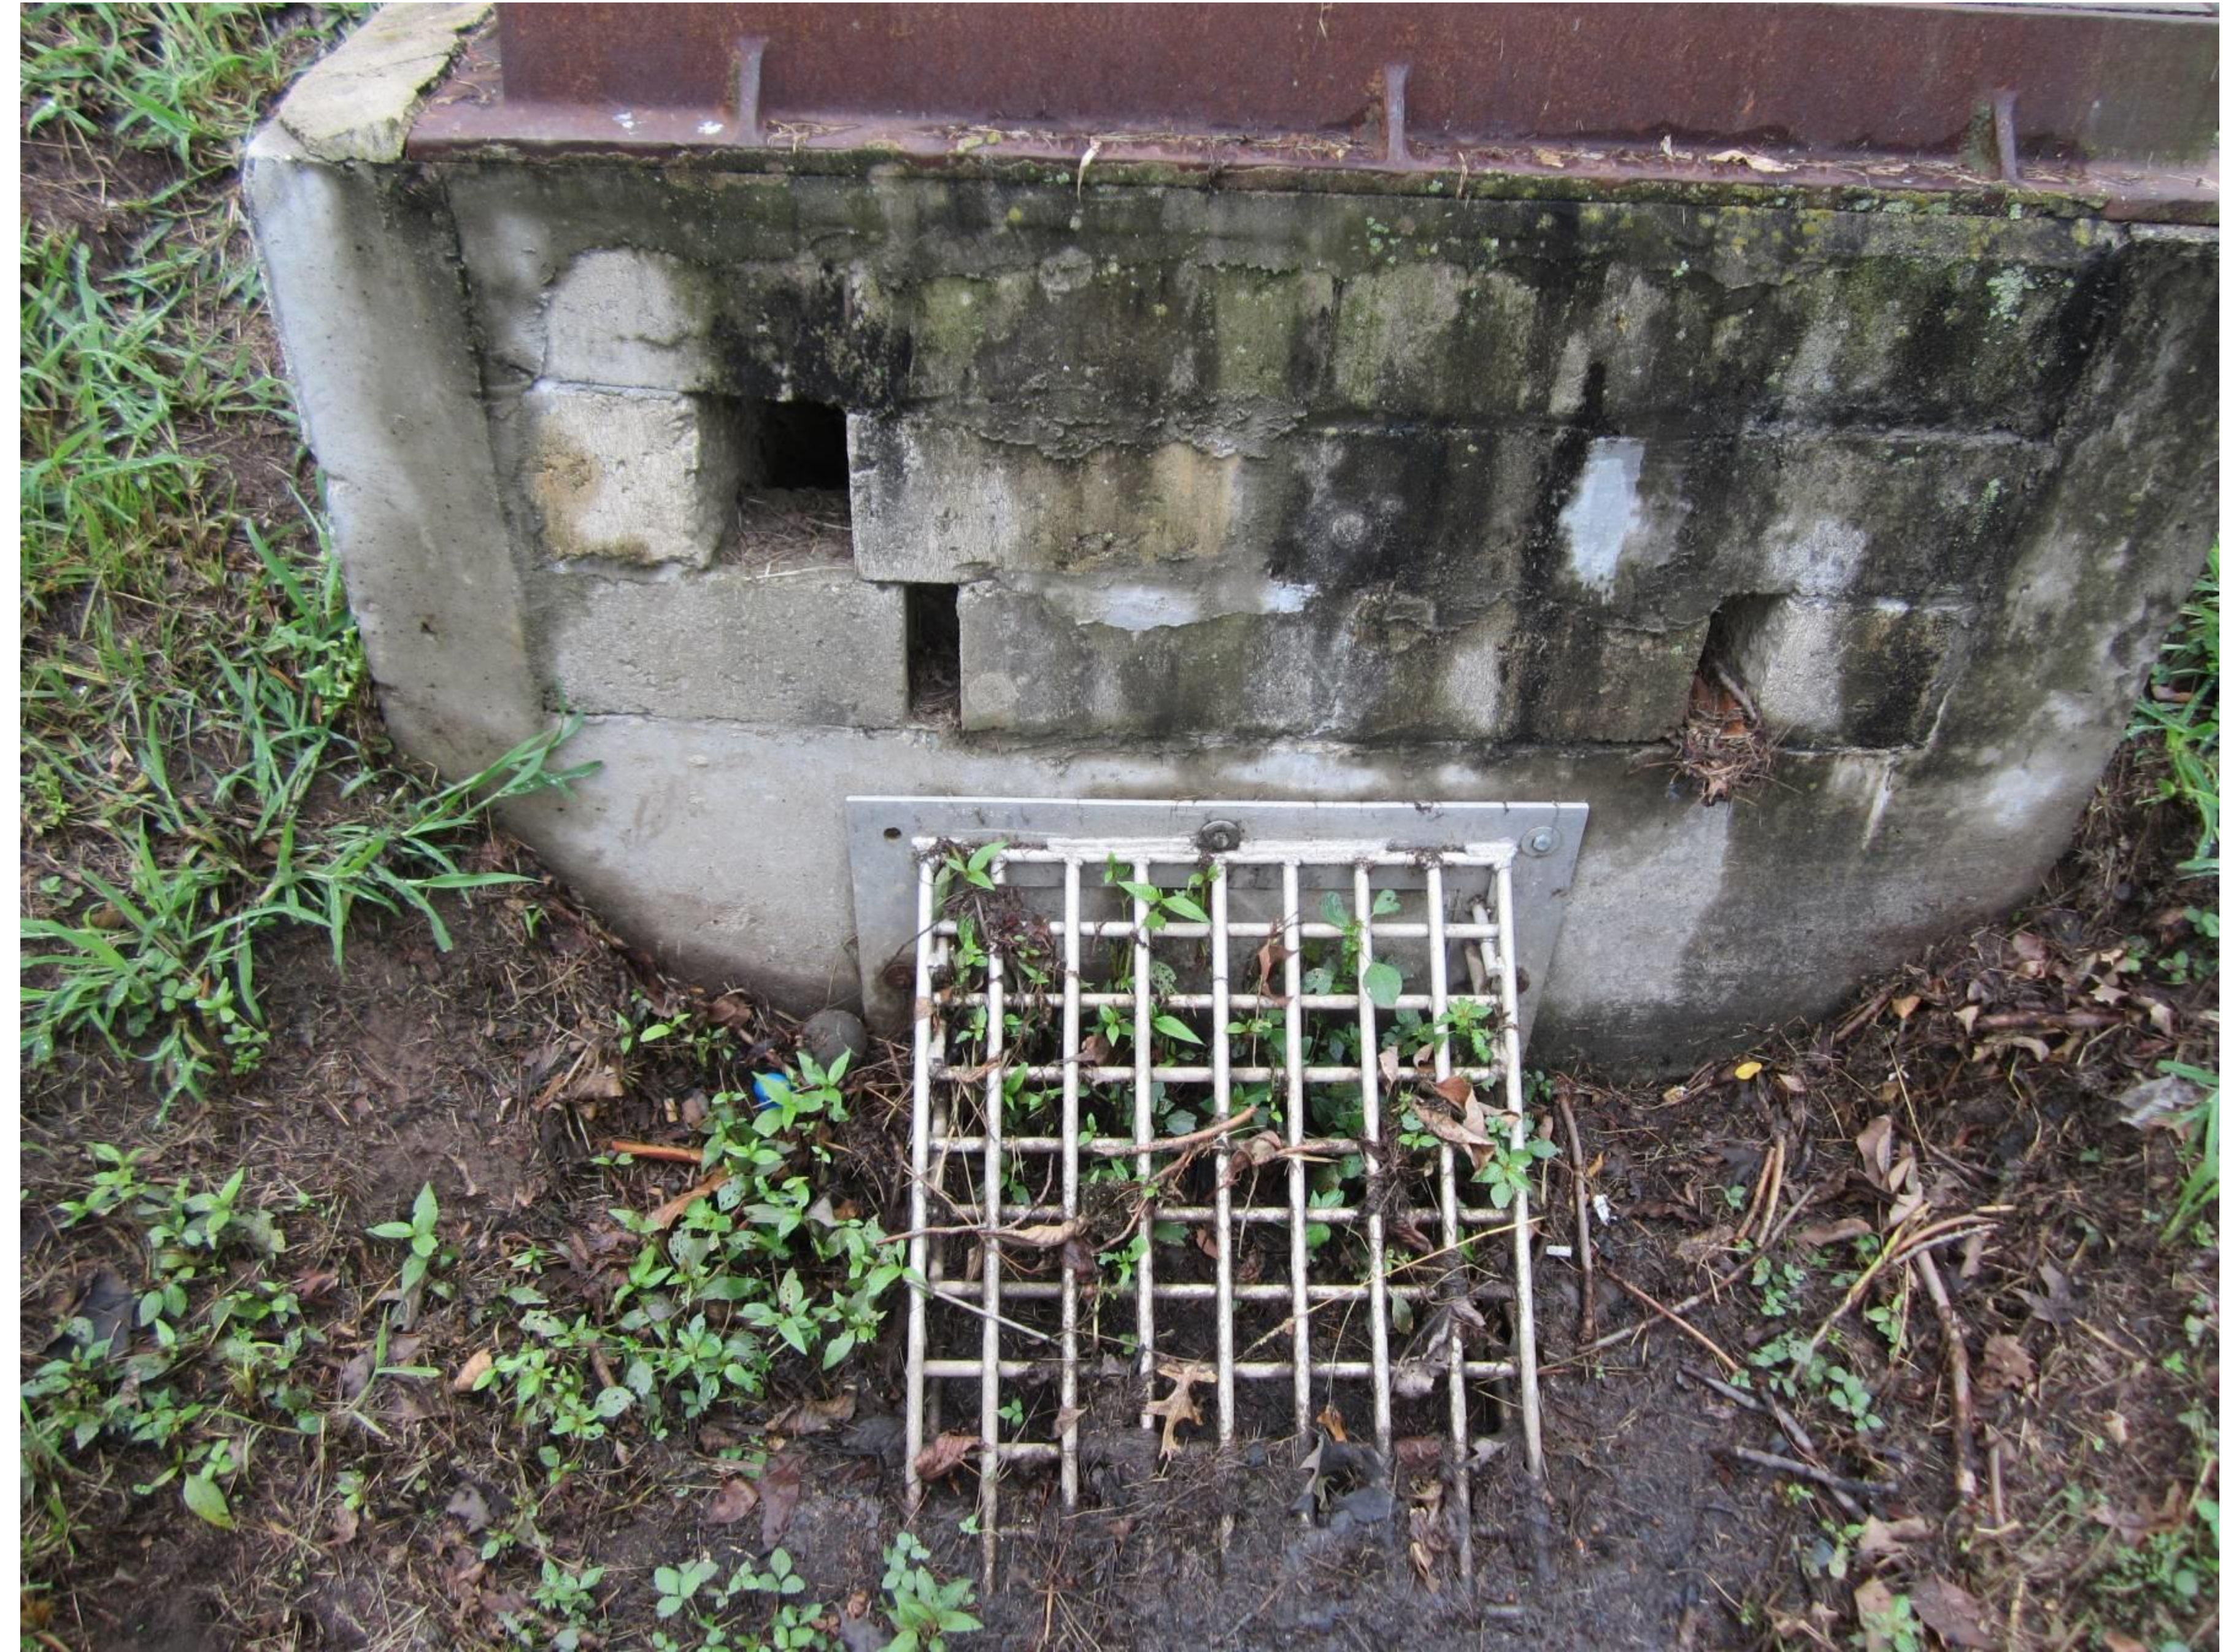
Clogged trash rack at outlet

- Standing water in low flow channel
- Outlet has structural damage and trash rack is clogged with sediment/debris

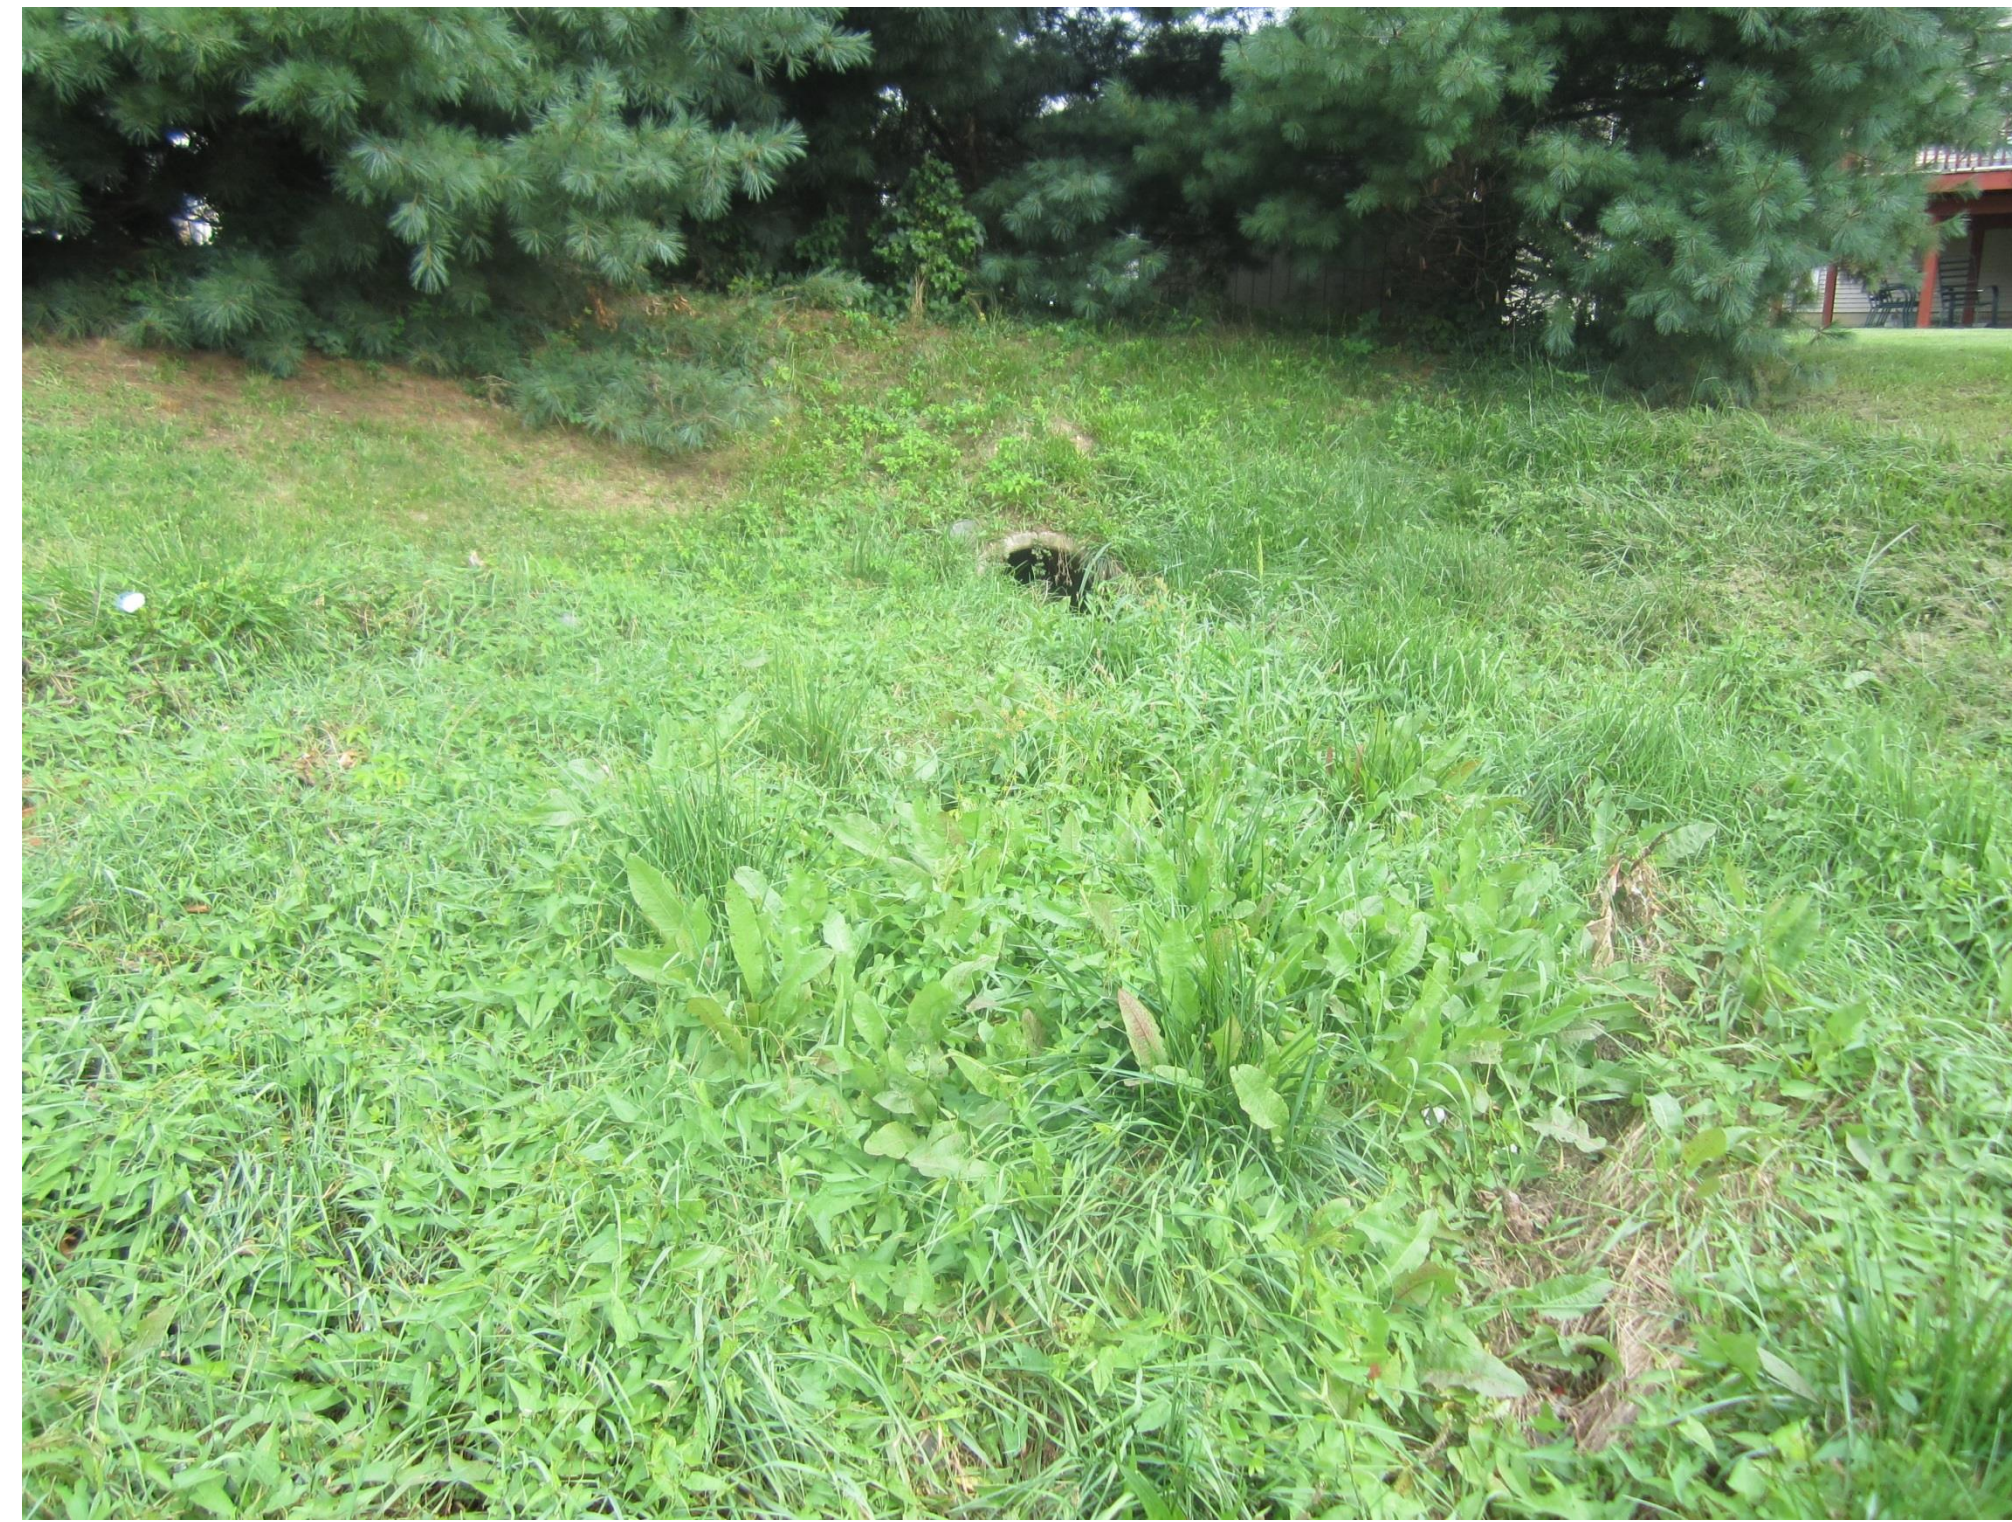
Inlet structure and overgrown rip-rap apron

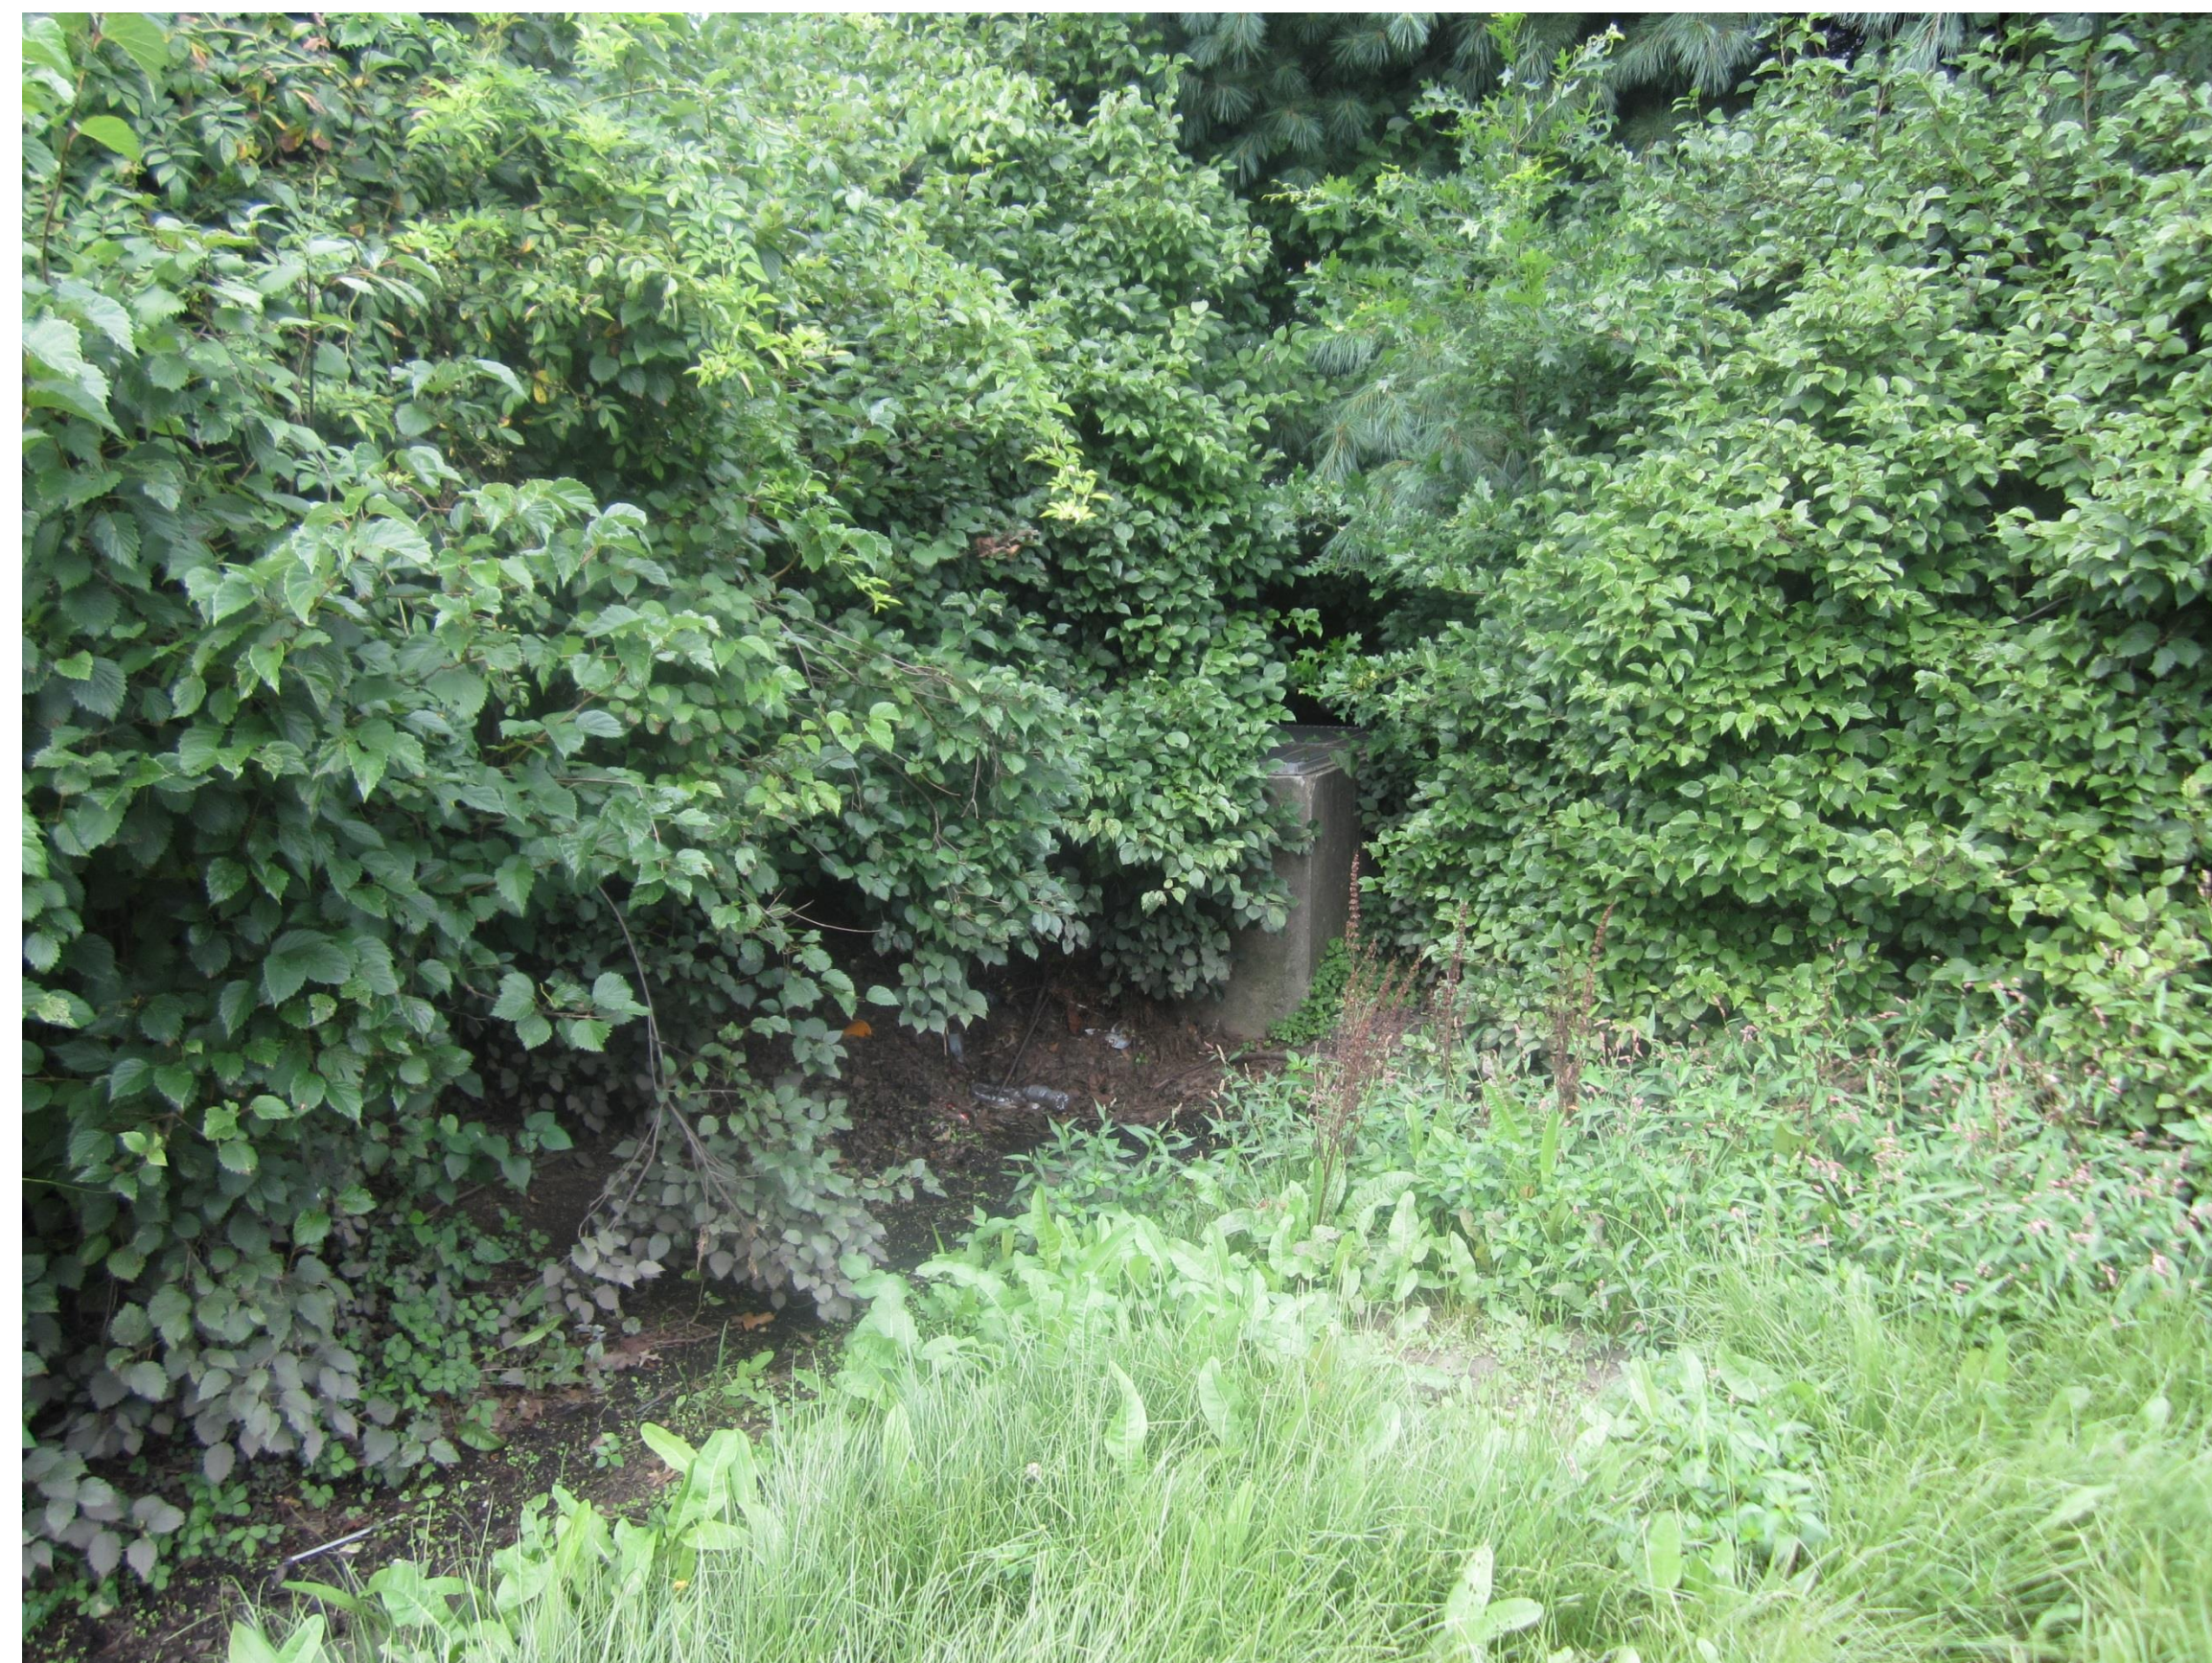
Overgrown outlet structure

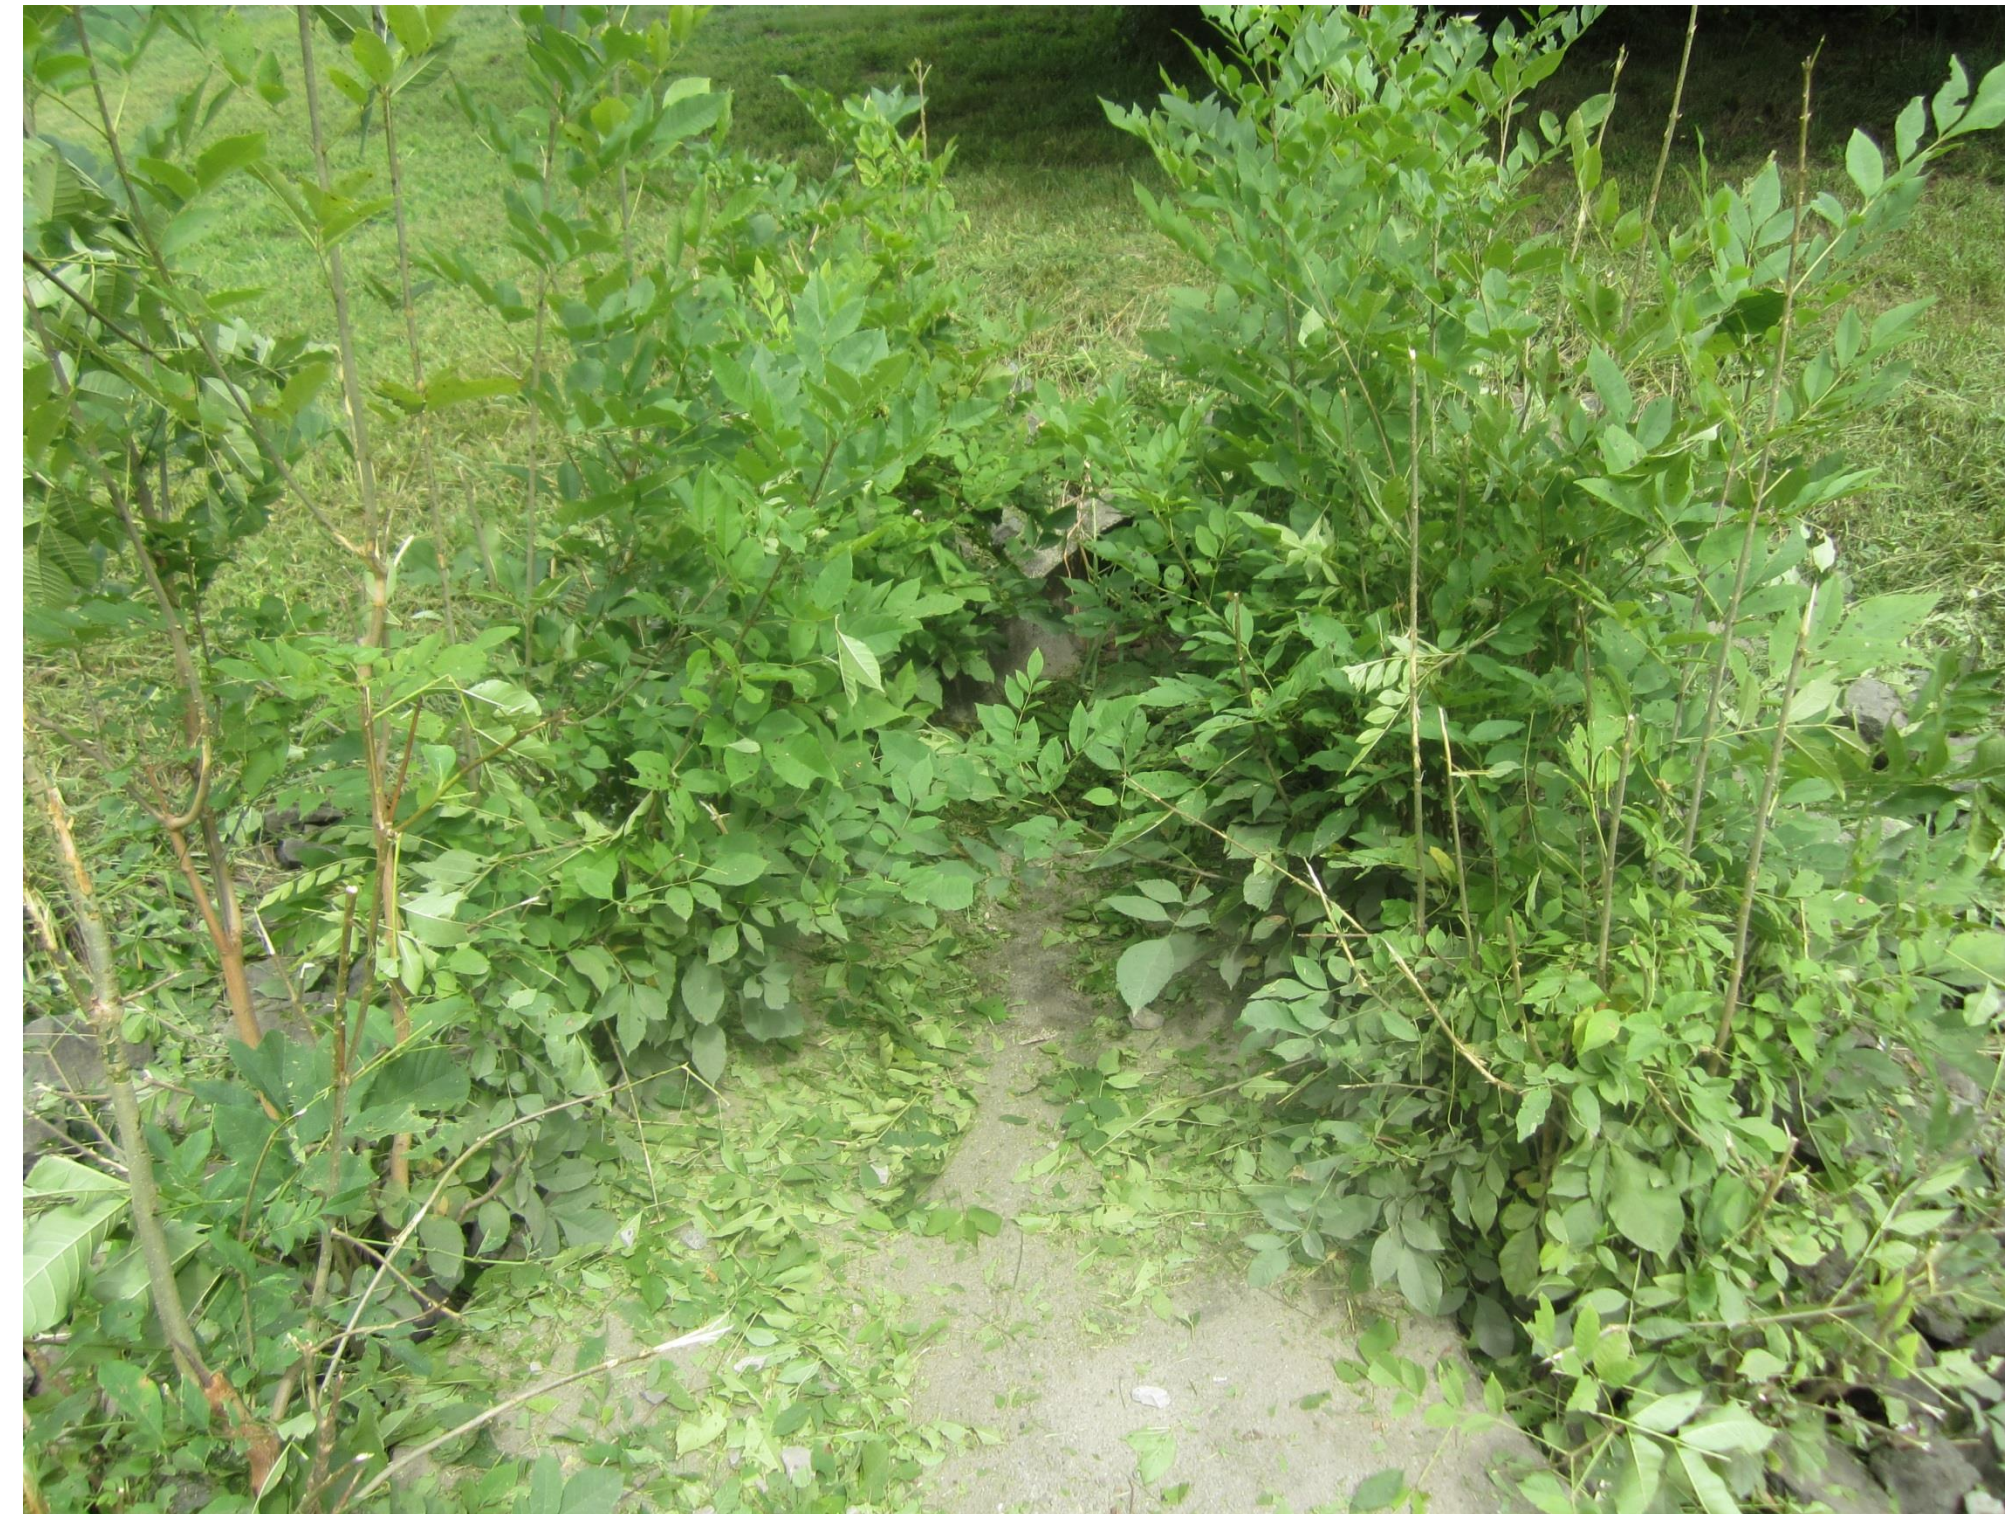
Overgrown inlet structure
