**Hamilton Township (Mercer County)
Stormwater Basin Assessment Summary
Hamilton Owned Addendum (Year 5A)**

Developed by the Rutgers Cooperative Extension Water Resources Program
Funded by Hamilton Township, Mercer County, New Jersey

November 27, 2019

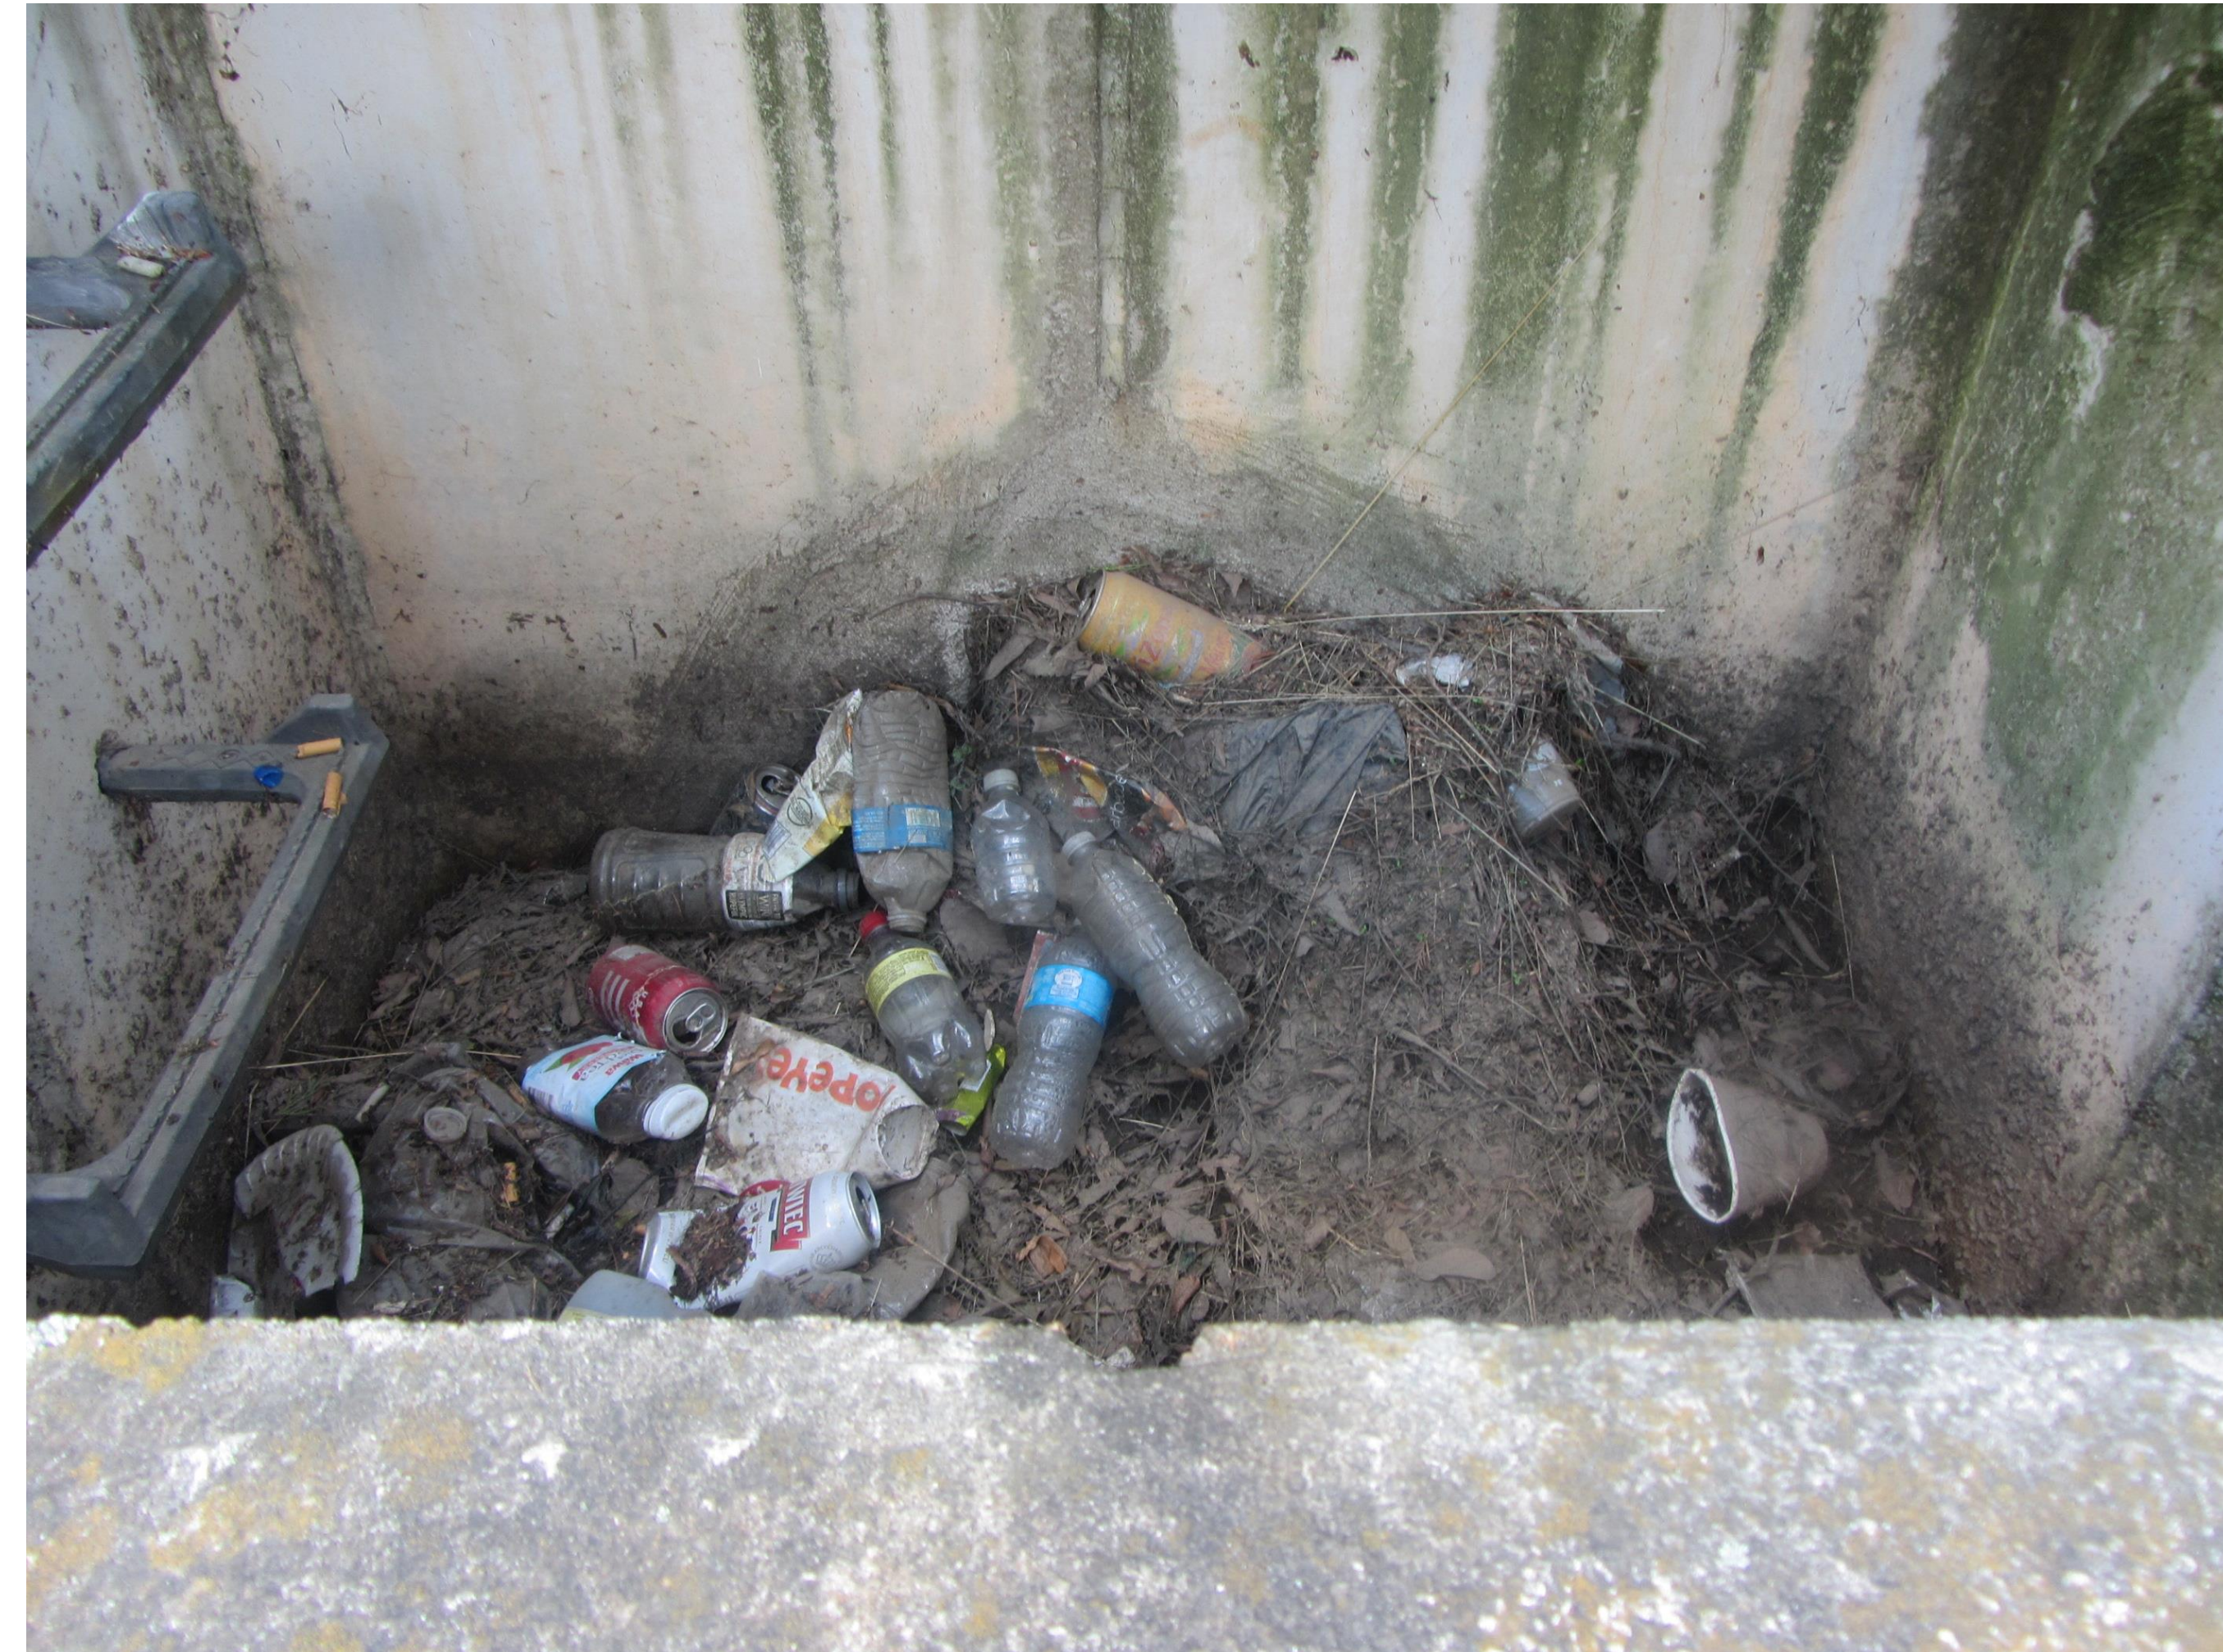
Litter and debris accumulated inside outlet

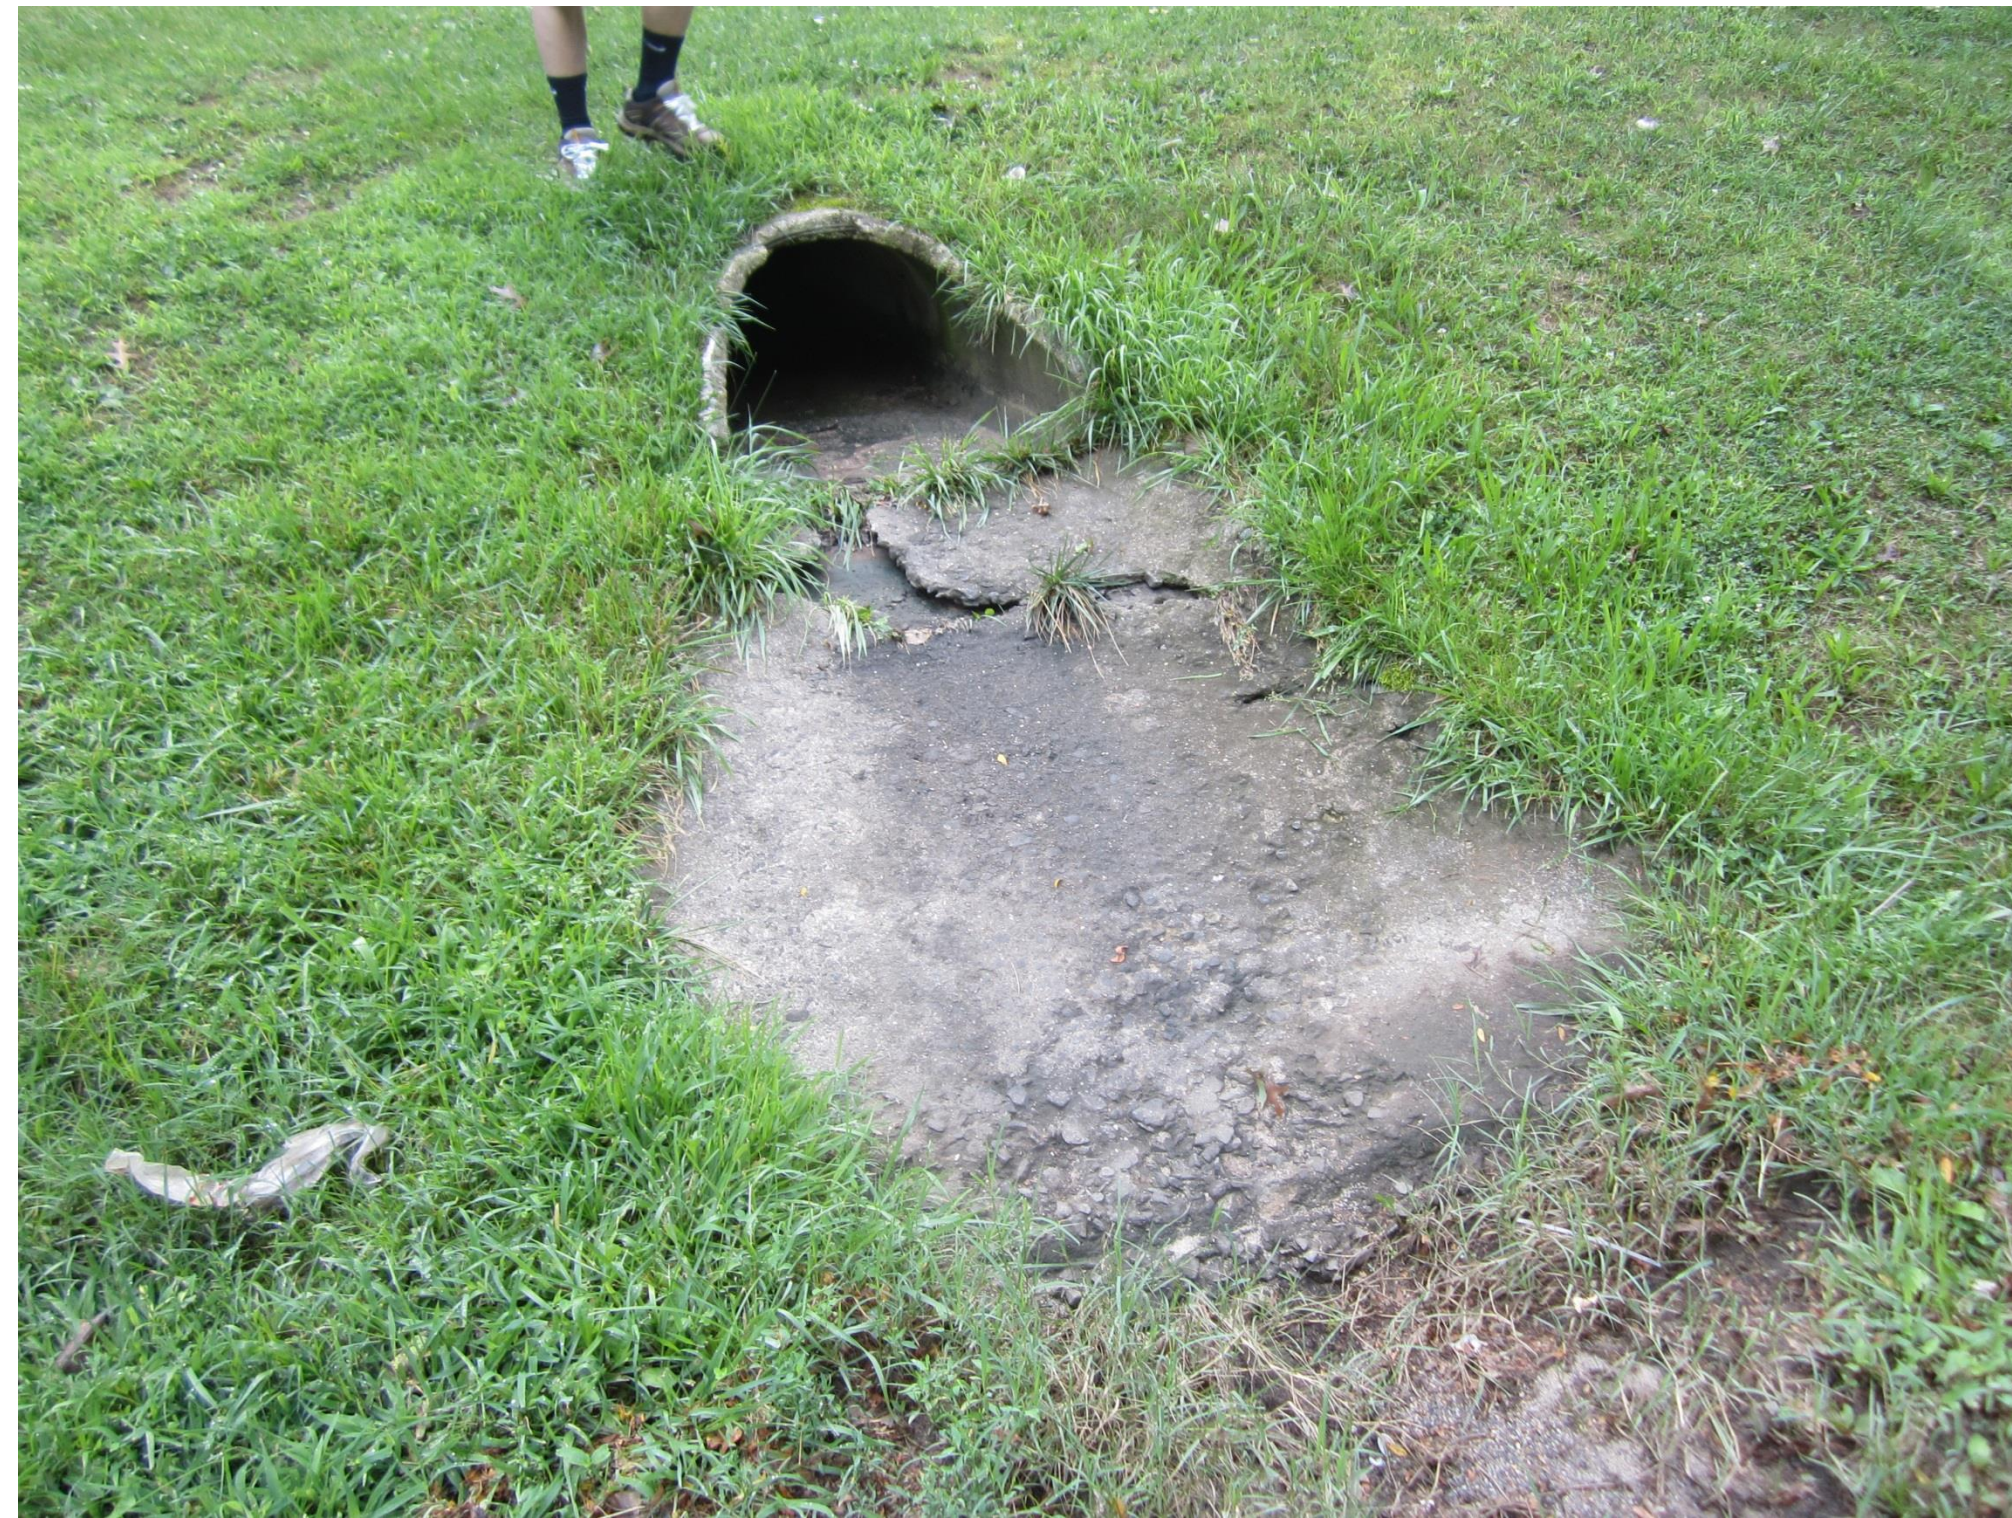
Northeastern inlet structure

- The southern inlet is about halfway filled with sediment
- The northeastern inlet is in need of replacement
- The basin bottom has many gullies throughout and excess sediment accumulation
- There is standing water and erosion in front of the outlet

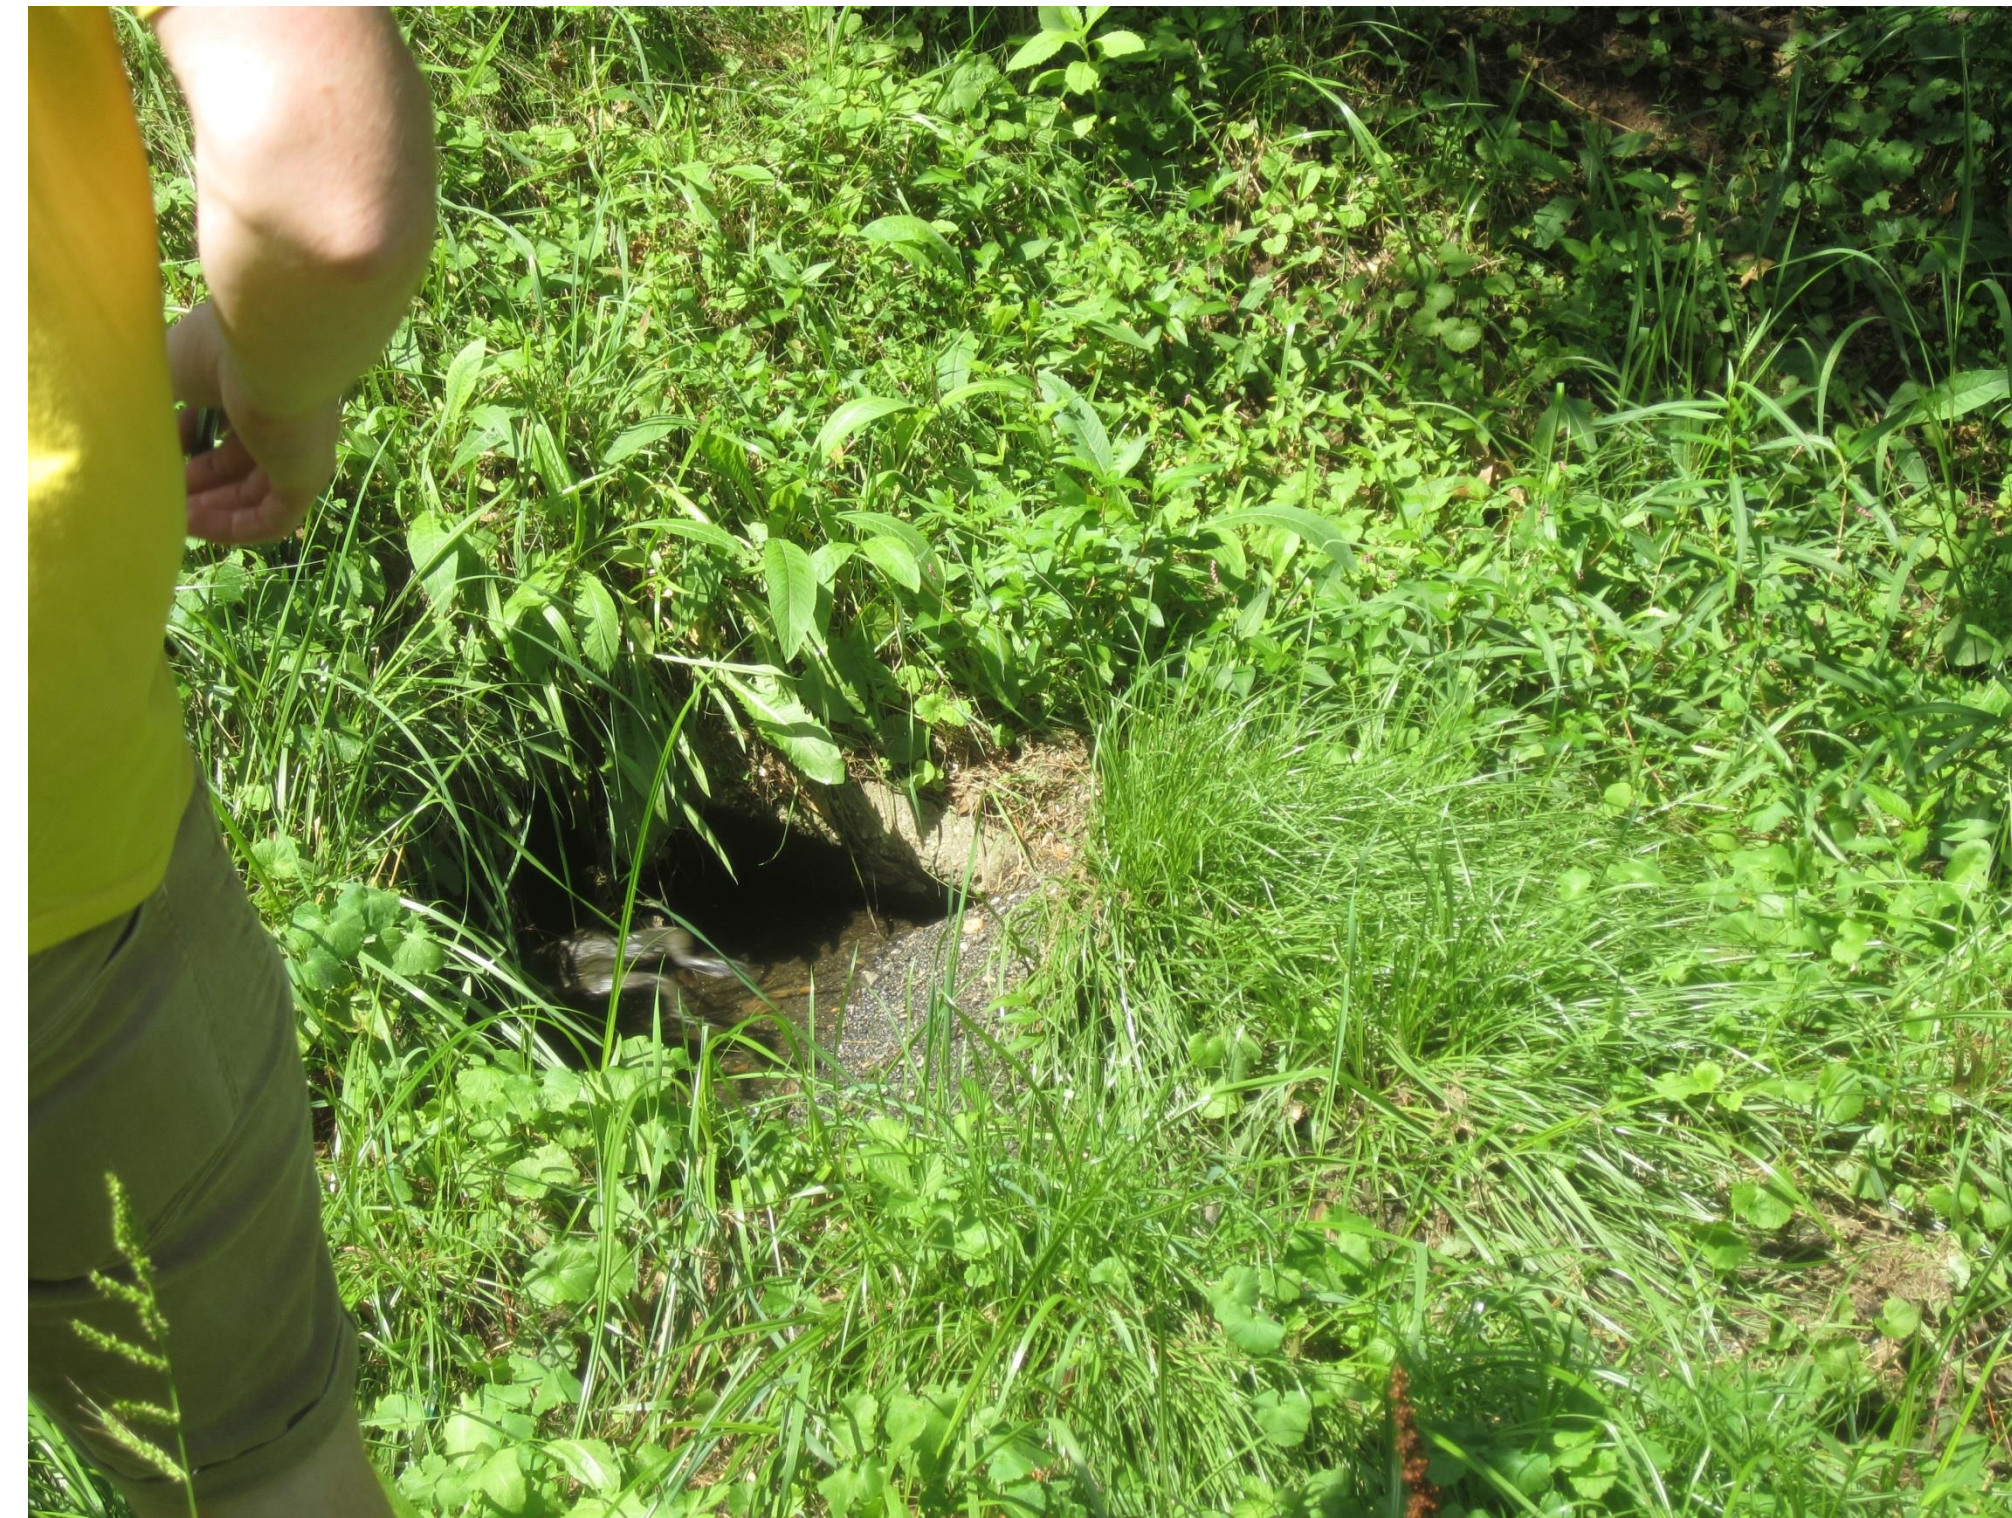
Southern inlet structure filled with sediment

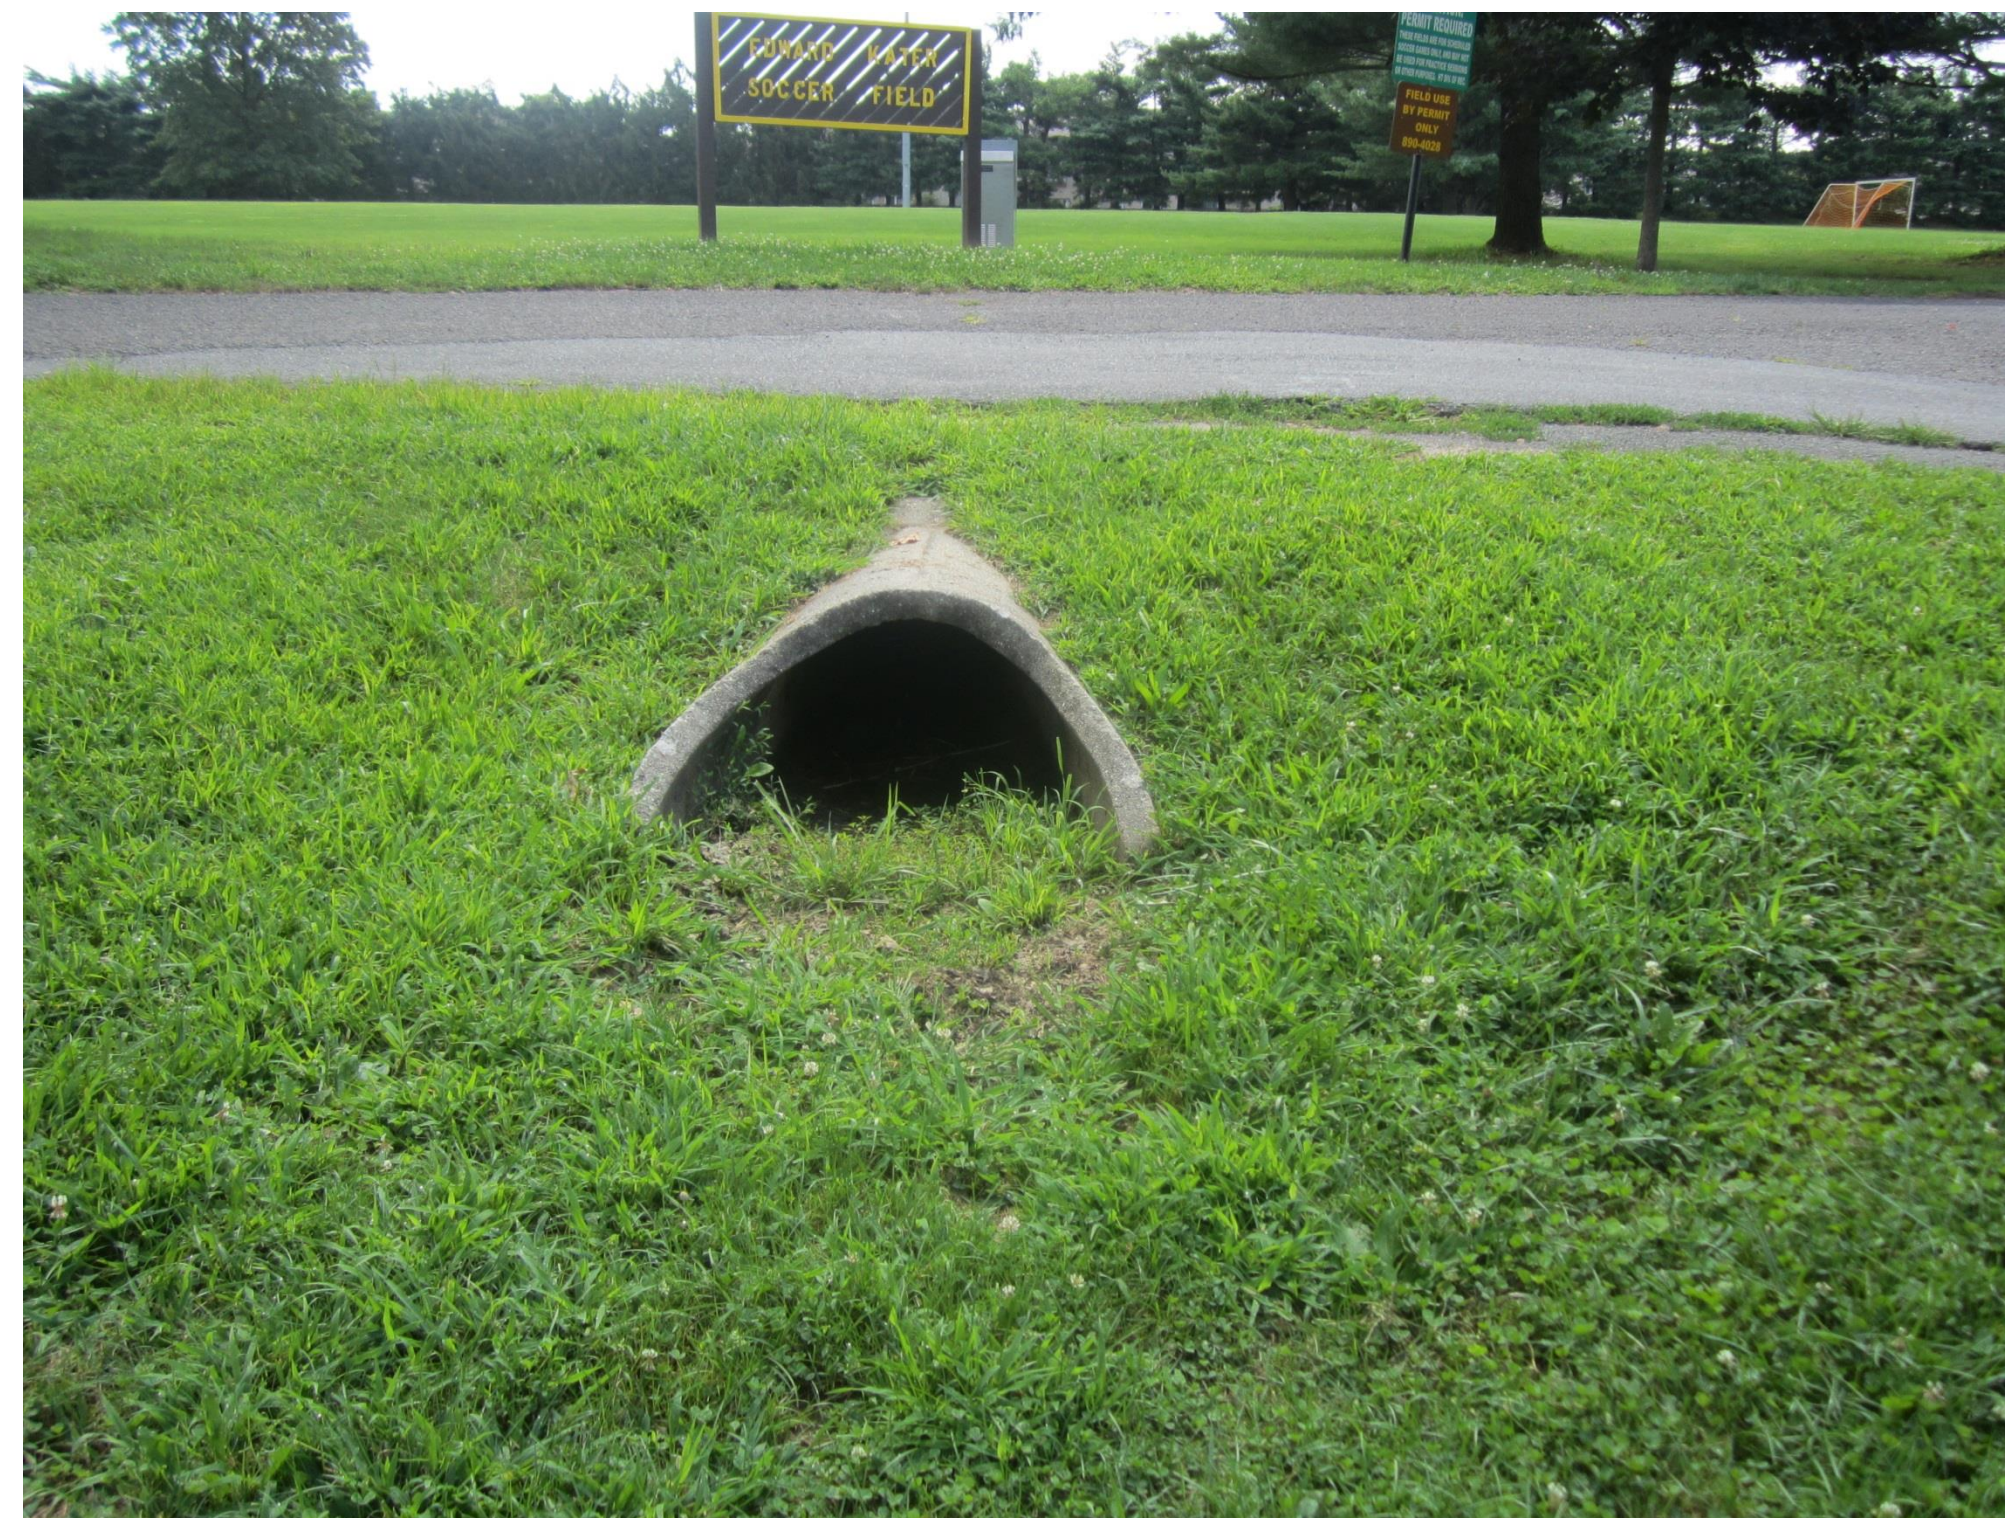
Basin #159 inlet structure

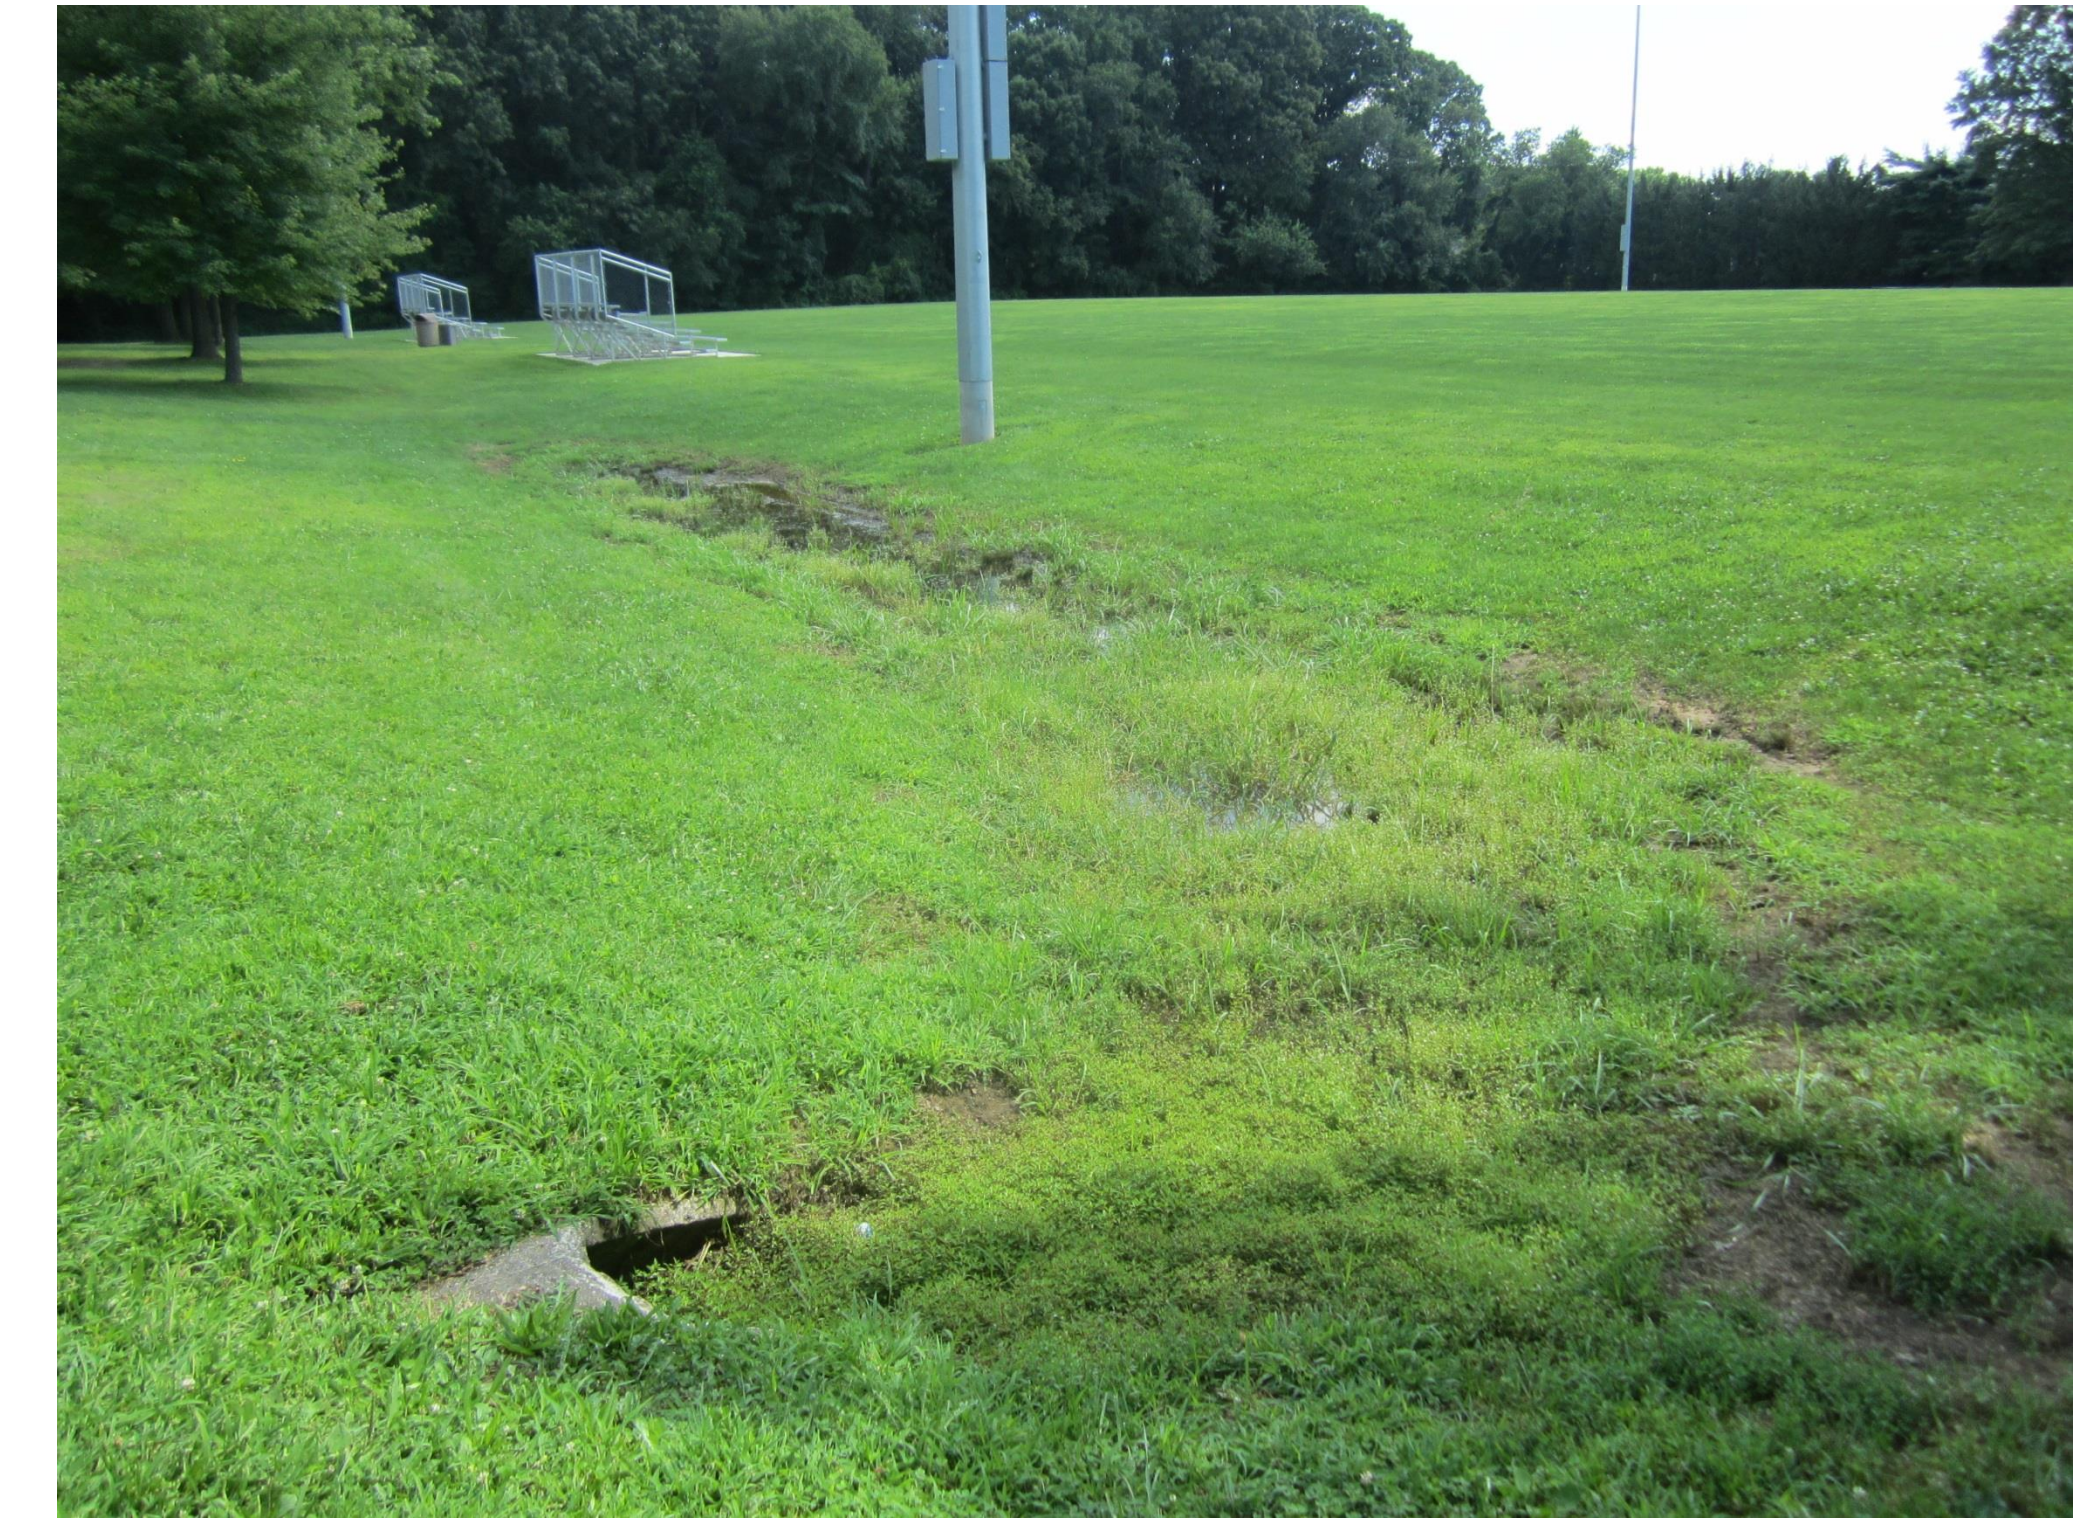
Basin #160 bottom looking north

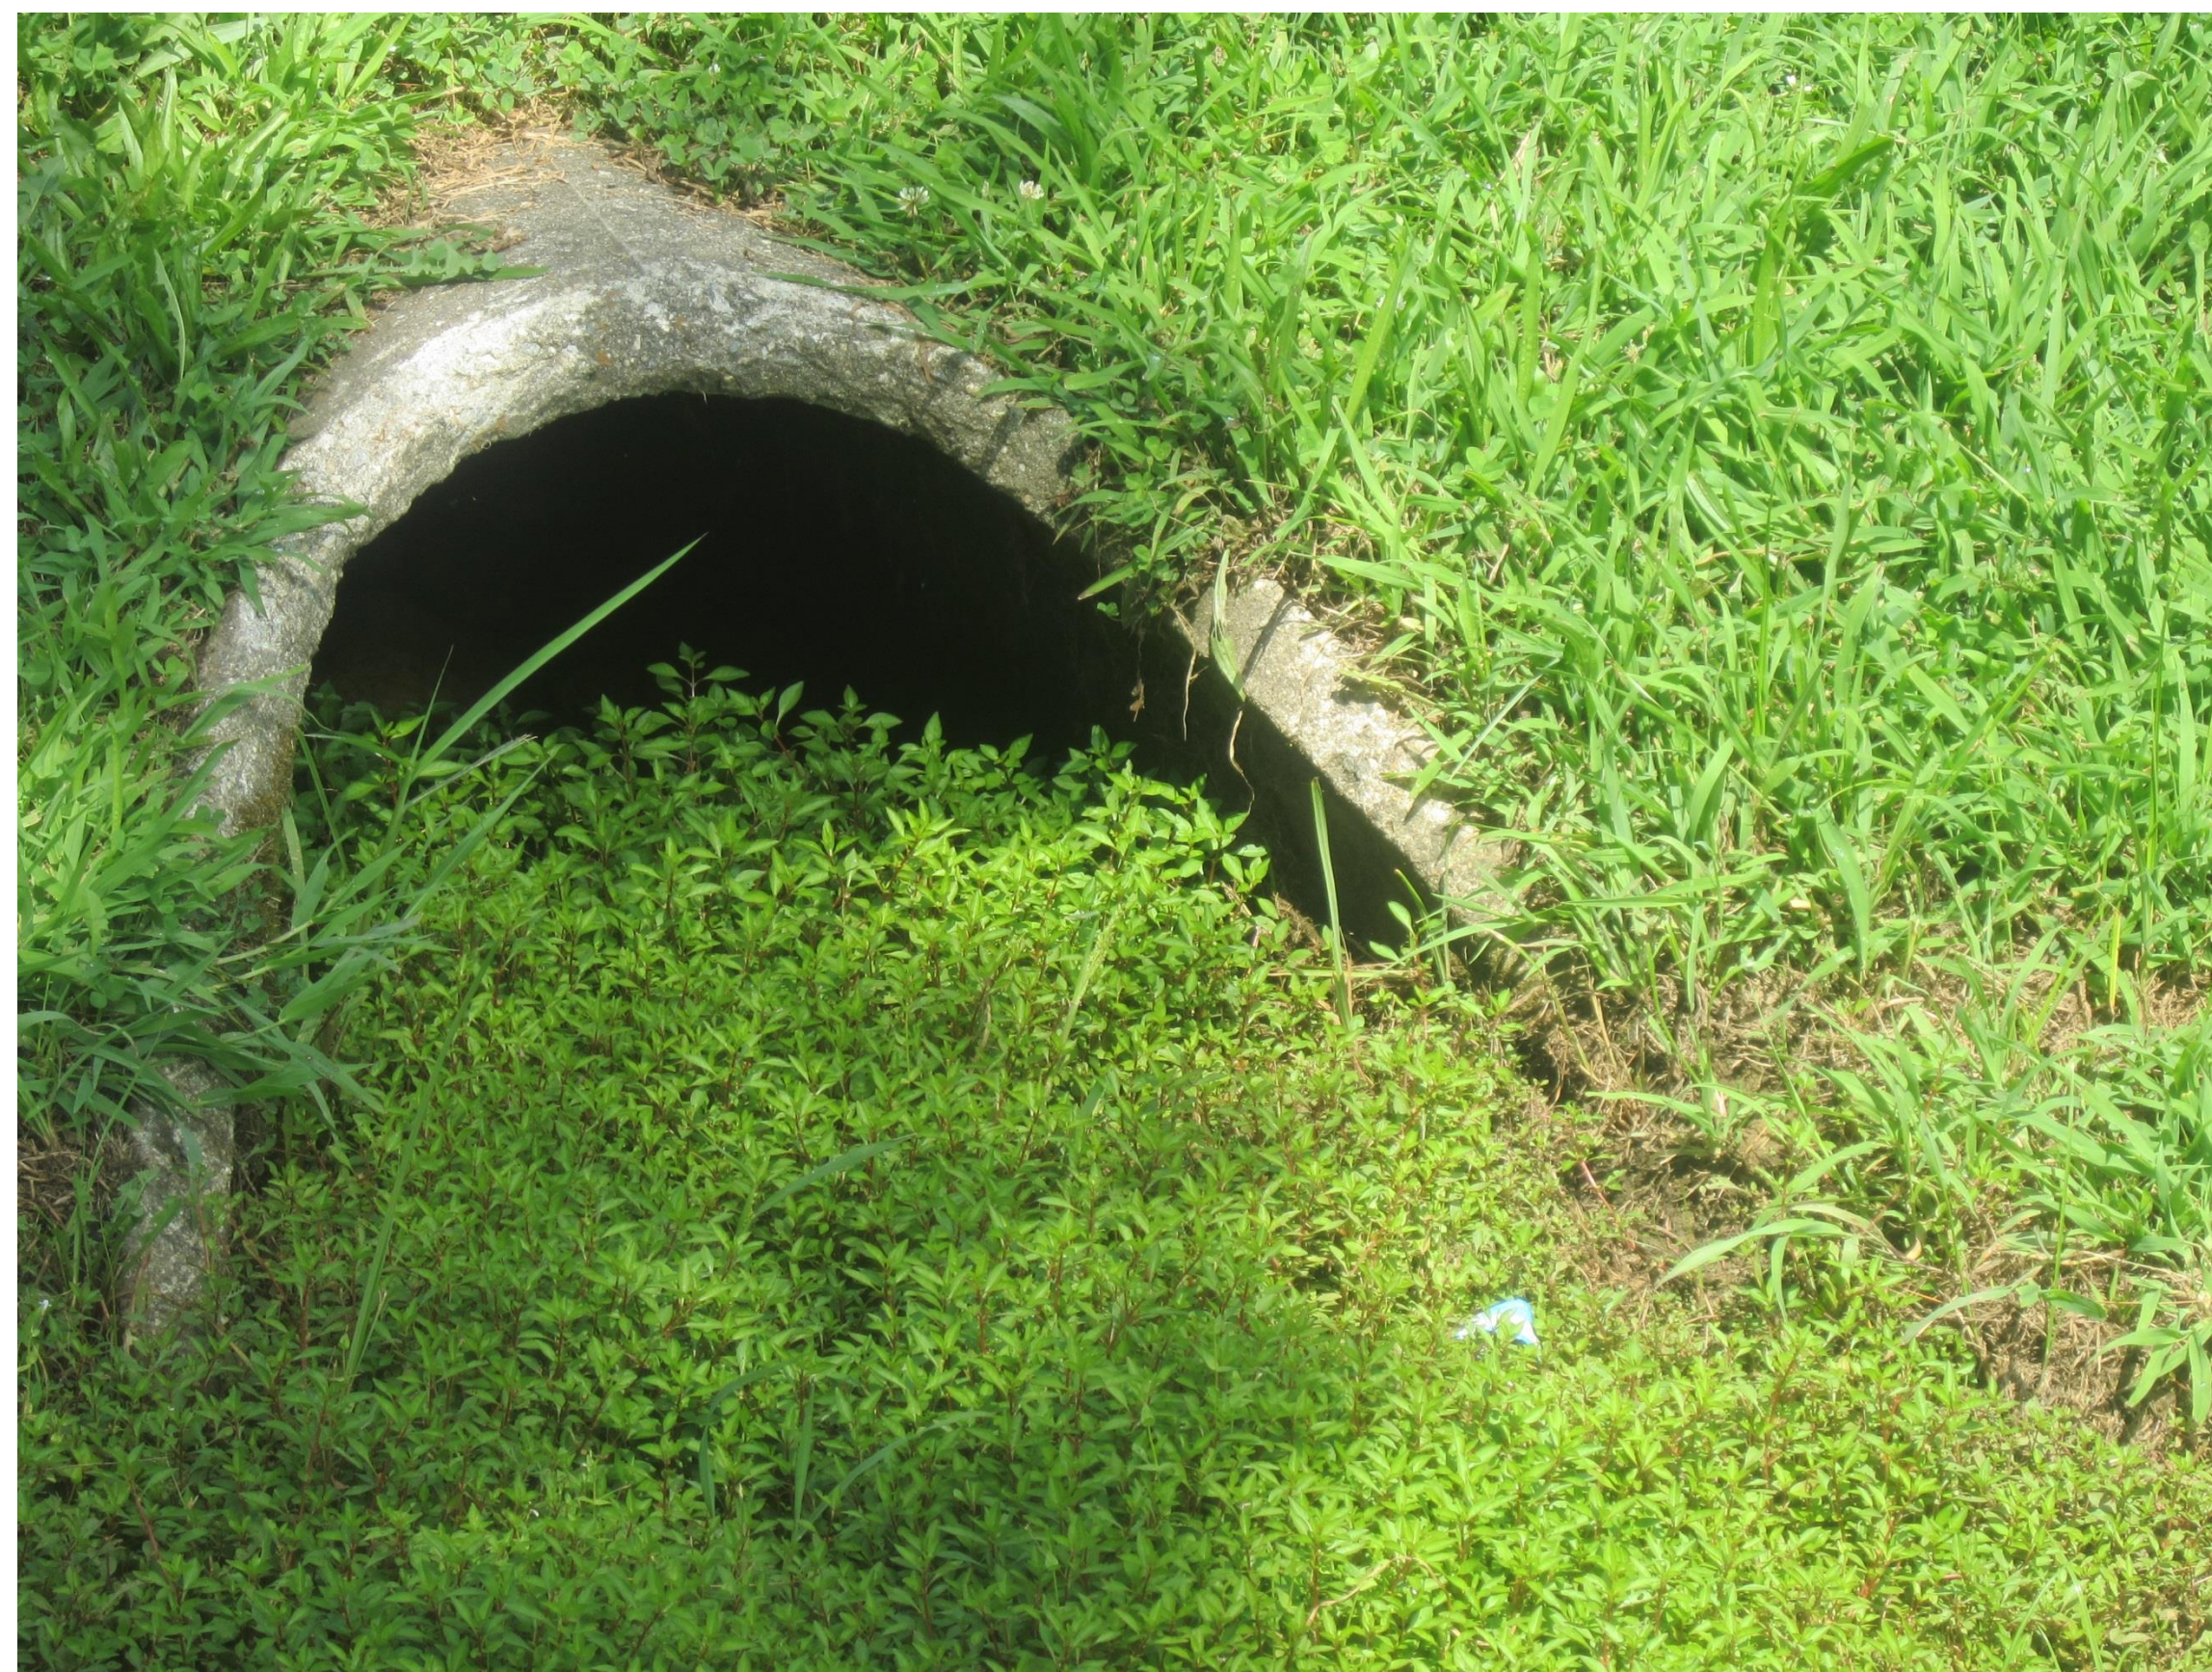
Basin #160 outlet structure
