**Hamilton Township (Mercer County)
Stormwater Basin Assessment Summary
Hamilton Owned Addendum (Year 5A)**

Developed by the Rutgers Cooperative Extension Water Resources Program
Funded by Hamilton Township, Mercer County, New Jersey

November 27, 2019

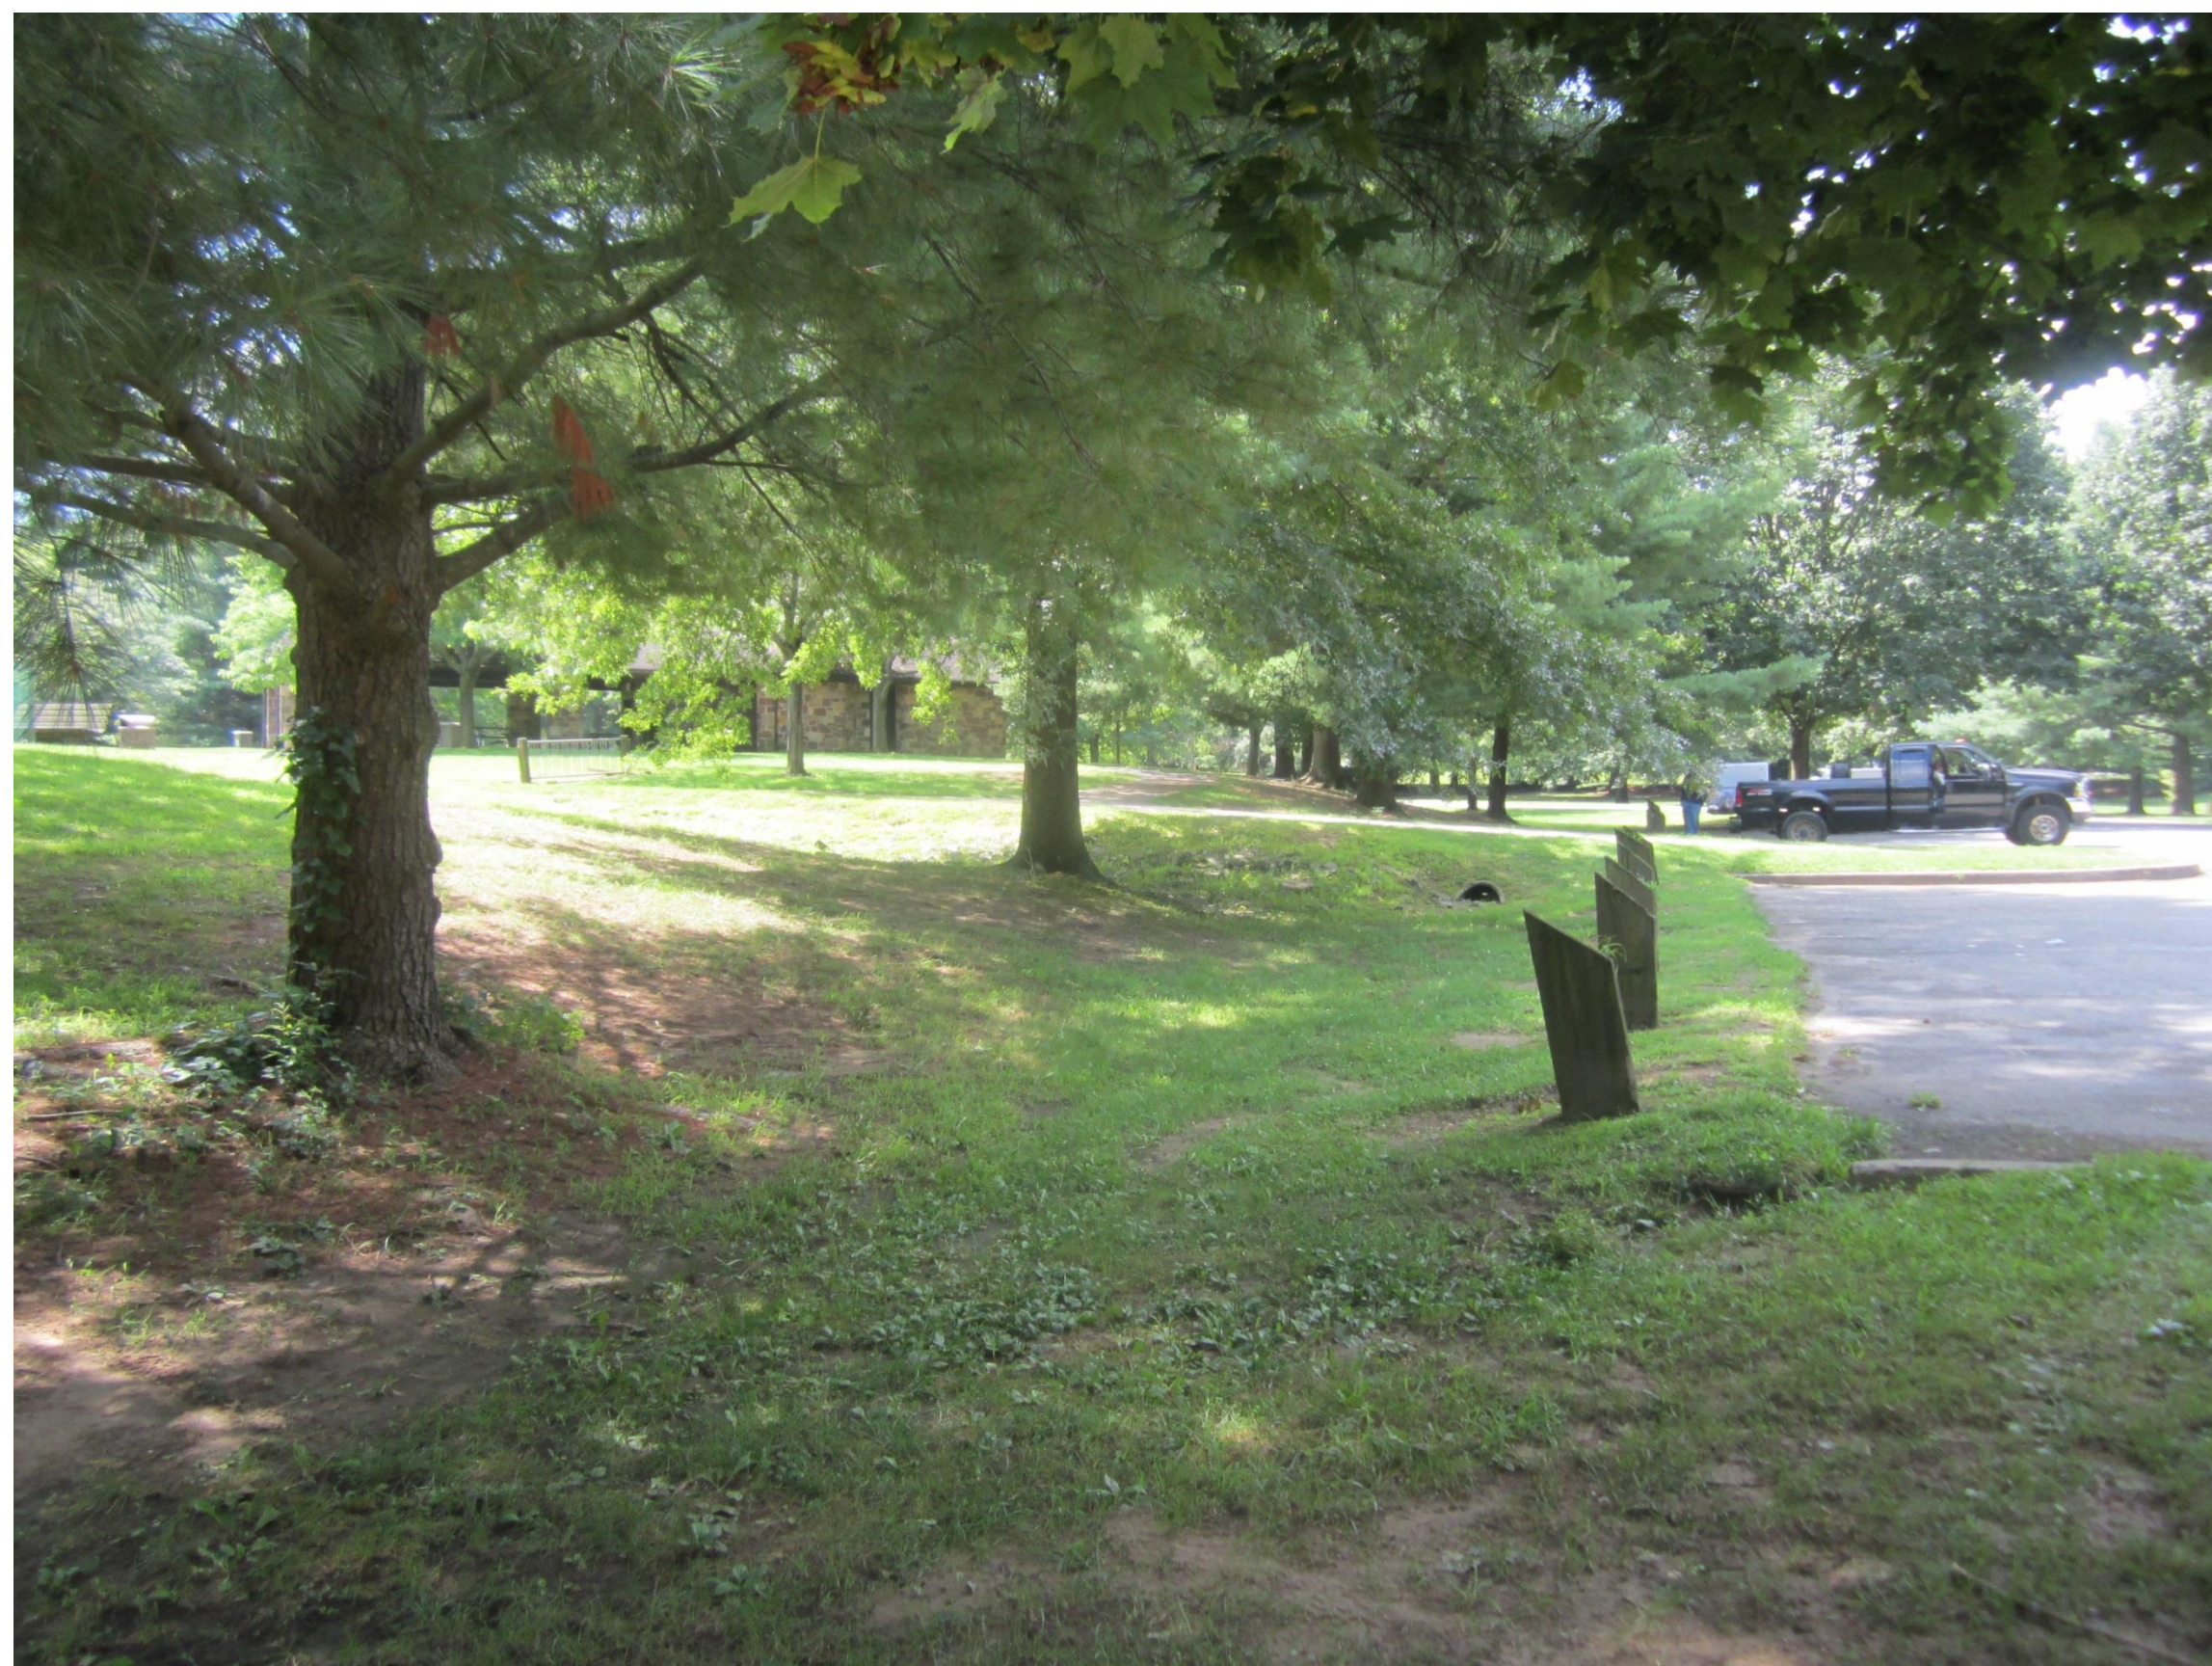
Swale that conveys two inlets to basin

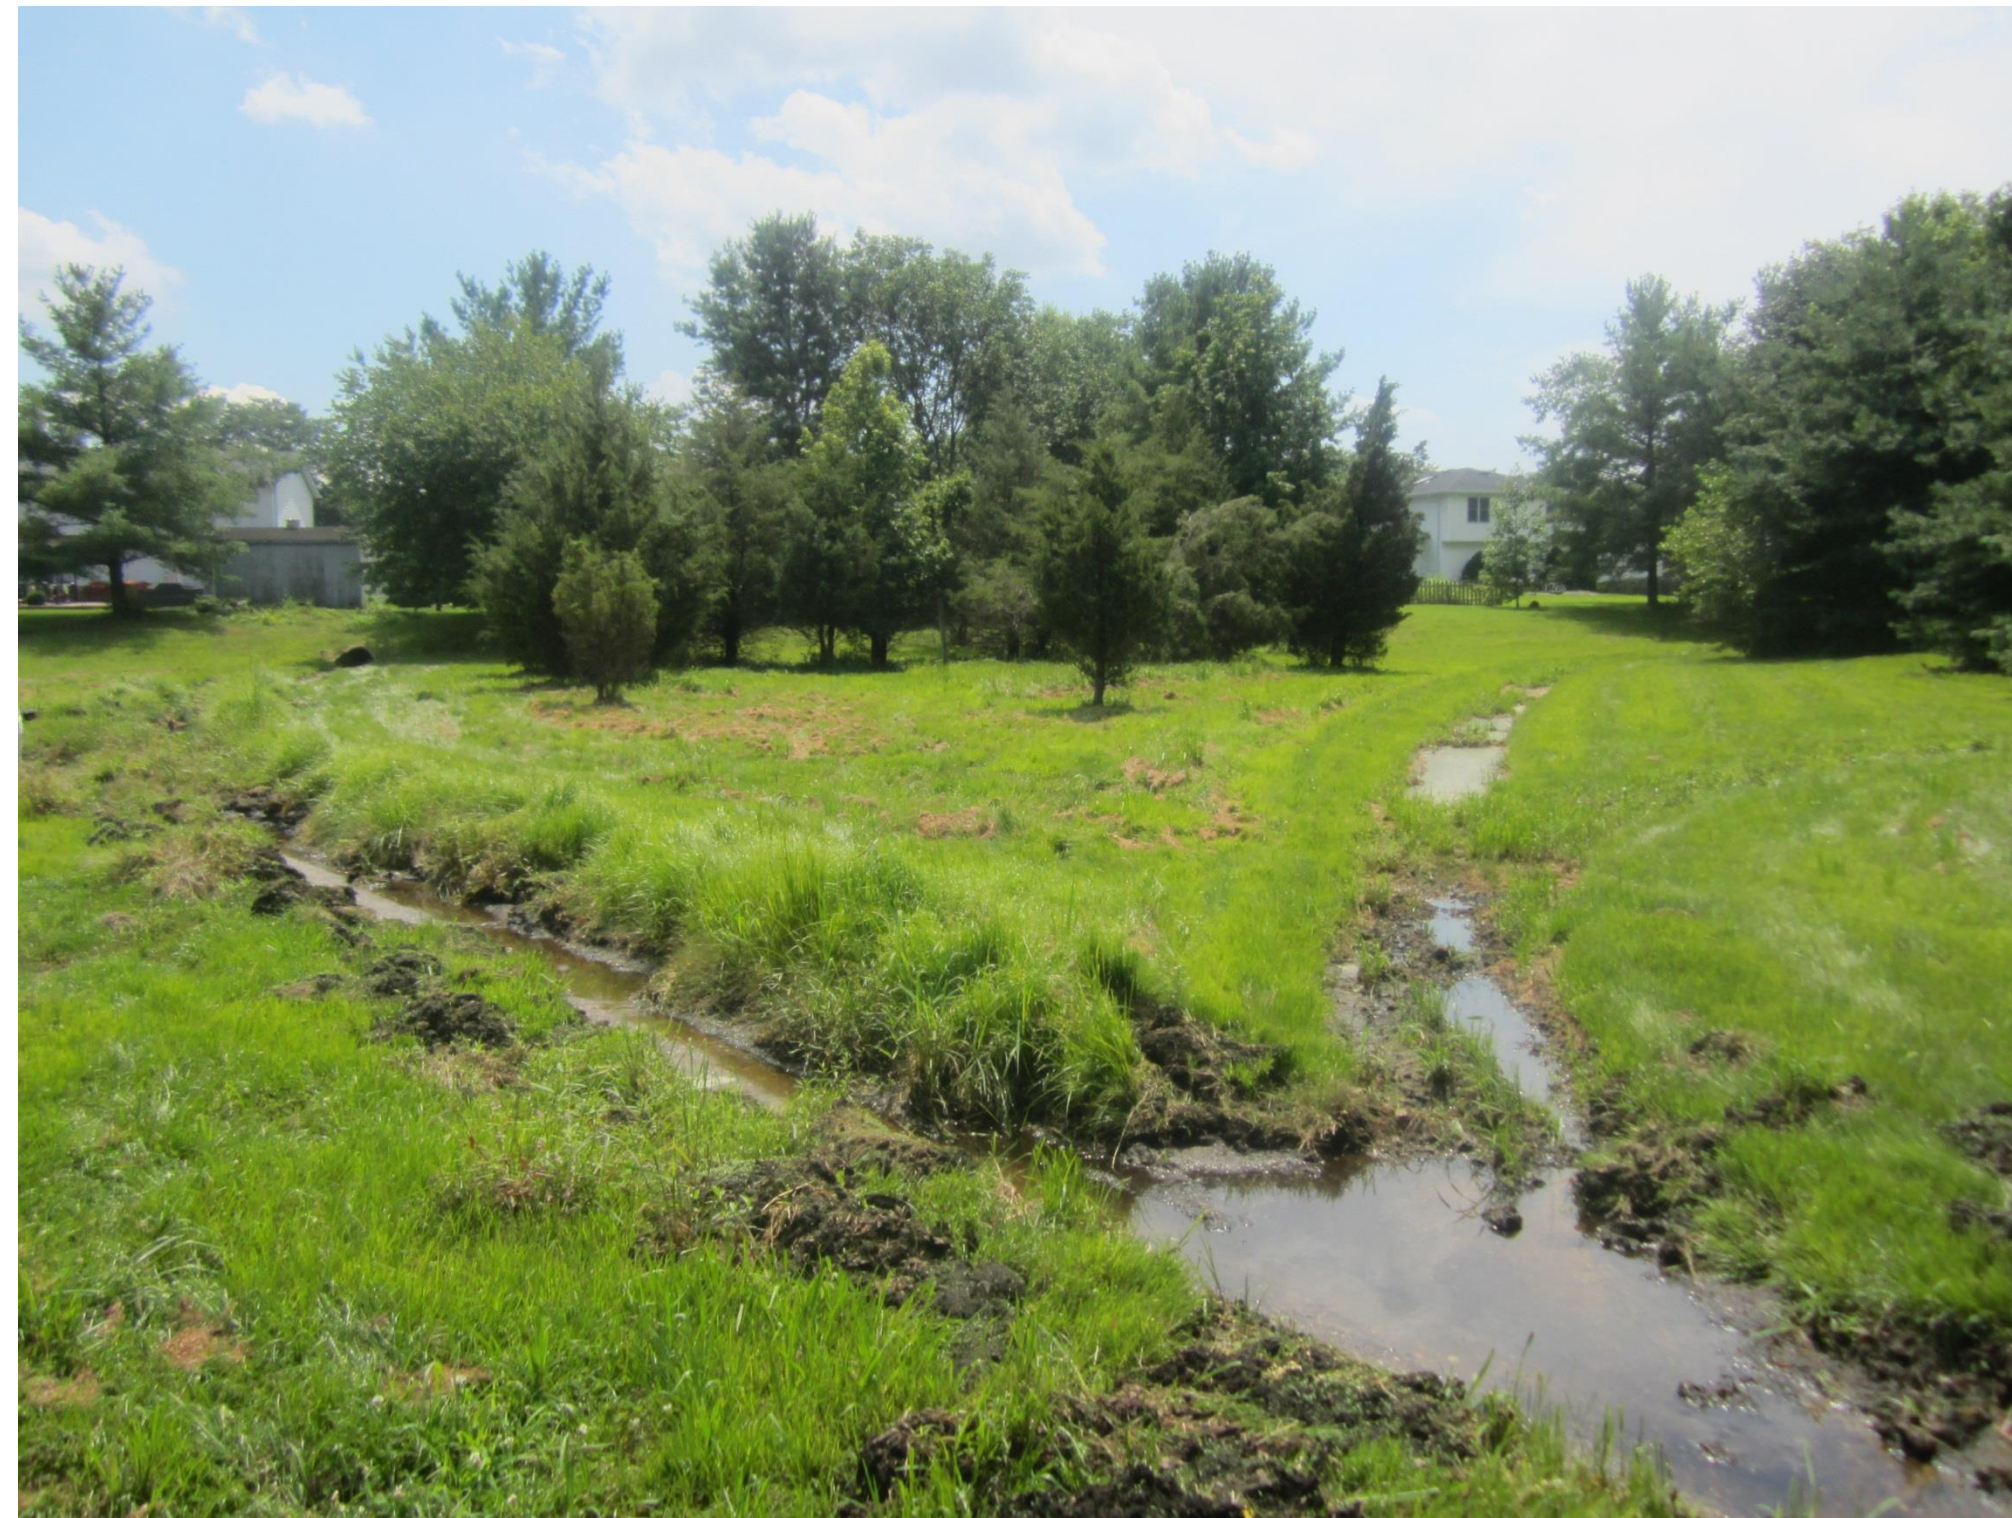
Basin bottom looking east

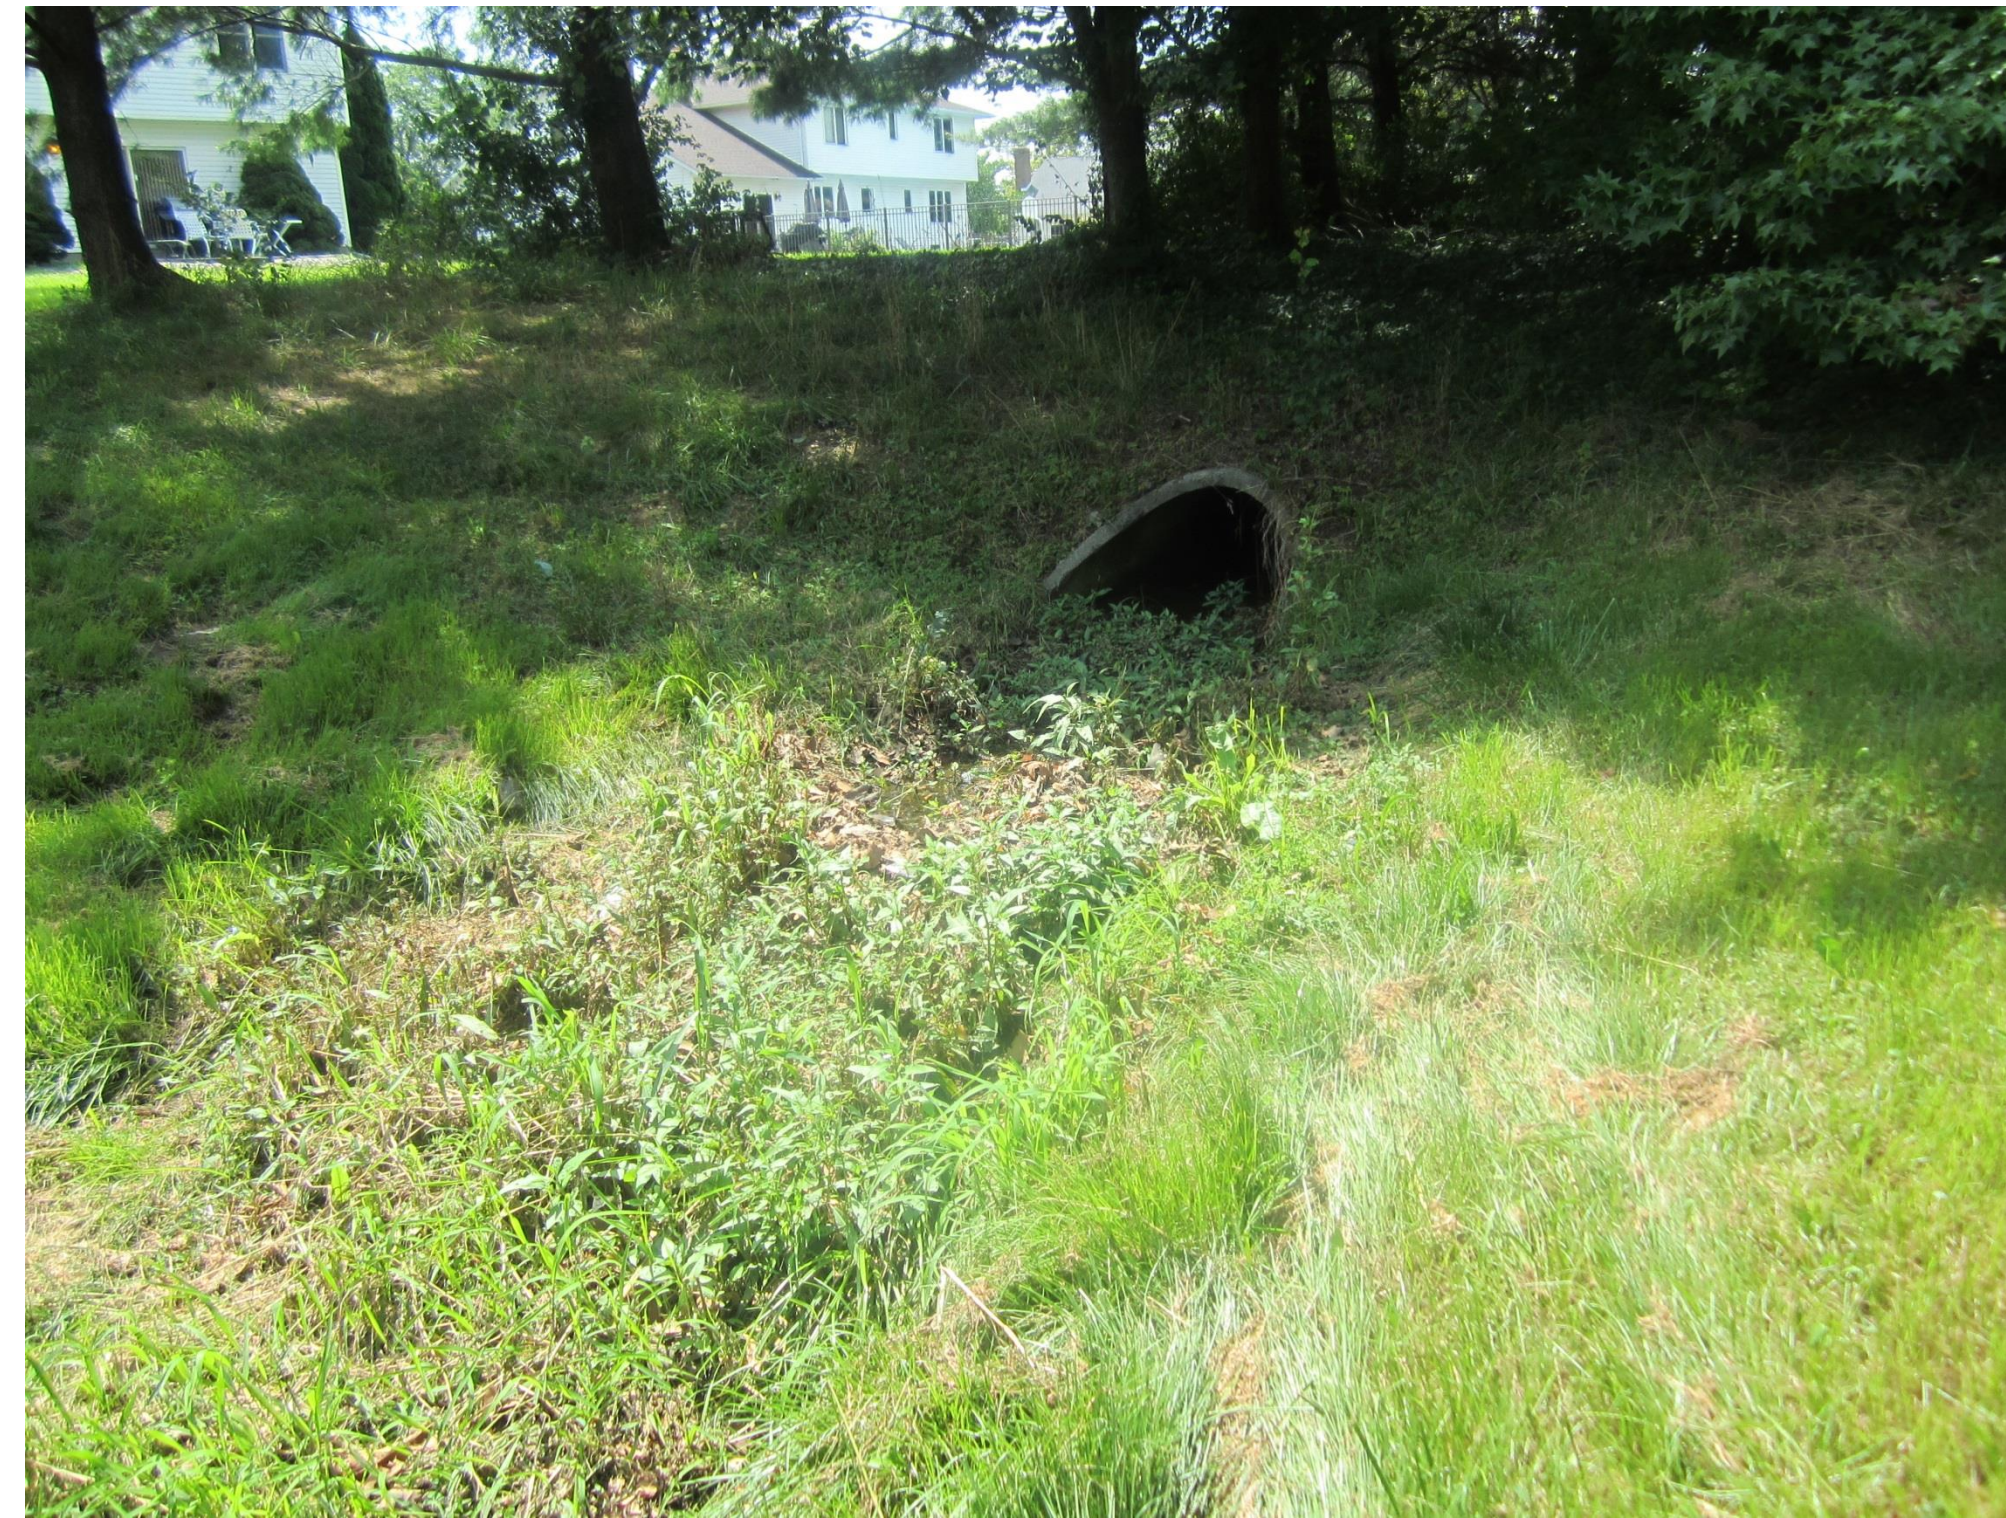
Excessive sediment in front of inlet

- Low flow channels in basin are clogged with accumulated sediment; there is ponding in the channels that appears very stagnant
- It appears that sediment was removed from the low flow channel, but left in the basin. The sediment needs to be hauled away.
- The inlet structures all have excessive sediment accumulated in front of them
- The southwestern inlet has some concrete deterioration and should be replaced
- The outlet structure is missing a trash rack and has some cracks in parging

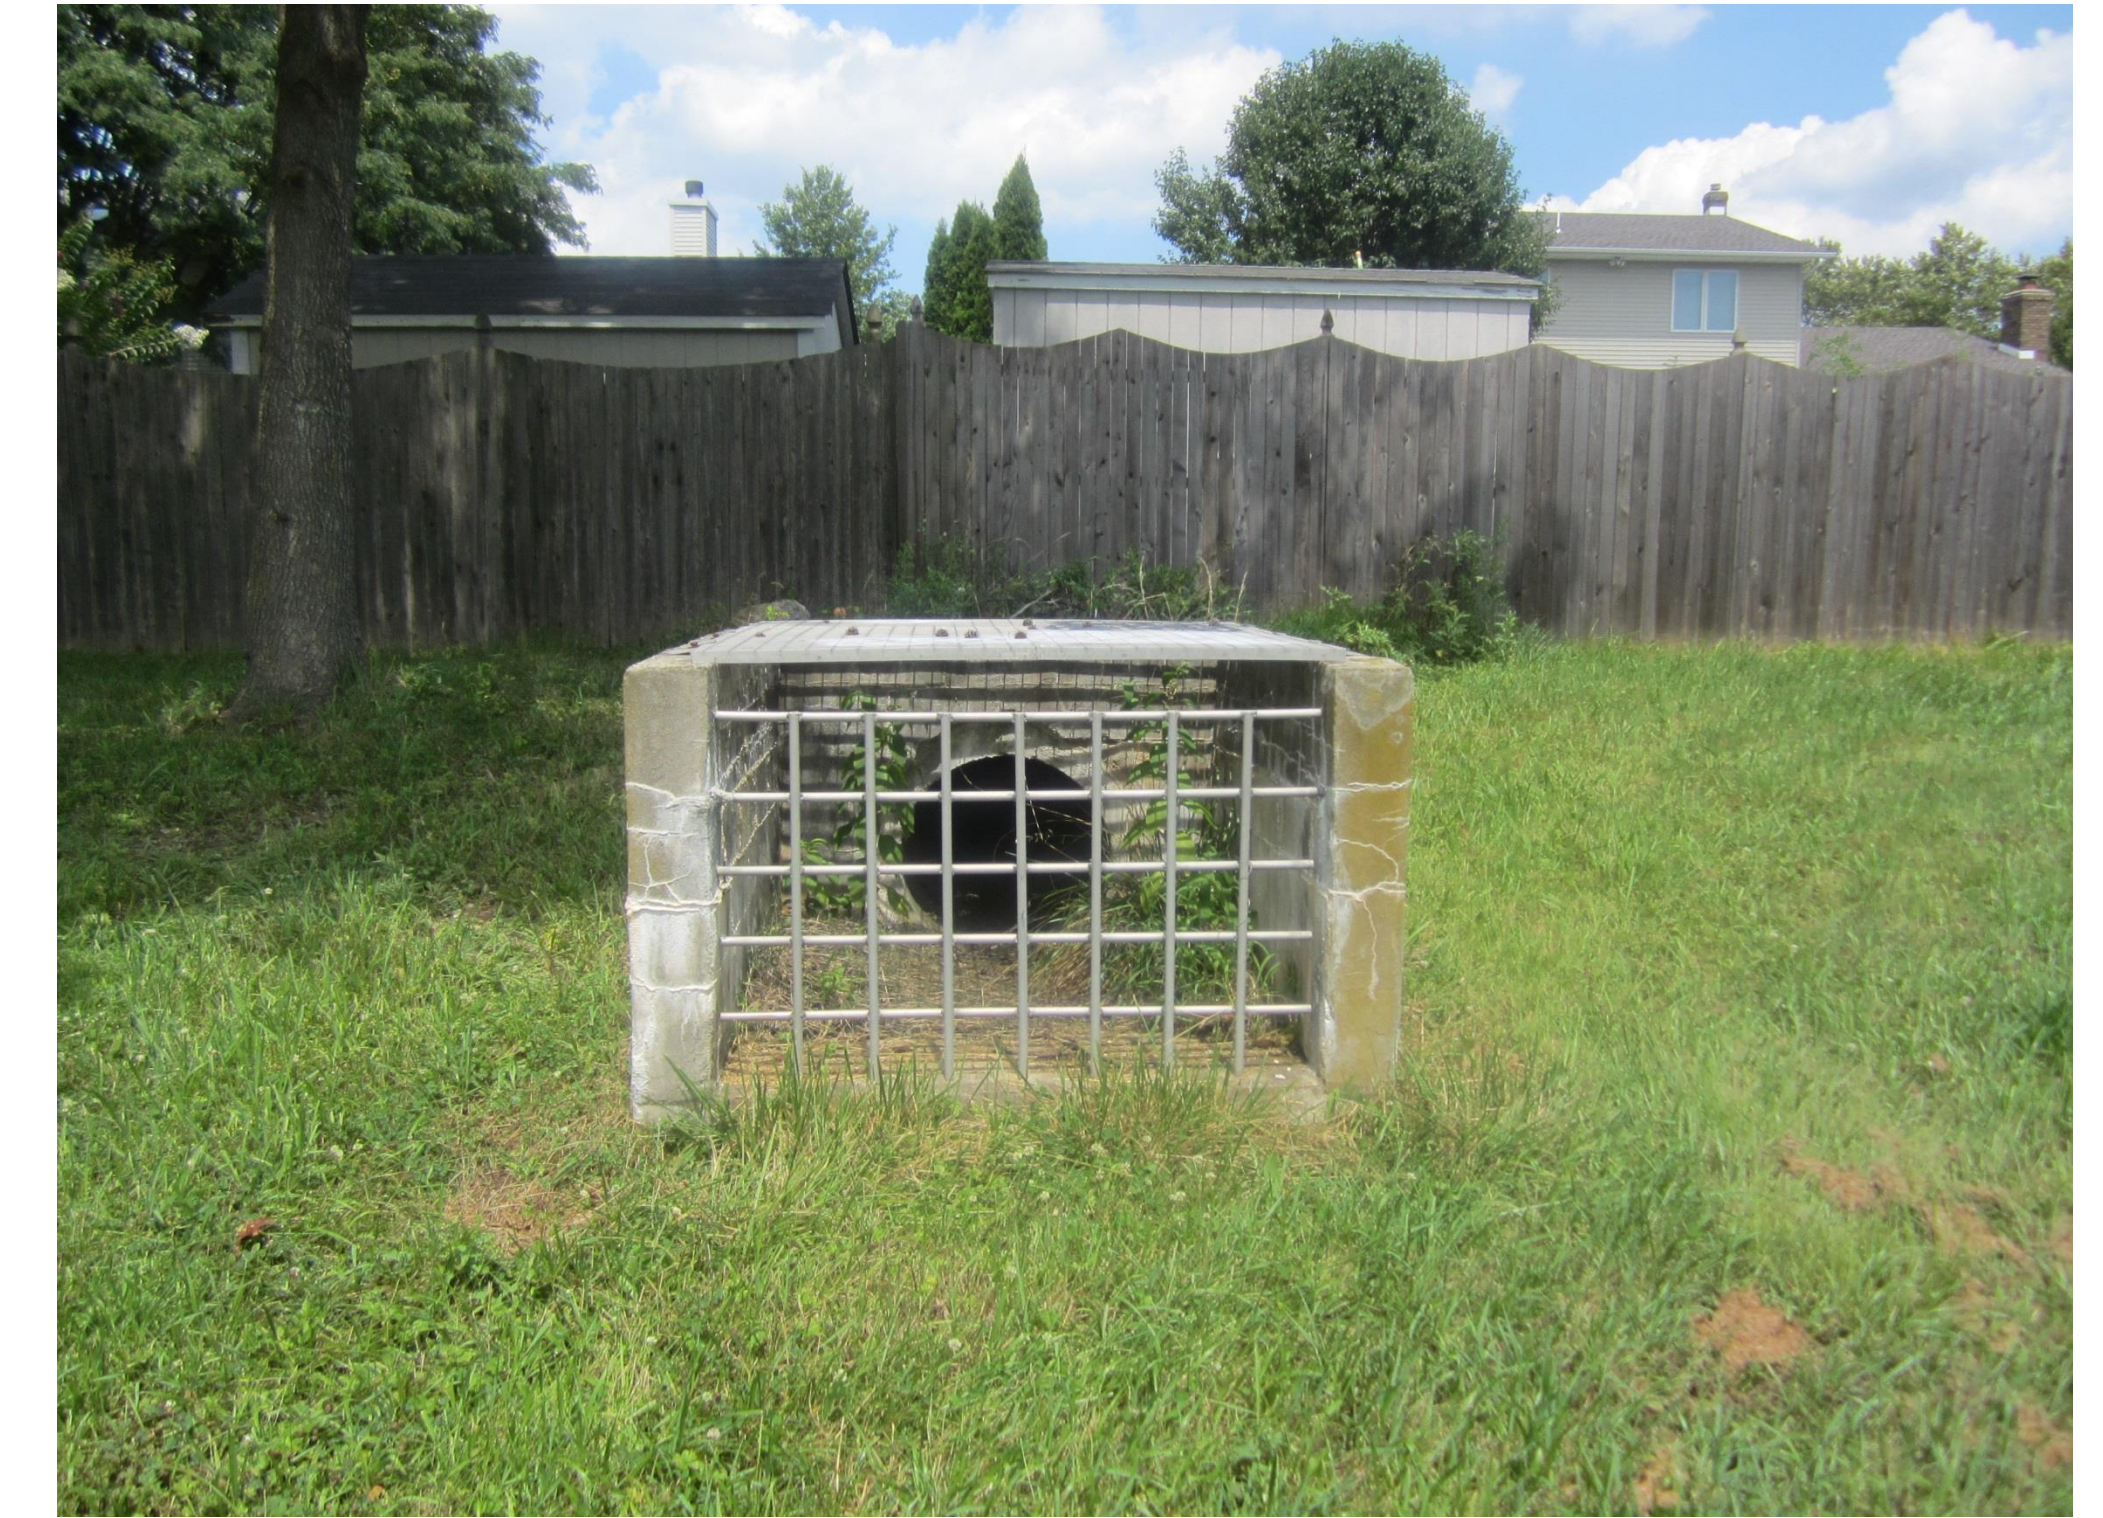
Secondary emergency overflow

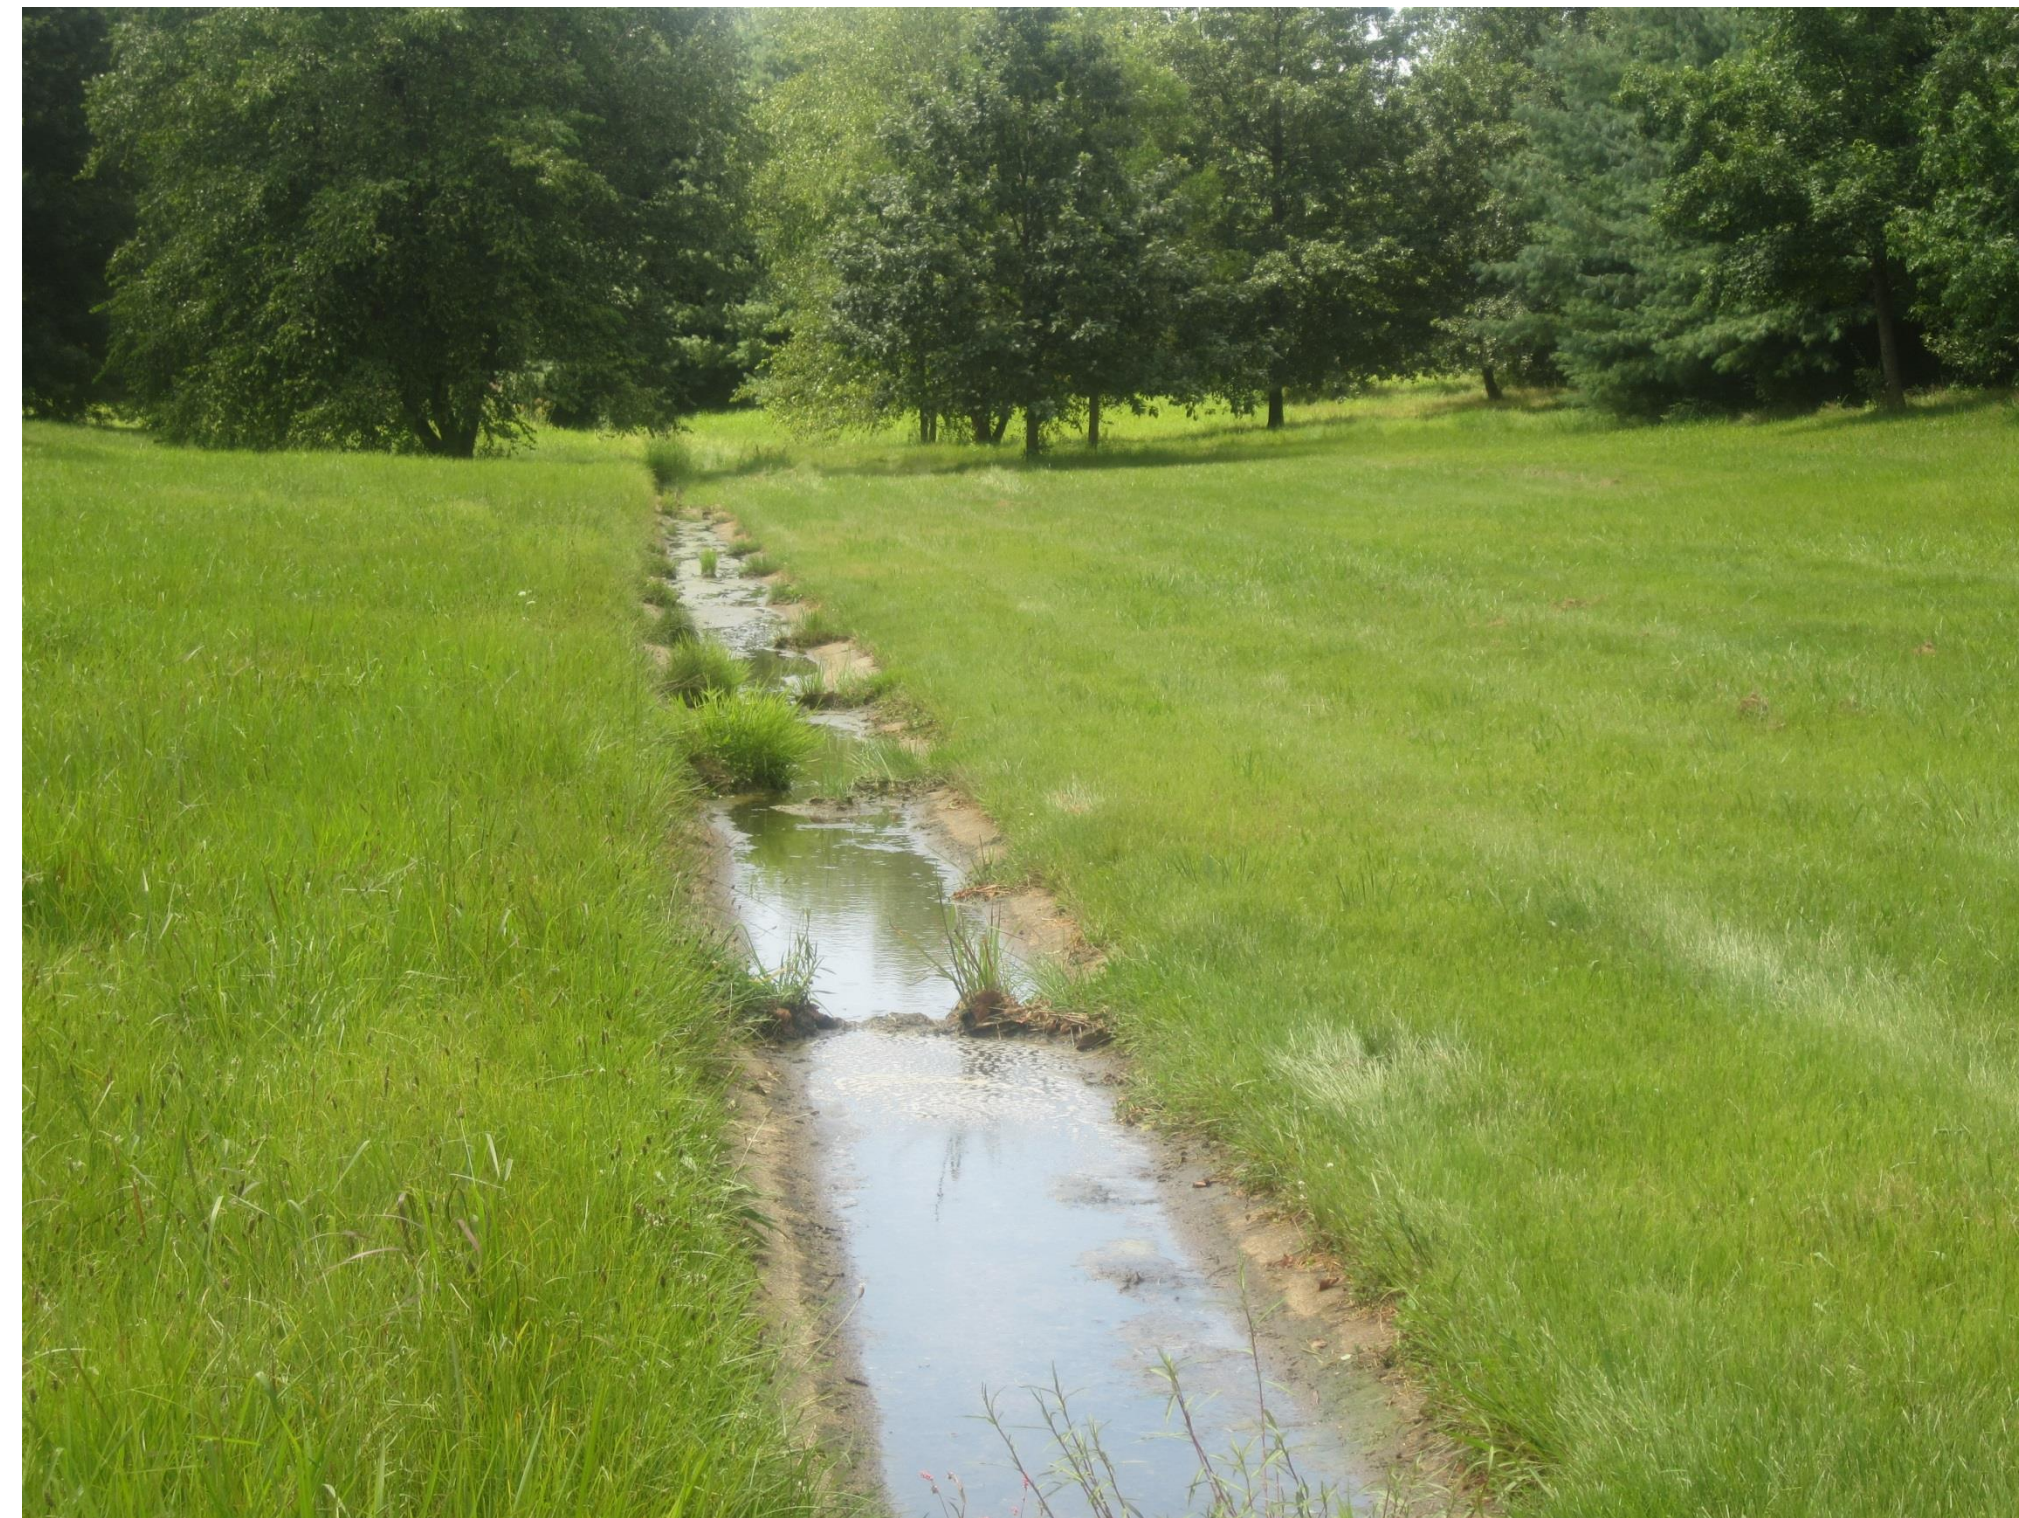
Basin bottom looking northwest

- There is excess sediment accumulated and standing water in the low flow channel
- The eastern and western inlets both have excess sediment accumulation and are overgrown with various types of vegetation
- The outlet structure has cracks in parging, the trash rack is broken, and the water is not discharging from the outlet causing the entire basin to back up

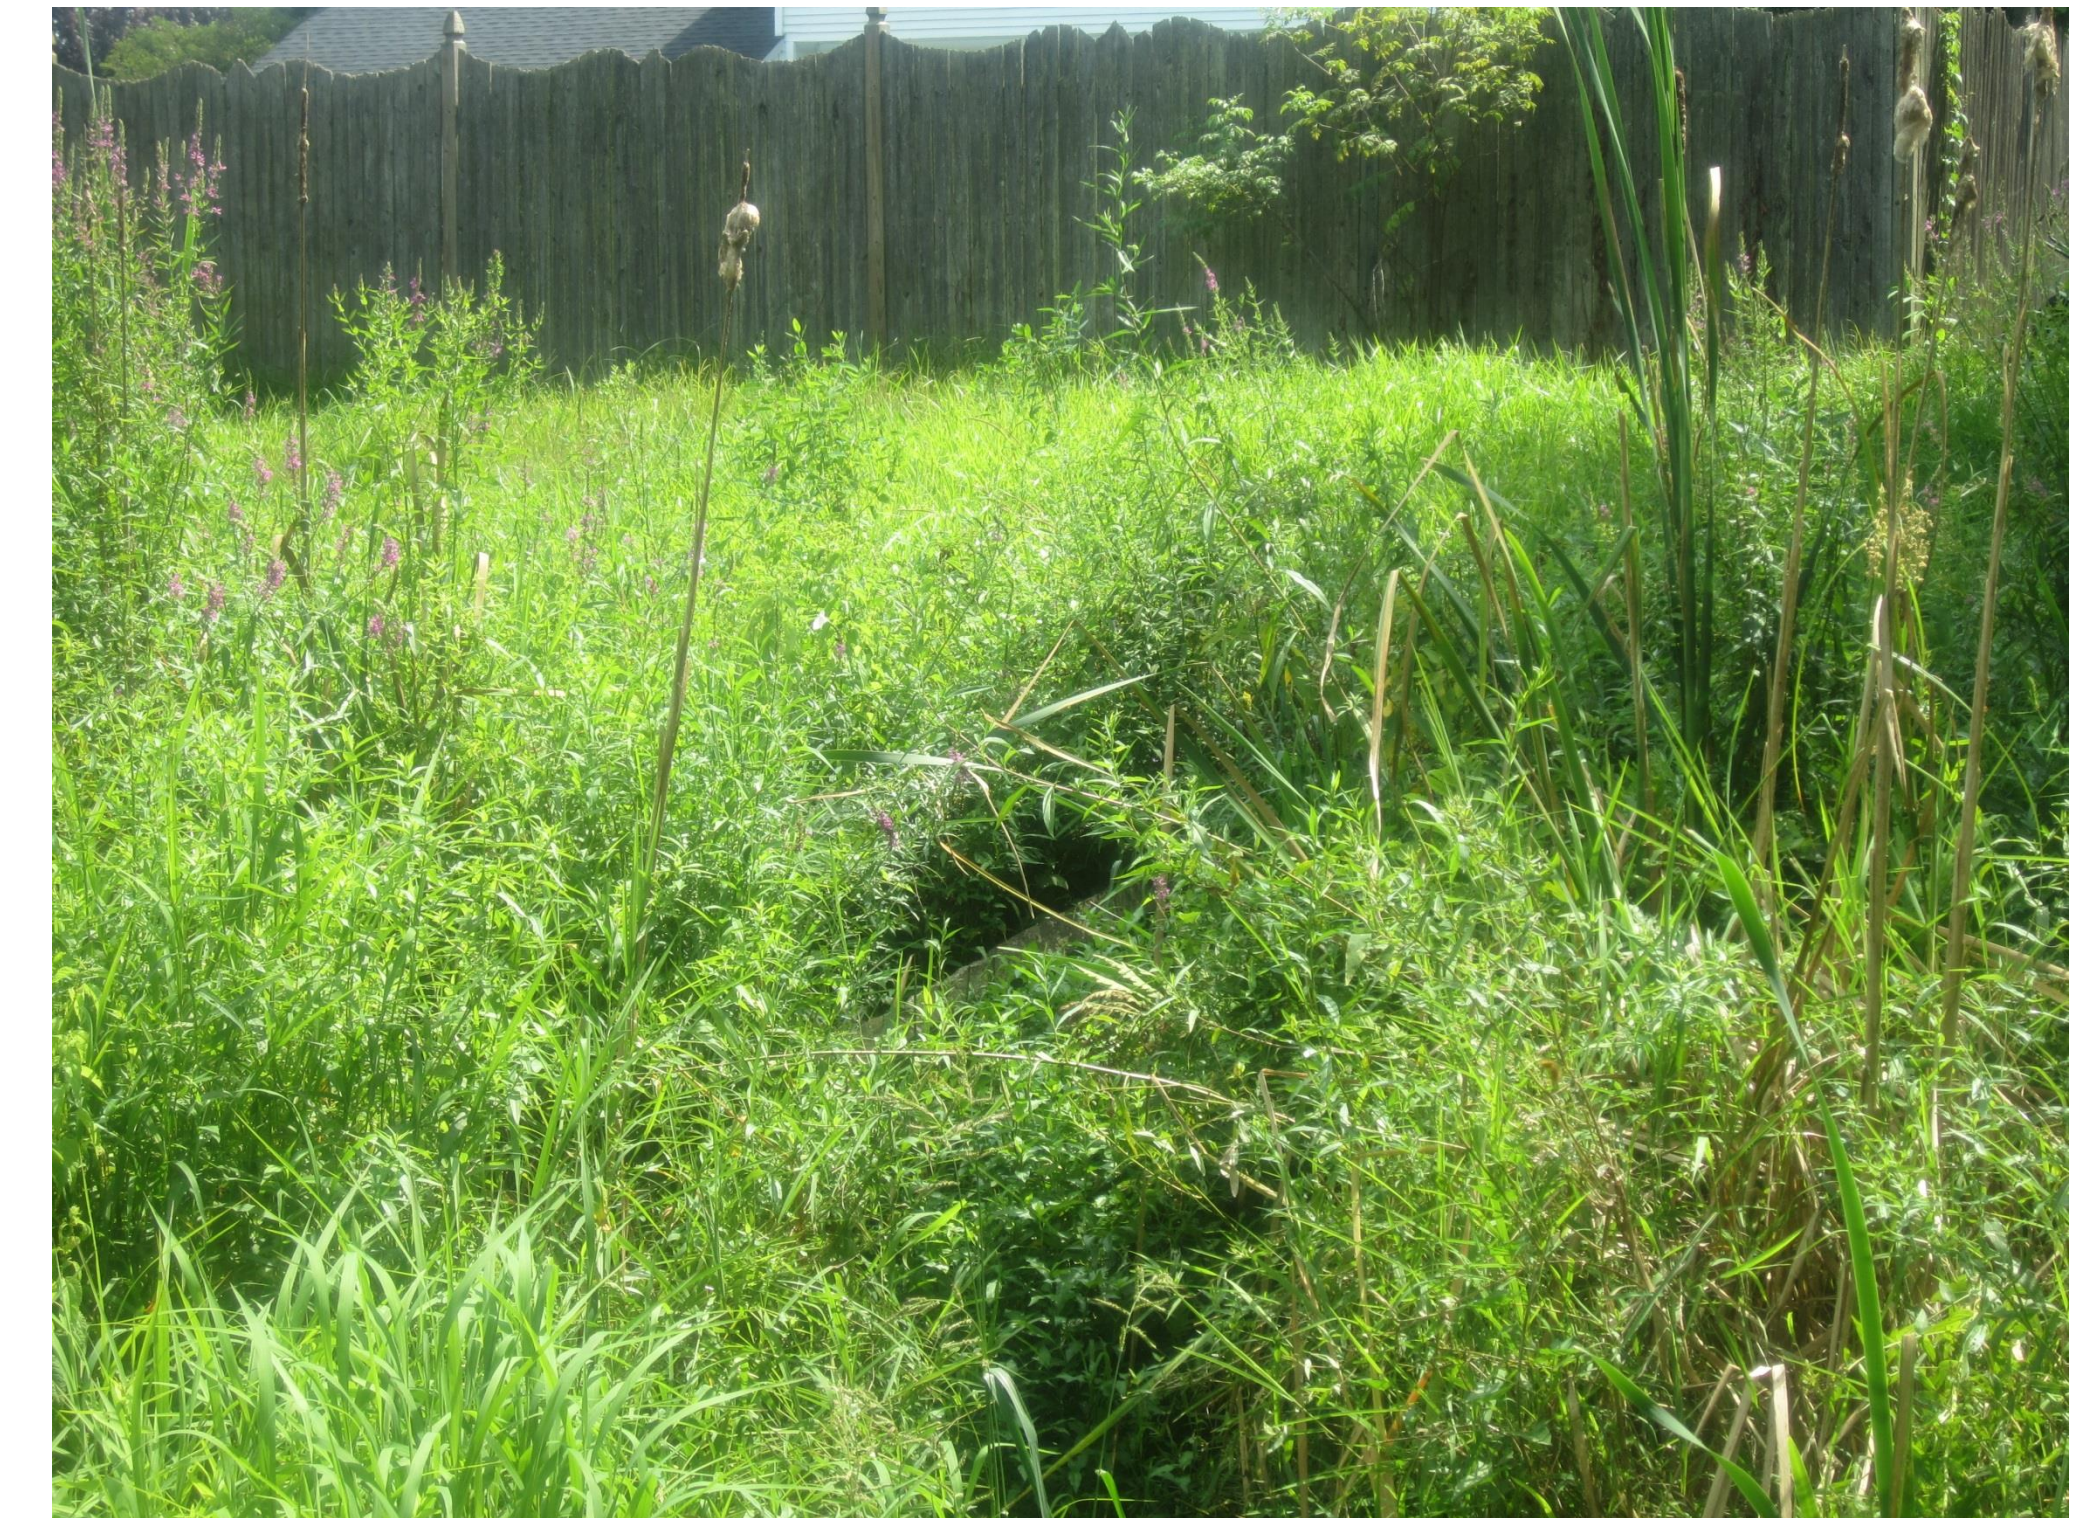
Overgrown western inlet

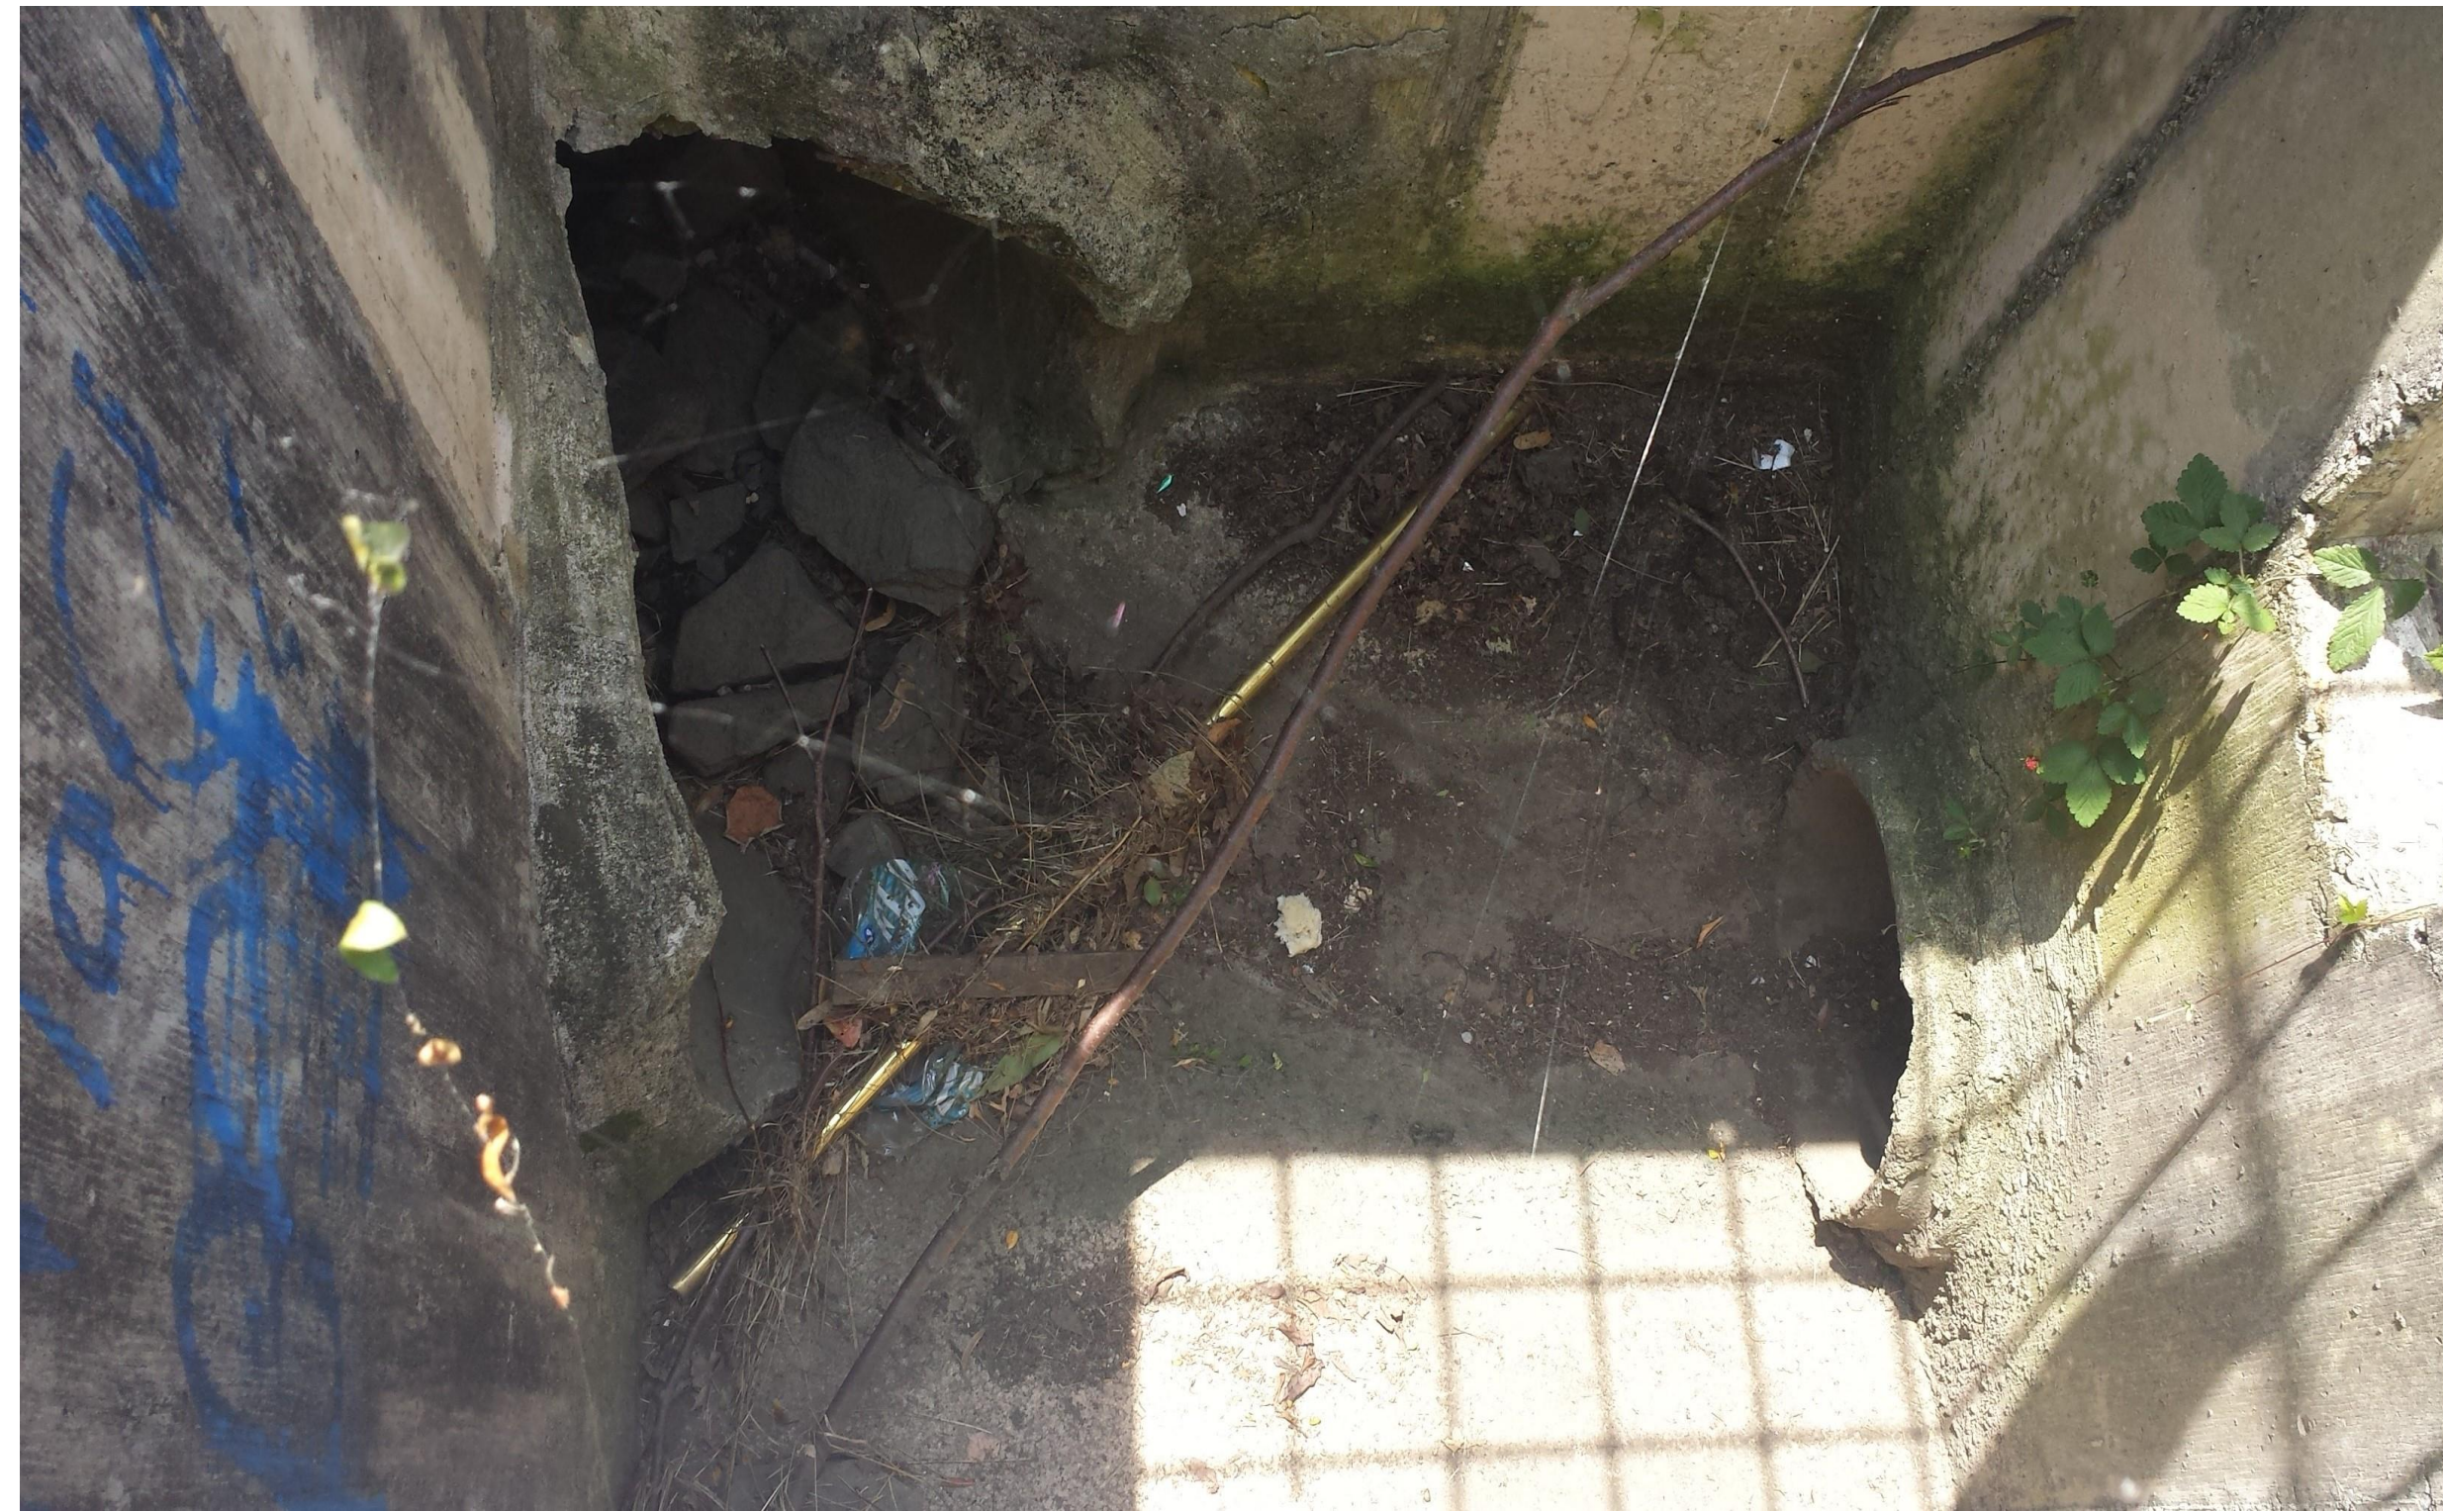
Inside of outlet
