**Hamilton Township (Mercer County)
Stormwater Basin Assessment Summary
Hamilton Owned Addendum (Year 5A)**

Developed by the Rutgers Cooperative Extension Water Resources Program
Funded by Hamilton Township, Mercer County, New Jersey

November 27, 2019

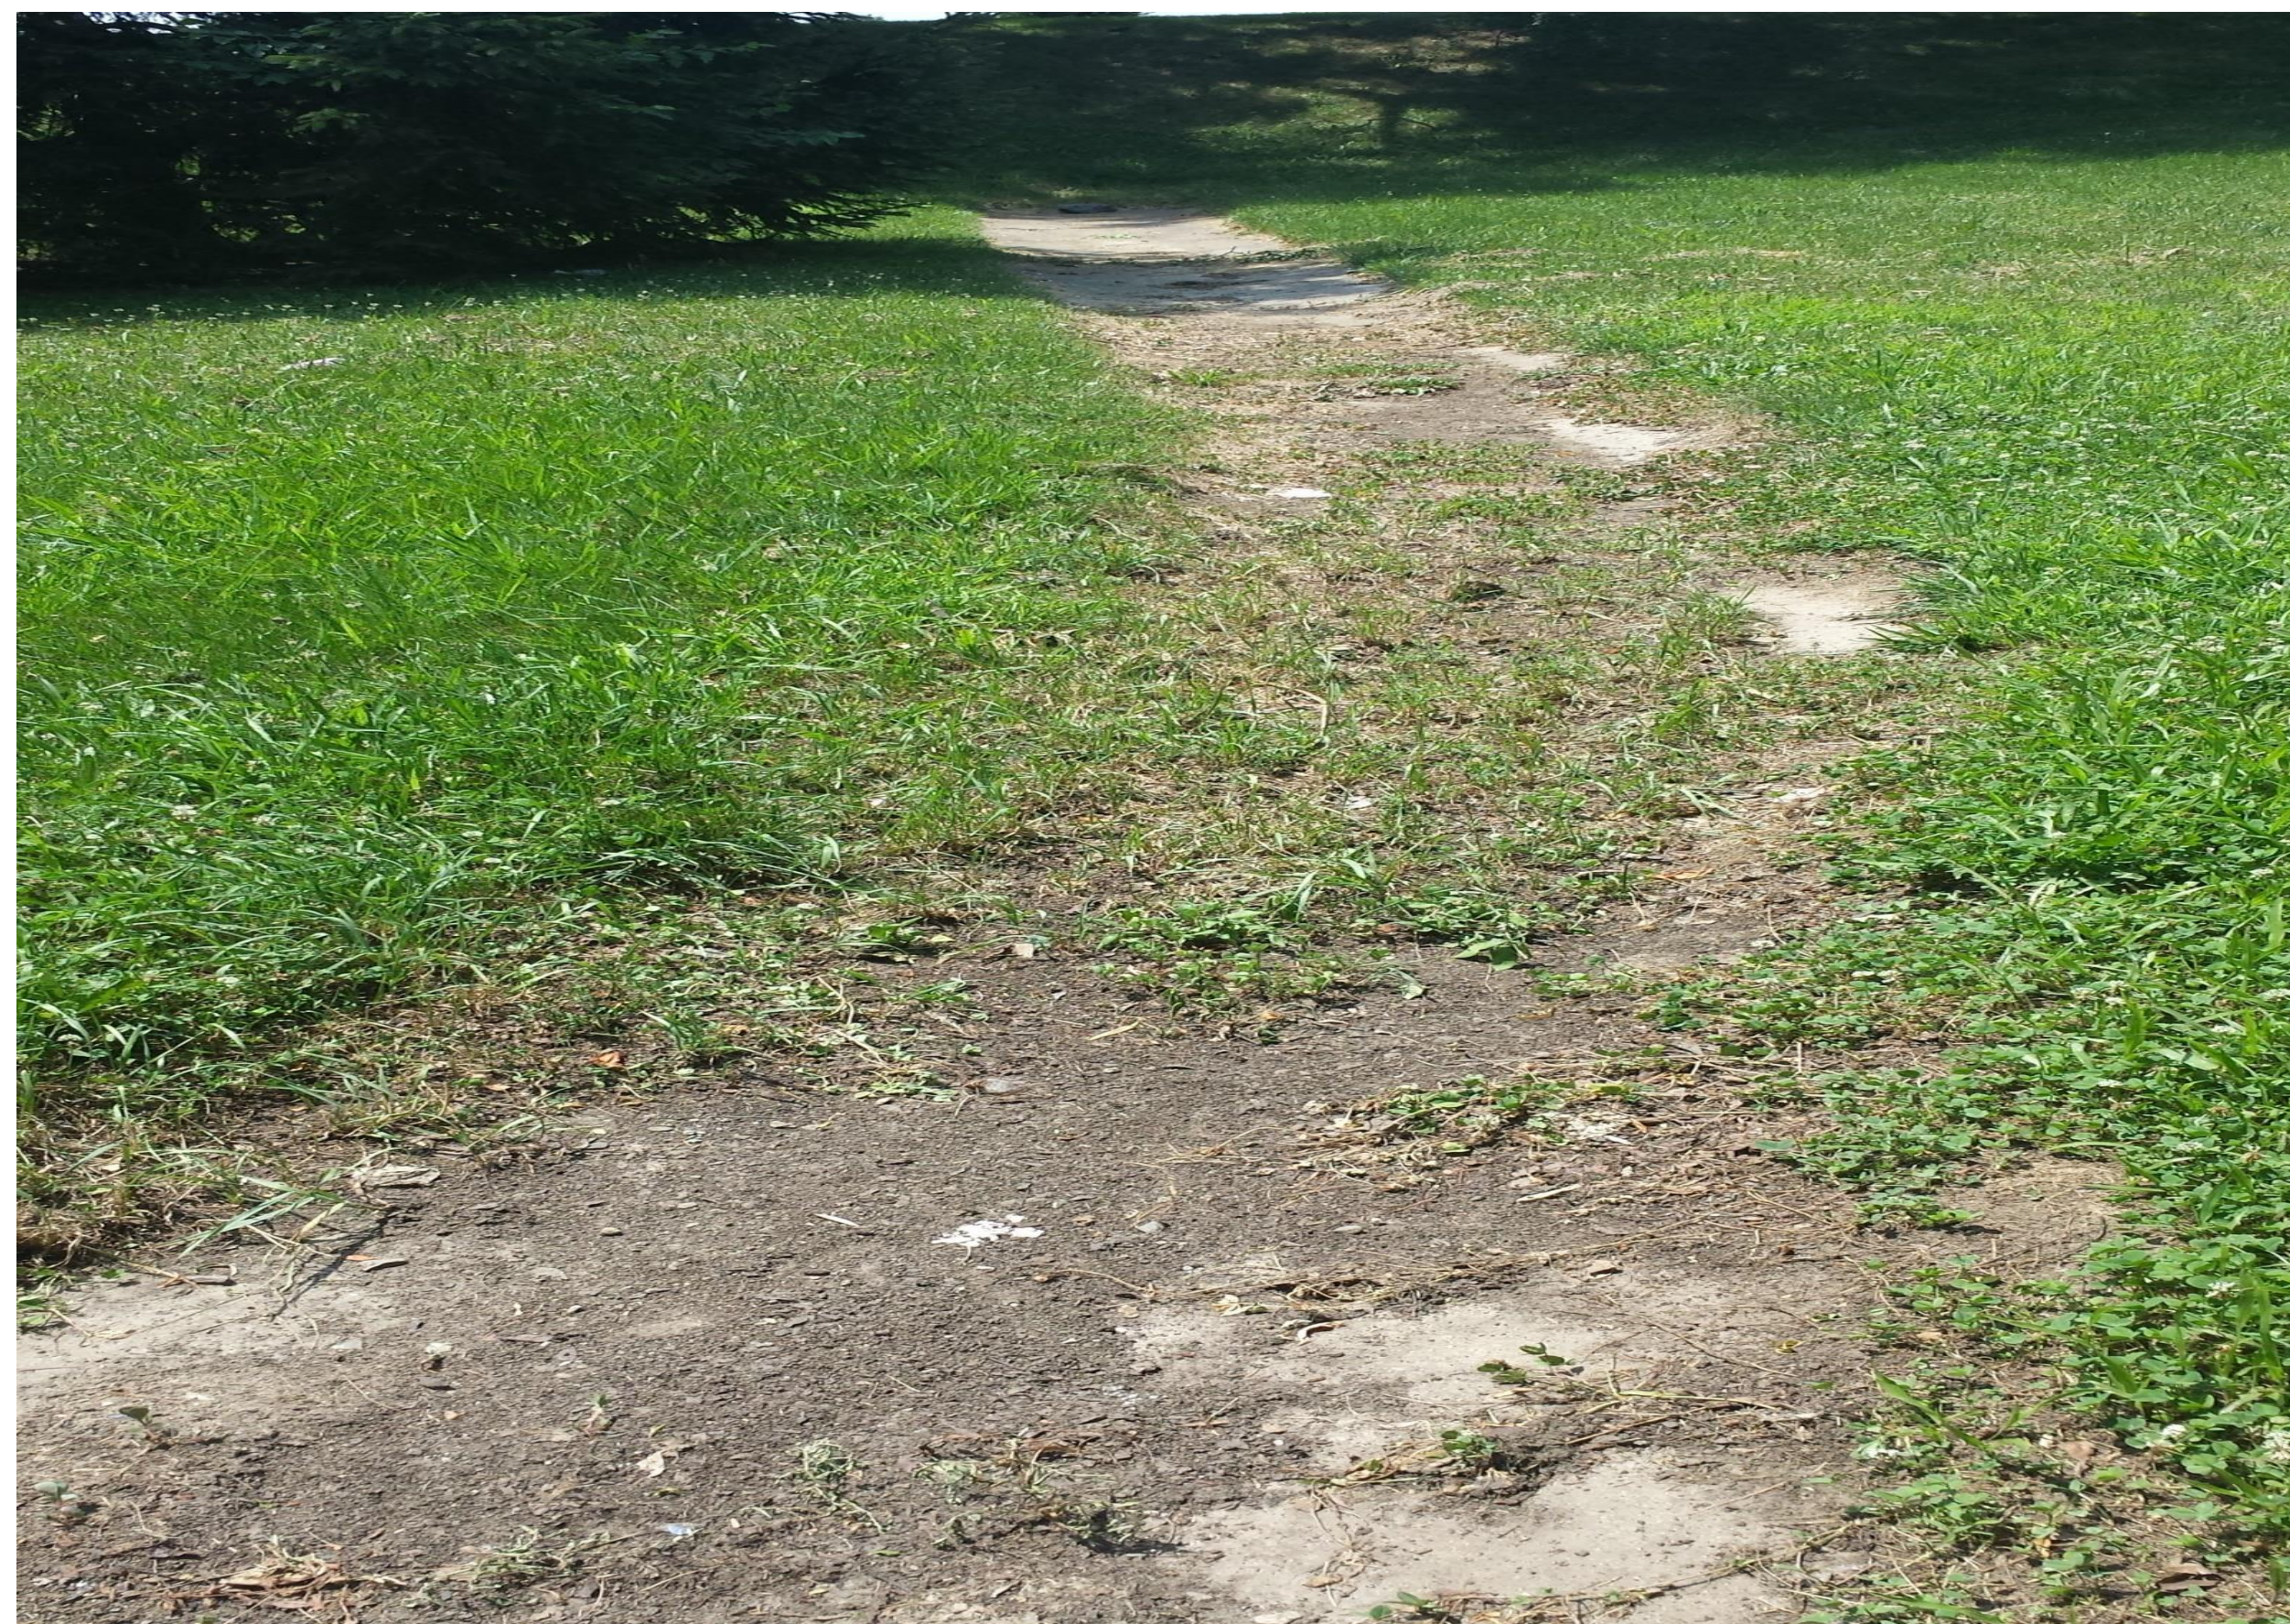
Overgrown on low flow channel

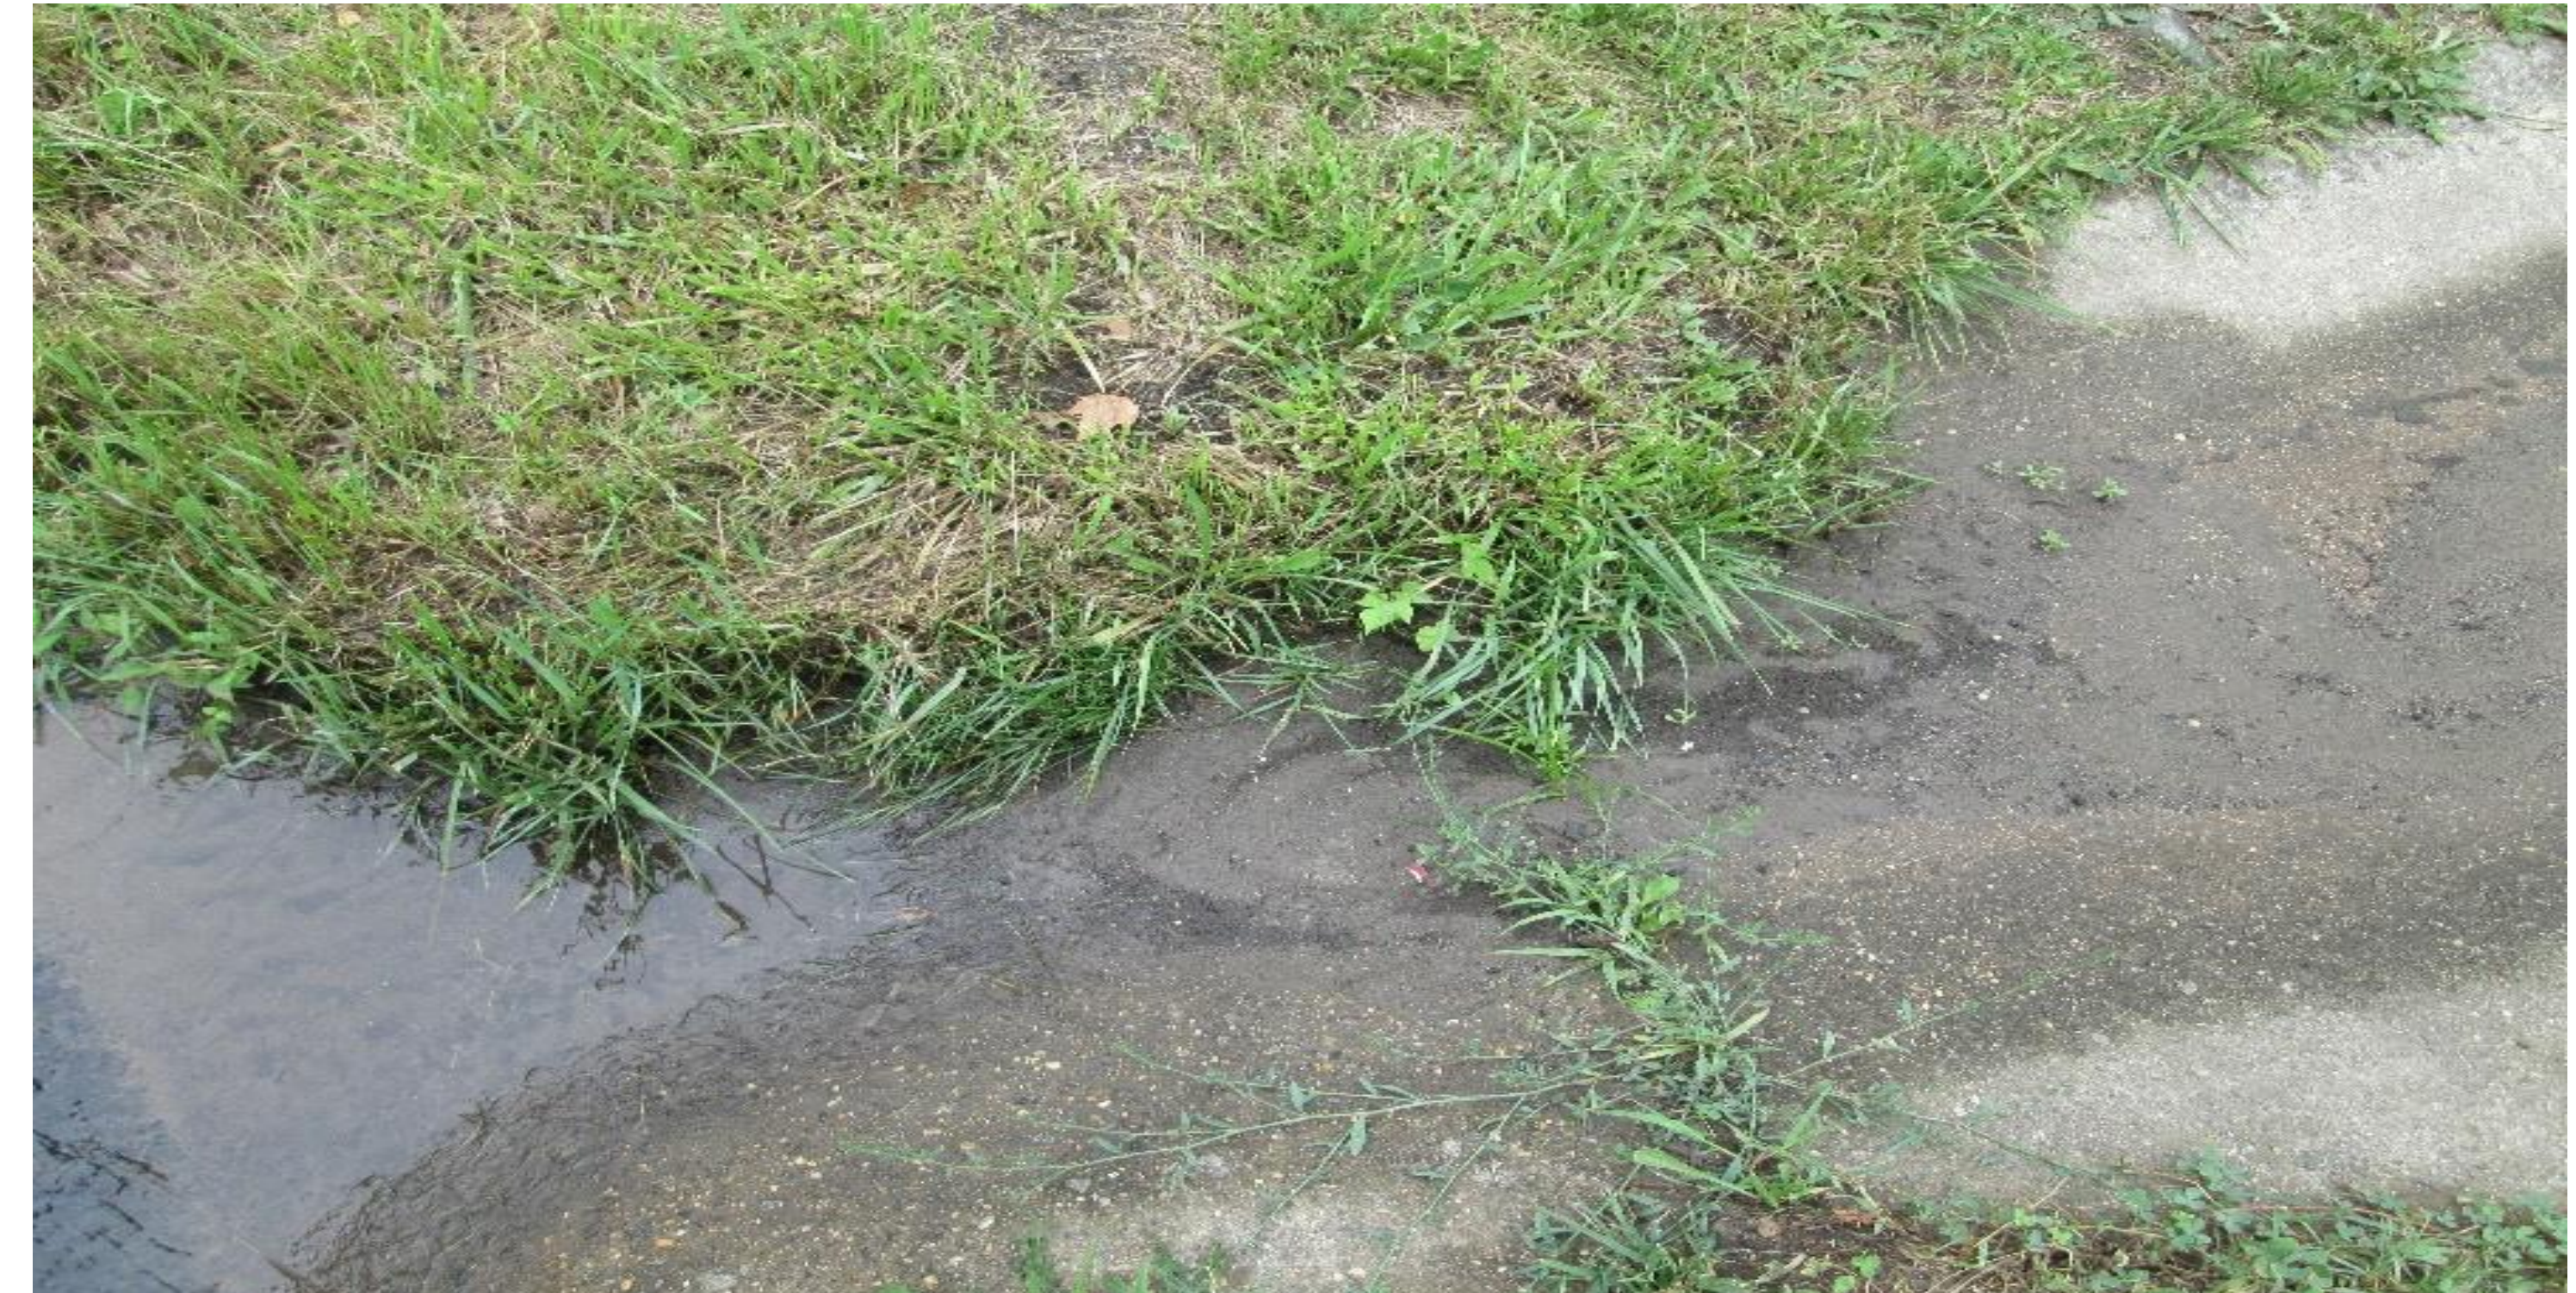
Low flow channel

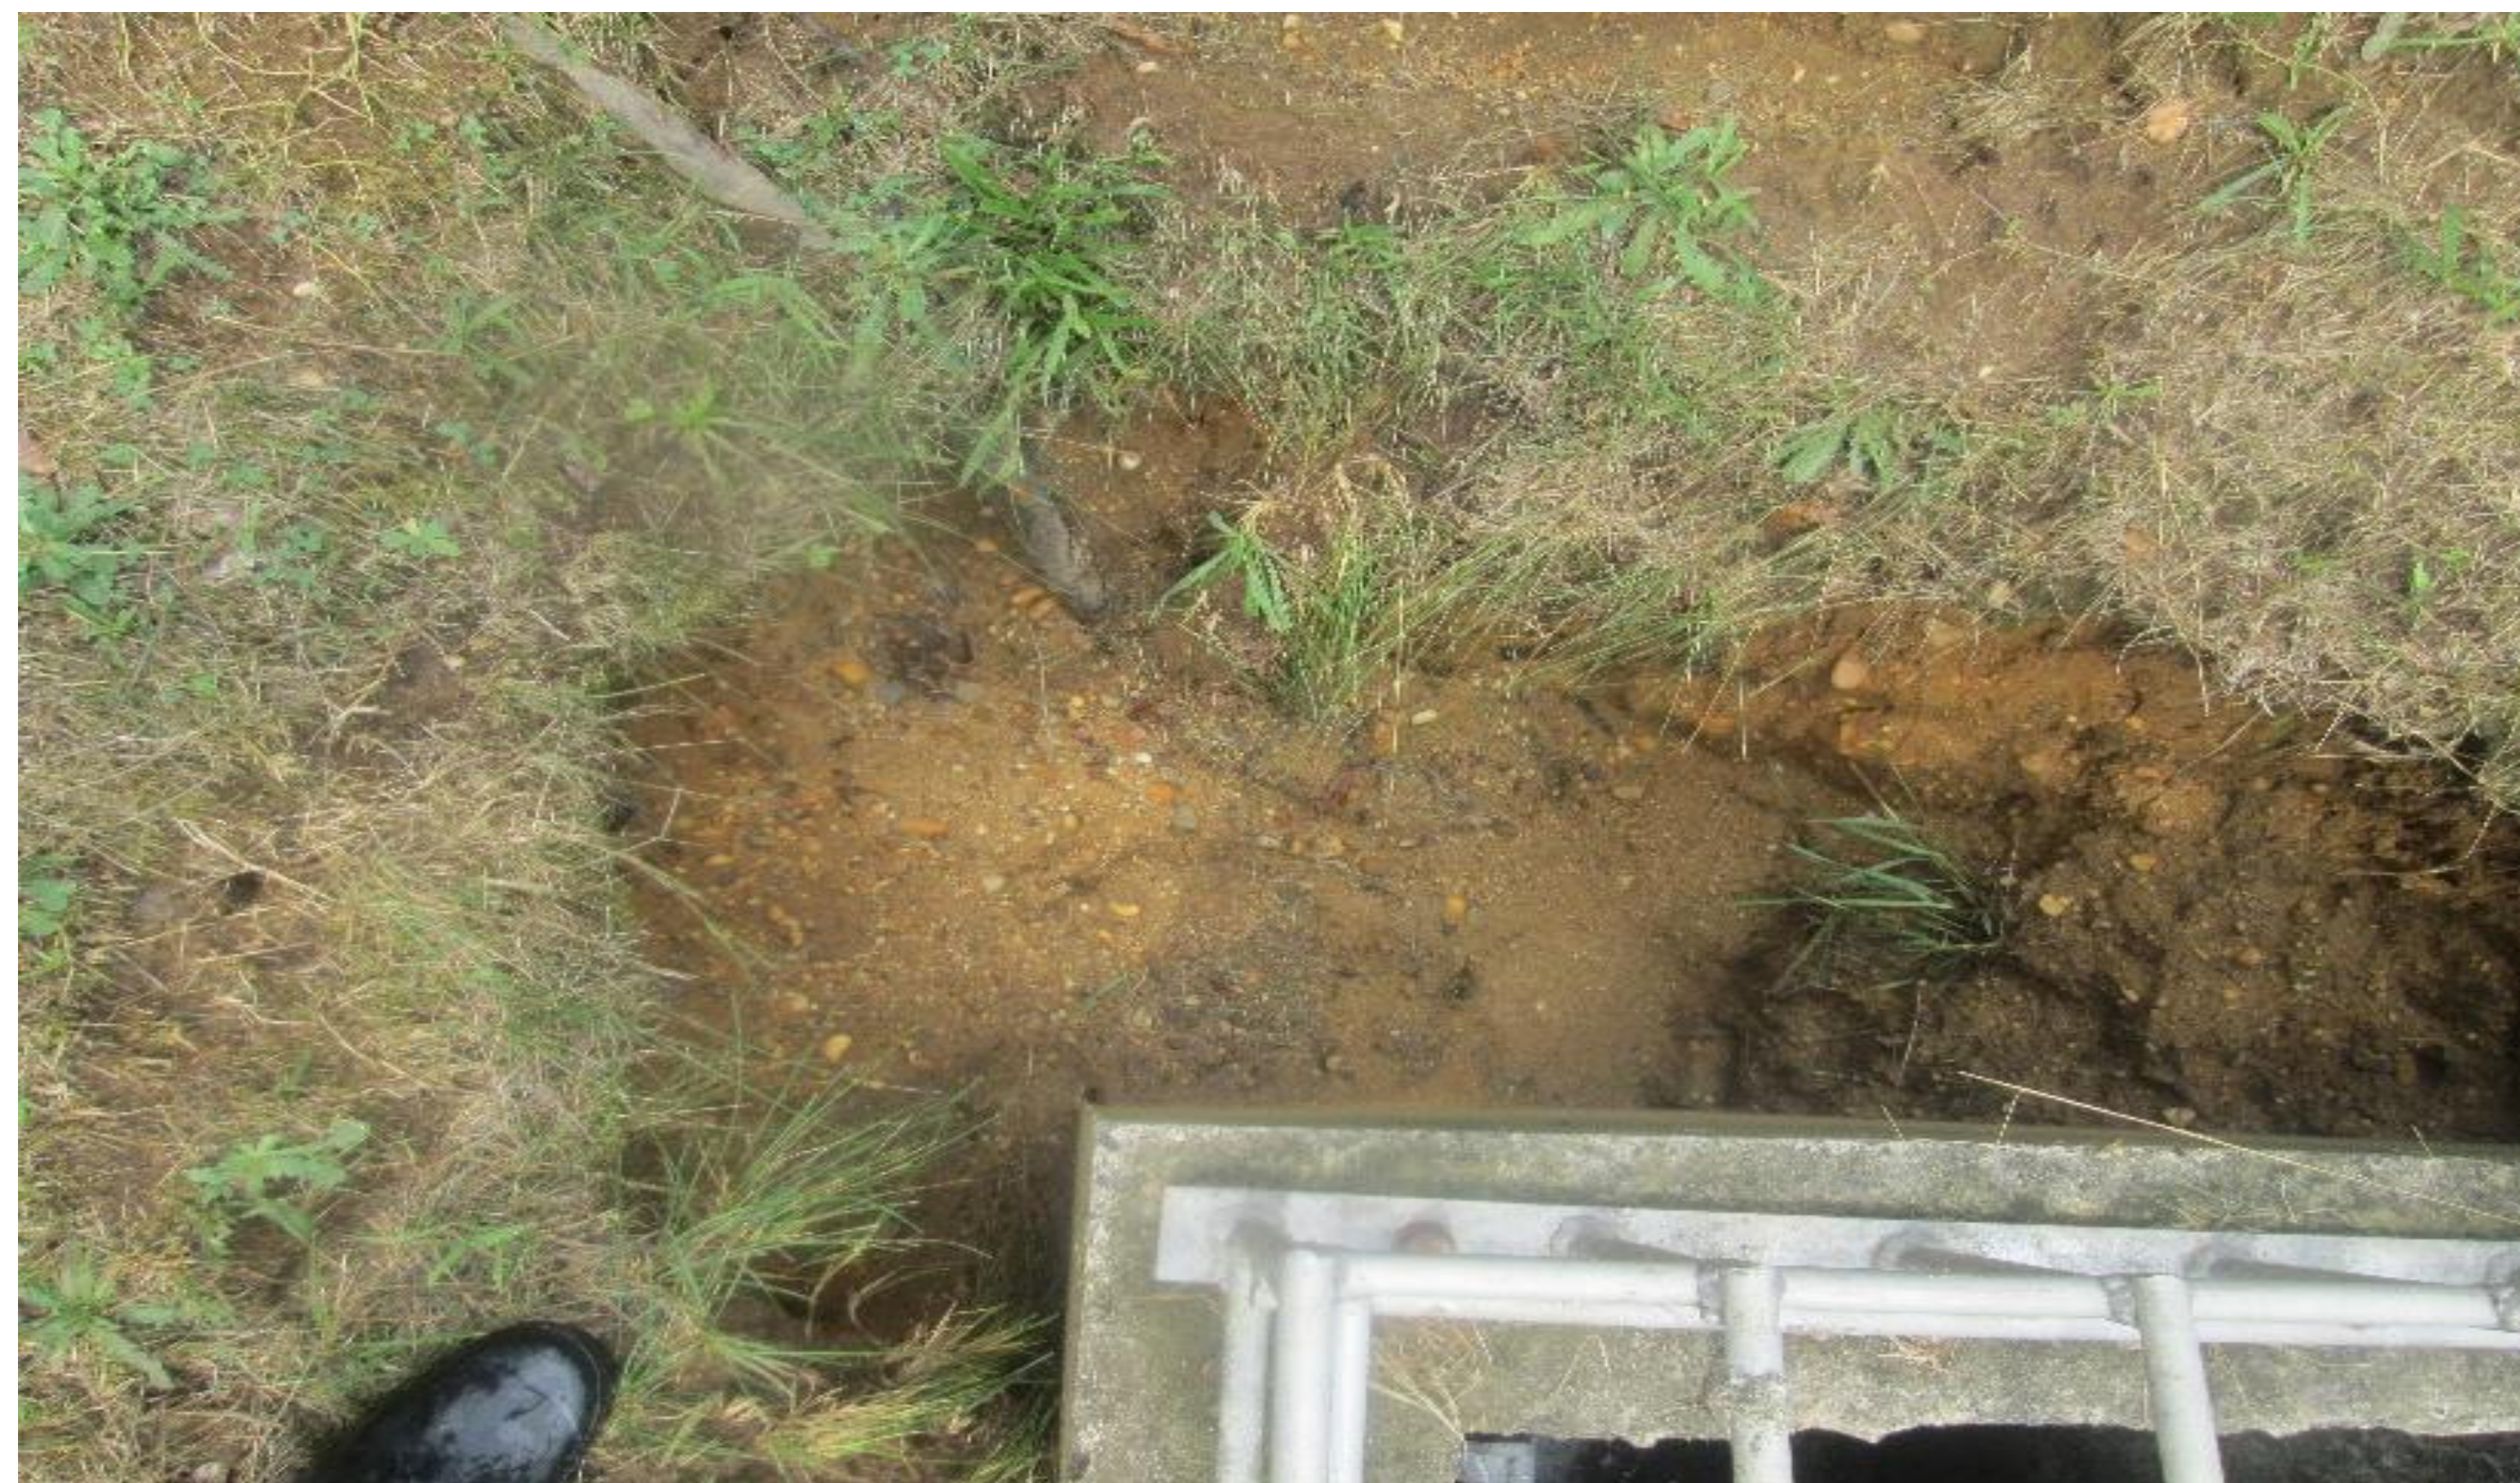
Erosion near outlet structure

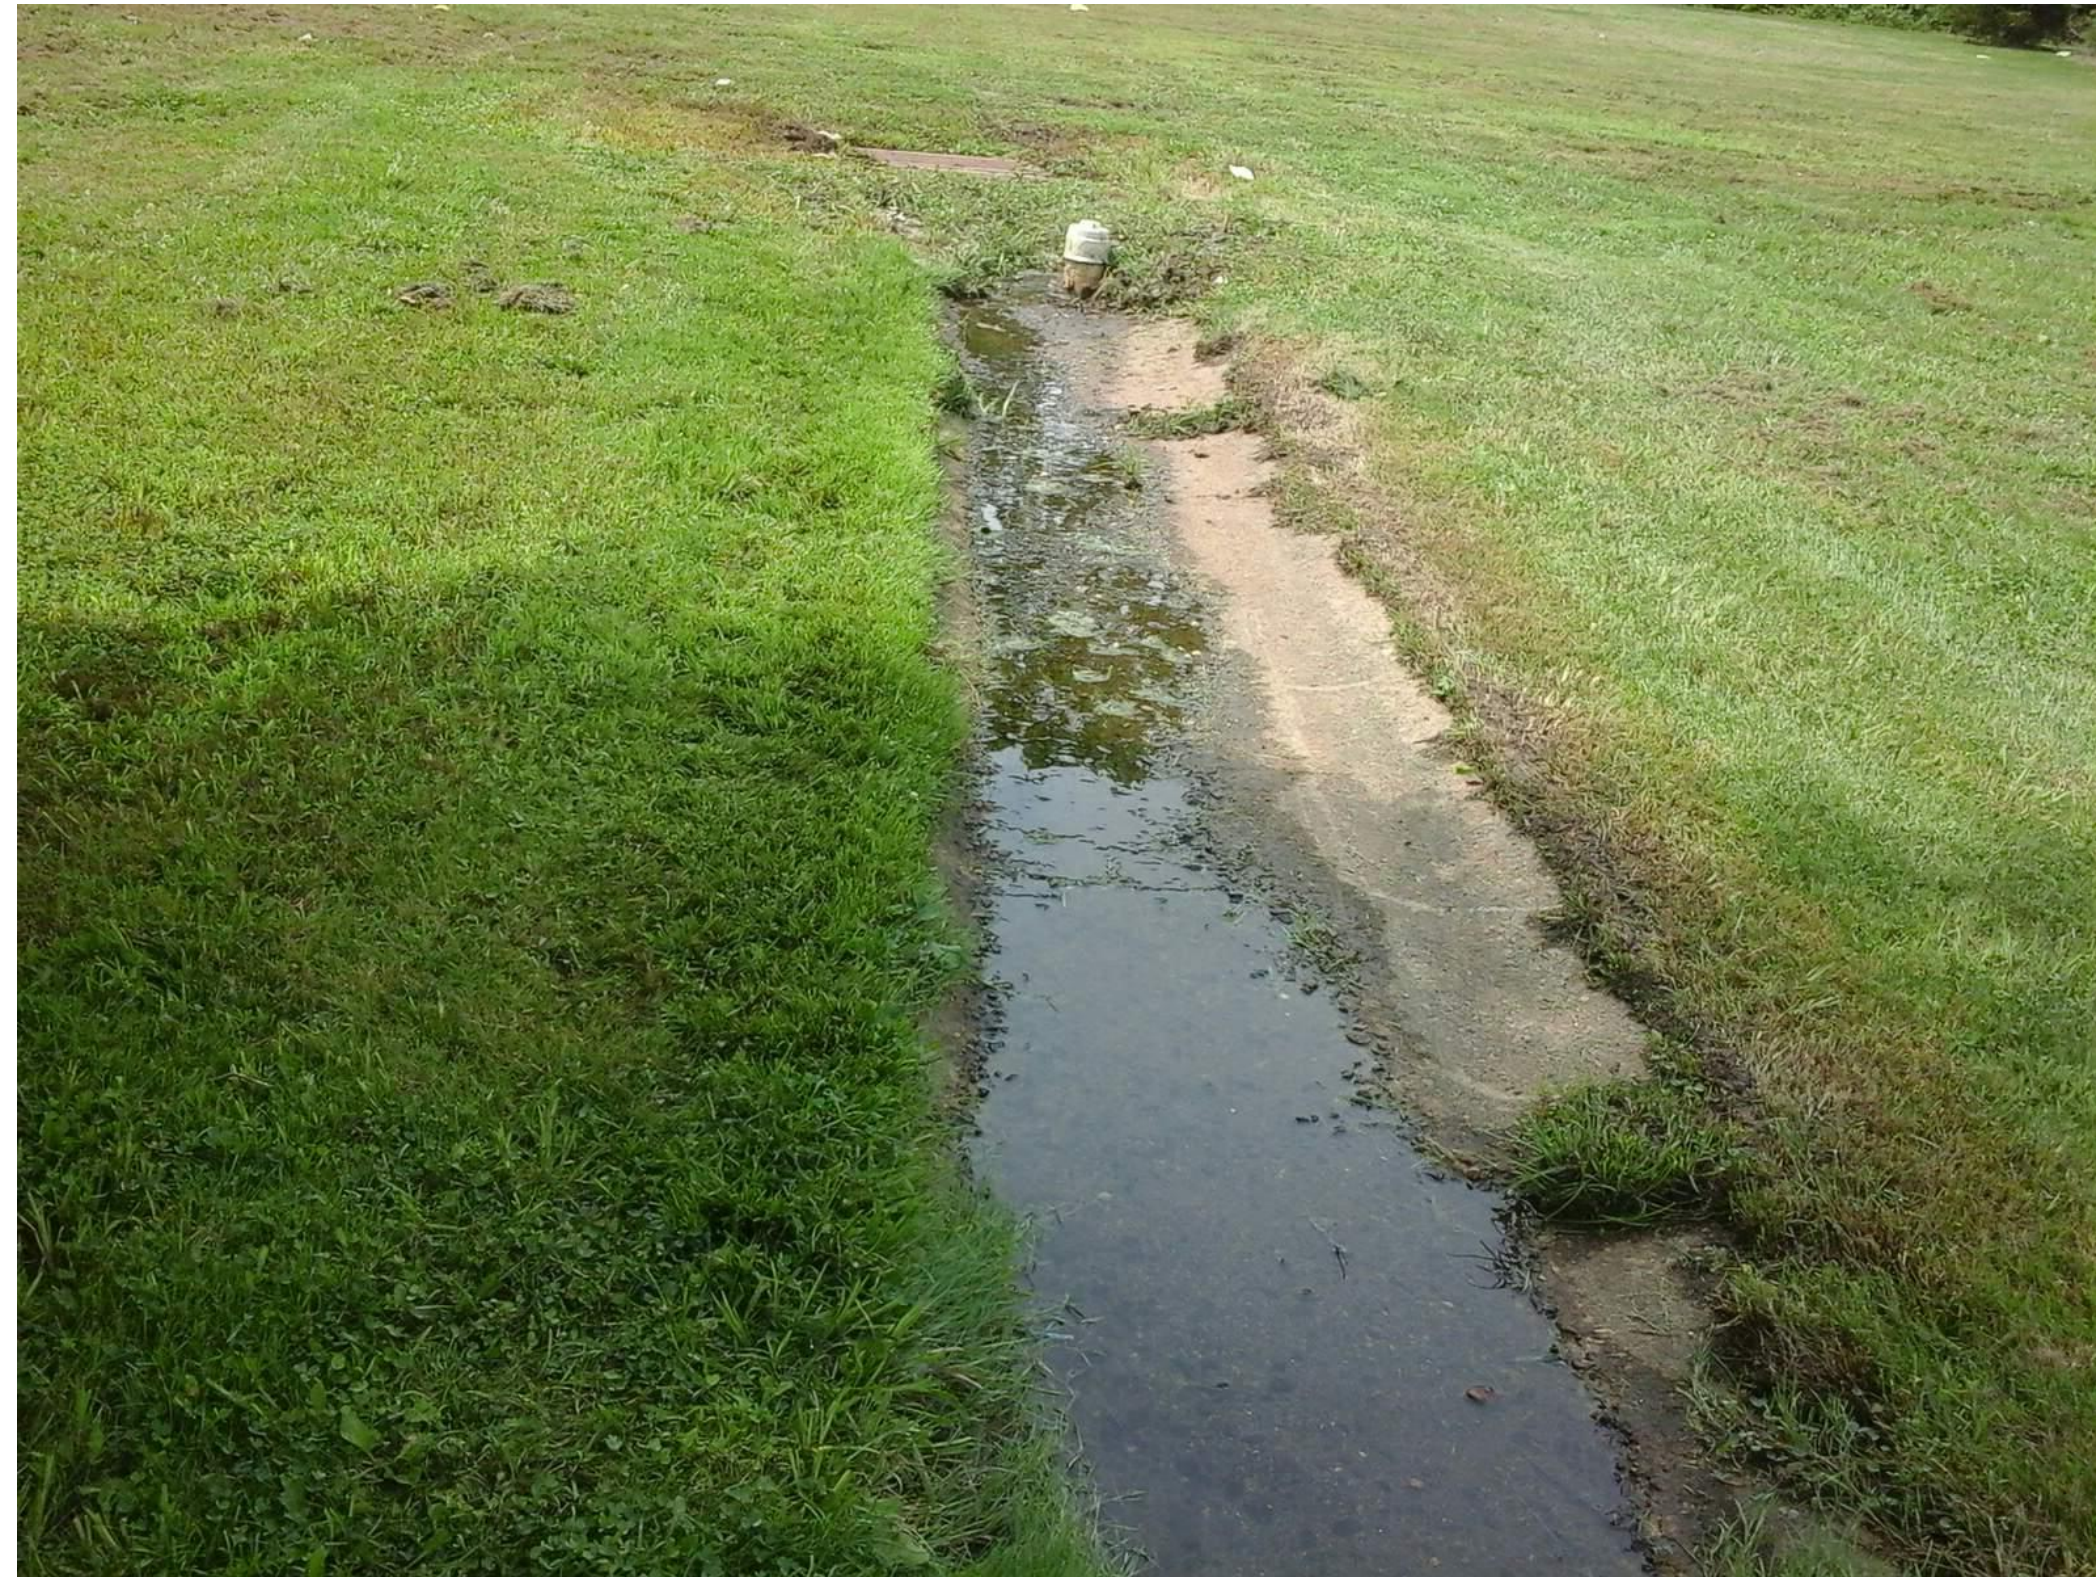
Low flow channel leading to catch basin

- Two low flow channels lead to a catch basin
- Basin can be naturalized using a stone lined channel to replace the low flow channel
- Reduce mowing and raise catch basin at the end of the low flow channels to allow better infiltration

- Sediment build up and grass in low flow channel leading to standing water
- Raise primary catch basin outlet and add low flow orifice to increase detention capacity
- Remove concrete low flow and add stone channel to enhance infiltration capacity
- Naturalize with herbaceous plants

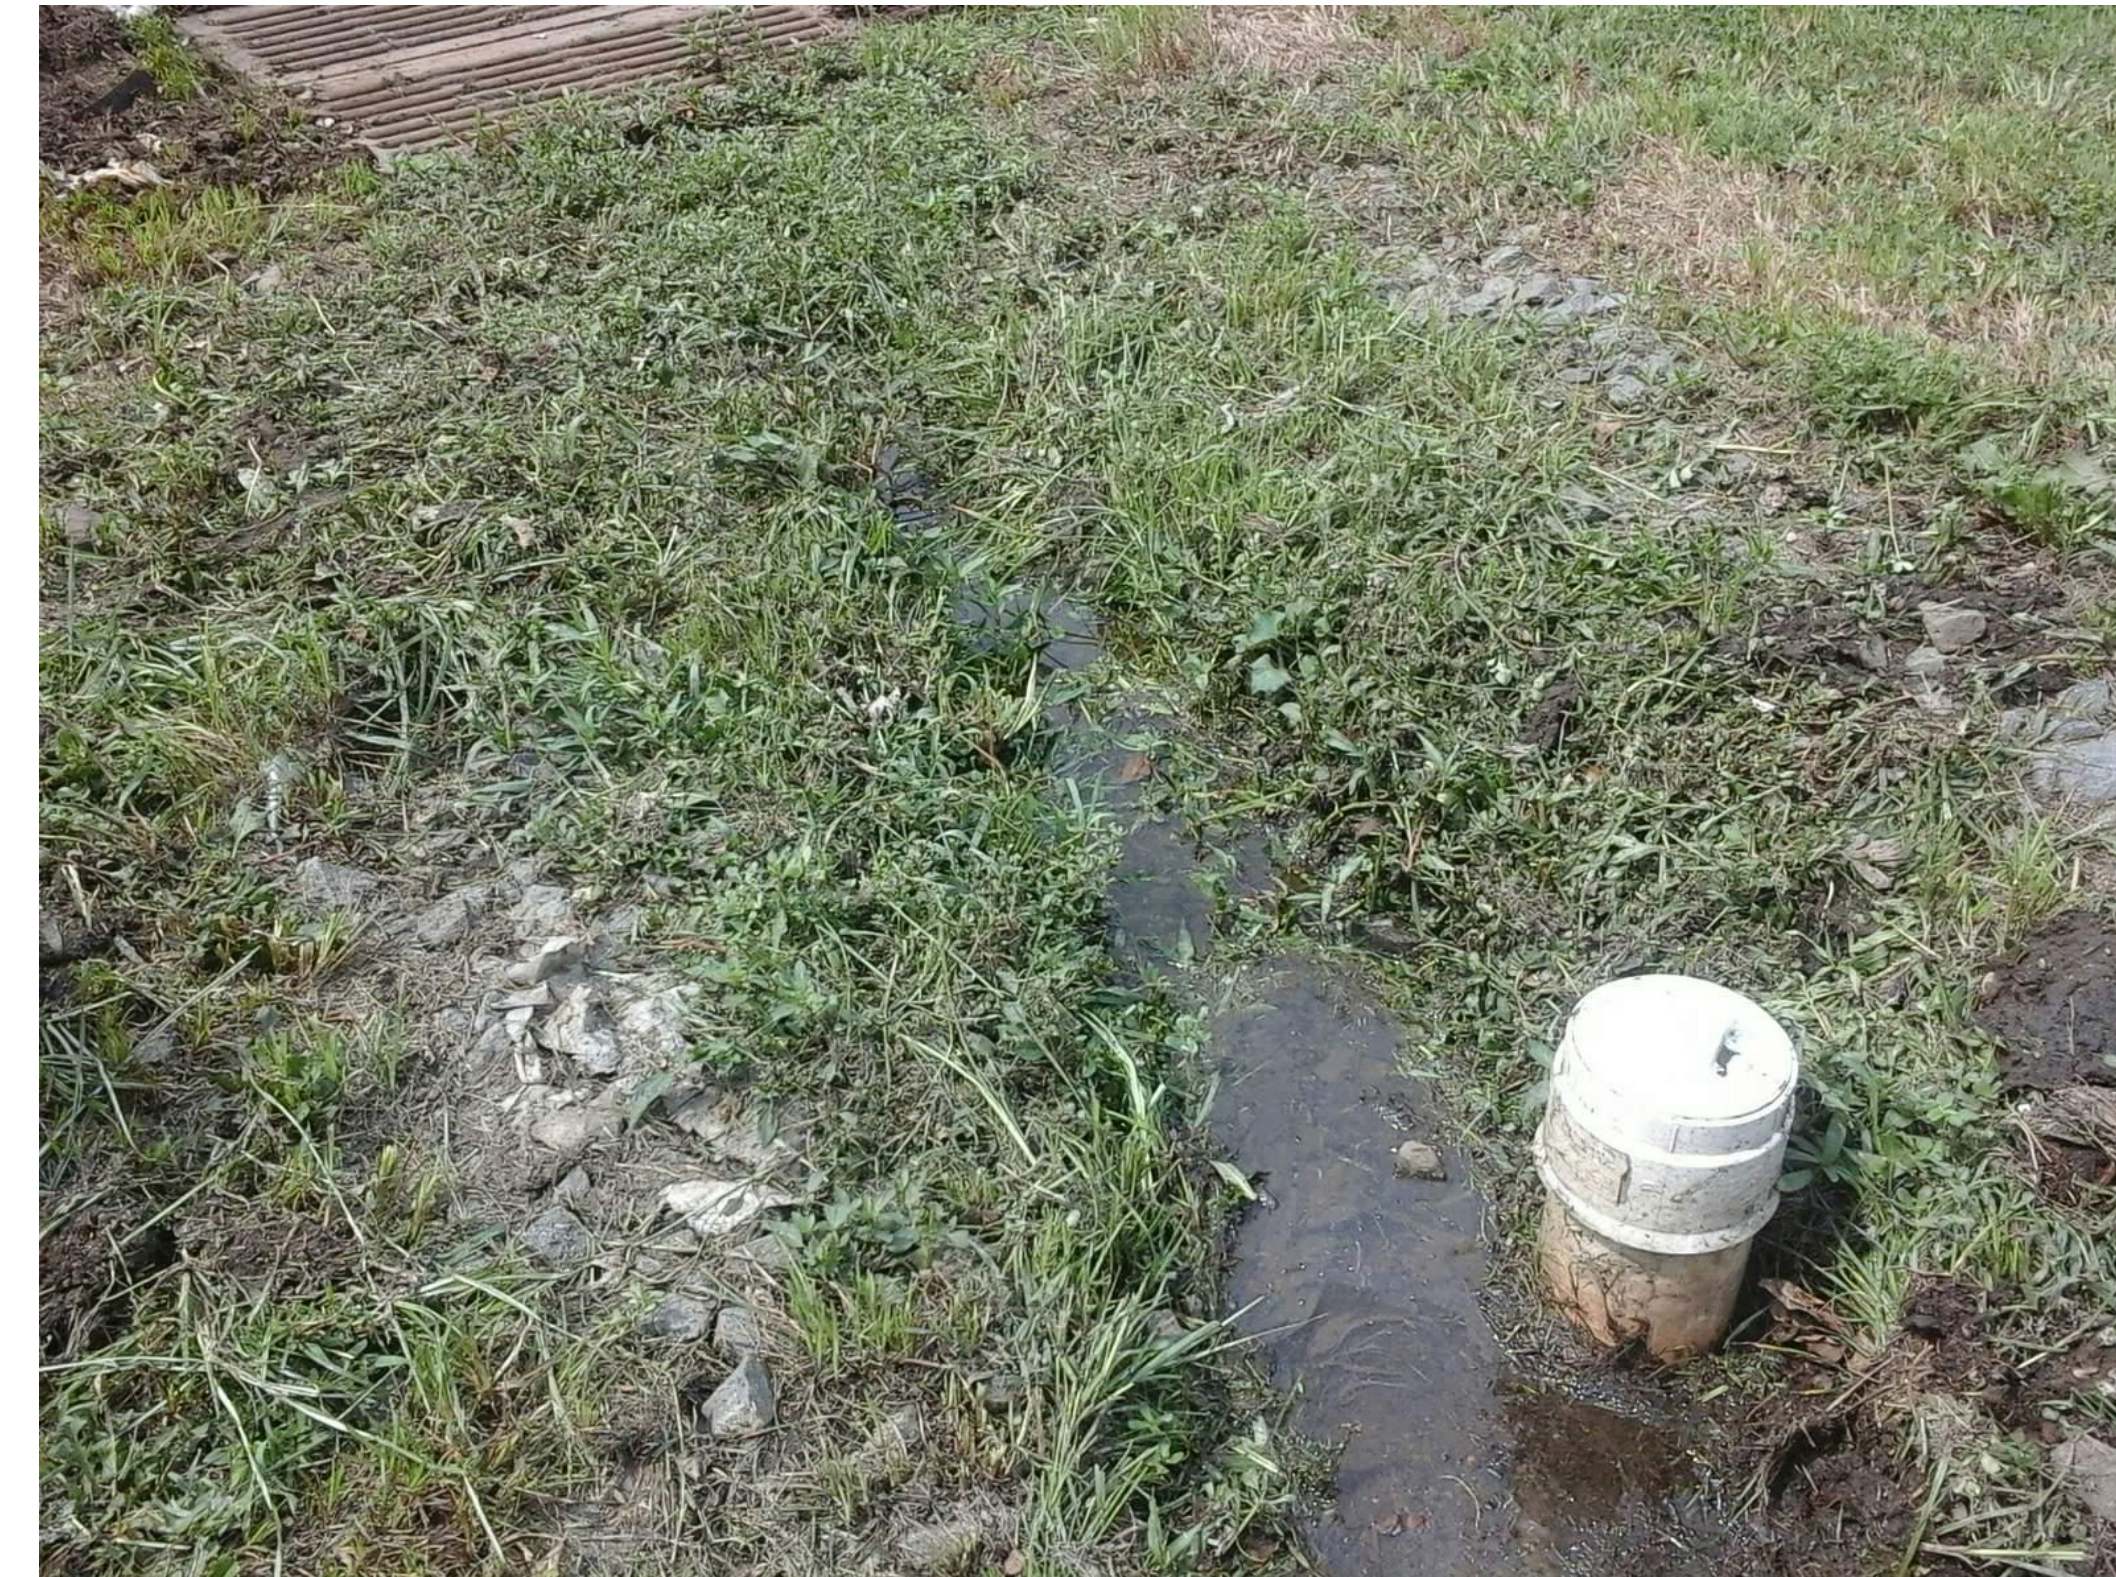
Clean out in low flow channel

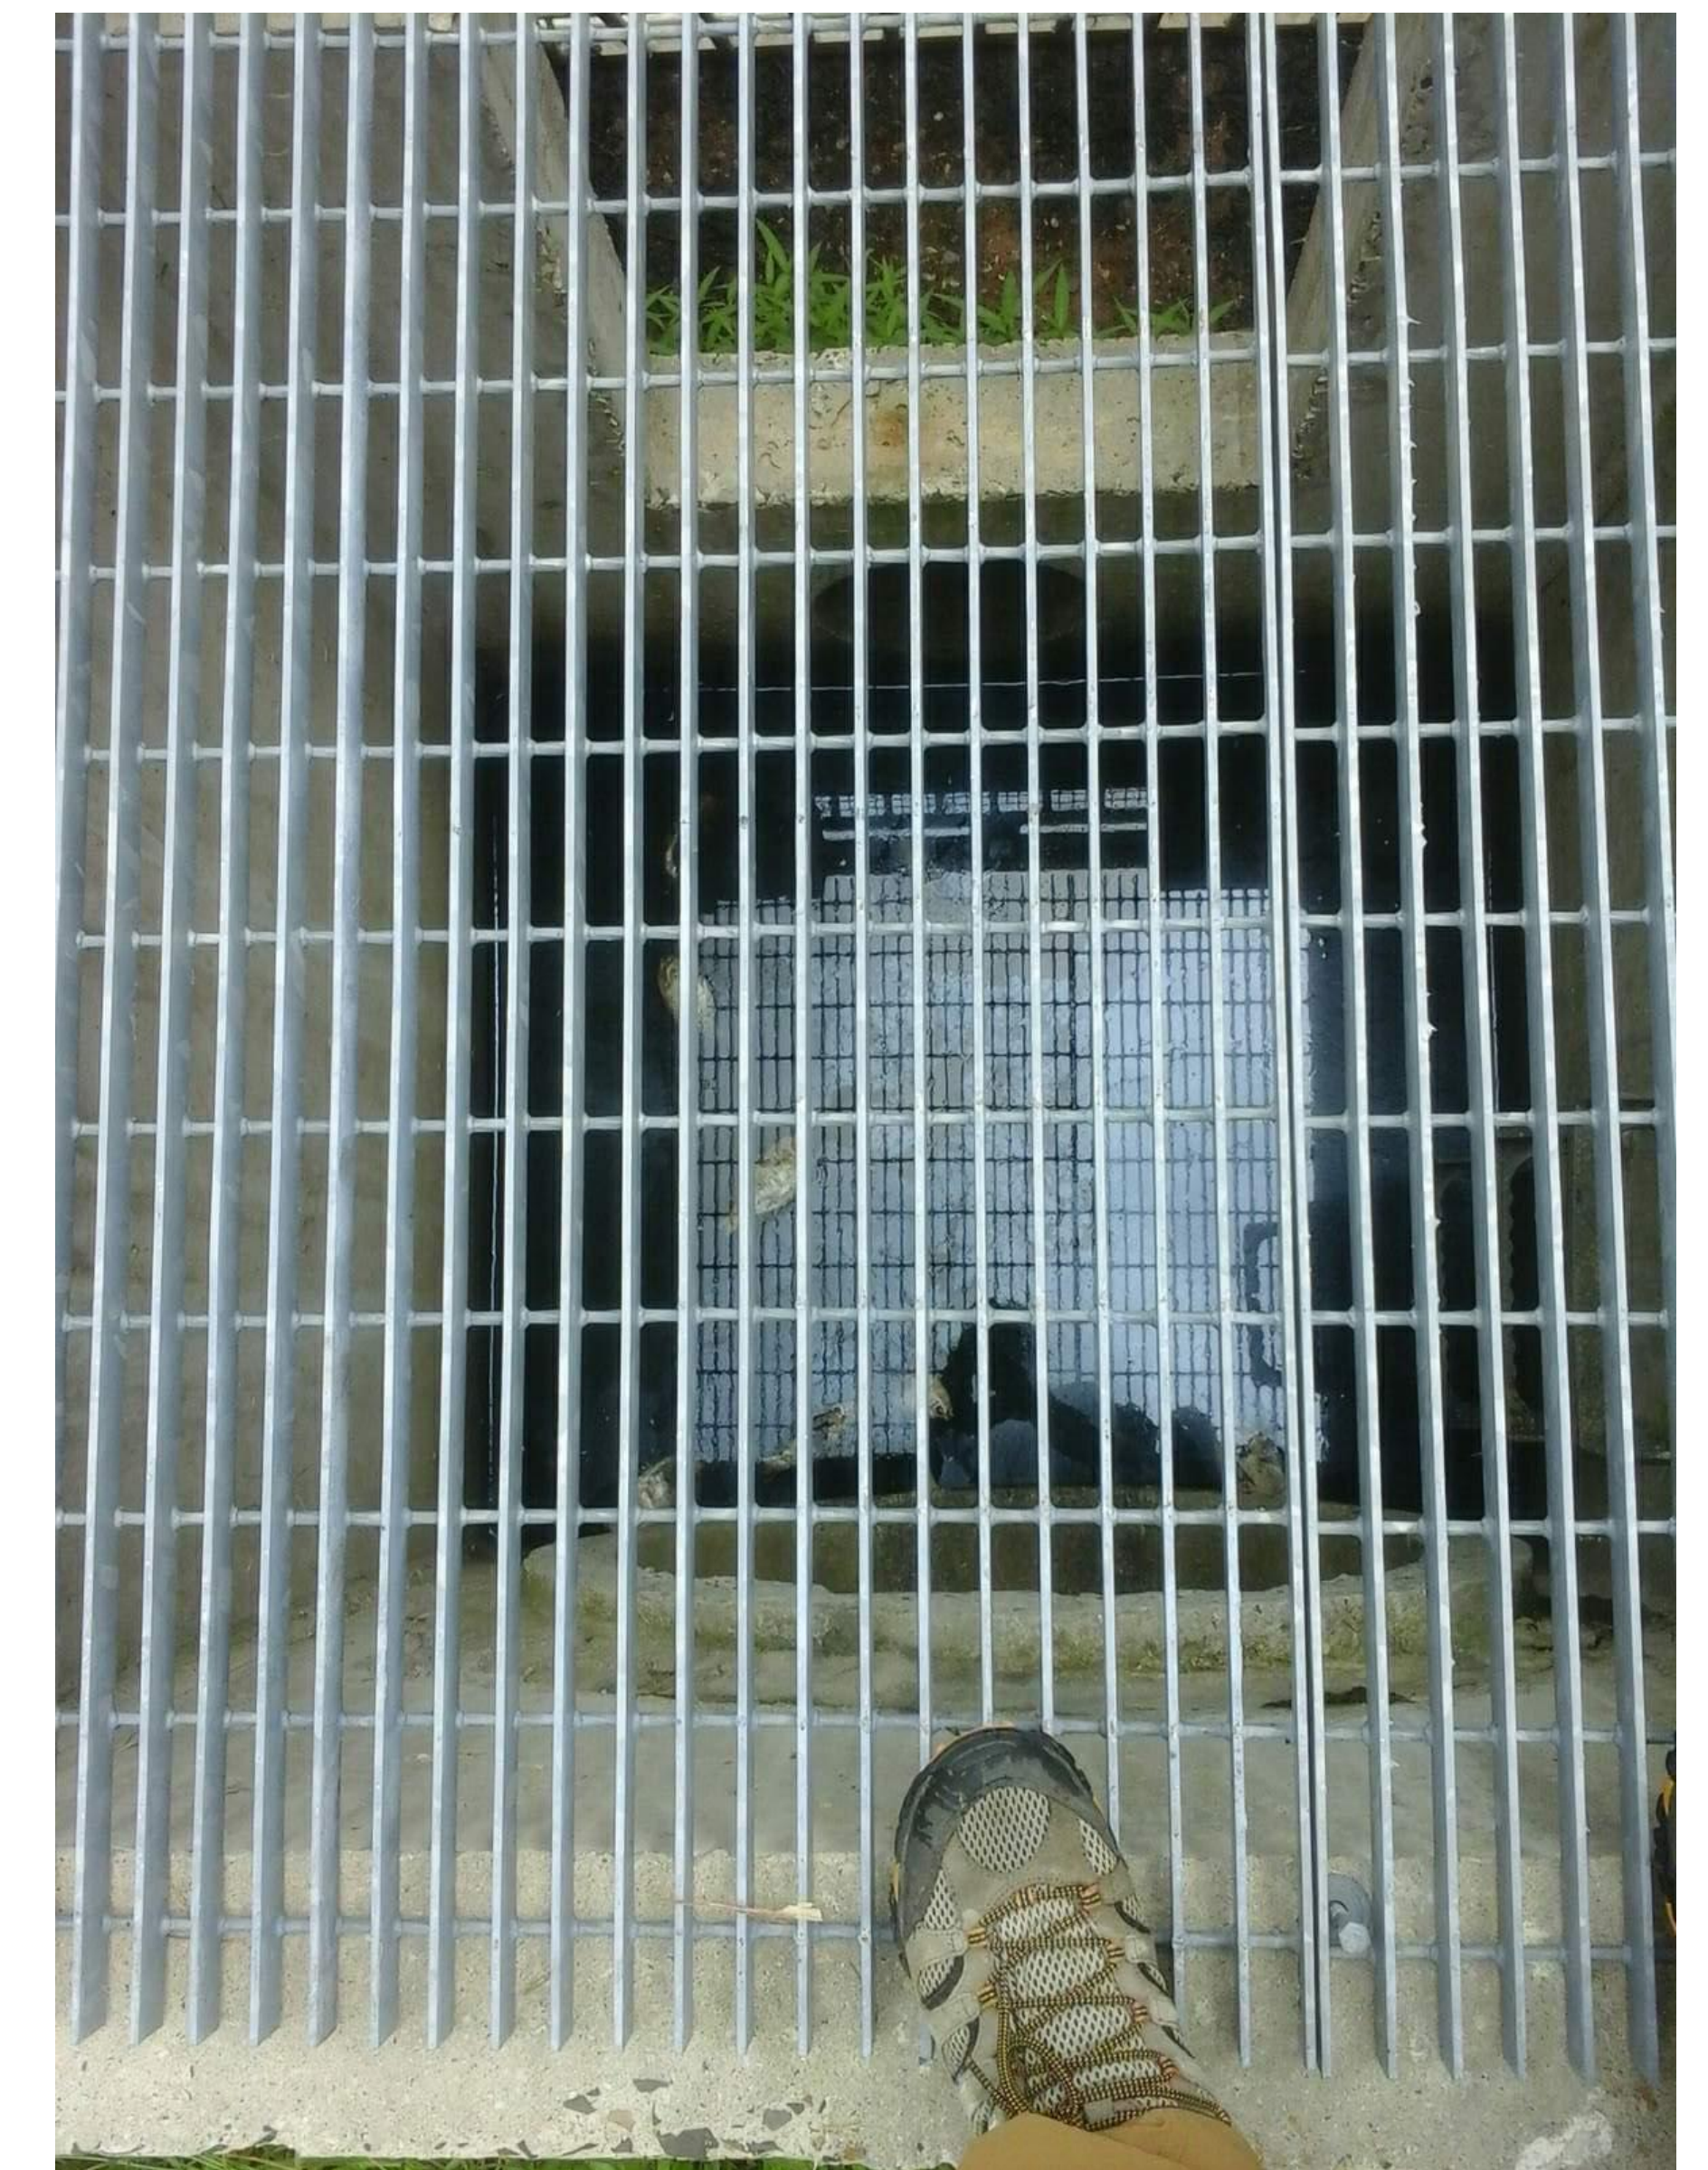
Fish in outlet structure
