**Hamilton Township (Mercer County)
Stormwater Basin Assessment Summary
Addendum (Year 3)**

Developed by the Rutgers Cooperative Extension Water Resources Program
Funded by Hamilton Township, Mercer County, New Jersey

September 30, 2014

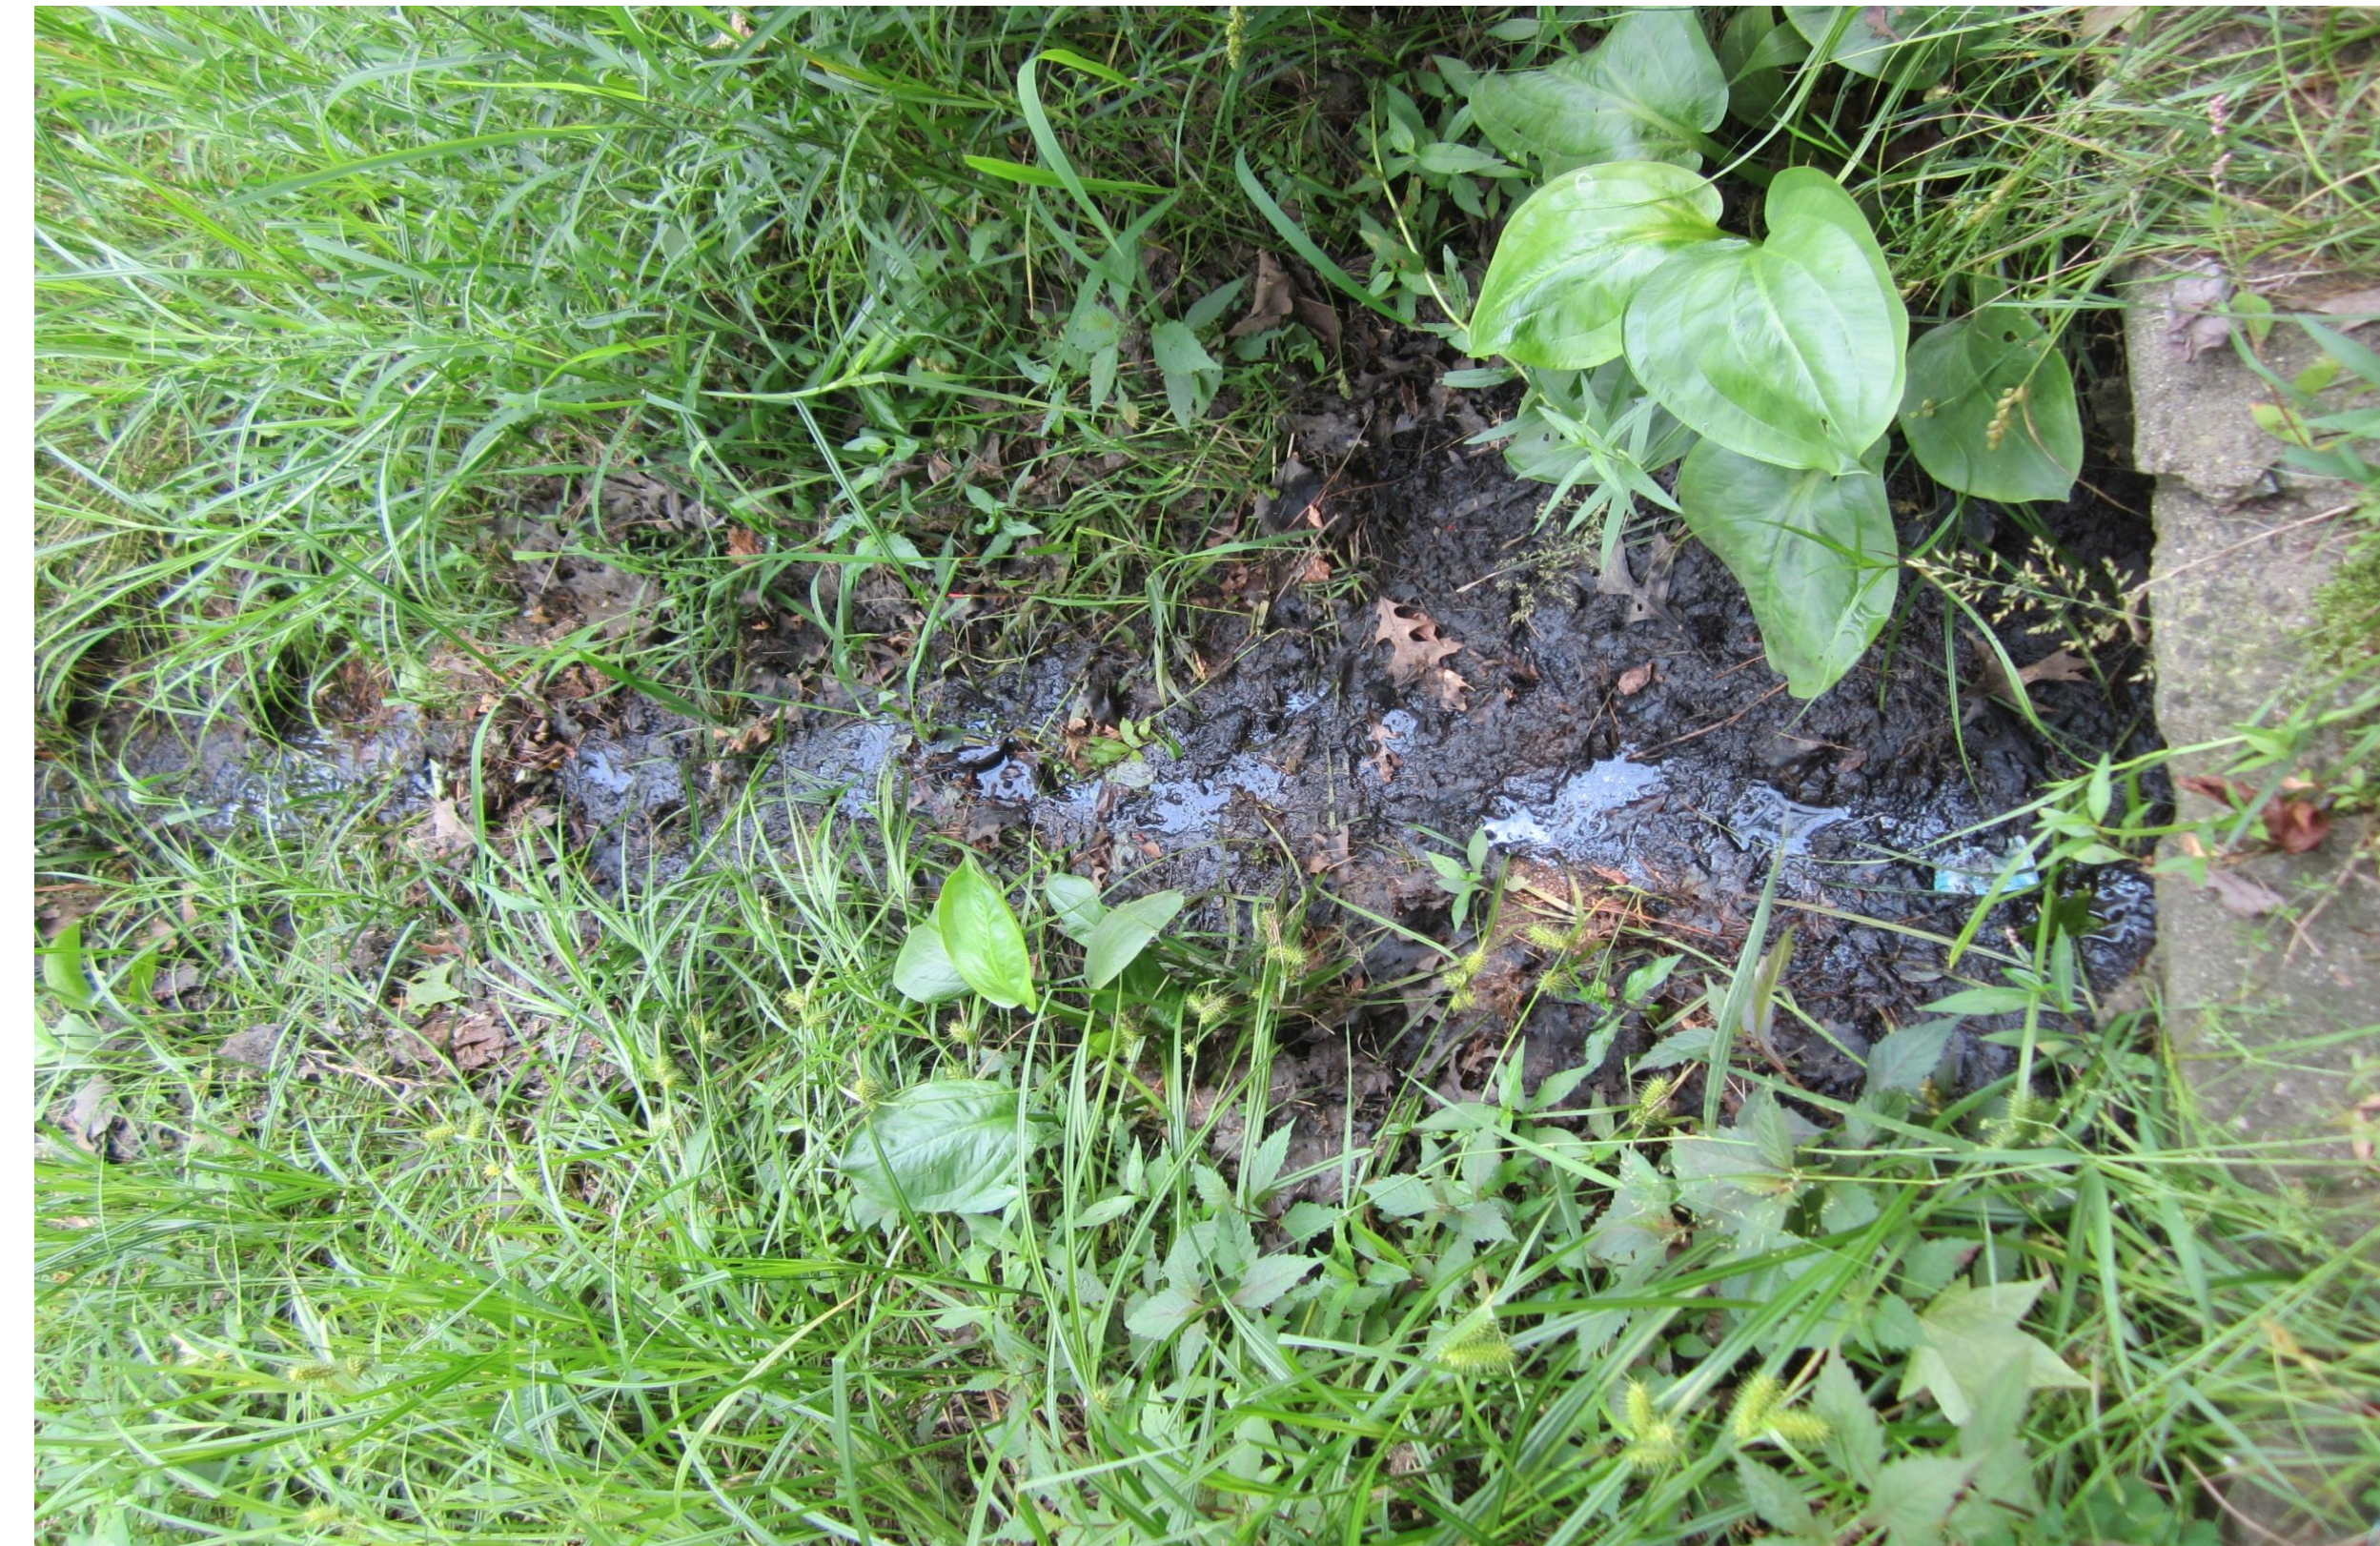
Low flow channel near outlet

- Standing water and sediment in basin bottom and low flow channel
- Basin appears to be treated as infiltration basin
- Naturalized basin bottom

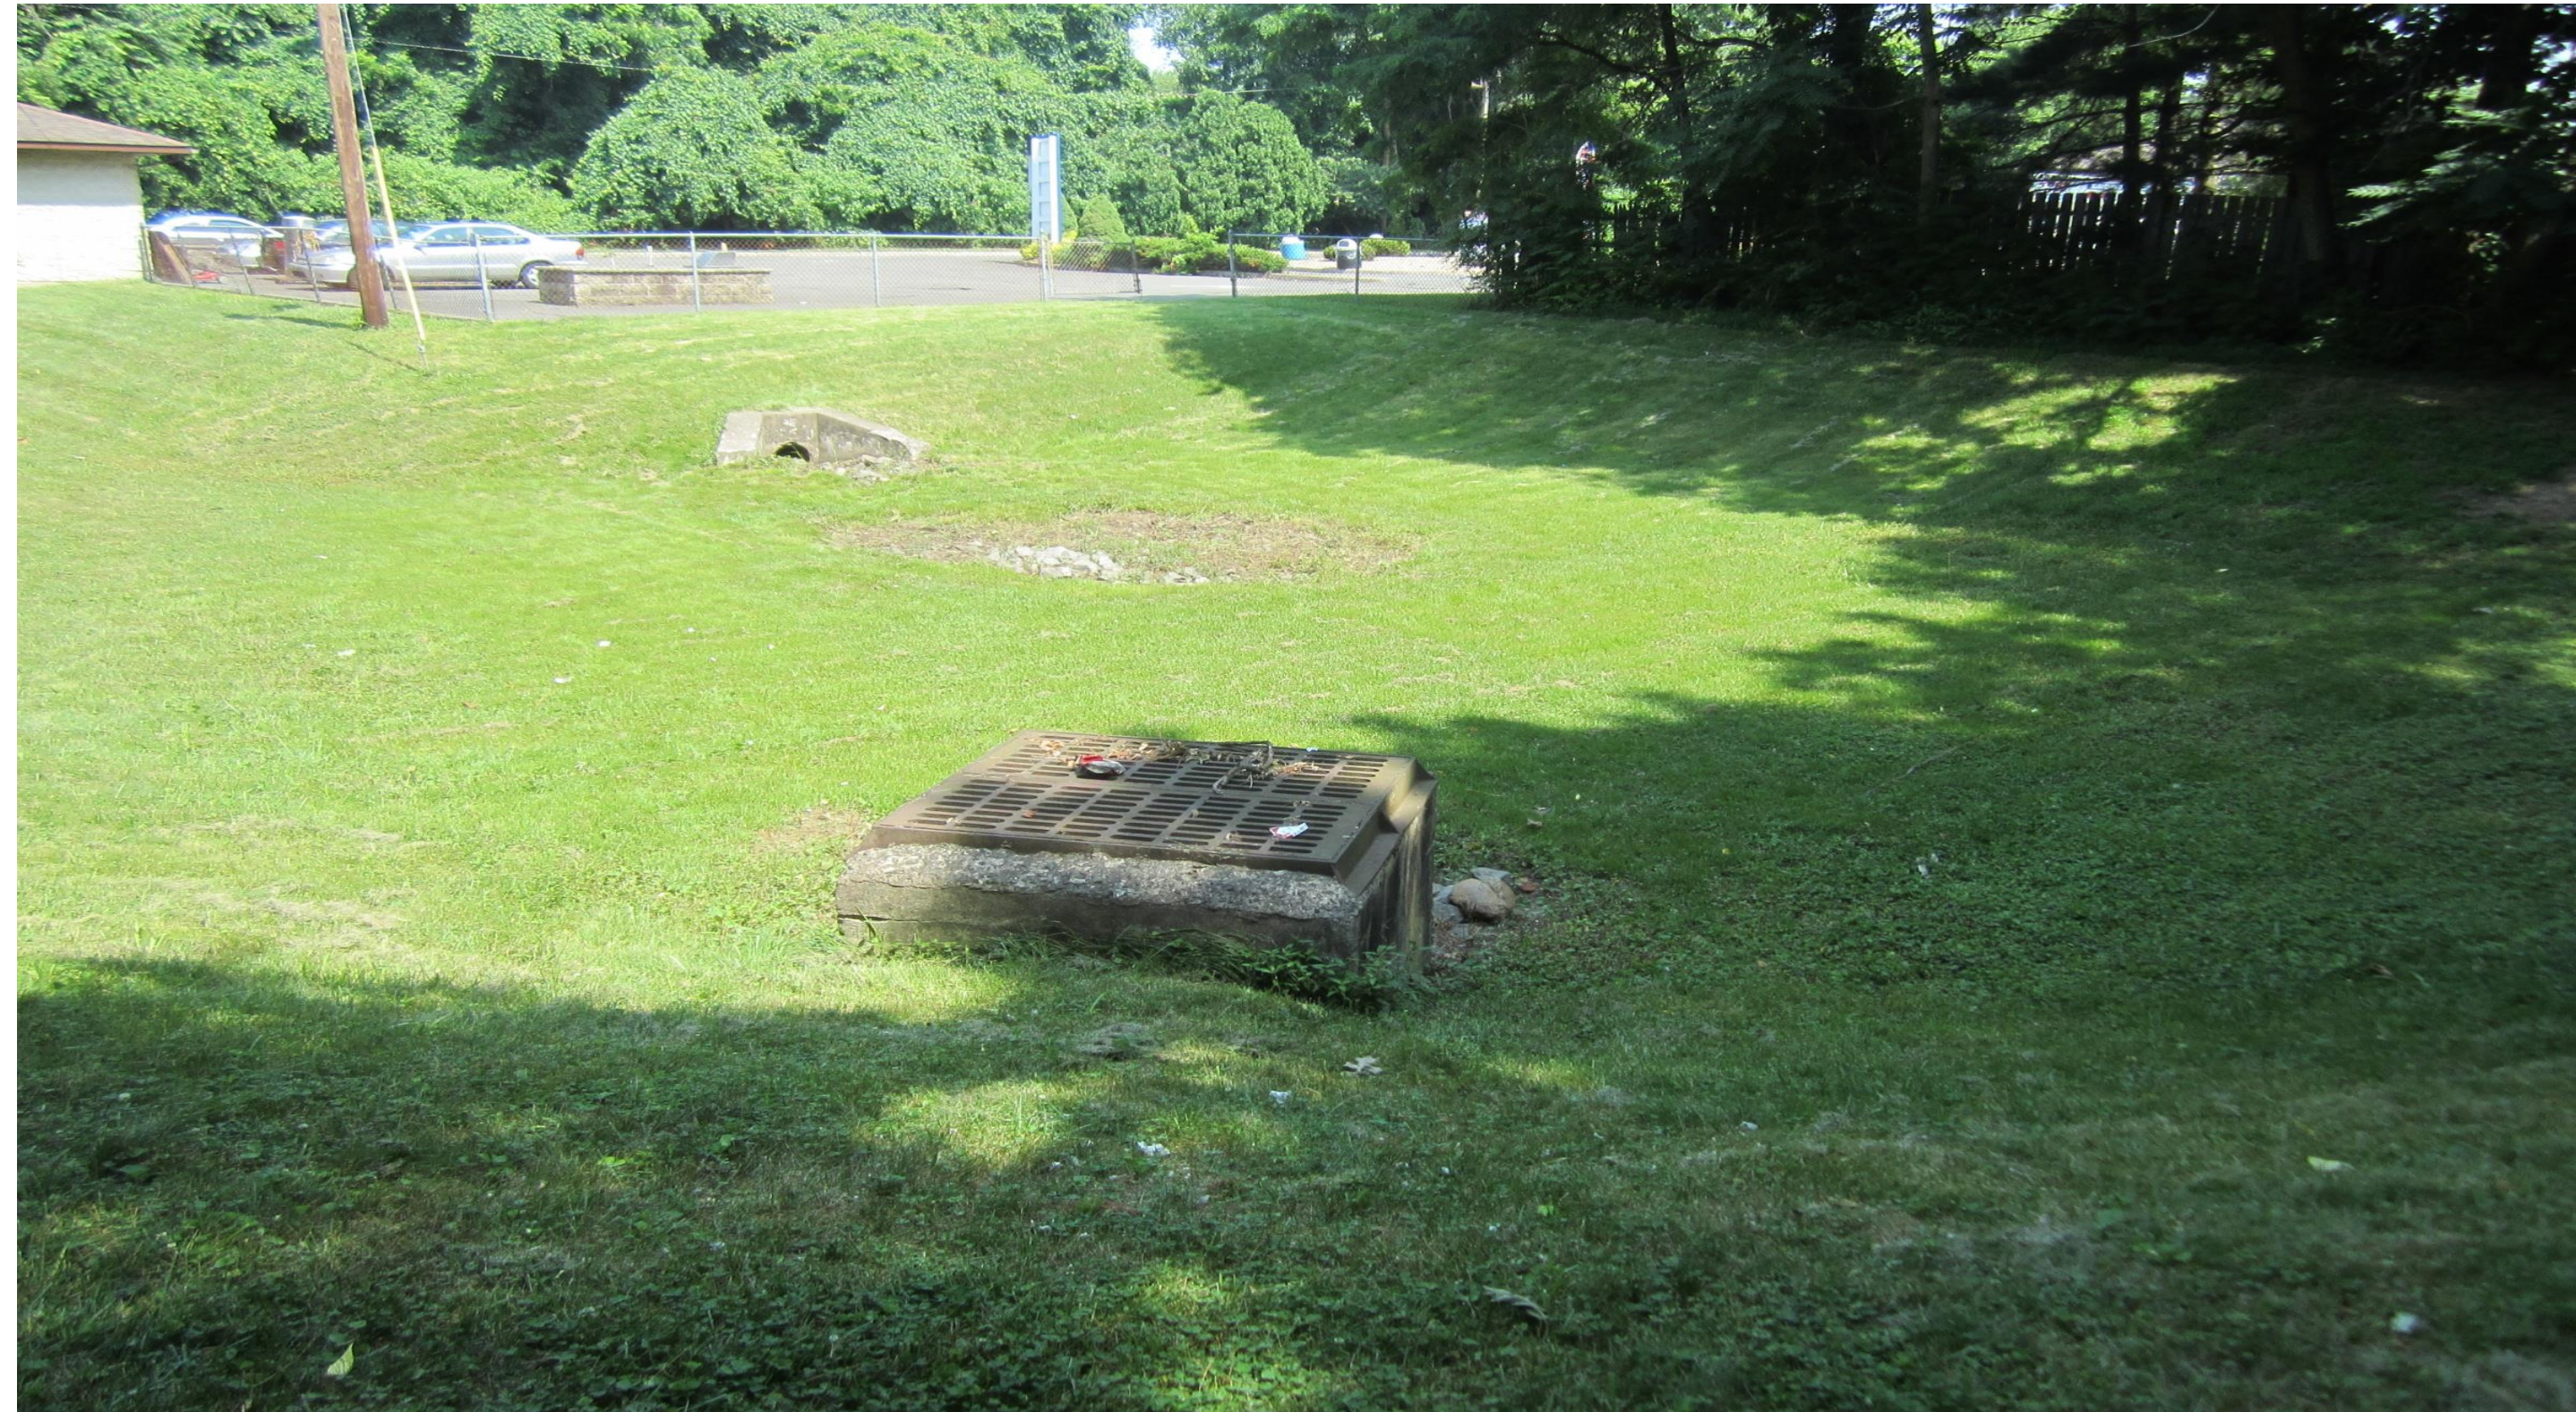
Overview of basin

- Riprap around inlet and outlet
- No low flow channel
- Appears to be infiltration basin
- Emergency spillway directed to local stream
- Exposed earth near basin inlet and center

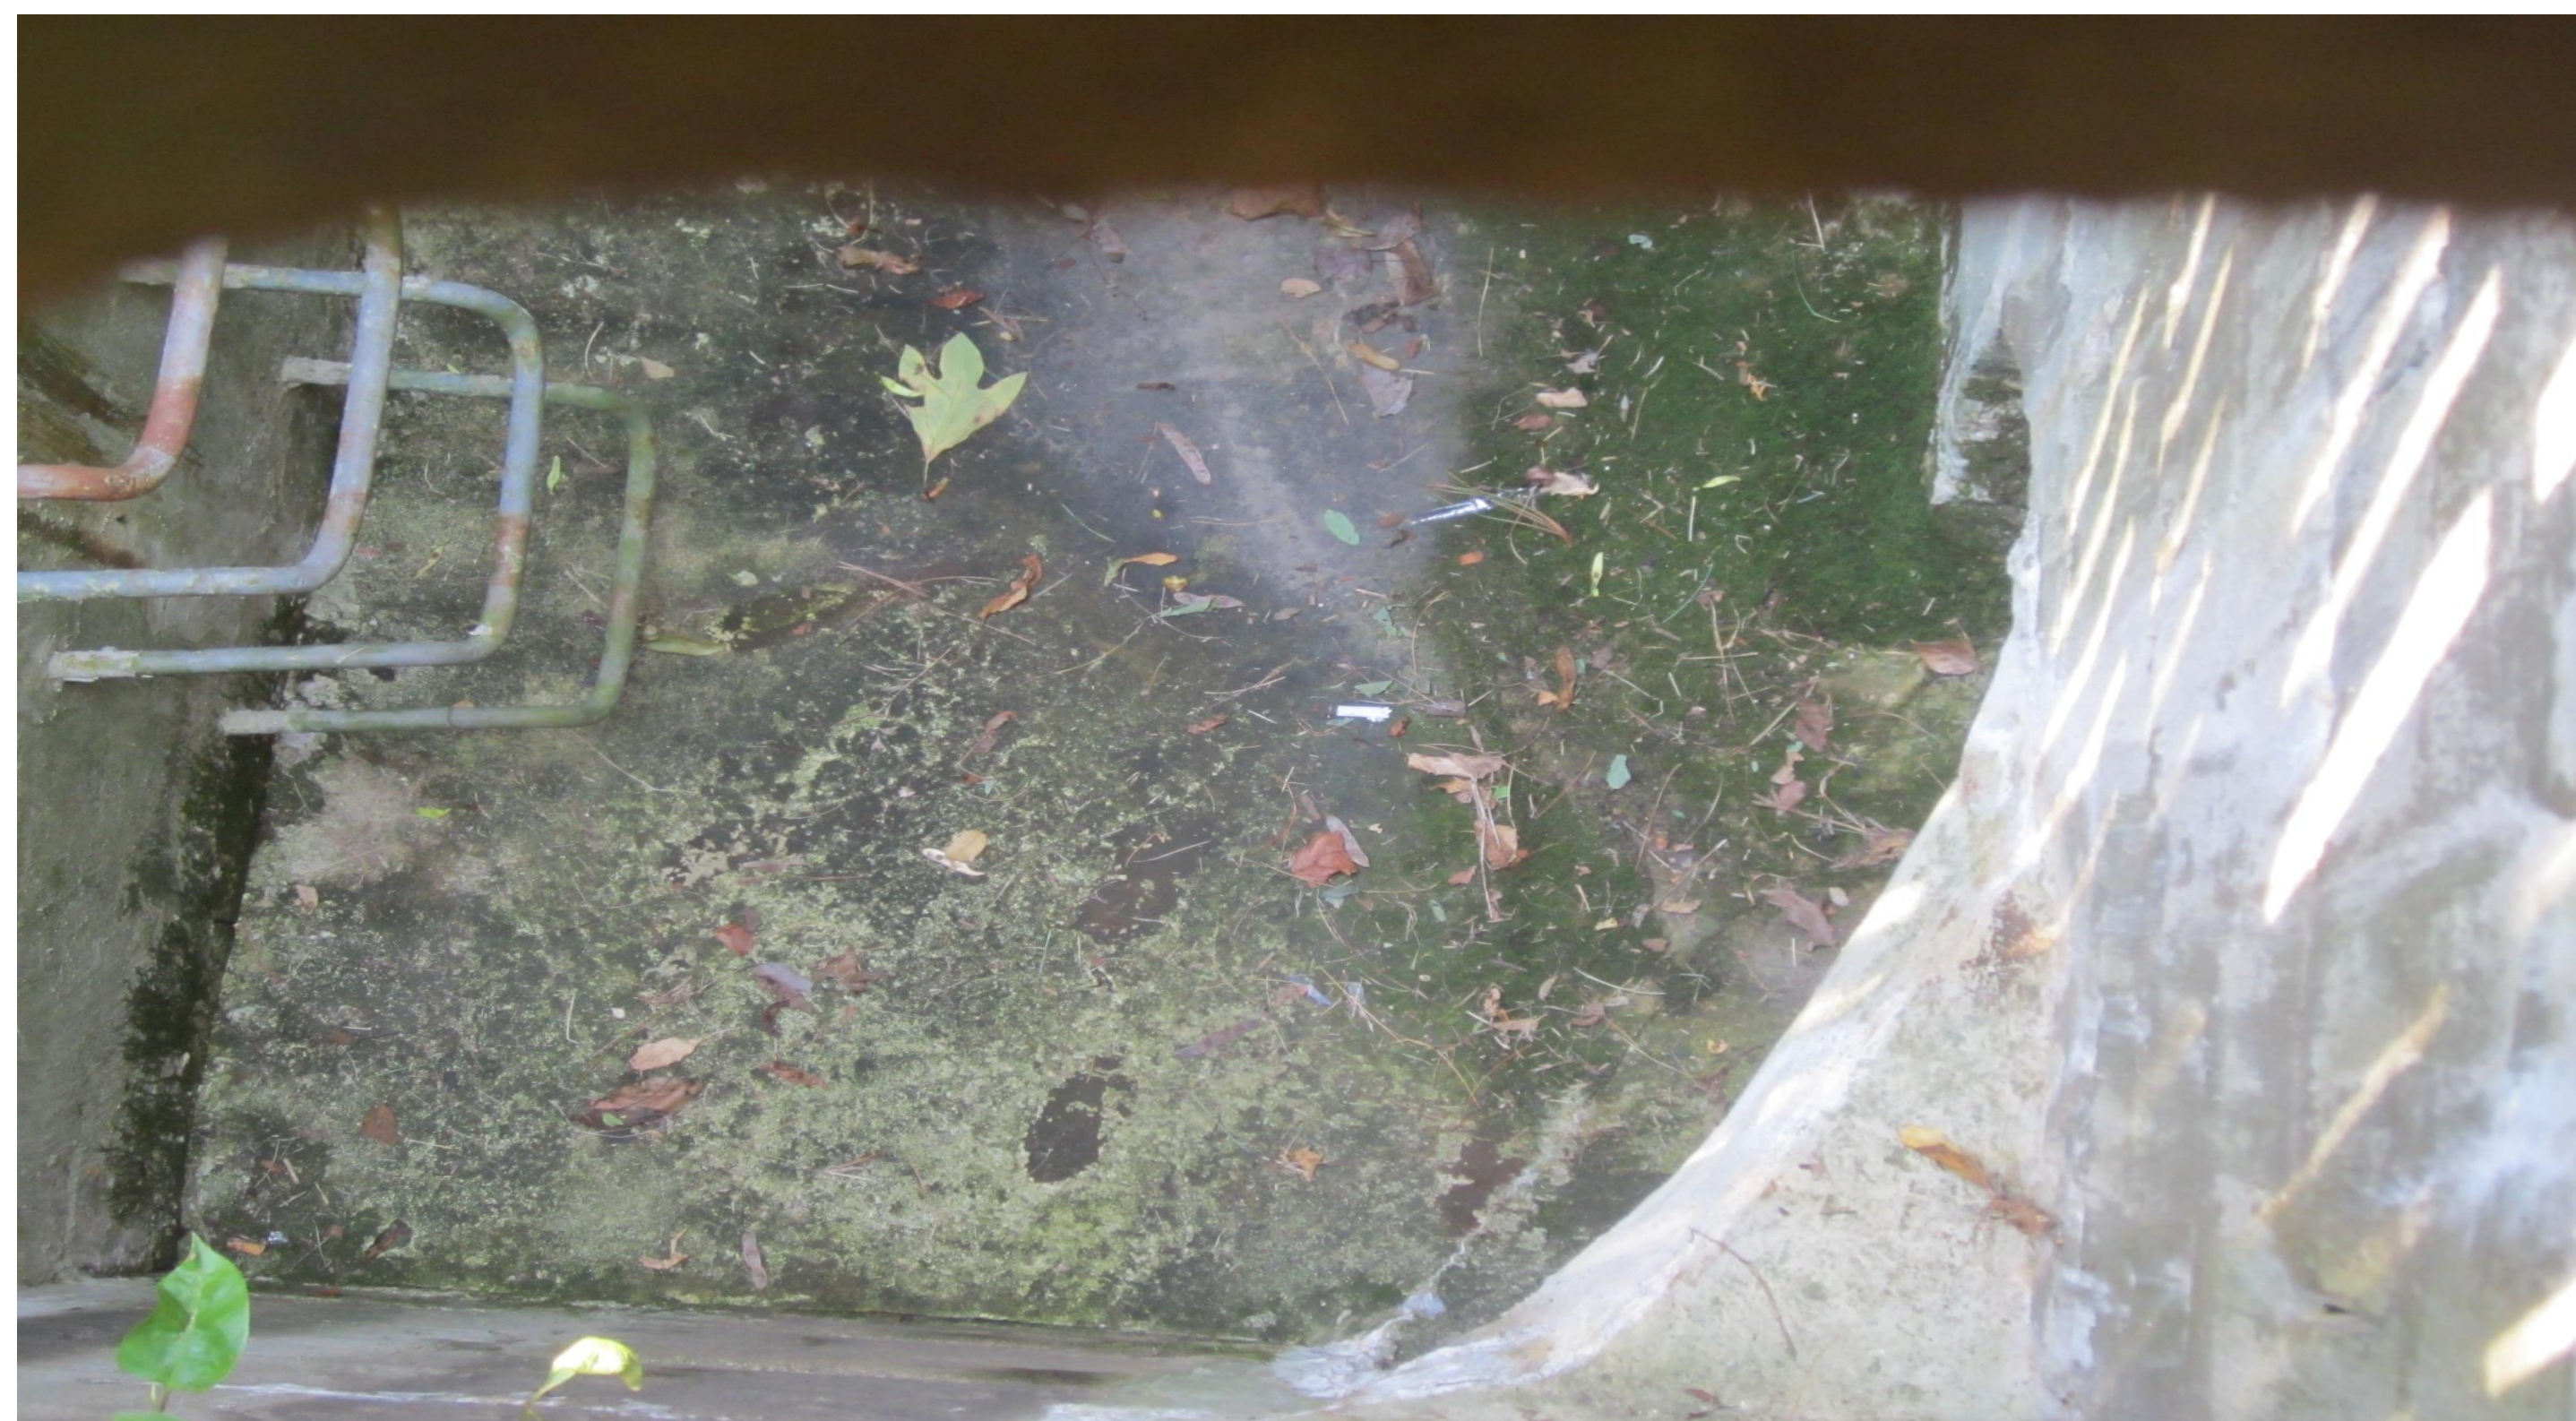
Inside of outlet

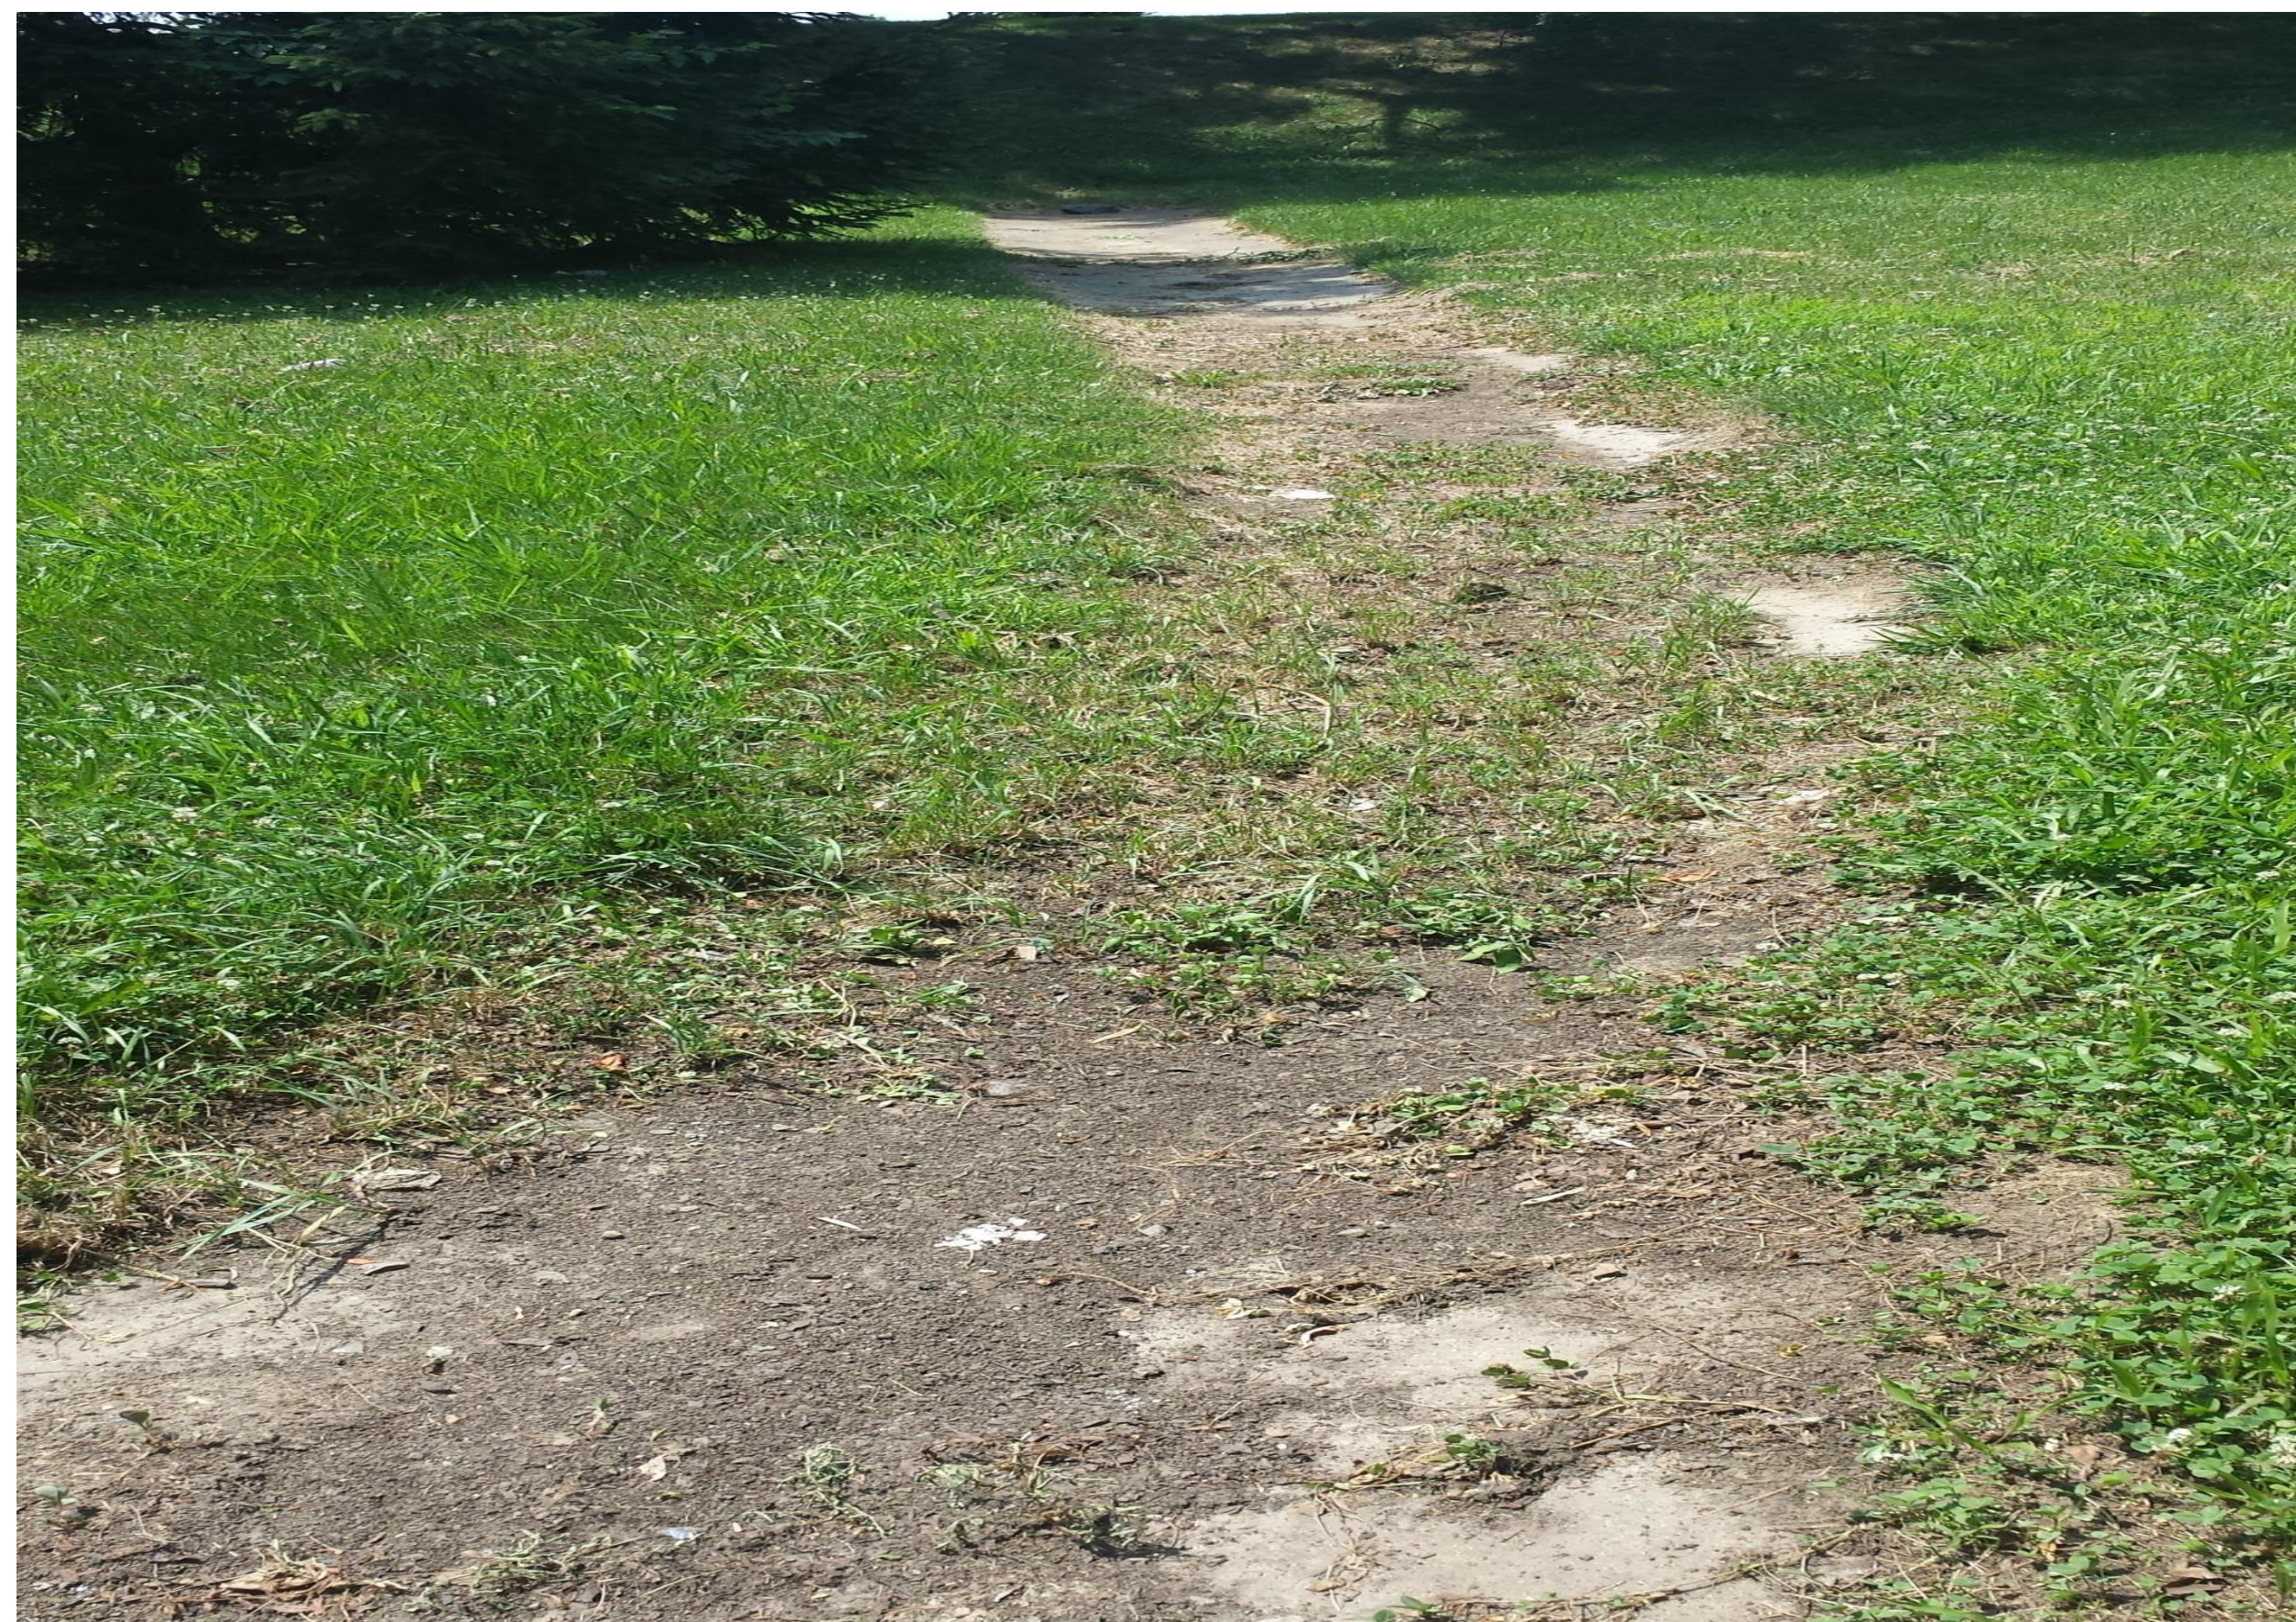
Overgrown on low flow channel

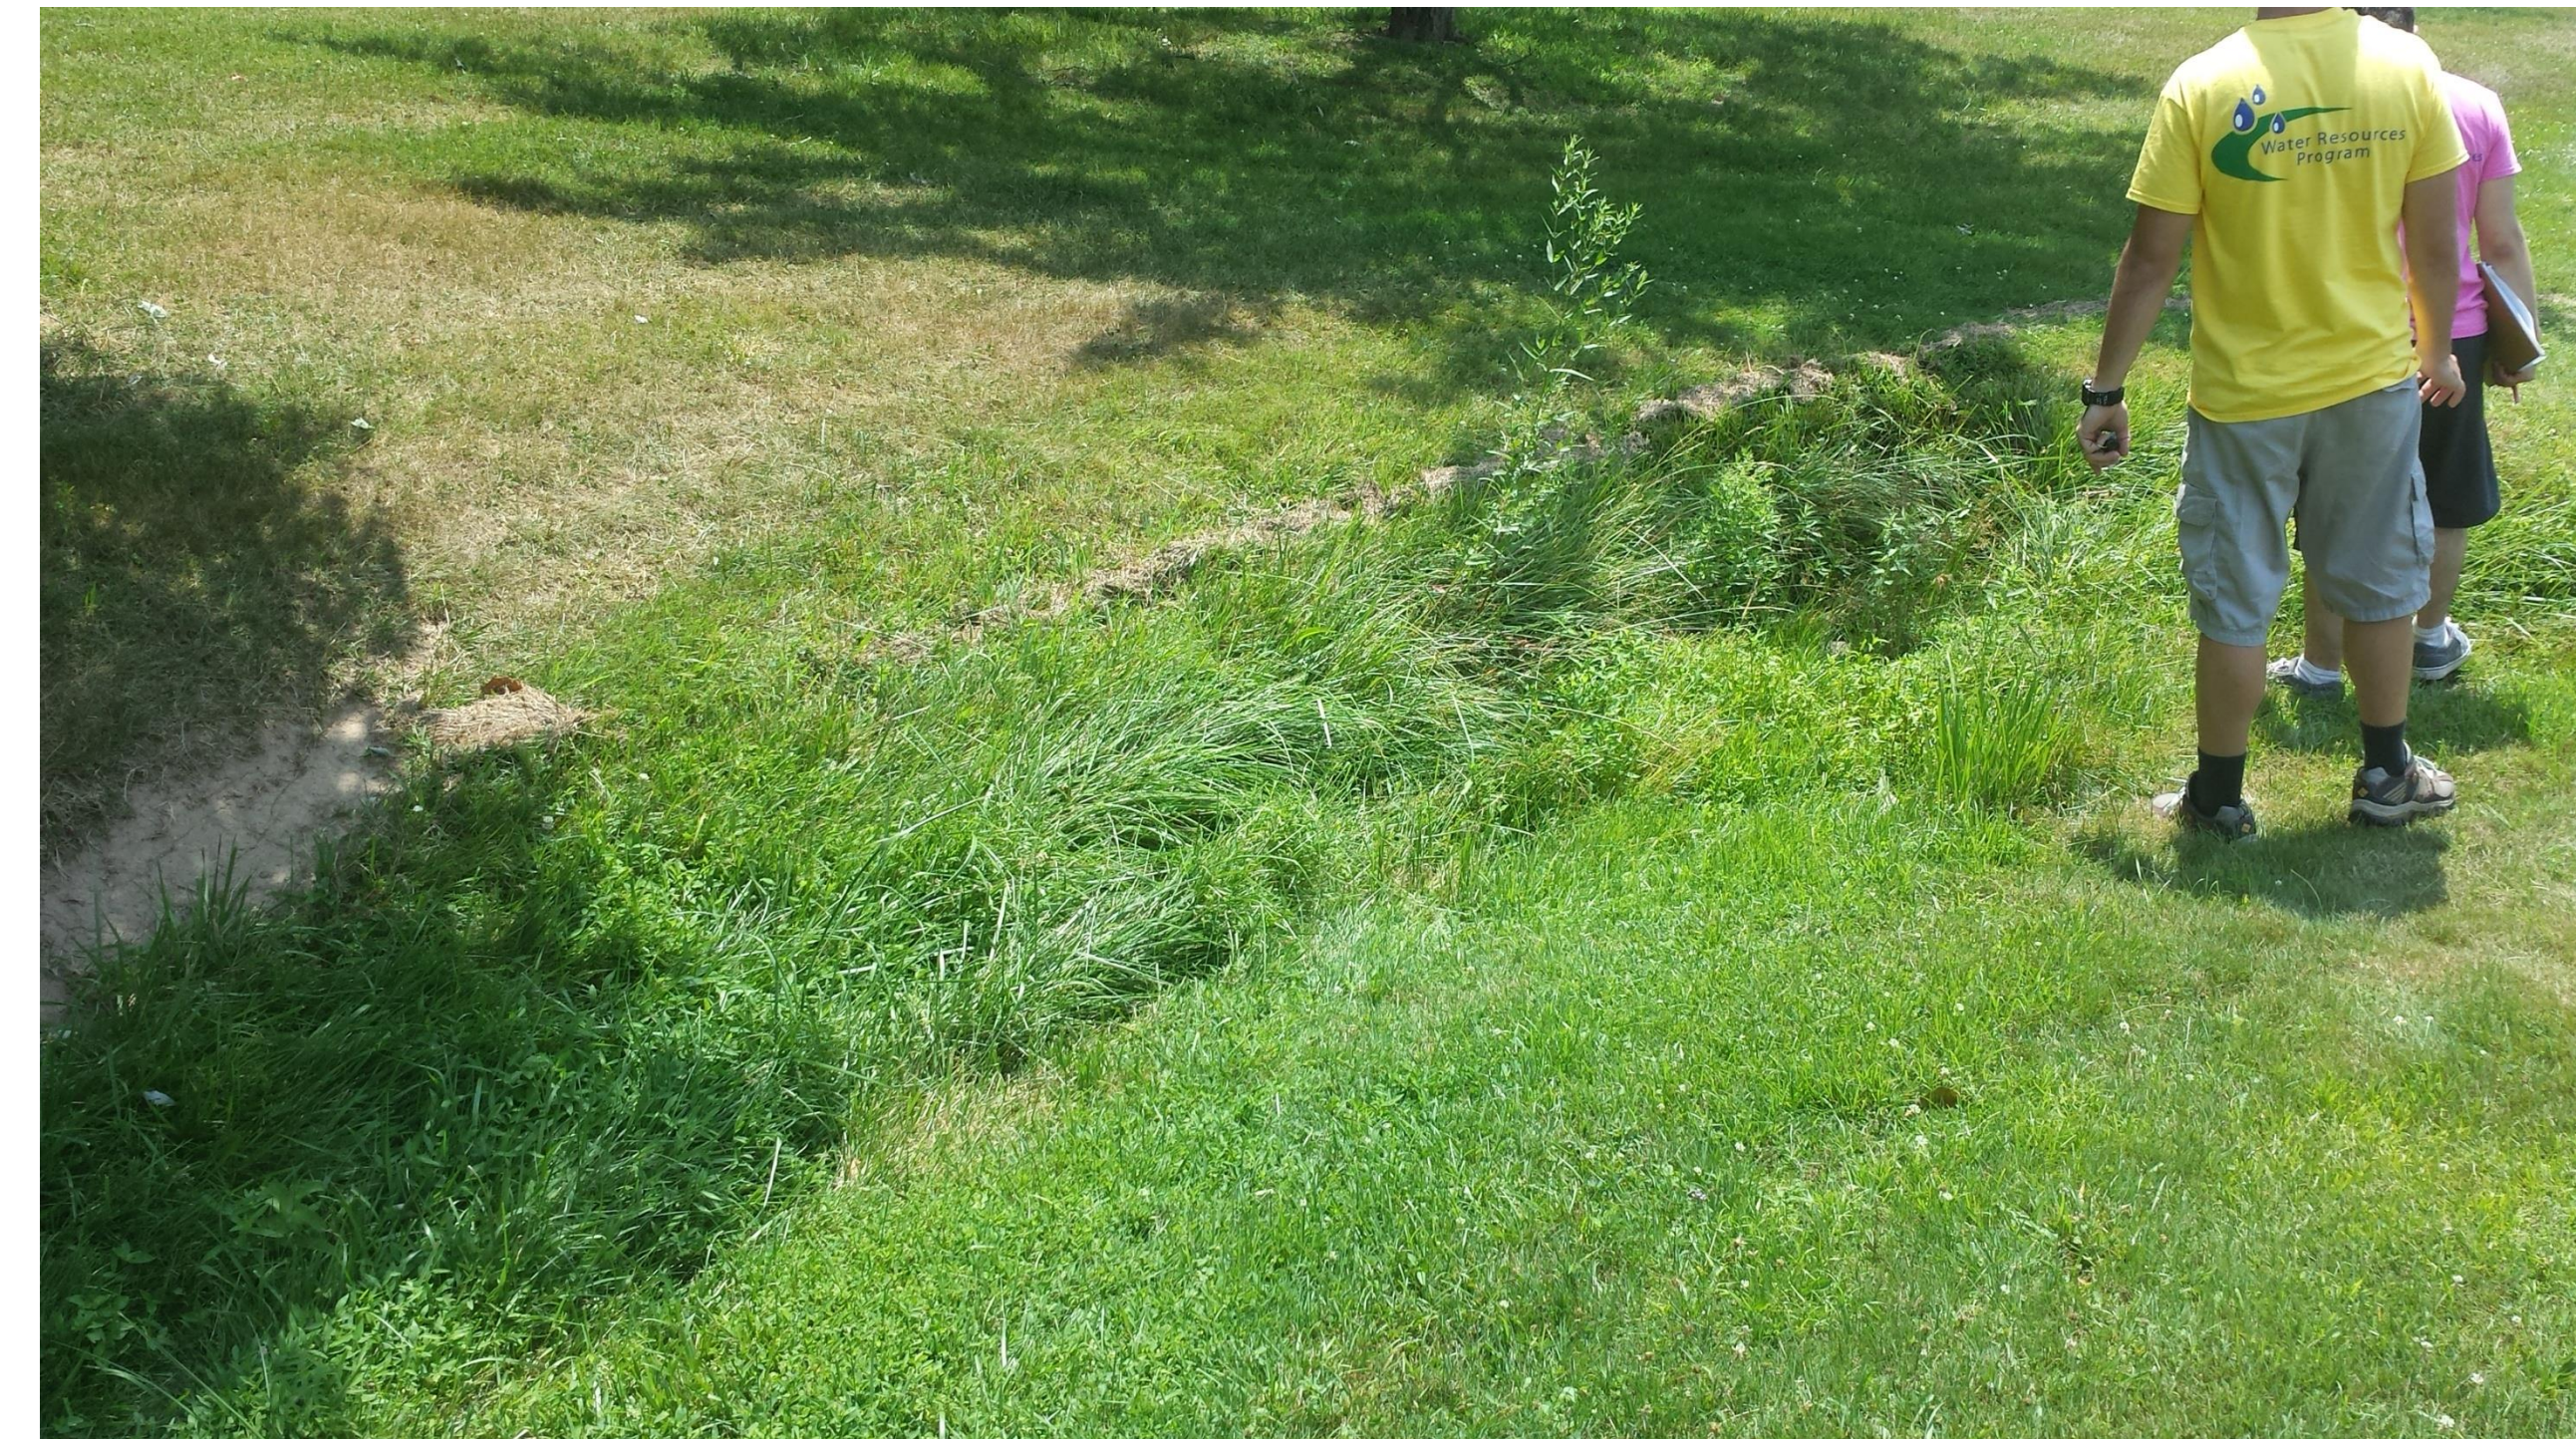
Swale feature leading to basin

- Inlet has grass and plants restricting water flow
- Water flows to a maintained garden
- Minimal erosion caused by running water
- No outlets apparent
- Emergency spillway leads to depressed area near basin center
- Swale receives water from northern parking lot

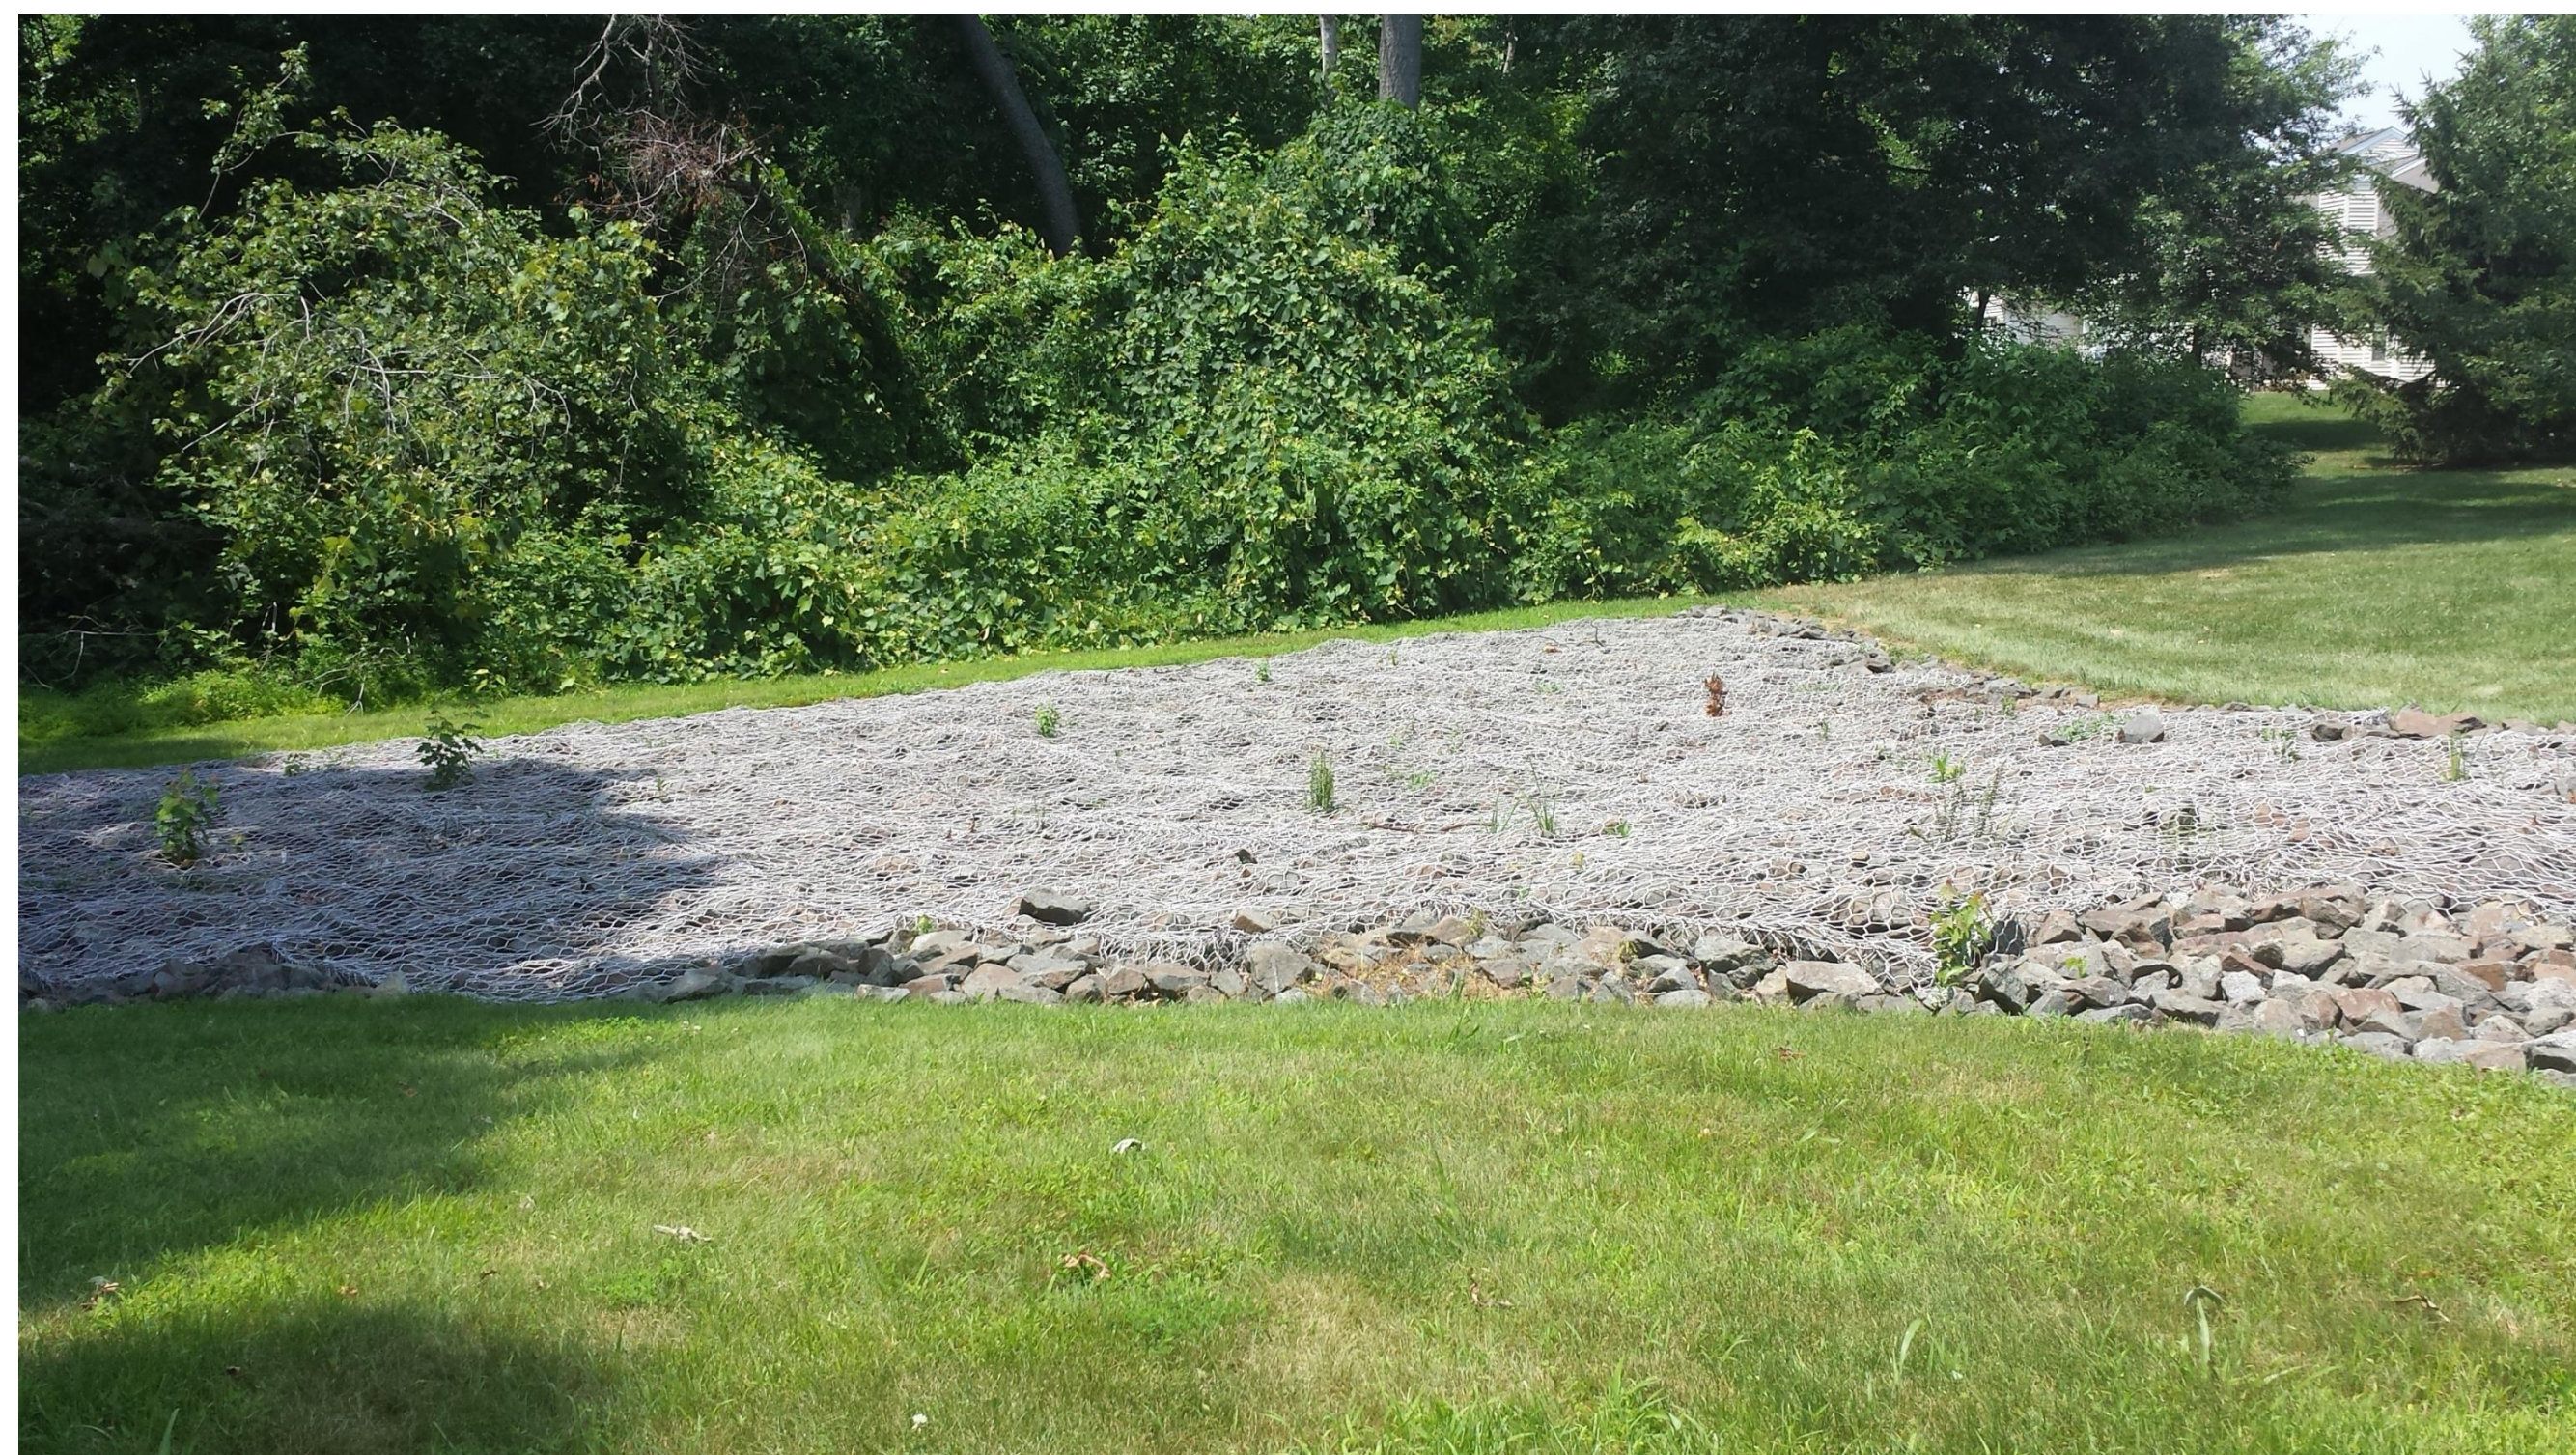
Stone bed as emergency spillway
