**Hamilton Township (Mercer County)
Stormwater Basin Assessment Summary
Addendum (Year 3)**

Developed by the Rutgers Cooperative Extension Water Resources Program
Funded by Hamilton Township, Mercer County, New Jersey

September 30, 2014

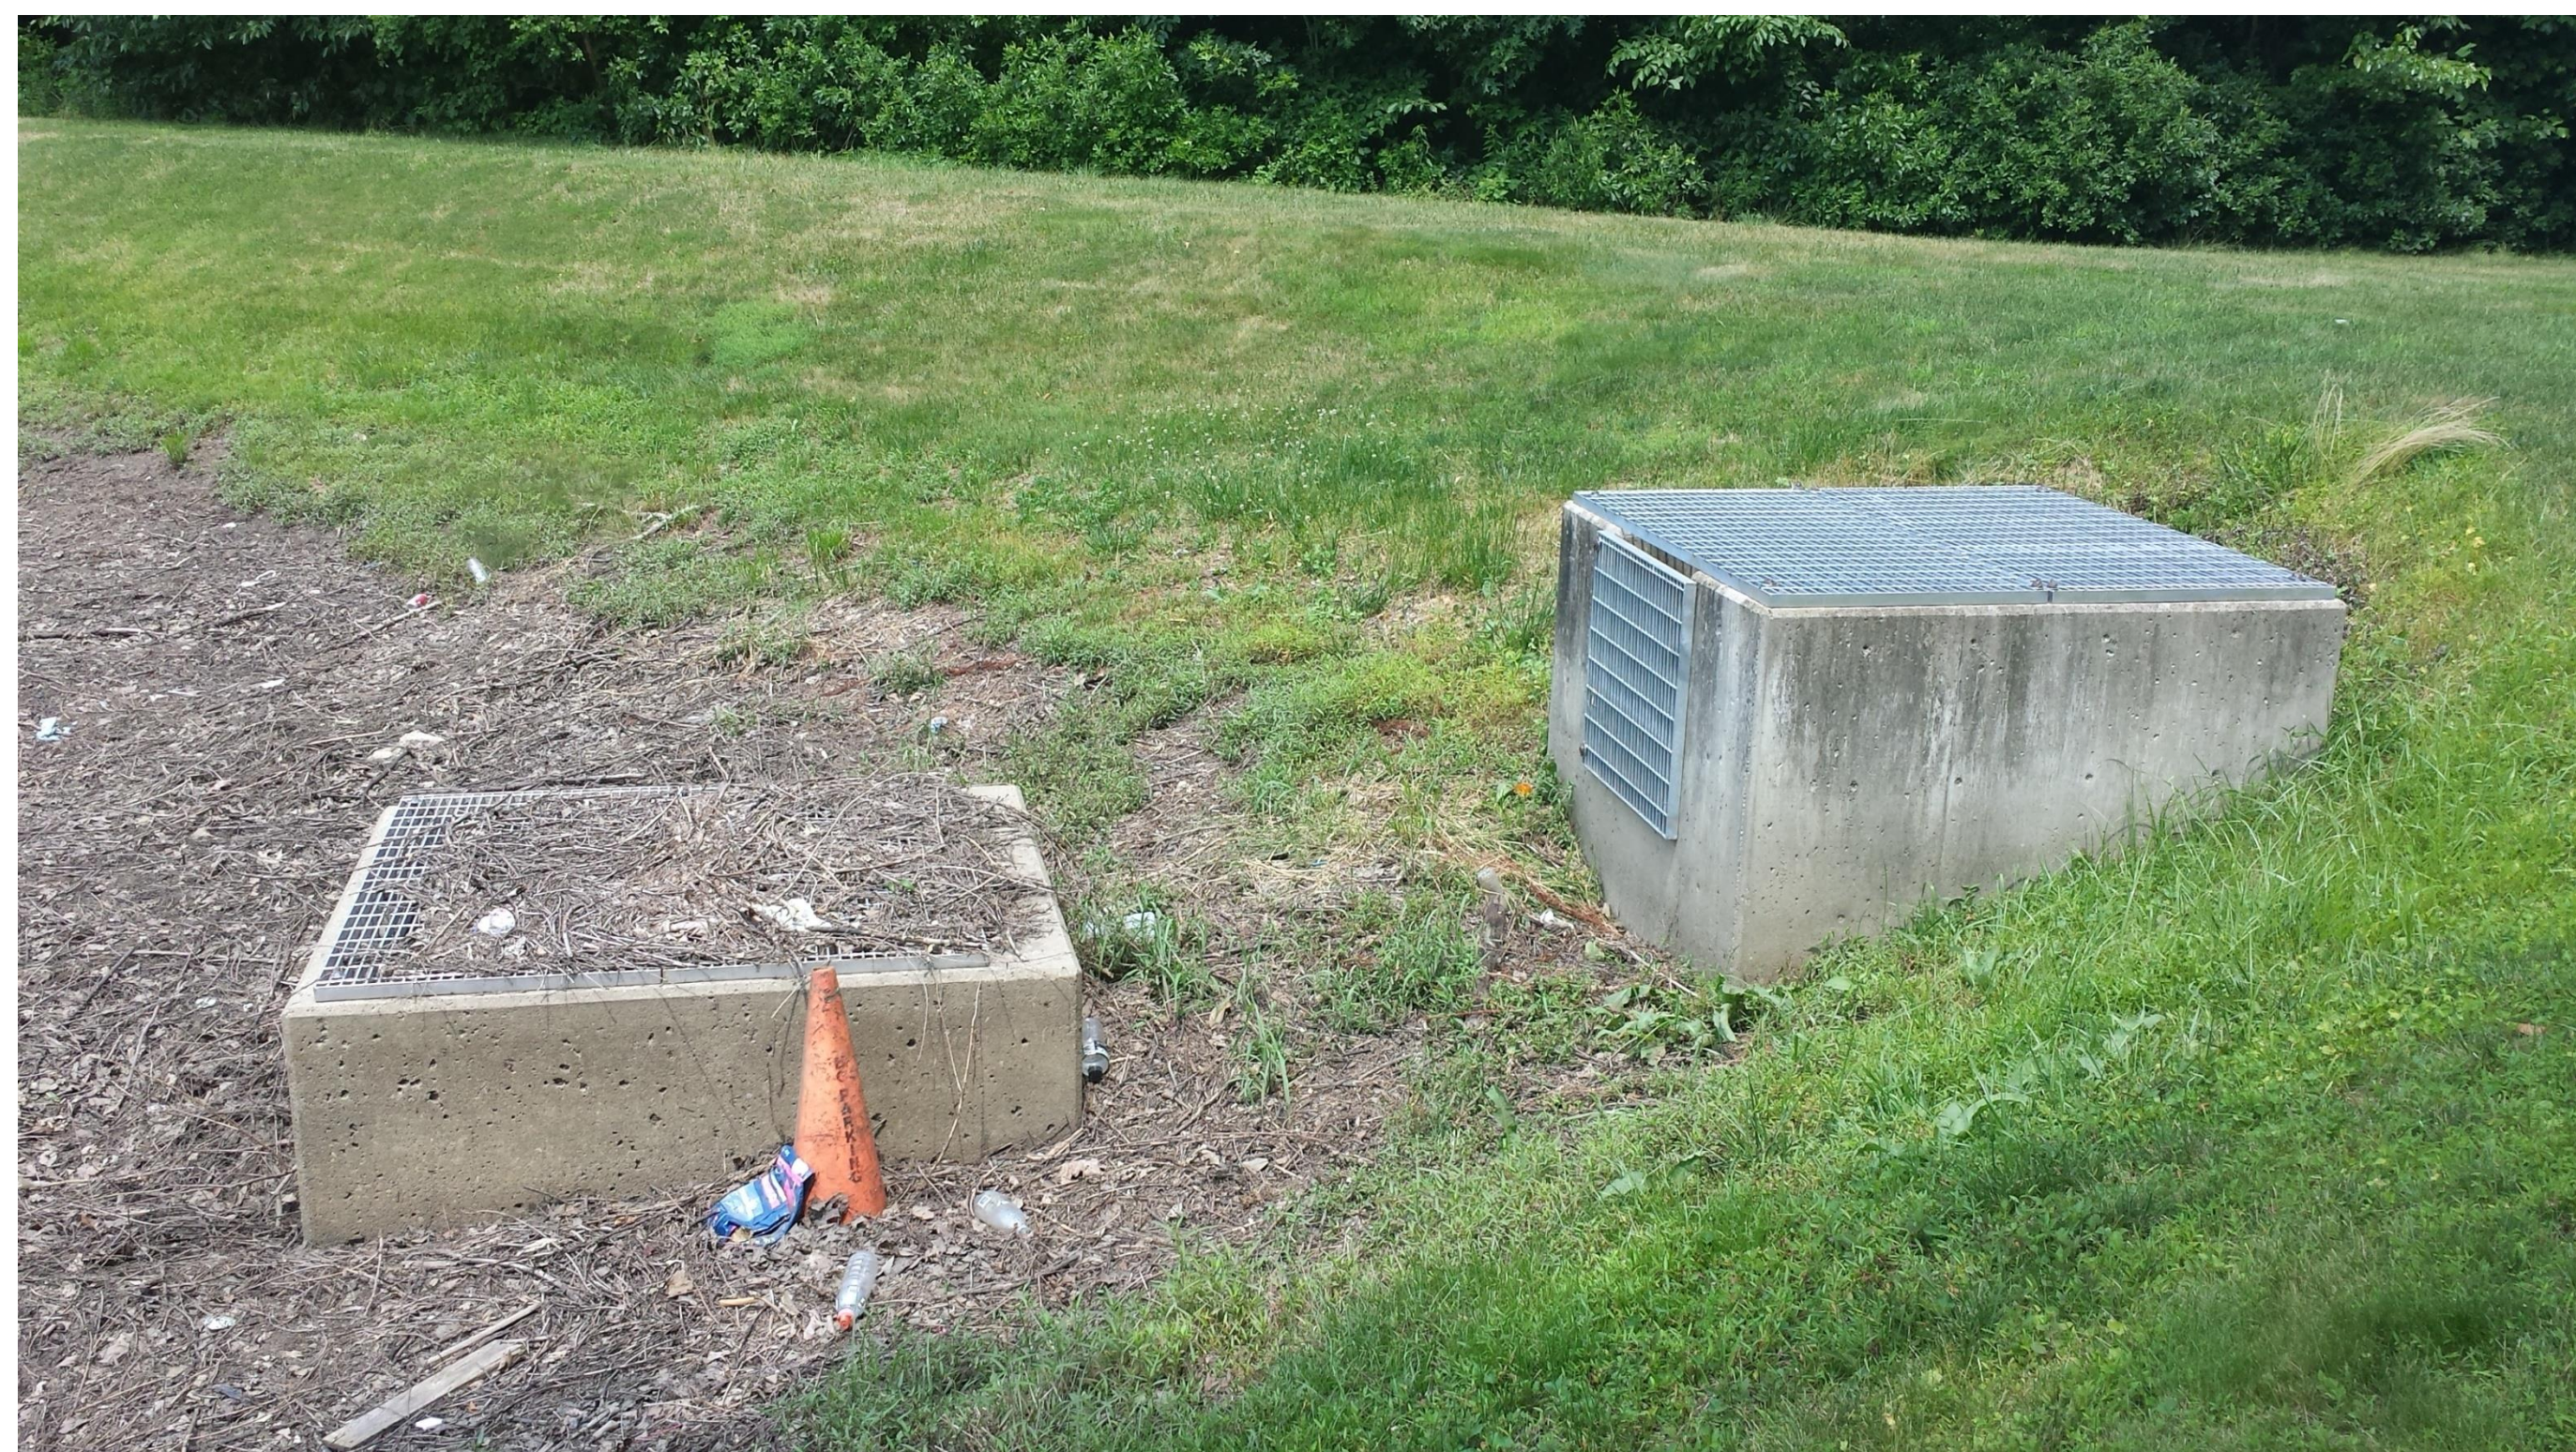
Side view of outlet

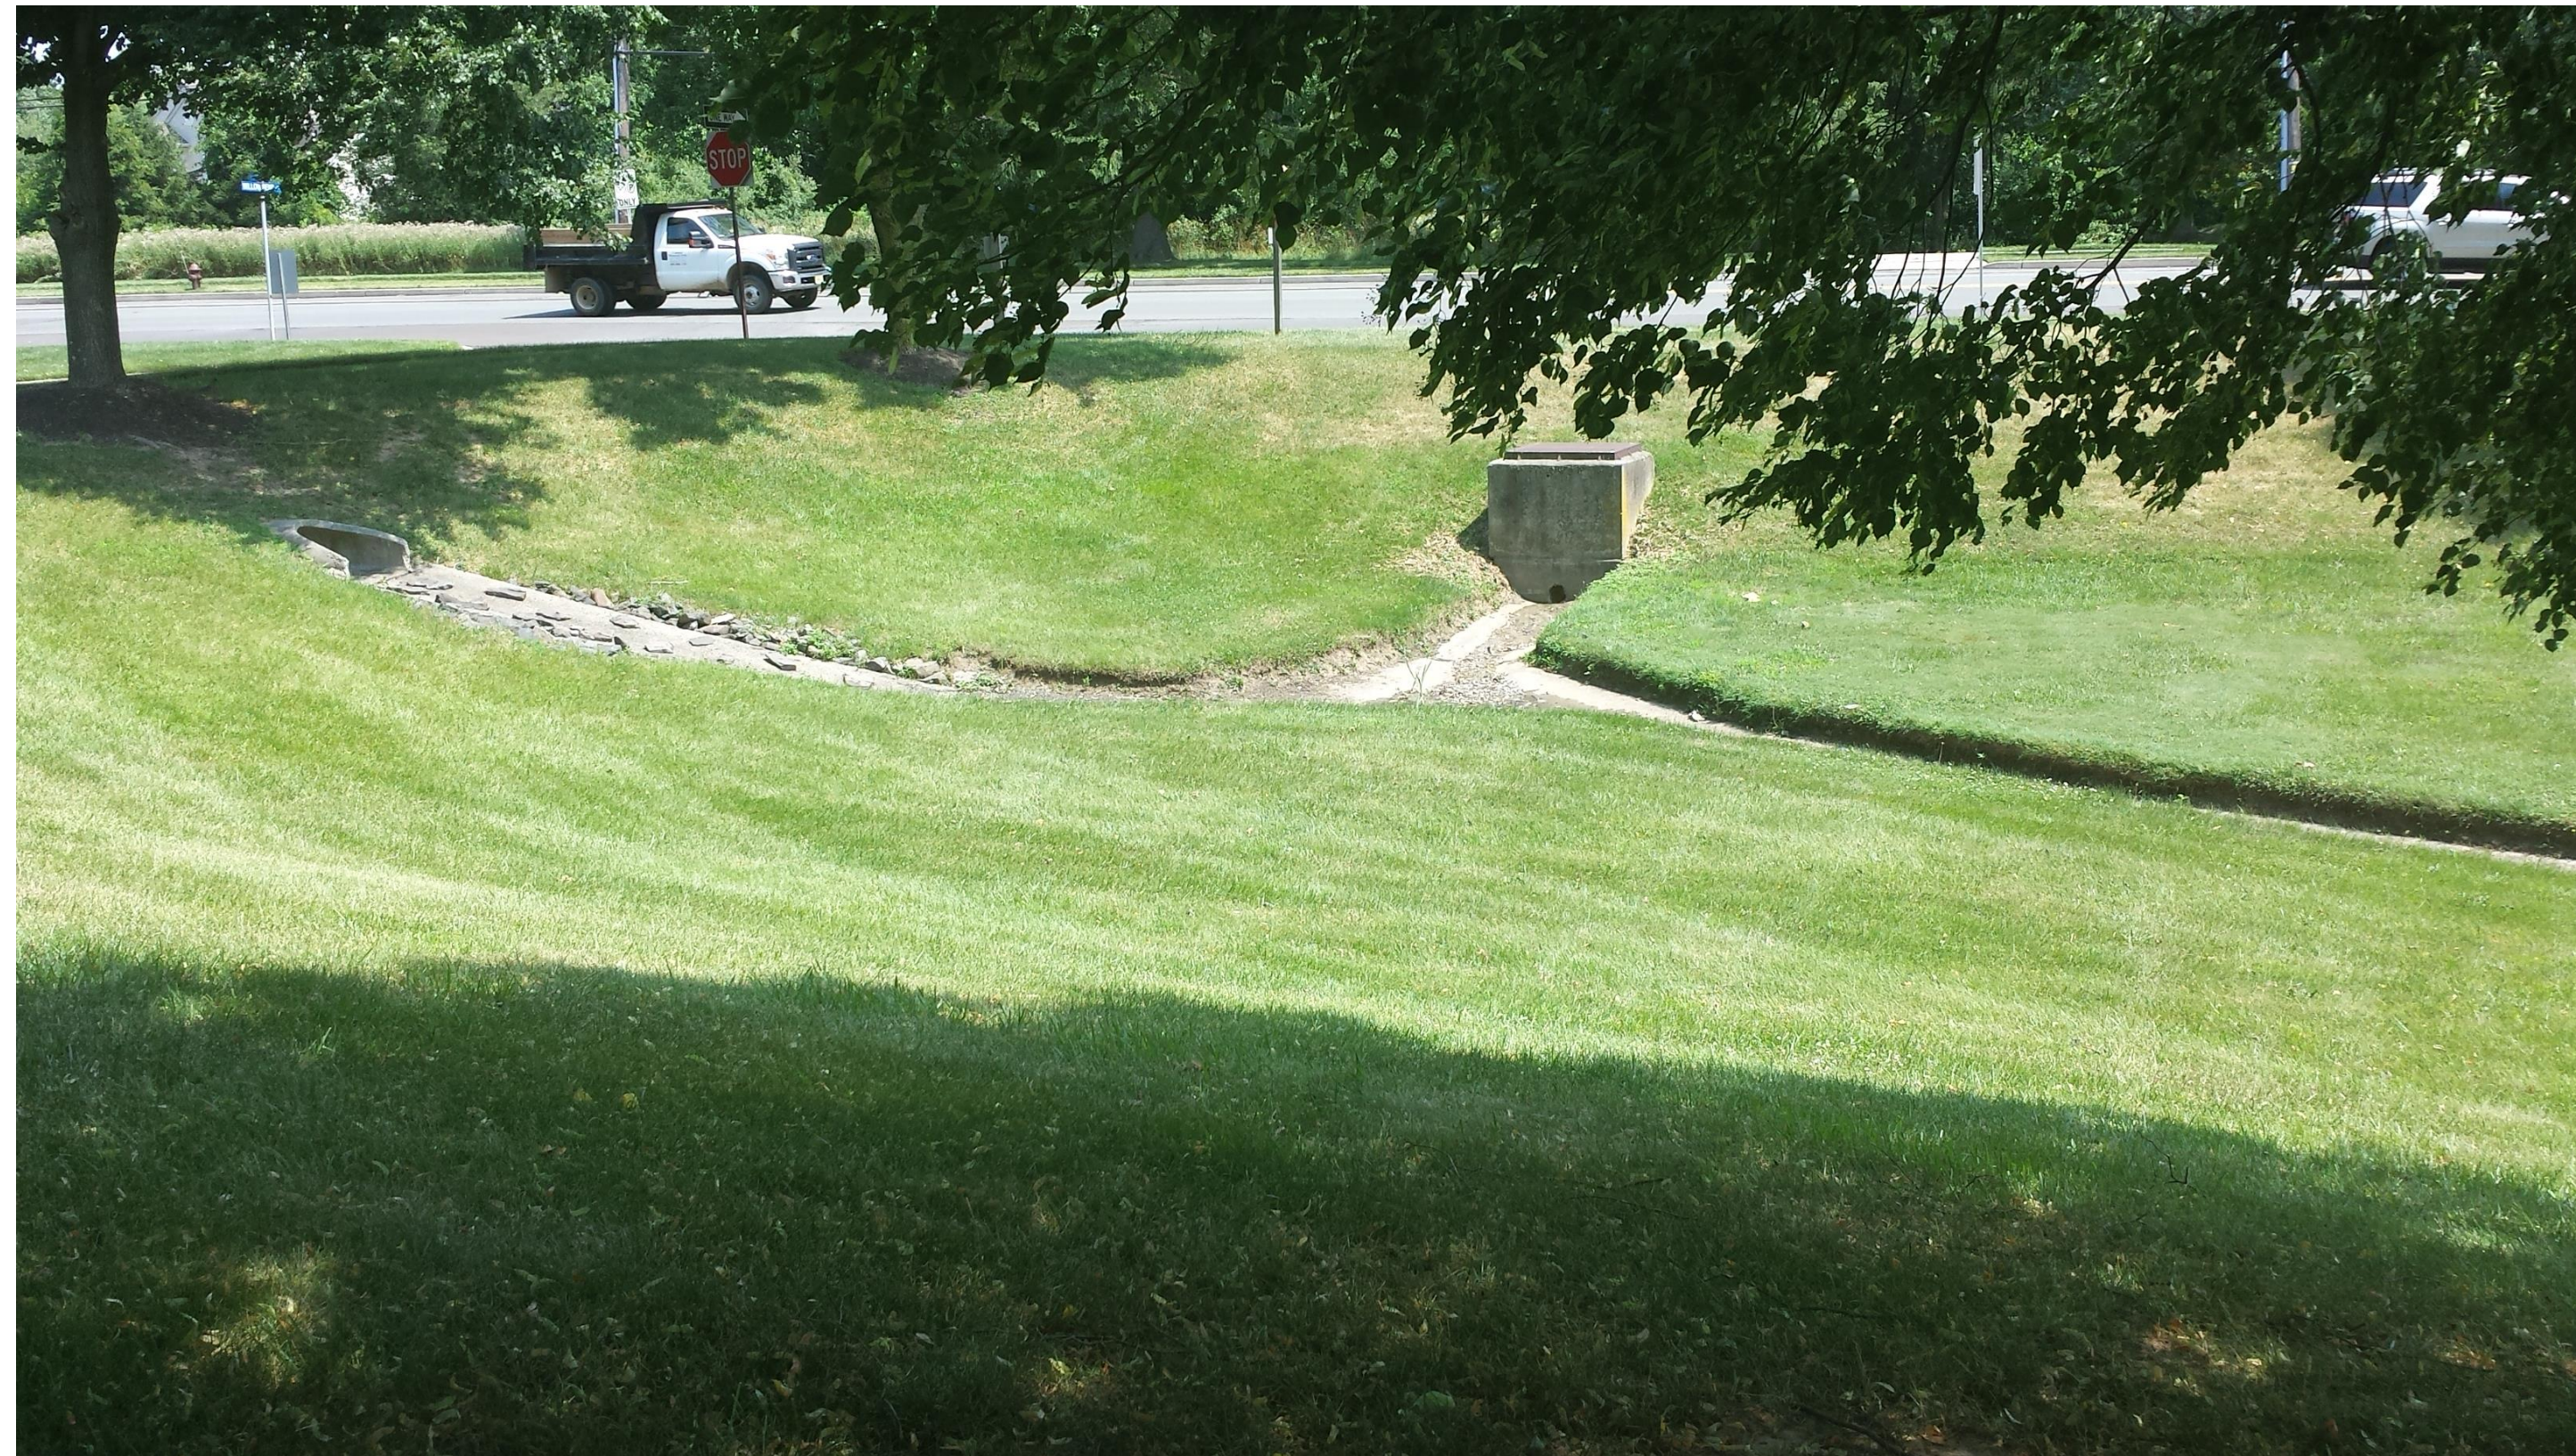
Overview of basin

- Noticeable amount of iron in low flow channel
- Minimal amounts of sediment near outlet structure
- Emergency spillway adjacent to basin flows to nearby field
- Overall in good condition

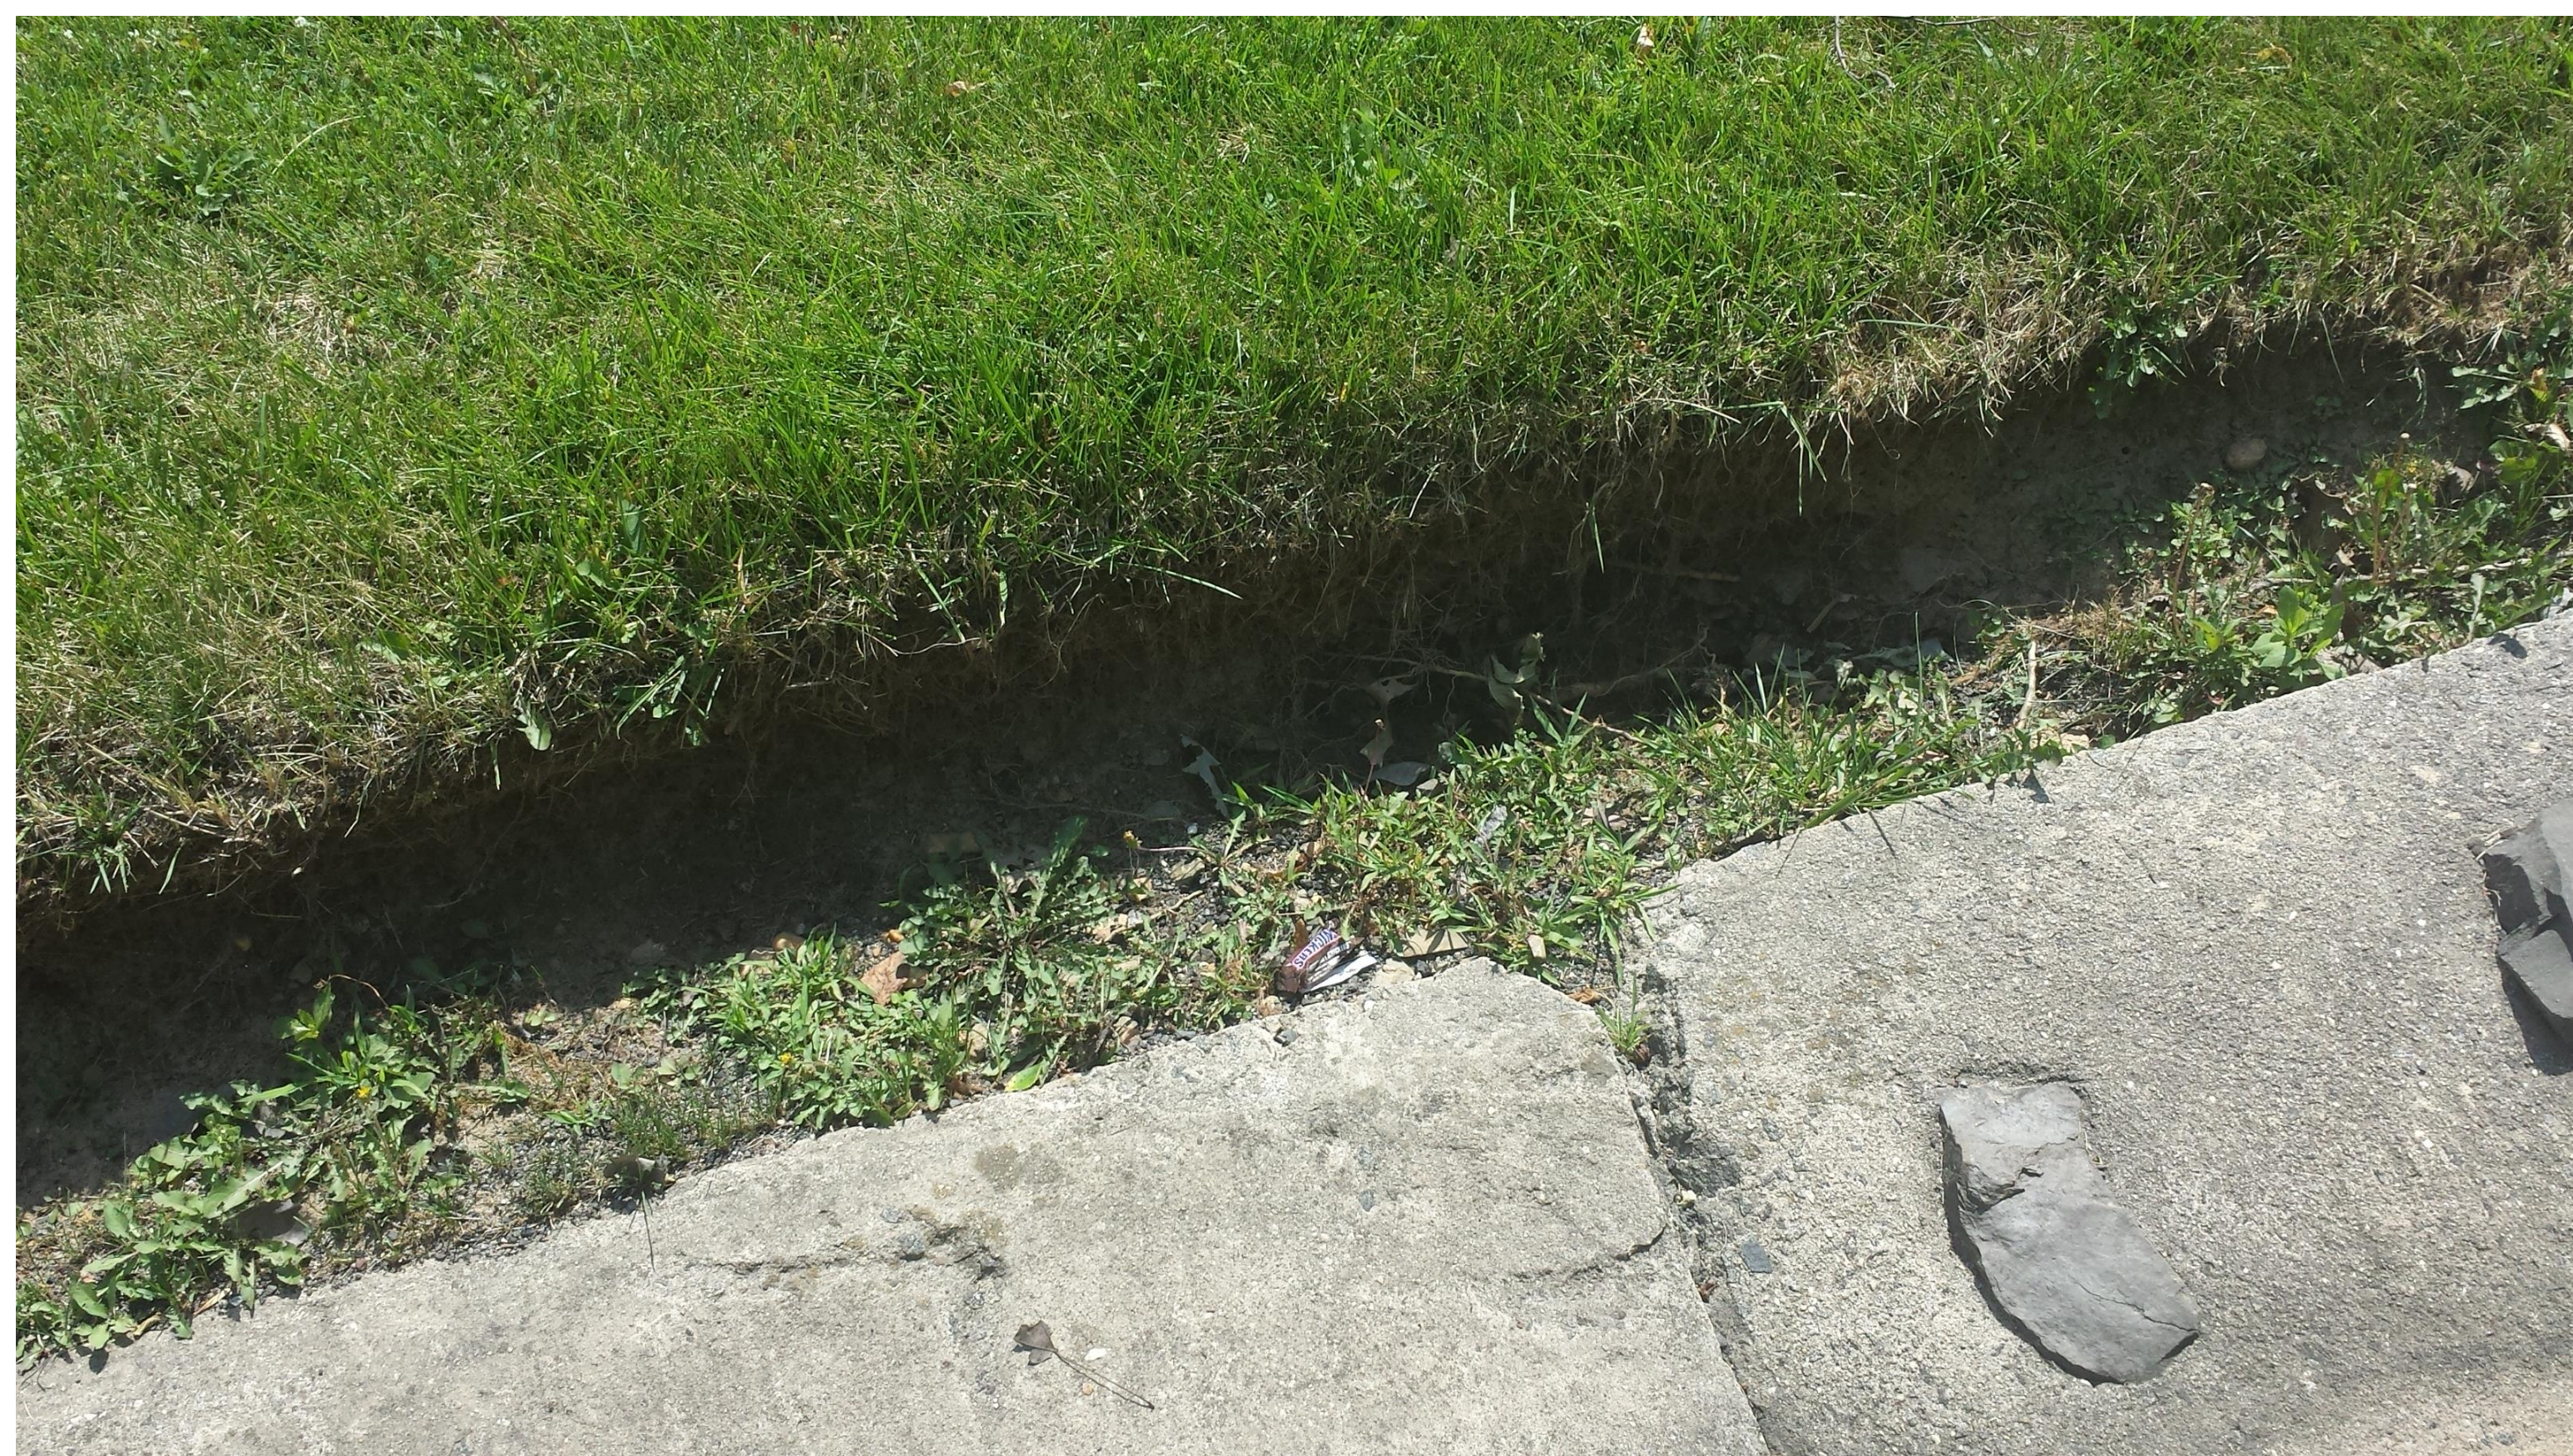
Erosion near inlet

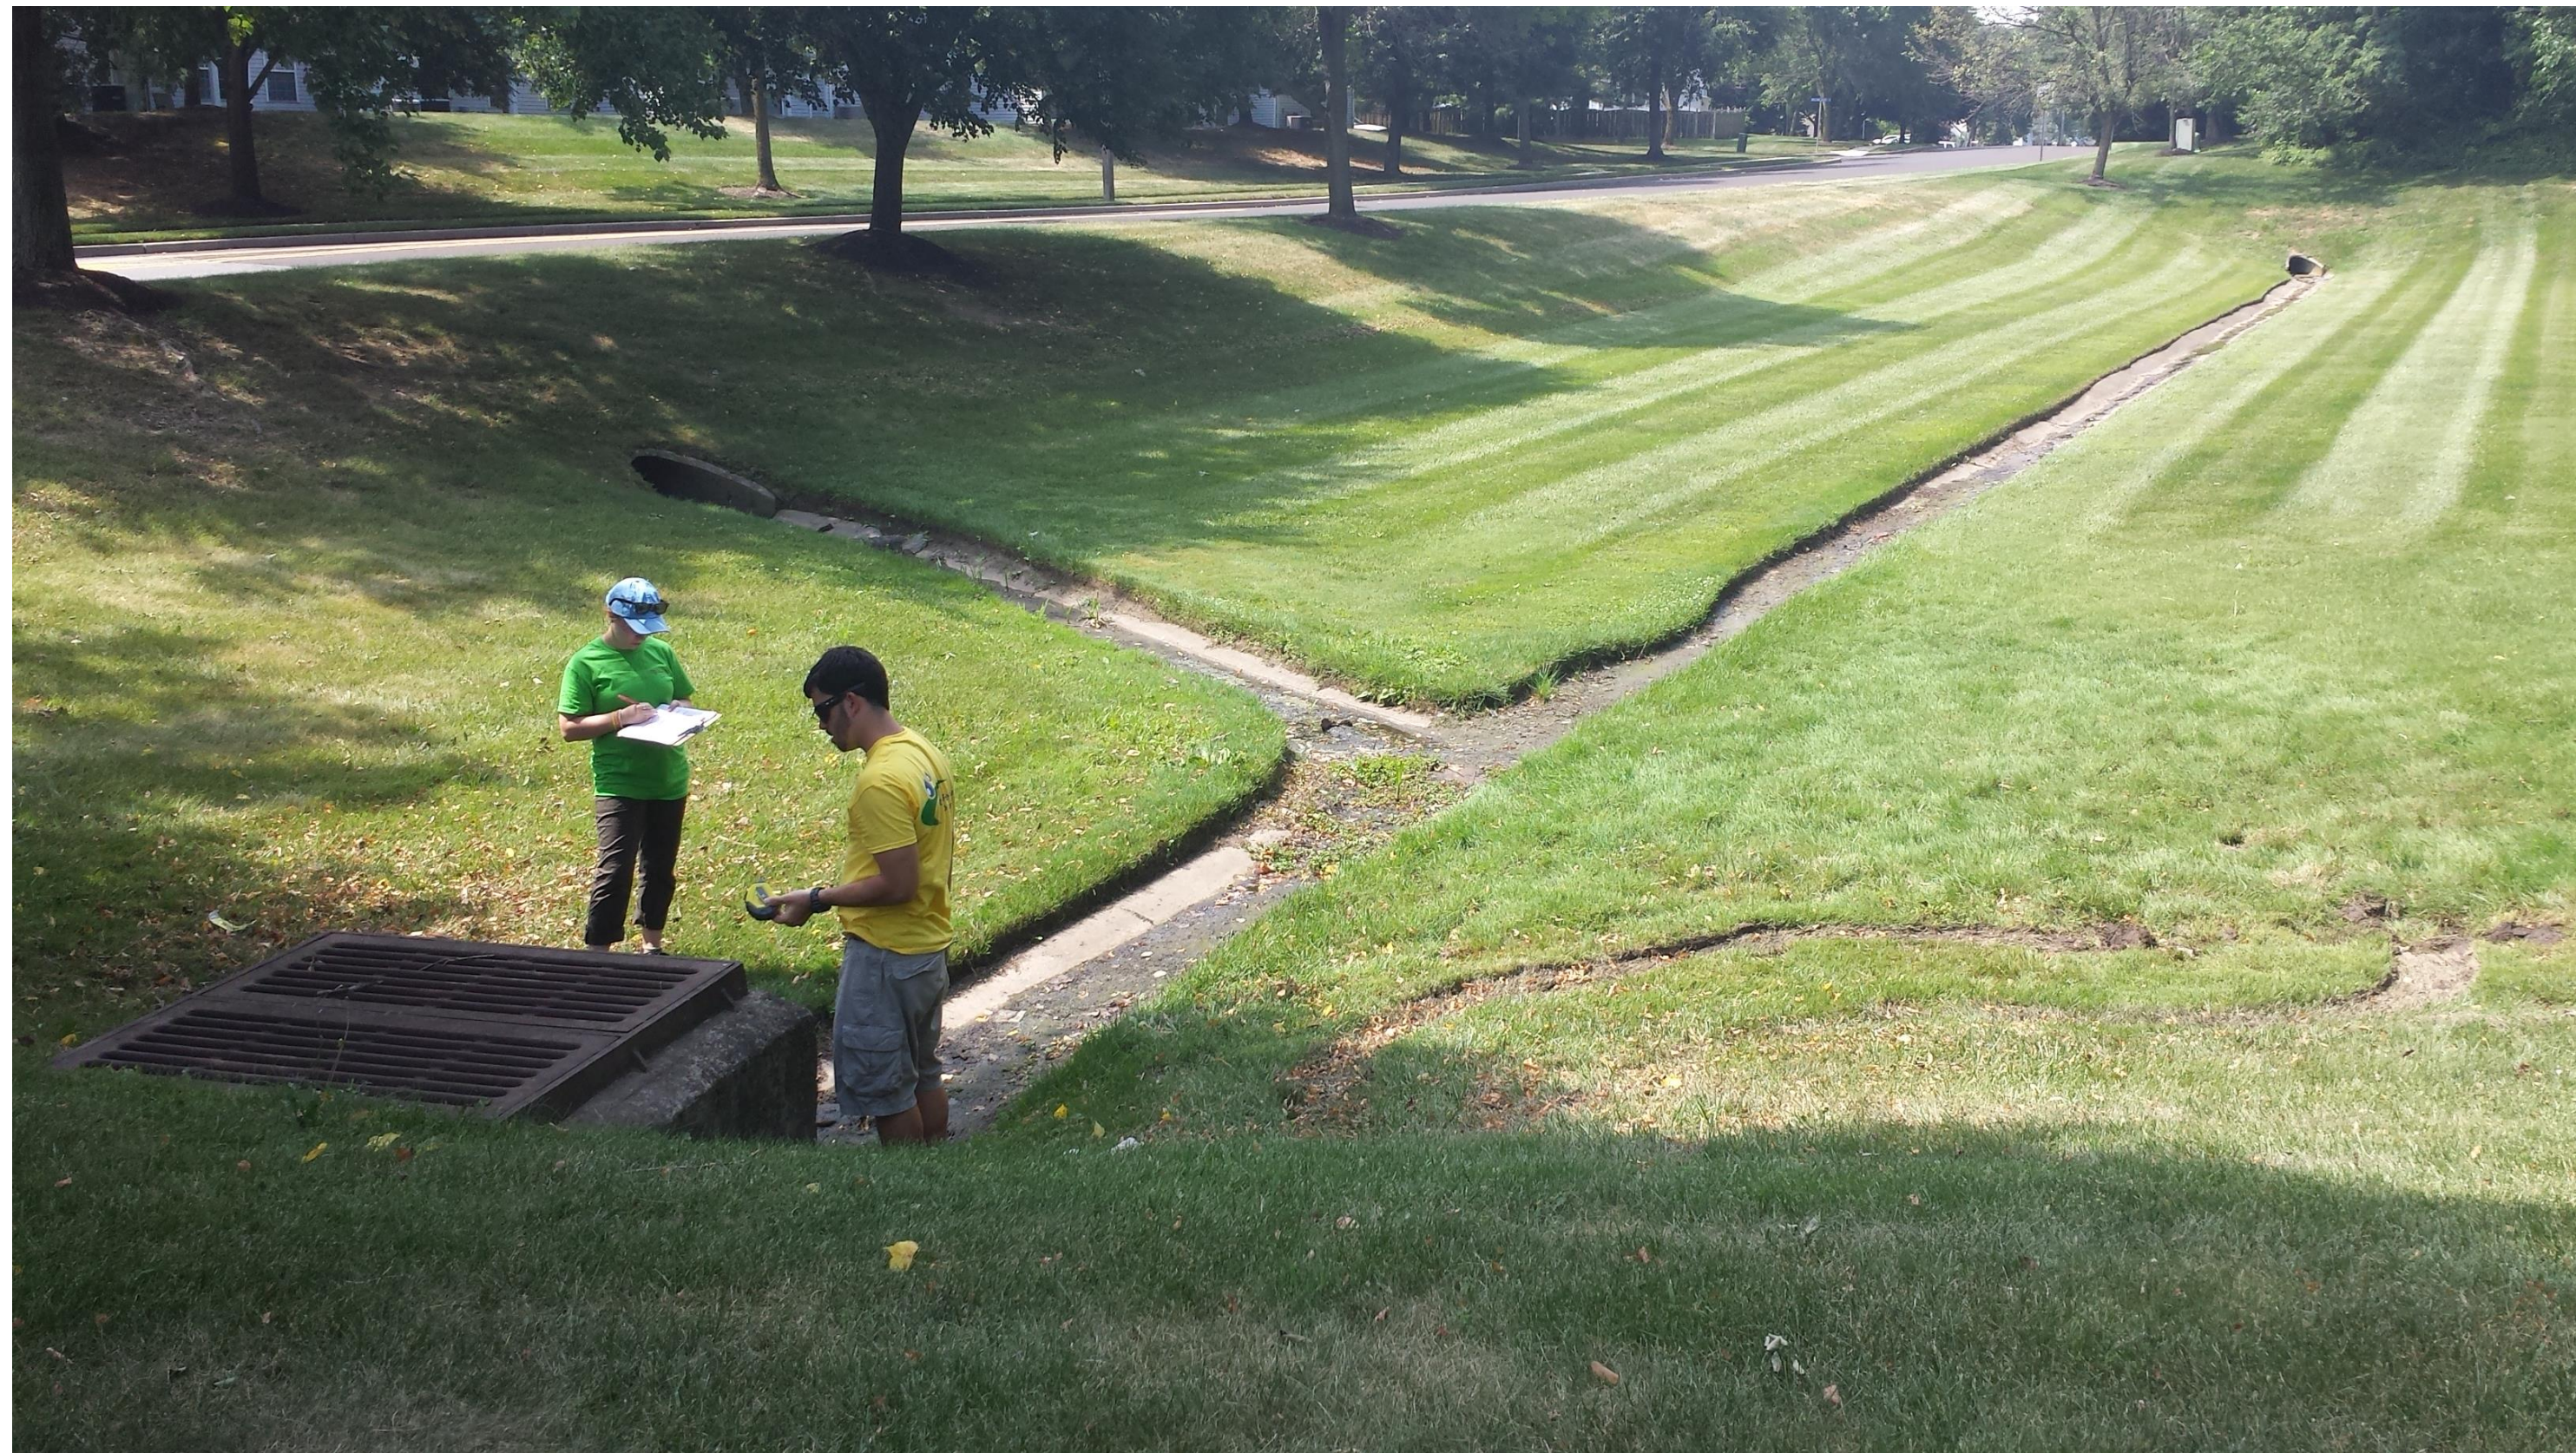
Overview of basin

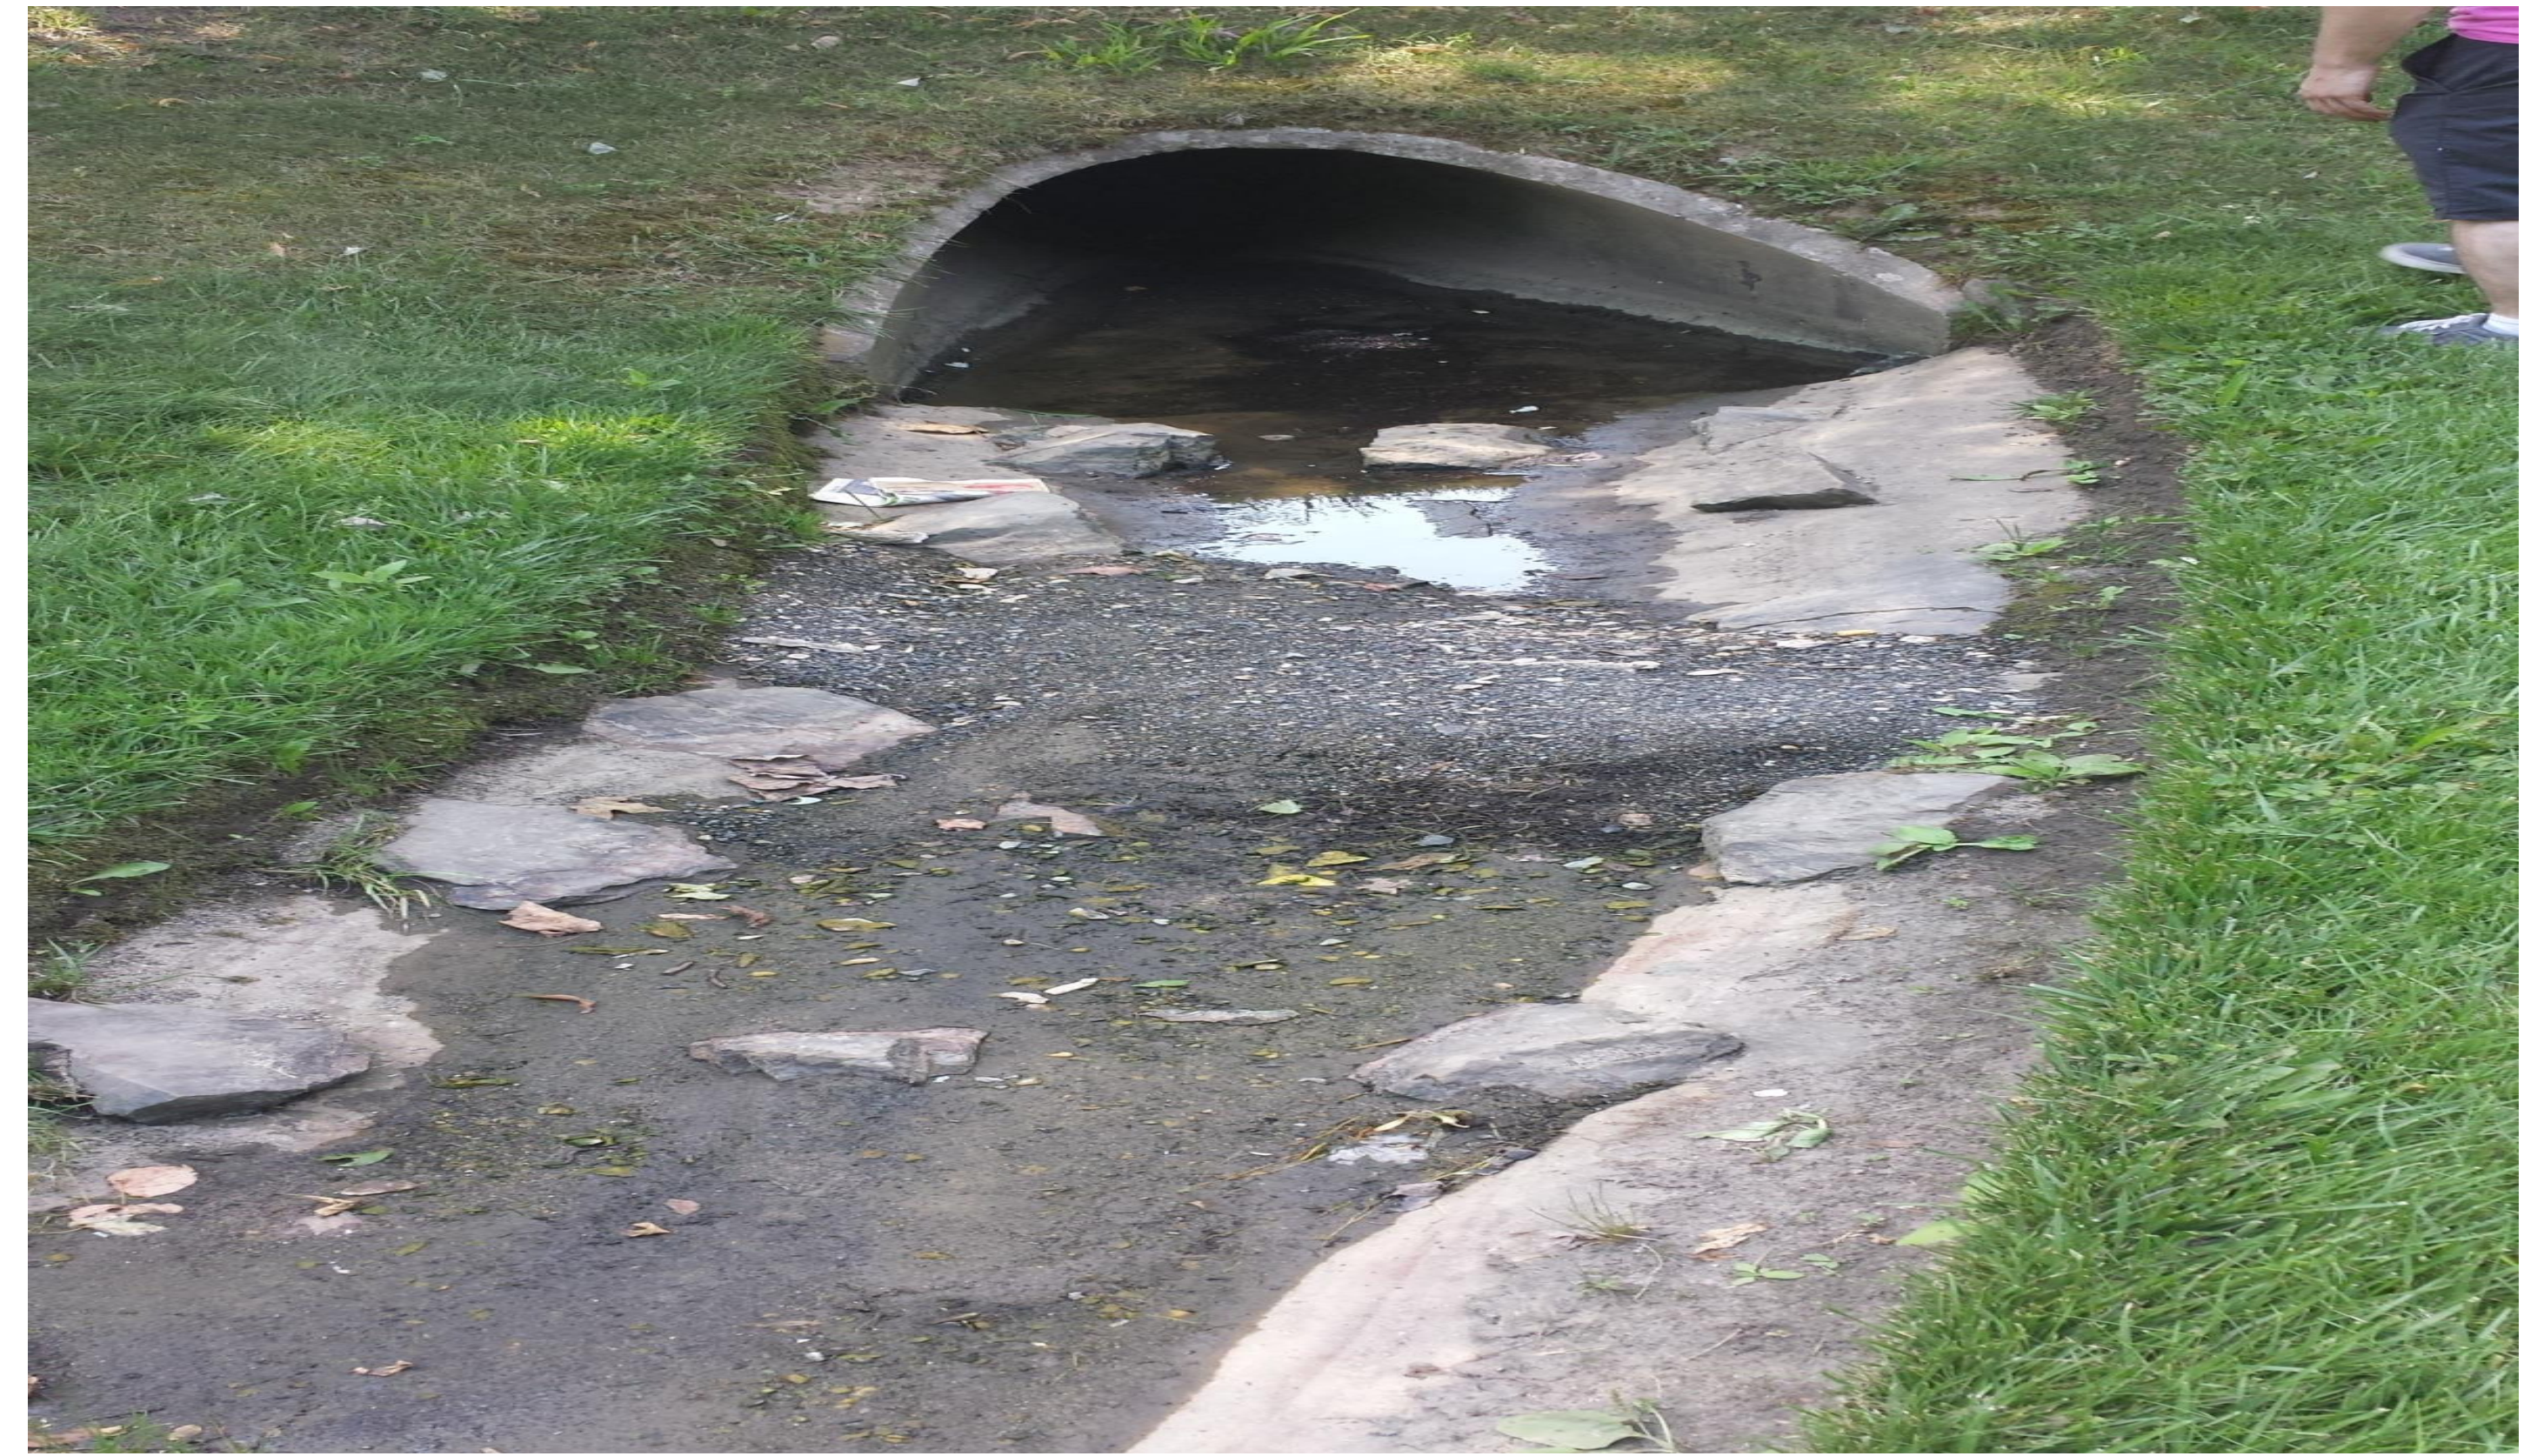
Sediment in low flow channel

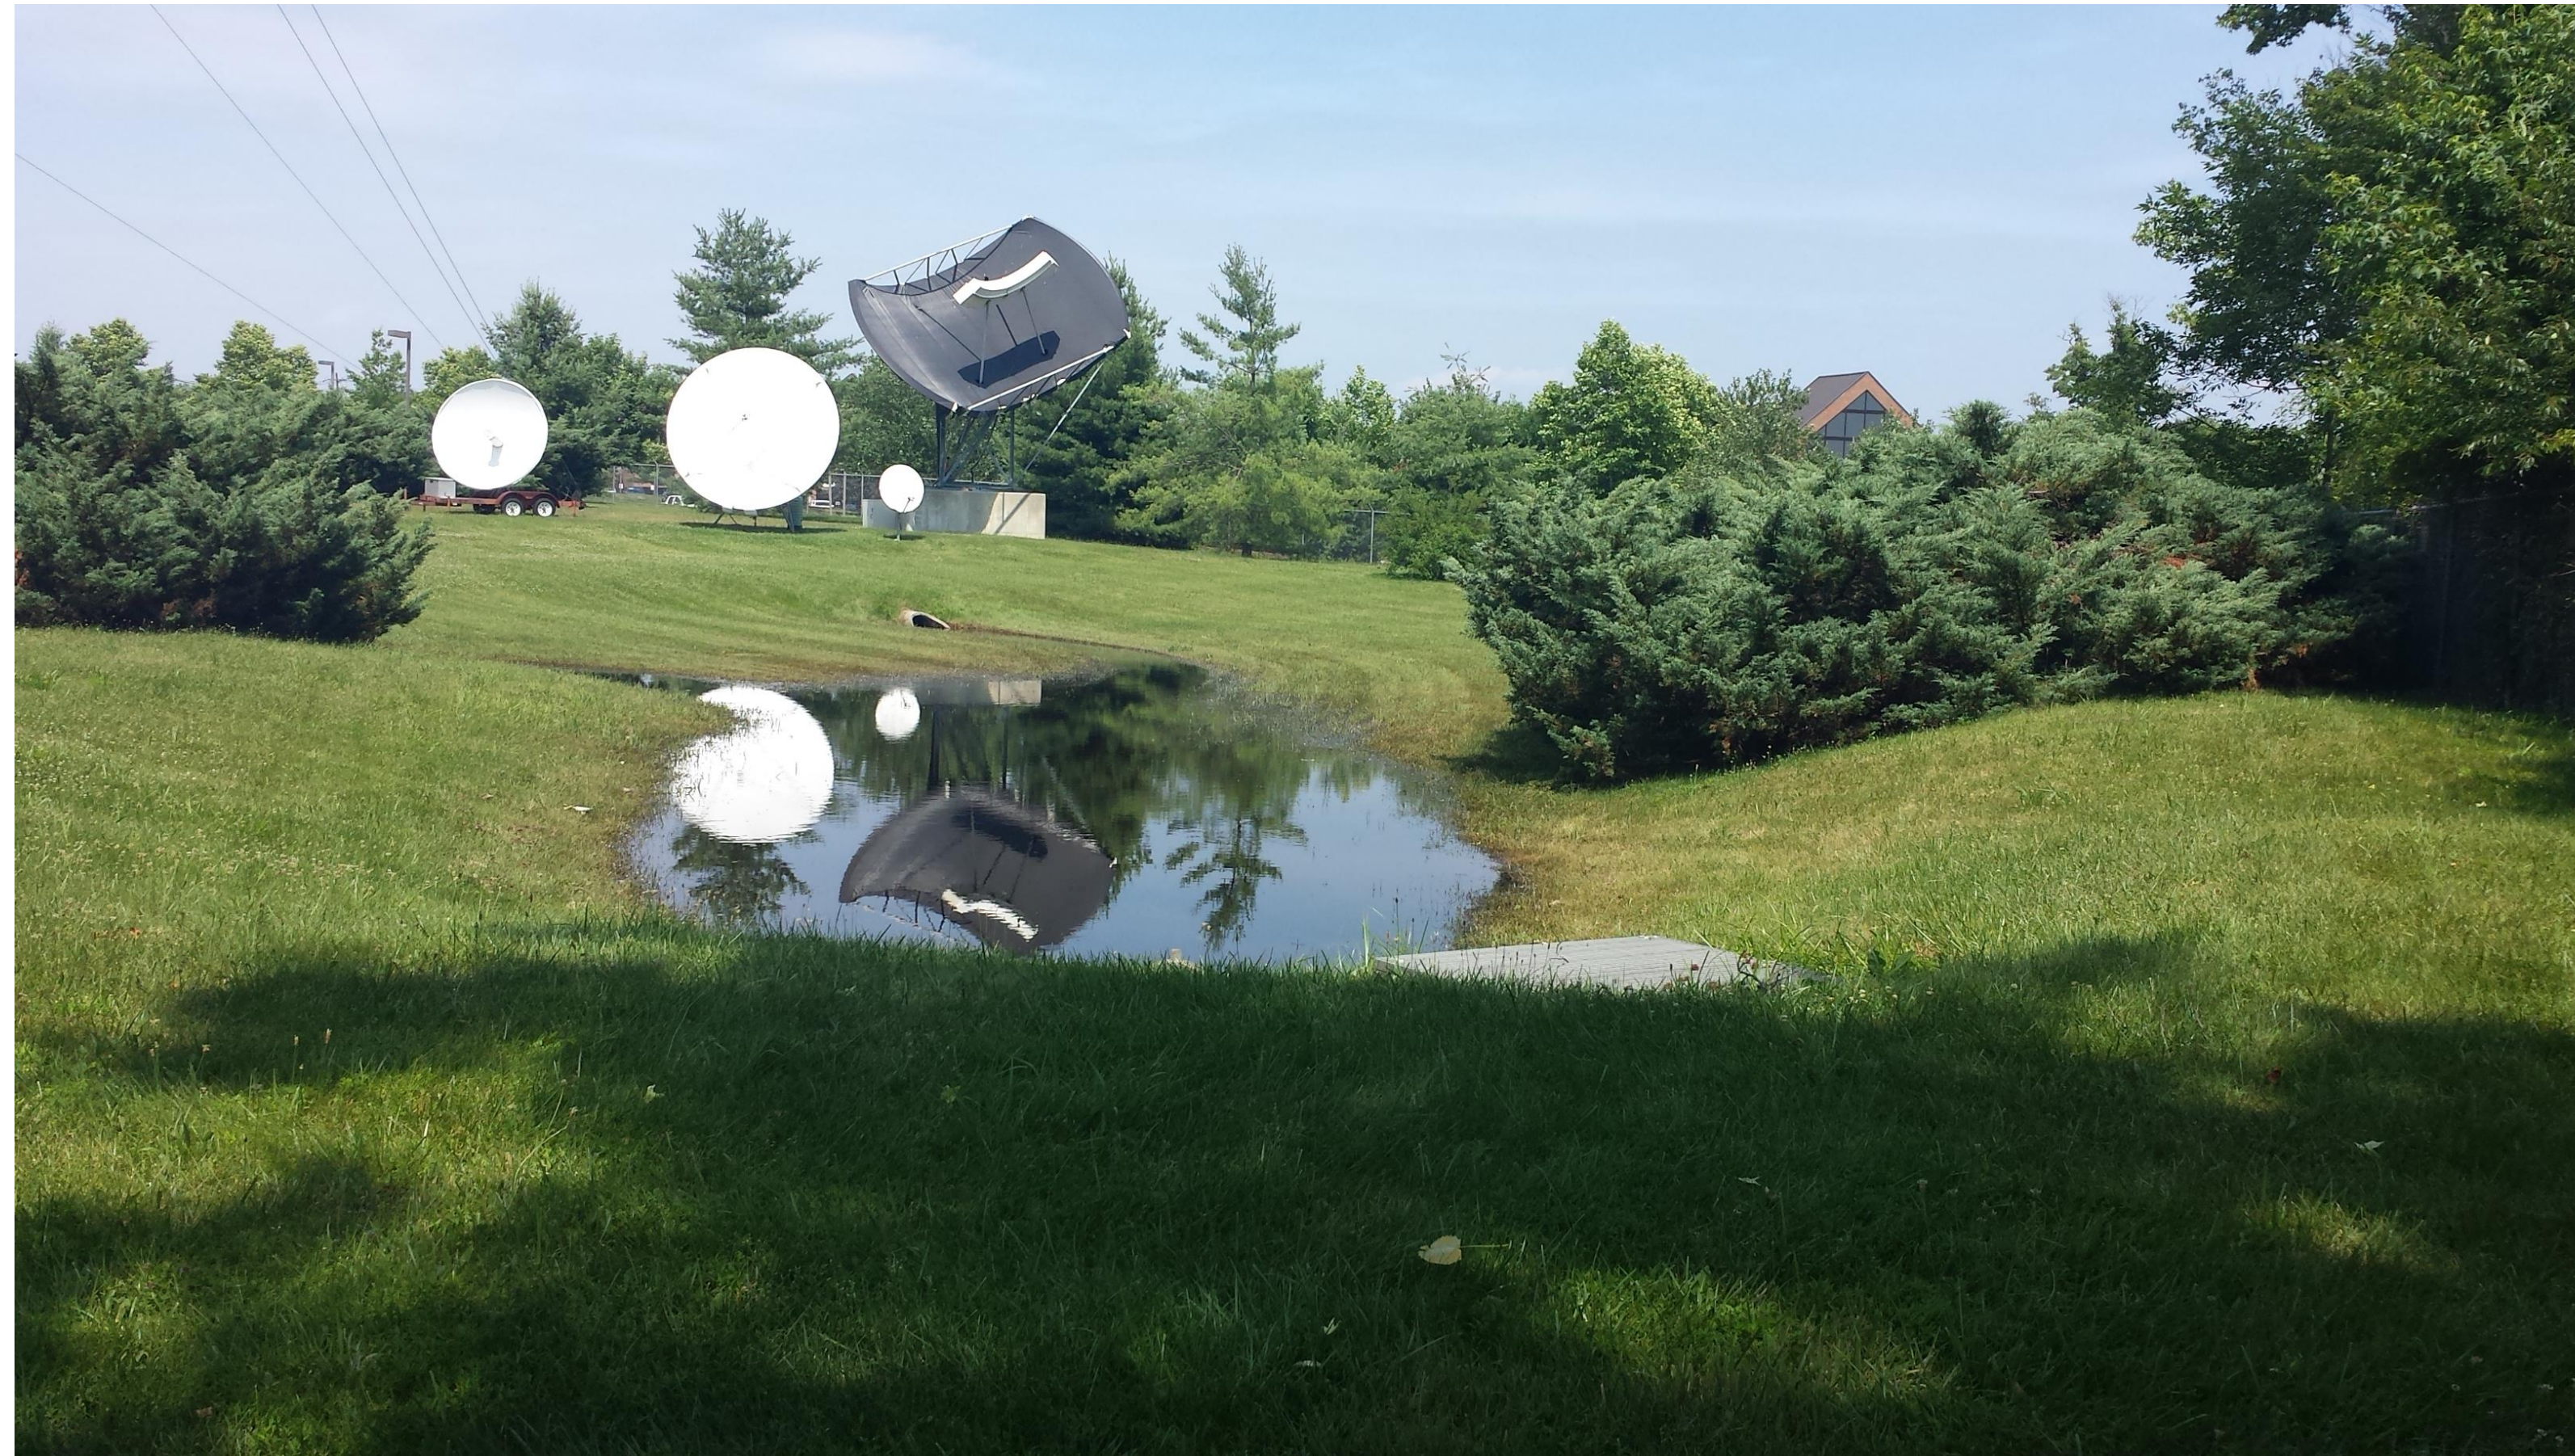
Overview of basin
