**Hamilton Township (Mercer County)
Stormwater Basin Assessment Summary
Addendum (Year 3)**

Developed by the Rutgers Cooperative Extension Water Resources Program
Funded by Hamilton Township, Mercer County, New Jersey

September 30, 2014

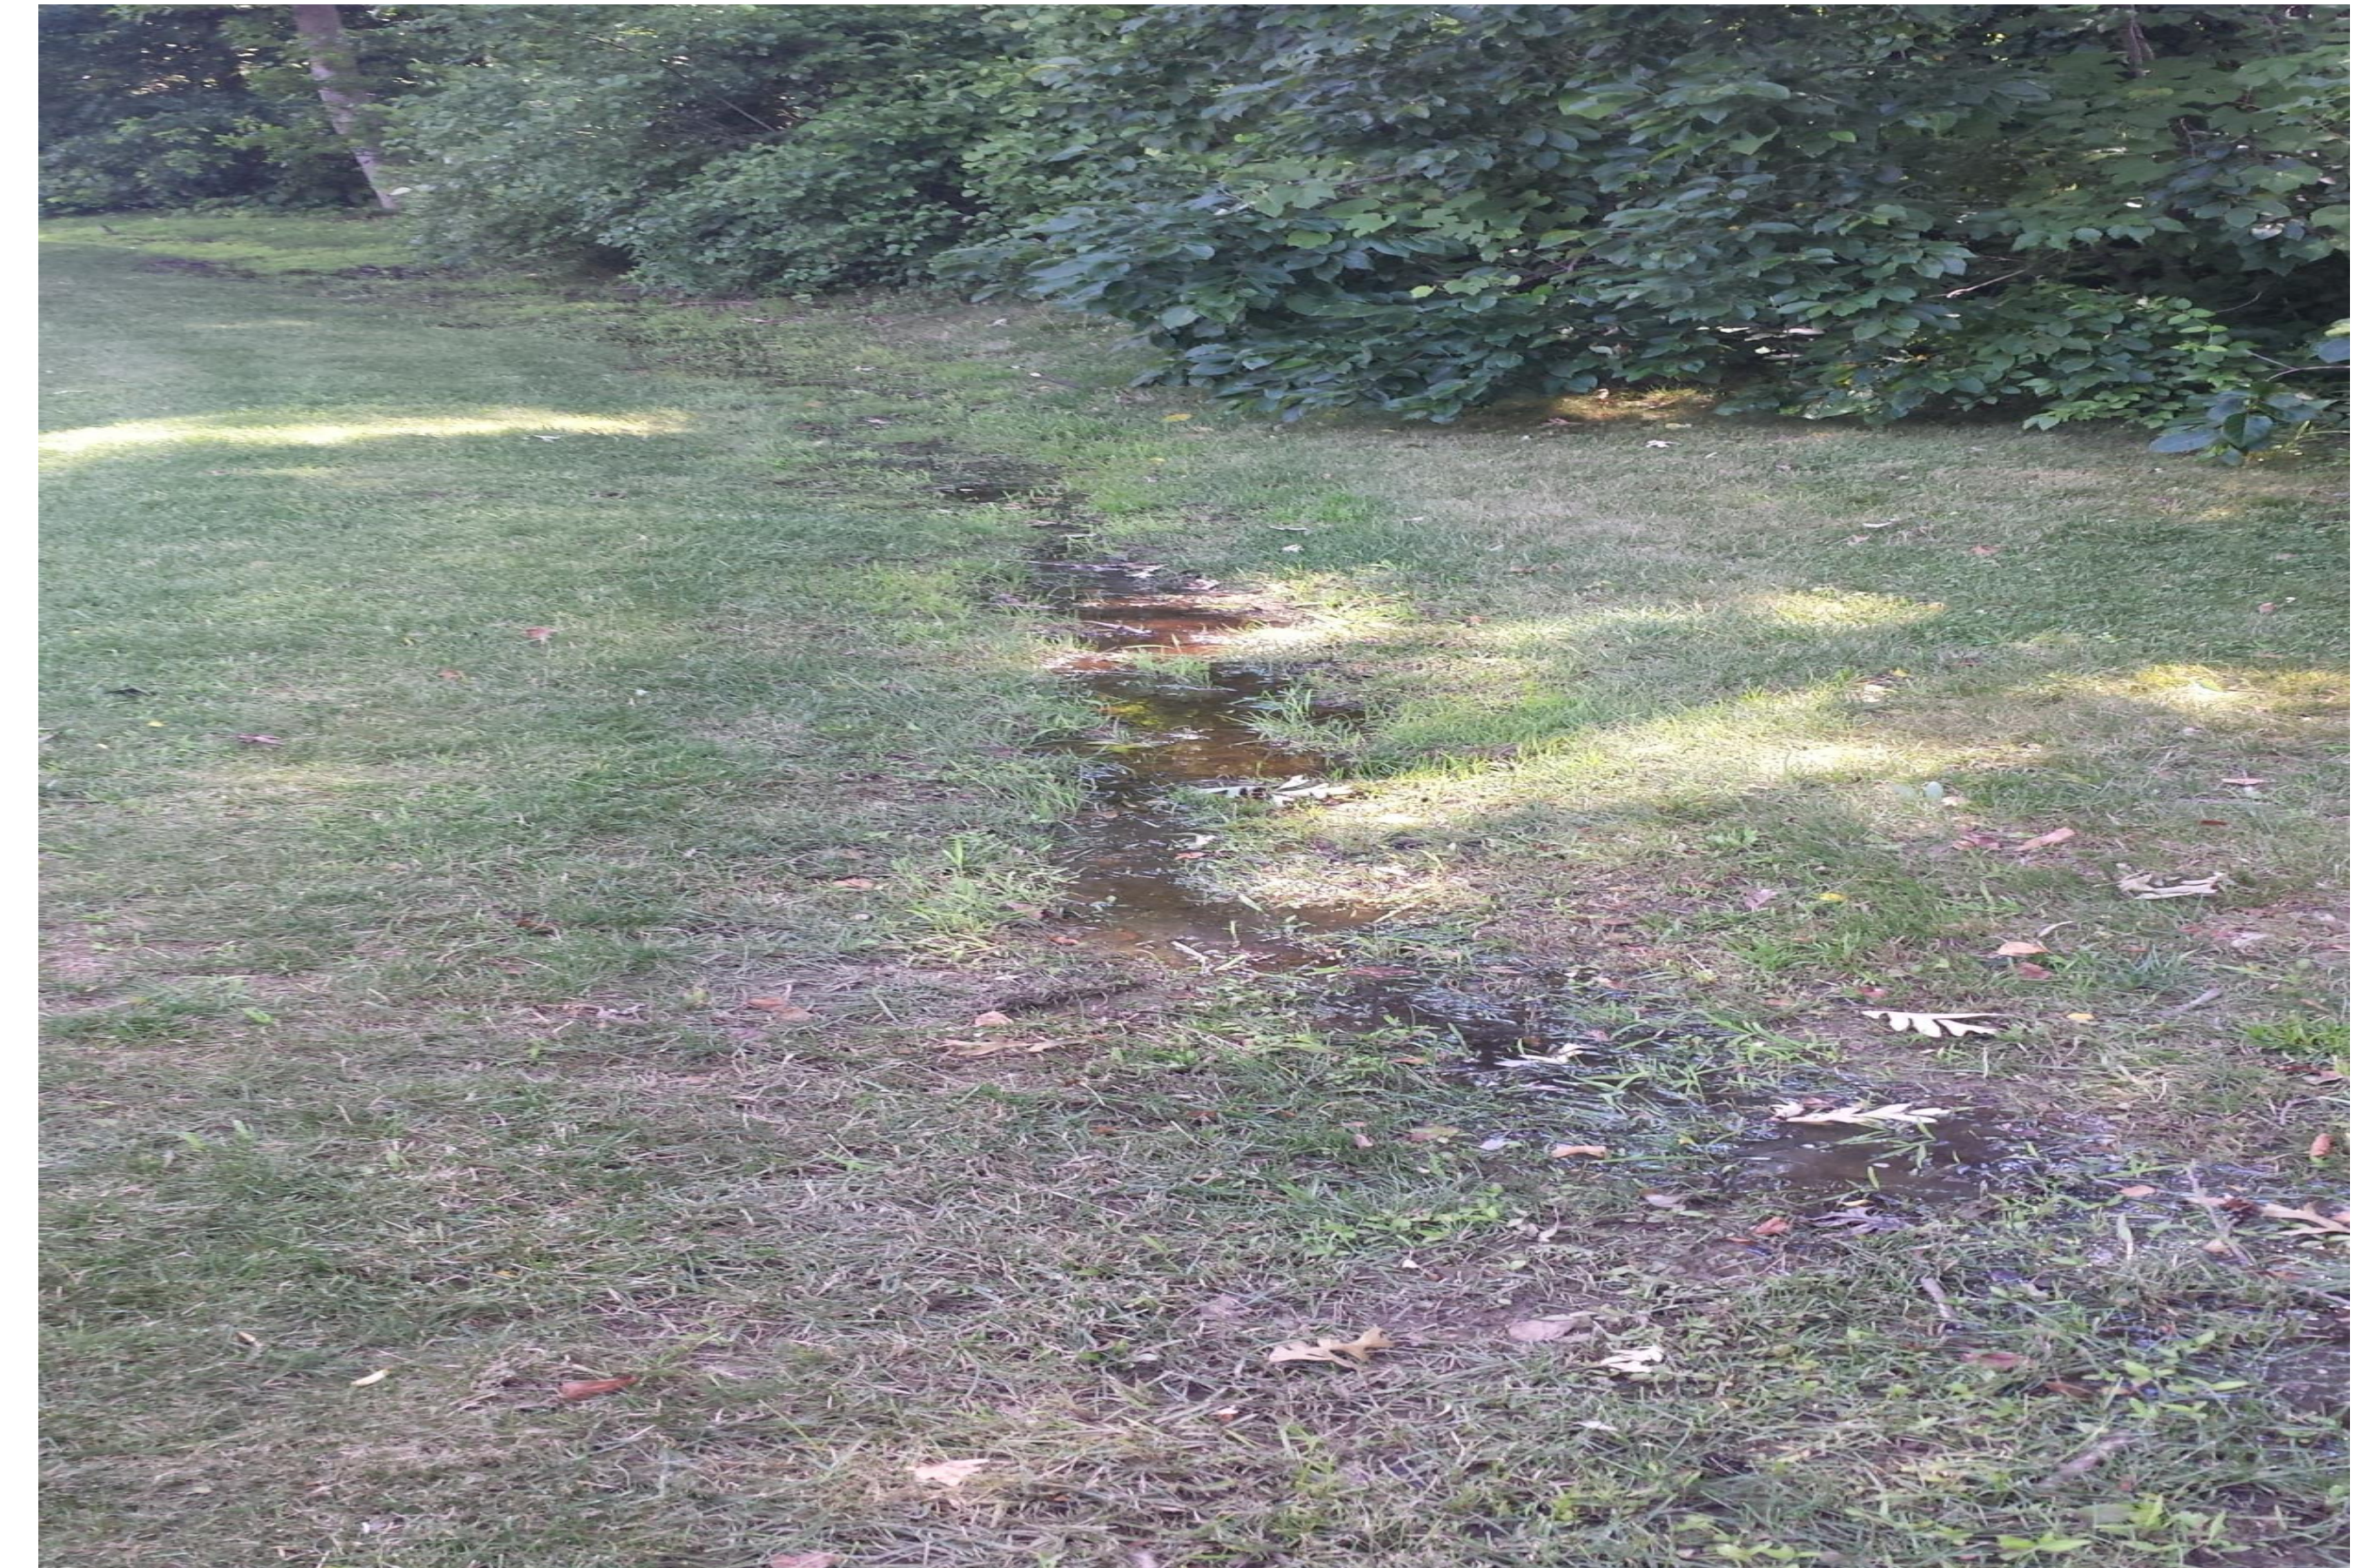
Swale exiting basin

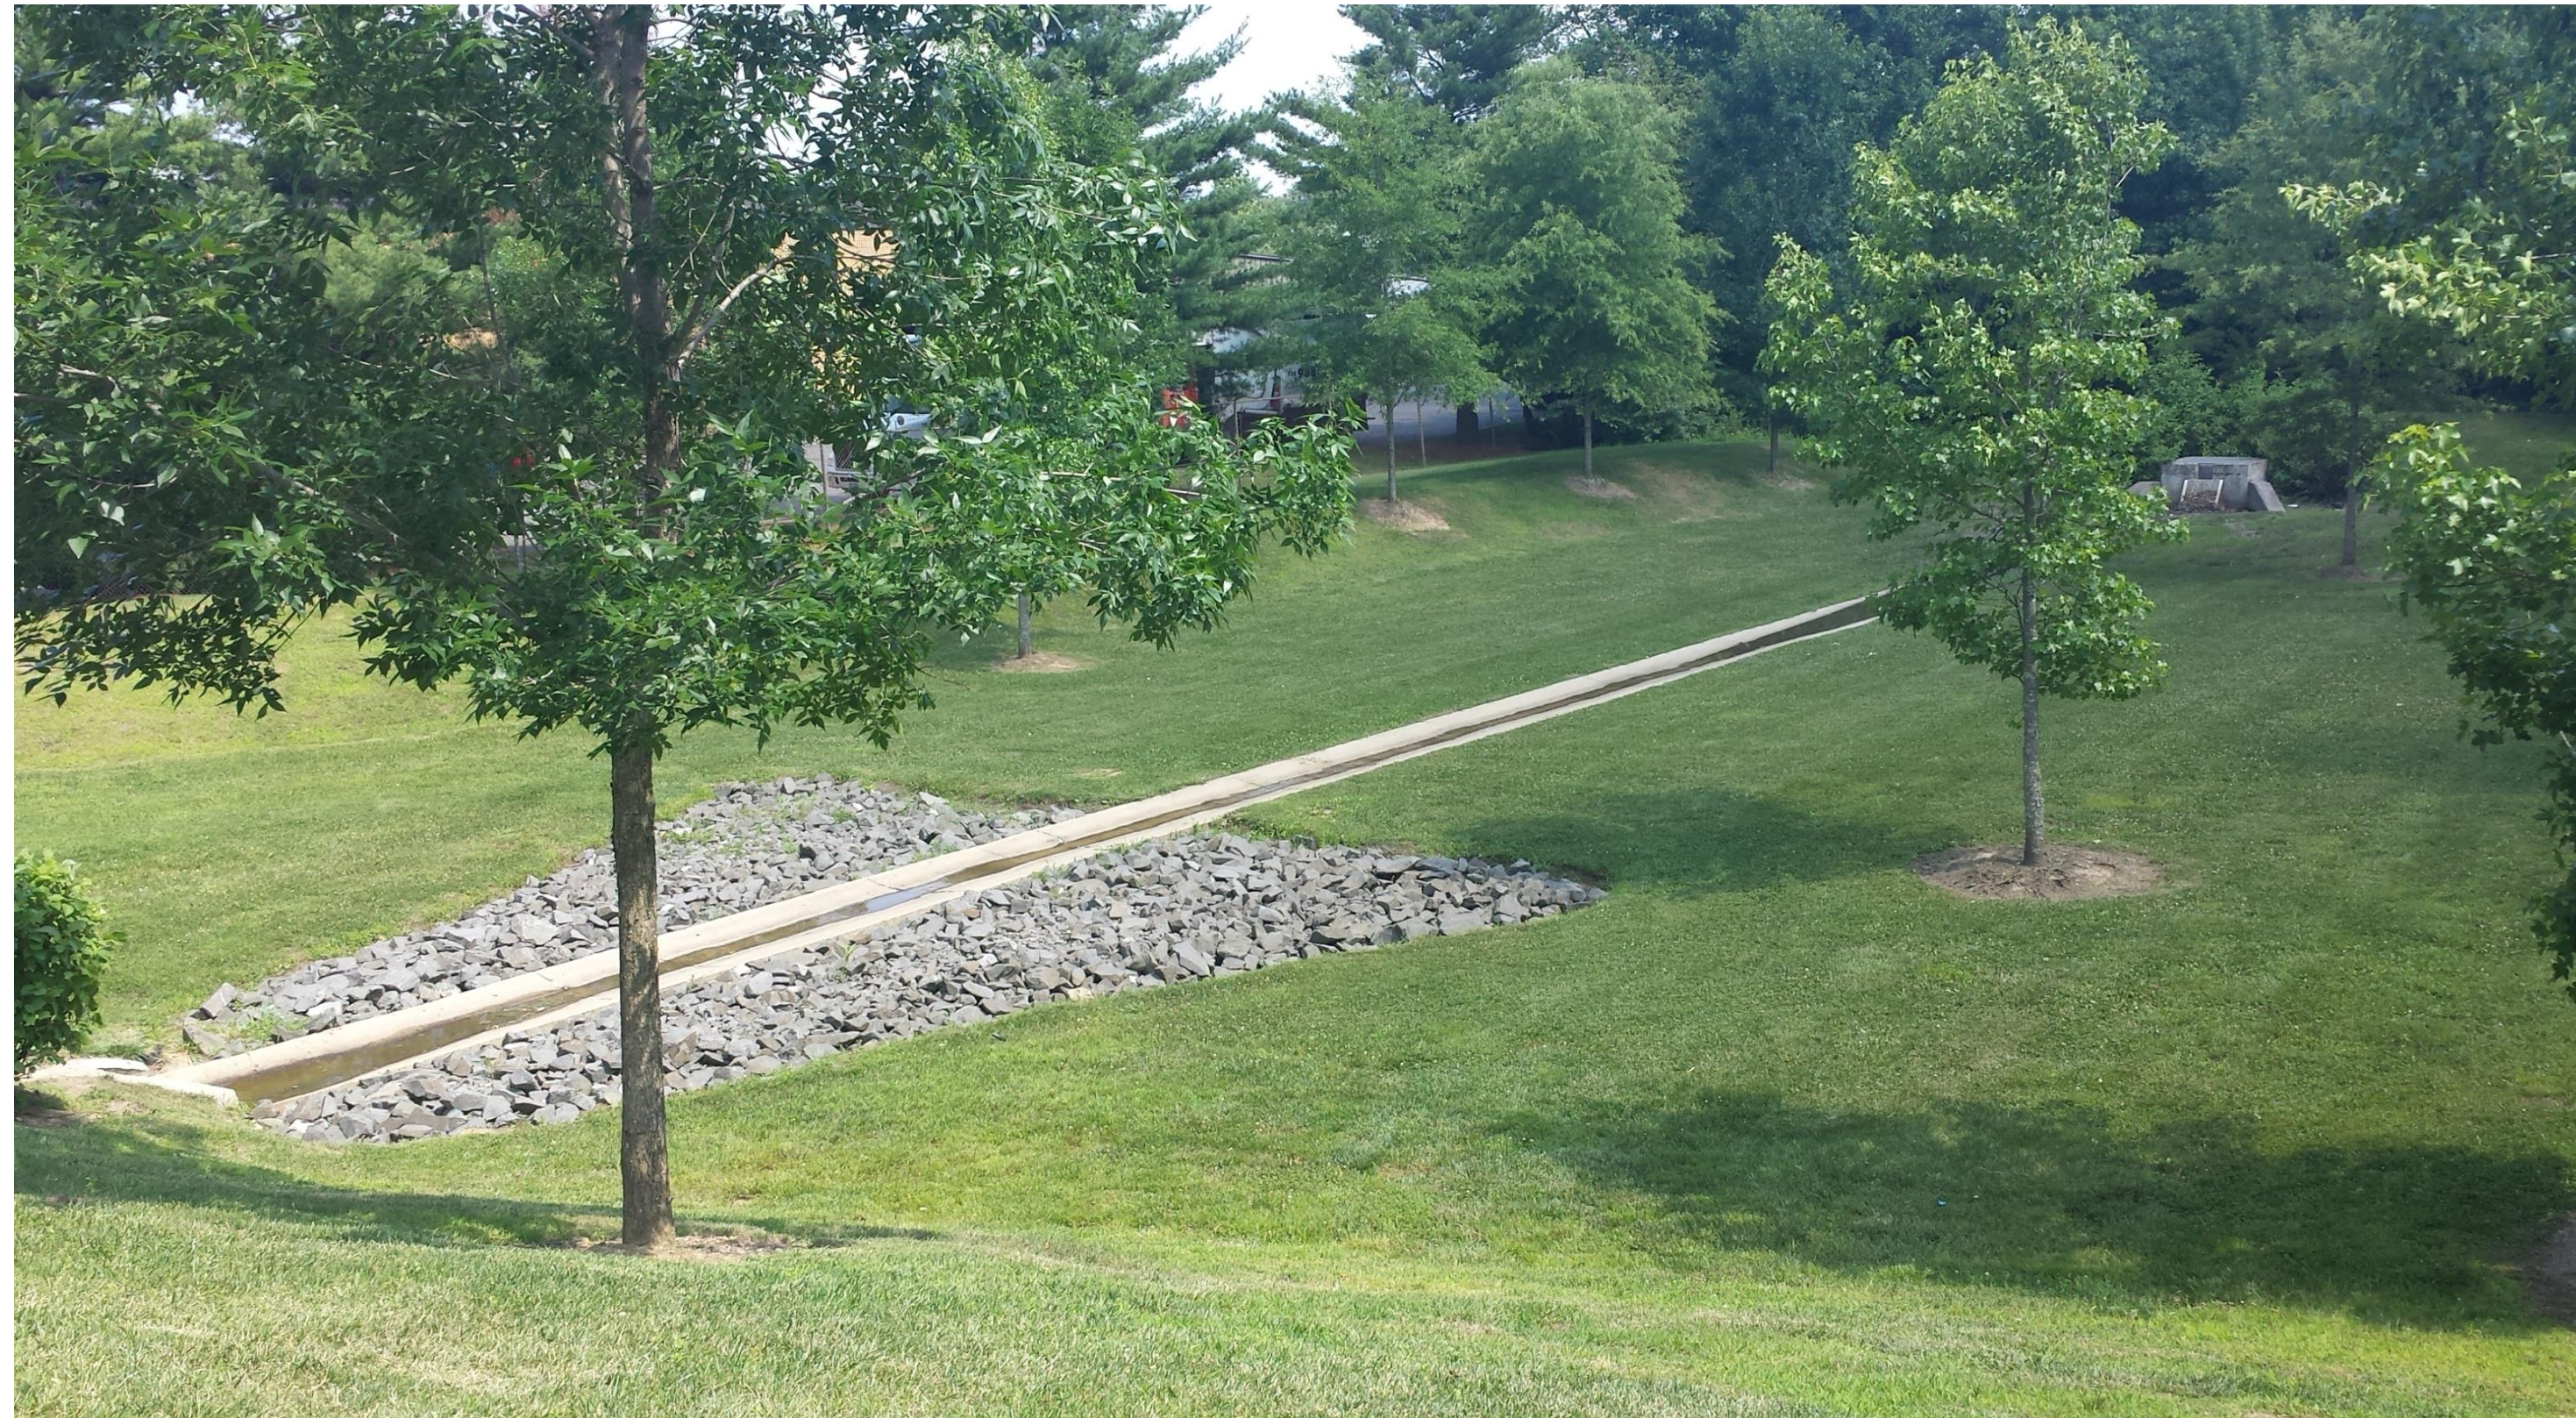
Overview of basin

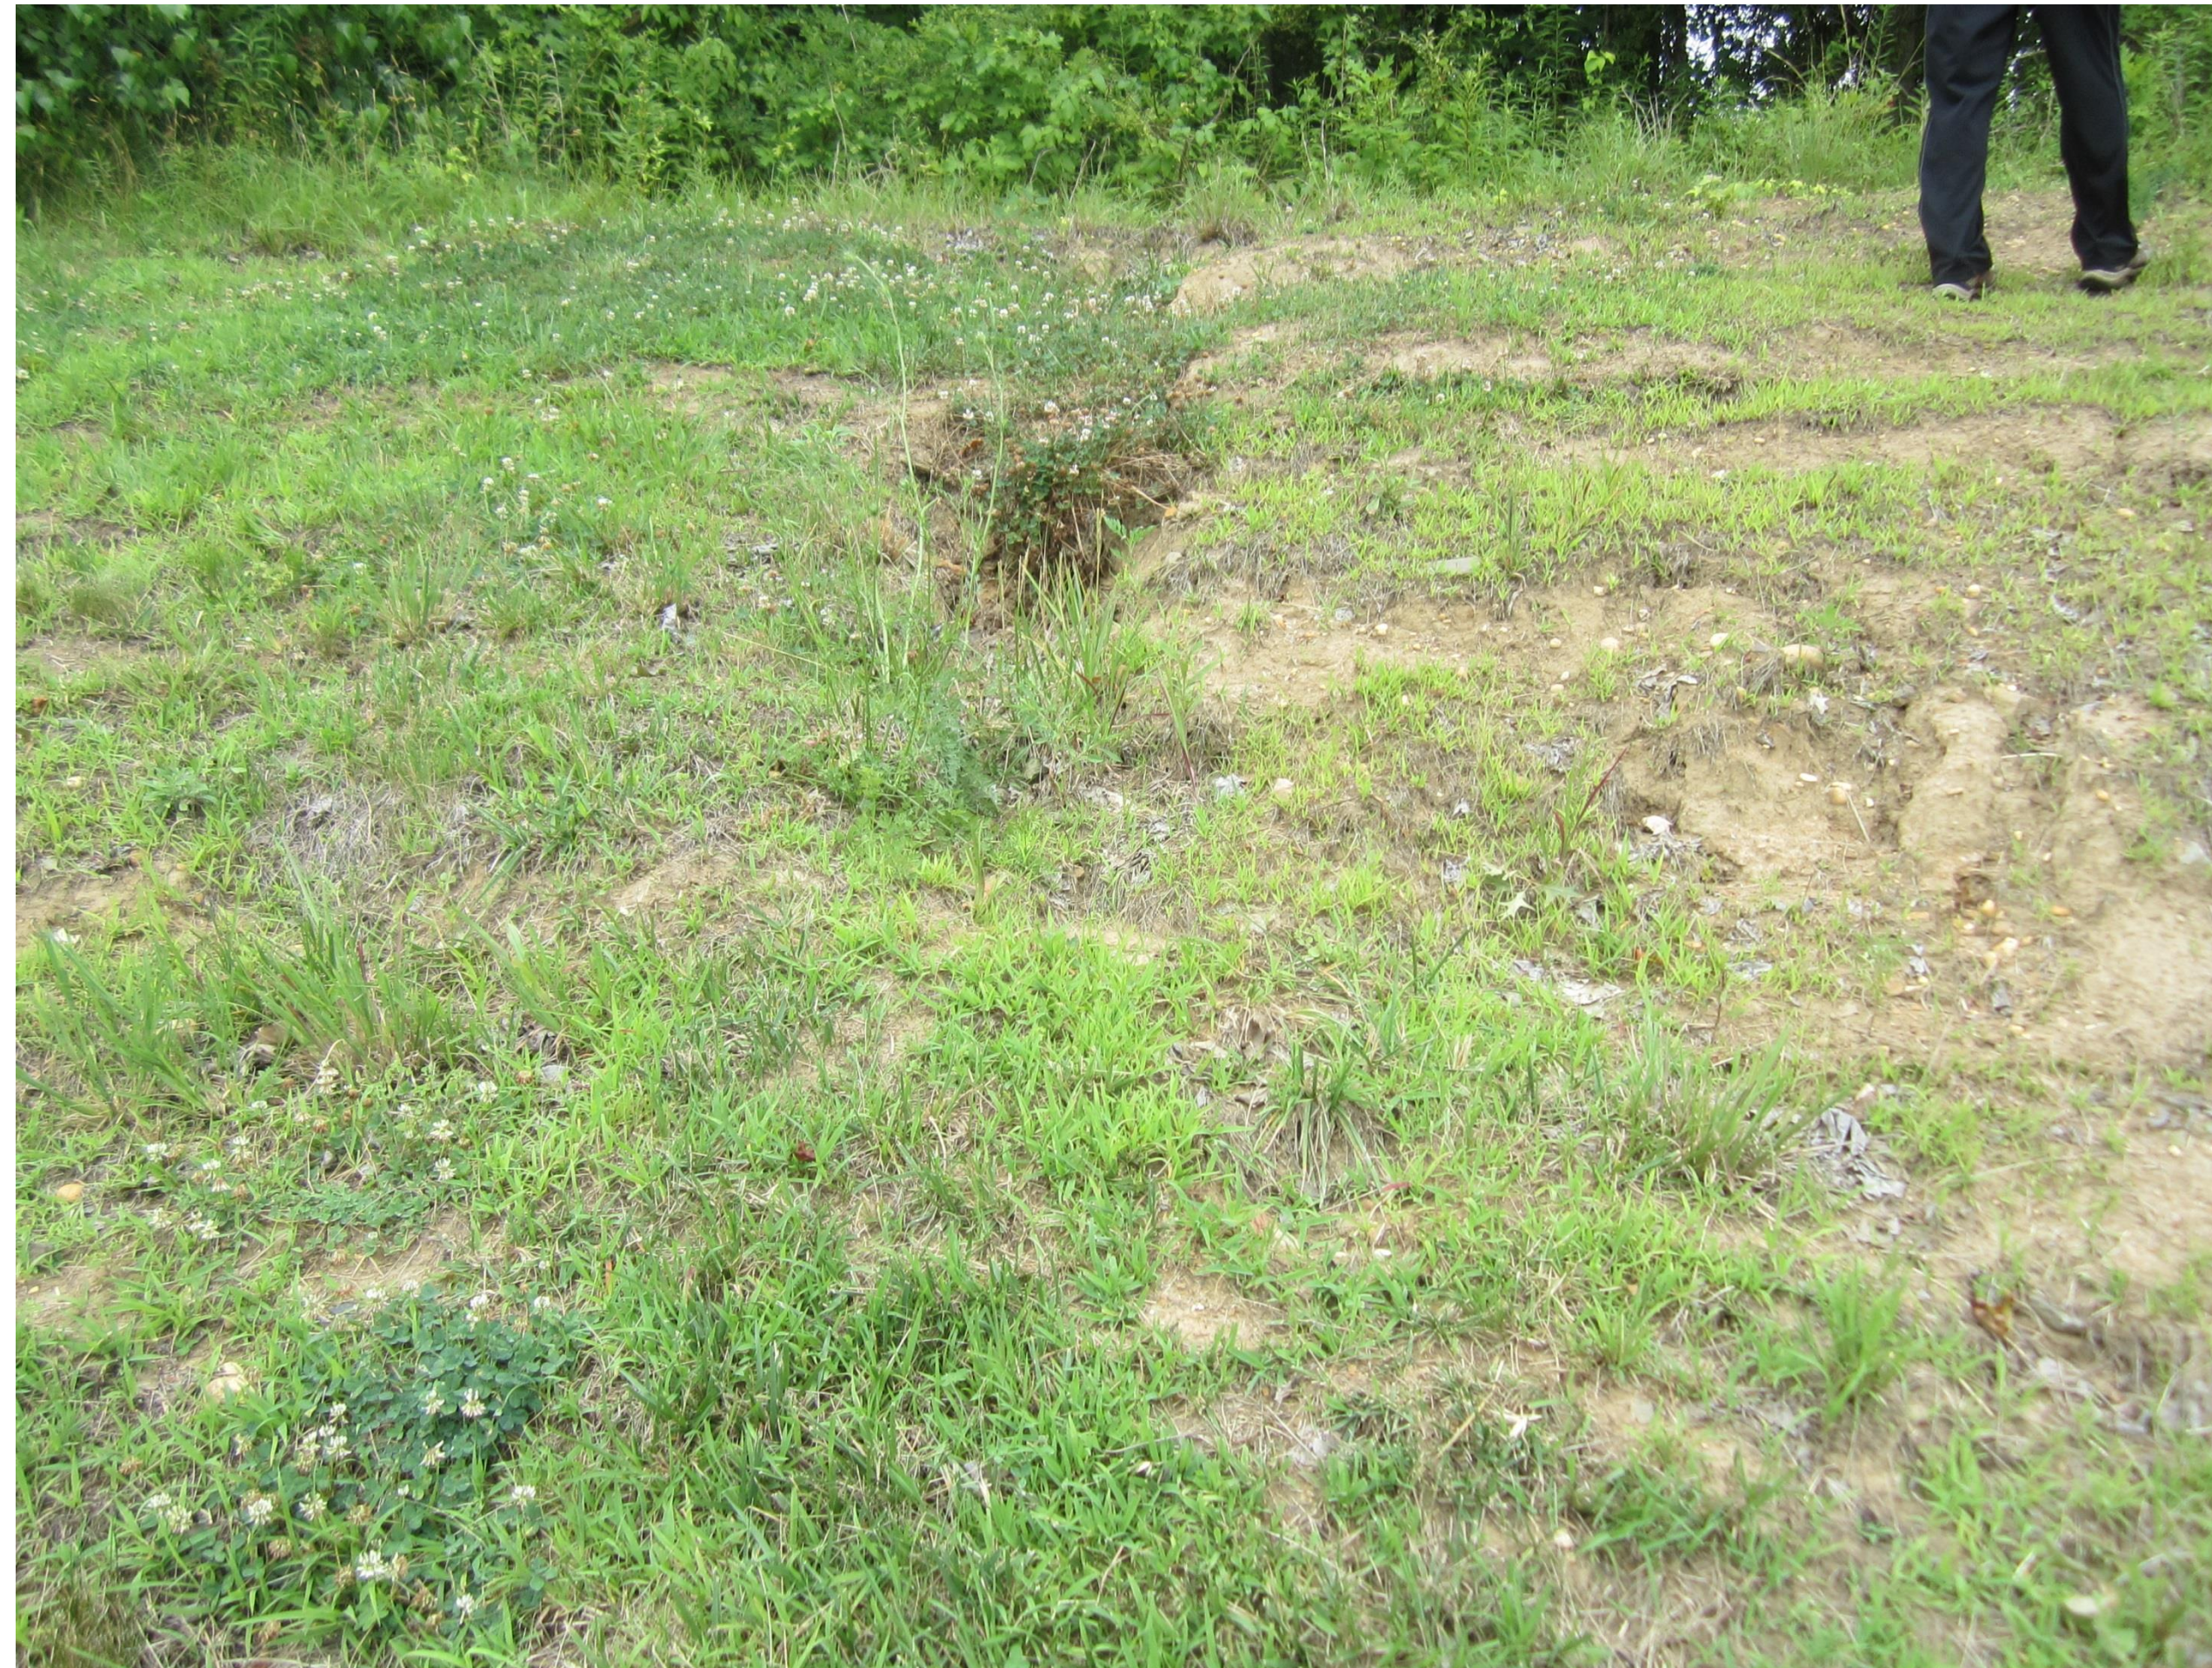
Gullying near west end of swale

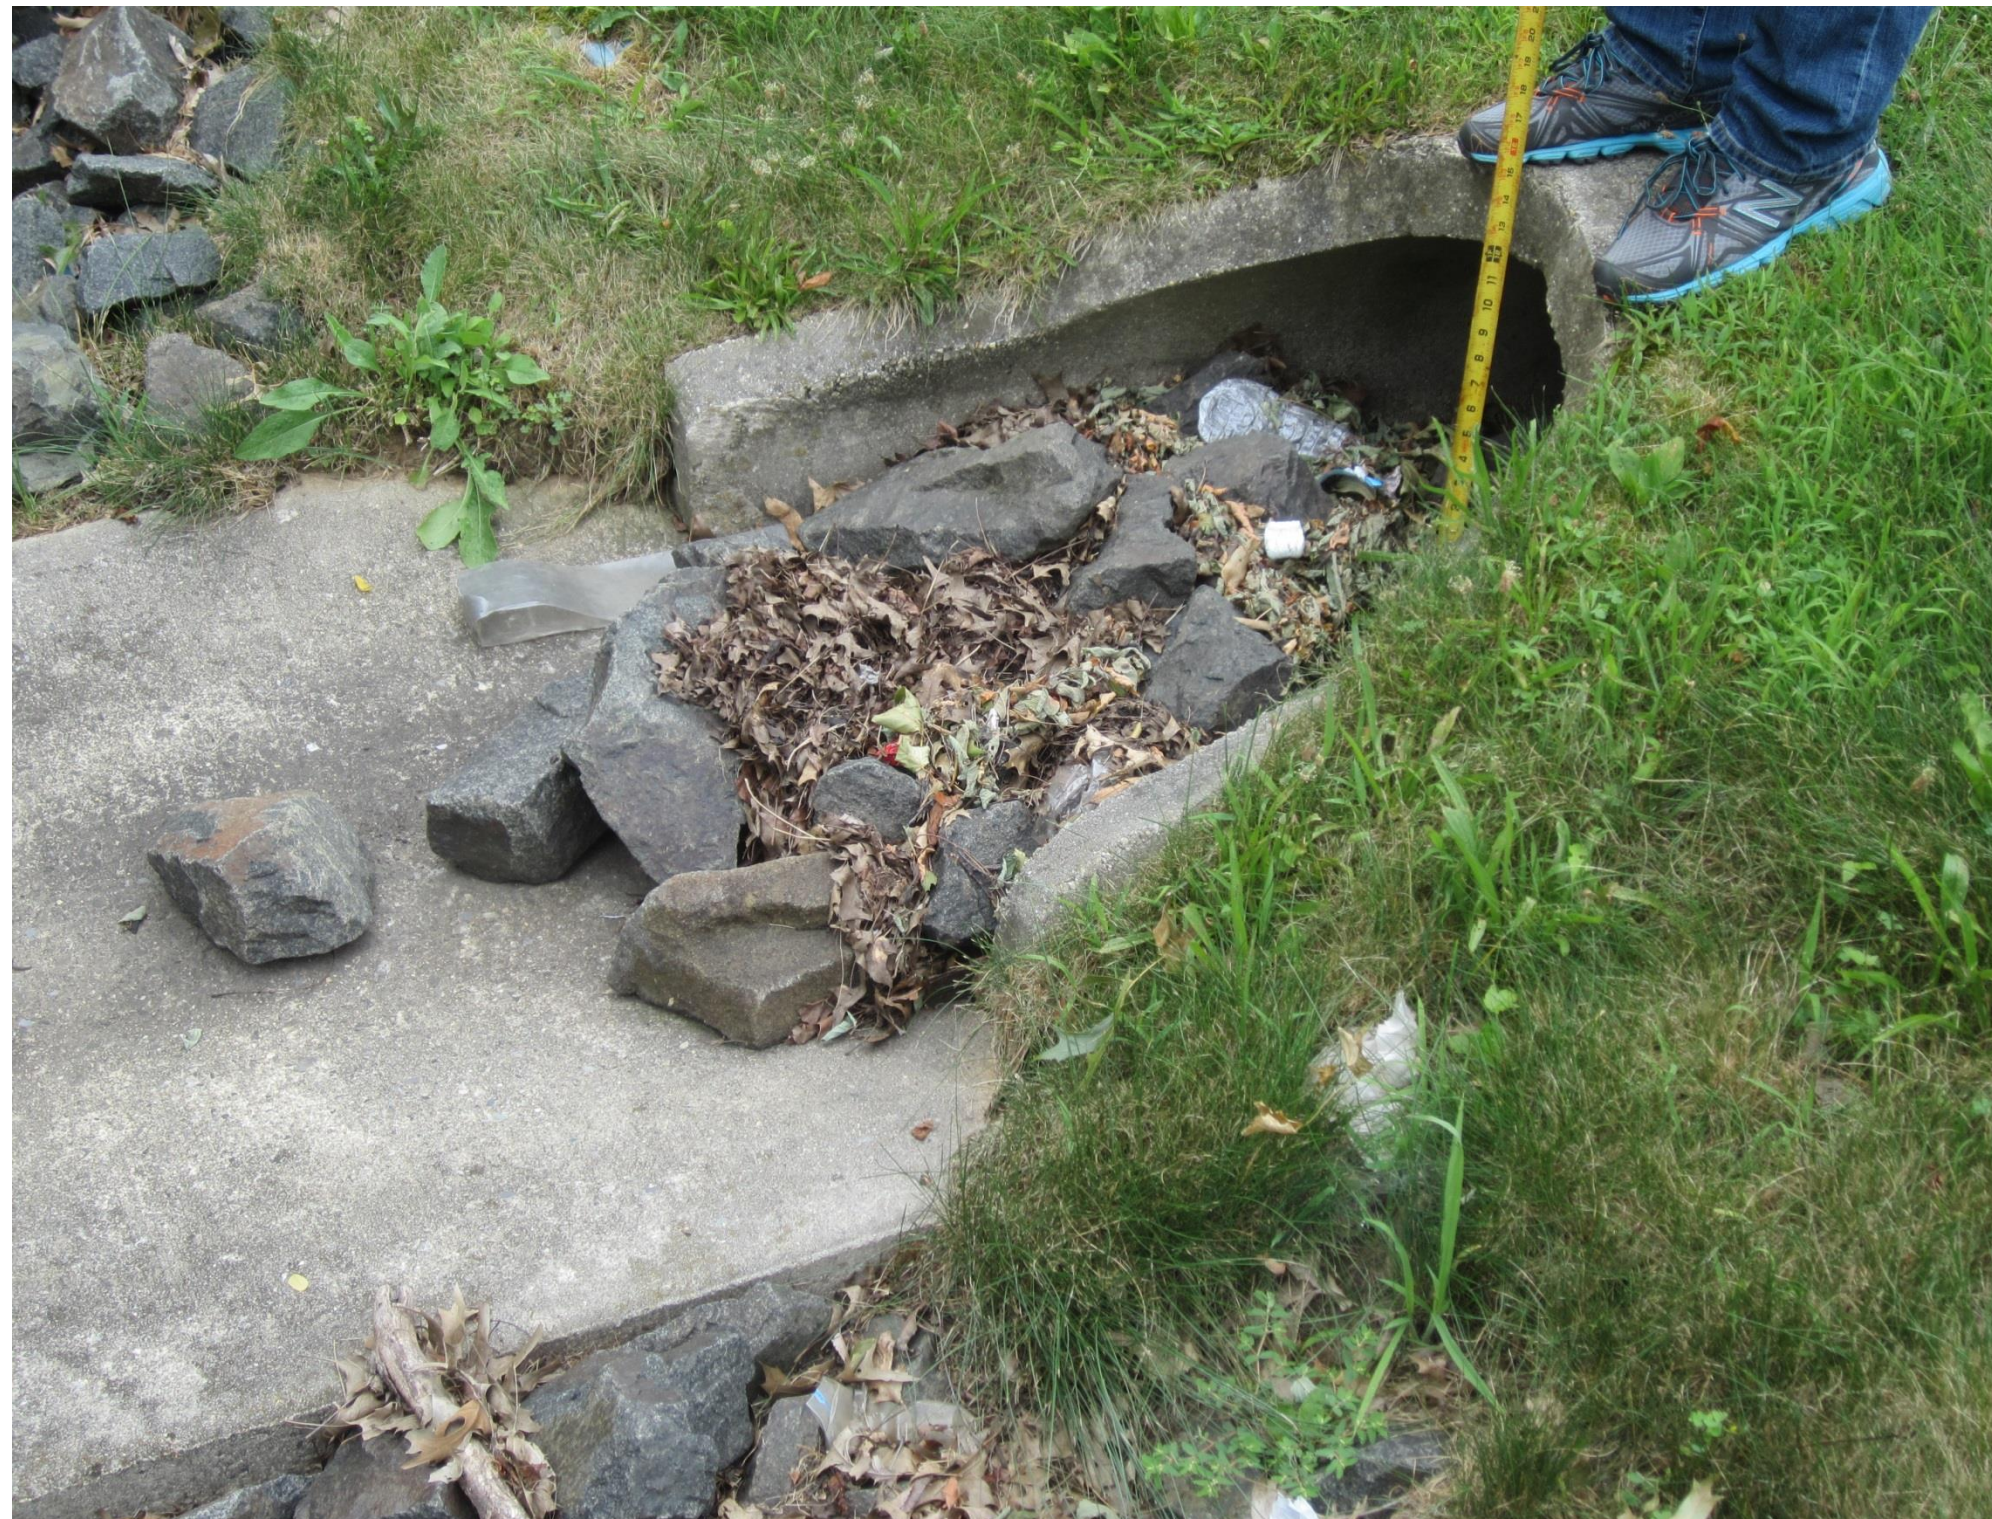
Rip rap, debris, and leaves are restricting the flow of water in inlet

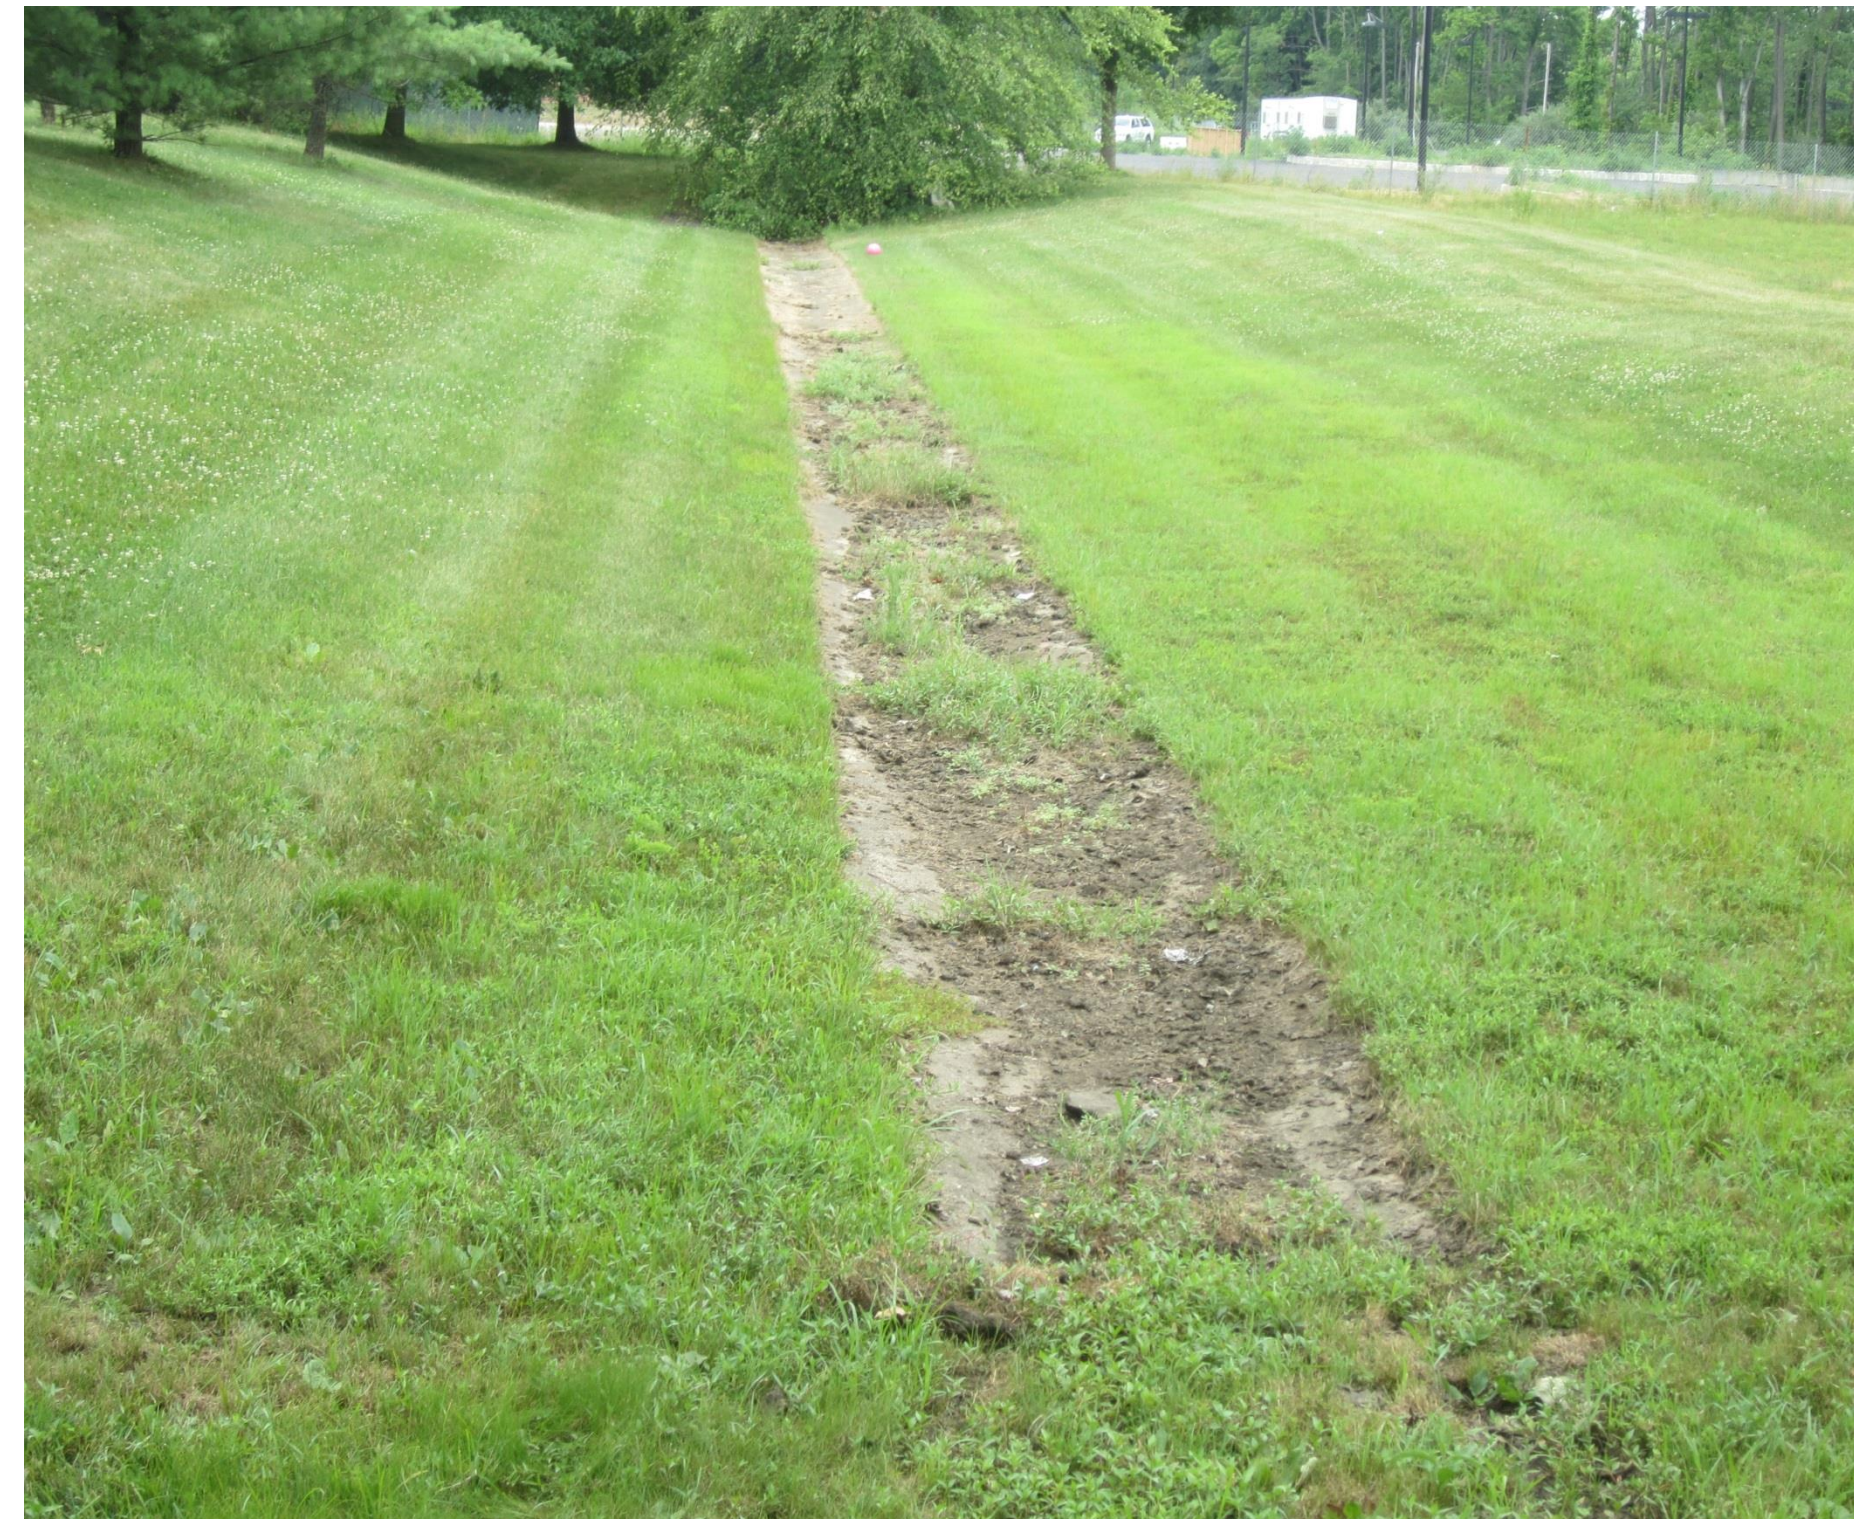
Sediment in low flow channel

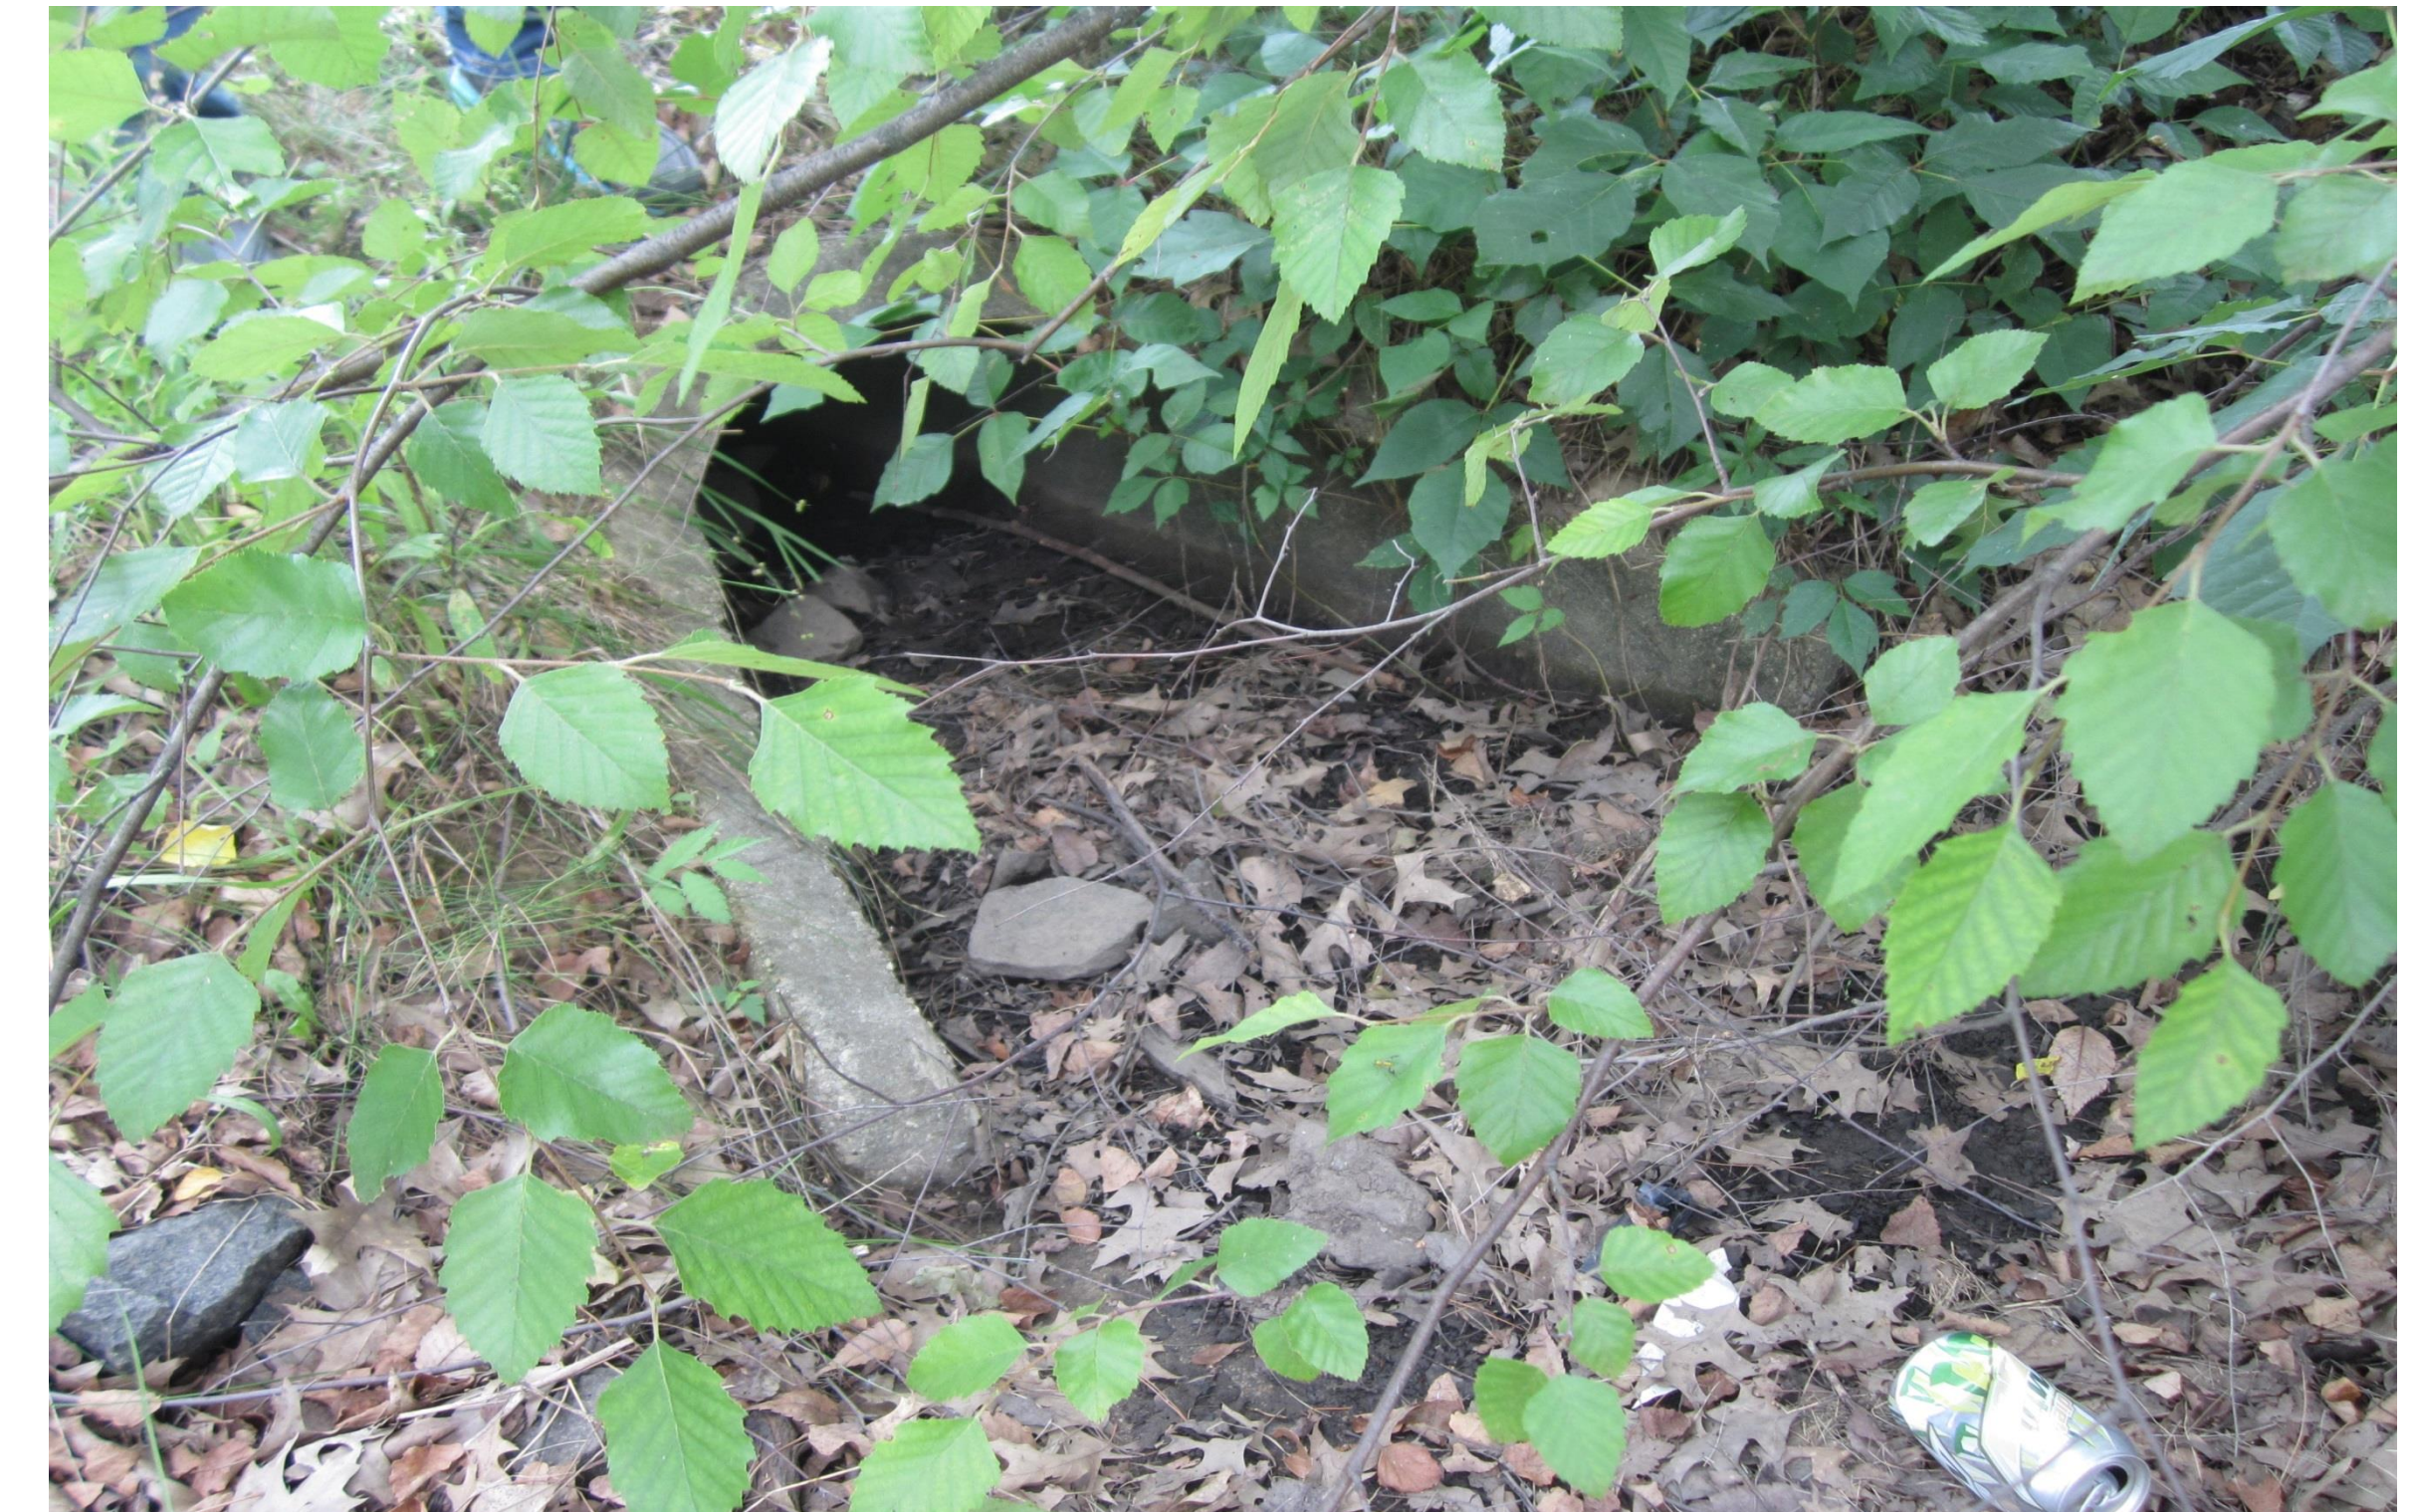
Debris, litter, and sediment accumulation near inlet
