**Hamilton Township (Mercer County)
Stormwater Basin Assessment Summary
Addendum (Year 3)**

Developed by the Rutgers Cooperative Extension Water Resources Program
Funded by Hamilton Township, Mercer County, New Jersey

September 30, 2014

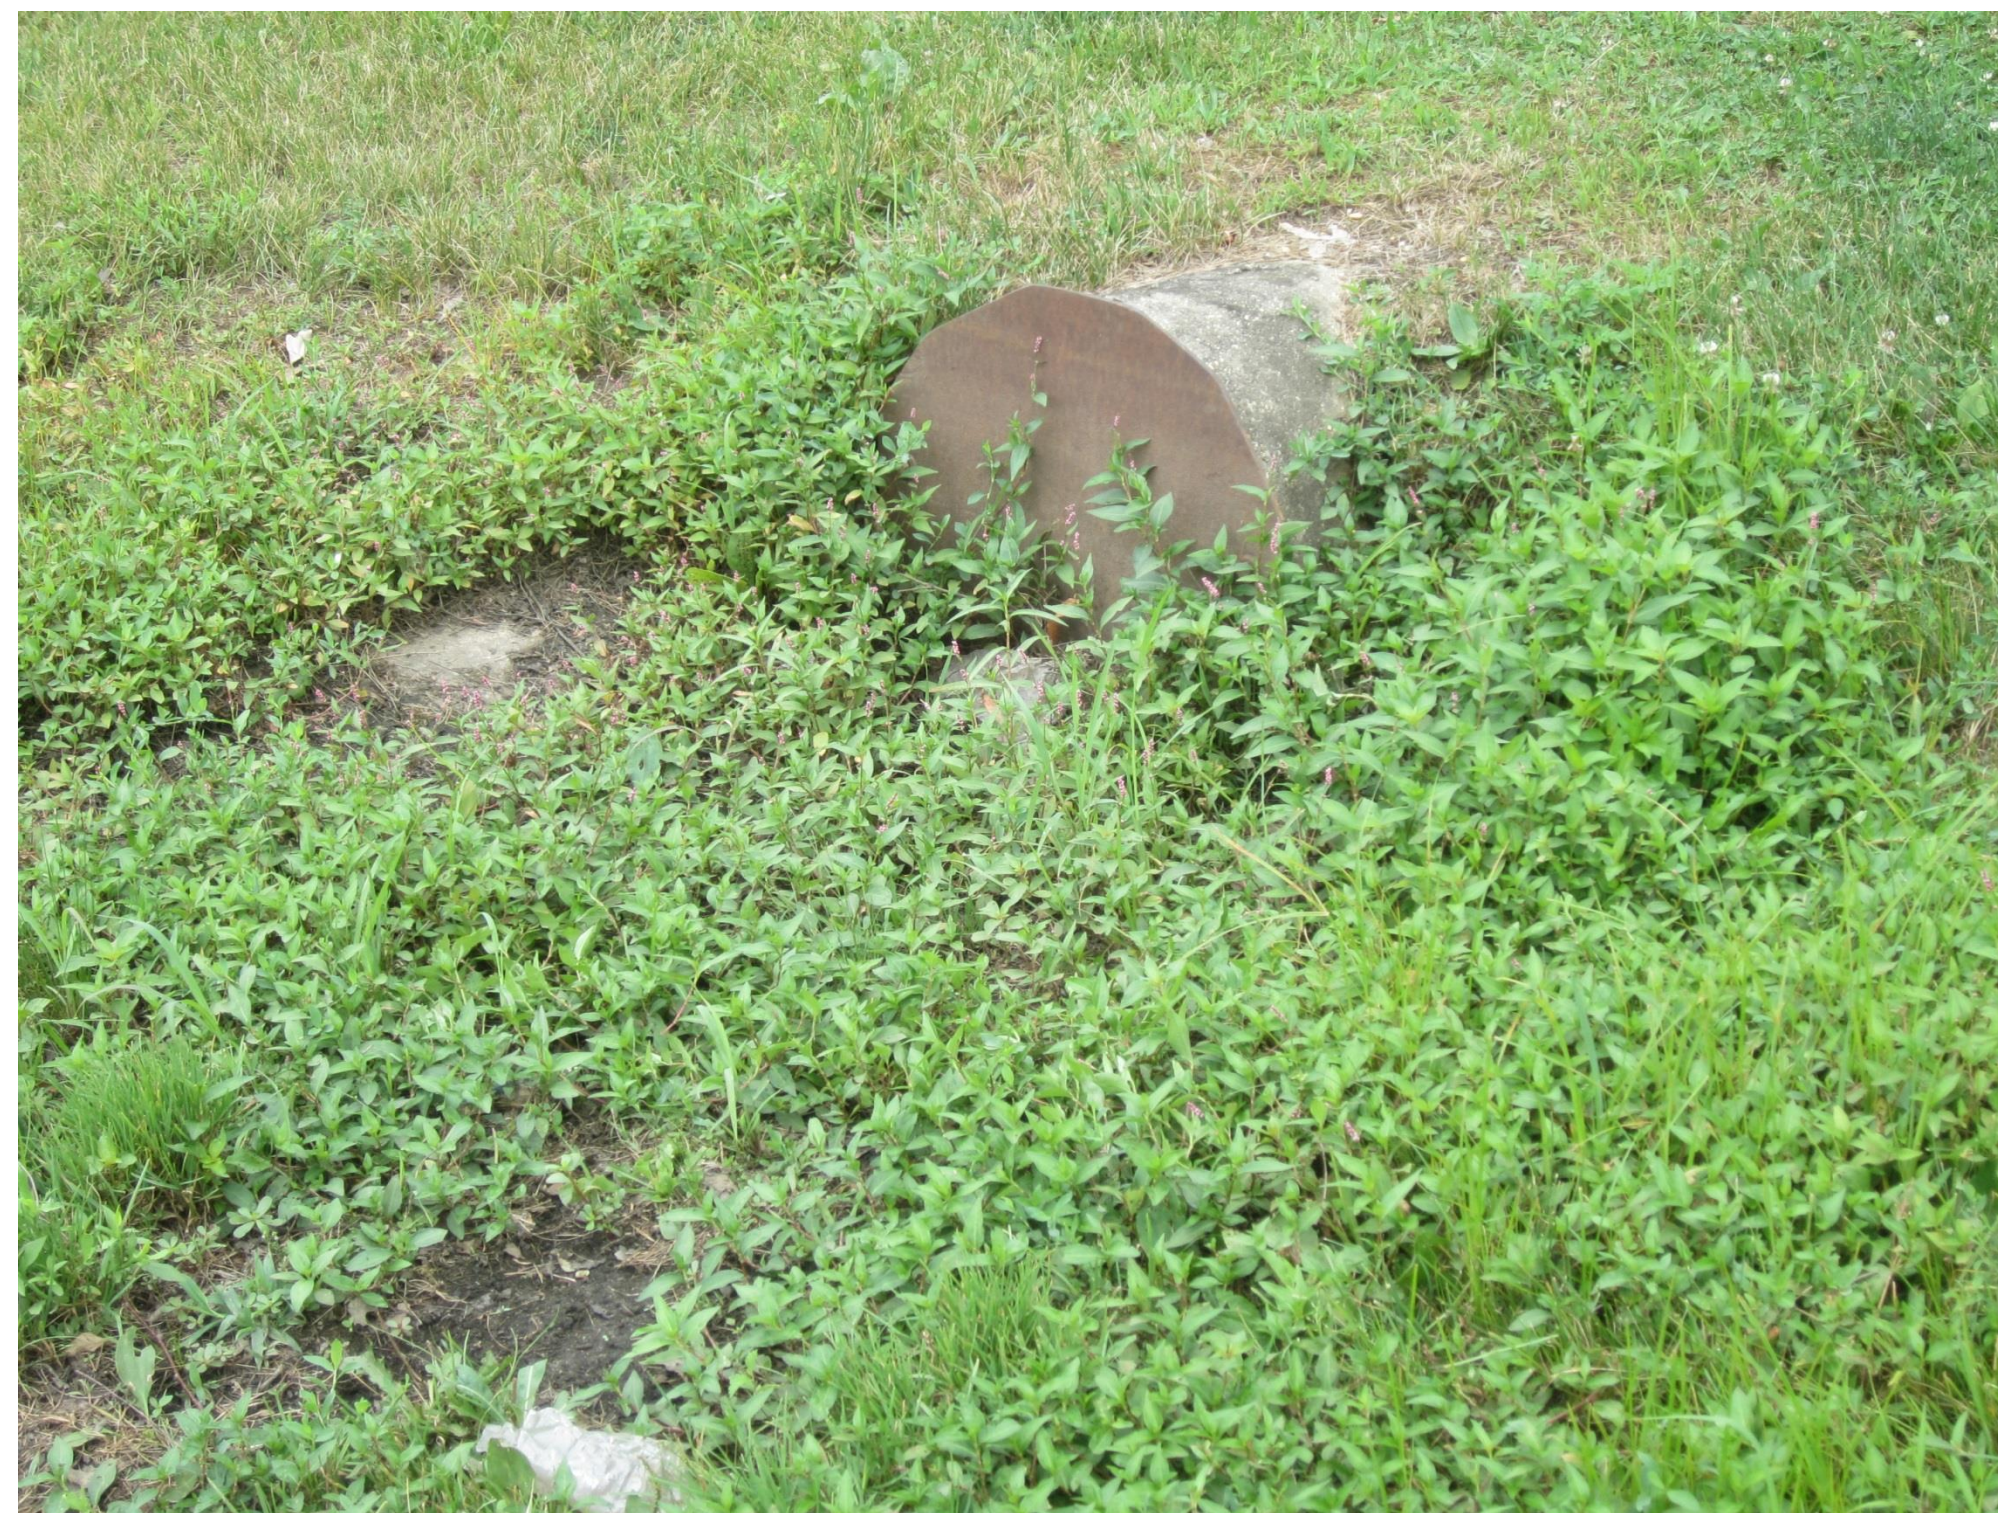
Invasive turf has accumulated in low flow channel

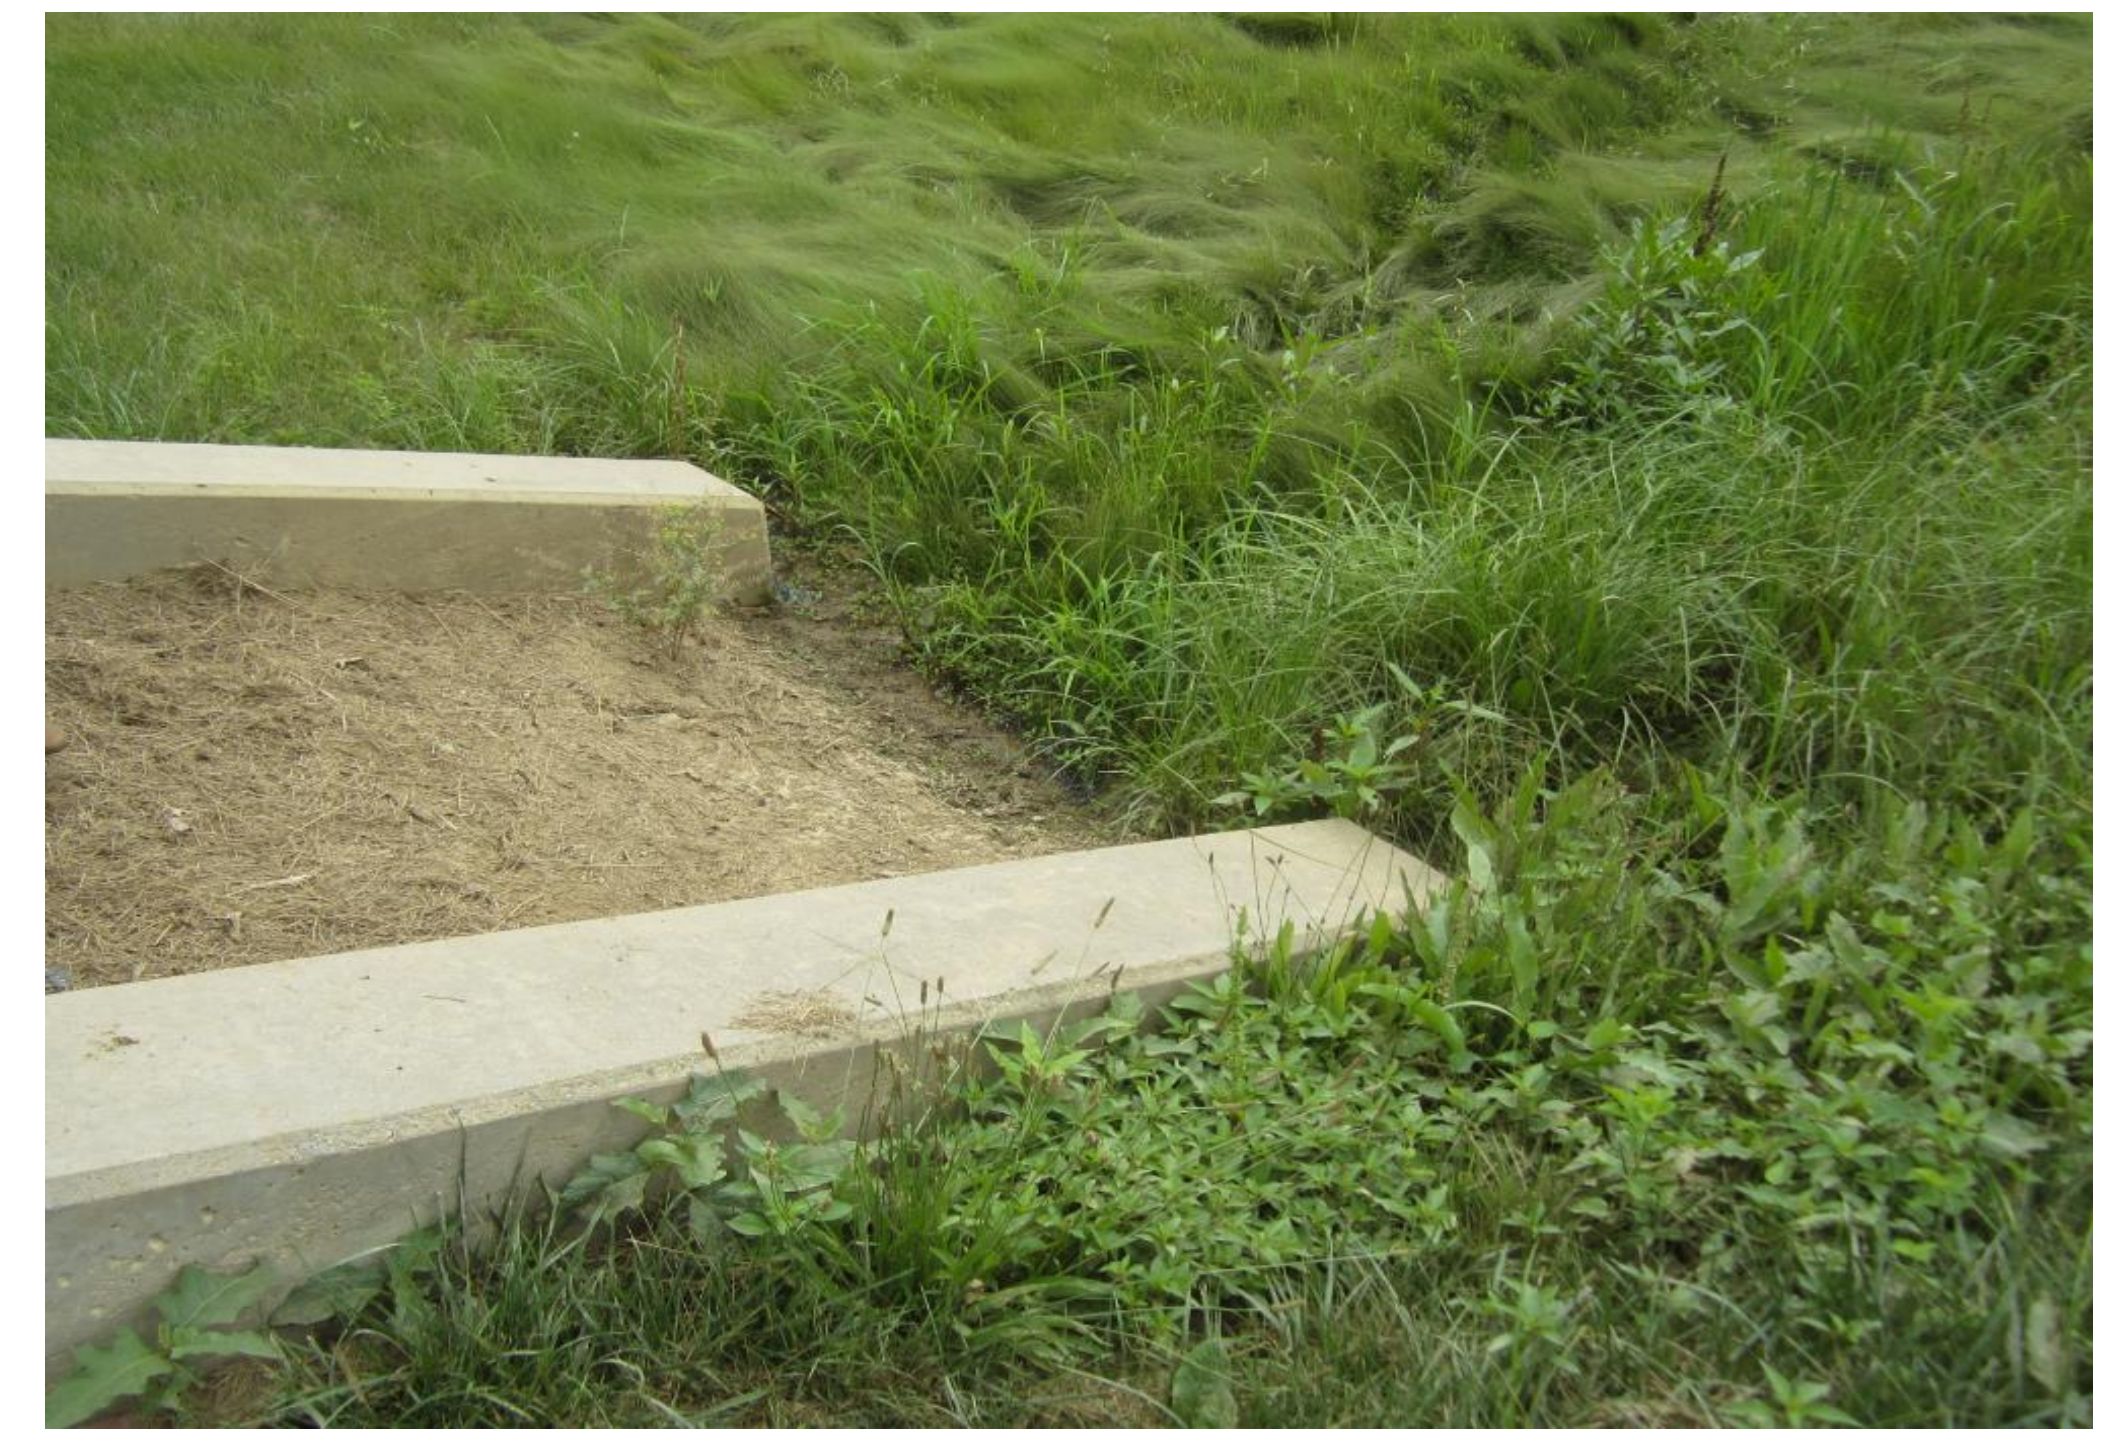
Grass clippings accumulated near outlet structure

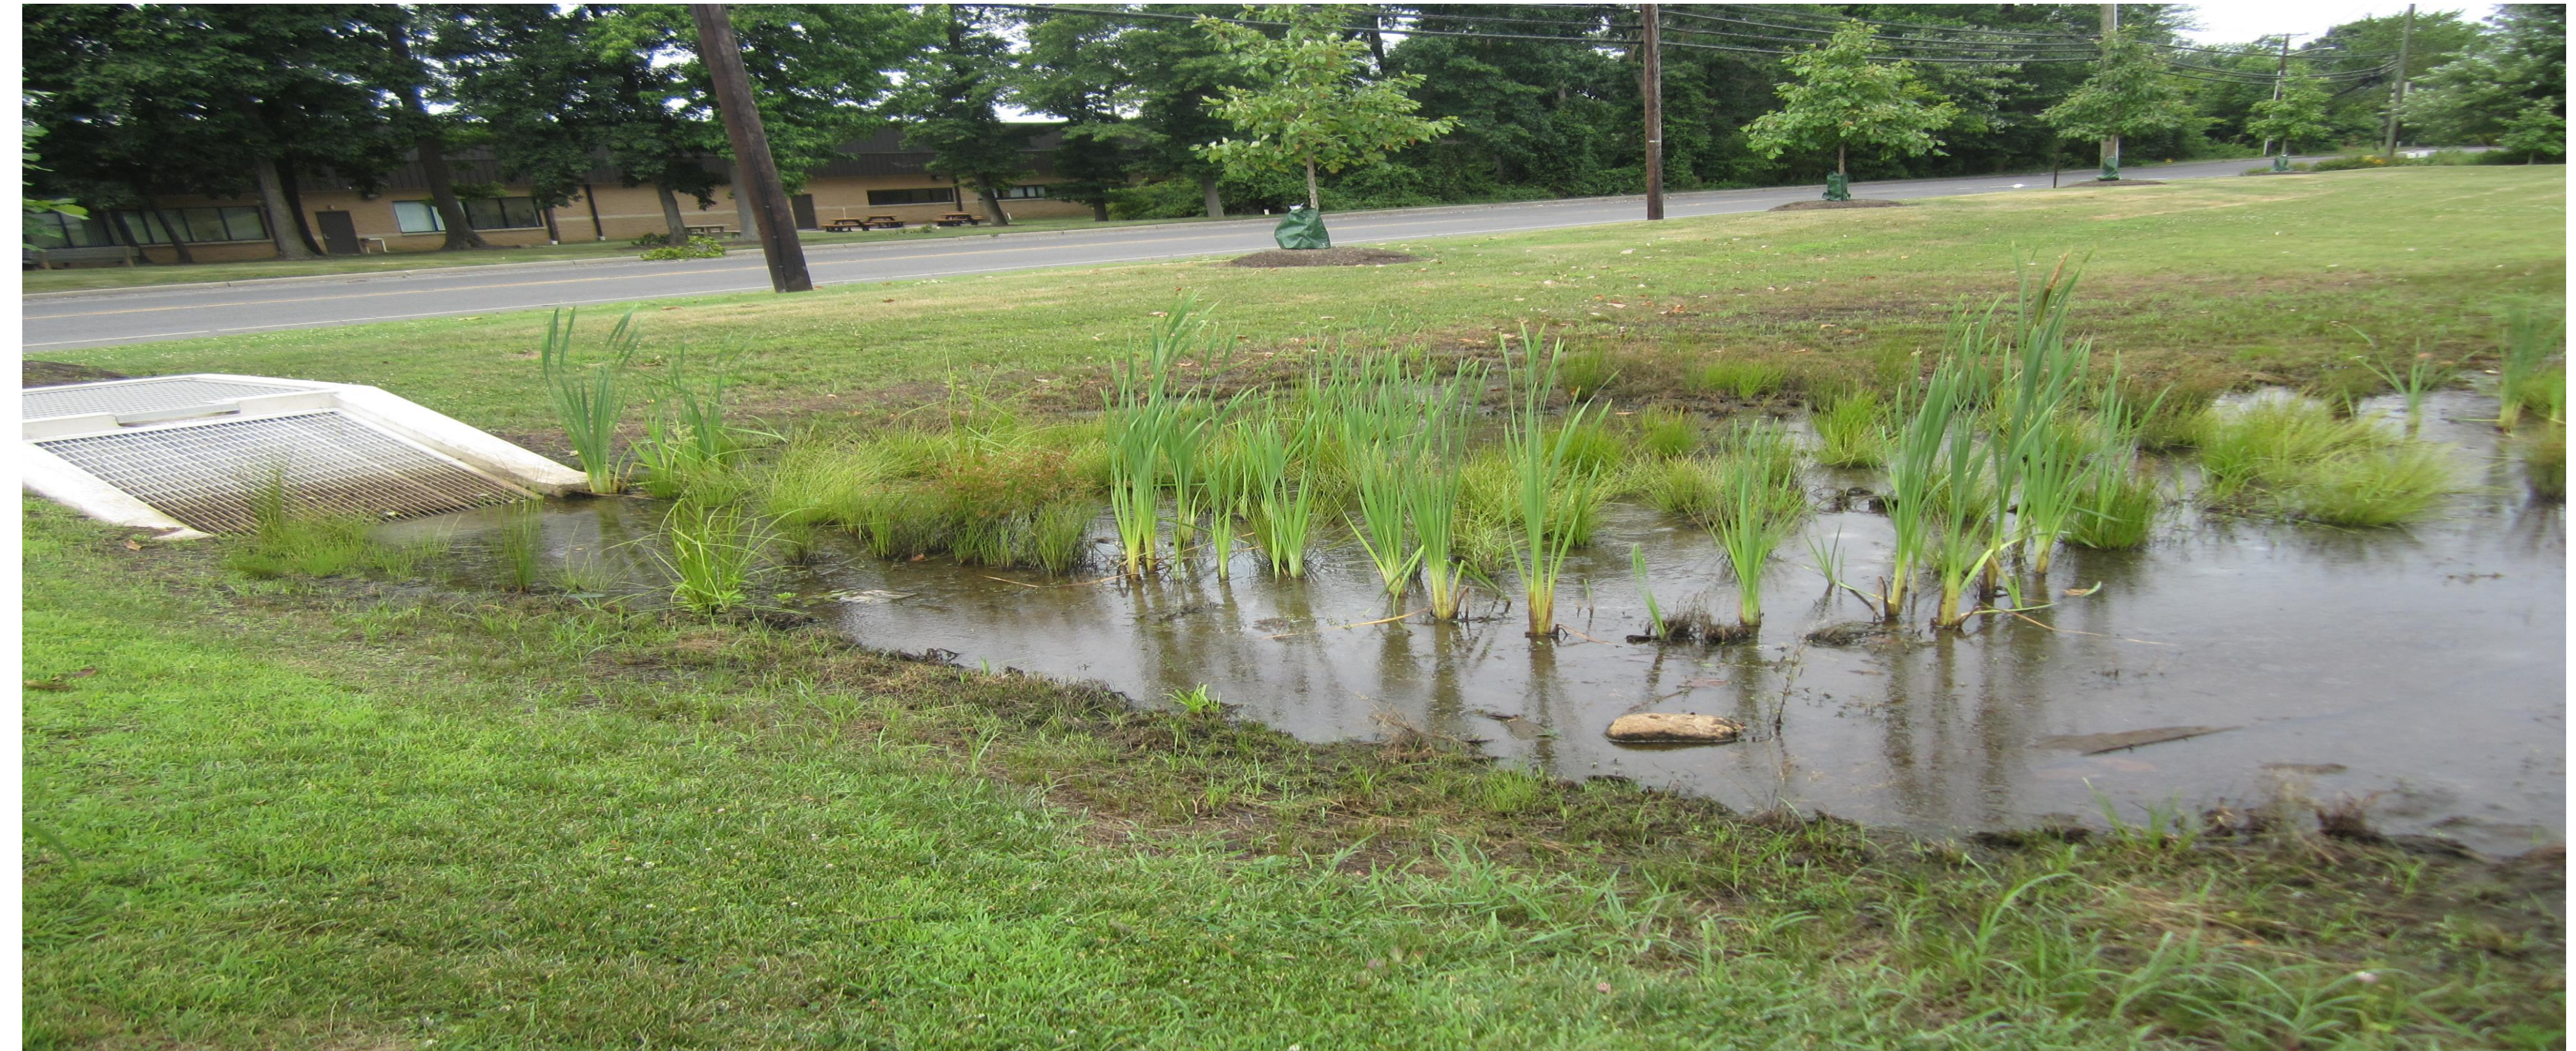
Standing water in basin bottom

- Inlet piping coming from roof runoff
- Deteriorated landscape fabric as low flow channel
- Sediment accumulation and standing water in basin bottom
- Outlet structure was clogged with sediment and debris

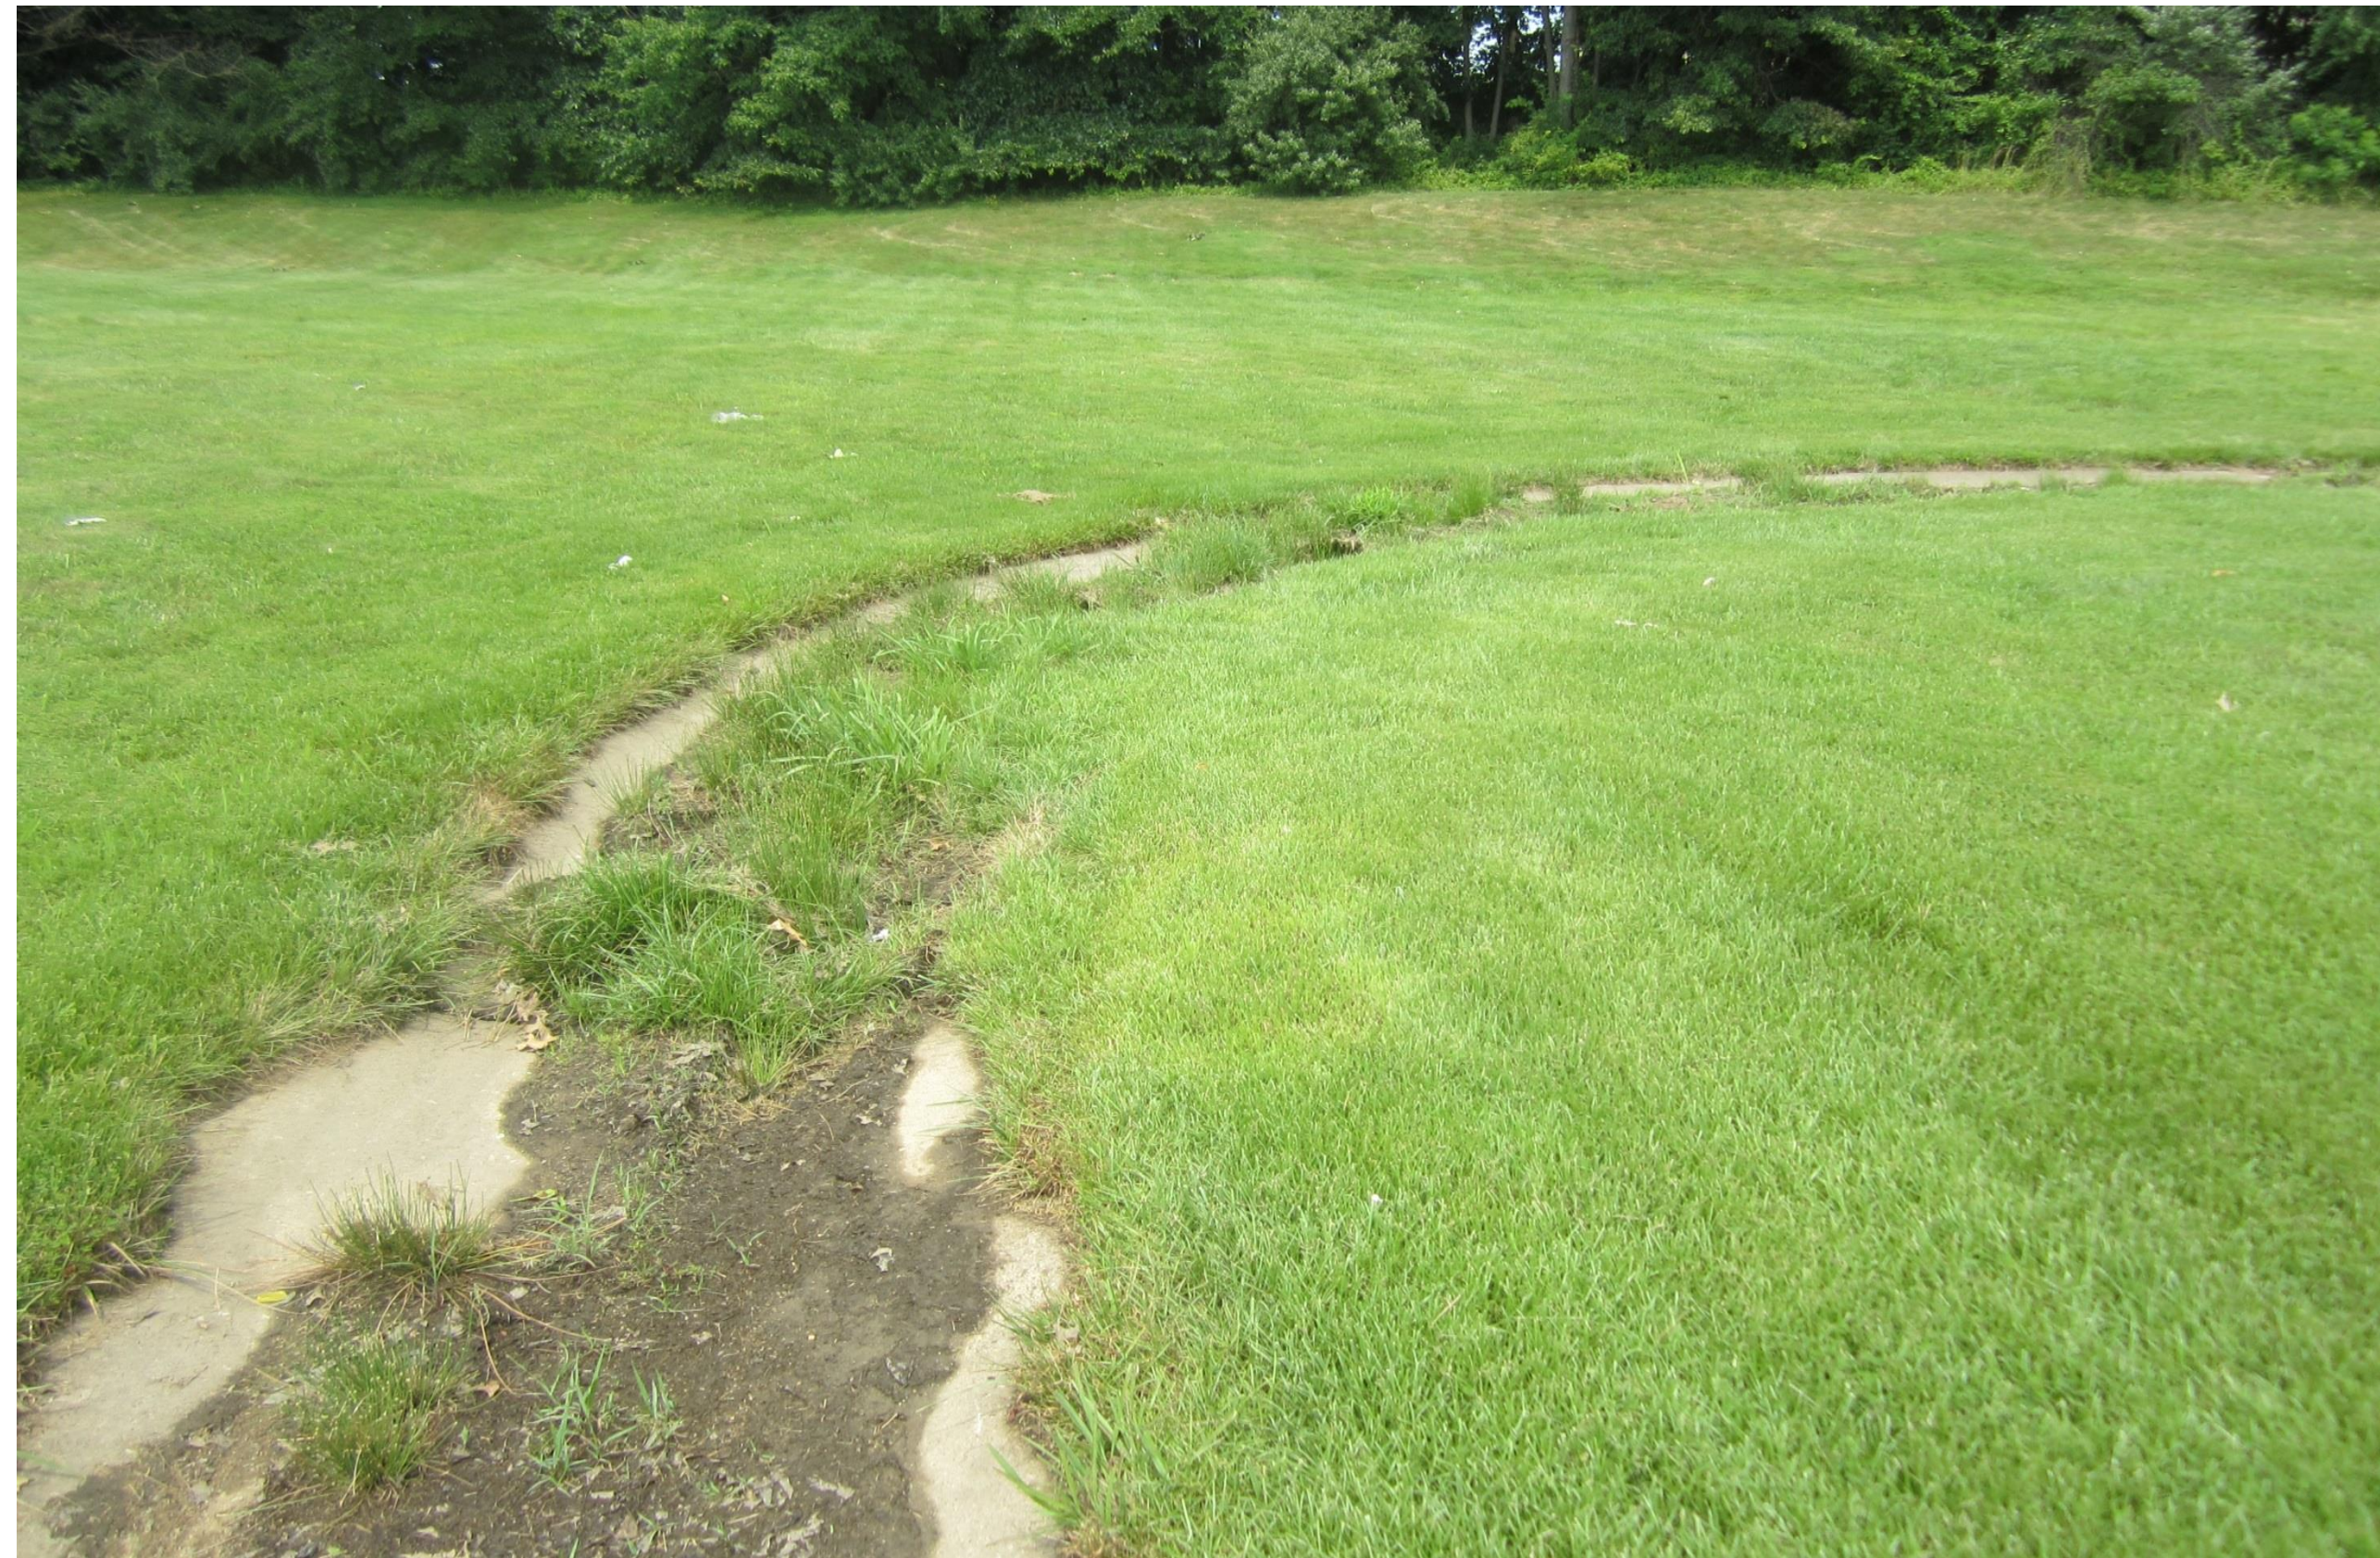
Sediment in low flow channel

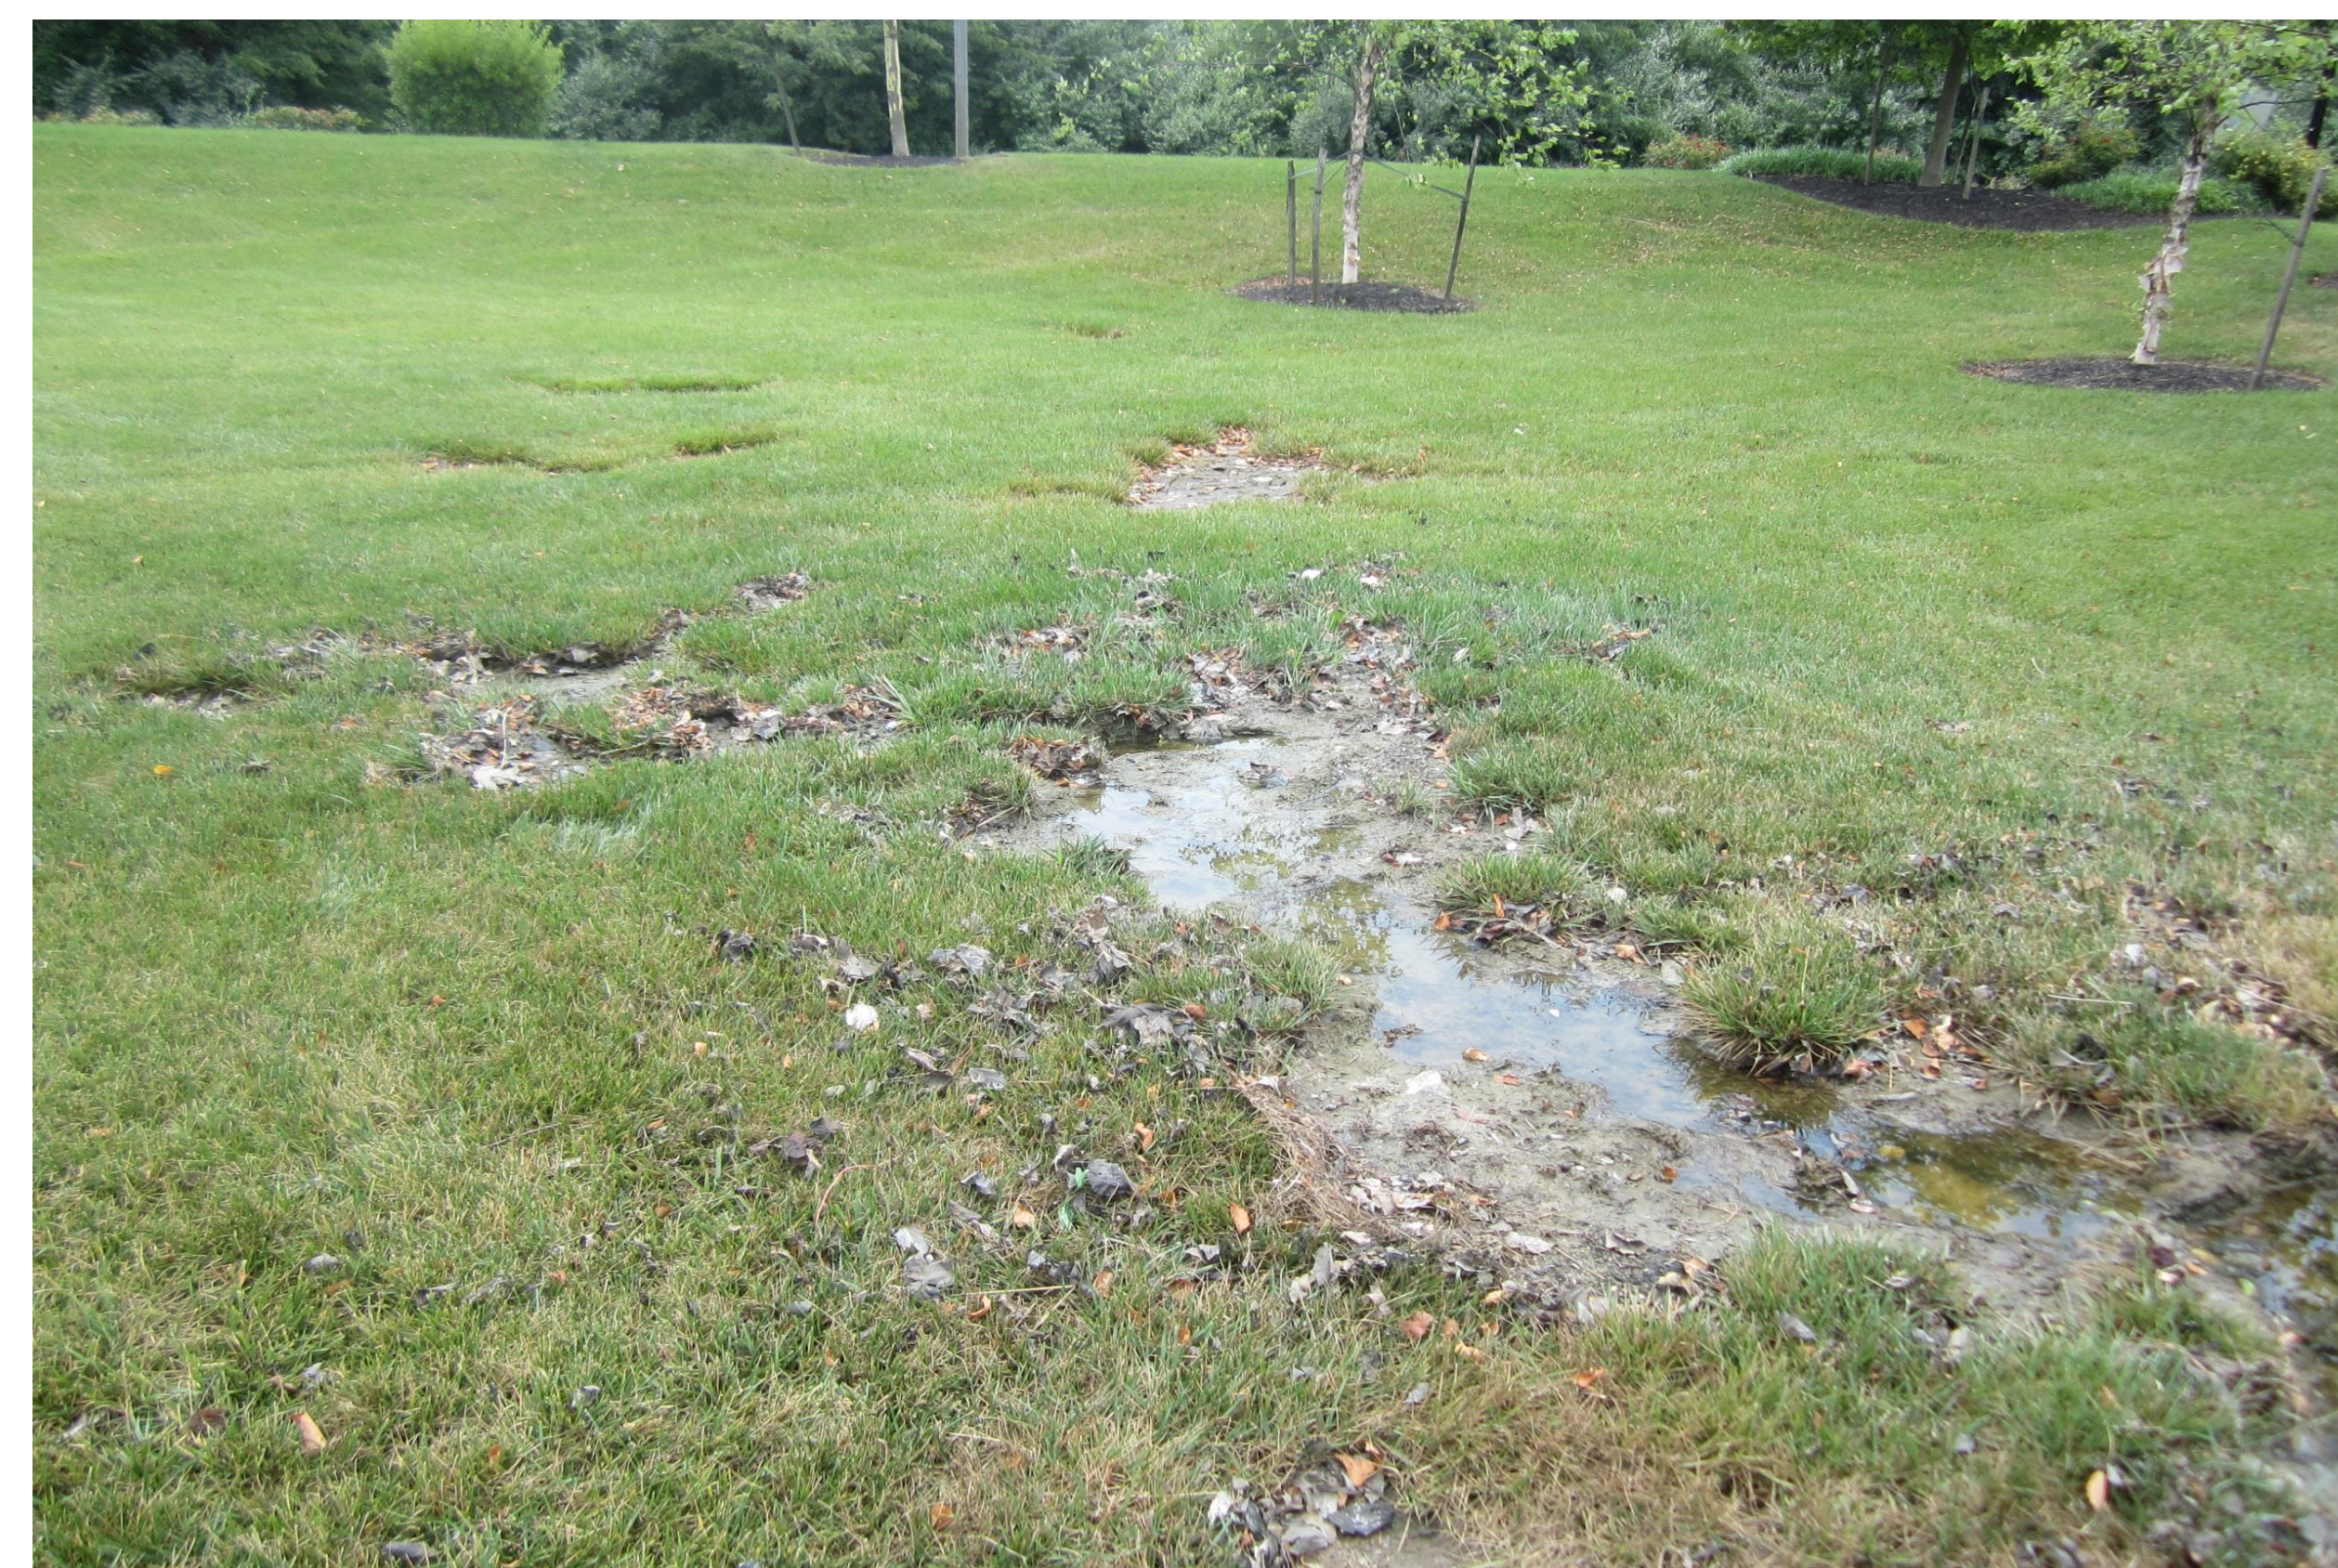
Exposed earth by inlet

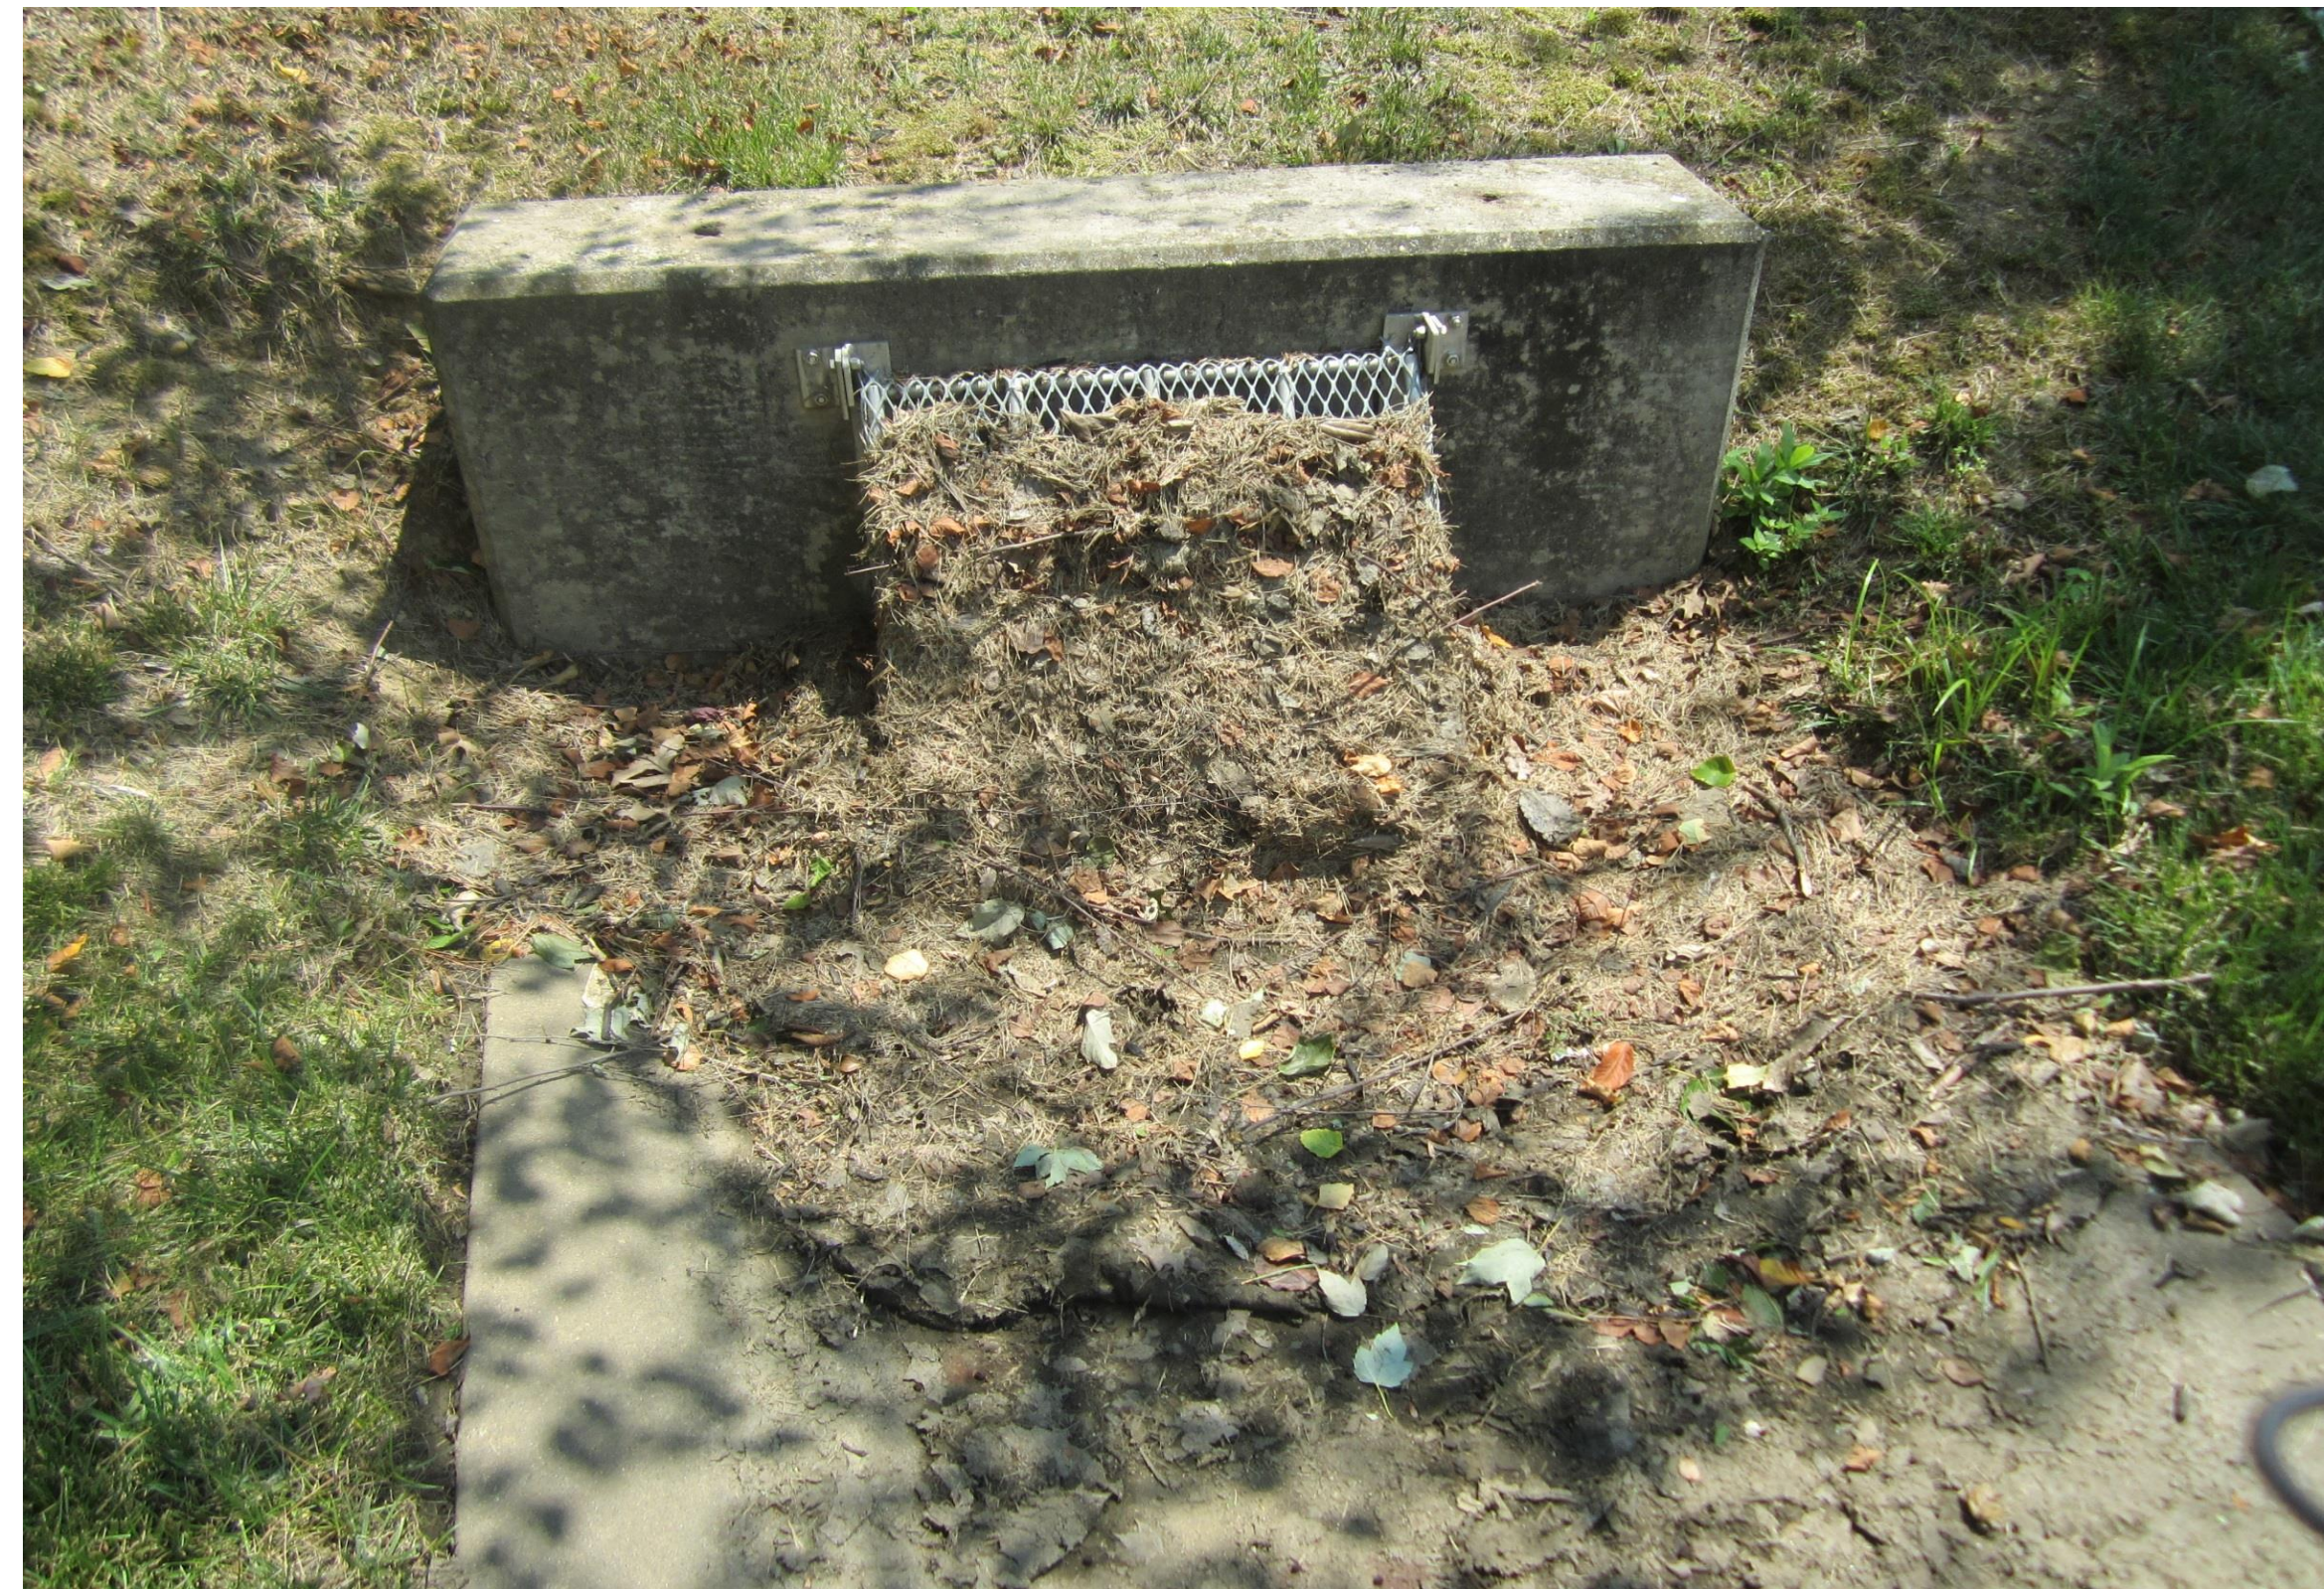
Front view of trash rack

- Exposed earth in basin bottom
- Excess sediment in basin bottom
- Secondary spillway is missing top grate
- Trash rack is clogged with leaves and debris
- Standing water near outlet structure
