**Hamilton Township (Mercer County)
Stormwater Basin Assessment Summary
Addendum (Year 3)**

Developed by the Rutgers Cooperative Extension Water Resources Program
Funded by Hamilton Township, Mercer County, New Jersey

September 30, 2014

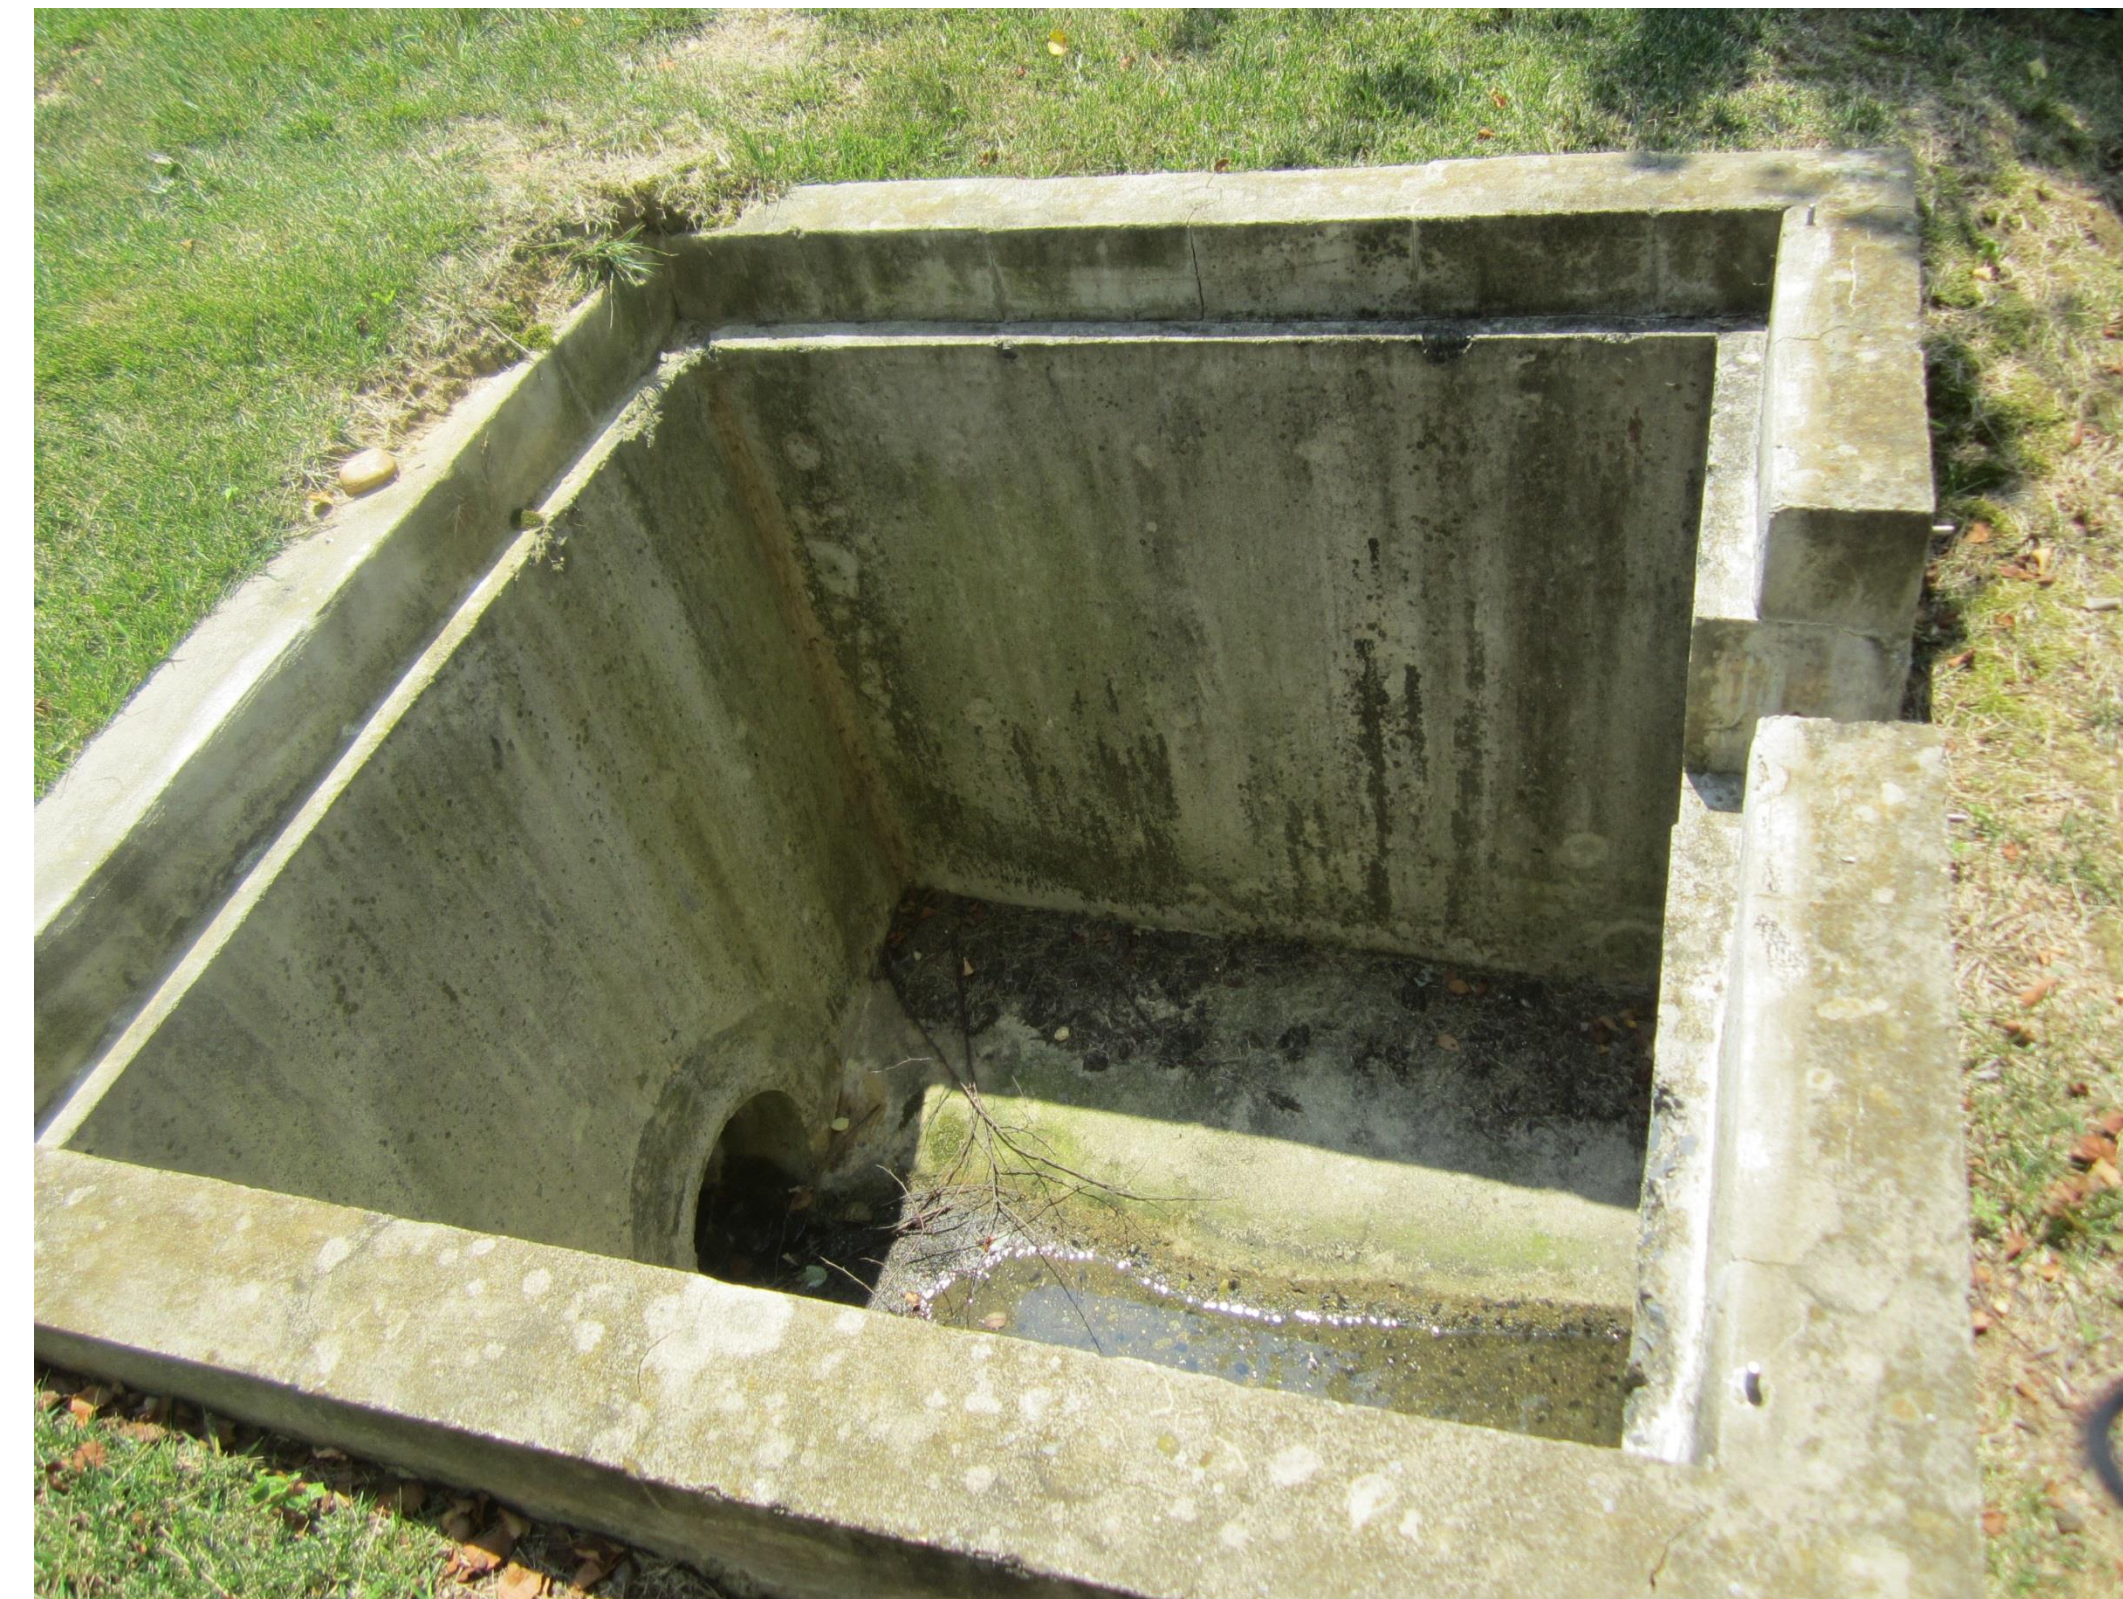
Top view of outlet structure

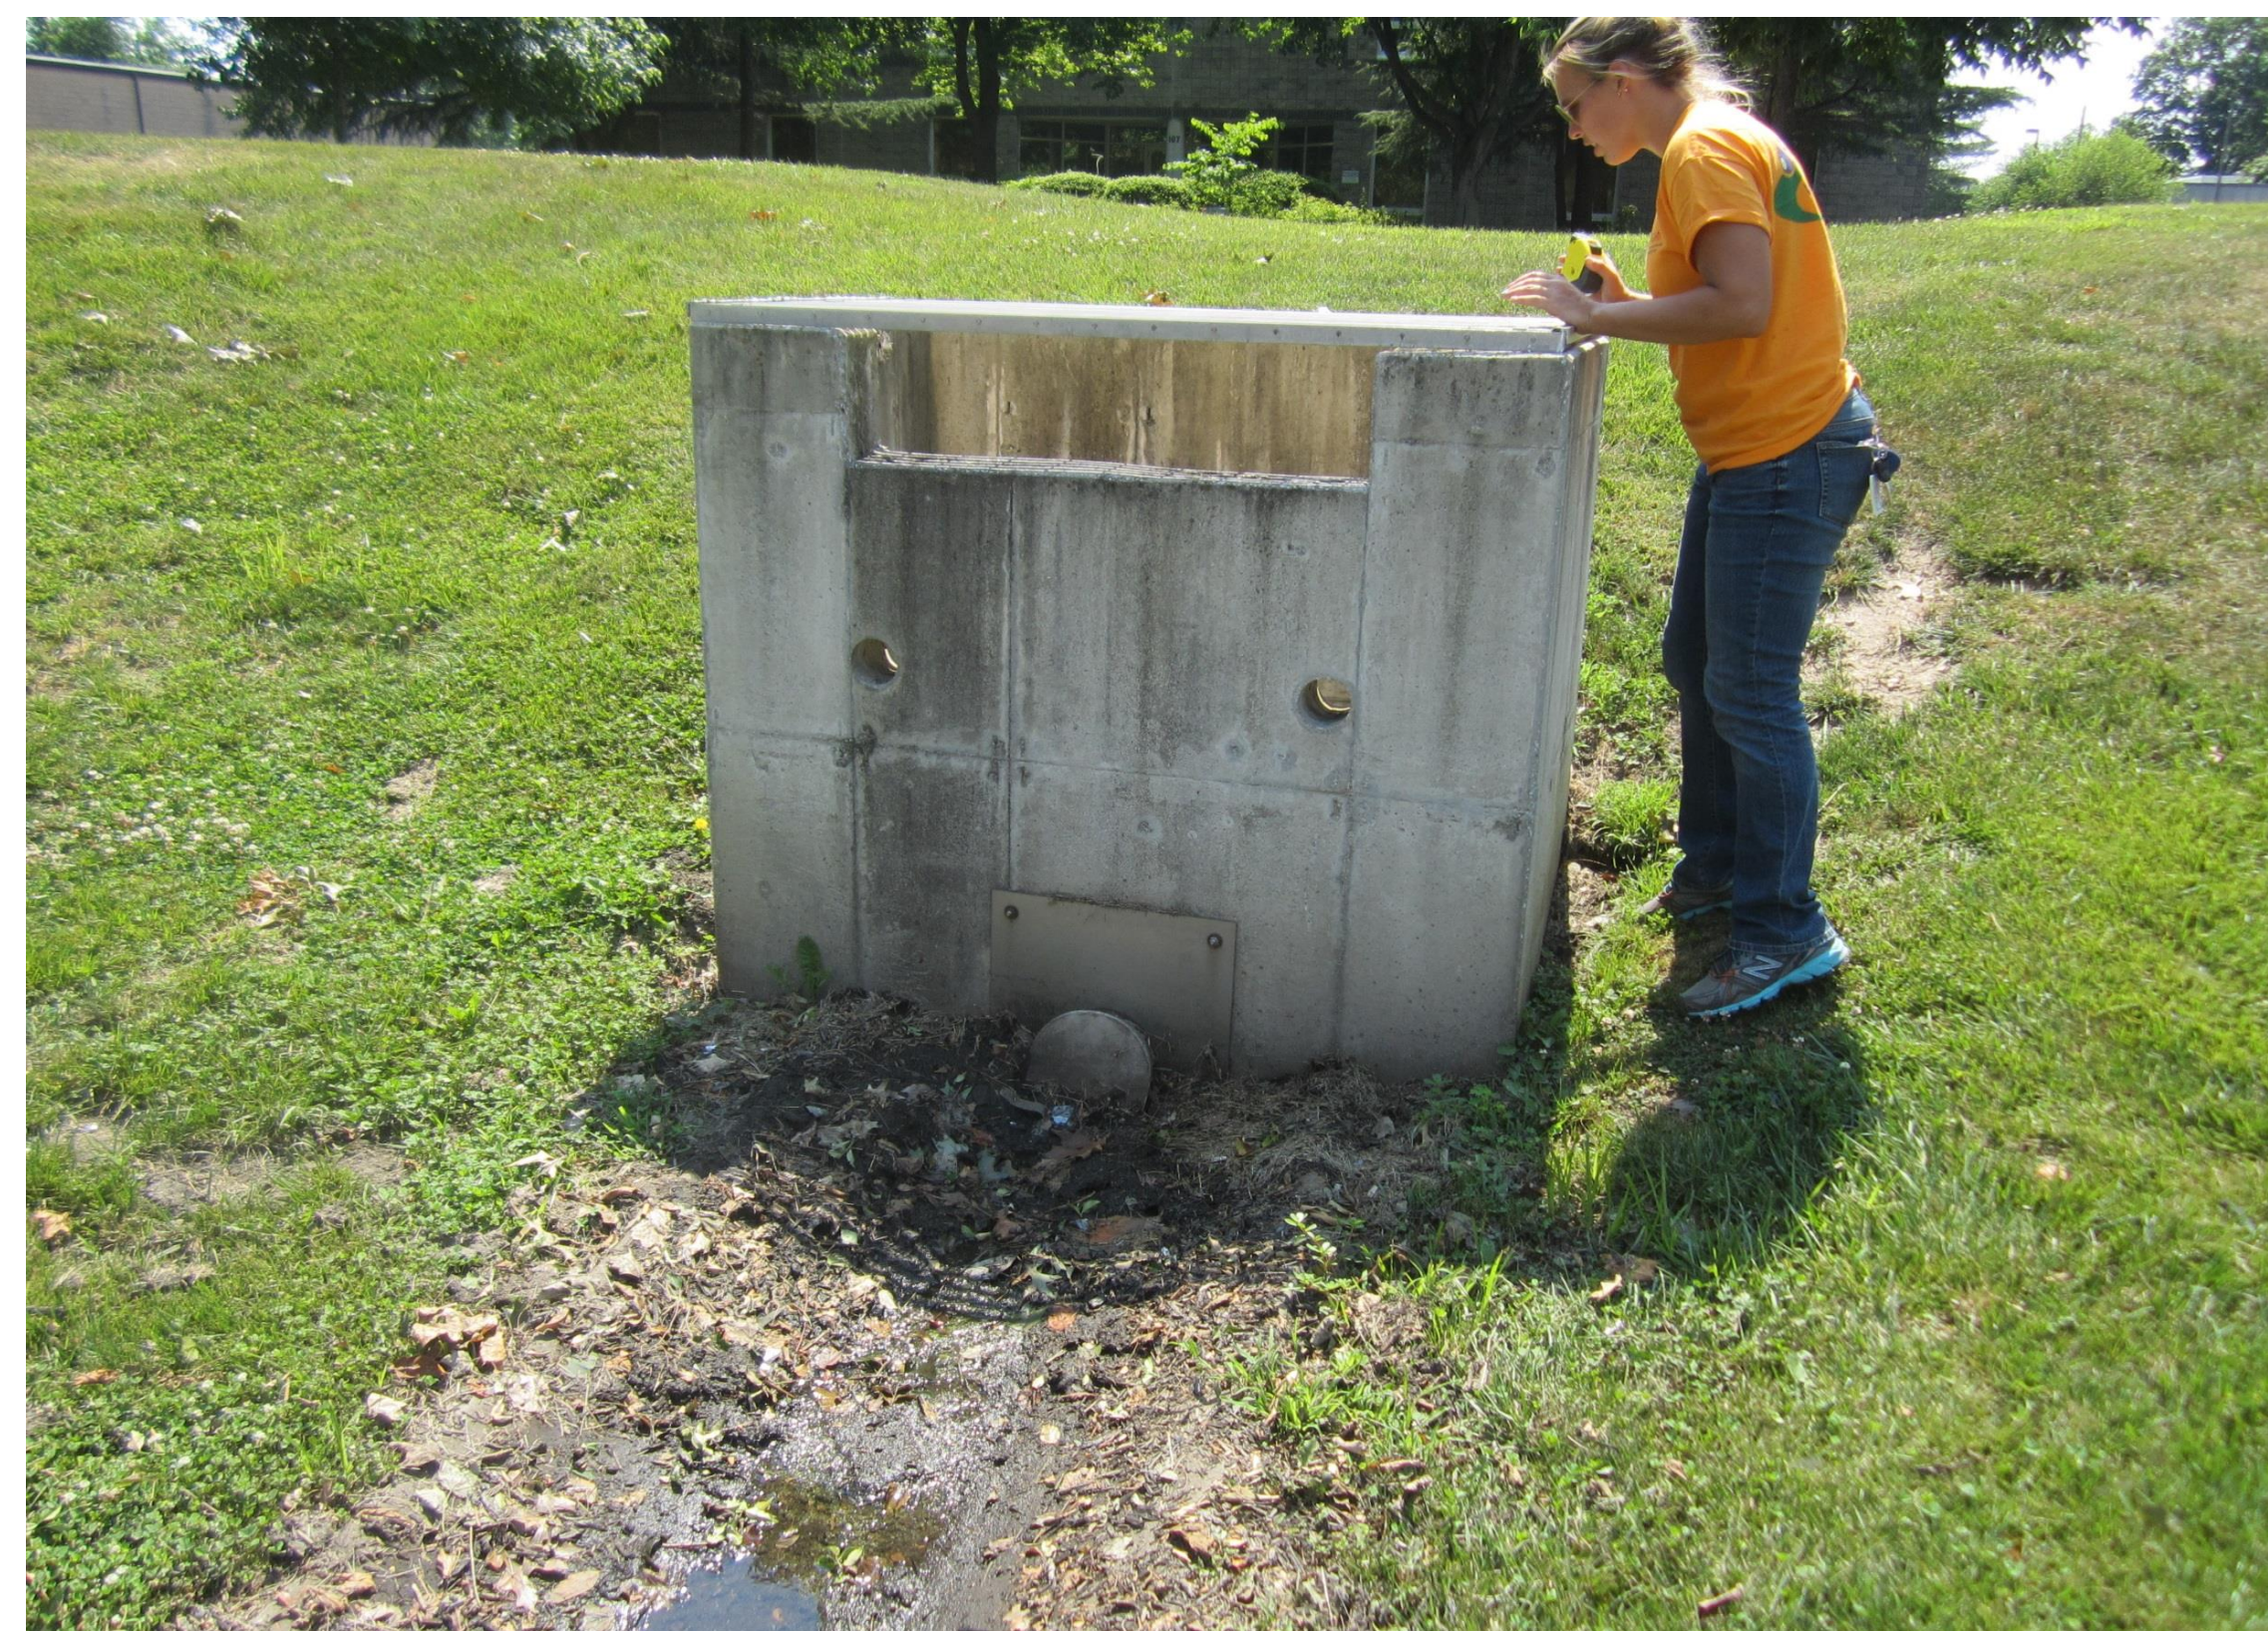
Front view of outlet structure

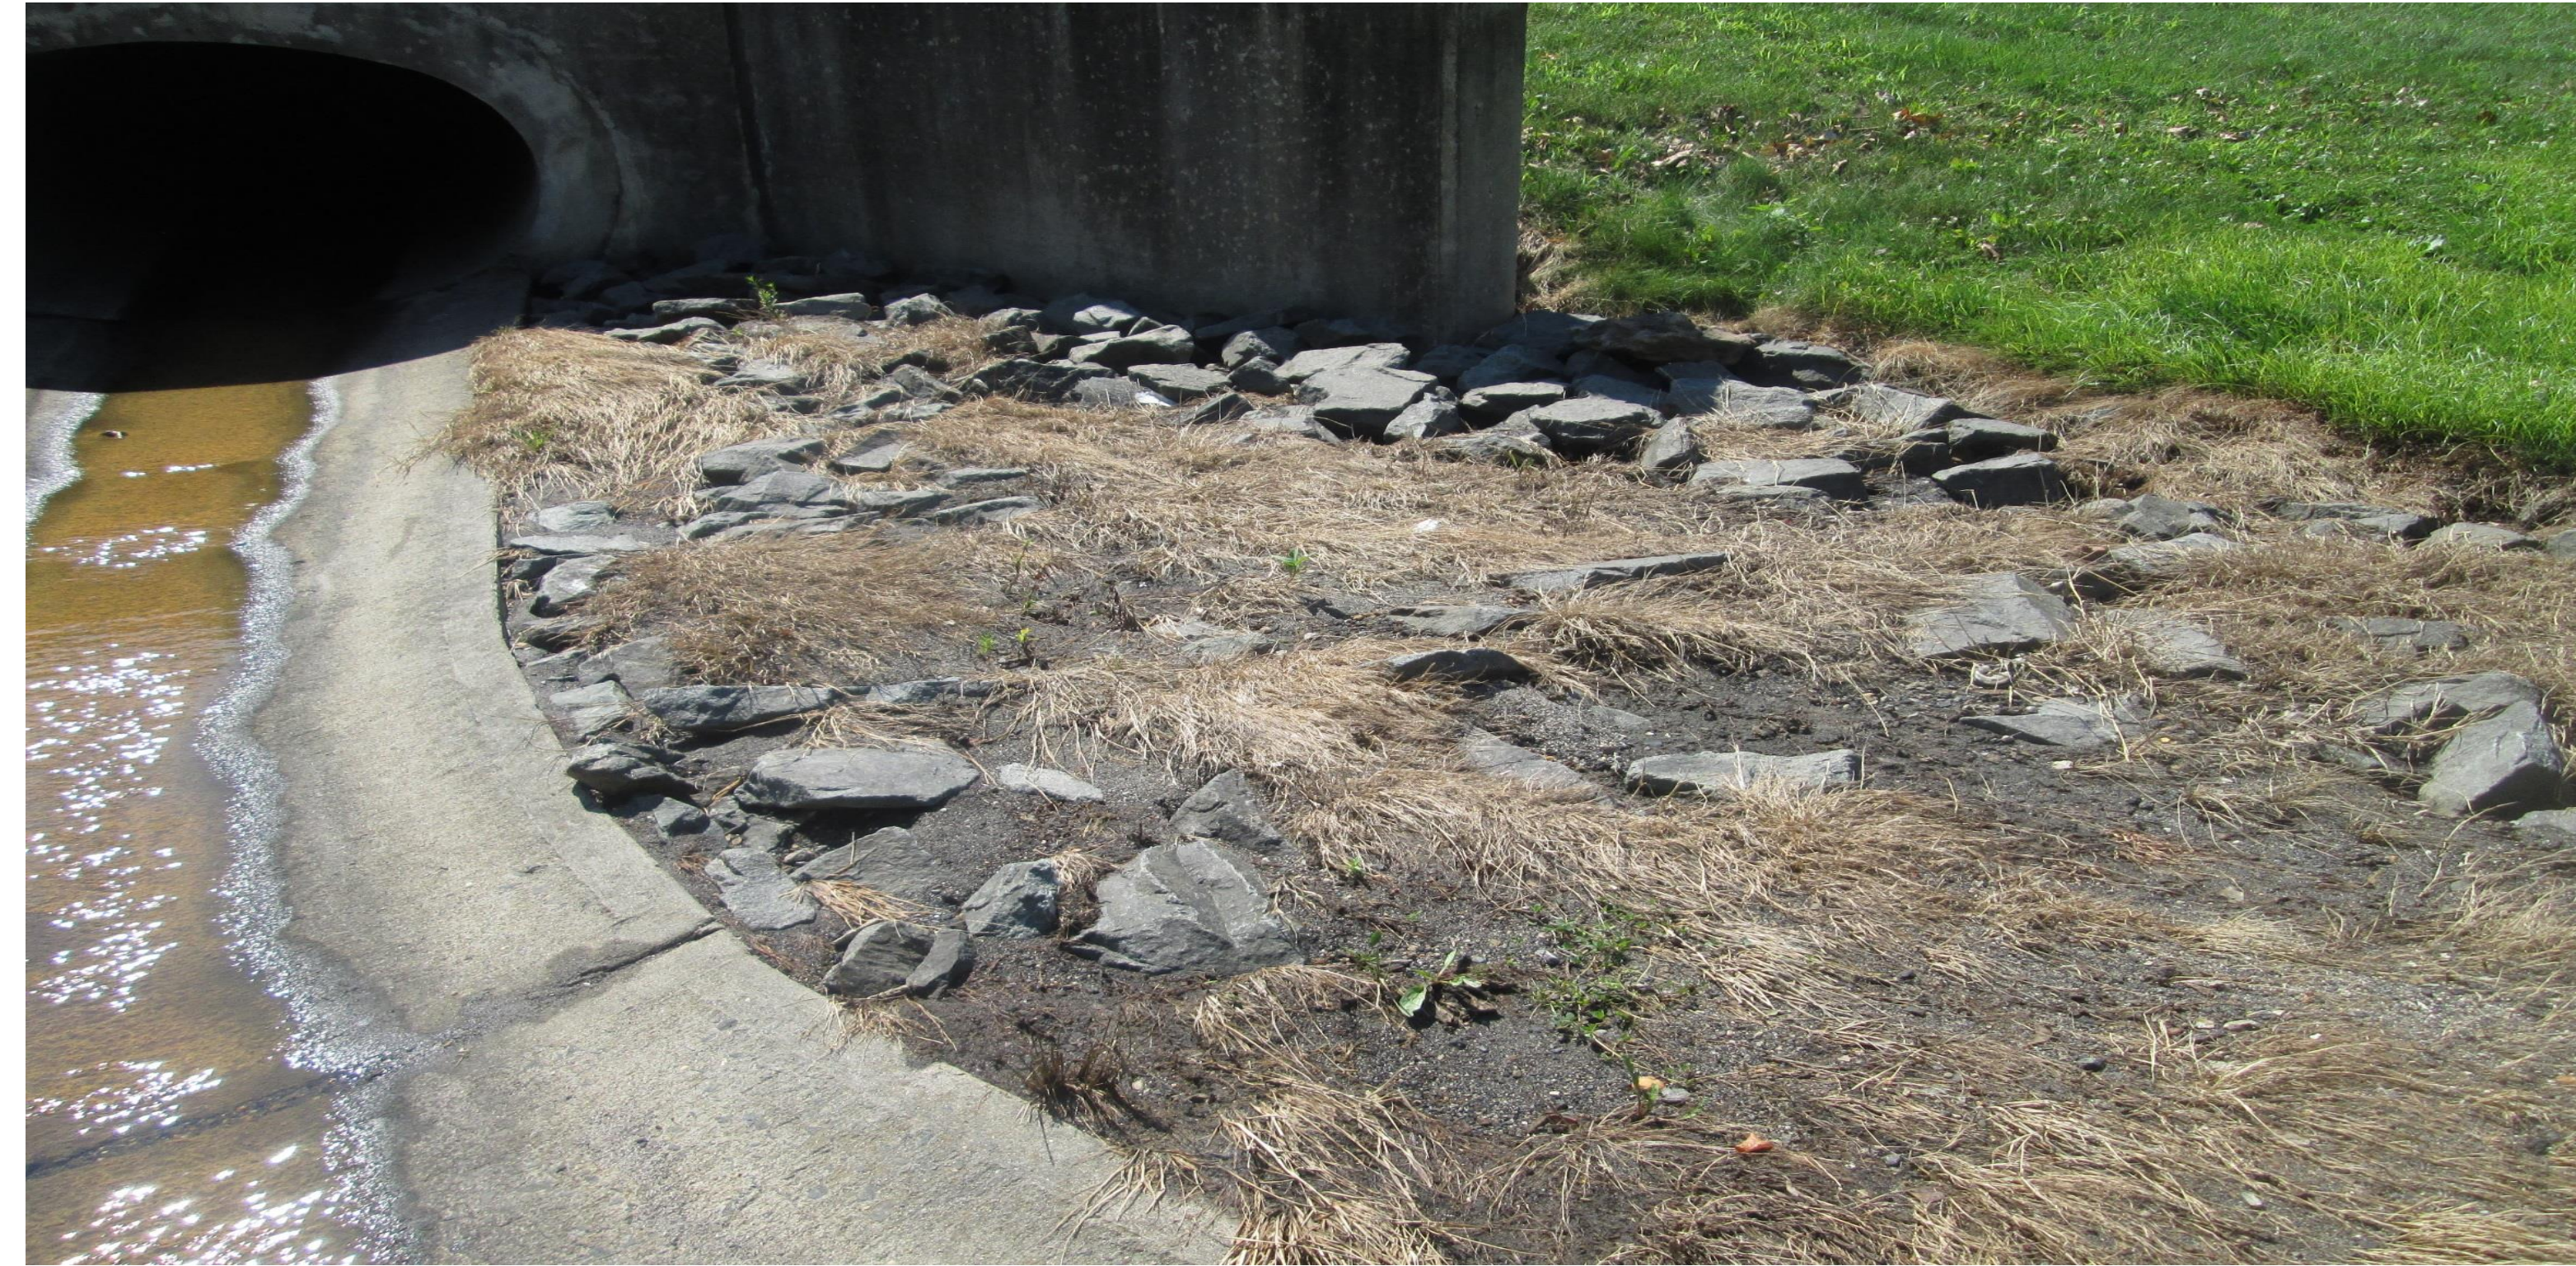
Overgrown rip-rap near inlet

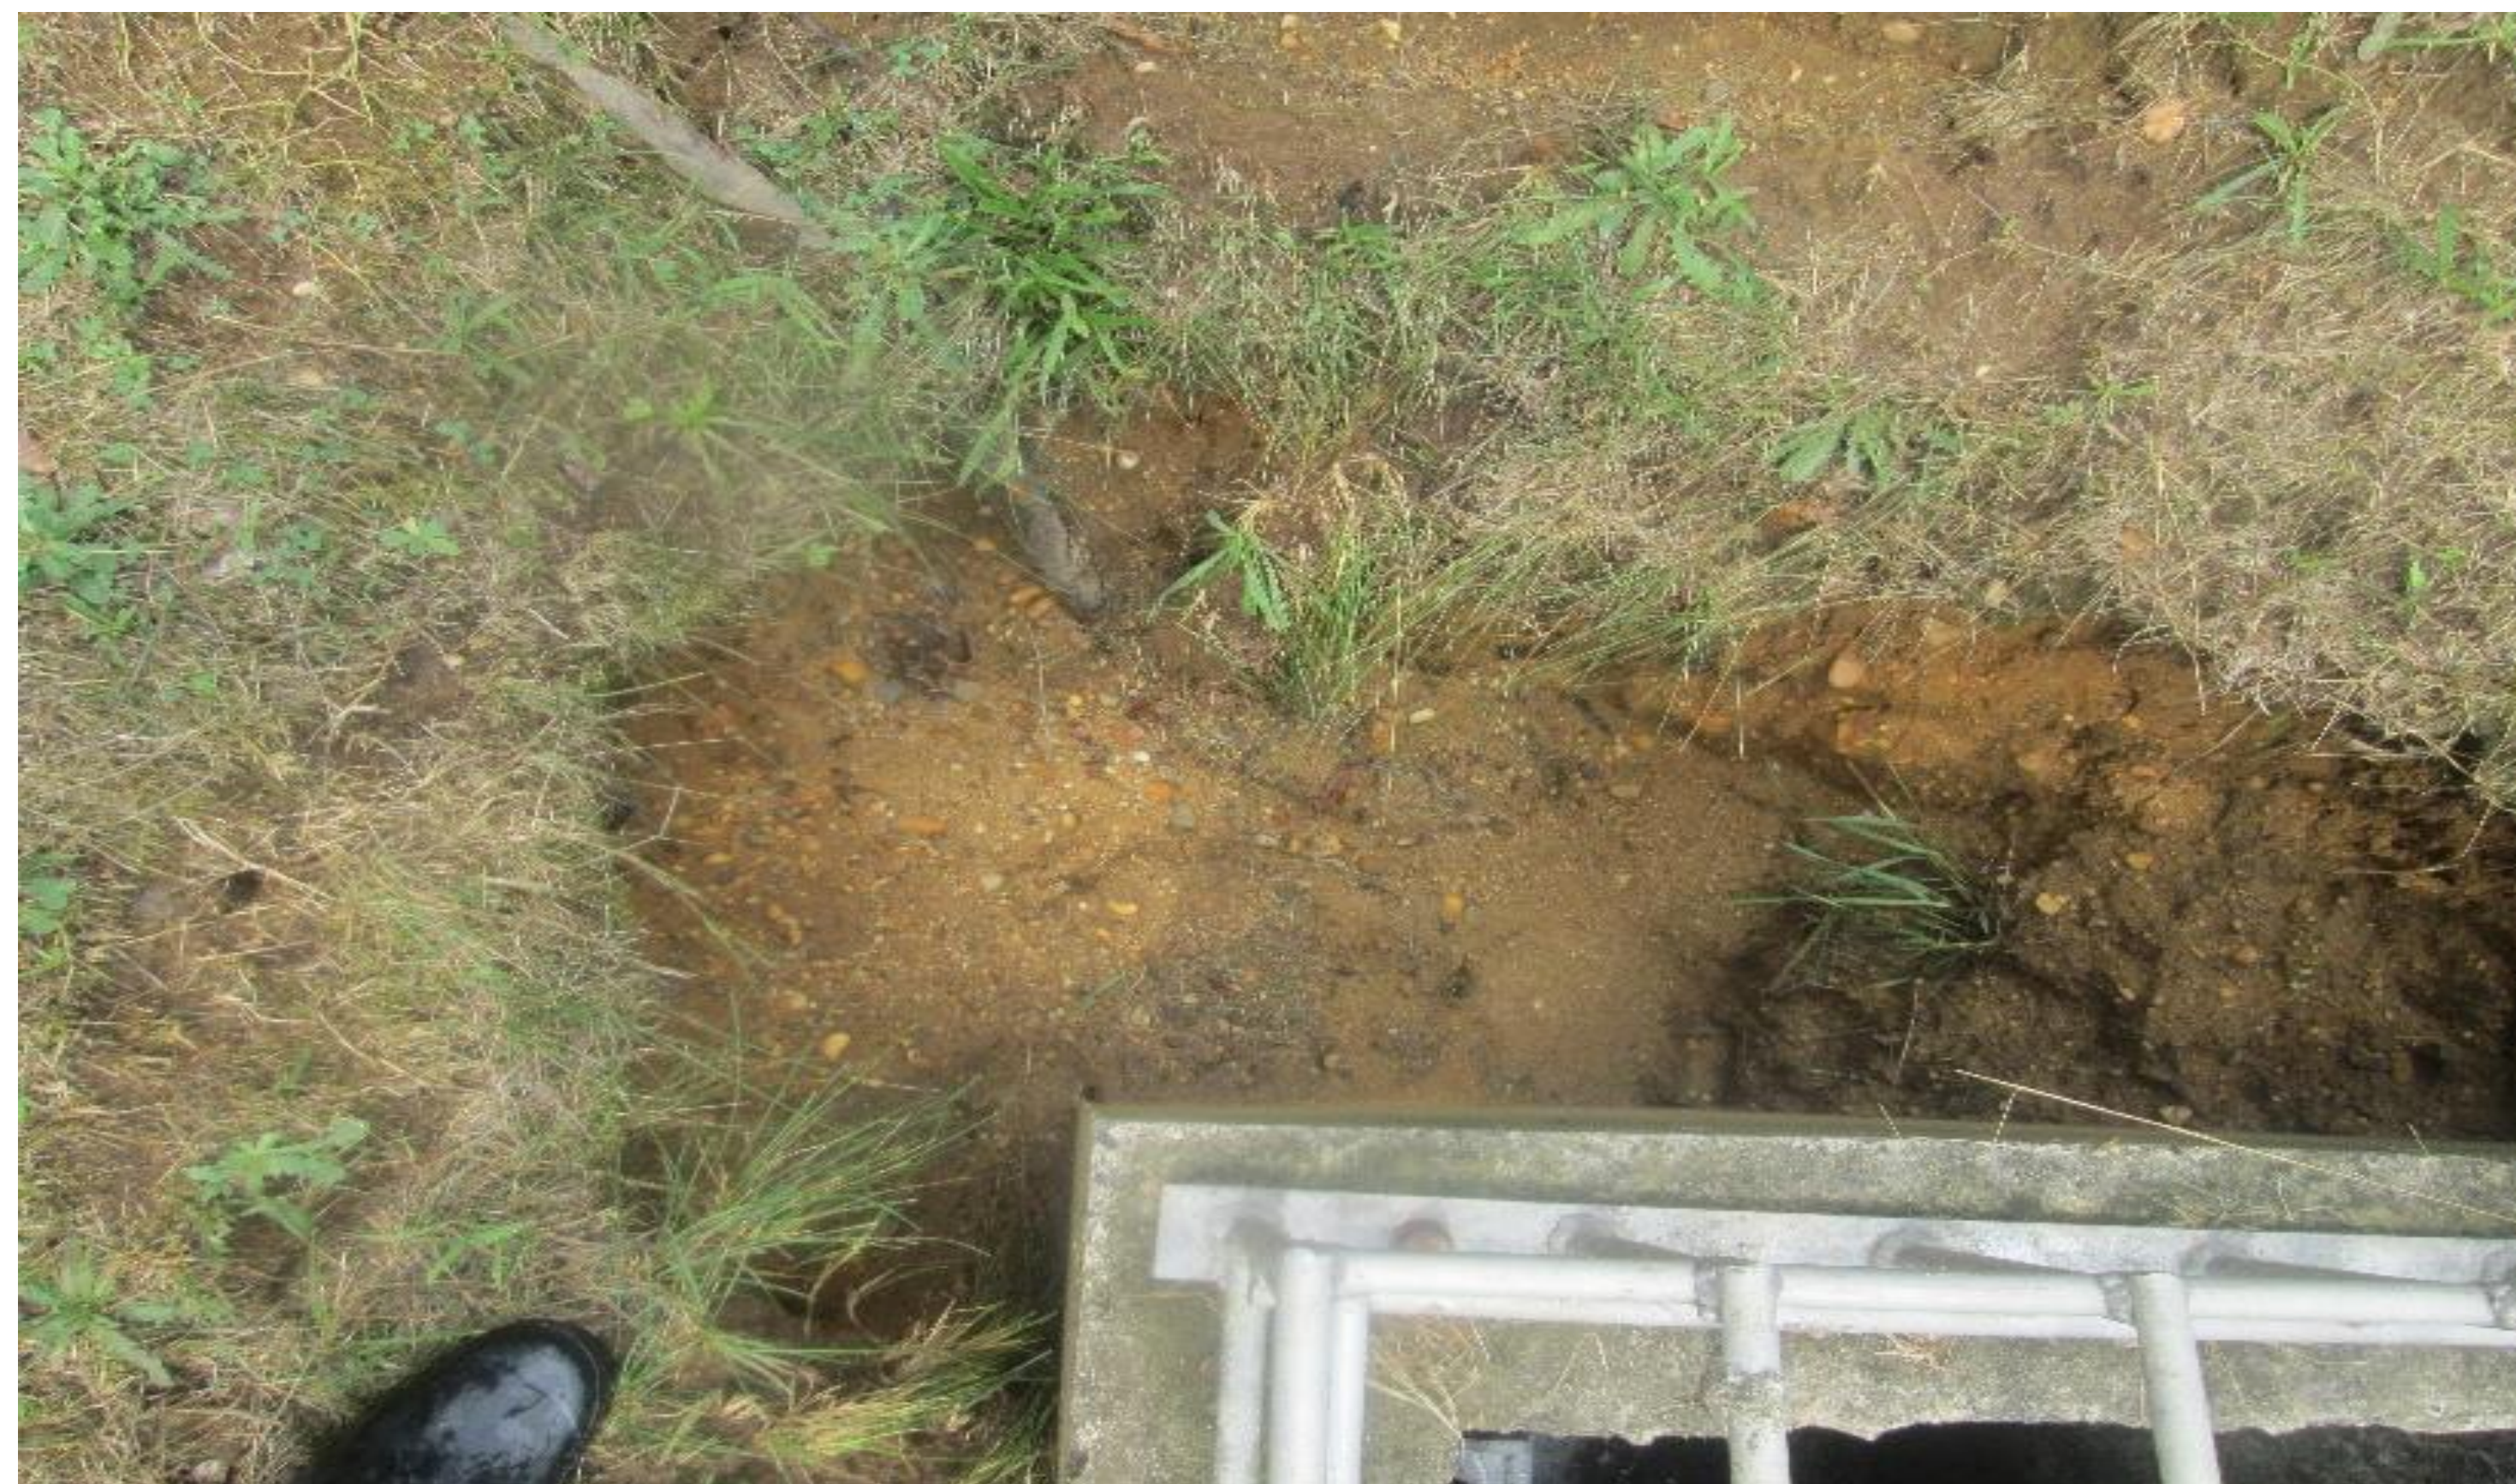
Erosion near outlet structure

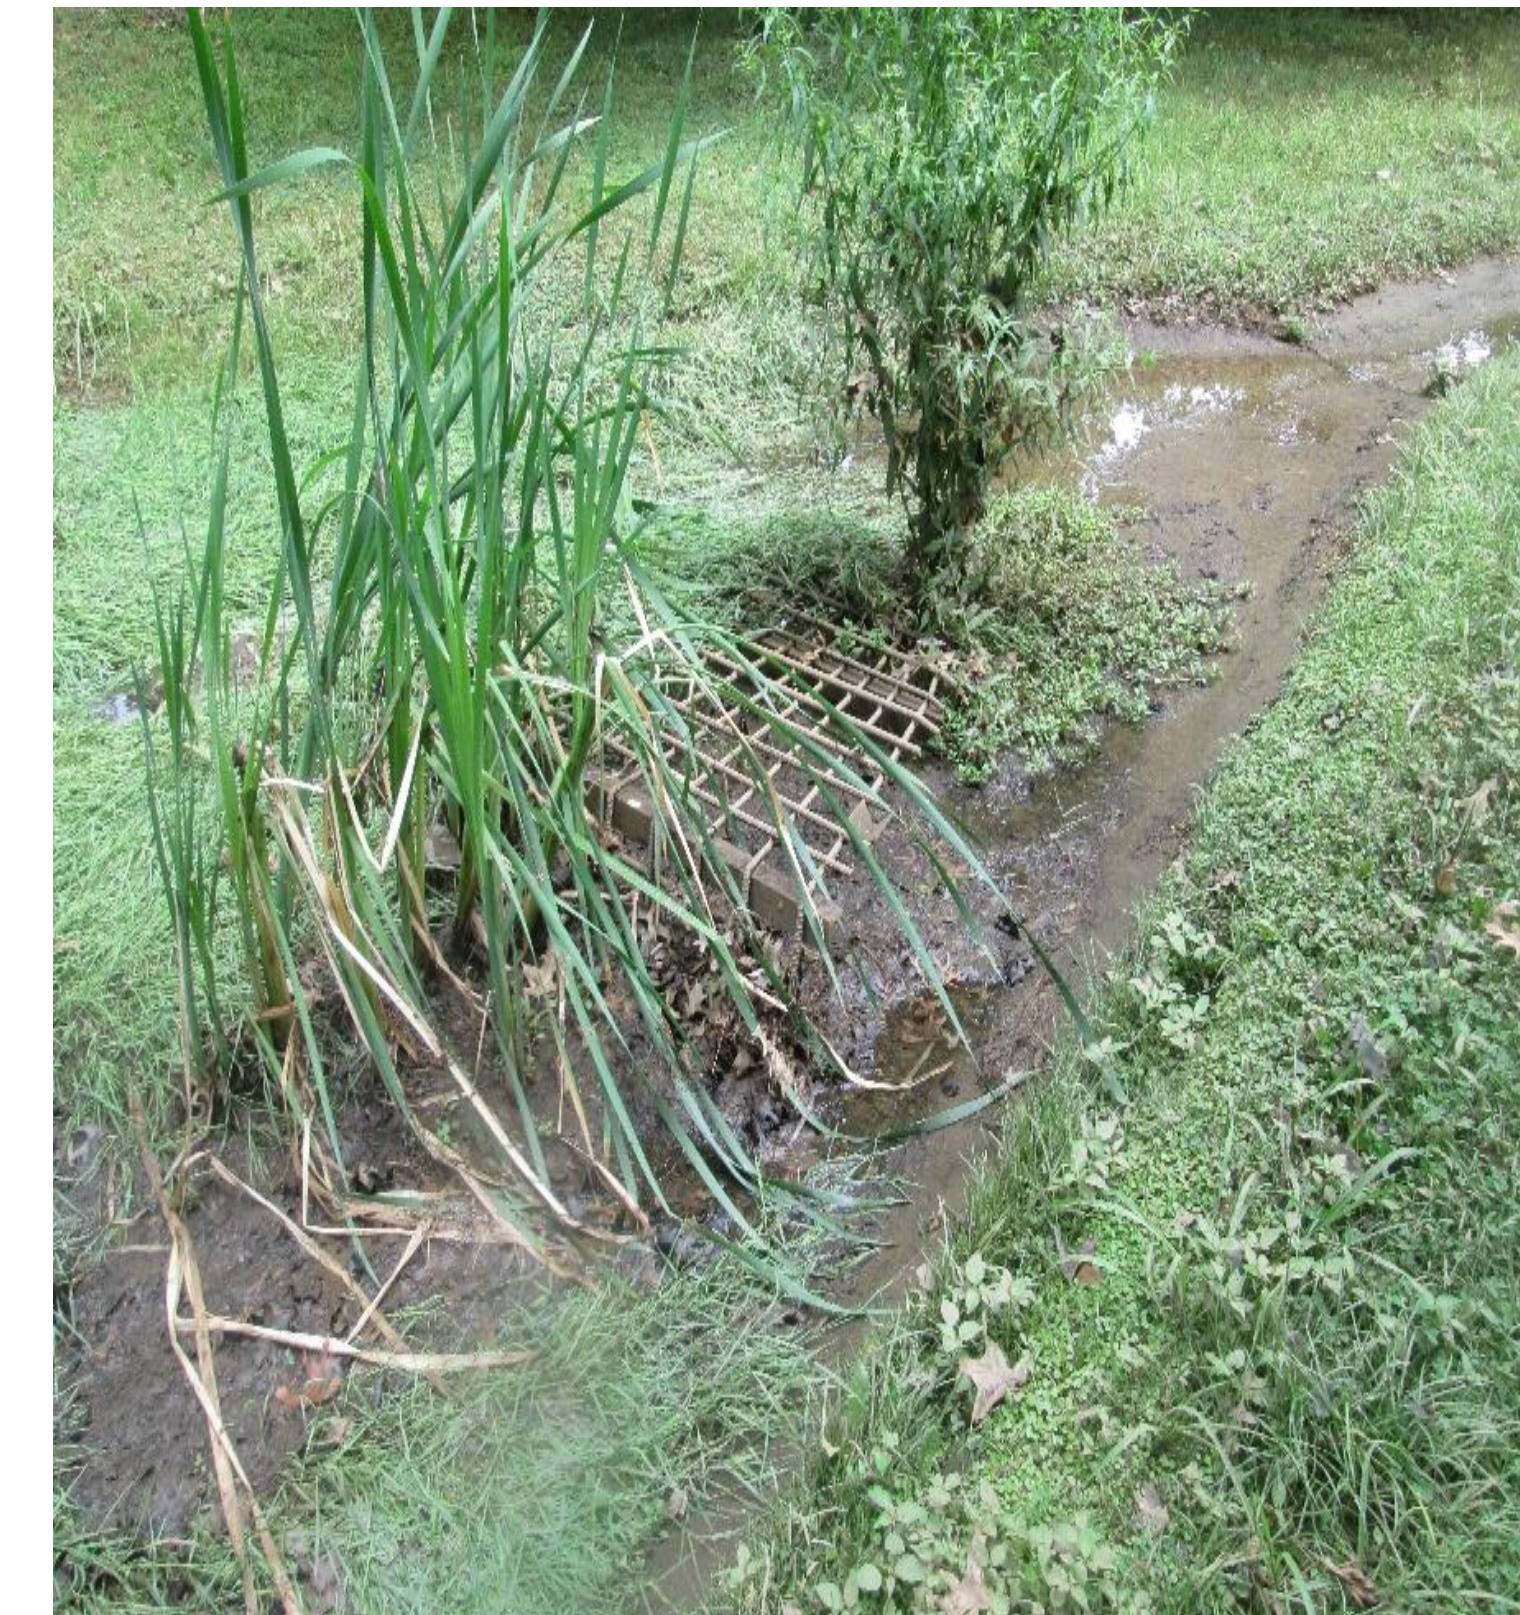
Metal grate in low flow channel

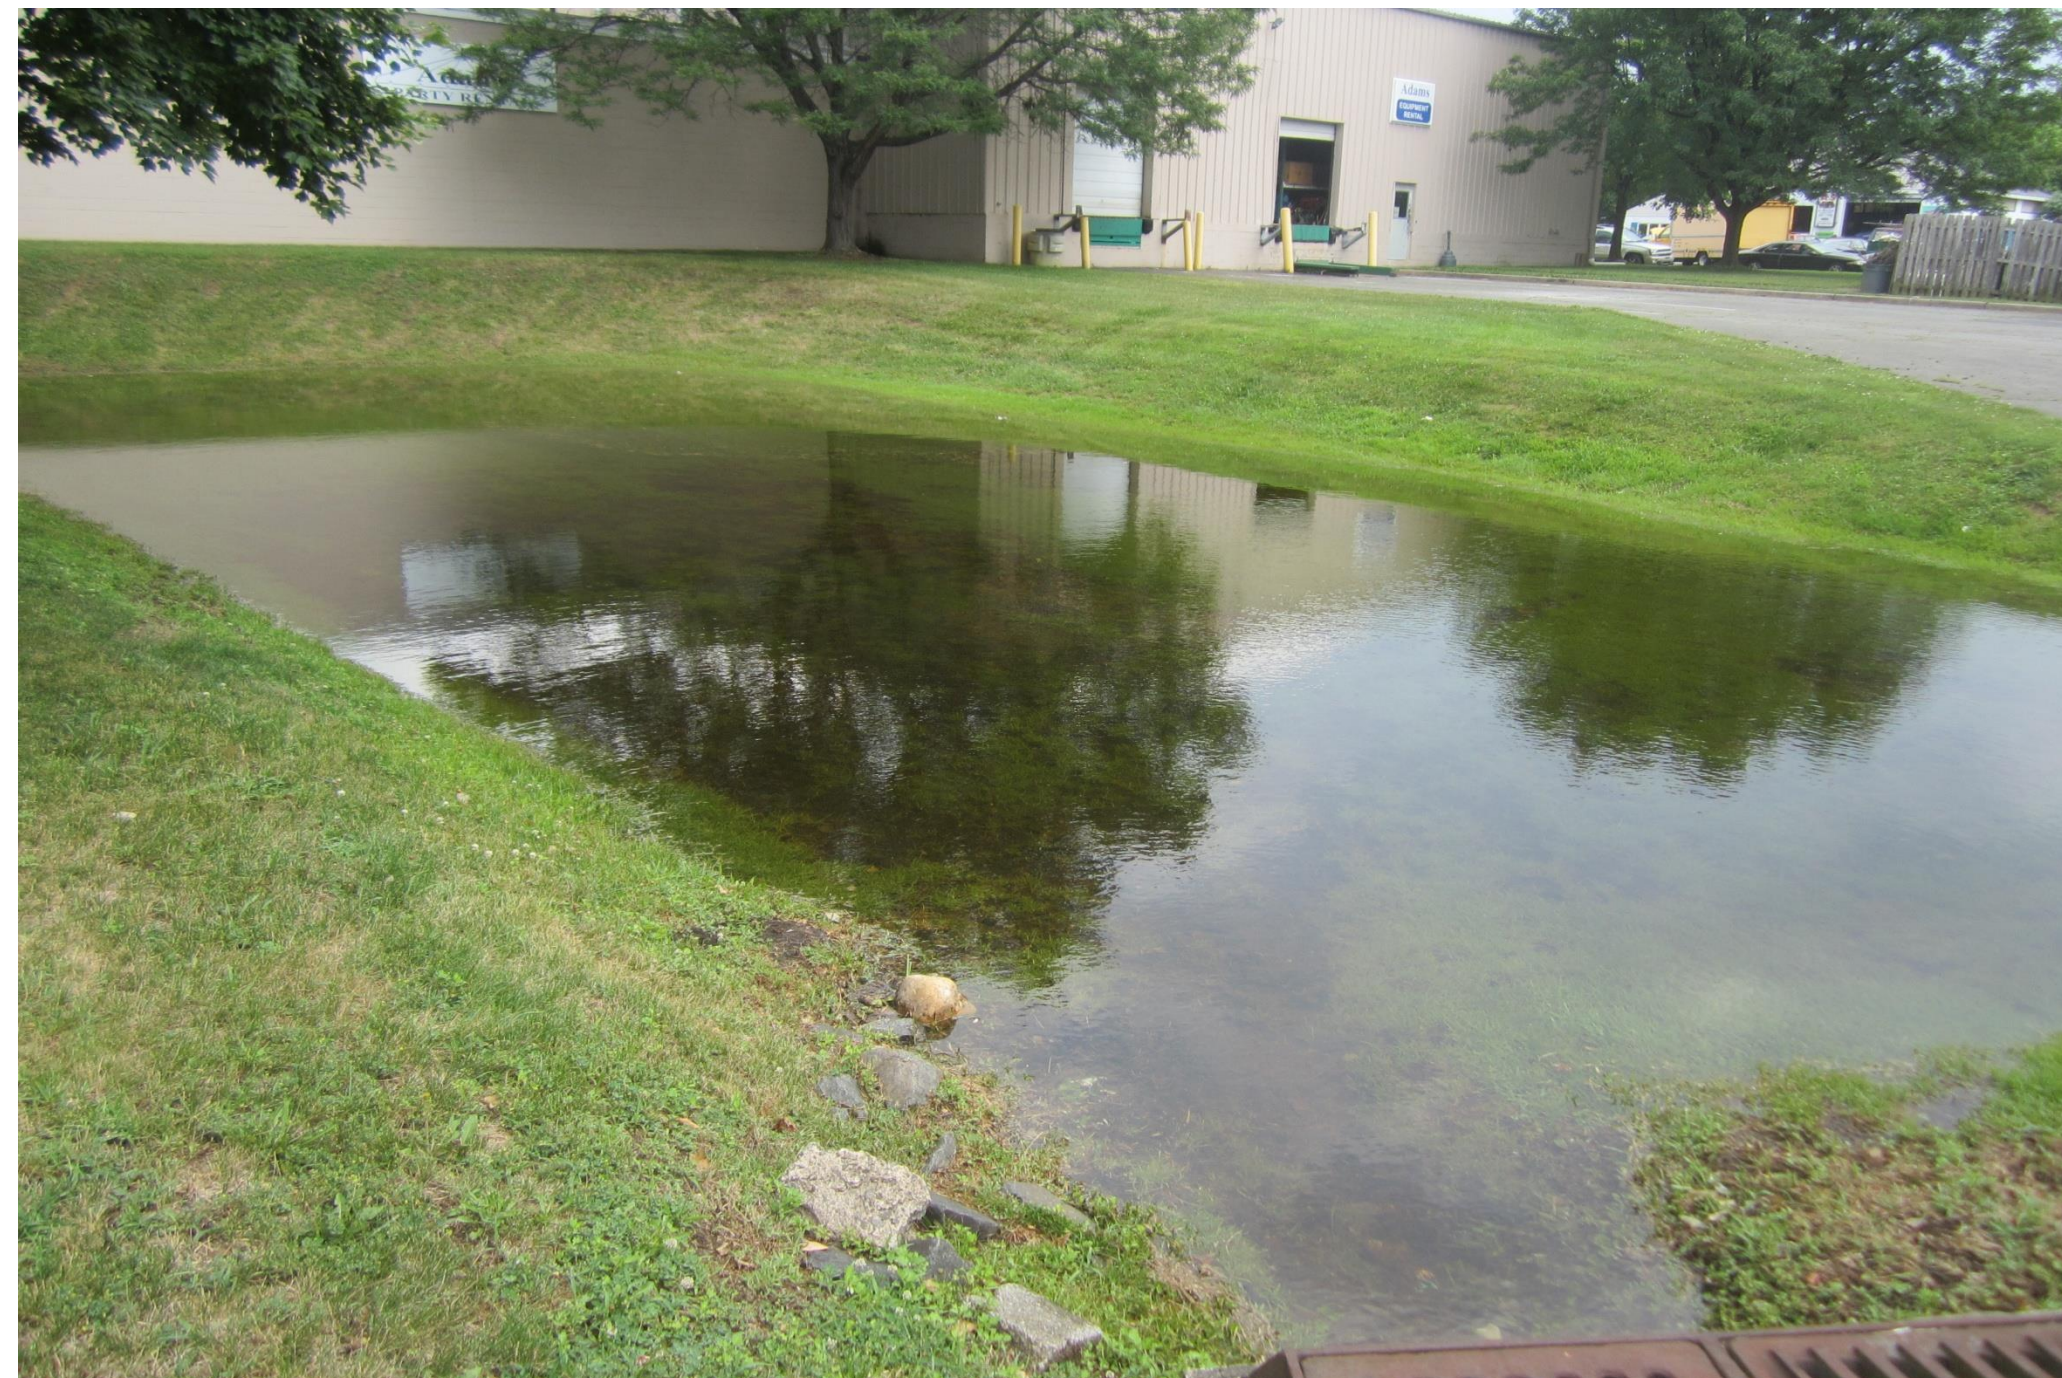
Severe ponding in basin

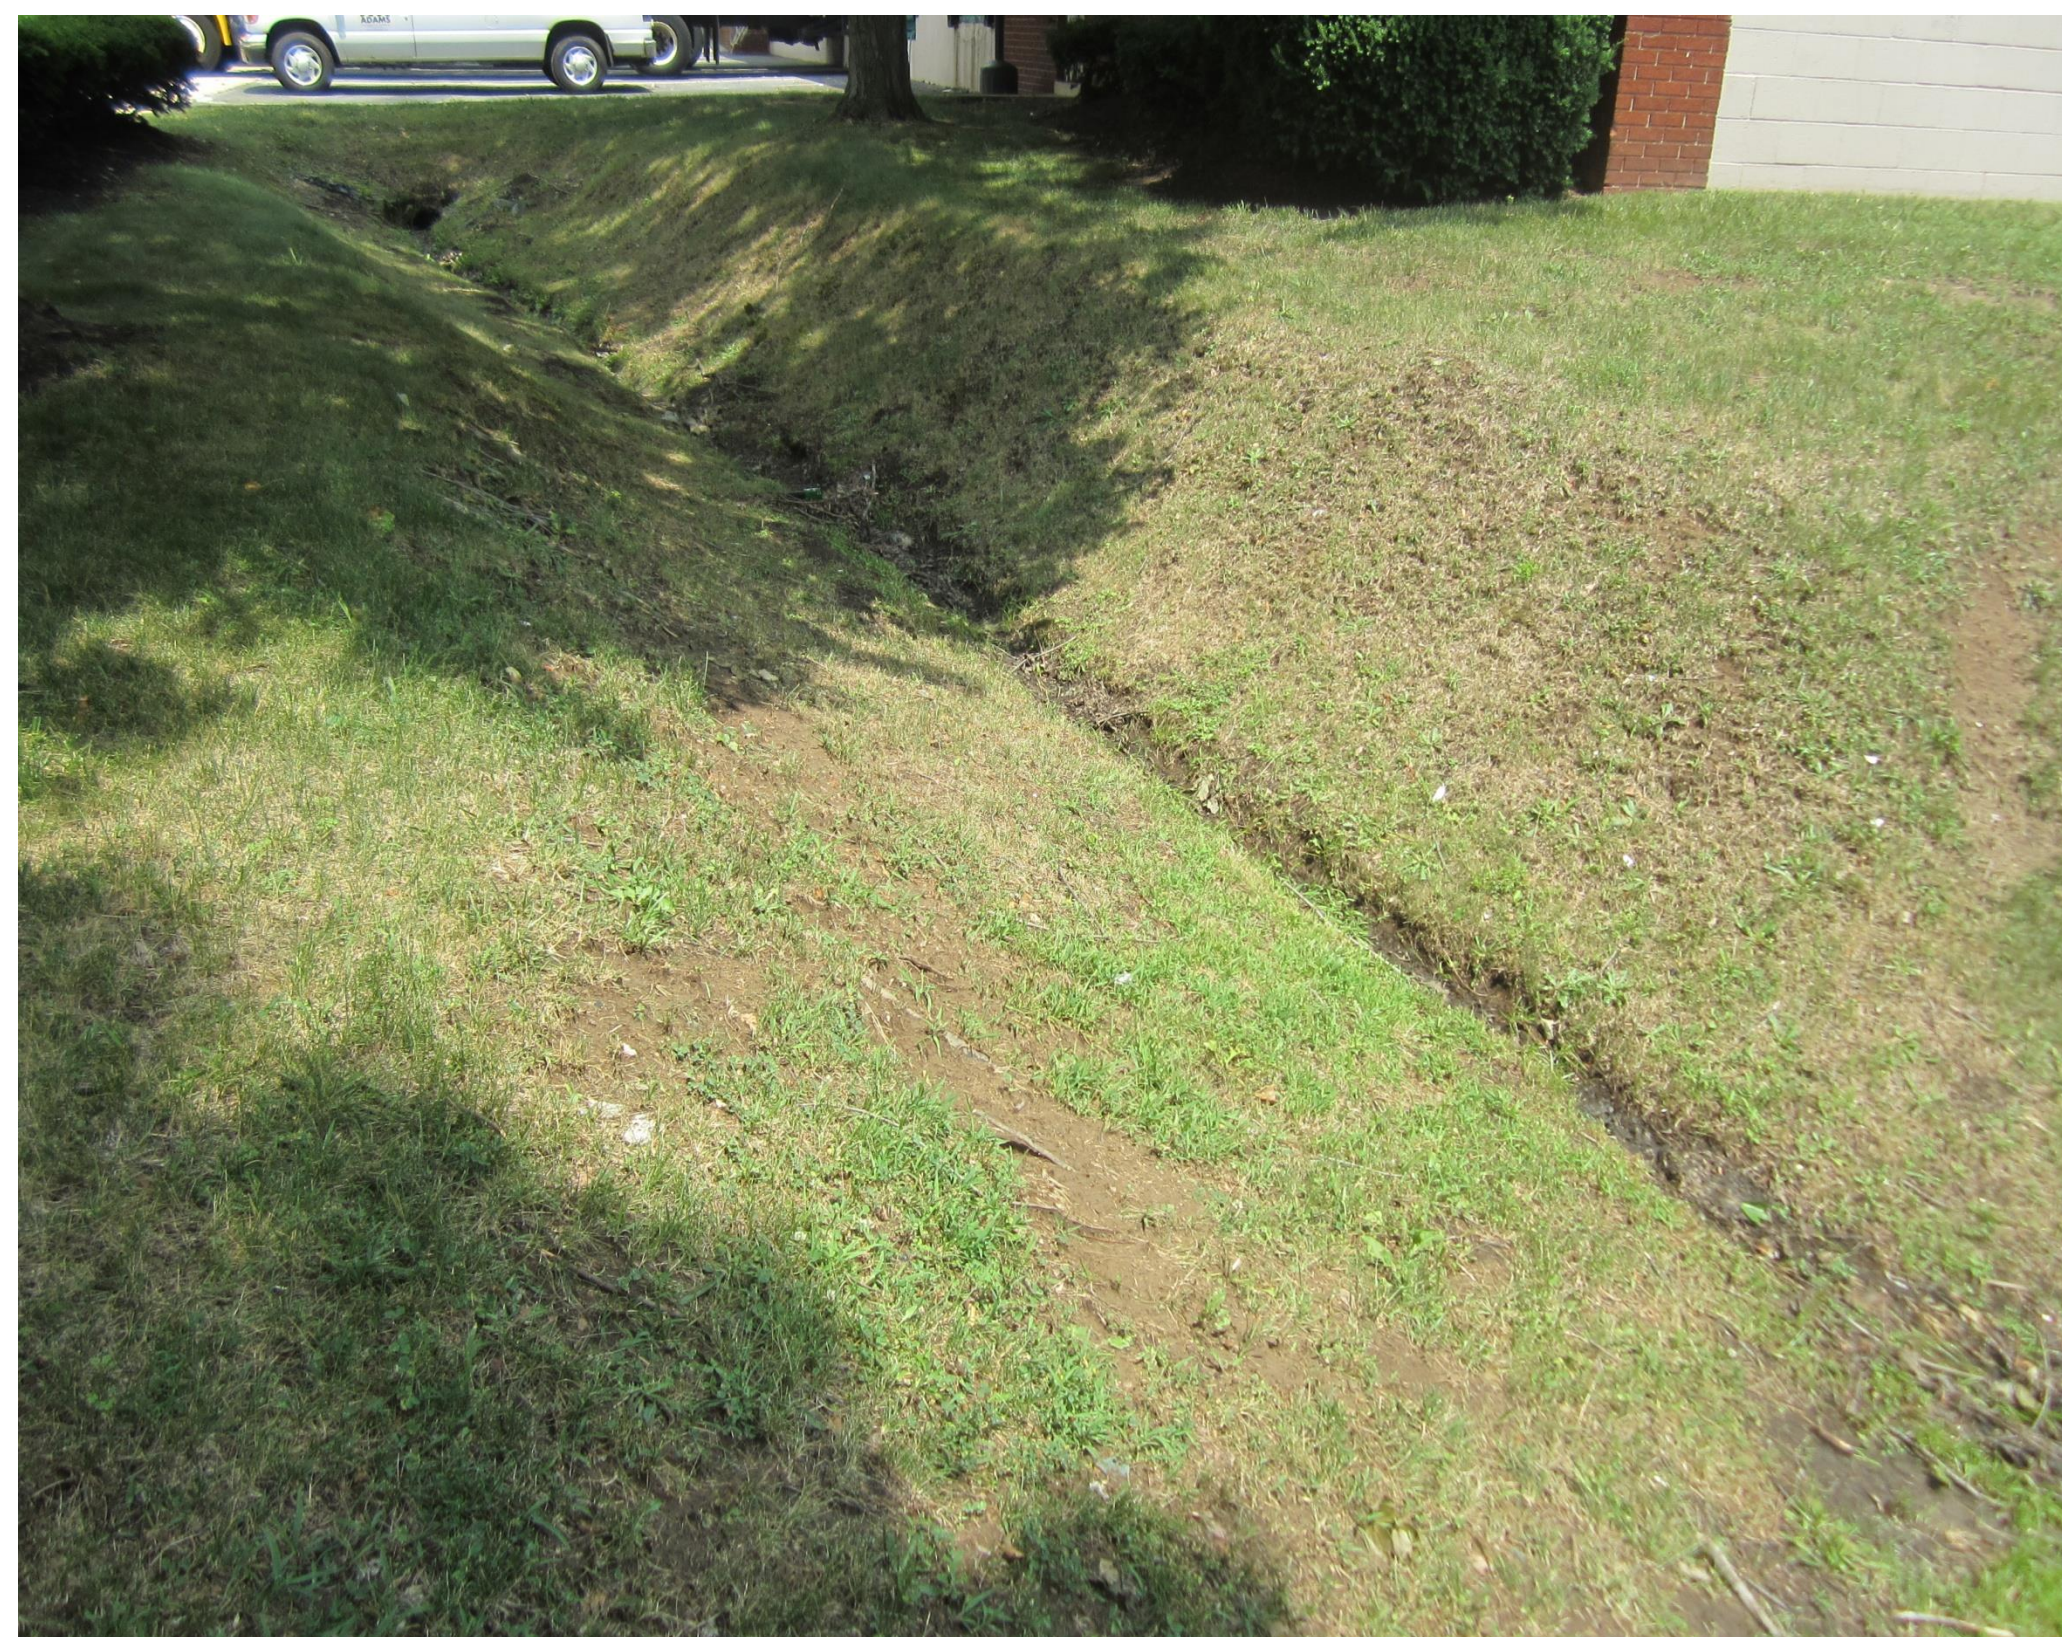
Eroded swale bottom
