**Hamilton Township (Mercer County)
Stormwater Basin Assessment Summary
Addendum (Year 3)**

Developed by the Rutgers Cooperative Extension Water Resources Program
Funded by Hamilton Township, Mercer County, New Jersey

September 30, 2014

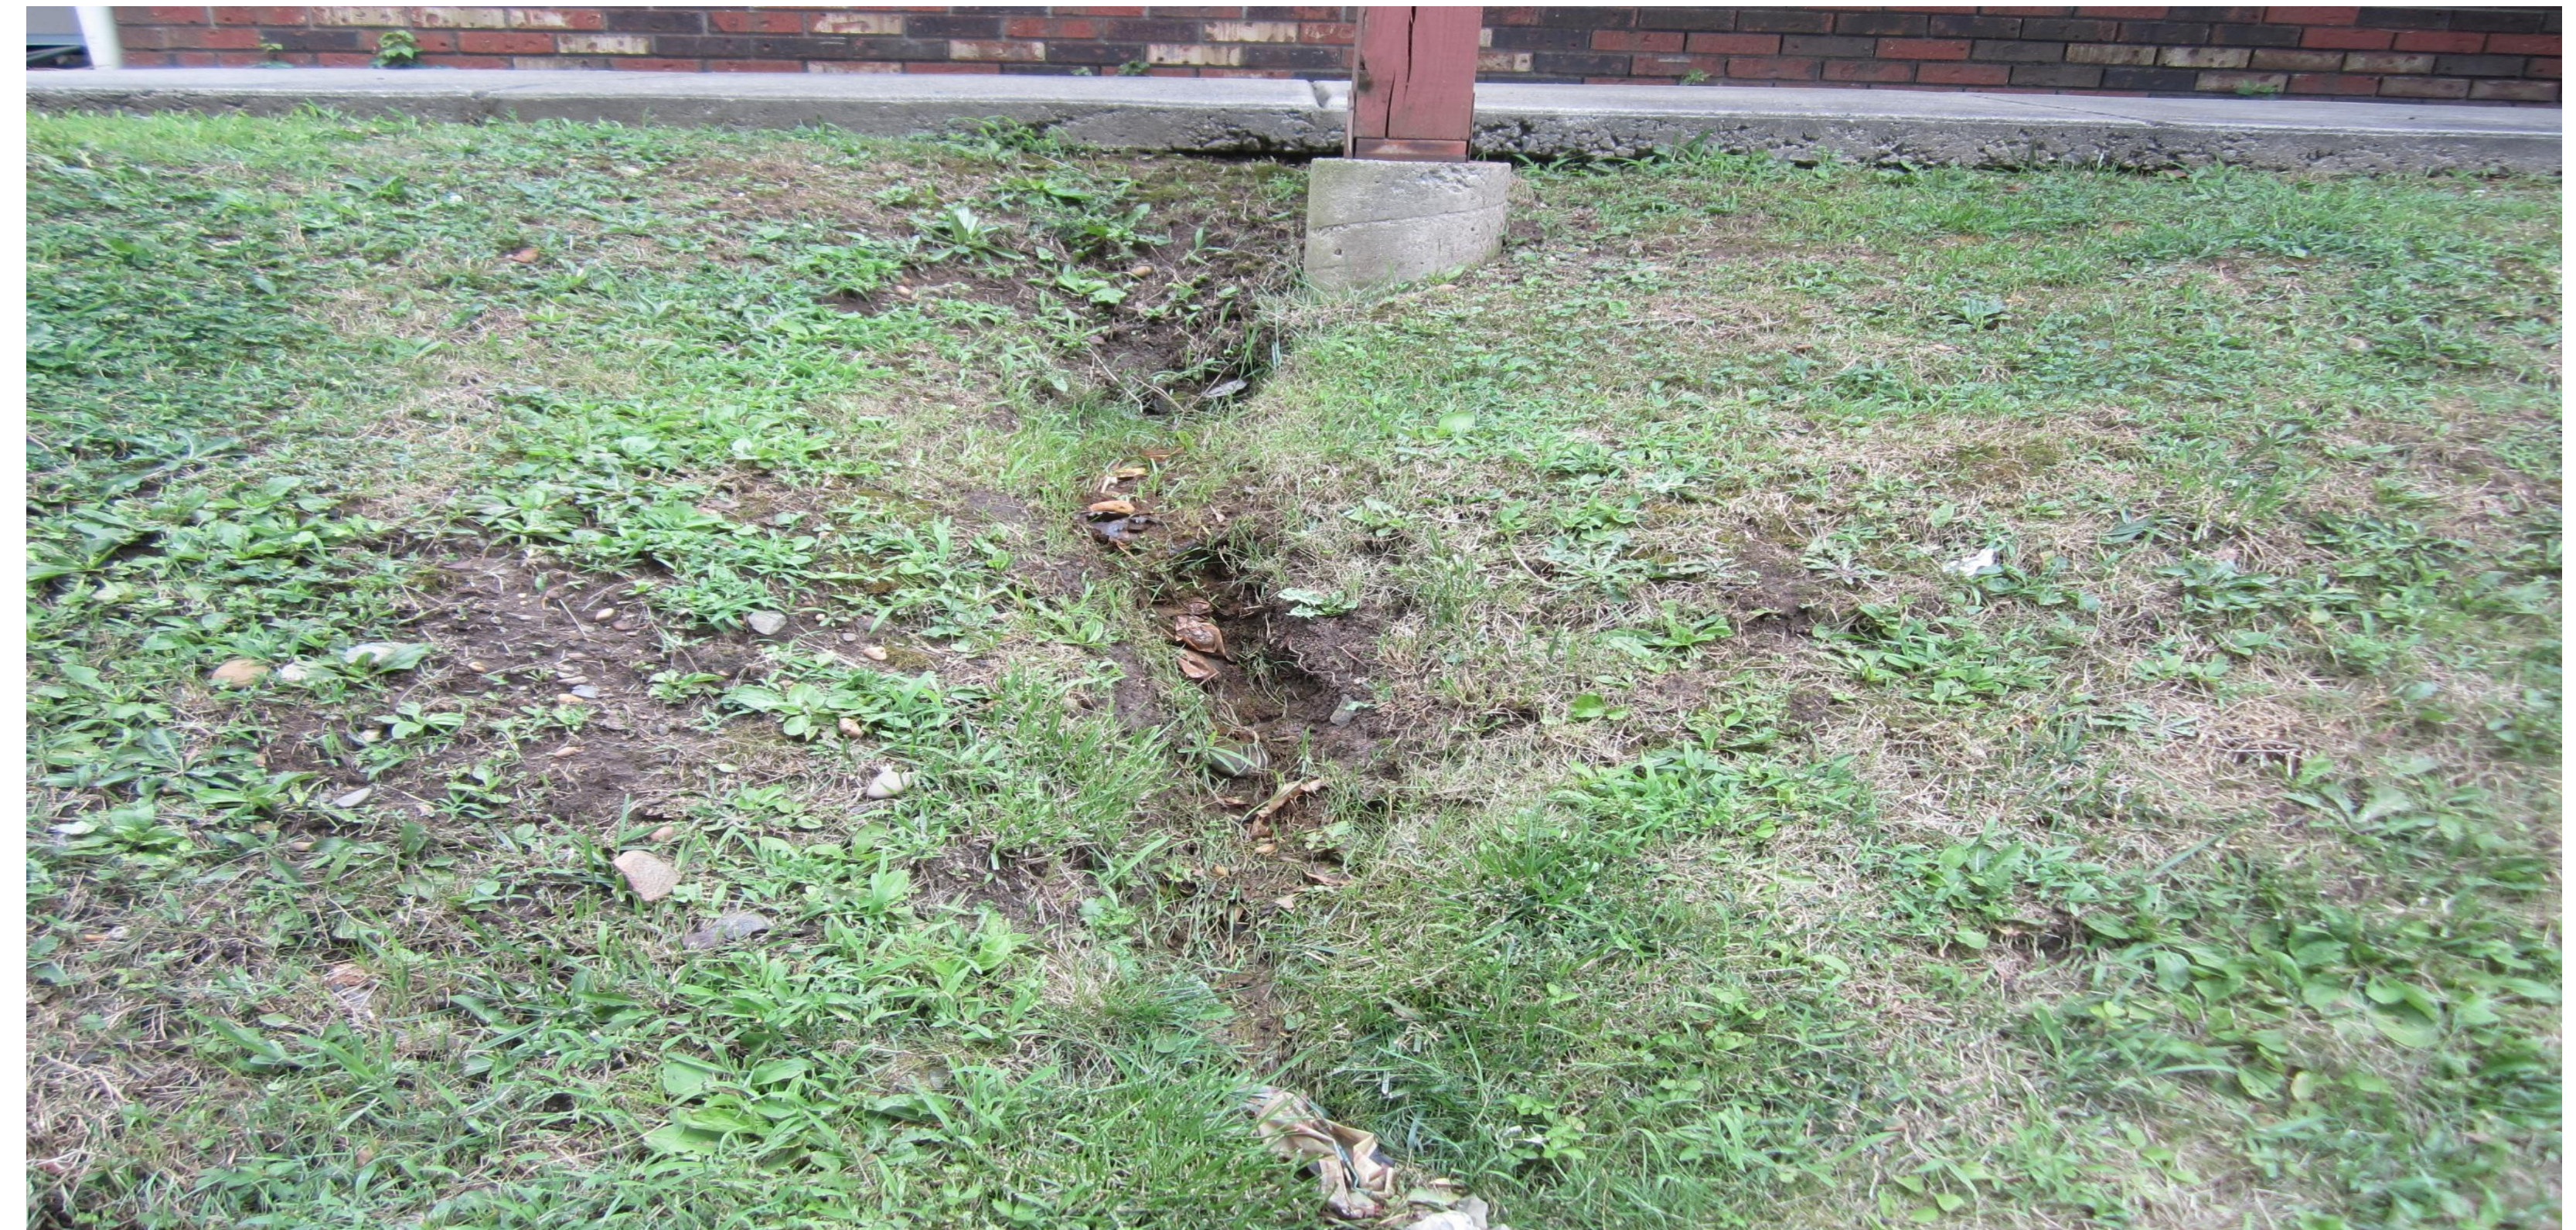
Erosion near eastern embankment

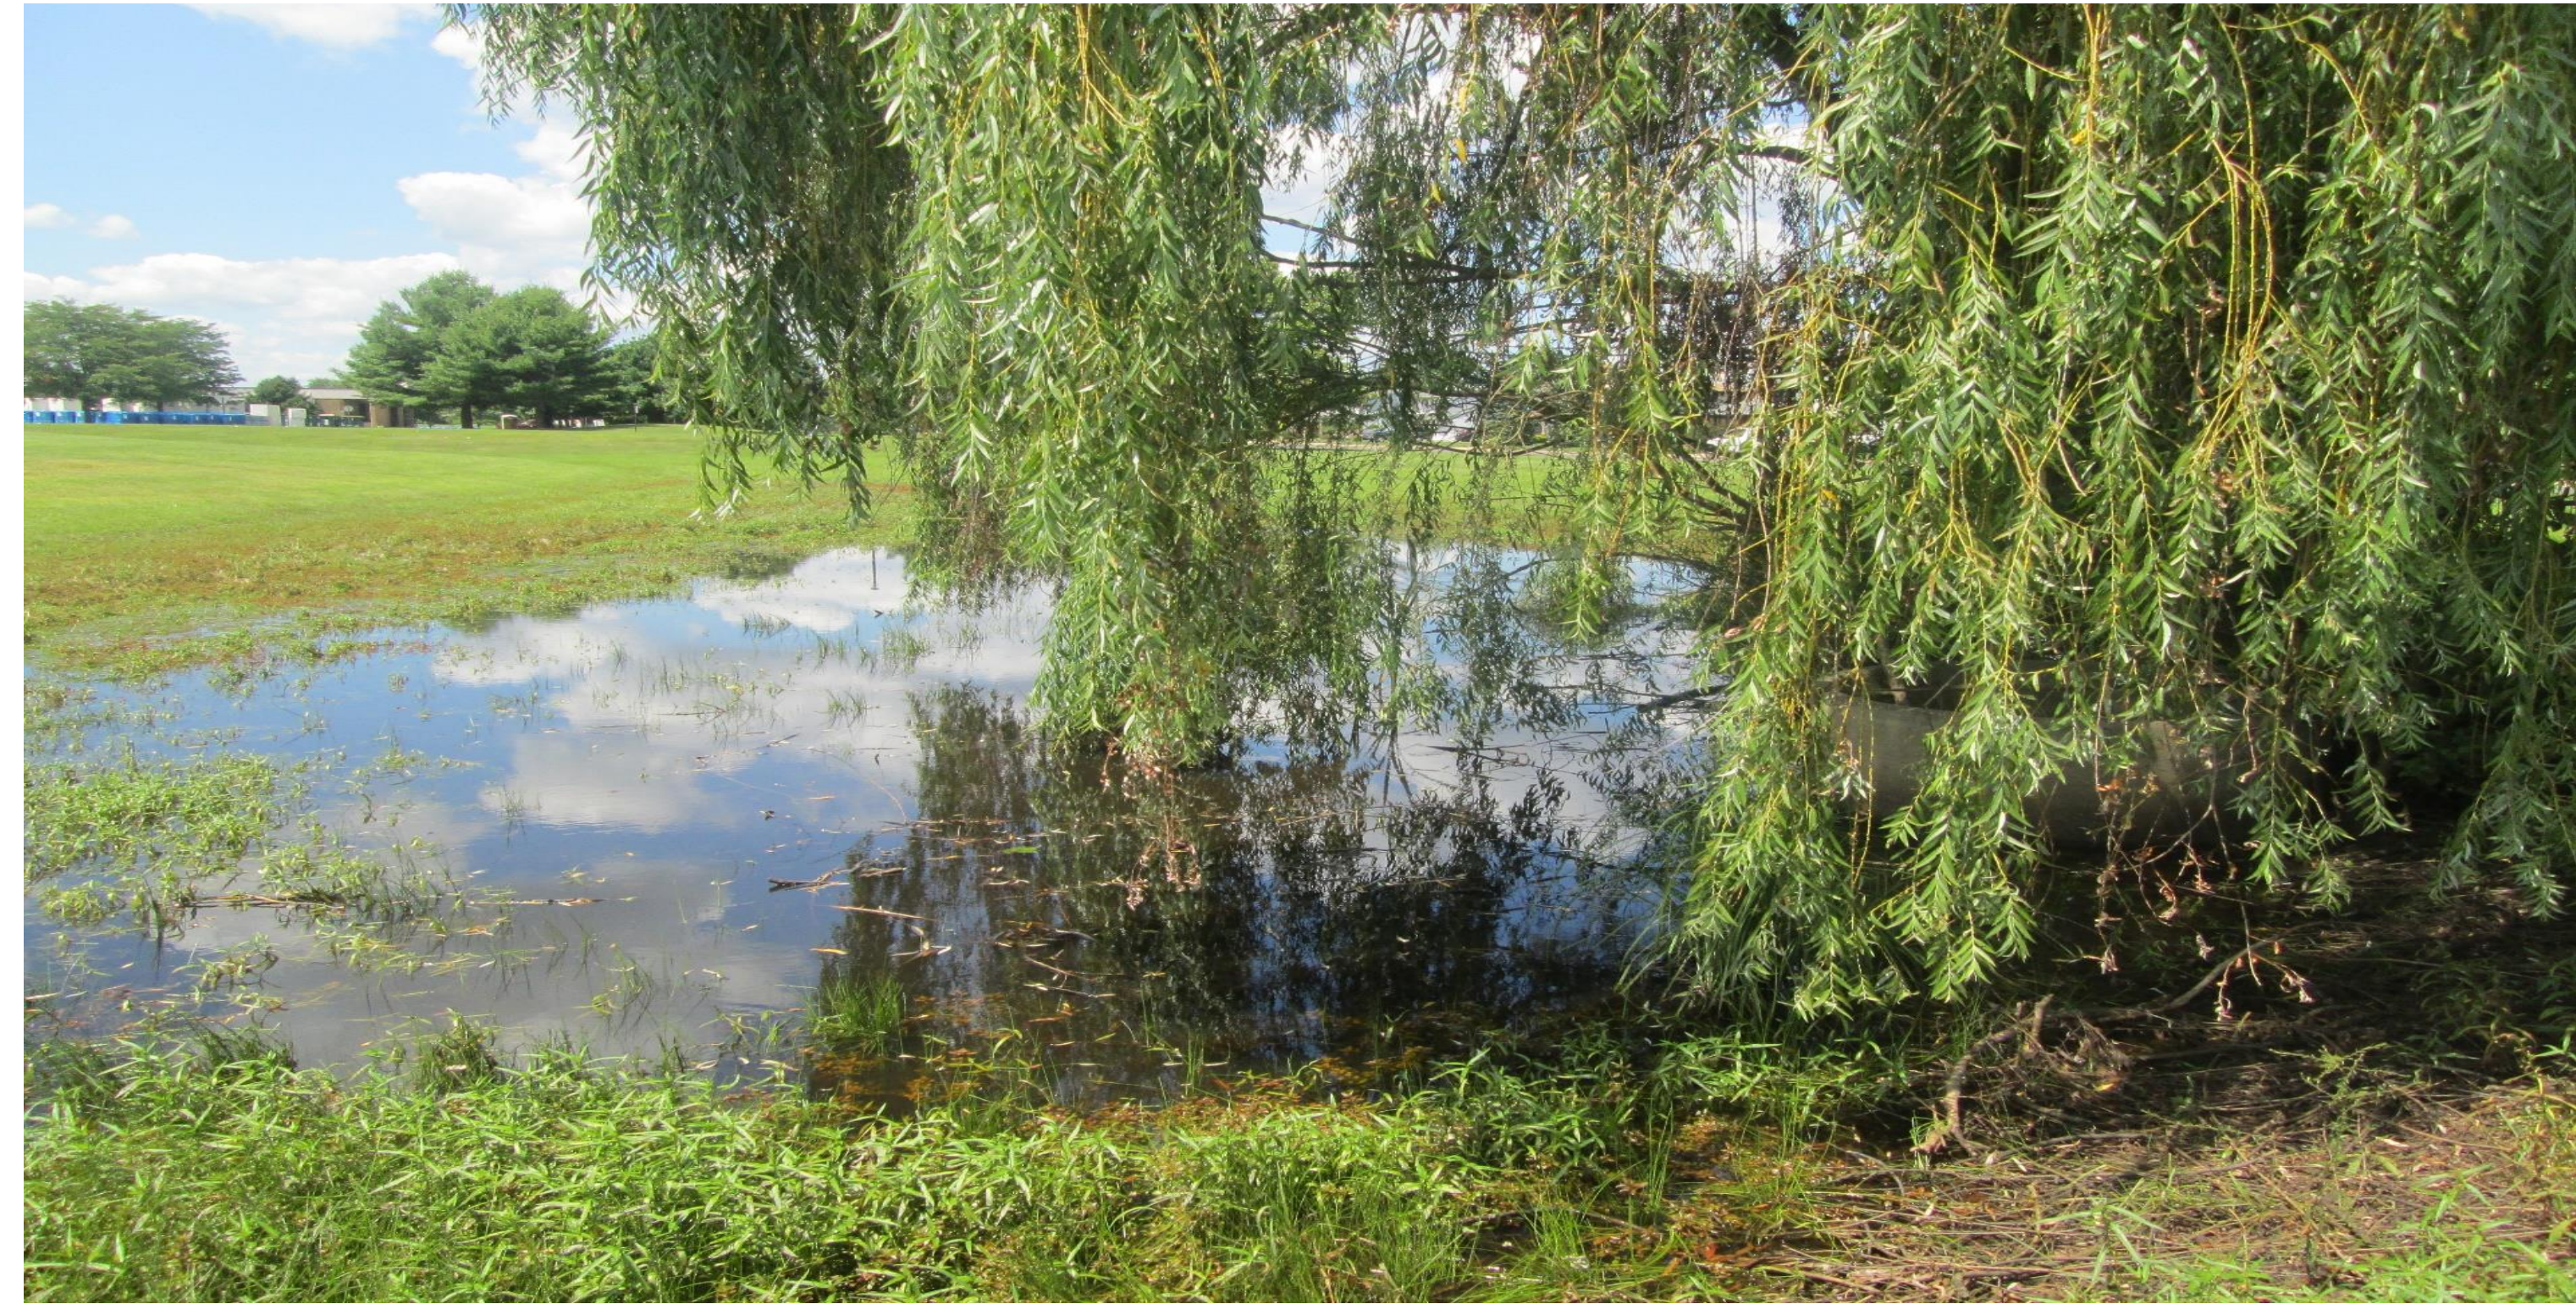
Overview of Basin

- Outlet structure is clogged with sediment and debris
- Standing water in the basin bottom
- Outlet structure is missing secondary spillway grate

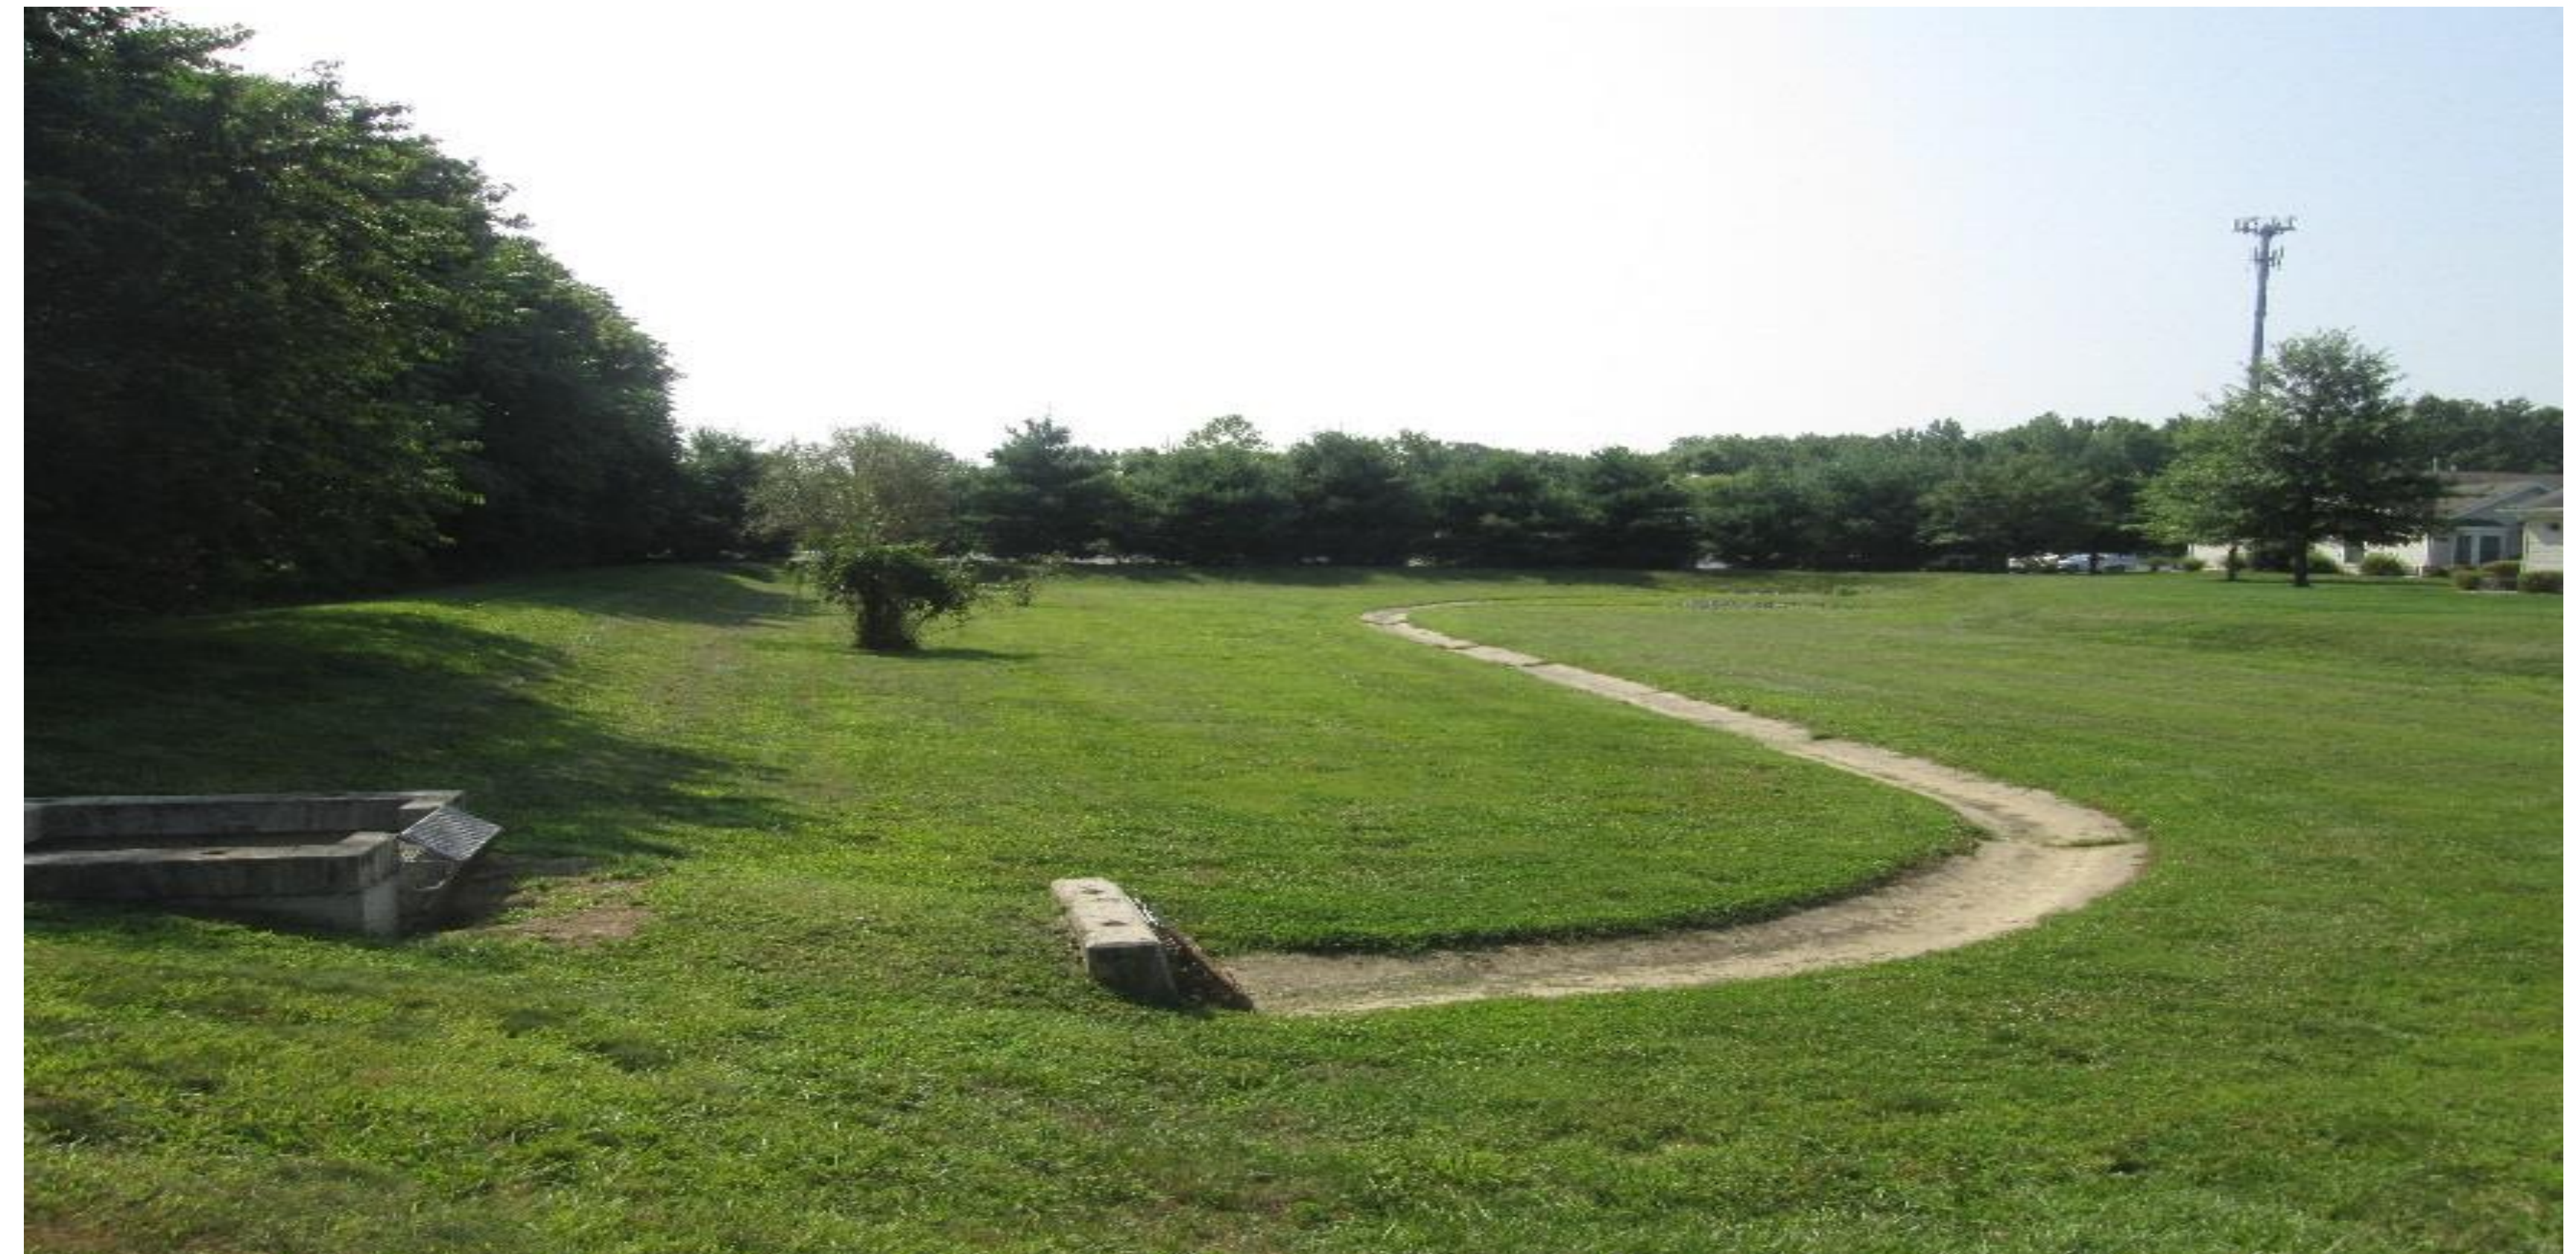
Overview of basin

- Excessive sediment in low flow channel and near inlets and outlet
- Outlet structure is missing secondary spillway grate
