MILESTONE 4 OF REGIONAL STORMWATER MANAGEMENT PLAN FOR THE  
 POMPESTON CREEK  
 NEW JERSEY DEPARTMENT OF ENVIRONMENTAL PROTECTION  
 FOUNDATION FARMS PARK, CINNAMINSON, NJ  
 STREAM BANK STABILIZATION

JOB	CONCEPT SHEET #
POMP	4
BID	TOTAL
4	12

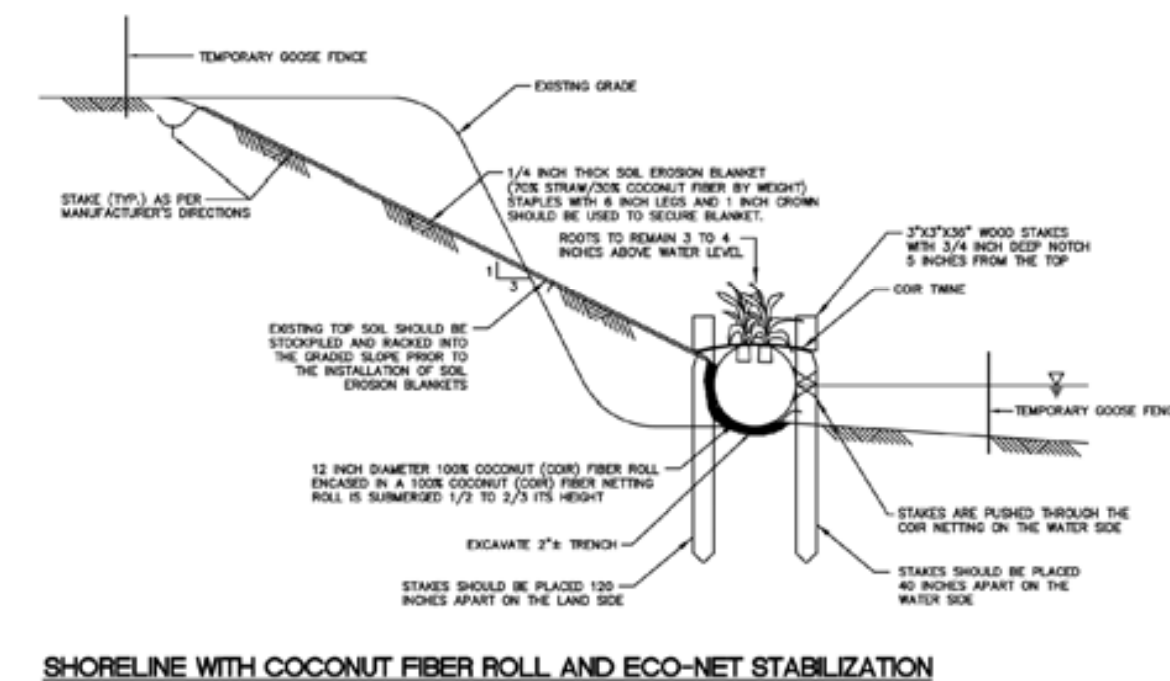
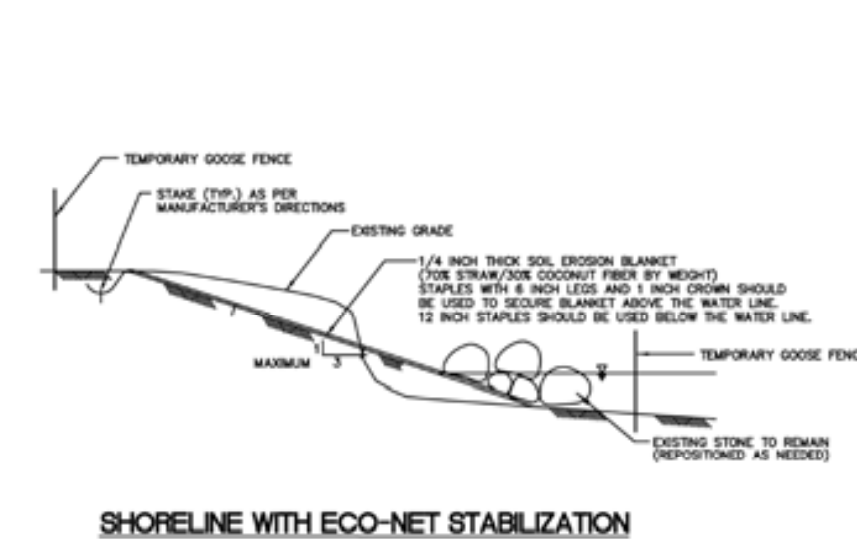
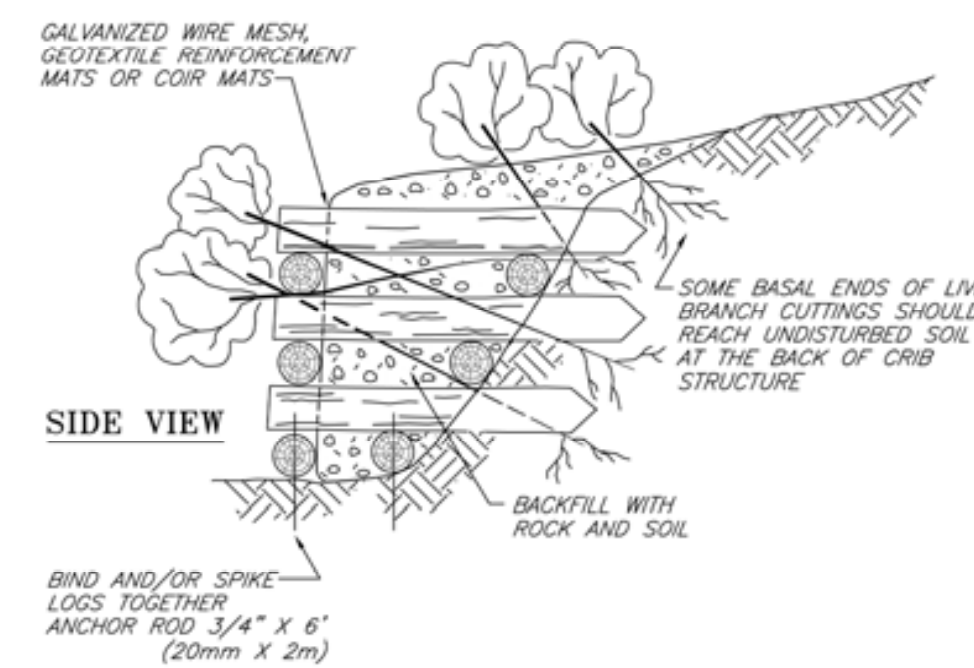
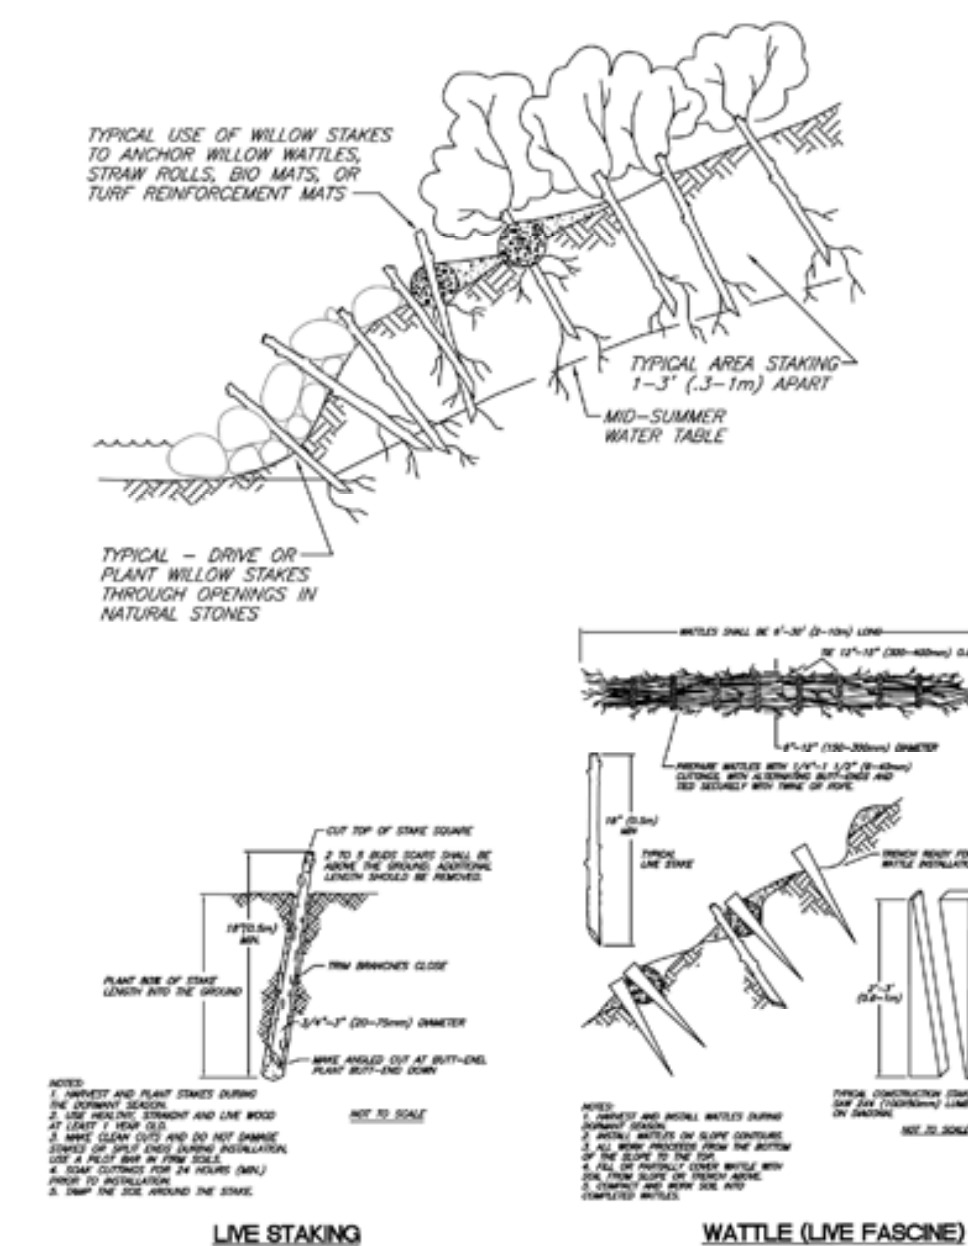
PHOTOS OF EXISTING UNSTABLE STREAM BANK

1. THE AREA INDICATED ON THE MAP IS SELECTED FOR STREAM BANK AND HABITAT RESTORATION. AS SHOWN IN THE PICTURES BELOW, OVER THE YEARS, THE STREAM BANK HAS ERODED INTO AN UNSTABLE PART OF THE STREAM. THIS CAN BE A SERIOUS HAZARD TO CHILDREN PLAYING IN THIS PARK. THE DROP FROM THE TOP OF THE BANK TO THE STREAM BED IS OVER 3 FEET. THIS PART OF THE STREAM IS LOCATED IN FOUNDATION FARMS PARK, THEREFORE CHILDREN ARE AROUND THIS HAZARD ON A FREQUENT BASIS.

2. THE PROBLEM IS THE ERODED STREAM BANK FOR THIS SECTION OF THE STREAM. IT CAN BE A HAZARD TO PEOPLE WHO MIGHT FALL IN. WHEN A STORM EVENT OCCURS THE STREAM LEVEL RISES AND ERODES THE STREAM BANK EVEN MORE CONTAMINATING THE STREAM WITH HEAVY LEVELS OF TOTALS SUSPENDED SOLIDS. THE GOAL OF THIS RESTORATION TO STABILIZE THE STREAM BANK WHILE CONTINUING TO ALLOW FOR RECREATIONAL FISHING.

8. DURING A SITE VISIT, ONE OF THE PIPES PRODDING OUT FROM THE STREAMBANK HAD WATER RUNNING FROM IT AND IT HAD NOT RAINED FOR AT LEAST 3 DAYS. RCE RECOMMENDS INVESTIGATING WHERE THIS WATER IS COMING FROM BEFORE RESTORING THIS STREAM BANK.

3. THE VARIOUS DETAILS BELOW DEMONSTRATE DIFFERENT METHODS THAT COULD BE BUILT TO REPAIR THE ERODED STREAM BANK.
4. THE TWO DETAILS ON THE FAR LEFT THAT INCLUDE ECO-NET STABILIZATION INVOLVE THE STREAM BANK BEING GRADED BACK FROM A NEAR STRAIGHT DROP TO A 2:1 SLOPE. THIS ELIMINATES THE FALL HAZARD FROM THE SITE. AFTER THE SITE IS REGRADED IT IS PLANTED WITH VARIOUS PLANTS MUCH LIKE THE ONES BELOW IN THE SUGGESTED PLANT LIST. THE PLANTS AS THEY GROW WILL HOLD THE SOIL AND VASTLY REDUCE THE AMOUNT OF TOTAL SUSPENDED SOLIDS FROM THAT STREAM BANK.

6. A LIVE TIMBER CRIBWALL COULD ALSO BE CONSTRUCTED. THE SYSTEM WOULD BE FAMILAR TO THAT IN THE DETAIL BELOW. THE STREAM BANK IS REBUILT USING LOGS, WIRE MESH AND LIVE STAKINGS. THE VOIDS BETWEEN THE LOGS ARE FILLED WITH ROCKS AND SOIL. LIVE STAKINGS ARE LIKE PLANTING PARTS OF LIVE PLANTS THAT CAN GROW INTO A NEW PLANT. IT IS CHEAPER THAN BUYING PLANTS AND JUST AS EFFECTIVE FOR CERTAIN PLANTS. AS THE PLANTS GROW THE LOGS DECAY AND THE ROOTS FROM THE NEW PLANTS REPLACE THE LOGS FOR SOIL STABILITY.

7. THE LAST DETAIL ON THE RIGHT IS A KIND OF COMBINATION OF THE OTHER TWO. THE STREAM BANK IS REGRADED BUT NOT AS SHALLOW ECO-NET AND INSTEAD OF JUST VARIOUS AMOUNTS OF PLANTINGS, IT RELIES MORE ON LIVE STAKINGS OF PLANTS.
