**Impervious Cover Reduction Action Plan
for
Buena Borough, Atlantic County, New Jersey**

*Prepared for Buena Borough by the
Rutgers Cooperative Extension Water Resources Program*

November 29, 2018

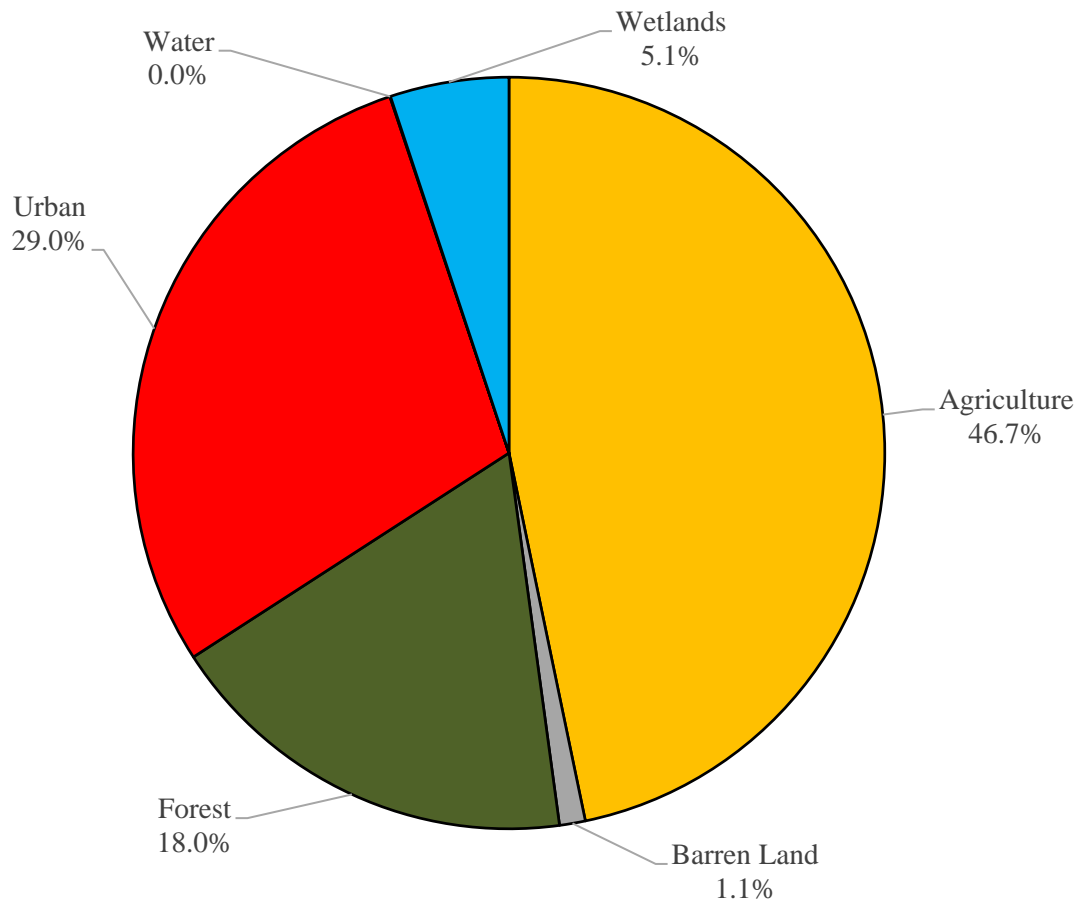
Figure 2: Pie chart illustrating the land use in Buena Borough

Located in Atlantic County, New Jersey, Buena Borough covers approximately 6.52 square miles. Figures 1 and 2 illustrate that Buena Borough is dominated by agriculture land uses. A total of 29.0% of the municipality's land use is classified as urban. Of the urban land in Buena Borough, rural residential is the dominant land use (Figure 3).

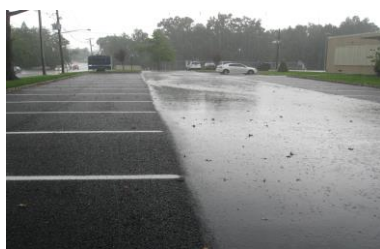
Pervious pavements

There are several types of permeable pavement systems including porous asphalt, pervious concrete, permeable pavers, and grass pavers. These surfaces are hard and support vehicle traffic but also allow water to infiltrate through the surface. They have an underlying stone layer to store stormwater runoff and allow it to slowly seep into the ground.

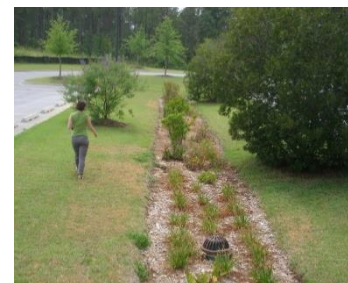
Bioswale

Bioswales are landscape features that convey stormwater from one location to another while removing pollutants and providing water an opportunity to infiltrate.

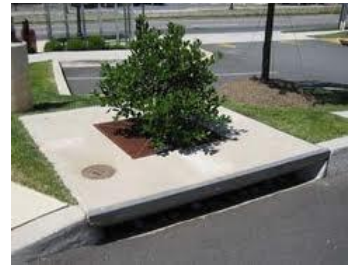
Tree filter boxes

These are pre-manufactured concrete boxes that contain a special soil mix and are planted with a tree or shrub. They filter stormwater runoff but provide little storage capacity. They are typically designed to quickly filter stormwater and then discharge it to the local sewer system.

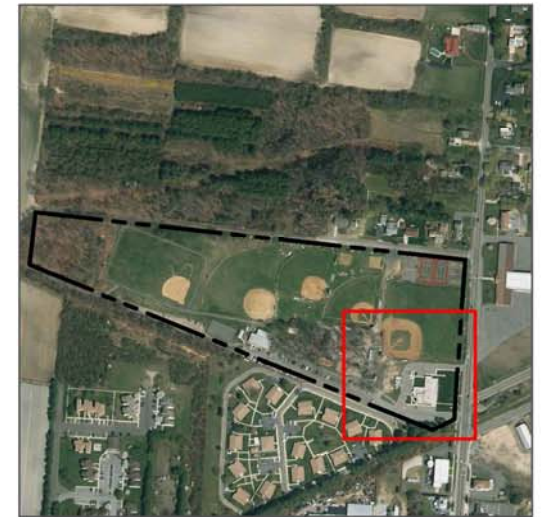
Buena Municipal Center

Connected downspouts on the east side of the building can be disconnected and led to bioretention systems on the southeast and northeast corners of the building to capture, treat, and infiltrate rooftop runoff. A preliminary soil assessment suggests that the soils have suitable drainage characteristics for green infrastructure.

Recommended Green Infrastructure Practices	Recharge Potential (Mgal/yr)	TSS Removal Potential (lbs/yr)	Maximum Volume Reduction Potential (gal/storm)	Peak Discharge Reduction Potential (cu. ft./second)	Estimated Size (sq. ft.)	Estimated Cost
Bioretention systems	0.079	13	5,849	0.22	765	\$3,825

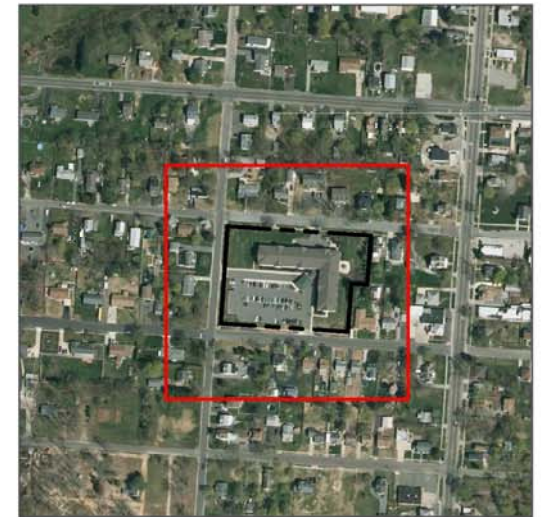
Buena Gardens Senior Apartments

Two bioretention systems can be installed in the turfgrass areas at the northwest corner of the building. Two strips of parking spaces in the parking lot can be retrofitted with pervious pavement to allow stormwater runoff to infiltrate the ground before it reaches the catch basins. Four planter boxes can be installed at each of the three downspouts on the east side of the building. Rainwater can be harvested from the roof of the building and stored in a cistern on the southeast side of the building. A preliminary soil assessment suggests that the soils have suitable drainage characteristics for green infrastructure.

Recommended Green Infrastructure Practices	Recharge Potential (Mgal/yr)	TSS Removal Potential (lbs/yr)	Maximum Volume Reduction Potential (gal/storm)	Peak Discharge Reduction Potential (cu. ft./second)	Estimated Size (sq. ft.)	Estimated Cost
Bioretention systems	0.100	17	7,345	0.28	960	\$4,800
Pervious pavement	1.021	171	38,739	1.46	8,620	\$215,500
Planter boxes	n/a	9	n/a	n/a	12 (boxes)	\$12,000
Rainwater harvesting	0.019	3	560	0.02	560 (gal)	\$1,120

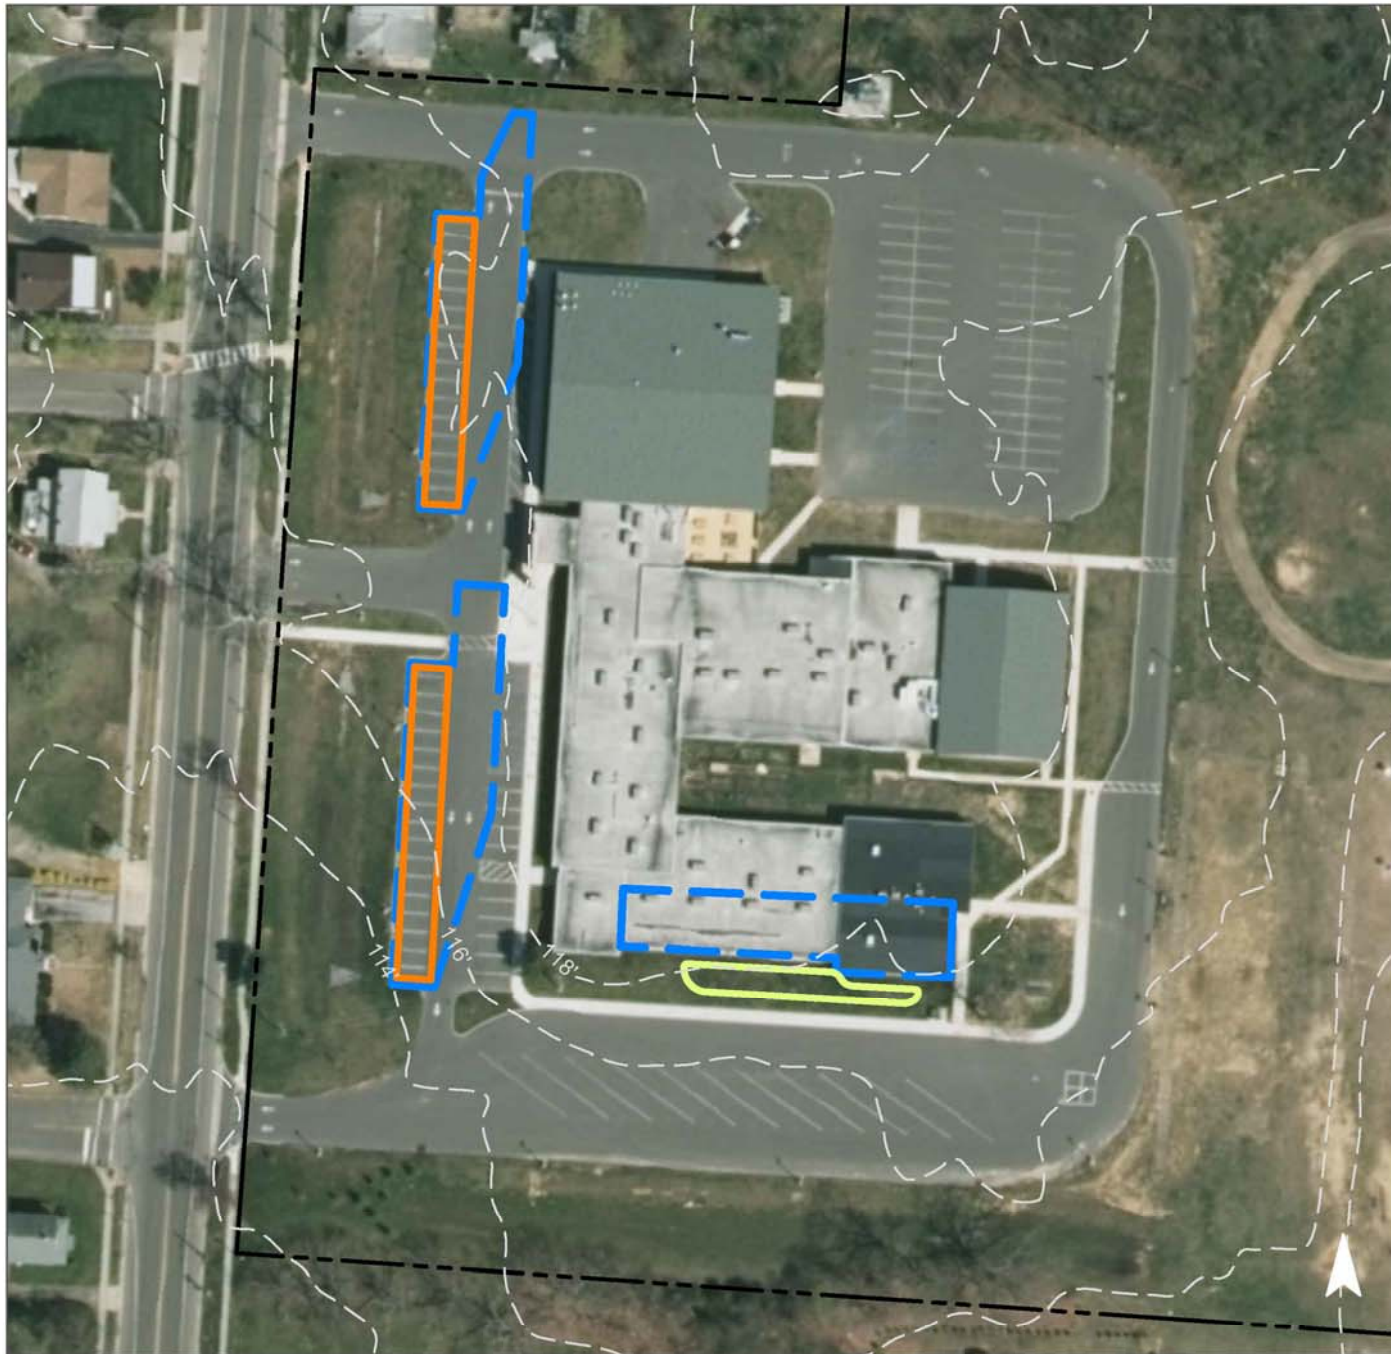
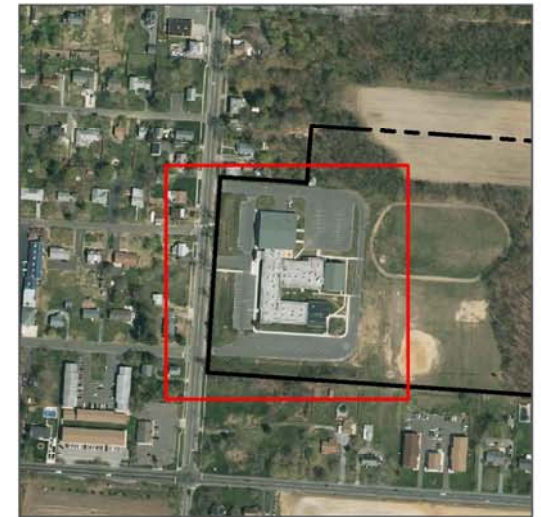
Cleary Elementary School

The downspouts on the south side of the building can be disconnected and led to a bioretention system to capture, treat, and infiltrate rooftop runoff. Sections of pervious pavement can be installed in the parking lot along the west side of the building to capture and infiltrate stormwater runoff from the parking lot. A preliminary soil assessment suggests that the soils have suitable drainage characteristics for green infrastructure.

Recommended Green Infrastructure Practices	Recharge Potential (Mgal/yr)	TSS Removal Potential (lbs/yr)	Maximum Volume Reduction Potential (gal/storm)	Peak Discharge Reduction Potential (cu. ft./second)	Estimated Size (sq. ft.)	Estimated Cost
Bioretention system	0.150	25	11,048	0.42	1,440	\$7,200
Pervious pavement	0.391	65	28,768	1.08	5,620	\$140,500

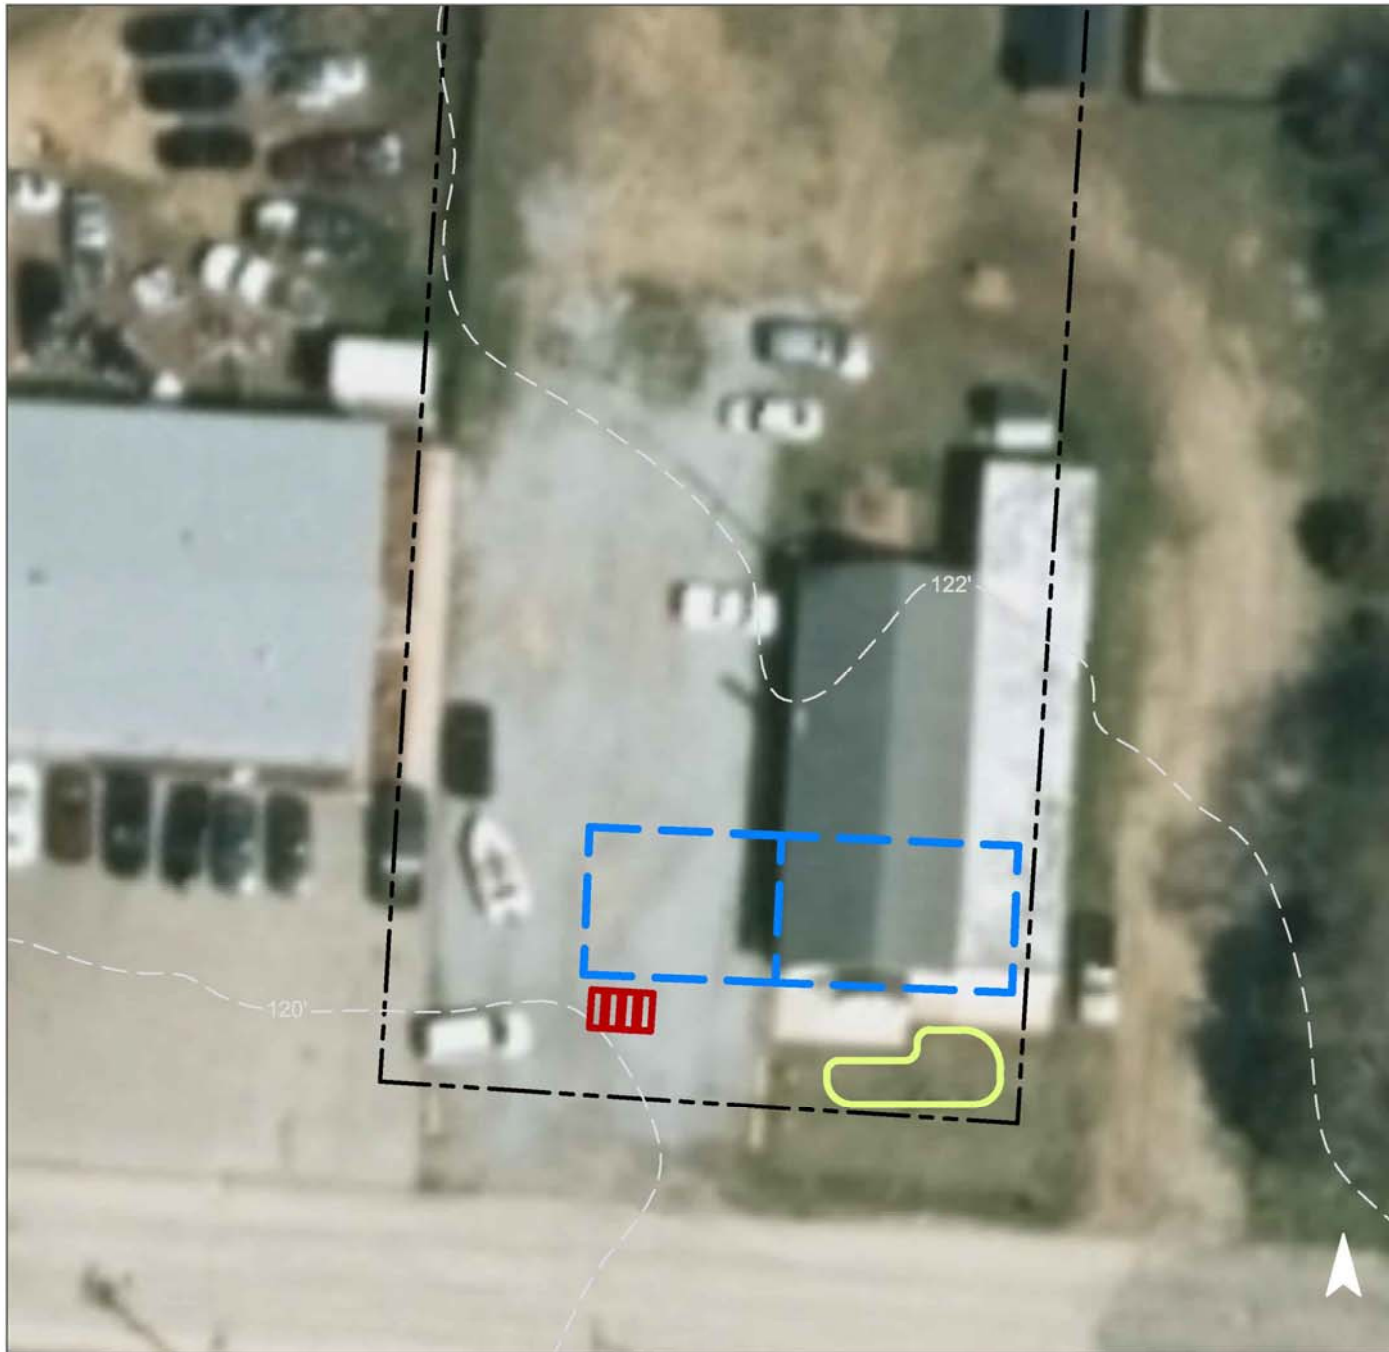
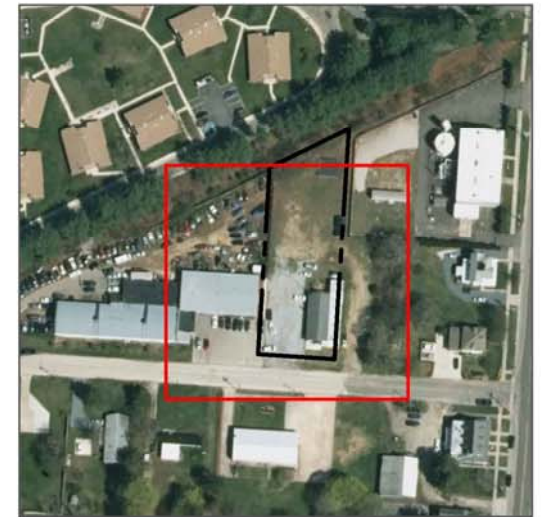
Grace Orthodox Fellowship Church

The connected downspout at the southwest corner of the church can be disconnected and led to a downspout planter box to allow roof runoff to be filtered and reused. The disconnected downspout in the middle of the south side of the church can be redirected to join with the connected downspout on the southeast corner of the church to lead to a bioretention system. A preliminary soil assessment suggests that the soils have suitable drainage characteristics for green infrastructure. *(Aerial is not up to date with current building)*

Recommended Green Infrastructure Practices	Recharge Potential (Mgal/yr)	TSS Removal Potential (lbs/yr)	Maximum Volume Reduction Potential (gal/storm)	Peak Discharge Reduction Potential (cu. ft./second)	Estimated Size (sq. ft.)	Estimated Cost
Bioretention system	0.022	4	1,631	0.06	215	\$1,075
Planter boxes	n/a	3	n/a	n/a	4 (boxes)	\$4,000

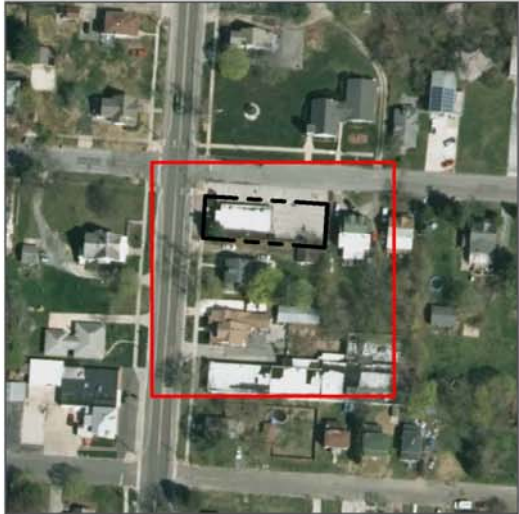
Minotola Dental Associates

A strip of parking spaces on the west side of the building can be replaced with pervious pavement to capture and infiltrate stormwater runoff from the roof. A preliminary soil assessment suggests that the soils have suitable drainage characteristics for green infrastructure.

Recommended Green Infrastructure Practices	Recharge Potential (Mgal/yr)	TSS Removal Potential (lbs/yr)	Maximum Volume Reduction Potential (gal/storm)	Peak Discharge Reduction Potential (cu. ft./second)	Estimated Size (sq. ft.)	Estimated Cost
Pervious pavement	0.063	11	4,668	0.18	1,205	\$30,125

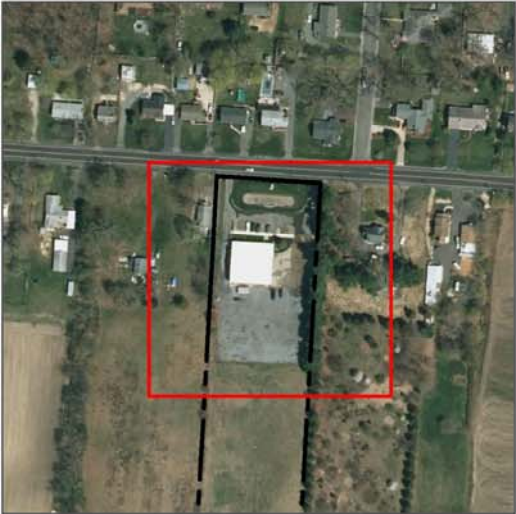
Minotola Fire Company

The downspout on the southwest corner of the building can lead to cisterns to capture stormwater runoff from the roof. Collected stormwater from the cistern can be used to wash off emergency vehicles or for other non-potable purposes. A preliminary soil assessment suggests that the soils have suitable drainage characteristics for green infrastructure.

Recommended Green Infrastructure Practices	Recharge Potential (Mgal/yr)	TSS Removal Potential (lbs/yr)	Maximum Volume Reduction Potential (gal/storm)	Peak Discharge Reduction Potential (cu. ft./second)	Estimated Size (sq. ft.)	Estimated Cost
Rainwater harvesting	0.042	7	1,245	0.12	1,245 (gal)	\$2,490

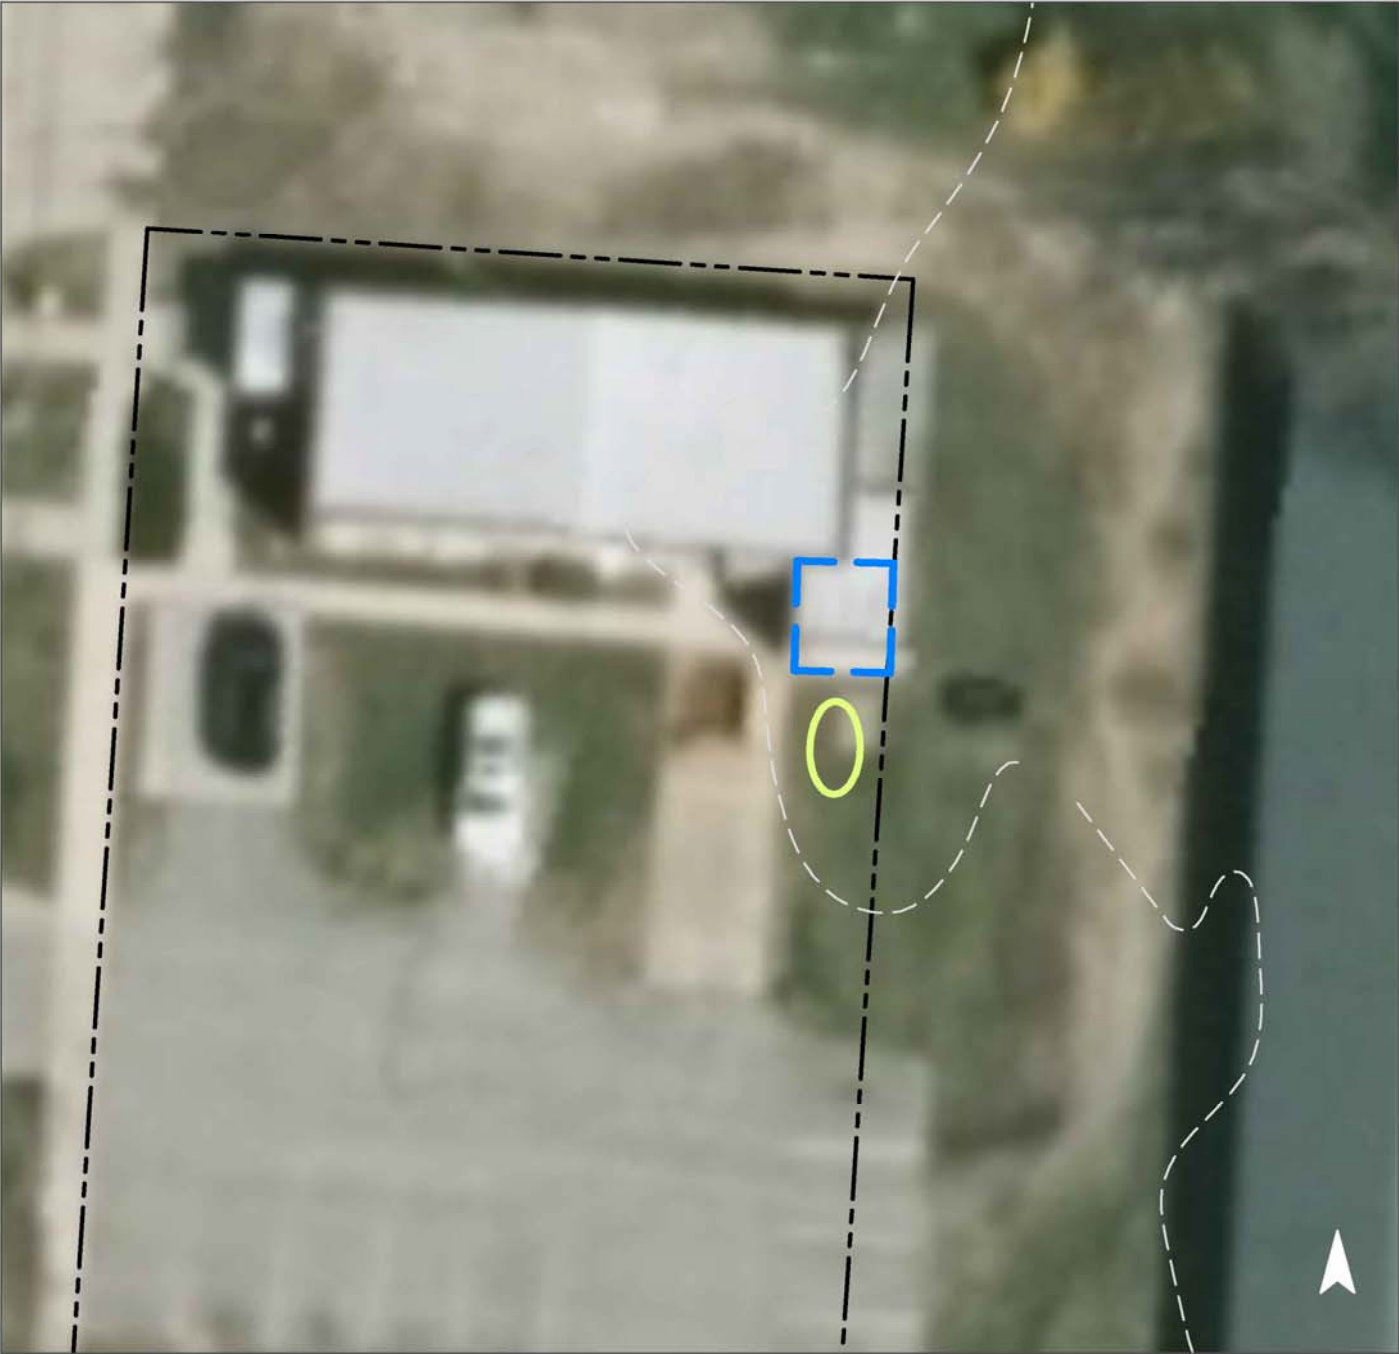
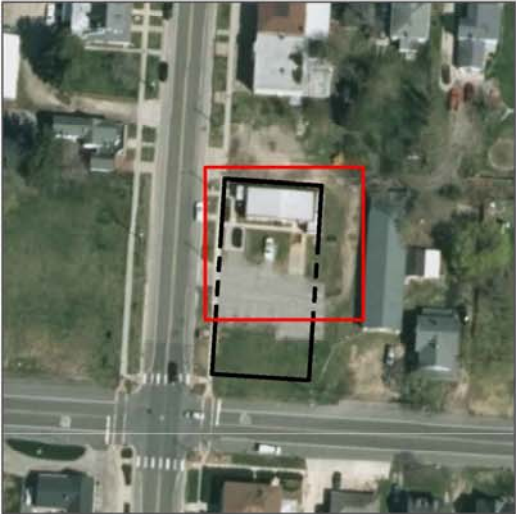
Minotola Post Office

A bioretention system can be installed at the southeast corner of the building to capture, treat, and infiltrate rooftop runoff. A preliminary soil assessment suggests that the soils have suitable drainage characteristics for green infrastructure.

Recommended Green Infrastructure Practices	Recharge Potential (Mgal/yr)	TSS Removal Potential (lbs/yr)	Maximum Volume Reduction Potential (gal/storm)	Peak Discharge Reduction Potential (cu. ft./second)	Estimated Size (sq. ft.)	Estimated Cost
Bioretention system	0.003	1	217	0.01	30	\$150

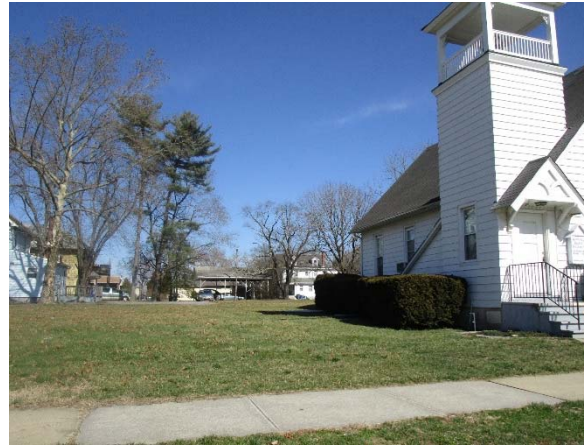
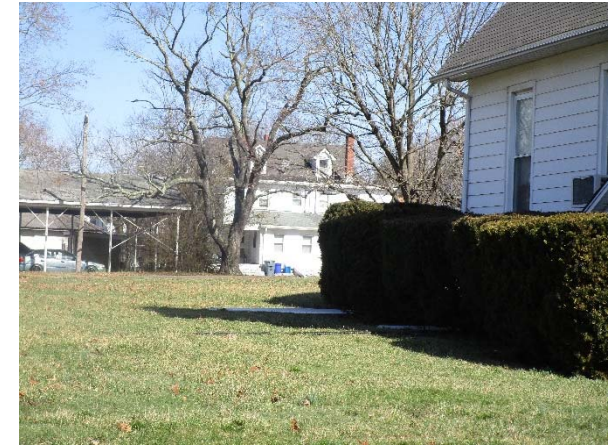
Block and Lot: Block 191, Lot 11

A bioretention system can be installed on the west side of the church to capture, treat, and infiltrate rooftop runoff. A preliminary soil assessment suggests that the soils have suitable drainage characteristics for green infrastructure.

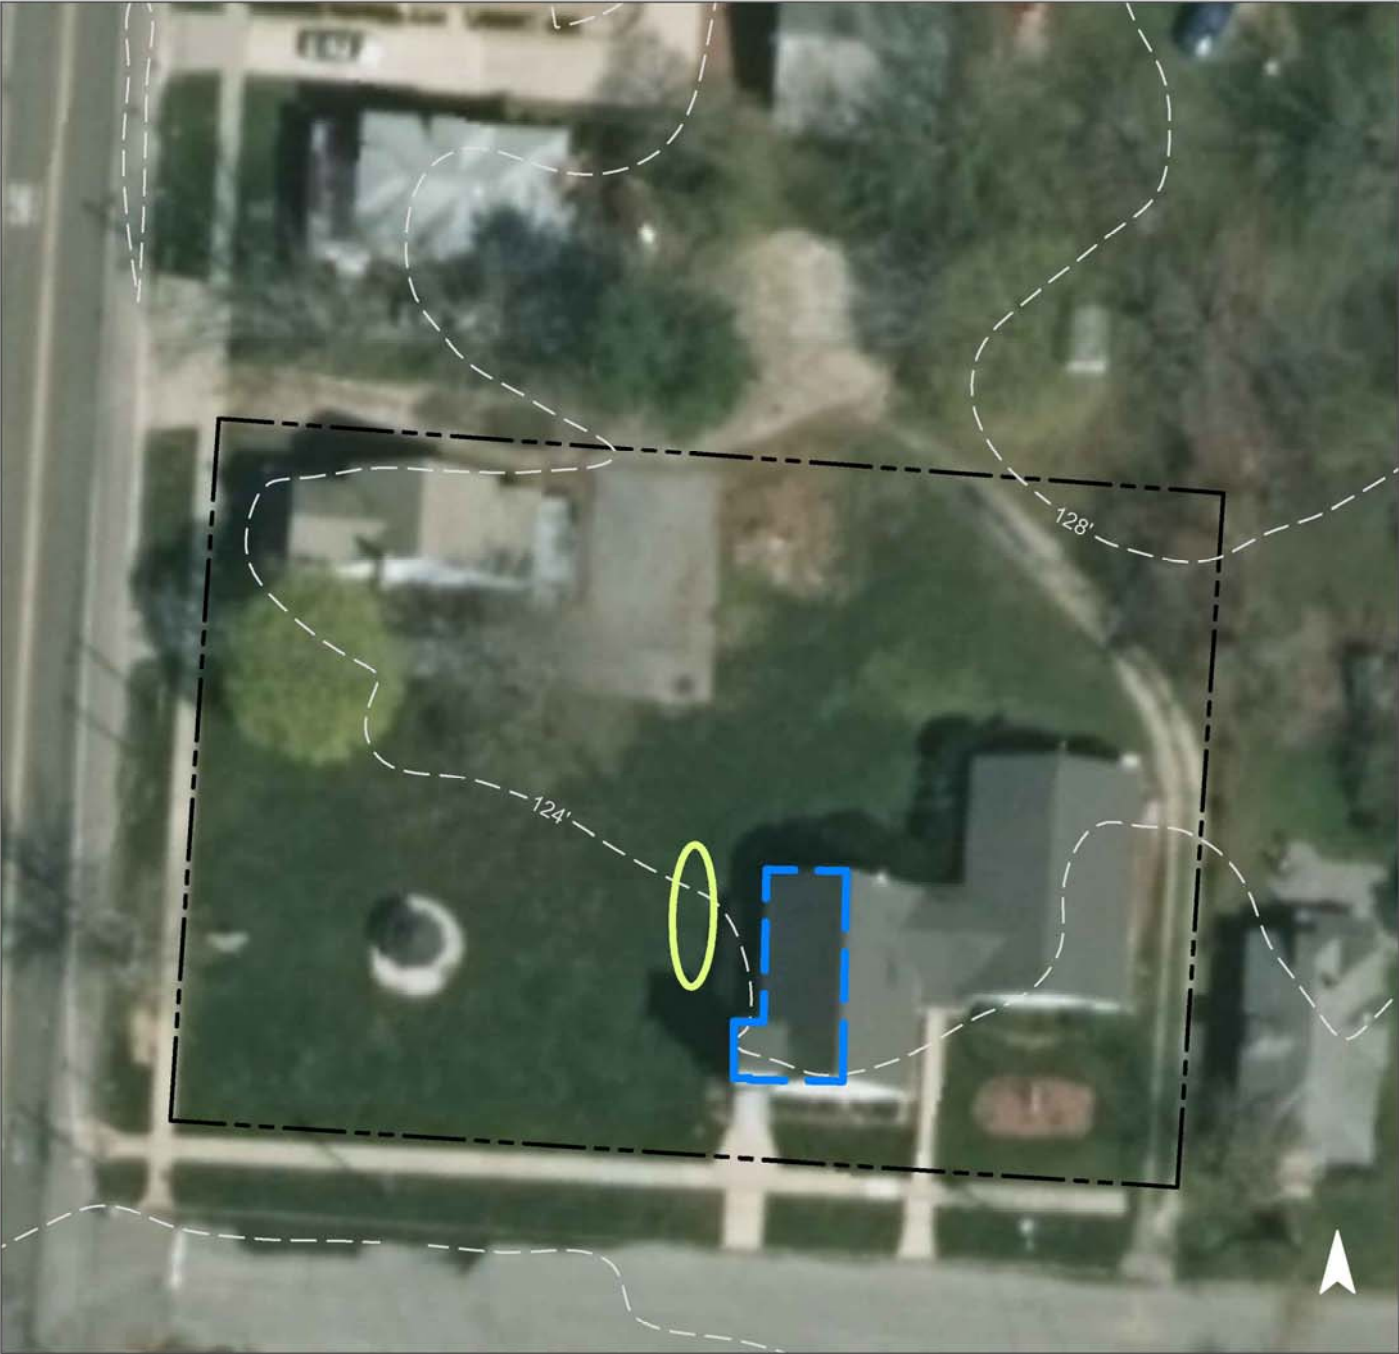
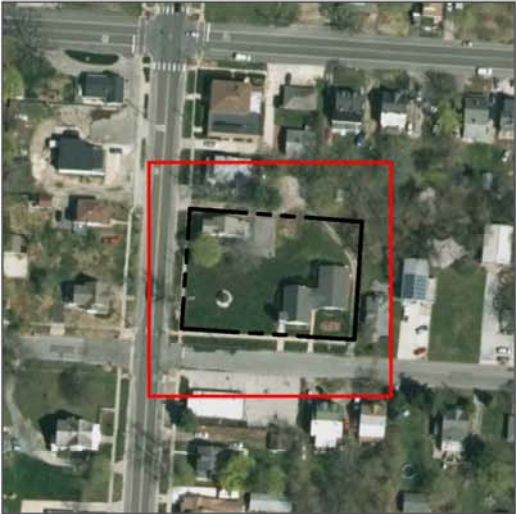
Minotola United Methodist Church

GREEN INFRASTRUCTURE RECOMMENDATIONS

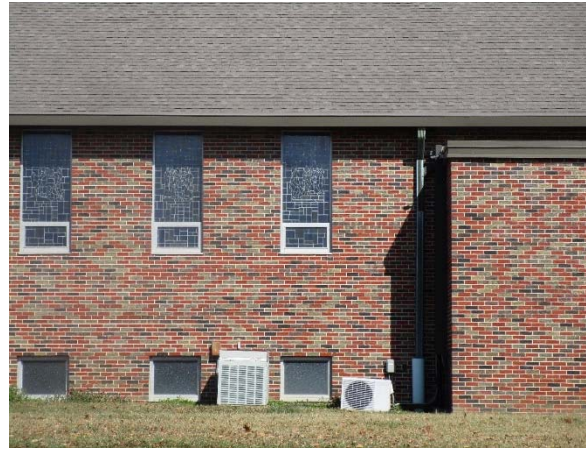
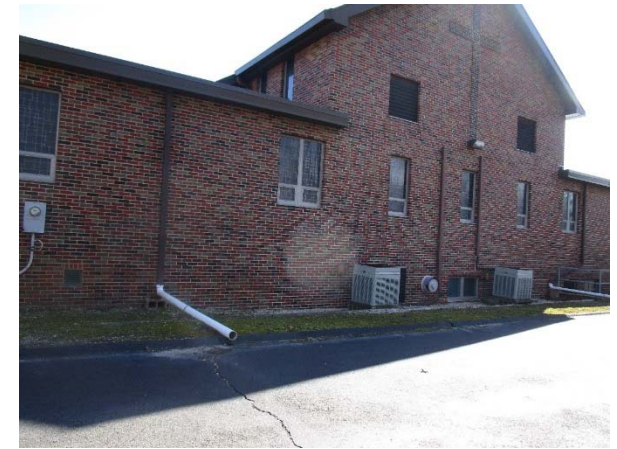
Block and Lot: Block 184, Lot 3

Bioretention systems can be installed at the north and south sides of the church to capture, treat, and infiltrate rooftop runoff. The five parking spaces on the southwest side of the church can be replaced with pervious pavement to capture and infiltrate stormwater runoff from the parking lot and roof. The downspout at the northwest corner of the building can lead to a downspout planter box to allow rooftop runoff to be filtered and reused. A preliminary soil assessment suggests that the soils have suitable drainage characteristics for green infrastructure.

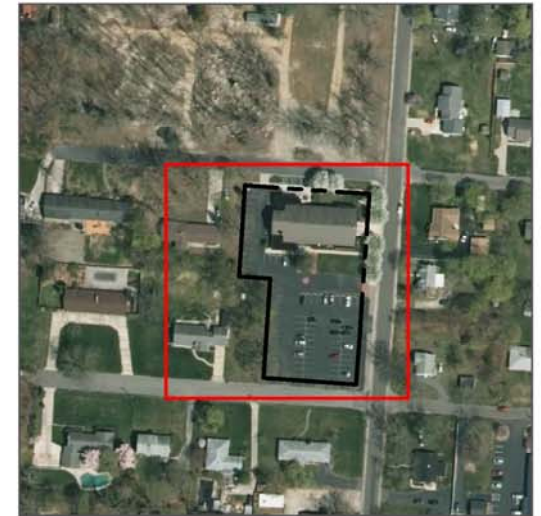
Our Lady of the Blessed Sacrament Church

GREEN INFRASTRUCTURE RECOMMENDATIONS

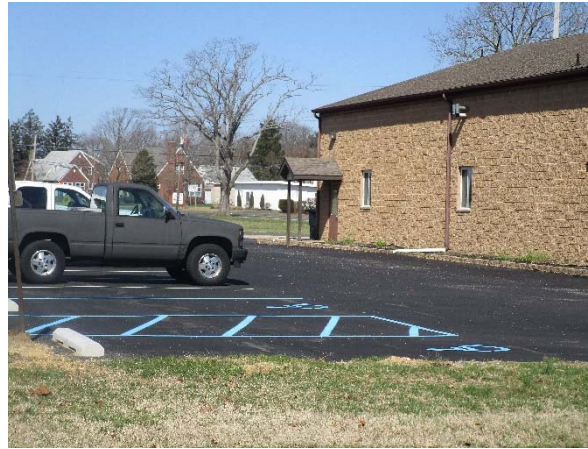
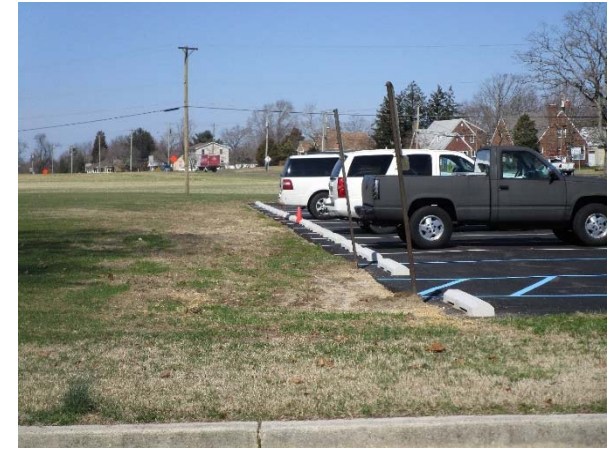
Block and Lot: Block 136, Lot 4

A bioretention system can be installed along the parking lot on the west side of the property to capture, treat, and infiltrate stormwater runoff from the parking lot. The downspout on the south side of the building along the driveway can lead to a cistern. Collected stormwater from the cistern can be used to wash off emergency vehicles or for other non-potable purposes. A preliminary soil assessment suggests that the soils have suitable drainage characteristics for green infrastructure.

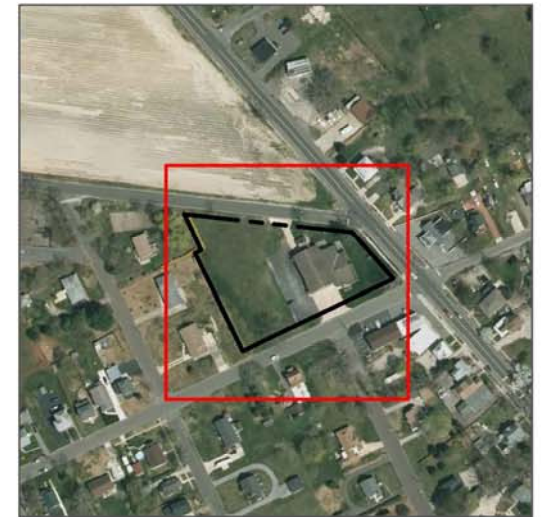
Landisville Fire Company

GREEN INFRASTRUCTURE RECOMMENDATIONS

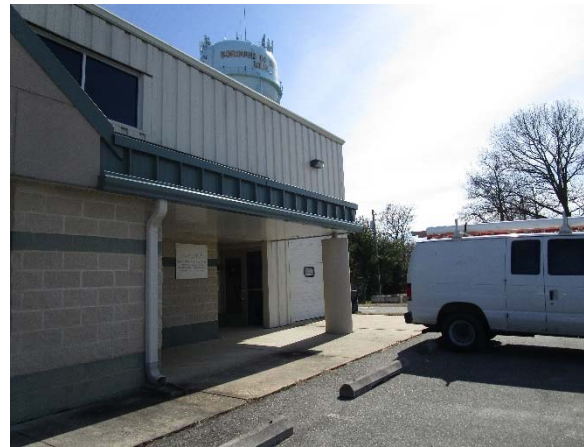
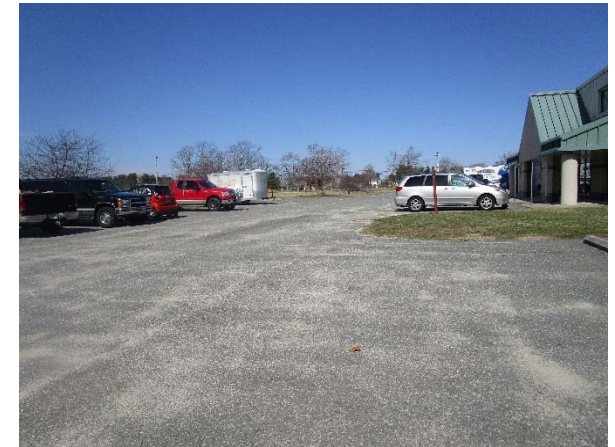
Subwatershed: Panther Creek
Site Area: 204,927 sq. ft.
Address: 525 Southwest Boulevard
Buena, NJ 08341
Block and Lot: Block 145, Lot 8

A strip of parking spaces on the west side of the building can be replaced with pervious pavement to capture and infiltrate stormwater. A preliminary soil assessment suggests that the soils have suitable drainage characteristics for green infrastructure.

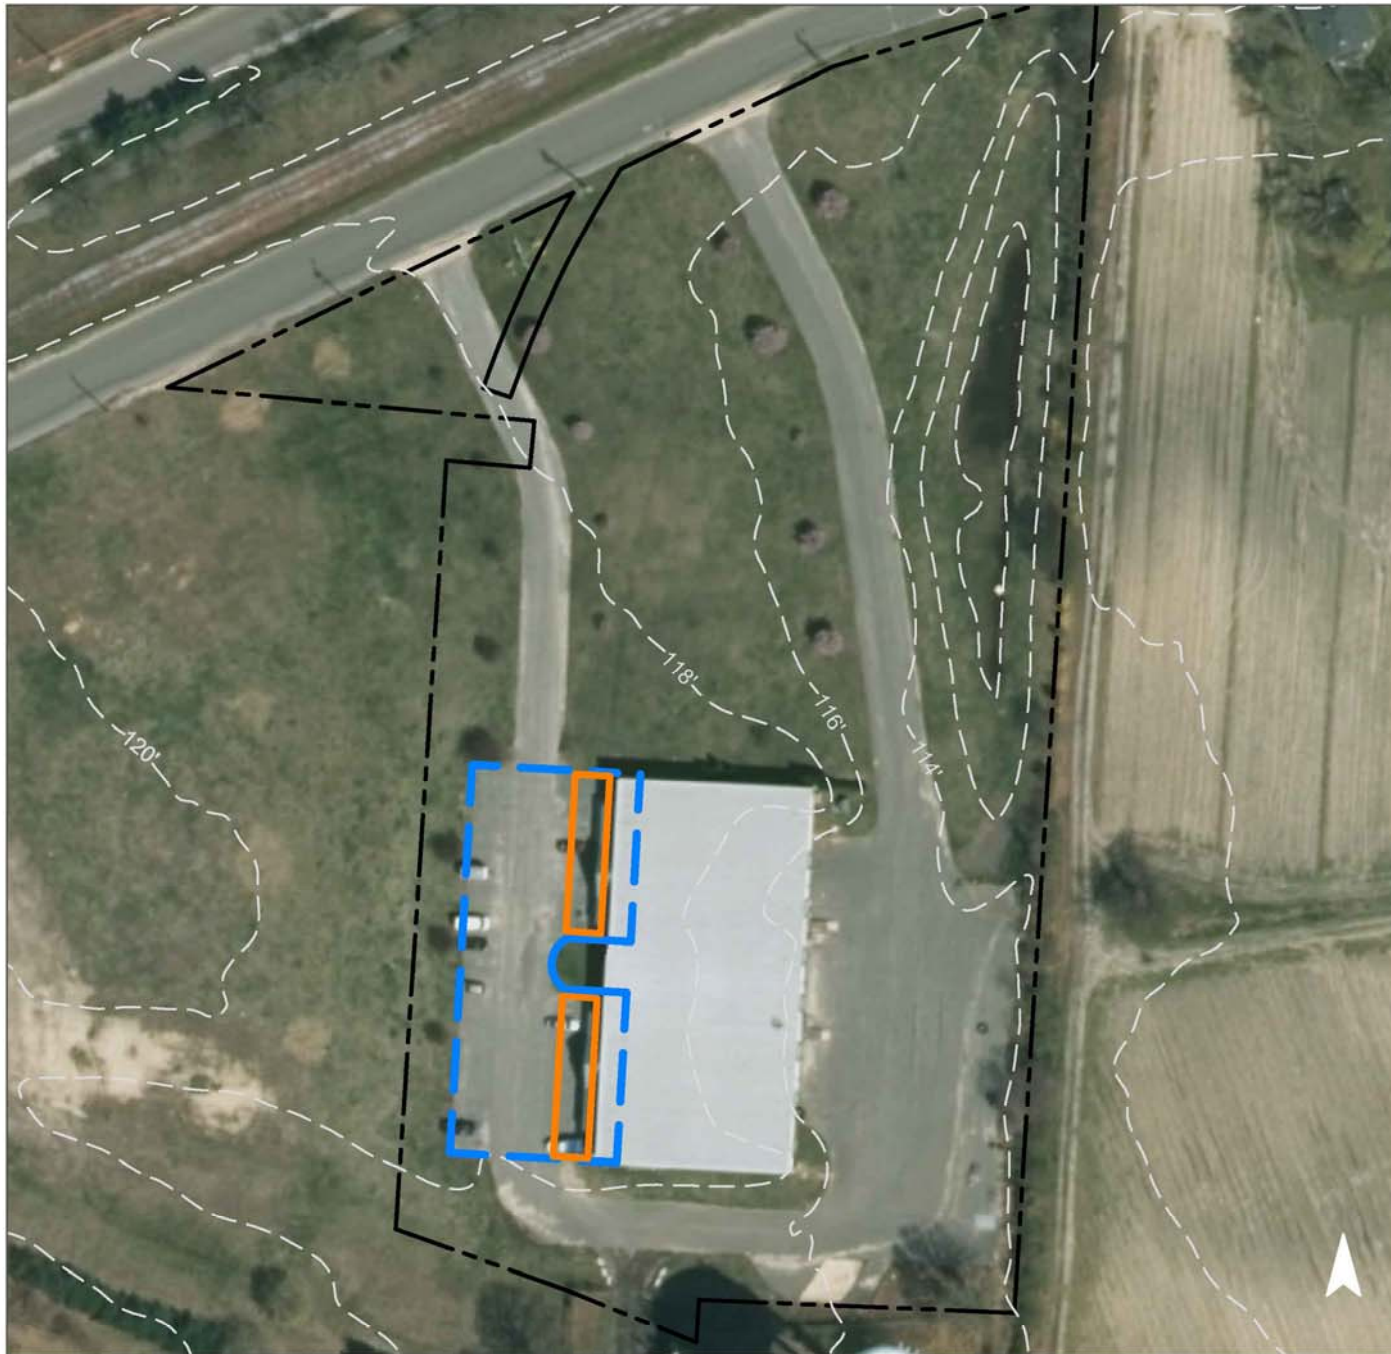
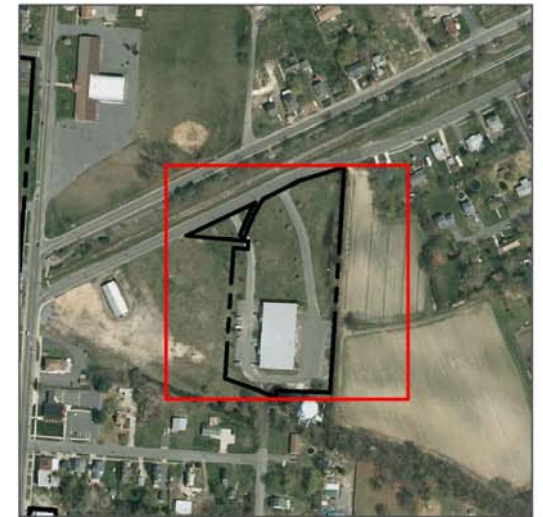
Buena EMS and Crossfit Complex

GREEN INFRASTRUCTURE RECOMMENDATIONS
