#### Impervious Cover Reduction Action Plan for Tewksbury Township, Hunterdon County, New Jersey

Prepared for Tewksbury Township by the Rutgers Cooperative Extension Water Resources Program

May 19, 2020

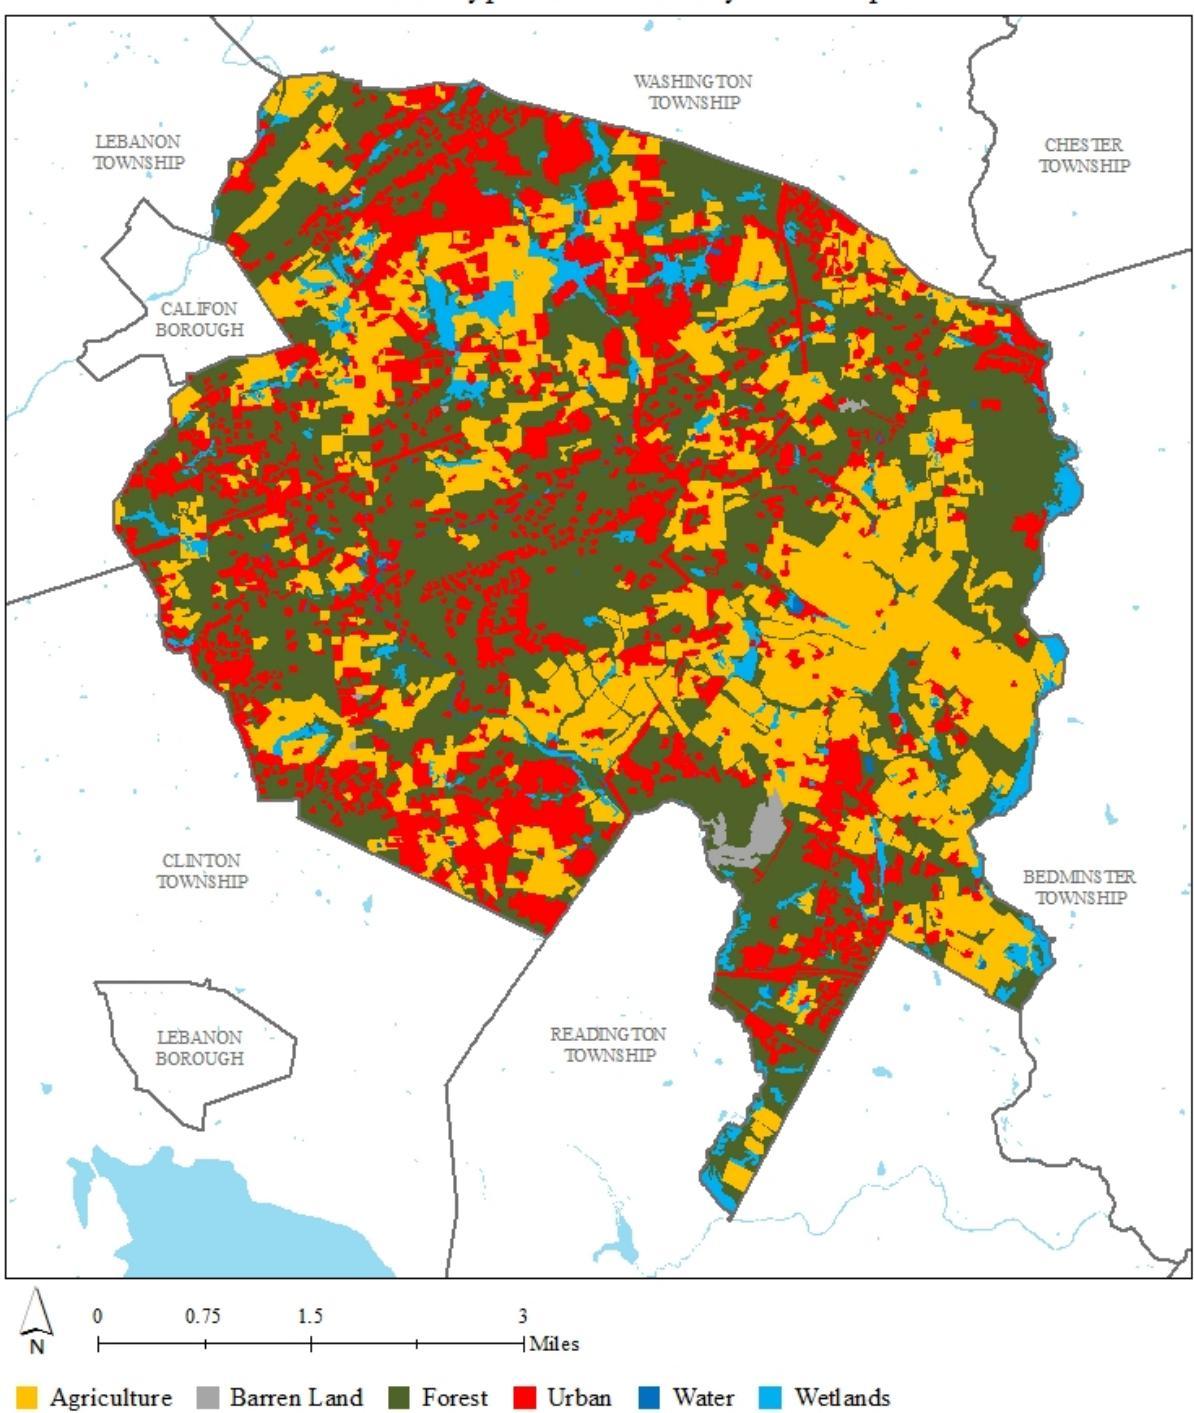
Figure 1: Map illustrating the land use in Tewksbury Township

Located in Hunterdon County, New Jersey, Tewksbury Township covers approximately 31.70 square miles. Figures 1 and 2 illustrate that Tewksbury Township is dominated by forest land use. A total of 22.9% of the municipality's land use is classified as urban. Of the urban land in Tewksbury Township, rural residential is the dominant land use (Figure 3).

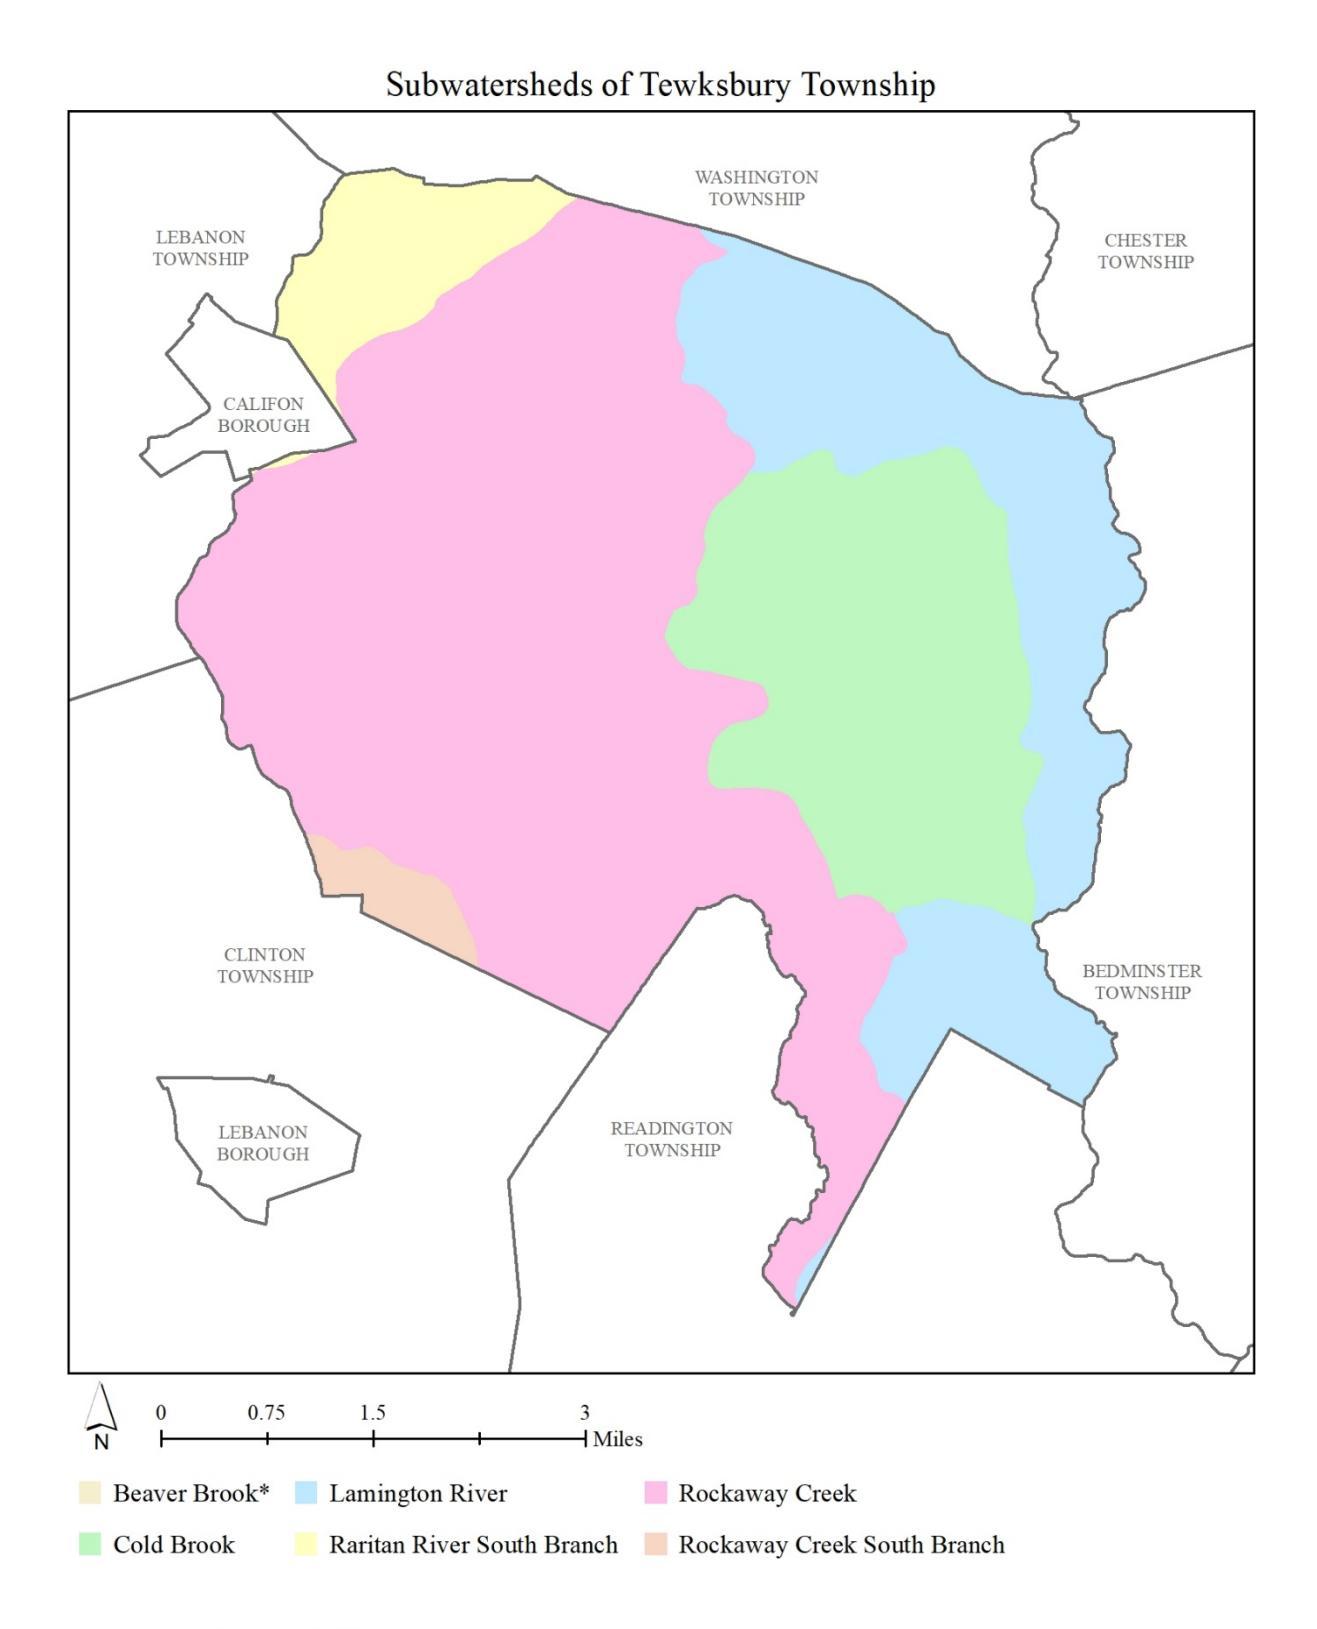
Figure 4: Map of the subwatersheds in Tewksbury Township

Tewksbury Township contains portions of six subwatersheds (Figure 4). For this impervious cover reduction action plan, projects have been identified in three of these watersheds. Initially, aerial imagery was used to identify potential project sites that contain extensive impervious cover. Field visits were then conducted at each of these potential project sites to determine if a viable option exists to reduce impervious cover or to disconnect impervious surfaces from draining directly to the local waterway or storm sewer system. During the site visit, appropriate green infrastructure practices for the site were determined. Sites that already had stormwater management practices in place were not considered.

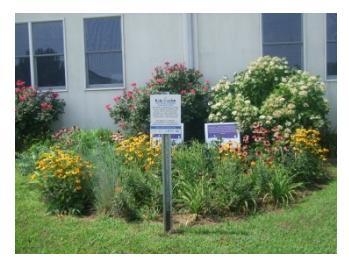
These are landscaped features that are designed to capture, treat, and infiltrate stormwater runoff. These systems can easily be incorporated into existing landscapes, improving aesthetics and creating wildlife habitat while managing stormwater runoff. Bioretention systems also can be used in soils that do not quickly infiltrate by incorporating an underdrain into the system.

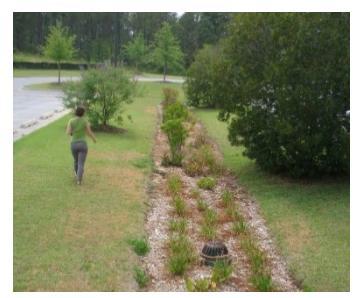
Bioswales are landscape features that convey stormwater from one location to another while removing pollutants and providing water an opportunity to infiltrate.

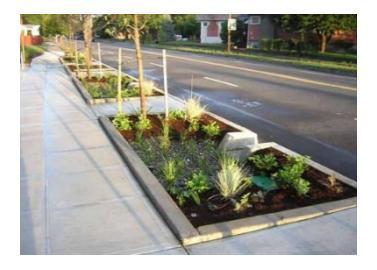
Stormwater planters are vegetated structures that are built into the sidewalk to intercept stormwater runoff from the roadway or sidewalk. Many of these planters are designed to allow the water to infiltrate into the ground while others are designed simply to filter the water and convey it back into the stormwater sewer system.

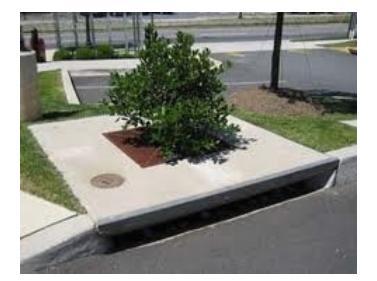
These are pre-manufactured concrete boxes that contain a special soil mix and are planted with a tree or shrub. They filter stormwater runoff but provide little storage capacity. They are typically designed to quickly filter stormwater and then discharge it to the local sewer system.

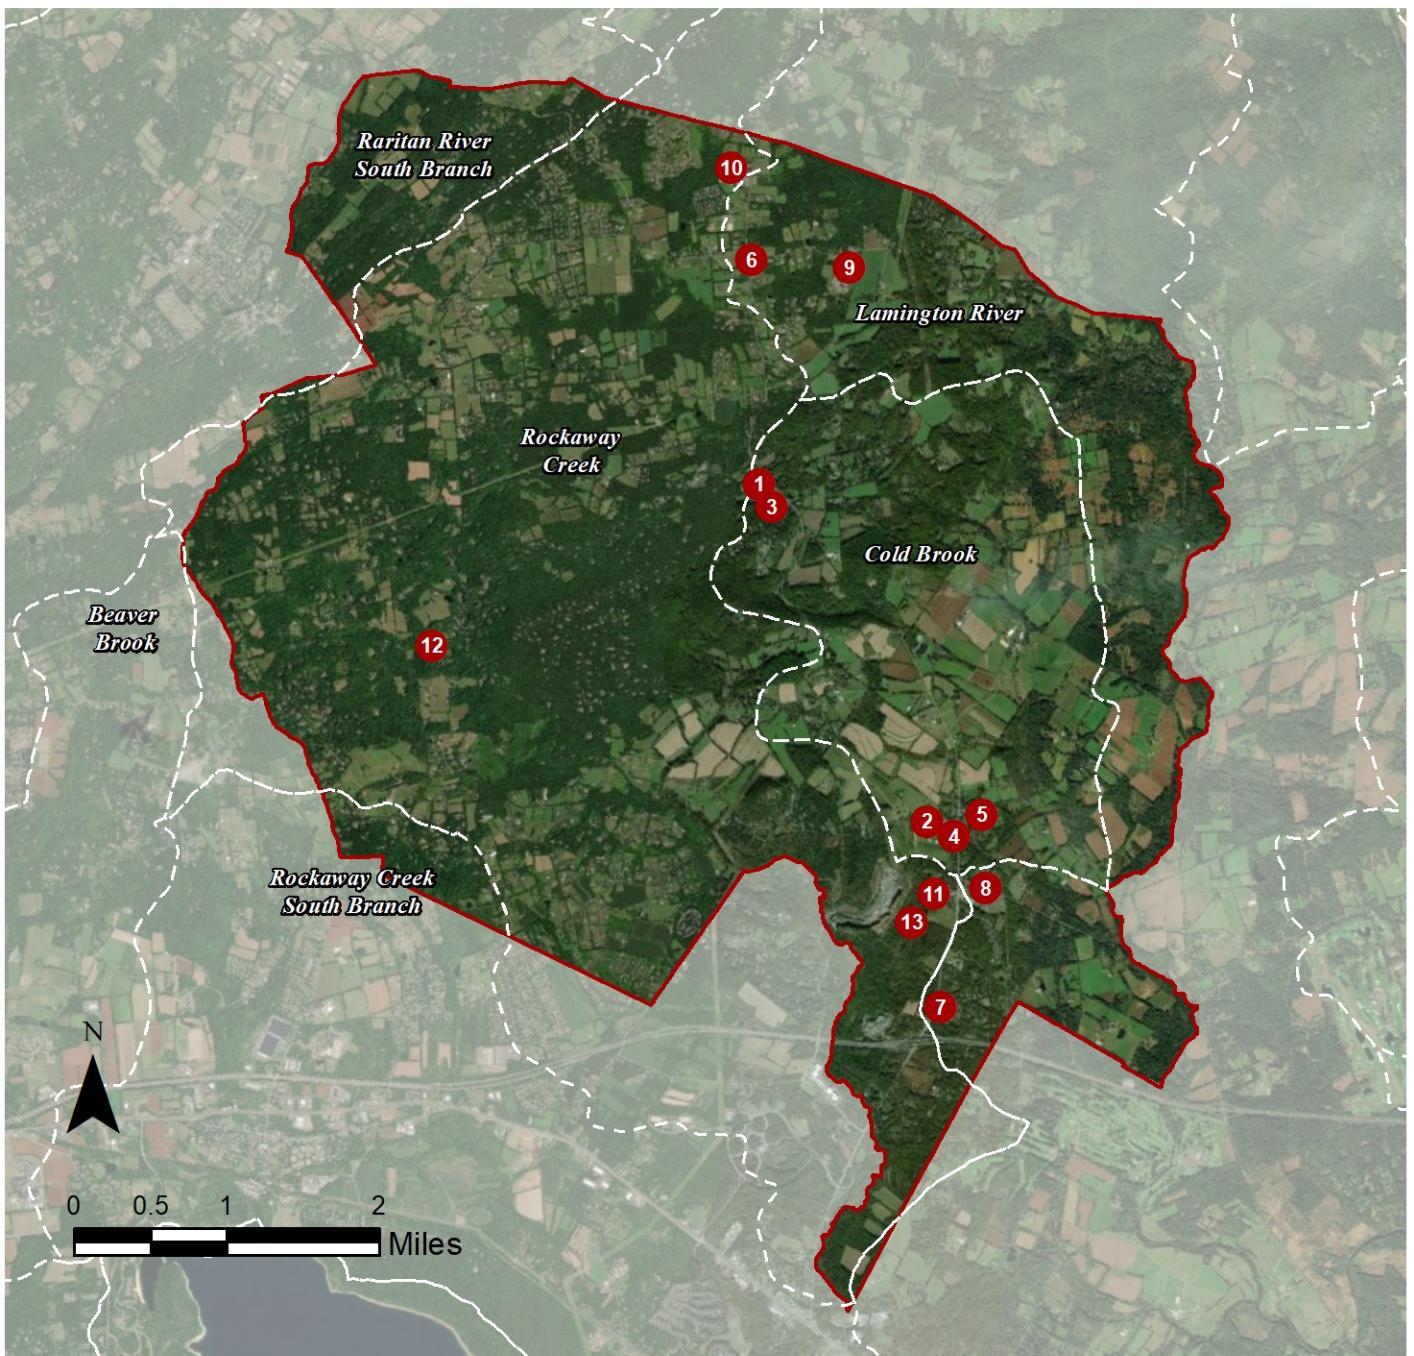
#### **TEWKSBURY TOWNSHIP: GREEN INFRASTRUCTURE SITES**

- 1. Old Turnpike Middle School
- 2. Oldwick Park
- 3. Tewksbury First Aid & Rescue, Administration/ Police, and Municipal Complex
- 4. Tewksbury Township Library
- 5. Zion Lutheran Church

- 6. Fairmount United Methodist Church
- 7. Oldwick Animal Hospital
- 8. Oldwick Post Office
- 9. Tewksbury Elementary School

- 10. Haytown Nursery School
- 11. Oldwick Fire Company Social Hall
- 12. Tewksbury Historical Society
- 13. The Meadows At Oldwick

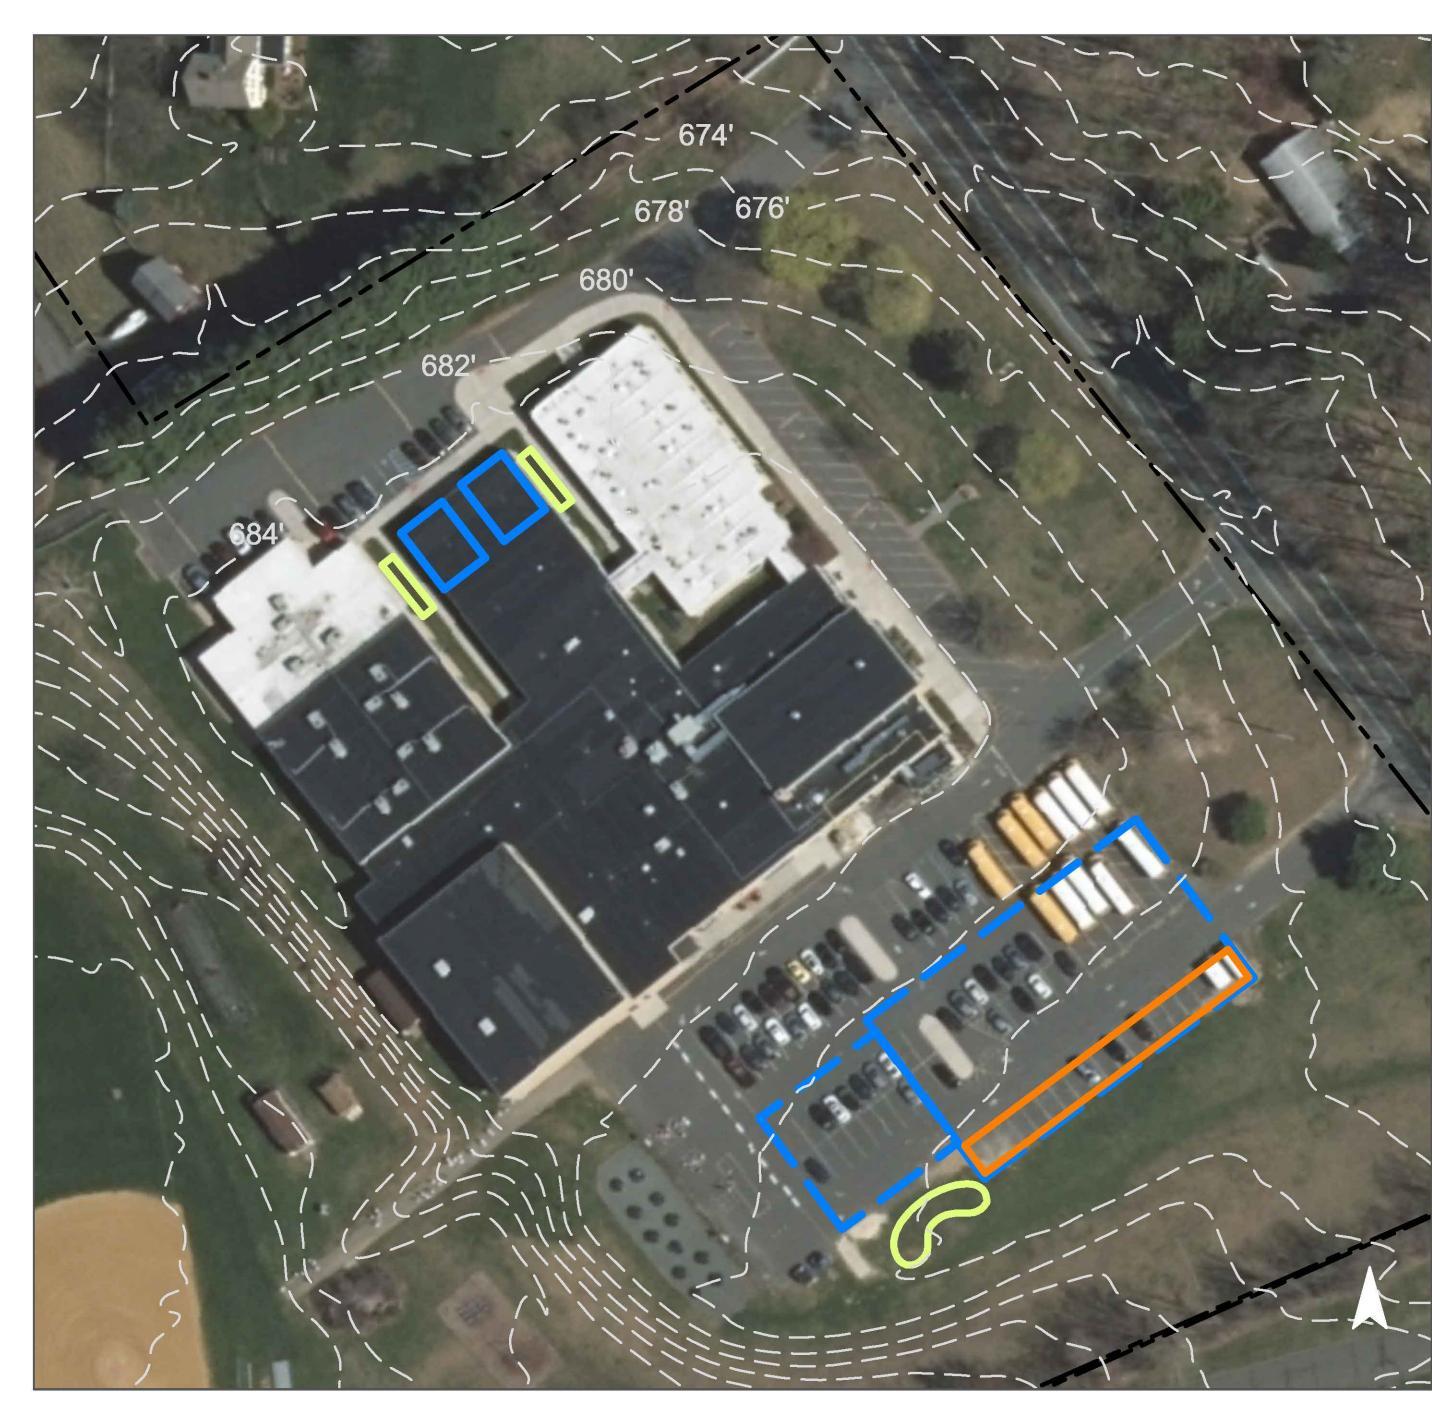
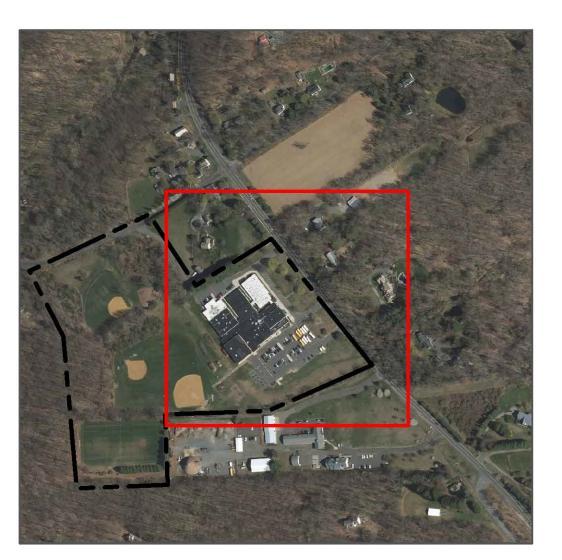
#### Old Turnpike Middle School

Two rain gardens can be installed adjacent to the entrance of the building and in the turfgrass south of the building to capture, treat, and infiltrate rooftop runoff. A section of parking spaces can be converted to pervious pavement to capture and infiltrate stormwater. A preliminary soil assessment suggests that more soil testing would be required before determining the soil's suitability for green infrastructure.

- bioretention system
- pervious pavement
- drainage area
- [] property line
- 2015 Aerial: NJOIT, OGIS

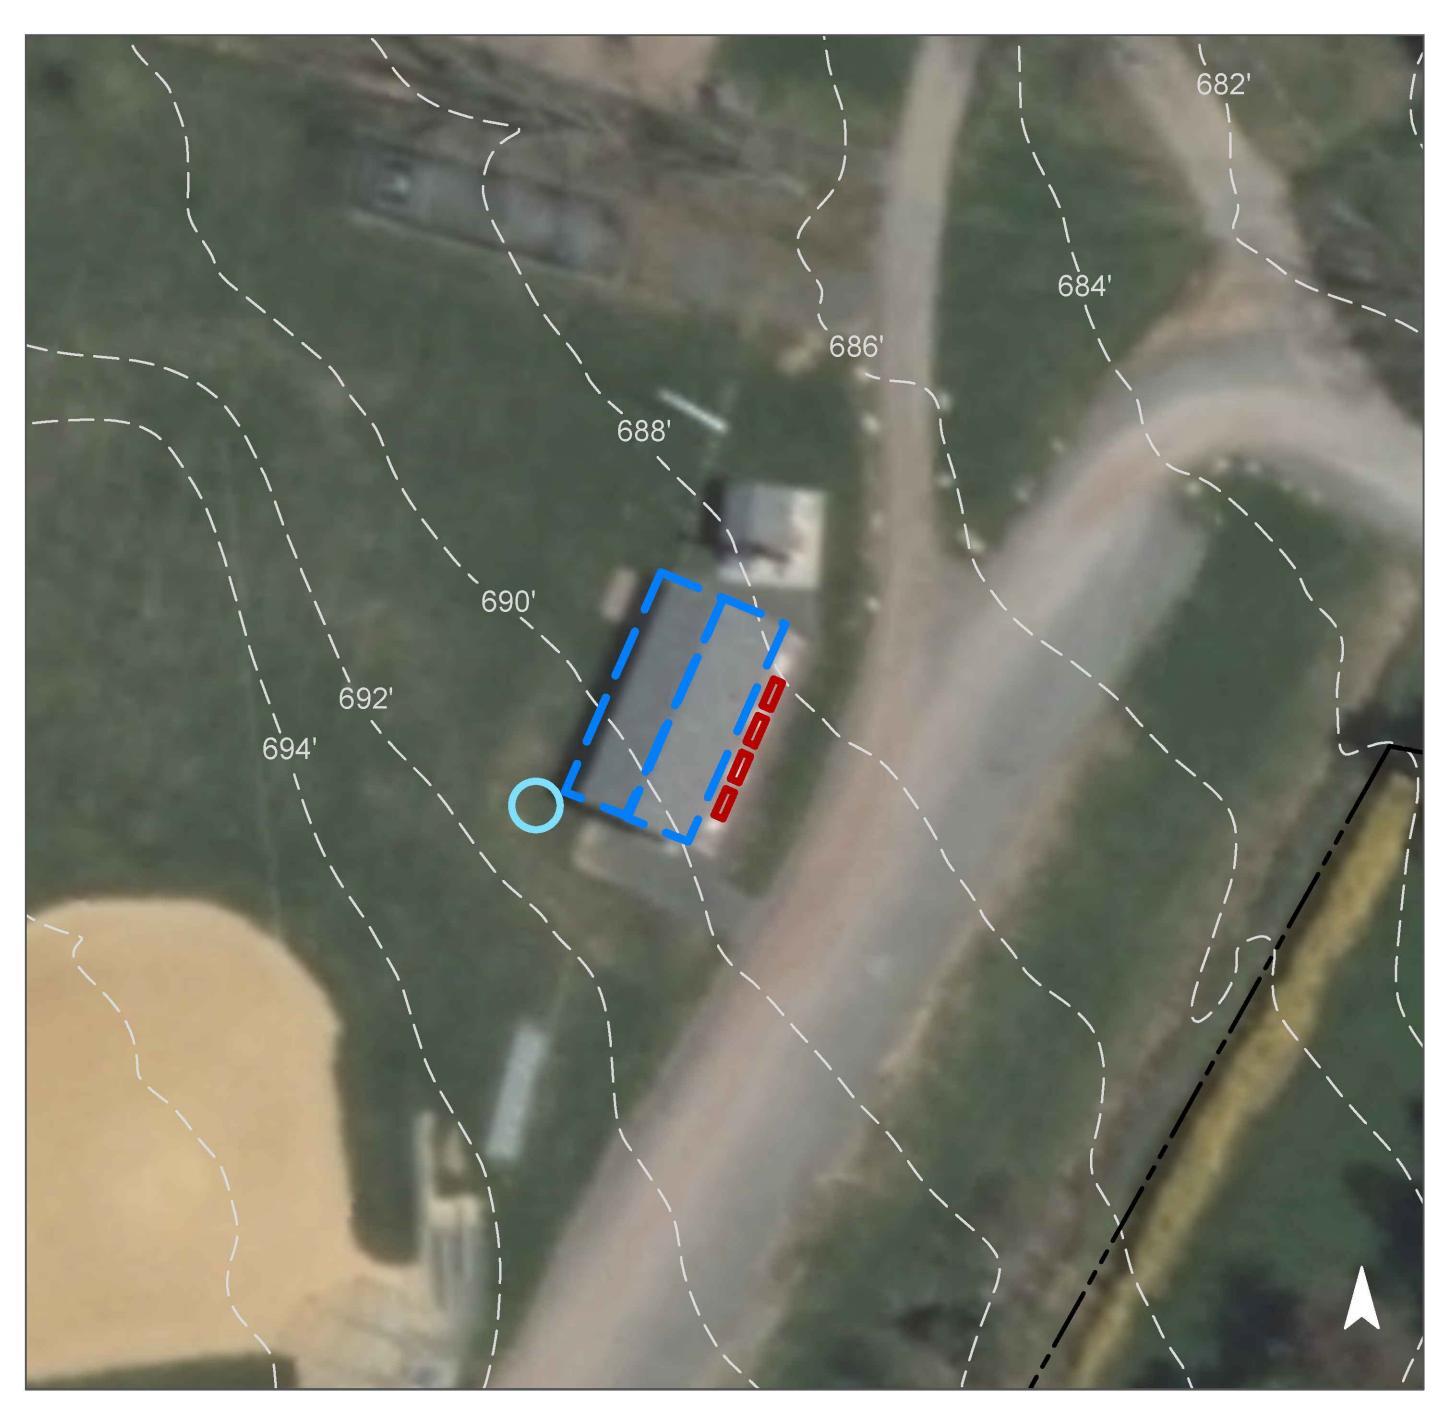
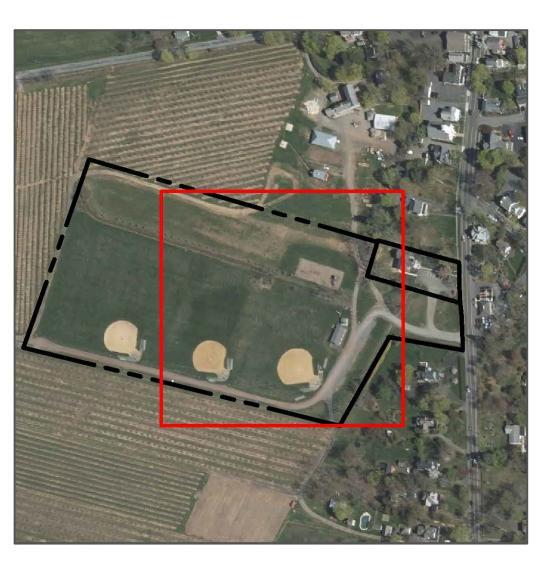
#### **Oldwick Park**

A cistern can be installed on the southern side of the building near a downspout to capture stormwater from the roof. The water can then be used for watering gardens, washing vehicles, or for other non-potable uses. Four downspout planter boxes can be constructed along the building to allow roof runoff to be reused. A preliminary soil assessment suggests that more soil testing would be required before determining the soil's suitability for green infrastructure.

planter box
 rainwater harvesting
 drainage area
 property line
 2015 Aerial: NJOIT, OGIS

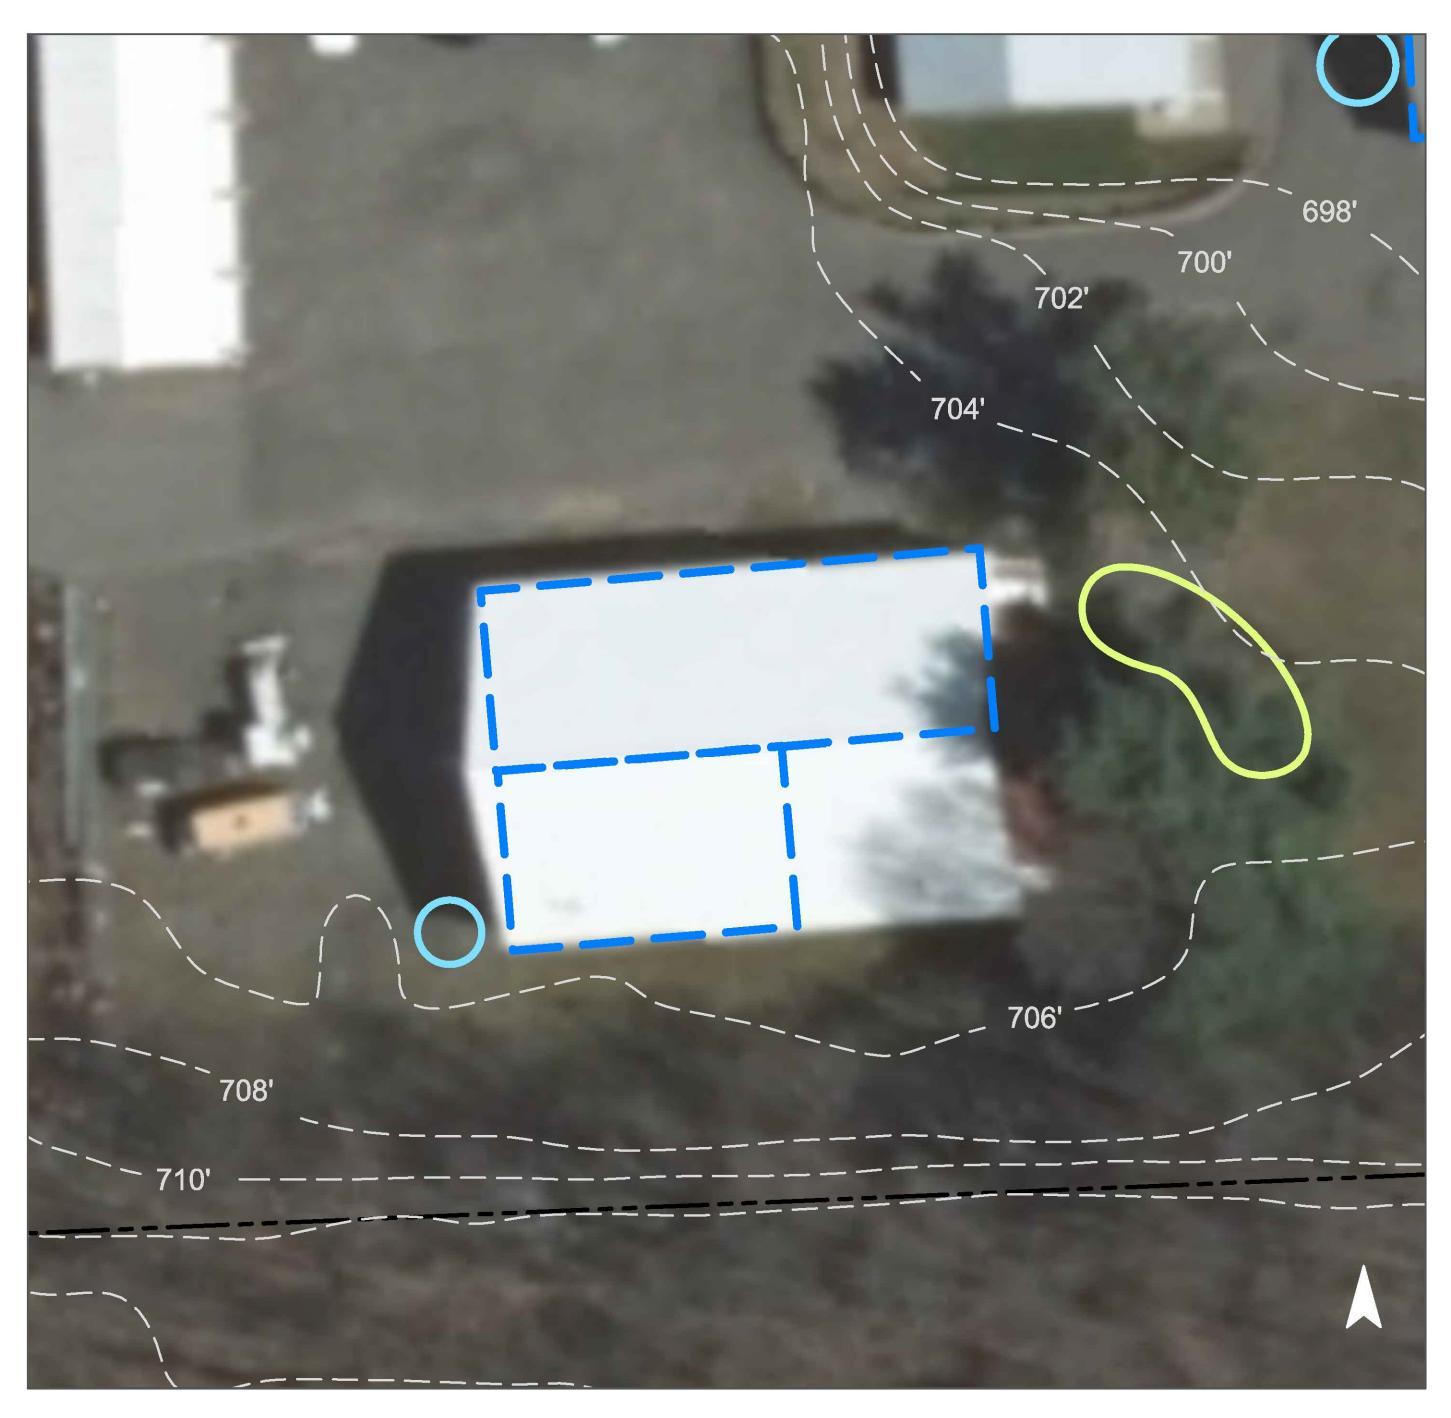
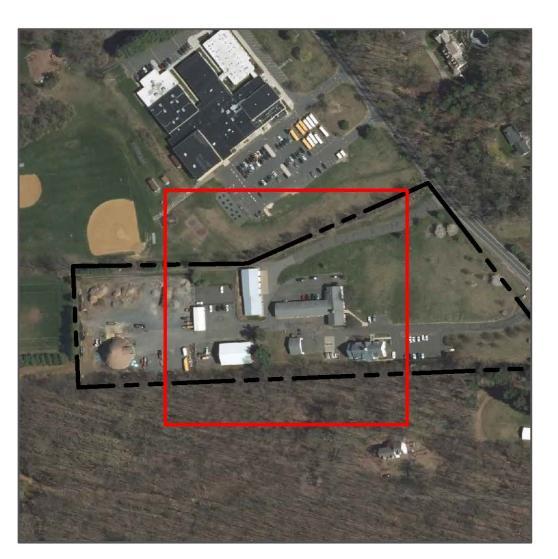
# Tewksbury First Aid & Rescue

Rain gardens can be installed near the First Aid & Rescue building and the new Municipal Complex building to capture, treat, and infiltrate runoff from the roofs. Cisterns can be installed on each building, and the water can then be used for watering gardens, washing vehicles, or for other non-potable uses. A preliminary soil assessment suggests that the soils have suitable drainage characteristics for green infrastructure.

- bioretention system
- rainwater harvesting
- C drainage area
- [] property line
- 2015 Aerial: NJOIT, OGIS

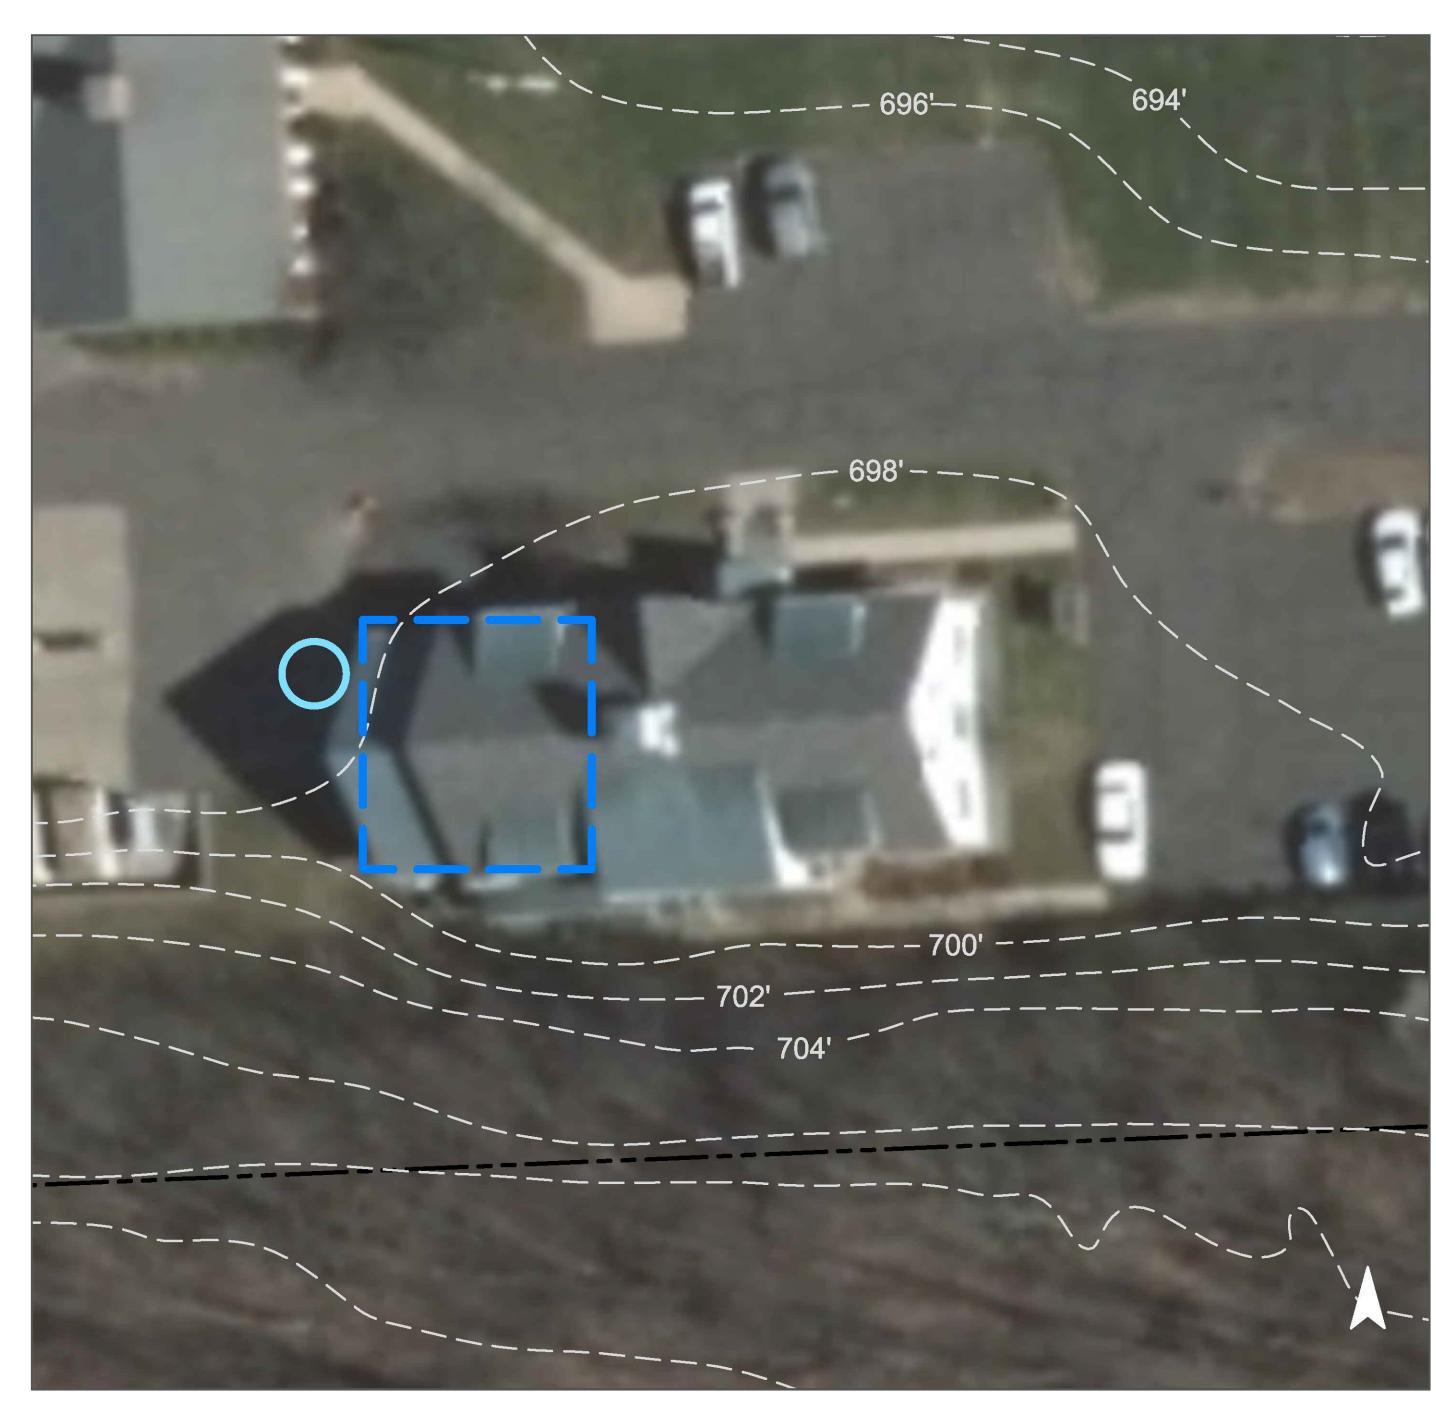
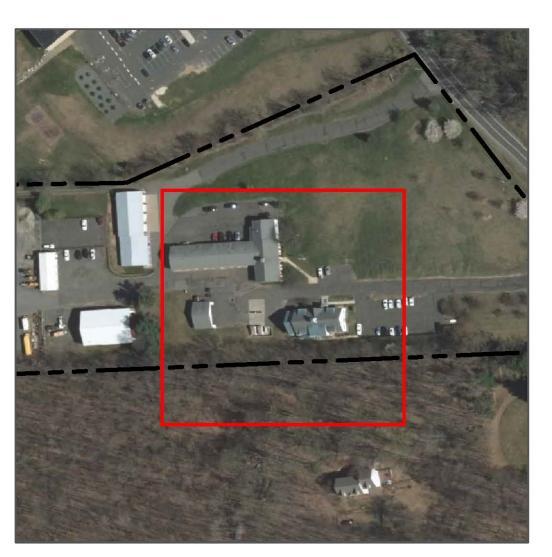
### Tewksbury Administration/ Police

- rainwater harvesting
- **[]** drainage area
- [] property line
- 2015 Aerial: NJOIT, OGIS

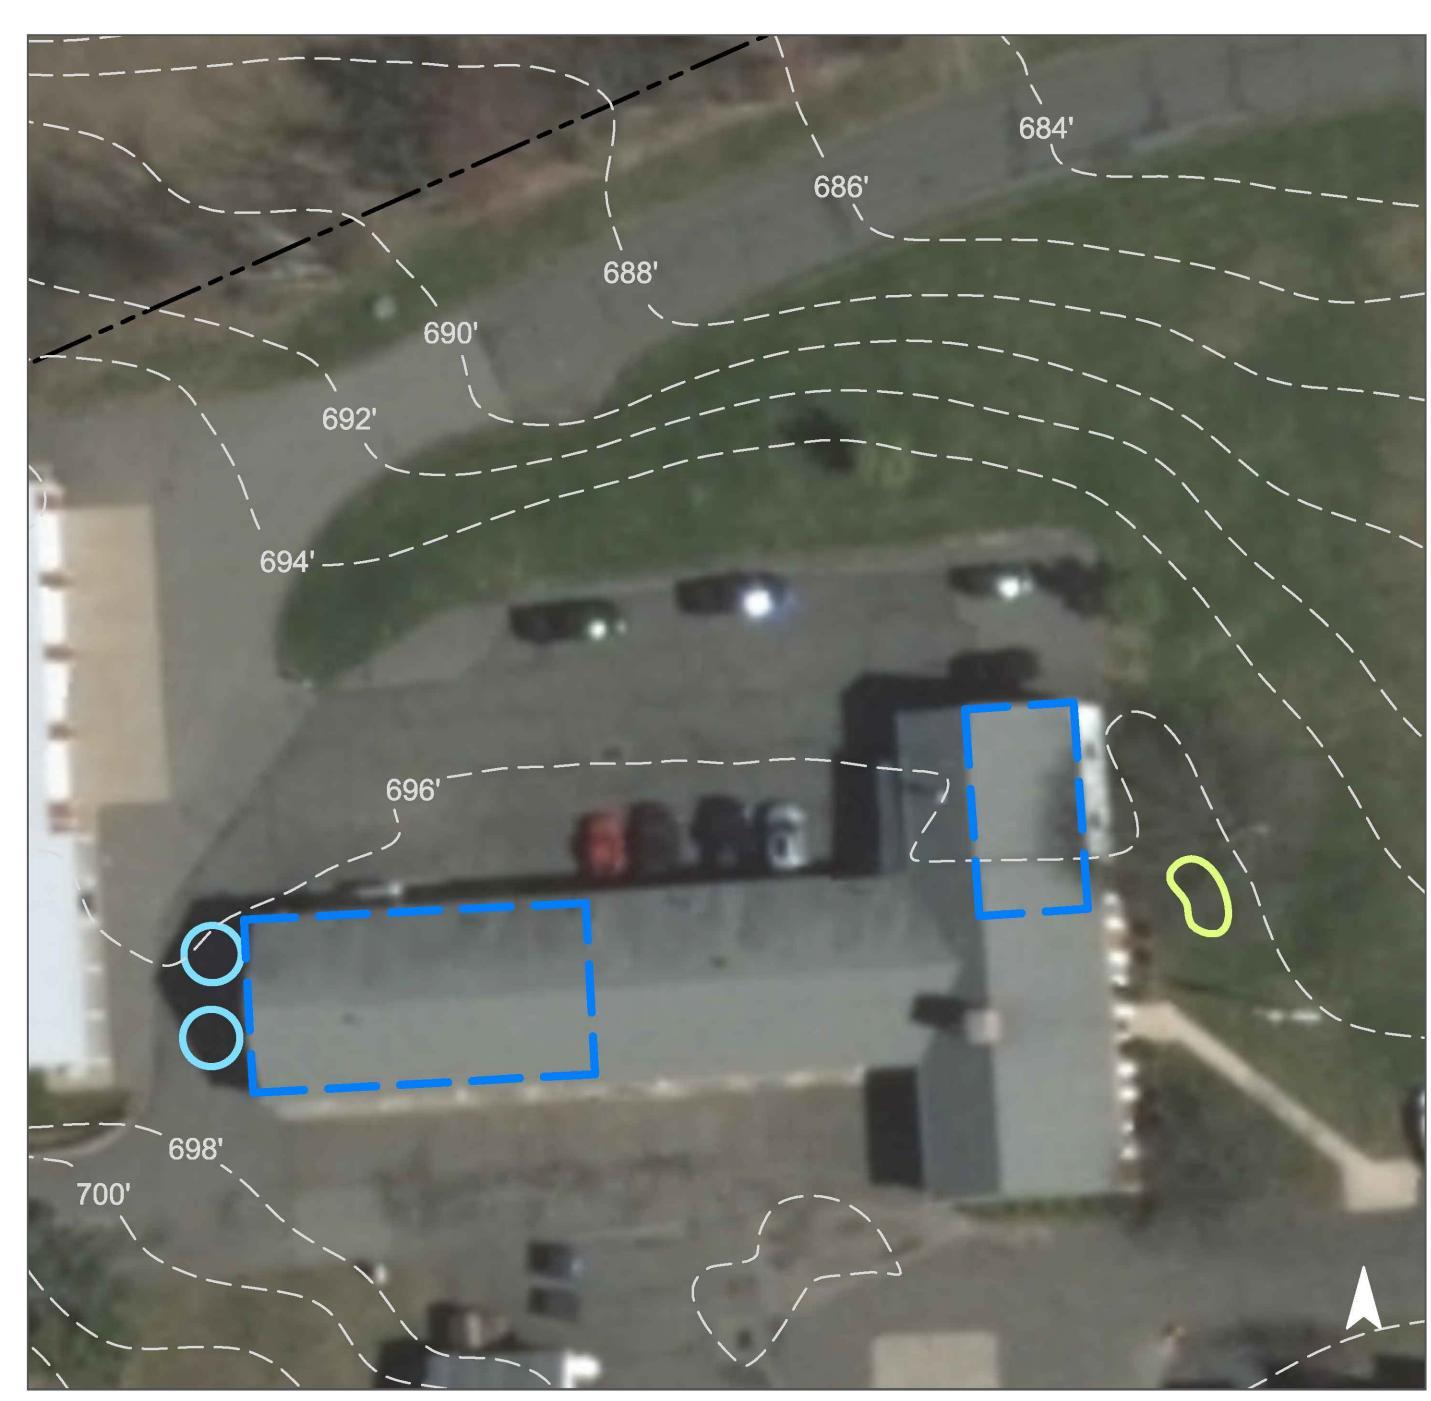
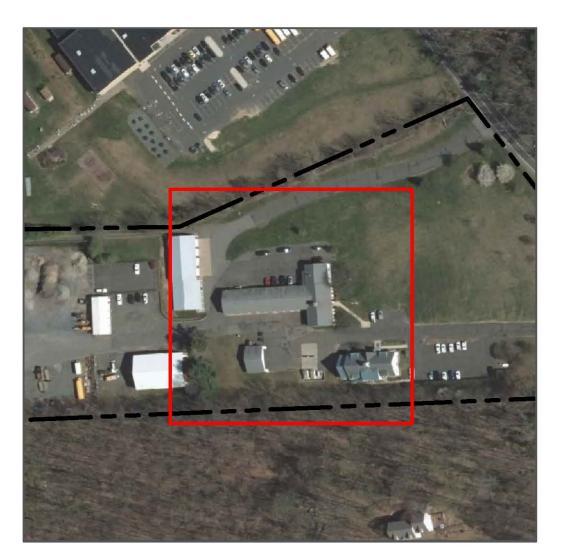
### Tewksbury Municipal Complex

- bioretention system
- rainwater harvesting
- **C** drainage area
- **[]** property line
- 2015 Aerial: NJOIT, OGIS

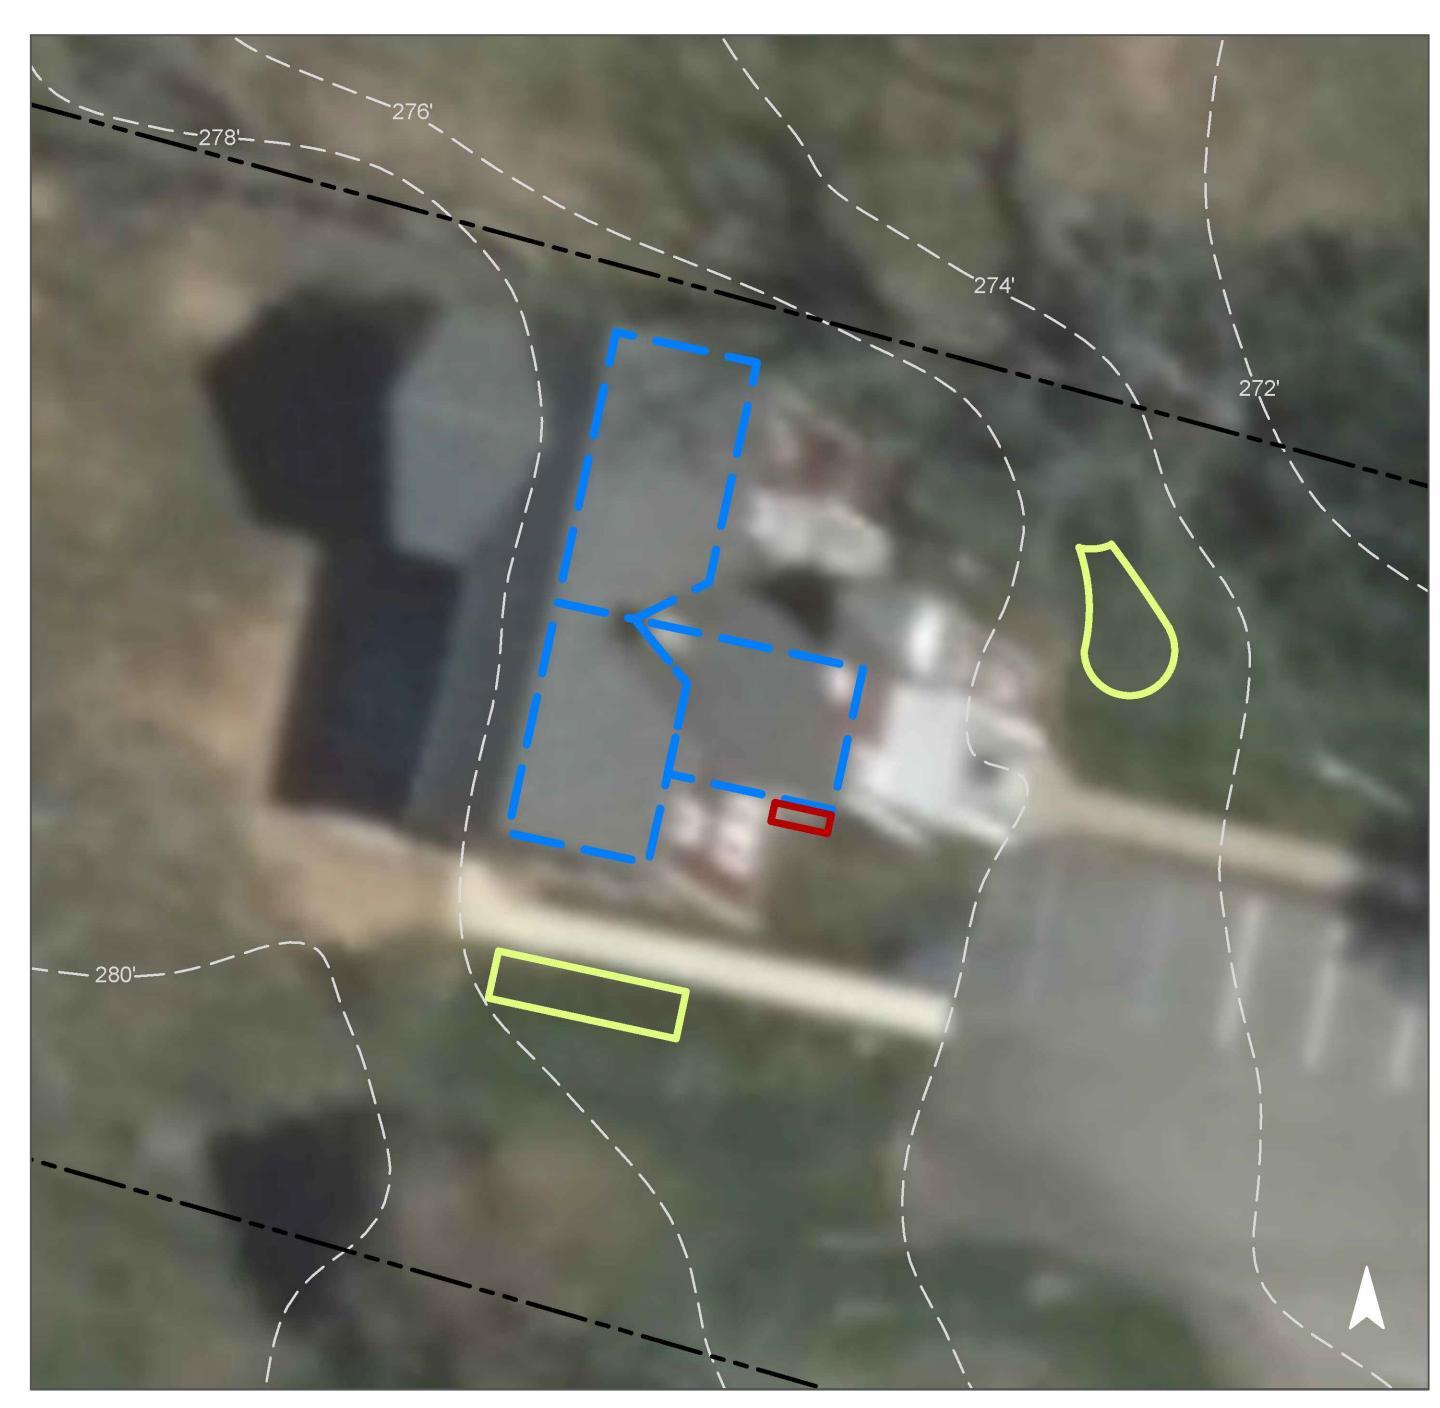
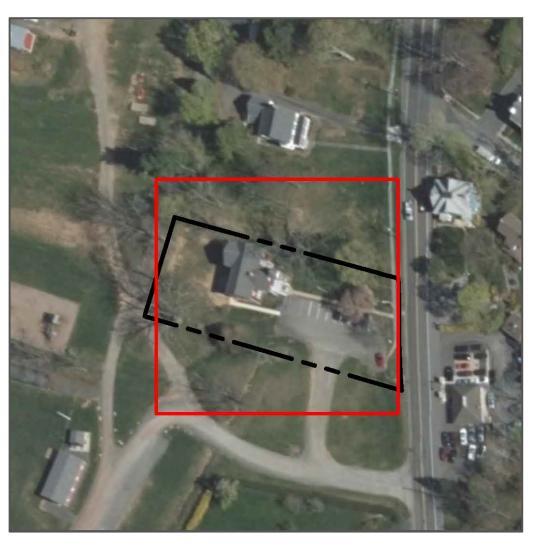
### Tewksbury Township Library

Two rain gardens can be used to capture, treat, and infiltrate rooftop runoff. A downspout planter box can be constructed along the building to allow roof runoff to be captured and reused. A preliminary soil assessment suggests that the soils have suitable drainage characteristics for green infrastructure.

- bioretention system
- planter box
- **[]** drainage area
- [] property line
- 2015 Aerial: NJOIT, OGIS
