#### Impervious Cover Reduction Action Plan for Tewksbury Township, Hunterdon County, New Jersey

Prepared for Tewksbury Township by the Rutgers Cooperative Extension Water Resources Program

May 19, 2020

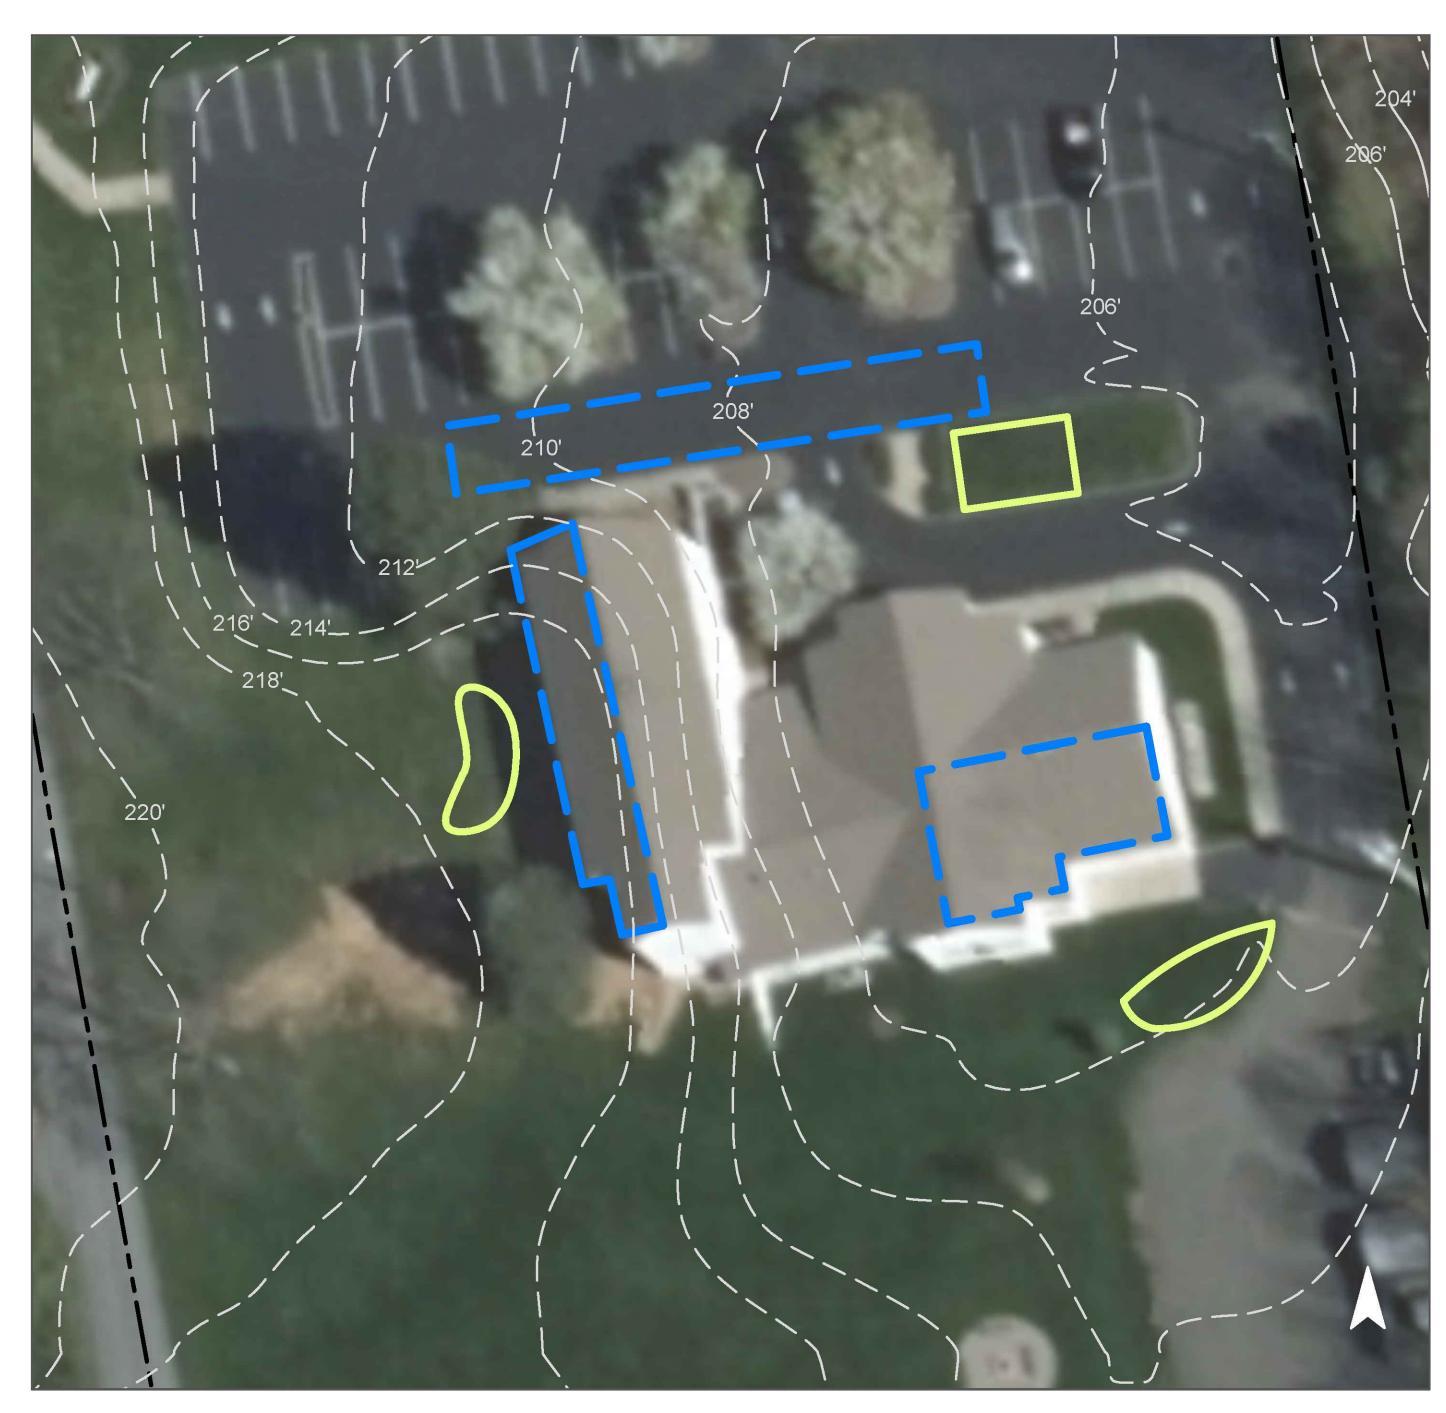
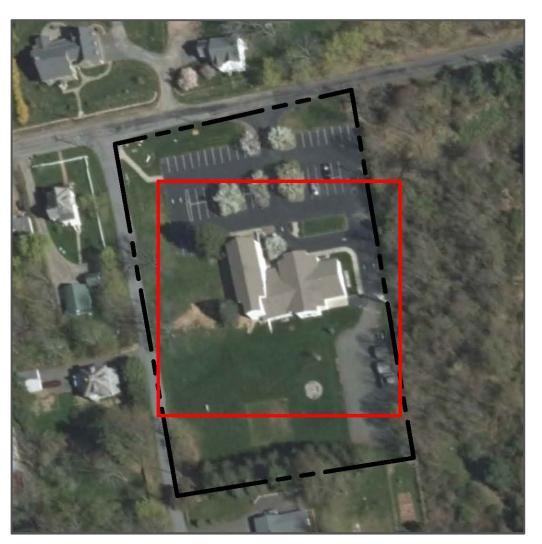
### Zion Lutheran Church

Two rain gardens can be installed in the turfgrass areas adjacent to the building to capture, treat, and infiltrate stormwater runoff from the roof. Another rain garden can be installed in a parking lot island to capture, treat, and infiltrate stormwater runoff from the parking lot. A preliminary soil assessment suggests that more soil testing would be required before determining the soil's suitability for green infrastructure.

bioretention system
23	drainage area
[]	property line
	2015 Aerial: NJOIT, OGIS

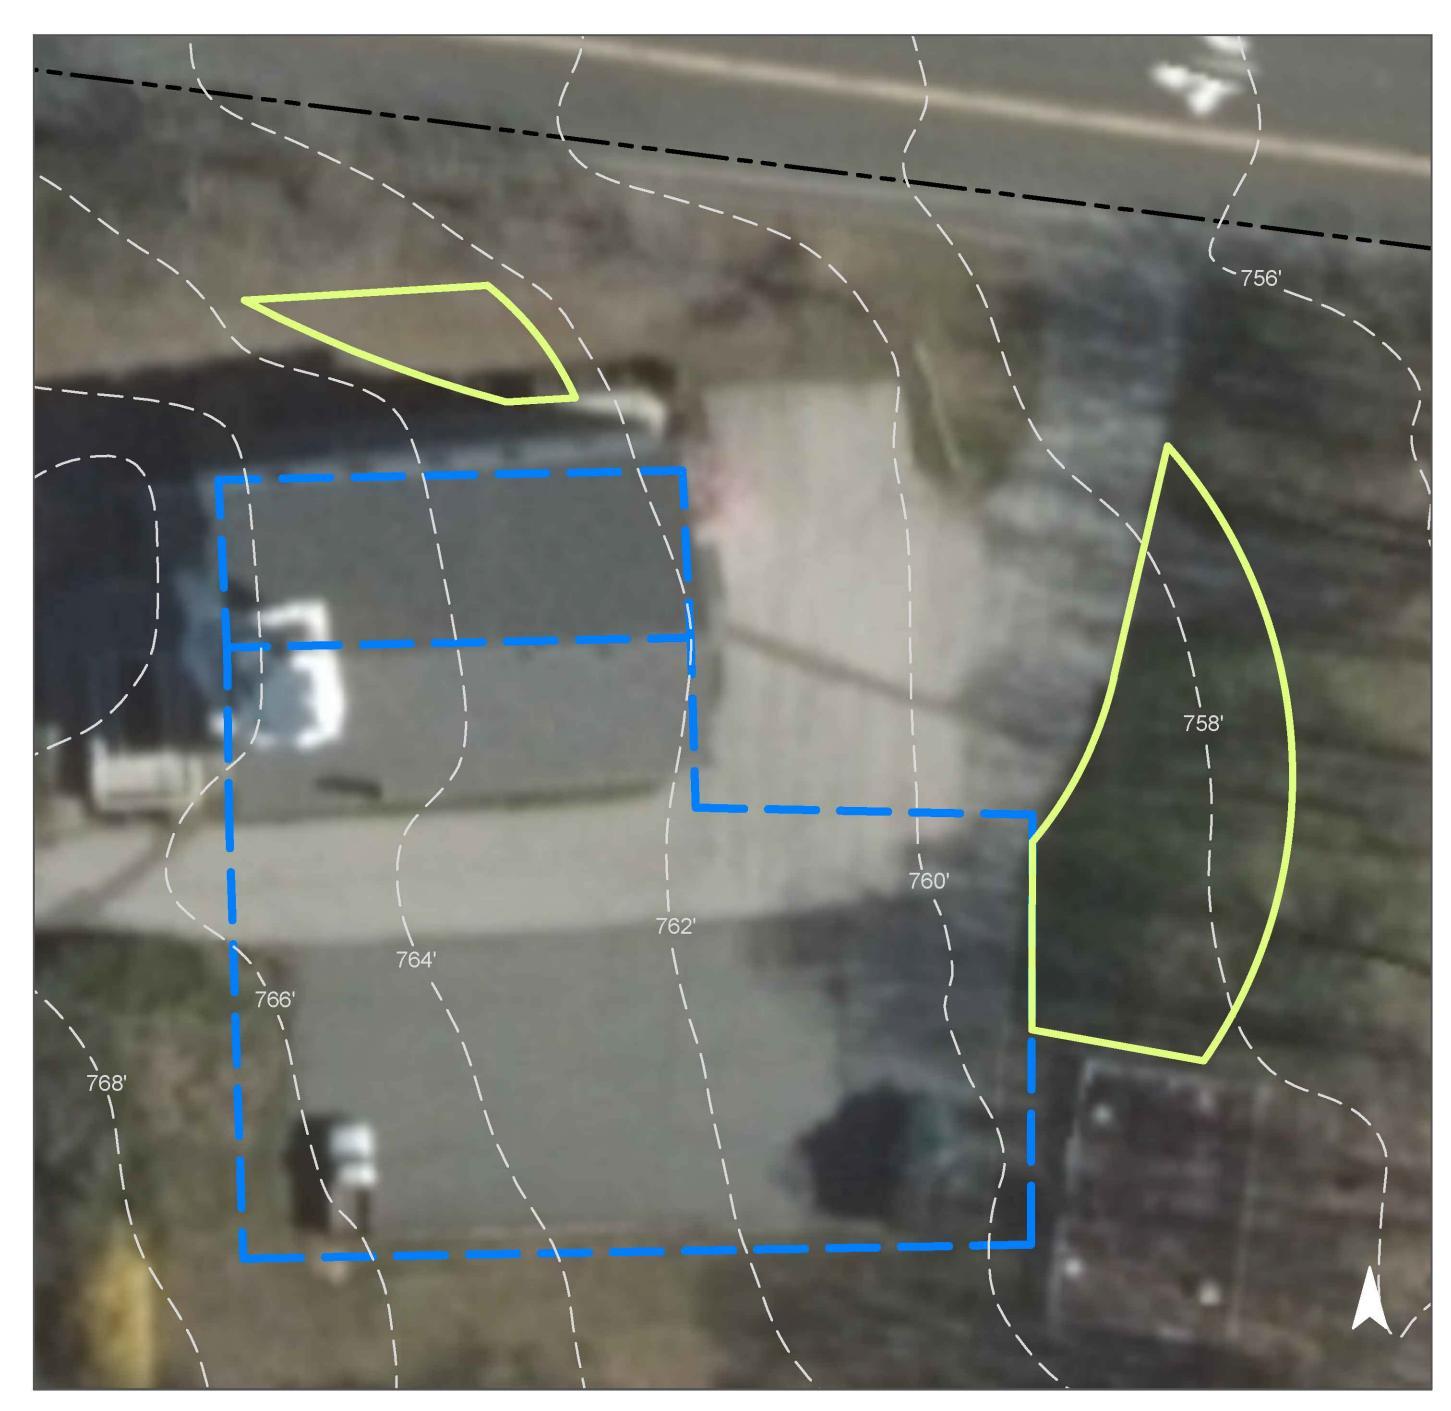
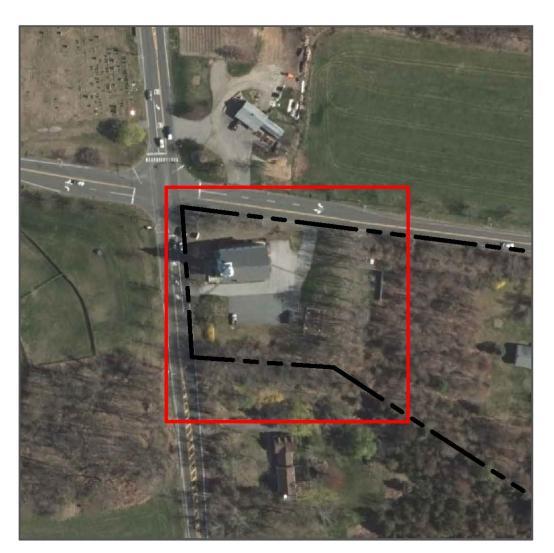
#### Fairmount United Methodist Church

Rain gardens can be installed on the north side of the building and on the turfgrass area east of the parking lot to capture, treat, and infiltrate stormwater runoff from the roof. A preliminary soil assessment suggests that more soil testing would be required before determining the soil's suitability for green infrastructure.

- bioretention system
- C drainage area
- [] property line
- 2015 Aerial: NJOIT, OGIS

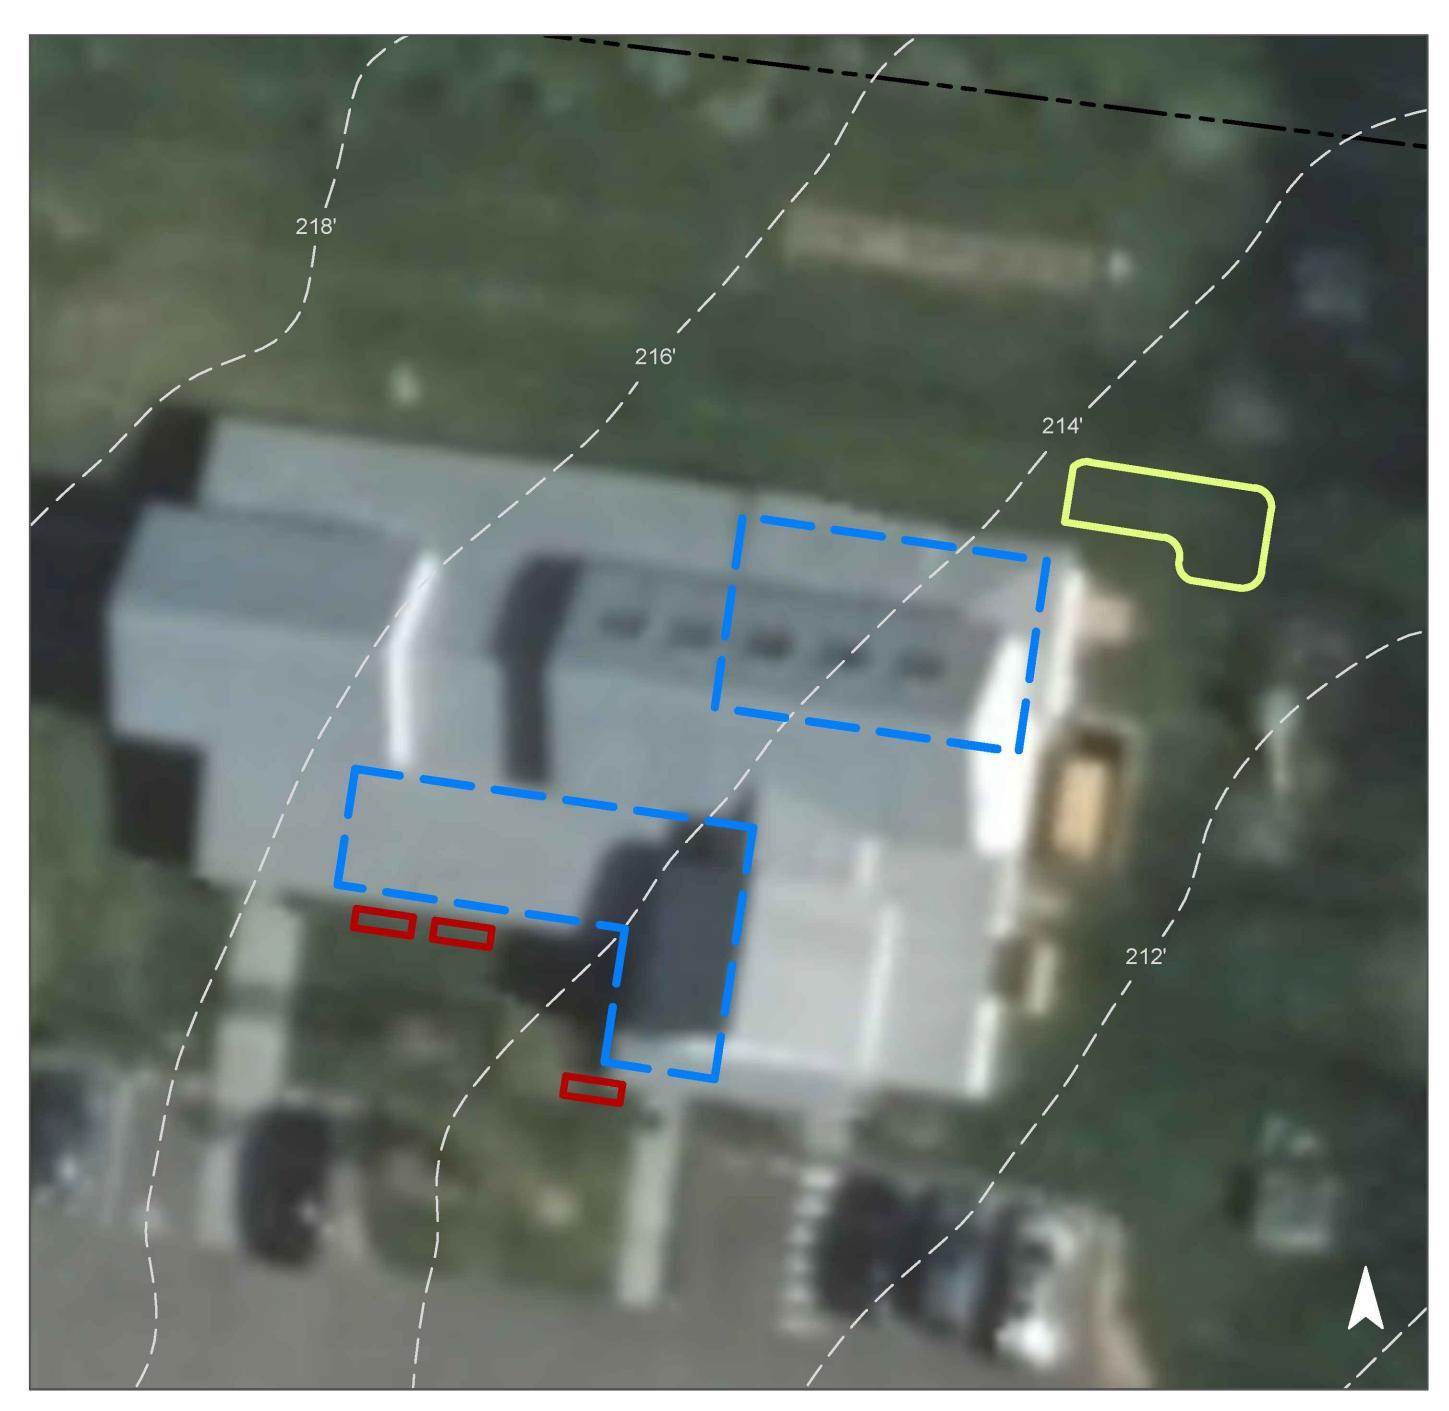
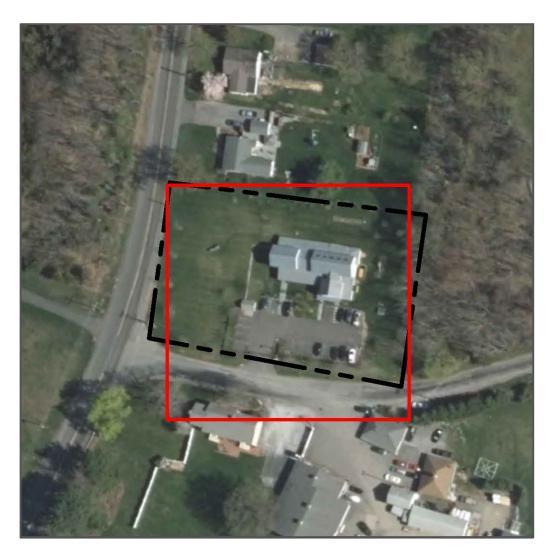
### **Oldwick Animal Hospital**

A rain garden can be installed in the turfgrass area to capture, treat, and infiltrate stormwater runoff from the roof. Downspout planter boxes can be constructed along the building to allow roof runoff to be captured and reused. A preliminary soil assessment suggests that more soil testing would be required before determining the soil's suitability for green infrastructure.

- bioretention system
- planter box
- **[]** drainage area
- [] property line
- 2015 Aerial: NJOIT, OGIS

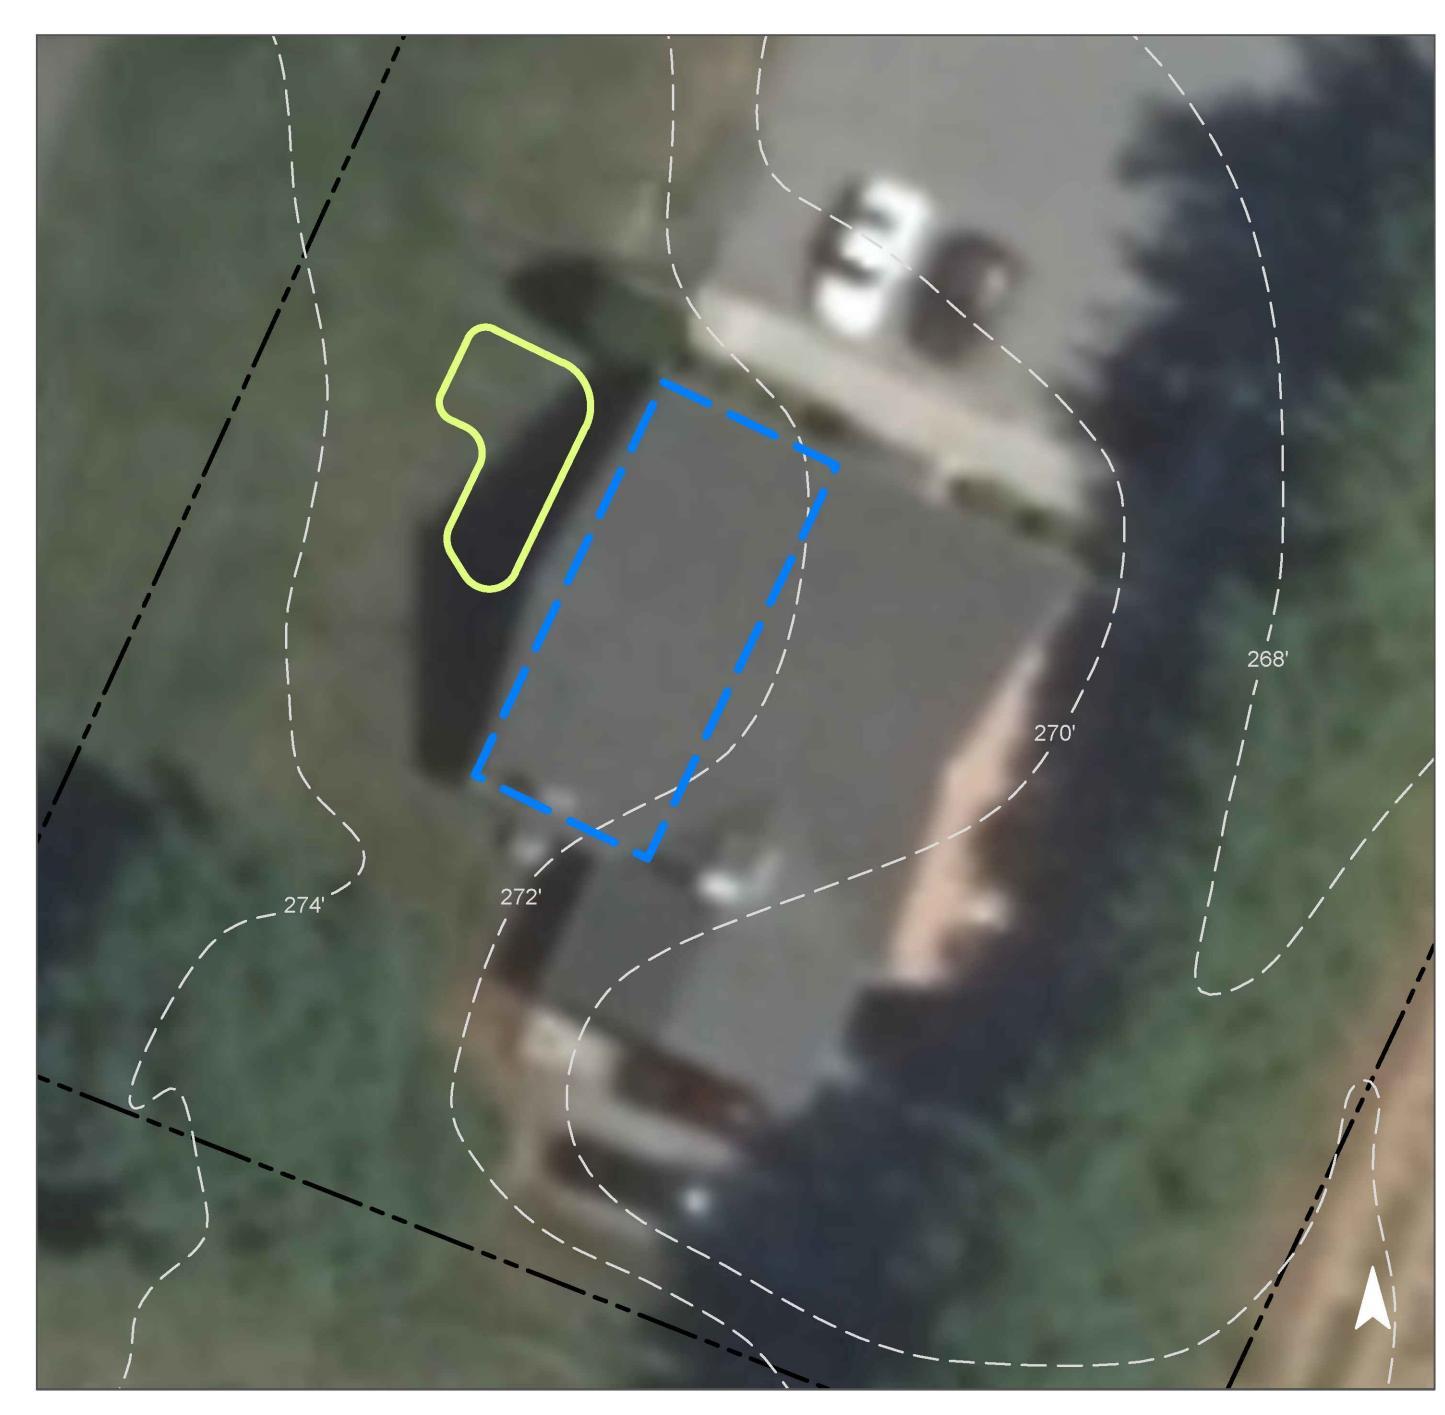
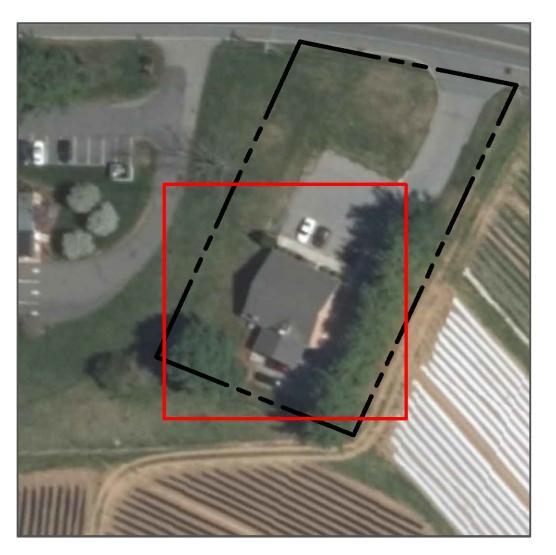
### **Oldwick Post Office**

A rain garden can be installed on the west side of the building to capture, treat, and infiltrate stormwater runoff from the roof. A preliminary soil assessment suggests that more soil testing would be required before determining the soil's suitability for green infrastructure.

- bioretention system
- drainage area
- [] property line
- 2015 Aerial: NJOIT, OGIS

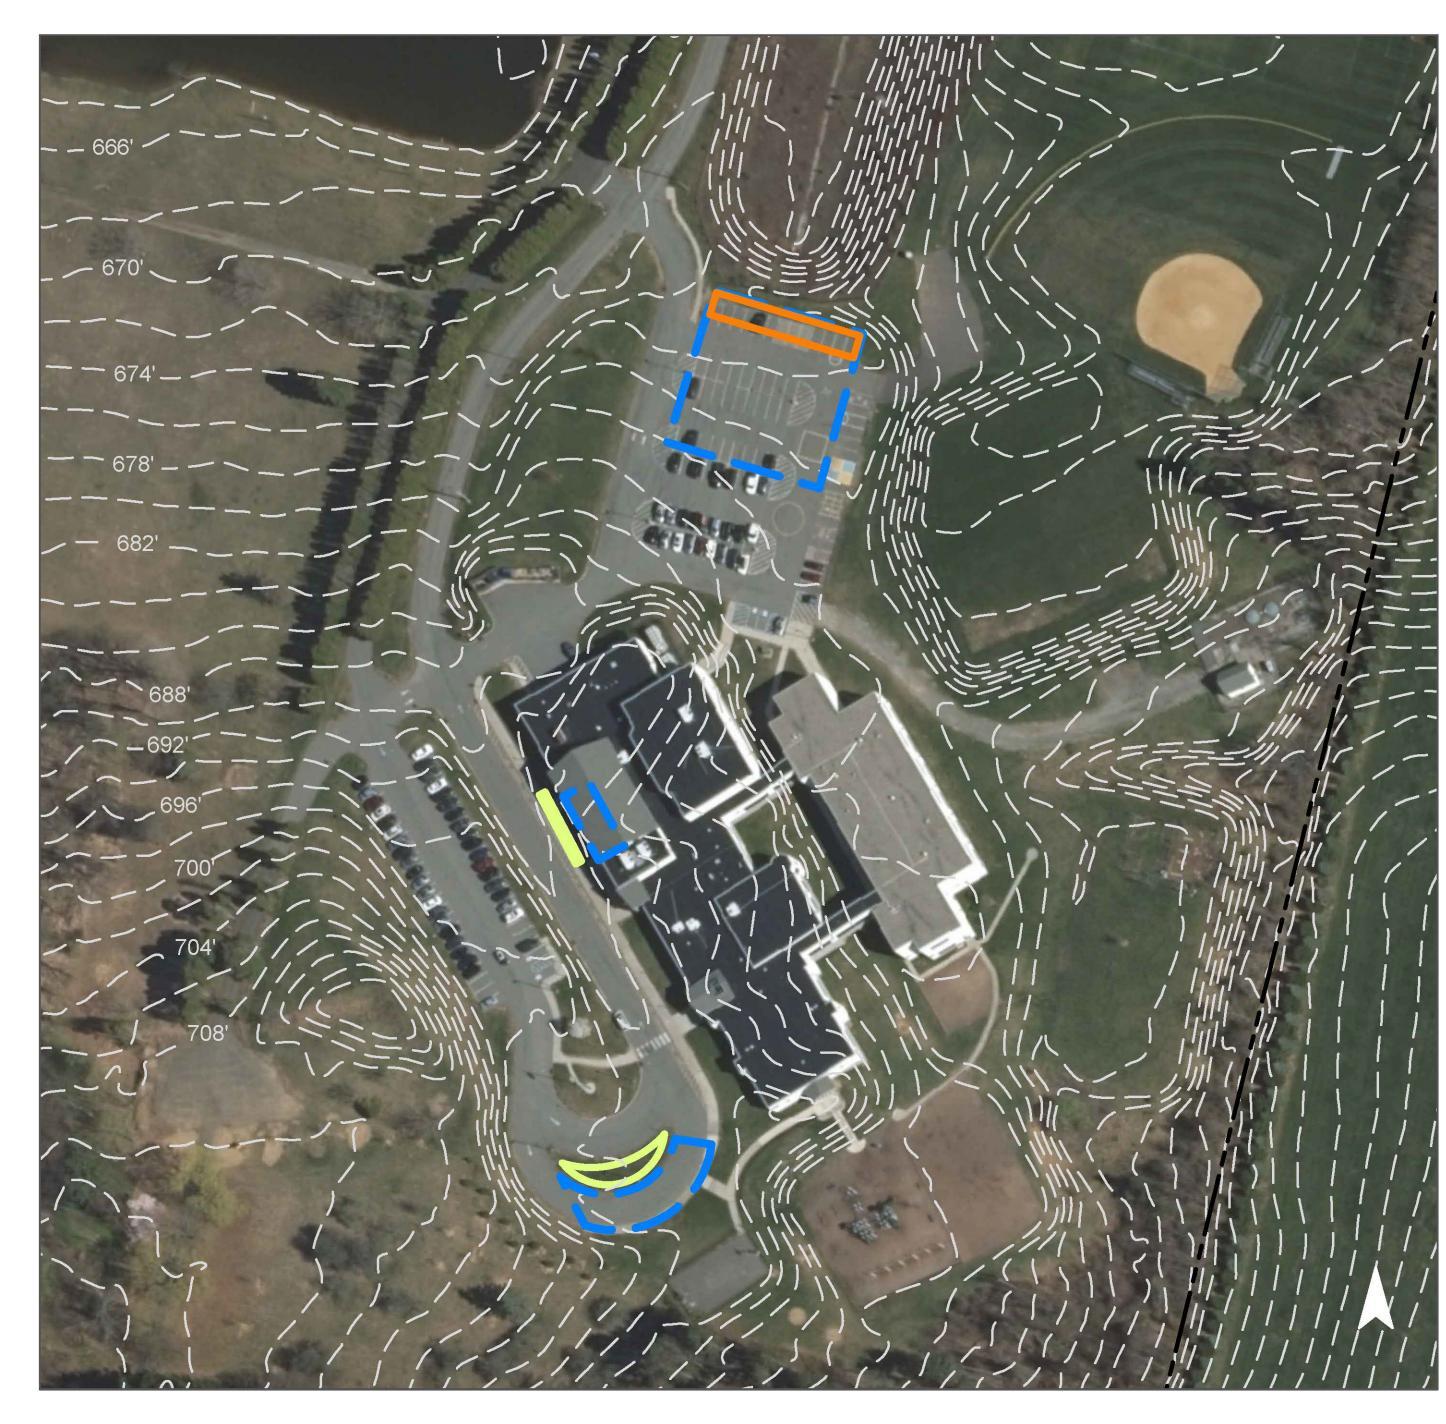
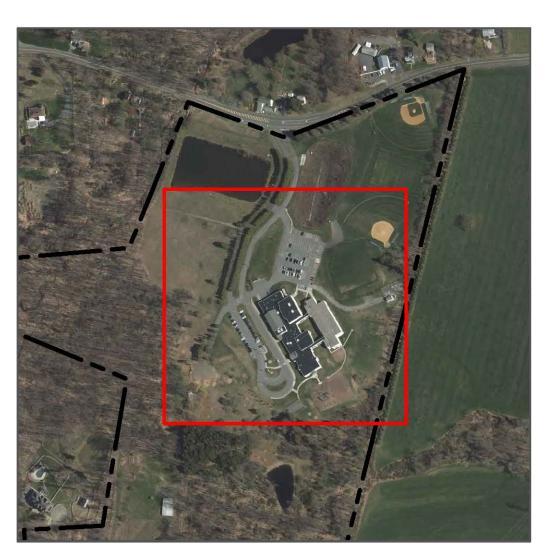
#### Tewksbury Elementary School

A rain garden can be installed in the turfgrass area on the west side of the building and on the turfgrass area in the parking lot to capture, treat, and infiltrate stormwater runoff from the roof. Parking spaces north of the building can be replaced with pervious pavement to capture and infiltrate stormwater runoff from the parking lot. A preliminary soil assessment suggests that more soil testing would be required before determining the soil's suitability for green infrastructure.

- bioretention system
- pervious pavement
- **C** drainage area
- [] property line
  - 2015 Aerial: NJOIT, OGIS

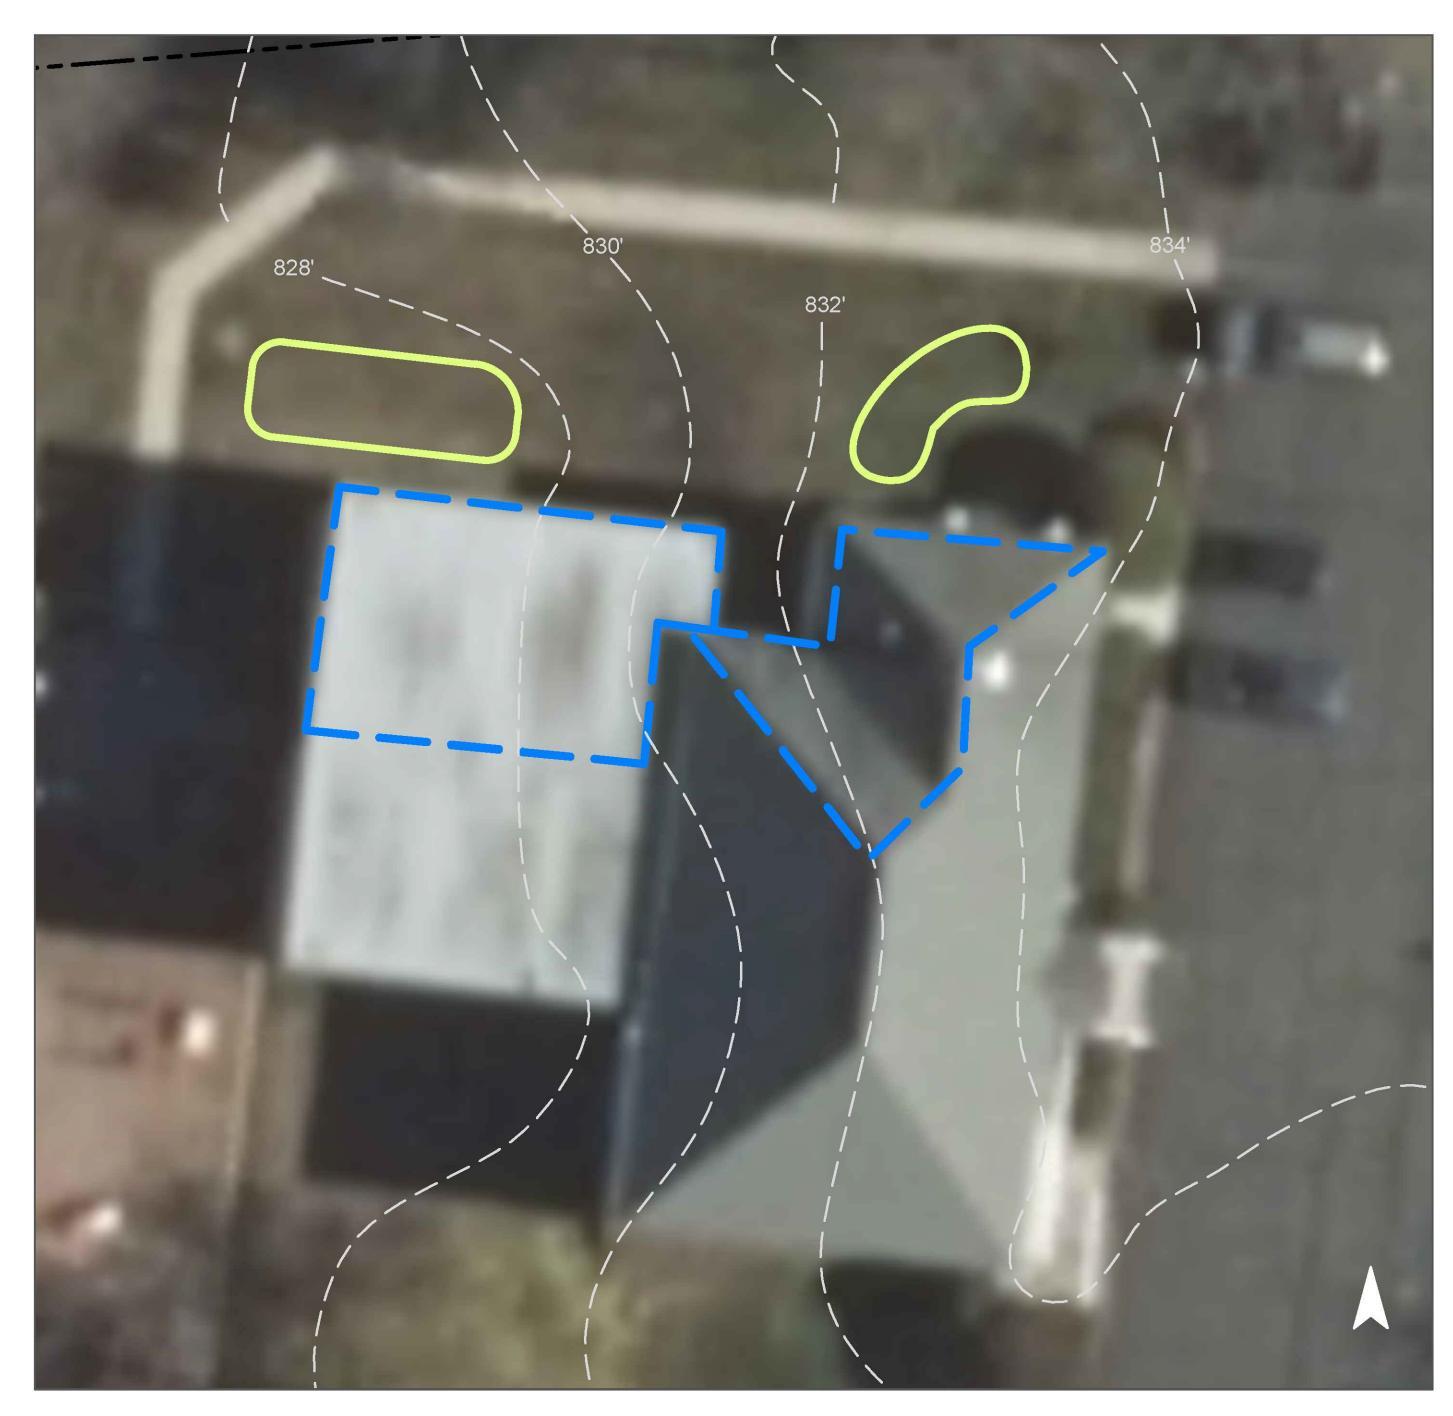
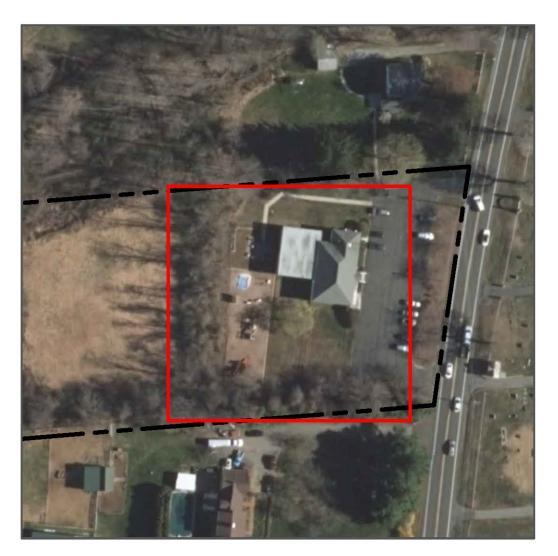
### Haytown Nursery School

Two rain gardens can be installed on the north side of the building to capture, treat, and infiltrate stormwater runoff from the roof. A preliminary soil assessment suggests that the soils have suitable drainage characteristics for green infrastructure.

bioretention system
3	drainage area
3	property line
	2015 Aerial: NJOIT, OGIS

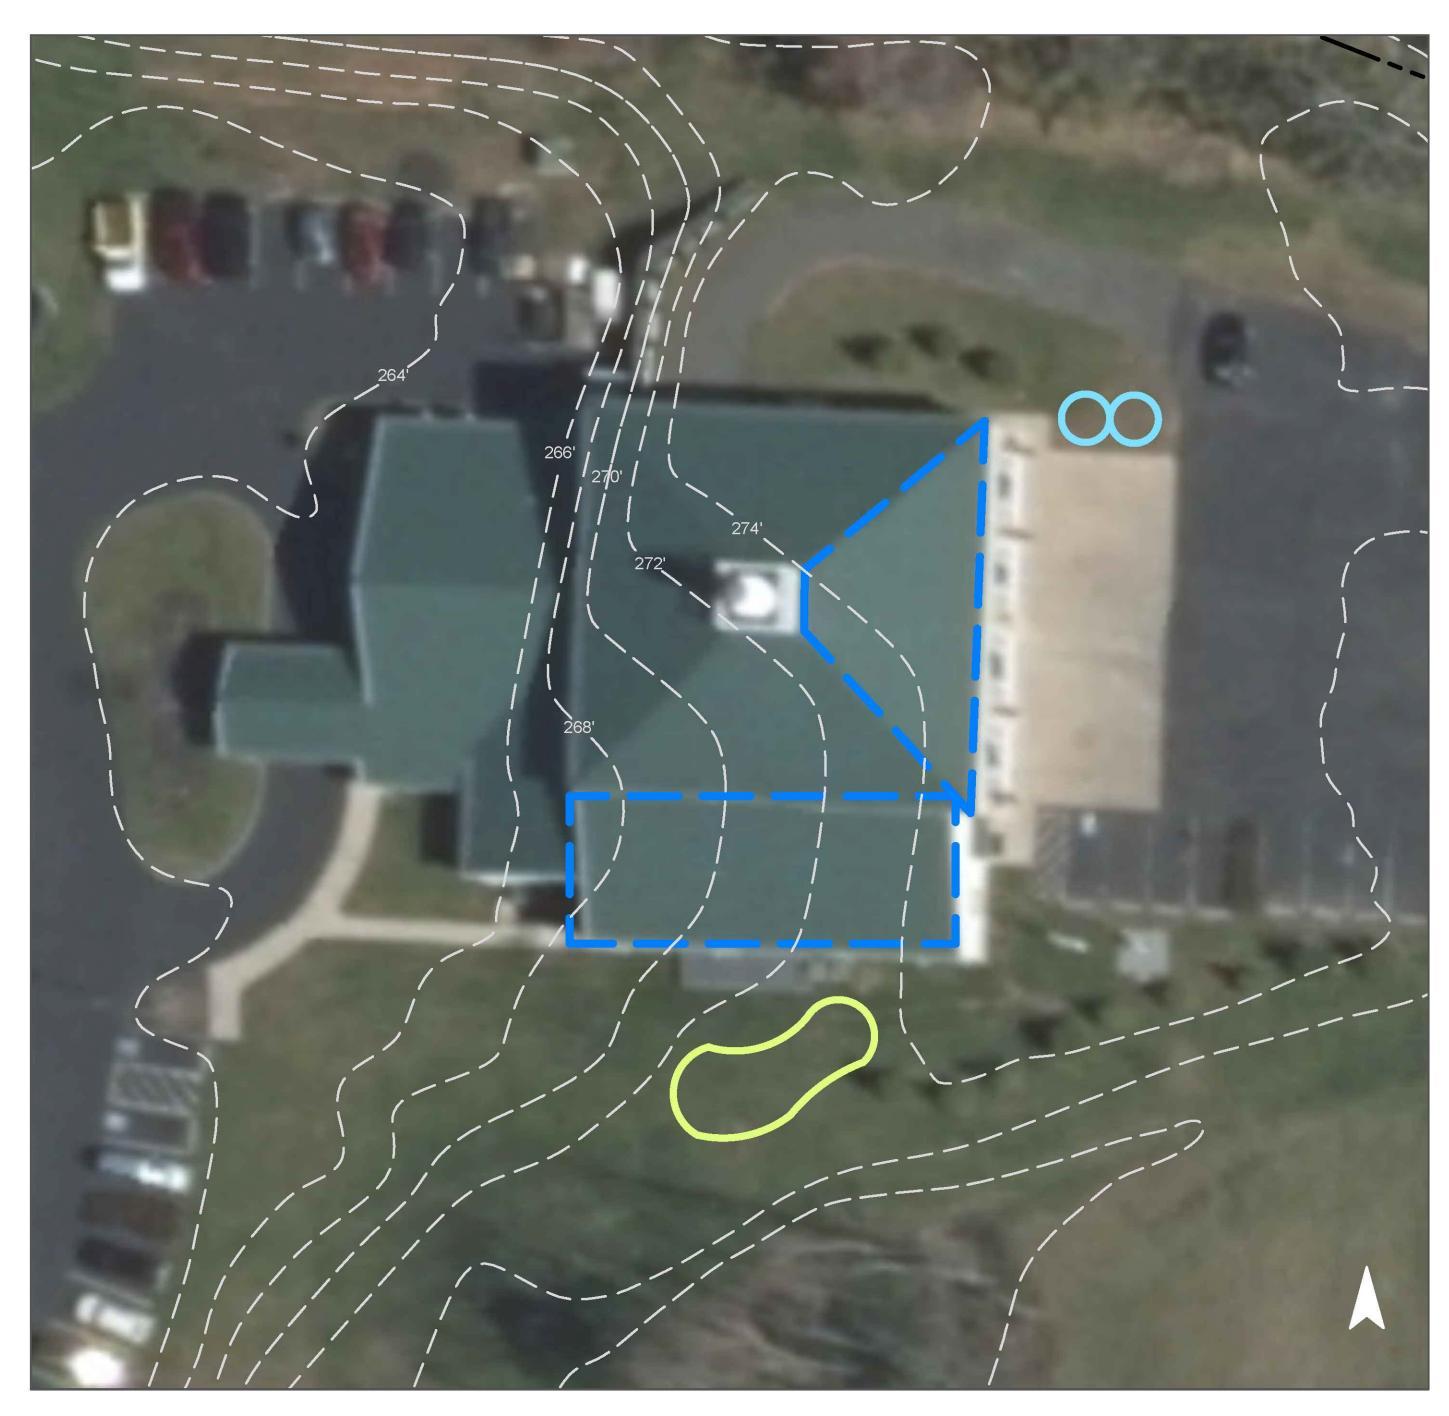
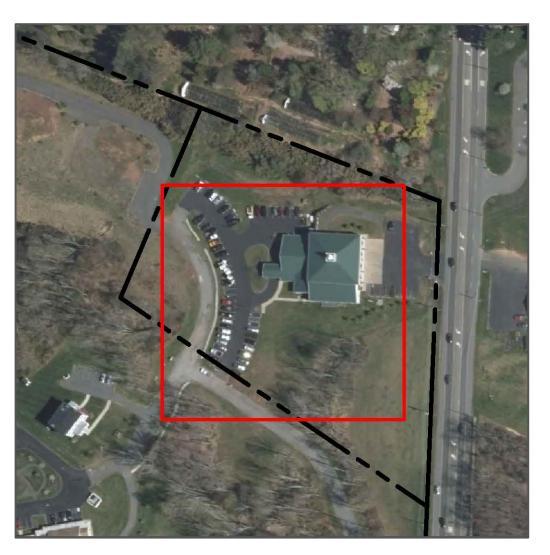
### Oldwick Fire Company Social Hall

A rain garden can installed on the south side of the building to capture, treat, and infiltrate stormwater runoff from the roof. Two cisterns can be installed on the north side of the building to capture stormwater from the roof. The water can then be used for watering gardens, washing vehicles, or for other non-potable uses. A preliminary soil assessment suggests that more soil testing would be required before determining the soil's suitability for green infrastructure.

- bioretention system
- rainwater harvesting
- drainage area
- [] property line
- 2015 Aerial: NJOIT, OGIS

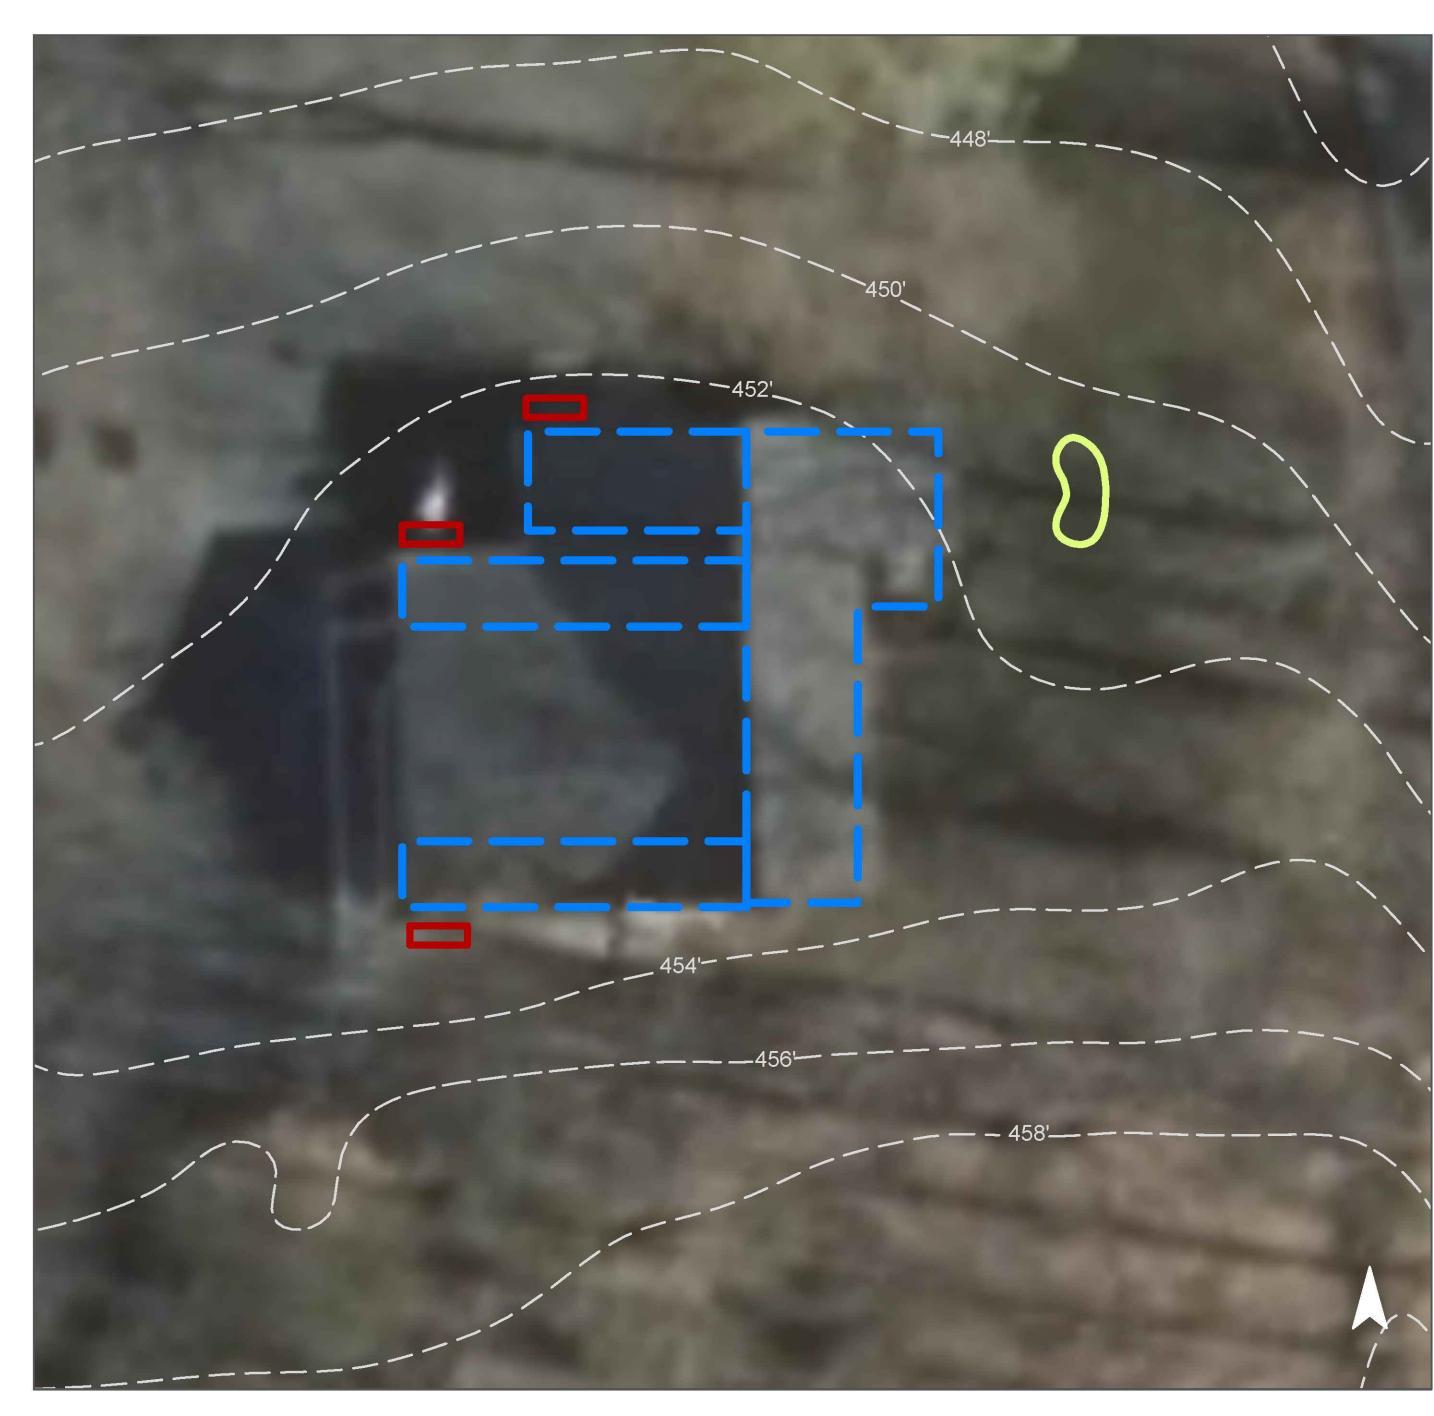
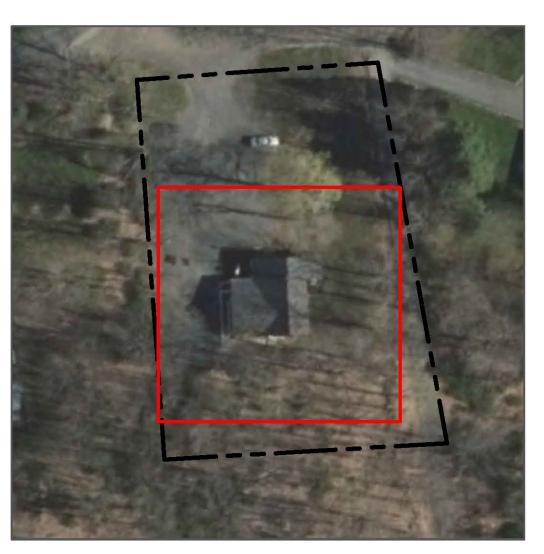
### Tewksbury Historical Society

A rain garden can be installed in the turfgrass area on the east side of the building to capture, treat, and infiltrate stormwater runoff from the roof. Downspout planter boxes can be installed to allow roof runoff to be captured and reused. A preliminary soil assessment suggests that the soils have suitable drainage characteristics for green infrastructure.

- bioretention system
- planter box
- C drainage area
- [] property line
  - 2015 Aerial: NJOIT, OGIS

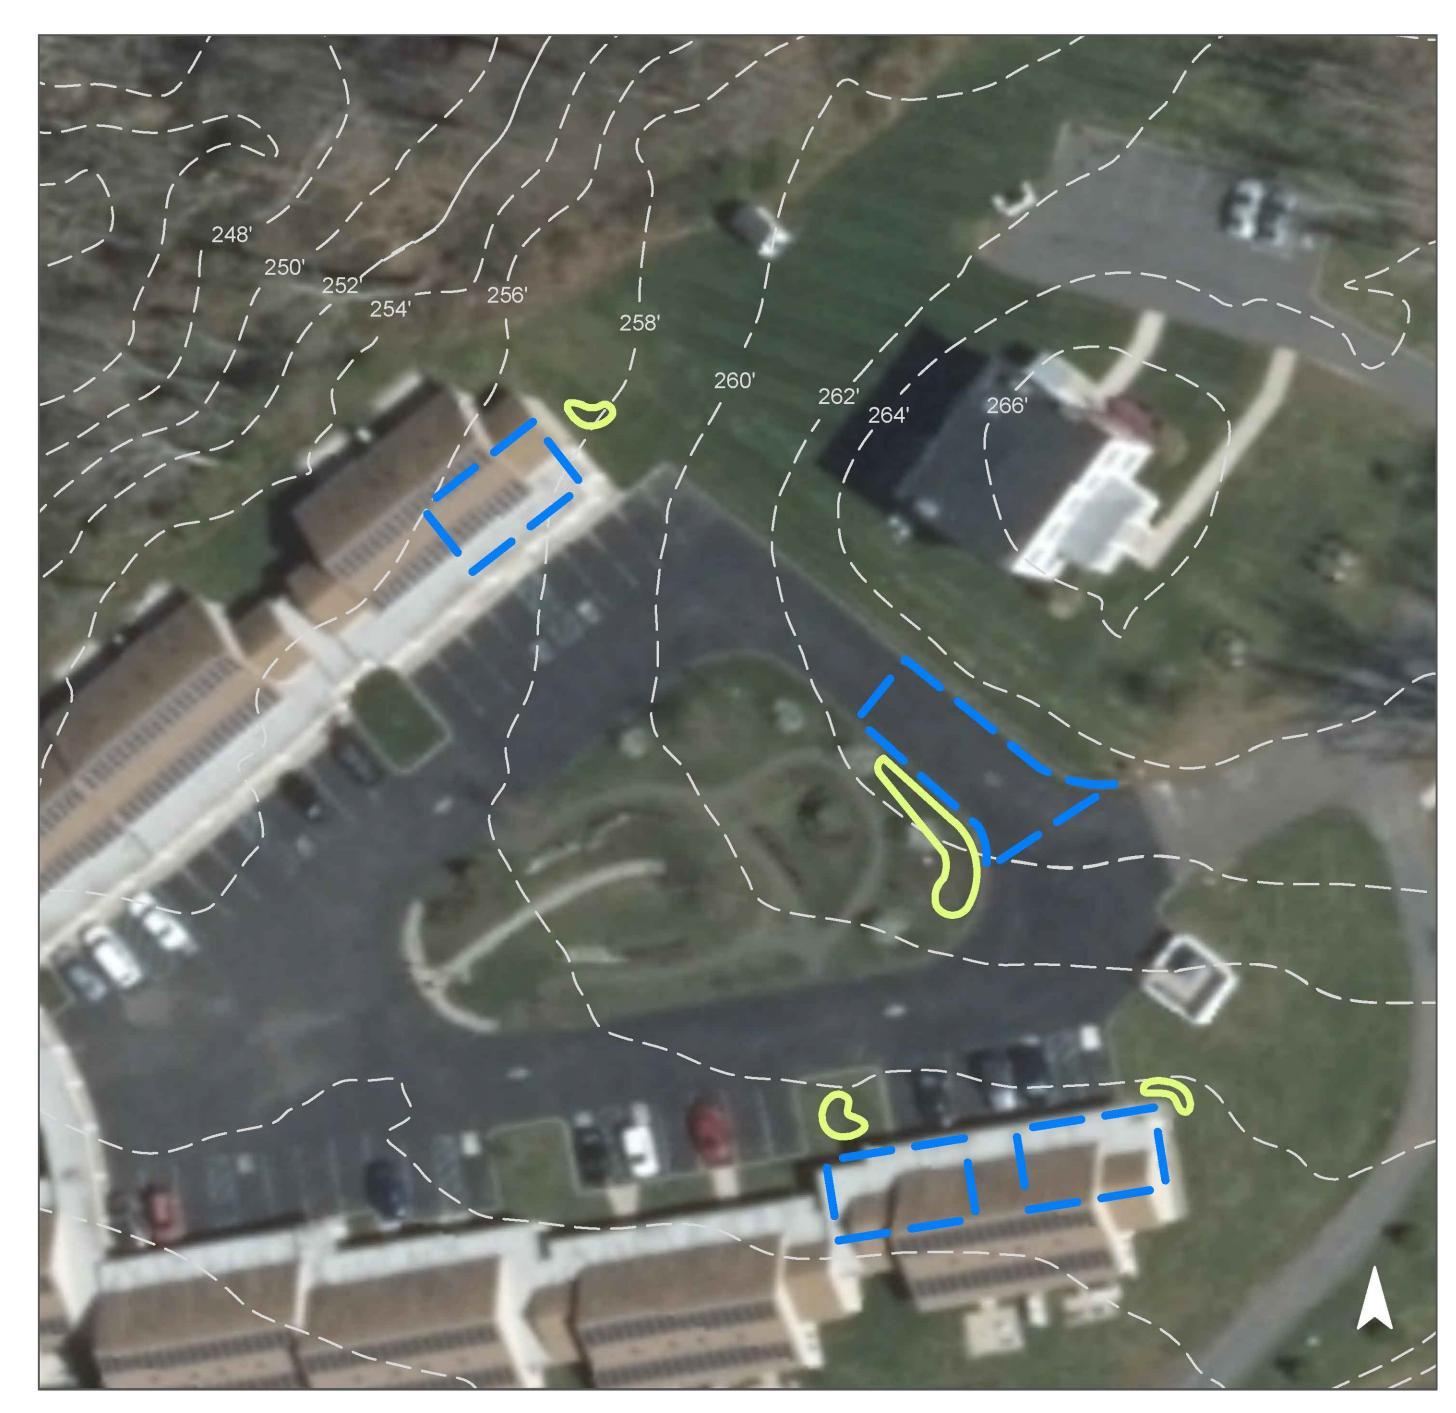
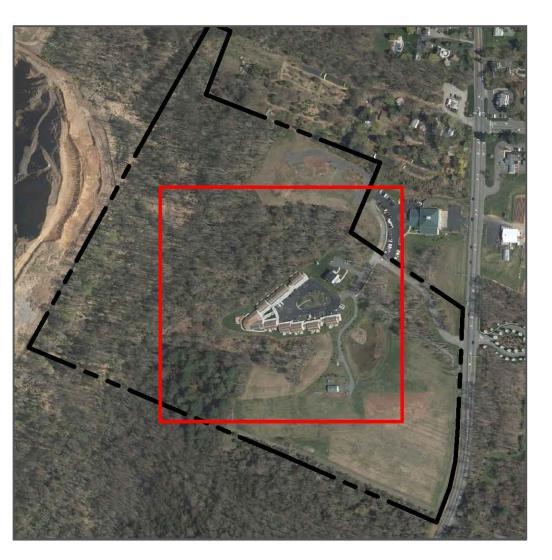
### The Meadows At Oldwick

Multiple rain gardens can be installed in the turfgrass area adjacent to the buildings and in the center parking lot island to capture, treat, and infiltrate stormwater runoff from the roof. A preliminary soil assessment suggests that more soil testing would be required before determining the soil's suitability for green infrastructure.

- bioretention system
- drainage area
- [] property line
- 2015 Aerial: NJOIT, OGIS
