## Impervious Cover Assessment for Middlesex Borough, Middlesex County, New Jersey

Prepared for Middlesex Borough by the Rutgers Cooperative Extension Water Resources Program

February 1, 2015

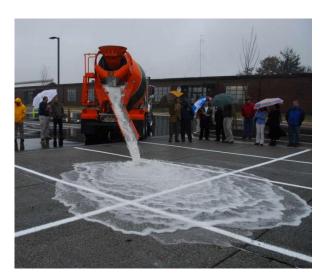
Figure 2: Rapid infiltration of water through porous pavement is demonstrated at the USEPA Edison New Jersey test site

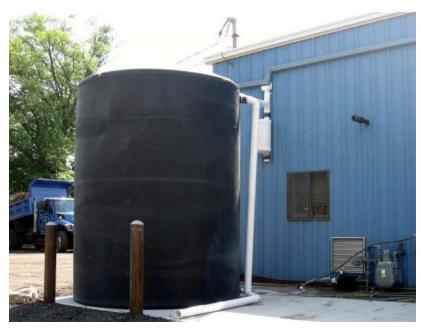
Figure 8b: A 5,000 gallon cistern used to disconnect the rooftop of the Department of Public Works in Clark Township to harvest rainwater for nonprofit car wash events

• Rainwater Harvesting: Rainwater harvesting includes the use of rain barrels and cisterns (Figures 8a and 8b). These can be placed below downspouts to collect rooftop runoff. The collected water has a variety of uses including watering plants and washing cars. This practice also helps cut down on the use of potable water for nondrinking purposes. It is important to divert the overflow from the rainwater harvesting system to a pervious area.

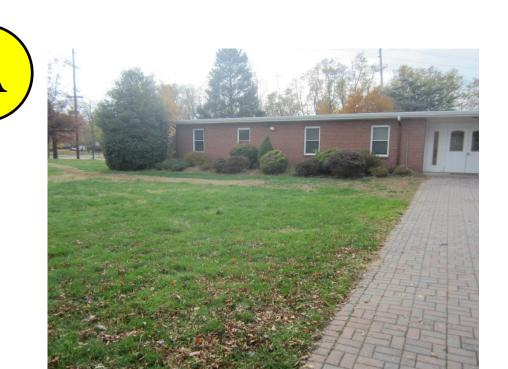
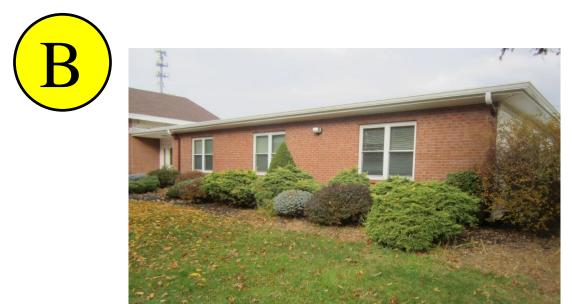
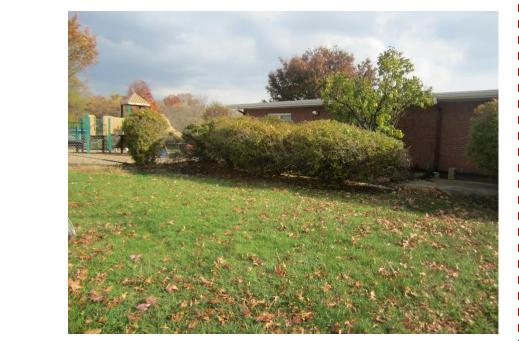
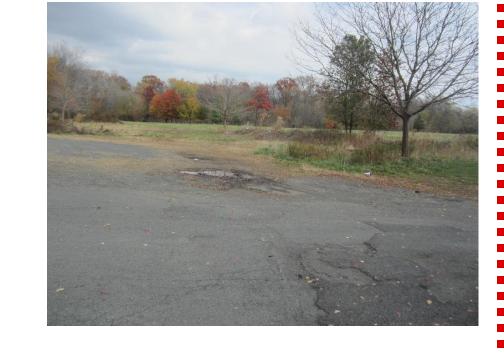
- BIORETENTION SYSTEM: On this property multiple rain gardens can be installed to capture rooftop runoff to reduce sediment and nutrient loading to the local waterways and increase groundwater recharge.
- POROUS PAVEMENT: For the parking lot, one option is to repave the lot with strips of porous pavement. Porous pavement promotes groundwater recharge and filters stormwater.
- BIOSWALE: A second option for the parking lot would be to repave it and slope it towards a bioswale. A bioswale is a vegetated system that will convey stormwater to an outlet while removing sediment and nutrients.

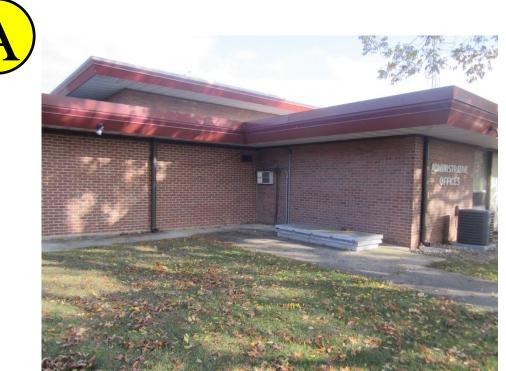
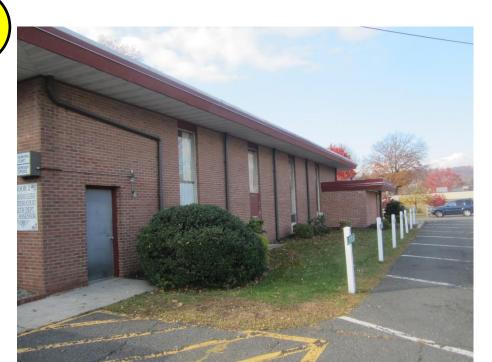
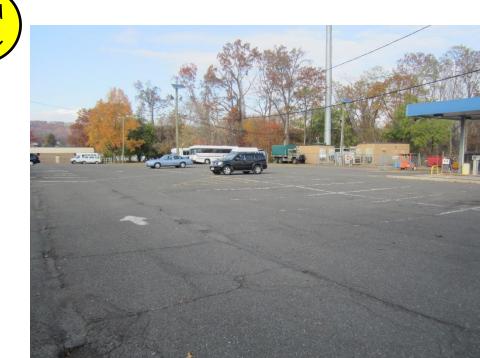
The parking lot is eroded. It is uneven and has numerous holes and puddles. Disconnected downspouts currently drain roof runoff directly onto grass.

Disconnected downspouts could be directed into bioretention systems which will capture and treat roof runoff before allowing it to naturally infiltrate and recharge groundwater. There are three suitable locations for bioretention systems at this site. One on the southwest side of the building, one on the southeast side of the building, and one on the northeast side of the building. To address the parking lot issue there are two viable options. One option would be to repave the lot with traditional pavement and slope it into a bioswale that would be installed in the grass area behind the lot. The second option would be to repave the parking lot with porous pavement.
