**Impervious Cover Assessment
for
Mountainside Borough, Union County, New Jersey**

*Prepared for Mountainside Borough by the
Rutgers Cooperative Extension Water Resources Program*

February 5, 2015

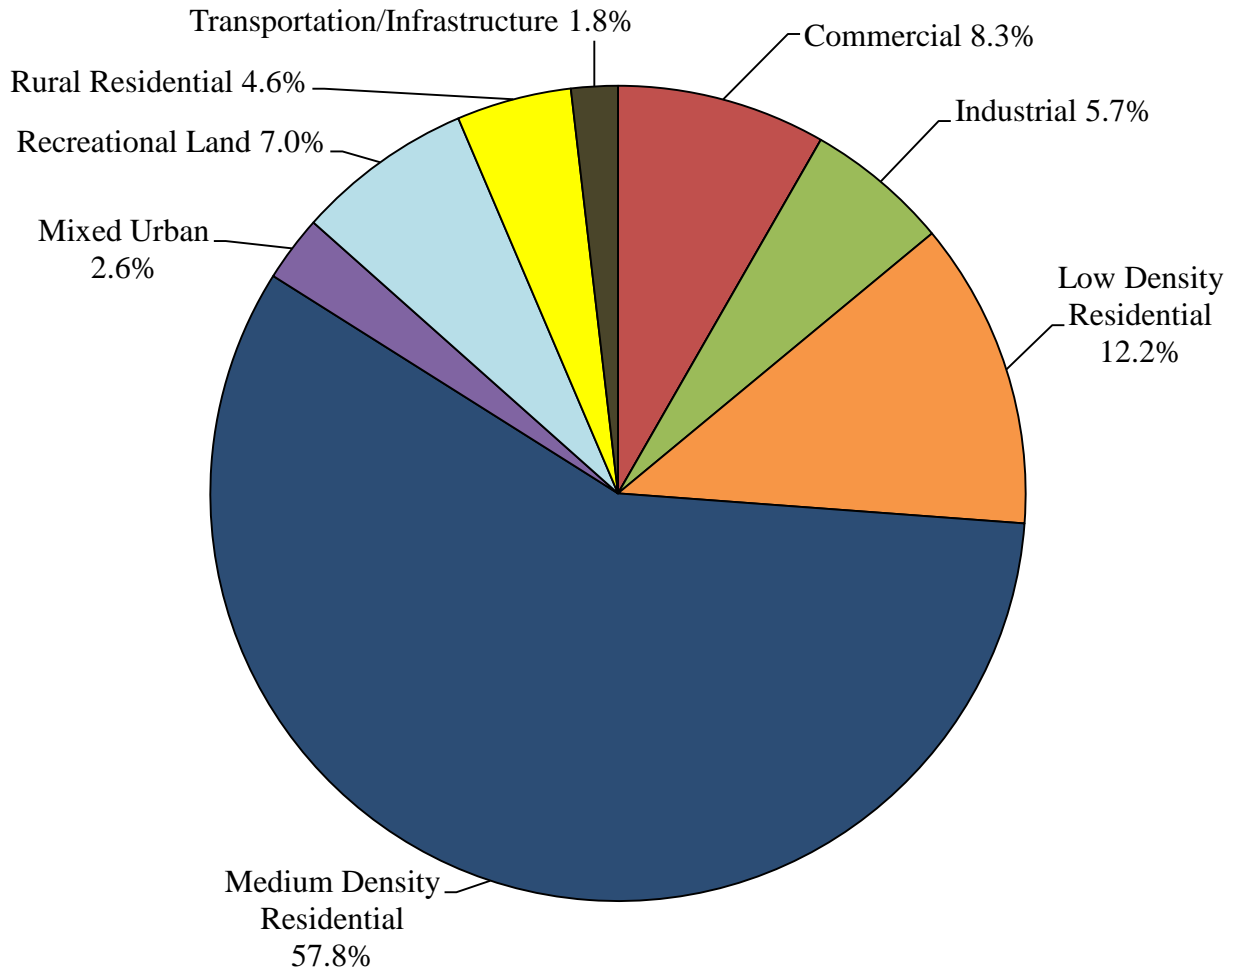
Figure 5: Pie chart illustrating the various types of urban land use in Mountainside Borough

Located in Union County in central New Jersey, Mountainside Borough covers approximately 4.0 square miles. Figures 3 and 4 illustrate that Mountainside Borough is dominated by urban land uses. A total of 60.5% of the municipality's land use is classified as urban. Of the urban land in Mountainside Borough, medium density residential is the dominant land use (Figure 5).
