**Impervious Cover Assessment
for
North Plainfield Borough, Somerset County, New Jersey**

*Prepared for North Plainfield Borough by the
Rutgers Cooperative Extension Water Resources Program*

February 4, 2015

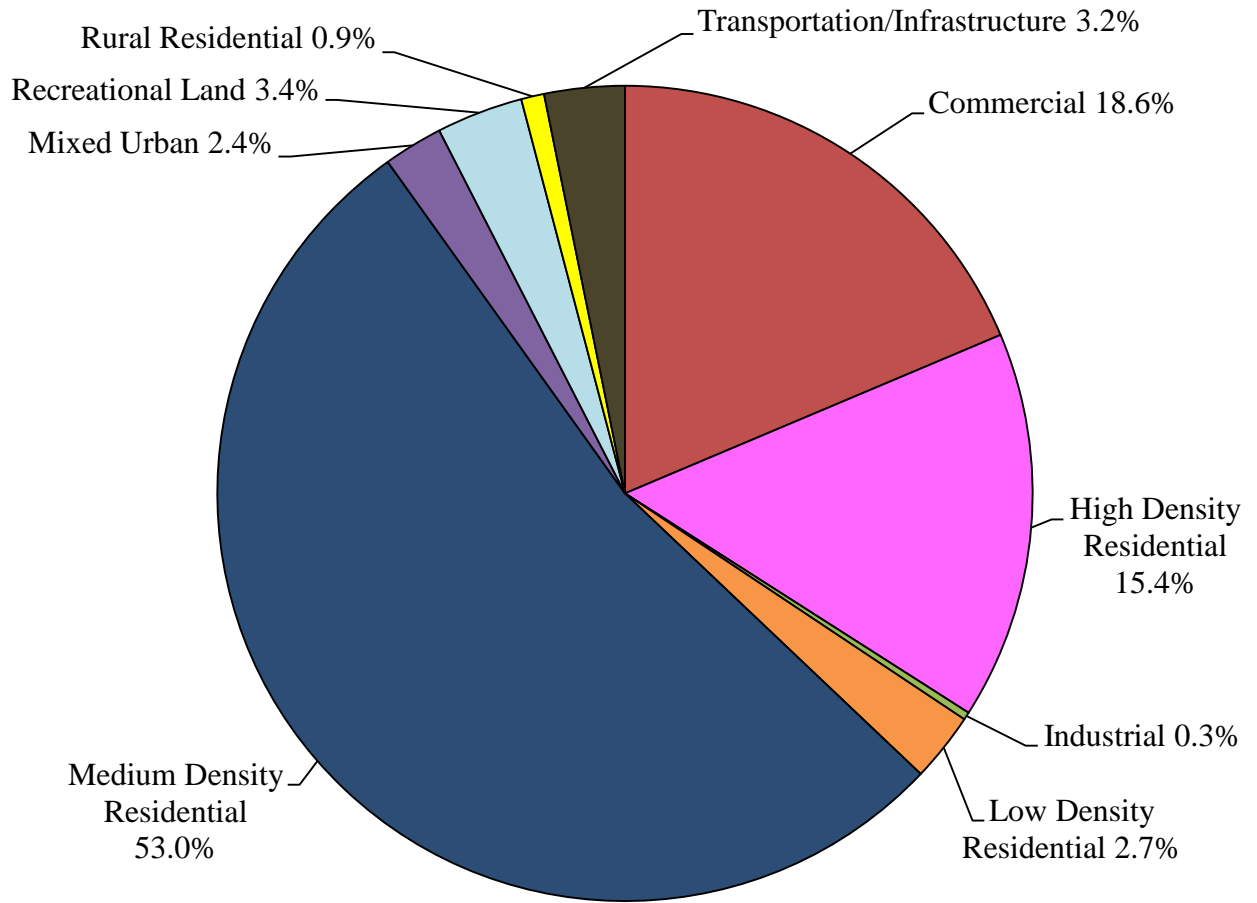
Figure 5: Pie chart illustrating the various types of urban land use in North Plainfield Borough

Located in Somerset County in central New Jersey, North Plainfield Borough covers approximately 2.82 square miles north of Plainfield Township. Figures 3 and 4 illustrate that North Plainfield Borough is dominated by urban land uses. A total of 69.8% of the municipality's land use is classified as urban. Of the urban land in North Plainfield Borough, medium density residential is the dominant land use (Figure 5).

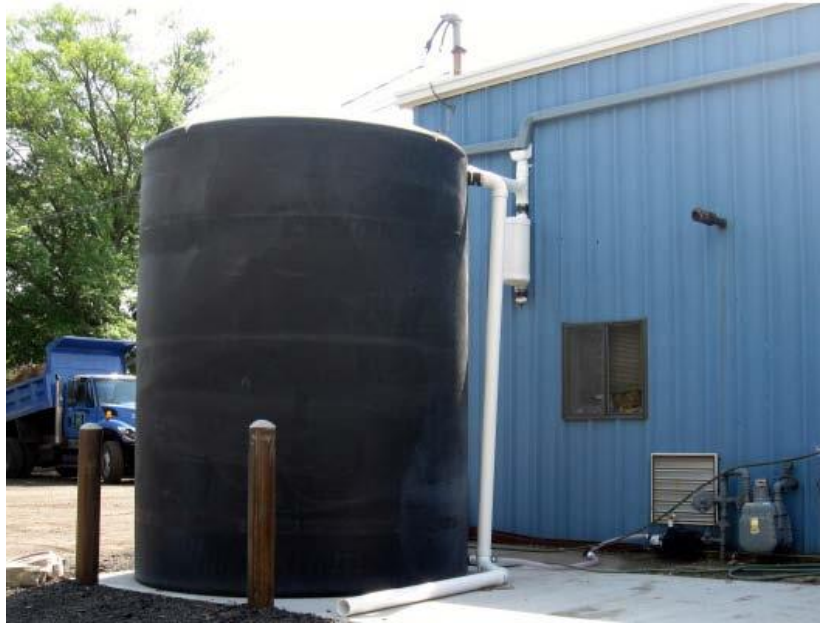
Figure 8b: A 5,000 gallon cistern used to disconnect the rooftop of the Department of Public Works in Clark Township to harvest rainwater for nonprofit car wash events

- Rainwater Harvesting: Rainwater harvesting includes the use of rain barrels and cisterns (Figures 8a and 8b). These can be placed below downspouts to collect rooftop runoff. The collected water has a variety of uses including watering plants and washing cars. This practice also helps cut down on the use of potable water for nondrinking purposes. It is important to divert the overflow from the rainwater harvesting system to a pervious area.

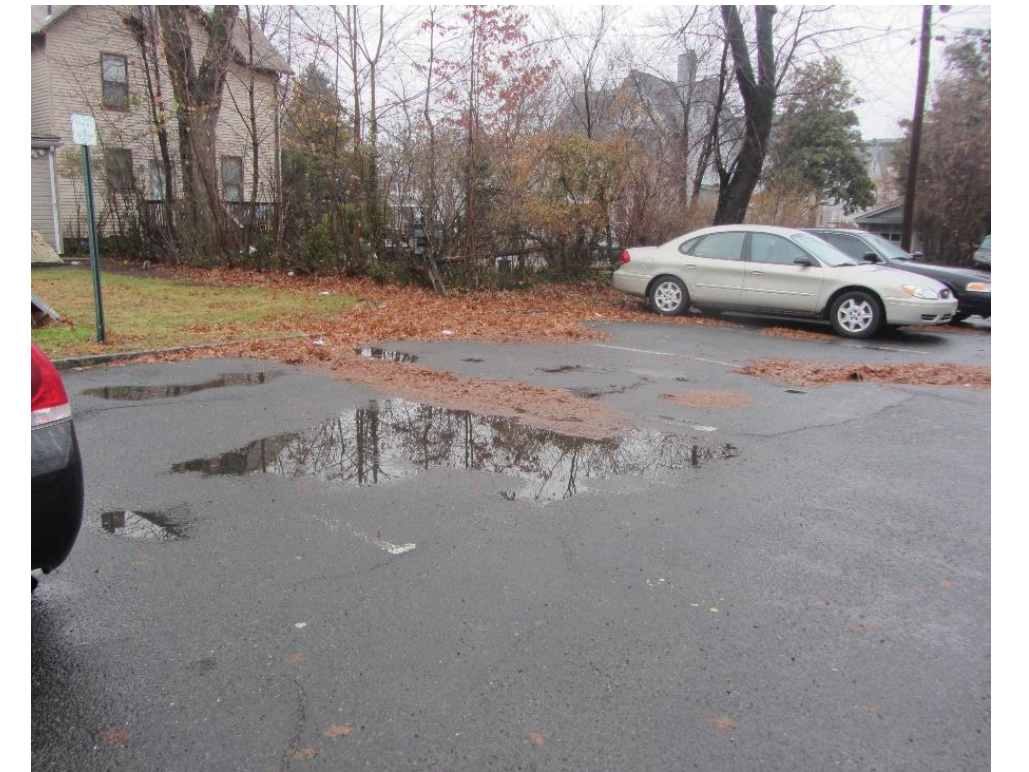
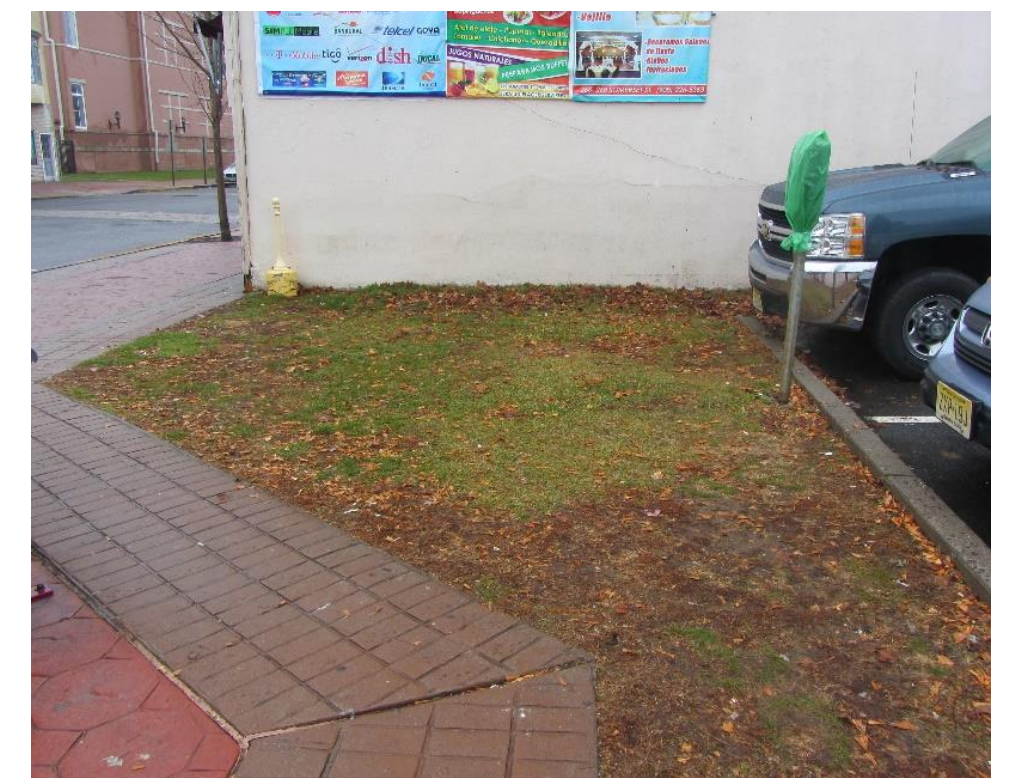
SITE PLAN:

1 BIORETENTION SYSTEM: A bioretention system could be installed at the western corner of the parking lot at Somerset Street and Race Street. A bioretention system will reduce runoff and allow stormwater infiltration, decreasing the amount of contaminants that reaches catch basins. A curb cut should be installed to allow the flow of runoff into the bioretention system.

2 POROUS PAVEMENT: The rear parking area could be repaved with porous pavement. Porous pavement promotes groundwater recharge and filters stormwater.

<p>Proposed Solution(s): A bioretention system could be installed in the grass at the western corner of the parking lot at the corner of Somerset Street and Race Street. This system would require a curb cut to receive runoff from the parking lot. Porous pavement could be installed in the parking lot behind the municipal building to reduce flooding and capture runoff.</p>	
<p>Anticipated Benefits: Since the bioretention system would be designed to capture, treat, and infiltrate the entire 2-year design storm (3.3 inches of rain over 24 hours), this system is estimated to achieve a 95% pollutant load reduction for TN, TP, and TSS. A bioretention system would also provide ancillary benefits such as enhanced wildlife habitat and aesthetic appeal. Curb cuts allow stormwater runoff to flow into vegetated areas and bioretention systems rather than flow into catch basins. Porous pavement allows stormwater to penetrate through to soil layers which will promote groundwater recharge as well as intercept and filter stormwater runoff. The porous pavement system will achieve the same level of pollutant load reduction for TN, TP and TSS as the bioretention system.</p>

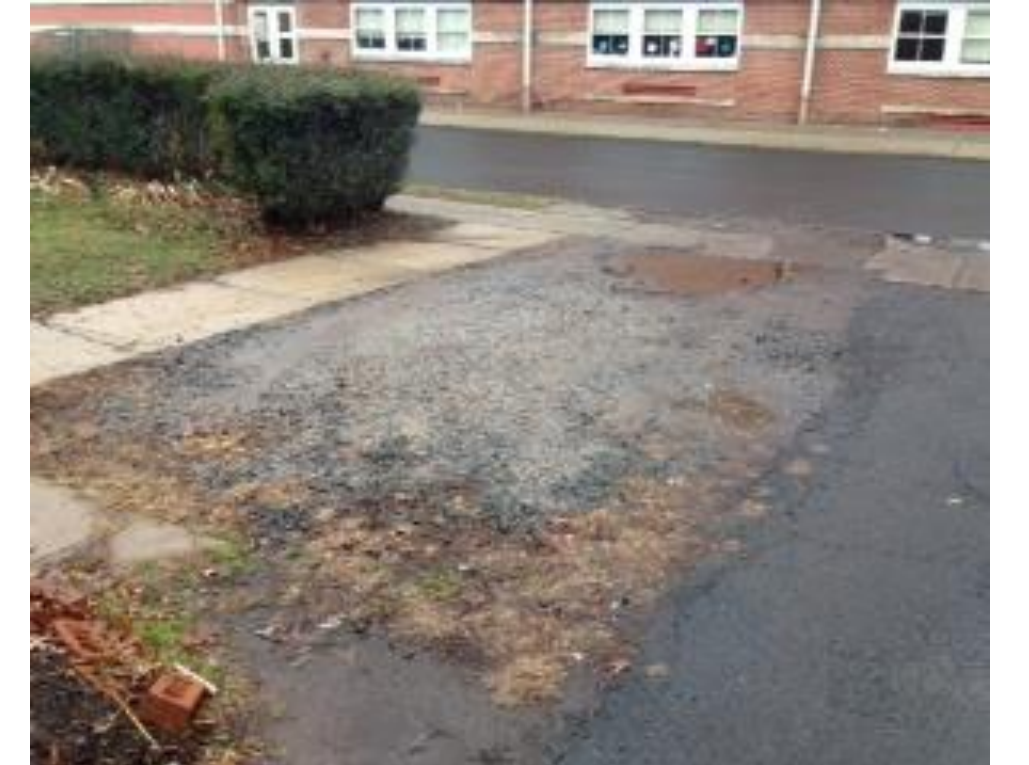
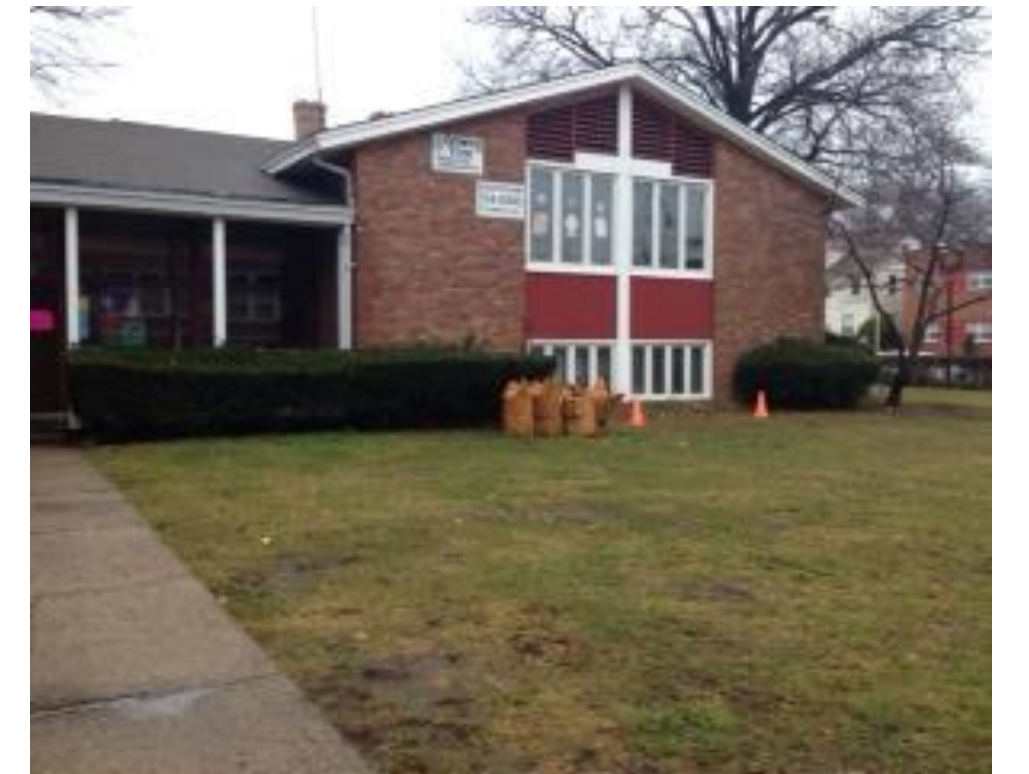
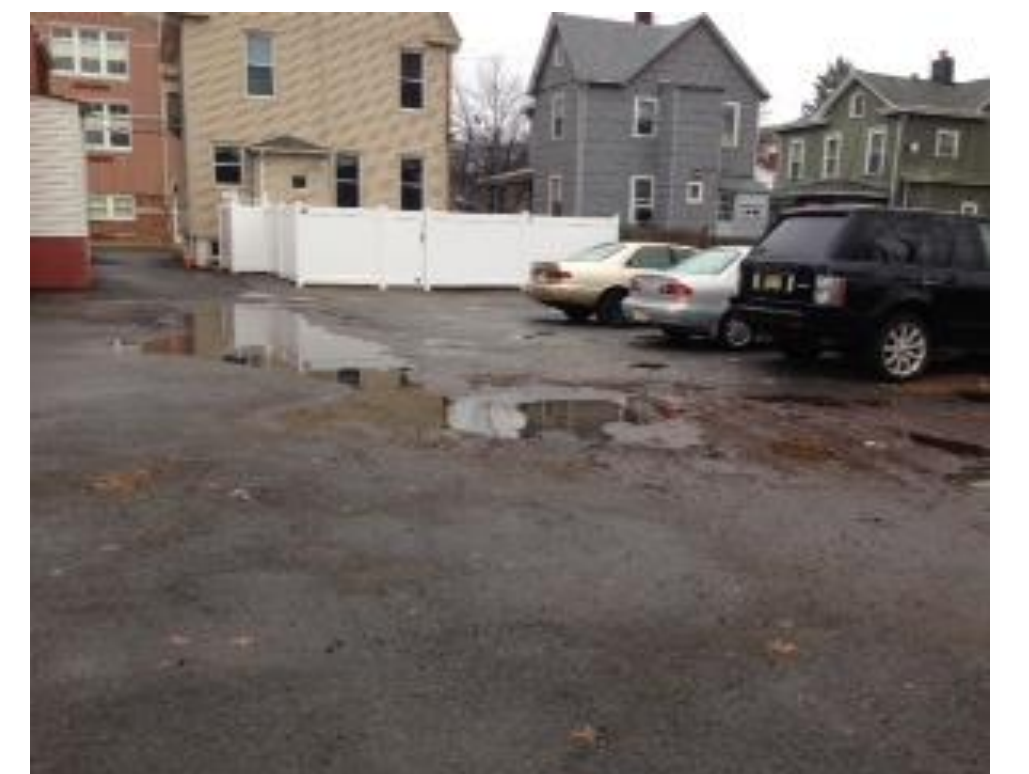
SITE PLAN:

- 1 BIORETENTION SYSTEM:** Two bioretention systems could be installed in the front yard of the church. One system would be installed near the Park Place driveway; another would be installed near the front walkway. Bioretention systems will reduce runoff and allow stormwater infiltration, decreasing the amount of contaminants that reaches catch basins.
- 2 POROUS PAVEMENT:** A porous pavement system could be installed in the church's parking lot. Porous pavement promotes groundwater recharge and filters stormwater.

<p>Proposed Solution(s): A bioretention system could be installed in the grass/gravel space of the lawn at the driveway. This system would have one downspout routed to it. A second bioretention system could be installed on the southeastern face of the building near the front walkway to treat runoff from two of the church's downspouts. Porous pavement could be installed in the parking lot to alleviate flooding.</p>	
<p>Anticipated Benefits: Since the bioretention systems would be designed to capture, treat, and infiltrate the entire 2-year design storm (3.3 inches of rain over 24 hours), these systems are estimated to achieve a 95% pollutant load reduction for TN, TP, and TSS. A bioretention system would also provide ancillary benefits such as enhanced wildlife habitat and aesthetic appeal. Porous pavement allows stormwater to penetrate through to soil layers which will promote groundwater recharge as well as intercept and filter stormwater runoff. Porous pavement will achieve the same level of pollutant load reduction for TN, TP and TSS as the bioretention systems.</p>

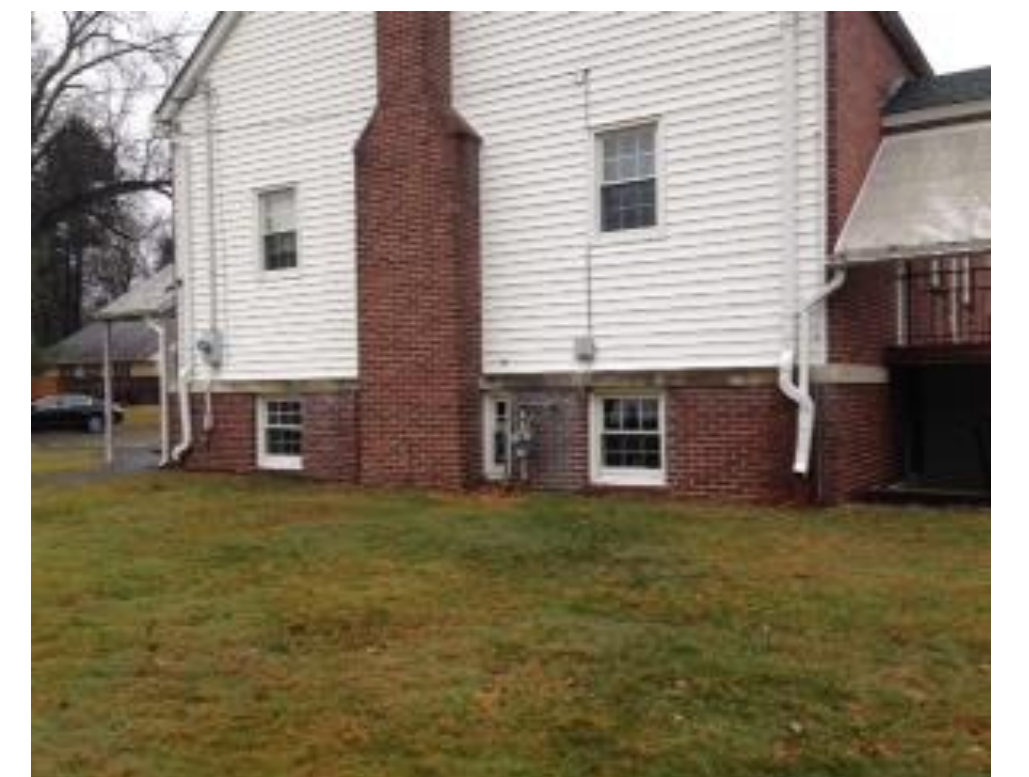
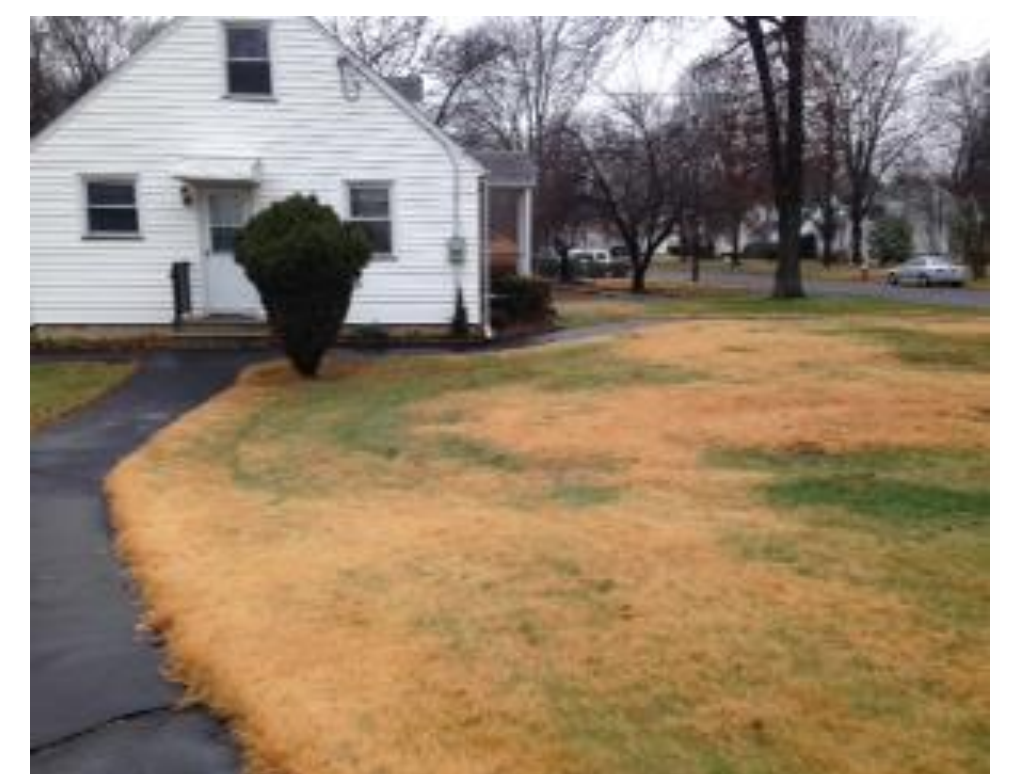
SITE PLAN:

1 BIORETENTION SYSTEM: Two bioretention systems could be installed in the lawn to the southwest of the church. The first system would be installed alongside the church; the second system would be installed in a depression along the rear walkway. Bioretention systems will reduce runoff and allow stormwater infiltration, decreasing the amount of contaminants that reaches catch basins.

<p>Proposed Solution(s): Two bioretention systems could be installed in the lawn to the southwest of the church. The first system would be installed alongside the church; the second system would be installed in a depression along the rear walkway.</p>	
<p>Anticipated Benefits: Since the bioretention systems would be designed to capture, treat, and infiltrate the entire 2-year design storm (3.3 inches of rain over 24 hours), these systems are estimated to achieve a 95% pollutant load reduction for TN, TP, and TSS. A bioretention system would also provide ancillary benefits such as enhanced wildlife habitat and aesthetic appeal.</p>	
<p>Possible Funding Sources: mitigation funds from local developers NJDEP grant programs North Plainfield Borough North Plainfield Baptist Church local social and community groups</p>	
<p>Partners/Stakeholders: North Plainfield Borough</p>
