**Impervious Cover Assessment
for
Summit, Union County, New Jersey**

*Prepared for Summit by the
Rutgers Cooperative Extension Water Resources Program*

February 5, 2015

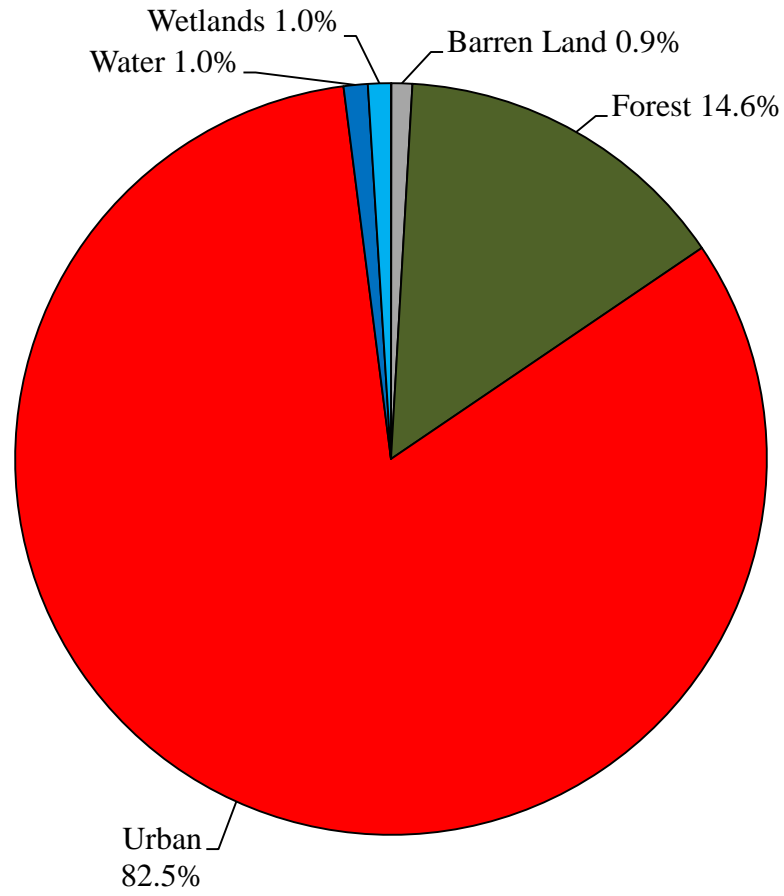
Figure 3: Pie chart illustrating the land use in Summit

Located in Union County in central New Jersey, Summit covers approximately 6.0 square miles southwest of Millburn. Figures 3 and 4 illustrate that Summit is dominated by urban land uses. A total of 82.5% of the municipality's land use is classified as urban. Of the urban land in Summit, medium density residential is the dominant land use (Figure 5).

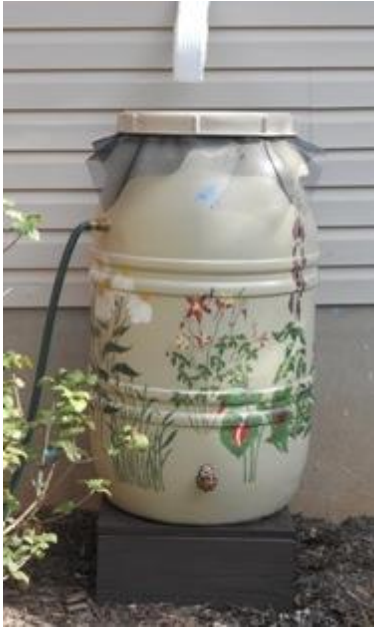
Figure 8a: Rain barrel used to disconnect a downspout with the overflow going to a flower bed

- Rainwater Harvesting: Rainwater harvesting includes the use of rain barrels and cisterns (Figures 8a and 8b). These can be placed below downspouts to collect rooftop runoff. The collected water has a variety of uses including watering plants and washing cars. This practice also helps cut down on the use of potable water for nondrinking purposes. It is important to divert the overflow from the rainwater harvesting system to a pervious area.

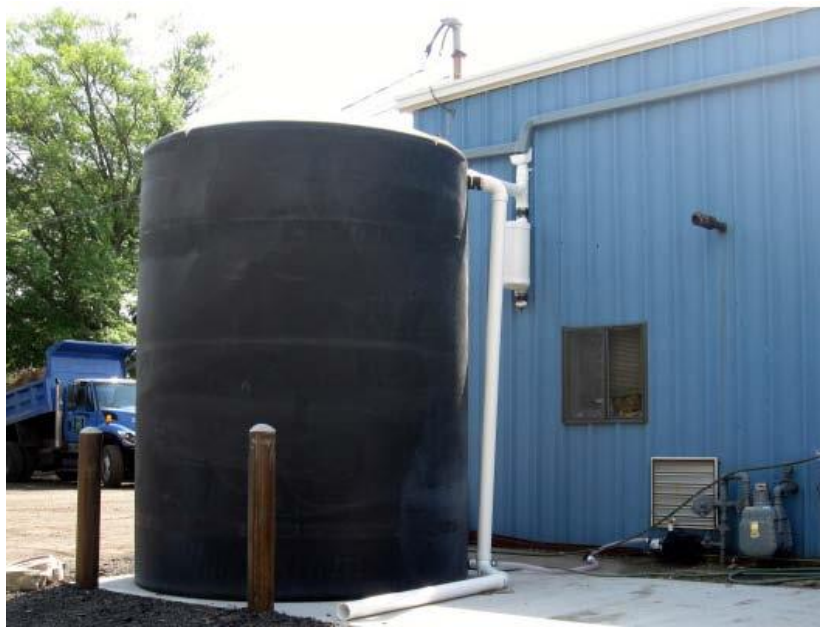
Figure 8b: A 5,000 gallon cistern used to disconnect the rooftop of the Department of Public Works in Clark Township to harvest rainwater for nonprofit car wash events
