**Impervious Cover Assessment
for
Bethlehem Township, Hunterdon County, New Jersey**

*Prepared for Bethlehem Township by the
Rutgers Cooperative Extension Water Resources Program*

January 7, 2020

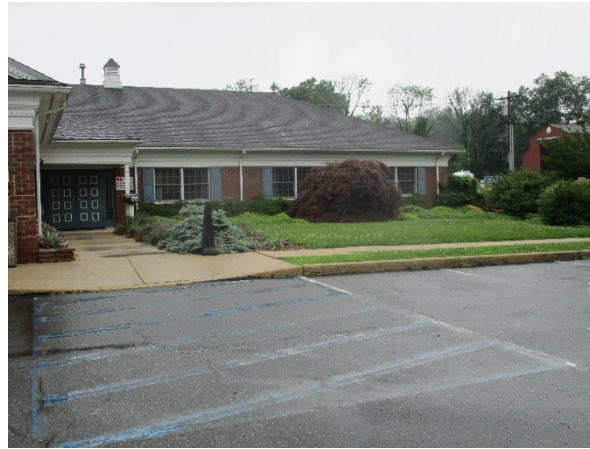
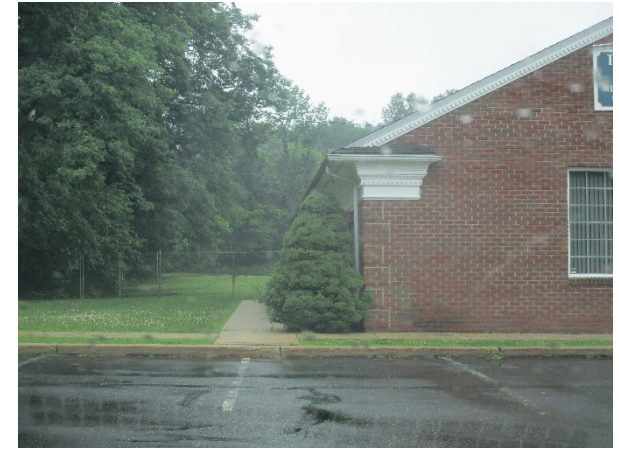
BETHLEHEM TOWNSHIP MUNICIPAL COURT

A cistern can be installed on the north side of the public works building near a connected downspout. The water from the cistern can then be used for watering gardens, washing vehicles, or for other non-potable uses. A rain garden can be installed on the west and east side of the building to capture, treat, and infiltrate rooftop runoff.

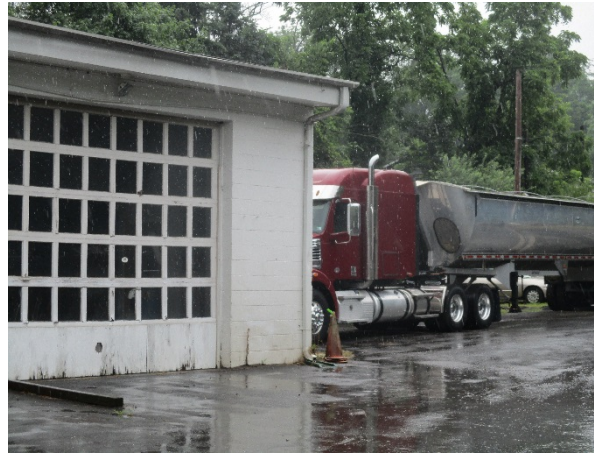
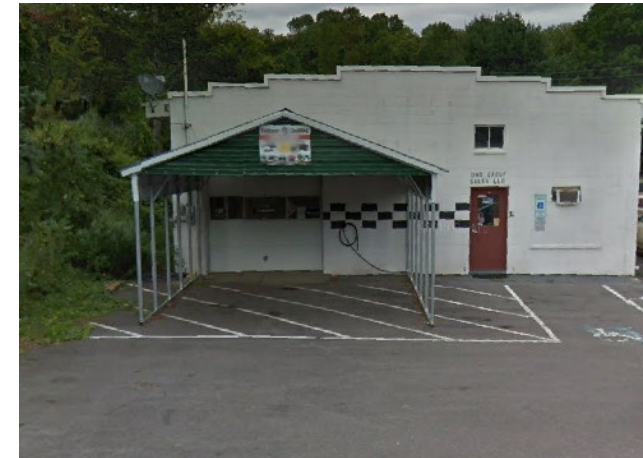
DND AUTO GROUP 2

A cistern can be installed north of the building near a disconnected downspout. The water from the cistern can then be used for watering gardens, washing vehicles, or for other non-potable uses.

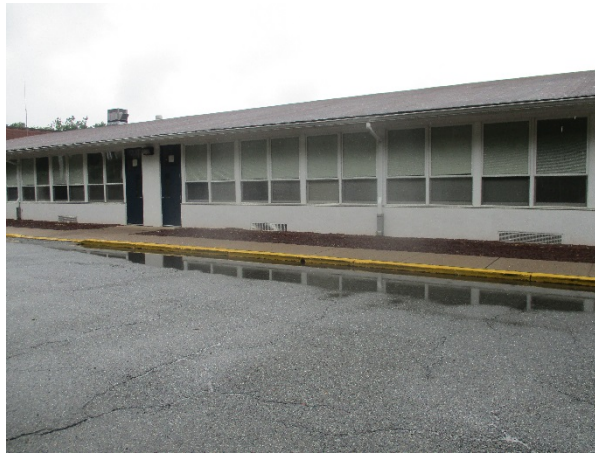
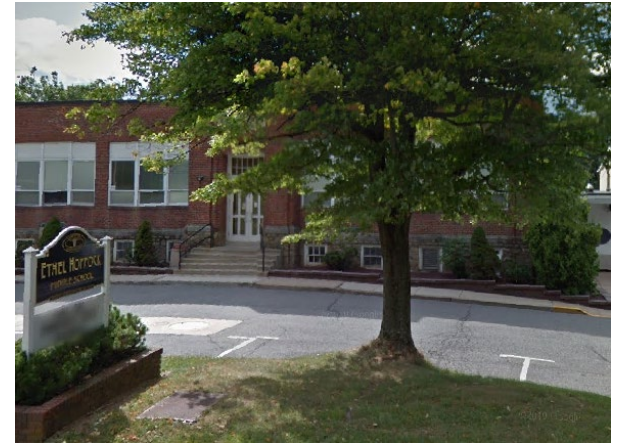
ETHEL HOPPOCK MIDDLE SCHOOL

Parking spaces east of the building can be replaced with pervious pavement to capture and infiltrate stormwater. Downspout planter boxes can be constructed along the east side of the building to allow roof runoff to be reused.
