**Impervious Cover Assessment
for
Glen Gardner Borough, Hunterdon County, New Jersey**

*Prepared for Glen Gardner Borough by the
Rutgers Cooperative Extension Water Resources Program*

January 7, 2020

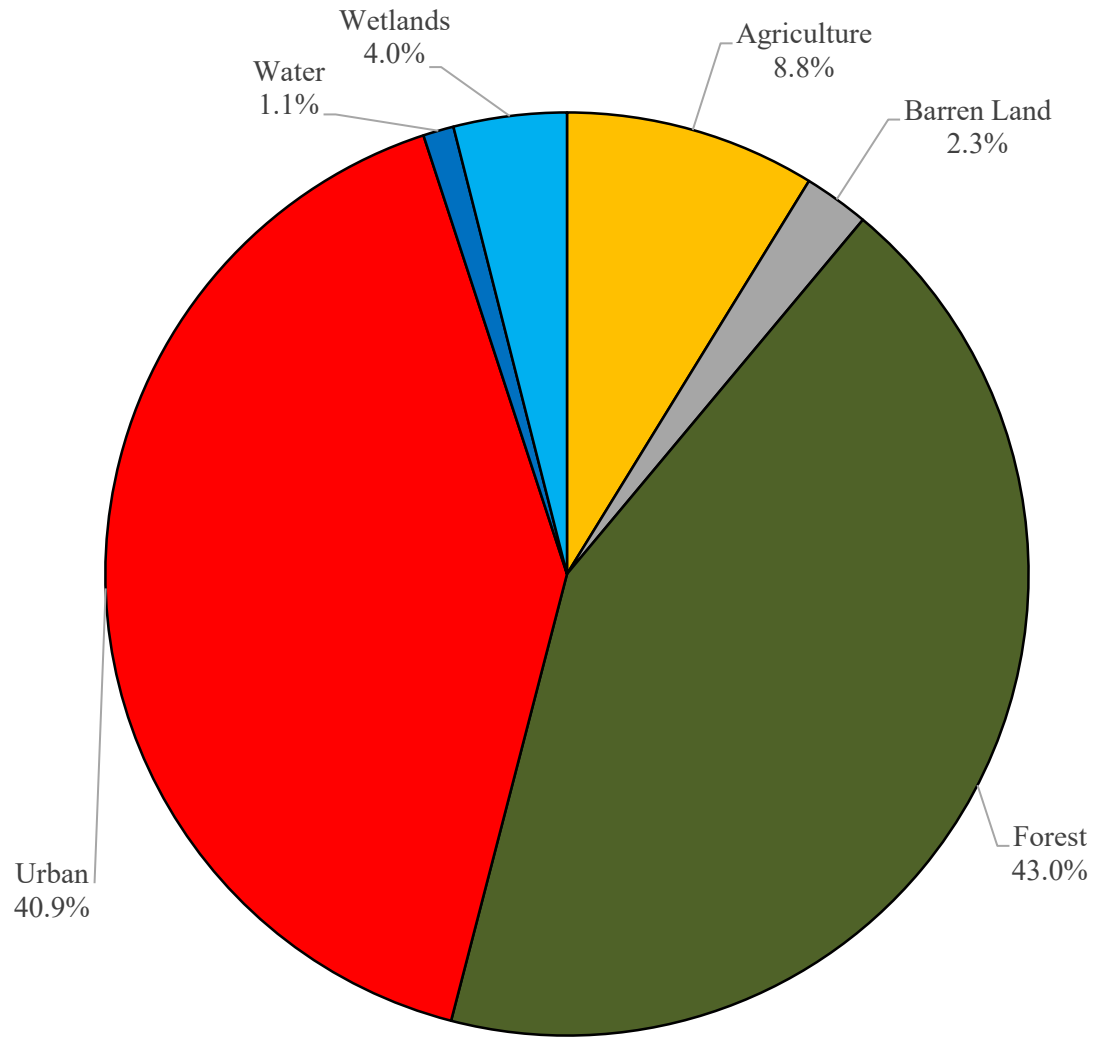
Figure 3: Pie chart illustrating the land use in Glen Gardner Borough

Glen Gardner Borough is located in Hunterdon County, New Jersey and covers approximately 1.52 square miles. Figures 3 and 4 illustrate that Glen Gardner Borough is dominated by forest land uses. A total of 40.9% of the municipality's land use is classified as urban. Of the urban land in Glen Gardner Borough, rural residential is the dominant land use (Figure 5).

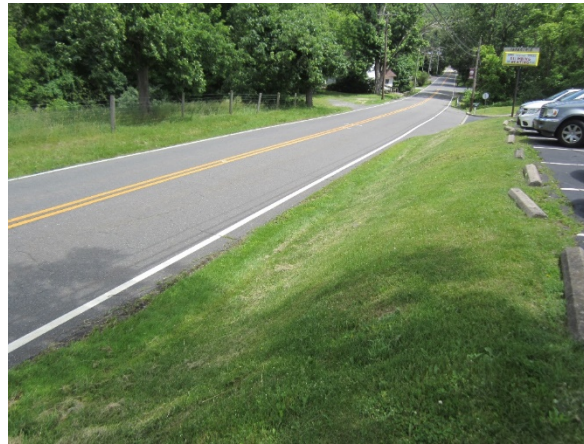
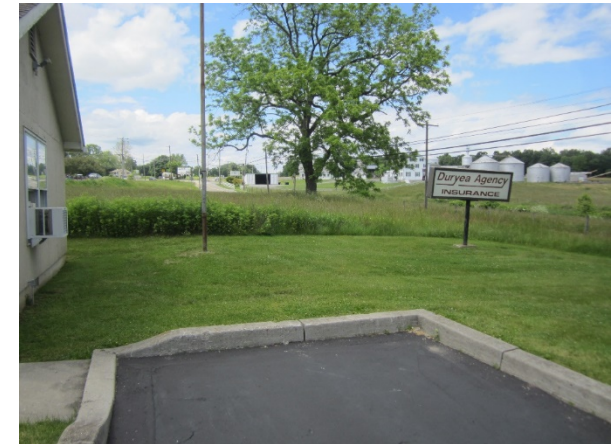
DURYEA AGENCY

The steep road grade and connected turfgrass section provides a suitable location for a bioswale. A rain garden can be installed in the turfgrass area northwest of the building to capture stormwater from the rooftop of the building.

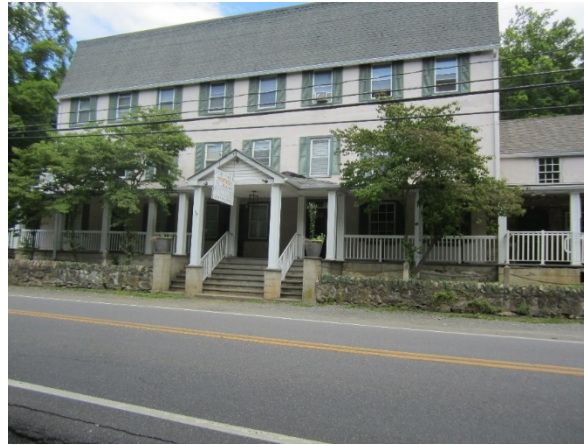
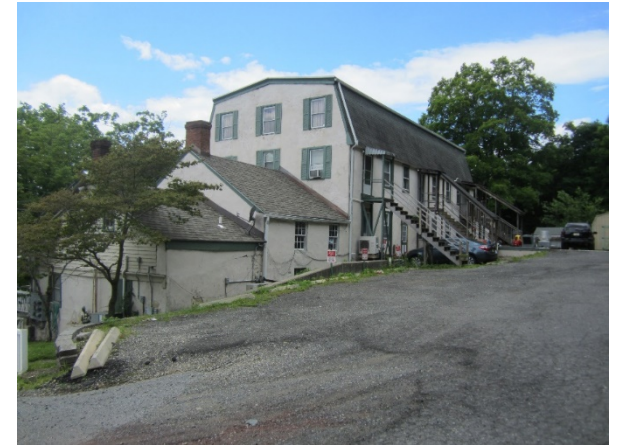
HUMPHREY'S TAVERN

Two similar rain gardens can be installed in the turfgrass in front of the tavern to capture stormwater from the front half of the building. A strip of pervious pavement can be installed in the lower parking section to collect stormwater from the larger parking lot.

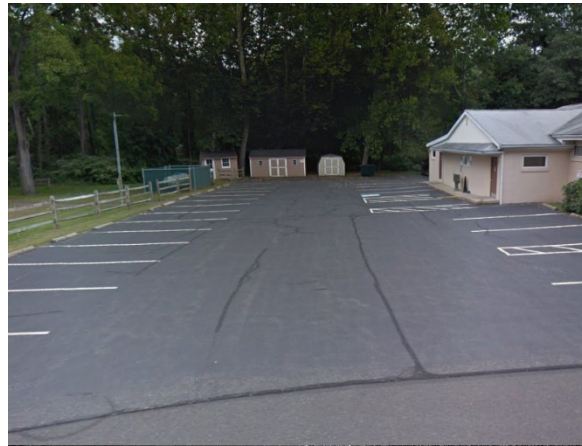
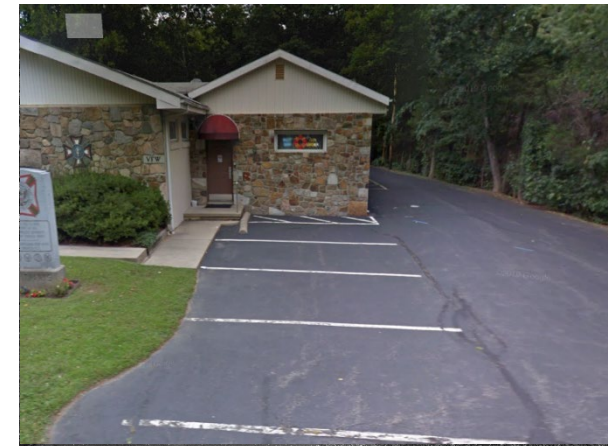
VETERANS OF FOREIGN WARS MEMORIAL BUILDING

Pervious pavement can be installed to replace sections of the parking lot, as shown in the details, to collect stormwater from the pavement and rooftop.
