**Impervious Cover Assessment
for
Mendham Borough, Morris County, New Jersey**

*Prepared for Mendham Borough by the
Rutgers Cooperative Extension Water Resources Program*

January 7, 2020

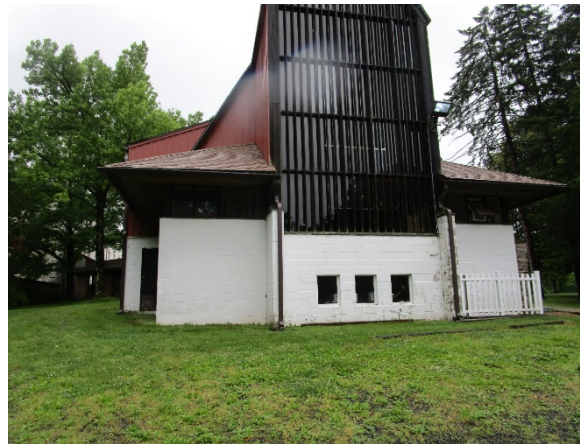
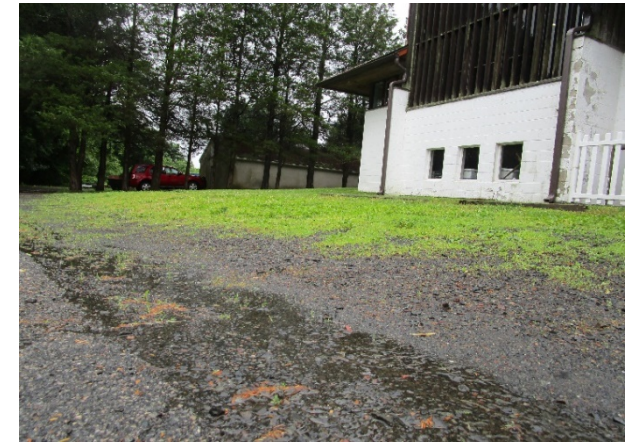
DAYTOP PREPARATORY SCHOOL

Due to pooling and buildup at the bottom of the hill, on top of which the school is located, a rain garden is suggested between the school and the parking lot to receive the stormwater from the downspouts to aid infiltration. Pervious pavement can be installed at the northwest corner of the parking lot to infiltrate the stormwater from the driveway, and downspout planter boxes can be installed along the front of the school.

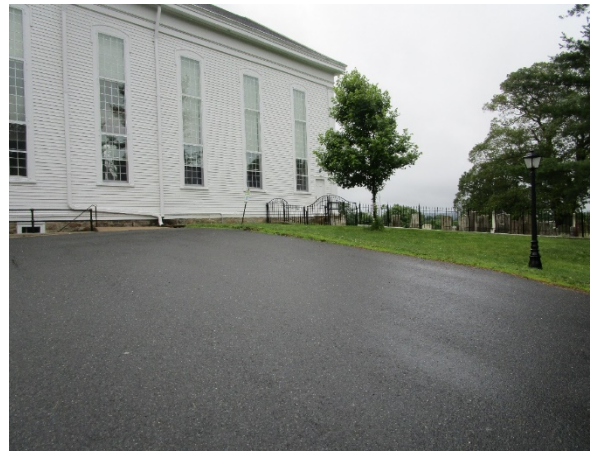
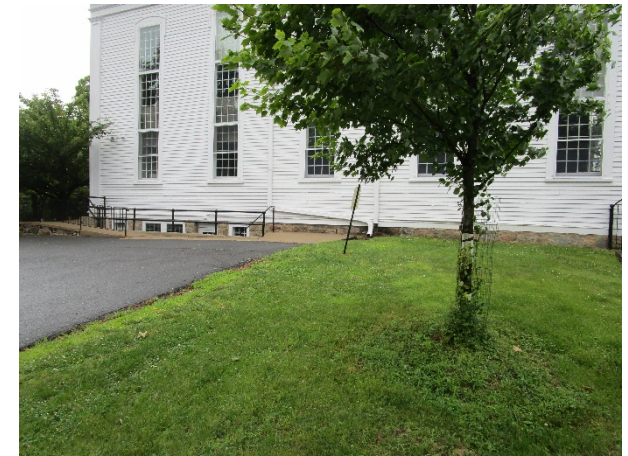
HILLTOP PRESBYTERIAN CHURCH

Due to the pitch of the pavement and the location of the downspouts on the building, pervious pavement would help prevent pooling in the adjacent street. Additionally, the front of the building can either be treated with a bioretention system or downspout planter boxes to infiltrate the rooftop drainage.

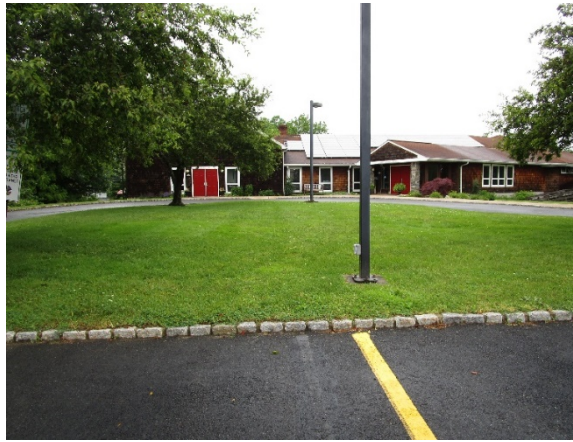
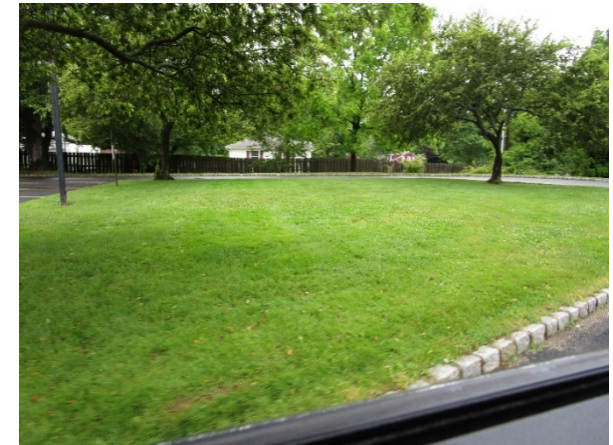
GRACE LUTHERAN CHURCH

Due to the number of downspouts in the front of the building, a rain garden can be installed either in the front (separated) turfgrass area or the turfgrass area in the southwest corner of the building. Downspout planter boxes can also be installed along the front of the building to treat the rooftop drainage. Additionally, pervious pavement can be installed in the south parking lot to infiltrate the stormwater draining from the parking lot.
