**Impervious Cover Assessment
for
Holmdel Township, Monmouth County, New Jersey**

*Prepared for Holmdel Township by the
Rutgers Cooperative Extension Water Resources Program*

January 12, 2021

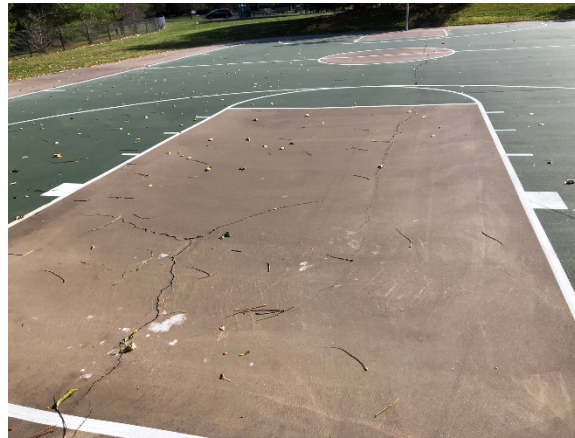
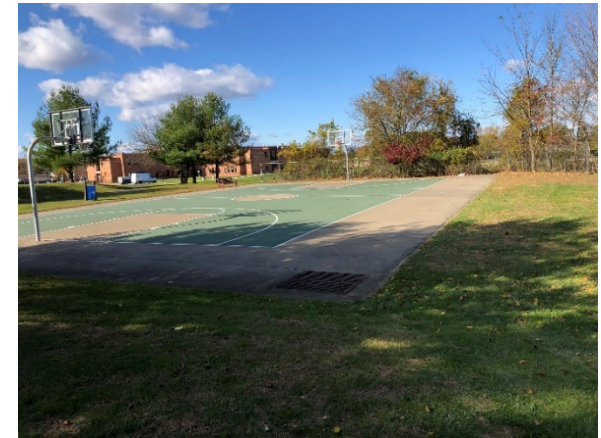
ACKERSON PARK

A rain garden can be installed near the playground area to capture, treat, and infiltrate stormwater runoff and also serve as an educational demonstration. Pervious pavement can be installed to treat the drainage area of the basketball court and also improve the structure of the existing cracked pavement.

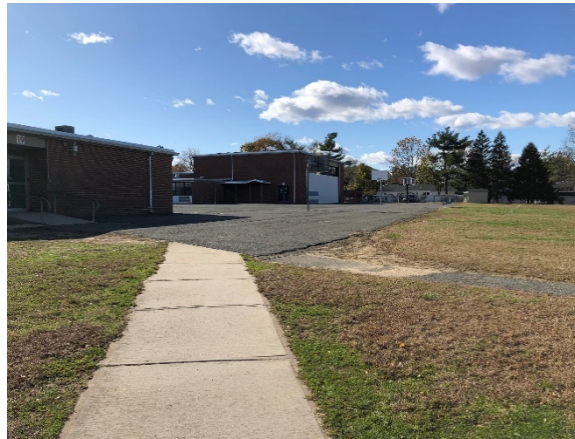
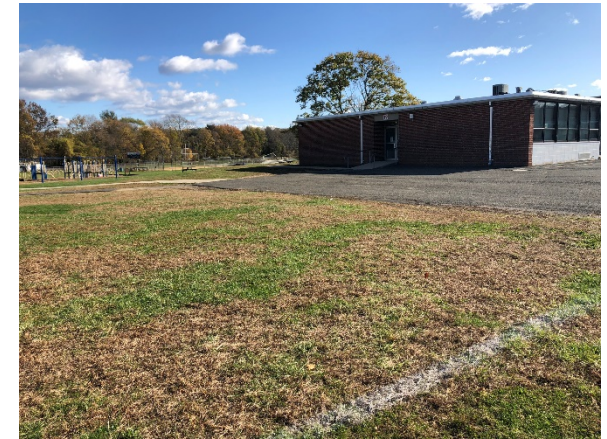
INDIAN HILL SCHOOL

A rain garden can be installed adjacent to the northeast corner of the parking lot to capture, treat, and infiltrate runoff from the parking lot. Additionally, two raingardens can be installed to treat the rooftops of the adjacent buildings.
