**Impervious Cover Assessment
for
Quinton Township, Salem County, New Jersey**

*Prepared for Quinton Township by the
Rutgers Cooperative Extension Water Resources Program*

February 15, 2018

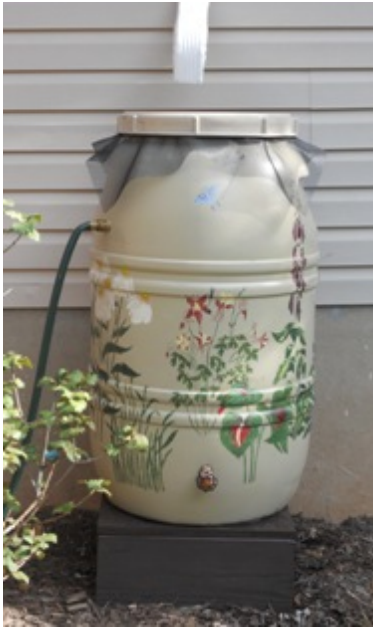
Figure 8a: Rain barrel used to disconnect a downspout with the overflow going to a flower bed

- Rainwater Harvesting: Rainwater harvesting includes the use of rain barrels and cisterns (Figures 8a and 8b). These can be placed below downspouts to collect rooftop runoff. The collected water has a variety of uses including watering plants and washing cars. This practice also helps cut down on the use of potable water for nondrinking purposes. It is important to divert the overflow from the rainwater harvesting system to a pervious area.

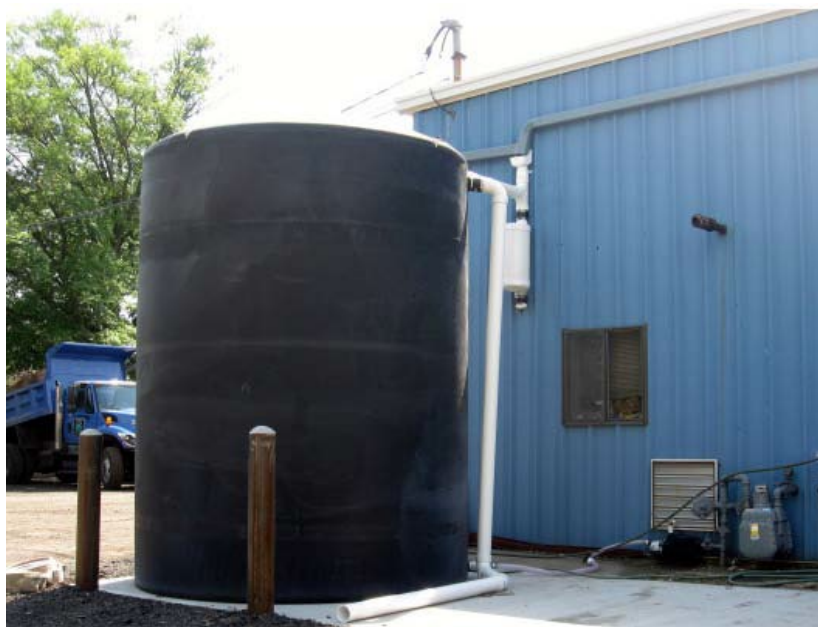
Figure 8b: A 5,000 gallon cistern used to disconnect the rooftop of the Department of Public Works in Clark Township to harvest rainwater for nonprofit car wash events
