Impervious Cover Assessment for Hampton Borough, Hunterdon County, New Jersey

Prepared for Hampton Borough by the Rutgers Cooperative Extension Water Resources Program

August 10, 2016

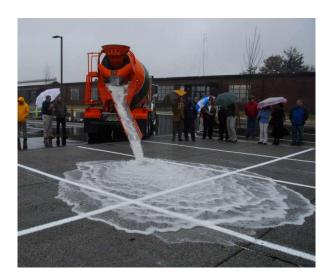
Figure 2: Rapid infiltration of water through porous pavement is demonstrated at the USEPA Edison New Jersey test site

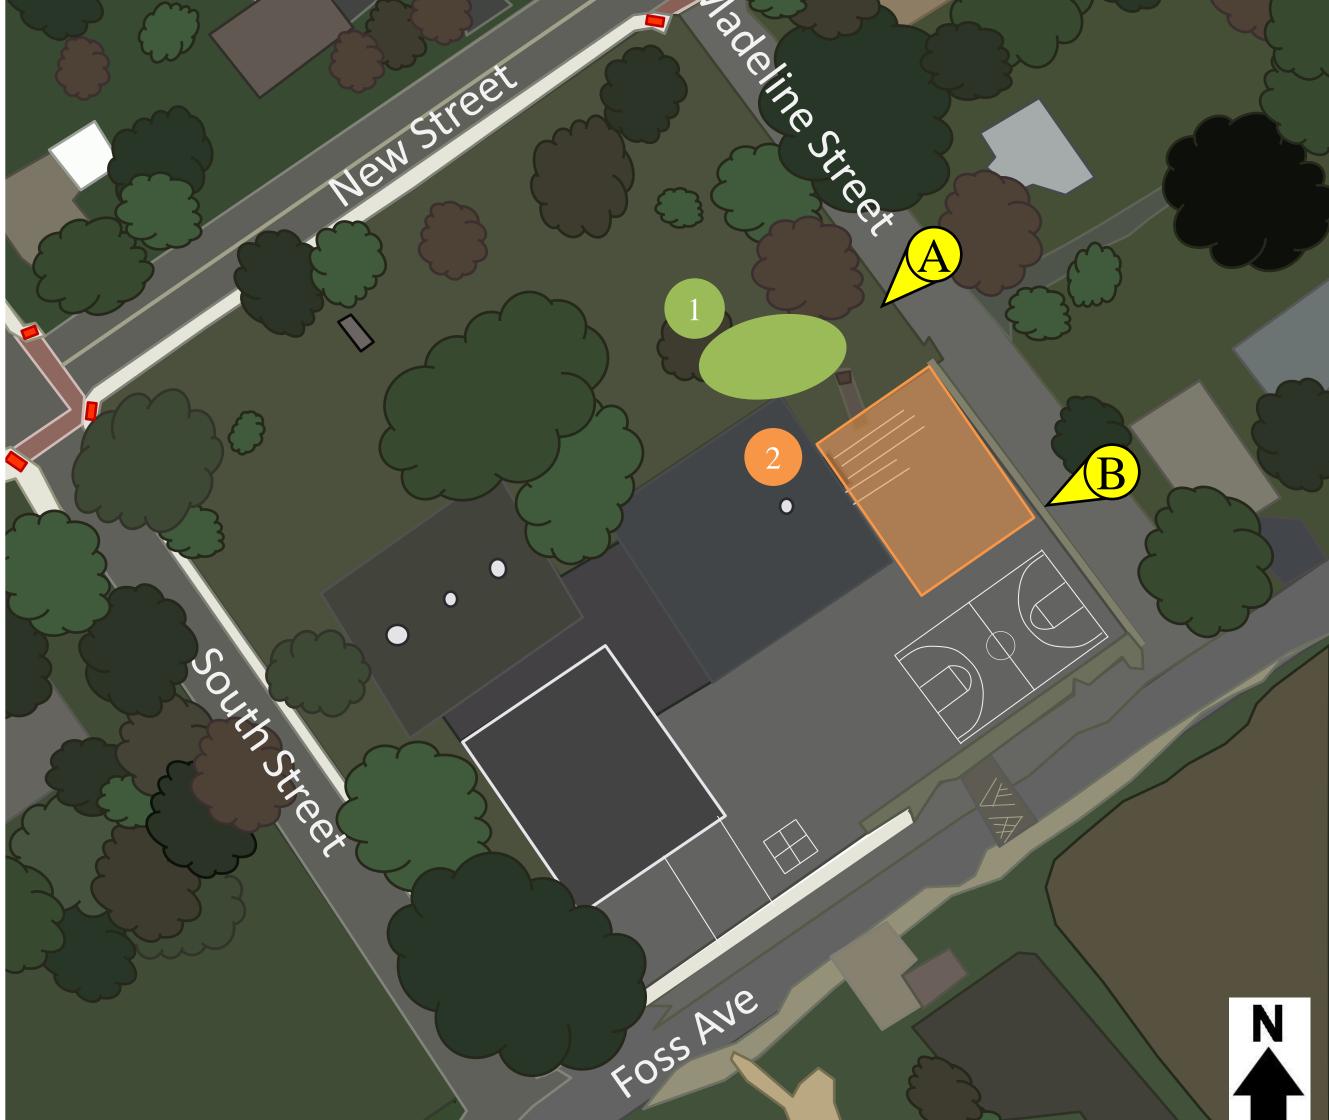
SITE PLAN:

- BIORETENTION SYSTEM: A rain garden at the northeast corner will be used to reduce sediment and nutrient loading to the local waterway and increase groundwater recharge by redirecting rooftop runoff into it.
- POROUS PAVEMENT: Porous pavement promotes groundwater recharge and filters stormwater. Despite the playground area appearing to be newly paved, there is an abundance of patched cracks. A new porous pavement playground would allow the water to infiltrate into the soil instead of reaching the catch basin on the northeast side of the pavement.

The existing pavement in the playground area of the school appears new, but there are many patched cracks throughout the area. The entire playground also pitches towards the school itself and an existing catch basin. All of the building's downspouts are connected.

The paved playground area can be partially repaved with porous pavement to capture, treat, and allow infiltration of stormwater as well as prevent water from flowing towards the school. A rain garden can also be placed just off the northeast corner of the school building to capture, treat, and allow infiltration of roof runoff from redirected downspouts.

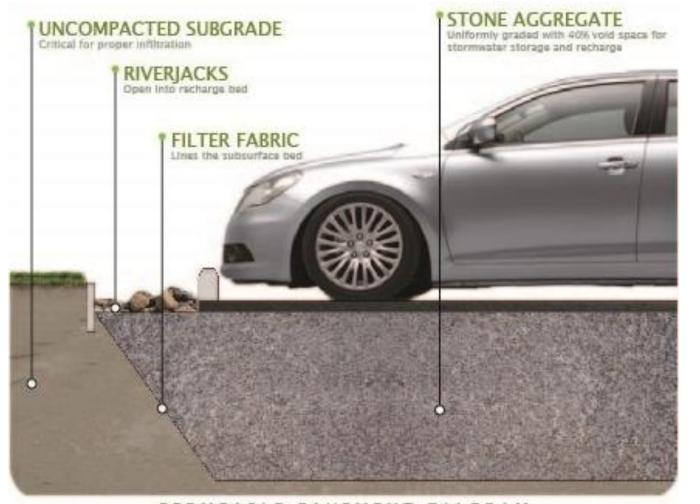
POROUS PAVEMENT

Porous pavement allows stormwater to infiltrate through to soil layers which will promote groundwater recharge as well as intercept and filter stormwater runoff. The porous pavement system will achieve the same level of pollutant load reduction for TN, TP, and TSS as the bioretention system.

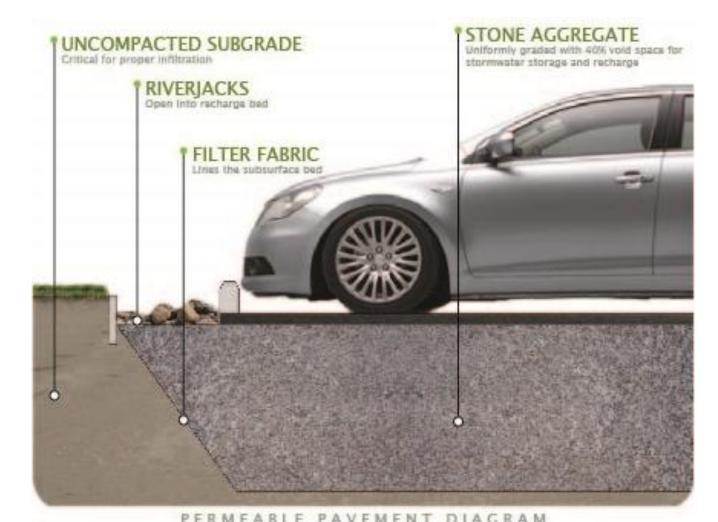
POROUS PAVEMENT

Porous pavement allows stormwater to infiltrate through to soil layers which will promote groundwater recharge as well as intercept and filter stormwater runoff. The porous pavement system will achieve the same level of pollutant load reduction for TN, TP, and TSS as the bioretention system.
