**Impervious Cover Assessment
for
Franklin Township, Somerset County, New Jersey**

*Prepared for Franklin Township by the
Rutgers Cooperative Extension Water Resources Program*

Updated February 24, 2021

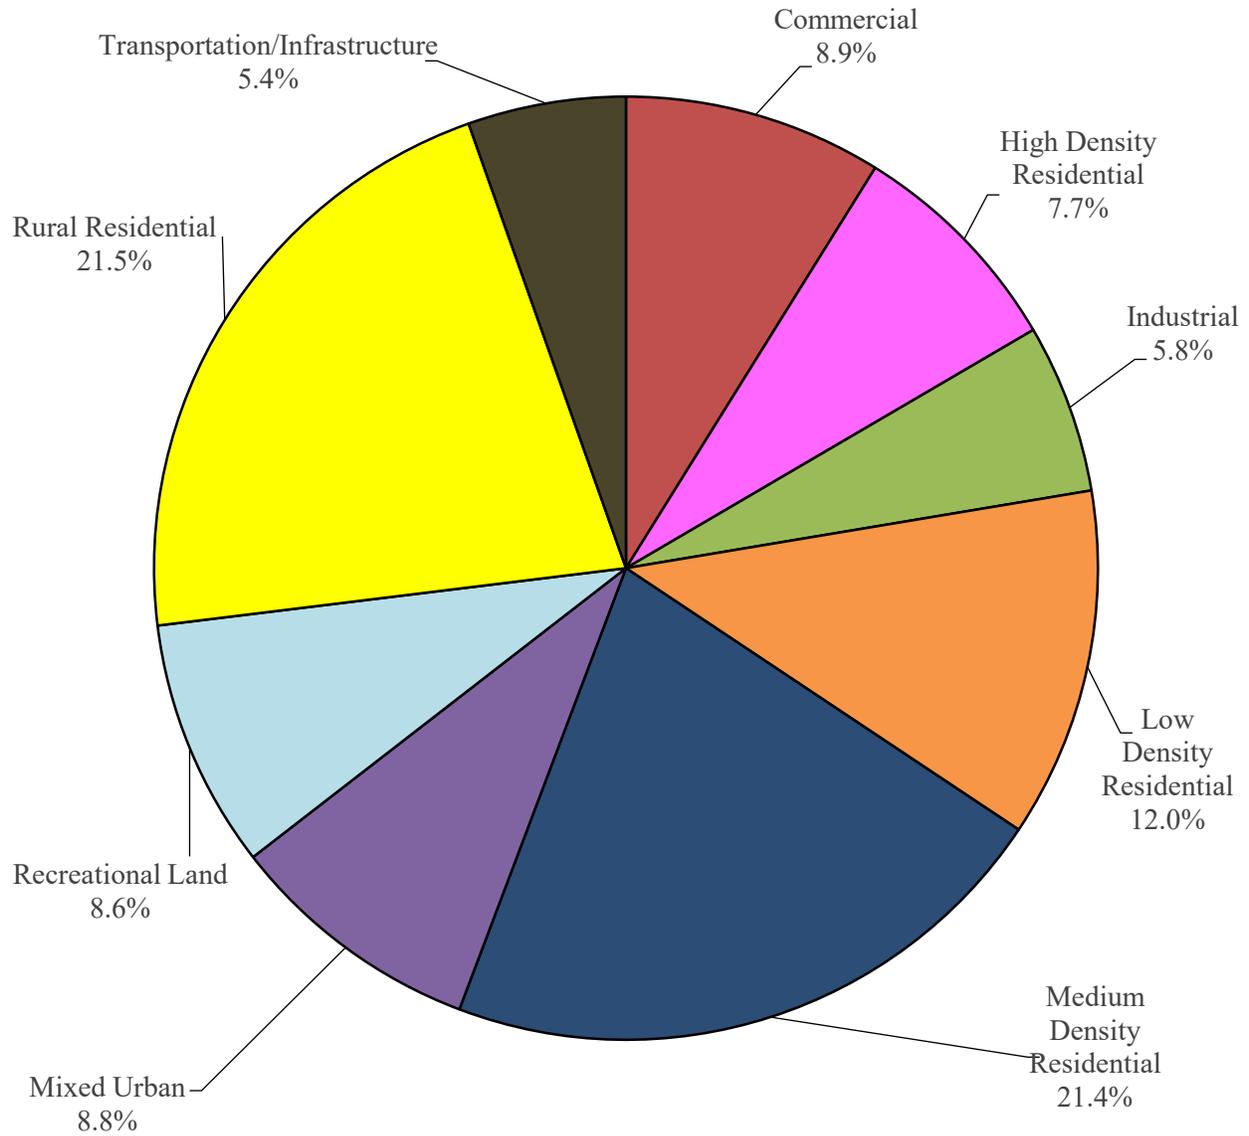
Figure 5: Urban Land Uses (by Percentage) — Franklin Township

Urban Land Use Label	Area (Acres)	Land Use %
Commercial	1,176	8.9%
High Density Residential	1,024	7.7%
Industrial	769	5.8%
Low Density Residential	1,592	12.0%
Medium Density Residential	2,839	21.4%
Mixed Urban	1,162	8.8%
Recreational Land	1,135	8.6%
Rural Residential	2,857	21.5%
Transportation/Infrastructure	718	5.4%

Franklin Township is located in Somerset County, New Jersey and covers approximately 46.9 square miles. Figures 3 and 4 illustrate that Franklin Township is dominated by urban land uses. A total of 44.2% (13,272 acres) of the municipality's land use is classified as urban. This is a 0.8% increase from the 2015 ICA. Of the urban land in Franklin Township, rural residential is the dominant land use (Figure 5).

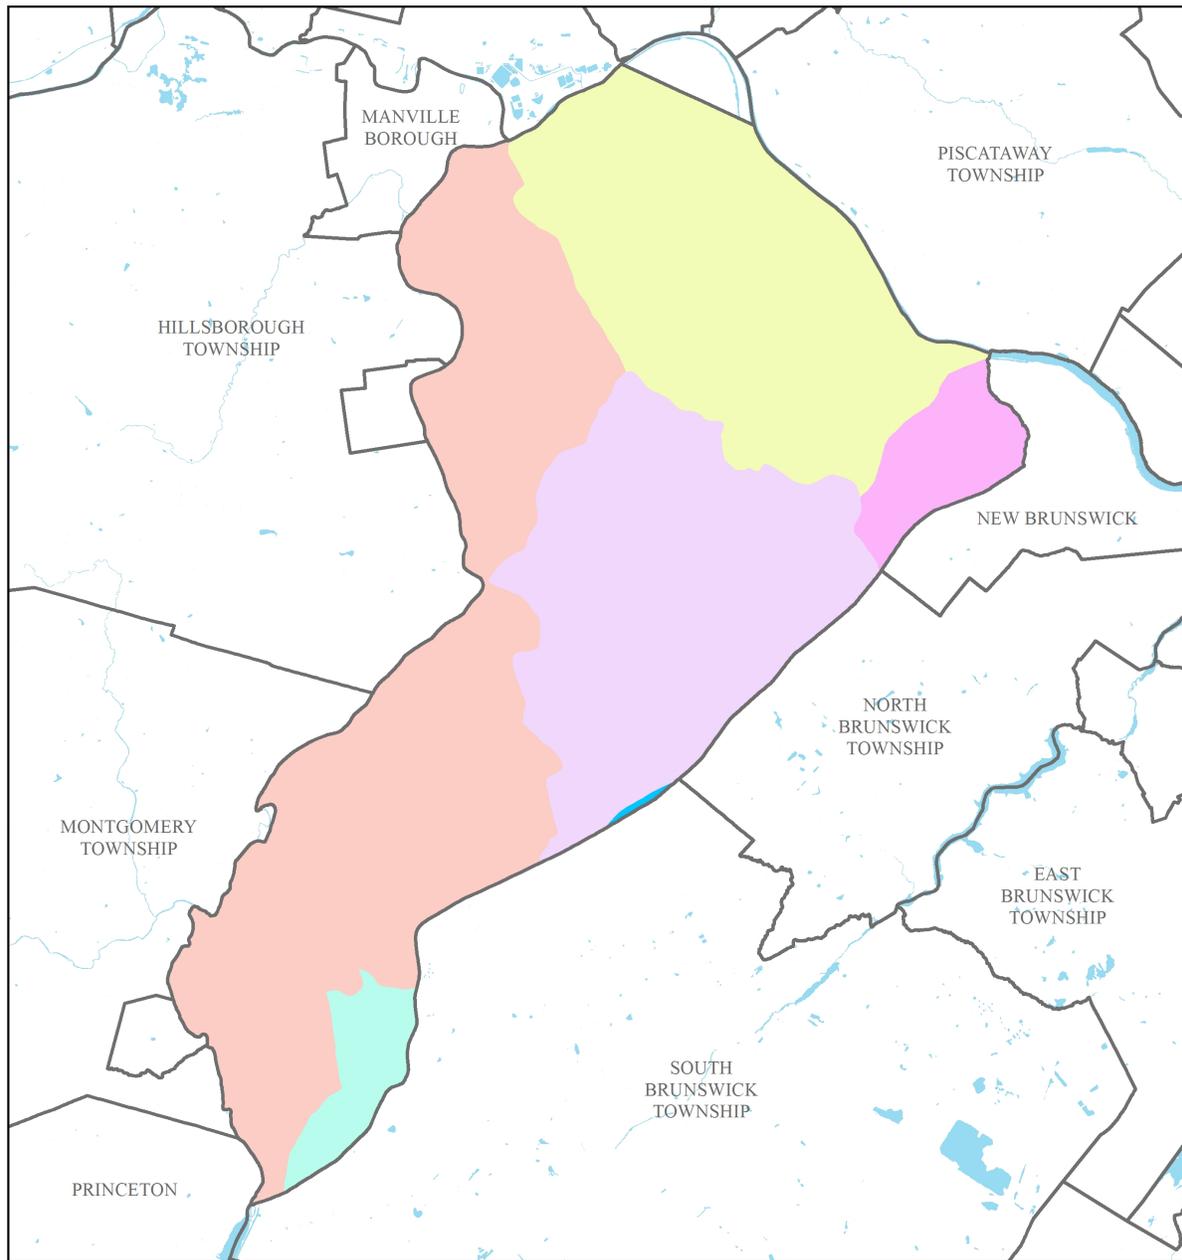
Figure 7: Subwatersheds — Franklin Township

- Heathcote Brook
- Millstone River
- Raritan River (Lower)
- Six-Mile Run
- Mile Run
- Oakeys Brook
- Royce Brook

Water resources are typically managed on a watershed/subwatershed basis; therefore, an impervious cover analysis was performed for each subwatershed within Franklin Township (Table 1 and Figure 7). On a subwatershed basis, impervious cover ranges from 0.0% in the Royce Brook subwatershed to 66.5% in the Oakeys Brook subwatershed. Evaluating impervious cover on a subwatershed basis allows the municipality to focus impervious cover reduction or disconnection efforts in the subwatersheds closer to where frequent flooding occurs.

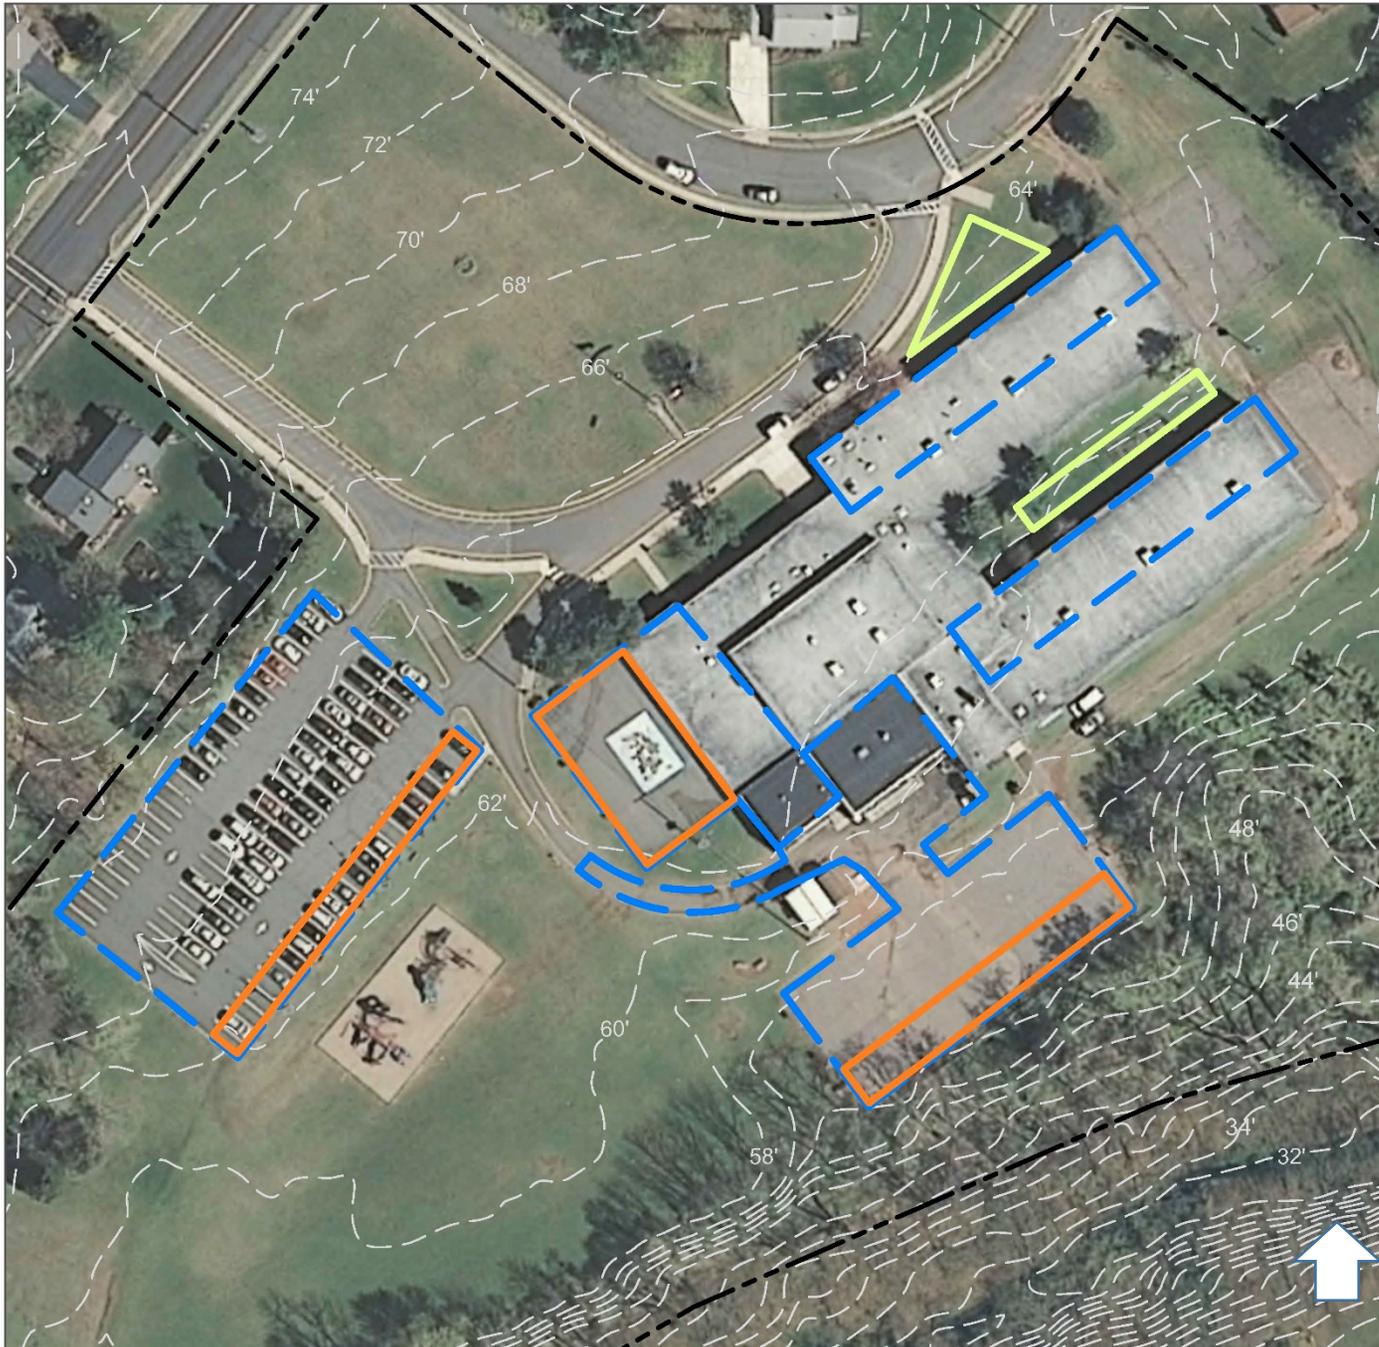
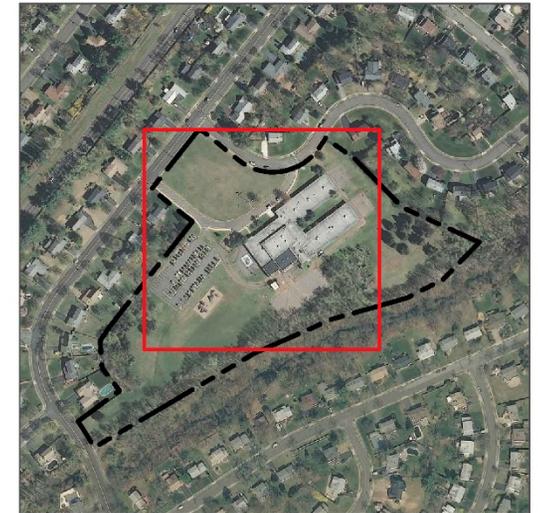
Conerly Road School

Rain gardens can be installed to capture, treat, and infiltrate roof runoff by disconnecting and redirecting nearby downspouts. These rain gardens can serve as an educational tool for students to learn about stormwater management using green infrastructure. The two play areas at the back of the school are suitable for replacement with porous asphalt. In addition, parking spaces can also be replaced with pervious pavement to capture and infiltrate stormwater.

Impervious Cover		Existing Loads from Impervious Cover (lbs/yr)			Runoff Volume from Impervious Cover (Mgal)	
%	sq. ft.	TP	TN	TSS	For the 1.25" Water Quality Storm	For an Annual Rainfall of 44"
32	173,800	8.4	87.8	798.0	0.135	4.77

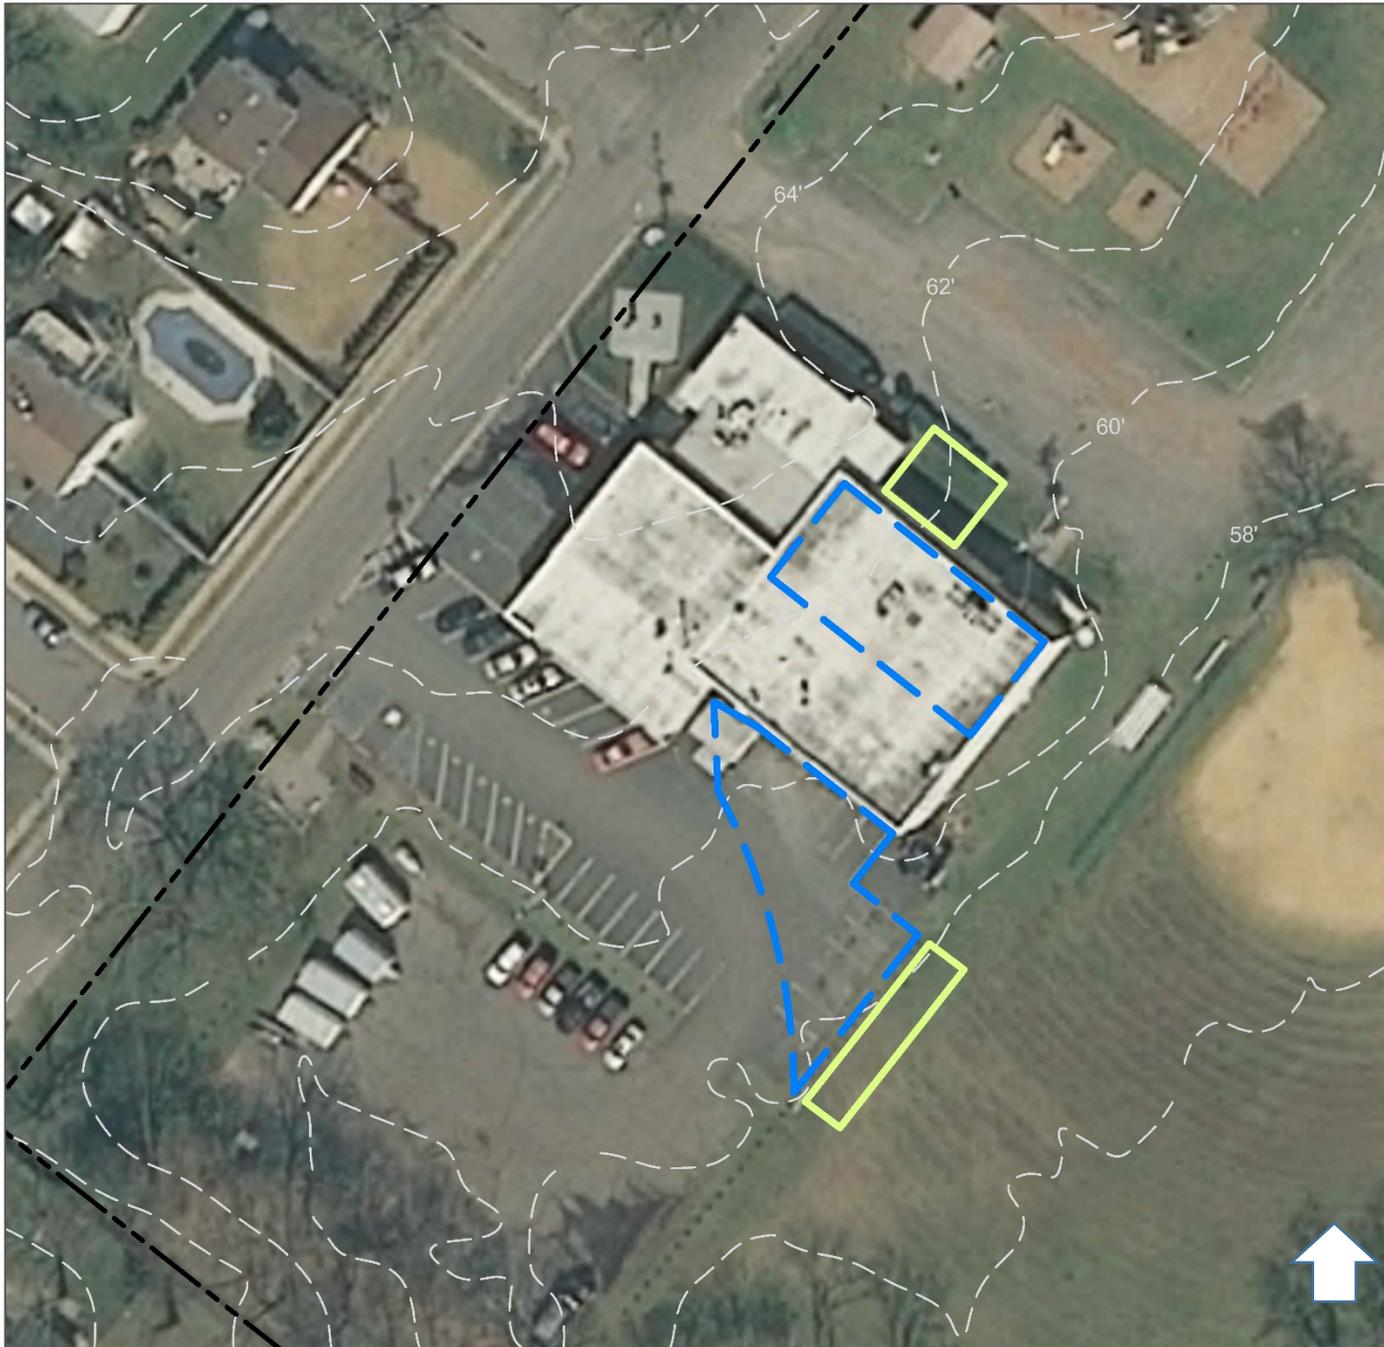
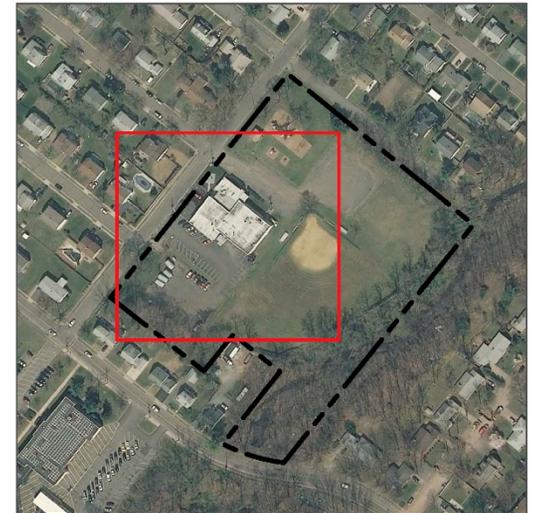
East Franklin Firehouse Company

A rain garden can be installed in the turfgrass area to the south of the parking area to capture, treat, and infiltrate stormwater runoff from a portion of the parking lot. Another rain garden can also be installed to capture rooftop runoff from the downspouts on the building.

Impervious Cover		Existing Loads from Impervious Cover (lbs/yr)			Runoff Volume from Impervious Cover (Mgal)	
%	sq. ft.	TP	TN	TSS	For the 1.25" Water Quality Storm	For an Annual Rainfall of 44"
35	101,840	4.9	51.4	467.6	0.079	2.79

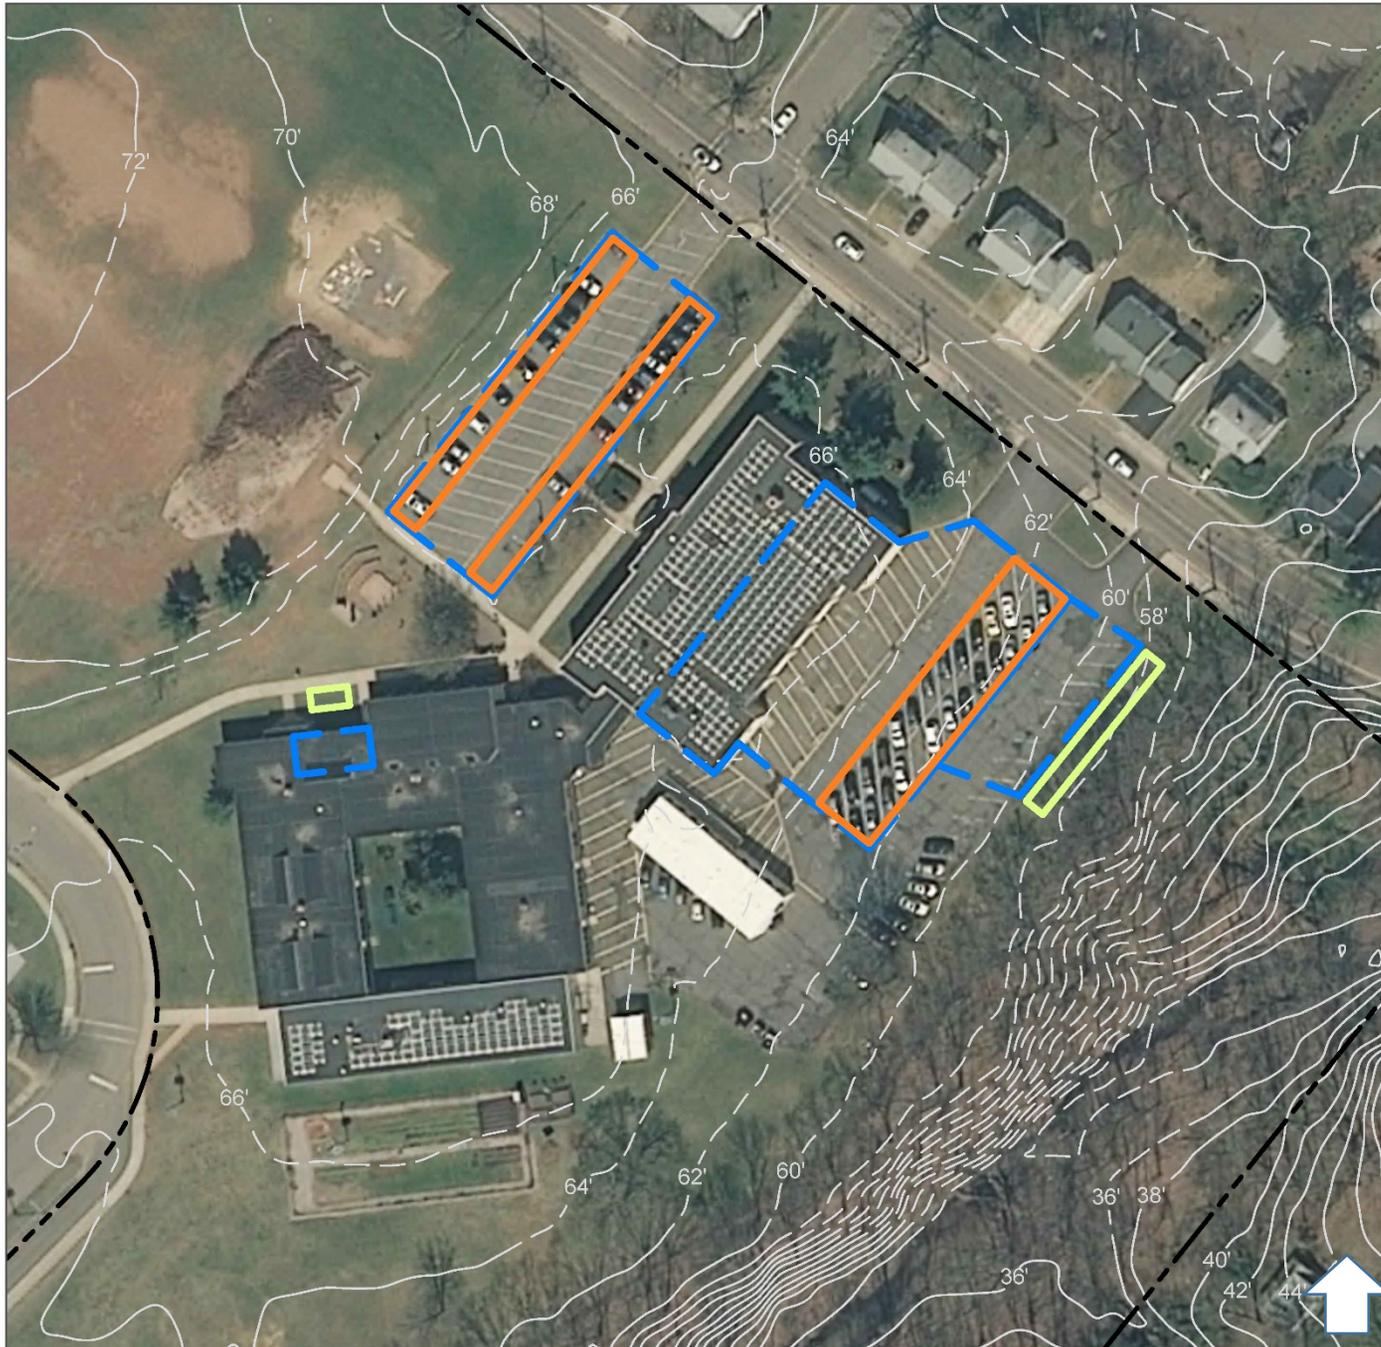
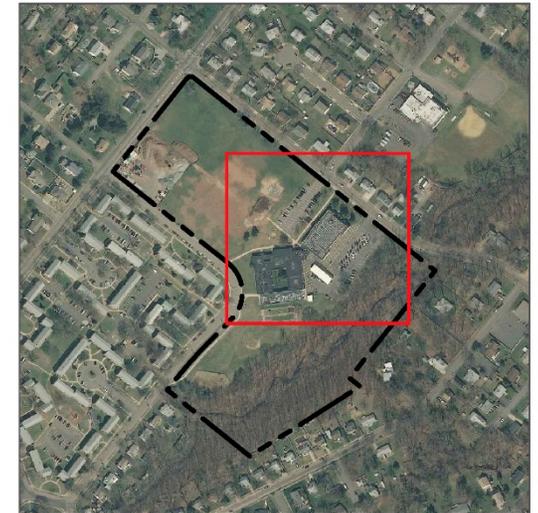
Pine Grove Manor School

Parking spaces can be replaced with pervious pavement to capture and infiltrate stormwater. A rain garden can be installed in the turfgrass area adjacent to the parking lot to capture and infiltrate additional runoff from the parking lot. Another rain garden can be installed near the main entrance of the school to manage rooftop runoff from the building.

Impervious Cover		Existing Loads from Impervious Cover (lbs/yr)			Runoff Volume from Impervious Cover (Mgal)	
%	sq. ft.	TP	TN	TSS	For the 1.25" Water Quality Storm	For an Annual Rainfall of 44"
27	202,284	9.8	102.2	928.8	0.158	5.55
