**Impervious Cover Assessment
for
Frelinghuysen Township, Warren County, New Jersey**

*Prepared for Frelinghuysen Township by the
Rutgers Cooperative Extension Water Resources Program*

August 6, 2021

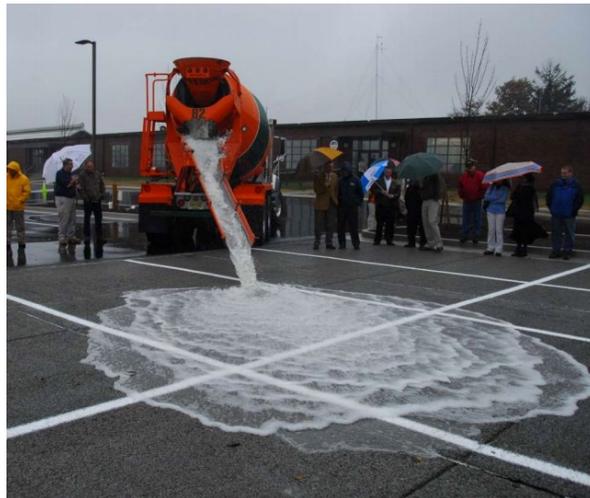
Figure 2: Rapid infiltration of water through porous pavement is demonstrated at the USEPA Edison New Jersey test site

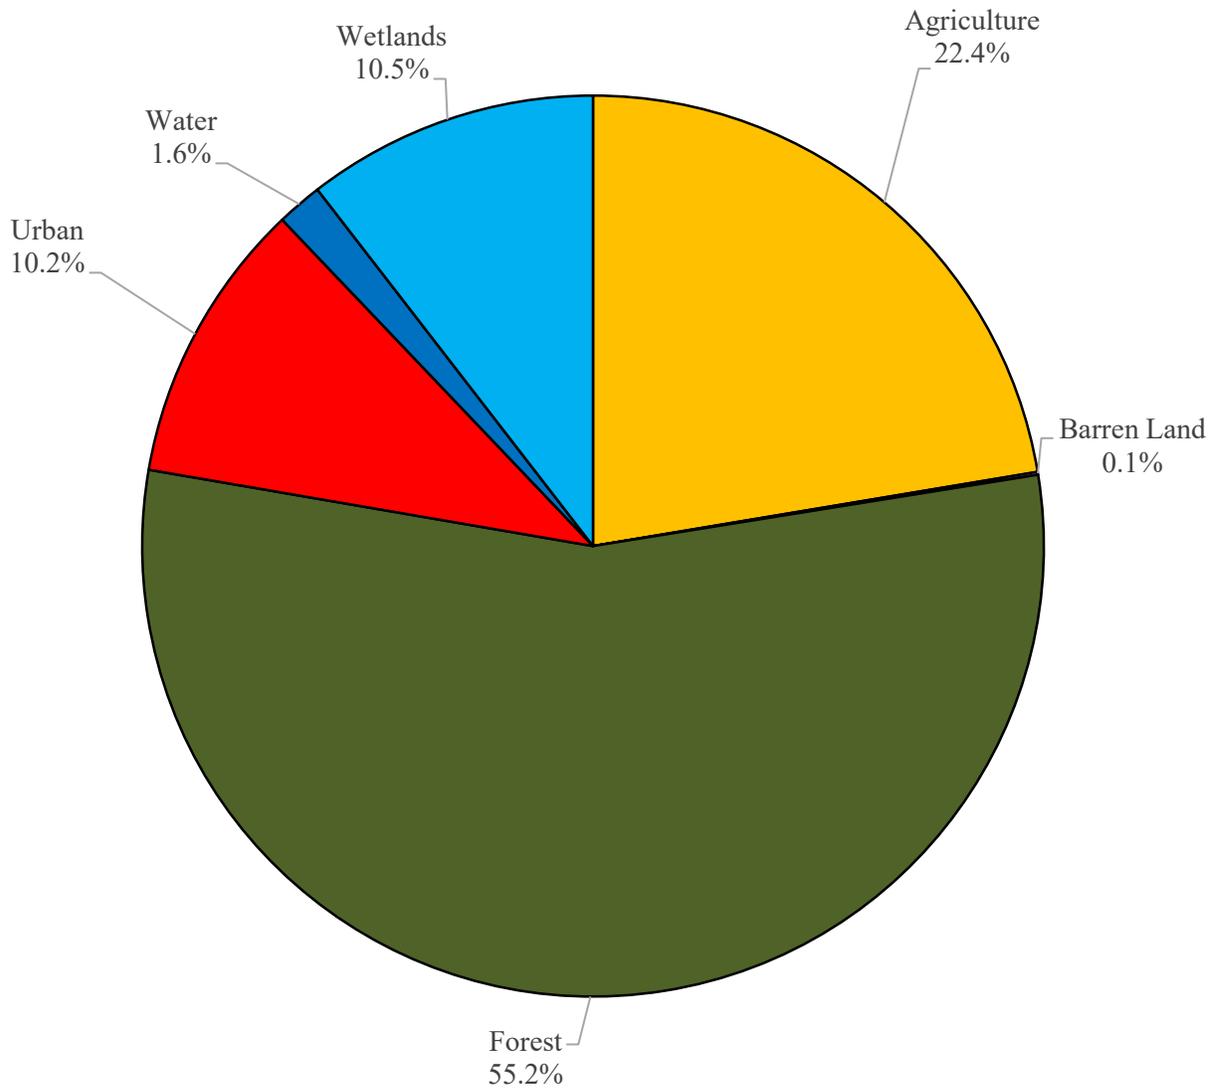
Figure 3: Pie chart illustrating the land use in Frelinghuysen Township

Frelinghuysen Township is located in Warren County, New Jersey and covers approximately 23.48 square miles. Figures 3 and 4 illustrate that Frelinghuysen Township is dominated by forest land uses. A total of 10.2% of the municipality's land use is classified as urban. Of the urban land in Frelinghuysen Township, rural residential is the dominant land use (Figure 5).

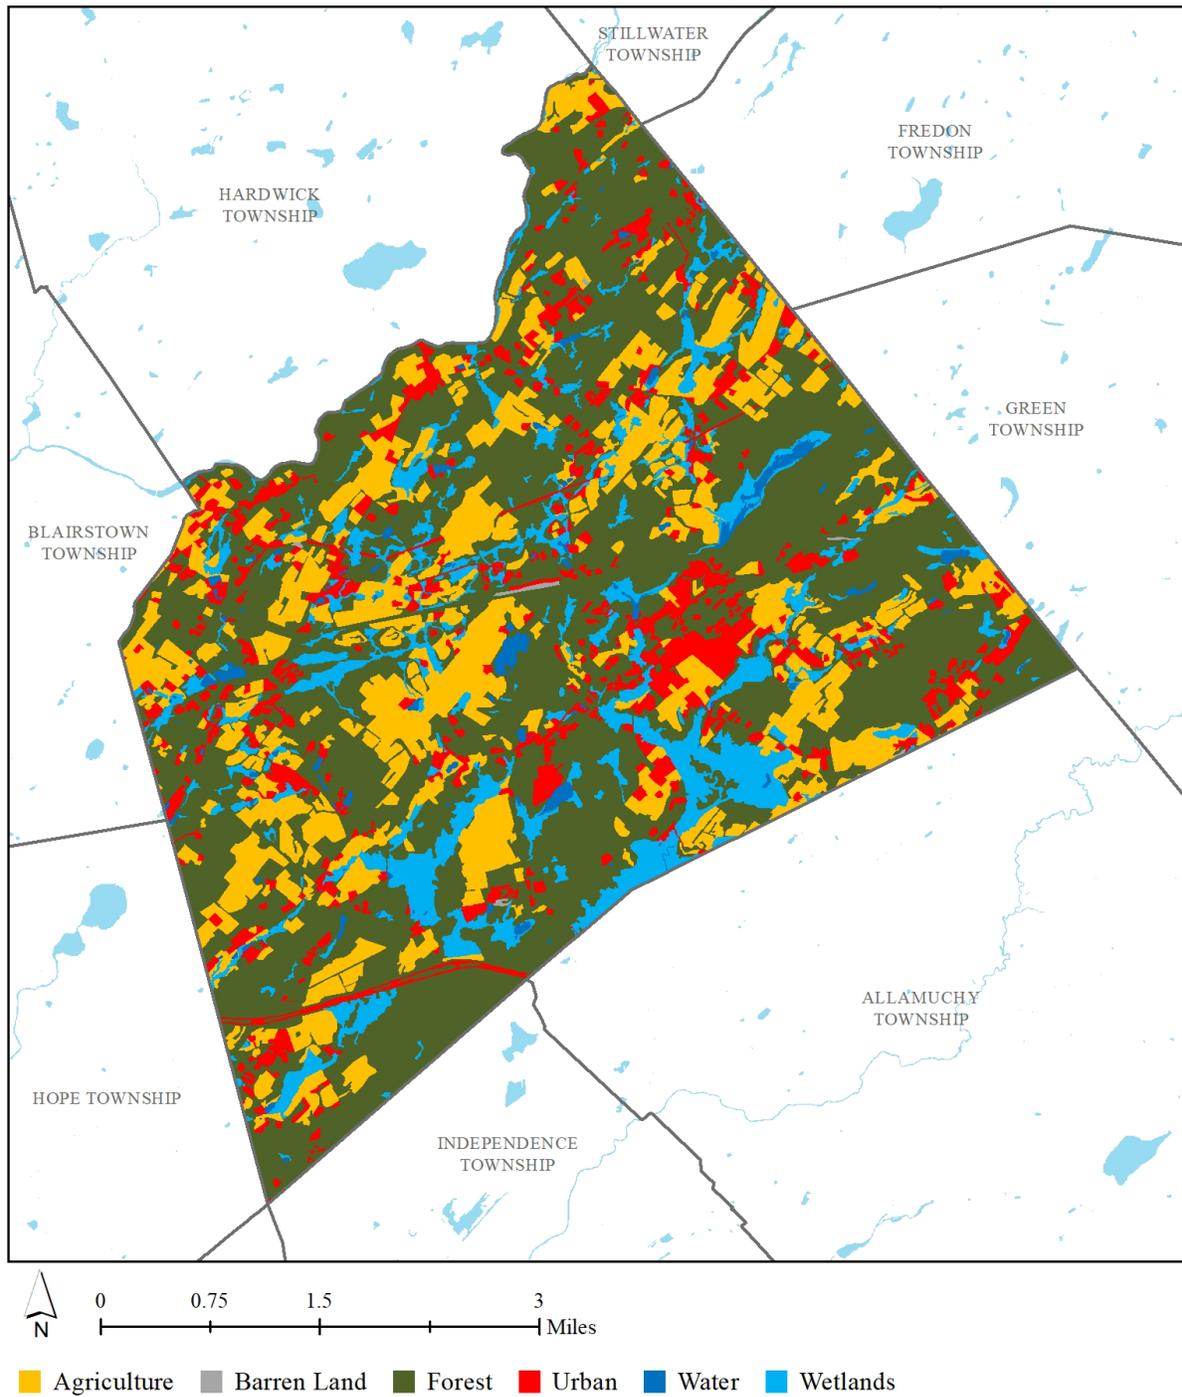
Figure 4: Map illustrating the land use in Frelinghuysen Township

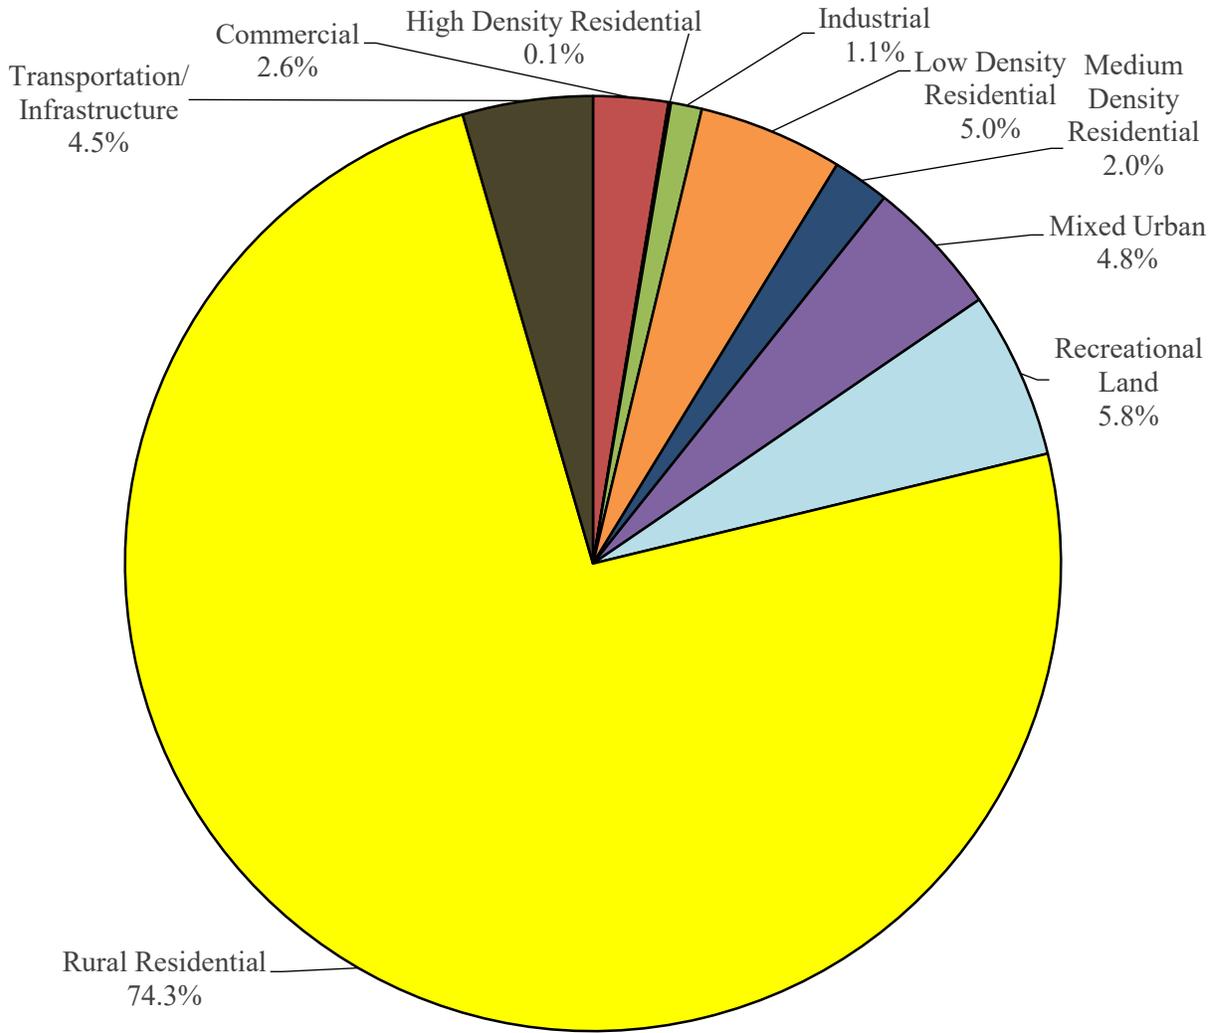
Figure 5: Pie chart illustrating the various types of urban land use in Frelinghuysen Township

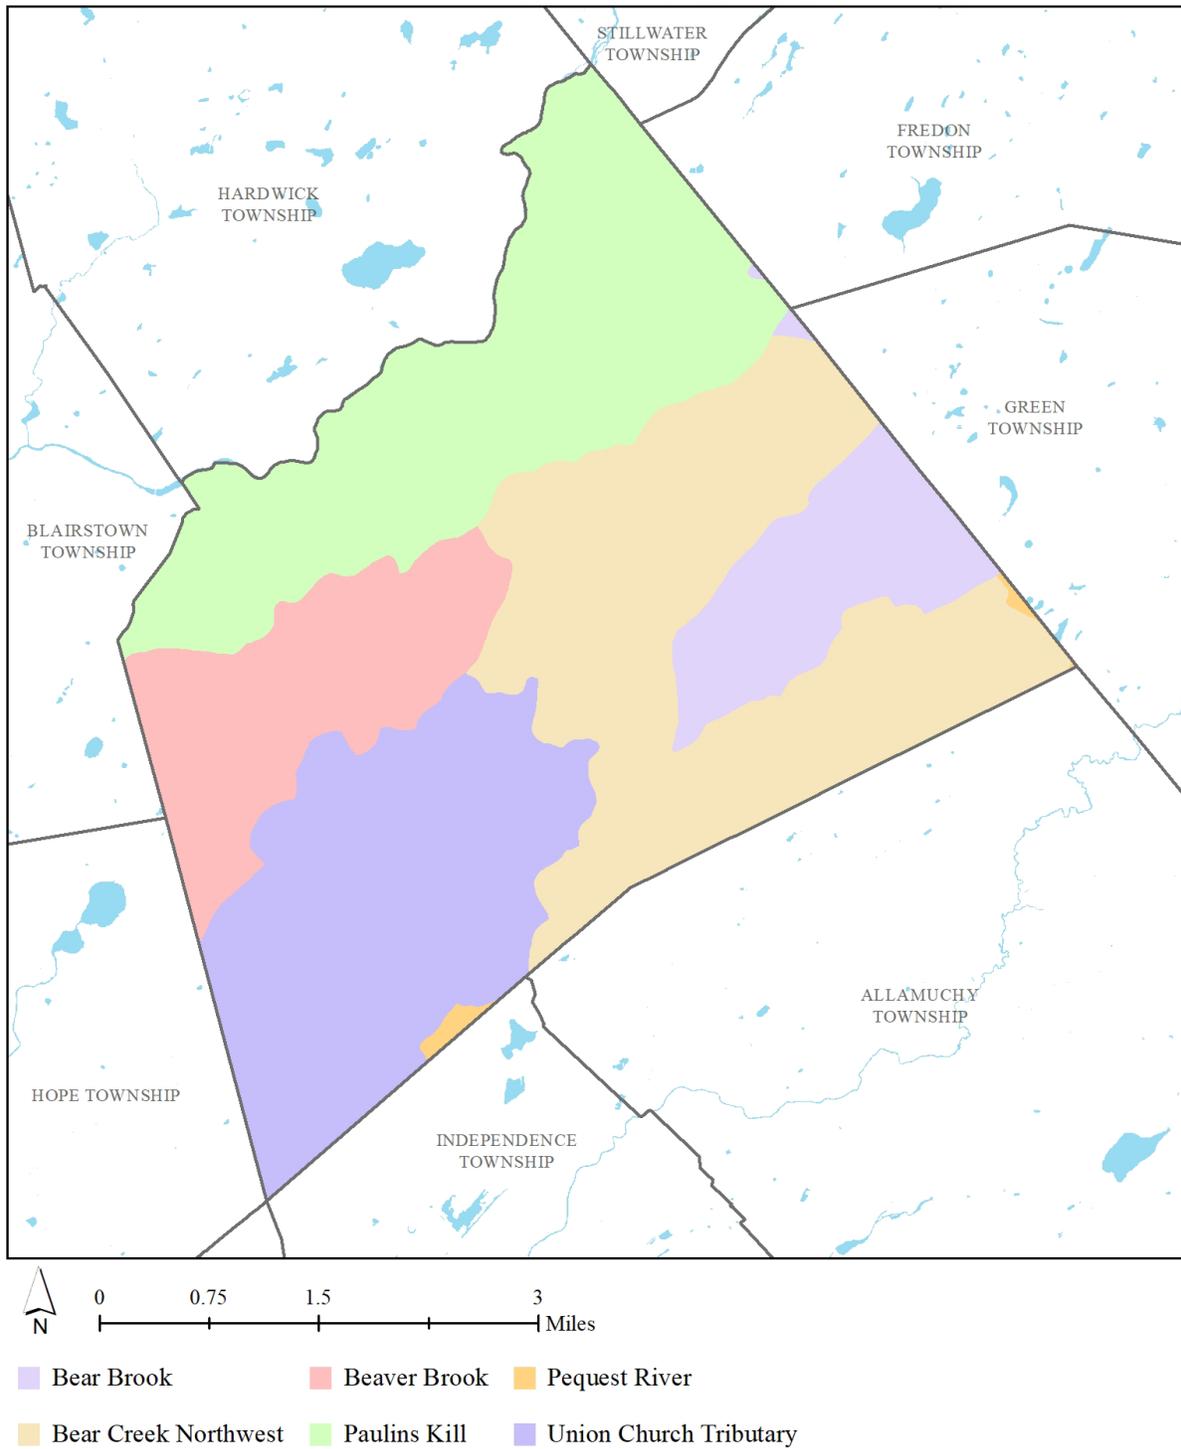
Figure 6: Map of the subwatersheds in Frelinghuysen Township

Water resources are typically managed on a watershed/subwatershed basis; therefore, an impervious cover analysis was performed for each subwatershed within Frelinghuysen Township (Table 1 and Figure 6). On a subwatershed basis, impervious cover ranges from 3.1% in the Pequest River subwatershed to 4.6% in the Beaver Brook subwatershed. Evaluating impervious cover on a subwatershed basis allows the municipality to focus impervious cover reduction or disconnection efforts in the subwatersheds where frequent flooding occurs.

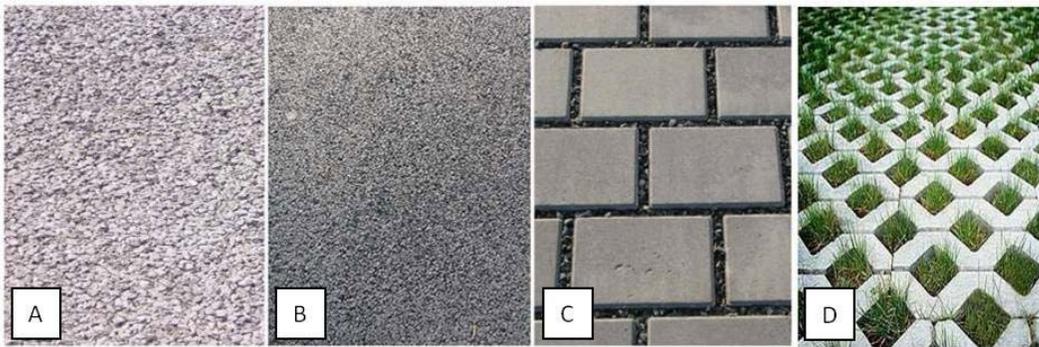
Permeable surfaces: (A) pervious concrete, (B) porous asphalt, (C) interlocking concrete pavers, (D) grid pavers (Rowe, 2012)

Pervious concrete and porous asphalt are the most common of the permeable surfaces. They are similar to regular concrete and asphalt but without the fine materials. This allows water to quickly pass through the material into an underlying layered system of stone that holds the water, allowing it to infiltrate into the underlying uncompacted soil.

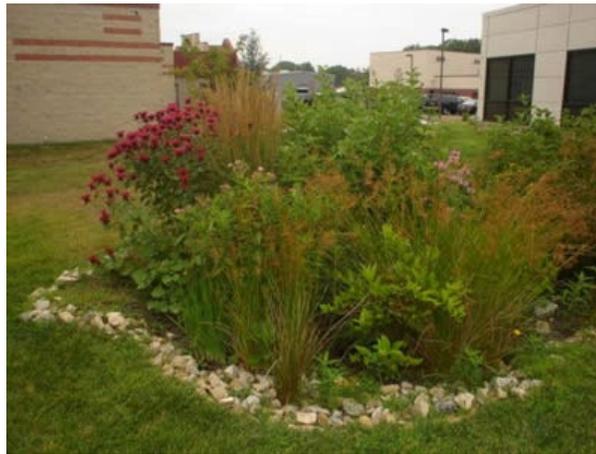
Figure 7: Rain garden outside the RCE of Gloucester County office which was designed to disconnect rooftop runoff from the local storm sewer system

- Rain Gardens: Stormwater can be diverted into shallow landscaped depressed areas (i.e., rain gardens) where the vegetation filters the water, and it is allowed to soak into the ground. Rain gardens, also known as bioretention systems, come in all shapes and sizes and can be designed to disconnect a variety of impervious surfaces (Figure 7).

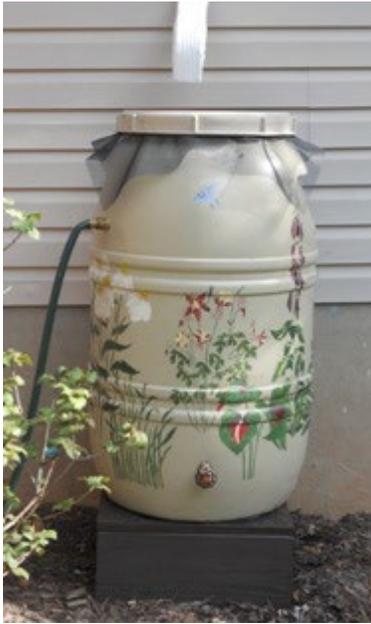
Figure 8a: Rain barrel used to disconnect a downspout with the overflow going to a flower bed

- Rainwater Harvesting: Rainwater harvesting includes the use of rain barrels and cisterns (Figures 8a and 8b). These can be placed below downspouts to collect rooftop runoff. The collected water has a variety of uses including watering plants and washing cars. This practice also helps cut down on the use of potable water for nondrinking purposes. It is important to divert the overflow from the rainwater harvesting system to a pervious area.

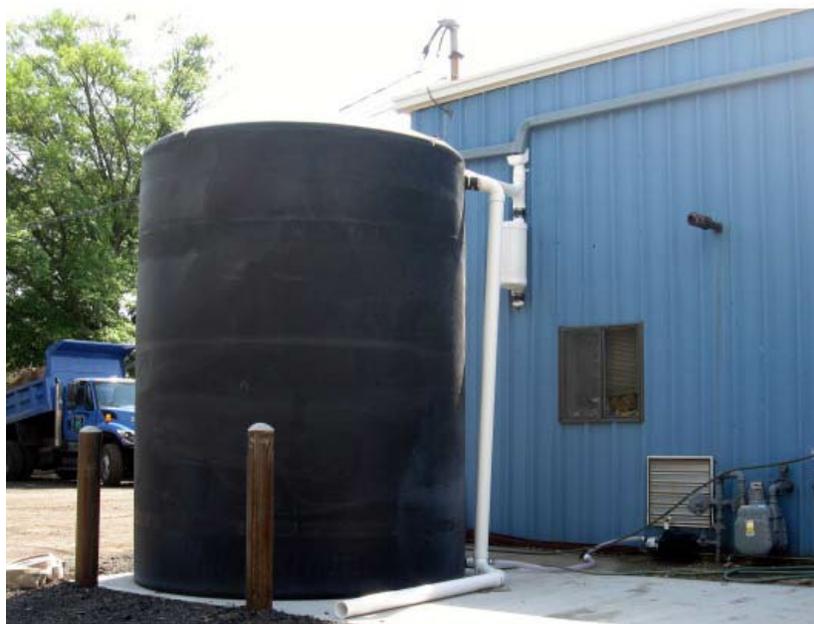
Figure 8b: A 5,000 gallon cistern used to disconnect the rooftop of the Department of Public Works in Clark Township to harvest rainwater for nonprofit car wash events

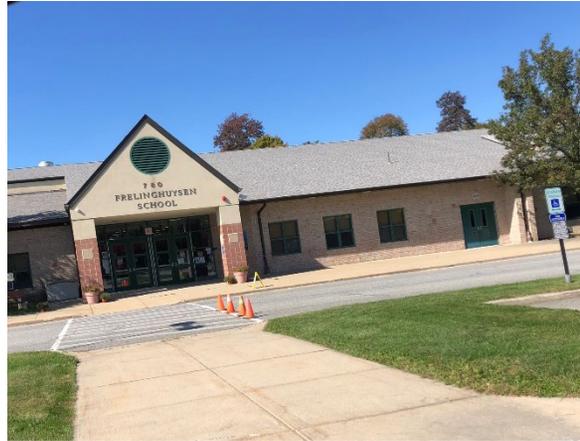
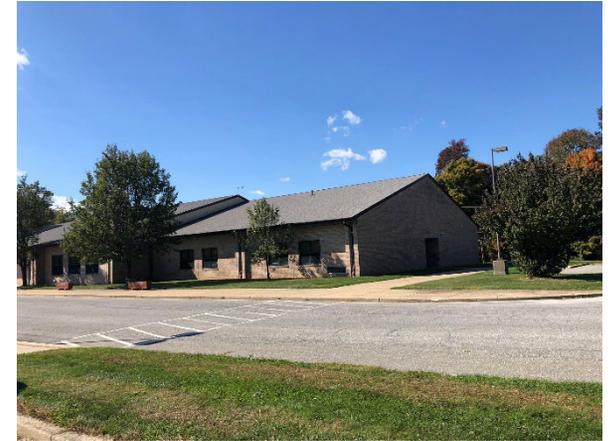
FRELINGHUYSEN ELEMENTARY SCHOOL

Downspout planter boxes can be installed to the right of the main entrance to capture and treat stormwater runoff from the rooftop using the existing downspouts. A bioretention system can be installed in the turfgrass area to the northwest of the building to capture, treat, and infiltrate the stormwater runoff from the rooftop.

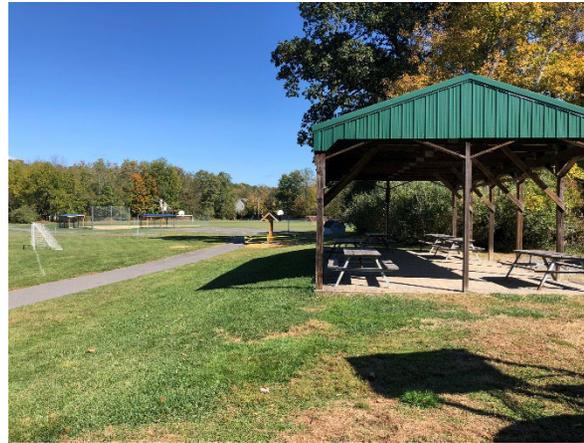
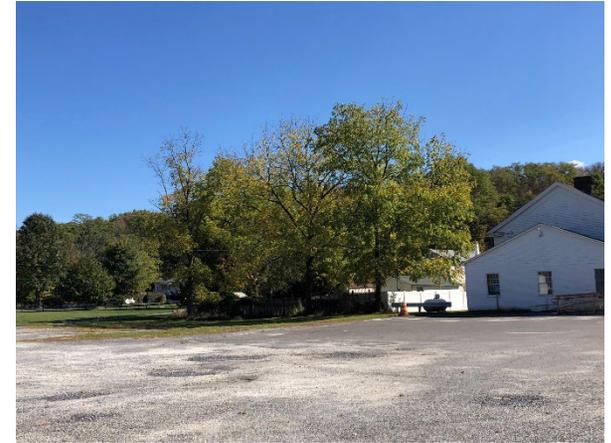
FRELINGHUYSEN TOWNSHIP MUNICIPAL BUILDING

Two bioretention systems can be installed on the property to capture, treat, and infiltrate the stormwater runoff from the parking lot and from the shade structure north of the parking lot. The parking area south of the building can be converted to pervious pavement to capture and infiltrate the stormwater runoff from the southern parking lot and a section of the roadway.

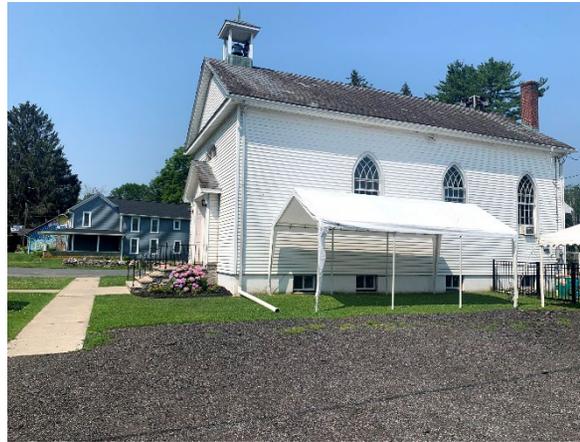
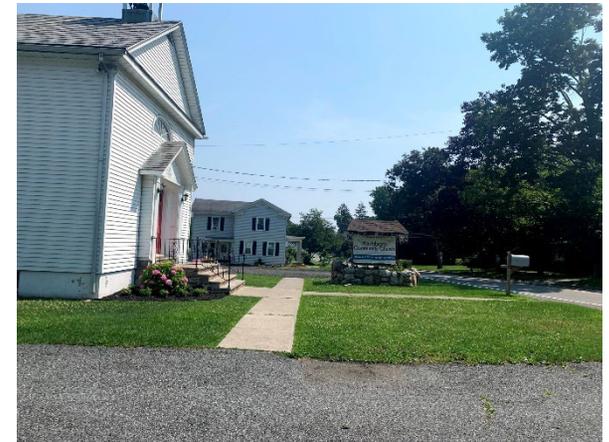
MARKSBORO COMMUNITY CHURCH

The building's front southern downspouts can have downspout planter boxes installed to capture and treat the stormwater runoff from the rooftop. A bioretention system can be installed in the turfgrass section to the south of the building to capture, treat, and infiltrate the stormwater runoff from the nearby roadway.
