**Impervious Cover Assessment
for
Stanhope Borough, Sussex County, New Jersey**

*Prepared for Stanhope Borough by the
Rutgers Cooperative Extension Water Resources Program*

August 5, 2021

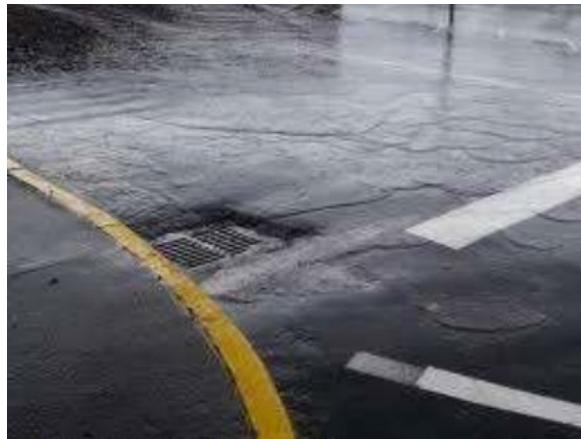
Figure 1: Stormwater draining from a parking lot

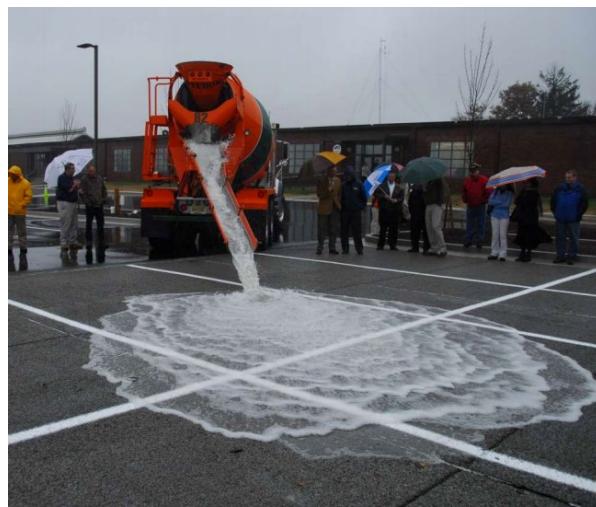
Figure 2: Rapid infiltration of water through porous pavement is demonstrated at the USEPA Edison New Jersey test site

1. ***Eliminate surfaces that are not necessary.*** For example, a paved courtyard at a public school could be converted to a grassed area.
2. ***Reduce or convert impervious surfaces.*** There may be surfaces that are required to be hardened, such as roadways or parking lots, but could be made smaller while maintaining functionality. A parking lot that has two-way car ways could be converted to one-way car ways. Permeable paving materials such as porous asphalt, pervious concrete, or permeable paving stones can be substituted for impermeable paving materials (Figure 2).

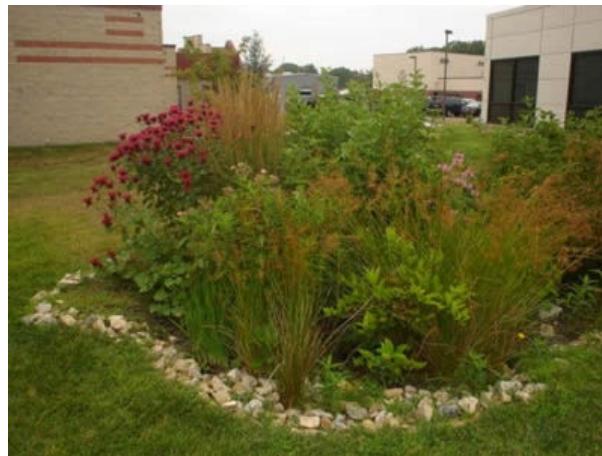
Figure 7: Rain garden outside the RCE of Gloucester County office which was designed to disconnect rooftop runoff from the local storm sewer system

- Rain Gardens: Stormwater can be diverted into shallow landscaped depressed areas (i.e., rain gardens) where the vegetation filters the water, and it is allowed to soak into the ground. Rain gardens, also known as bioretention systems, come in all shapes, sizes, and scales and can be designed to disconnect a variety of impervious surfaces (Figure 7).

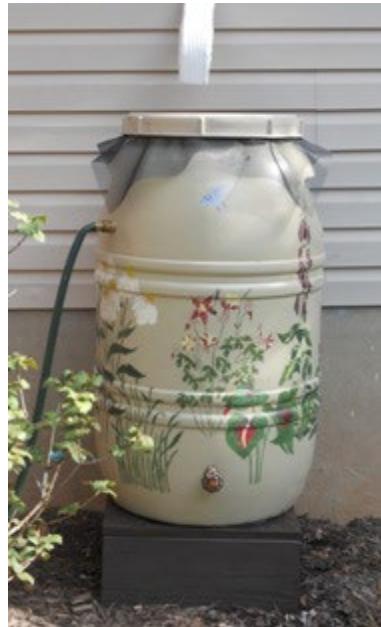
Figure 8a: Rain barrel used to disconnect a downspout with the overflow going to a flower bed

- Rainwater Harvesting: Rainwater harvesting includes the use of rain barrels and cisterns (Figures 8a and 8b). These can be installed below downspouts to collect rooftop runoff. The collected water has a variety of uses including watering plants and washing cars, ultimately reducing the use of potable water for non-drinking purposes. Rain barrels and cisterns must be designed with an overflow valve to allow excess water to be diverted to a nearby pervious area.

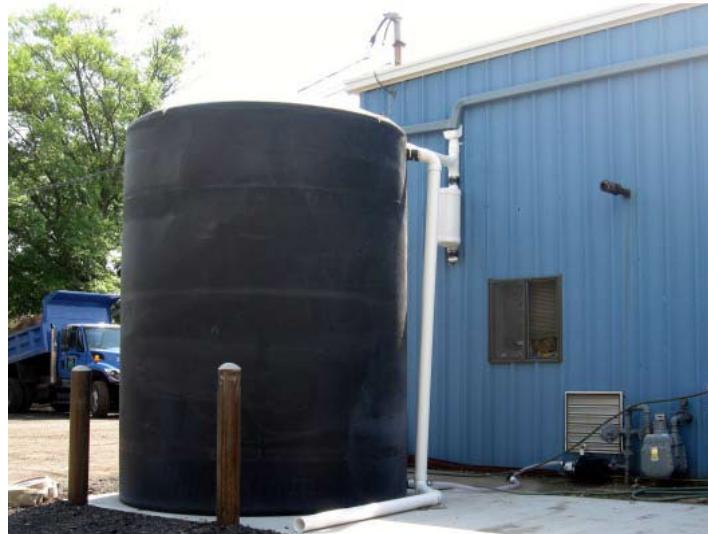
Figure 8b: A 5,000 gallon cistern used to disconnect the rooftop of the Department of Public Works in Clark Township to harvest rainwater for nonprofit car wash events

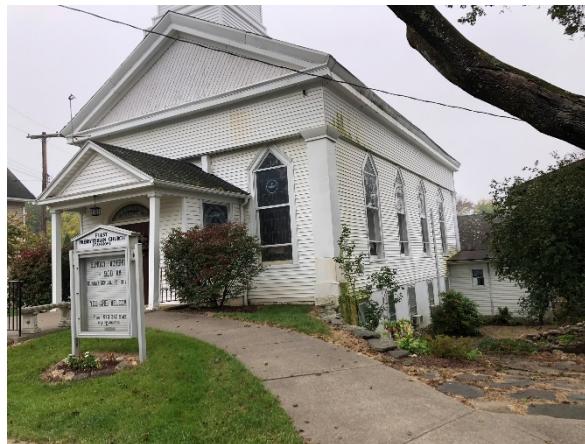
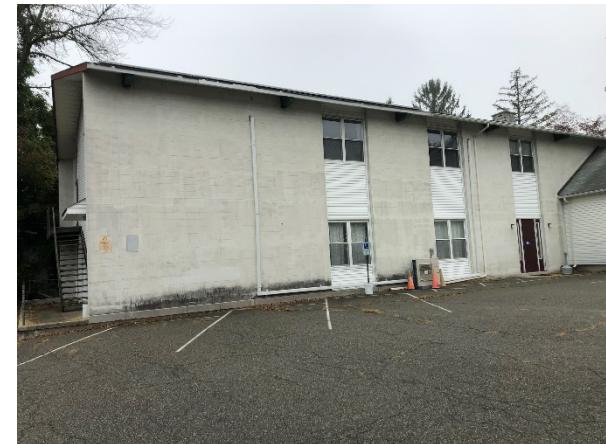
FIRST PRESBYTERIAN CHURCH

Parking spaces in the parking lot to the west of the building can be converted to porous pavement to capture and infiltrate stormwater runoff from the parking lot. A bioretention system can be installed southeast of the building to capture, treat, and infiltrate stormwater runoff from the roof.

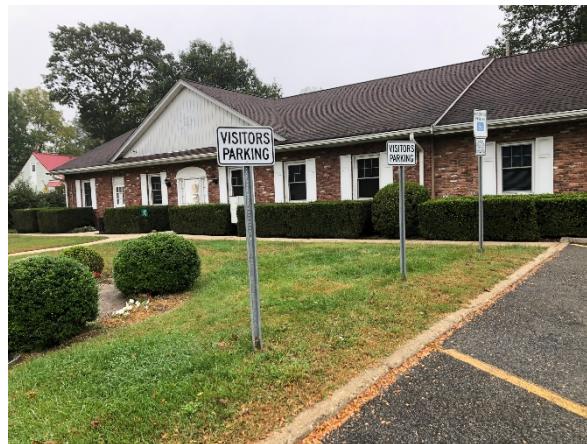
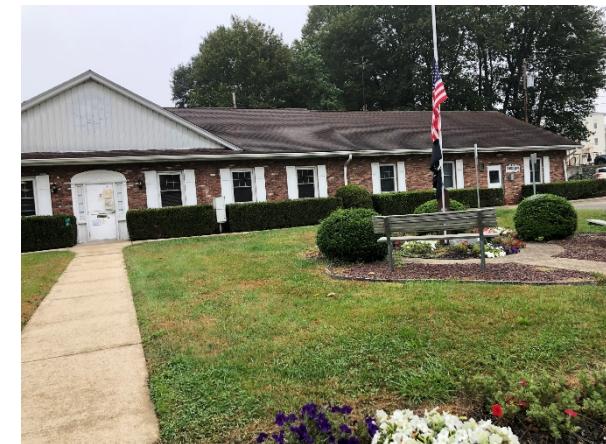
STANHOPE BOROUGH HALL

Parking spaces in the parking lot to the southwest of the building can be converted to porous pavement to capture and infiltrate stormwater runoff from the parking lot. Bioretention systems can be installed west of the building to capture, treat, and infiltrate stormwater runoff from the roof.

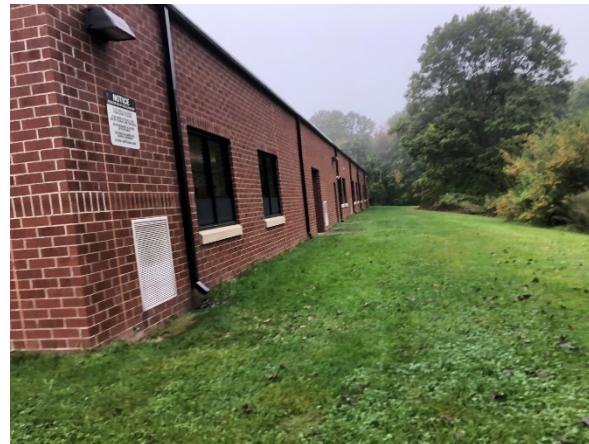
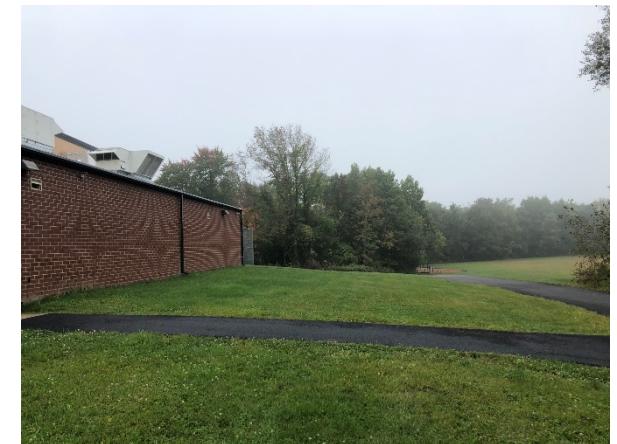
VALLEY ROAD SCHOOL

A bioretention system can be installed west of the building to capture, treat, and infiltrate stormwater runoff from the rooftop.
